# **Teck Highland Valley Copper Partnership**

**2019 Dam Safety Inspection Report**

***Bethlehem No.1 Tailings Storage Facility***

April 2020

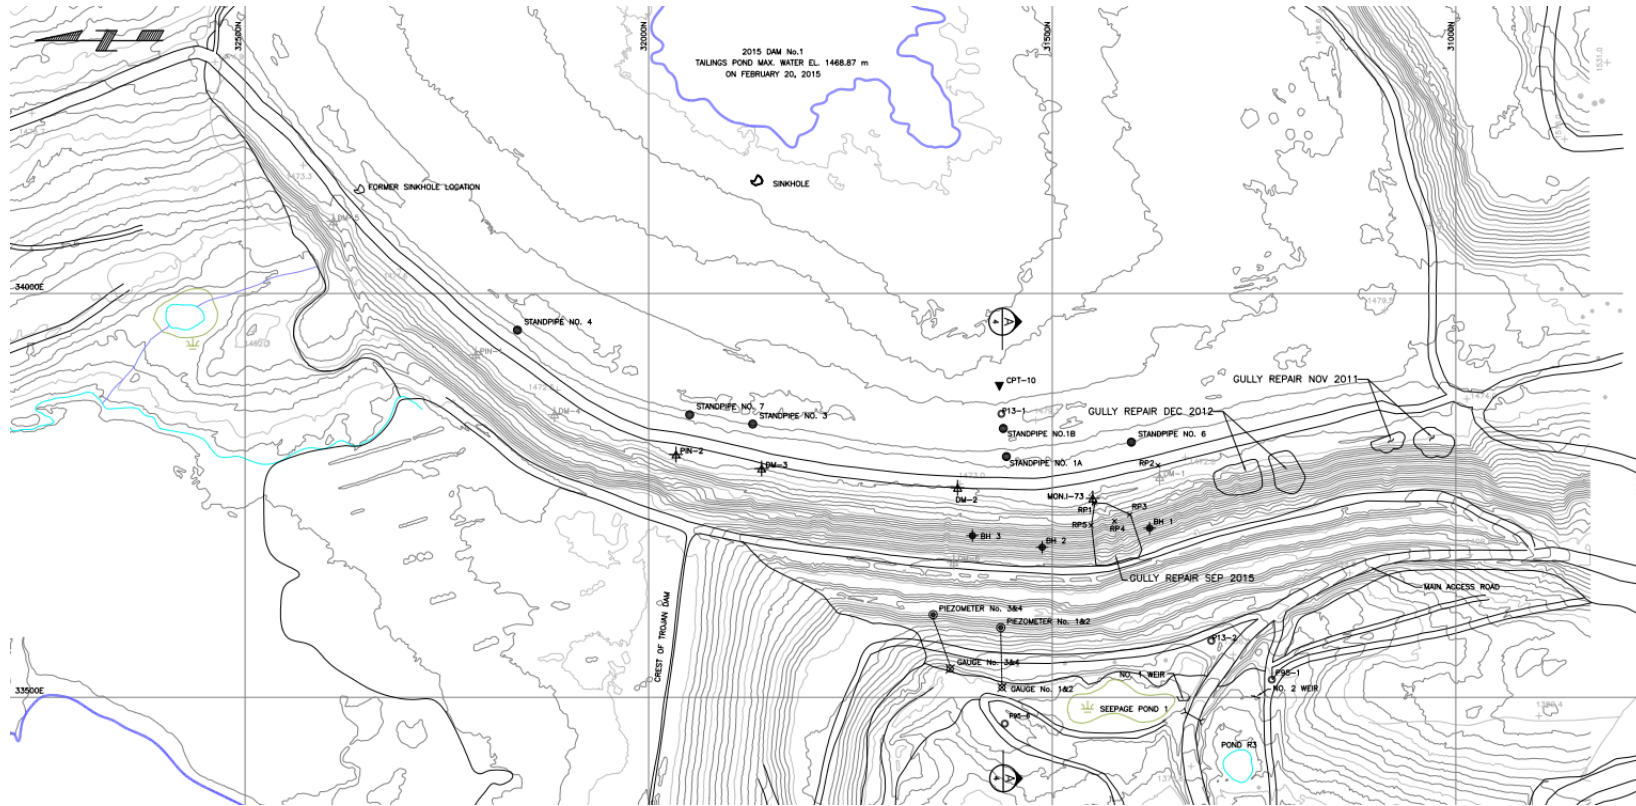
# SITE PLAN

- No significant visual change to sinkhole based on 2019 inspection and photos from recent DSIs. Feature is setback from the crest and present for an extended period. No indicators that is an issue of concern under existing condition but warrant ongoing visual observations.
- Cracking present along rockfill/downstream slope of Dam No.1. Known features; no significant change from previous DSIs; related to stability of shallow sloughing in rockfill and not overall structure.

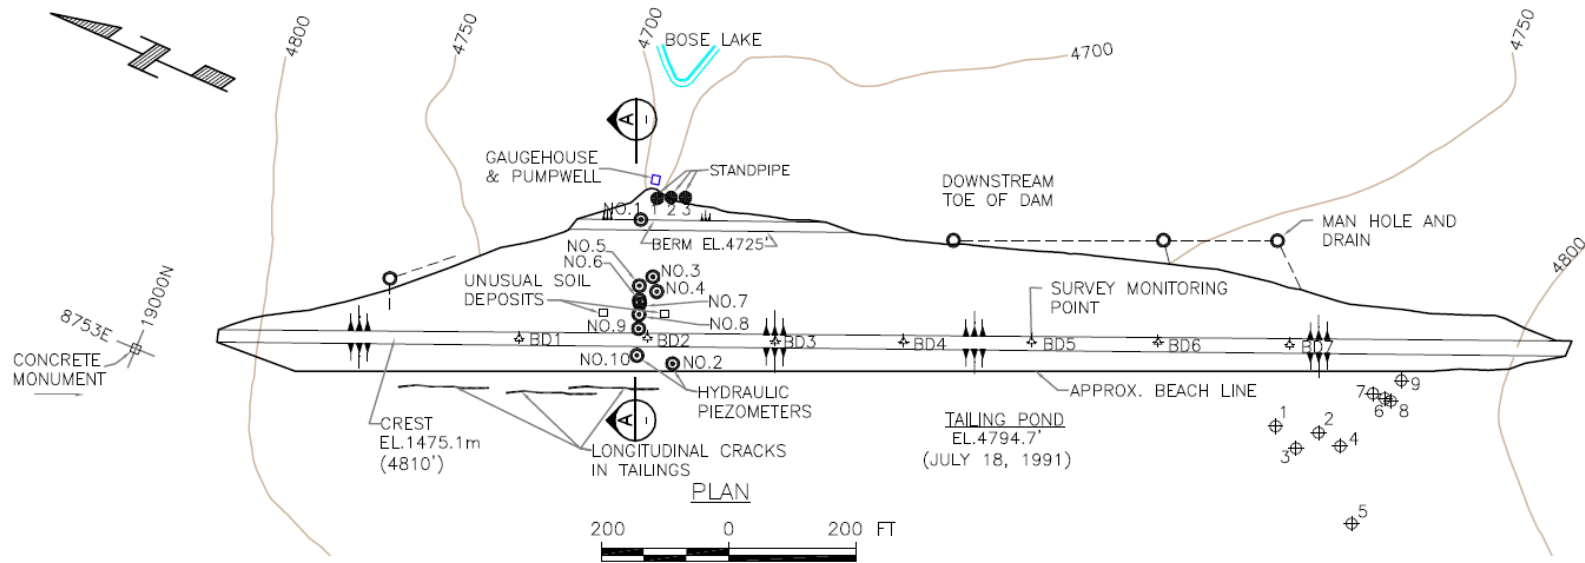
**SITE PLAN**

- Similar to the observation during the 2018 inspection, vegetation growth was observed at the upstream portion of the riprap lined channel section near the concrete sill. Vegetation should be monitored and removed as part of the routine maintenance.
- Bose Lake Dam sign by the road was knocked down.

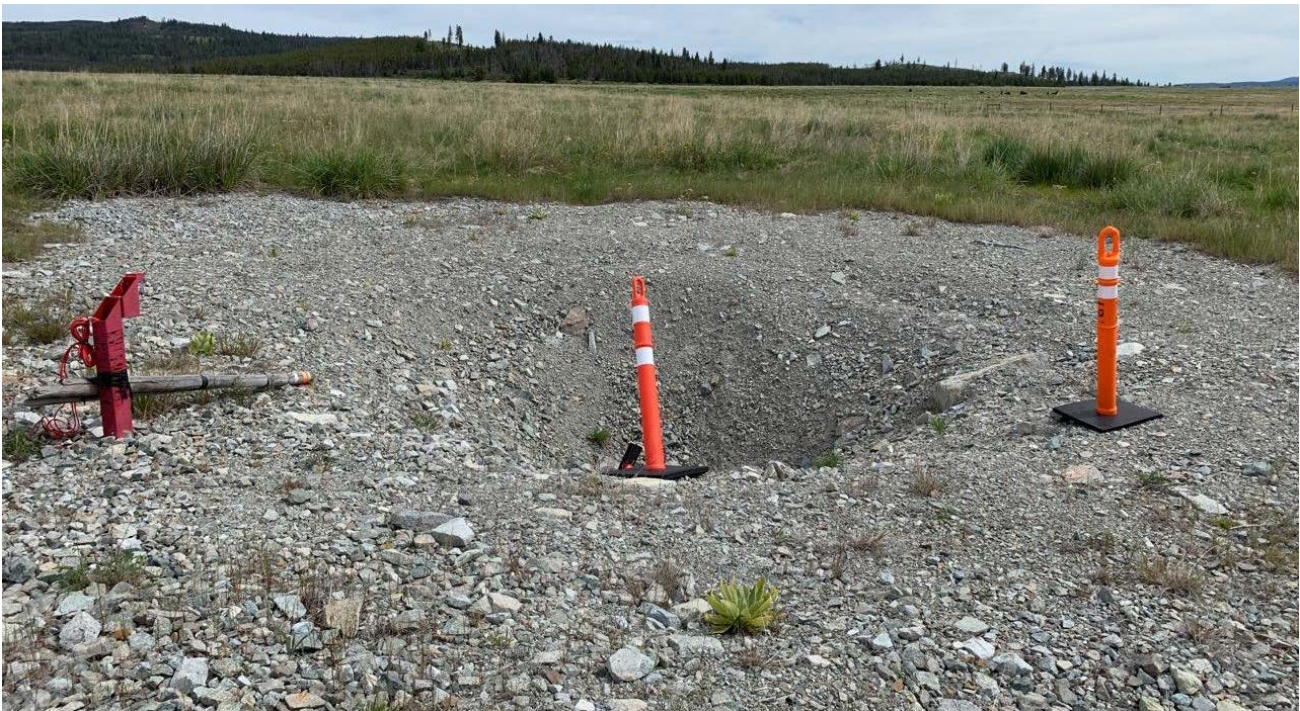
### Photo II-A-2 Bethlehem sinkhole on tailings beach, no visual change from 2018 DSI. (BTH-2019-02)

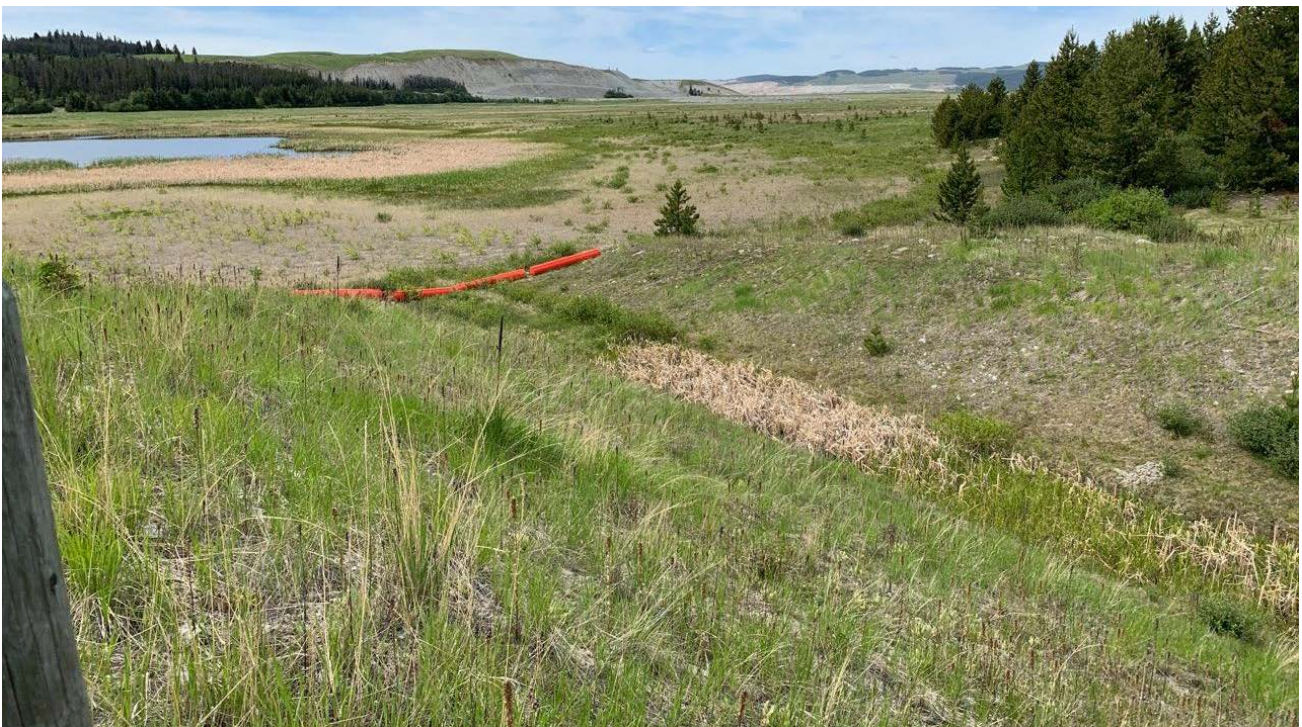
**Photo II-B-11 Spillway inlet and approach channel. Vegetation to be cleared from flow channel as part of routine maintenance including approach channel and initial segment of riprap channel (BTH-2019-11)**

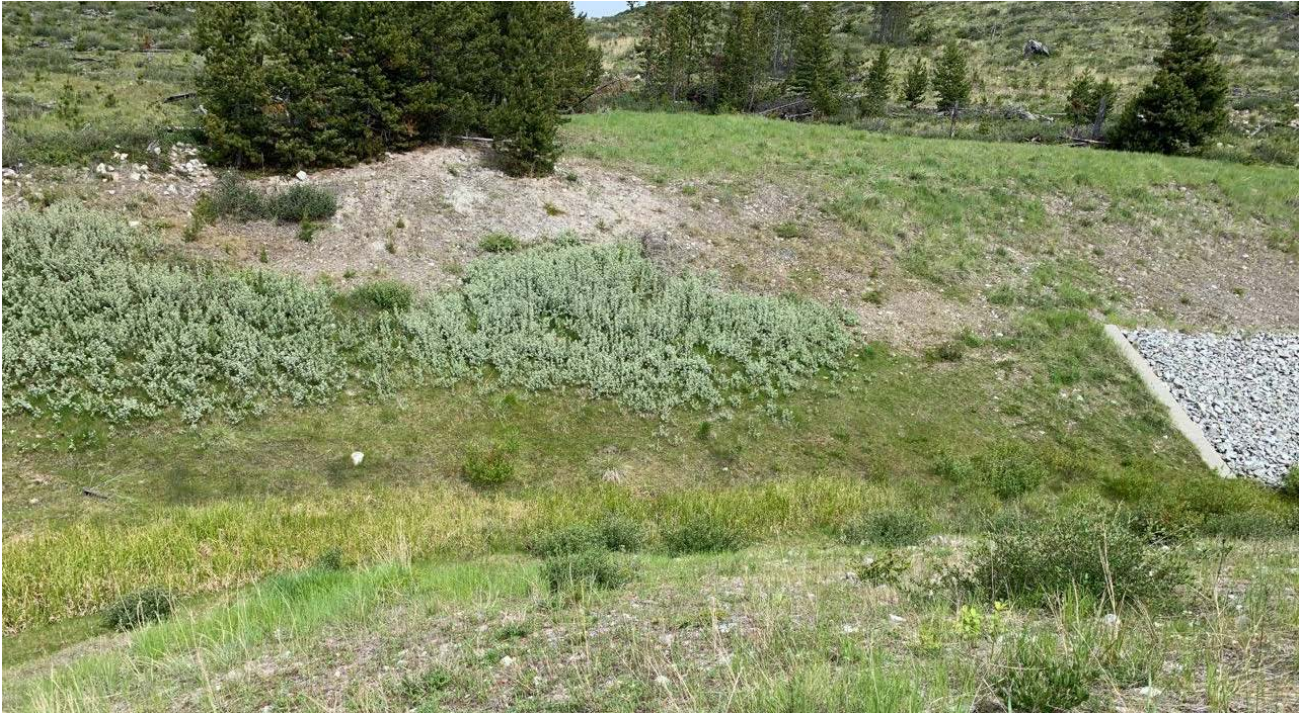
**Photo II-B-12 Spillway channel at transition point between inlet and riprap-lined segment, looking towards north. Vegetation to be cleared from flow channel as part of routine maintenance (BTH-2019-11)**

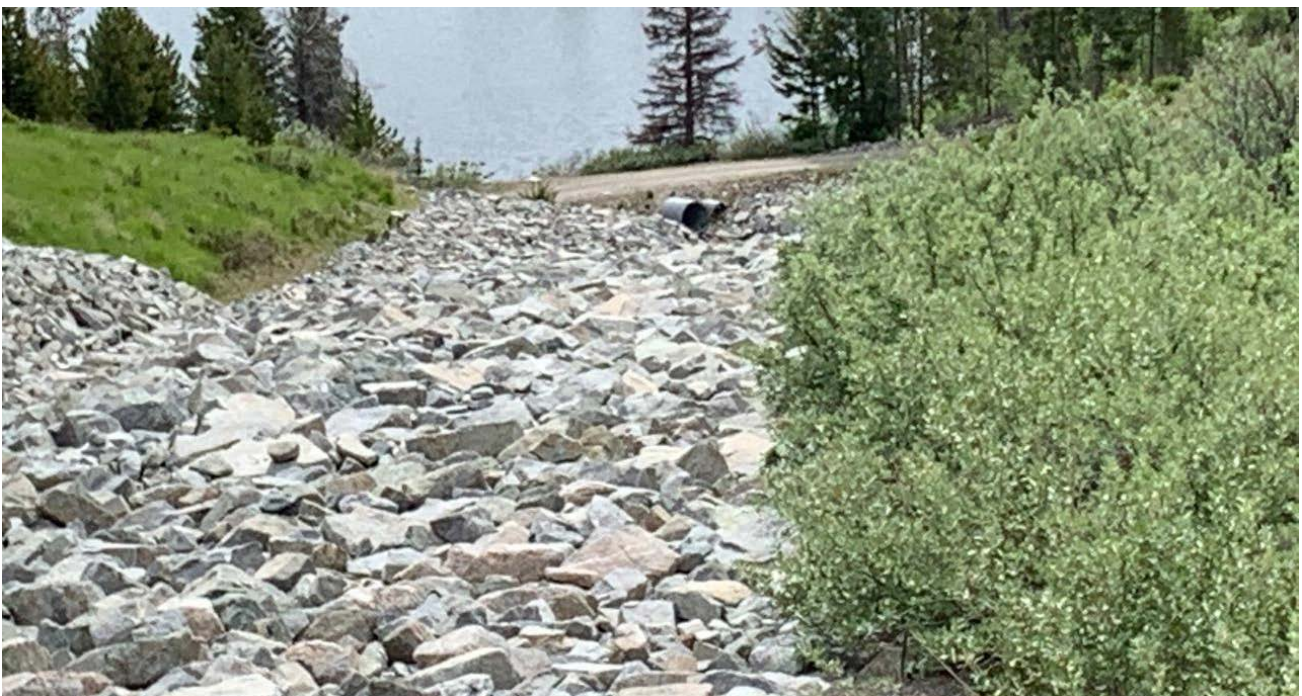
**Photo II-B-18 Spillway road culverts – not significantly obstructed (BTH-2019-14)**

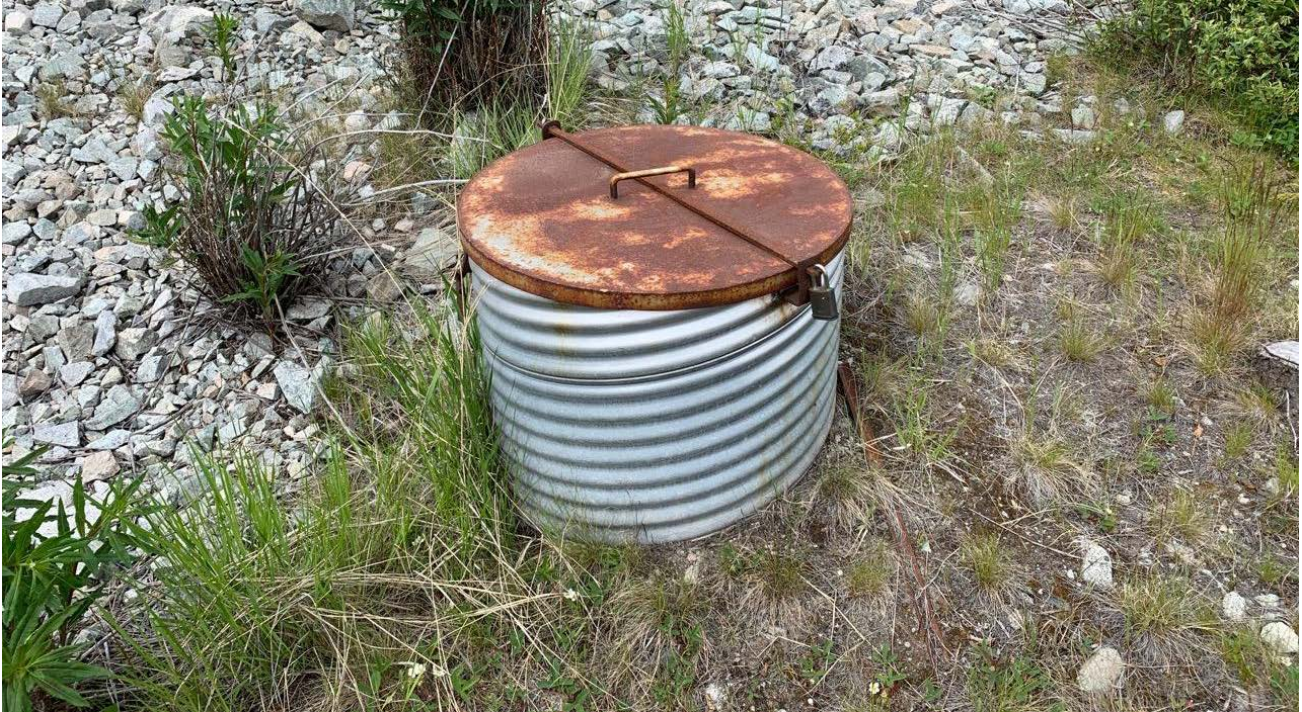
**Photo II-B-19 Seepage relief well at downstream toe, looking west (upstream) – Well was locked but low flow inside could be heard (BTH-2019-15)**

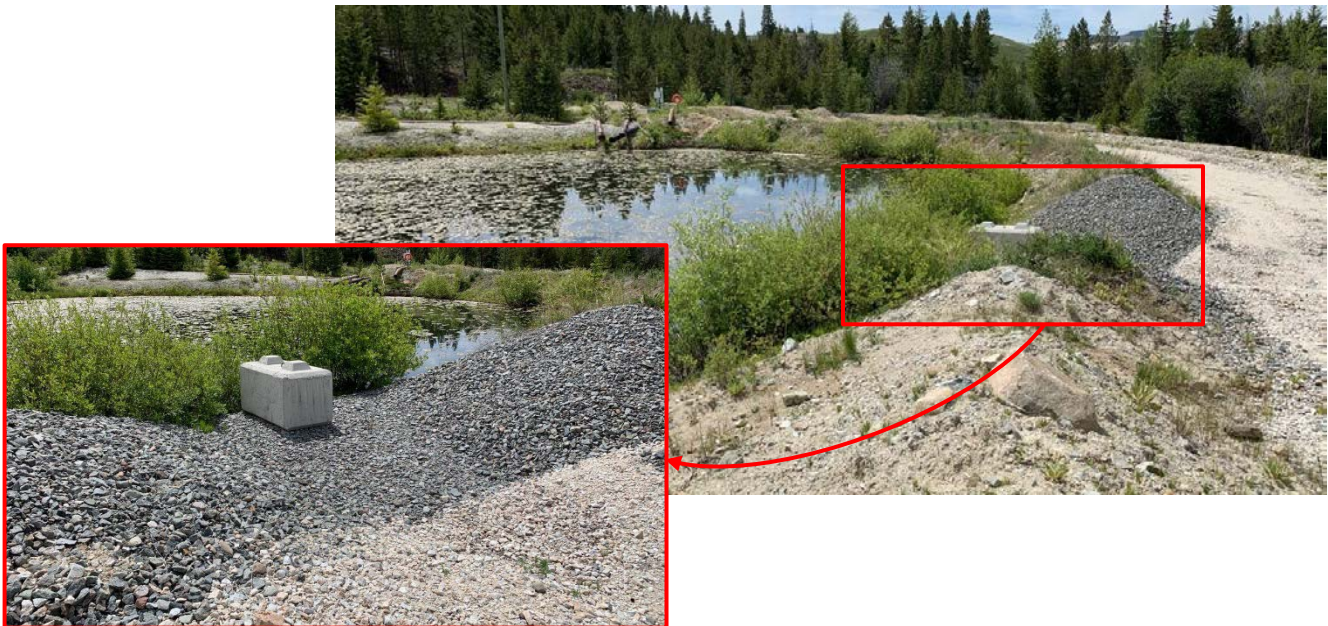
- R3 Seepage Pond spillway inlet is obstructed by heavy vegetation and a lock block. Obstructions should be cleared as part of THVCP routine monitoring and maintenance. THVCP noted the lock-block may be there as vehicle barrier. If so, an alternate barrier type which does not obstruct flow is required.
- R3 Seepage Pond outlet pipe trash rack was partially obstructed from vegetation; this should be cleared as part of THVCP routine monitoring and maintenance. The upstream debris fence was also obstructed which may be cleared or replaced as part of routine maintenance but not required for dam safety.
- Bose Dam spillway inlet, approach channel and initial segment of riprap channel are covered with vegetation and should be cleared as part of routine maintenance.

**Photo II-C-2 overview of spillway inlet and right abutment. Lock-block and vegetation to be cleared from inlet (BTH-2019-16 and BTH-2019-17)**

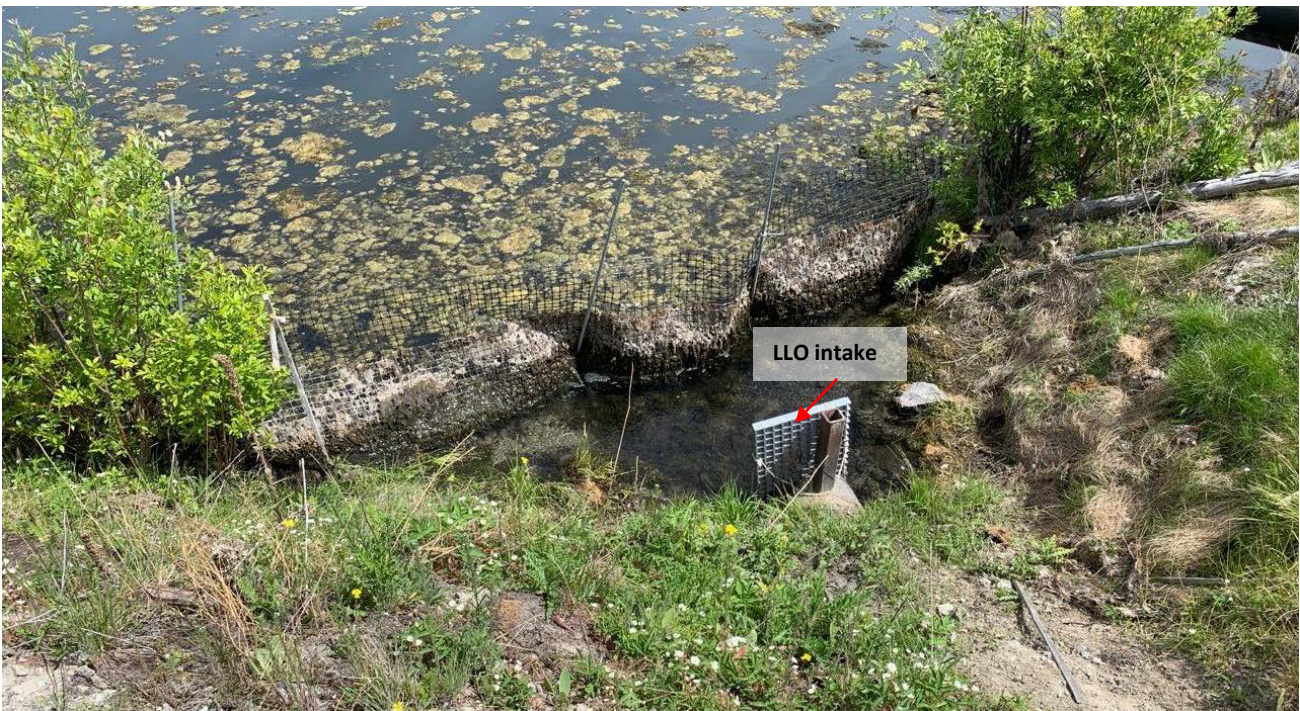
- Lock block and vegetation at the spillway inlet should be cleared as part of routine maintenance
- Low Level Outlet intake trash rack is clogged and required cleaning (Not related to flood routing)

**Photo II-C-4 Pond and trash rack for Low-Level Outlet (LLO) (BTH-2019-18)**

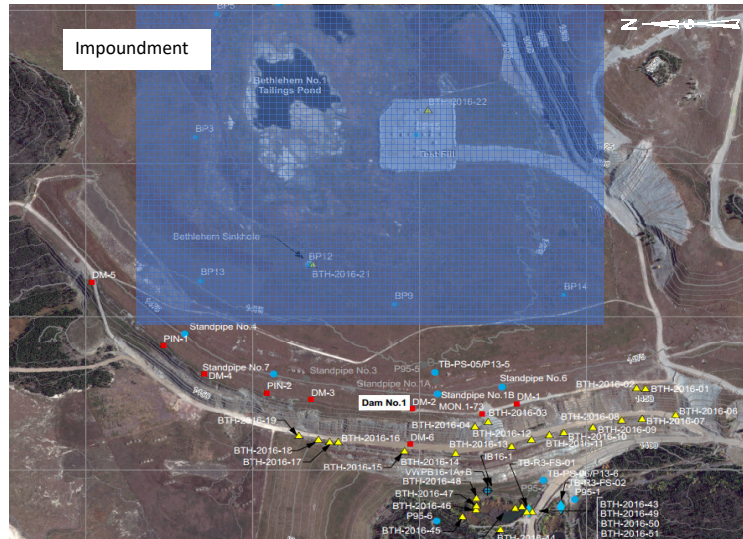
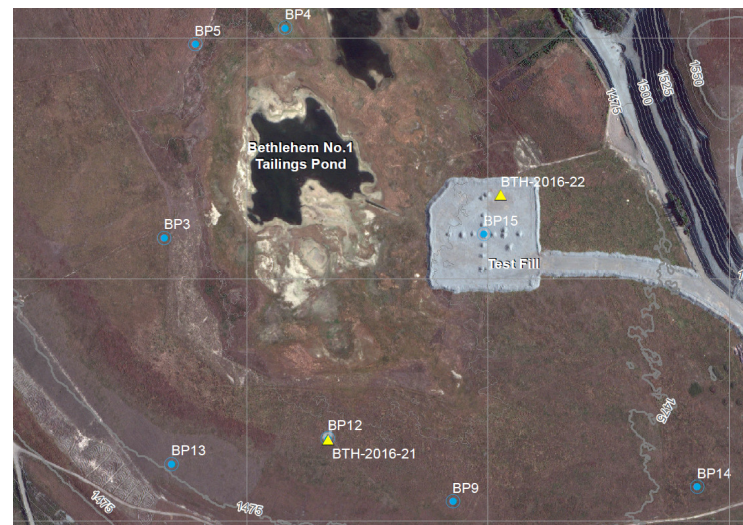
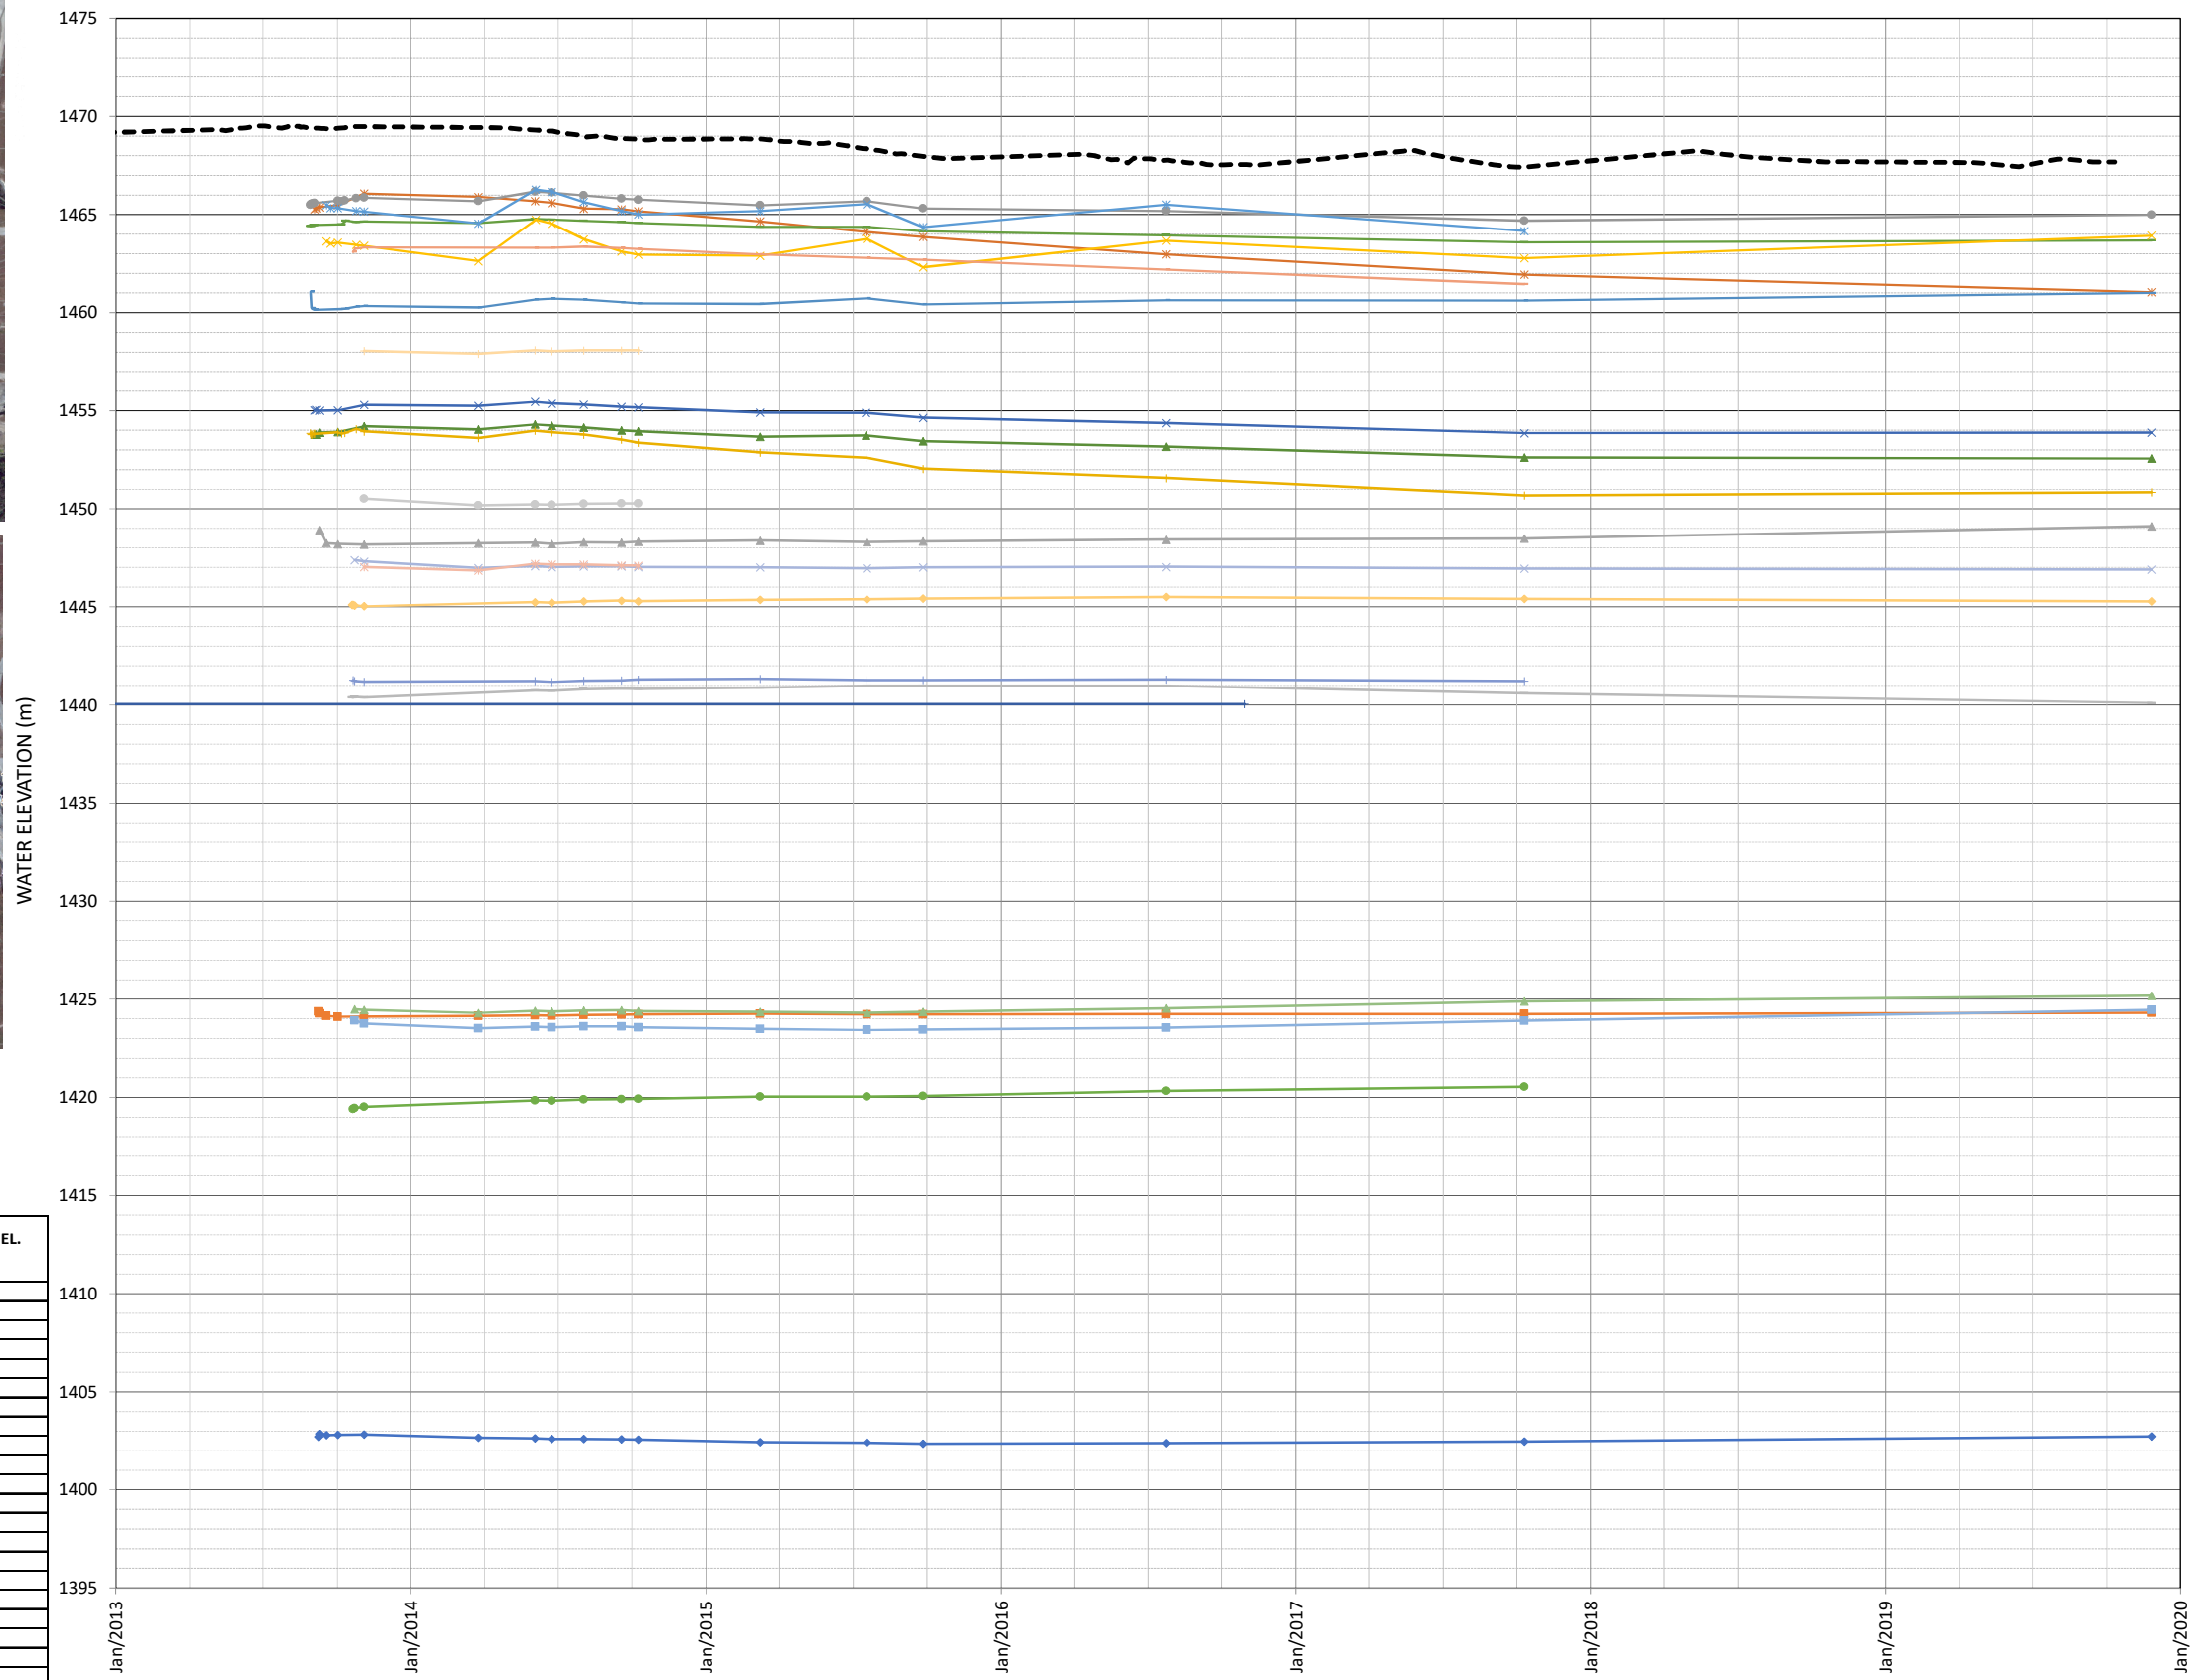
CLIENT Highland Valley Copper / Teck	PROJECT BETHLEHEM NO. 1 TAILINGS STORAGE FACILITY 2019 DAM SAFETY INSPECTION
		TITLE DAM No. 1 PIEZOMETRIC DATA 2013-2019
PROJECT NO. M02341B53		FIG. NO. IV-B-1

1. One reading was taken for each piezometer in December 2019.
2. No reading was taken in December 2019 for BP10B as the wire was cut.
3. No readings were collected for BP12 or B15 series in December 2019.

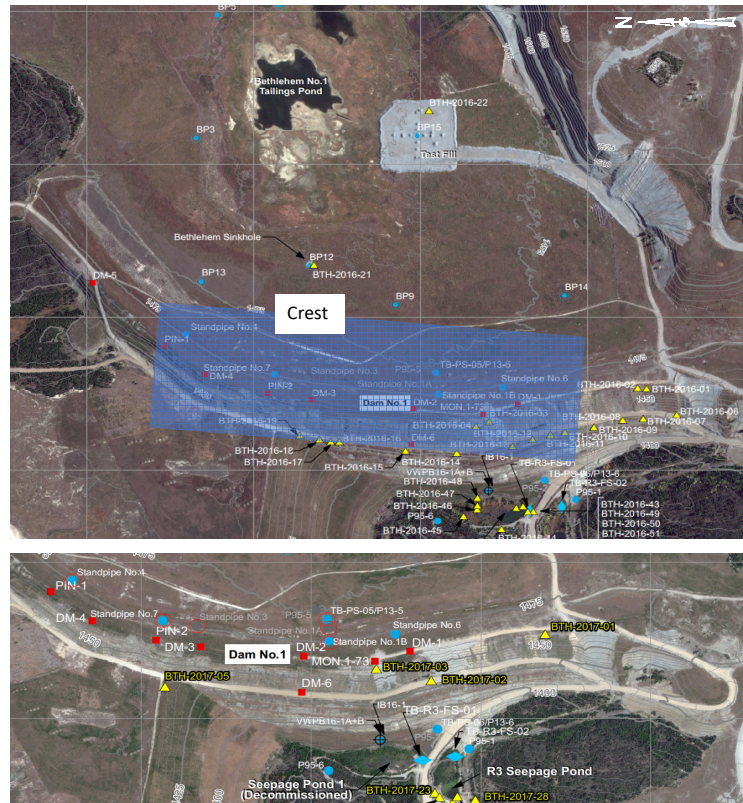
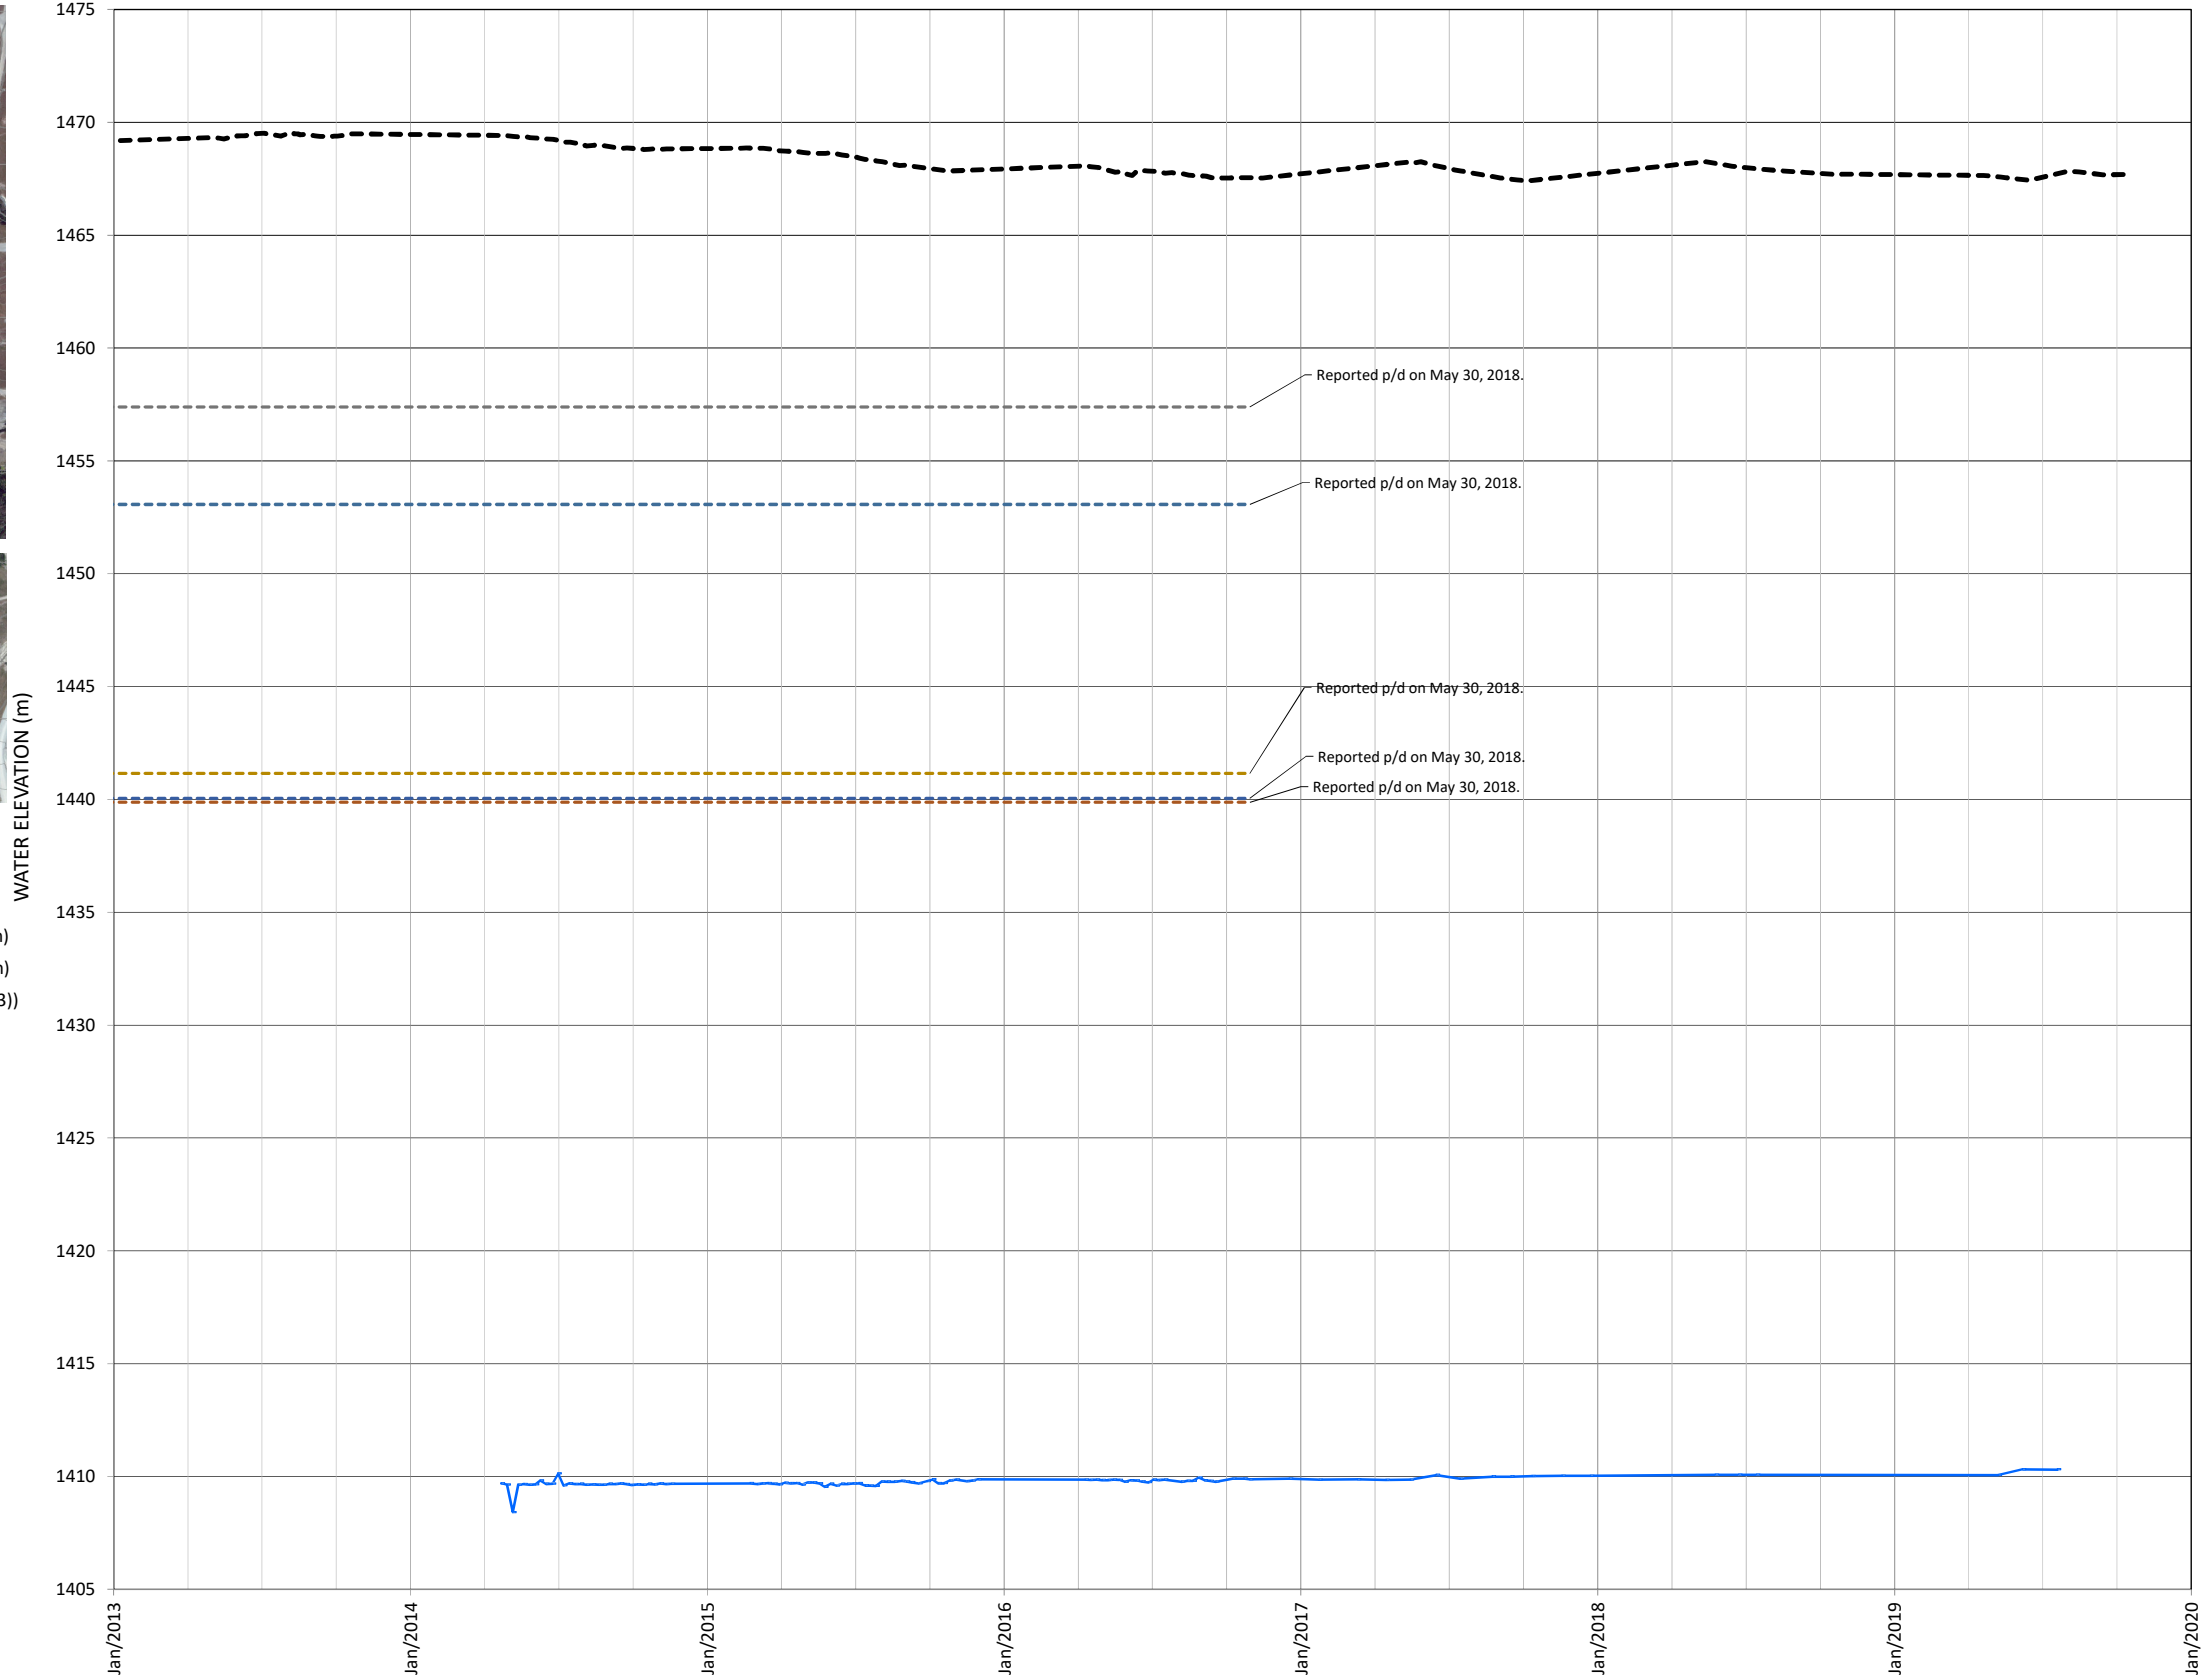
PROJECT: BETHLEHEM NO. 1 TAILINGS STORAGE FACILITY 2019 DAM SAFETY INSPECTION
		TITLE: DAM No. 1 PIEZOMETRIC DATA 2013-2019
		CREST
PROJECT NO. M02341B53	REV. NO. IV-B-2

1. STANDPIPE NO. 3 HAS BEEN NOTED AS DRY/PLUGGED IN THE RECORDS AND LIKELY EXPLAINS THE ERRATIC JUMPS IN MEASUREMENTS. HOWEVER A FALLING HEAD TEST CONDUCTED IN 2015 INDICATED THE PIEZOMETER WAS STILL RESPONDING.
2. STANDPIPE NO. 6 WAS TESTED IN 2015 AND FOUND TO BE DEFUNCT.
3. TIP ELEVATION FROM ORIGINAL LOGS. THE INSTRUMENT WAS SOUNDED IN 2015 AND THE TIP ELEVATION WAS FOUND TO BE EL. 1441.05 m WHICH WAS USED TO SET THE ALERT THRESHOLD.

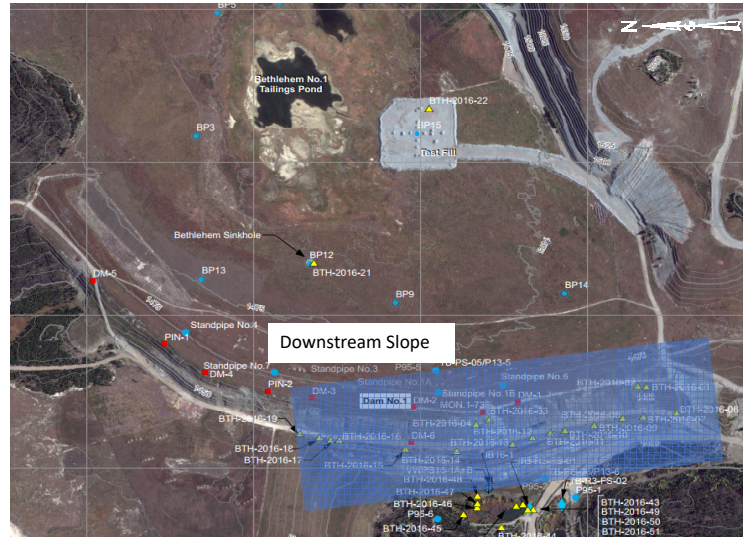
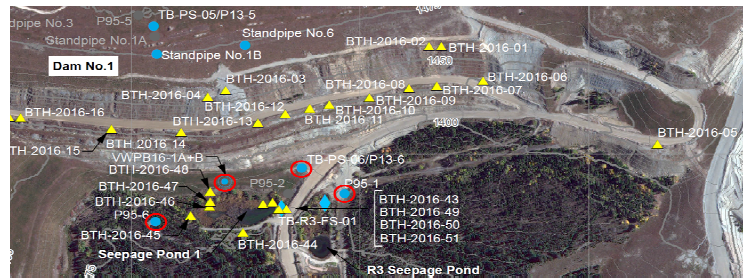
CLIENT Highland Valley Copper / Teck	PROJECT BETHLEHEM NO. 1 TAILINGS STORAGE FACILITY 2019 DAM SAFETY INSPECTION
			TITLE DAM No. 1 PIEZOMETRIC DATA 2013-2019 DOWNSTREAM SLOPE
PROJECT NO. M02341B53		PID NO. IV-B-3

1. PIEZOMETER WATER ELEVATIONS PLOTTED ON PRIMARY (LEFT) AXIS, POND ELEVATION PLOTTED ON SECONDARY (RIGHT) AXIS.
2. FALLING HEAD TEST CARRIED OUT ON P95-6 DURING JULY 2015 - CAUSE OF SPIKE IN PIEZOMETRIC LEVELS

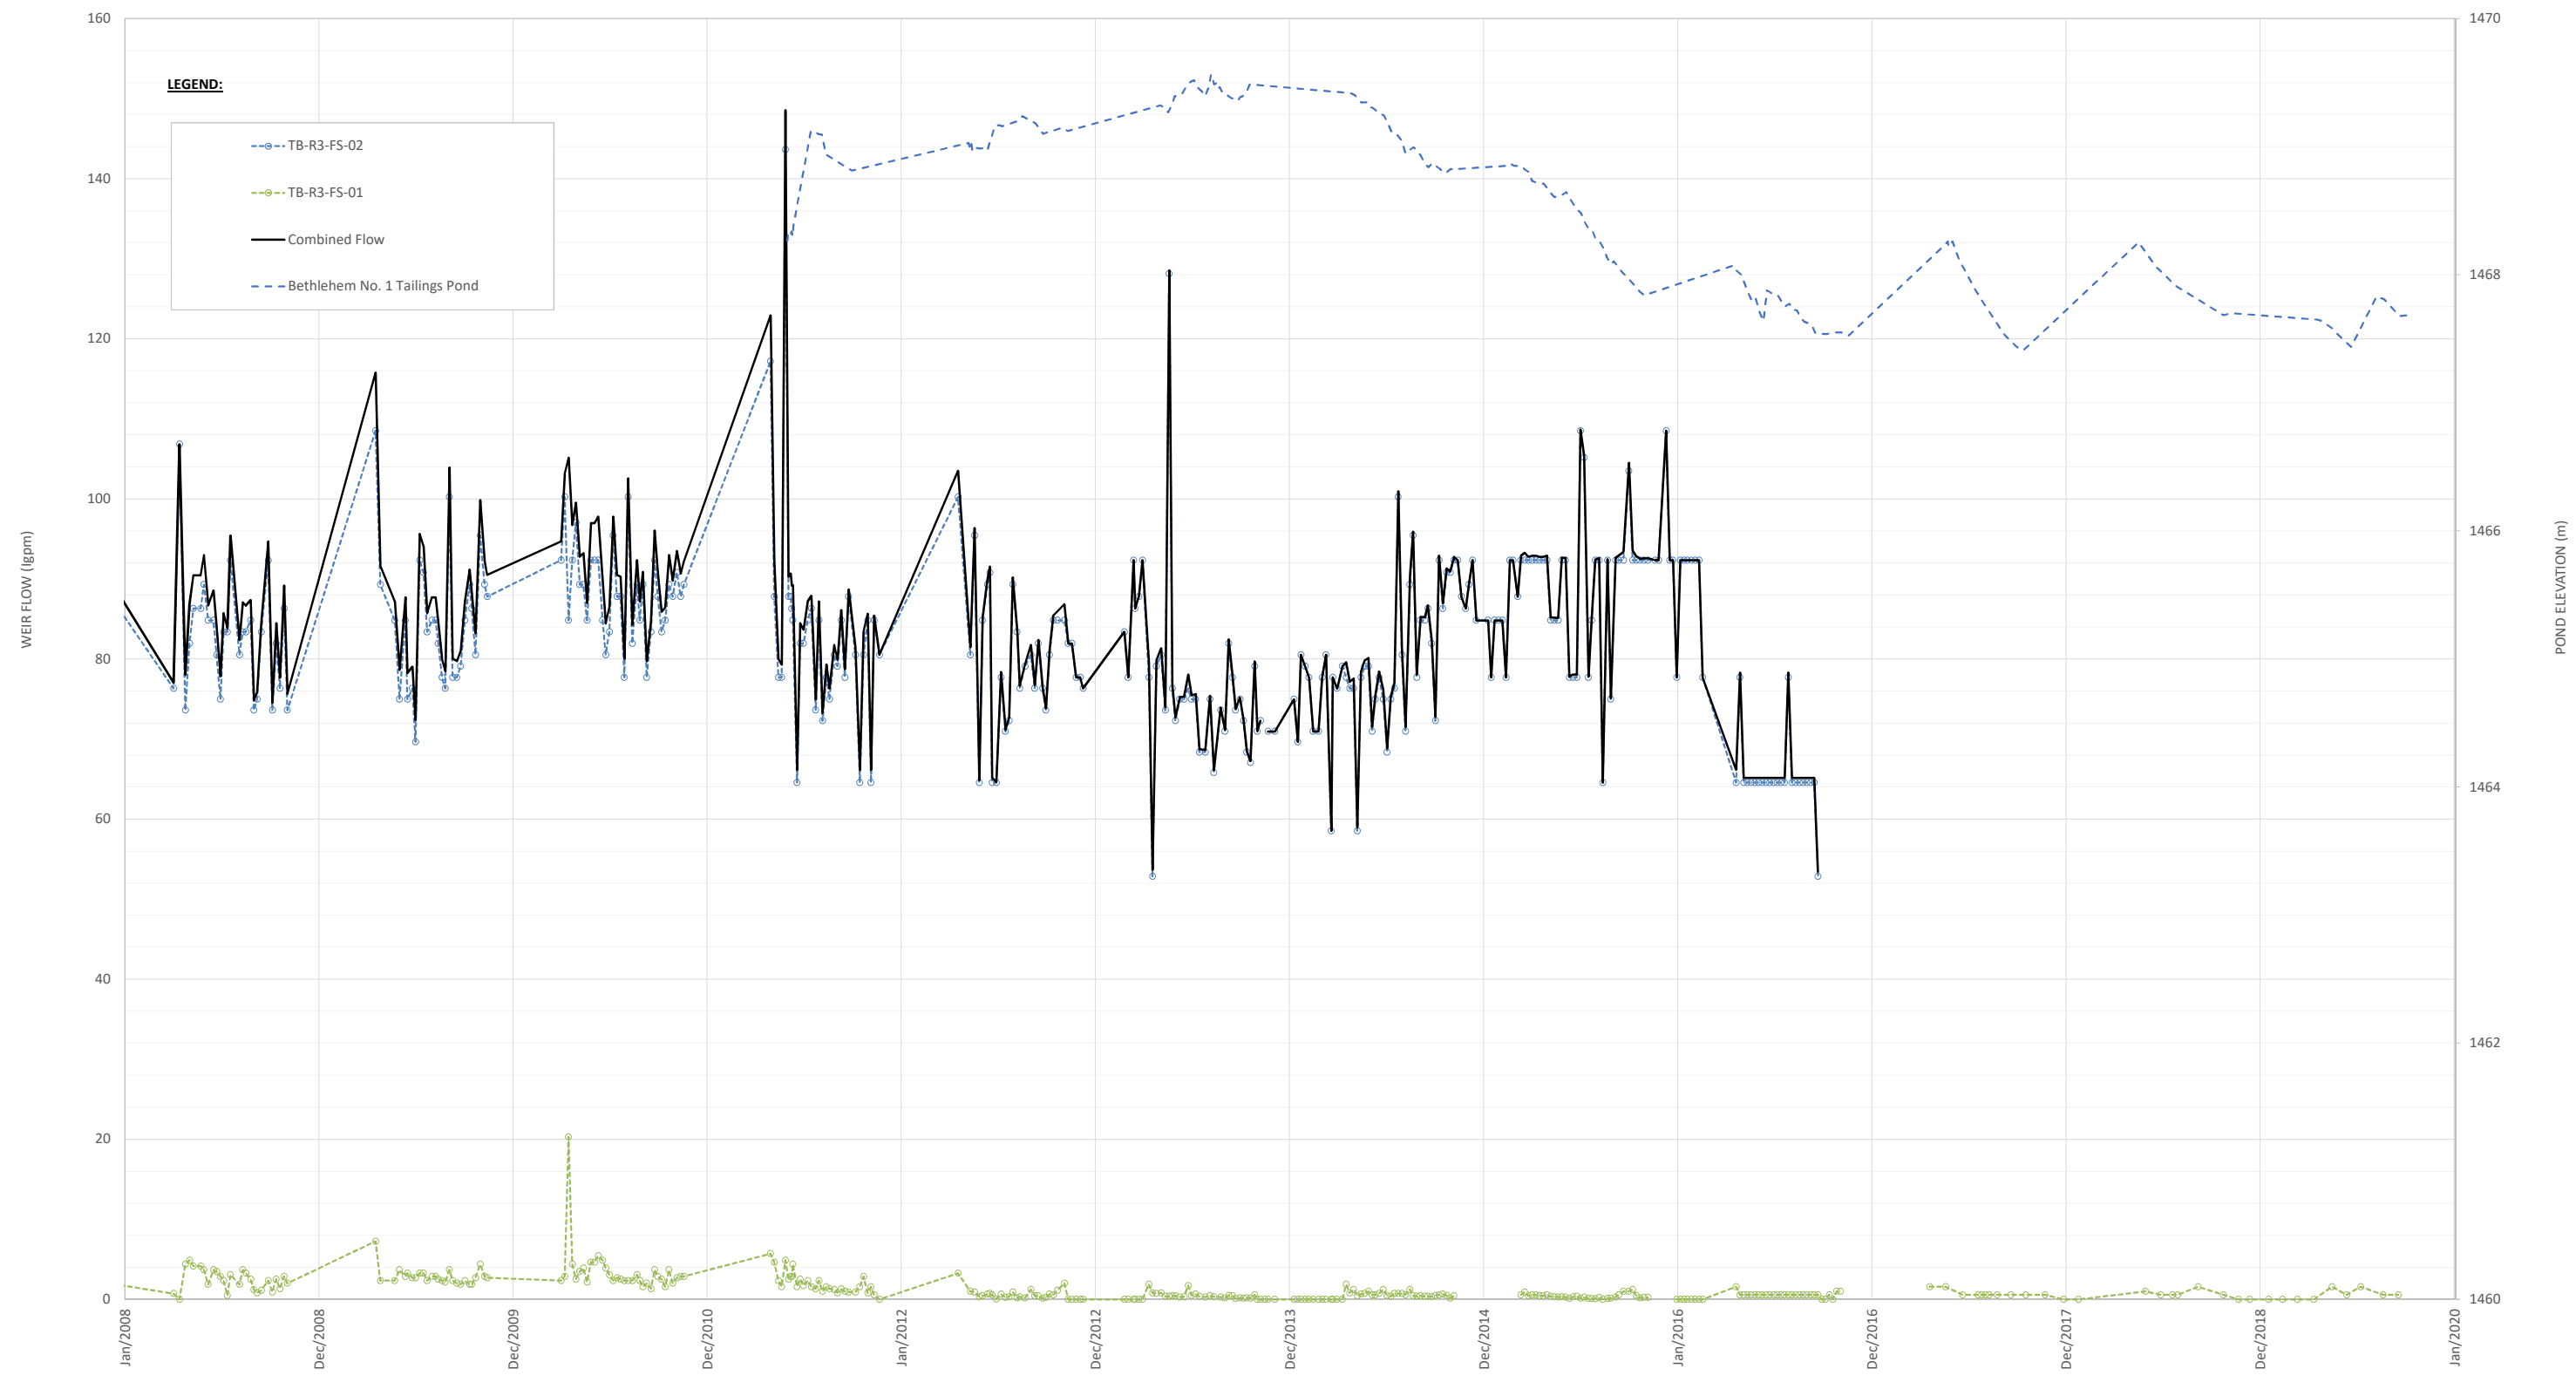
- NOTES:**
1. WEIR FLOW PLOTTED ON PRIMARY (LEFT) AXIS, BETHLEHEM NO. 1 TAILINGS POND ELEVATION PLOTTED ON SECONDARY (RIGHT) AXIS.
  2. TB-R3-FS-02 (WEIR 1) REMOVED OCTOBER 2016, COMBINED FLOW ONLY PLOTTED UNTIL THAT DATE.
