# **Teck Highland Valley Copper Partnership**

**2019 Dam Safety Inspection Report**

***Bethlehem No.1 Tailings Storage Facility***

April 2020

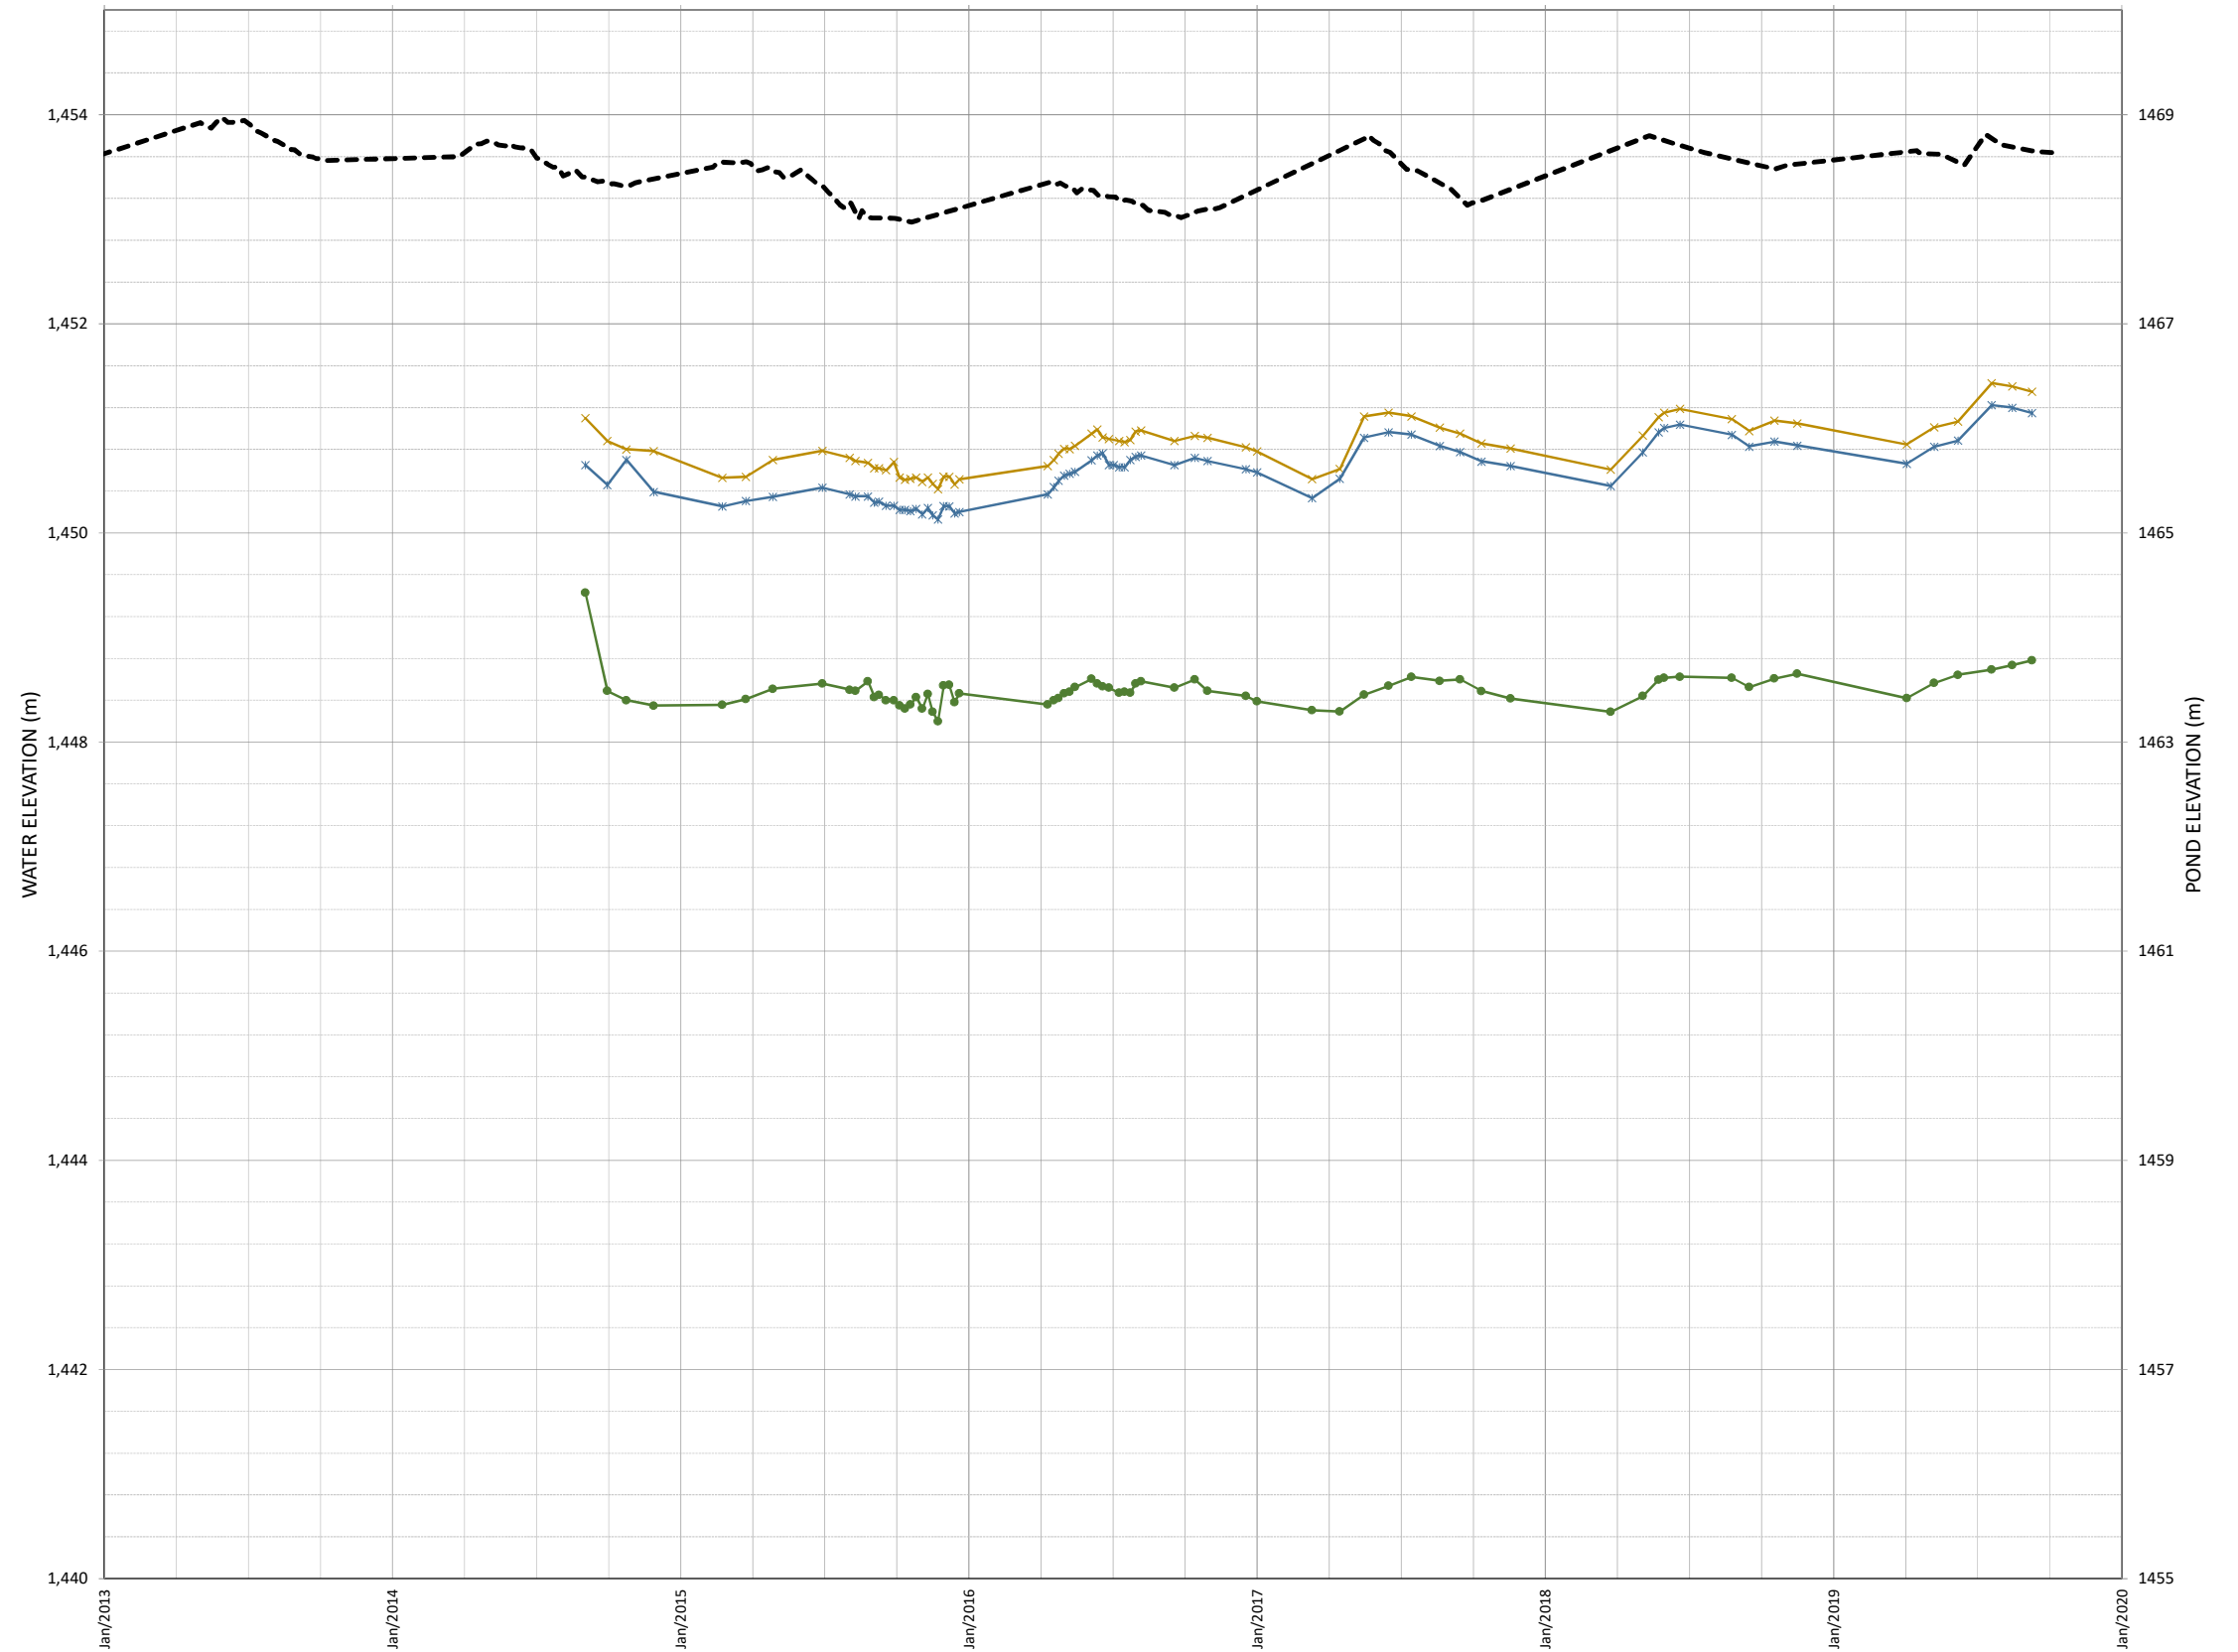
PIEZOMETER ID	2019 THRESHOLD EL. (m)
BD-VWP14-1A	1451.6
BD-VWP14-1B	1451.3
BD-VWP14-1C	1449.9

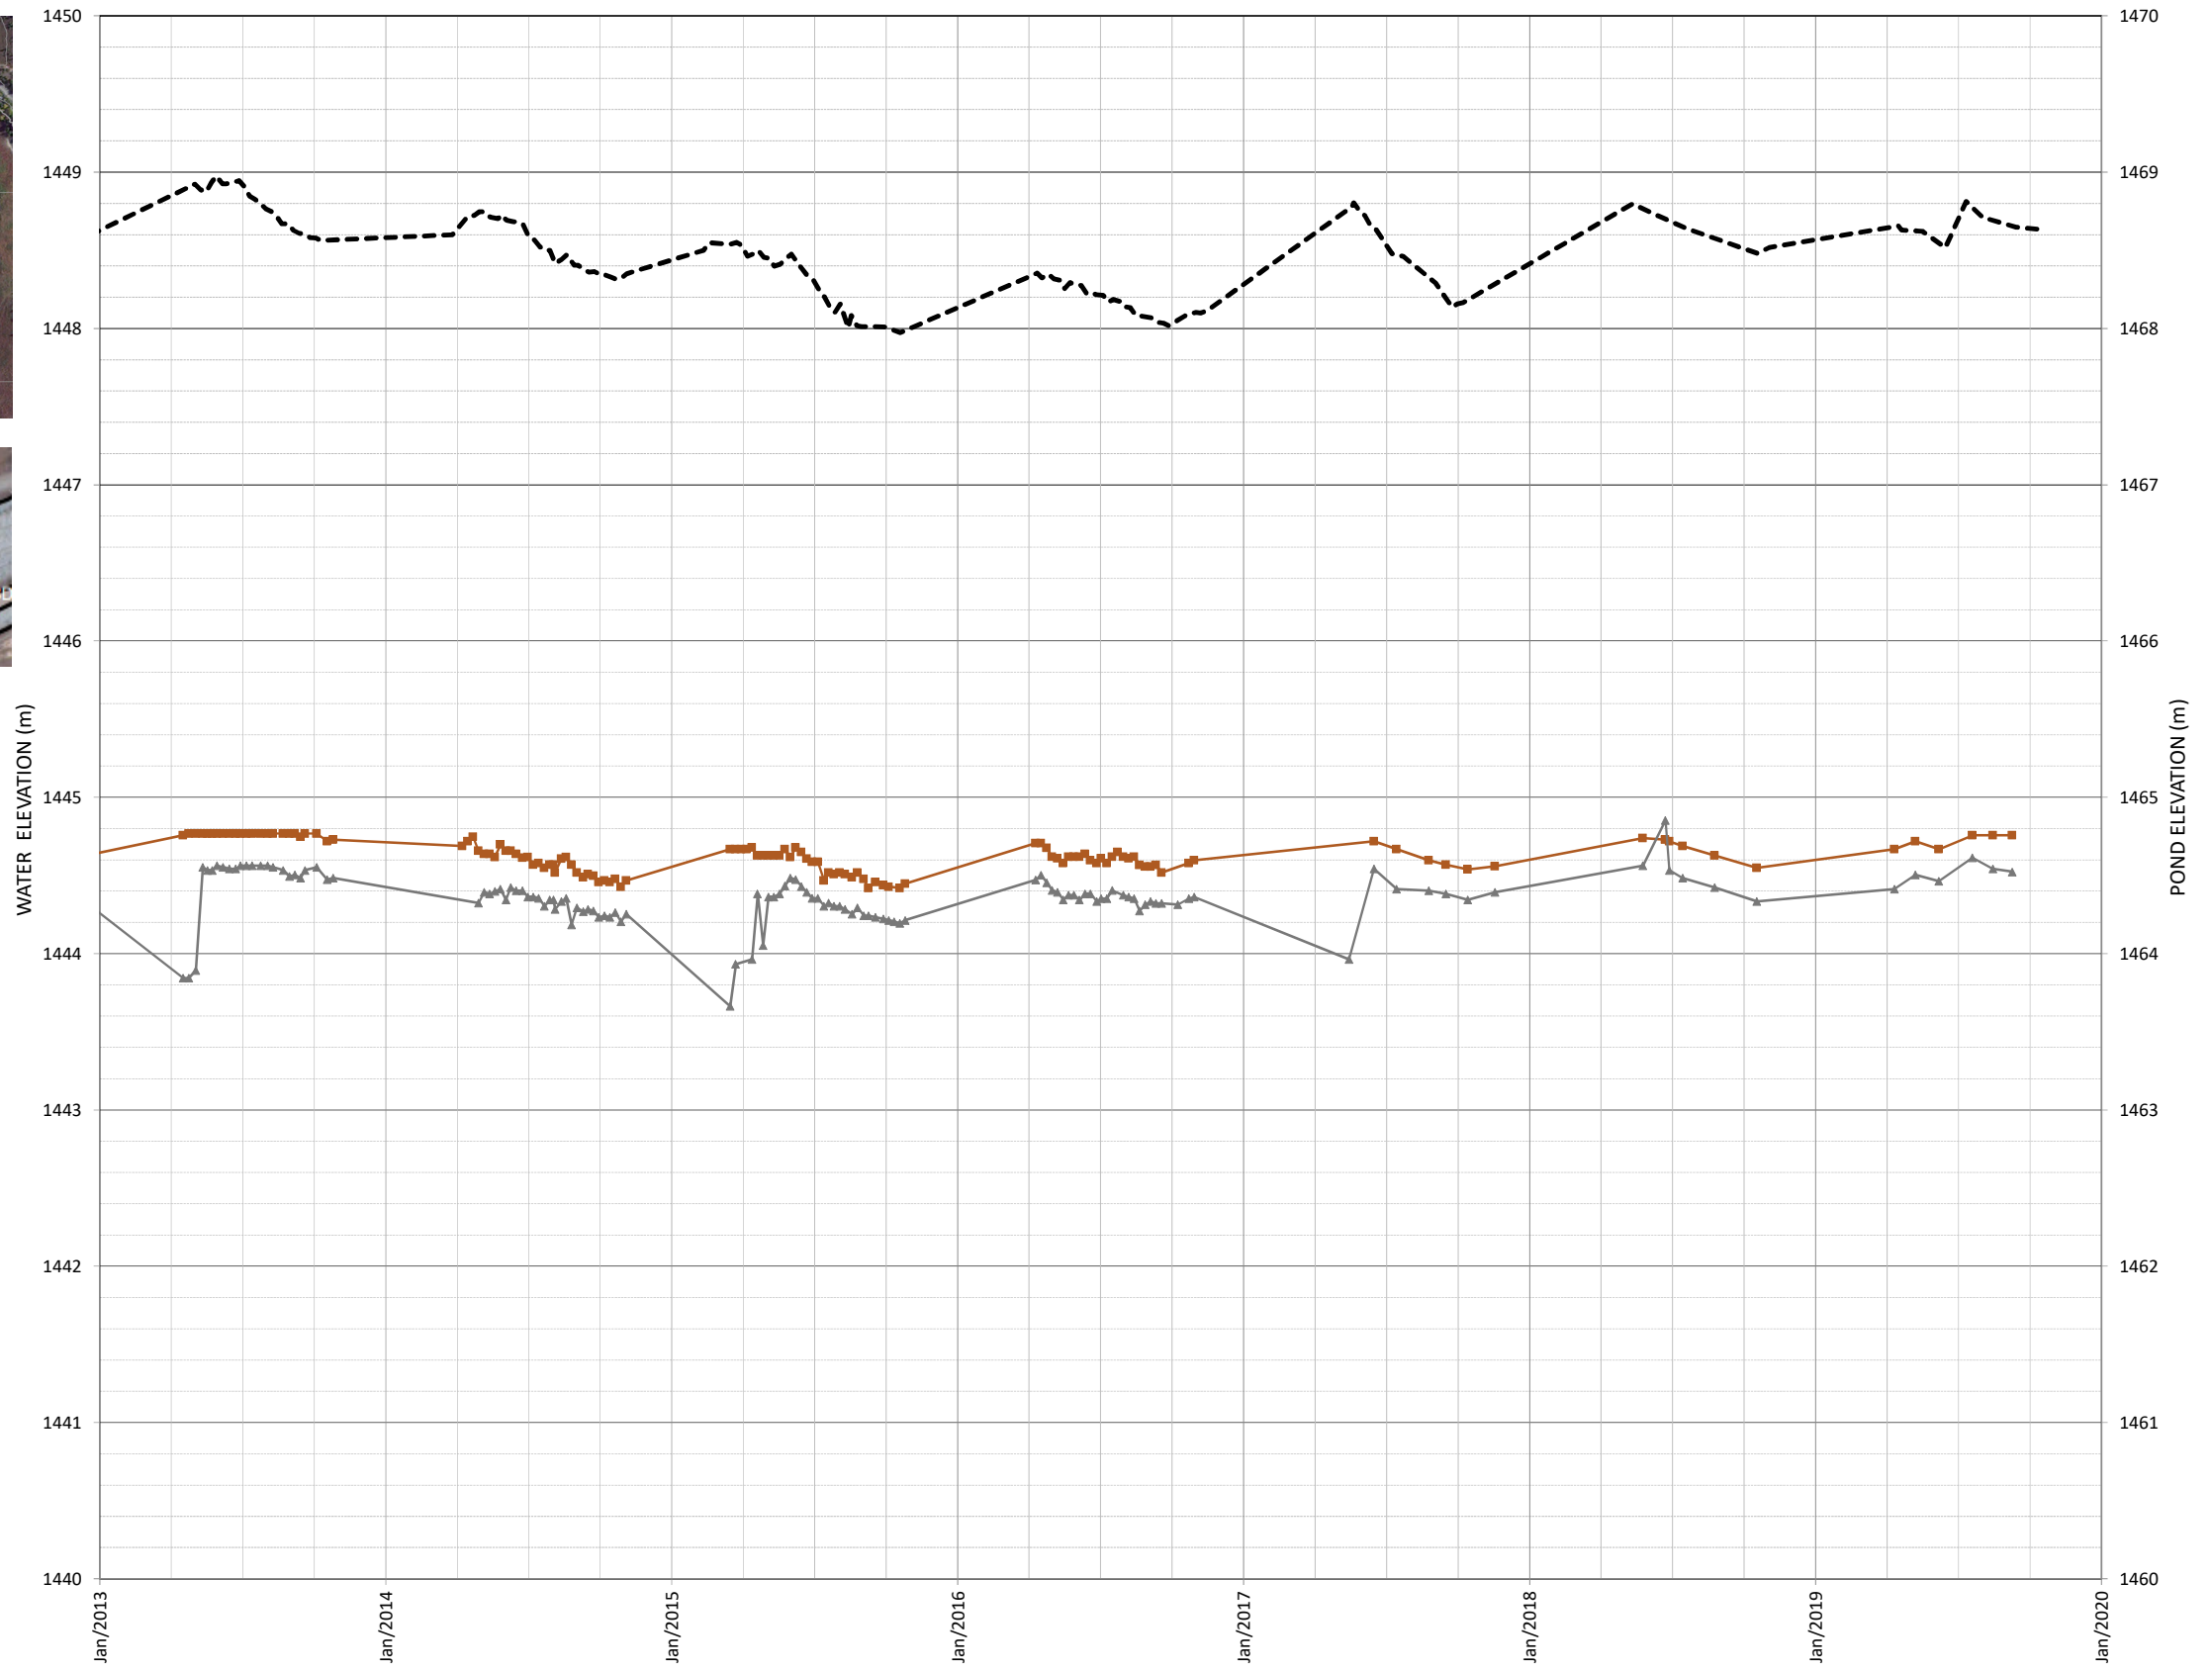
CLIENT Highland Valley Copper / Teck	PROJECT BETHLEHEM NO. 1 TAILINGS STORAGE FACILITY 2019 DAM SAFETY INSPECTION
		TITLE BOSE LAKE DAM PIEZOMETRIC DATA 2013-2018  DOWNSTREAM TOE
PROJECT NO. M02341B53		PID NO. IV-B-9

PIEZOMETER ID	2019 THRESHOLD EL. (m)
No. 1	1445.3
No. 2	1445.2

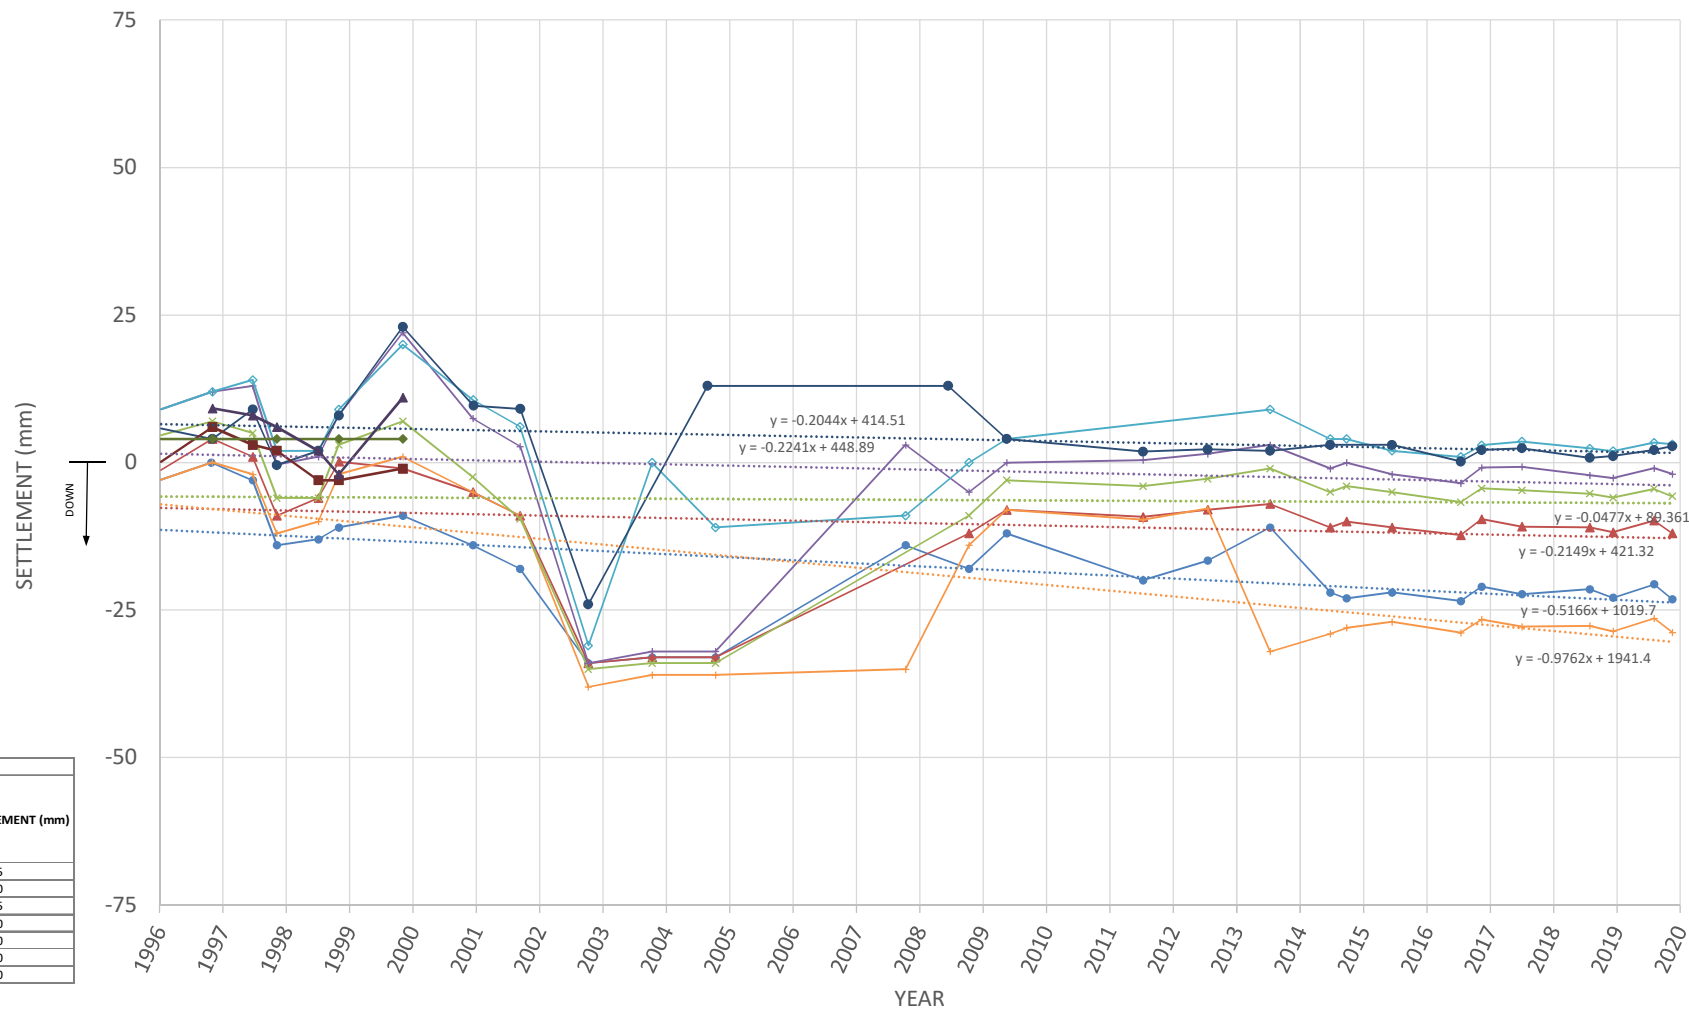
MONUMENT ID	2019 THRESHOLDS		
	HORIZONTAL DISPLACEMENT FROM ORIGINAL POSITION (mm)	INCREMENTAL SETTLEMENT BETWEEN READINGS (mm)	TOTAL SETTLEMENT (mm)
BD-1	80	20	75
BD-2			50
BD-3			75
BD-4			50
BD-5			50
BD-6			50
BD-7			50

1. BOSE LAKE DAM CREST MOVEMENT MONITORING DATA PRIOR TO 1996 NOT SHOWN.
2. REFER TO FIGURE 3 FOR MONUMENT LOCATIONS IN PLAN VIEW.
3. BD-8, BD-9 AND BD-10 DESTROYED IN 1999 OR 2000.
4. BD-1 2010 READING (NOT SHOWN IN PLAN PLOT) LOCATED 1505 mm FROM INITIAL 1993 READING. READING WAS REVIEWED AND FOUND MORE LIKELY RELATED TO SURVEY ERROR THAN DISPLACEMENT.
5. BD-5 2010 READING (NOT SHOWN IN PLAN PLOT) LOCATED 294 mm FROM INITIAL 1993 READING. READING WAS REVIEWED AND FOUND MORE LIKELY RELATED TO SURVEY ERROR THAN DISPLACEMENT.
6. BD-3 SHIFT BETWEEN PRE AND POST 2013 SURVEYS WHICH COULD BE THE RESULT OF DAMAGE OR SURVEY DATUM. NOT AN INDICATOR OF DAM SAFETY ISSUE.
7. BD-7 2003 SETTLEMENT DATA WAS OUTLIER AND NOT PLOTTED.
8. 2007 SETTLEMENT DATA OF BD-4, AND BD-2 WERE OUTLIERS AND NOT PLOTTED.
