Teck Resources Limited

Bullmoose Mine

Bullmoose Tailings Dam

2019 Dam Safety Inspection

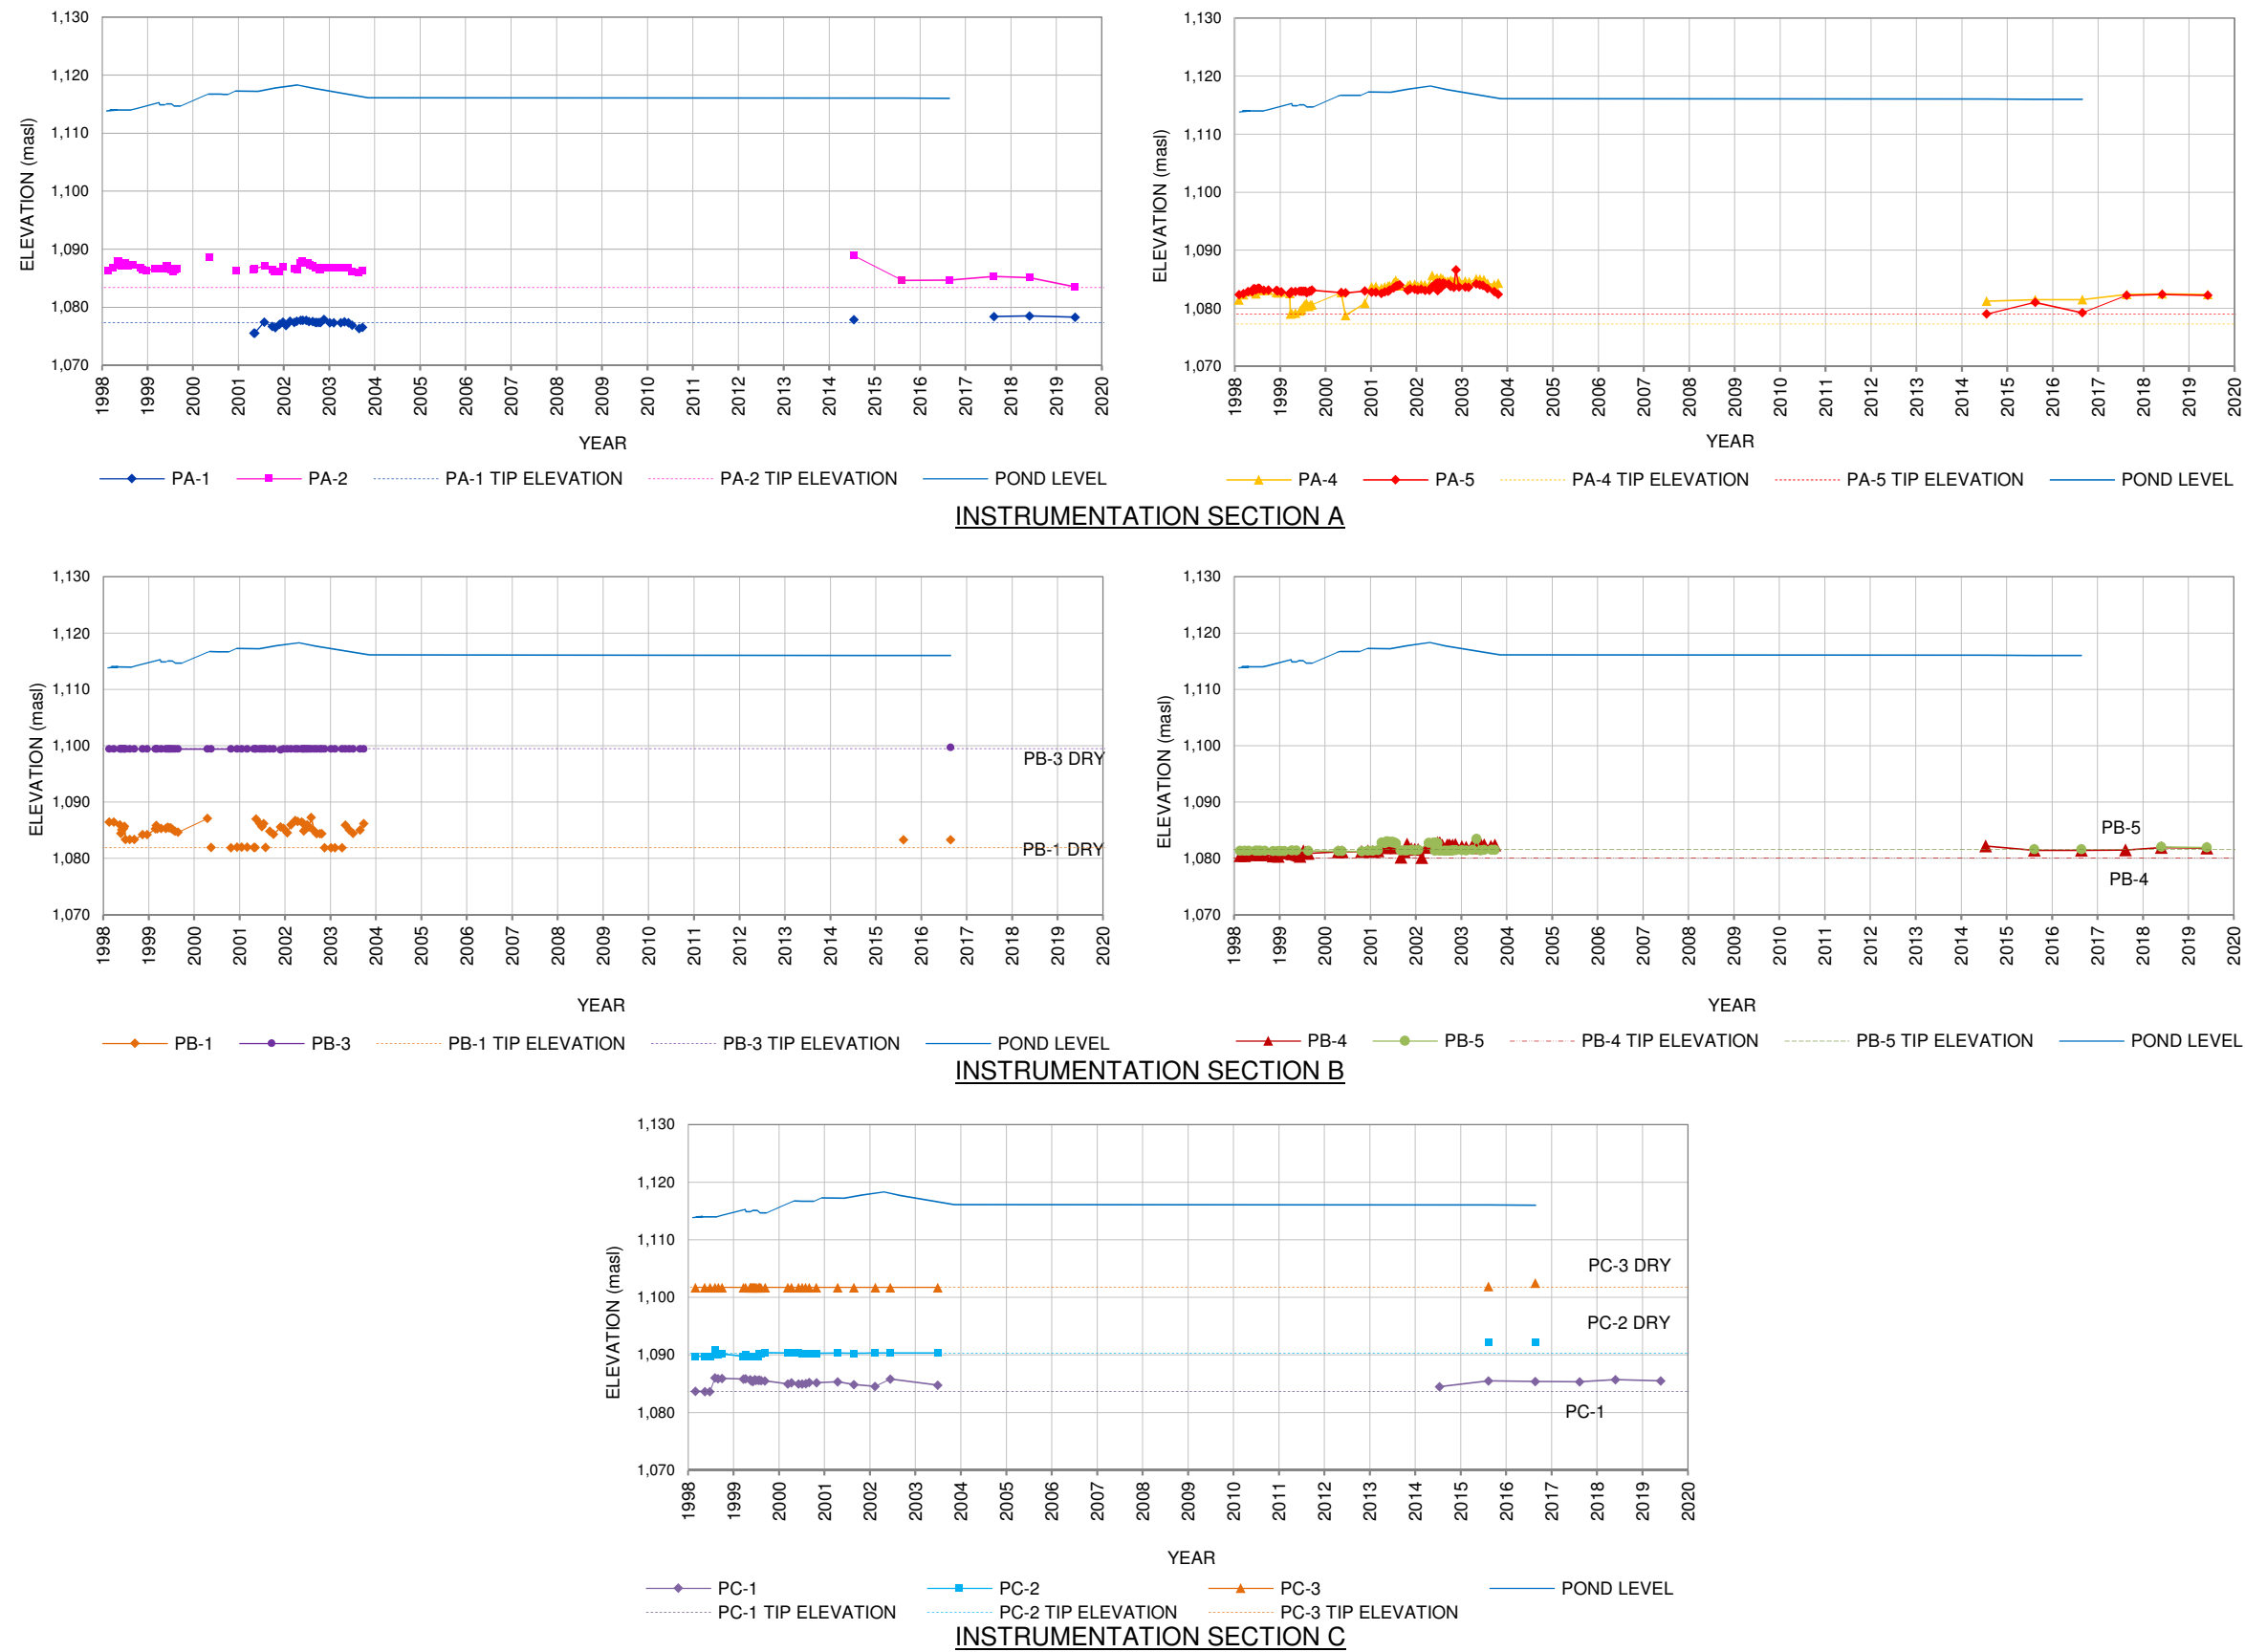
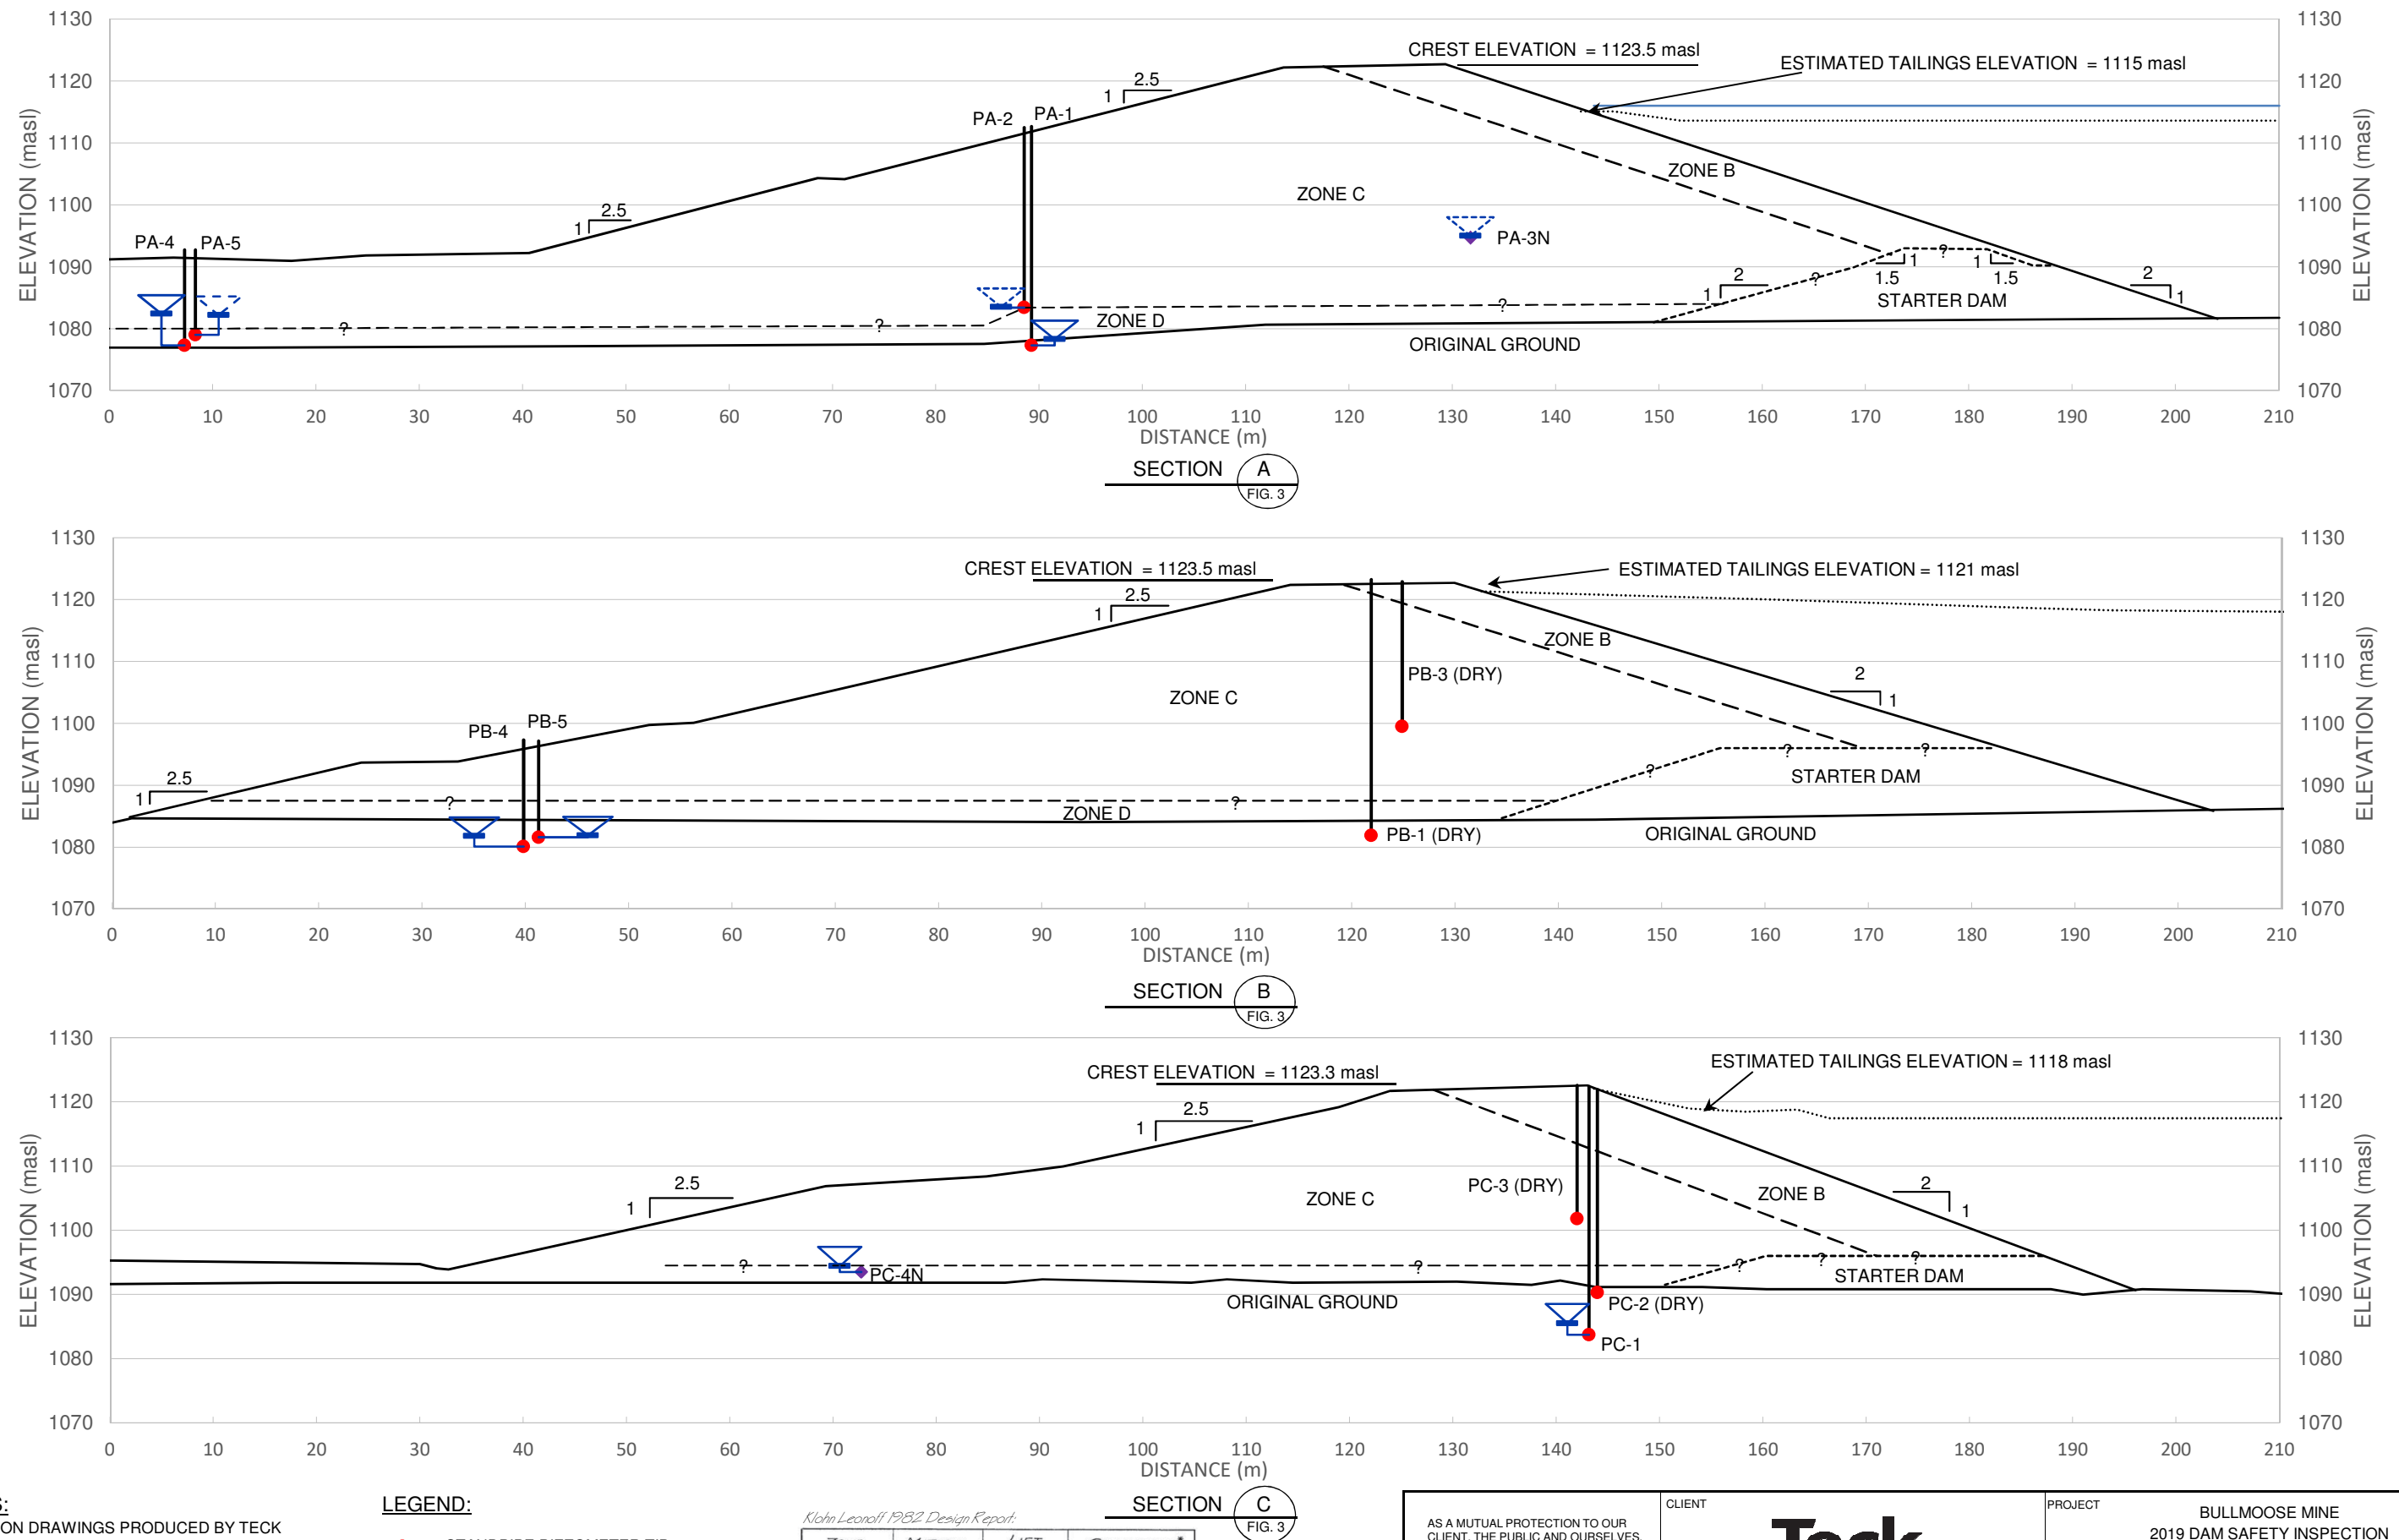
CLIENT Teck 	PROJECT BULLMOOSE MINE 2019 DAM SAFETY INSPECTION	
	TITLE BULLMOOSE TAILINGS DAM INSTRUMENTATION SCHEMATIC SECTIONS A, B AND C	
	PROJECT No. M09893A09	FIG. No. 7

- None of the measured piezometers exceed Threshold Level 1.
- All measured piezometers have similar water levels to those measured in 2018 (see Figures 5 and 6):
 - ◆ PA-1, PA-4, PA-5, PB-4, PB-5 and PC-1 appeared to be stable with no general decreasing or increasing trend.
 - ◆ PA-2 water level dropped about 4 m between 2014 and 2015; the instrument has been relatively stable since 2015.
 - ◆ PB-3 and PC-3, installed in the dam, have been registered as “dry” since 2017 indicating relatively low phreatic level across the BTM embankment.
 - ◆ PB-1 and PC-2, installed in the foundation, continue to show a piezometric level below the instrument tips (i.e., they are dry). Other foundation piezometers PB-4, PB-5 and PC-1 indicate water levels are slightly below PB-1 and PC-2 tips.

The piezometer measurements show that pore pressures have been stable, and the dam shell is drained with low gradient of approximately 0.04 to 0.05 (KCB 2018c). Operation and construction induced pore pressure responses are no longer observed. Therefore, piezometers monitoring frequency of once per year is sufficient for ongoing monitoring of the structure under “Closure-Passive Care” conditions.

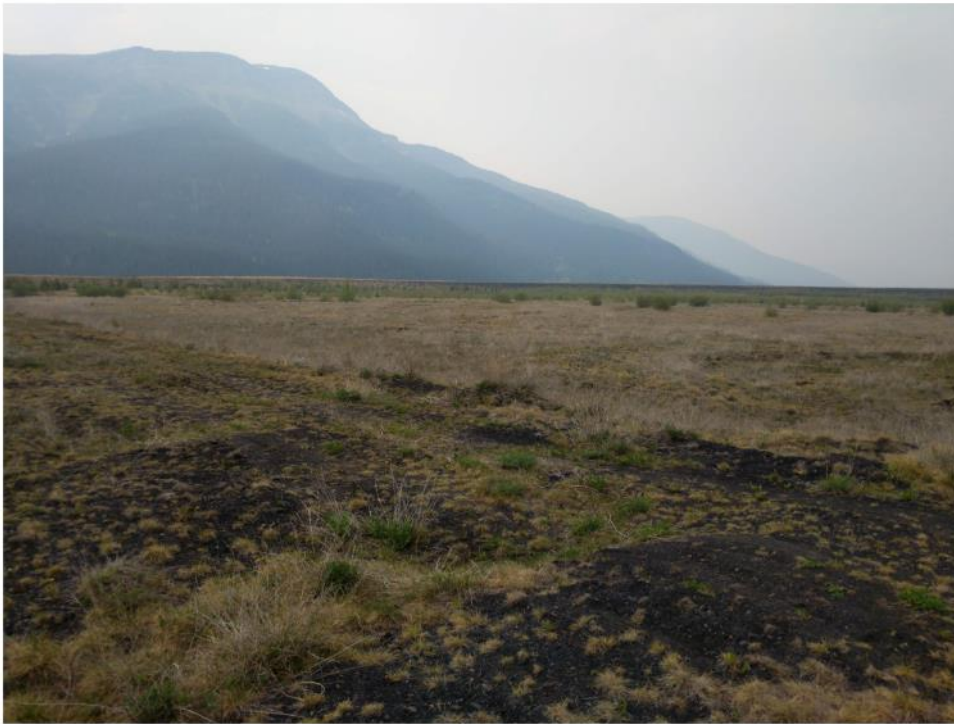
- **Dam Crest:** Good condition. No signs of lateral movement, differential settlement or cracking of the dam crest (Photos II-1, II-3 to II-5, II-7, and II-10).
- **Downstream Slope and Toe:** Good condition. No visible signs of significant erosion, displacement, or bulging (Photos II-14 to II-20). Vegetation (grasses and moss) are well established.
 - ◆ An erosion gully was observed at the toe near the East Abutment (Photo II-15). The gully was first observed in 2017 and dimensions appeared similar to observations to previous DSIs (approximately 0.2 m to 0.3 m wide, 0.1 m deep and 10 m to 15 m long). The likely cause was concentrated local flow during spring freshet. This feature continues to be monitored and inspected for signs of change during routine visual inspections and annual DSI site visits.

Photo II-3 BTD Crest – looking north (BTD-2019-02)

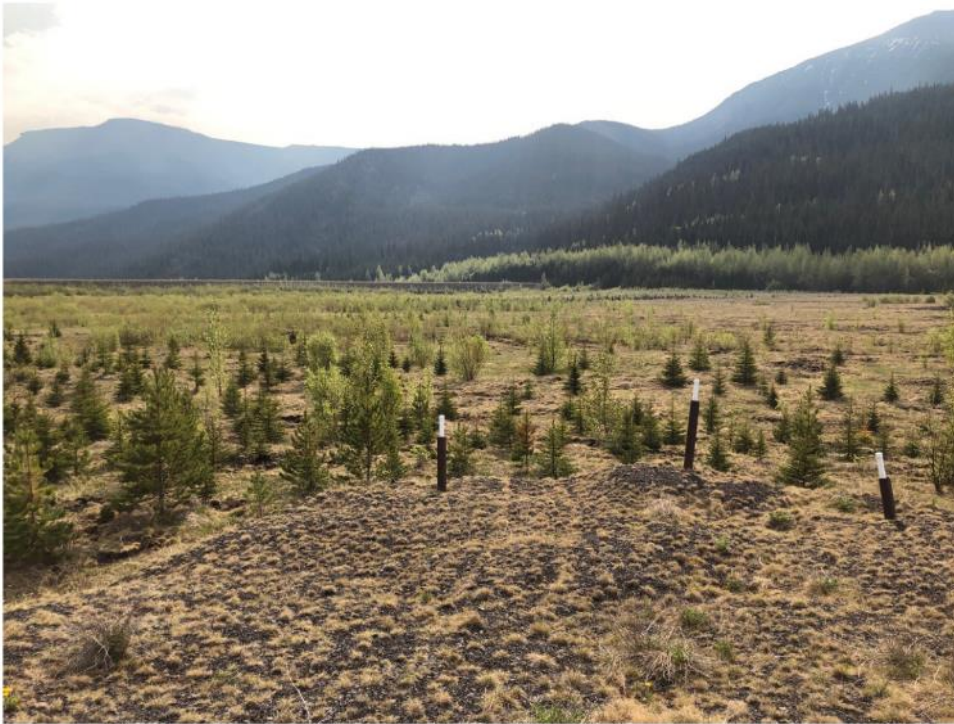
Photo II-7 BTD Crest – looking east (BTD-2019-04)

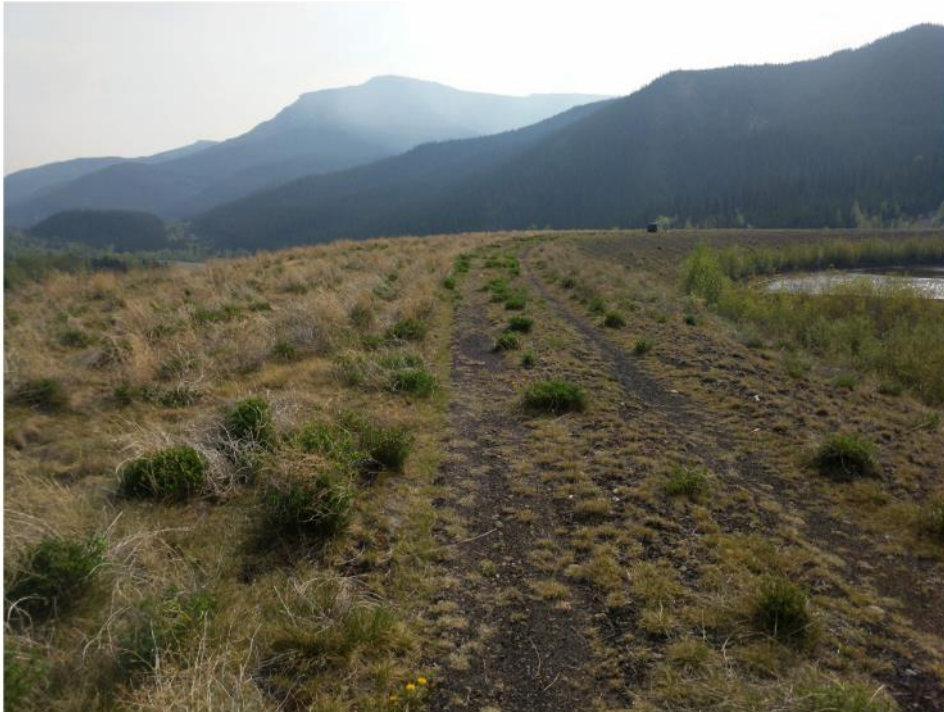
- **Upstream Slope:** Good condition. No signs of significant erosion or displacement (Photos II-9 and II-10).
- **West Abutment:** Good condition. The spillway is excavated through the west abutment, no signs of erosion at the abutment (Photo II-20).

Photo II-9 BTD Pond – looking south (BTD-2019-06)

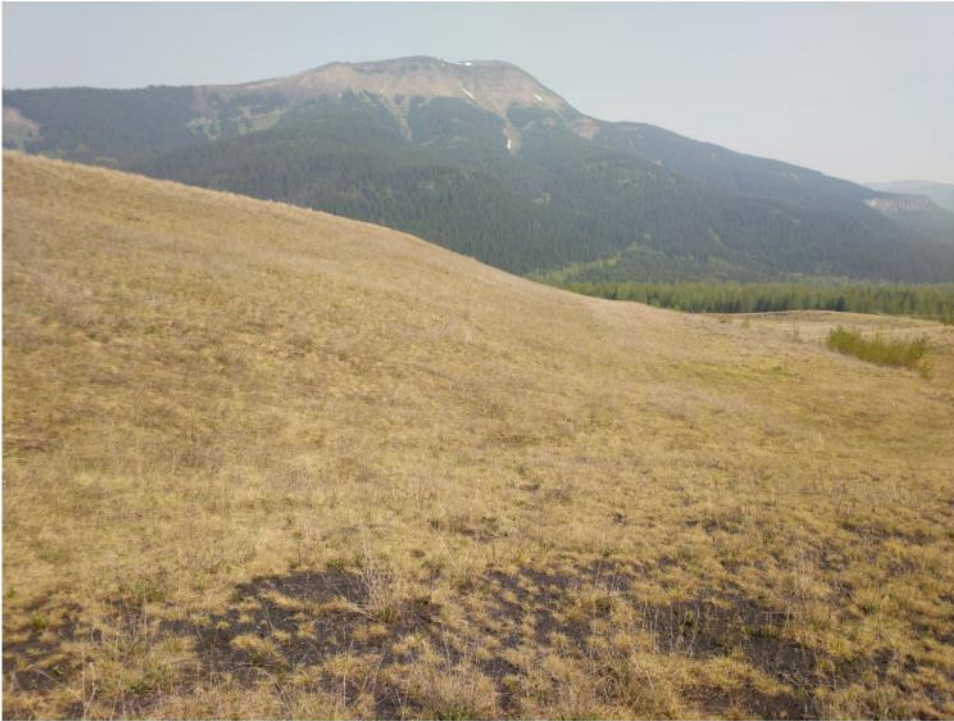
Photo II-15 BTD Toe. Erosion gulley observed during previous inspections. No obvious signs of change – looking north (BTD-2019-11)

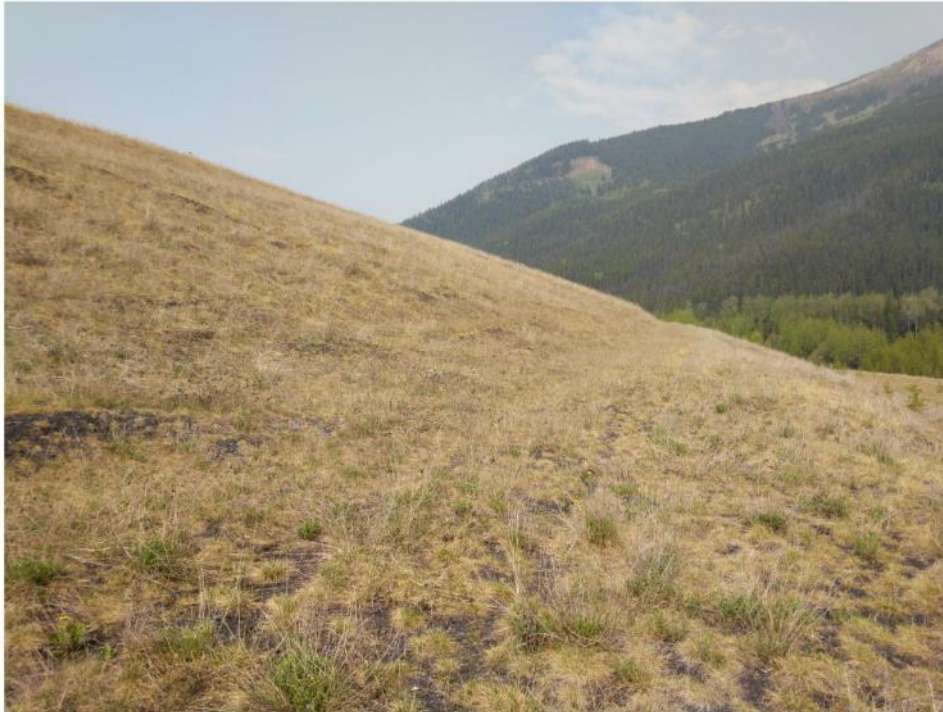
Photo II-17 BTD Downstream Slope – looking west (BTD-2019-13)

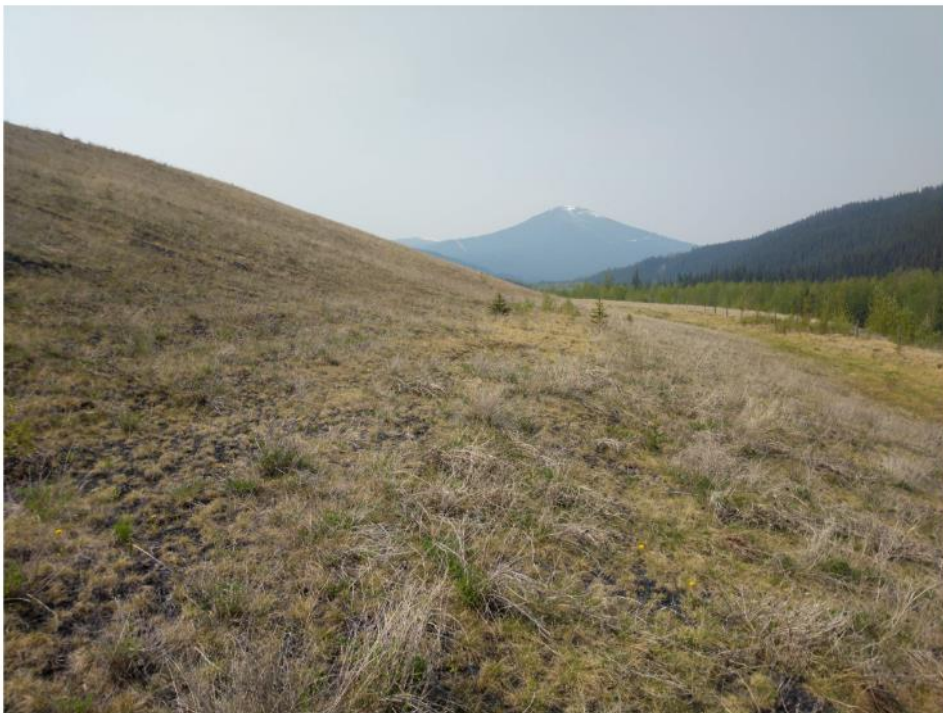
- ♦ A small wet area was noted near the toe of the north arm of the BTD during the DSI site visit (Photo II-18). There were no signs of seepage emerging from the downstream slope, and the wet area is believed to be due to ponding from snowmelt from the slopes.

Photo II-18 **BTD Downstream Toe. Wet area along the toe. Noted in previous DSI reports as being an area where snowmelt water collects. No signs of seepage emerging from the slope – looking east (BTD-2019-14)**

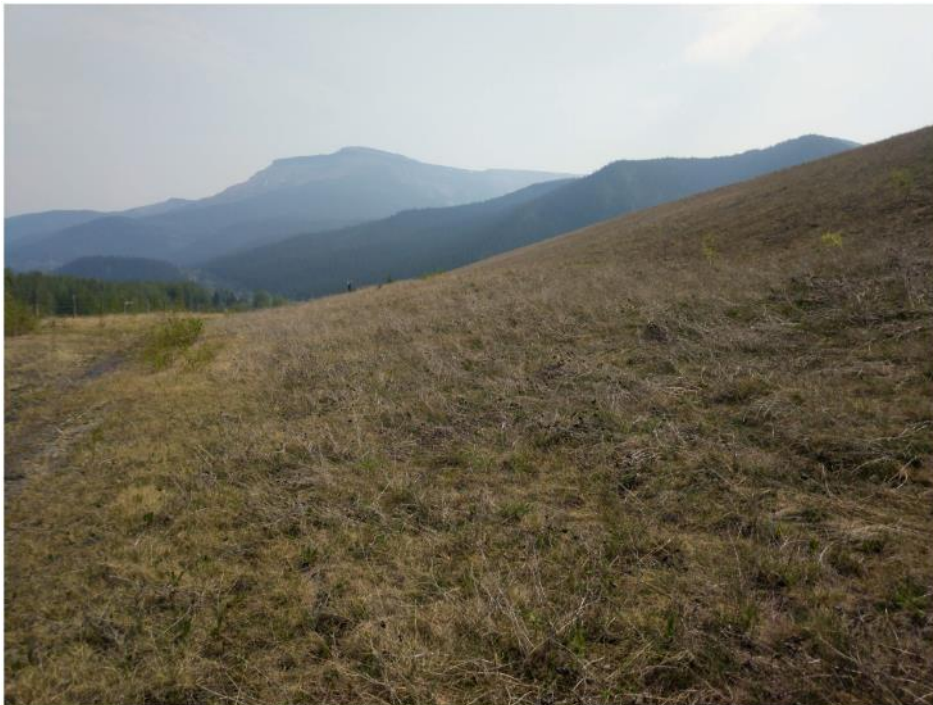
Photo II-20 BTD Downstream Slope and West Abutment – looking north (BTD-2019-15)
