Klohn Crippen Berger

Teck Coal Limited Elkview Operations

West Fork Tailings Facility and Lagoons A, B, C, and D

2019 Dam Safety Inspection

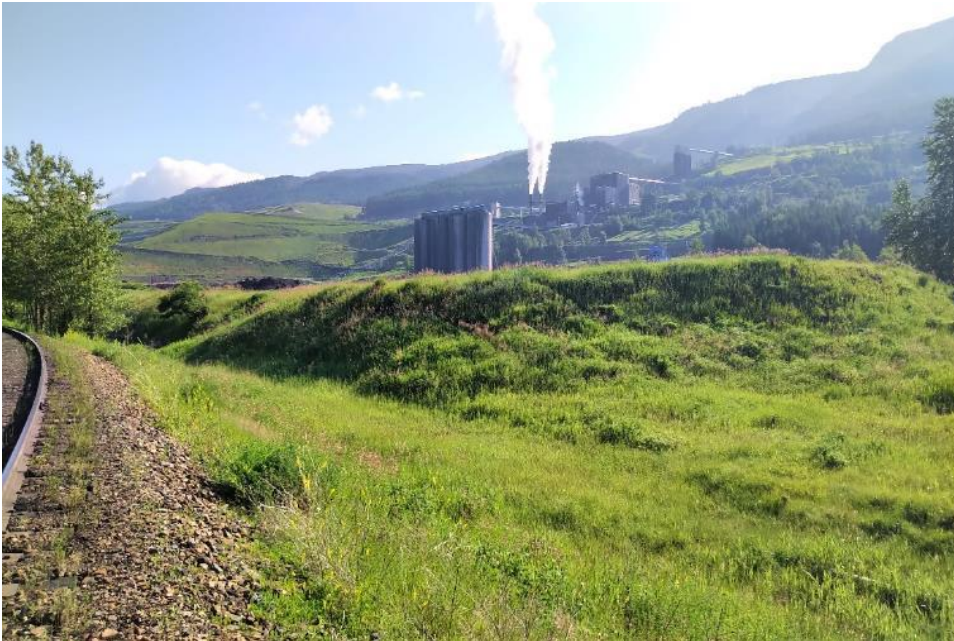
- Lagoon B appeared to be in a satisfactory condition, with no evidence of deformations, slumps or wet spots.
- Minor slumping of the lagoon into the marsh was observed. **(Photo IB-4)**

Photo IB-4 Minor slumping of Lagoon B. (looking northeast)

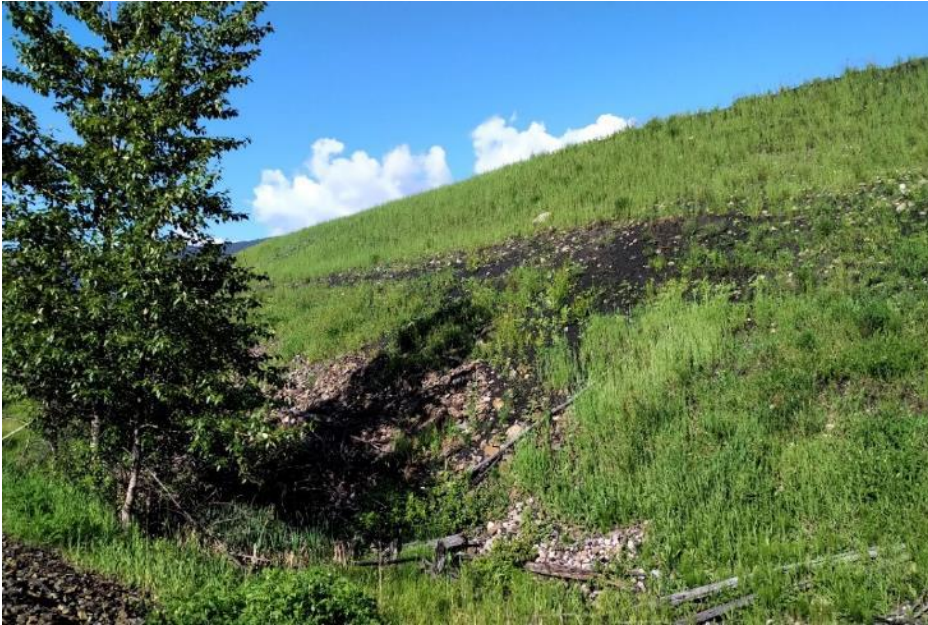
- Lagoon C was observed to generally be in good condition, however localised erosion was observed. **(Photo IC-5, IC-8)**
- Local ponding of water on the crest was observed. **(Photo IC-6)**
- Changes in vegetation on the downstream slope adjacent to Elk River may indicate that wet spots occasionally form in these areas. **(Photo IC-7)**
- Erosion on the upstream side of the crest was observed at the north section of the Lagoon near the pumphouse. **(Photo IC-8)**

Photo IC-5 Local erosion and sparse vegetation. (looking southwest)

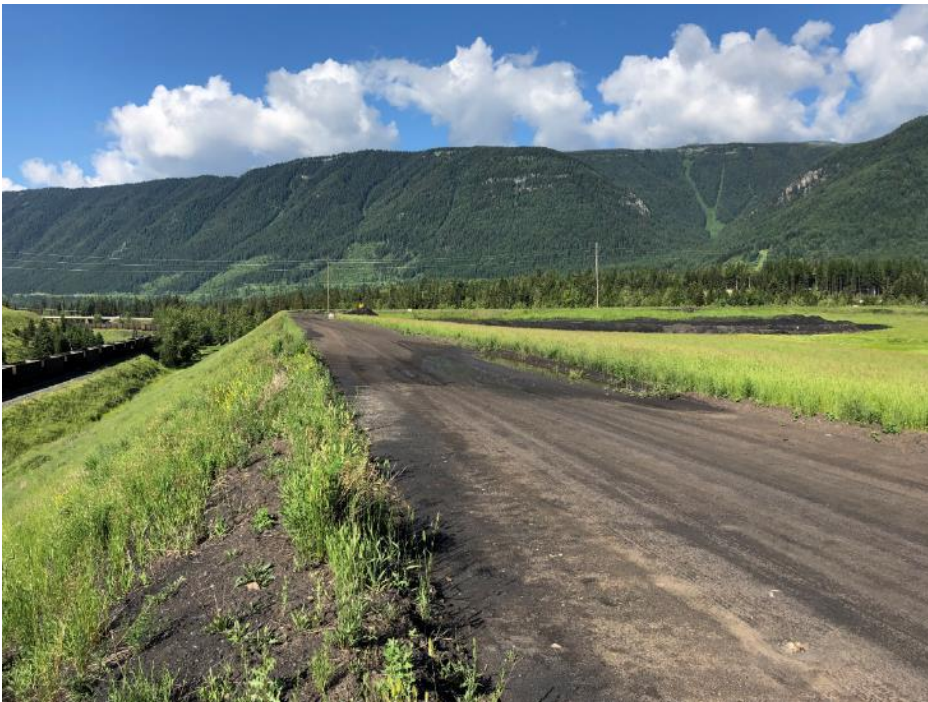
Photo IC-6 Local low spot on crest. (looking east)

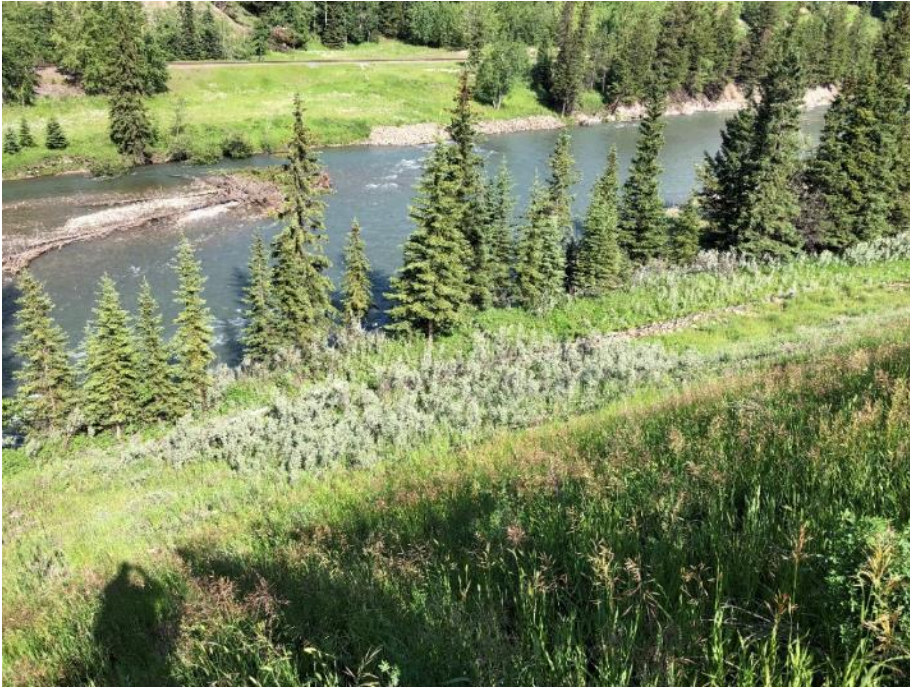
Photo IC-7 Changes in vegetation potentially indicating seepage or wet spots. (looking west)

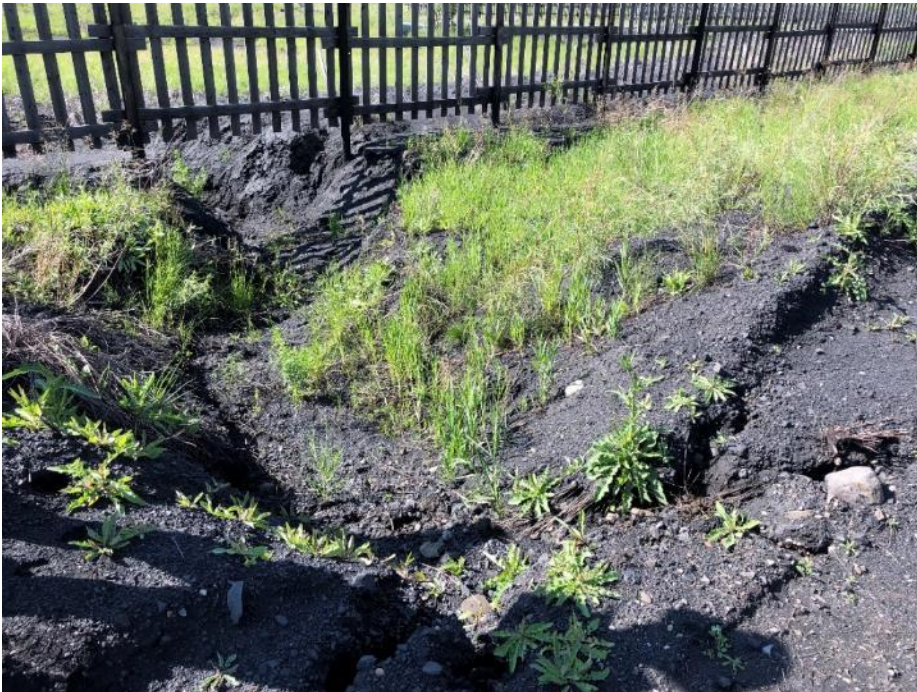
Photo IC-8 Erosion on the upstream side near the pumphouse. (looking south)

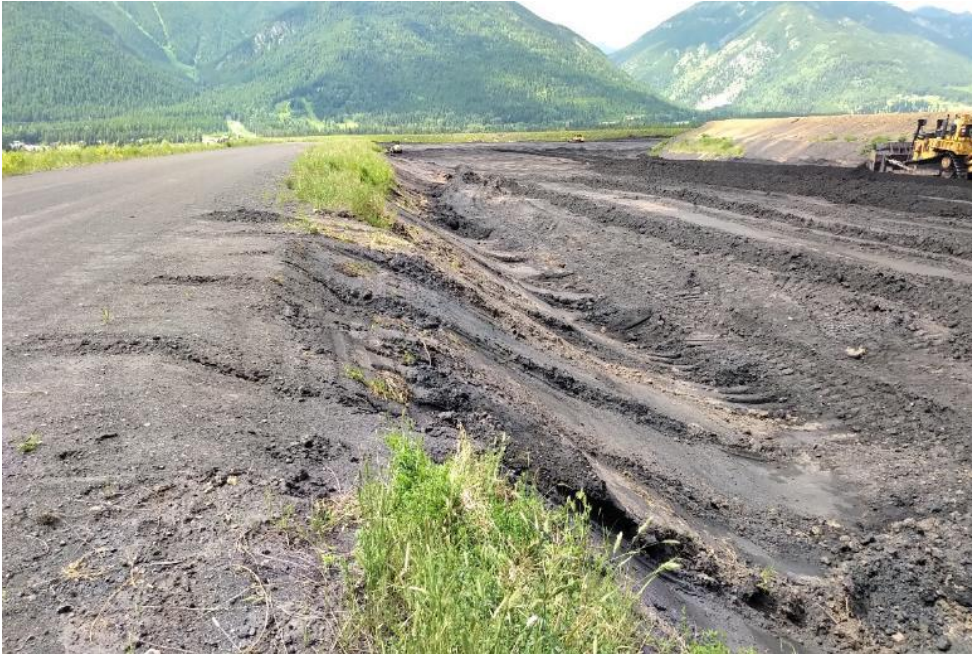
Photo ID-9 Upstream crest erosion 2. (looking west)

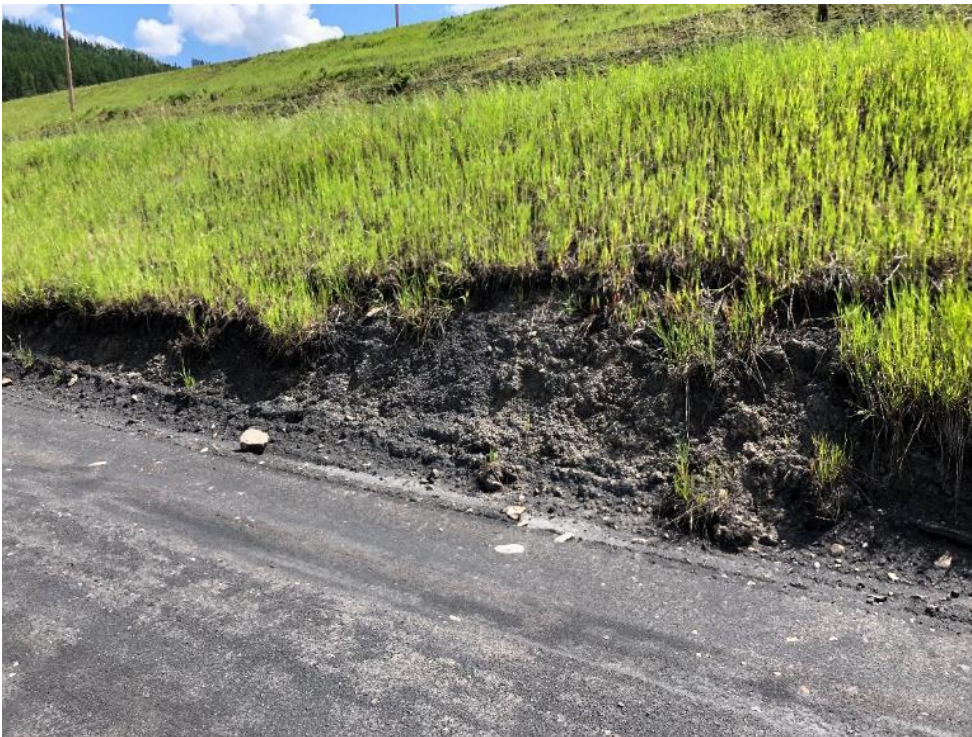
- The pipes draining the cells into the central area of Lagoon D appeared to have inconsistent elevations that may possibly be higher than the outer walls of the cells. This could result in flow over the crest of the cells or sidewalls if they were filled and hence the available freeboard would not be acceptable. **(Photo ID-3, ID-11)**
- Minor upstream erosion of the crest was visible. **(Photo ID-8, ID-9)**
- Minor downstream erosion was observed a several locations around the Lagoon D facility. **(Photo ID-10, ID-18, ID-19)**

Photo ID-10 Minor bench erosion. (looking south)

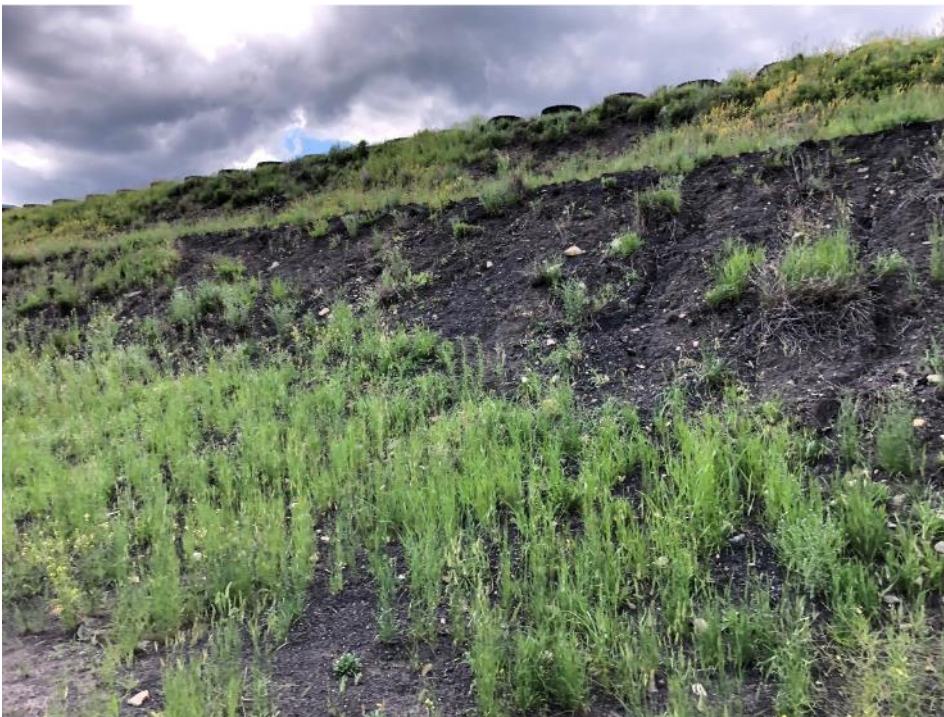
Photo ID-18 Downstream erosion and sparse vegetation. (looking west)

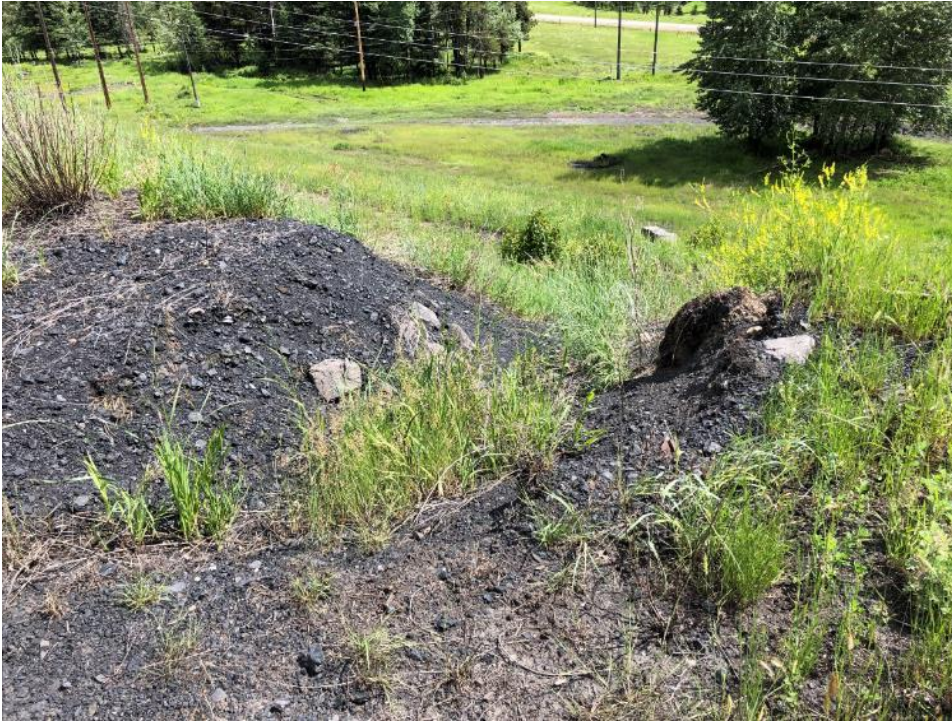
Photo ID-19 Minor gully erosion on the southern portion of the lagoon. (looking south)

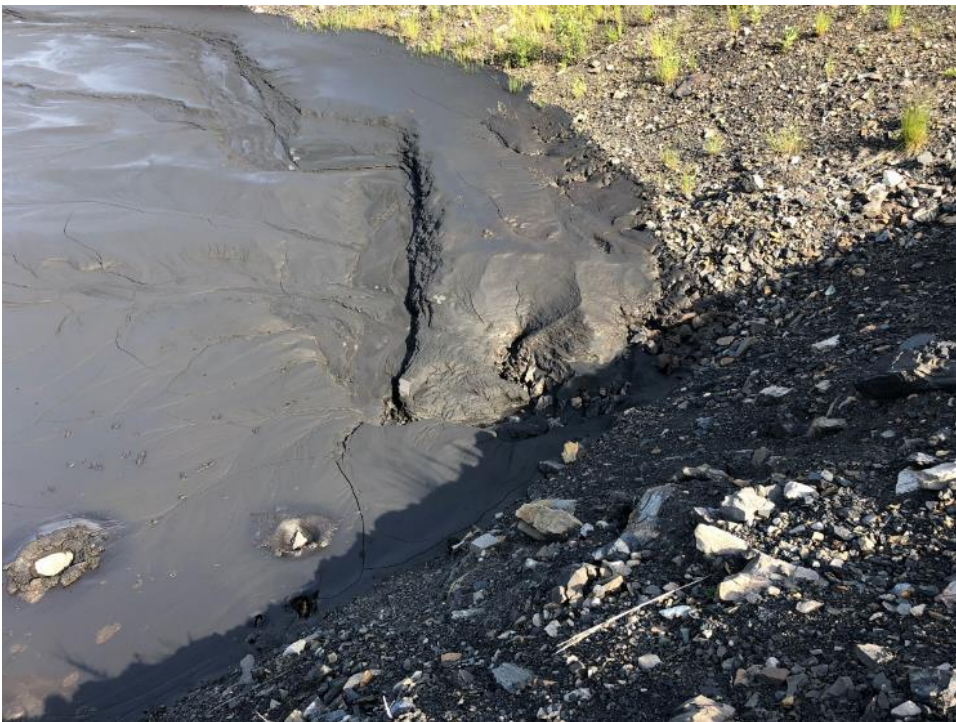
Photo IW-4 Tailings infiltration into east abutment. (looking north)

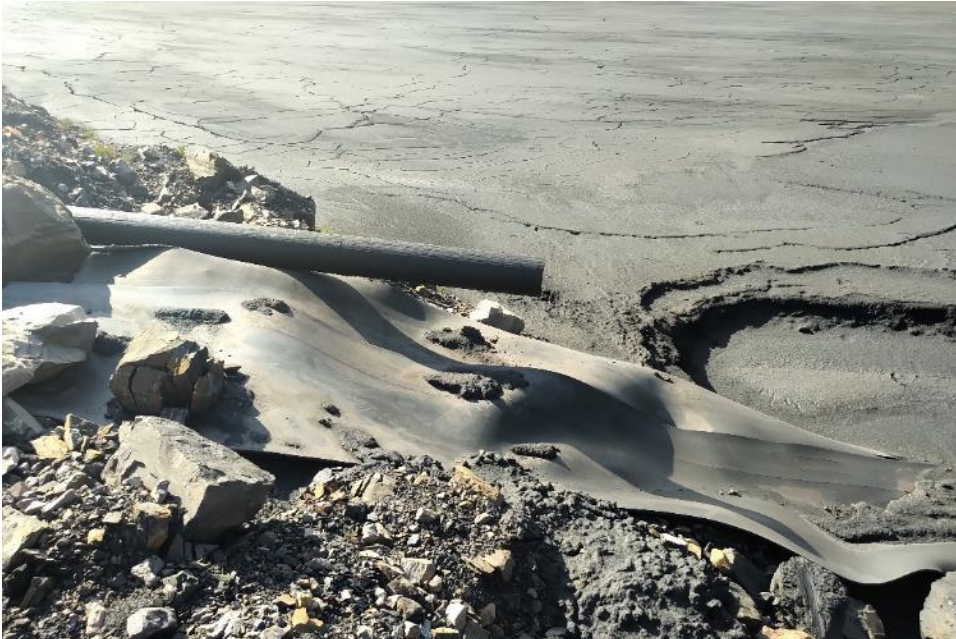
Photo IW-5 Upstream slope erosion protection at spigot 1. (looking northwest)

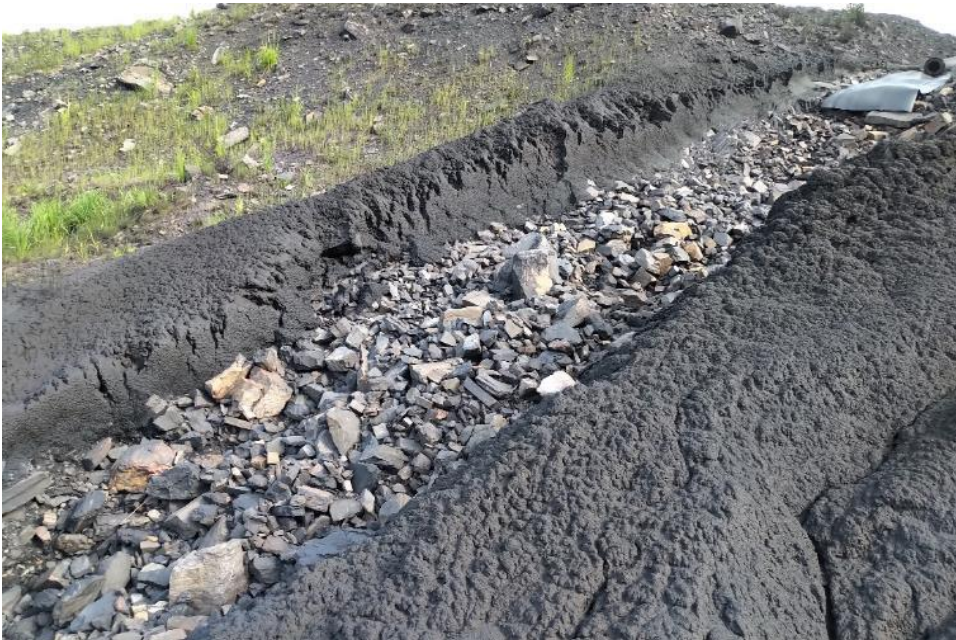
Photo IW-6 Upstream slope erosion protection at spigot 2. (looking south)

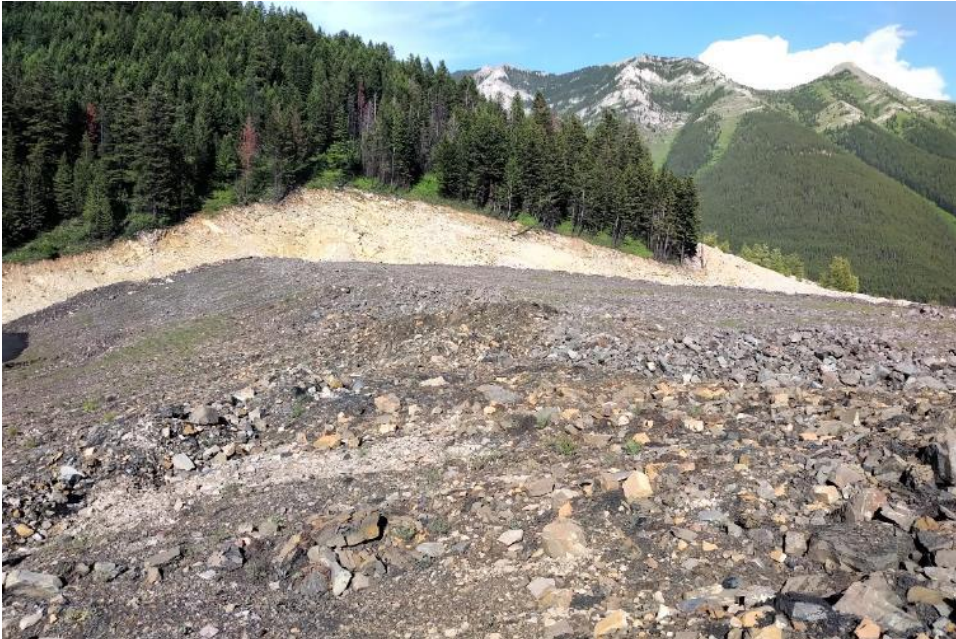
Photo IW-7 Crest typical conditions 1. (looking east)

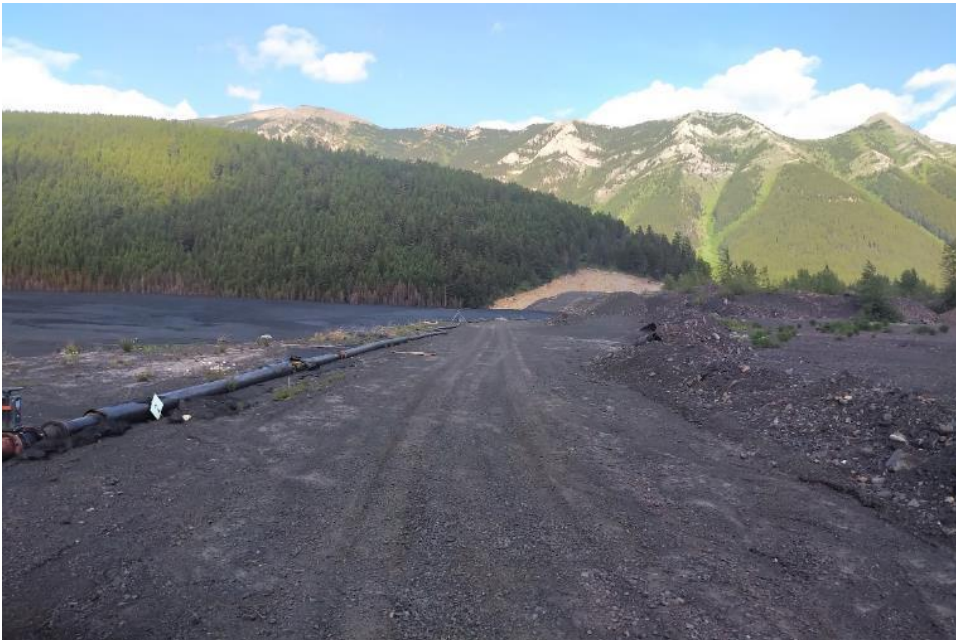
Photo IW-8 Crest typical conditions 2. (looking east)
