2019 Dam Safety Inspection

Greenhills Operations Tailings Storage Facility

Teck Coal Limited

Reference No. 18110798-2019-148-R-Rev0-3000

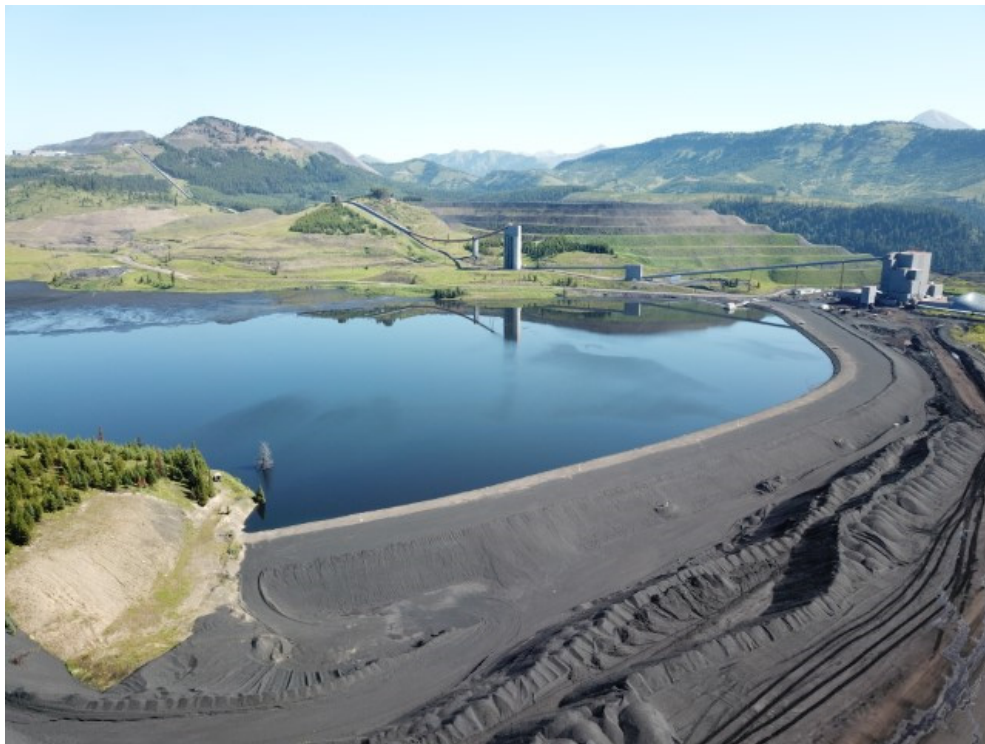
Photograph 1: Main Tailings Dam – looking Northeast, 26 September 2019

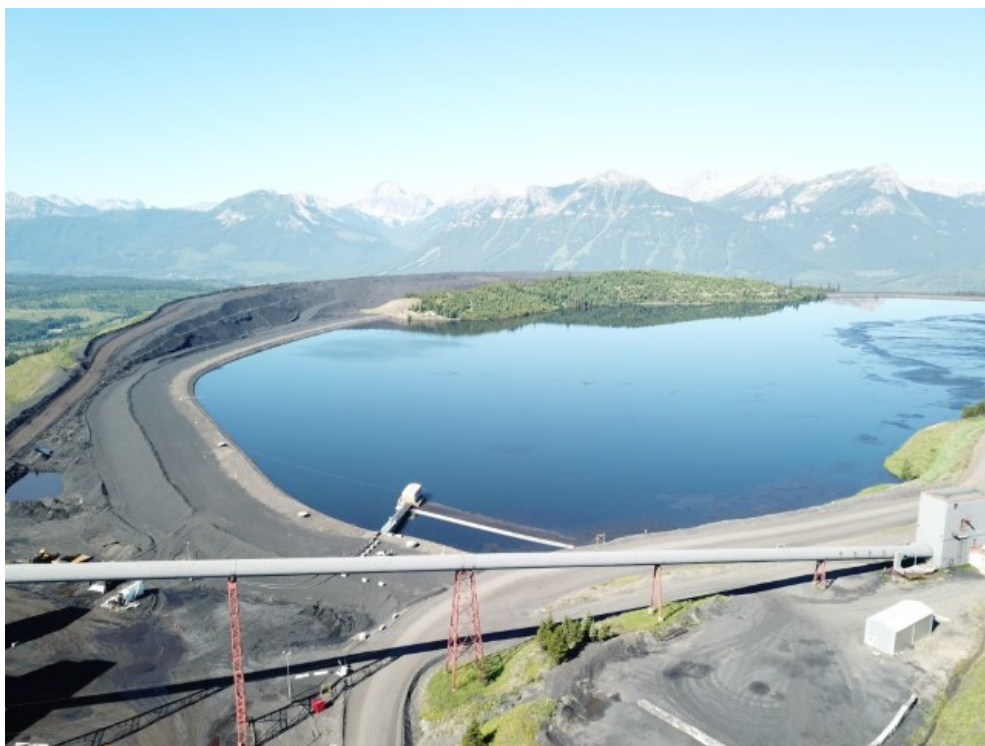
Photograph 2: Main Tailings Dam – looking West, 26 September 2019

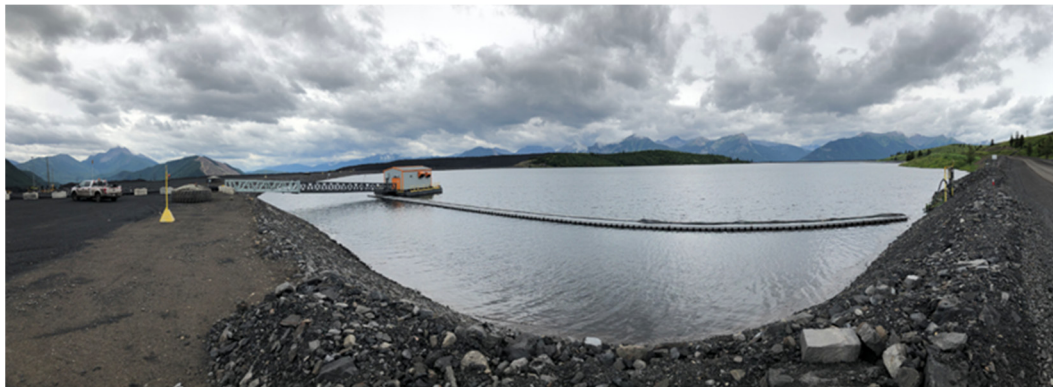
Photograph 3: Main Tailings Dam – Reclaim Barge; looking Southwest, 17 July 2019

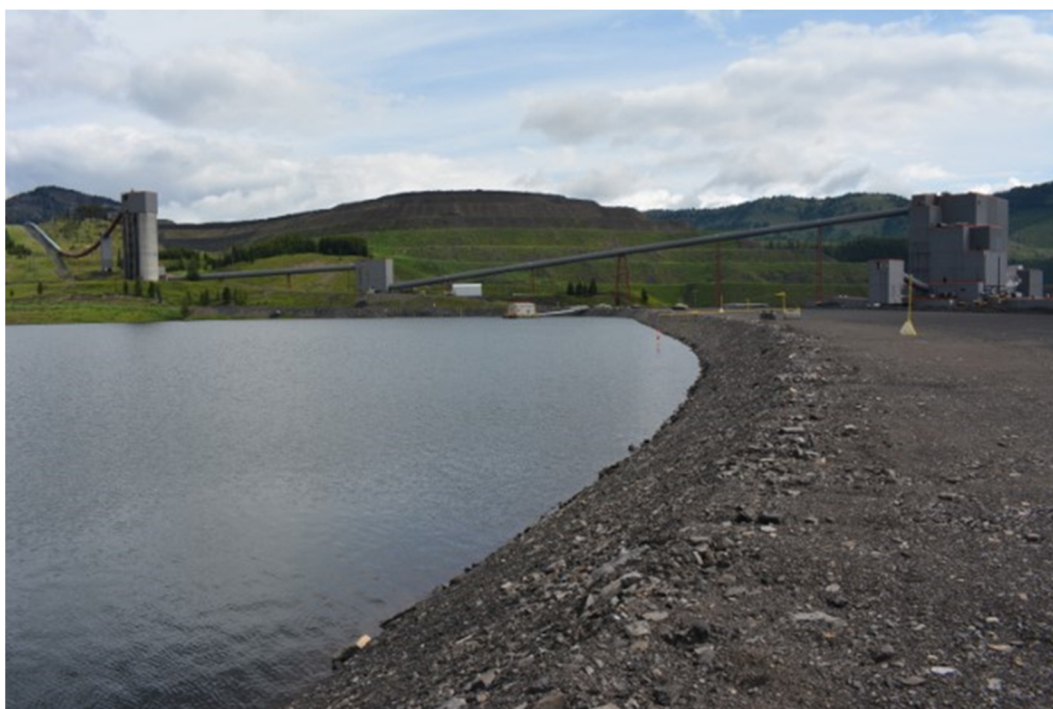
Photograph 4: Main Tailings Dam – Upstream Slope, Crest and East Abutment; looking Northeast, 17 July 2019

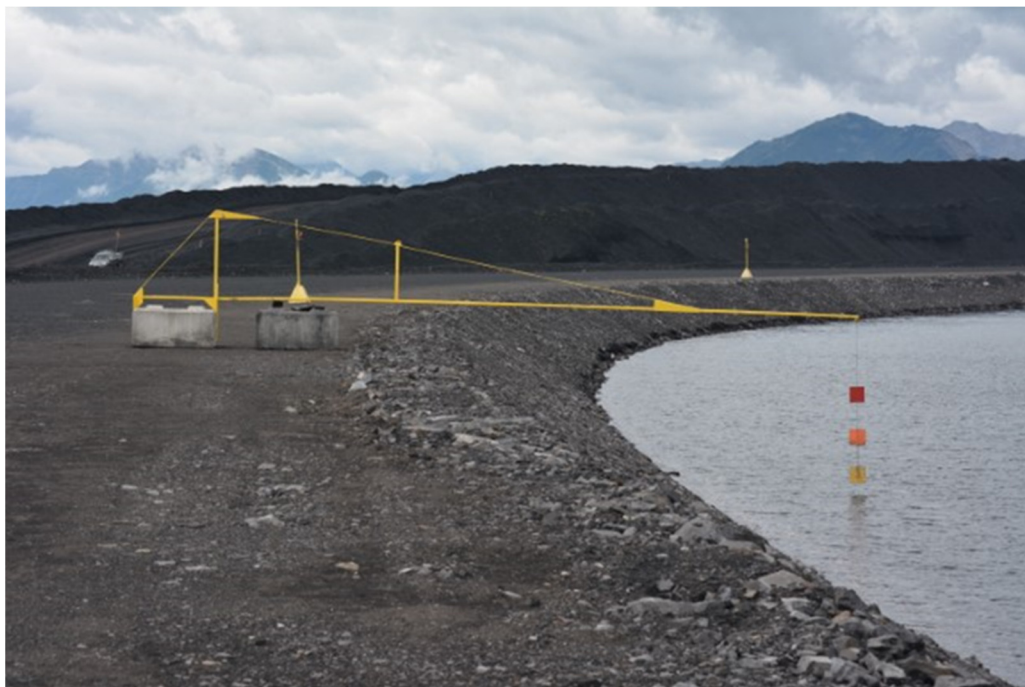
Photograph 5: Main Tailings Dam –Freeboard Indicator; looking Southwest, 17 July 2019

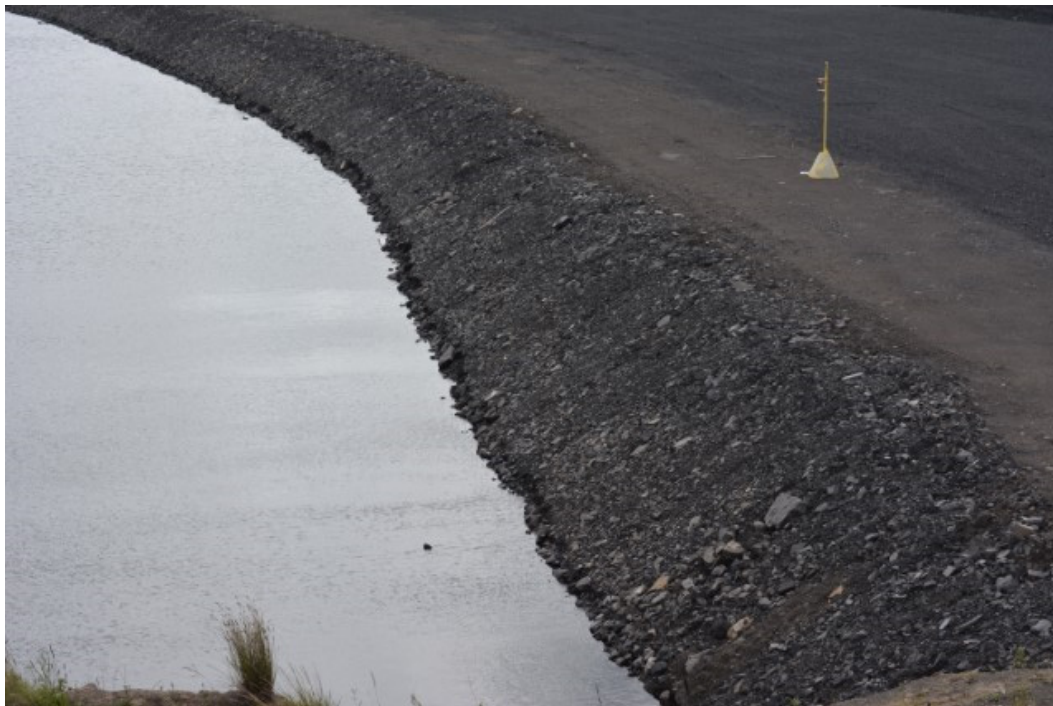
Photograph 7: Main Tailings Dam – Upstream Slope and Crest; looking Southeast, 17 July 2019

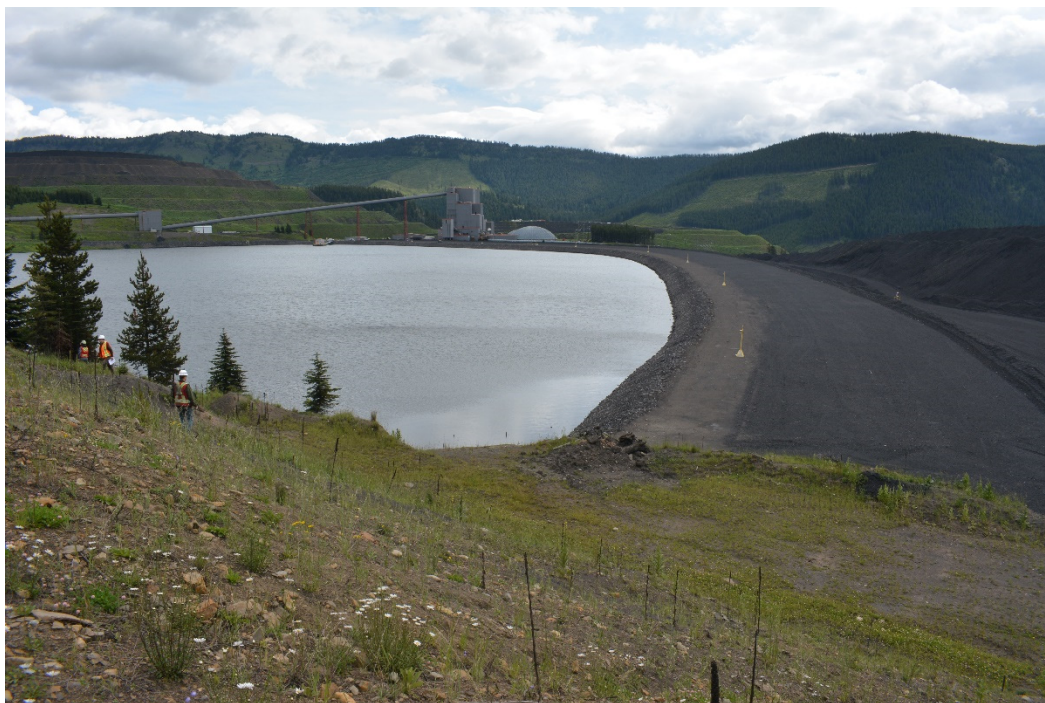
Photograph 8: Main Tailings Dam – Crest and West Abutment; looking East, 17 July 2019

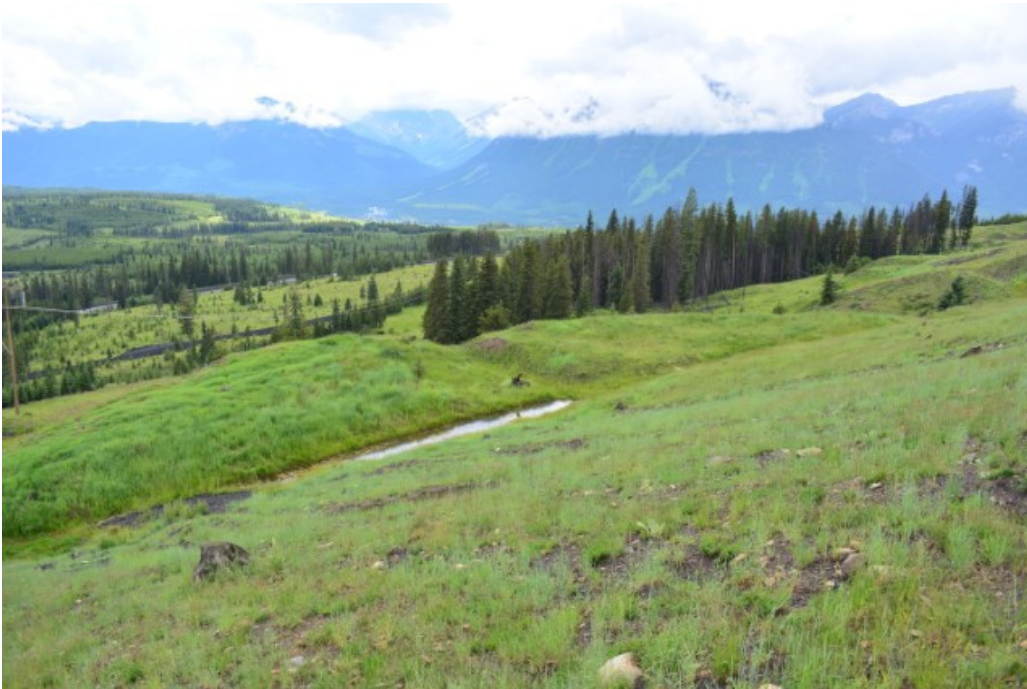
Photograph 11: Site D Coarse Coal Refuse Spoil – Downstream Toe Area; looking Southwest, 17 July 2019

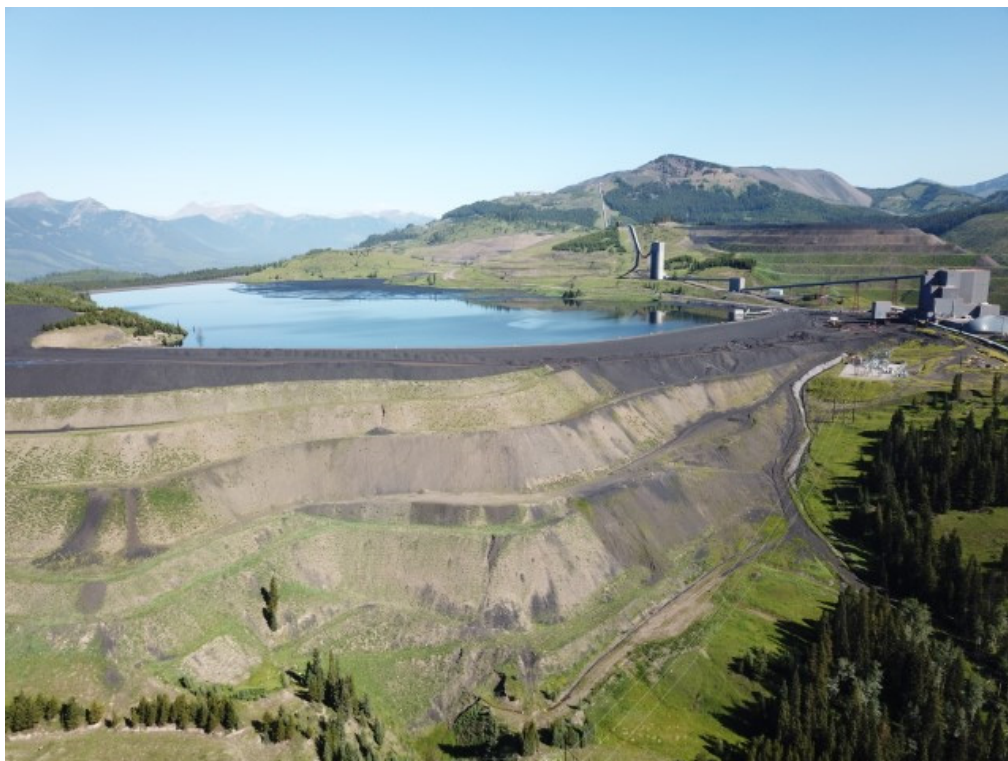
Photograph 13: Site C Coarse Coal Refuse Spoil and Main Dam – looking North, 26 September 2019

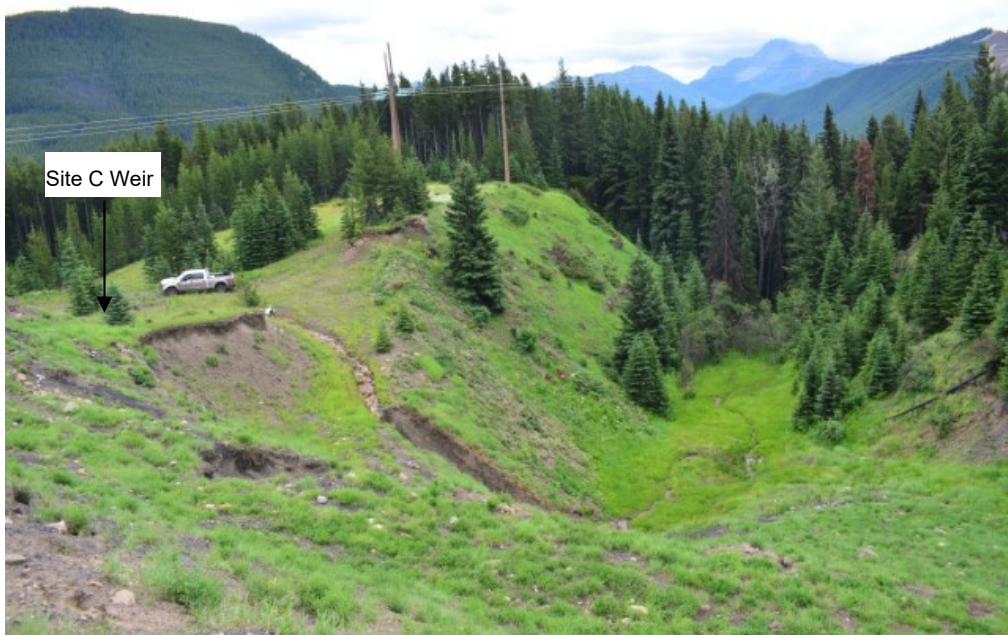
Photograph 14: Site C Weir and Downstream Creek; looking South, 17 July 2019

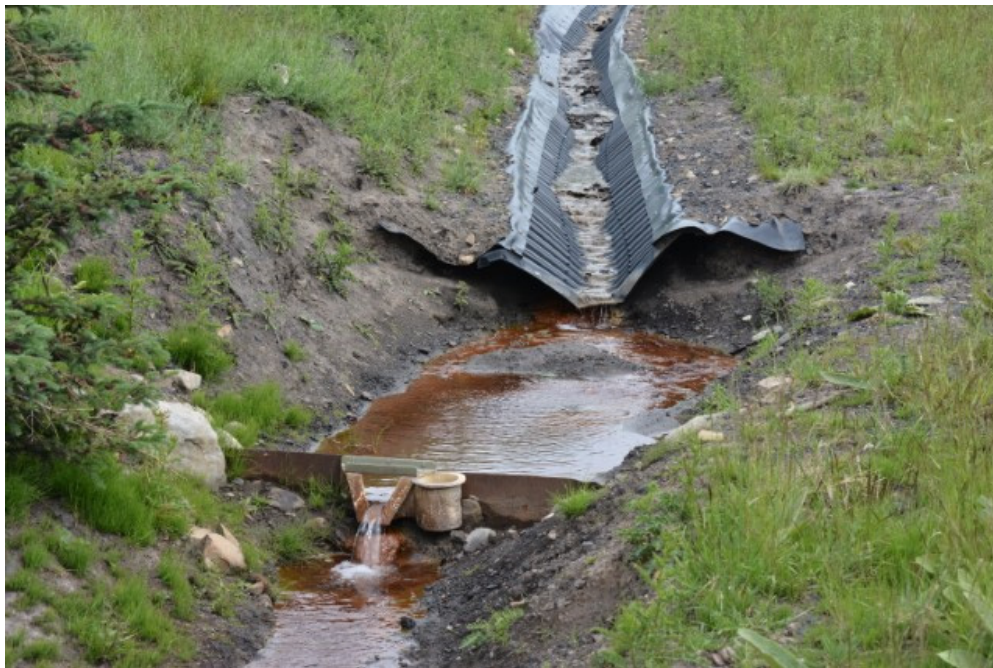
Photograph 15: Site C Seepage Weir - looking Northeast, 17 July 2019

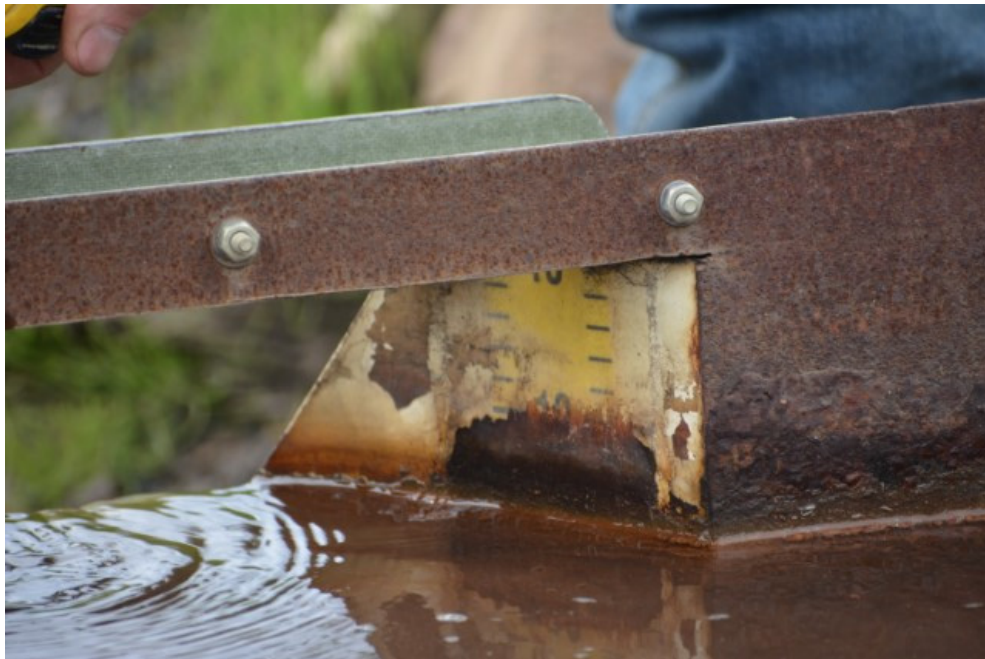
Photograph 16: Site C Seepage Weir – Measurement Gauge; looking West, 17 July 2019

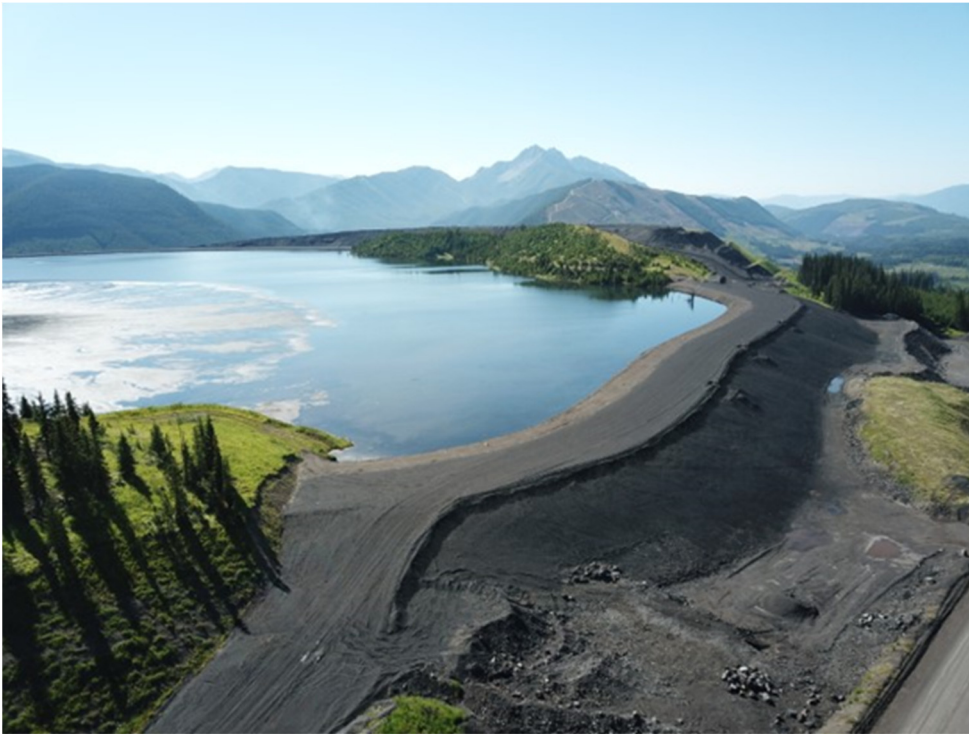
Photograph 19: West Tailings Dam – looking Southeast, 26 September 2019

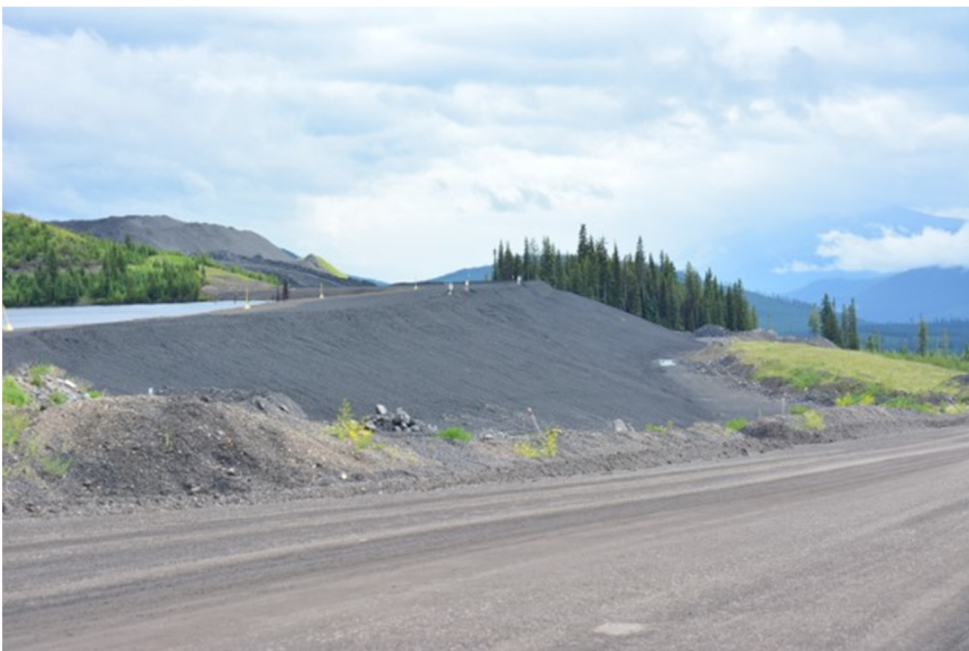
Photograph 20: West Tailings Dam – Downstream Slope and Toe Area; looking Southeast, 17 July 2019

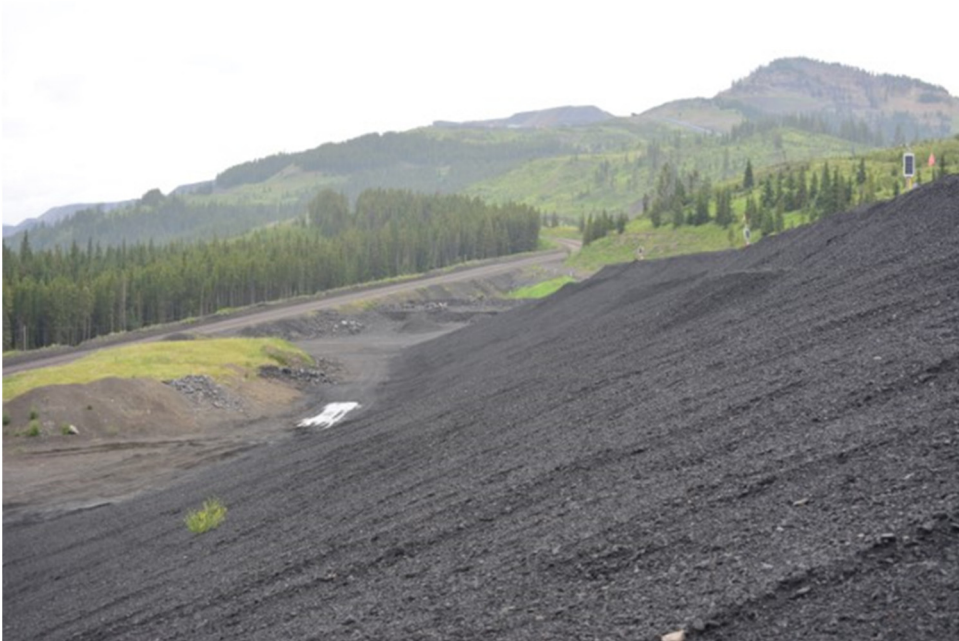
Photograph 22: West Tailings Dam – Downstream Slope and Toe Area; looking North, 17 July 2019

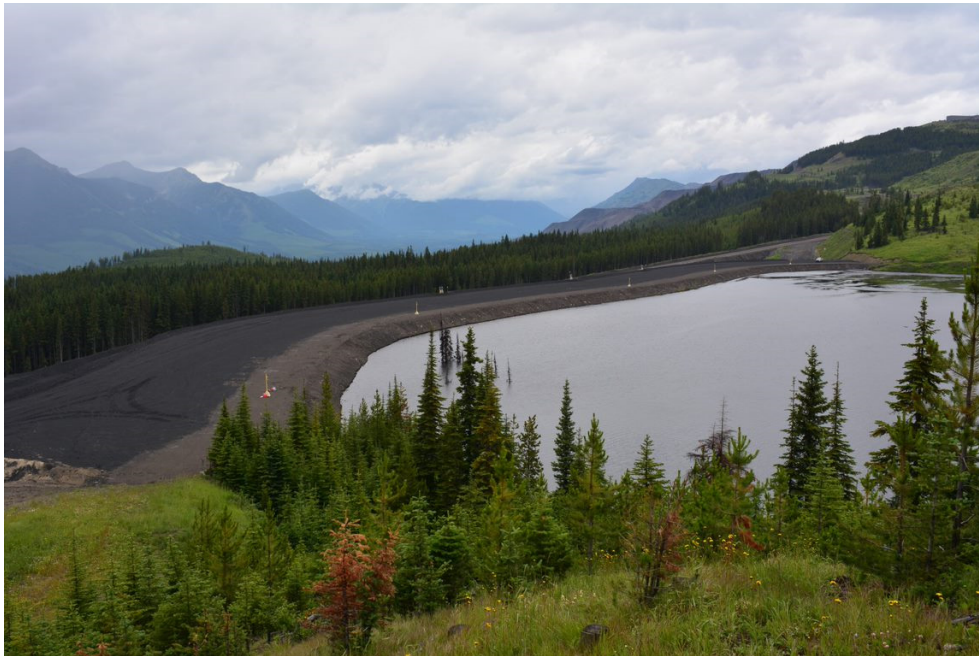
Photograph 23: West Tailings Dam – Crest and South and North Abutments; looking North, 17 July 2019

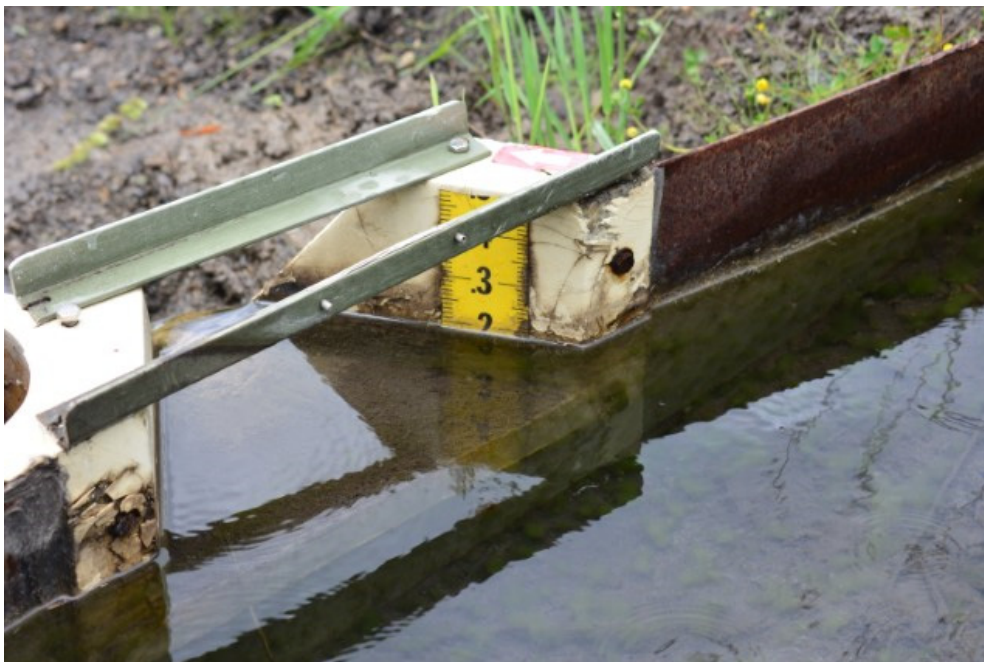
Photograph 24: West Tailings Seepage Weir - Measurement Gauge; 17 July 2019
