# **Teck Highland Valley Copper Partnership**

**2019 Dam Safety Inspection Report**

*Highmont Tailings Storage Facility*

April 2020

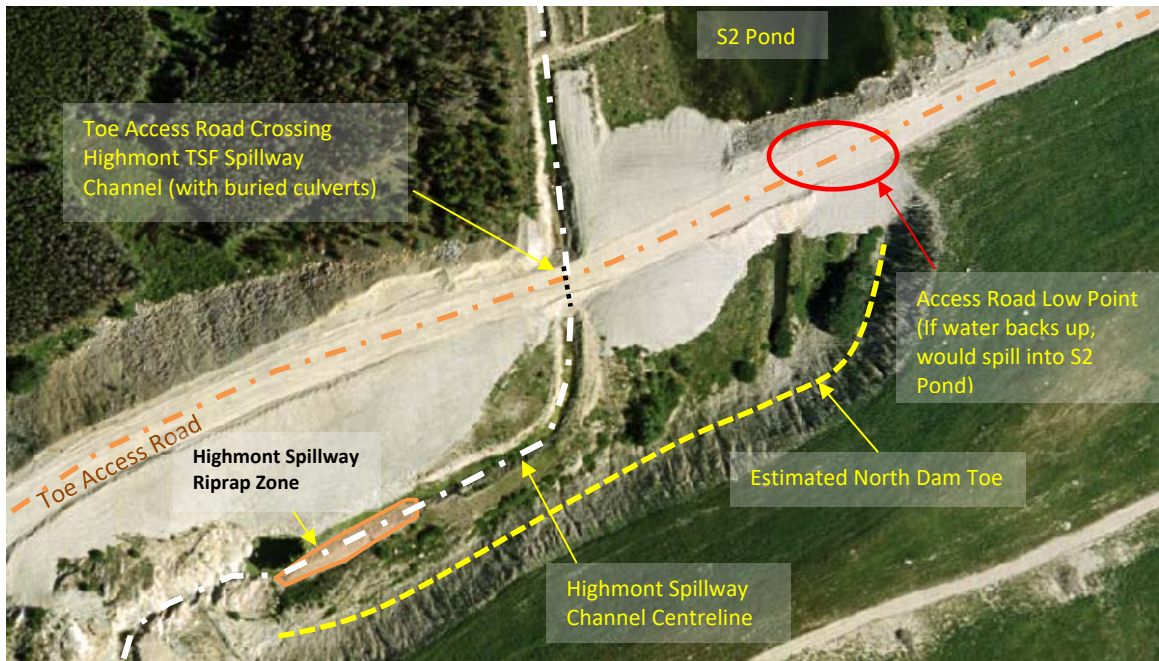
**Figure 4.3 Potential Flood Zone Along North Dam Toe Due to Access Road**

- The majority of the spillway channel near the North Dam is founded in bedrock. A portion of the channel, downstream of the toe and upstream the toe access road (Figure 4-3), is excavated entirely in Glacial Till and was covered by riprap. The DSR (SRK 2019) recommended that the riprap sizing in this area be reviewed under the spillway design flood based on the most recent climate information. Schedule to complete this work will be defined in 2020 along with other DSR recommendations.

- ◆ KCB recommends THVCP modify the area, where the toe access road crosses the spillway channel, to allow the peak spillway flow to pass beneath the access road (e.g. bridge or arch culvert) or regrade the road surface such that, if water that flows over the road, would report to the spillway channel as intended by design. Interim milestones dates were proposed in the 2018 DSI (KCB 2019b); however, these should be reviewed and revised, as appropriate.

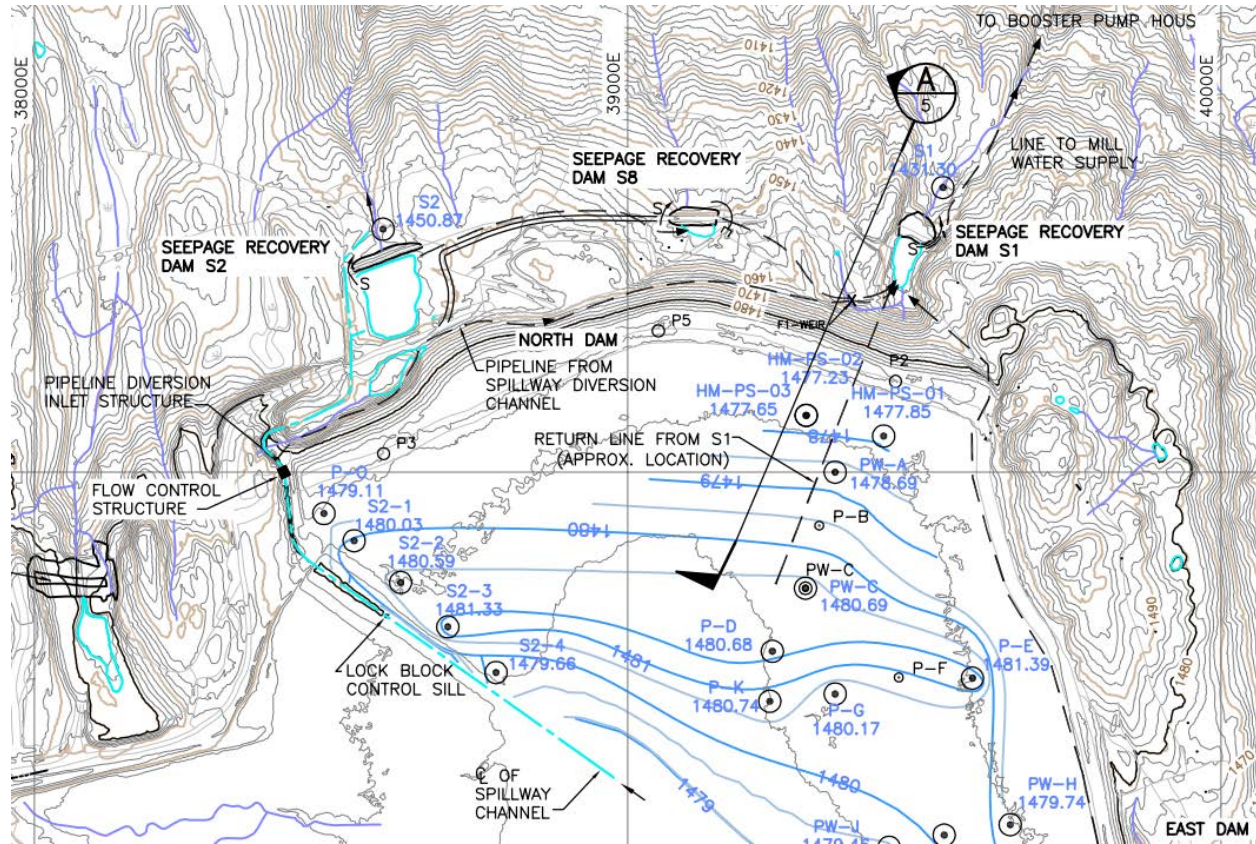
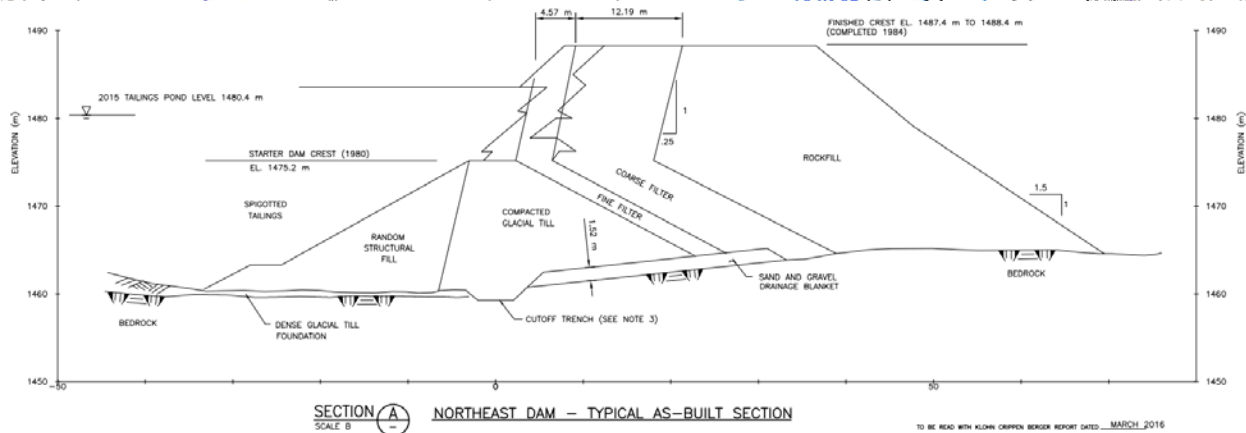
**SITE PLAN (North Dam)**

- There is vegetation growth at Highmont spillway channel (downstream of approach channel, and rock chute) which should be cleared as part of routine maintenance before freshet, including vegetation obstructing culverts crossing dam.
- Spillway flow control gate – No signage or safety grating is present at valve
- Completed walk-over of North Dam, near S1 Pond, where elevated piezo levels had been measured in 2017 and 2018. No visual indicators showing distress or concern observed. No seepage faces on downstream slope other than at toe, as expected.

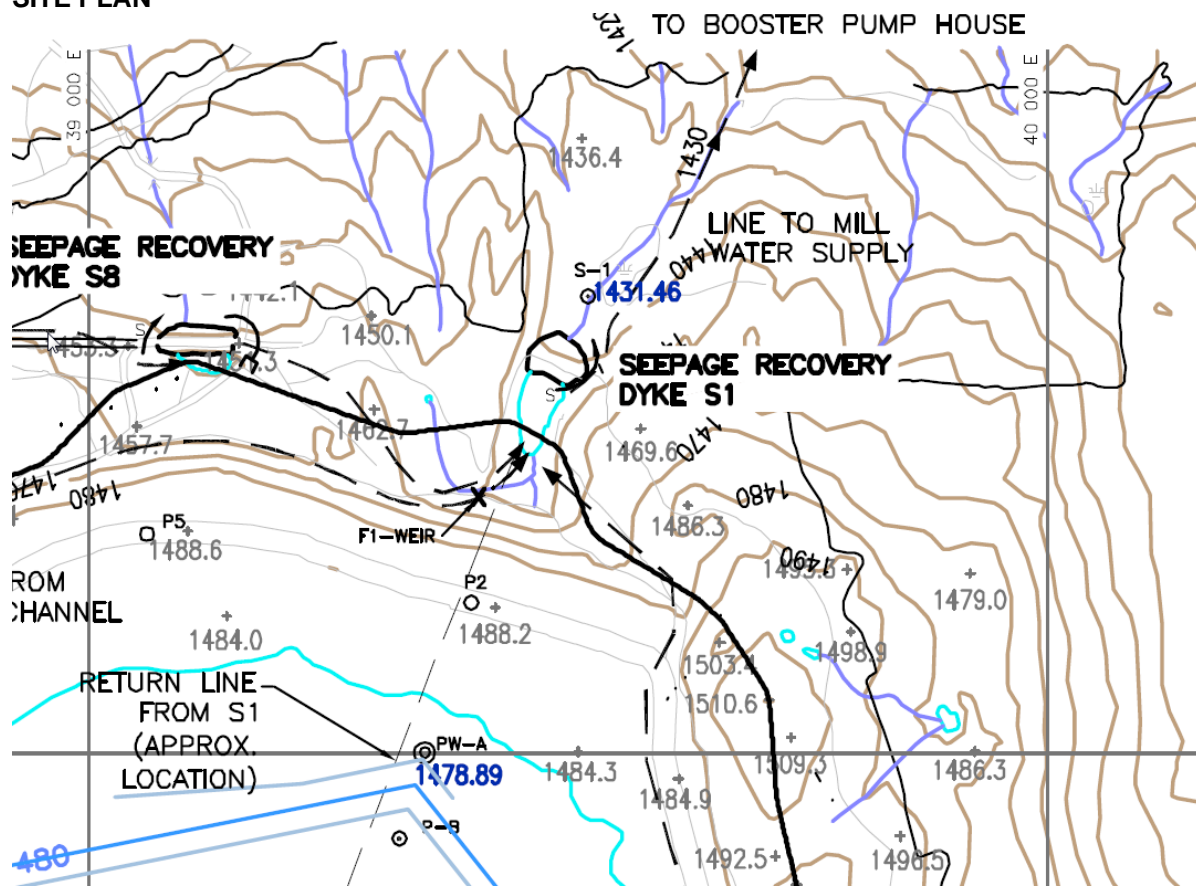
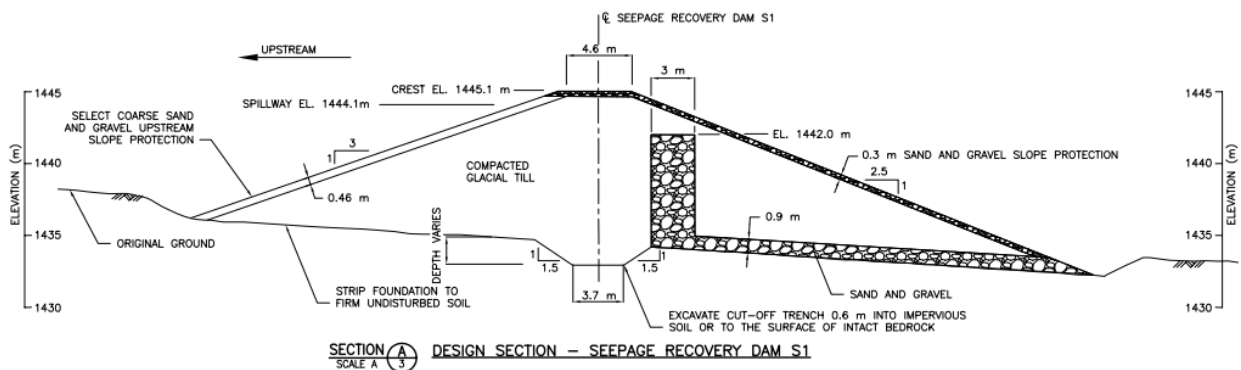
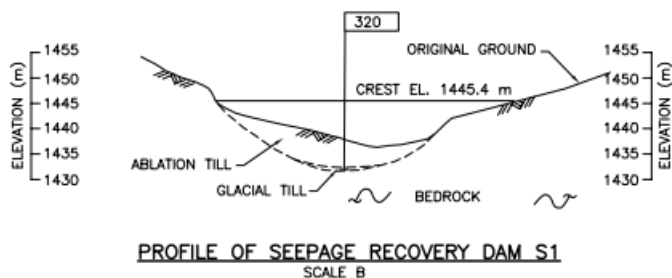
**SITE PLAN**

- Low level outlet intake is partially obstructed and should be cleared as part of THVCP routine maintenance. If obstructed, does not impact flood routing assumptions.

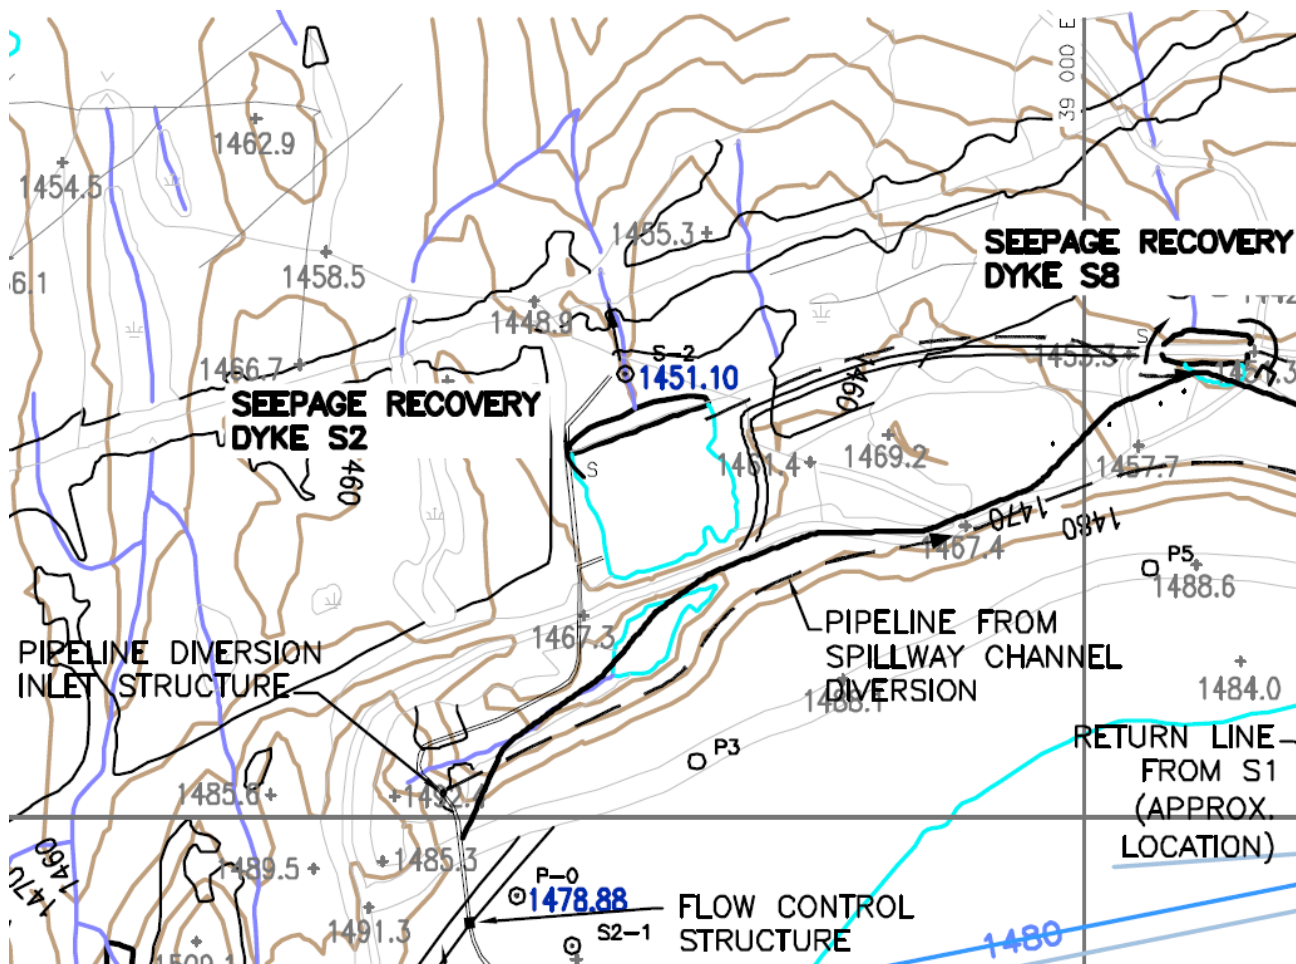
**SITE PLAN**

- Plug across inlet S2 channel to prevent flow from Highmont spillway channel from reporting to S2 Pond
- S2 Spillway is partially blocked (appears to be from a temporary access over the channel) and trees upstream of inlet. This do not pose an immediate dam safety concern but should be removed as part of regular maintenance by THVCP before freshet. Vegetation along spillway should be monitored and removed if reduces the outlet capacity.

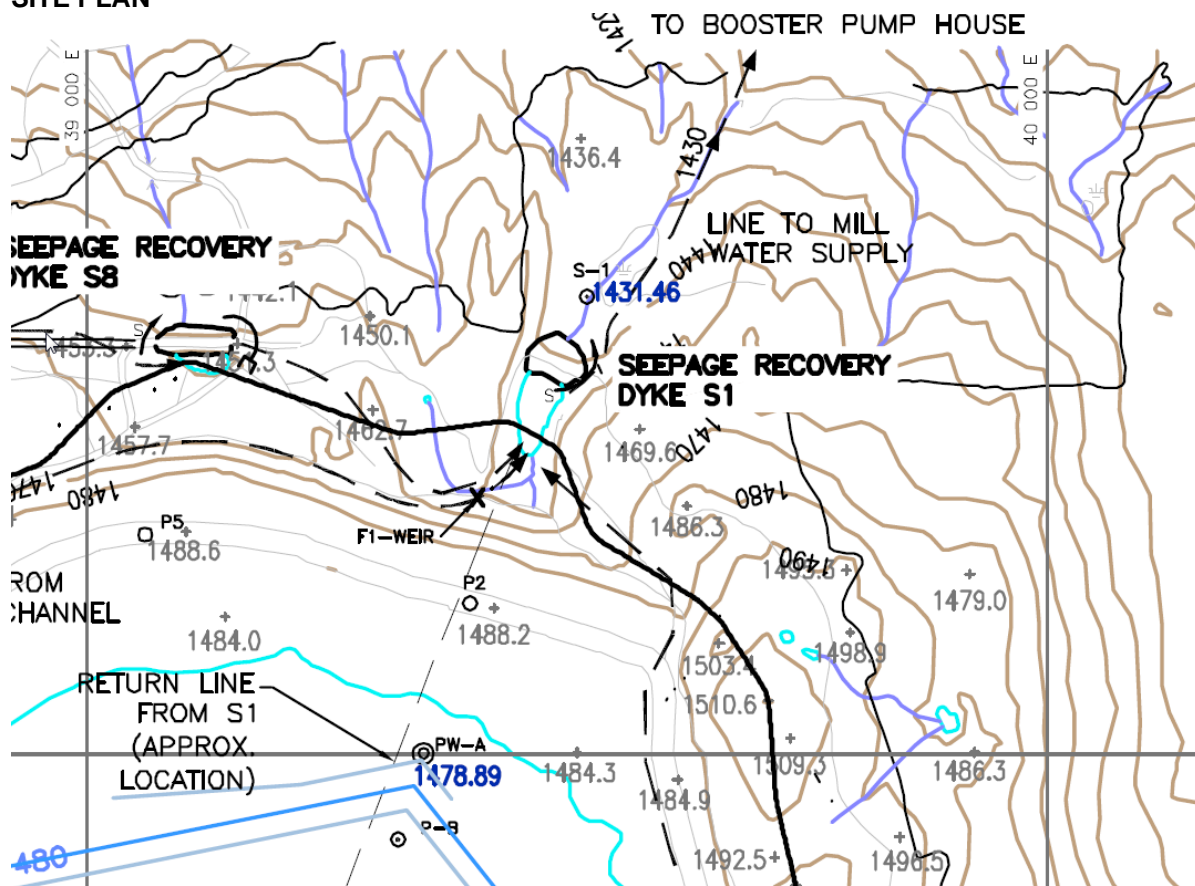
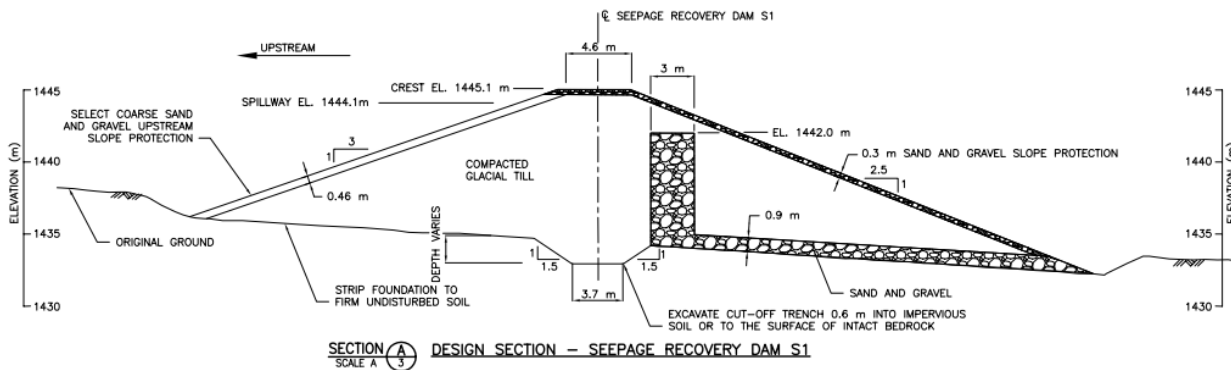
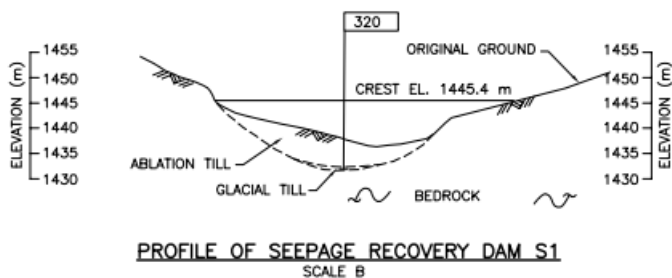
**SITE PLAN**

- Spillway intake is blocked with glacial till to prevent discharge of water during the IDF.
- Area around outlet control is heavily vegetated and may cause safety concern to personnel who require access to the outlet control.

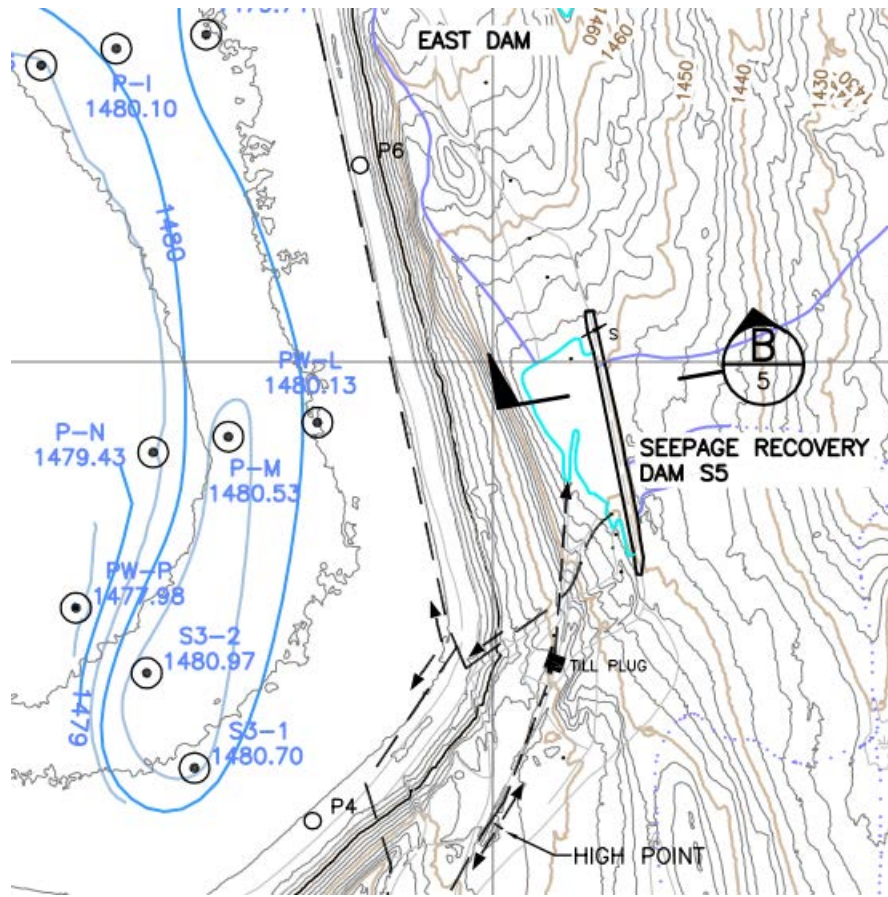
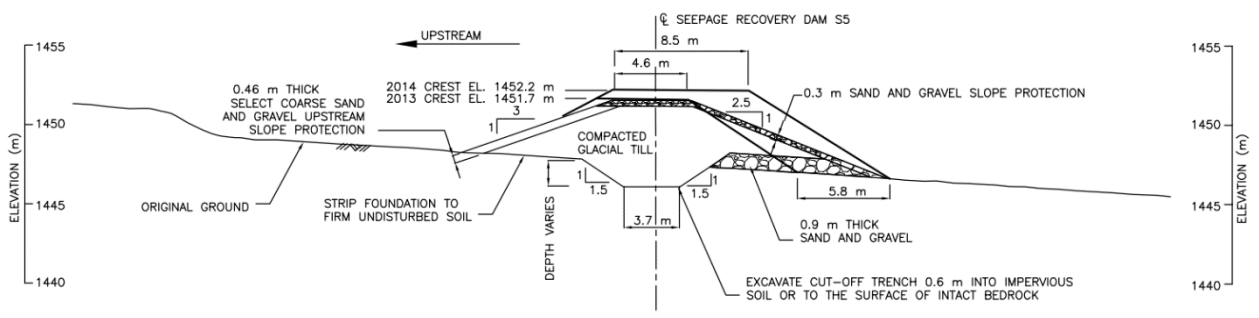
**SITE PLAN**

- Outlet pipes from pump sump sub-cell are sealed.
  - Refer to outstanding DSI recommendation RE: flood routing.
- Ruts observed on crest
- Spillway pipe valve is blocked and too low. It will not be accessible during a flood event
- Area around outlet control into the sub-cell where inflow reports to S5 Pond is heavily vegetated

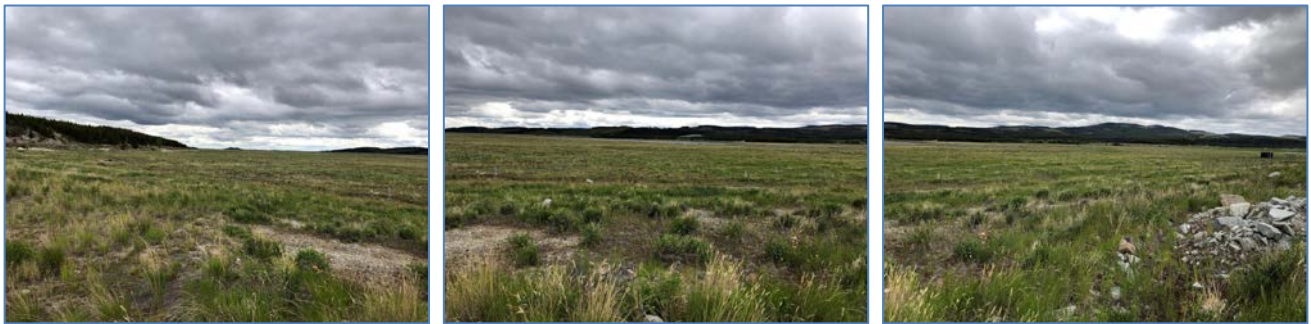
**Photo II-A-1 Overview of North Dam tailings beach, covered by vegetation. No signs of distress, settlement or depression. (HGH-2019-01)**

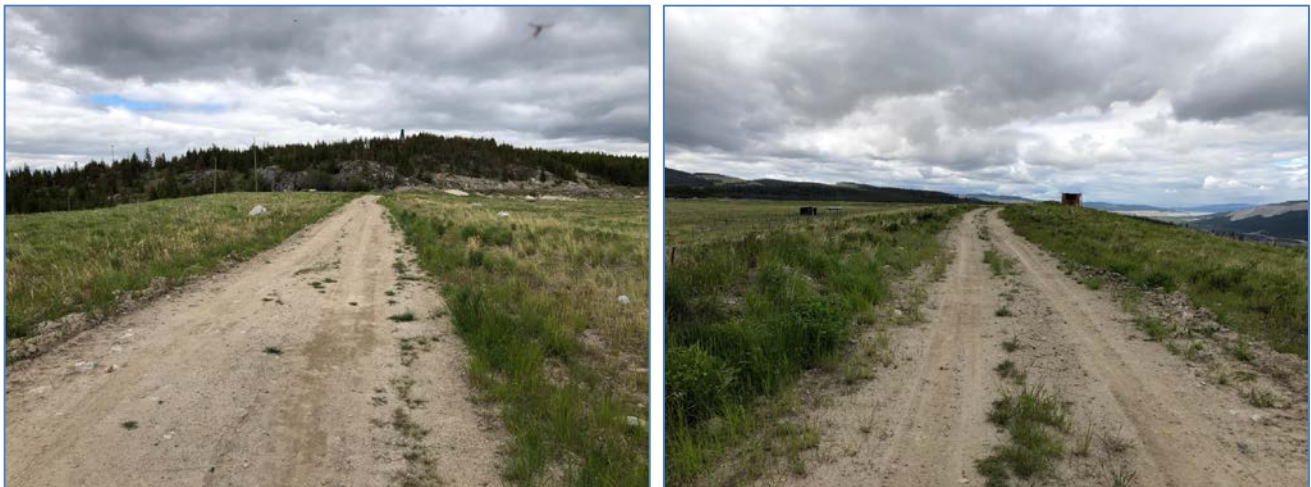
**Photo II-A-2 Overview of North Dam crest. No signs of distress, settlement or depression. (HGH-2019-01)**

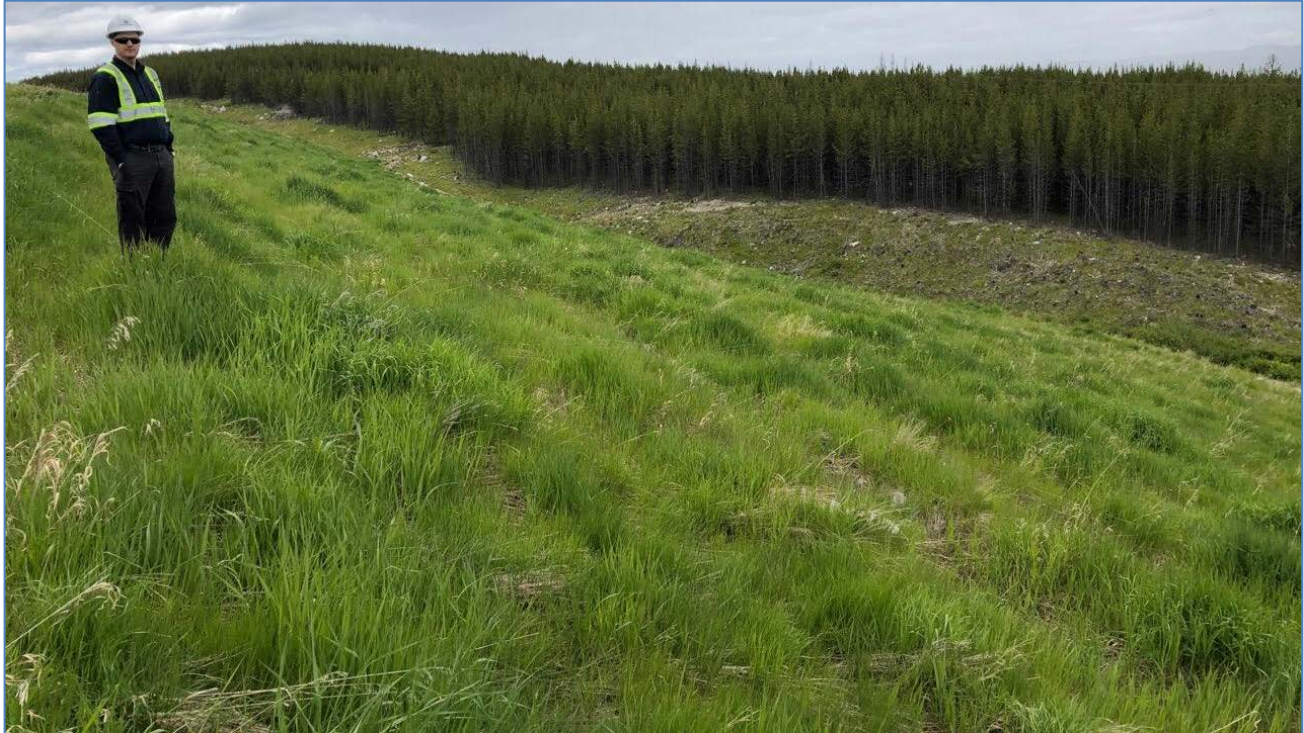
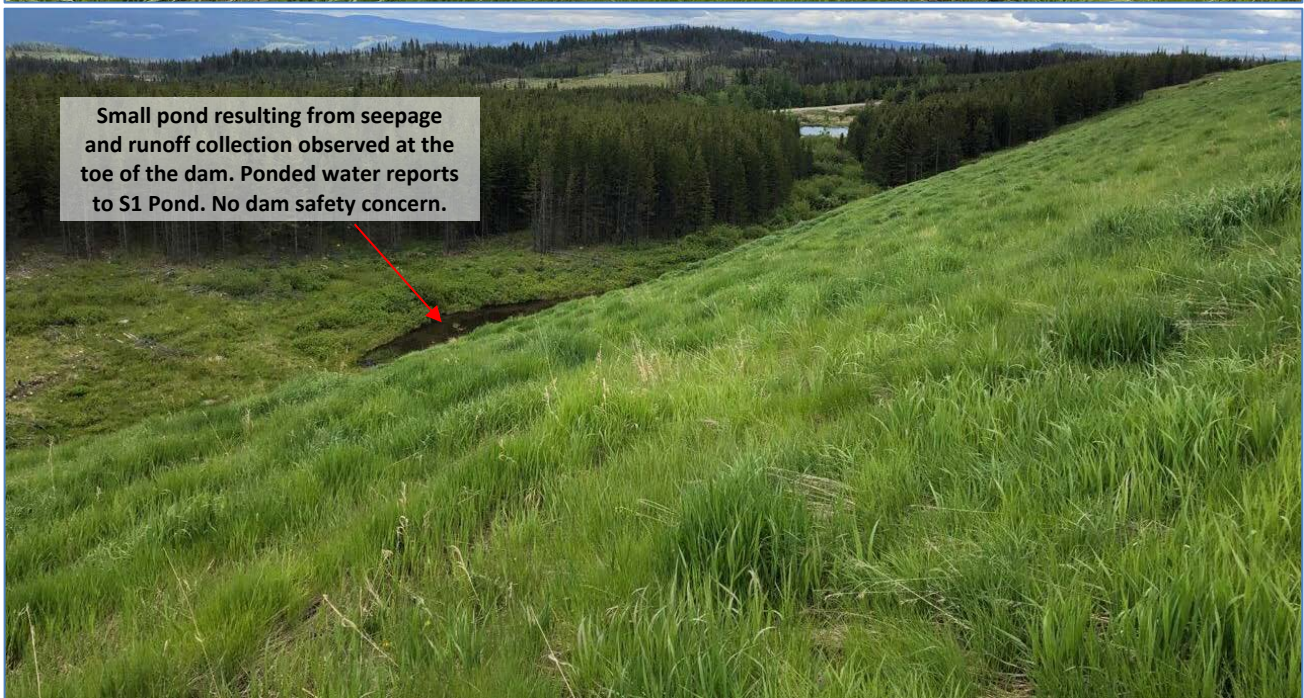
**Photo II-A-6 Overview of East Dam downstream slope, looking northeast. Slope covered by vegetation (HGH-2019-04)**

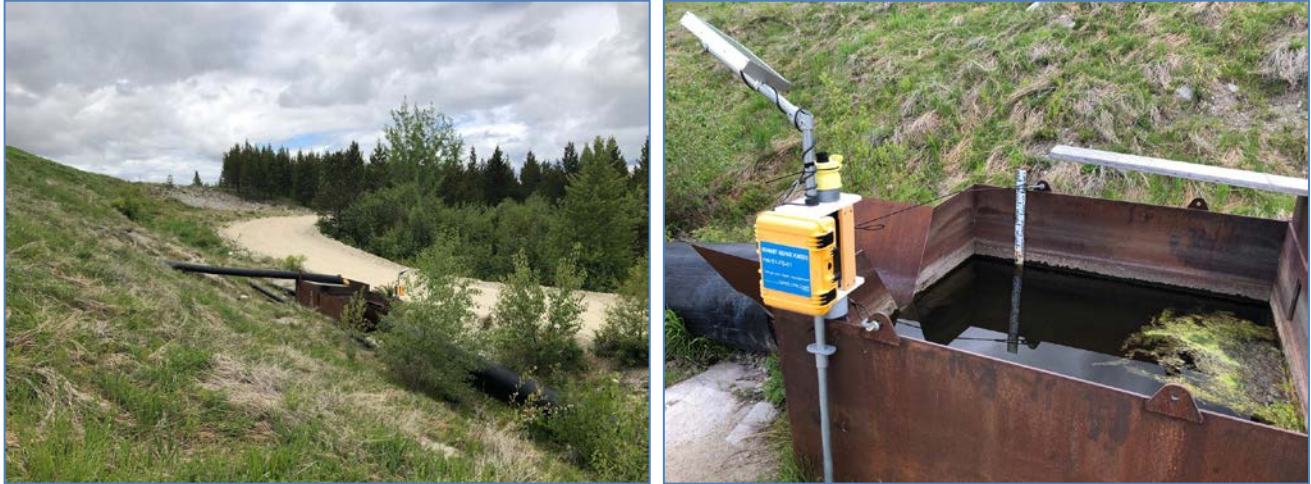
**Photo II-A-11 Highmont Spillway diversion pipe to S1 Pond. Water flowing (HGH-2019-10 and HGH-2019-11)**

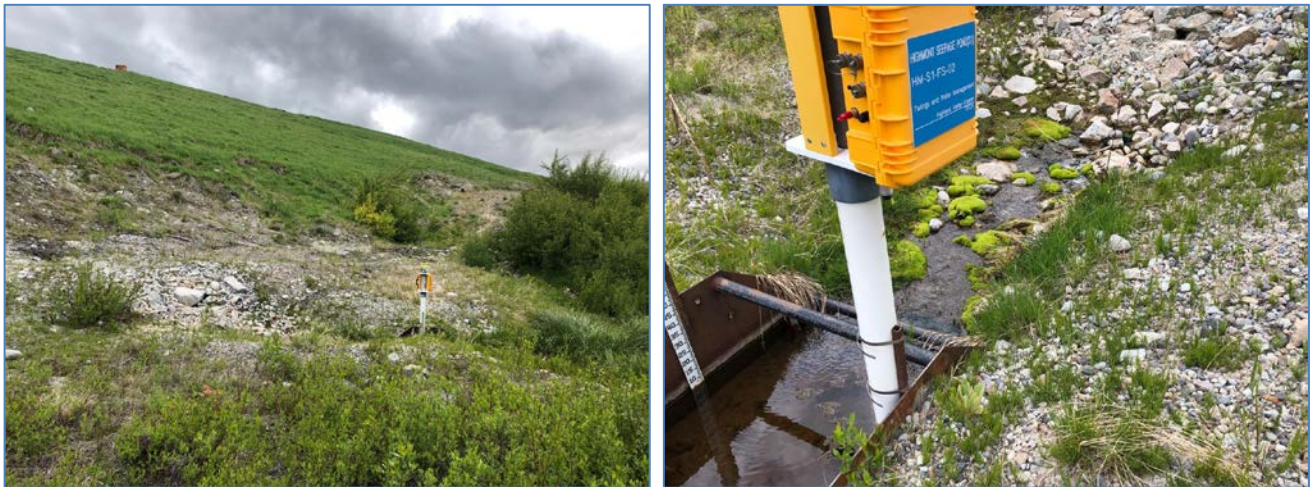
**Photo II-A-12 Seepage flow measurement weir at toe of Highmont Dam (HM-S1-FS-02). Water flowing. (HGH-2019-12 and HGH-2019-13)**

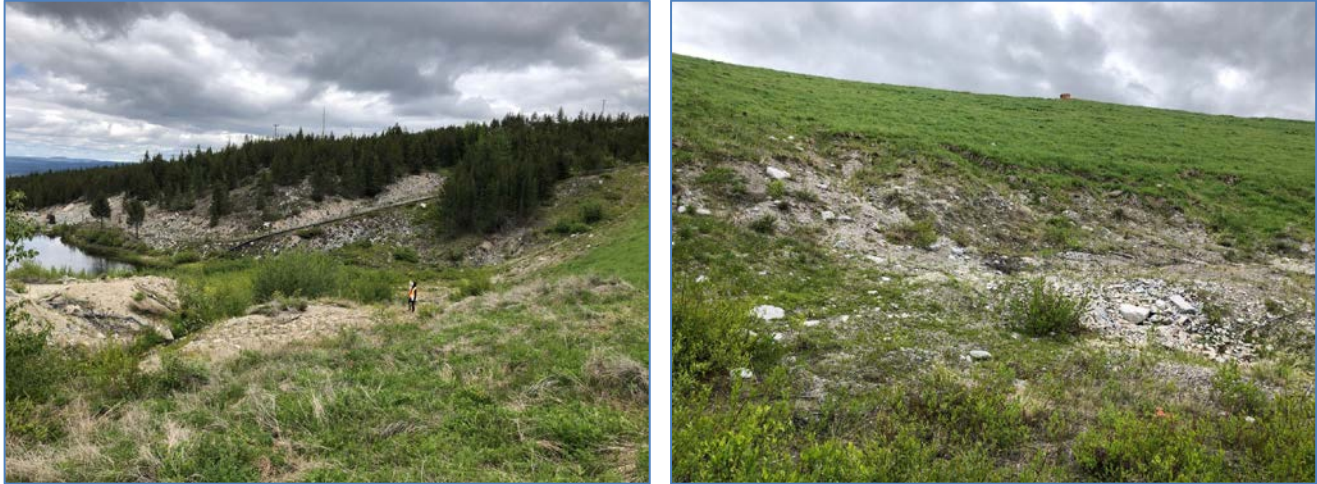
**Photo II-A-13 Overview of the North Dam downstream toe upstream of S1 Pond. No signs of seepage face on slope (HGH-2019-10 and HGH-2019-13)**

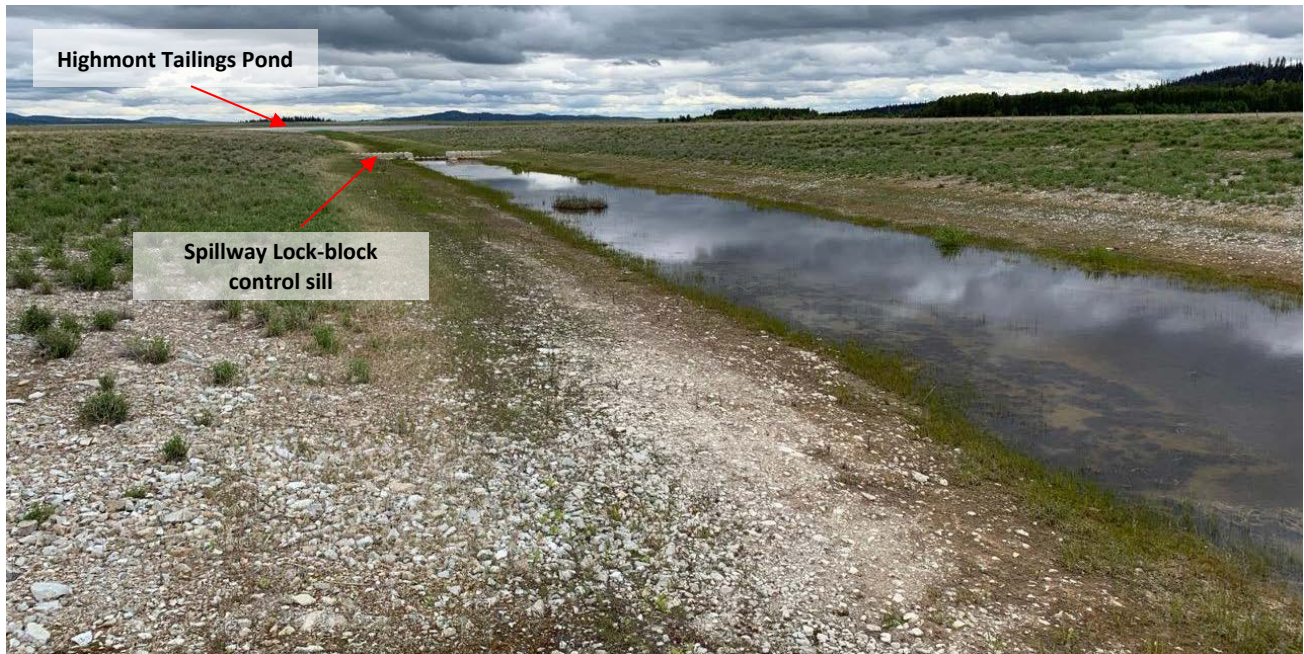
**Photo II-A-14 Highmont Spillway approach channel, concrete lock-block control sill – Spillway is inactive. Water ponded downstream of sill is controlled by level at spillway flow control gate (HGH-2019-14)**

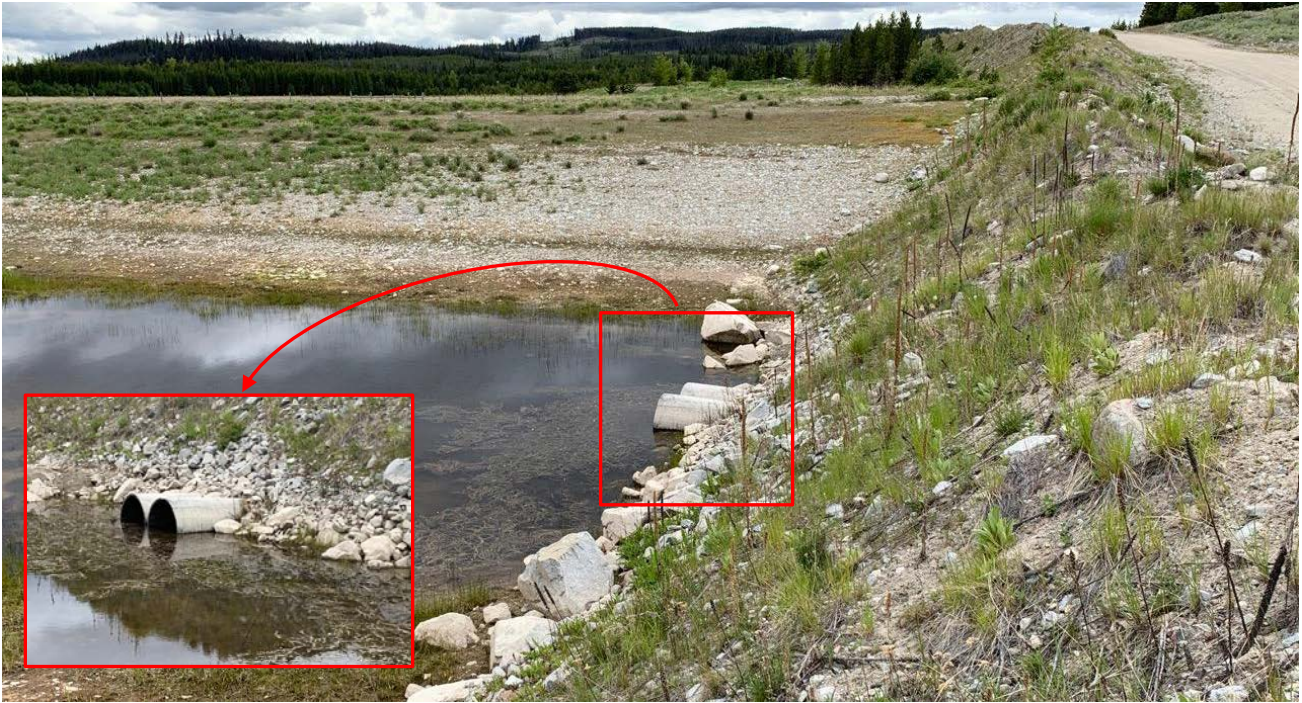
**Photo II-A-15 Approach channel - Road culverts are partially submerged, clear of debris and vegetation. (HGH-2019-14)**

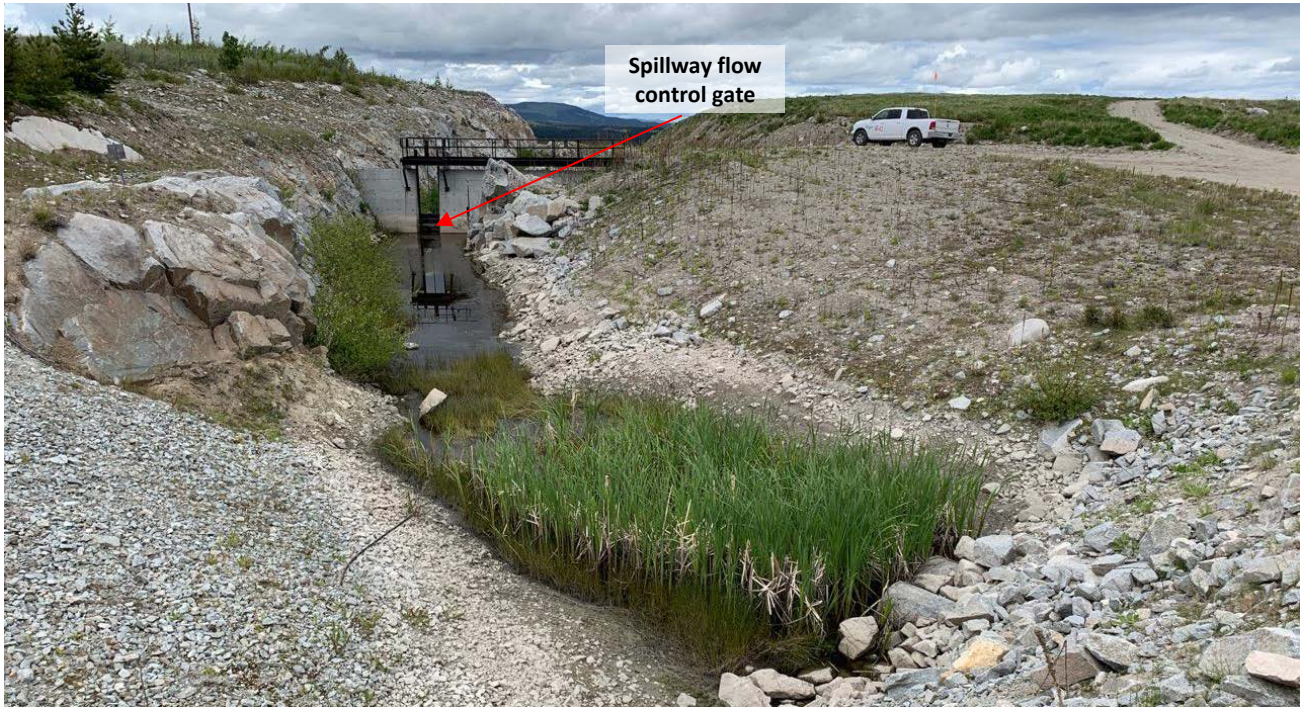
**Photo II-A-16 Area downstream of approach channel culverts and upstream of flow control gate – Culverts are obstructed by vegetation which should be removed as part of routine maintenance (HGH-2019-15)**

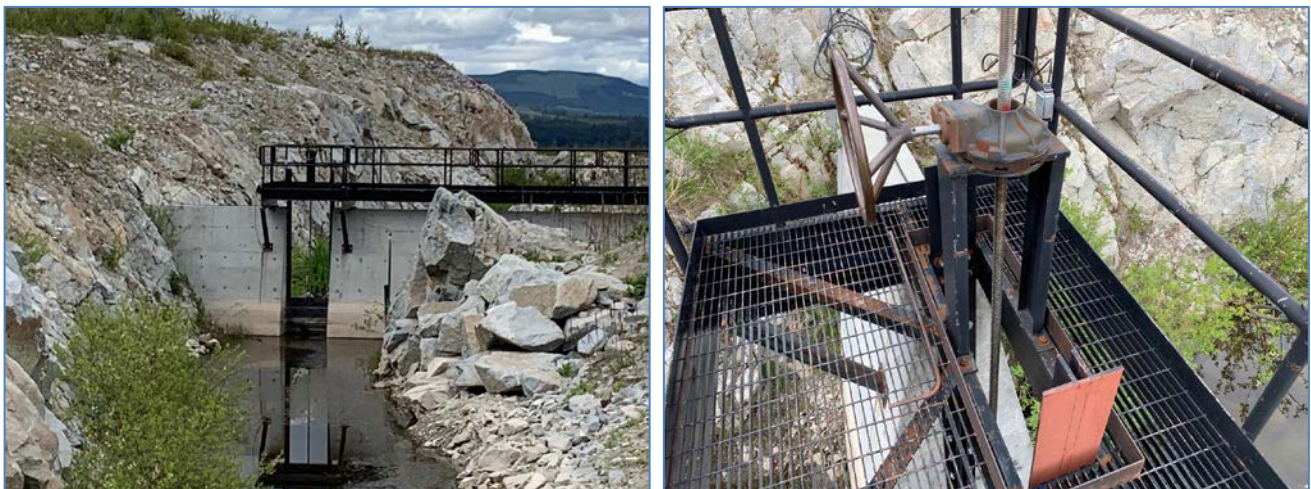
**Photo II-A-17 Spillway flow control gate – No signage or safety grating is present at valve. (HGH-2019-15)**

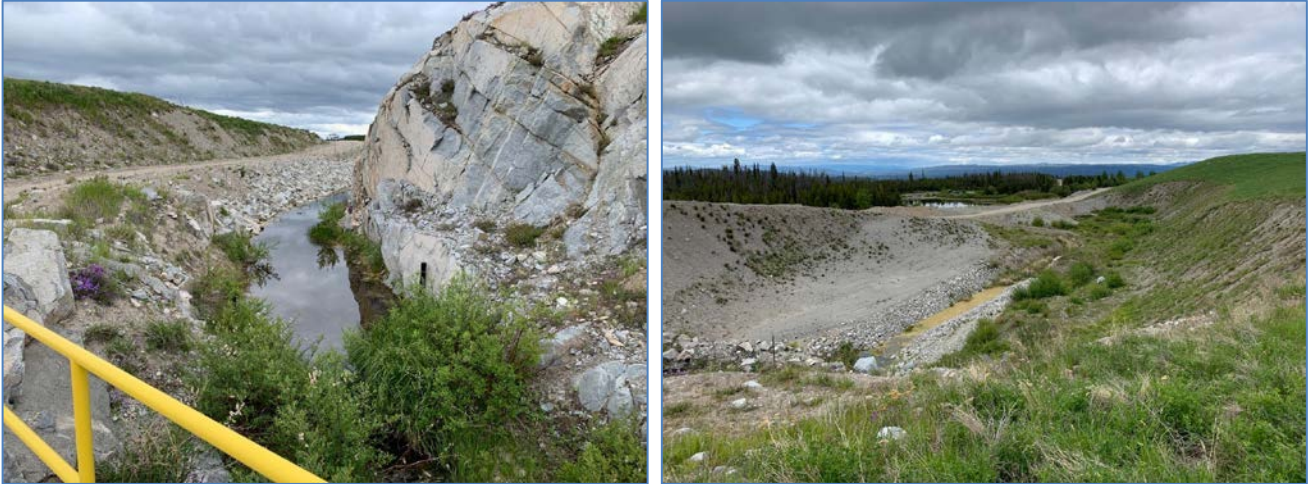
**Photo II-A-18 Highmont Spillway channel, looking downstream of S1 Pond diversion. No flow downstream in spillway. (HGH-2019-16)**

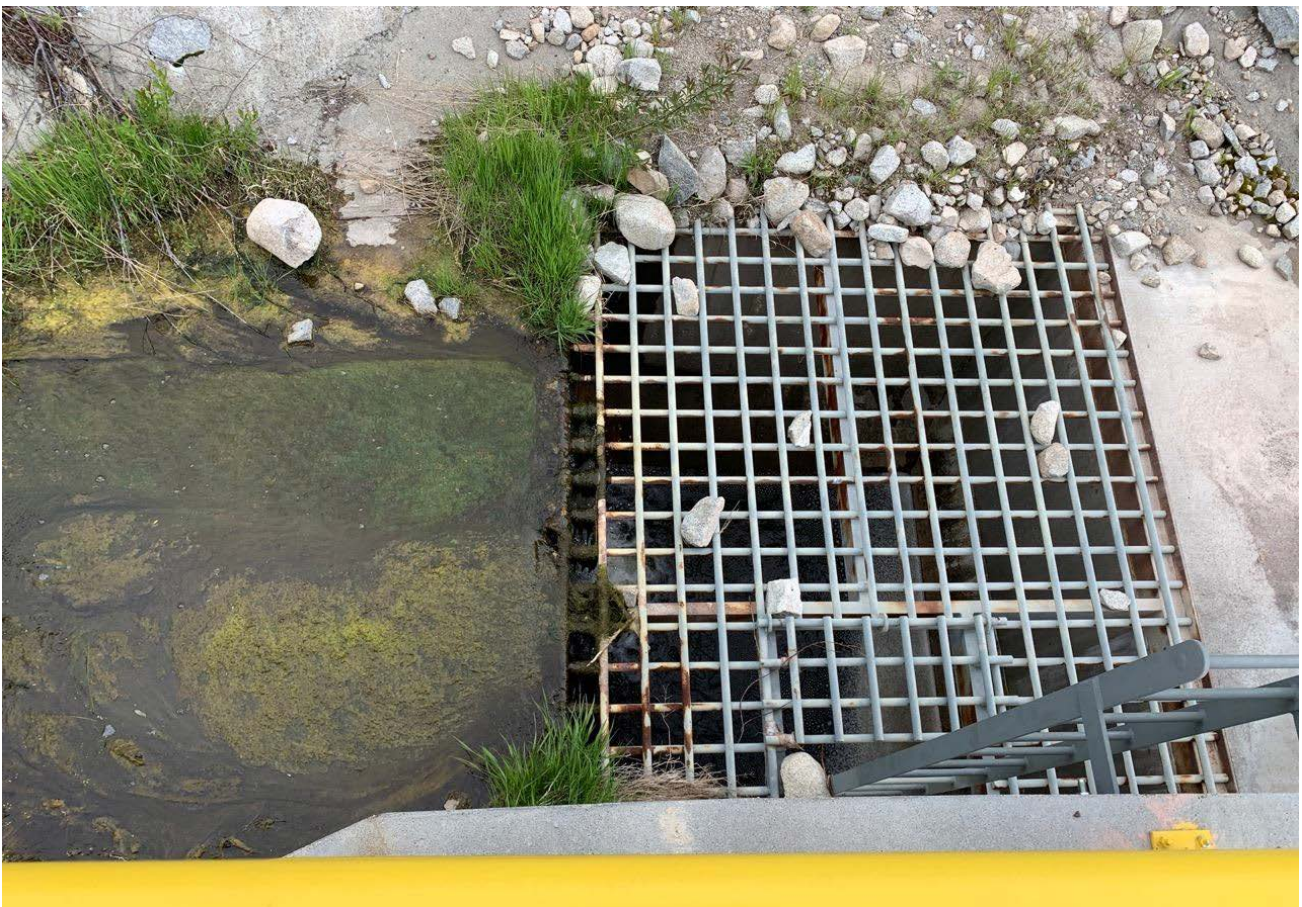
**Photo II-A-19 Highmont Spillway channel looking at inlet to S1 Pond diversion – Trash rack on invert is clear of debris and water is flowing through diversion (HGH-2019-16)**

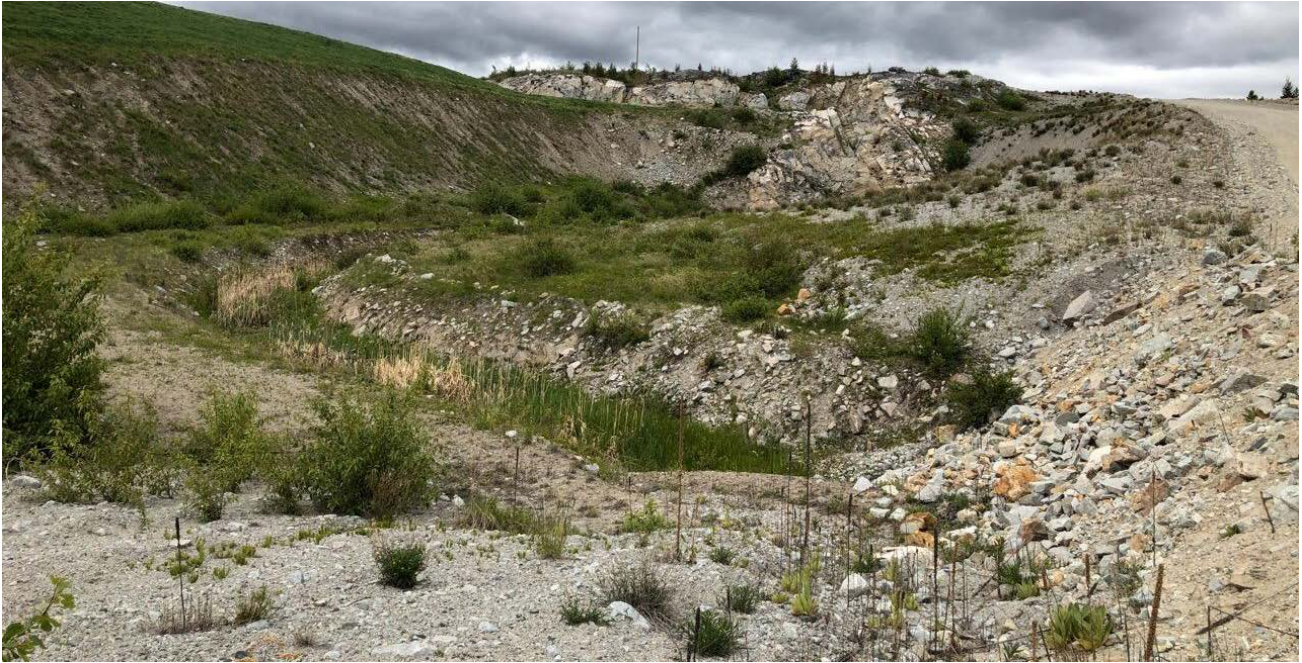
**Photo II-A-20 Overview of Highmont Spillway channel and rock chute downstream of North Dam. Channel is heavily vegetated near the culverts crossing road downstream of North dam (HGH-2019-06)**

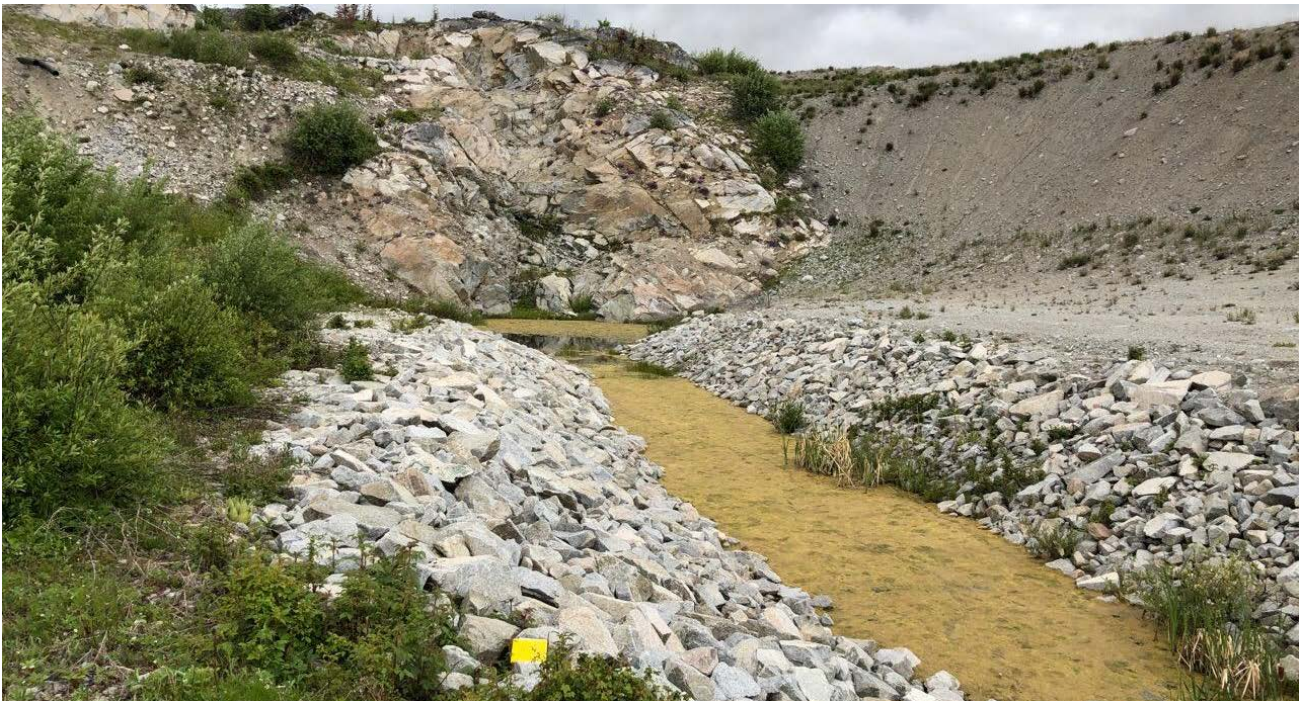
**Photo II-A-21 Highmont Spillway channel downstream of rock chute, portion of channel where base is not in bedrock and has been covered with riprap (HGH-2019-17)**

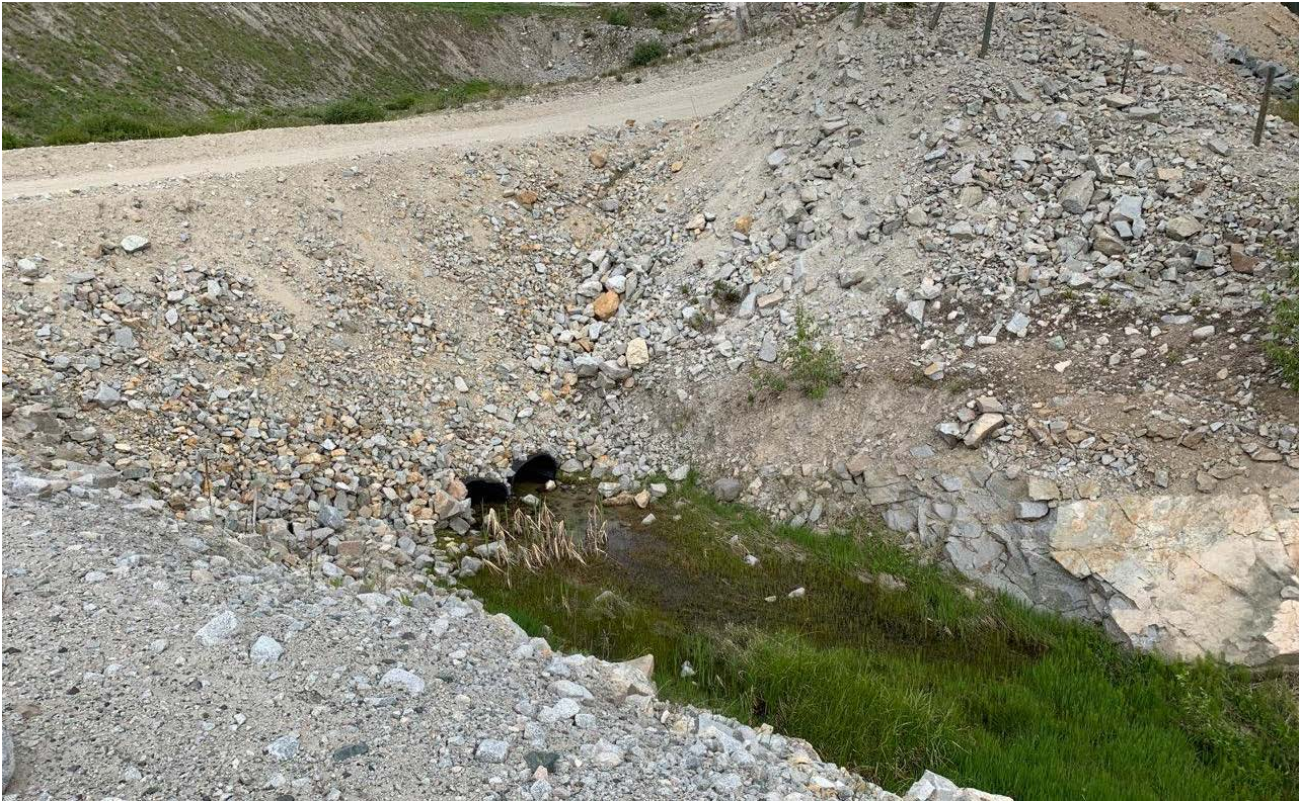
**Photo II-A-24 Highmont road-crossing culverts, downstream side of the road. Culverts are clear but misshapen. Vegetation similar to 2018 DSI (HGH-2019-19)**
