# **Teck Highland Valley Copper Partnership**

**2019 Dam Safety Inspection Report**

*Highmont Tailings Storage Facility*

April 2020

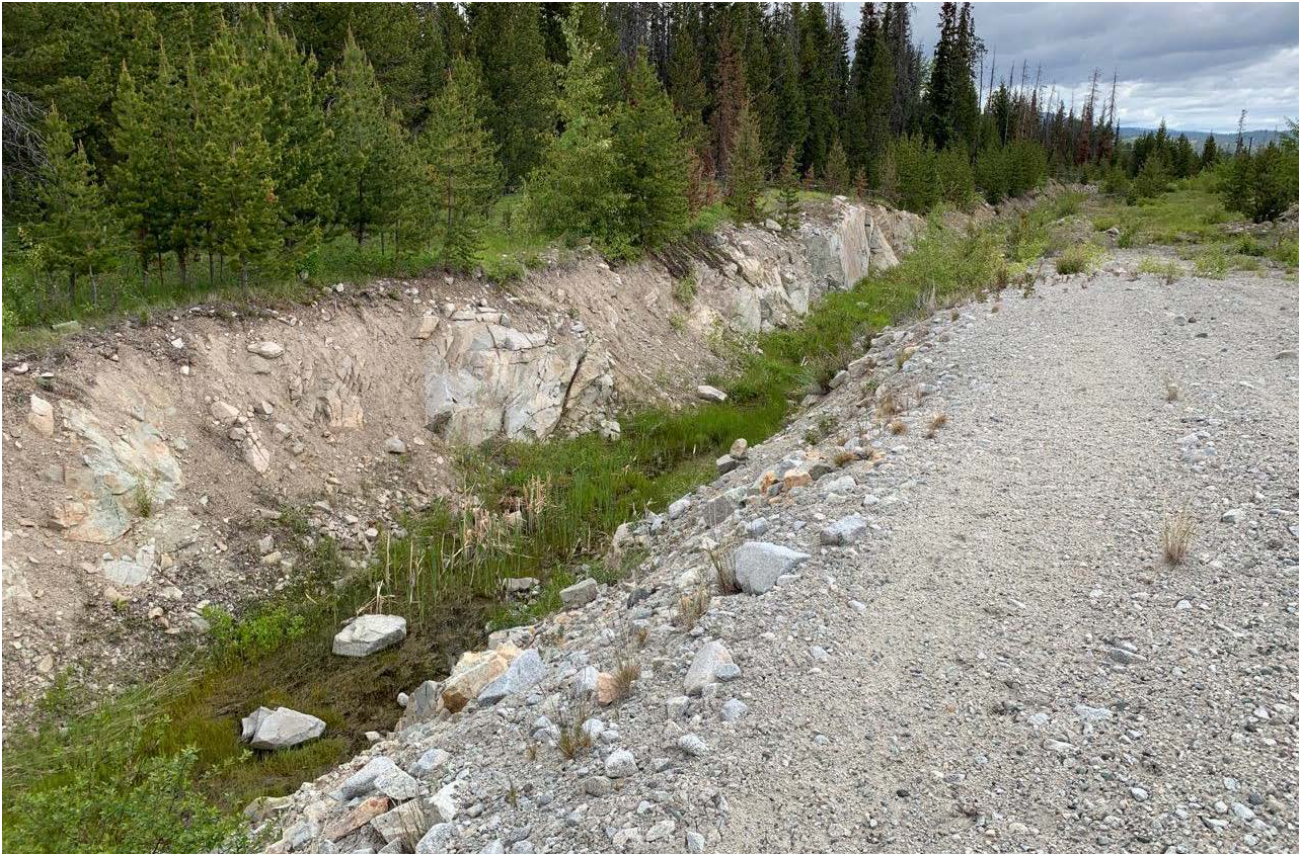
**Photo II-A-25 Highmont Spillway channel downstream of road. There is vegetation growth which will be cleared as part of routine maintenance (HGH-2019-19)**

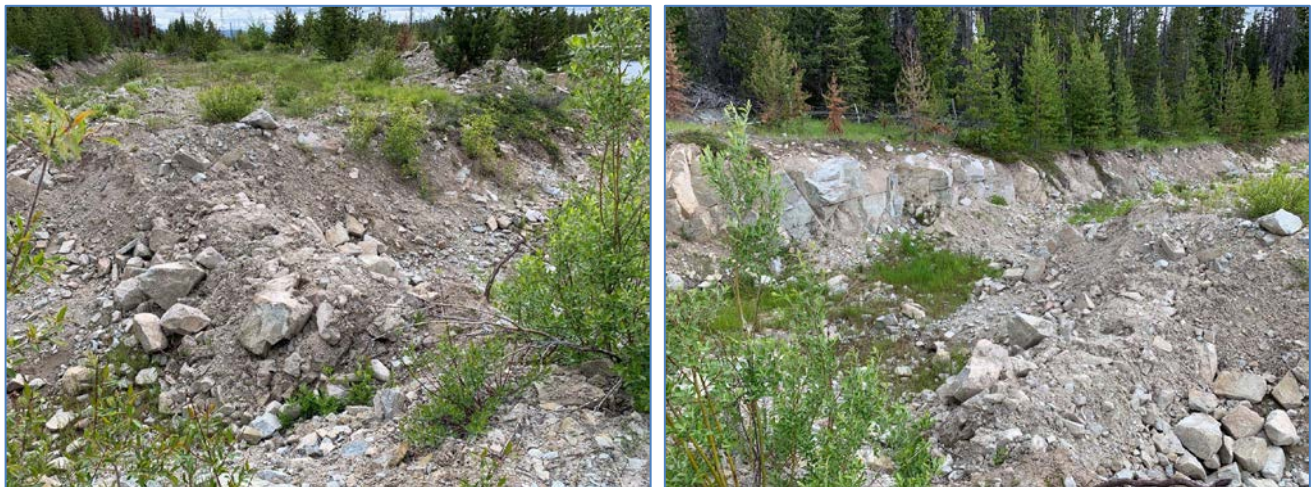
**Photo II-A-26 Highmont Spillway plug across S2 Pond inlet channel. No sign of recent flow in spillway or inlet channel (HGH-2019-20)**

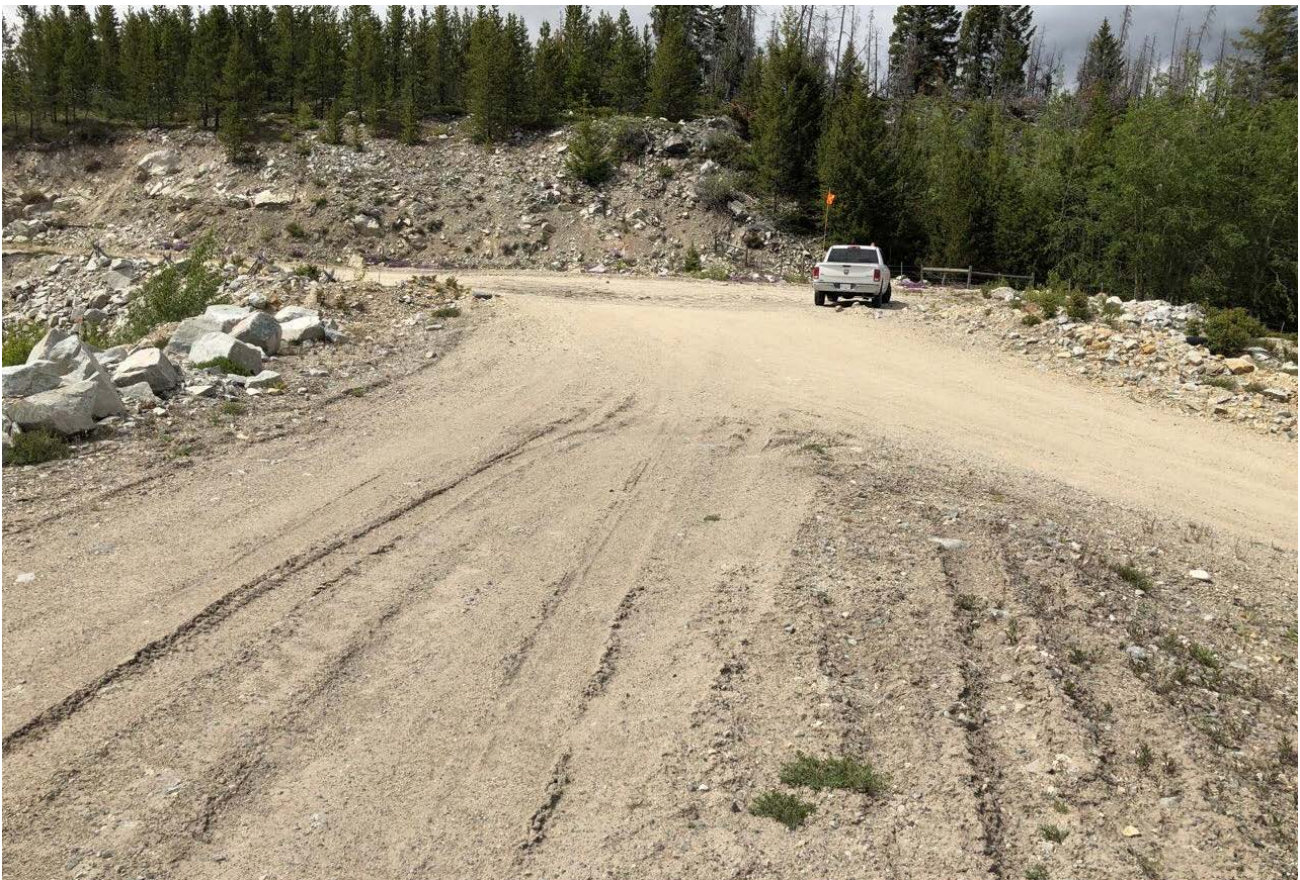
- **Crest:** Good physical condition. No signs of significant erosion, deterioration, displacement, or cracking (Photo II-B-1).
- **Left and Right Abutment:** Good physical condition. No signs of significant erosion, deterioration, displacement, or cracking (Photo II-B-1).

#### Photo II-B-1 S1 Pond: Overview of crest looking west towards left abutment (HGH-2019-21)

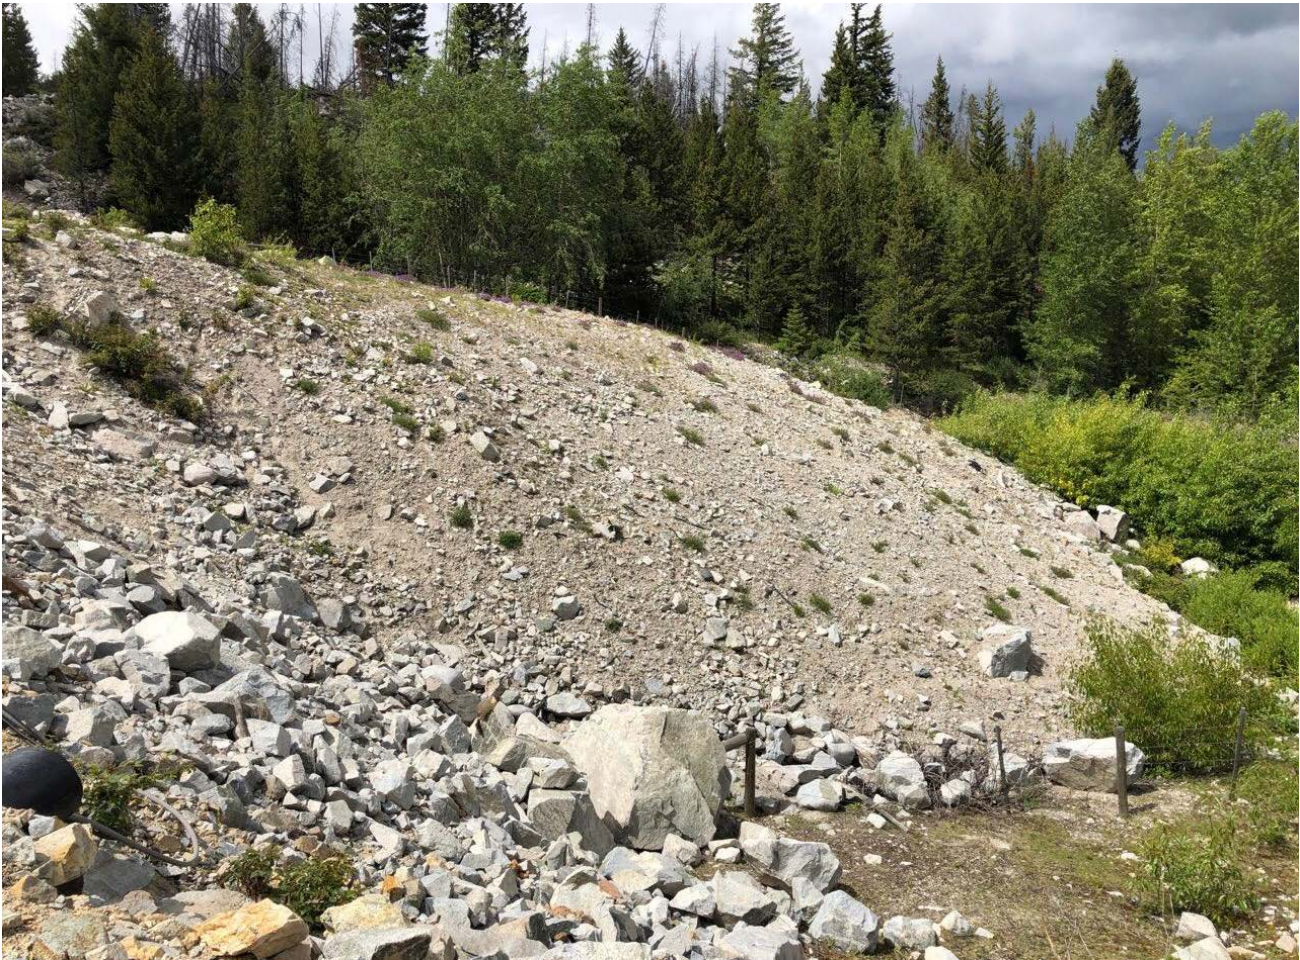
- **Downstream Slope:** Good physical condition. Slope covered in gravel and moderately vegetated. This combination provides adequate erosion protection based on performance over the service life (Photo II-B-2).

**Photo II-B-2 S1 Pond: Overview of S1 Pond dam downstream slope (HGH-2019-22)**

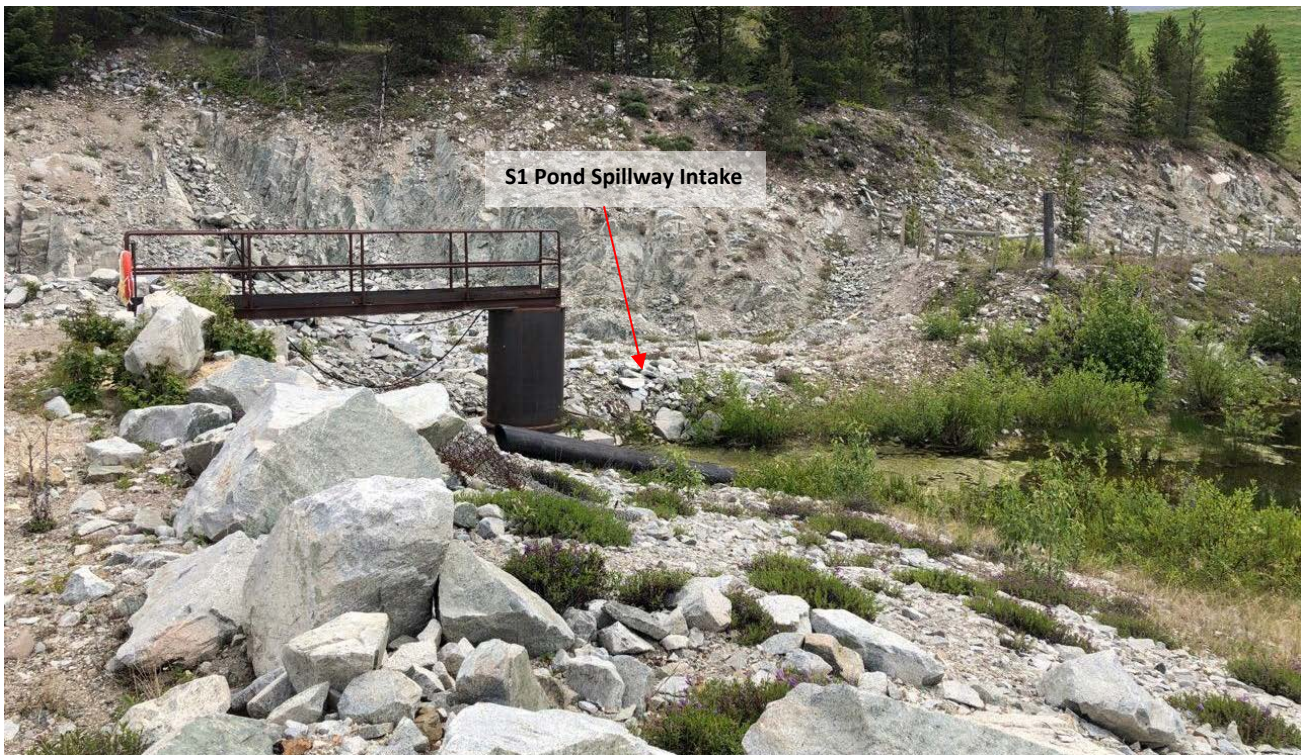
- **Spillway:** Good physical condition. Minor vegetation present downstream of spillway pipe and in riprap outfall. No immediate dam safety concern due to this, however should be monitored and removed during routine inspections (Photo II-B-5 through Photo II-B-9).

**Photo II-B-5 S1 Pond: Overview of upstream slope and S1 Pond Spillway intake. (HGH-2019-23)**

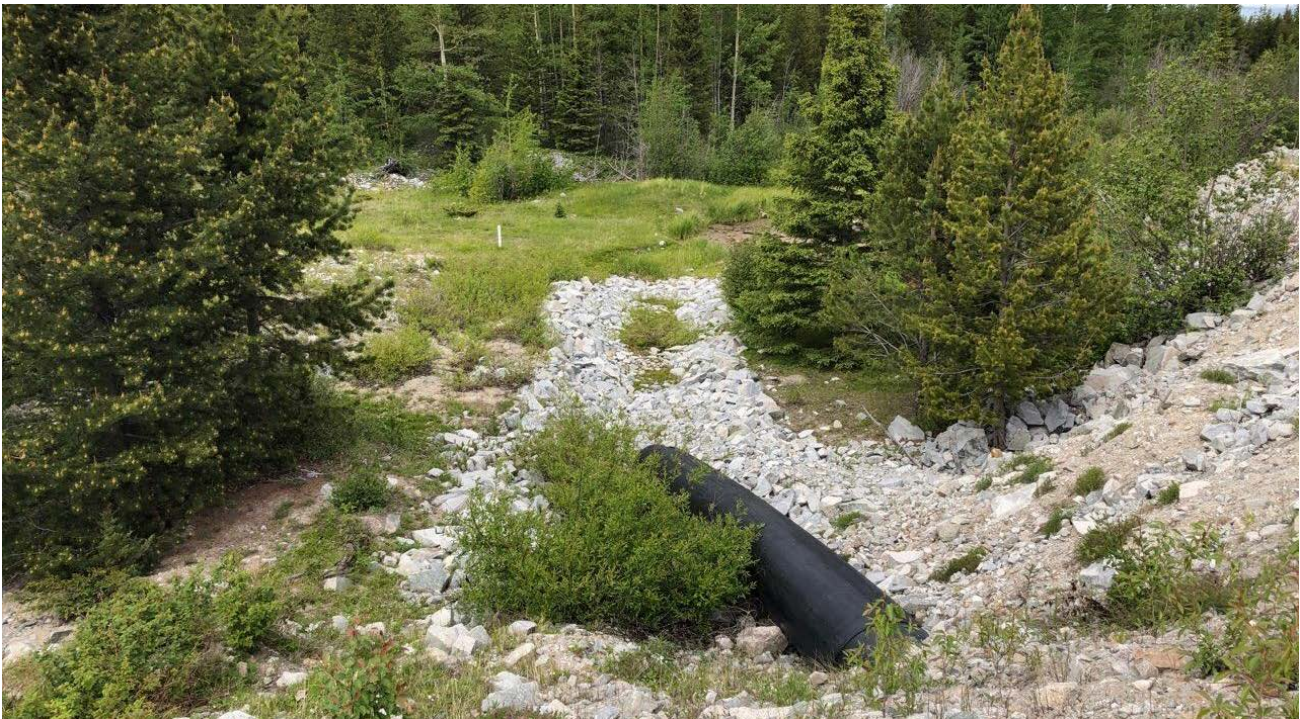
**Photo II-B-8 S1 Pond: Spillway pipe outlet with no obstruction (HGH-2019-26)**

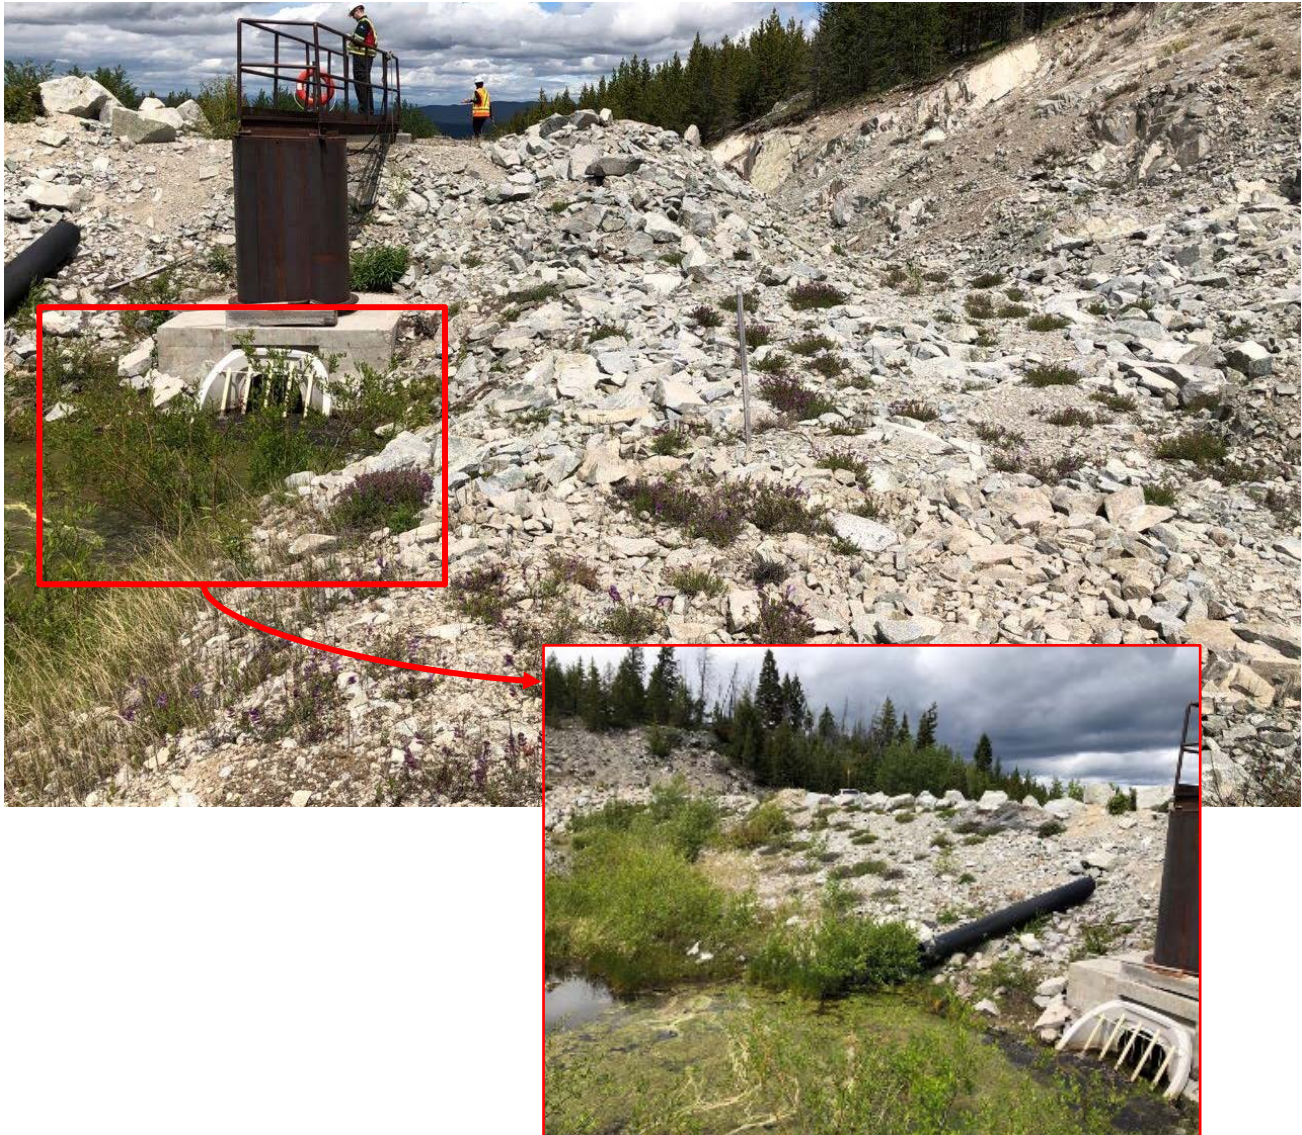
**Photo II-B-9 S1 Pond: Low-Level Outlet (LLO) to the left of spillway intake. Vegetation partially obstructing intake; will be cleared during routine maintenance. (HGH-2019-27)**

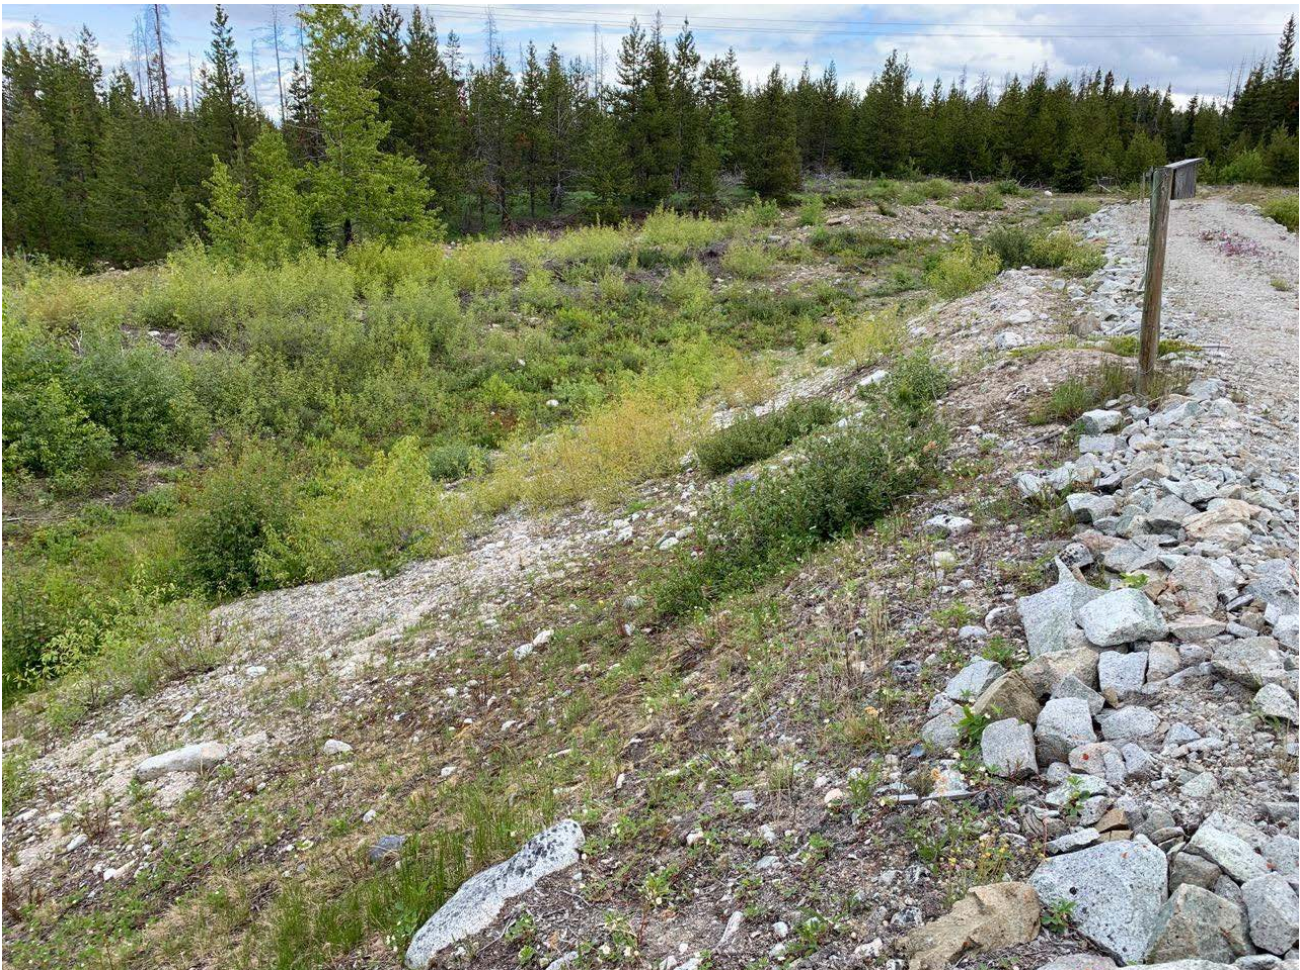
- **Downstream Slope:** Good physical condition. Well vegetated near left abutment, and sparsely vegetated throughout the rest of the downstream slope. Gravel and vegetation provides adequate erosion protection based on performance over the service life (Photo II-B-11).

Photo II-B-11 S2 Pond: downstream slope (HGH-2019-28)

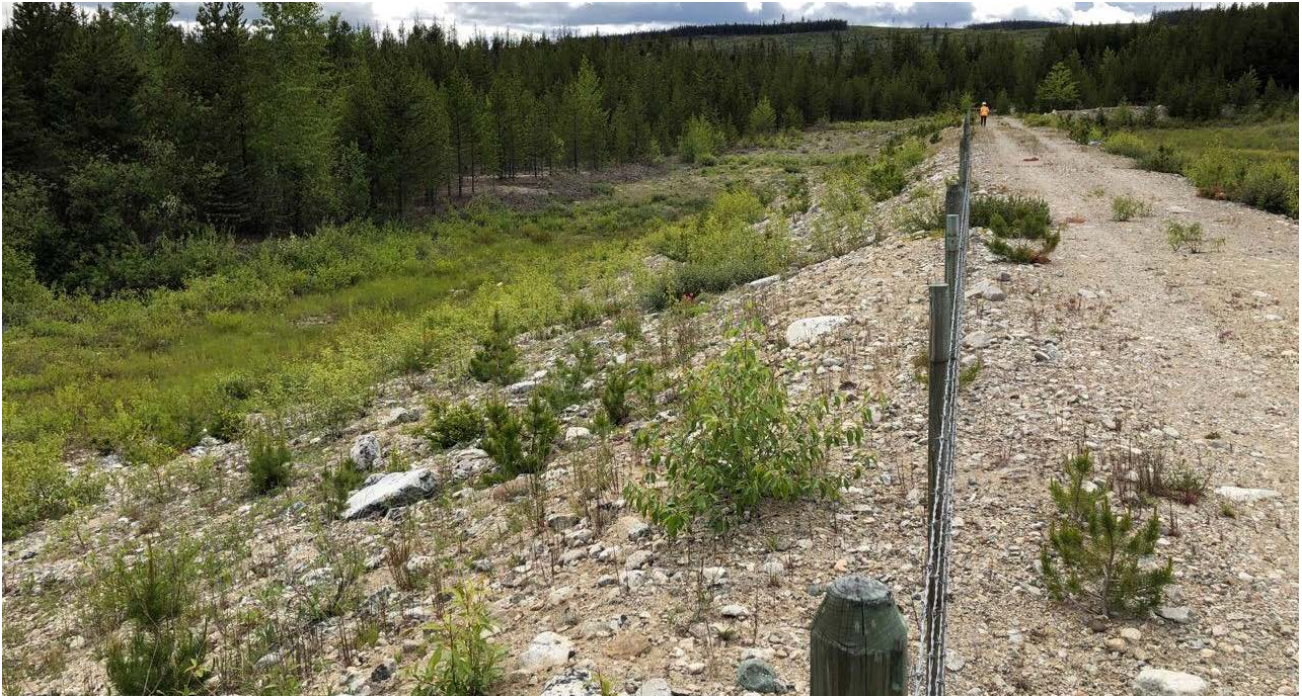
- **Crest:** Good physical condition. No indicators of significant concern observed (e.g. cracking, slumping, horizontal displacement) (Photo II-B-15 and Photo II-B-16).

**Photo II-B-15 S3 Pond: Overview of downstream slope and crest looking towards right abutment, from left abutment (HGH-2019-30)**

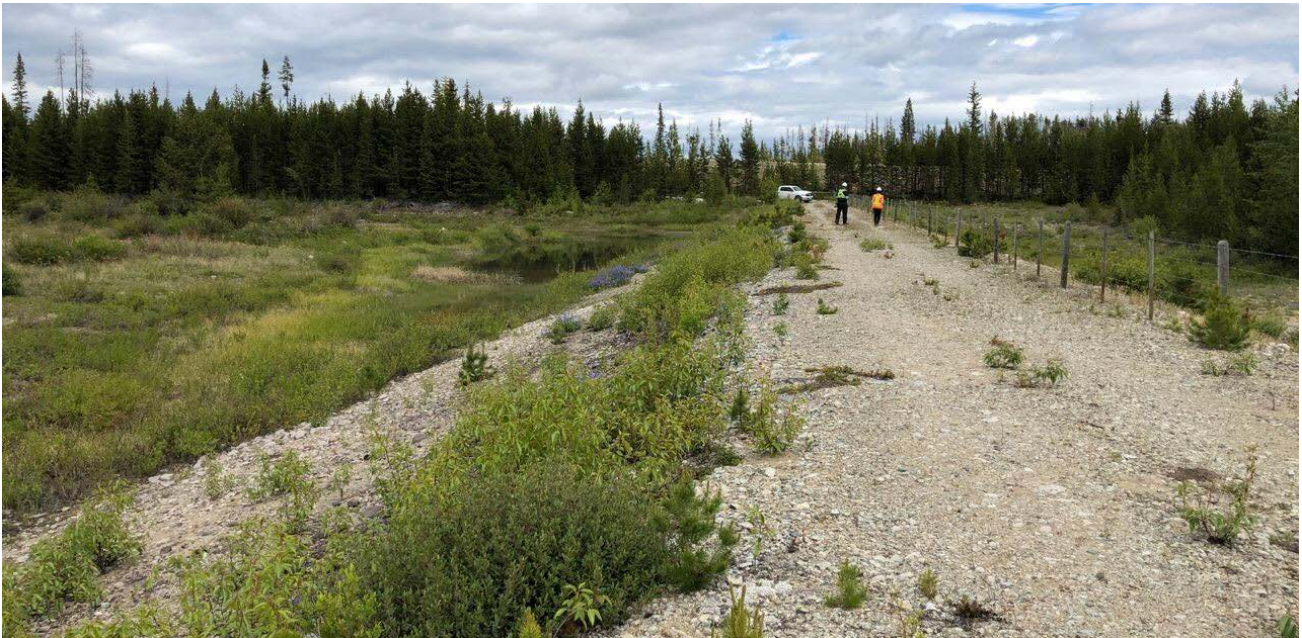
- **Downstream Slope:** Good physical condition. Slope is sparsely vegetated over the layer of gravel which provides adequate erosion protection based on performance over the service life (Photo II-B-16).

**Photo II-B-16 S3 Pond: Overview of dam crest, upstream slope and impoundment looking towards left abutment, from right abutment (HGH-2019-31)**

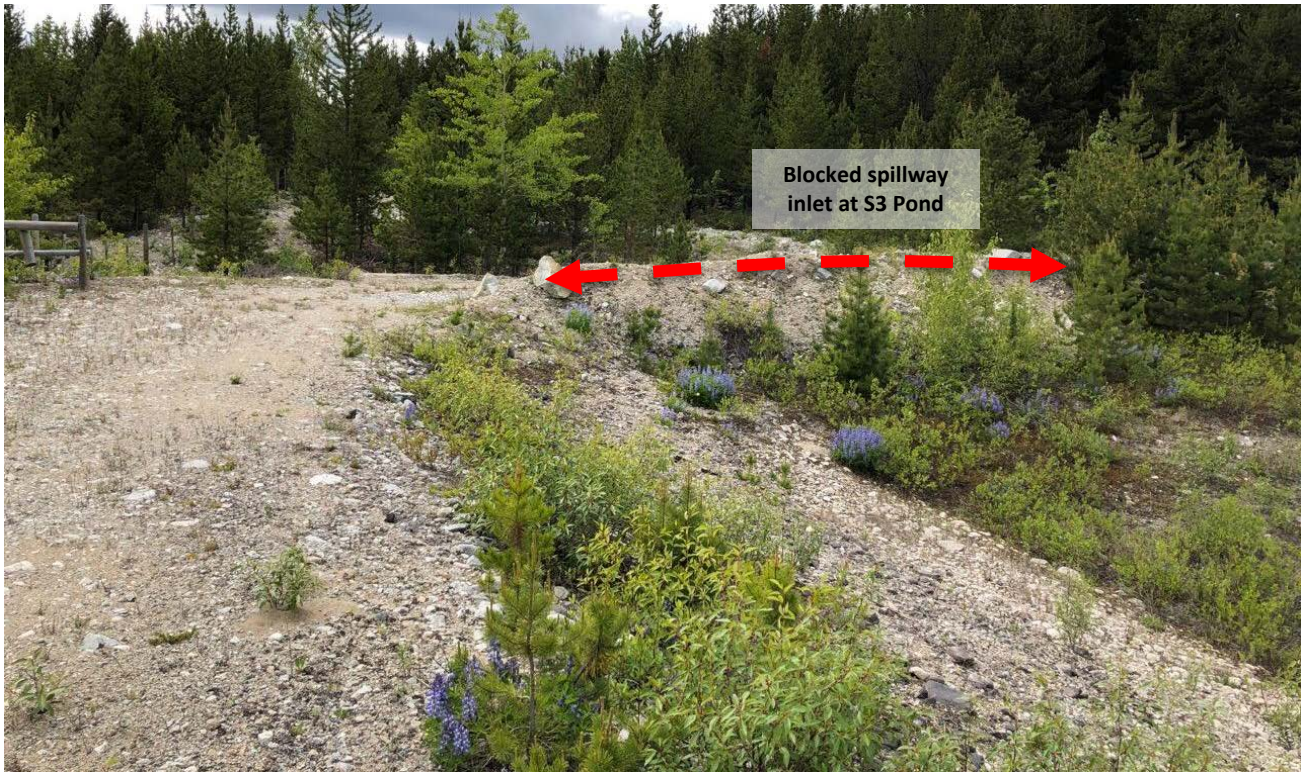
- **Seepage:** Seepage is not monitored downstream of the dam. No pond was observed at the downstream toe in a low point.
- **Spillway:** Spillway intake is blocked with glacial till to prevent discharge of water that does not meet water quality regulatory requirements (Photo II-B-19 and Photo II-B-20).

**Photo II-B-19 S3 Pond: Overview of upstream slope, pond and blocked spillway inlet.  
(HGH-2019-31)**

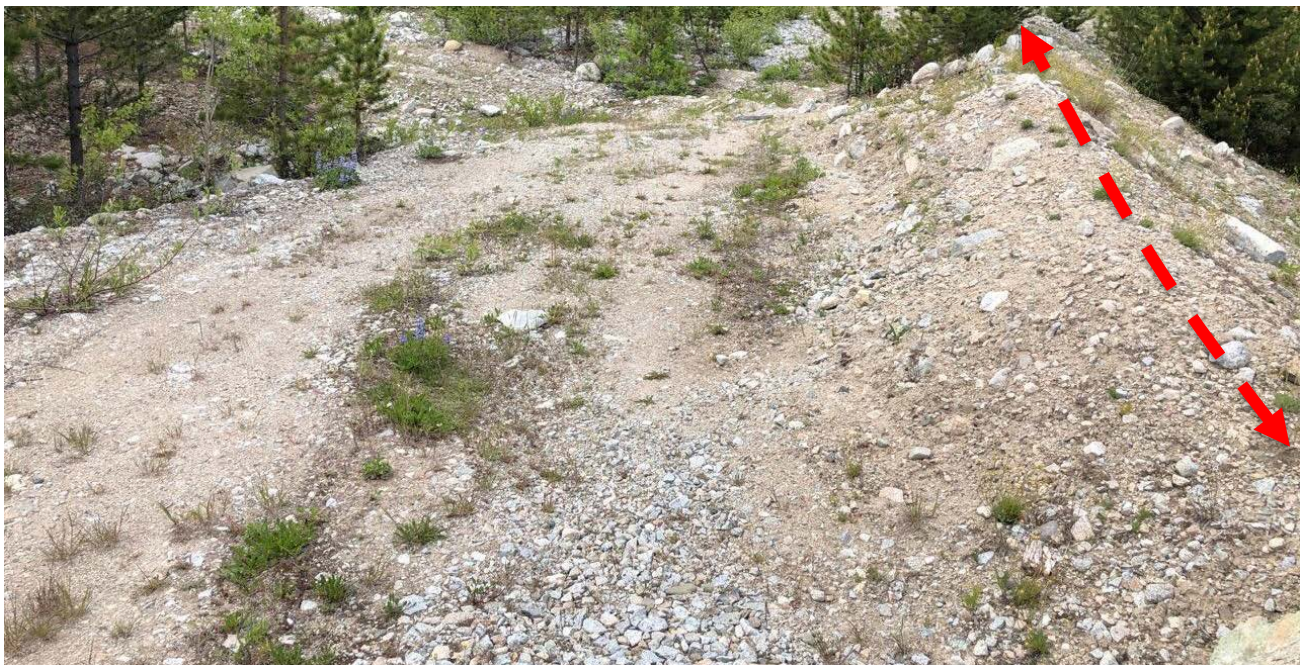
**Photo II-B-20 S3 Pond: Overview of right abutment and blocked spillway inlet Spillway intake is blocked (HGH-2019-32)**

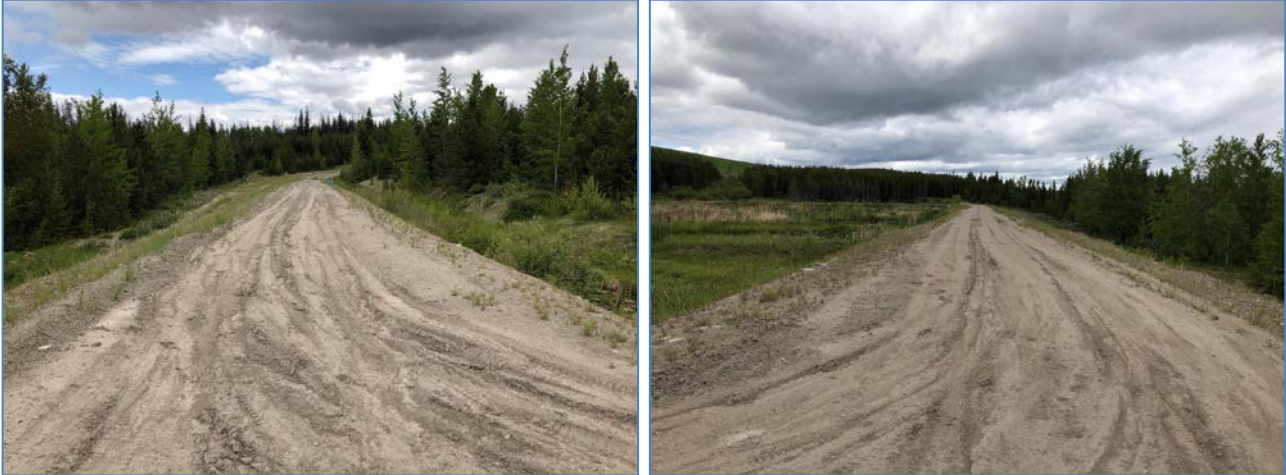
- **Crest:** Good physical condition. No signs of significant erosion, deterioration, displacement, or cracking (Photo II-B-21). The low point downstream of the outlet just south of Viewpoint HGH-2019-36 should be levelled and ruts on crest should be maintained (Photo II-B-22)

**Photo II-B-21 S5 Pond: Overview of crest (HGH-2019-34)**

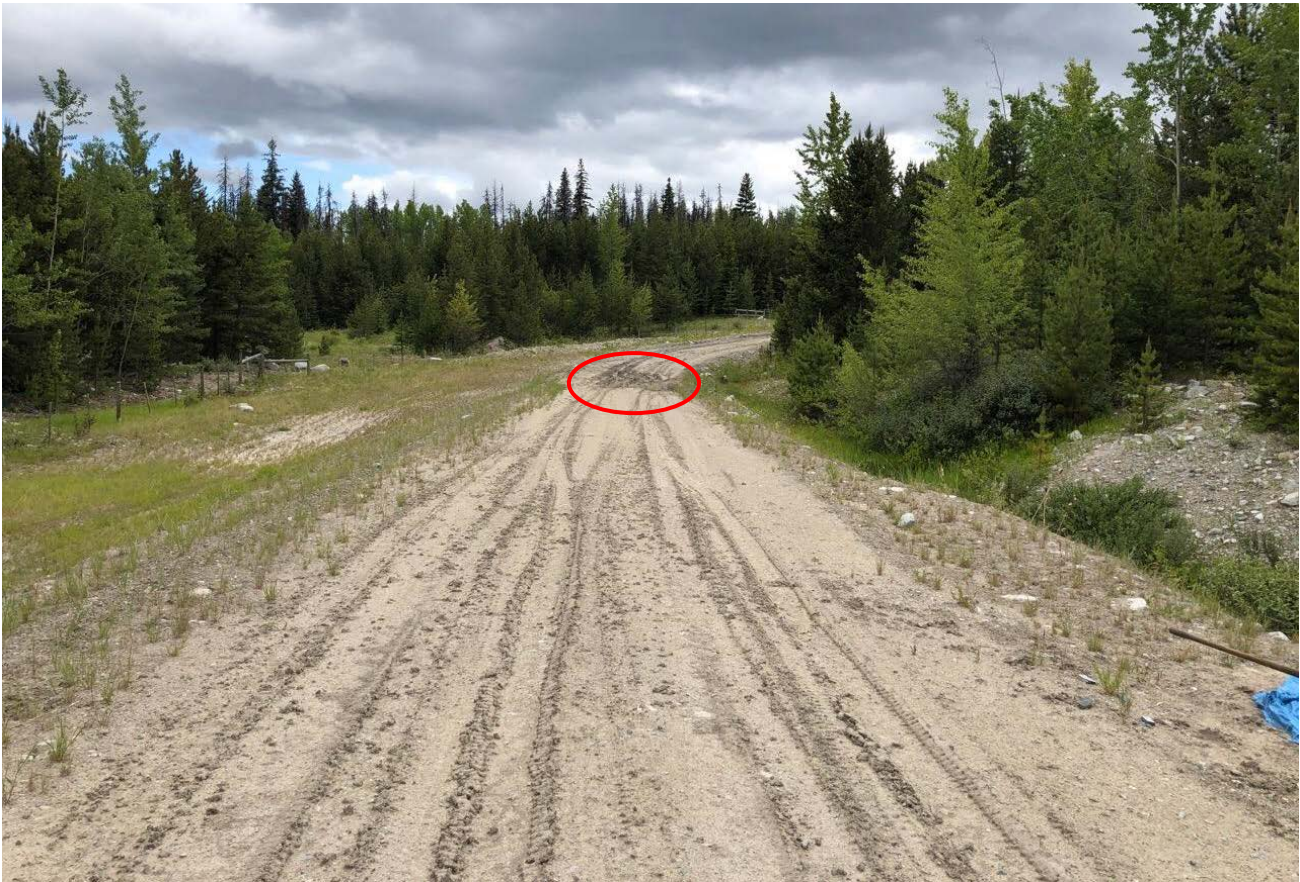
**Photo II-B-22 S5 Pond: perimeter crest of pumping sub-cell, looking south, both outlet pipes are blocked and the low point of the crest is the right (south) abutment (HGH-2019-35)**

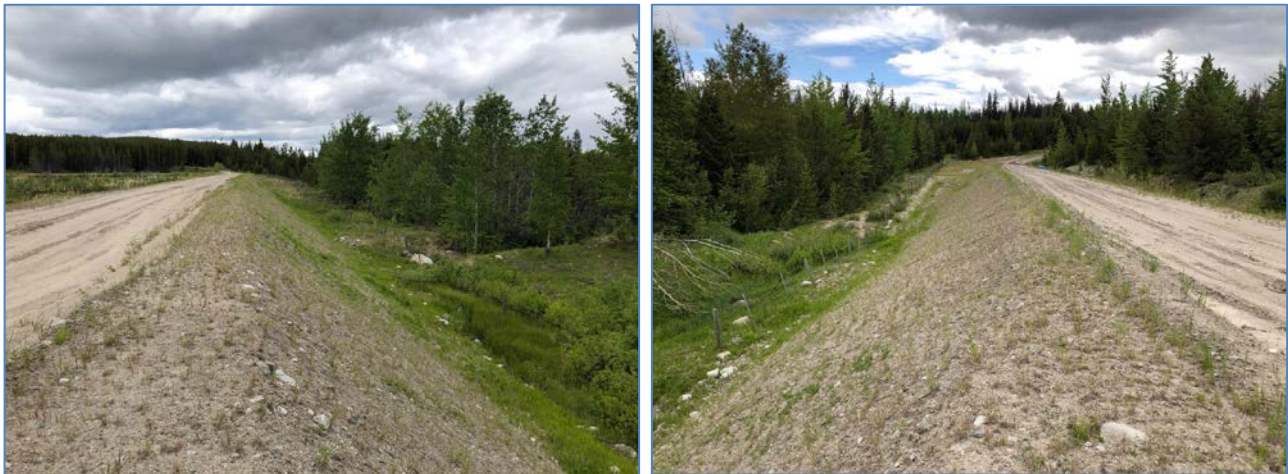
- **Left and Right Abutment:** Good physical condition. No signs of significant erosion, deterioration, displacement, or cracking.
- **Downstream Slope:** Good physical condition. Minor vegetation present throughout slope. No signs of erosion, deterioration, or animal activity (Photo II-B-24).

**Photo II-B-24 S5 Pond: Downstream slope of perimeter crest, looking north (left hand side) and South (right hand side) (HGH-2019-34)**

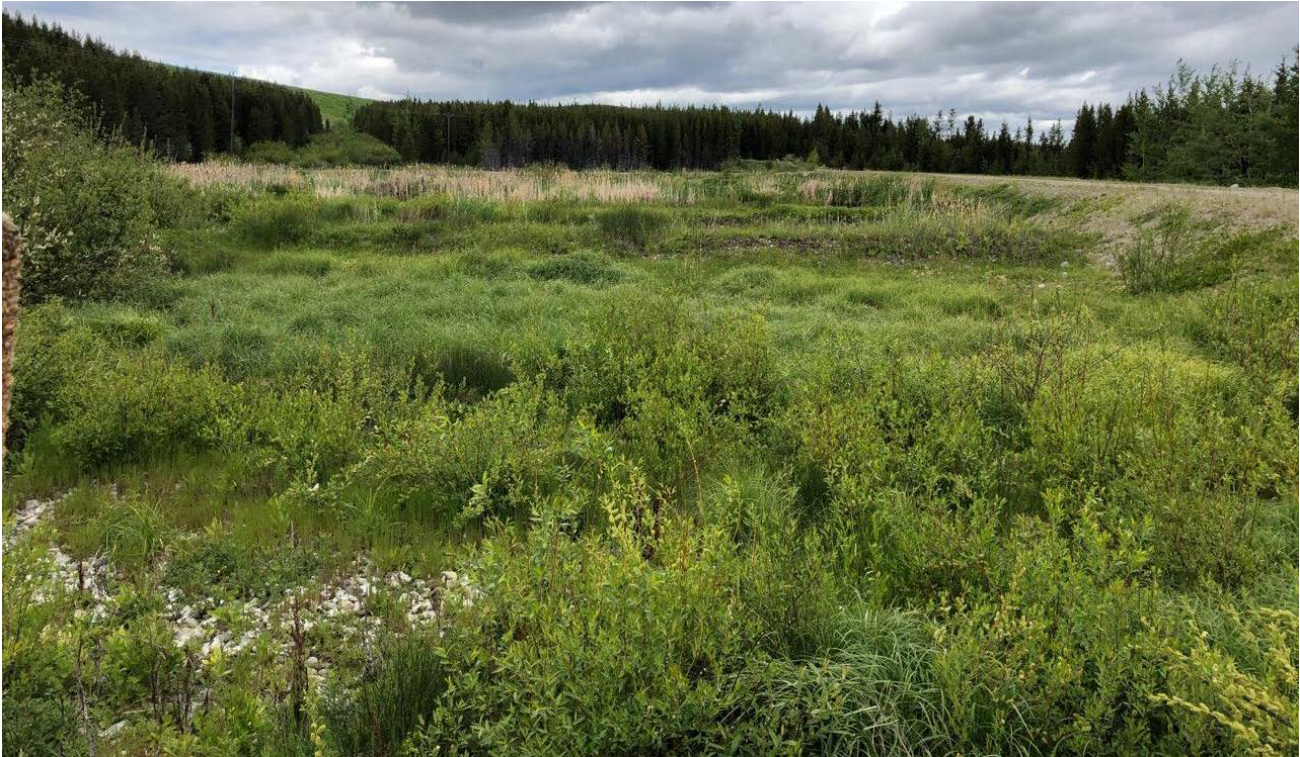
- **Pond:** During inspection pond observed to be more than 10 m below crest of dam which is typical for this time of the year. Pond was highly vegetated during the site visit and requires dredging (Photo II-B-25 to Photo II-B-28).

**Photo II-B-25 S5 Pond: Overview of S5 Pond basin (HGH-2019-37)**

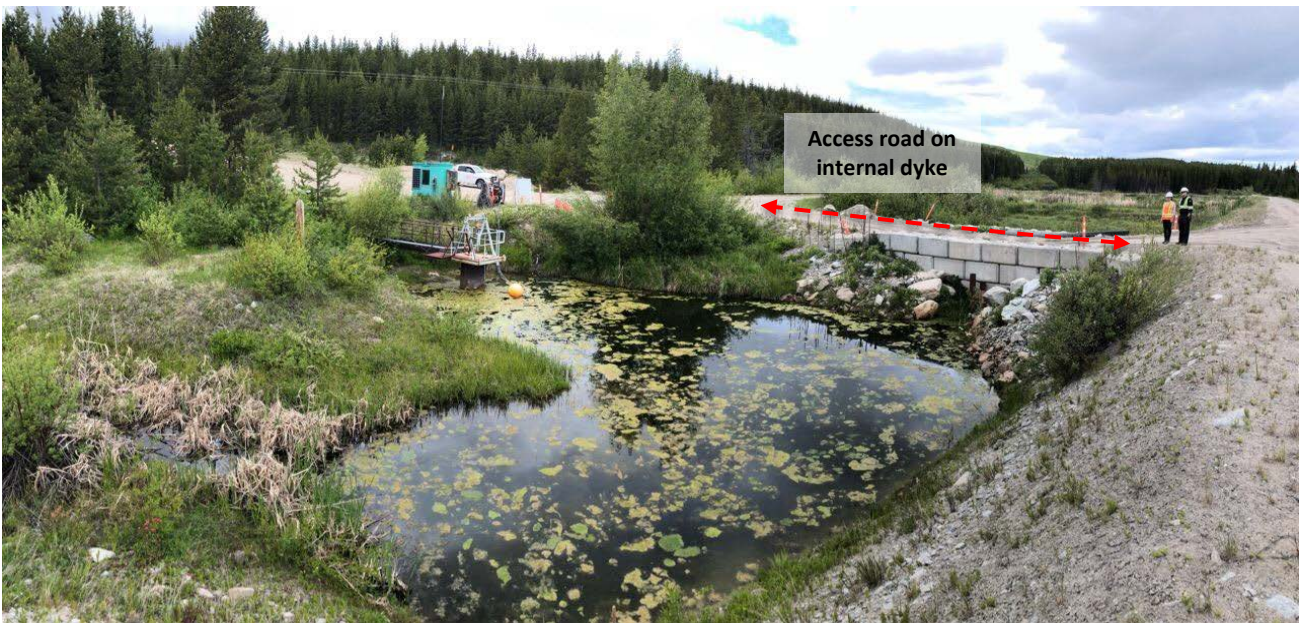
**Photo II-B-26 S5 Pond: Overview of Pumping Sub-cell (HGH-2019-38)**

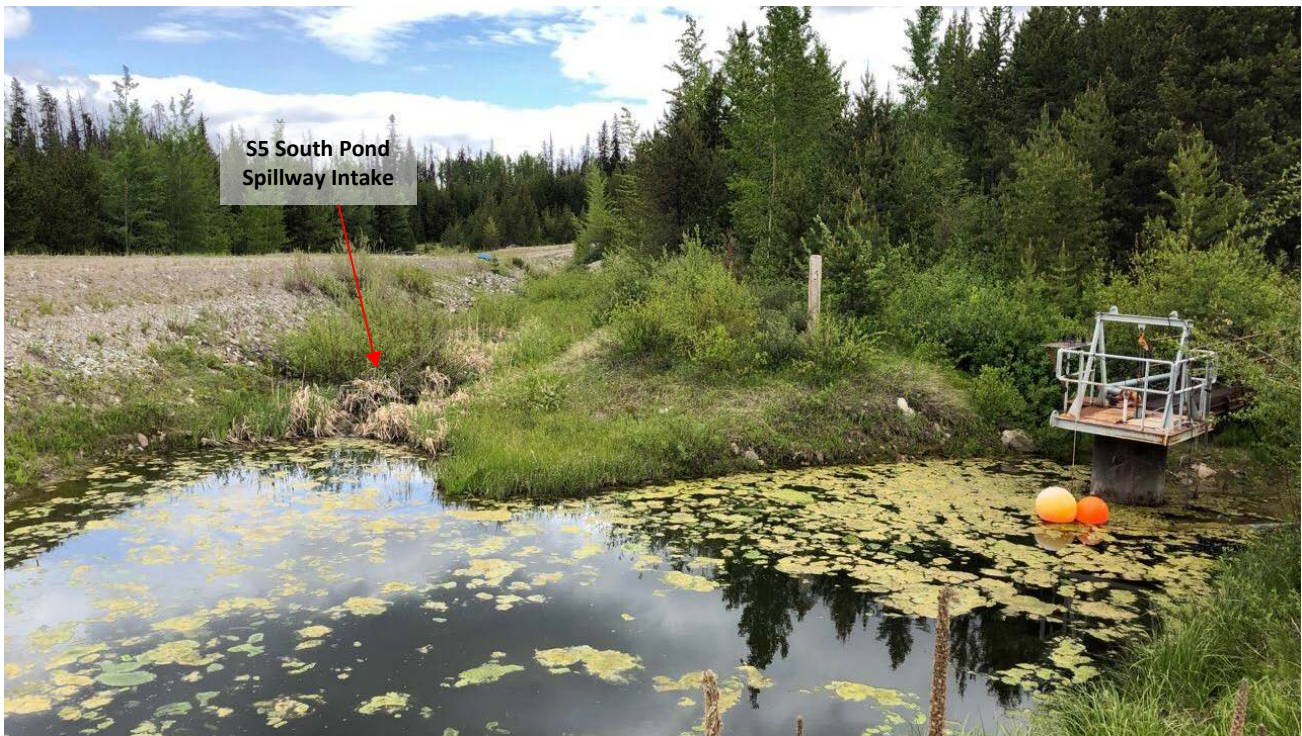
**Photo II-B-27 S5 Pond: Overview of Pumping Sub-cell catwalk and pump intake (HGH-2019-37)**

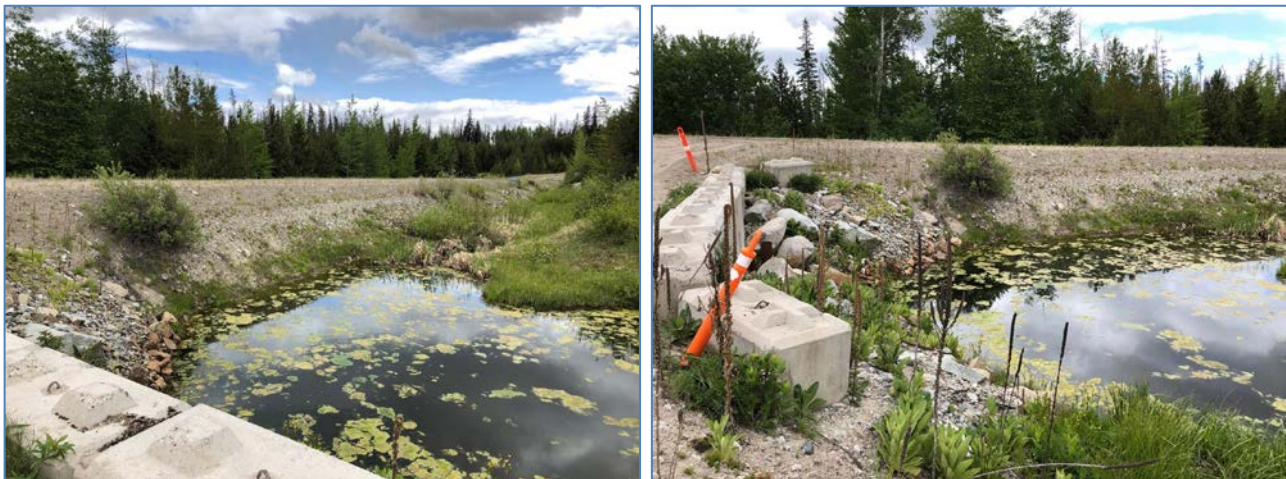
**Photo II-B-28 S5 Pond: Overview of Pumping Sub-cell and overflow point over internal dyke which is below perimeter crest (HGH-2019-37)**

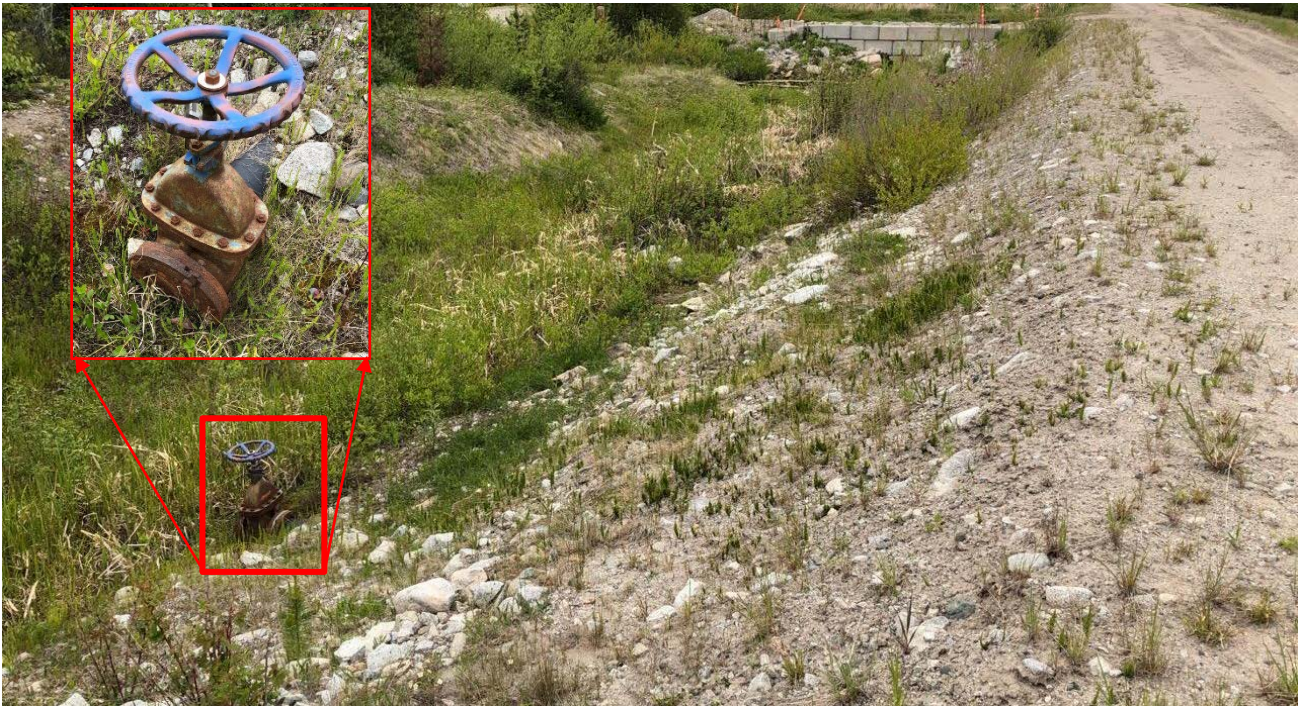
- **Low-level Outlet and Spillway:** As observed during the 2016 through 2018 DSI, the Low-Level Outlet valves were closed and the inlet of the spillway pipes were obstructed by sand bags (Photo II-B-29 and Photo II-B-30).

**Photo II-B-29 S5 Pond: Pumping Sub-cell North outlet pipe is blocked (HGH-2019-39)**

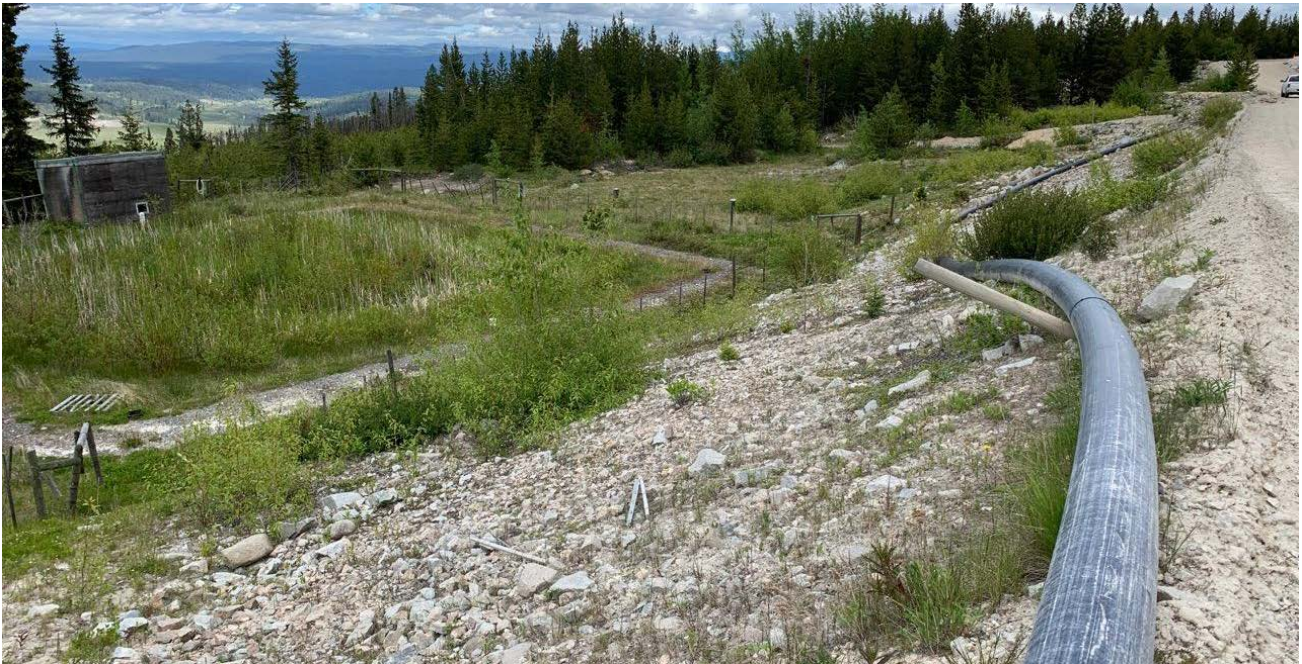
**Photo II-B-32 S8 Pond: Downstream slope; looking east from left abutment. Pipe on slope is not connected to anything and should be removed (HGH-2019-40)**
