# **Teck Highland Valley Copper Partnership**

**2019 Dam Safety Inspection Report**

*Highmont Tailings Storage Facility*

April 2020

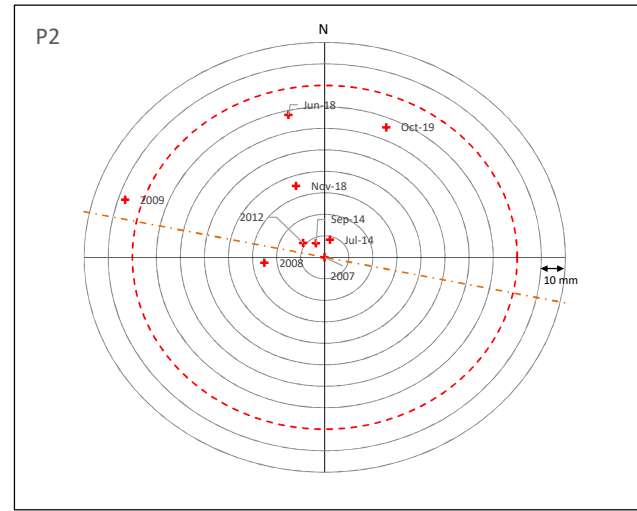
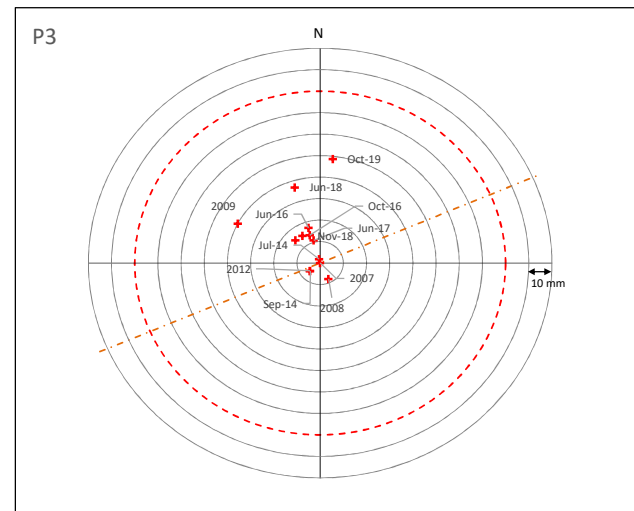
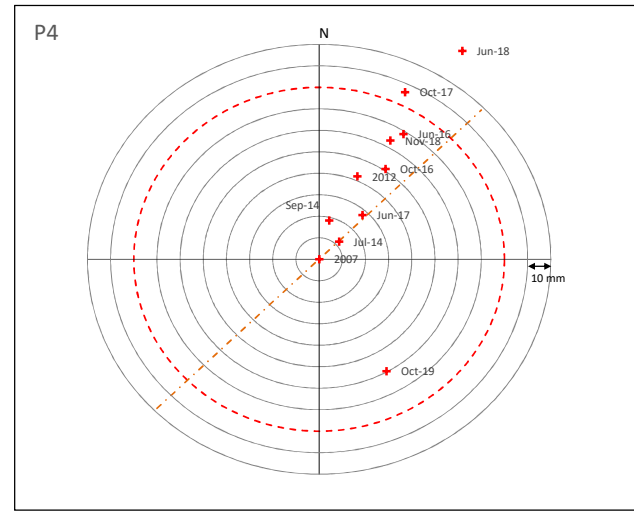
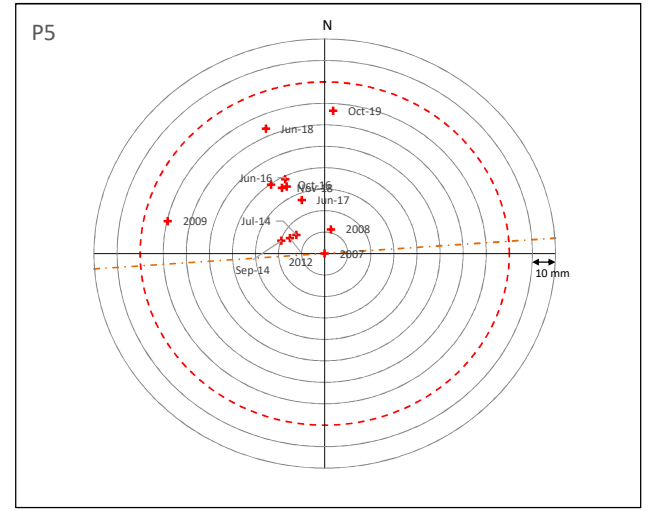
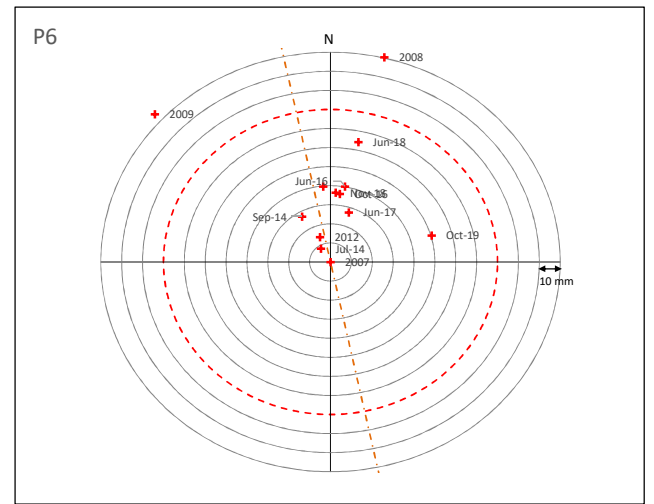
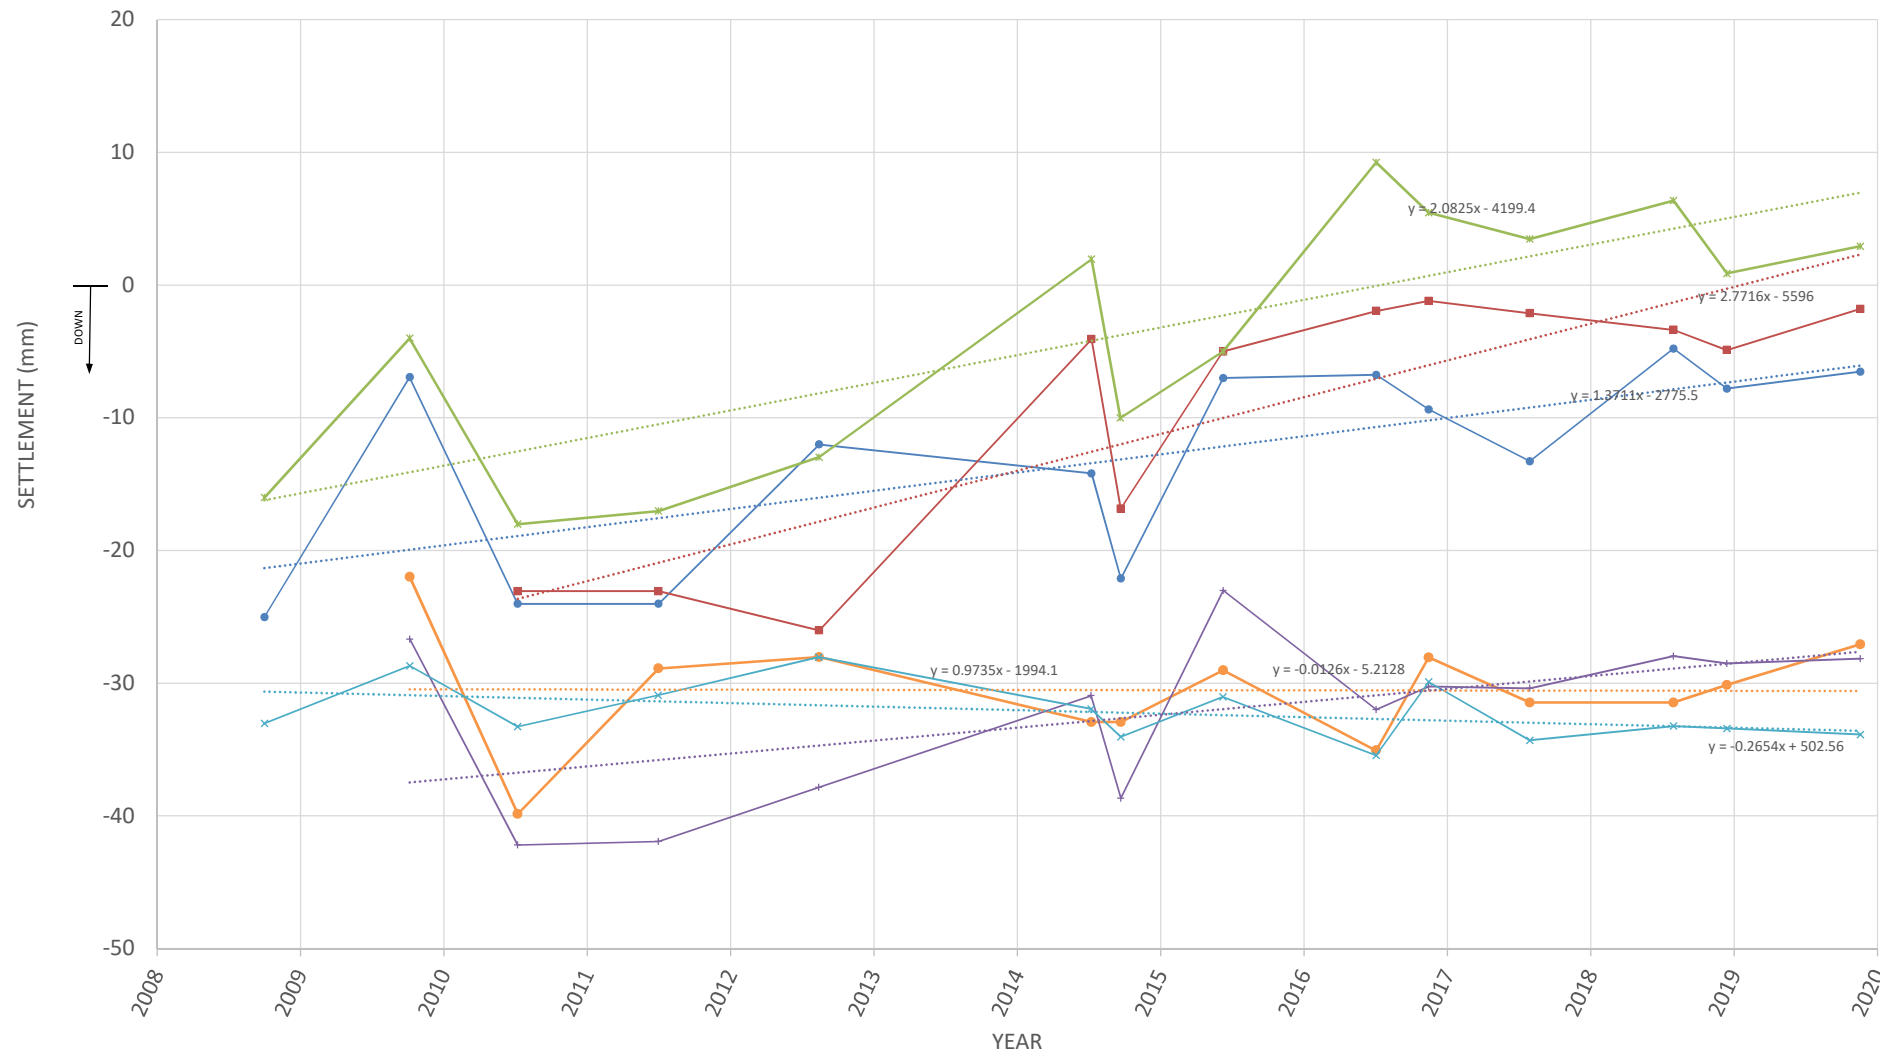
- There were no horizontal or vertical displacement threshold exceedances.
- In 2018 and 2017, P4 (South dam) exceeded its horizontal movement threshold relative to 2007 original location (threshold was set as 80 mm). The movement however was in the northeast direction perpendicular to the dam orientation, slightly in the upstream direction, which aligns with the variance observed at this location. No accompanying change in vertical settlement was observed. No significant indicators of distress in the dam observed in this area during site visit. Therefore, this was not considered a dam safety concern. 2019 readings are

- HIGHTMONT DAM CREST MOVEMENT MONITORING DATA PRIOR TO 2007 NOT SHOWN.
- P2 JUNE 2016 READING (NOT SHOWN IN PLAN PLOT) LOCATED 139 MM FROM INITIAL 2007 READING. READING WAS REVIEWED AND FOUND MORE LIKELY RELATED TO SURVEY ERROR THAN DISPLACEMENT. DISPLACEMENT WAS MOSTLY IN A NORTHWEST DIRECTION PERPENDICULAR TO THE DAM ORIENTATION, BUT SLIGHTLY IN THE DOWNSTREAM DIRECTION.
- P4 2008, AND 2009 READINGS (NOT SHOWN IN PLAN PLOT) LOCATED 240 mm AND 167 mm FROM INITIAL 2007 READING, RESPECTIVELY. READING WAS REVIEWED AND FOUND MORE LIKELY RELATED TO SURVEY ERROR THAN DISPLACEMENT.

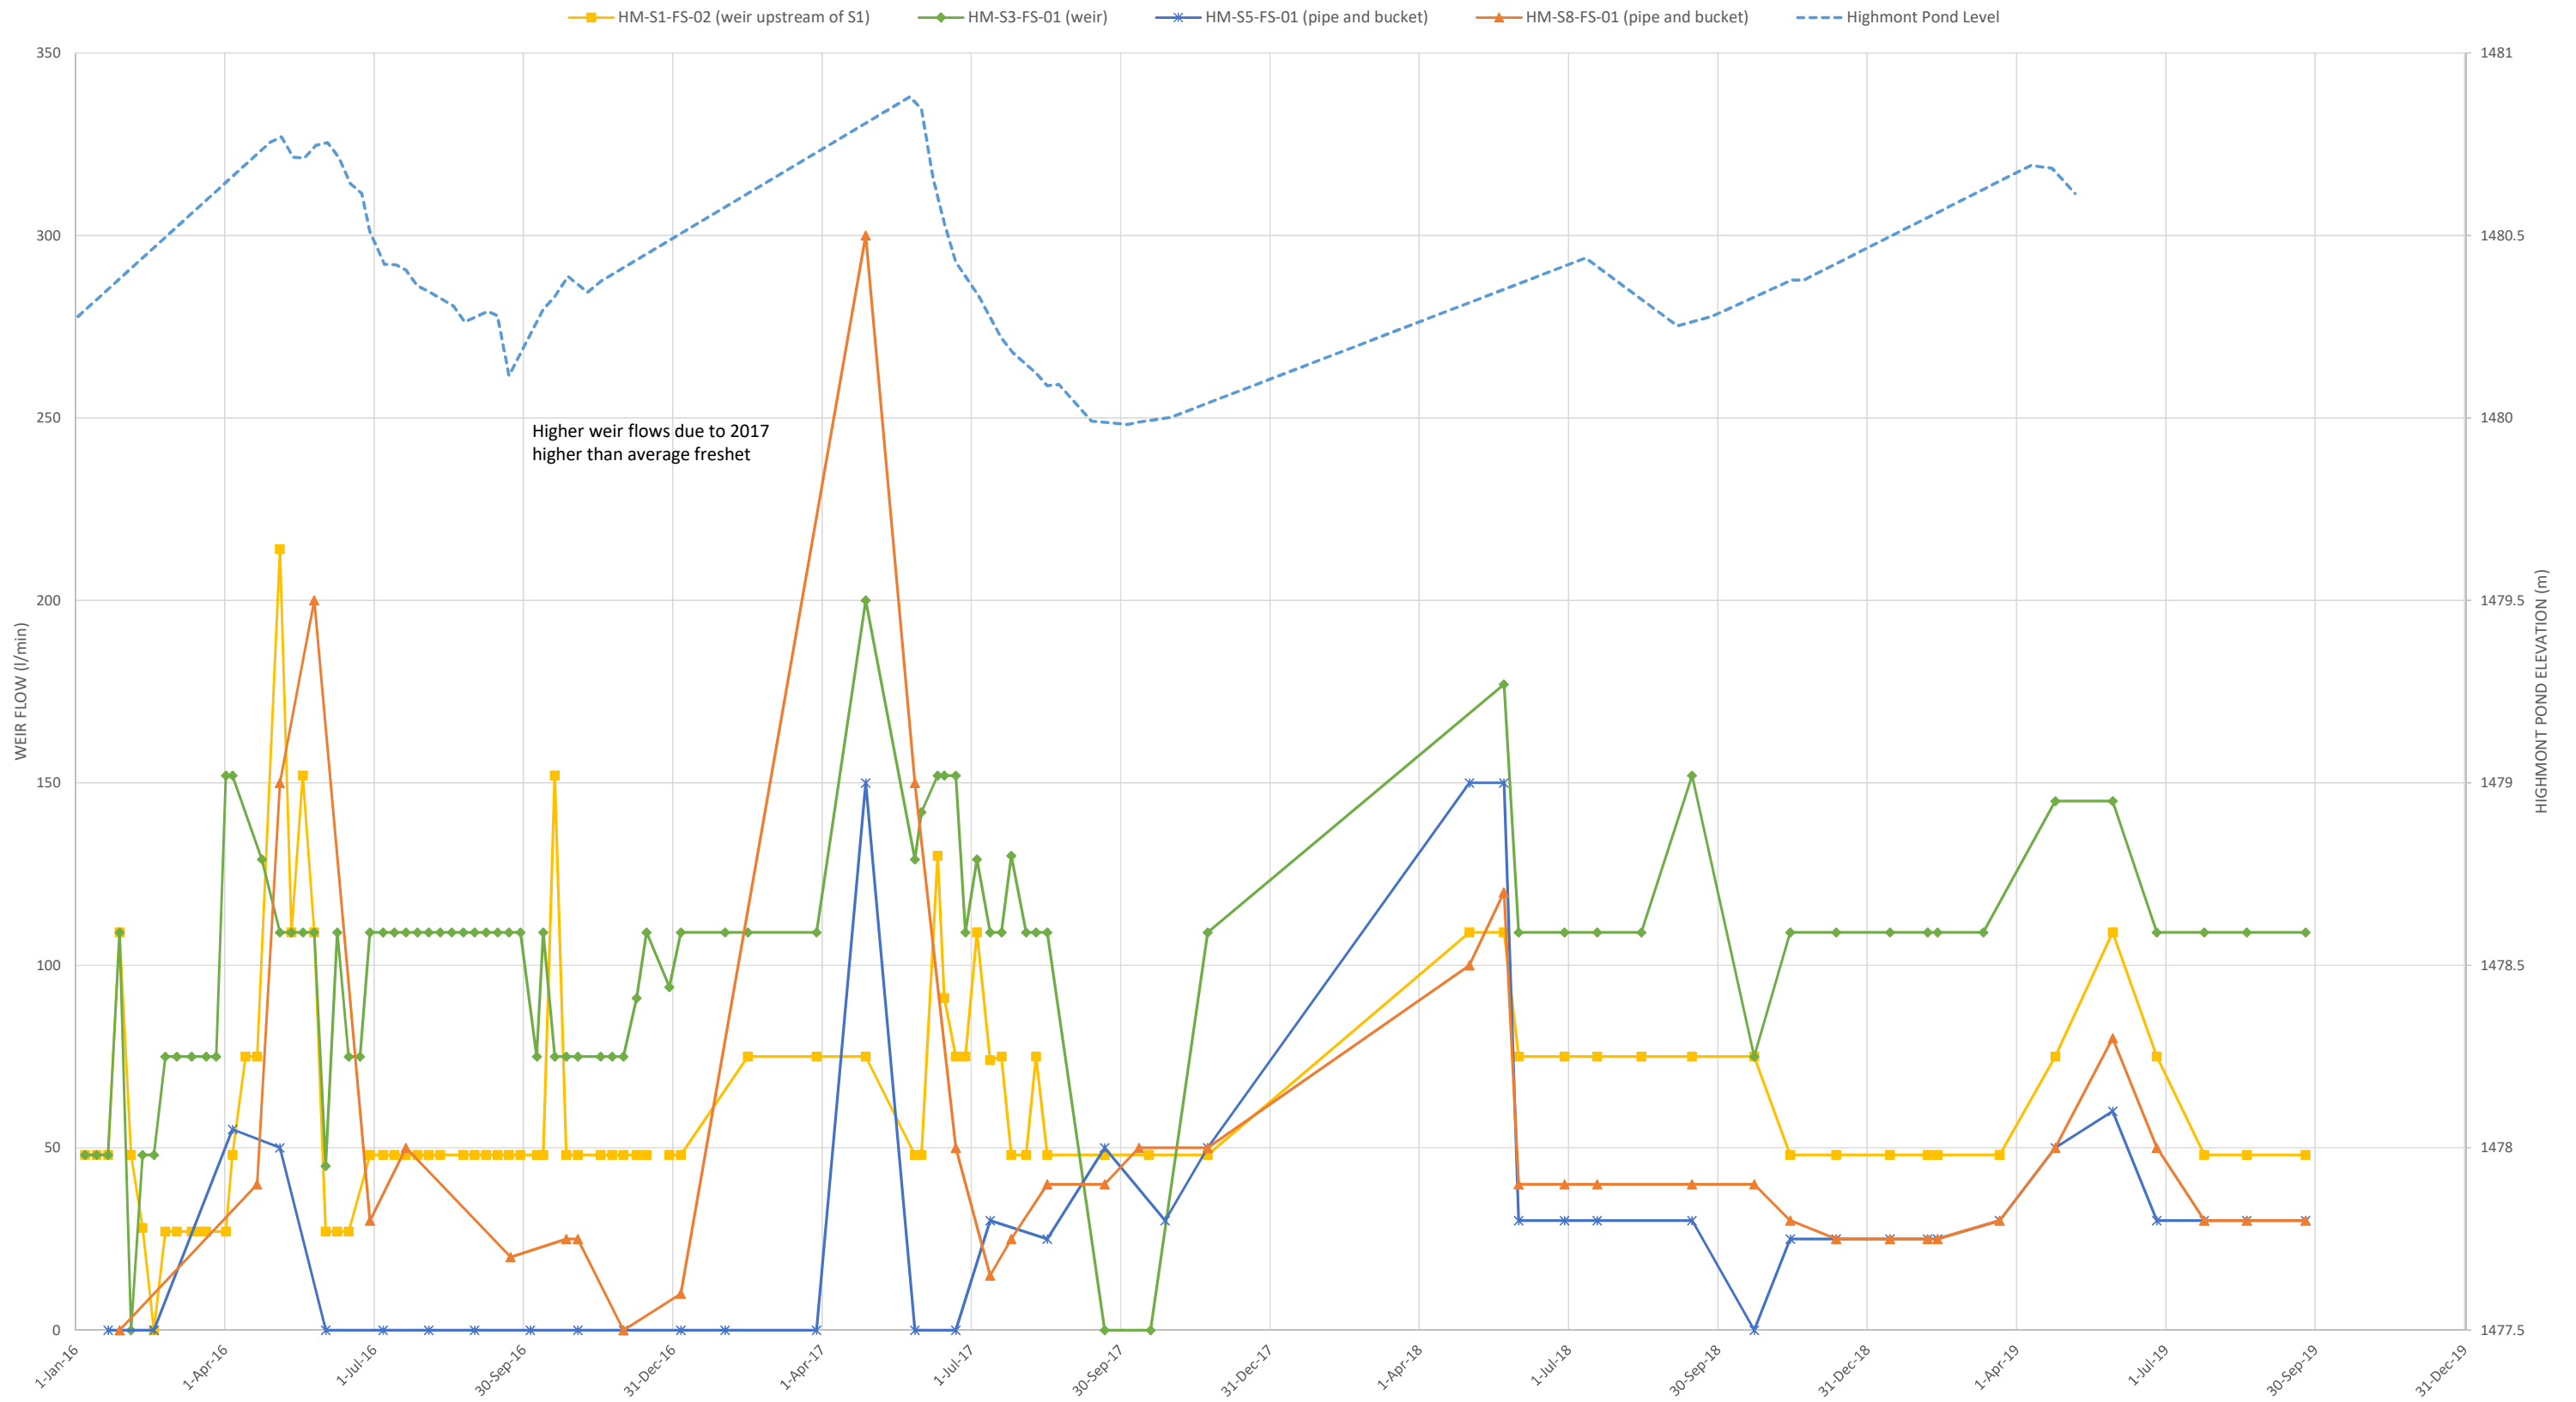
Typically, the peak flow rates are recorded in April/May during freshet. Although based on a lower number of readings, 2019 seepage measurements were generally similar to recent measurements during the same time period. The above average flows observed in all the seepage flow measurement instrumentation in 2017 was likely an early response to the freshet. This peak was not observed in 2018 or 2019, possibly influenced by the reduced frequency of readings and milder freshet.
