# **Teck Metals Ltd.**

## **Pinchi Lake Mine Tailings Storage Facility**

### ***2019 Dam Safety Inspection***

M07728A34.730

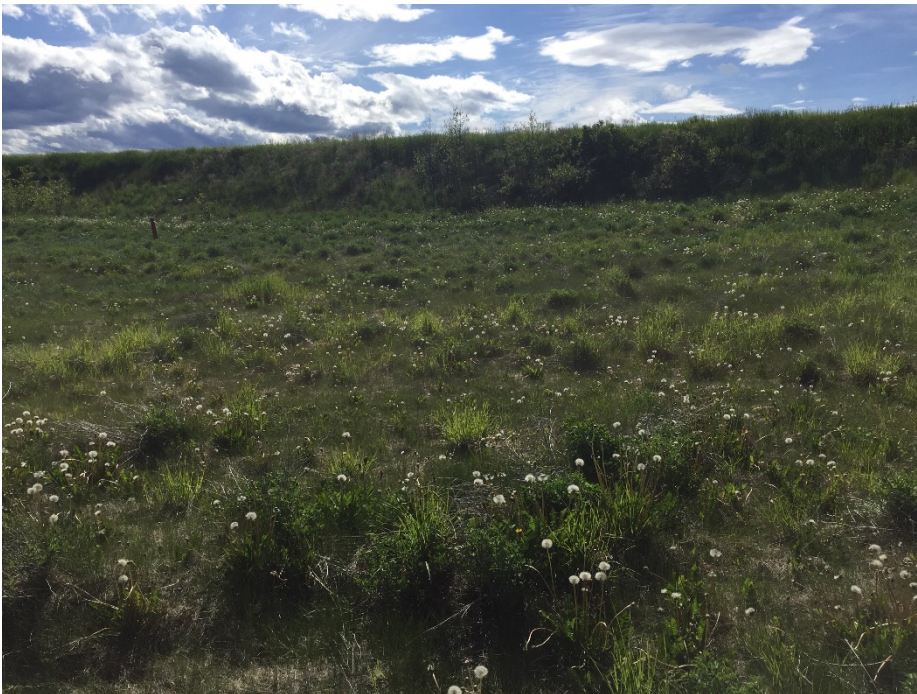
**Photo II-5 Tailings Dam – east leg, looking north. Note vegetation on dam slope.**

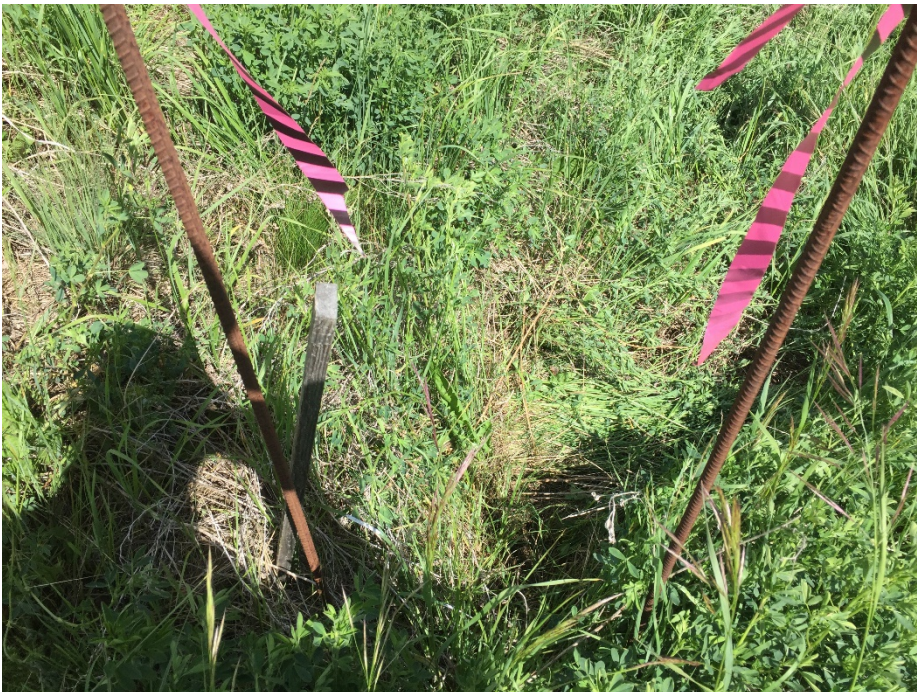
- Cracks were observed on the slope from 2013 to 2017 (Location 5 in Figure 4.1). These cracks are no longer visible due to vegetation growth, and no new cracks were observed during the inspection. Measurements of crack movements were taken from 2015 to 2018 using metal rods installed on either side of the cracks (Photo II-36), and these measurements showed no sign of ongoing movements. These measurements were discontinued and removed from routine surveillance in the OMS Manual in 2019 (KCB 2019).

**Photo II-36 Borrow Area A – crack monitoring rod location 103 (crack not visible).**

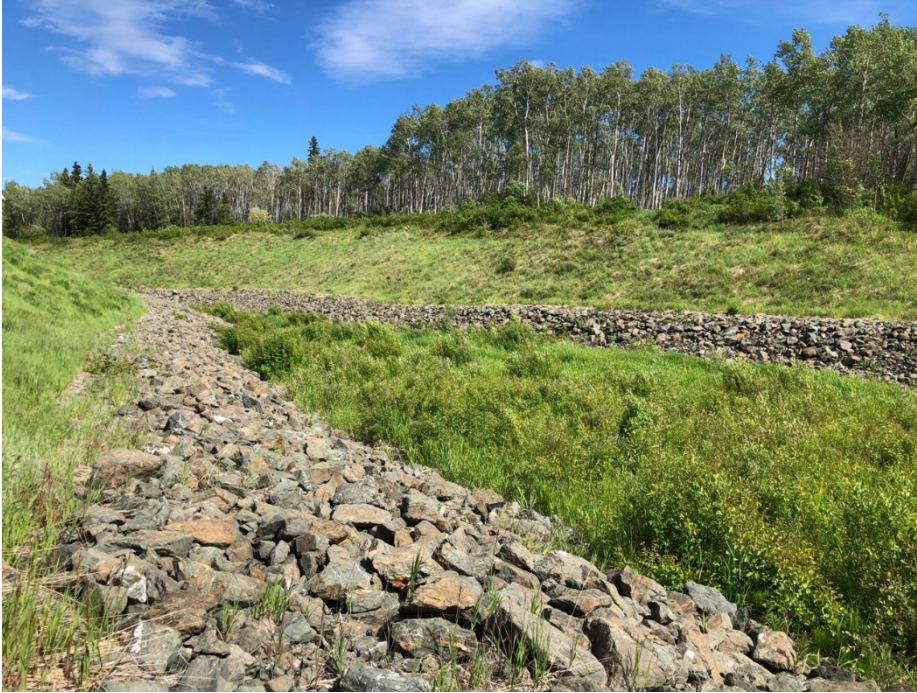
**Photo II-44** Ed Creek Diversion Channel – Riprap on right bank, showing weathering and breakage.

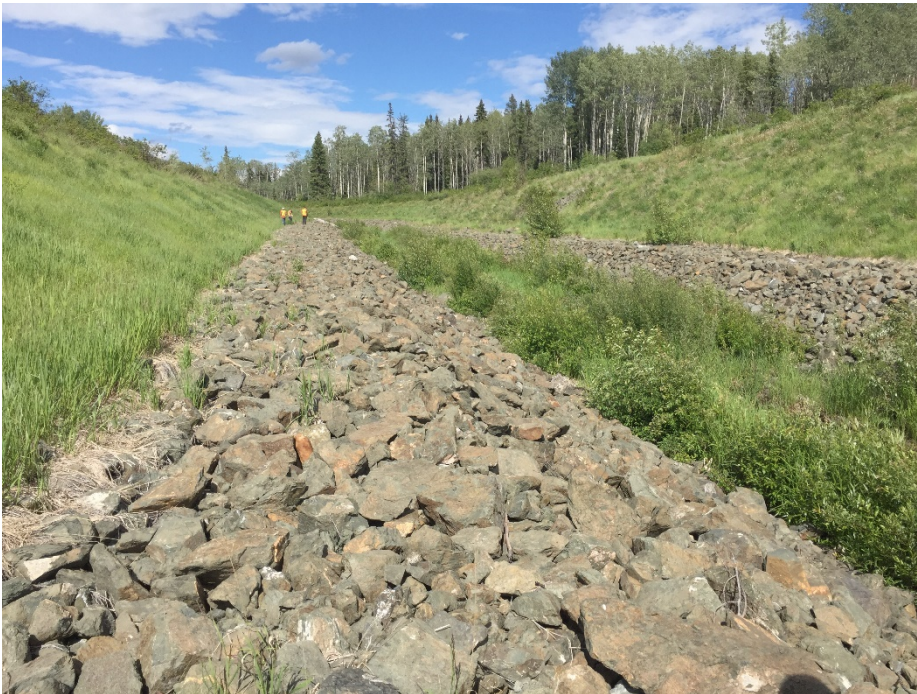
**Photo II-47** Ed Creek Diversion Channel – looking downstream from near second bend. Light-coloured area of riprap was replaced in 2014, and is in good condition.

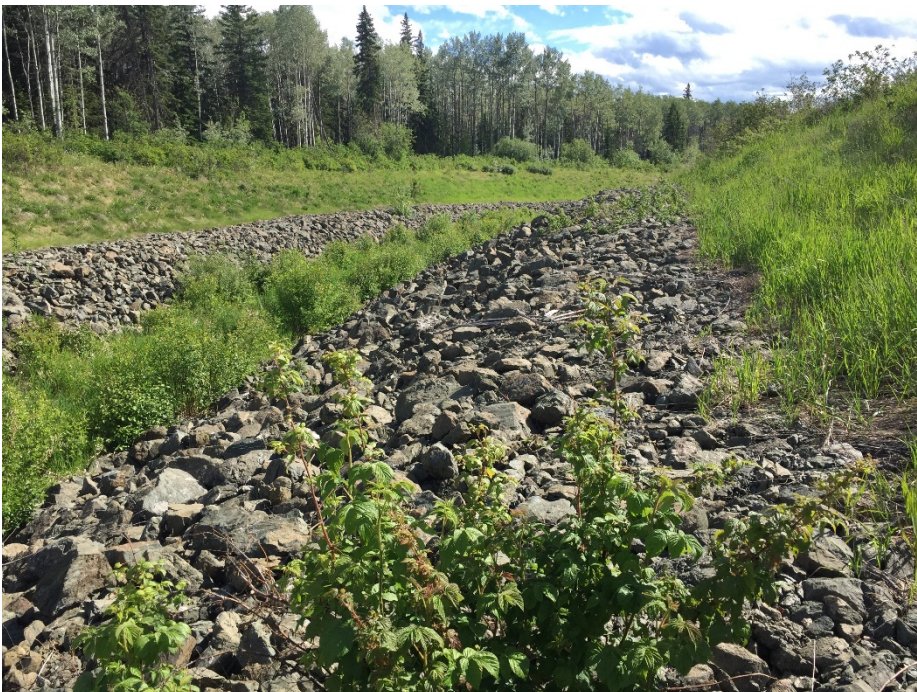
**Photo II-49** Ed Creek Diversion Channel – looking upstream from between first and second bends.

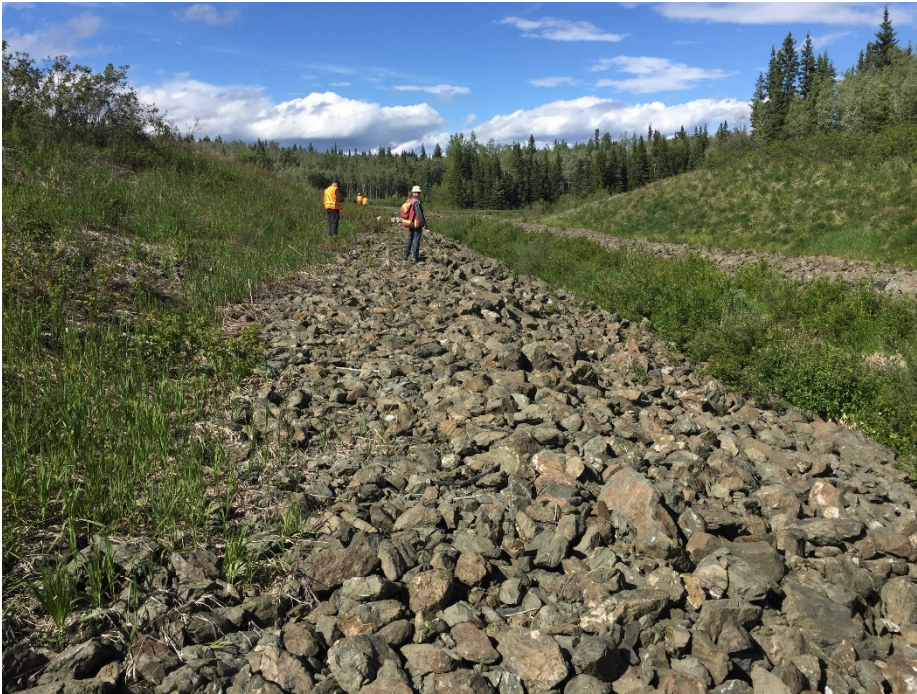
**Photo II-50** Ed Creek Diversion Channel – looking downstream from near first bend.

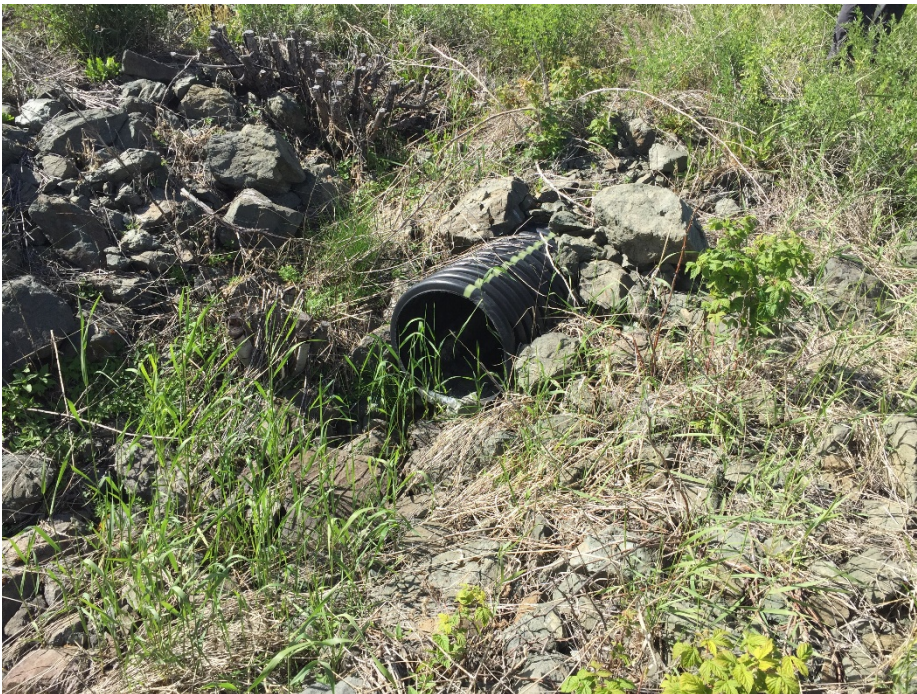
**Photo II-53** Inlet of 460 mm culvert on north bank of Ed Creek Diversion Channel. There is vegetation upstream of the inlet that could block the channel during flood conditions.

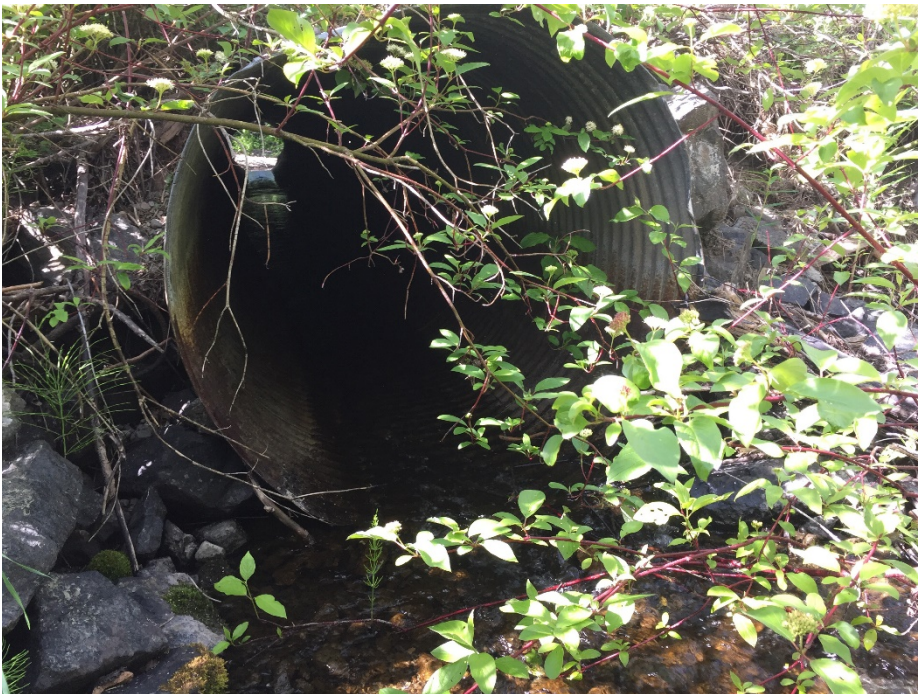
**Photo II-57** Outlets of Ed Creek culverts under Pinchi Lake Road. Note only one culvert is flowing.
