Teck Coal Ltd.

Quintette Coal Operations

Shikano North Tailings Dam

2019 Dam Safety Inspection

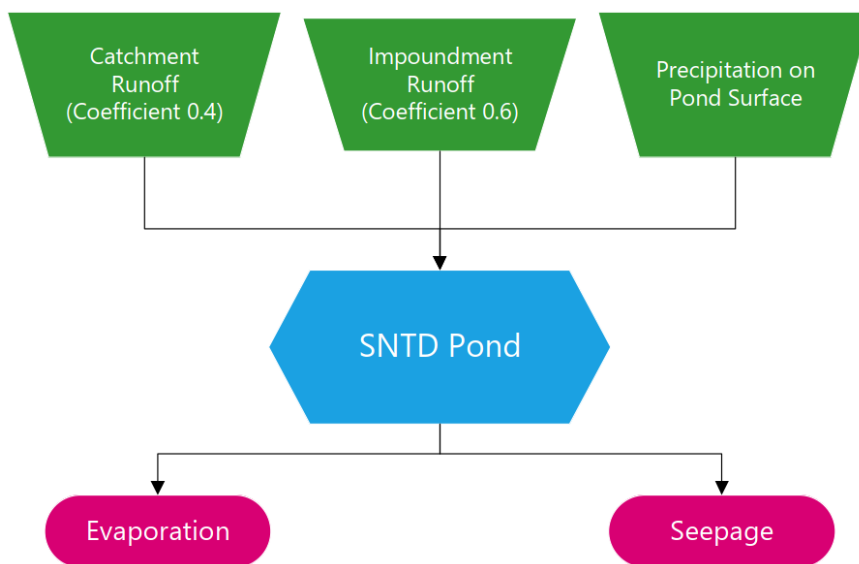
Figure 3.1 SNTD Water Accounting Diagram

Under existing conditions, inflows to the impoundment are predominantly from surface water runoff with limited observed contribution from pit wall seepage. Outflows from the impoundment are predominately seepage through the “flow-through” dam and evaporation from the pond. The size of the pond has been observed to change seasonally indicating there is some retention time in the impoundment. However, total water that enters the impoundment leaves the impoundment and does not accumulate on an annual basis. A simplified water accounting schematic is shown in Figure 3.1.

Seepage losses from the impoundment are estimated at an average flow rate of 7 L/s over the 12-month period. The flow rate during the 2019 DSI inspection was estimated 8 L/s, similar to the average annual flow and flow rates observed during previous DSI inspections. The average flow estimate includes the winter period when flows are likely zero. The seepage rate is within the expected performance range for the “flow-through” design and there are no planned changes to surface water management that would alter this observation.

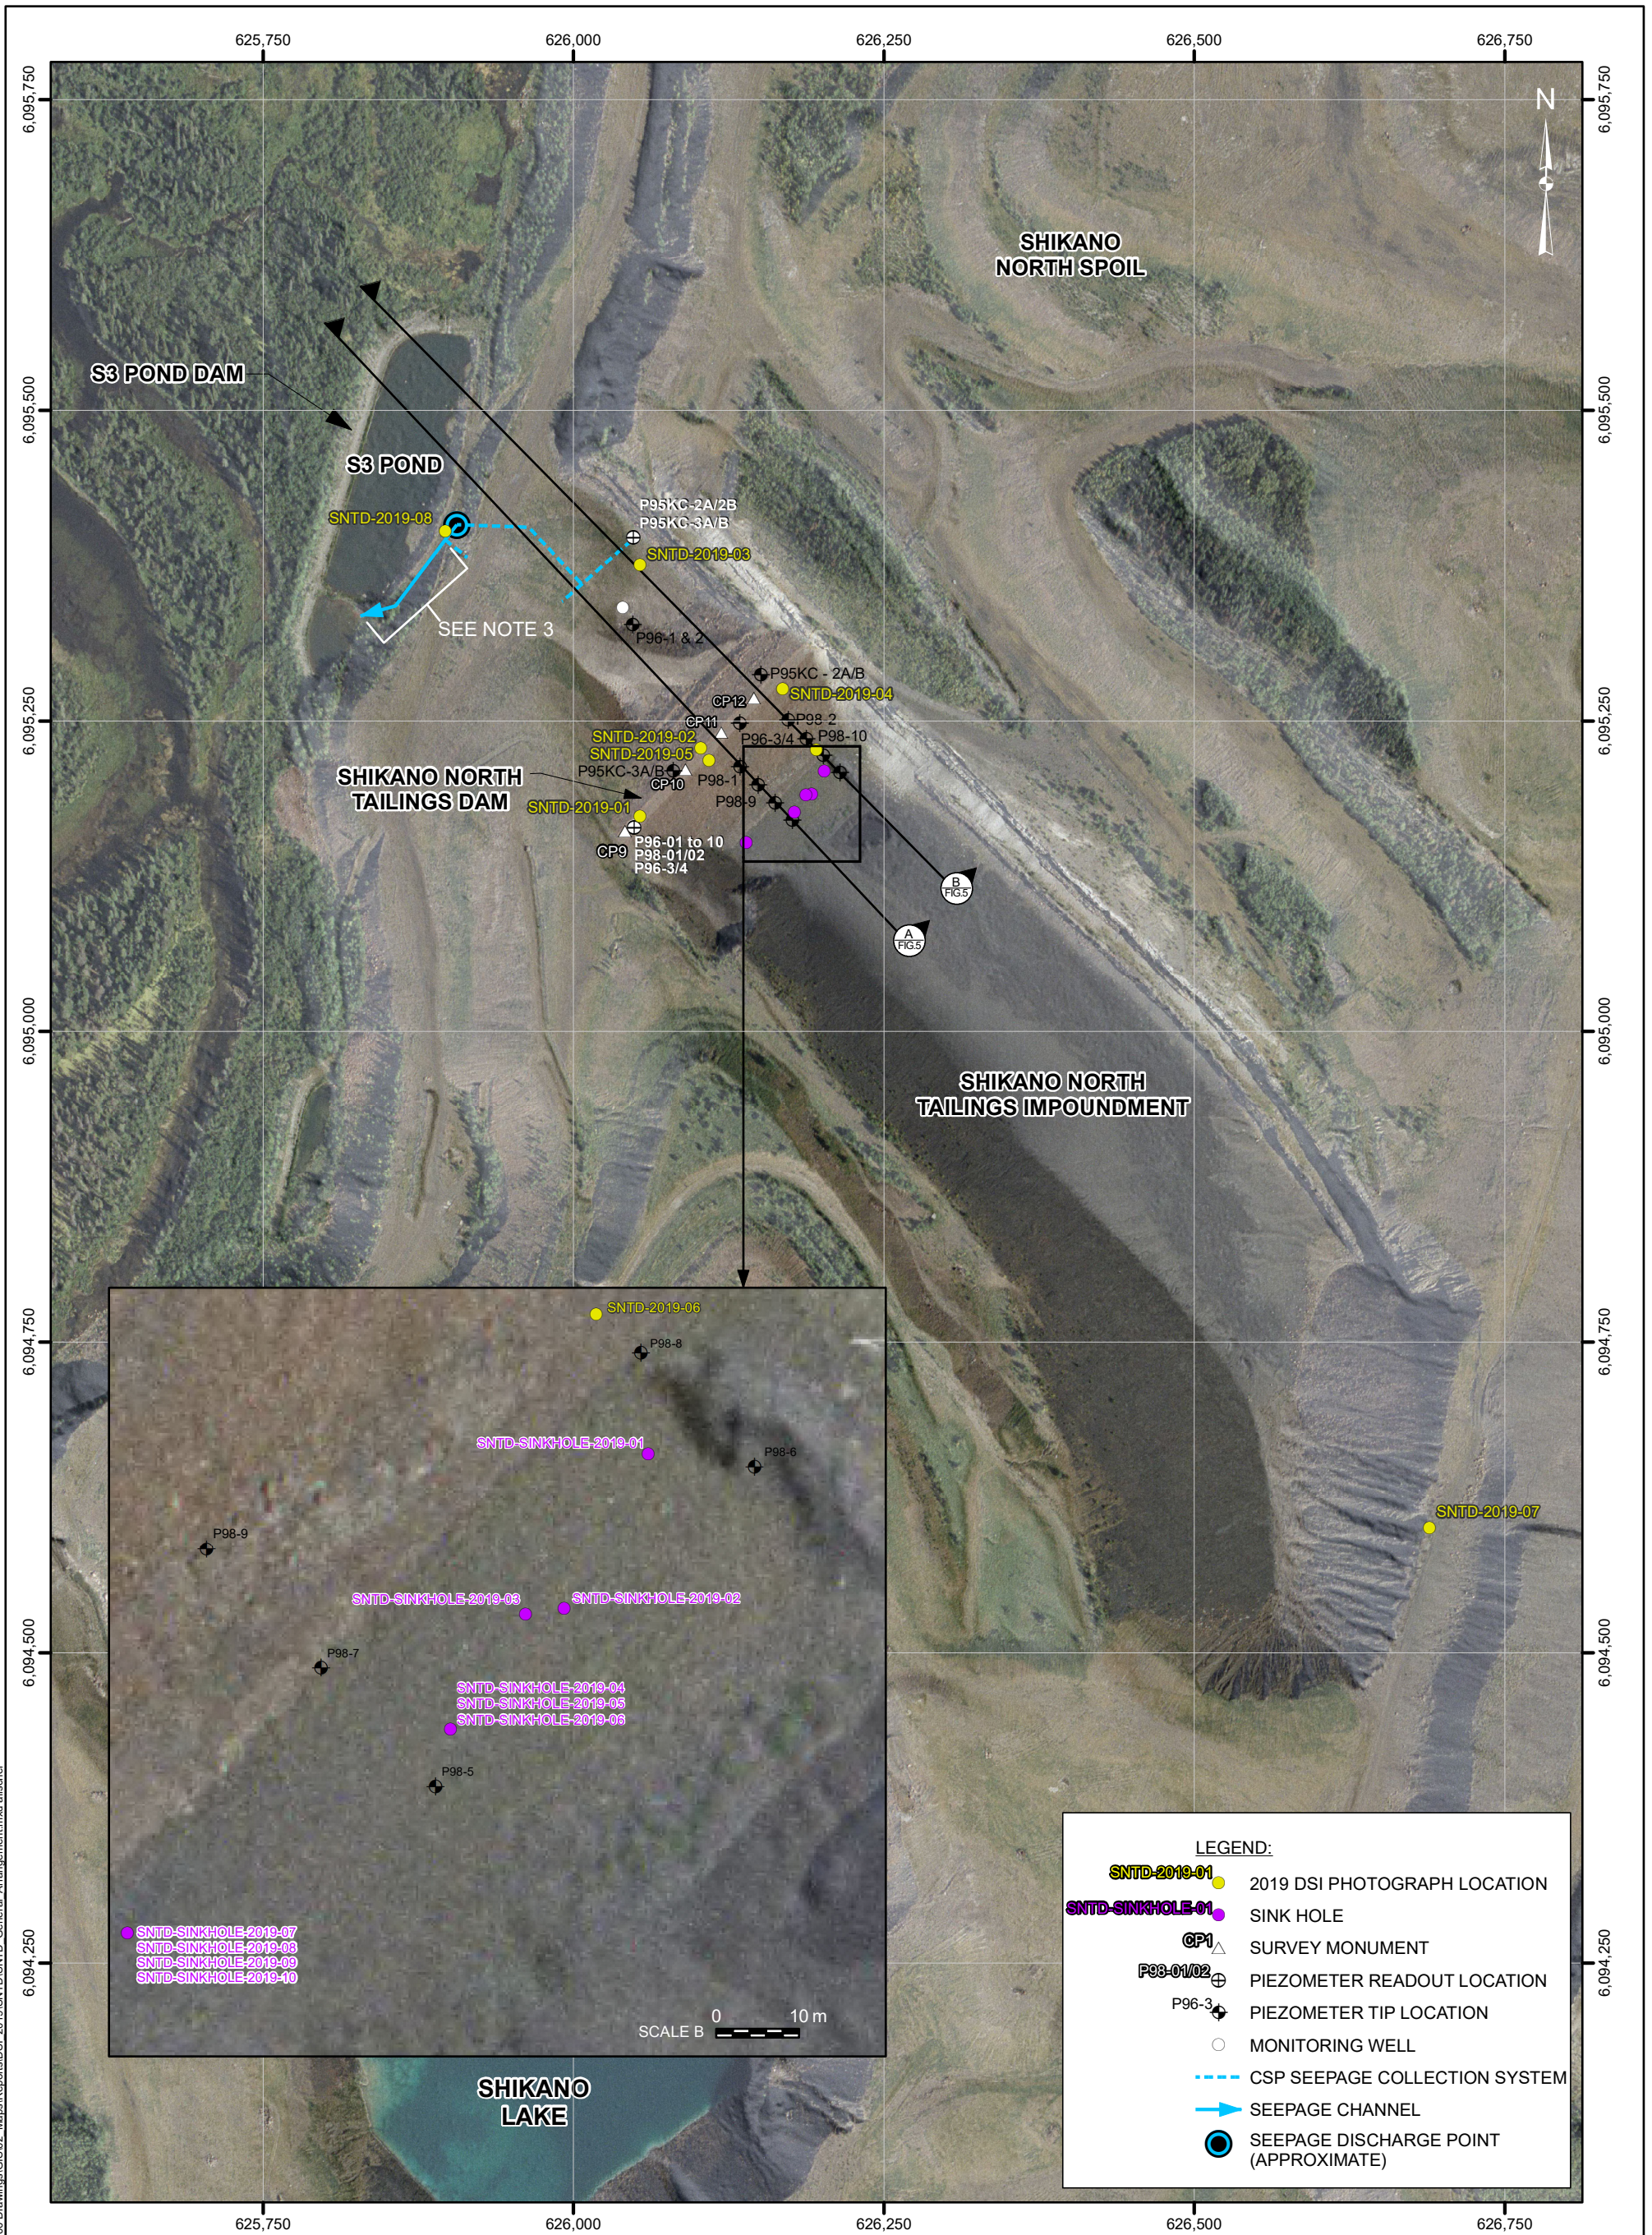
FIG No. 3

Of the 16 piezometers installed at SNTD, 10 are functional, (refer to Figure 3). Annual readings of the functioning pneumatic piezometers are taken once a year by Teck's Dam Inspector. 2019 pore pressure readings were collected on May 27, 2019 and are plotted on Figures 5 and 6.

Refer for Figure 3 for sinkholes general location. There was no visually obvious change in the sinkholes between the 2018 and 2019 inspections (Photos I-10, I-11, I-12, and I-13).

- Smaller sinkholes 4, 5, and 7 through 10 were first documented during the 2017 DSI site visit and appear to be unchanged in 2019. Sinkholes 7 through 10 are located between SNTD-2018-07 and SNTD-2018-08, refer to Figure 3. No photos taken for Sinkholes 7 to 11.

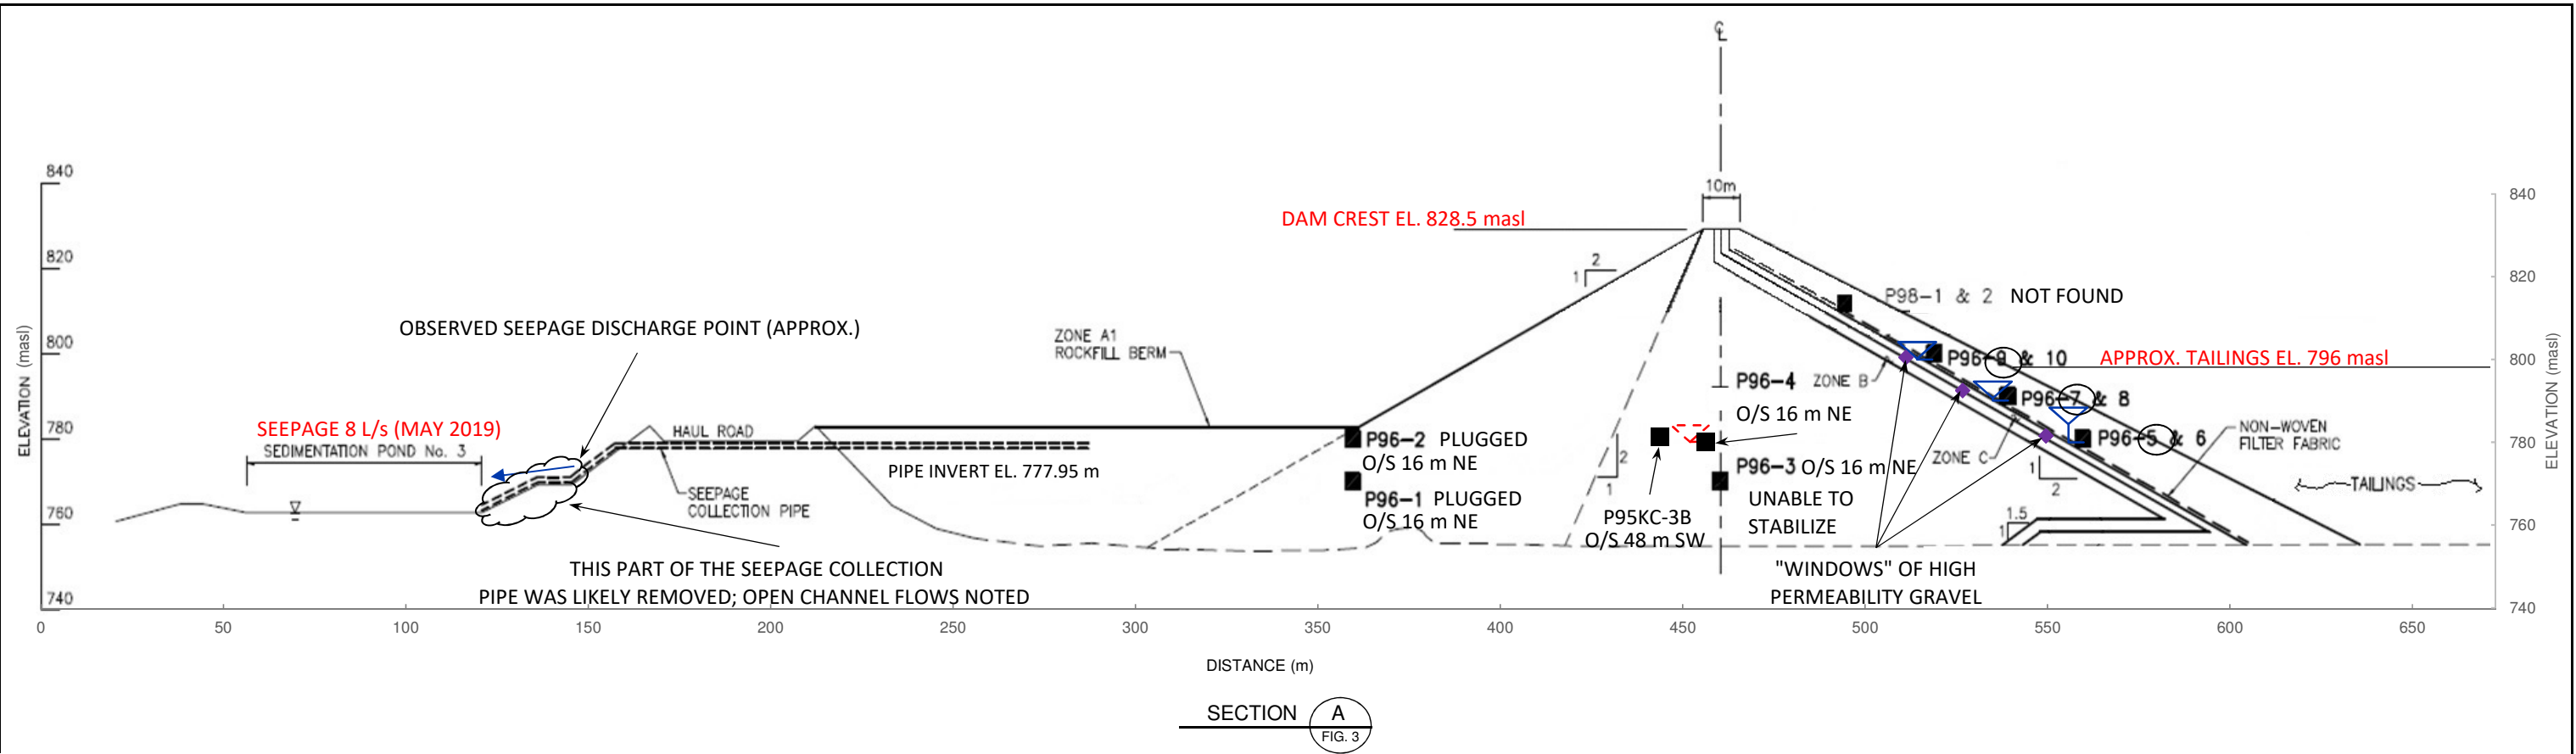
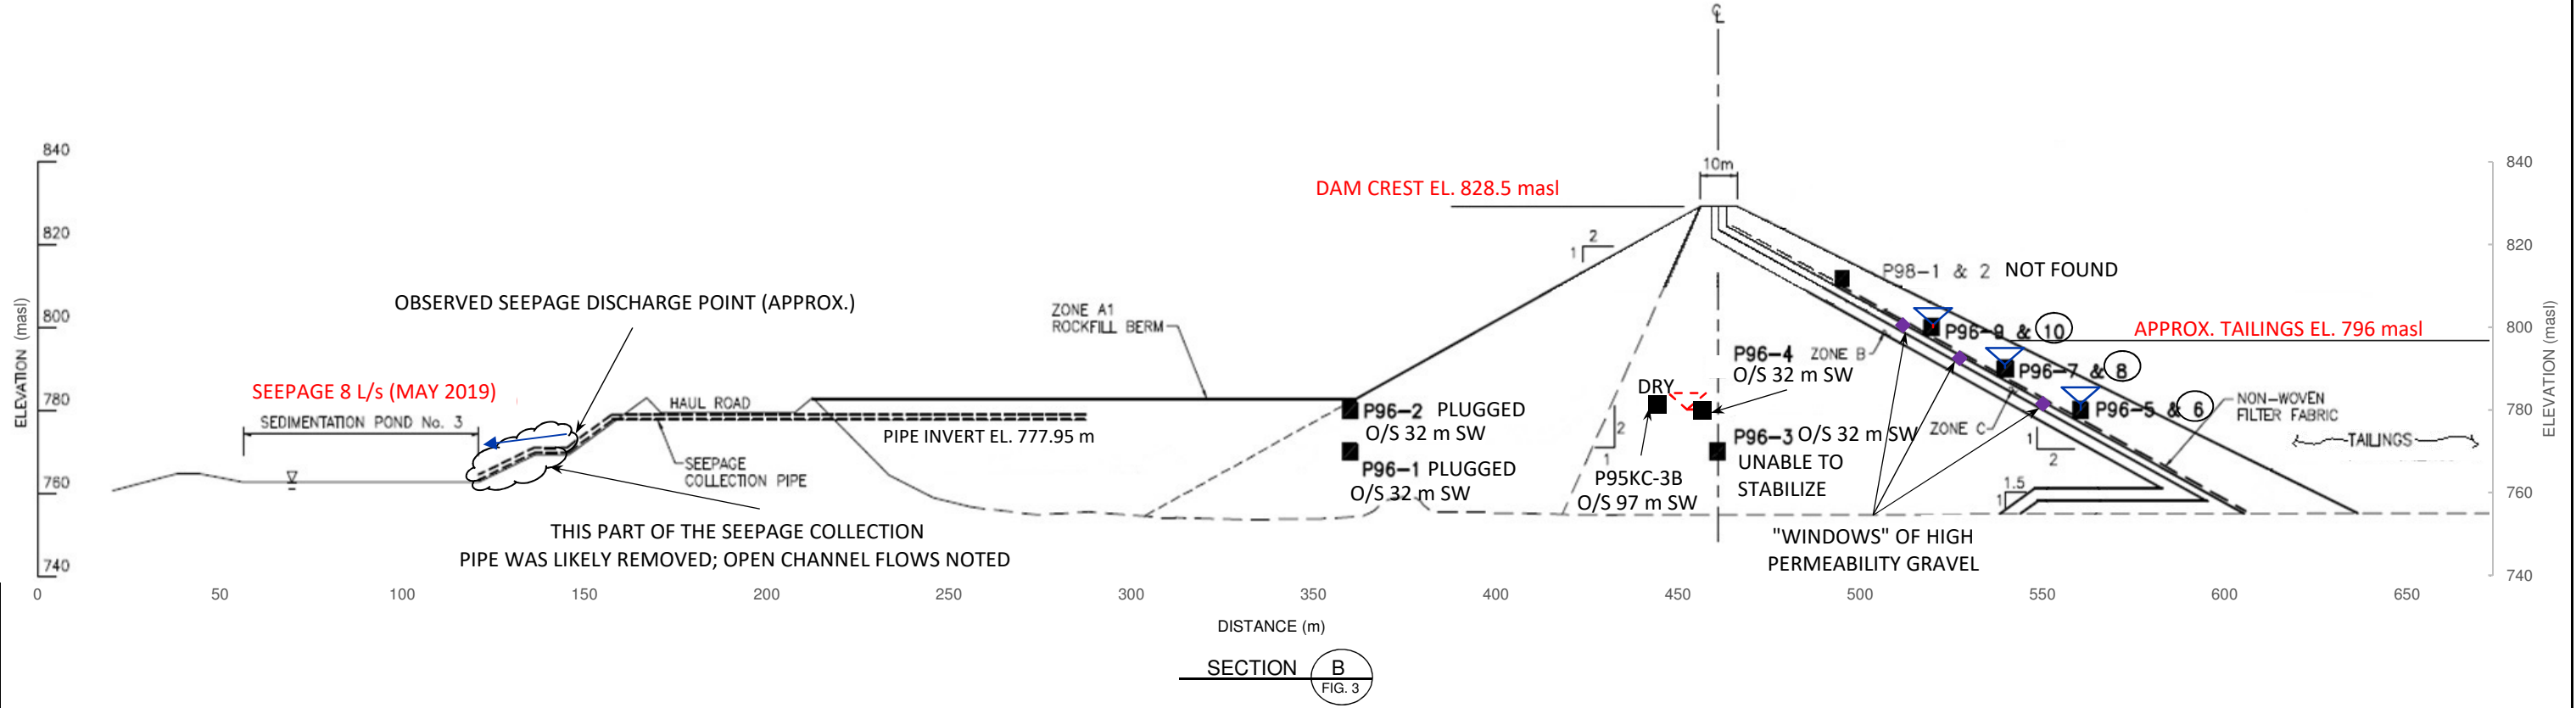
PROJECT QUINTETTE COAL OPERATIONS 2019 DAM SAFETY INSPECTION
	 	TITLE SHIKANO NORTH TAILINGS DAM SCHEMATIC SECTIONS A AND B WITH 2019 PIEZOMETER READINGS
PROJECT No. M09684A16		FIG. No. 5

- All piezometer readings are below the established threshold levels. No significant changes in established trends were observed.
- Instruments are accessible and functioning with the exceptions of those noted in Table 4.1.
- P96-6 measured water level has been slightly lower than other upstream piezometers installed below the current tailings level, but it has been consistent since 2014. This may be due to blockage in the instrument cable, or leakage in the instrument fitting.

- Similar to previous years, P96-9 continues to read a small pressure head and the elevation is above the current pond and tailings level. The reason for this is not known but its readings have been consistent since 2013. There is no visible seepage from the upstream face of the dam and P96-4 historical readings indicate the water level in the dam fill is below tailings level. Instrument error or locally entrained water around the instrument tip is the most likely cause for the readings. This is not a dam safety concern and no follow up action is required.
- P96-10 historical readings showed similar trend to that of P96-9; however, the May 2018 reading indicates the instrument was dry.
- The pore pressure measured for piezometers at the same elevation upstream of the filter zones generally show a downward gradient in the upstream rockfill zone, as expected.

The cause of these features is most likely the migration of tailings into the upstream coarse rockfill shell and “windows” of high permeability gravel (Figure 5) which are upstream of the filters. Sinkholes are considered a local condition and not a risk to the SNTD integrity.

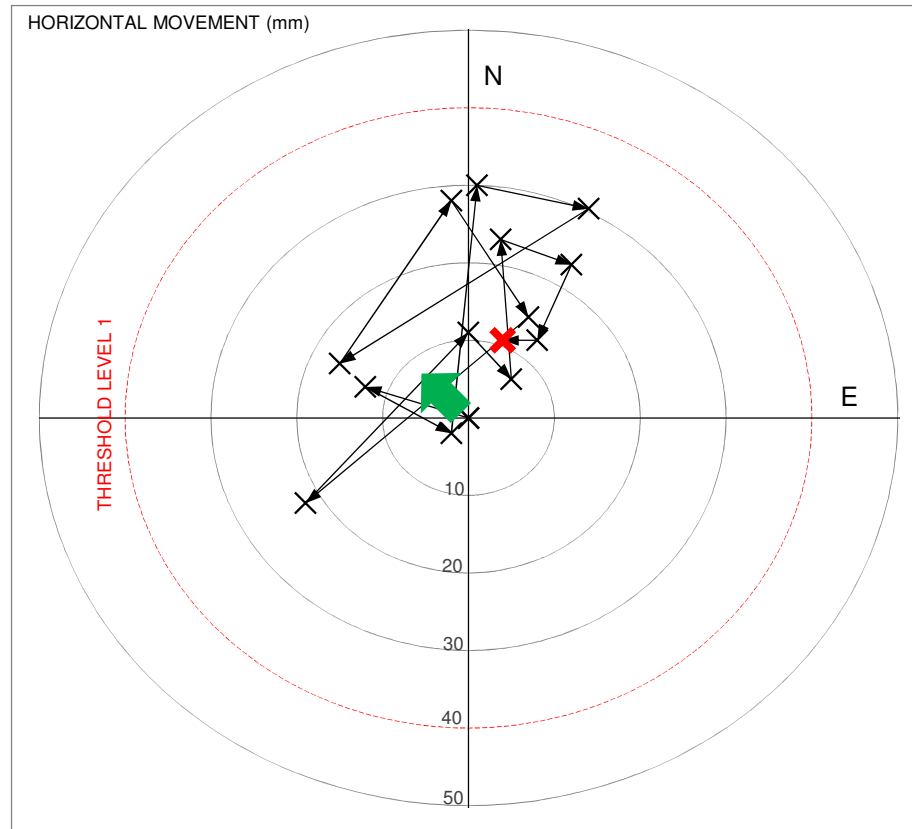
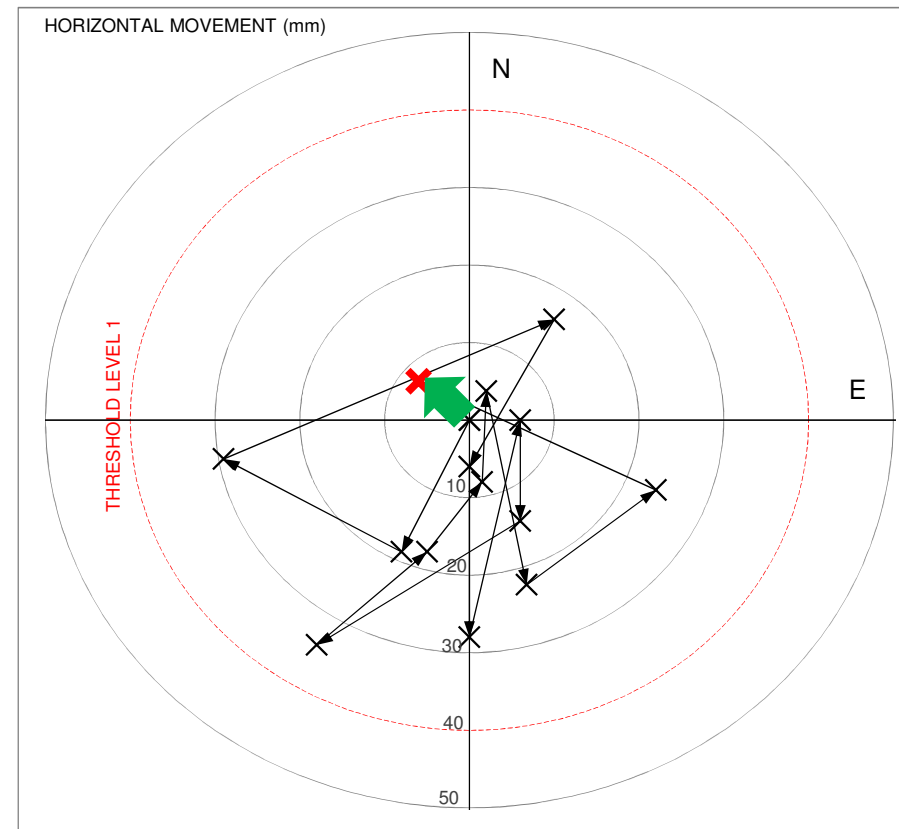
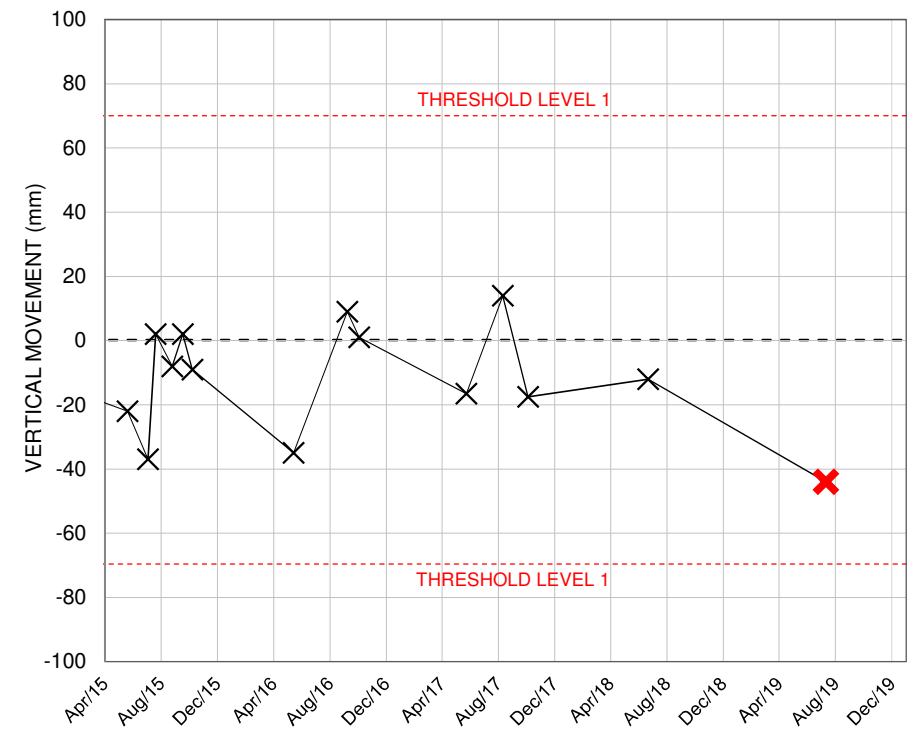
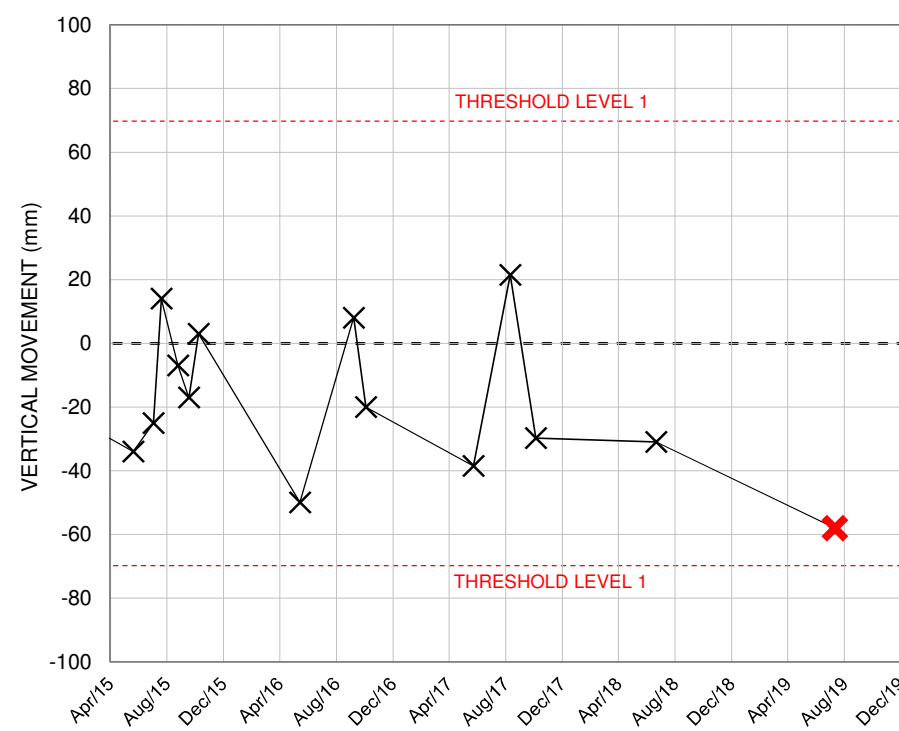
PROJECT	QUINTETTE COAL OPERATIONS 2019 DAM SAFETY INSPECTION	
TITLE	SHIKANO NORTH TAILINGS DAM 2019 SURVEY MONUMENT PLOTS CP9 AND CP10	
PROJECT No.	M09684A16	FIG. No. 8

From a review of the available data since 2014, none of the monuments indicate a trend of horizontal movement or significant crest settlement. Incremental movement is more likely attributed to survey accuracy than dam movement. There was no exceedance of thresholds in 2018 (Figures 8 and 9).
