## Sä Dena Hes Mine, Yukon Territory 2019 Dam Safety Inspection

SRK Consulting (Canada) Inc.  
May 2020

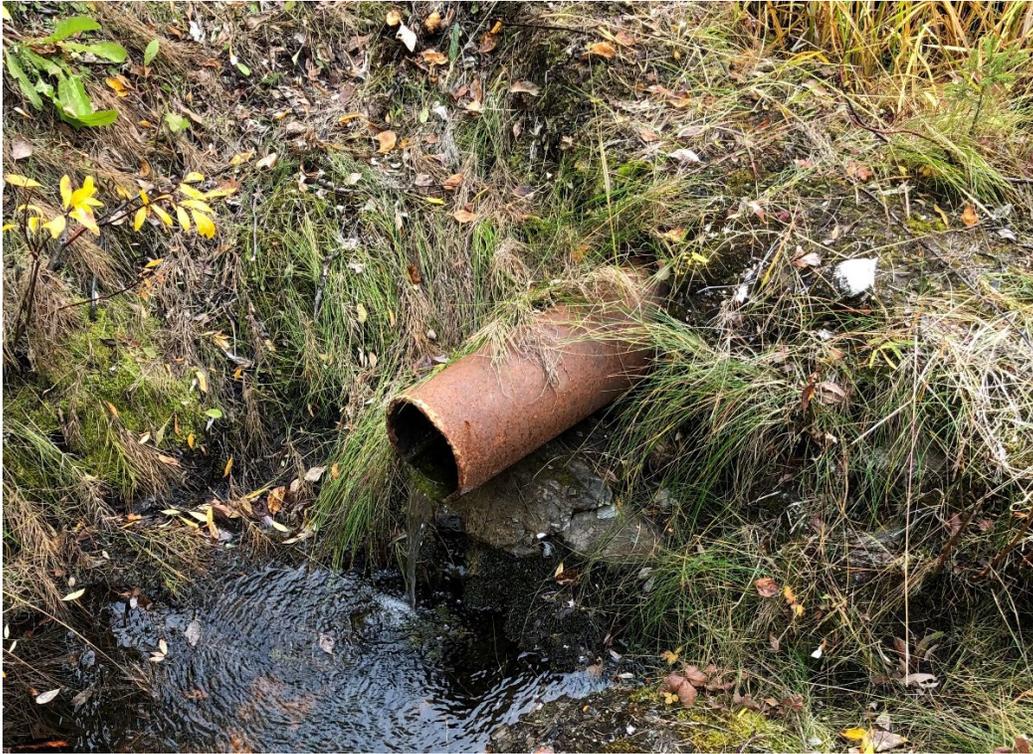
Photo 5: MH-02 Flow Gauge

Along the downstream toe of the North Dam there is an 80 m long seepage zone. Seepage from this zone is collected at a monitoring station referred to as MH-02 and is a combination of groundwater discharge from the surrounding hillsides to the west and minimal seepage flow from the impoundment. The monitoring station consists of a 6-inch diameter steel pipe (Photo 5) embedded in sandbags. A section of the seepage zone along the toe is shown in Photo 6.

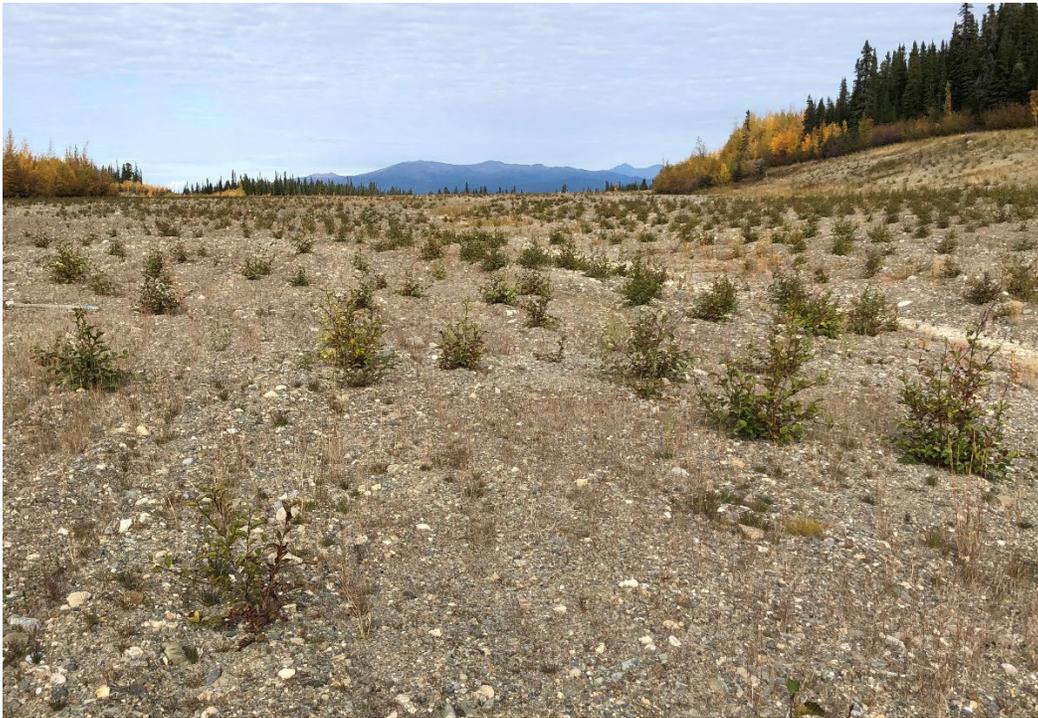
Photo 11: Vegetation on tailings cover looking north

As planned, vegetation is slowly developing over the entire area of the cover as shown in Photo 11.

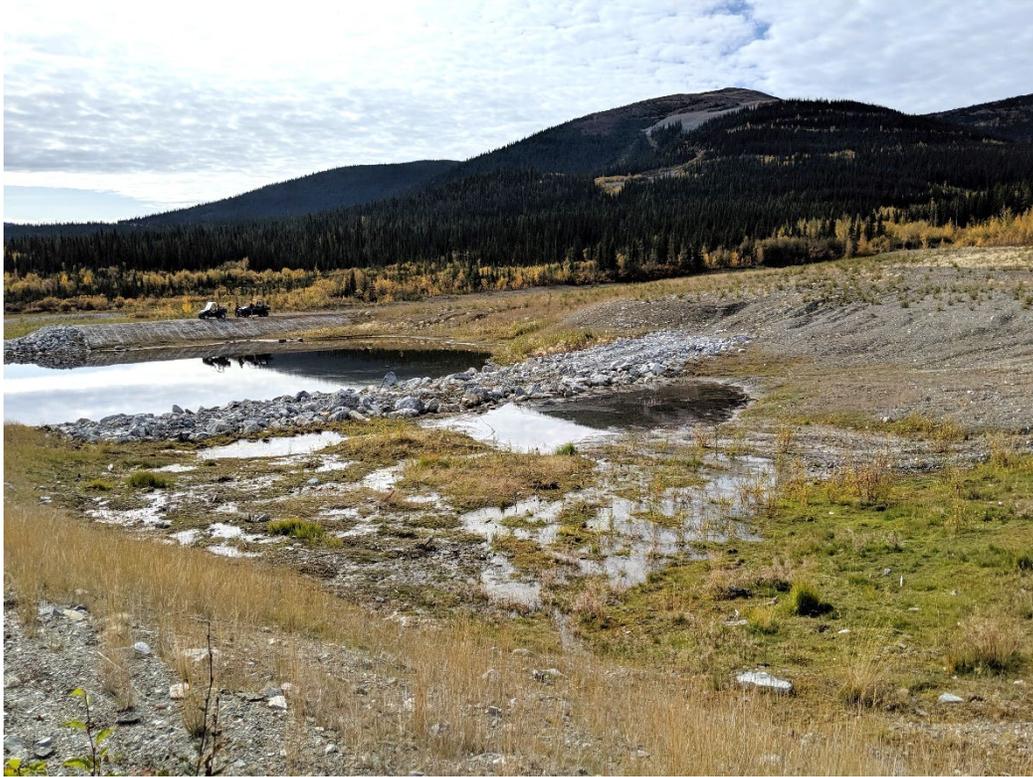
Photo 13: SRS and the rock cofferdam

The rock cofferdam and the sedimentation pond are functioning well. The sedimentation pond was clear at the time of our inspection with no evidence of any silt buildup (Photos 13 and 14).

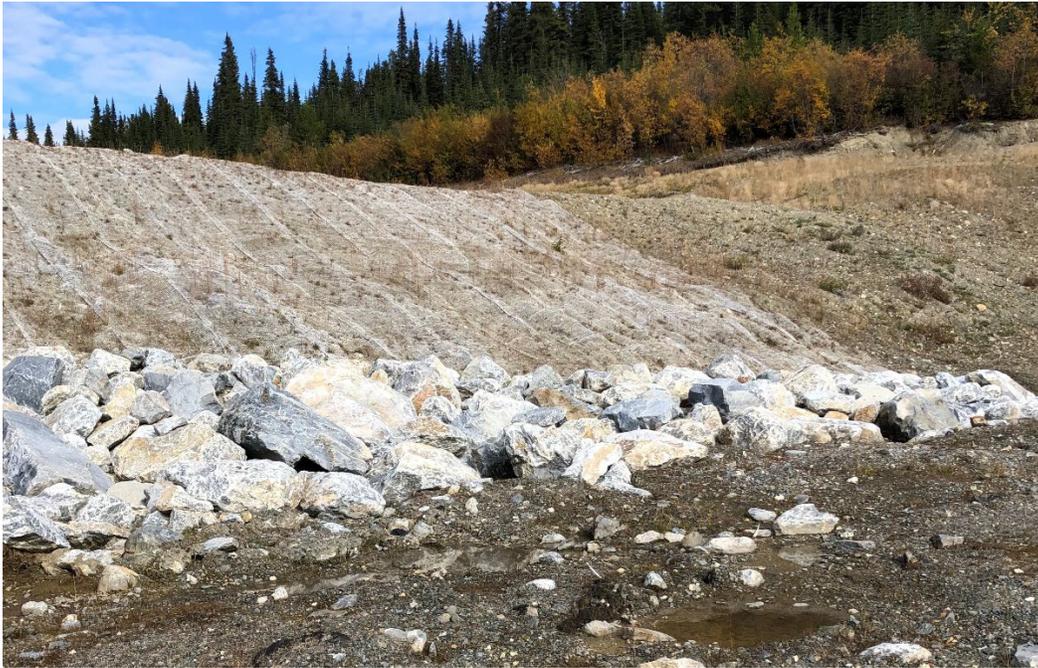
Photo 17: View of the rock protection along the downstream toe of the SRS on east side

The emergency spillway at the SRS is stable and has no safety concerns (Photo 15). The plunge pool shown in Photo 16 provides adequate capacity to accommodate any high flows over the spillway. Seepage from the hillside area to the east of the structure is still evident along the downstream toe of the SRS (Photo 17). A small active boil (Photo 18) that has been noted in previous inspections was still present. This boil is a remnant of pore pressures that were evident during and after the construction of the South Dam which prompted the construction of a toe buttress. The pore pressures were a result of the hydraulic gradient across the dam due to the stored water in behind the embankment. The pore pressures were accentuated by the sand and gravel zones in the foundation soils below the dam. Since the removal of the South Dam, the pore pressures have significantly reduced, but the small head of water due to the retained pond behind the SRS dike is the likely source of the small boil.

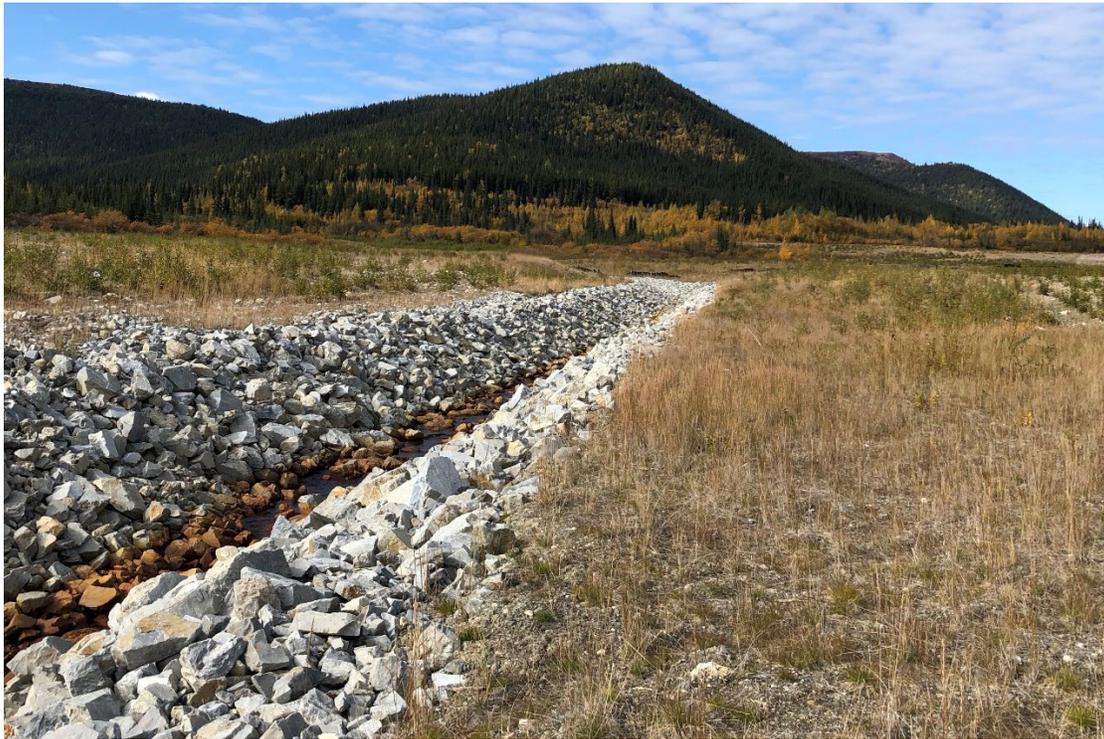
Photo 19: View west along the Camp Creek Drainage Channel

Photo 19 shows the Camp Creek channel looking north and Photo 20 shows the South channel. No movement of the riprap or subsidence was evident in any of these channels.

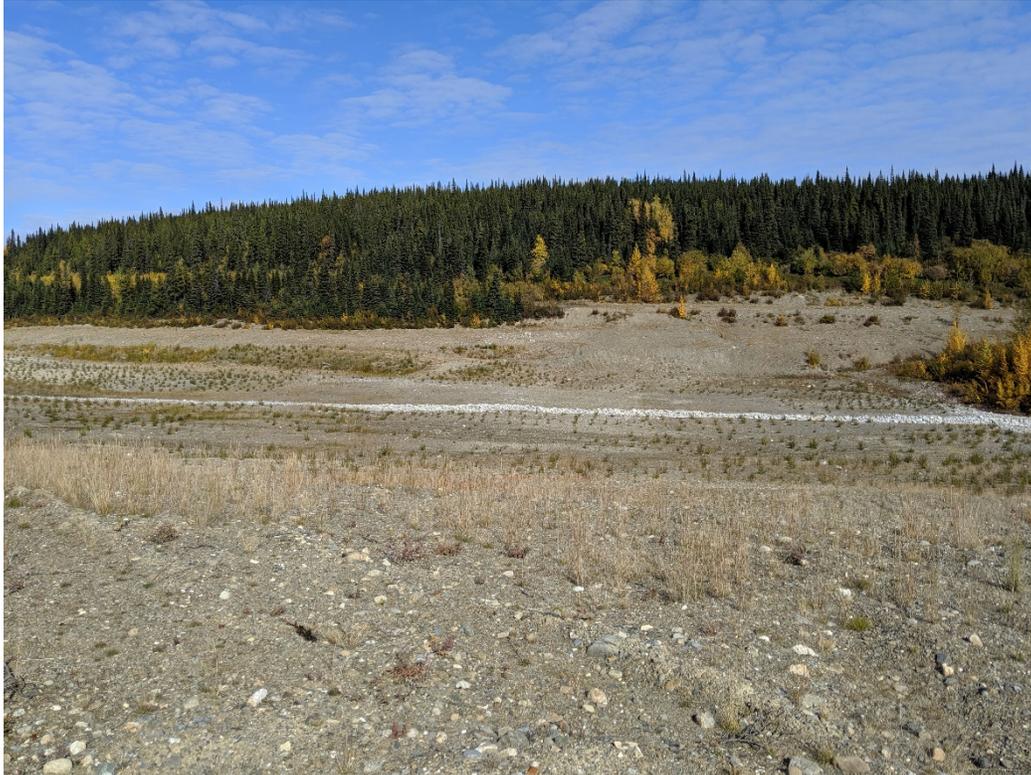
Photo 21: View east over the location of the original Reclaim Dam (removed)

Photos 21 and 22 show location of the Camp Creek channel at the lower reach (also location of the original Reclaim Dam) and the upper reach of the Camp Creek channel.
