**Teck Metals Ltd.**

**Sullivan Mine Tailings Facilities**

***2019 Dam Safety Inspection***

A05807A19

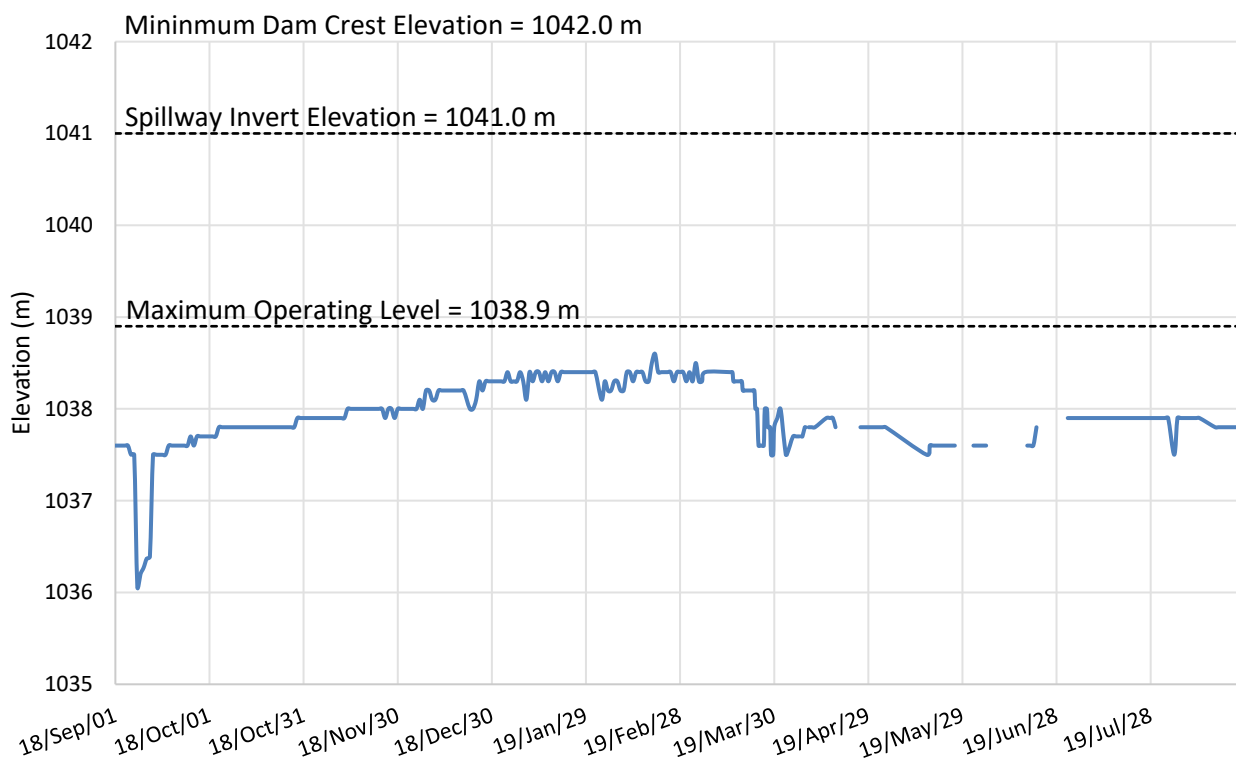
**Figure 3.3 Iron Pond Level 2018 – 2019**

Based on pond water levels, the maximum level observed during the reporting period was El. 1038.6 m around February 20, 2019, which is 2.2 m below the spillway crest elevation (spillway flows discharge to the downstream creek). There was no water discharged from the Iron Pond spillway during the water balance period, and records show that water has never been discharged to the spillway since it was constructed after mine closure.

As previously discussed in Section 3.3.2, and shown on Figure 3.3, the maximum water level elevation recorded in the Iron Pond over this monitoring period was 1038.6 m, which is 2.2 m below the emergency spillway crest elevation and 3.2 m below the minimum Iron Dike crest elevation.

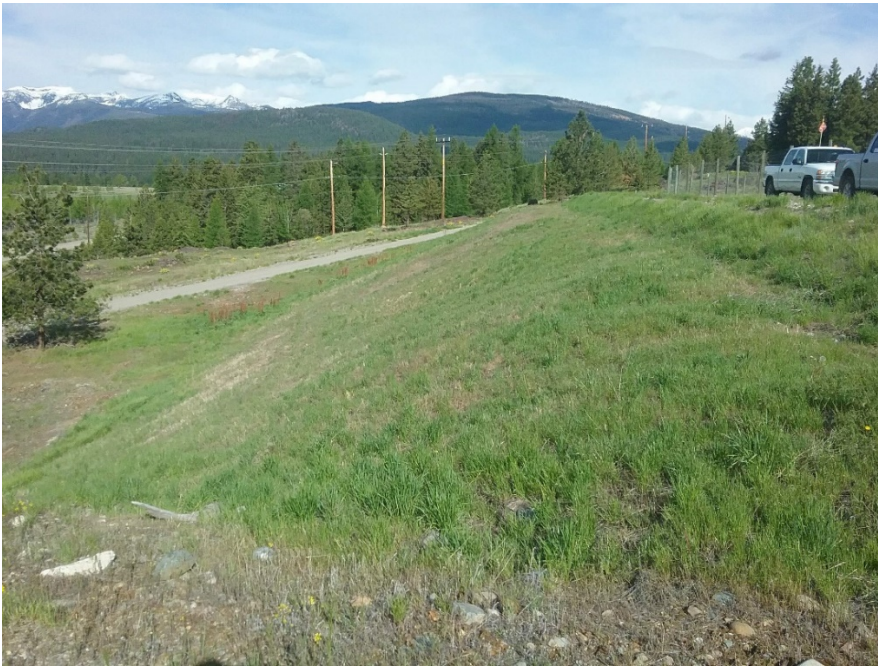
The downstream slope of the South Dam appeared to be in similar condition to past inspections (Photo 1.1). The slope is well grassed with no significant patches of bare or loose soil observed. Animal tracks were observed on the left abutment of the dam.

**Photo 1.1 Downstream Slope of ARD South Dam (238)**

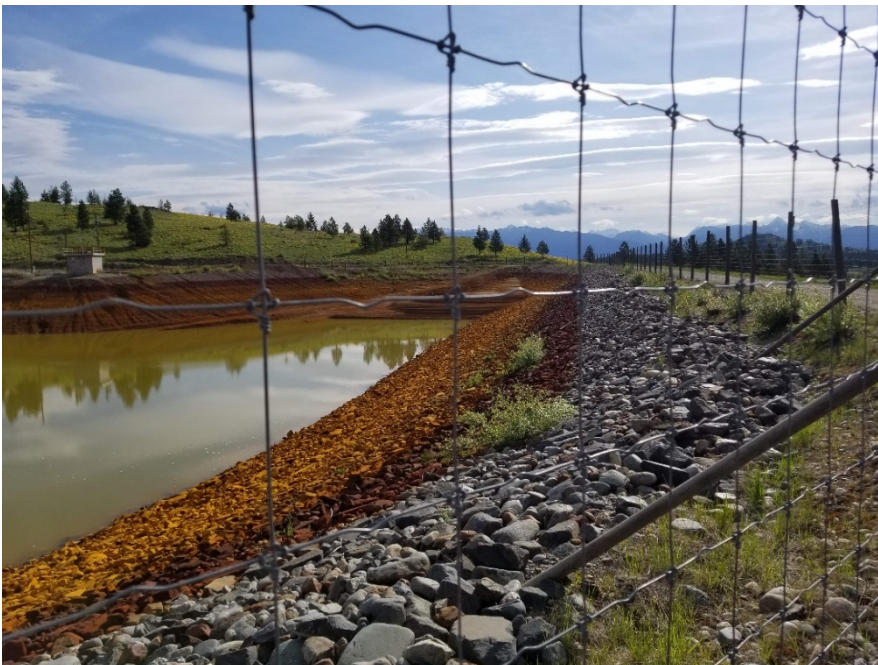
The visual inspection indicated that the North and South Dams were in good physical condition with no signs of structural distress. The riprap on the upstream side of both dams was in good condition with no evidence of movements or damage (Photo 1.2 and 1.7). It was noted that there is sporadic vegetation growth on the upstream face of both dams but is not a dam safety concern at this time and should be managed as part of the vegetation management program on site.

**Photo 1.2 Upstream Slope of ARD South Dam (83)**

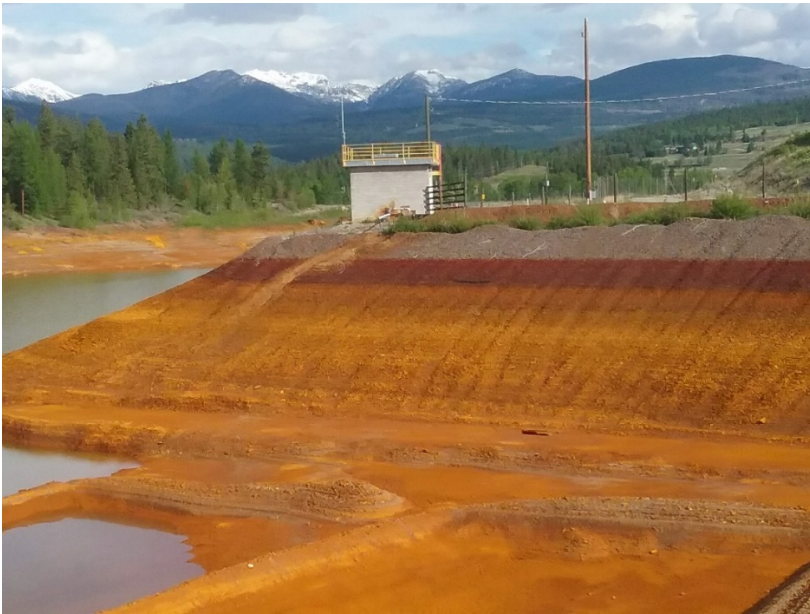
An area of erosion was observed at an outlet pipe adjacent to the pumphouse located near the South Dam of the ARD Pond (Photo 1.3). This area should be monitored and repaired if it begins to encroach on the pumphouse. An erosion gully near the spillway was also observed. Teck reported that this gully had formed due to a high rainfall event just prior to the inspection and the area was flagged off for worker safety. The gully should be backfilled.

**Photo 1.3 Erosion near pumphouse (235)**

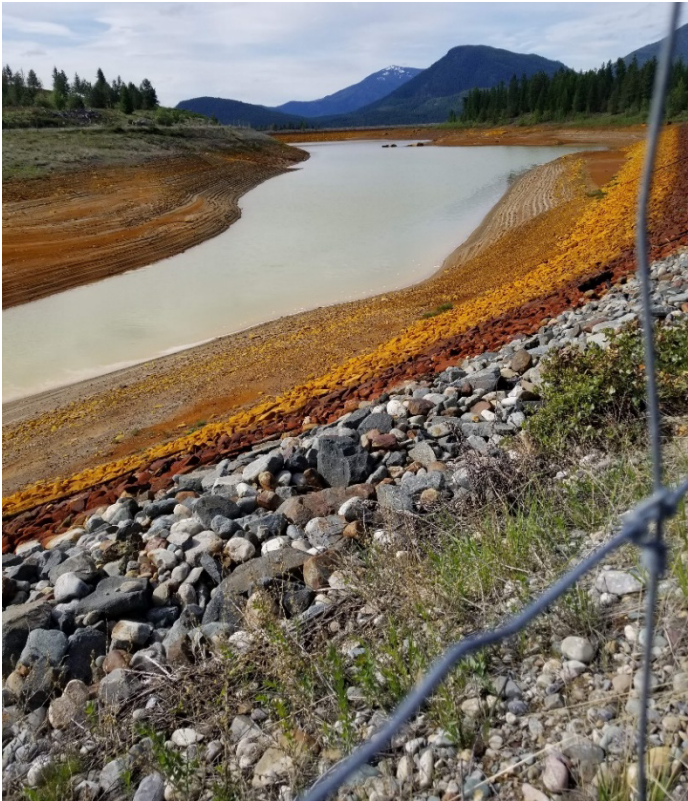
**Photo 1.7 ARD Pond from North Dam (106)**

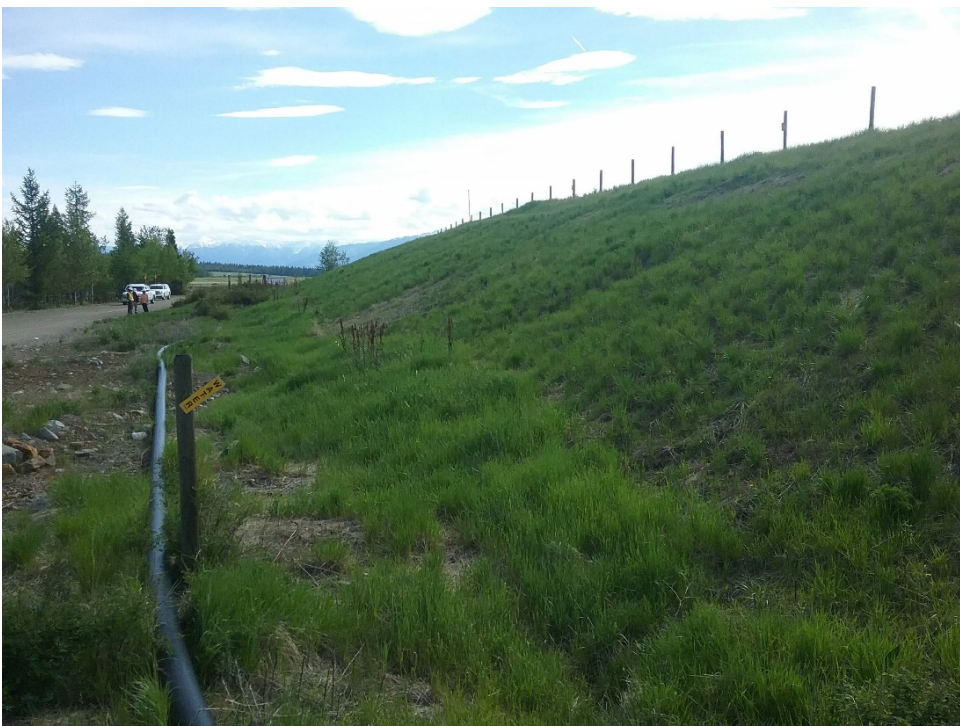
The downstream slope of the North Dam appeared to be in similar conditions to the previous years. The slope is well grassed with no significant patches of bare or loose soil observed (Photo 1.8). Localized depressions/steepened slopes along the toe of the North Dam have been noted during the annual inspections (Photo 1.9). These areas were purposely constructed by locally excavating into the dam slope to manage seepage exiting from the dam. Seepage collects in the toe ditch and flows to the seepage pond at the west end of the dam.

**Photo 1.8 ARD North Dam Downstream Slope (251)**

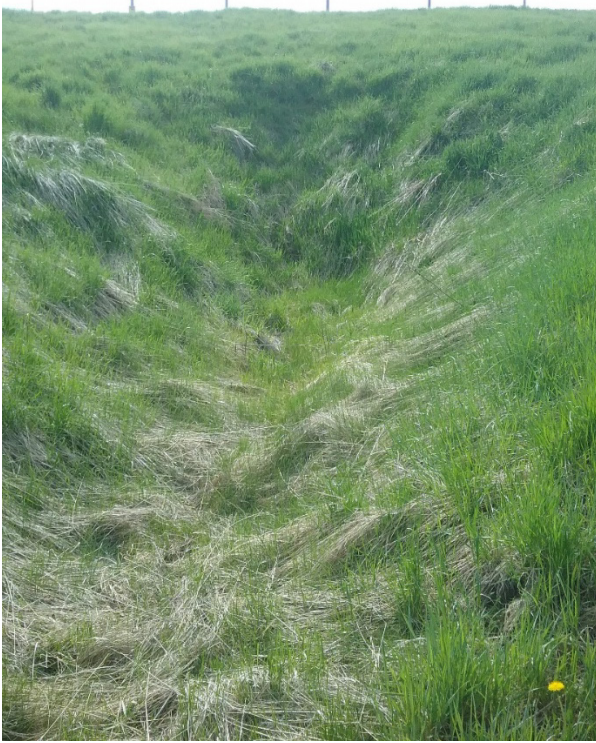
**Photo 1.9 Localized Depressions on ARD North Dam Downstream Side (259)**

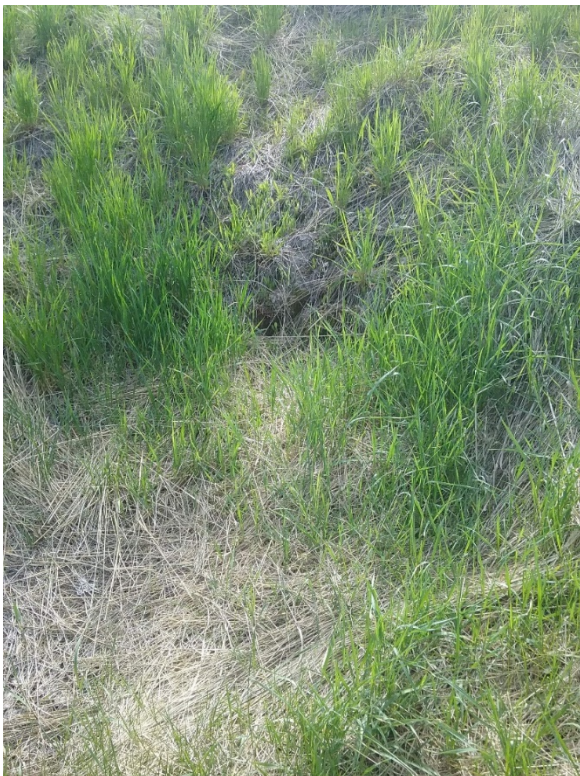
**Photo 1.10 Animal Burrow on ARD North Dam (256)**

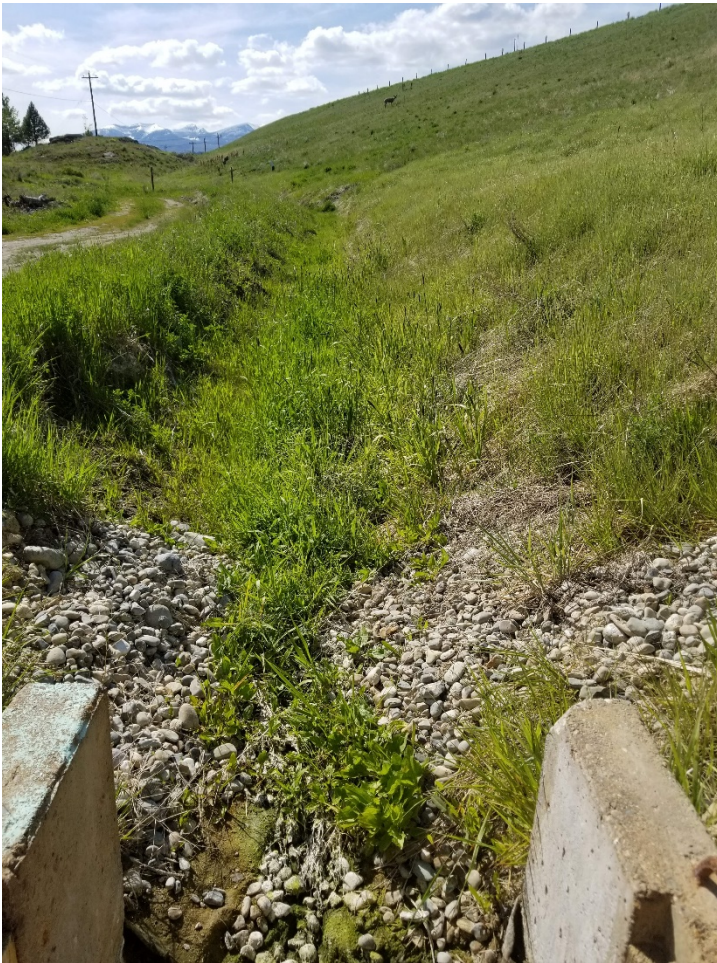
The ditch south of the South Dam that feeds into Weir #1 – ARDWU and Weir #2 are heavily vegetated with grass and other plants, which may impede flow (Photo 1.15). The ditches should be cleaned as part of the vegetation management program on site. The ditches and basins of the weirs were dry at the time of the inspection.

**Photo 1.15 Weir 1 and Toe of ARD South Dam (186)**

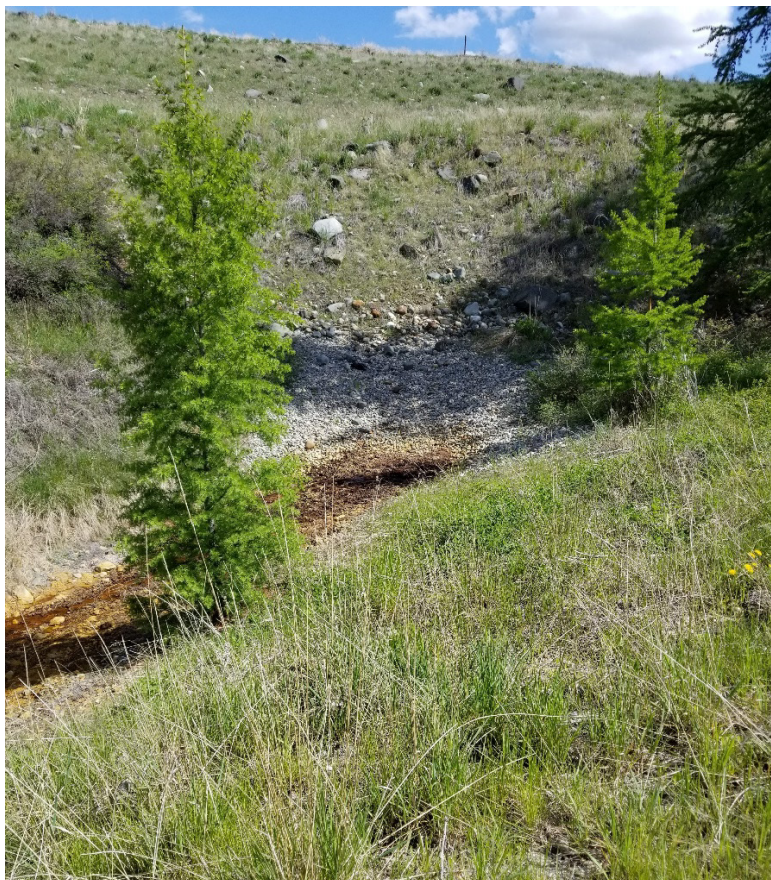
**Photo 2.6 Seepage at Toe of Iron Dike (139)**

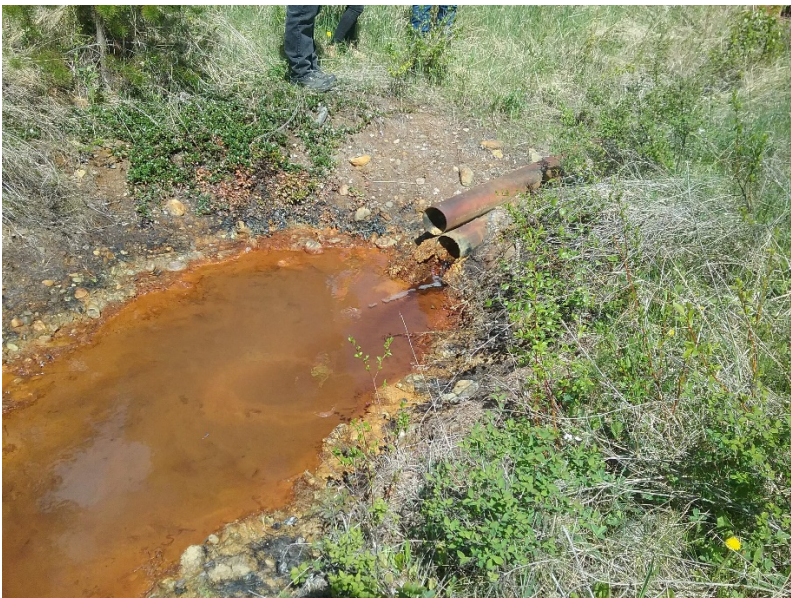
A small trickle of flow observed from the historical decant pipes installed into the No. 3 Siliceous Dike (Photo 3.2). It is KCB's understanding that flow is relatively constant through these pipes during the entire year. A decant installed in 2000 within the No. 2 Siliceous Dike was dry and generally only sees flow during freshet. Flow from both decants should be monitored and recorded as part of the regular inspections by Teck and KCB. Any changes in flow rate or sediment in the flow should be reported to KCB.

**Photo 3.2 Historic Decant Downstream of No. 3 Siliceous Dike (286)**

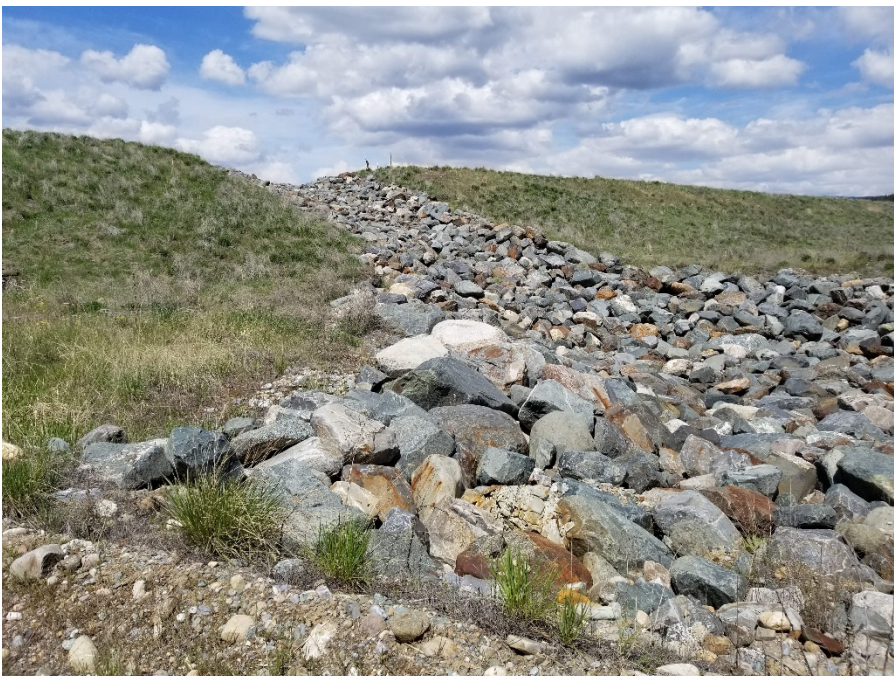
The surface water runoff conveyance channel from No. 1 Siliceous Cell across No. 3 Siliceous Cell, the diversion channel to the north of No. 1 and No. 3 cells, and the emergency spillway channel constructed on the east slope of No. 3 Siliceous Dike were in good physical condition at the time of the site visit with no signs of movement or particle breakdown (Photo 3.4 to 3.6).

**Photo 3.4 No. 3 Siliceous Dike Downstream Slope and Siliceous Spillway (149)**

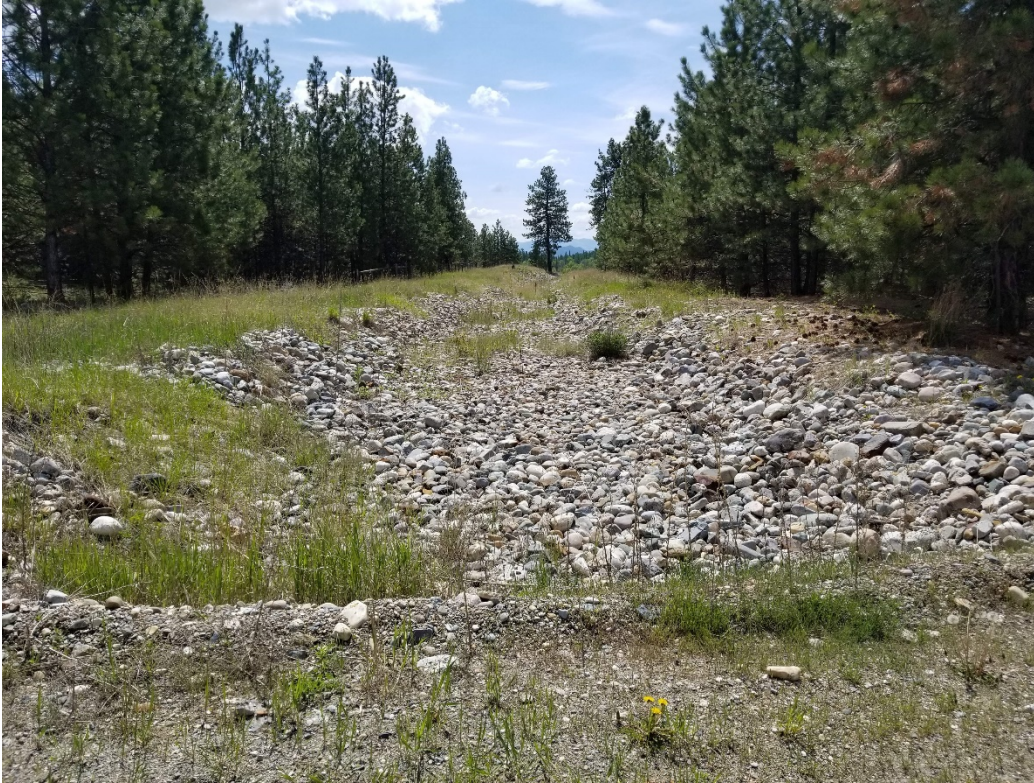
**Photo 3.5 Siliceous Spillway Downstream of Toe Road (151)**

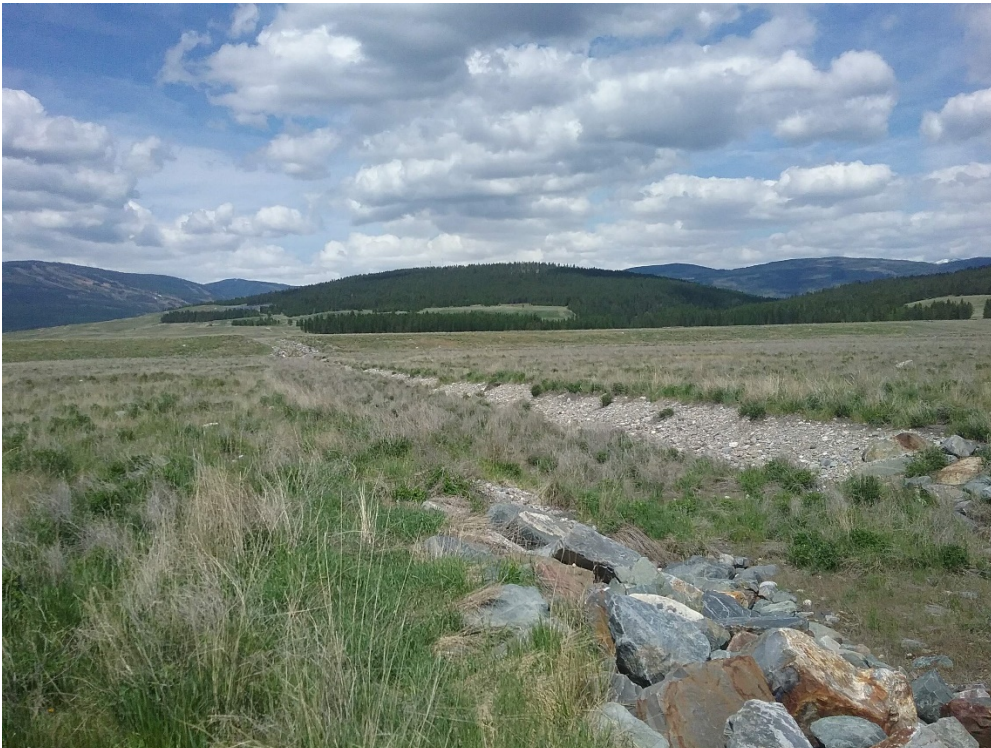
**Photo 3.6 No. 3 Siliceous Cell Surface, Siliceous Spillway, and No. 1 Siliceous Dike (293)**

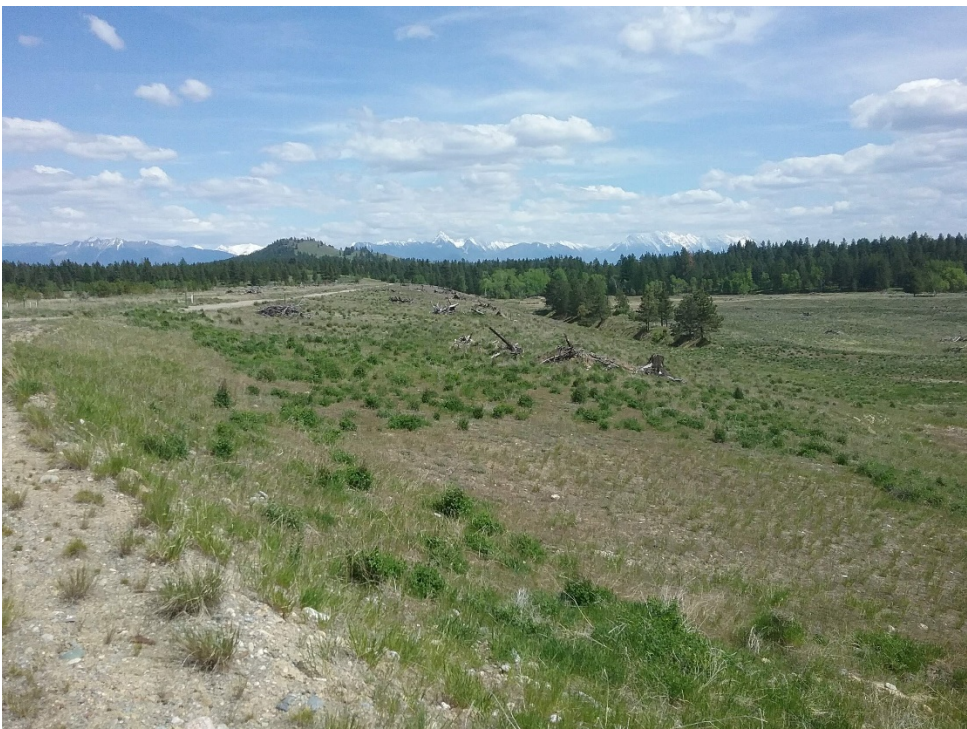
The visual inspection indicated that the East Gypsum Dike was in good physical condition with no signs of structural distress (Photo 4.1 and 4.2). Dike slopes were well-grassed with no significant areas of bare or loose soil observed. Several large rodent burrows were observed along the lower dam slopes and toe (Photo 4.3) but are not considered to be a dam safety issue. However, the burrows are a safety hazard to personnel walking along the dam toe and slope. Rodent burrows should be infilled as they're identified. Seepage was observed in the ditch at the toe of the dike. The observed seepage condition was similar to previous DSI site visits.

**Photo 4.1 Crest and Downstream Slope of East Gypsum Dike (295)**

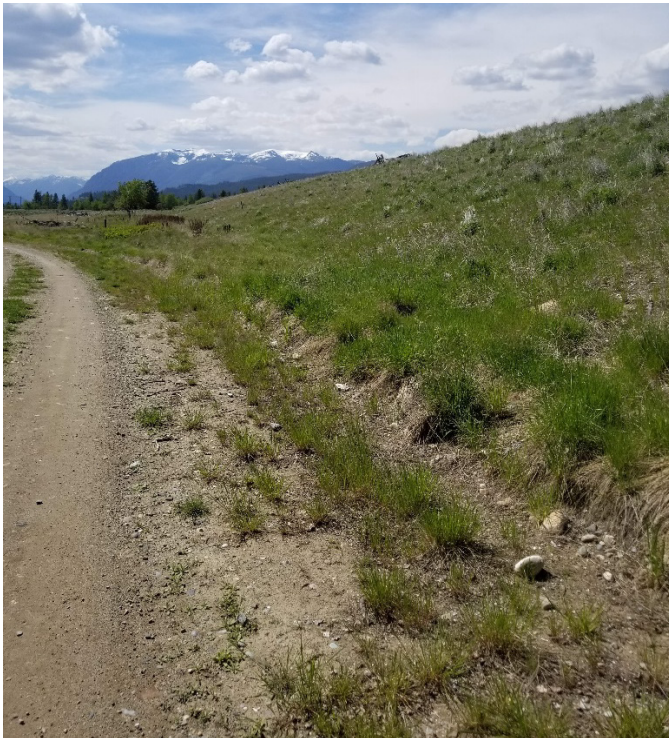
**Photo 4.2 Downstream Slope of East Gypsum Dike (172)**

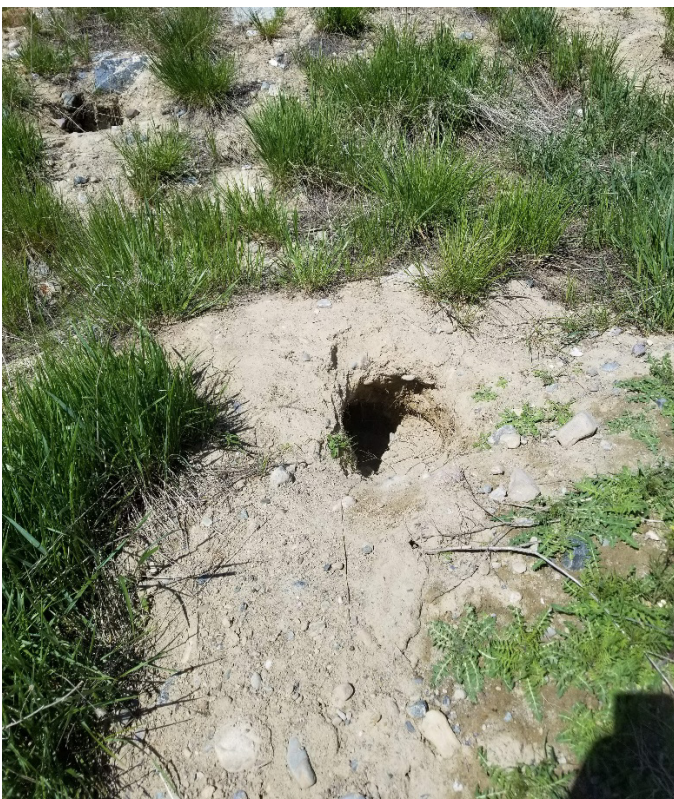
**Photo 4.3 Animal Burrows at Toe of East Gypsum (171)**

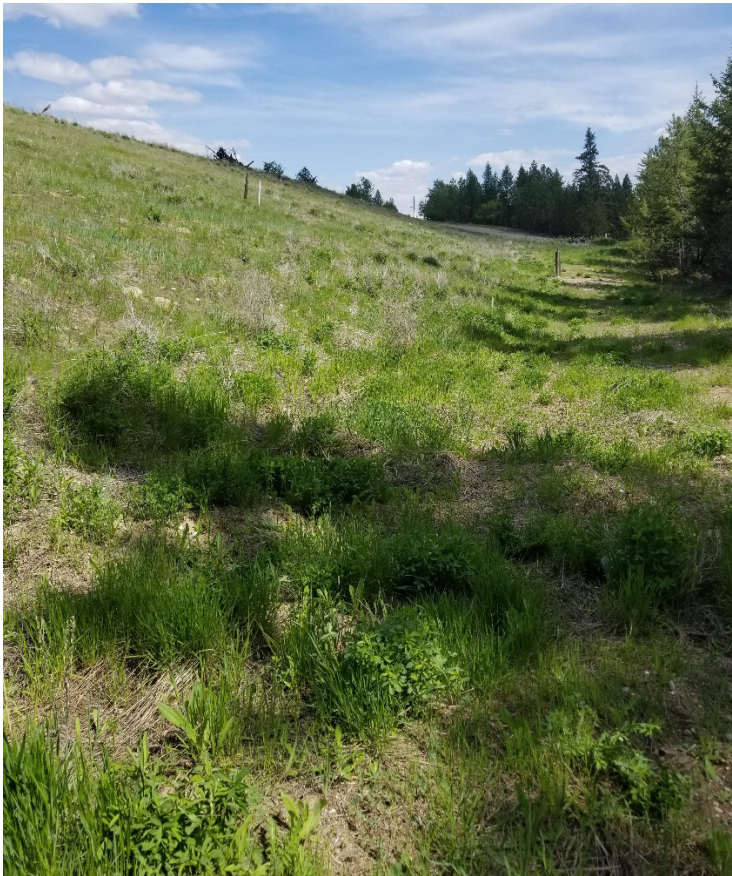
The visual inspection indicated that the West Gypsum Dike was in good physical condition with no signs of structural distress. Dike slopes were well-grassed with no significant areas of bare or loose soil observed (Photo 4.4 and 4.5). Animal burrows were observed near the dike toe, the number of

**Photo 4.4 Downstream Slope of West Gypsum Dike (176)**

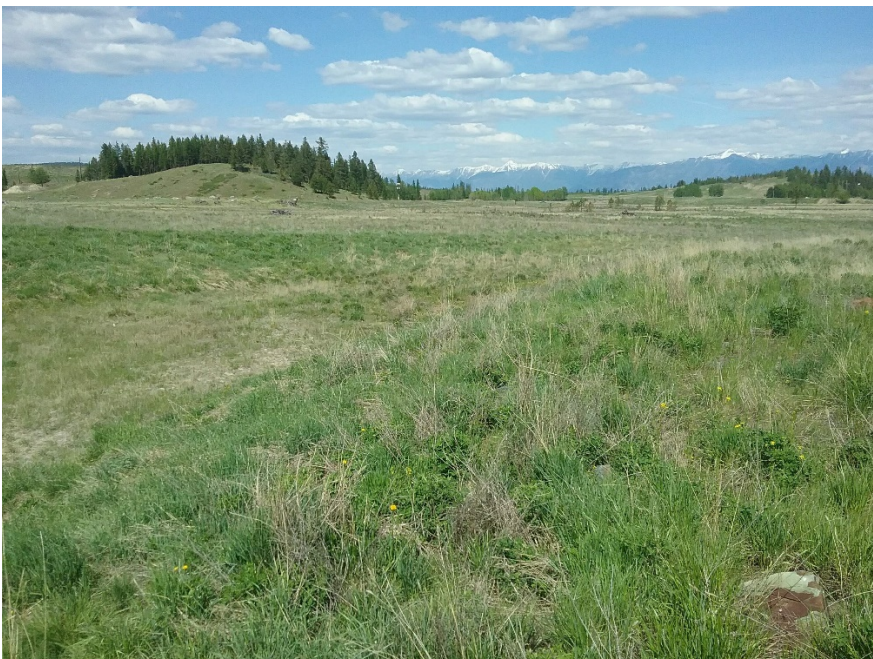
**Photo 4.5 West Gypsum Cell (320)**

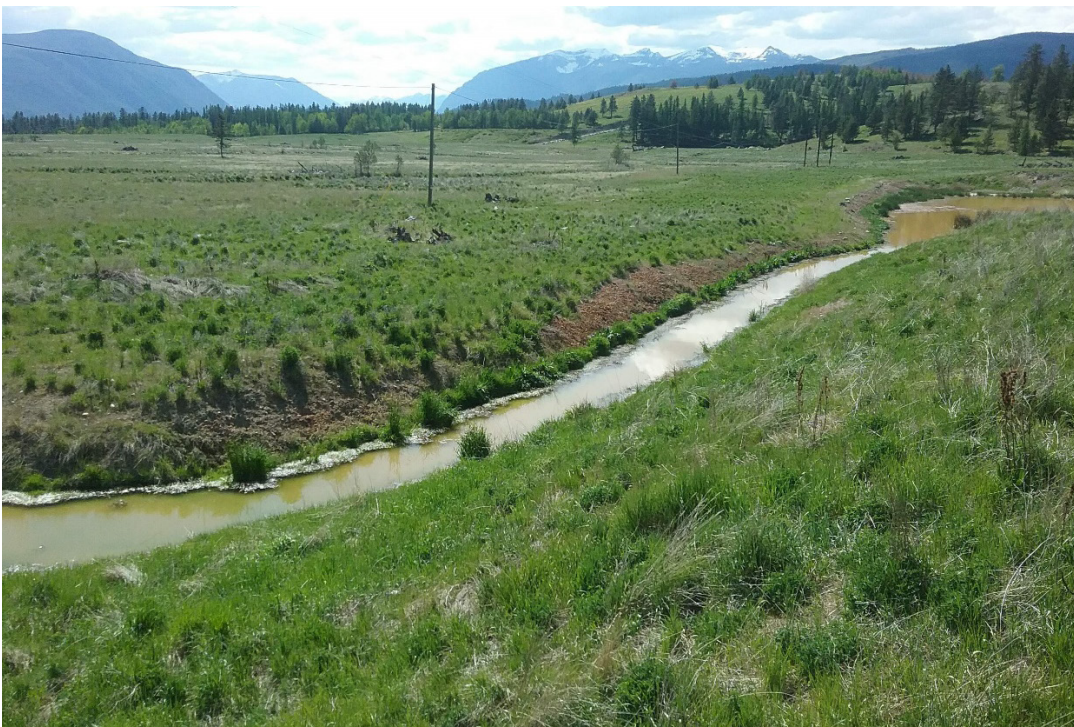
The visual inspection indicated that the Northeast Gypsum Dike and Recycle Dam were in good physical condition with no signs of structural distress. The slopes of both embankments were well-grassed (Photo 4.11). Animal tracks were observed along the downstream slope of the Northeast Gypsum Dike (Photo 4.10).

**Photo 4.10 Downstream Slope of Northeast Gypsum Dike Showing Animal Tracks (400)**

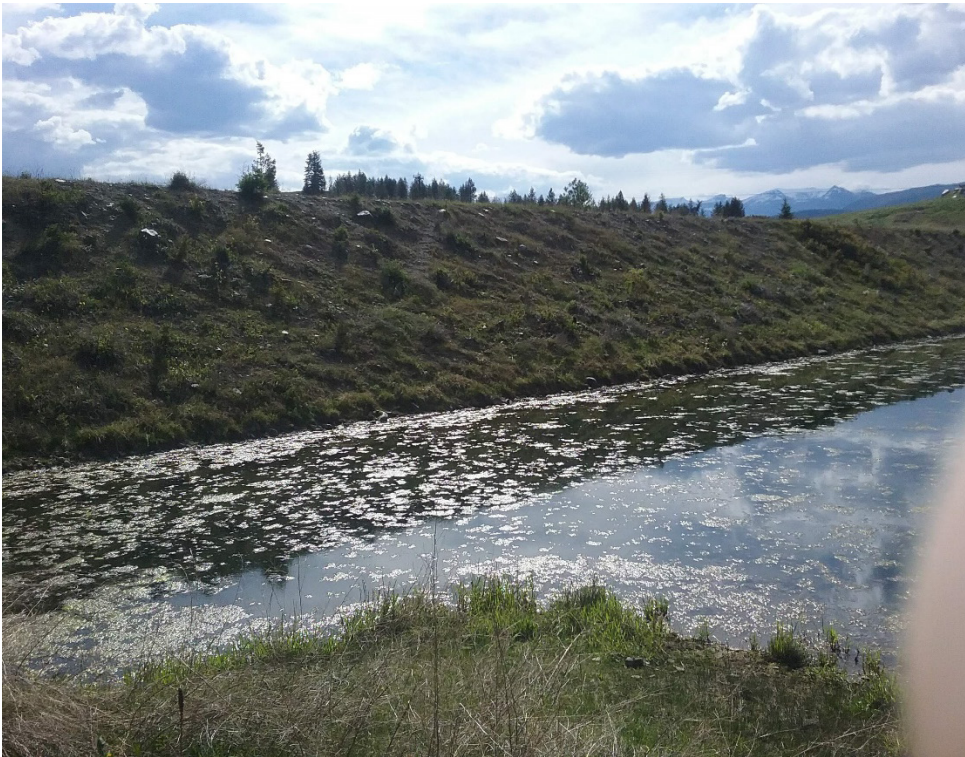
**Photo 4.11 Upstream Slope of Recycle Dam (390)**

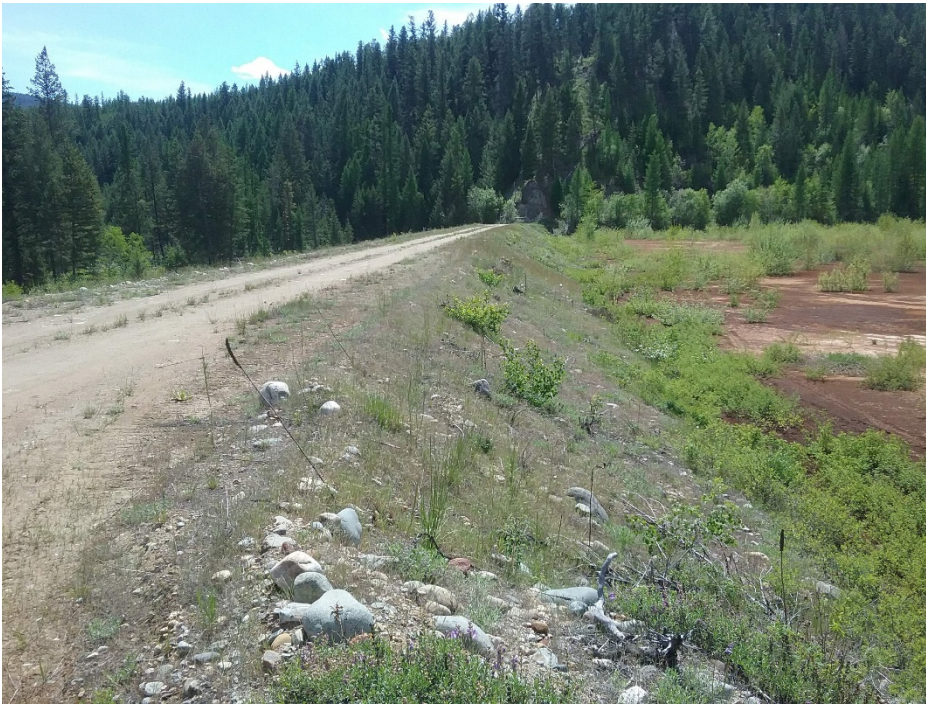
The visual inspection indicated that the Calcine Dike was in good physical condition with no signs of structural distress (Photo 6.1 and 6.2). The downstream slope of the dike was well vegetated and is buttressed by a municipal landfill.

**Photo 6.1 Crest of Calcine Dike (358)**

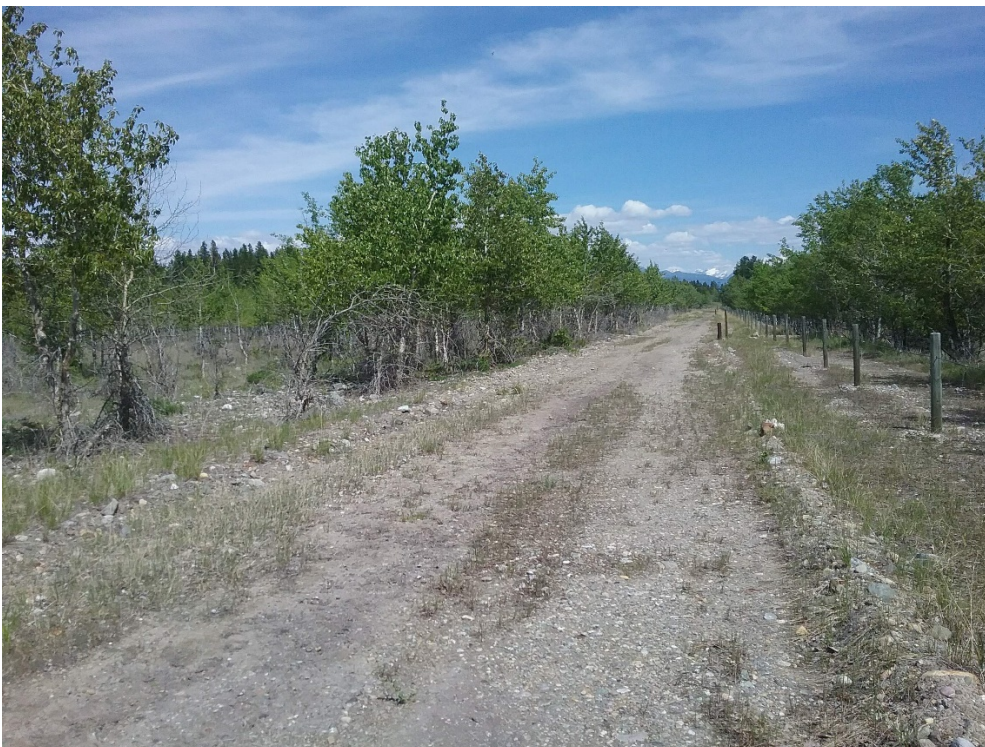
**Photo 6.2 Downstream Slope of Calcine Dike (364)**

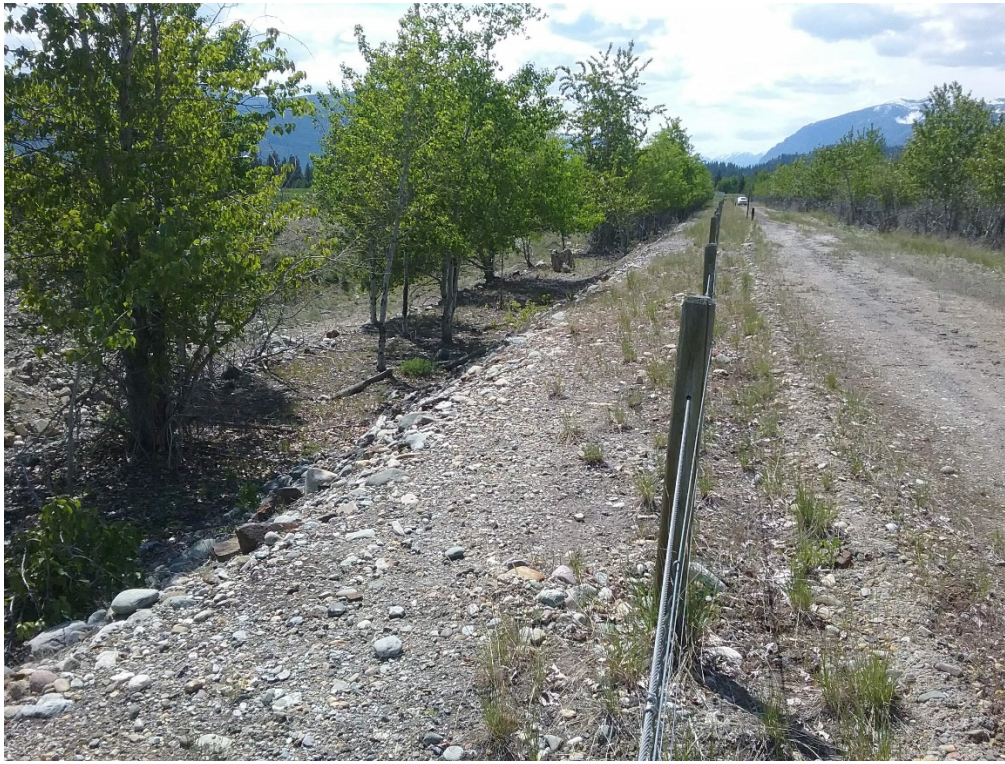
The old beach surface is at crest level upstream of the dike and gently slopes downward towards the north (upstream). There was no free water observed during the inspection and vegetation has become established over the entire impoundment. Calcine removal from a pit developed at the northwest side of the lower cell ceased in 2011/2012 and this area was reclaimed (Photo 6.3). The pit is well drained, and no standing water was observed.

**Photo 6.3 Excavation in Calcine Dike (366)**

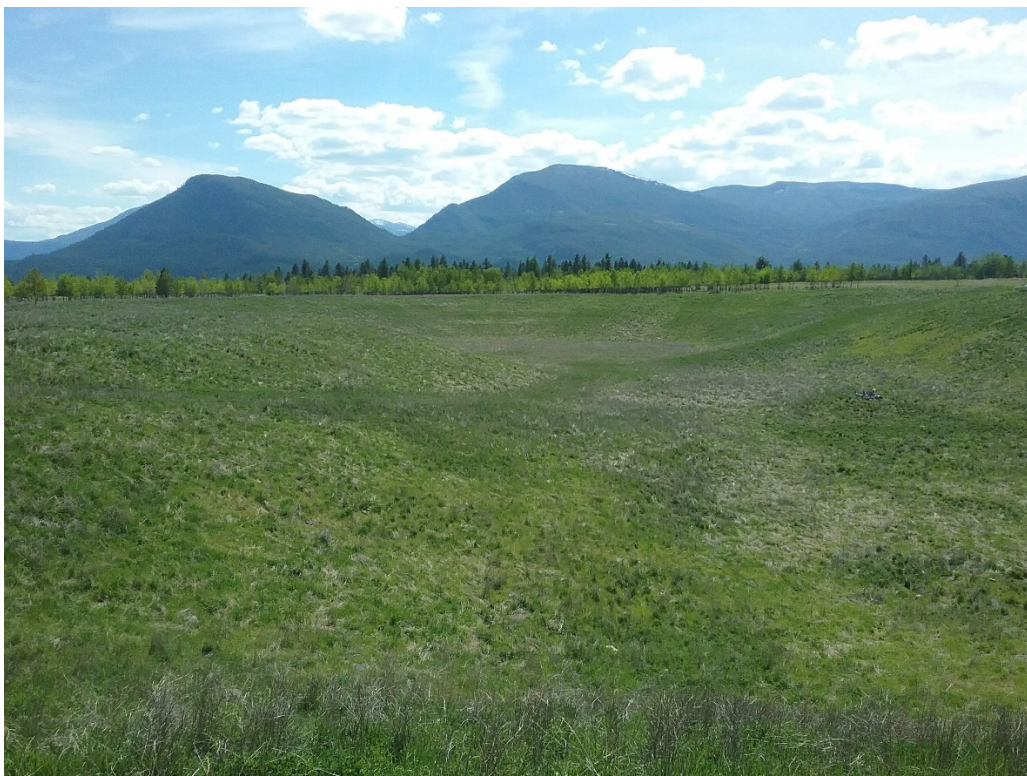
The visual inspection indicated that the Old Iron Dike and Iron TSF Divider Dike were in good physical condition with no signs of structural distress. The downstream slope of the Old Iron Dike was grassed, with no significant areas of bare or loose soil (Photo 7.1). There were no signs of seepage. The Iron TSF Divider Dike is buttressed by the Iron TSF and is currently being used as an access road between the two TSFs (Photo 7.3). No physical changes were observed from the previous DSI. The Iron TSF Divider Dike is buttressed on both sides with tailings.

**Photo 7.1 Downstream Slope Old Iron Dike (368)**

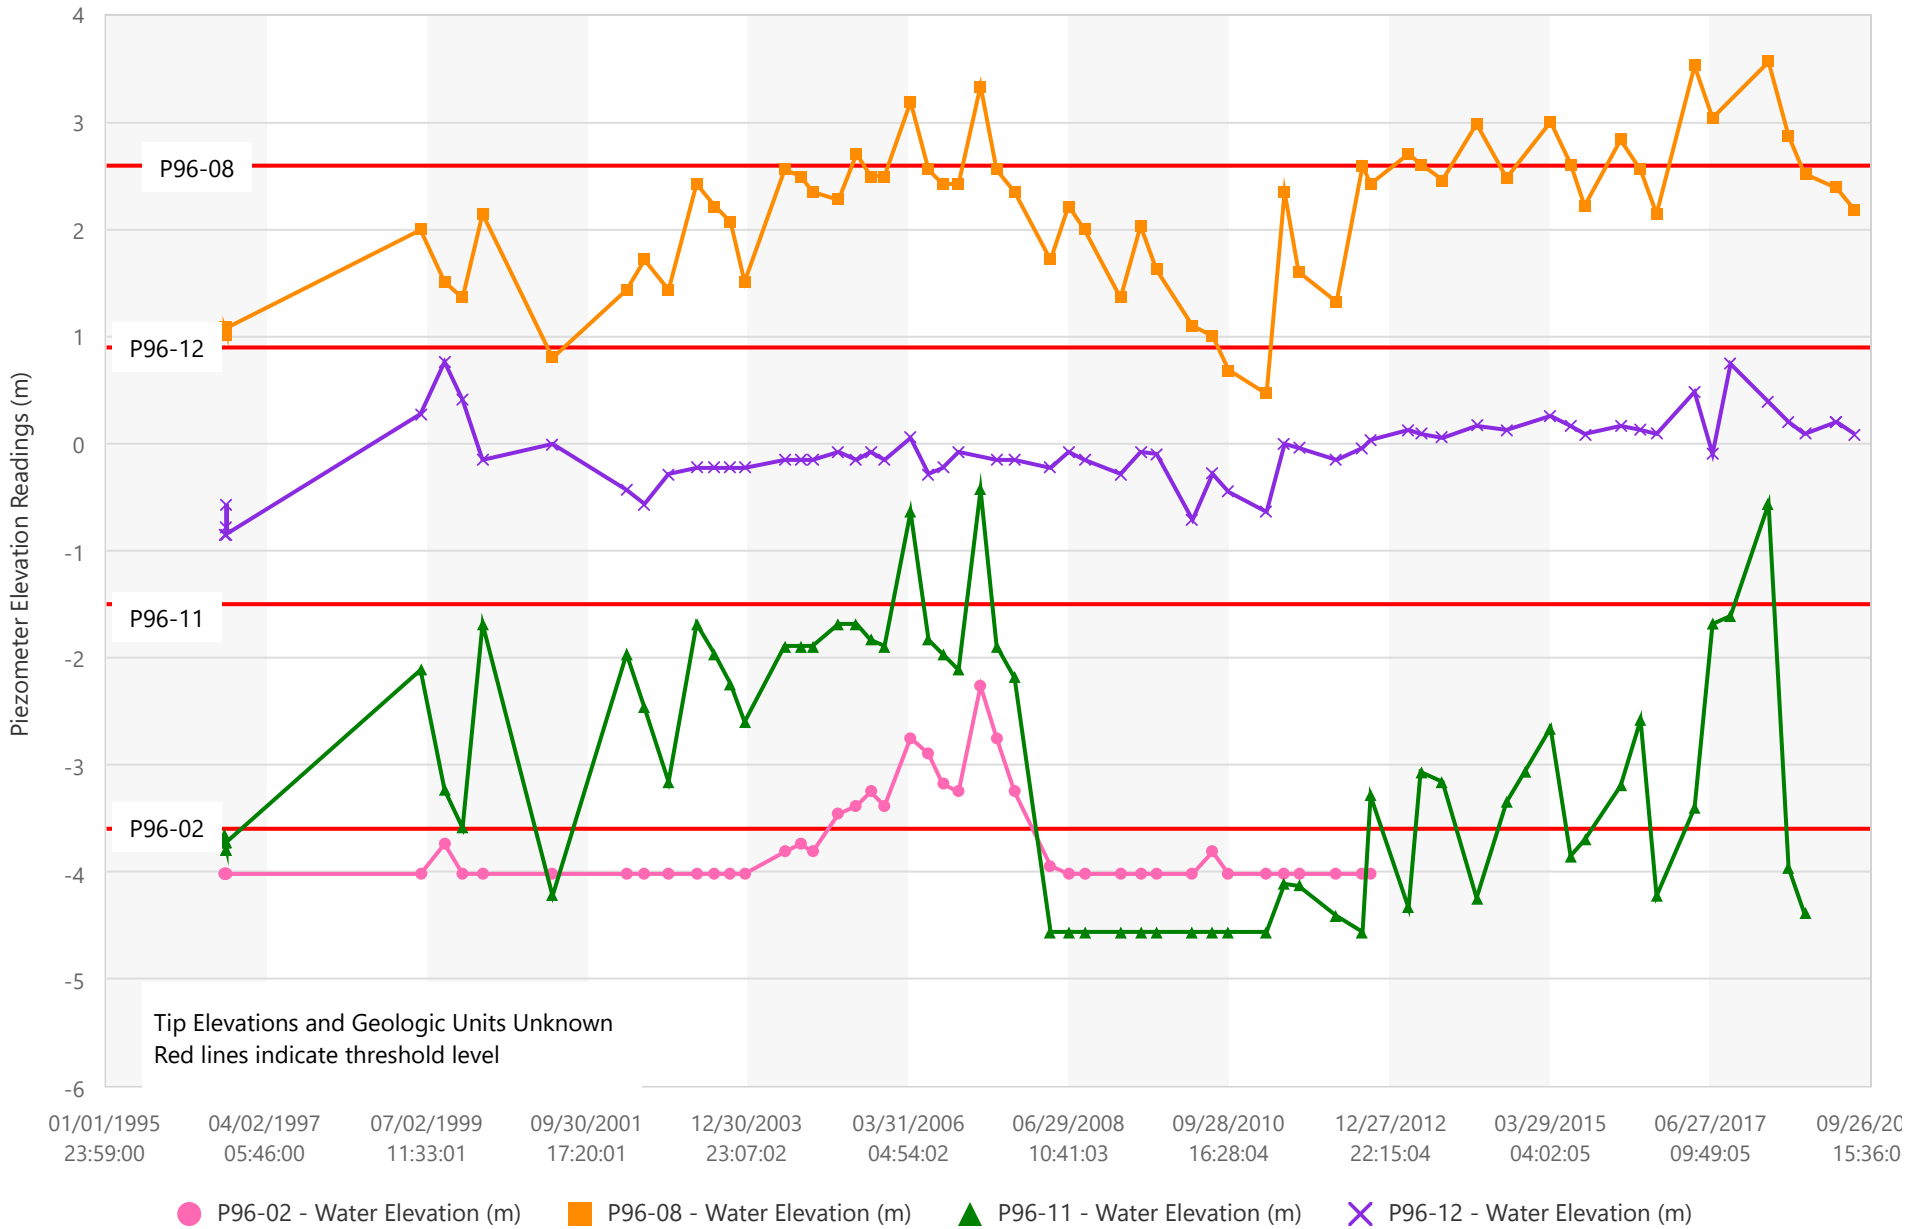
Figure V-1 Old Iron Dike Buttress

P96-02: Destroyed  
P96-11: Slow leak 2008 unable to get reading until 2011, erratic data since 2012, replaced in 2018

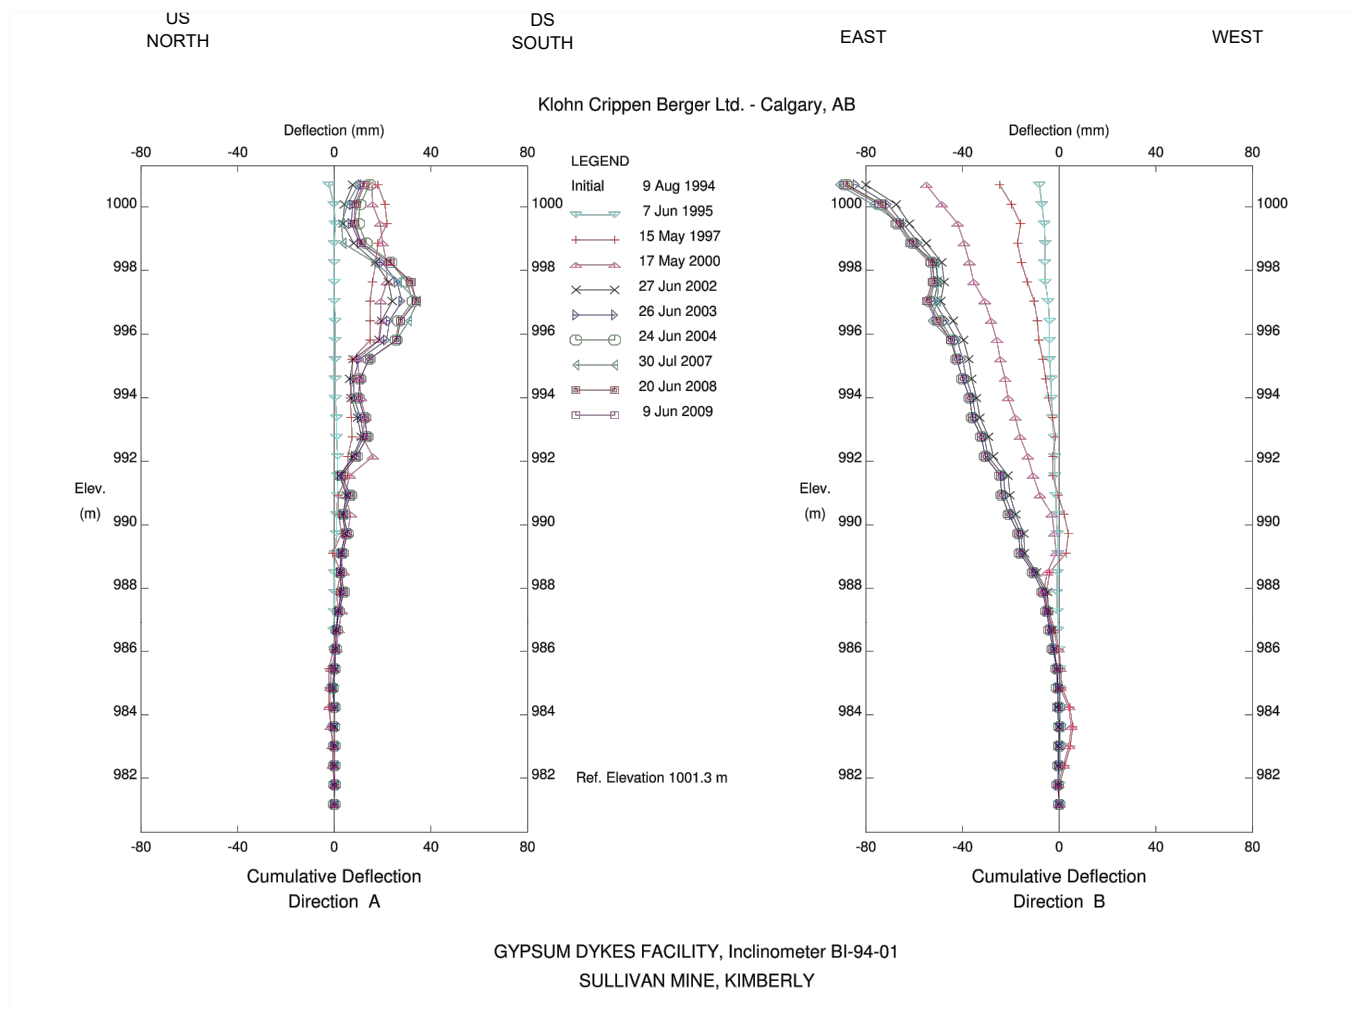
(CAN NO LONGER READ. BLOCKED AT 4.7 m BELOW THE GROUND SURFACE)
