Teck Highland Valley Copper Partnership

2019 Dam Safety Inspection Report

Trojan Tailings Storage Facility

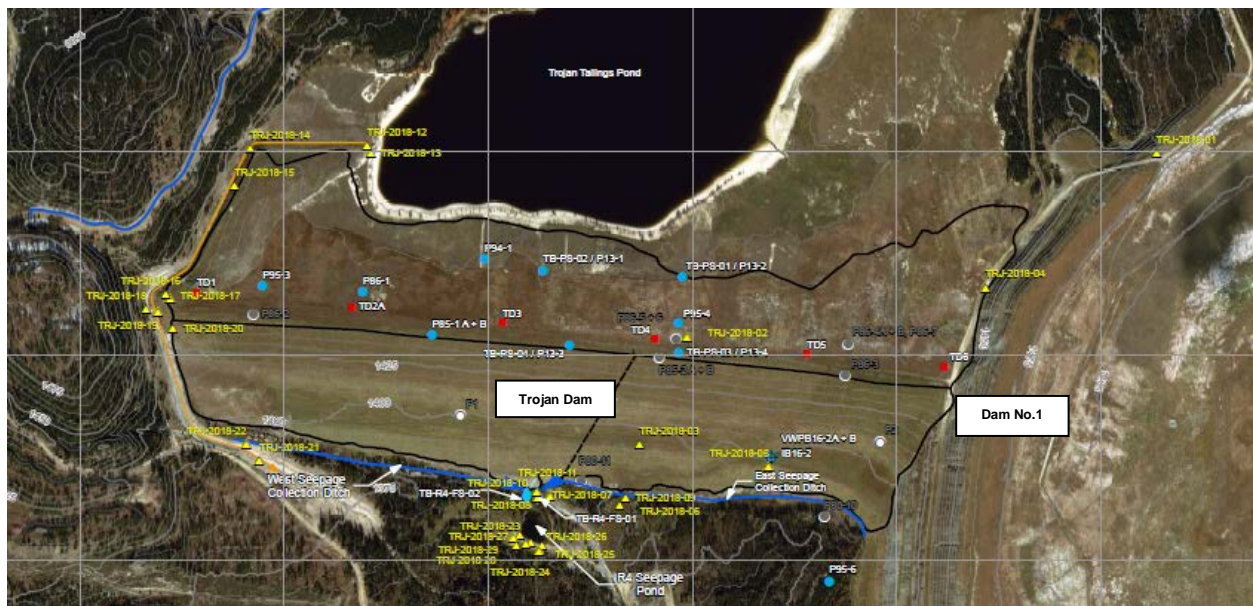
SITE PLAN

- Trojan Diversion Pipe is disconnected. THVCP is aware and repairs are planned. Flow is diverted away from the area.
- Minor erosion and gaps on closure cover present near spillway on right abutment (identified in 2018).
- Left abutment requires re-grading for freeboard beach width (work is planned for later in 2019).
- Some vegetation built up upstream of spillway bedrock chute which should be cleared as part of the routine maintenance.

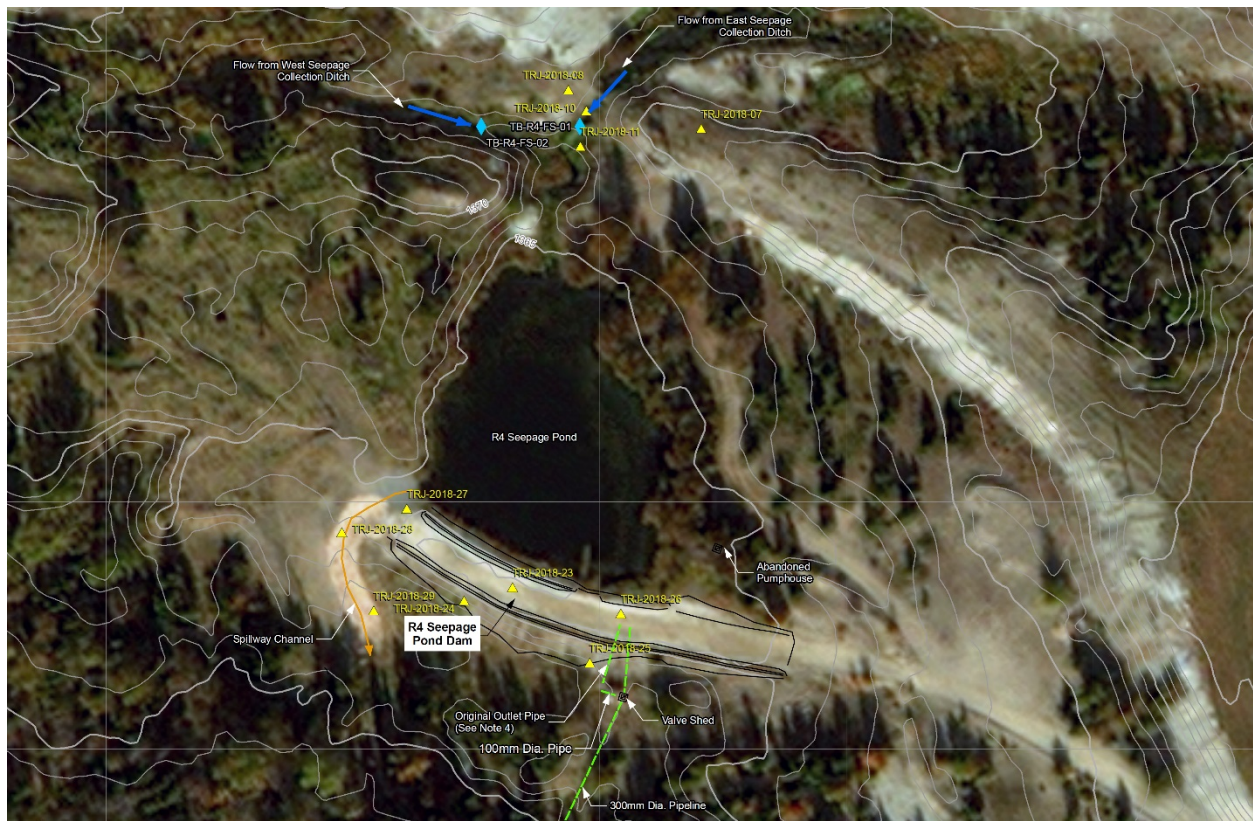
SITE PLAN

- Vegetation and small trees present on upstream and downstream slopes of the dam near spillway invert. Excess vegetation near spillway inlet should be removed as part of routine maintenance. Remaining of vegetation clearing is at THVCP discretion.

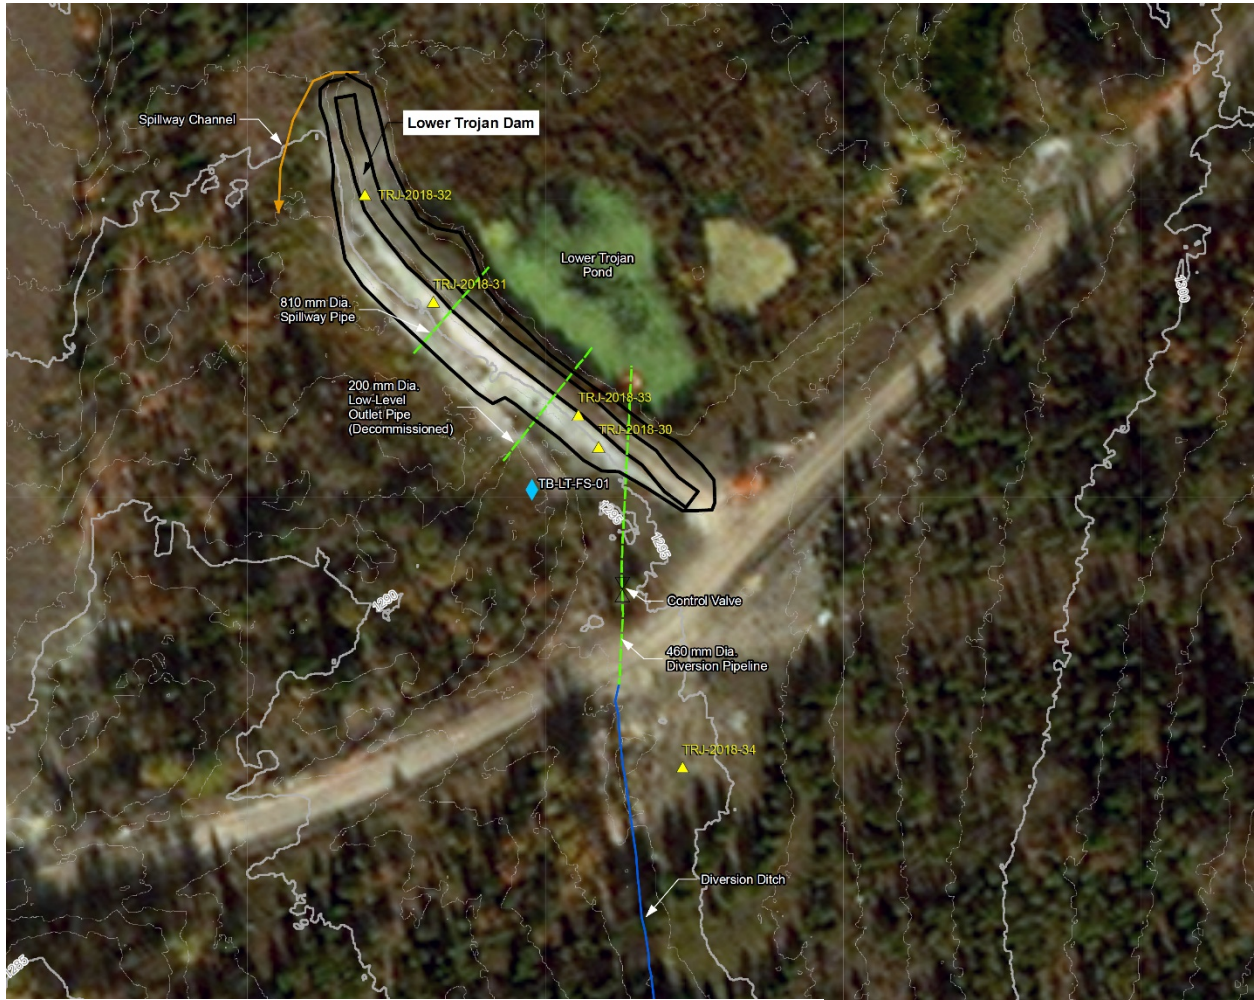
SITE PLAN

- Upper basin should be included in flood routing upgrade/decommissioning plan.

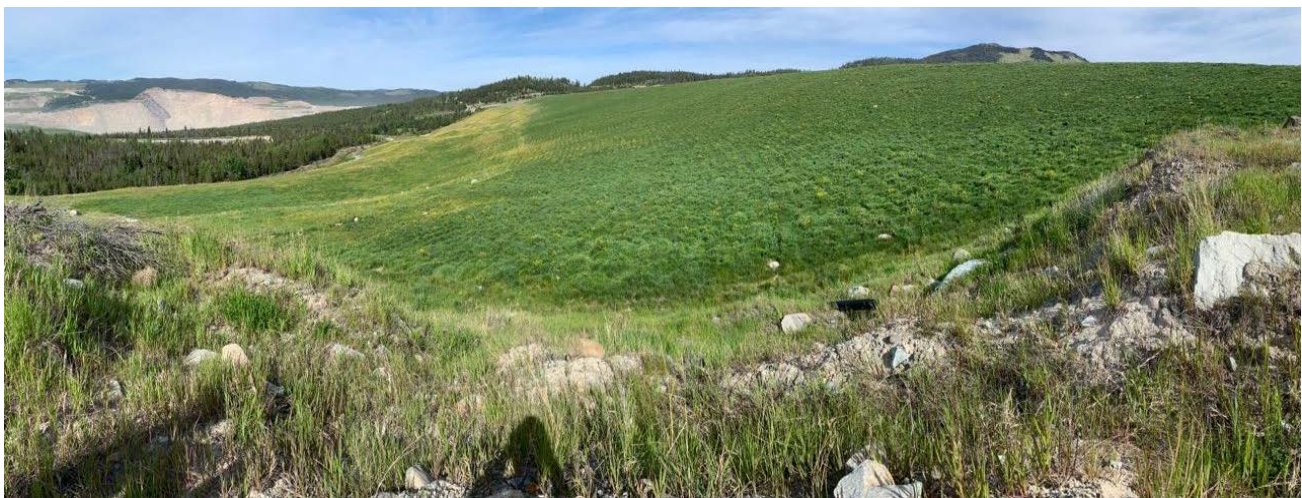
Photo II-A-2 Panoramic overview of Trojan Dam downstream slopes from left abutment. No visible erosion or scour. (TRJ-2019-02)

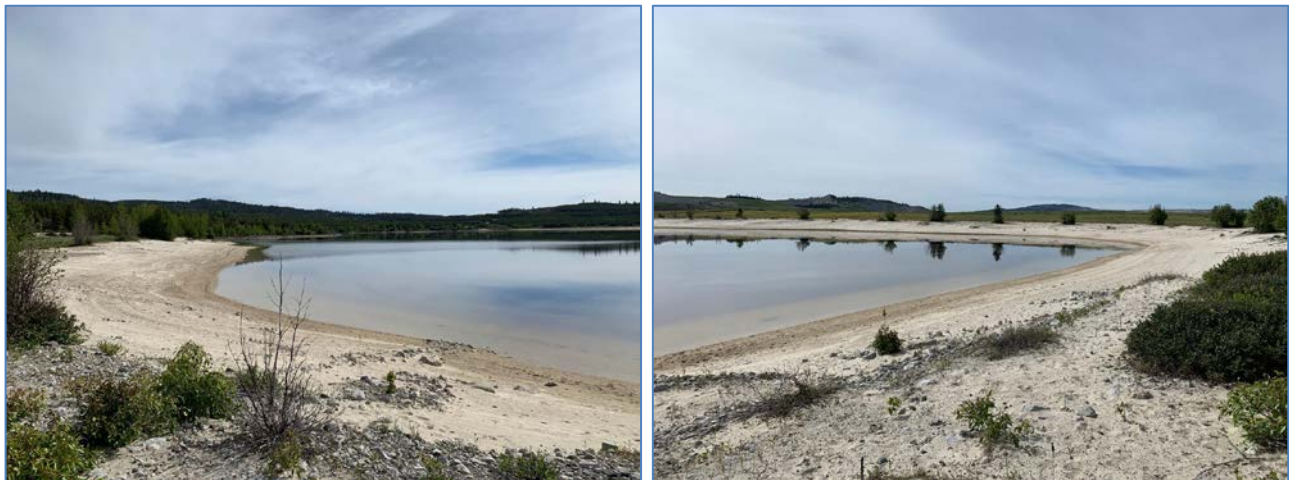
Photo II-A-9 Overview of Trojan Tailings Pond. Pond level appears similar to previous years. Sand beach is exposed. (TRJ-2019-06)

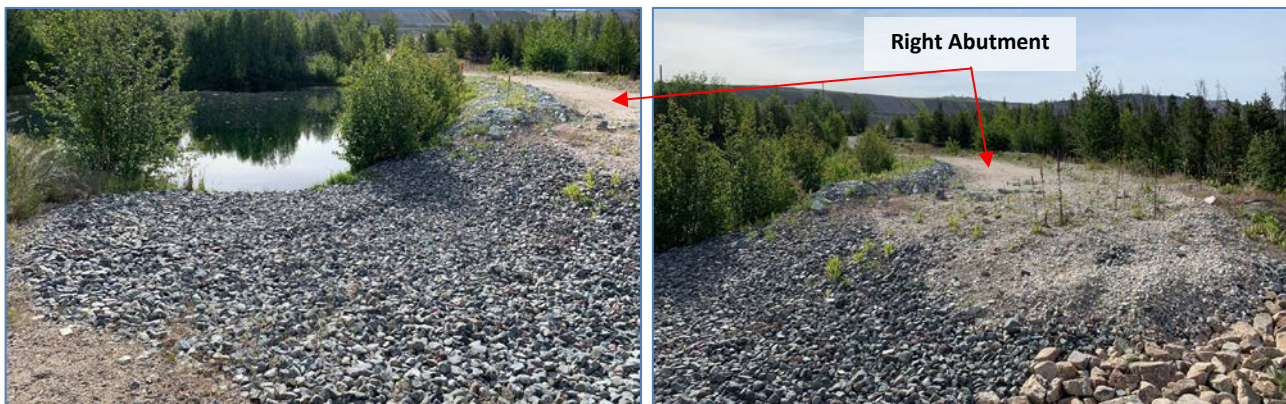
Photo II-B-5 Overview of pond and spillway inlet – Spillway inlet is clear of debris. Vegetation build up near inlet to be cleared as part of routine maintenance prior to 2020 freshet. (TRJ-2019-21)

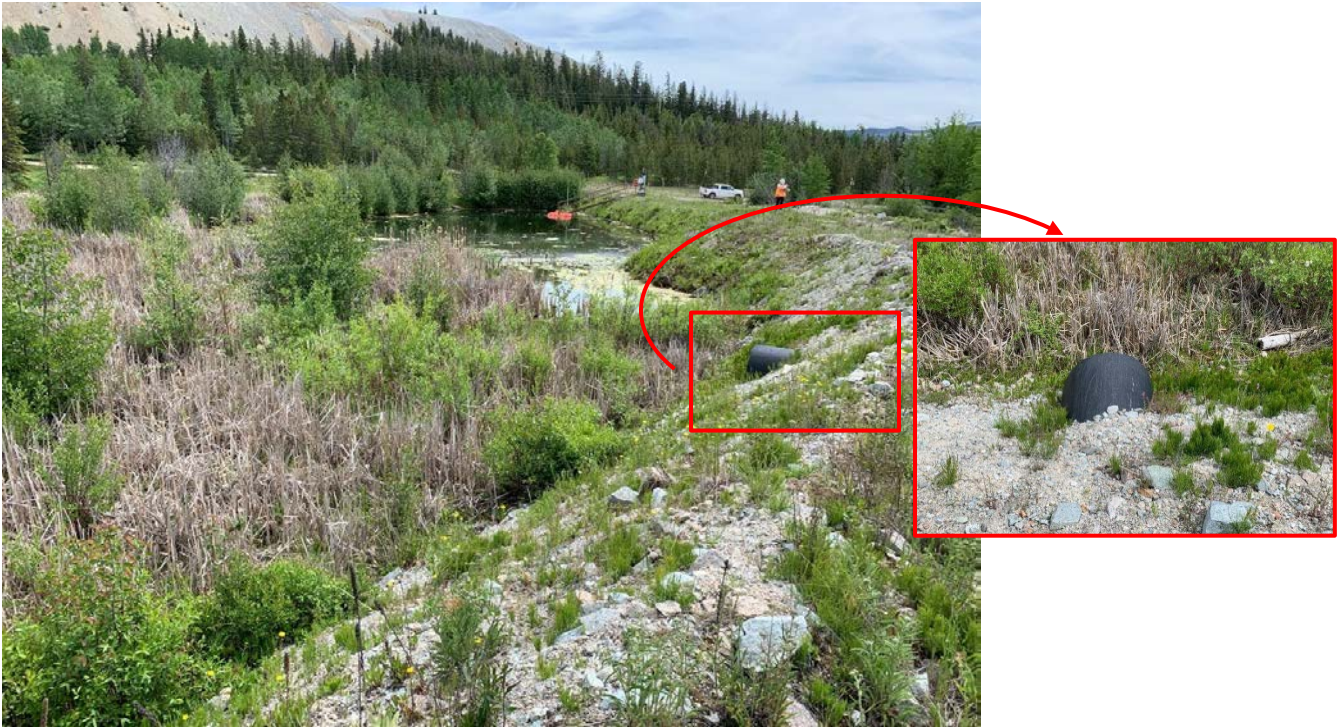
Photo II-C-4 Upstream slope near right abutment with overflow pipe through dam. No erosion at outlet (TRJ-2019-23 and TRJ-2019-25)

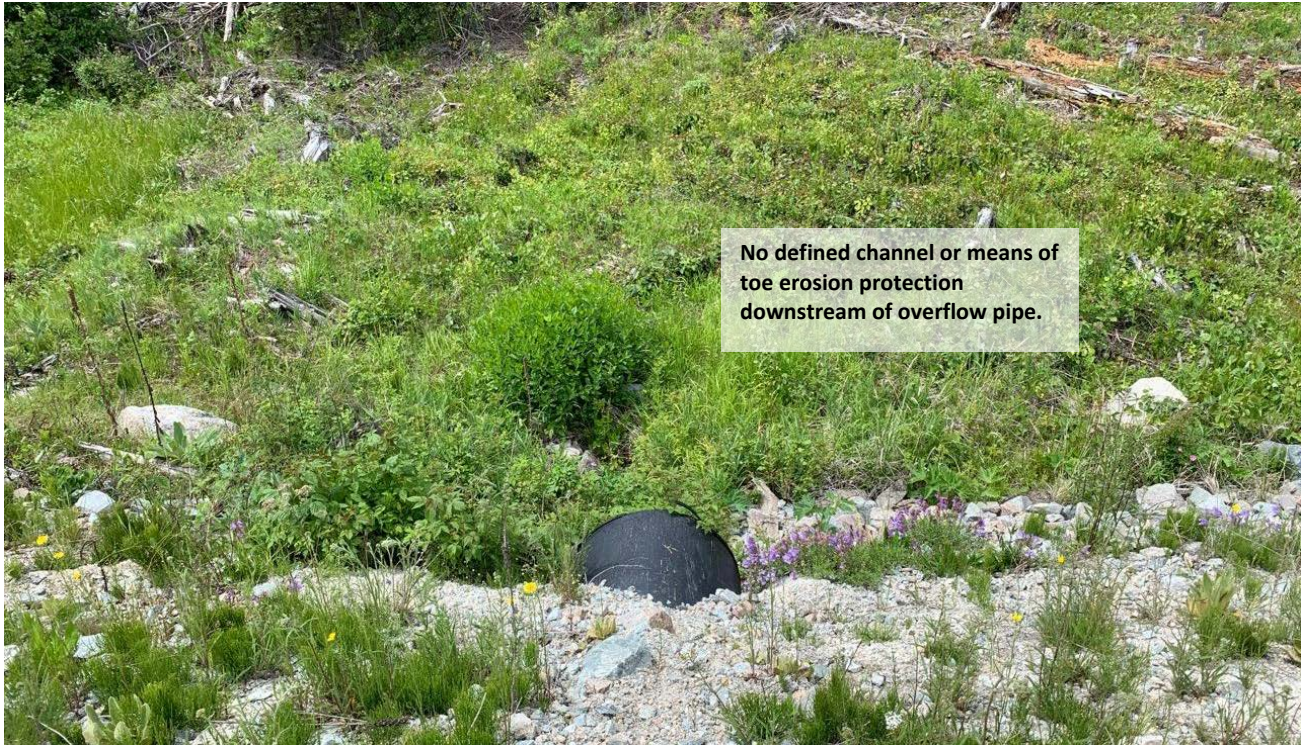
Good physical condition. Minor vegetation present, no signs of erosion or deterioration (Photo II-C-2). Downstream outflow pipe shown on Photos II-C-6 does not have a defined channel or means of toe erosion protection. KCB recommends that a mitigation be advanced.

**Photo II-C-6 Downstream slope near right abutment with overflow pipe through dam
(TRJ-2019-23)**

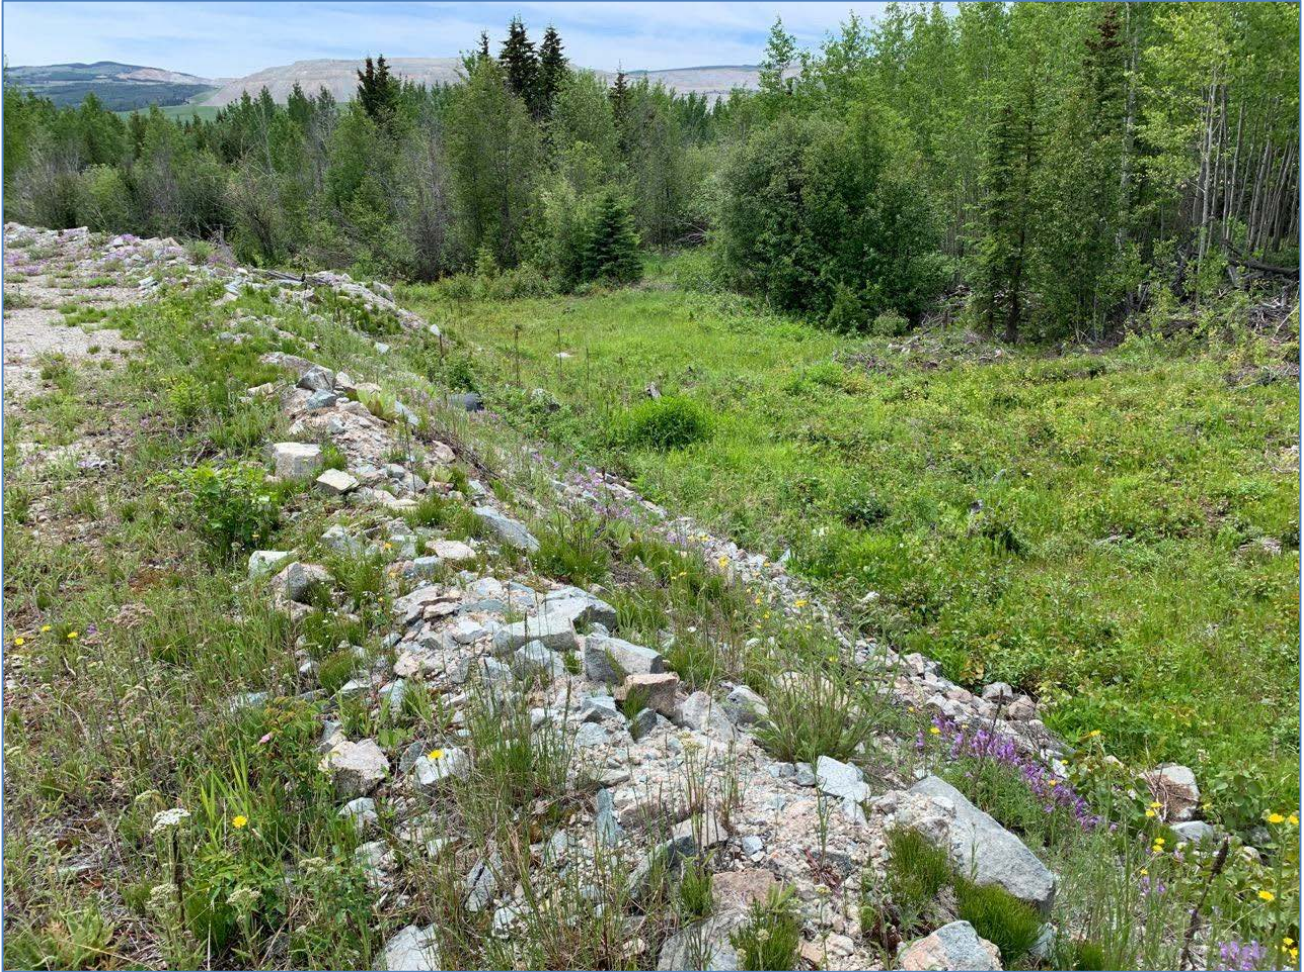
Good physical condition. Tree debris observed during 2018 DSI was cleared from the spillway channel at right abutment (Photo II-C-7).

Photo II-C-7 Spillway channel looking toward southwest. Channel is cleared from trees or major debris (TRJ-2019-25)

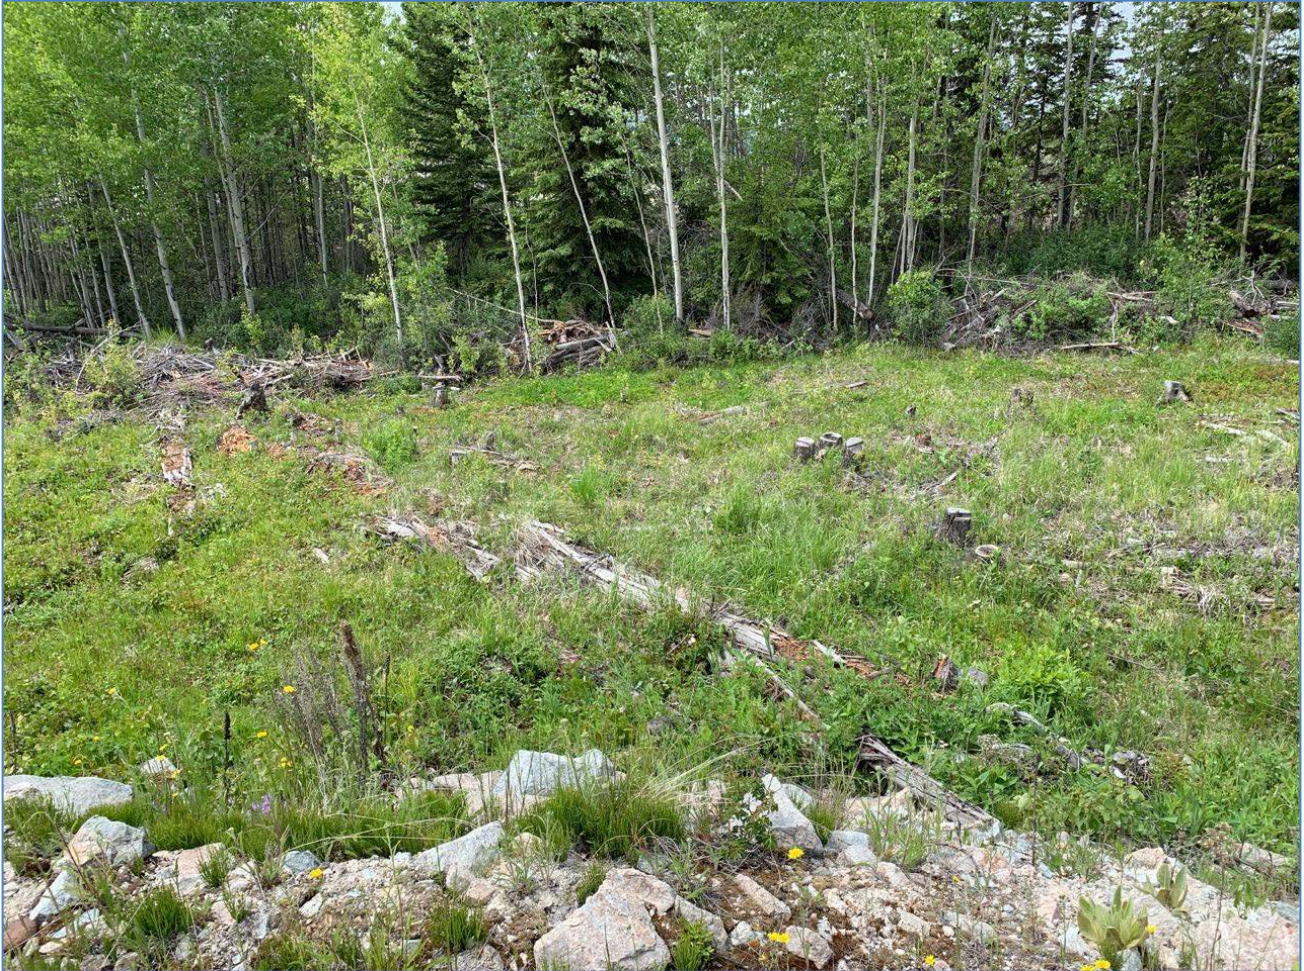
Photo II-C-8 Spillway channel looking toward west (TRJ-2019-25)

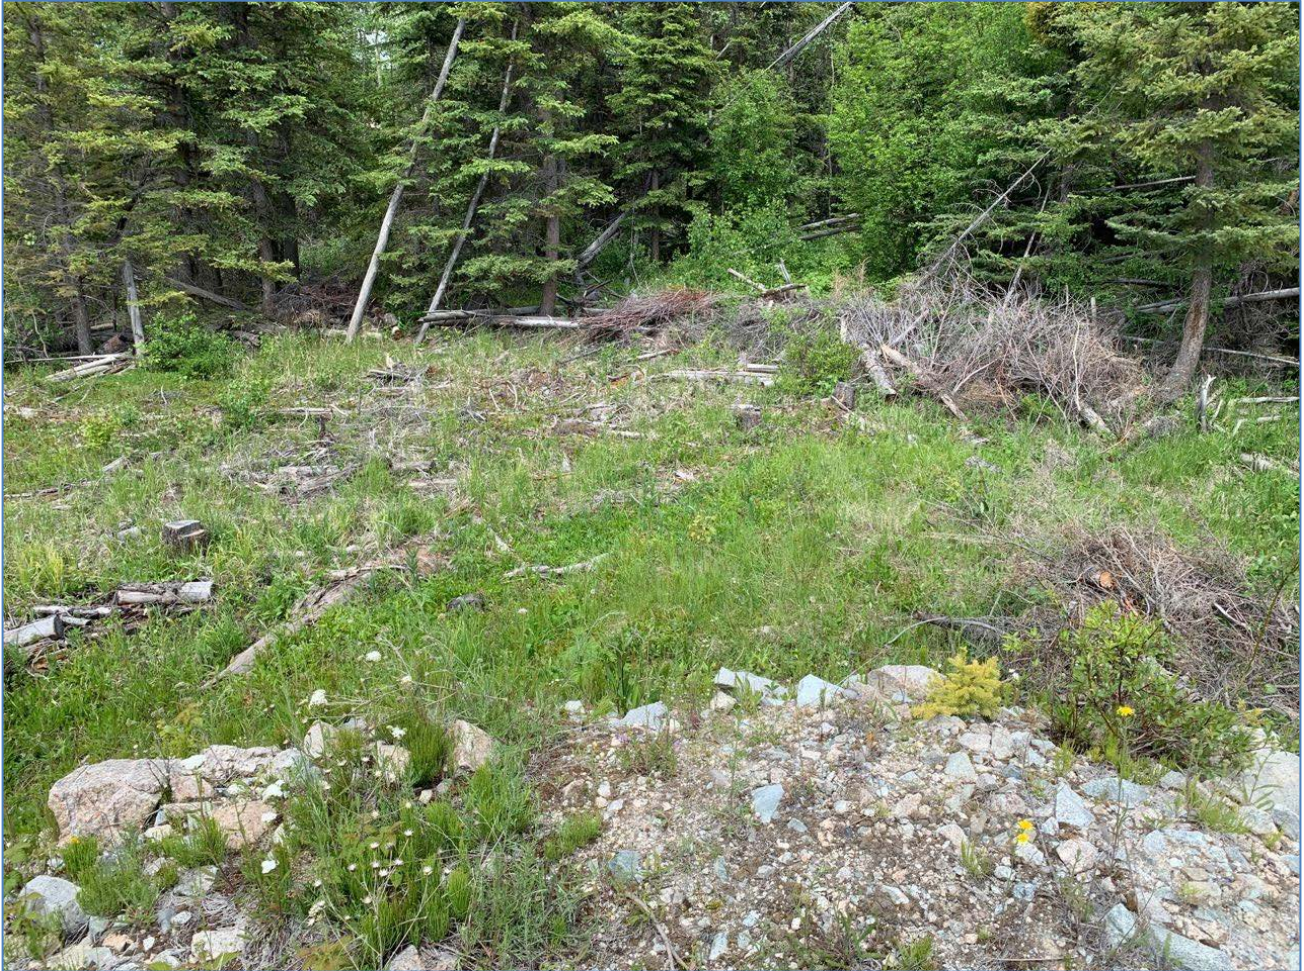
Photo II-C-9 Spillway approach channel (TRJ-2019-25)

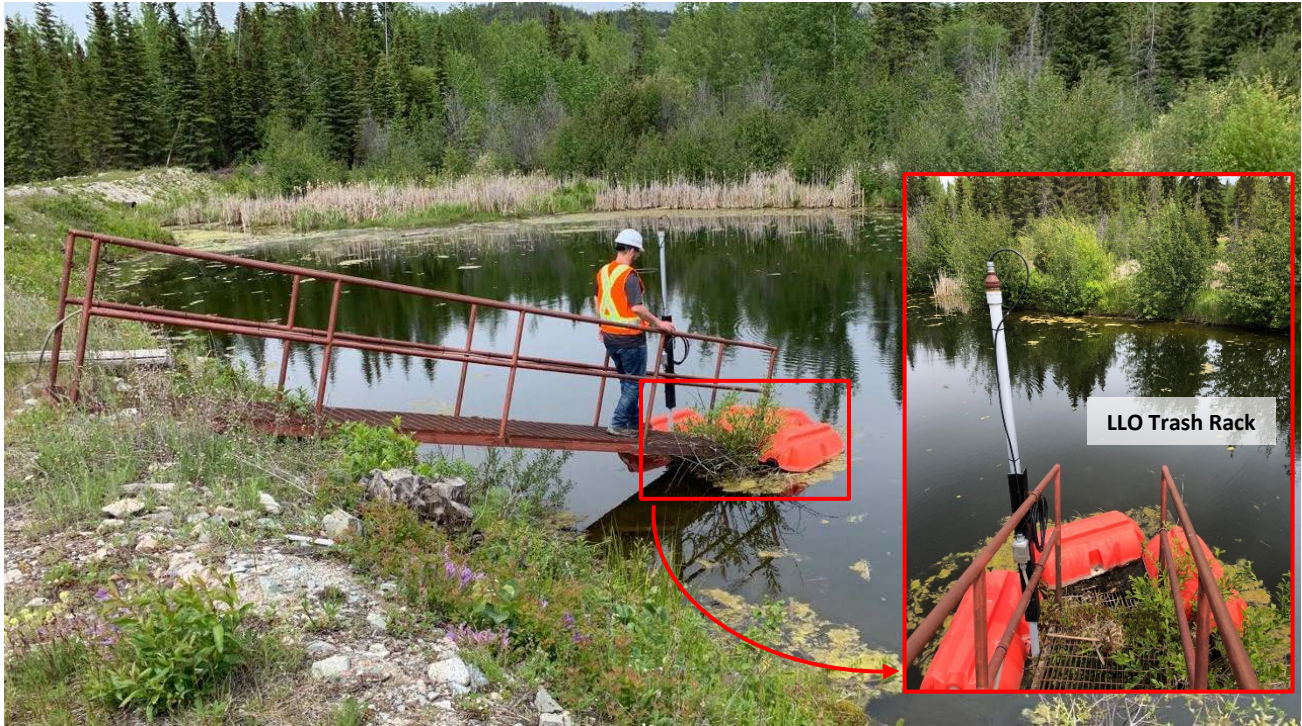
Debris boom in good condition. Build up of leaves present on intake cage will be removed as part of routine maintenance (Photo II-C-10).

Photo II-C-10 Overview of the pond, catwalk and Low-Level Outlet (LLO) inlet (TRJ-2019-20 and TRJ-2019-26)

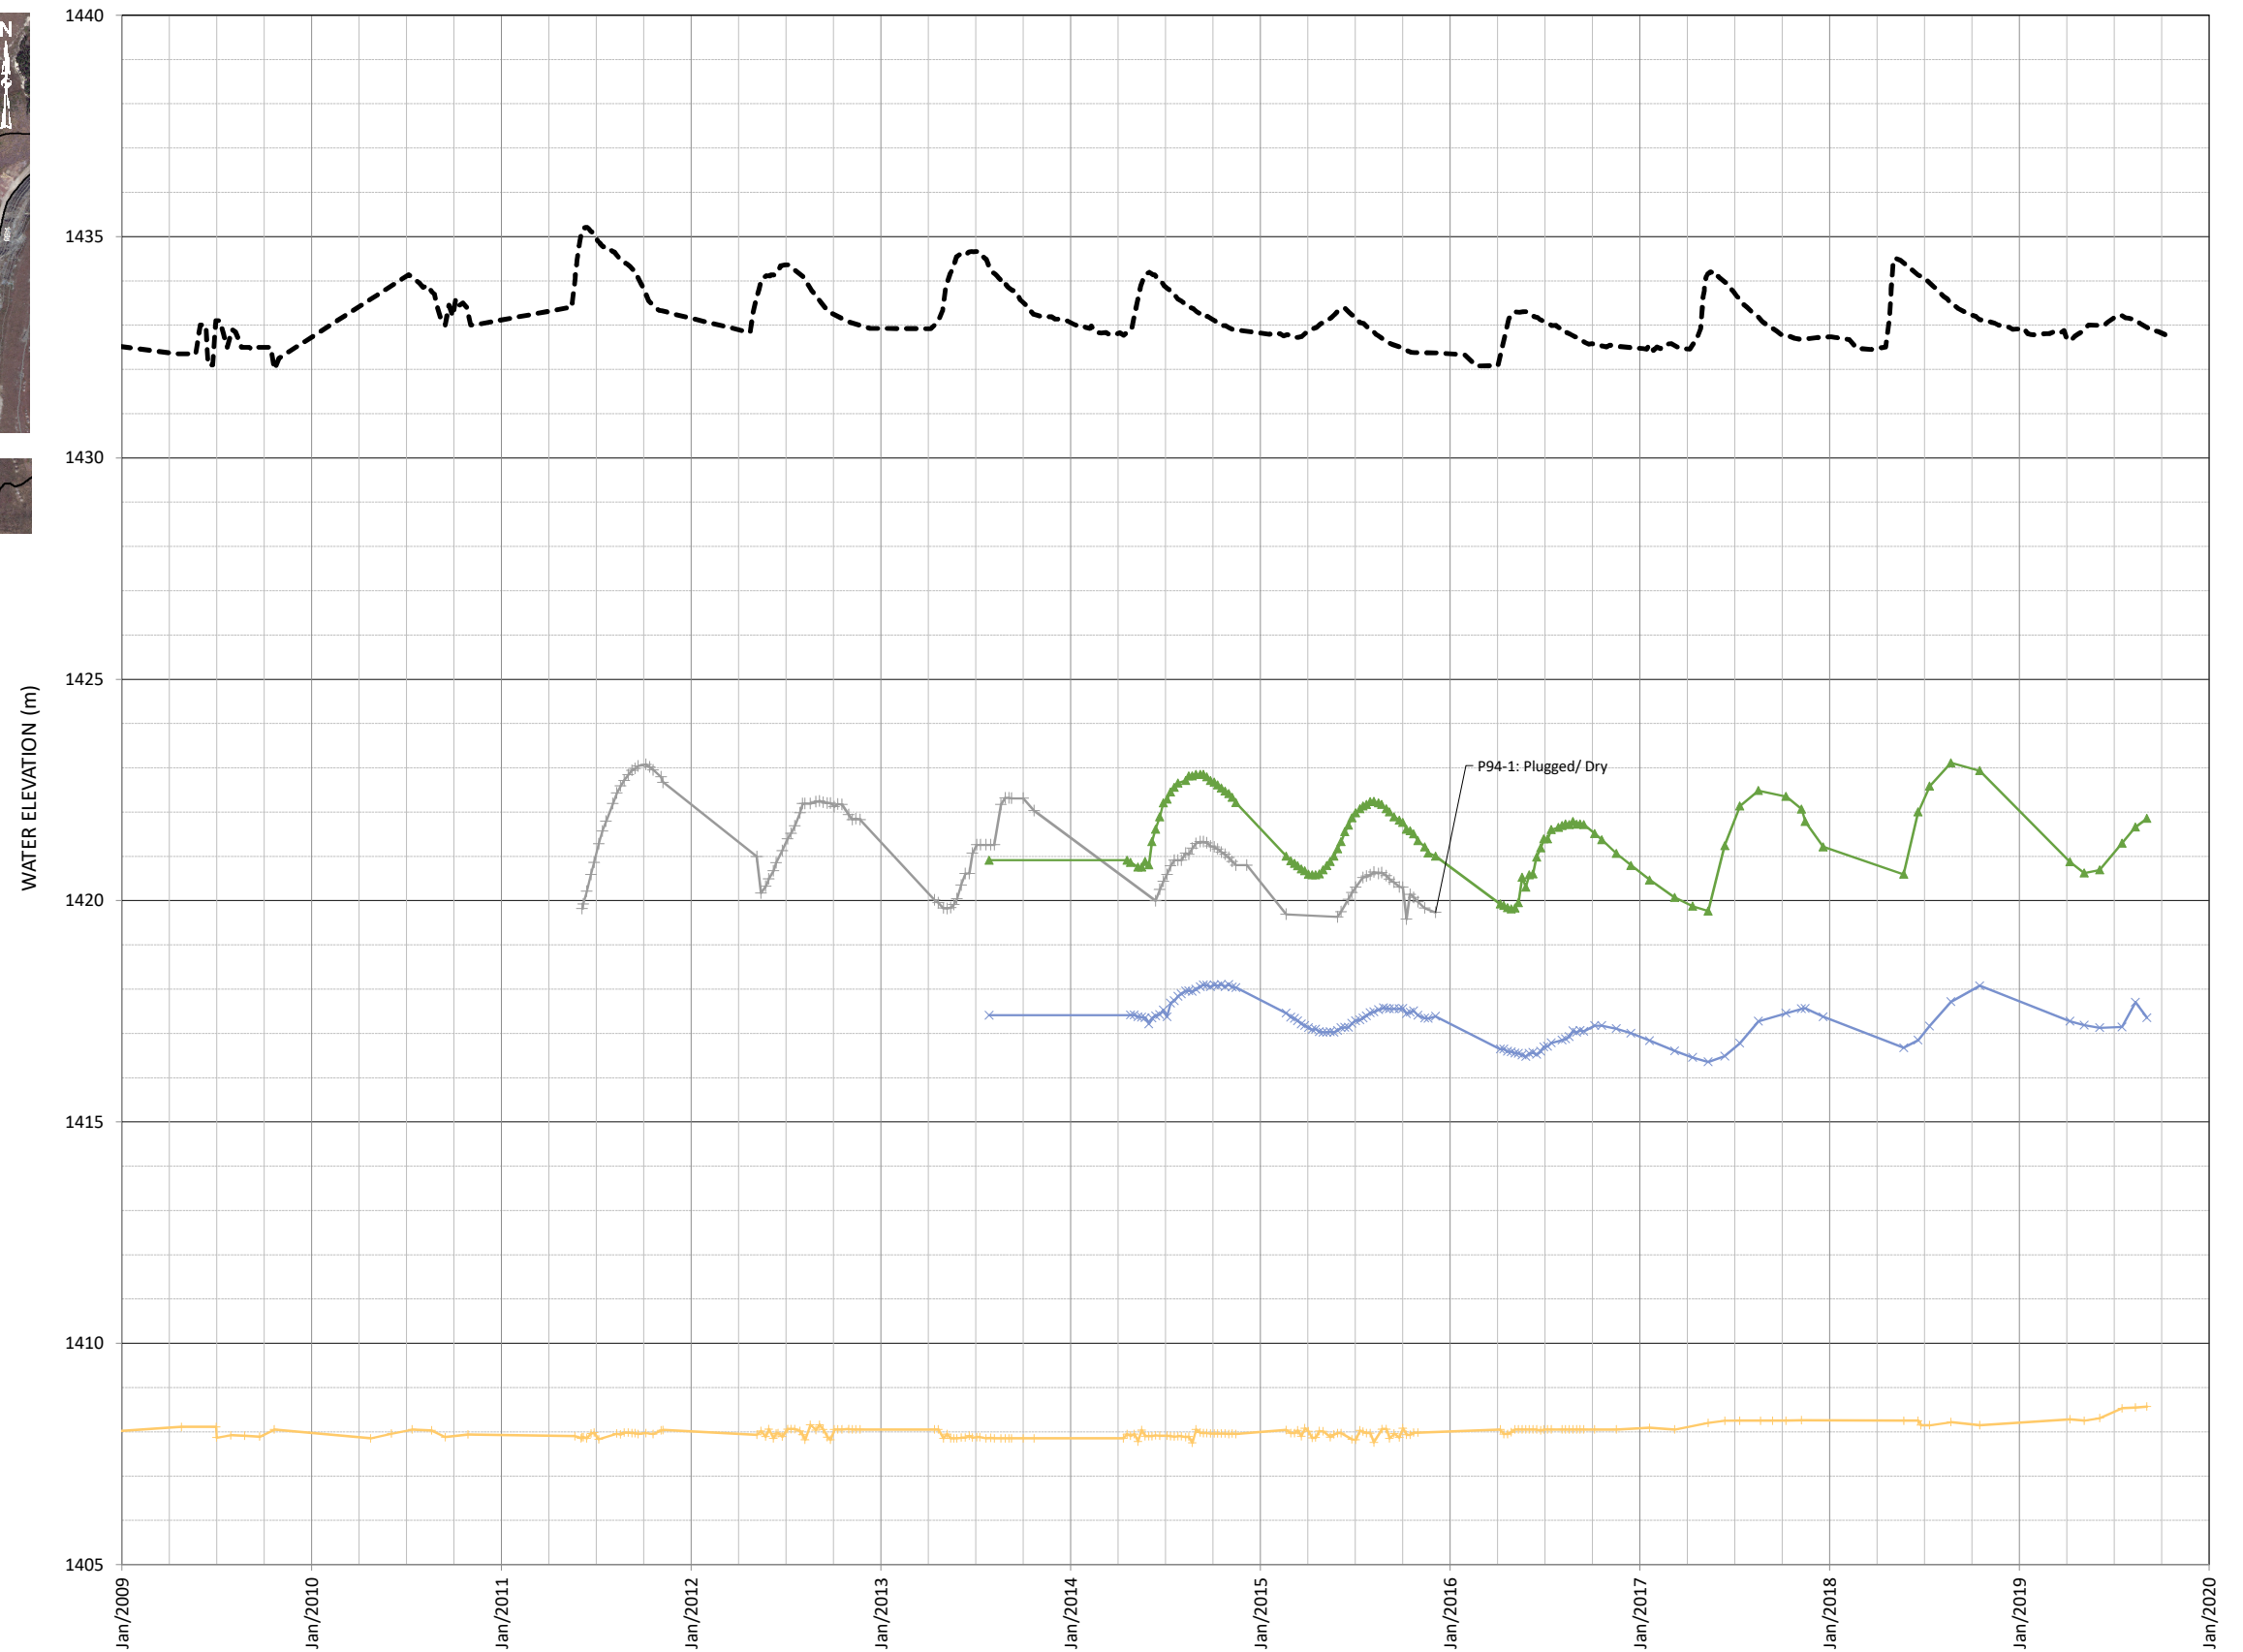
CLIENT Highland Valley Copper / Teck	PROJECT TROJAN TAILINGS STORAGE FACILITY 2019 DAM SAFETY INSPECTION
	TITLE TROJAN DAM PIEZOMETRIC DATA 2009-2019 IMPOUNDMENT
CLIENT Klohn Crippen Berger	PROJECT No. M02341B53
	FIG No. IV-B-1

- Piezometers within the tailings beach (between the pond and the dam crest) showed a continued downward trend from approximately 2014 (~0.5 m/yr to 0.75 m/yr). However, this trend reversed over the past 2 years and 2019 piezometric levels are similar to 2014 readings. The same general pattern is observed in pond level over this period which agrees with assumptions that pond level is primary controller of piezometric levels in the tailings under existing conditions.

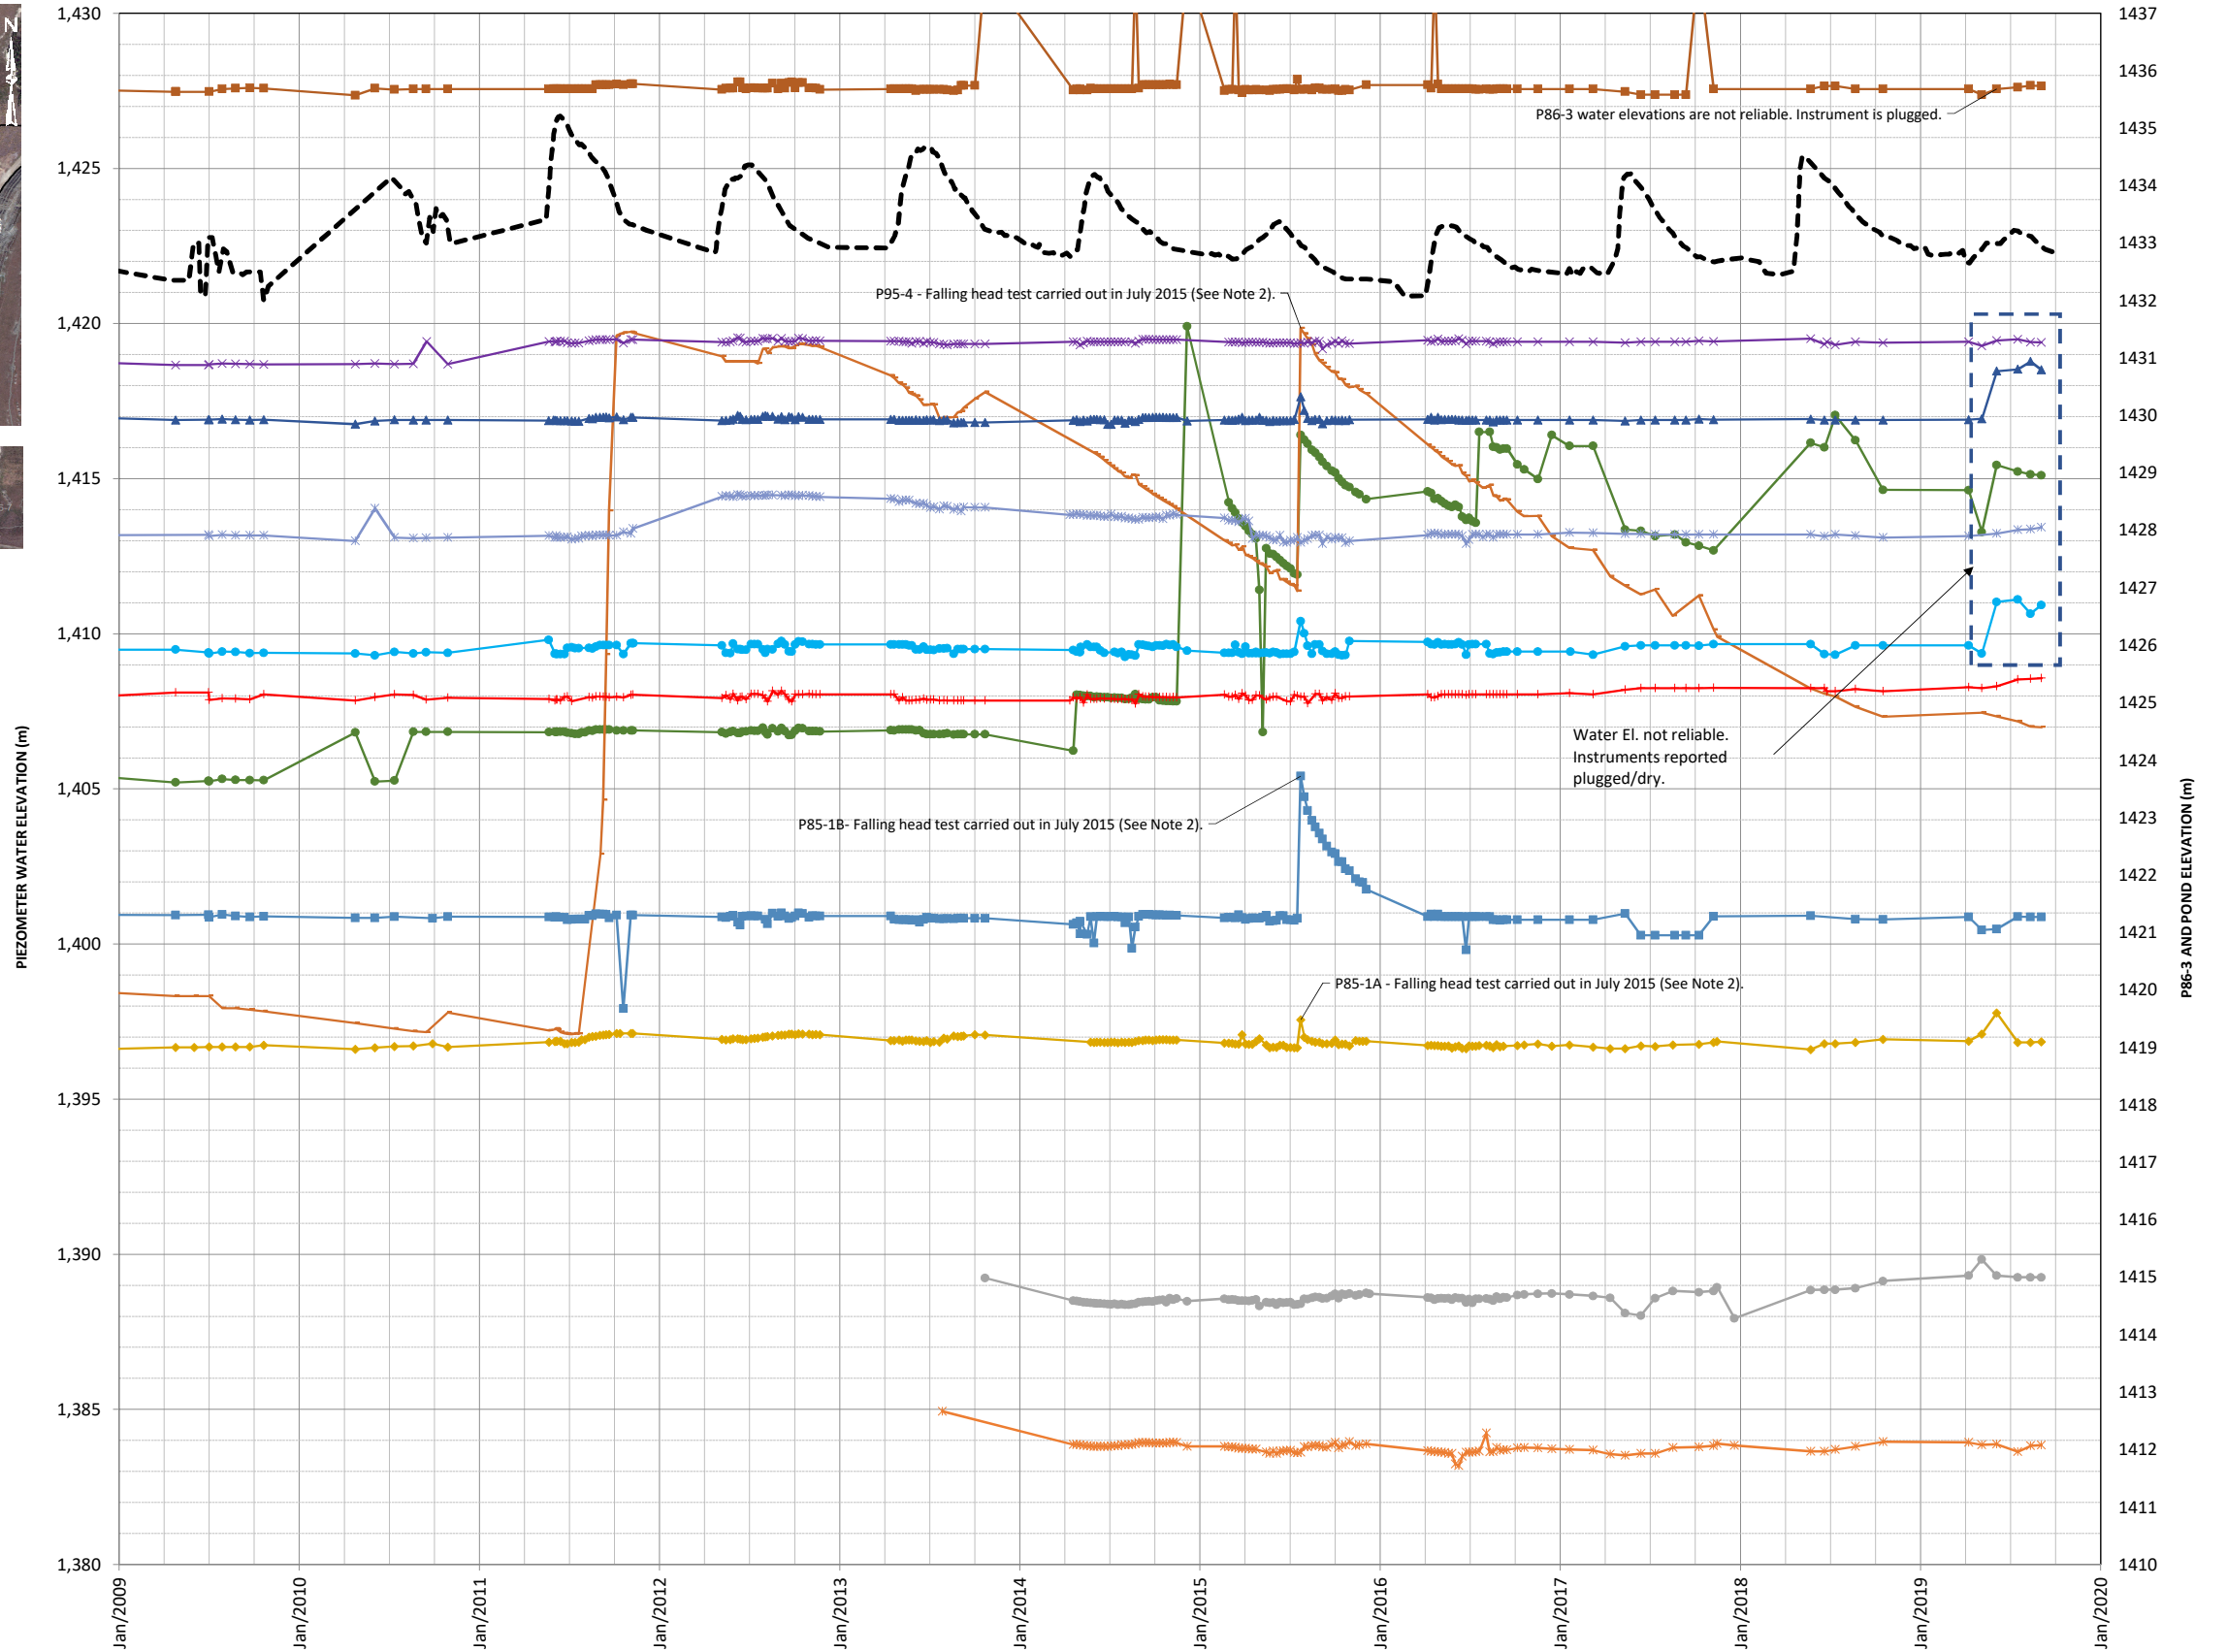
CLIENT Highland Valley Copper / Teck	PROJECT TROJAN TAILINGS STORAGE FACILITY 2019 DAM SAFETY INSPECTION
	TITLE TROJAN DAM PIEZOMETRIC DATA 2009-2019
PROJECT NO. M02341B53	FIG NO. IV-B-2

- Instruments P95-4 is located about 40 m upstream of dam centreline and inferred to be installed in cycloned sand based on its tip elevation and design cross section from KC (1996). A sudden increase in water level was measured during the extended wet period in 2011. This response was not observed in other instruments. Between 2011 and 2015, piezometric level declined by approximately 8.5 m to El. 1411.5 m. In 2015, P95-4 was slug tested as indicated by the spike in Figure IV-B-2. Following that test, piezometric measurements showed a steady decrease, until 2019 when the piezometric level was relatively constant at El. 1407.5 m which is below the crest of the starter dam (El. 1414 m). Assuming the 2019 levels are representative for this location, there is no dam safety concern as the current level is below the piezometric level assumed in design.

- Piezometers installed in the glacial till and sand and gravel fill zones of the starter dam at the upstream toe close to low point of the valley (TB-PS-04/P13-3 and TB-PS-03/P13-4) measure low piezometric heads. This supports the assumed downward gradient into the foundation. There was one piezometric threshold exceedances in 2019 (i.e. measured reading was higher than maximum value for closure condition): May 2019 reading for TB-PS-03/P13-4 was 0.13 m above threshold. These thresholds are just intended to identify change from normal patterns and not a tailings dam safety concern.
