Teck Highland Valley Copper Partnership

2019 Dam Safety Inspection Report

Trojan Tailings Storage Facility

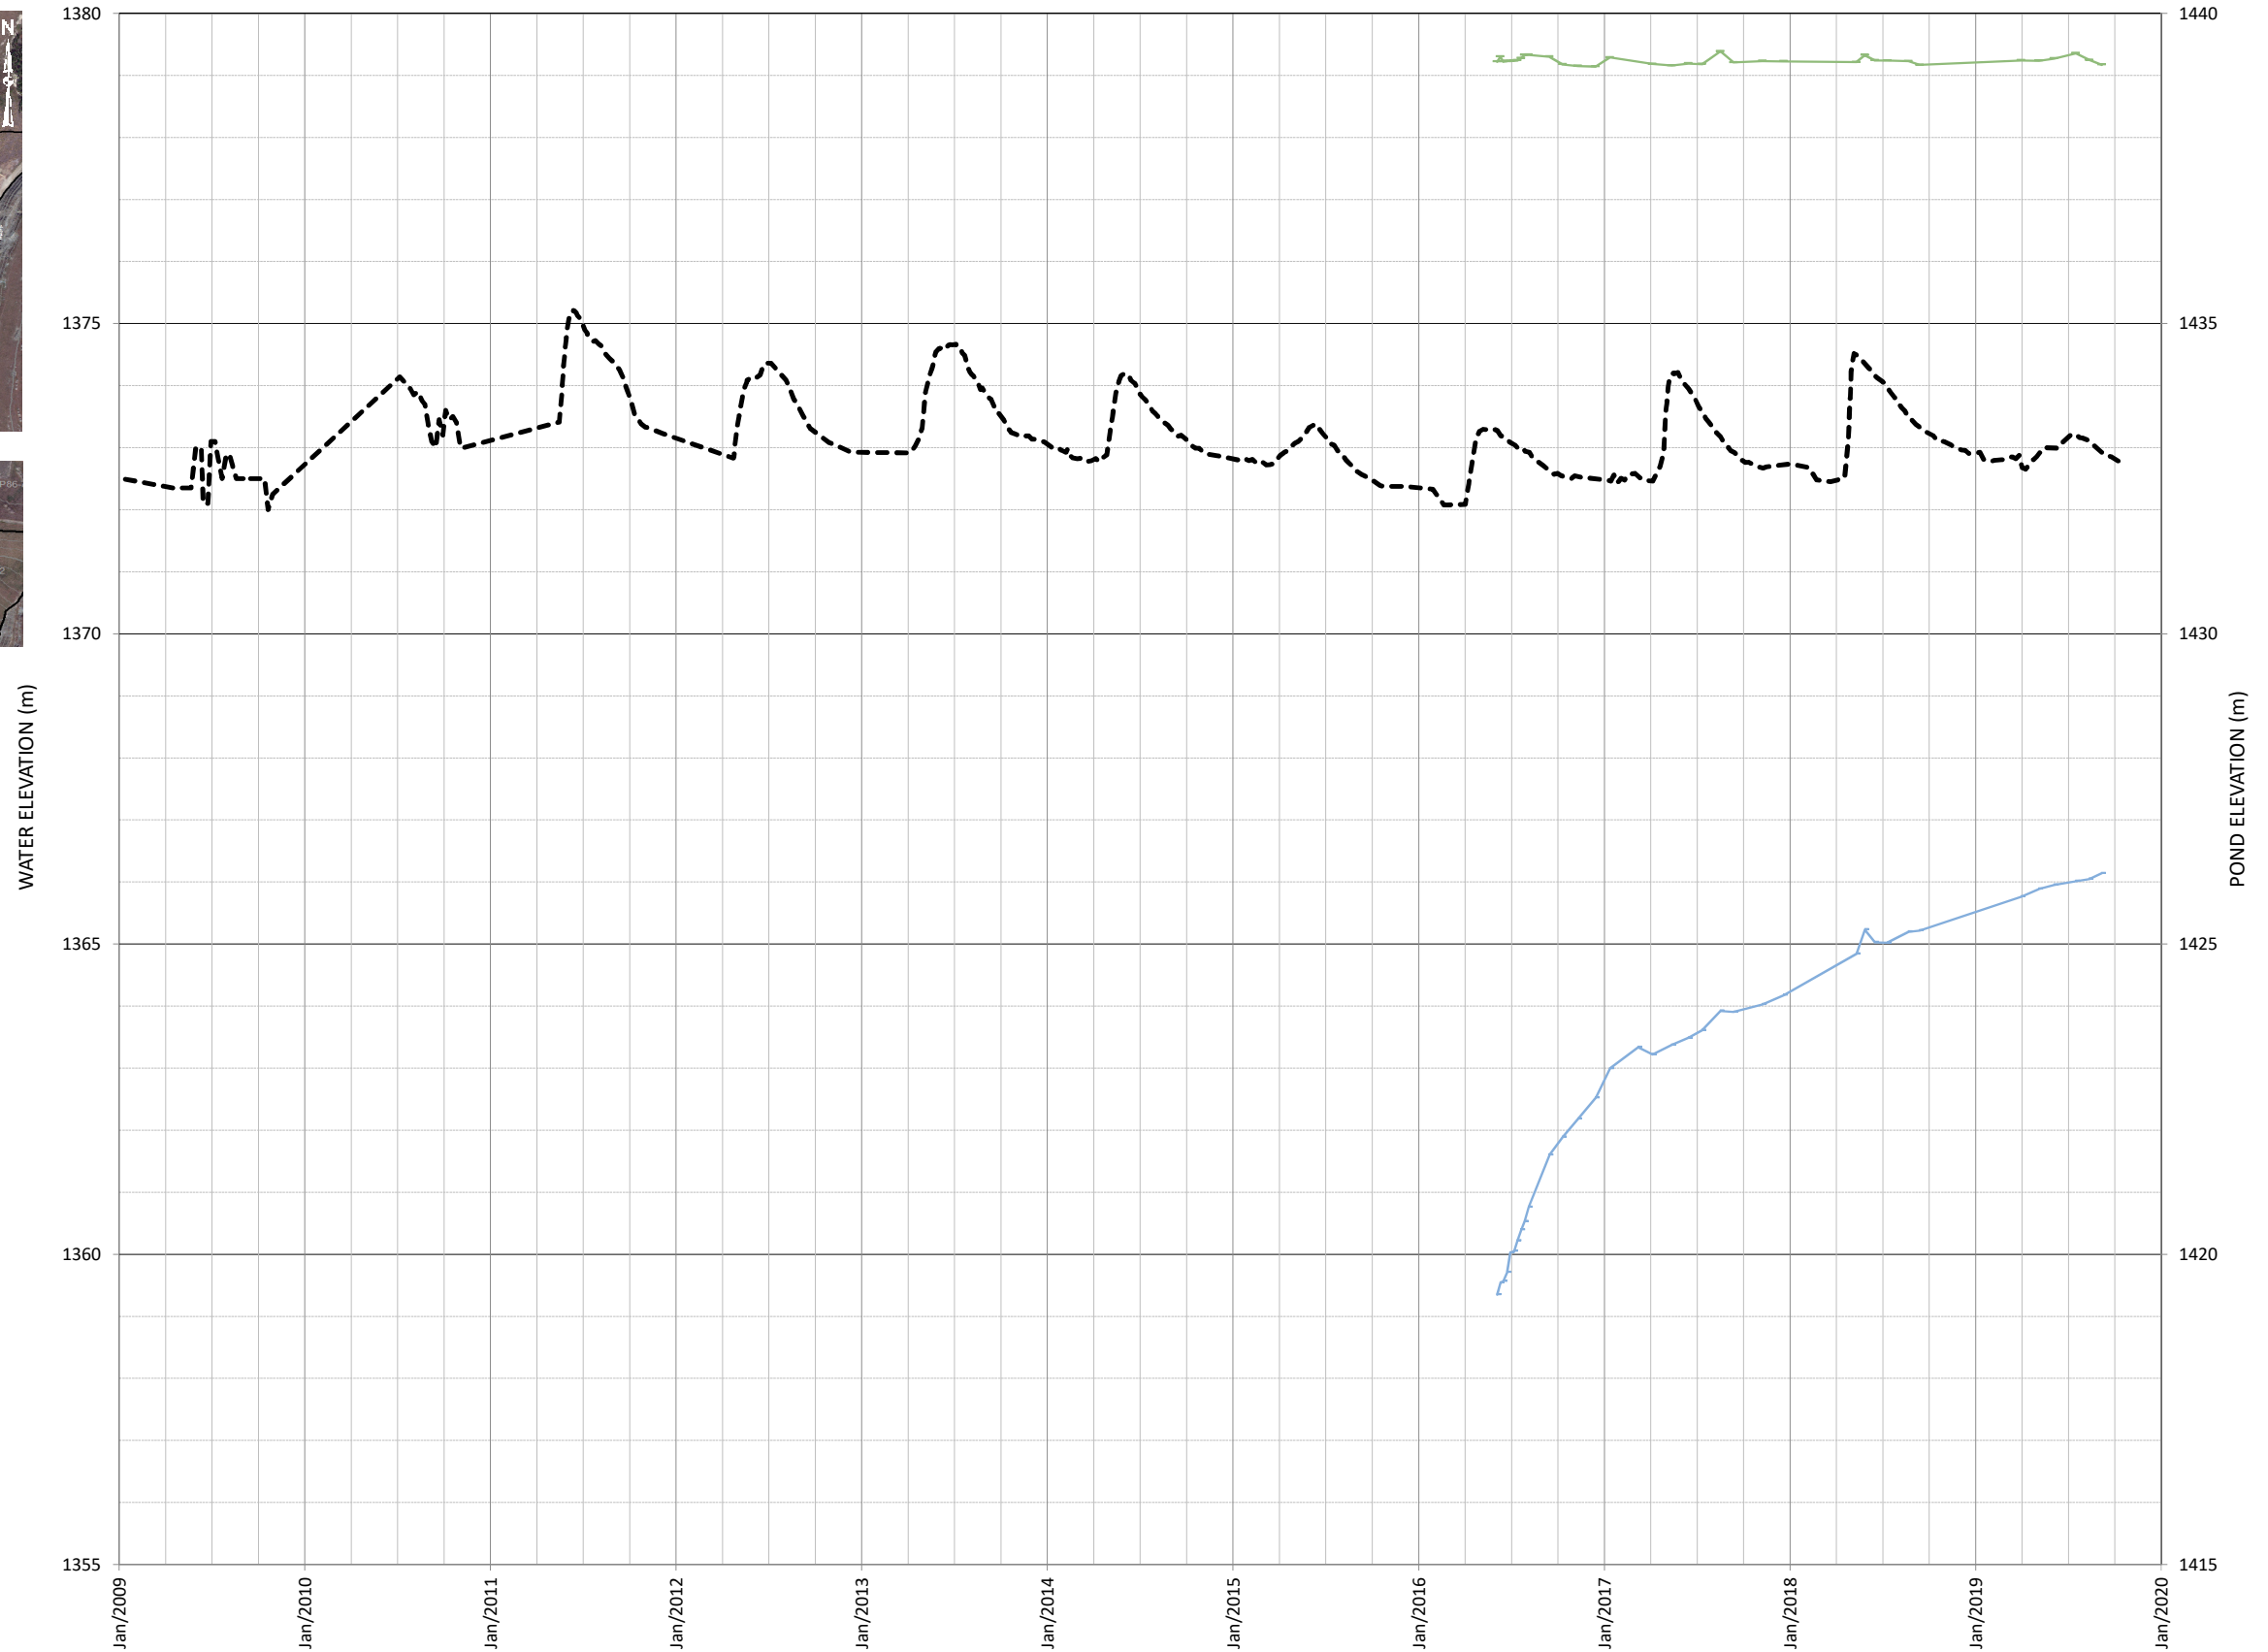
- The piezometric levels at VW16-2A has shown a rising trend since installation in 2016; refer to Figure IV-B-3. This, however, is not considered a dam safety concern as the current piezometric levels are approximately 12 m below the phreatic surface considered in the design (design assumes piezometric level at ground surface at 1378 m) and is still below the elevation of other piezometers in the foundation beneath the crest.

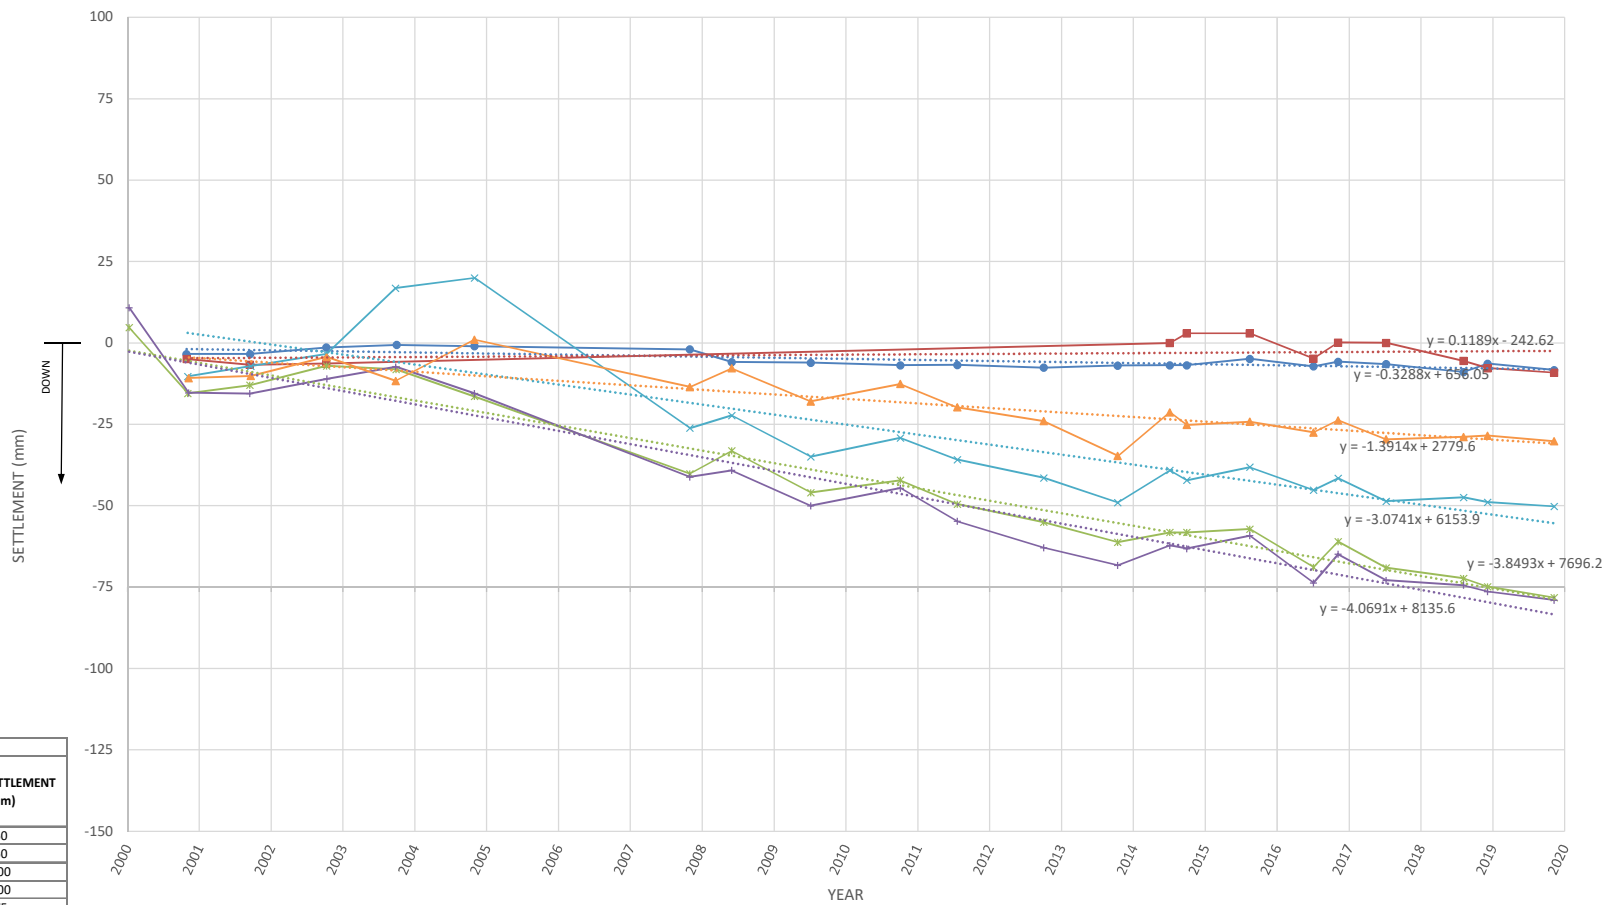
1. TROJAN DAM MOVEMENT MONITORING DATA PRIOR TO 2000 NOT SHOWN.
2. REFER TO FIGURE 3 FOR MONUMENT LOCATIONS IN PLAN VIEW.
3. TD-1 RELOCATED AFTER OCT 2001.
4. TD-1 2009 READING (NOT SHOWN IN PLAN PLOT) LOCATED 297 mm FROM INITIAL 1998 READING . READING WAS REVIEWED AND FOUND MORE LIKELY RELATED TO SURVEY ERROR THAN DISPLACEMENT.

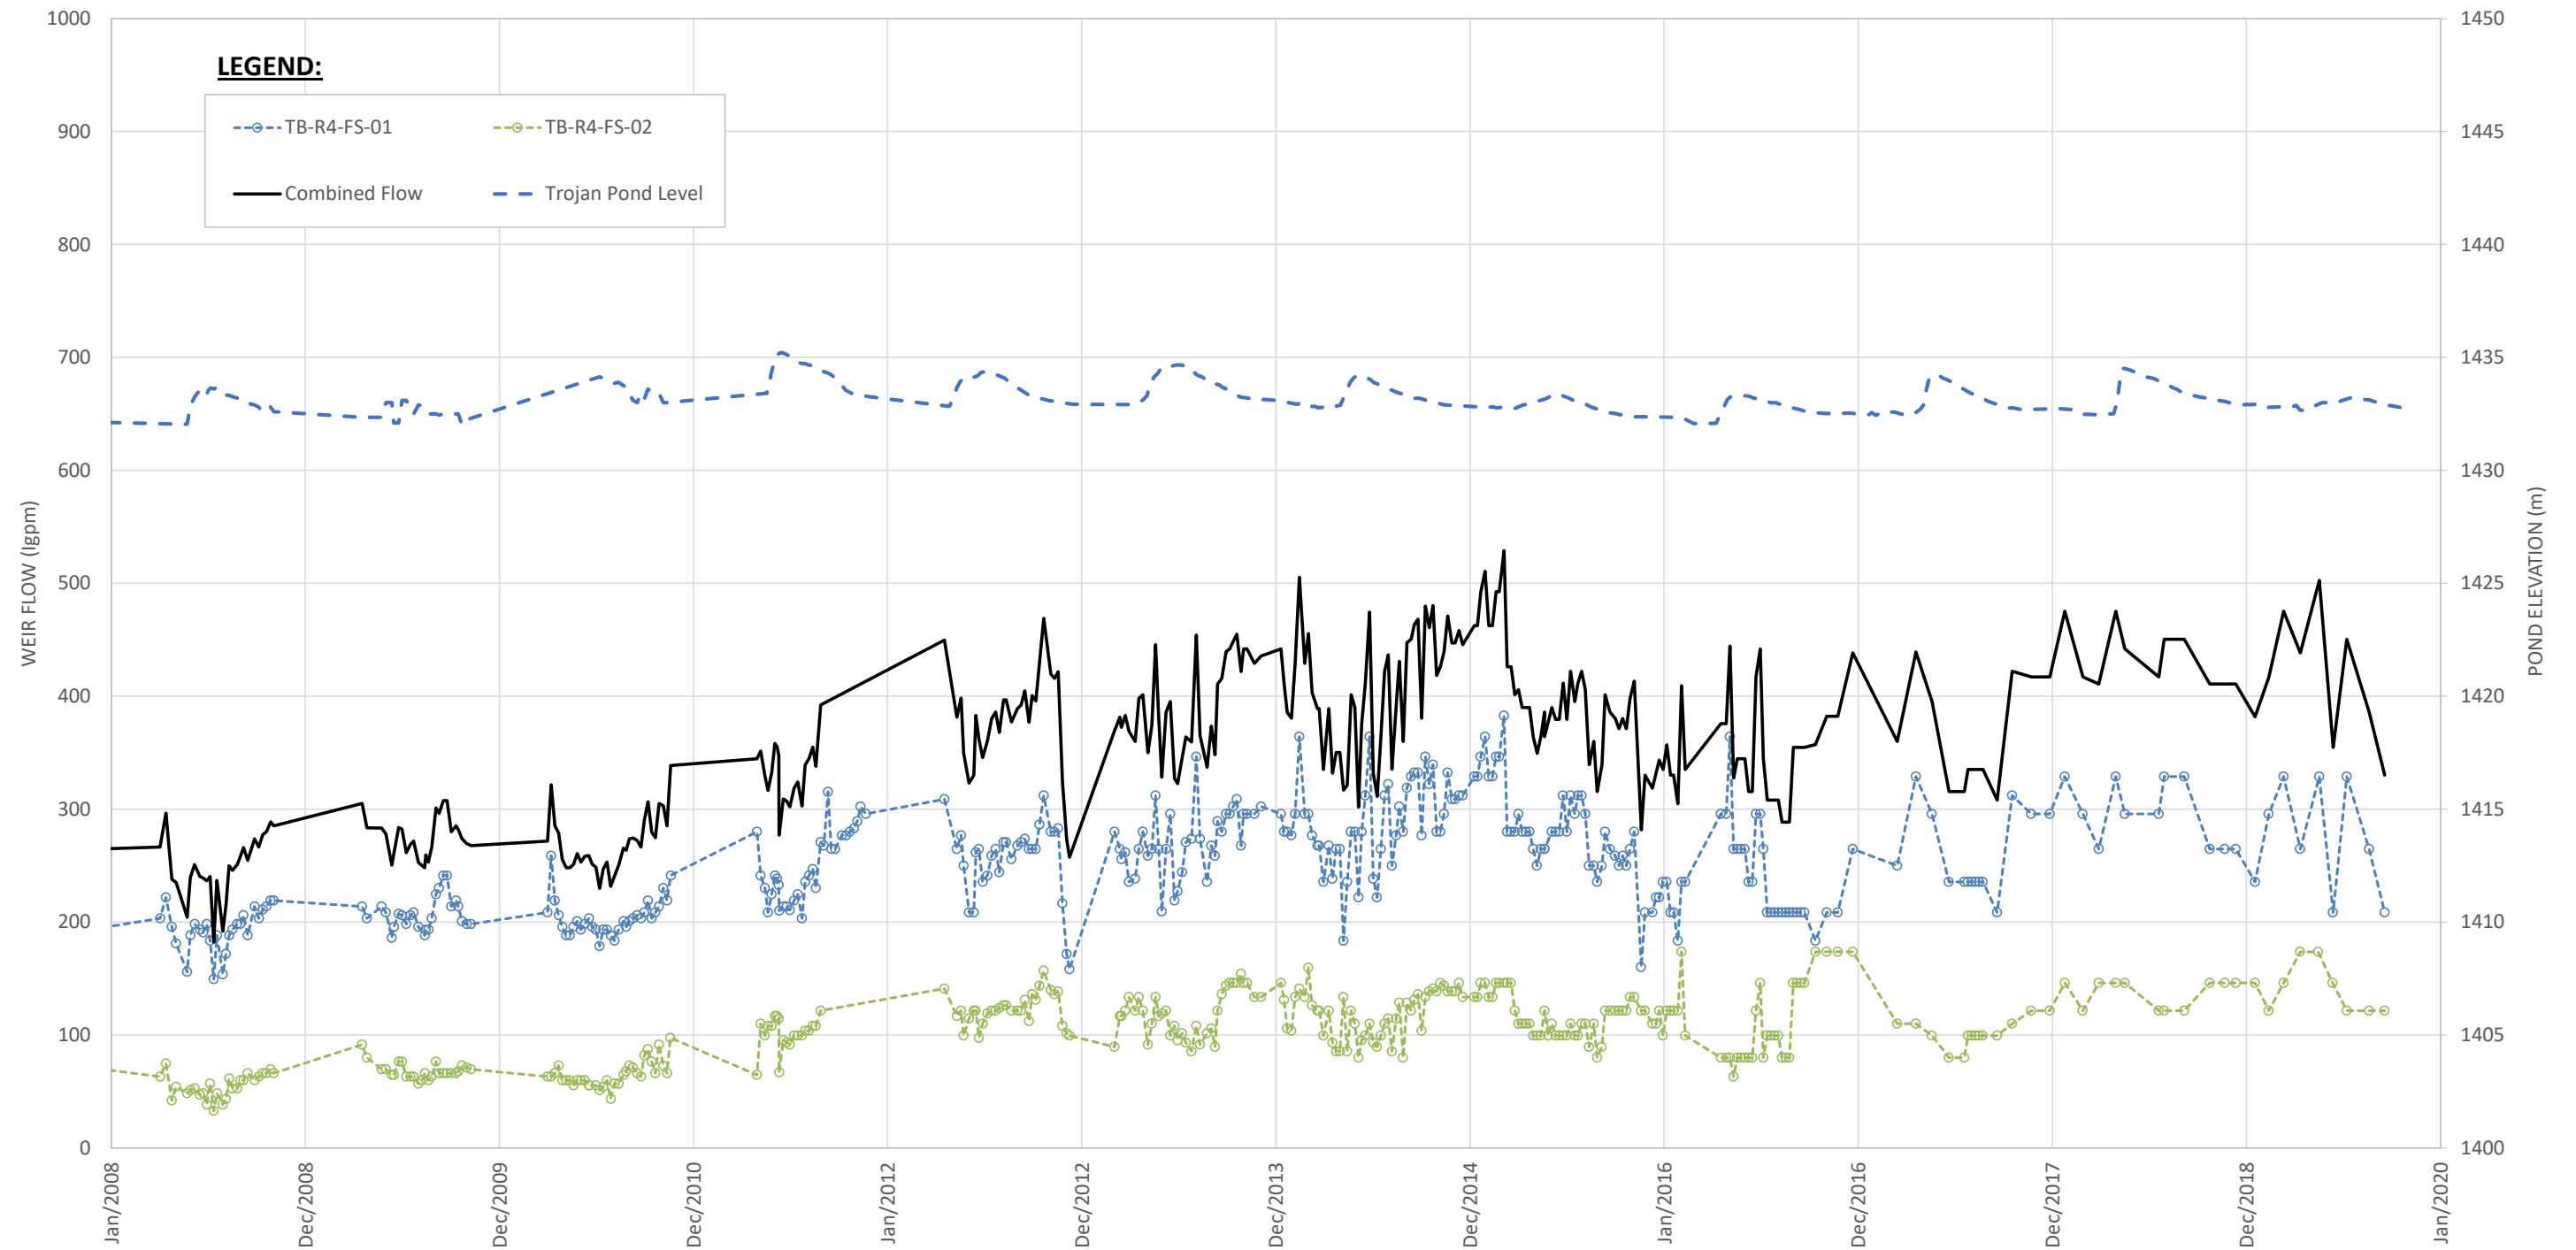
TITLE TROJAN DAM WEIR FLOWS	
	PROJECT No. M02341B53	FIG No. IV-B-6

- WEIR FLOW PLOTTED ON PRIMARY (LEFT) AXIS, TROJAN POND ELEVATION PLOTTED ON SECONDARY (RIGHT) AXIS.
- POND WATER LEVEL RECORDED ON NOVEMBER 8, 2009 HAD A 10 m JUMP AND IS NOT PLOTTED AS IT IS ALMOST CERTAINLY A MEASUREMENT OR DATA ENTRY ERROR.
