# **Teck Highland Valley Copper Partnership**

## **2020 Annual Facility Performance Report**

### ***7 Day Pond Tailings Storage Facility***

**2020 Annual Facility Performance Report  
7-Day Pond Tailings Storage Facility**

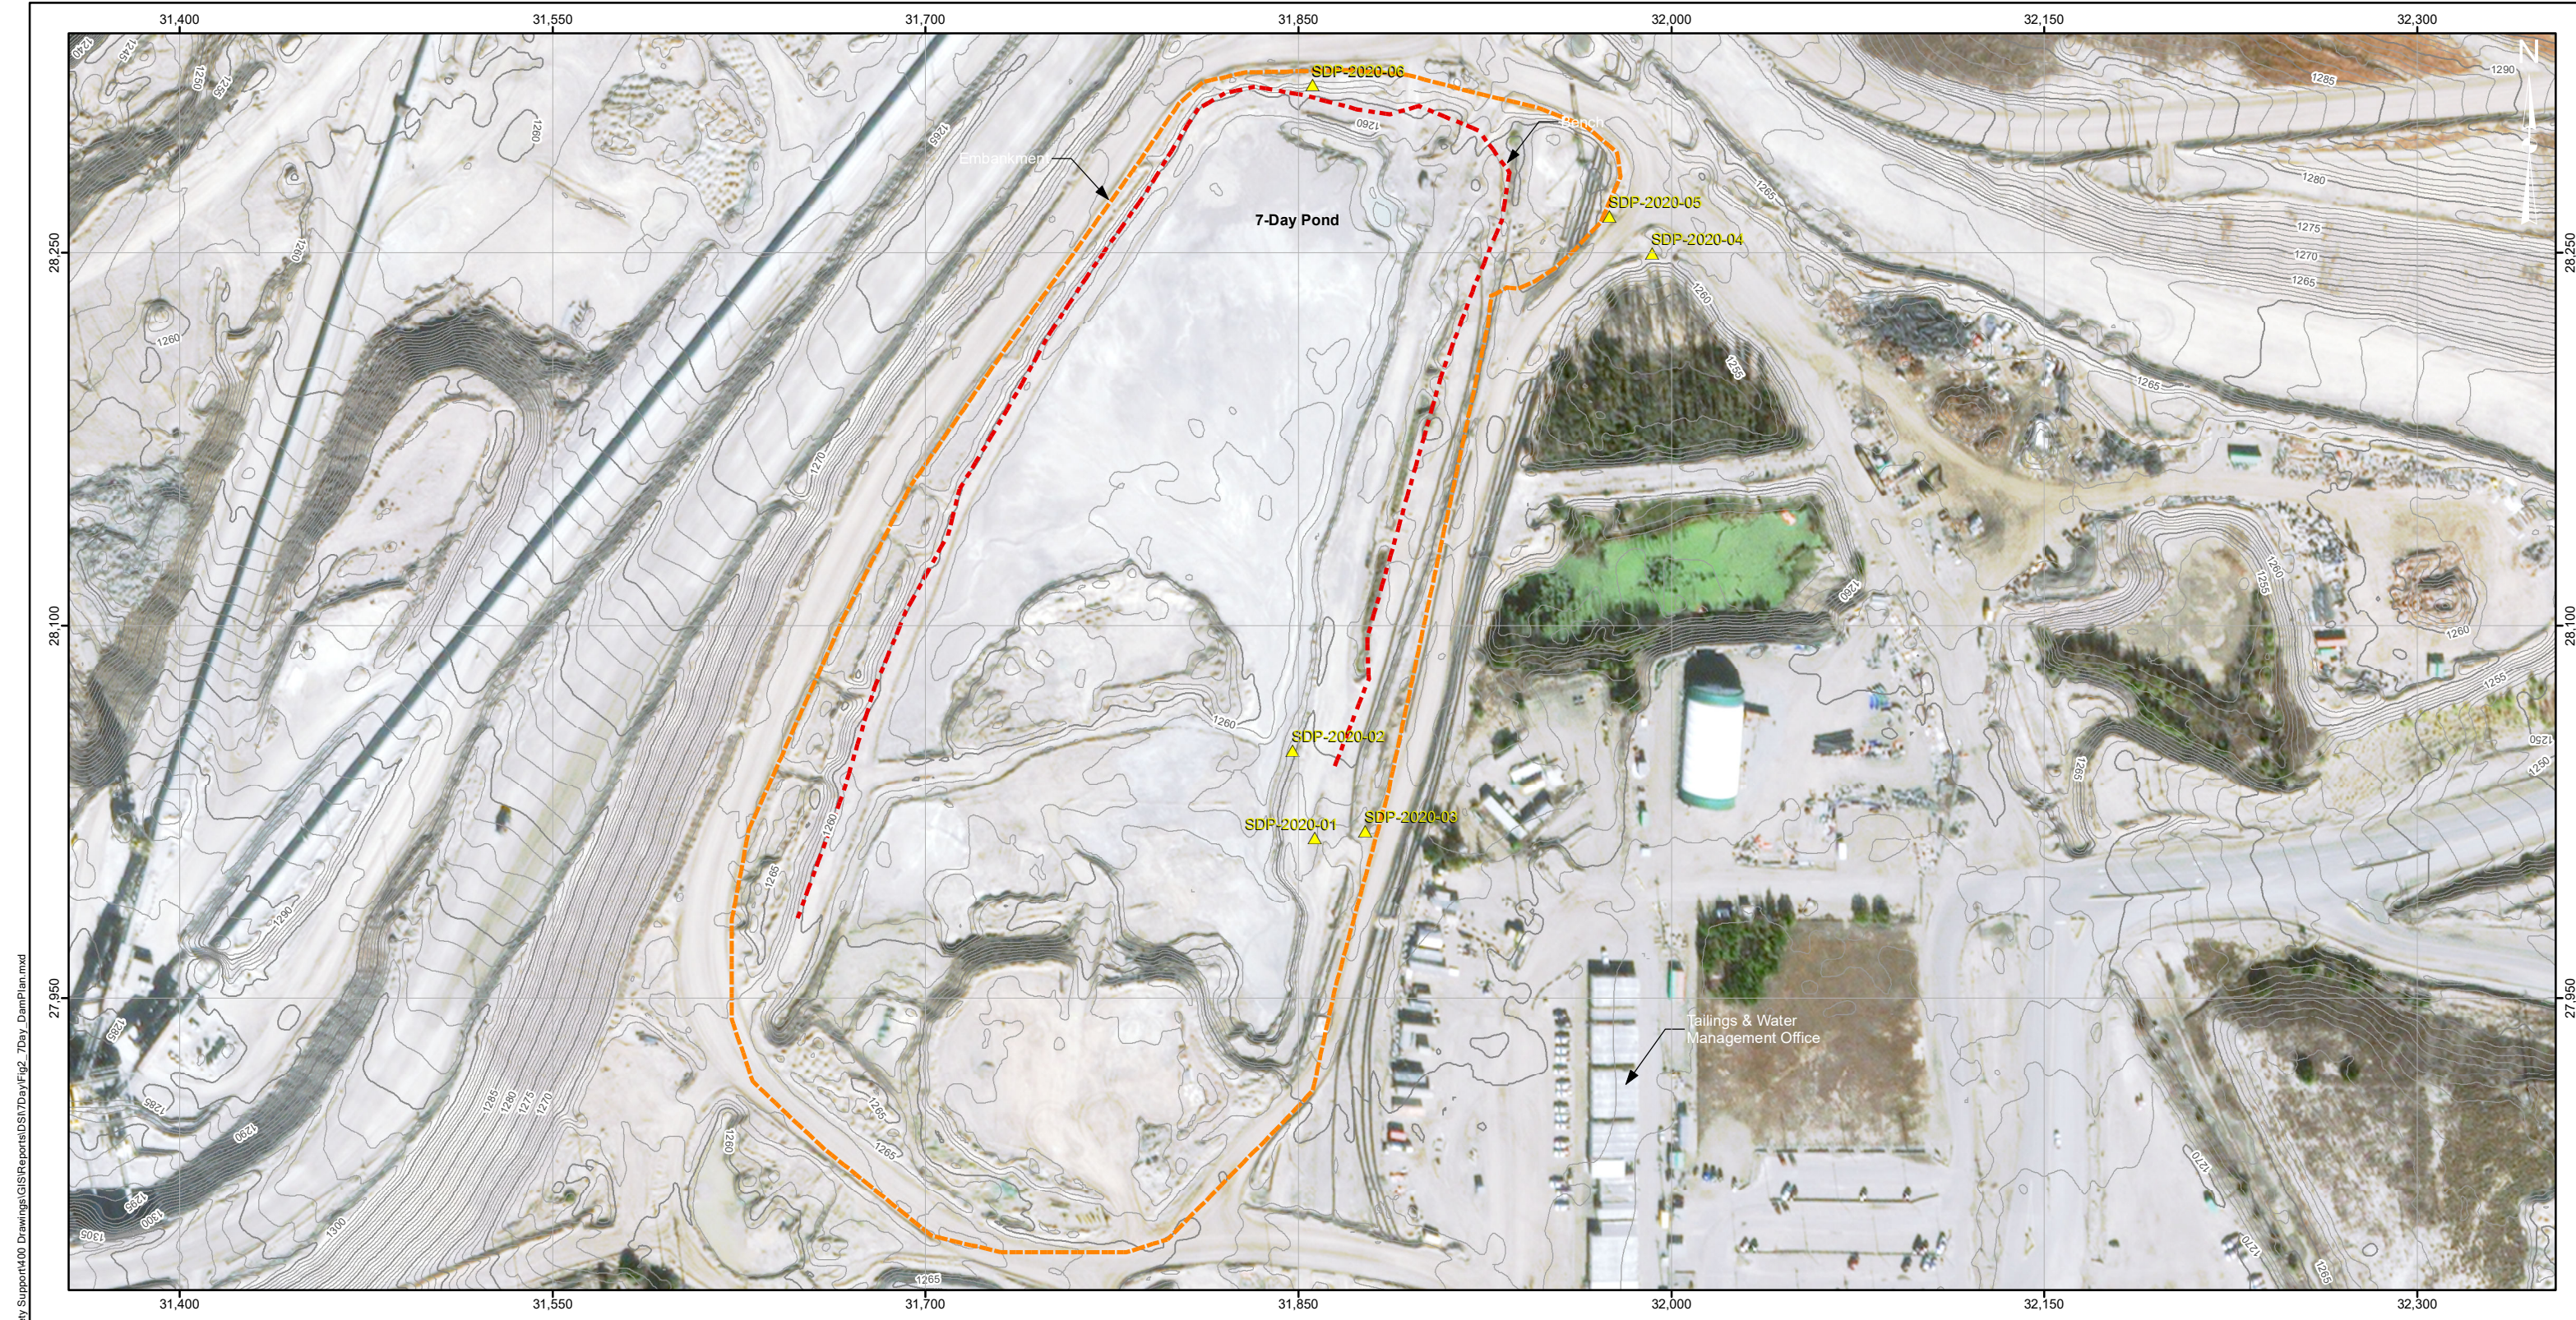
CLIENT Highland Valley Copper	PROJECT 7-DAY POND TAILINGS STORAGE FACILITY 2020 ANNUAL FACILITY PERFORMANCE REPORT		
	TITLE 7-DAY POND PLAN		
	SCALE 1:2,500	PROJECT No. M02341B83	FIG No. 2

The 7-Day Pond TSF East Berm (Figure 2) containment level was raised with general fill to El 1261.5 m (maximum of 1.5 m raise) between October and November 2020 to increase the available flood storage to store the inflow design flood (IDF). An additional 0.3 m of road surfacing was placed above the general fill but this is not considered in flood storage estimates as it is subject to regrading and is not water retaining.

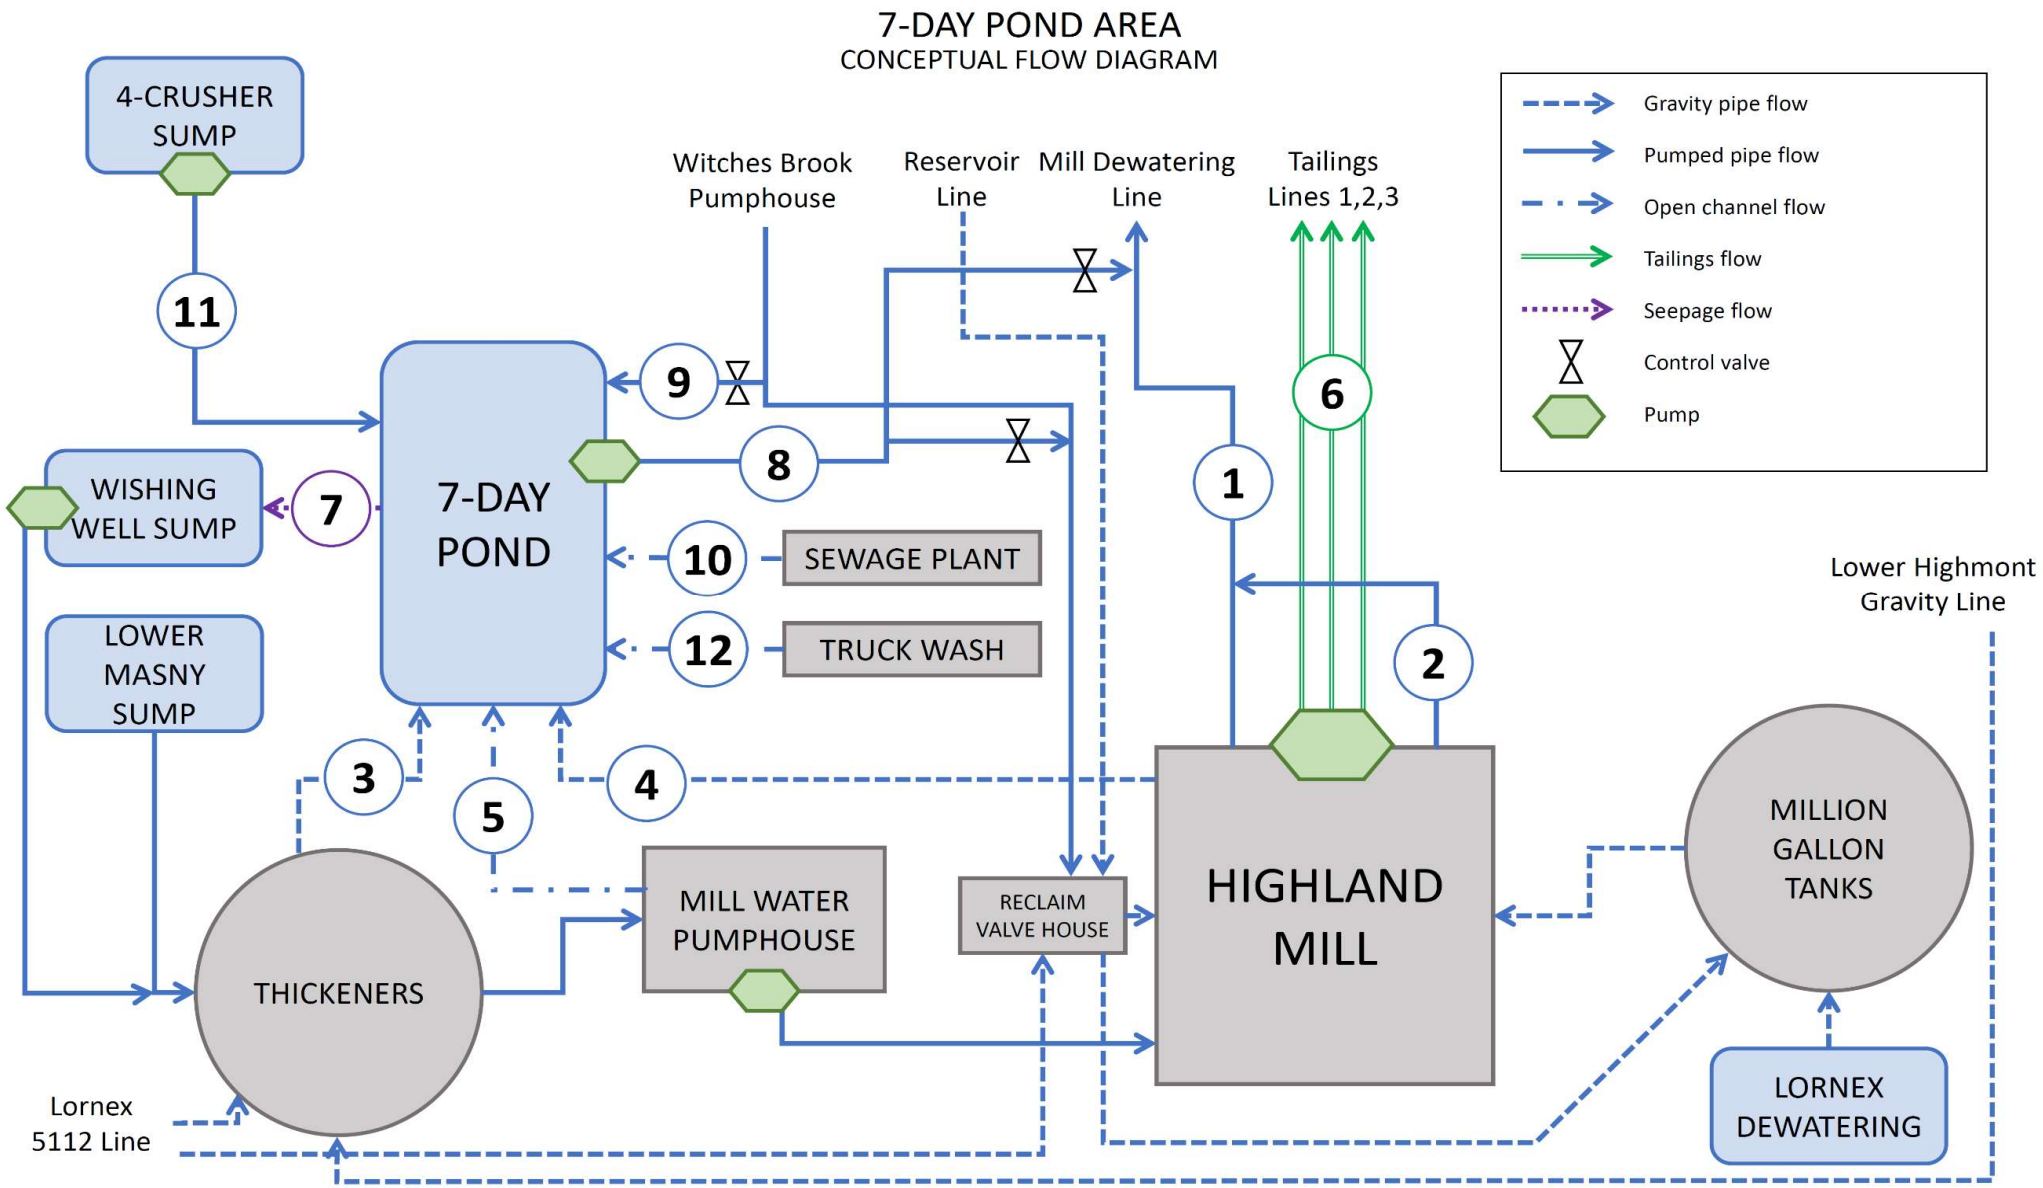
A schematic of the tailings and water management system for the 7-Day Pond TSF is shown on Figure 3. Inflow and outflow rates/volumes are not monitored.

Figure 3 is a simplified water schematic for the pond. Inflows and outflows are not measured. Outflows from the 7-Day Pond TSF are either related to dewatering by pumping or seepage (primarily to the Valley Pit). The water balance of the facility is maintained through pumping, as necessary, during high flow periods. With pumping, the facility can manage potential inflows to maintain appropriate flood capacity.
