Teck Highland Valley Copper Partnership

2020 Annual Facility Performance Report

Bethlehem No.1 Tailings Storage Facility

March 2021

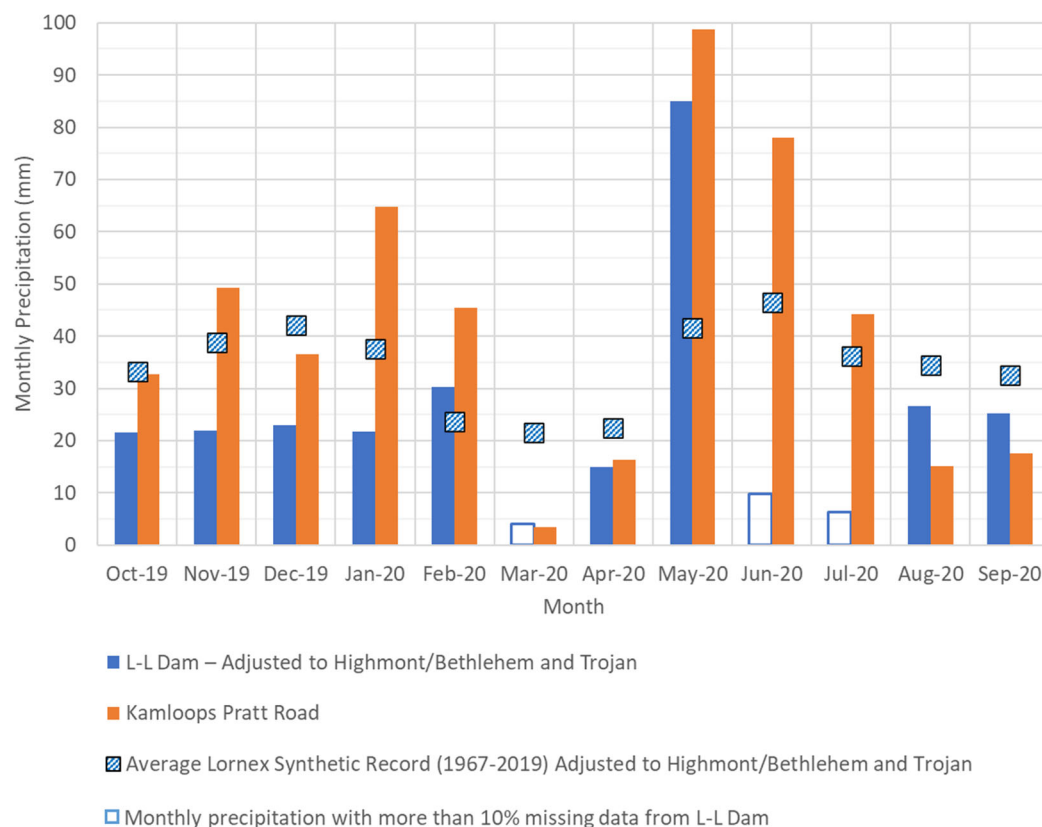
Figure 4.1 Monthly Precipitation

- Figure 4.1 indicates low precipitation at site during June and July; however, this is due to L-L Dam Weather Station data gaps during this period. THVCP inspection reports and regional climate station data indicate precipitation during this period was above historic normals.

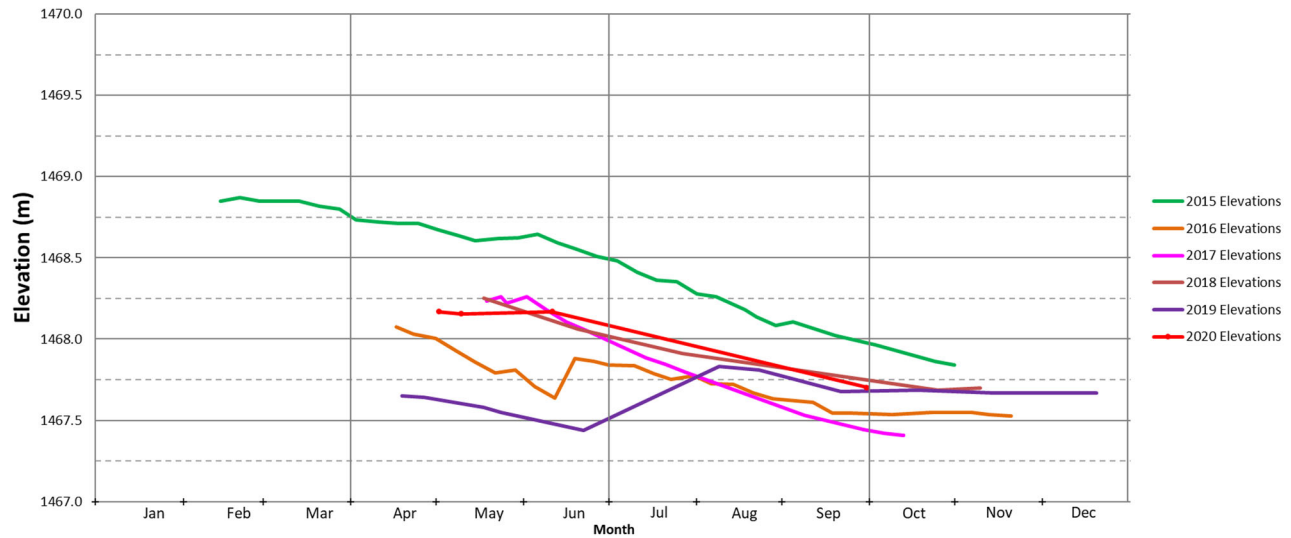
Figure 5.1 Pond No.1 Water Elevations – 2015 to 2020

- In general, 2020 levels were higher during freshet compared to 2019 levels, but the seasonal variations of pond rise and fall were consistent with historic observations which show no long-term trend of increasing pond volume (Figure 5.1 and Table 5.2).

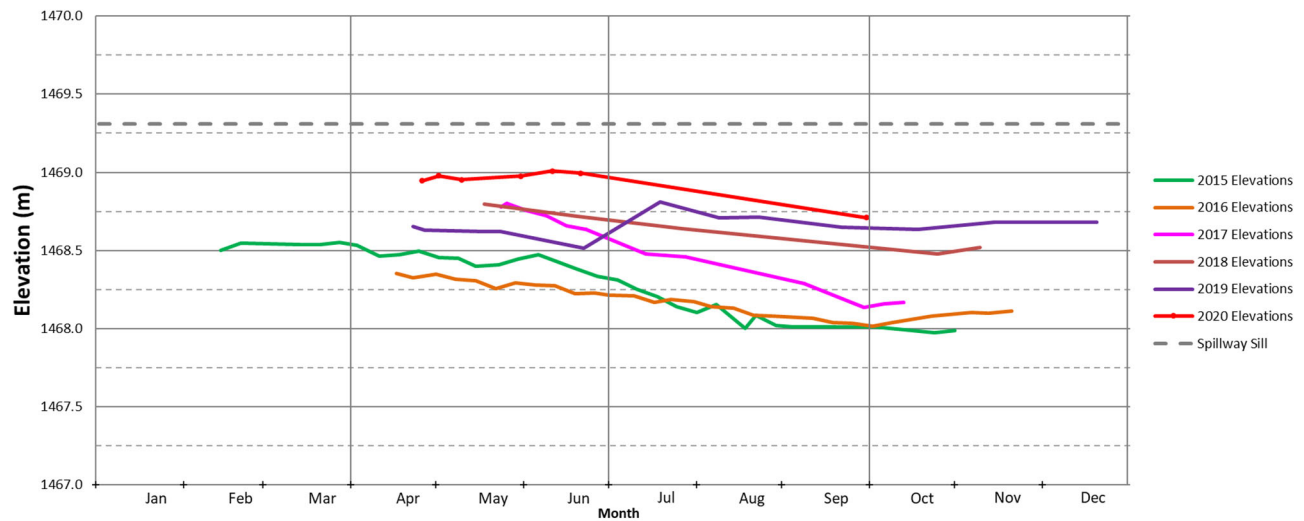
Figure 5.2 Pond No.2 Water Elevations – 2015 to 2020

- 2020 levels were the highest during freshet on the record dating back to 2015 (Figure 5.2 and Table 5.3). Since 2016, there has been a trend in rising pond levels (peak and end of year) which is associated with recent above average freshet events, most notably 2017. This trend is expected to reverse during drier periods as seepage and evaporation capacity exceeds inflows. Based on topography the volume of water which accumulated in the pond during 2020 was small (<5,000 m³). The overall water balance for the facility (Section 4.3) indicates a water deficit during 2020 which does not agree with pond levels. This is not a dam safety concern but an observation for THVCP to consider in future water balance calibrations.

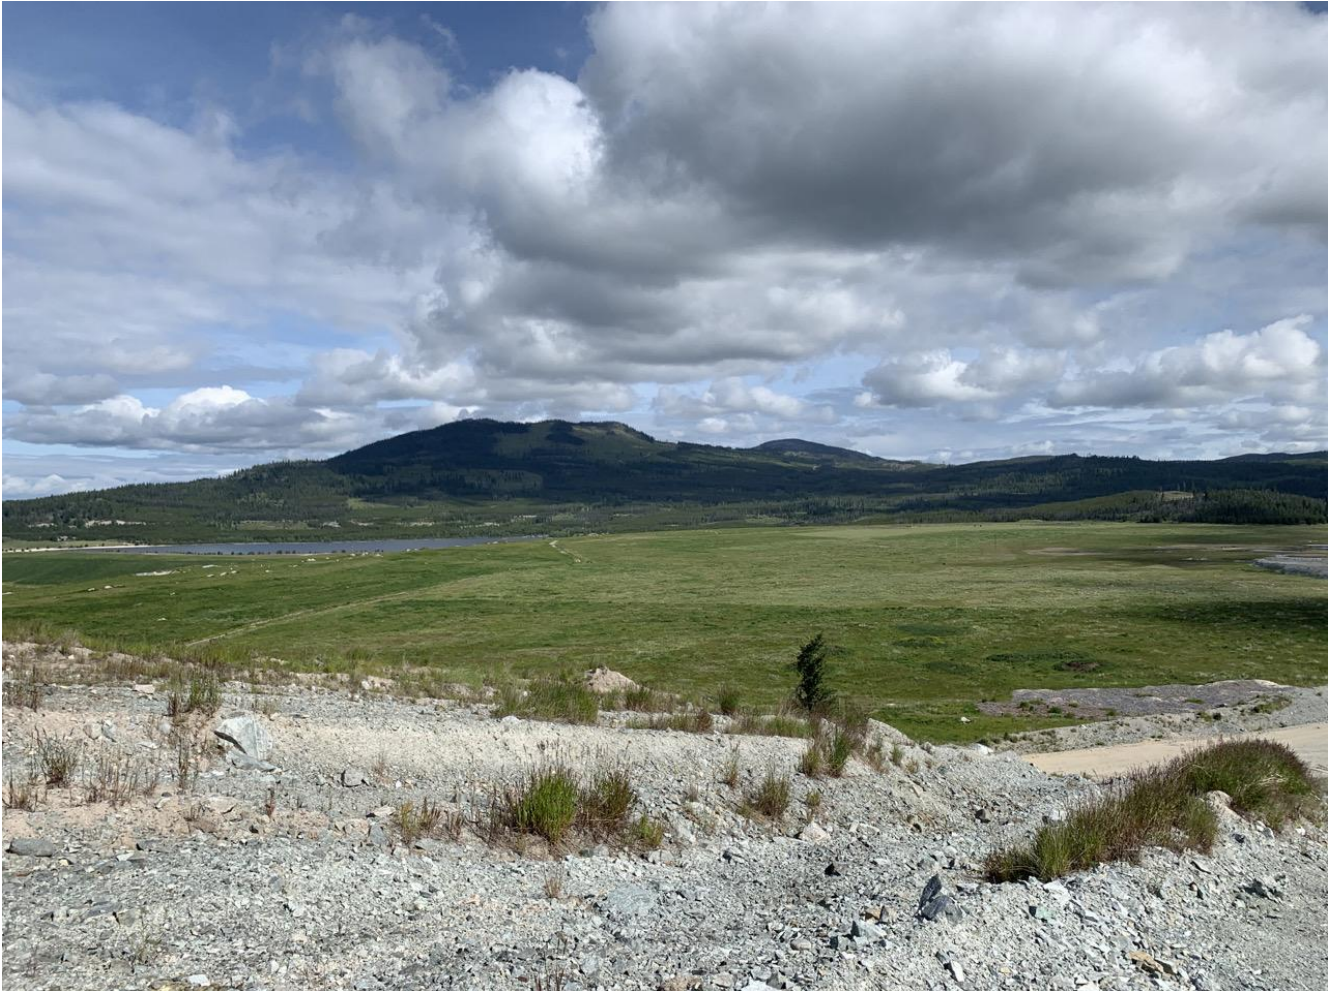
Photo I-A-3 Bethlehem sinkhole on tailings beach, no visual change from 2019 visual observations (BTH-2020-03)

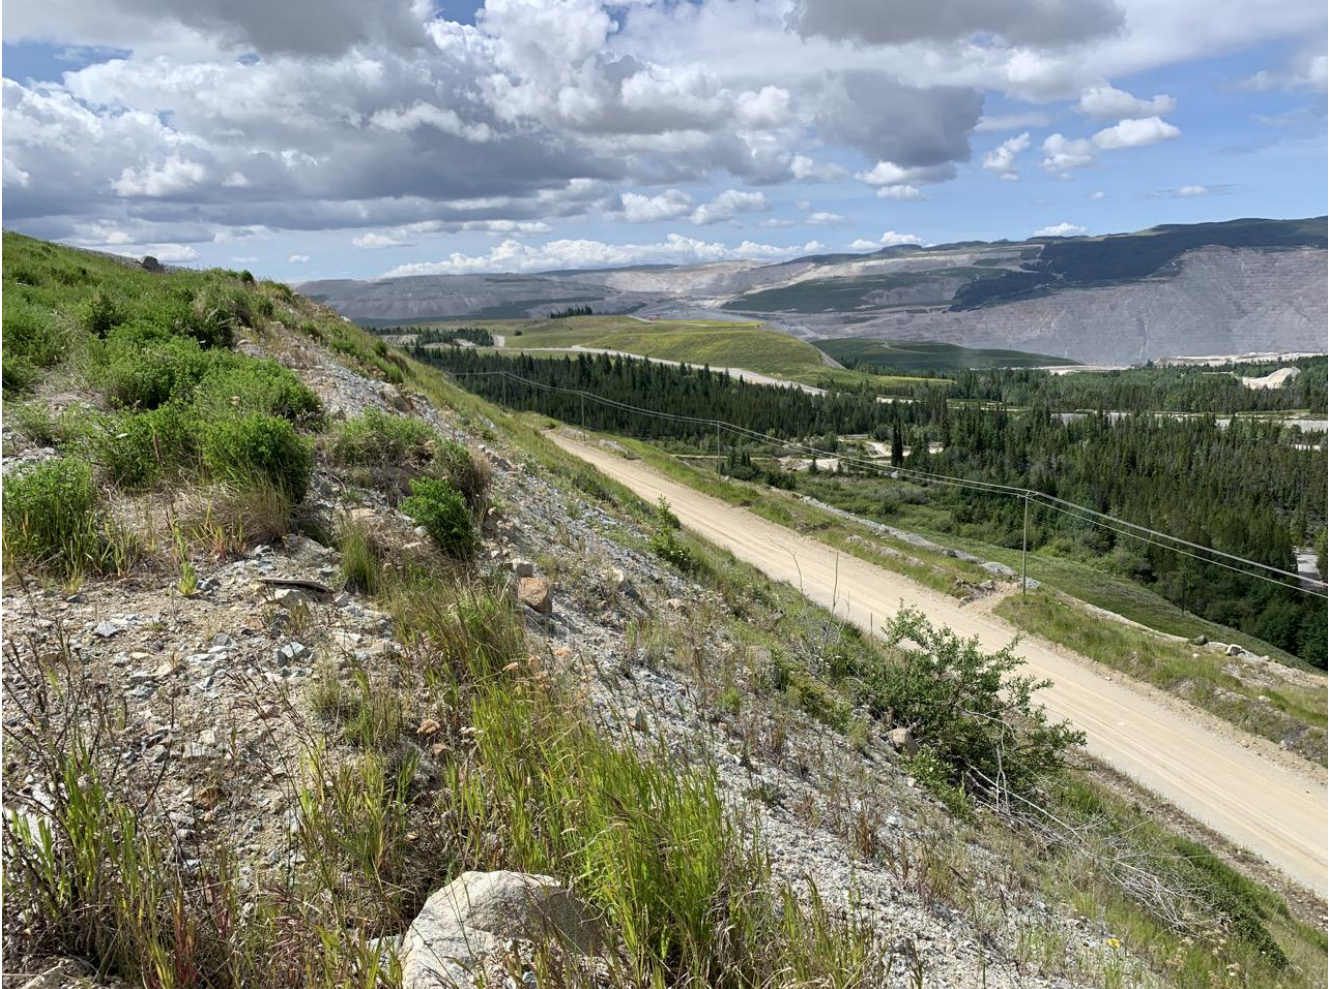
Photo I-A-5 Local cracking of rockfill pushed over downstream slope to fill erosion scour. Previously observed cracking has been filled, indicating area has been inactive (BTH-2020-05)

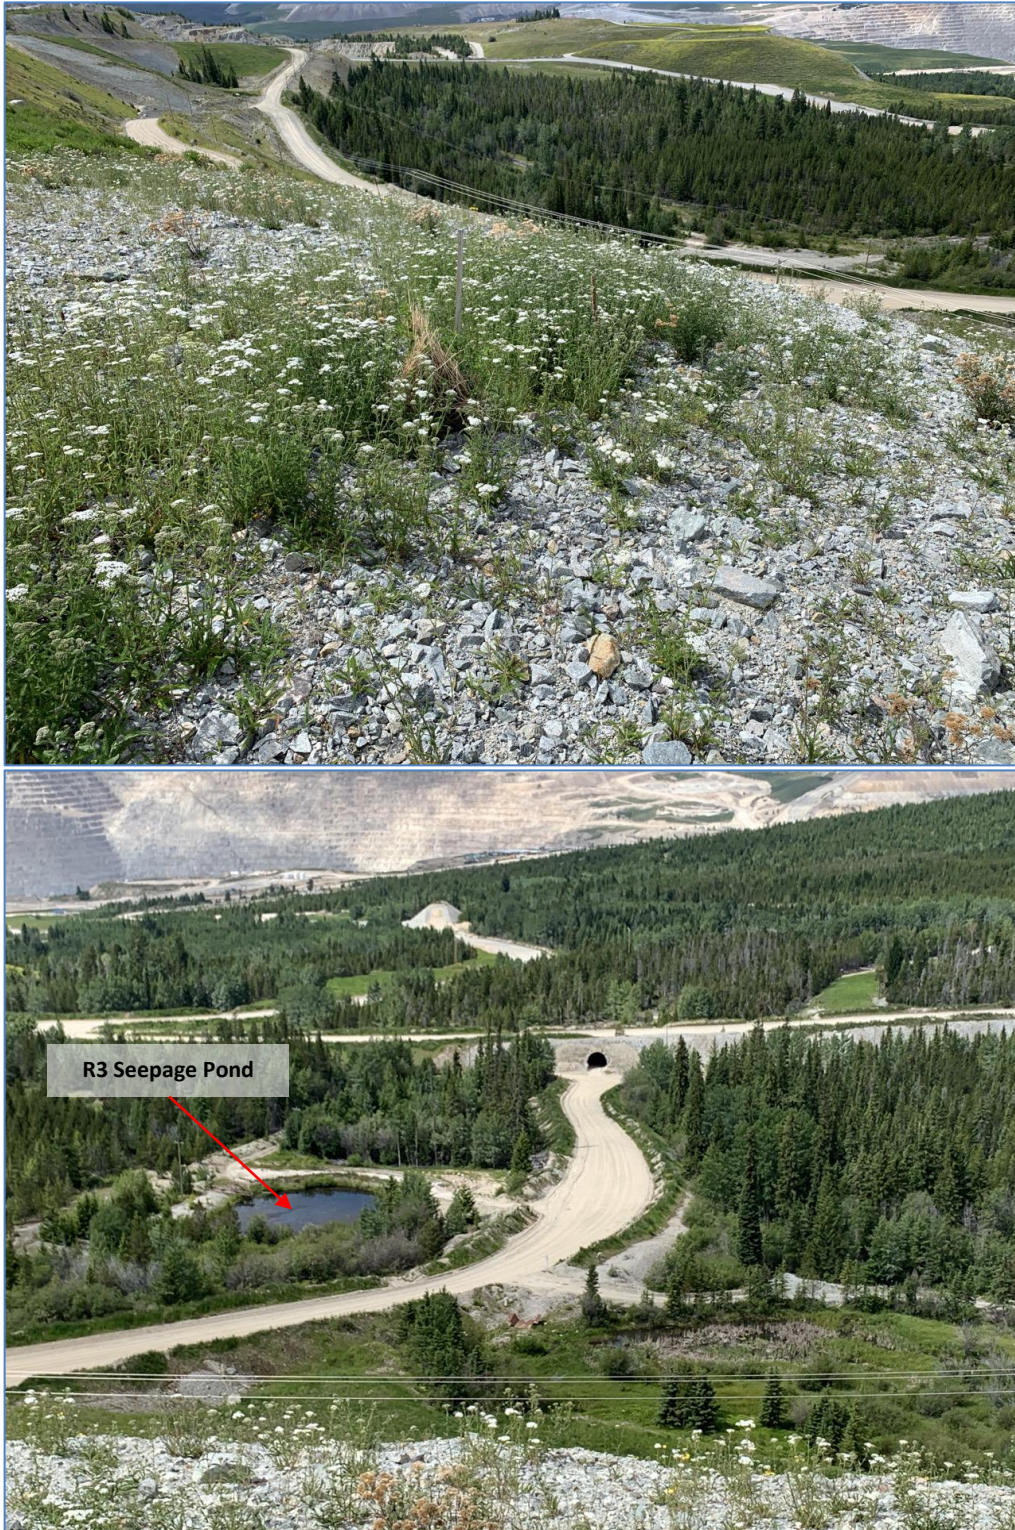
Photo I-A-7 Overview of downstream slope and toe from crest road, looking south. No major erosion areas were observed. (BTH-2020-01)

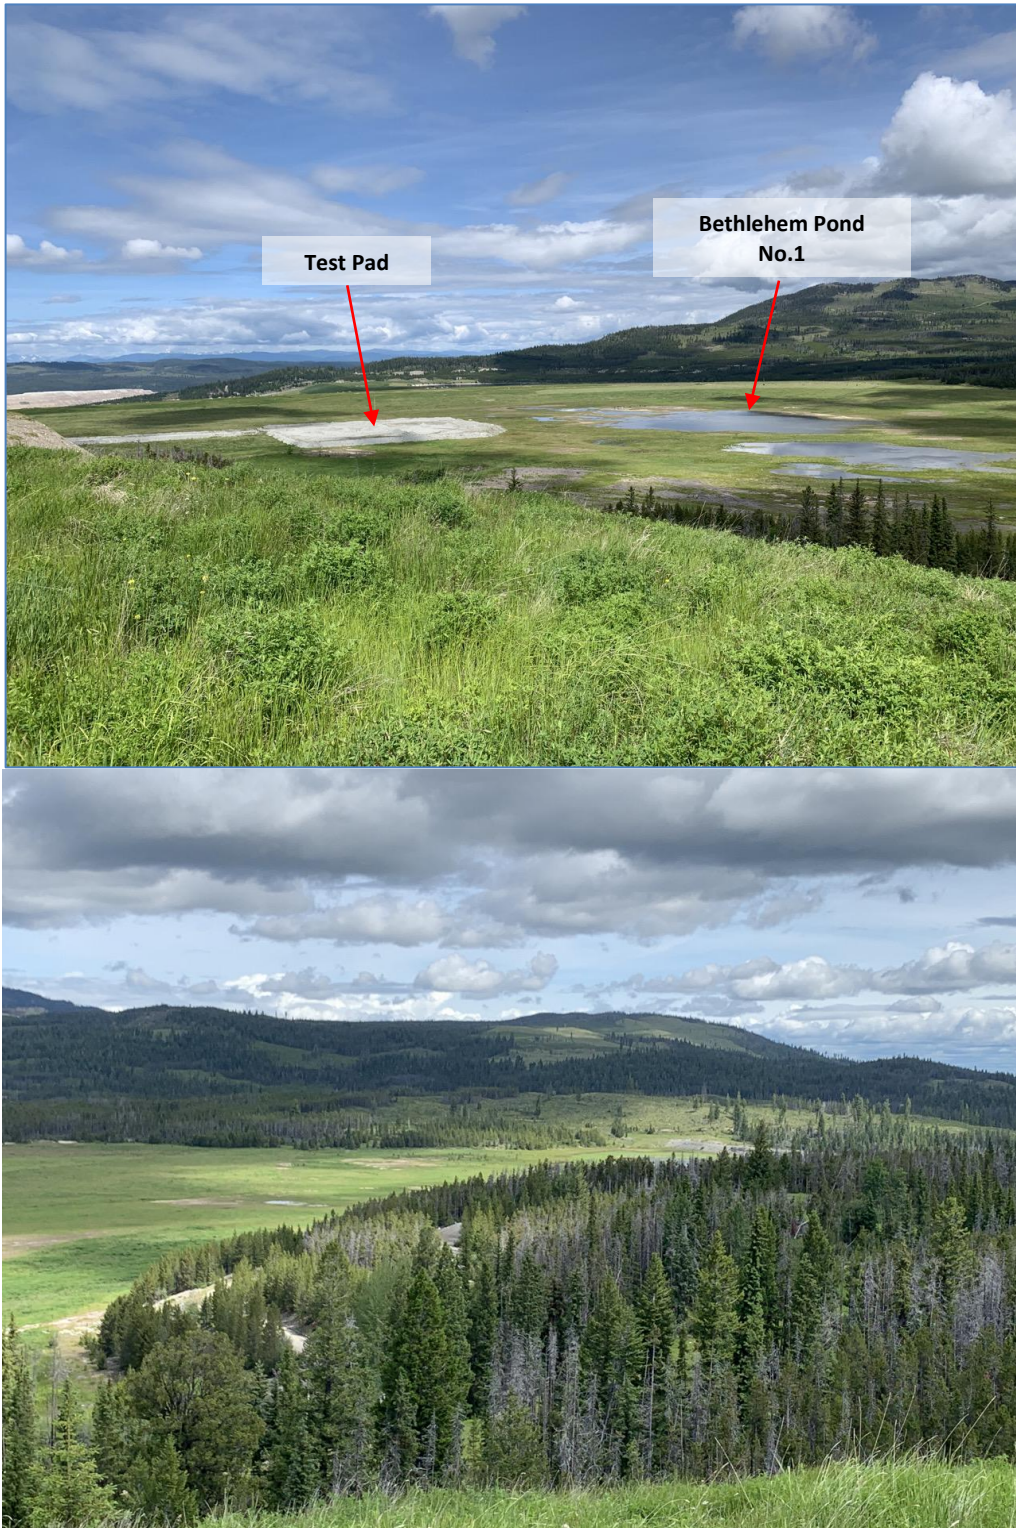
Photo I-A-10 Overview of Bethlehem Pond No.1 and the test pad (BTH-2020-02)

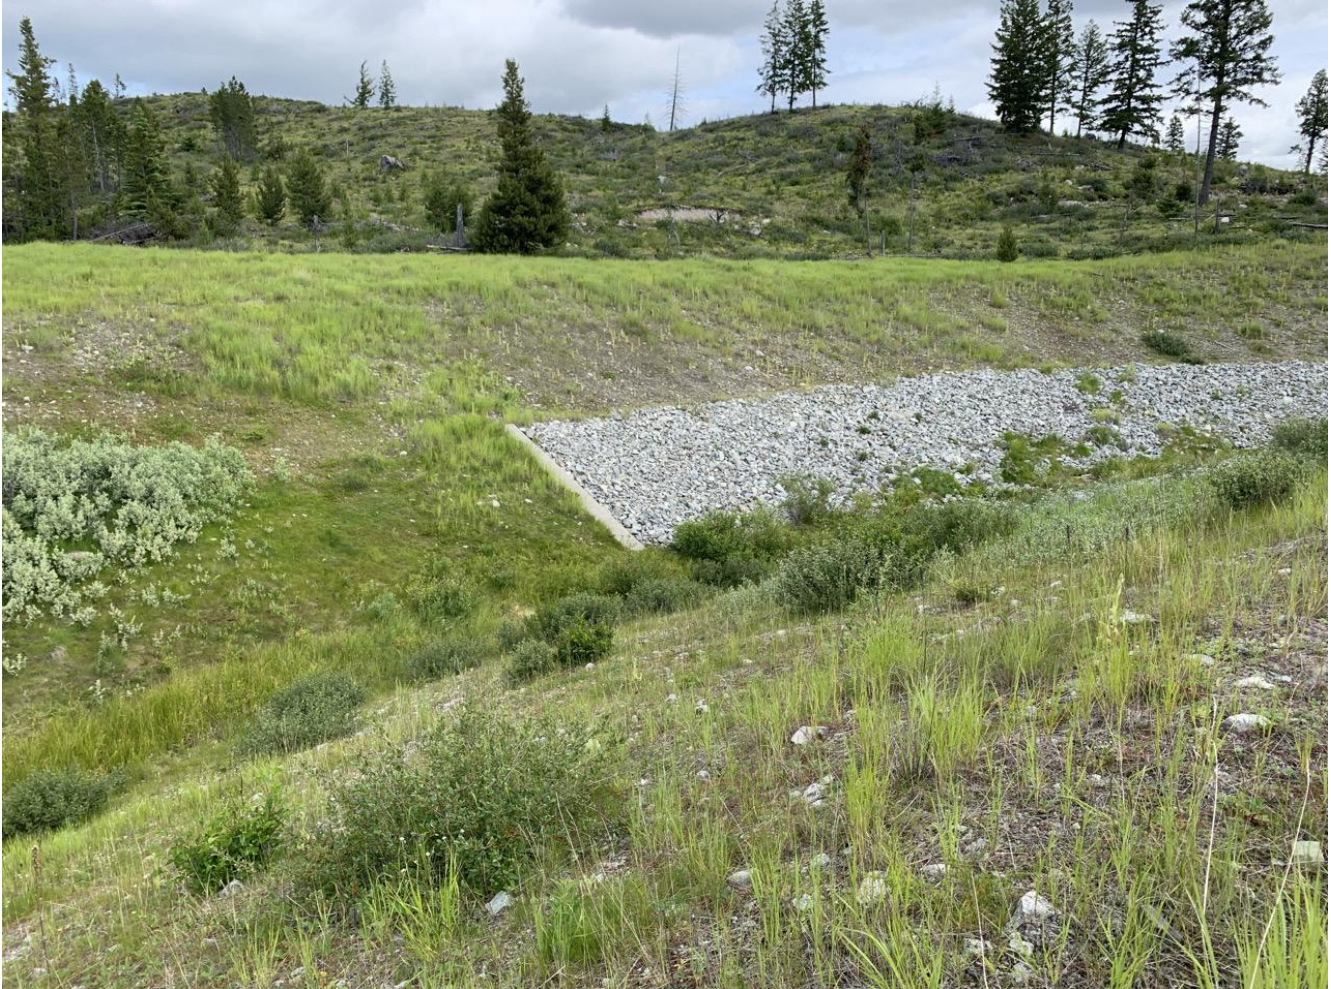
Photo I-B-18 Spillway channel at transition point between inlet and riprap-lined segment, looking towards north (BTH-2020-25)

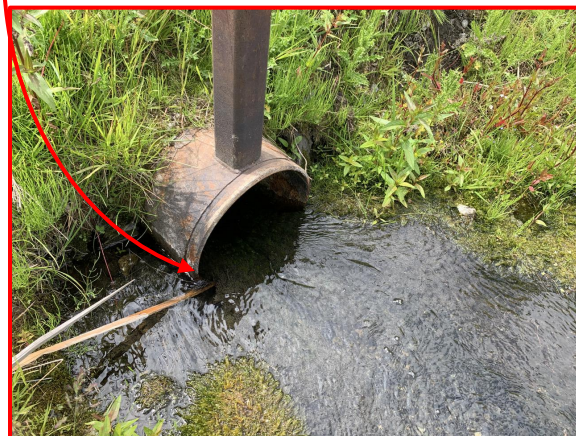
Photo I-C-4 View of R3 Seepage Pond and debris mesh for Low-Level Outlet (LLO). Clear water was flowing at the time of inspection. The debris mesh is clogged below and above water. This does not impact flood routing but could be part of routine maintenance. (BTH-2020-30)

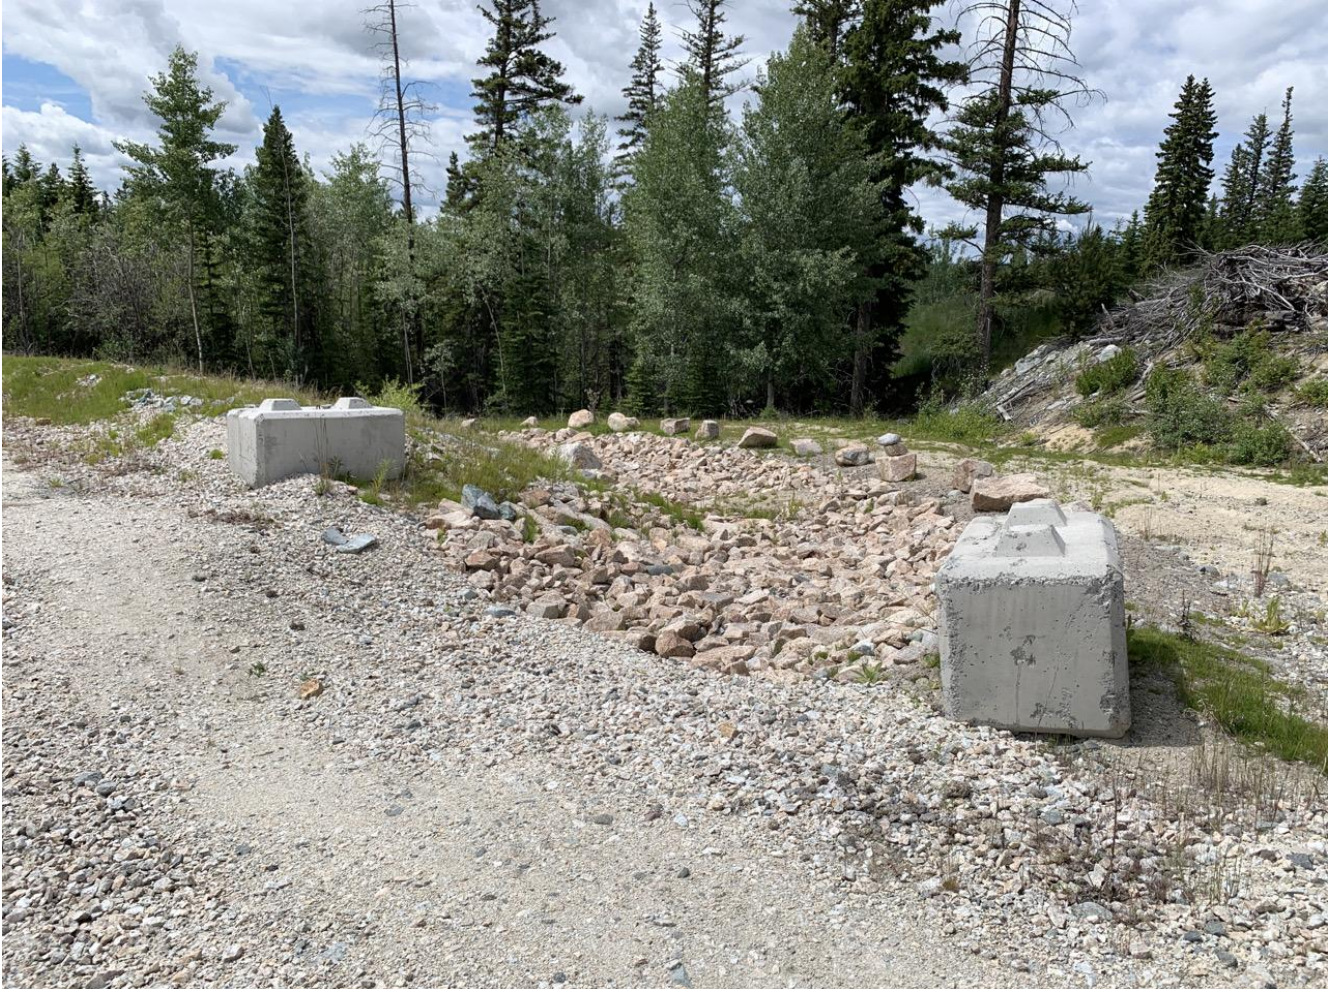
**Photo I-C-6 Spillway channel and road crossing at right abutment, looking downstream
(BTH-2020-31)**

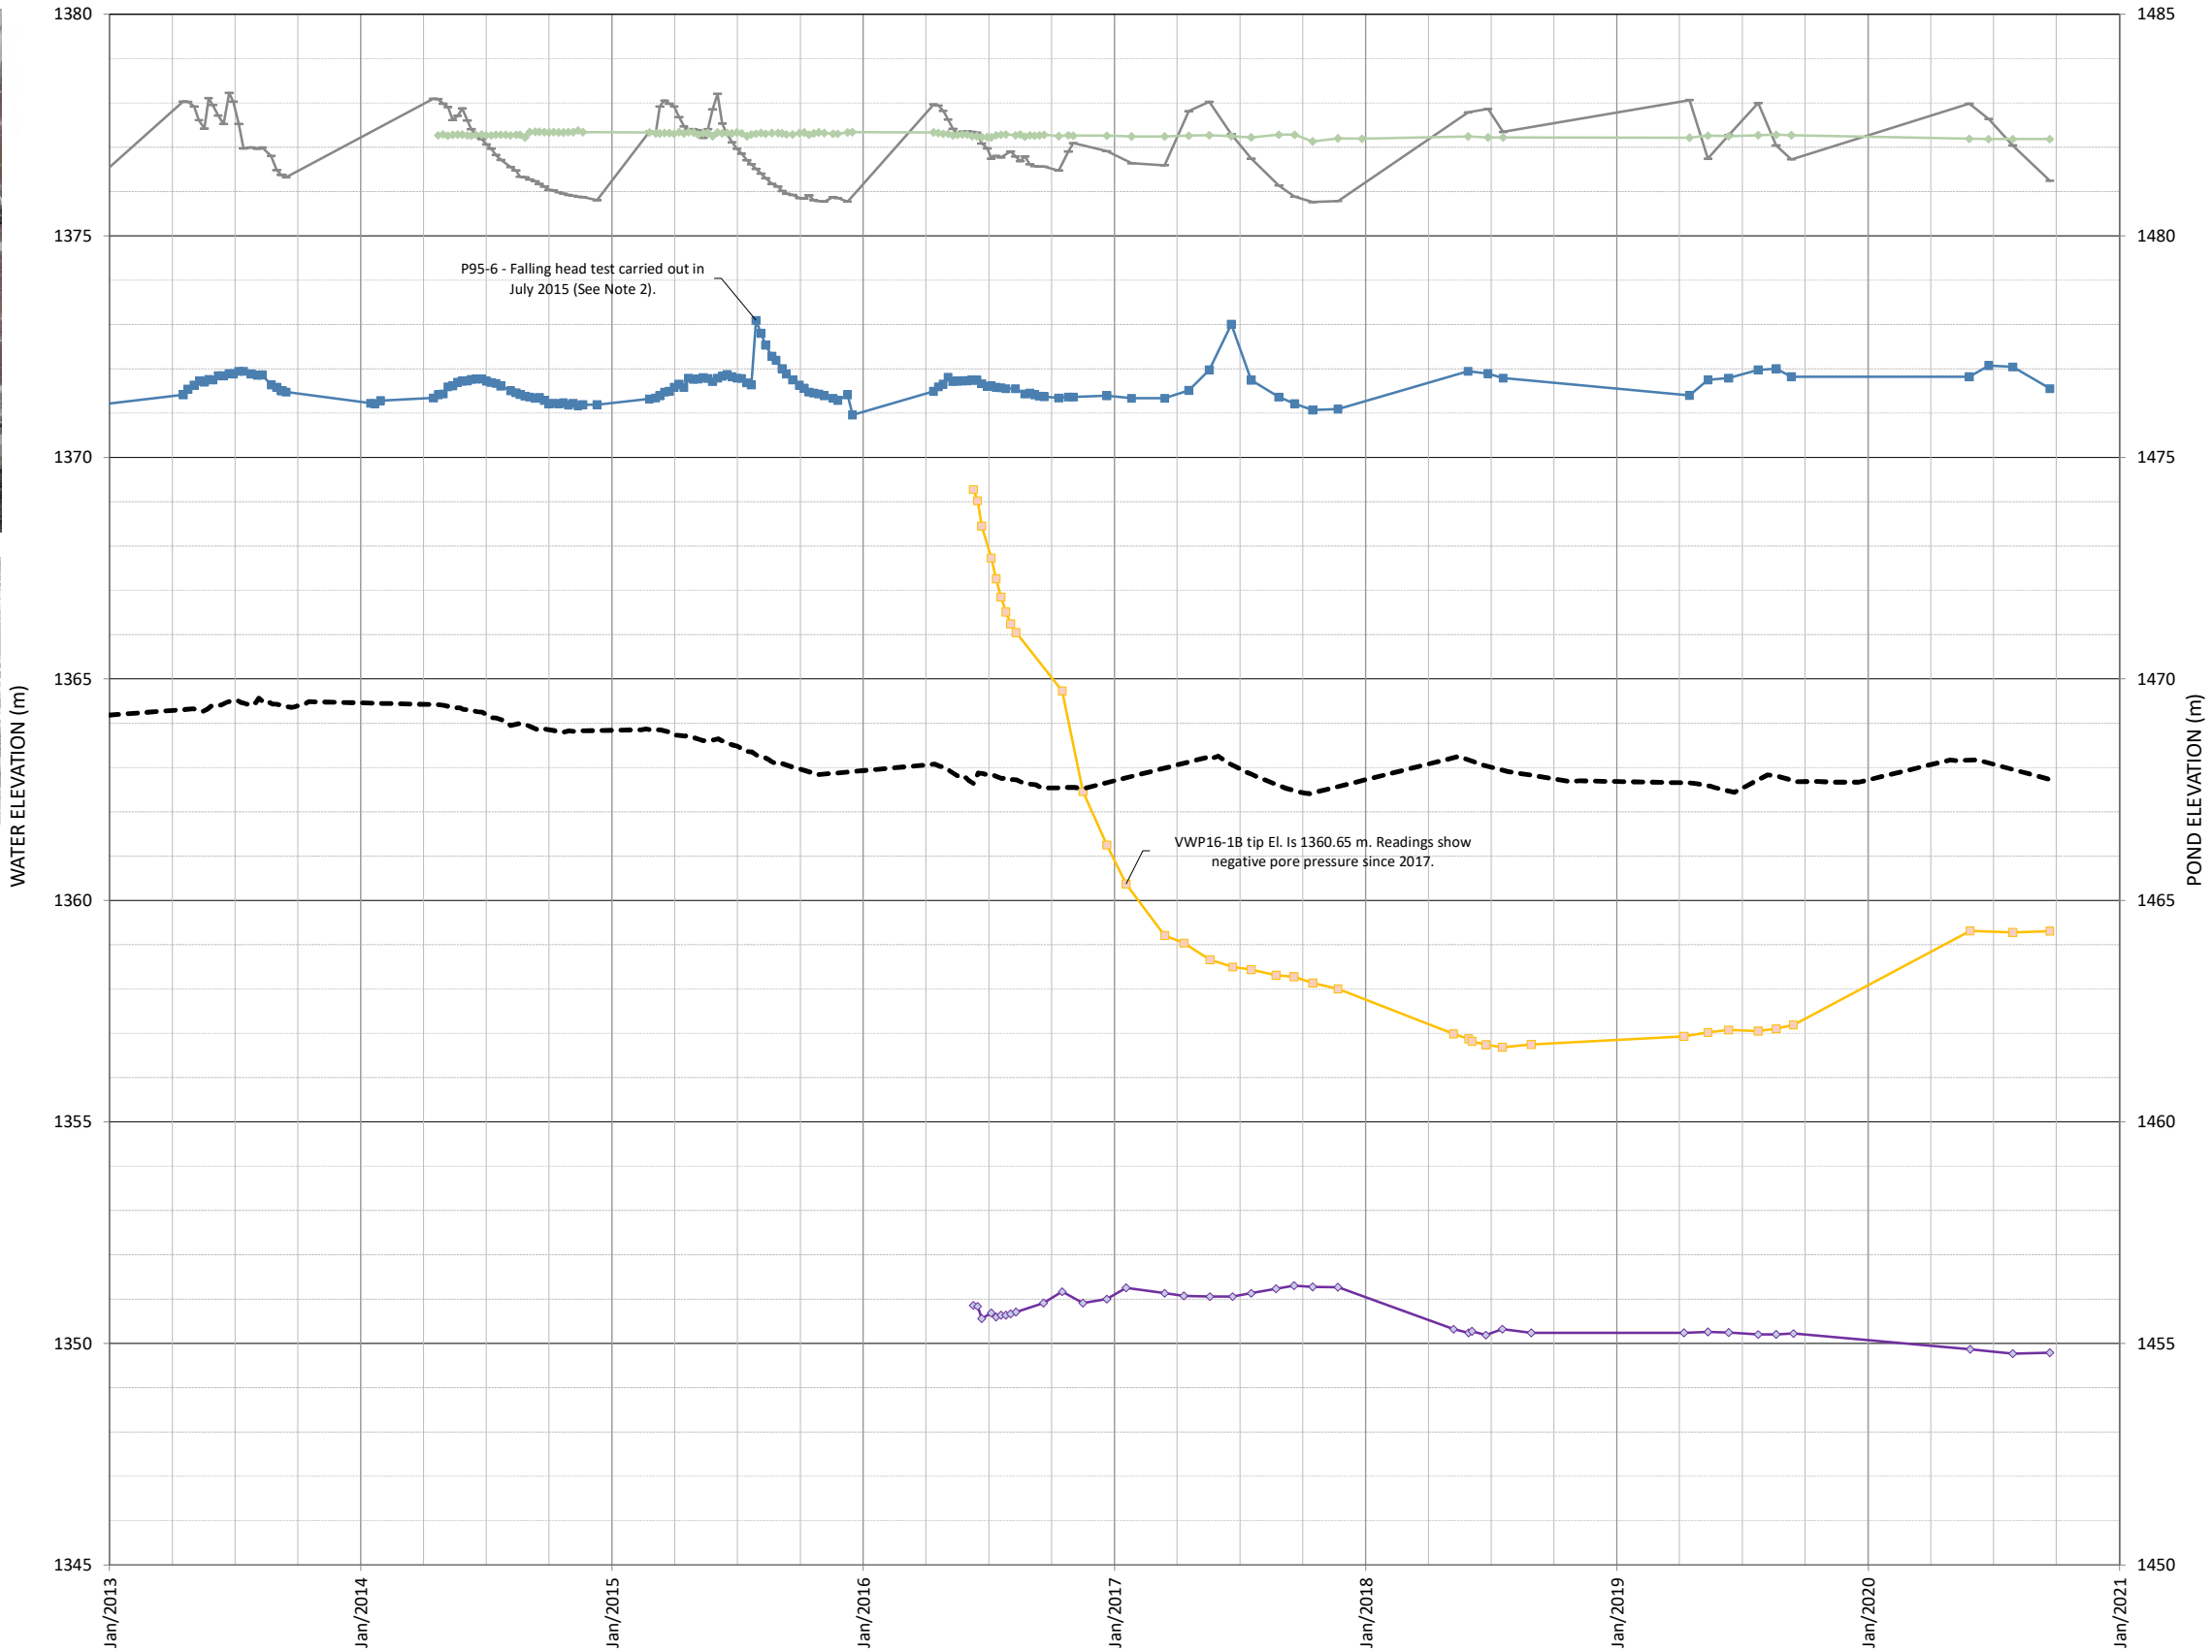
- STANDPIPE NO. 3 HAS BEEN NOTED AS DRY/PLUGGED IN THE RECORDS AND LIKELY EXPLAINS THE ERRATIC JUMPS IN MEASUREMENTS. HOWEVER A FALLING HEAD TEST CONDUCTED IN 2015 INDICATED THE PIEZOMETER WAS STILL RESPONDING.
- STANDPIPE NO. 6 WAS TESTED IN 2015 AND FOUND TO BE DEFUNCT.

- NOTES:**
- PIEZOMETER WATER ELEVATIONS PLOTTED ON PRIMARY (LEFT) AXIS, POND ELEVATION PLOTTED ON SECONDARY (RIGHT) AXIS.
 - FALLING HEAD TEST CARRIED OUT ON P95-6 DURING JULY 2015 - CAUSE OF SPIKE IN PIEZOMETRIC LEVELS.
 - JUNE 25, 2020 WATER LEVELS AT VWP16-1A AND VWP16-1B ARE NOT MEASURED AND PLOTTED BECAUSE THE BAROMETRIC PRESSUER READINGS WERE NOT TAKEN.

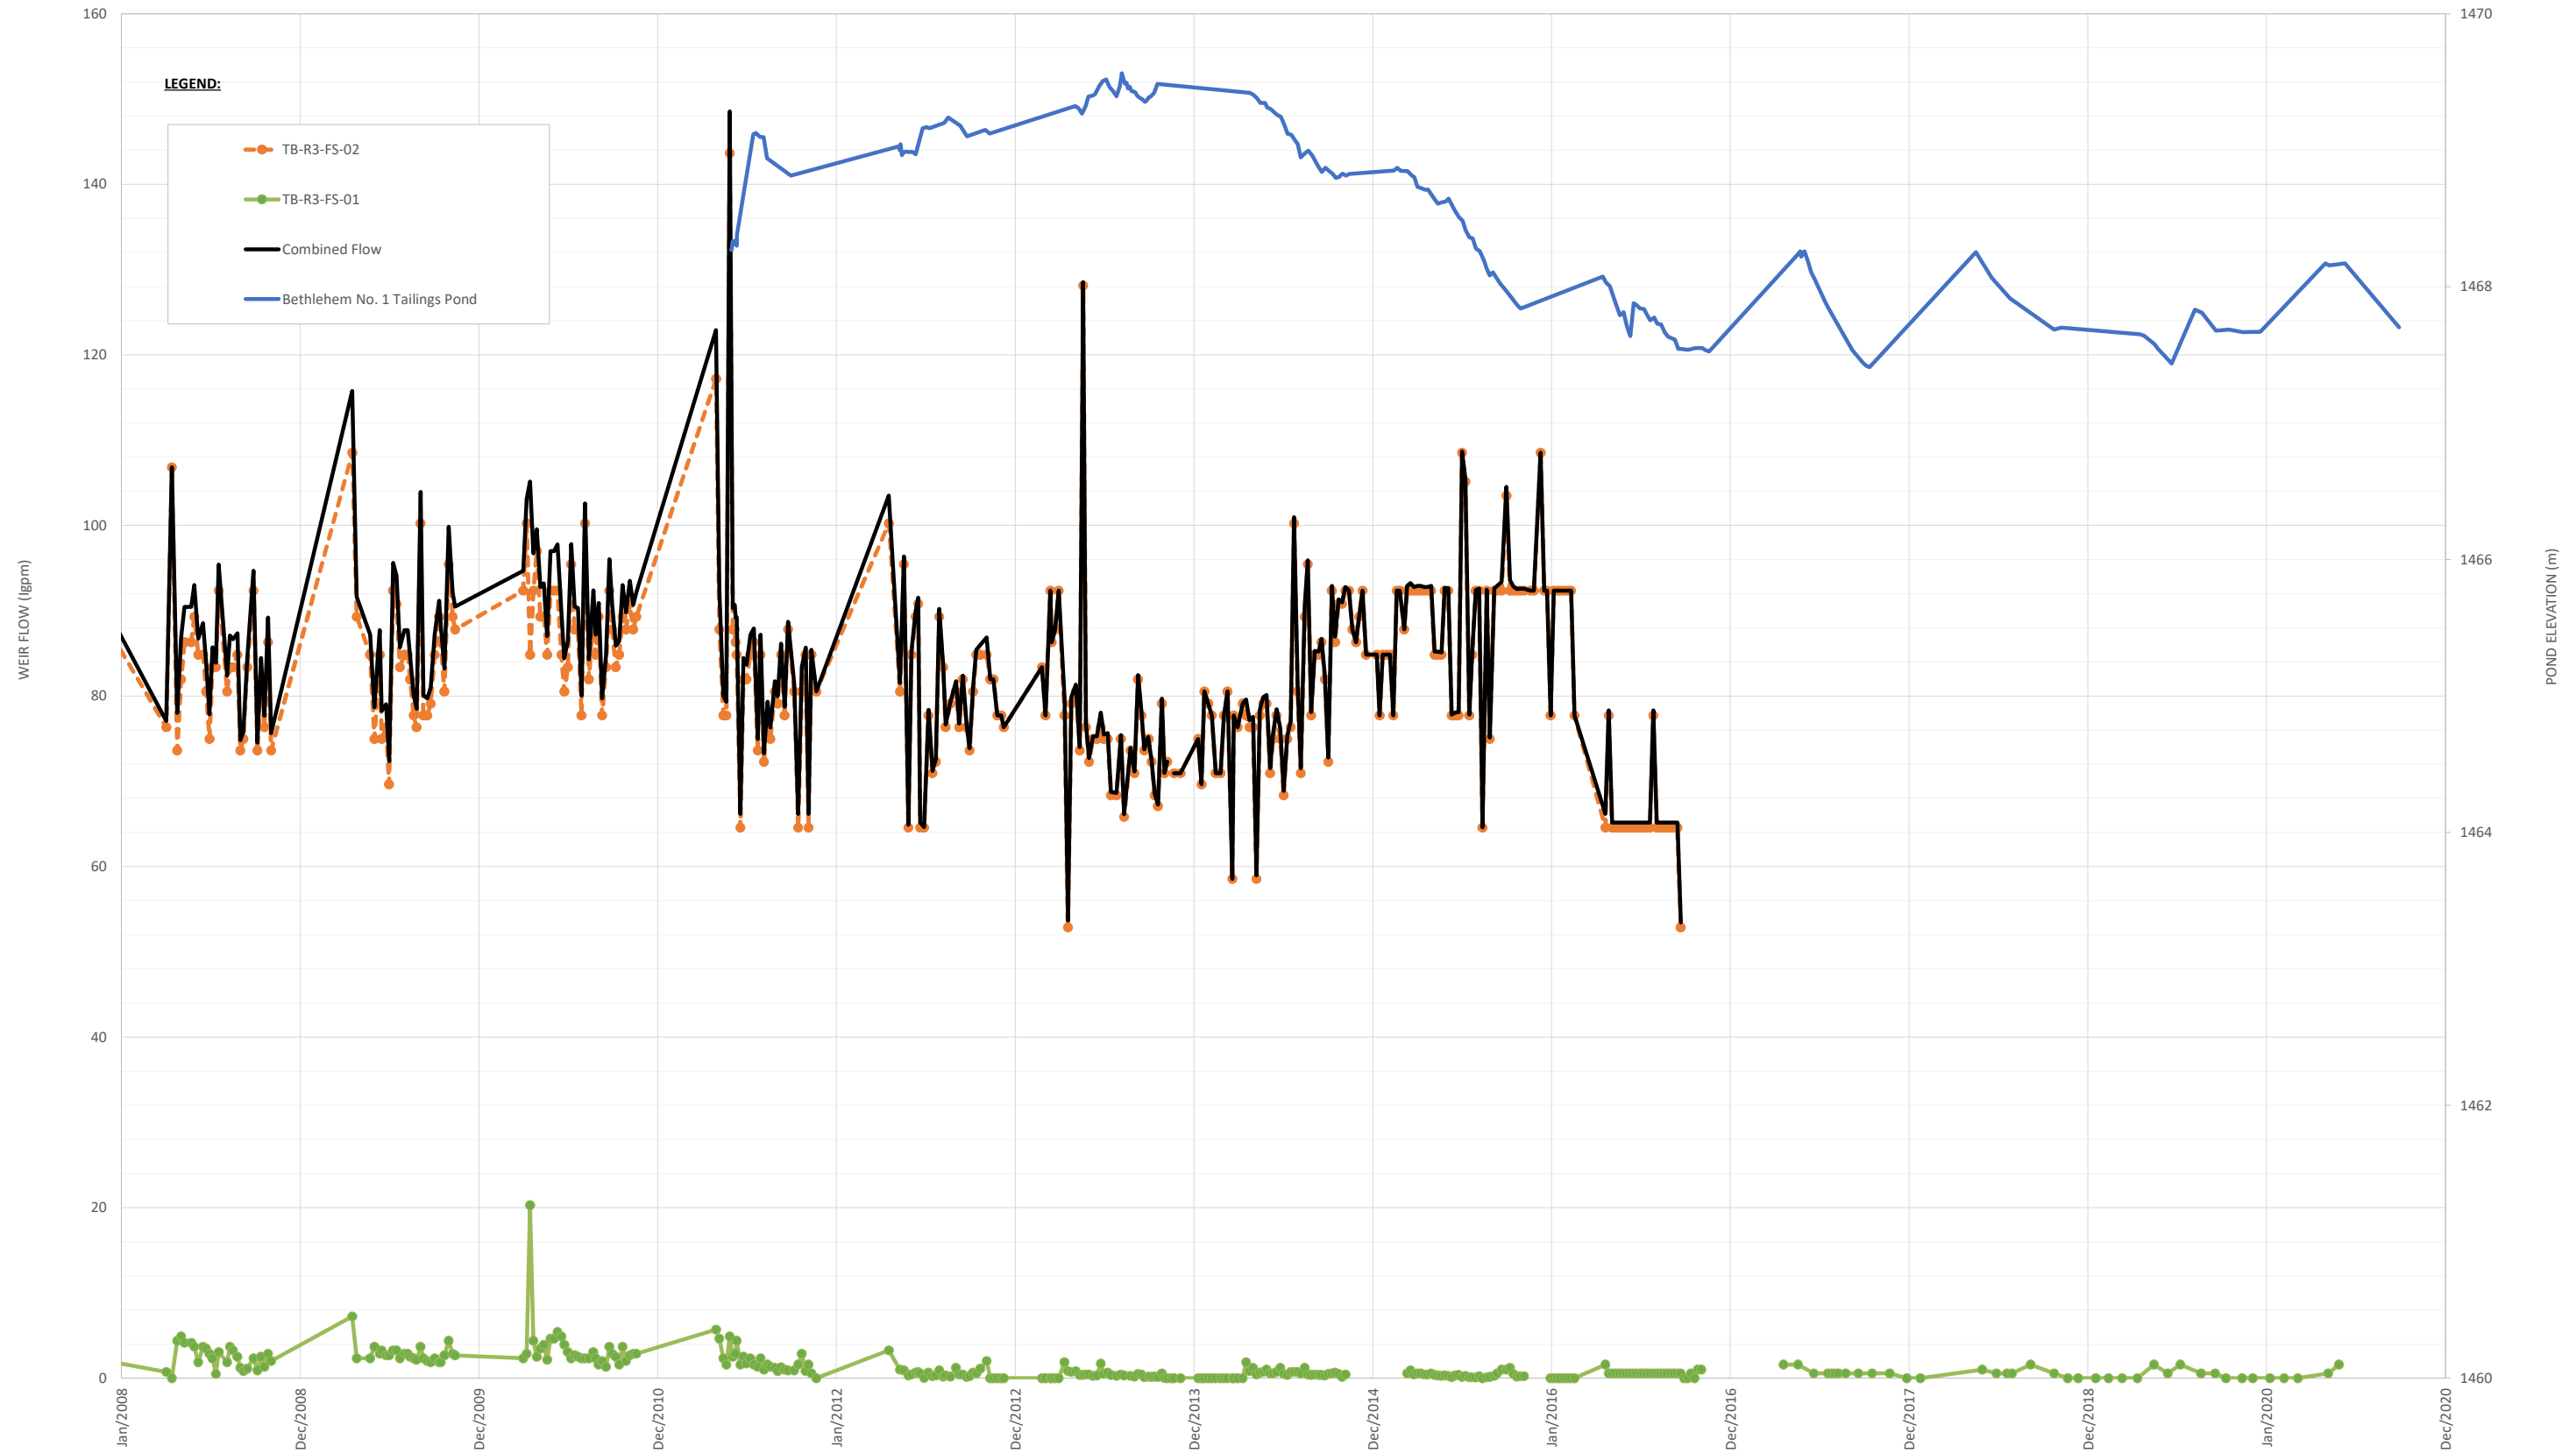
1. WEIR FLOW PLOTTED ON PRIMARY (LEFT) AXIS, BETHLEHEM NO. 1 TAILINGS POND ELEVATION PLOTTED ON SECONDARY (RIGHT) AXIS.
2. TB-R3-FS-02 (WEIR 1) REMOVED OCTOBER 2016, COMBINED FLOW ONLY PLOTTED UNTIL THAT DATE.

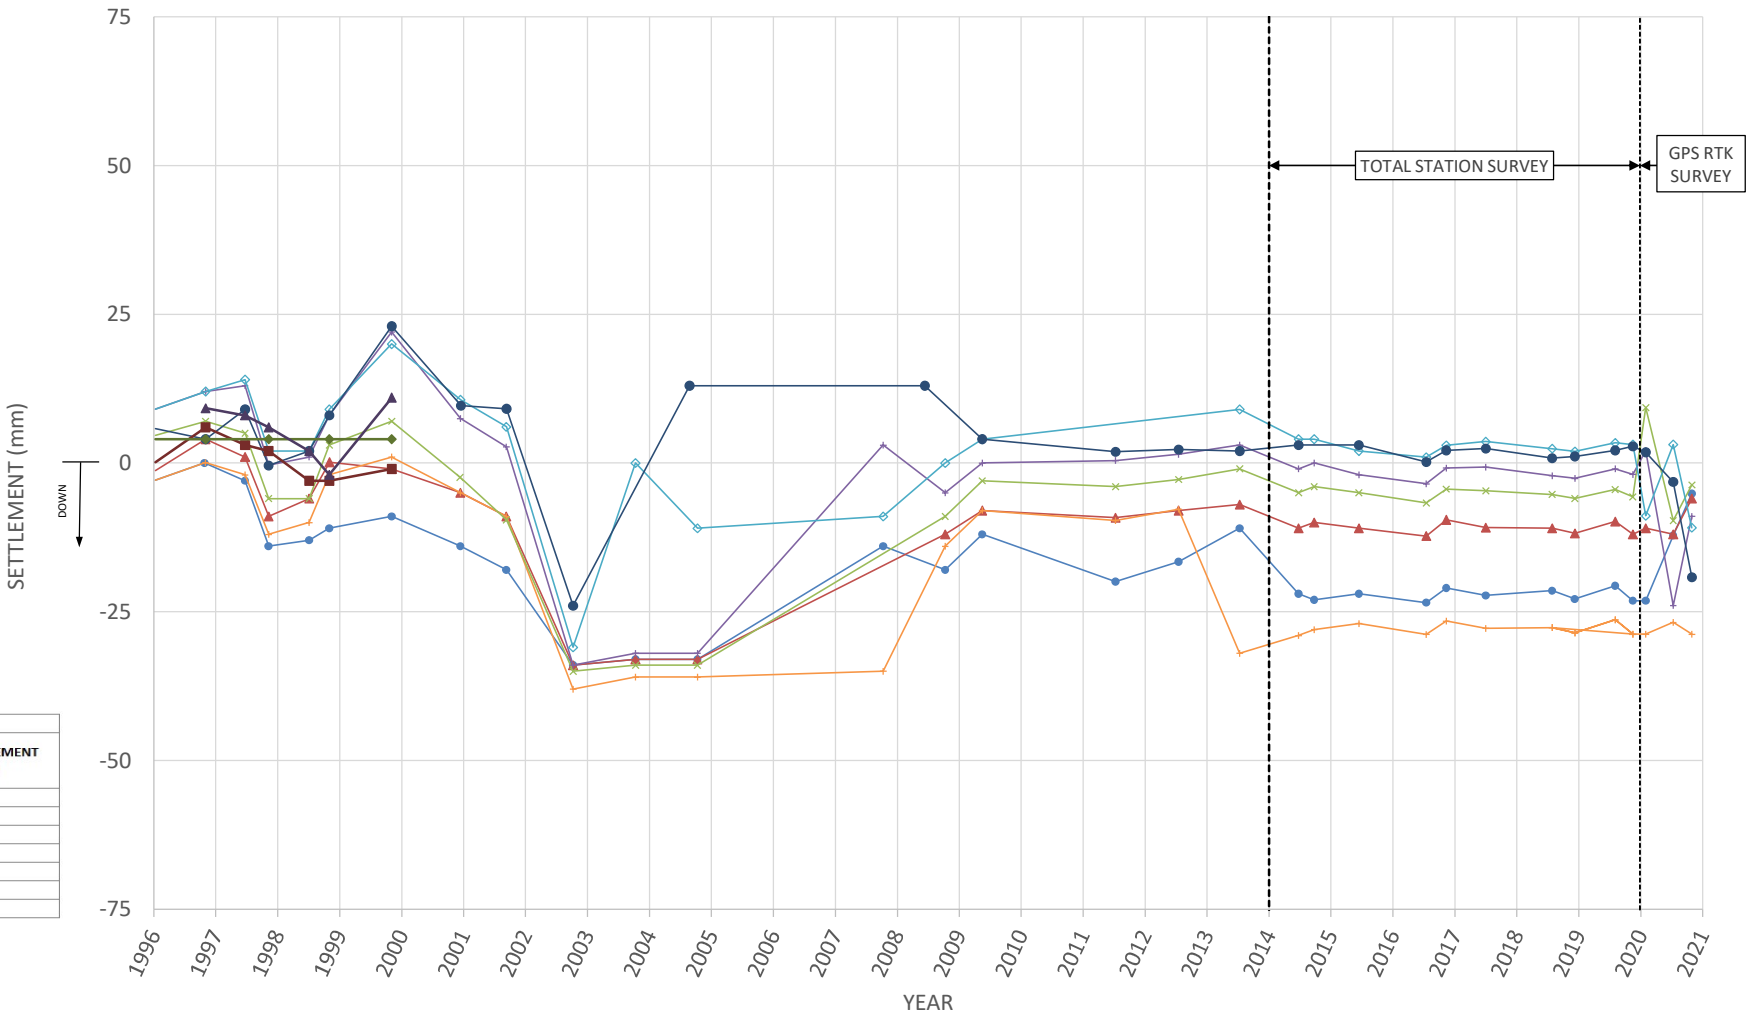
FIG No. II-B-9

6. BD-1 2010 READING (NOT SHOWN IN PLAN PLOT) LOCATED 1505 mm FROM INITIAL 1993 READING. READING WAS REVIEWED AND FOUND MORE LIKELY RELATED TO SURVEY ERROR THAN DISPLACEMENT.

7. BD-5 2010 READING (NOT SHOWN IN PLAN PLOT) LOCATED 294 mm FROM INITIAL 1993 READING. READING WAS REVIEWED AND FOUND MORE LIKELY RELATED TO SURVEY ERROR THAN DISPLACEMENT.

8. BD-3 SHIFT BETWEEN PRE AND POST 2013 SURVEYS WHICH COULD BE THE RESULT OF DAMAGE OR SURVEY DATUM. NOT AN INDICATOR OF DAM SAFETY ISSUE.
9. BD-7 2003 SETTLEMENT DATA WAS OUTLIER AND NOT PLOTTED.
