2020 Dam Safety Inspection for South Tailings Pond and North Tailings Pond

Teck Coal Limited, Fording River Operations

Reference No. 20136981-2020-219-R-Rev0-2000

18 March 2021

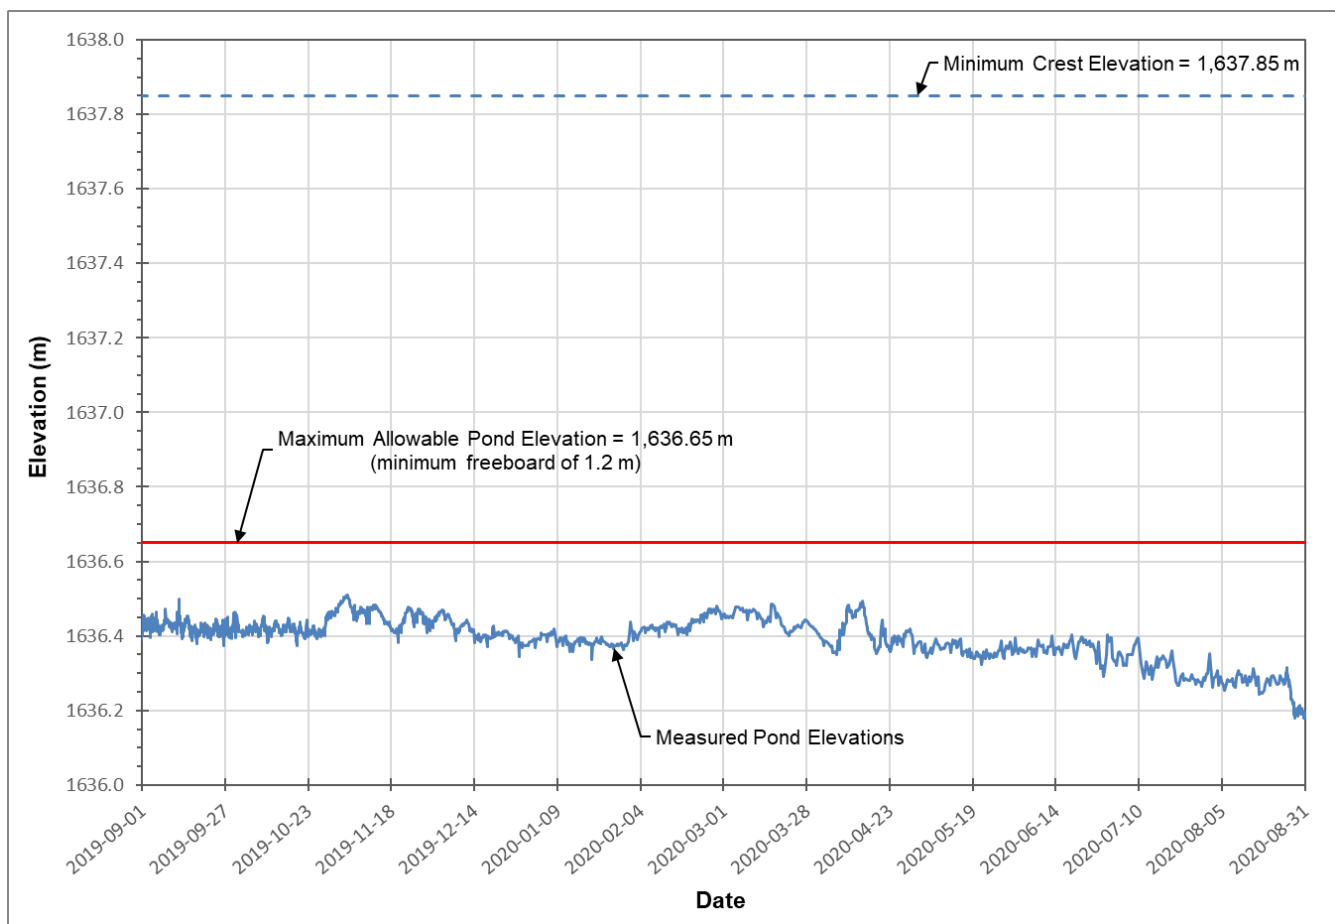
Chart 2: South Tailings Pond Water Elevation from 1 September 2019 to 31 August 2020

Chart 2 presents the pond elevation data for 1 September 2019 to 31 August 2020 at the STP based on data received from FRO. Pond water levels in the STP are monitored in real time with a water level sensor located on the water reclaim barge, and levels are actively managed by FRO processing plant personnel. The pond elevation data were provided in Mine Grid then converted to Elk Valley Elevation Datum by Golder.

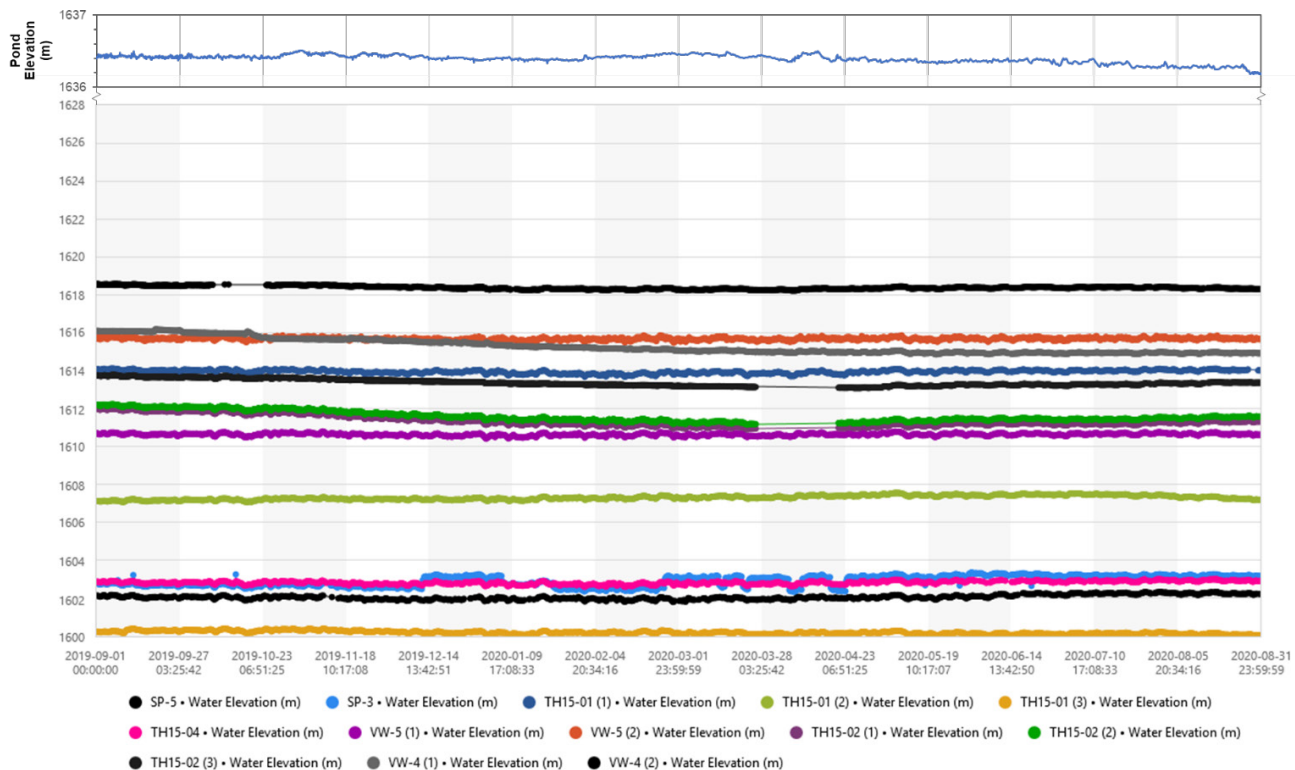
Chart 3: Main Dam Vibrating Wire Piezometer and Standpipe Water Elevations and South Tailings Pond Elevation from 1 September 2019 to 31 August 2020

Chart 3 presents the piezometer readings for 1 September 2019 to 31 August 2020, as well as the pond elevation over the same time period. The piezometer plots were taken from GeoExplorer. The number in parentheses next to the piezometer ID indicates the sensor number in GeoExplorer (for boreholes with more than one piezometer). The sensor number can be found in Table 18.

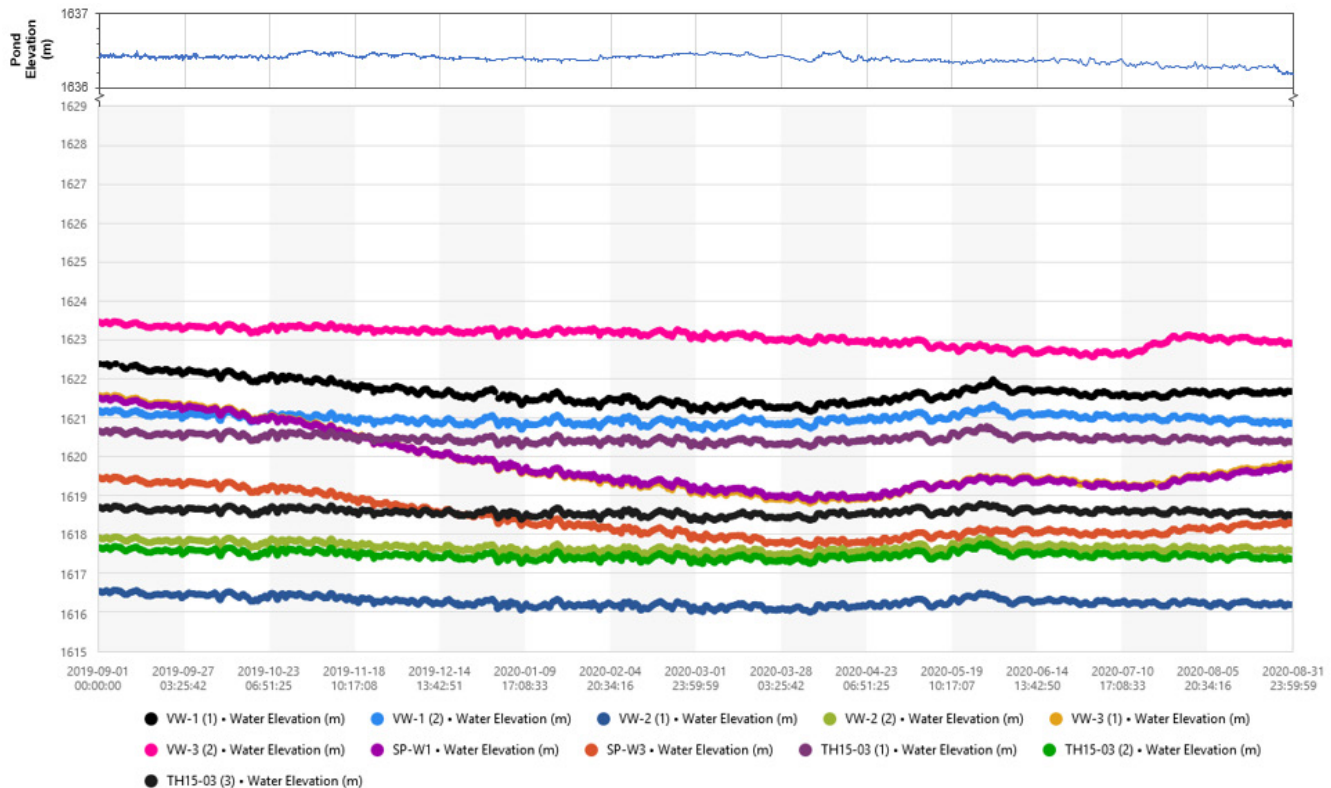
Chart 4: West Dam Vibrating Wire Piezometer and Standpipe Water Elevations and South Tailings Pond Elevation from 1 January 2019 to 31 August 2020

The location of VW piezometers and standpipes are presented in plan in Figure 3. Chart 4 presents the piezometer readings from 1 January 2019 to 31 August 2020, as well as the pond elevation over the same time period. The piezometer data were taken from GeoExplorer and the pond elevation was provided by FRO.

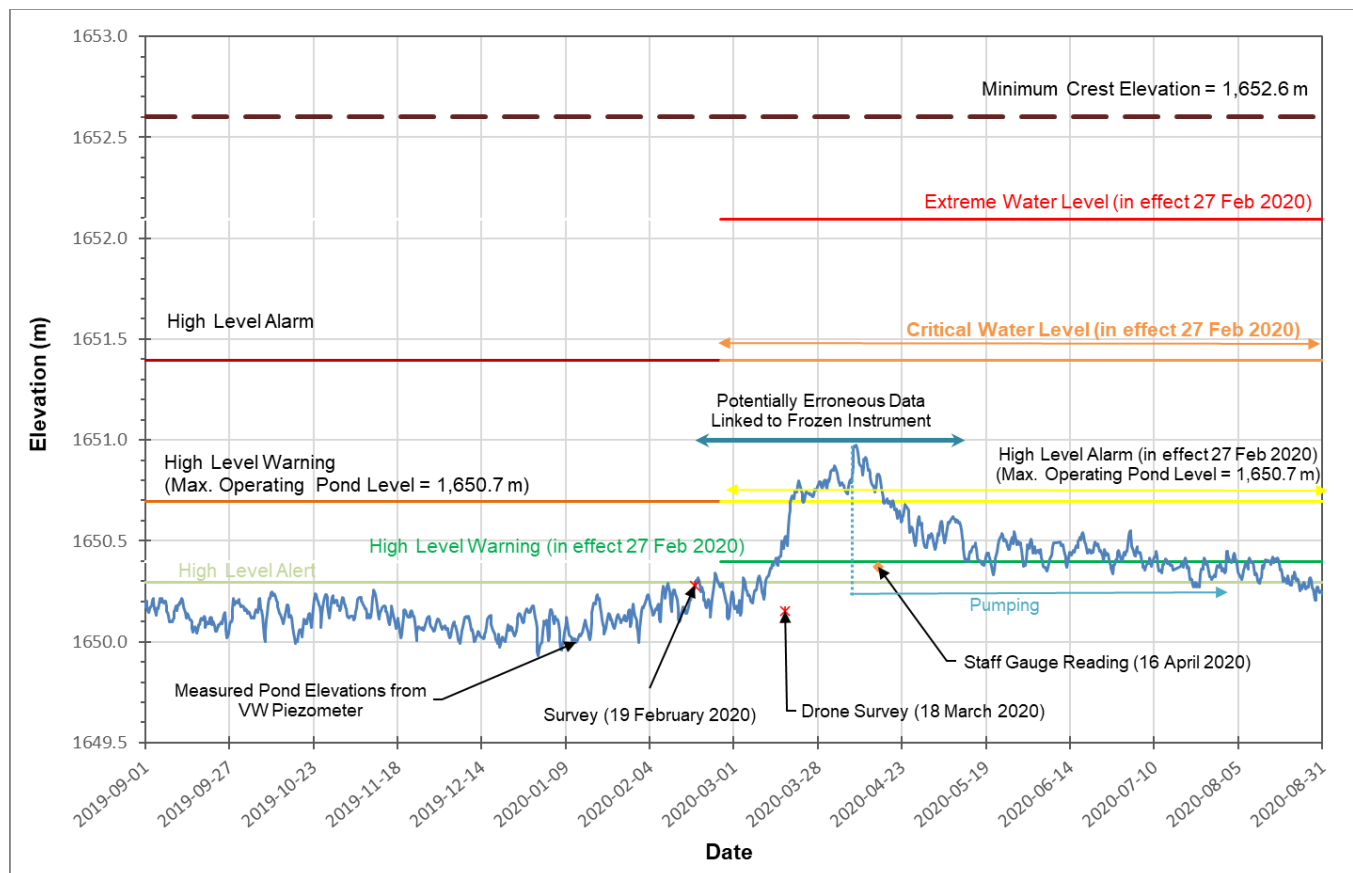
Pond elevation data were recorded by a VW piezometer and the data were downloaded by Golder from GeoExplorer. The VW piezometer was set up to collect readings every six hours. Chart 5 presents the pond elevation during the reporting period. During the reporting period, the pond level was also read by on-site surveyors, a drone survey, and manual readings from the staff gauge at specific dates shown in Chart 4.

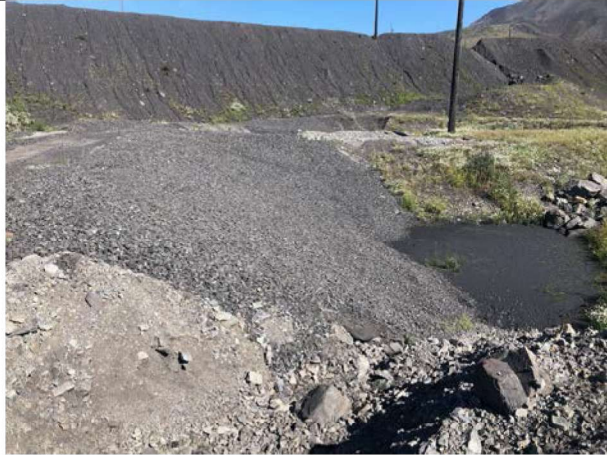
Photo 1: Looking upstream along alignment of NTP riprap that is buried (approx. Sta. 0+125). Work was completed at the NTP Sumps in Spring 2020.

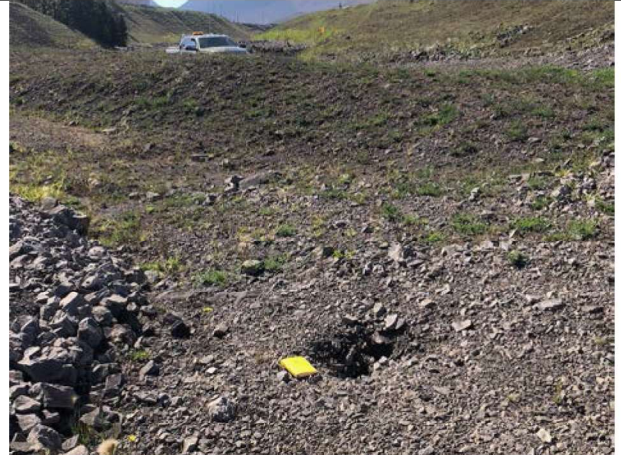
Photo 2: Small sinkhole about 0.5 by 0.5 m at approx. Sta. 0+140. This is along the alignment of the buried setback riprap.

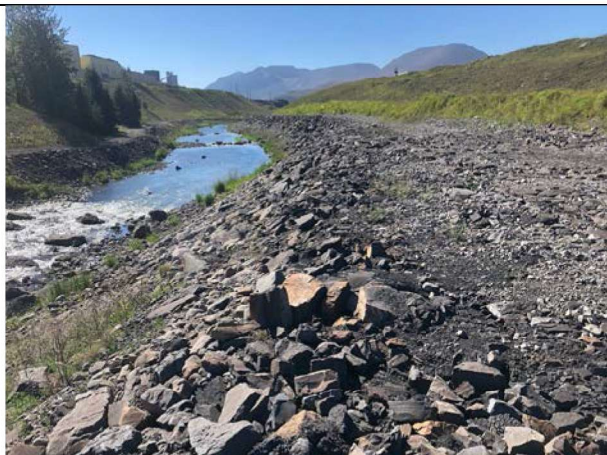
Photo 3: Looking downstream at NTP riprap (from approx. Sta. 0+225).

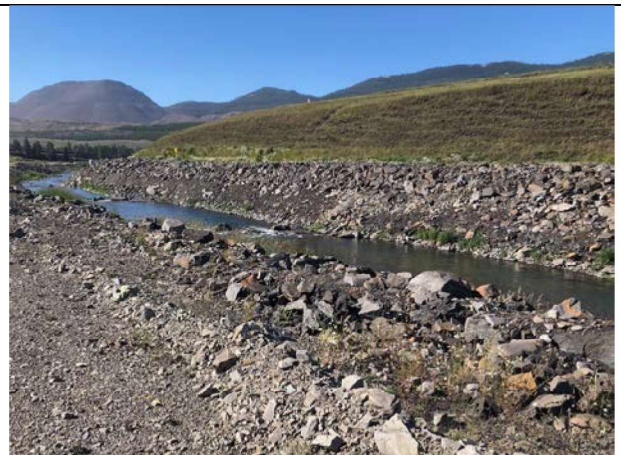
Photo 4: Looking downstream at NTP riprap (from approx. Sta. 0+475).

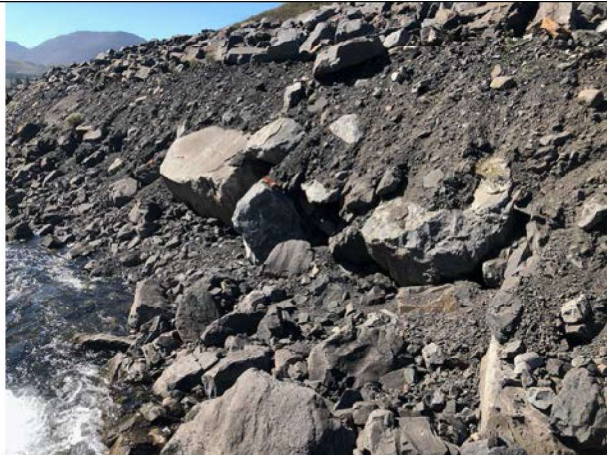
Photo 5: Looking at erosion of the gravel material placed on top of the riprap at one of the riffle crest bank tie-ins on the NTP (approx. Sta. 0+550).

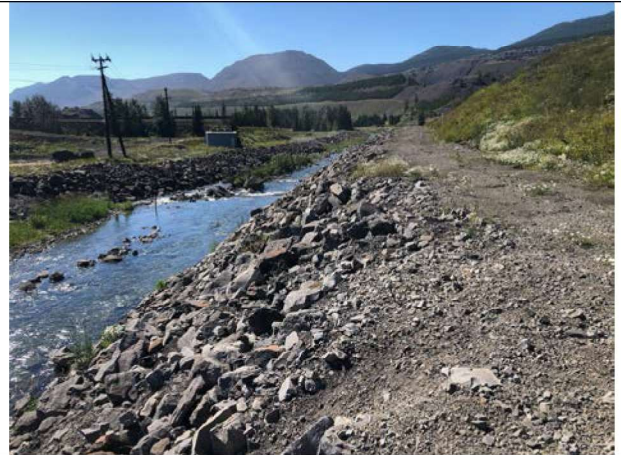
Photo 6: Looking downstream at NTP riprap (from approx. Sta. 0+725).

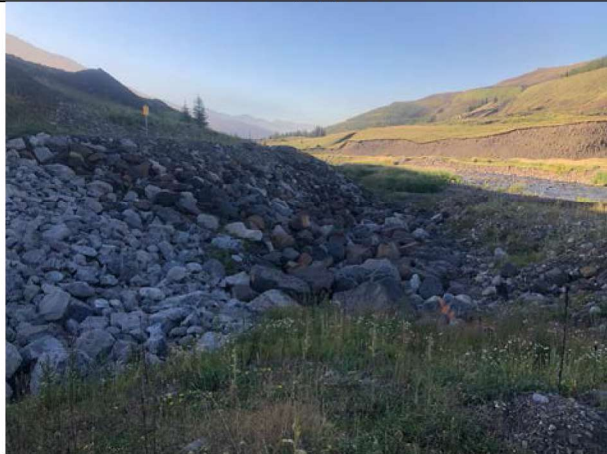
Photo 7: Looking downstream at STP riprap (from approx. Sta. 0+240).

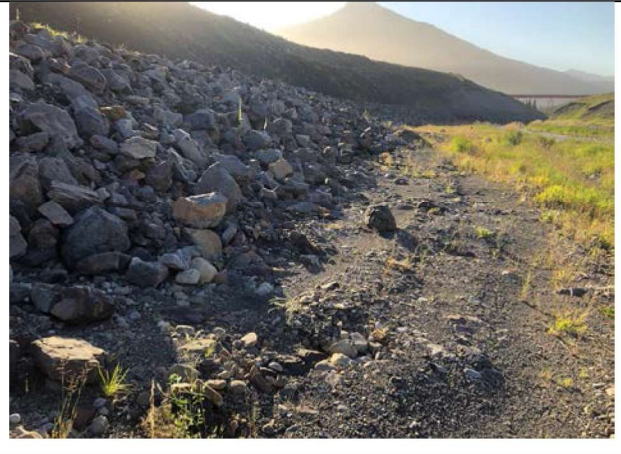
Photo 8: Looking downstream at STP riprap (approx. Sta. 0+380).

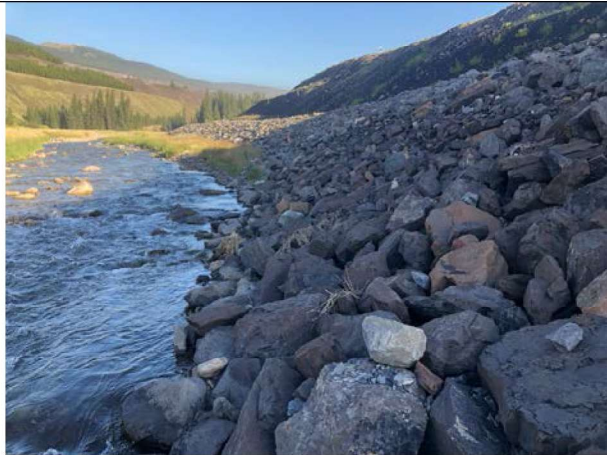
Photo 9: Looking upstream at STP riprap (from approx. Sta. 0+540).

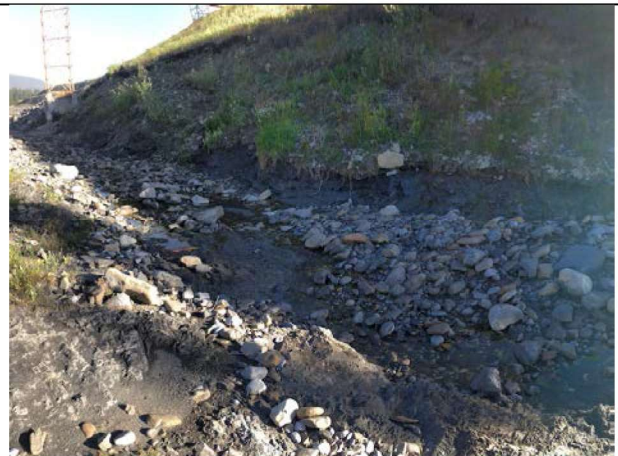
Photo 12: Erosion along the toe of the STP downstream of the pipe bridge. The erosion has exposed bedrock in some areas.

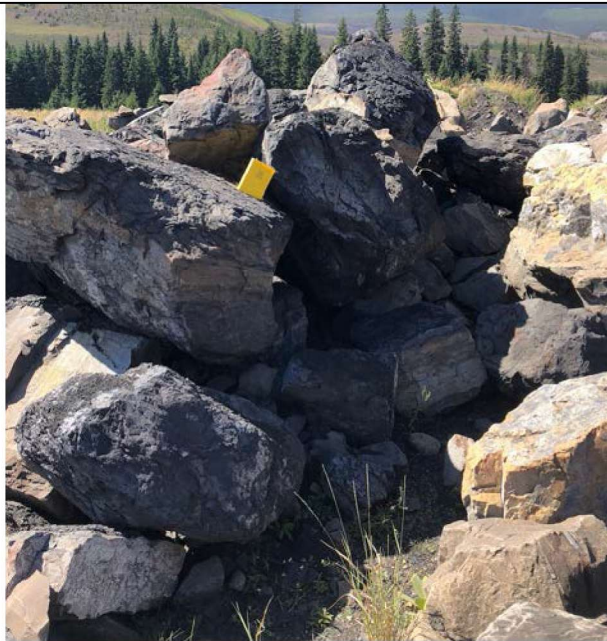
Photo 14: Weathering riprap at the emergency riprap stockpile.

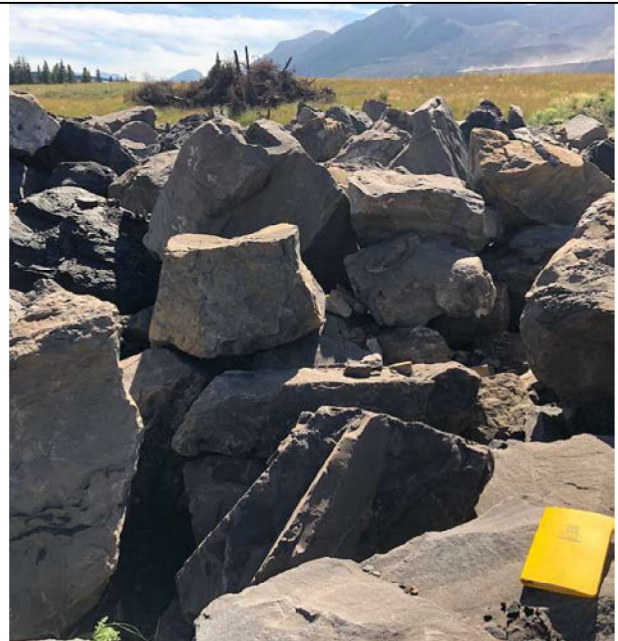
Photo 15: Riprap at emergency riprap stockpile.

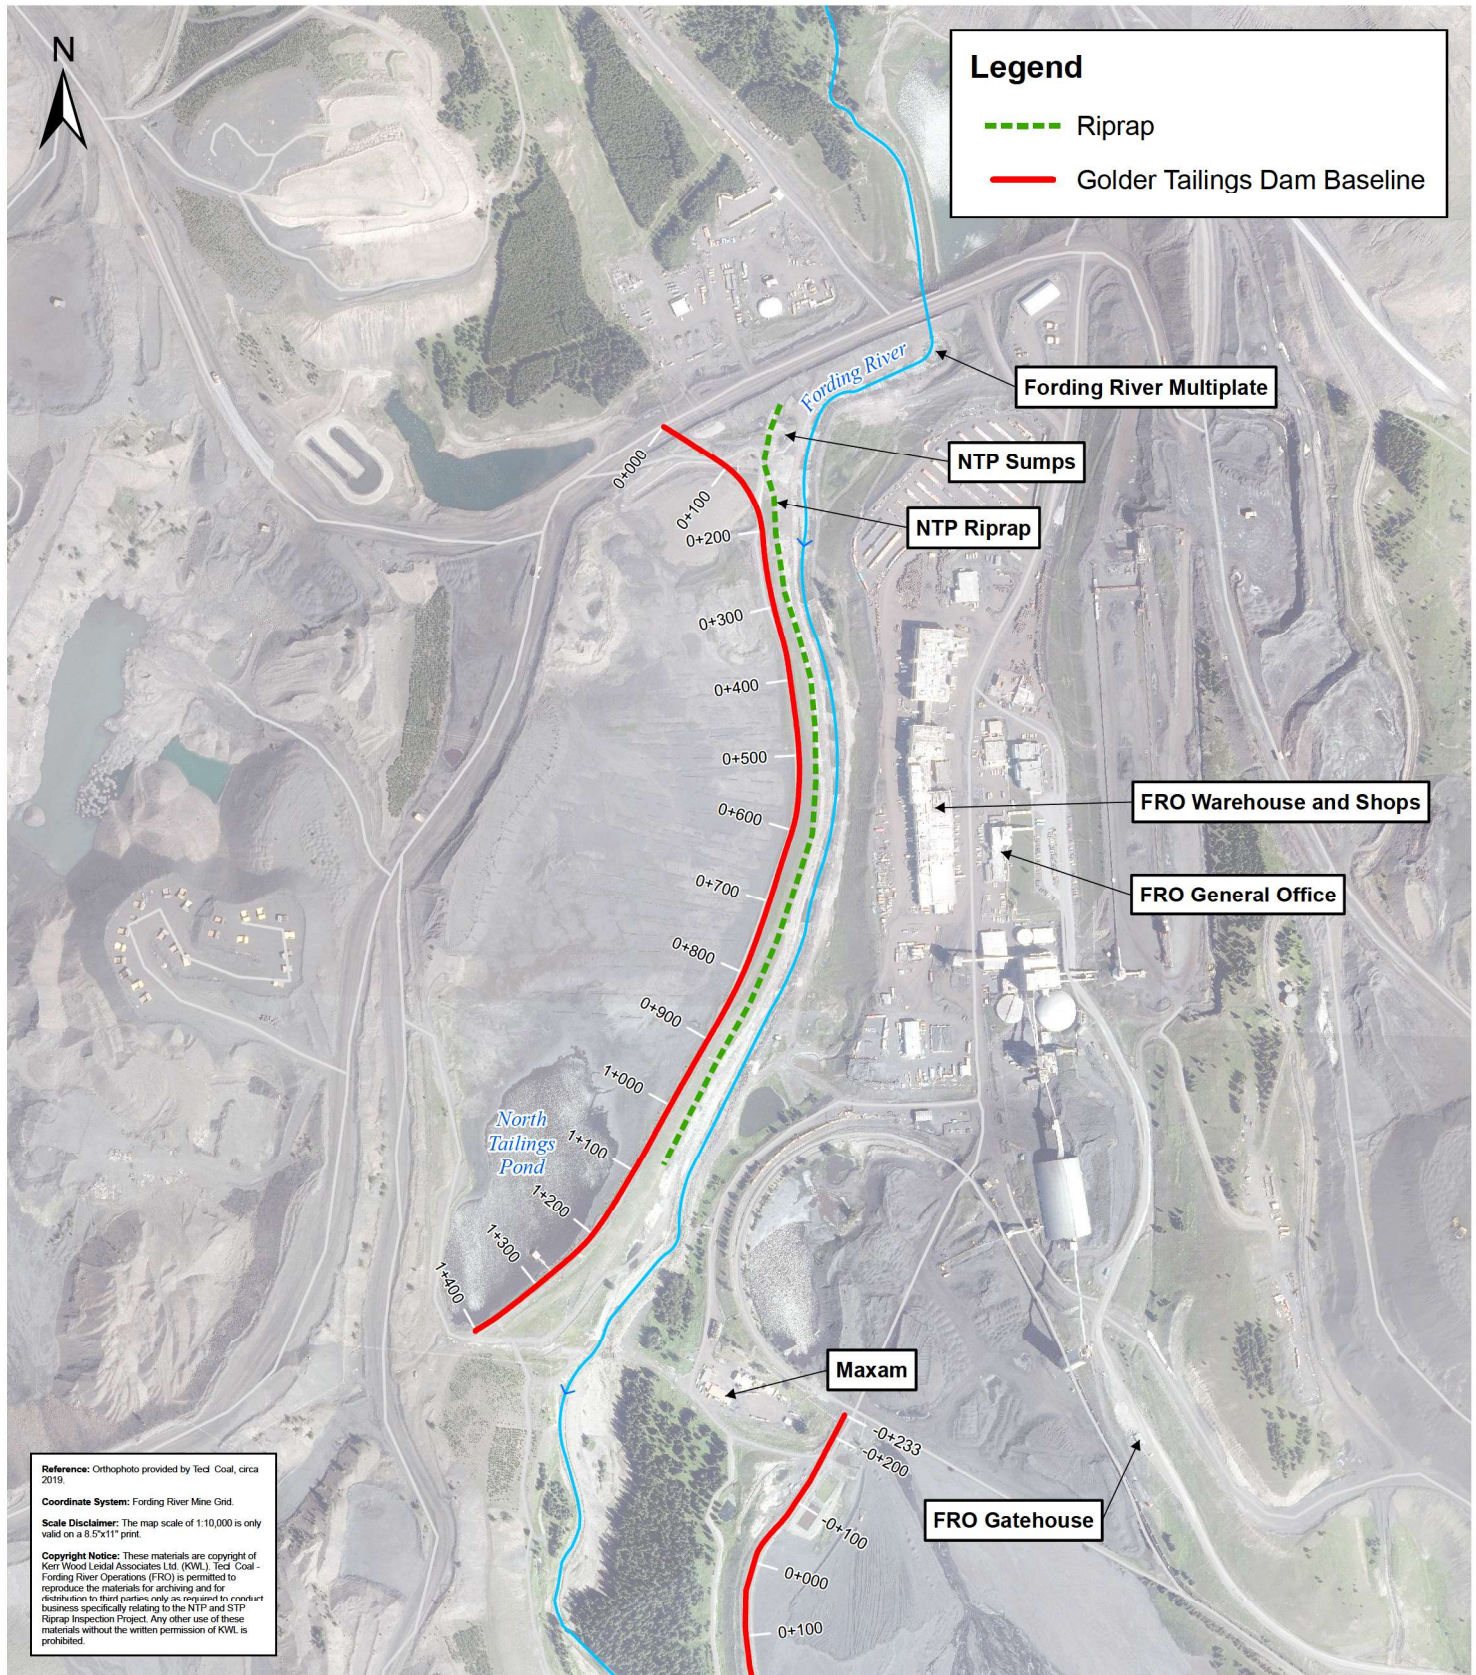
Figure 1

Riprap extends from upstream of the NTP to about Sta. 1+075 of the Golder NTP dam baseline as shown on Figure 1. Visual inspection of the lower riprap slope is impeded by gravel placed over the riprap during 2013 construction. The upper riprap slope placed during 2016/2017 is visible. The 2020 riprap inspection confirmed the riprap appears to be in good condition. Details of the inspection are provided below.

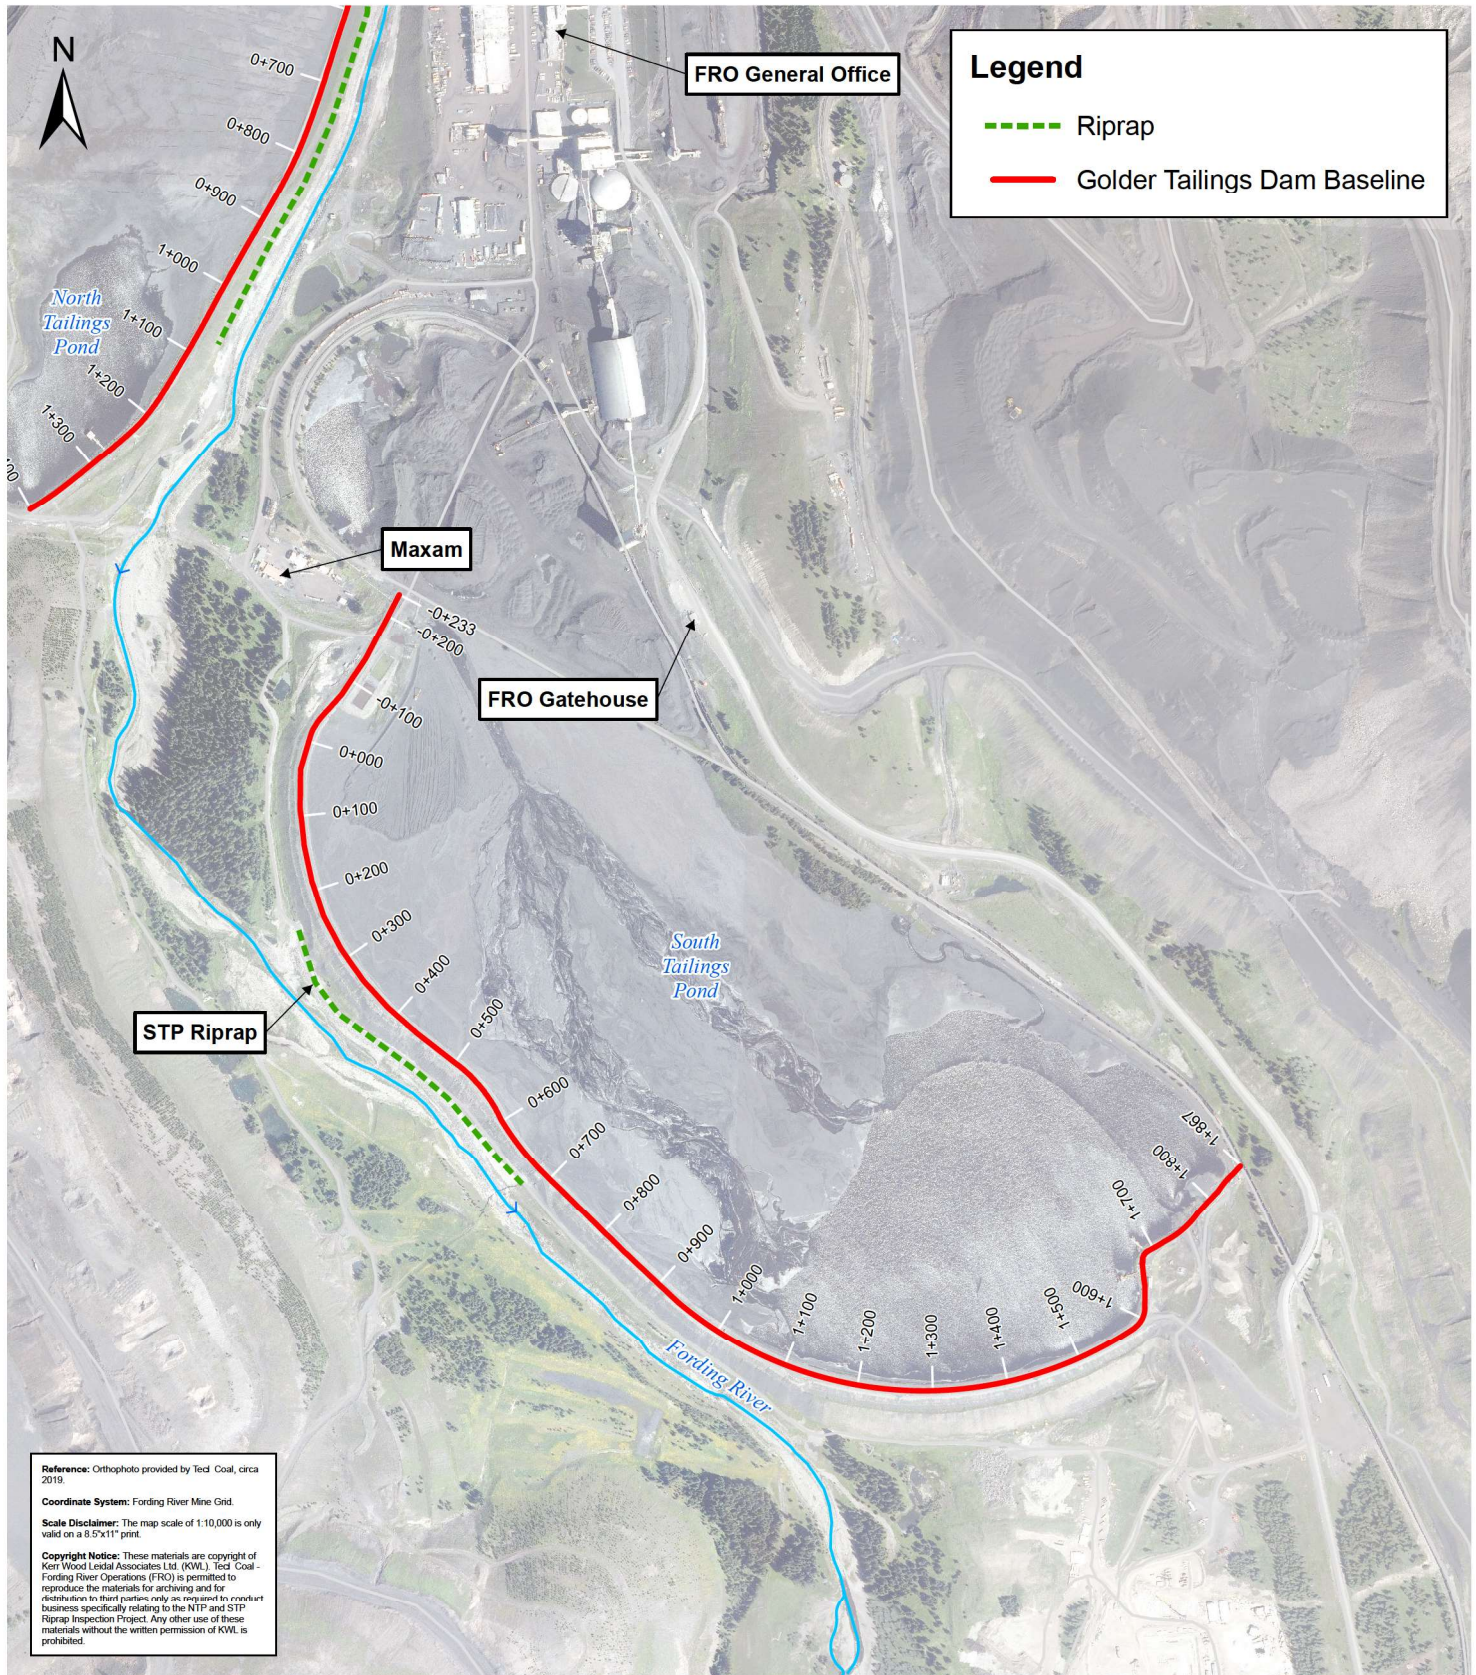
Figure 2

A riprap revetment protects the STP embankment toe from Sta. 0+240 to 0+685 of the Golder STP dam baseline (refer to Figure 2). Most of the riprap slope is exposed and visible along the length of the revetment, with the exception of a 20 m length at the upstream end which is covered in finer rock (200 mm minus rock). The riprap is well interlocked with smaller riprap filling the voids of the larger riprap. The riprap slope is about 2H:1V. The 2020 riprap inspection confirmed the riprap appears to be in good condition. Details of the inspection are provided below.
