# 2020 Annual Inspection Report

## *Greenhills Operations Tailings Storage Facility*

**Teck Coal Limited**

**Golder Associates Ltd.**

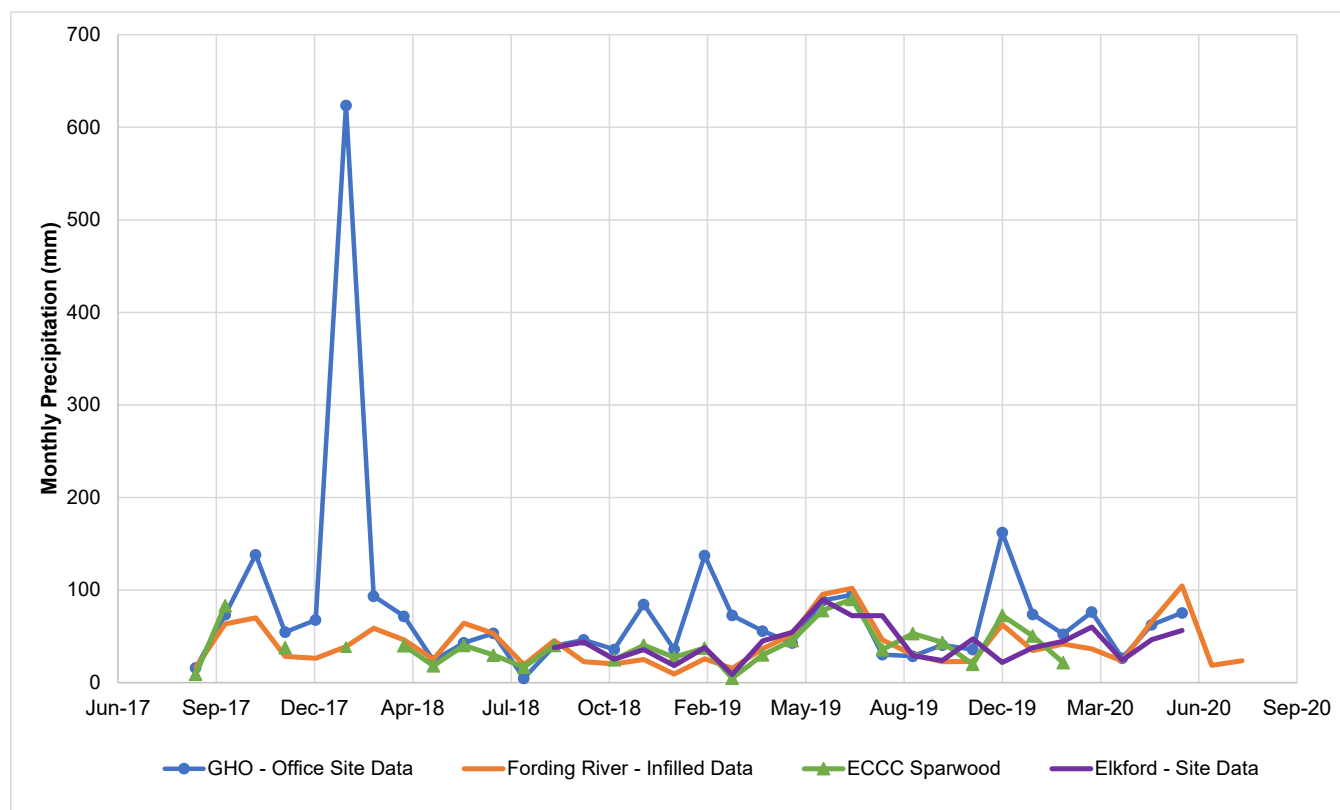
Precipitation data collected at the GHO Office climate station were provided by GHO. The data provided were reviewed and found to be unreliable when compared to nearby climate data (Teck Fording River synthetic dataset, known as Fording River Cominco, Environment and Climate Change Canada station at Sparwood [Climate #1157630], and measured site data at Elkford). Precipitation data from September 2017 to August 2020, from the various data sources, are compared in Illustration 2, and identified anomalies were:

- Monthly total precipitation at the GHO Office station shows a different trend to nearby climate data for the same period, especially during the winter season from October to April.
- Total recorded precipitation at the GHO Office station for December 2019, January 2020, and March 2020 was significantly higher than the values obtained from nearby climate stations for the reporting period.

**Illustration 2: GHO Office Precipitation Data Compared to Nearby Climate Datasets**

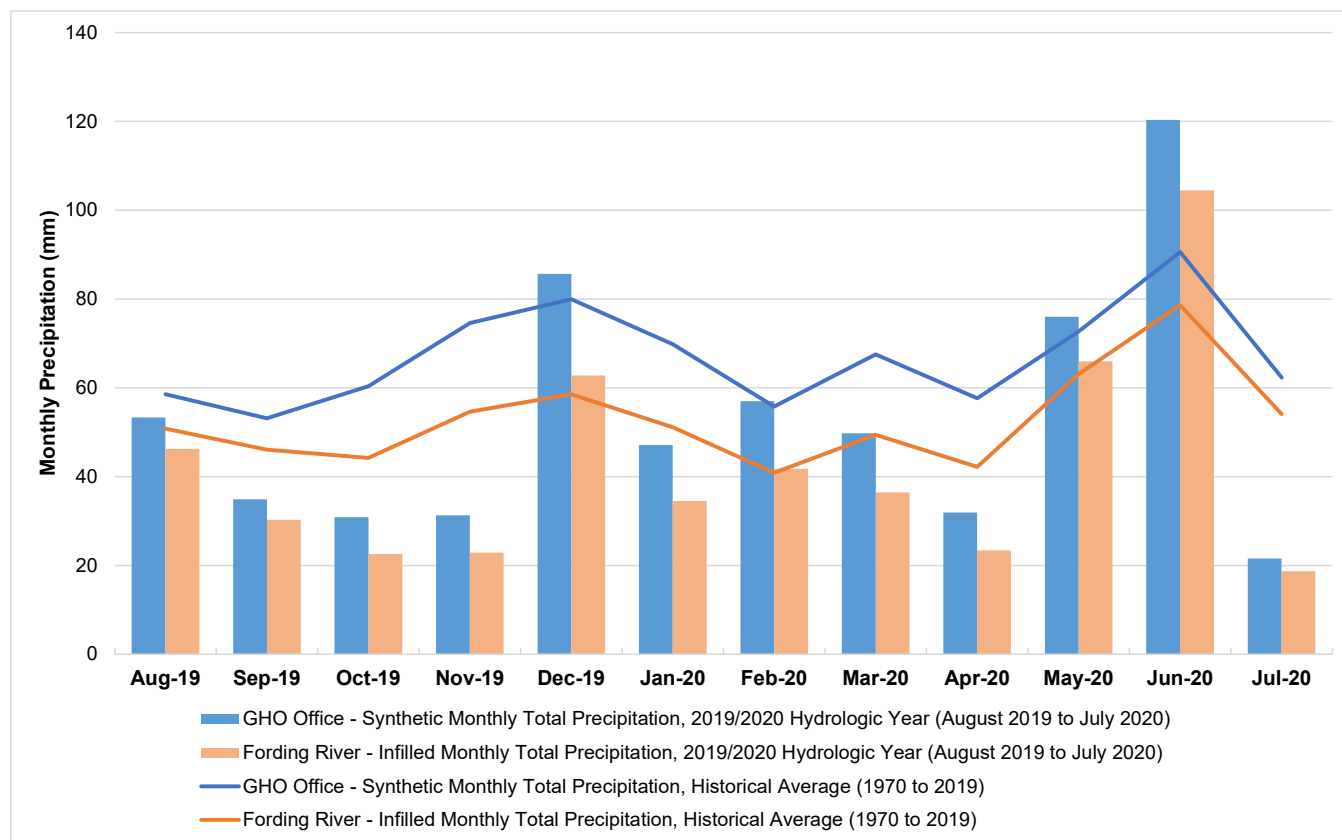
A summary of the recorded and synthetic monthly total precipitation for the reporting period (1 August 2019 to 31 July 2020), and the historical monthly averages at the GHO Office station location are presented in Illustration 3.

**Illustration 3: Comparison Between 2019/2020 Total Precipitation and Historical Average for Greenhills Operations**

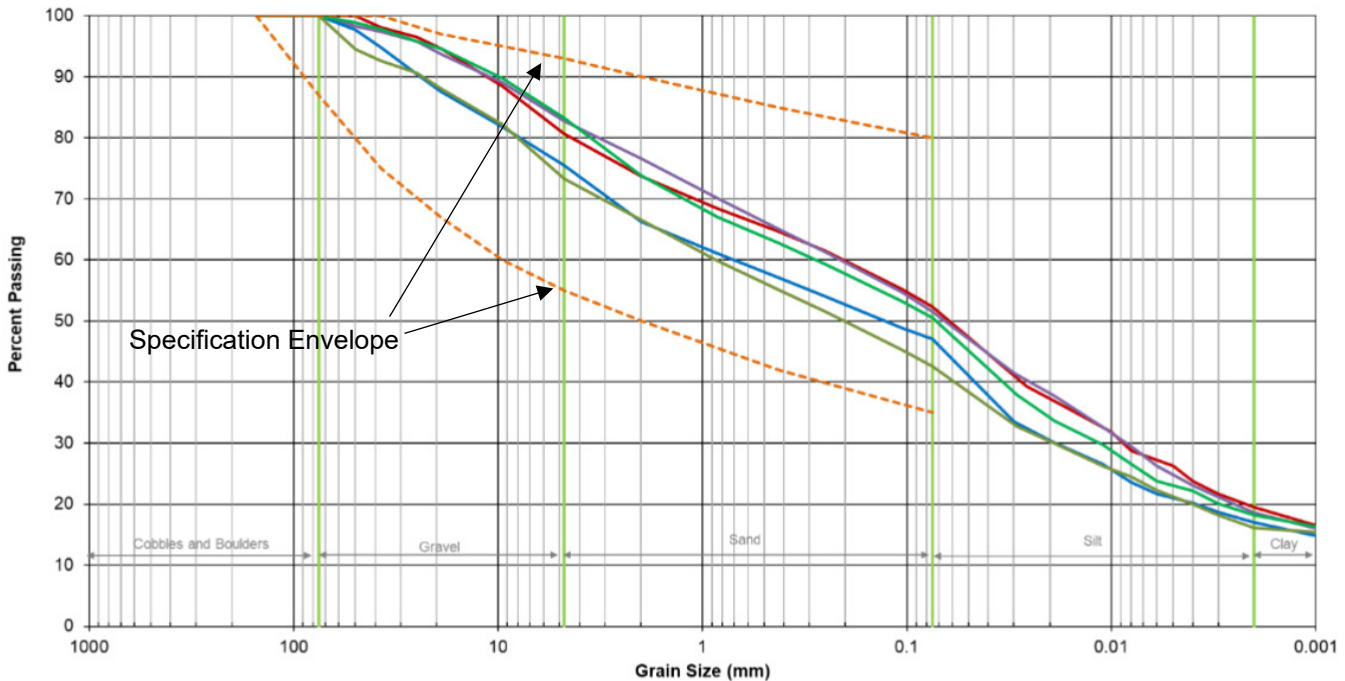
Grain size distribution tests were performed on 5 clay blanket (till) and 10 CR samples as part of the 2018 dam raise (Golder 2019a). Results are presented in Illustration 5 (till sample) and Illustration 6 (CR samples) along with the design specification envelopes. Tested till samples tested were within the specified envelope.

**Illustration 5: Grain Size Distribution and Specification Envelopes for Till**

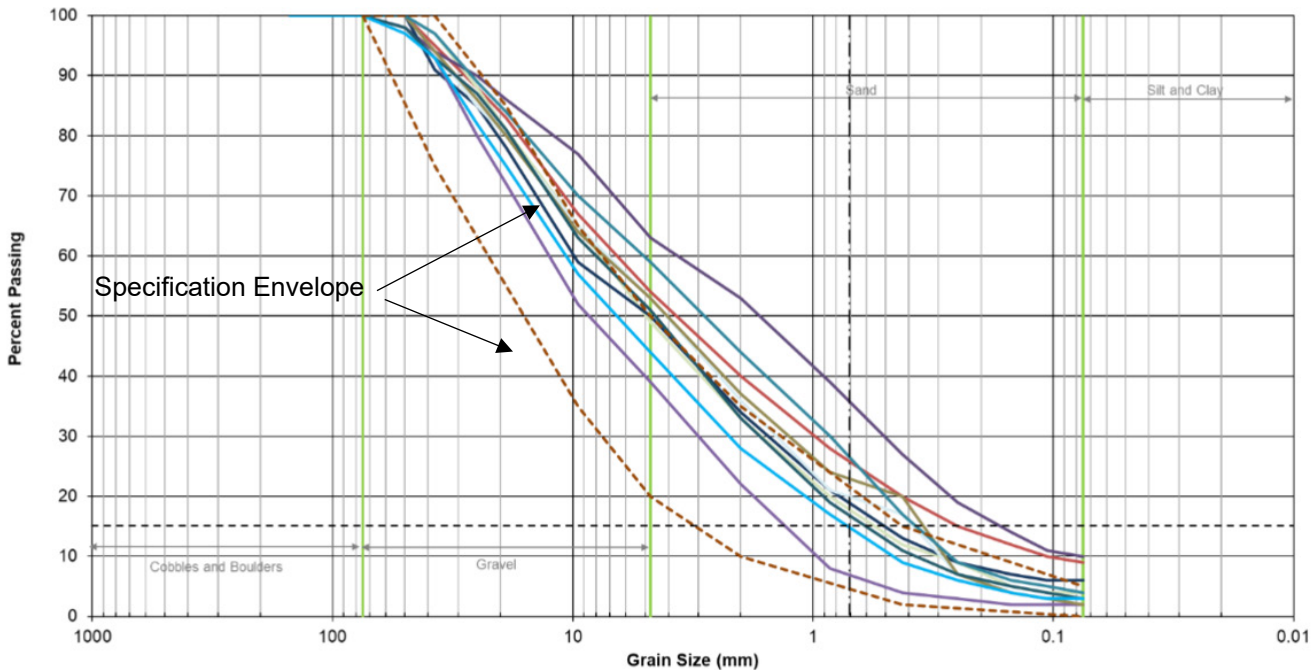
The CR has been tested throughout construction of the dams, and with occasional exception, was found to meet filter criteria. Results from construction in 2020 were pending at the time of this annual inspection report and will be reported as part of the 2021 annual inspection report.

**Illustration 6: Grain Size Distribution and Specification Envelopes for Coarse Refuse**

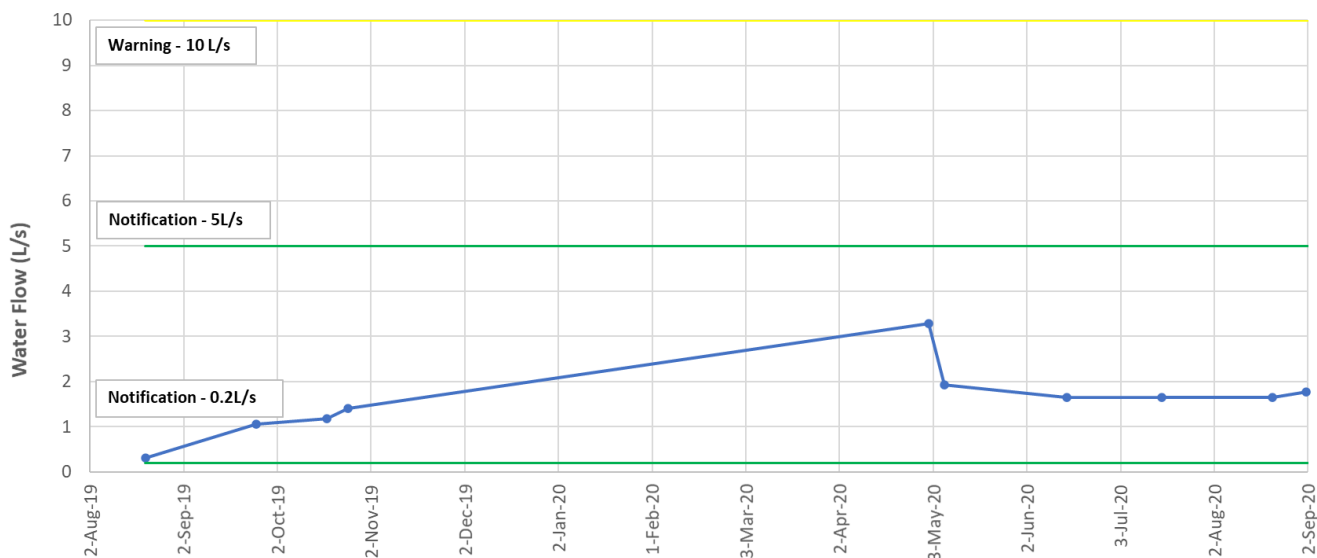
Recorded flow rates at the Site C Weir and West Dam Weir in the 2019/2020 reporting period are presented in Illustration 7 and Illustration 8, respectively. Data were not recorded from the Main Dam Weir between 26 October 2019 and 30 April 2020 due to difficulties accessing the weir during winter.

The flows in both weirs were low and within the expected range for normal operation. The West Dam Weir exceeded the green notification level during the May inspection, during the 2020 freshet.

**Illustration 7: Site C Weir Discharge**

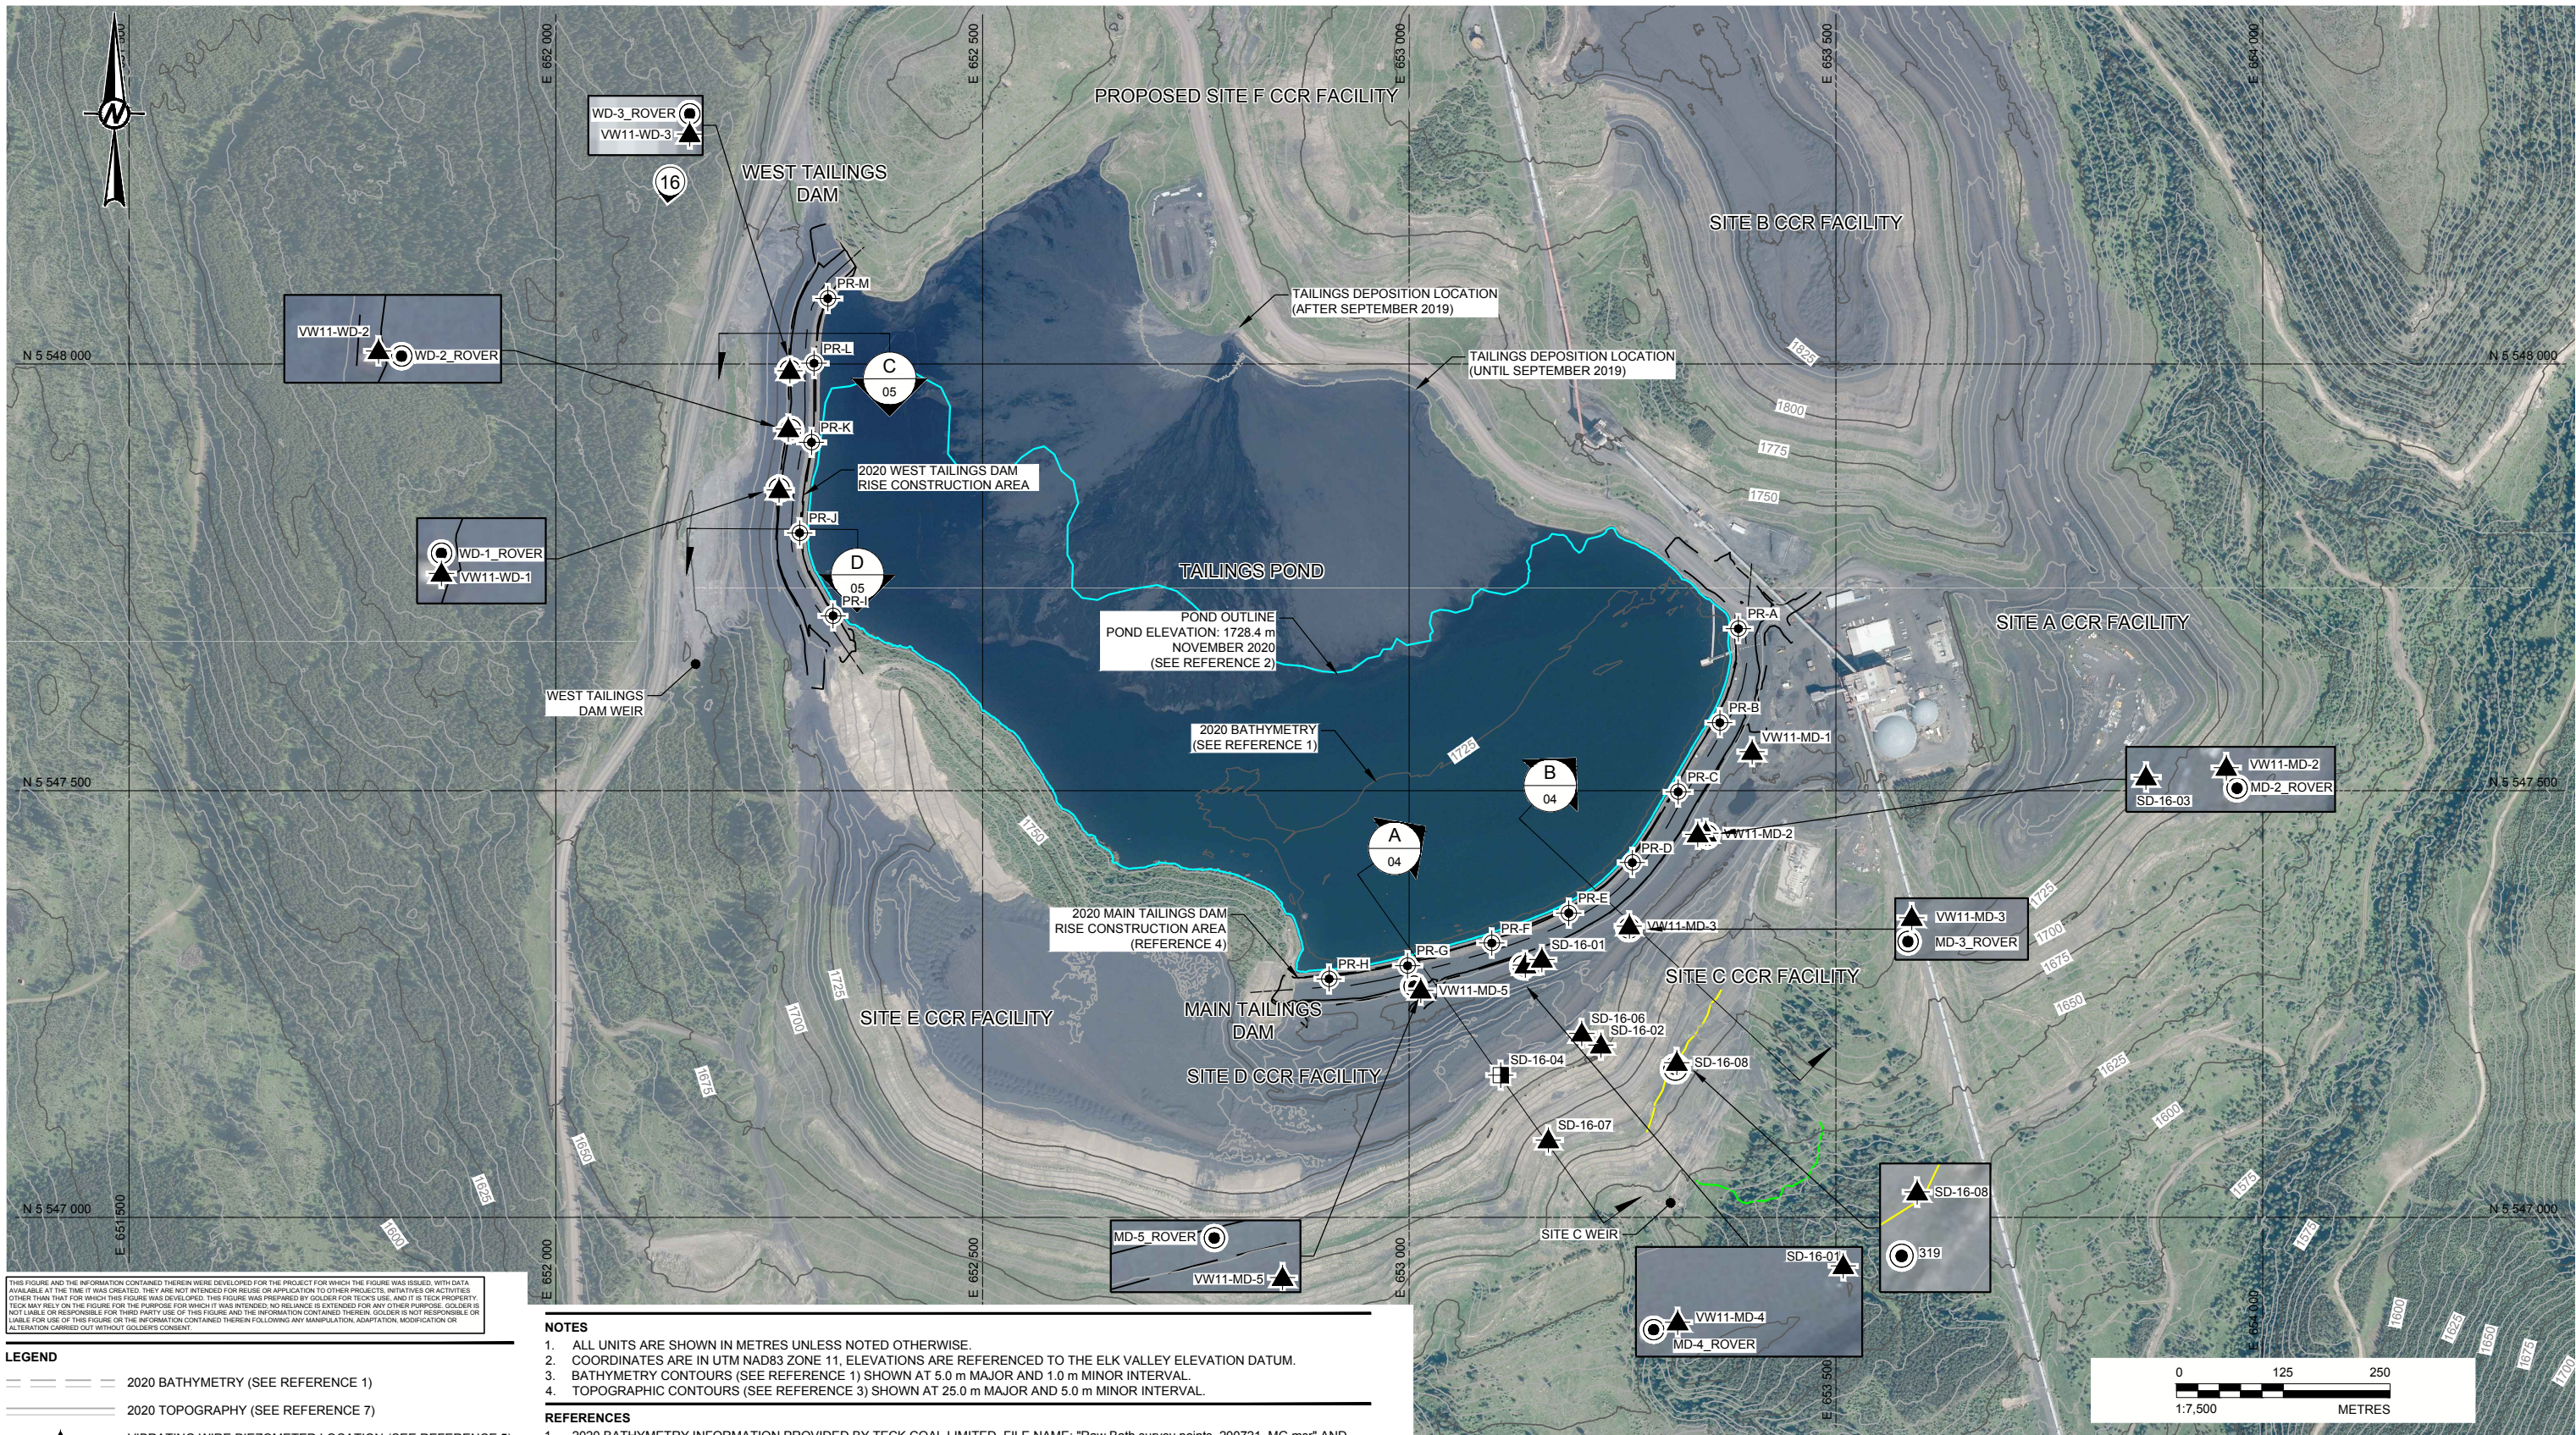
Slope deformation was observed at Site C during 2011 and 2012 when visual inspections noted the development of a head scarp and a toe bulge. Scarp and toe bulge locations are shown in Figure 3. GPS units 319 and 320 were installed on the benches of Site C. Some potential fresh movement of the Site C head scarp was noted during the 2020 site visit, these movements were minor and do not pose a risk to dam safety at this time, but should continue to be monitored on a monthly basis.

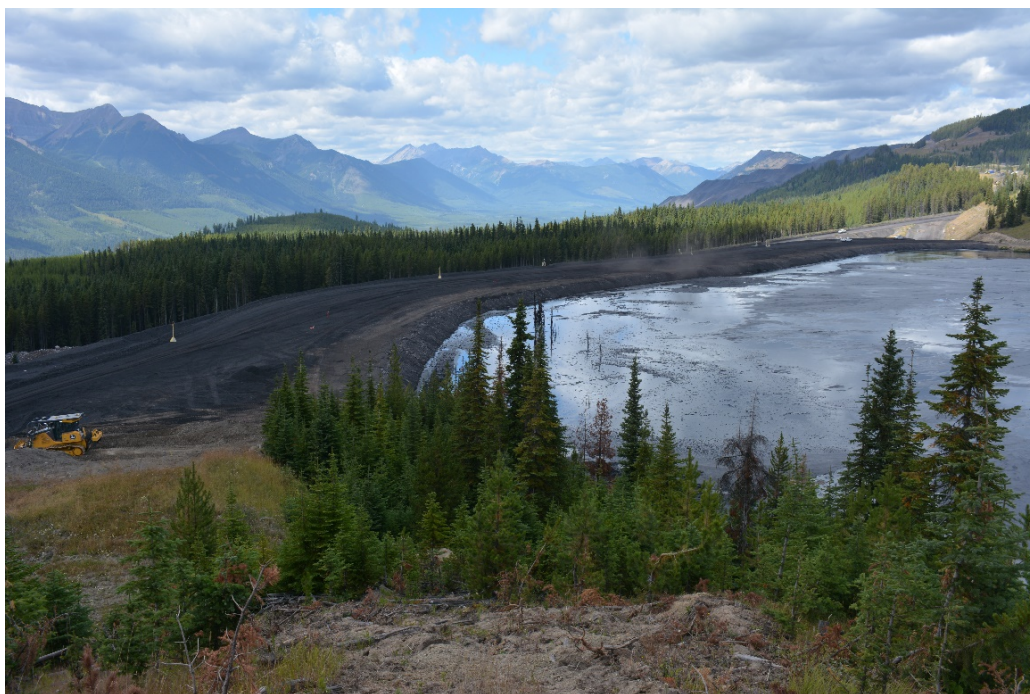
**Photograph 31: West Tailings Dam – Overview; Looking South, 21 August 2020**

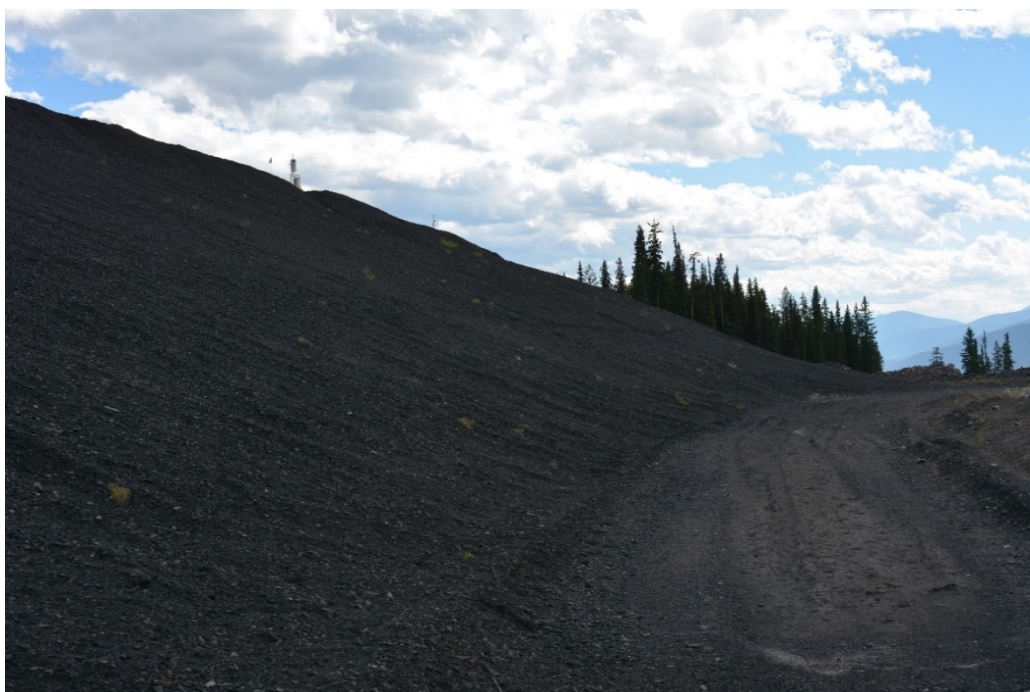
**Photograph 33: West Tailings Dam – Till Blanket and Upstream Slope; Preparation in Progress for 2020 Dam Raise; Looking North, 1 September 2020**

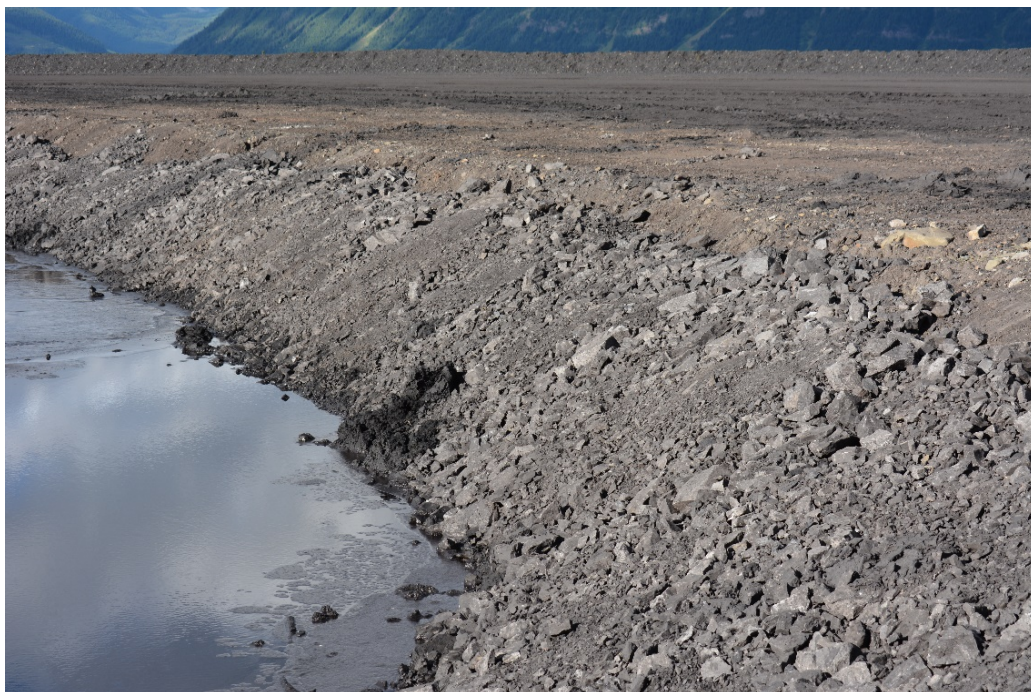
**Photograph 37: West Tailings Dam - Superficial Cracking on Till Blanket; Looking South, 1 September 2020**

1.4 Surface Cracking	Minor cracks in till at crest on upstream side near interface with riprap.	37	Regrade during 2020 dam raise
1.5 Unexpected Settlement	None observed

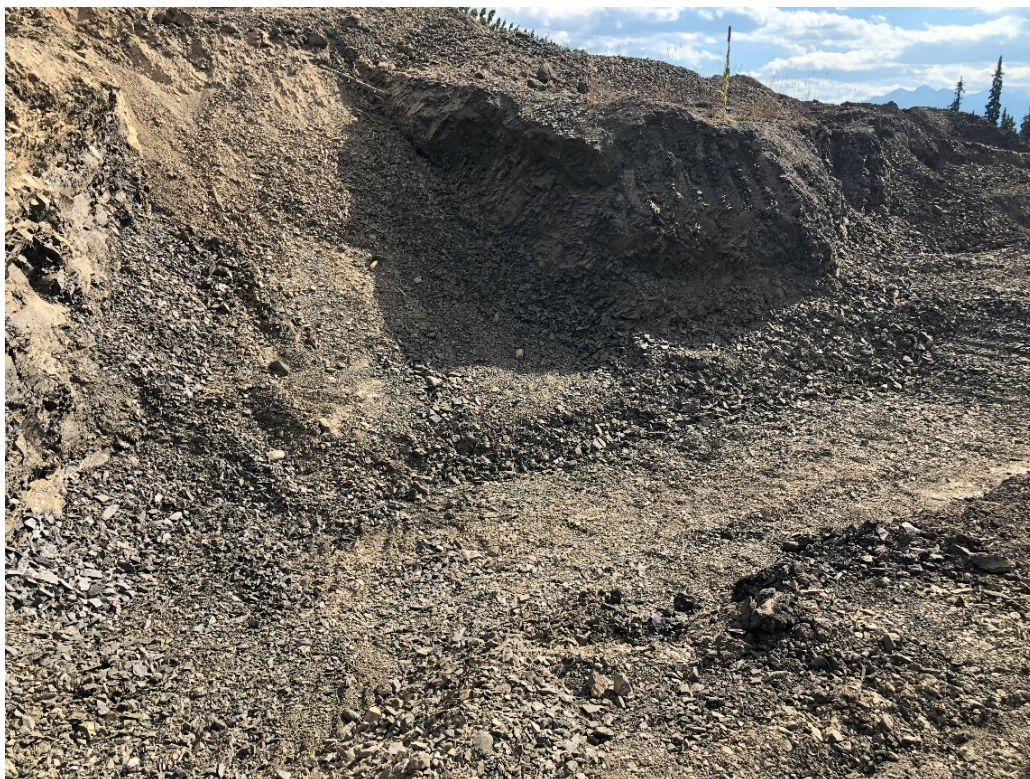
**Photograph 38: West Tailings Dam – Upstream Slope; Preparation in Progress for 2020 Dam Raise; Looking West, 1 September 2020**

1.6 Lateral Movement	None observed		
1.7 Other Unusual Conditions	Minor localized depressions at interface with riprap on upstream side	38	To be repaired during 2020 dam construction
<b>2. UPSTREAM SLOPE</b>		33,36,38,40

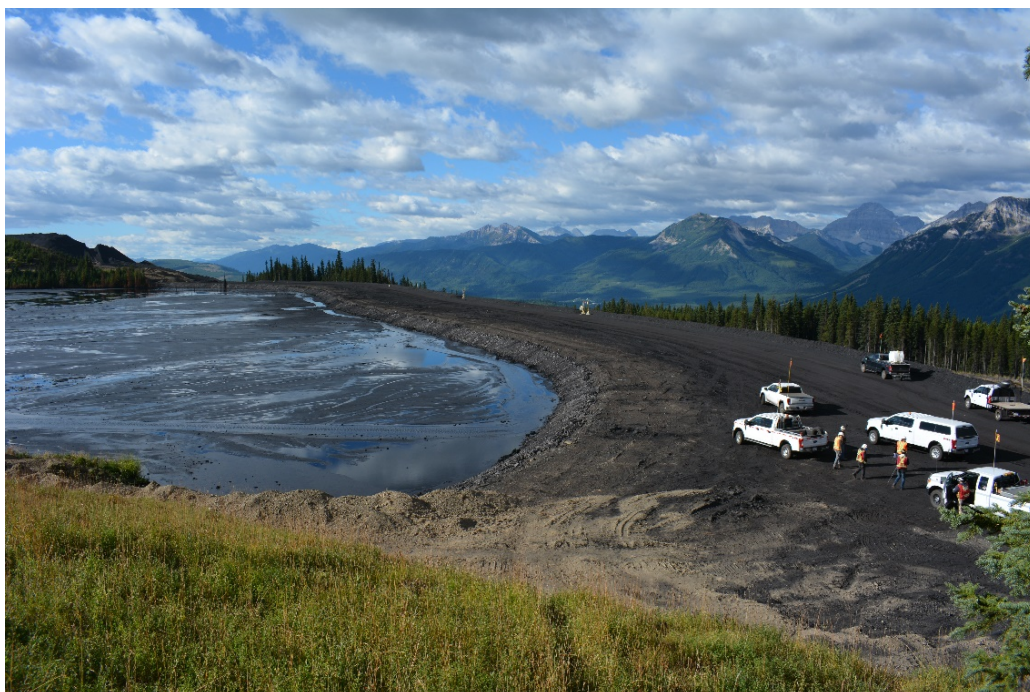
**Photograph 39: West Tailings Dam – North Abutment; Preparation in Progress for 2020 Dam Raise; Looking Northeast 1 September 2020**

5.3 Excessive Vegetation	None observed		
5.4 Presence of Rodent Burrows	None observed		
5.5 Other Unusual Conditions	None observed		Preparation of north abutment for dam construction in progress during inspection
<b>6. RESERVOIR</b>		31,32,33,36,40

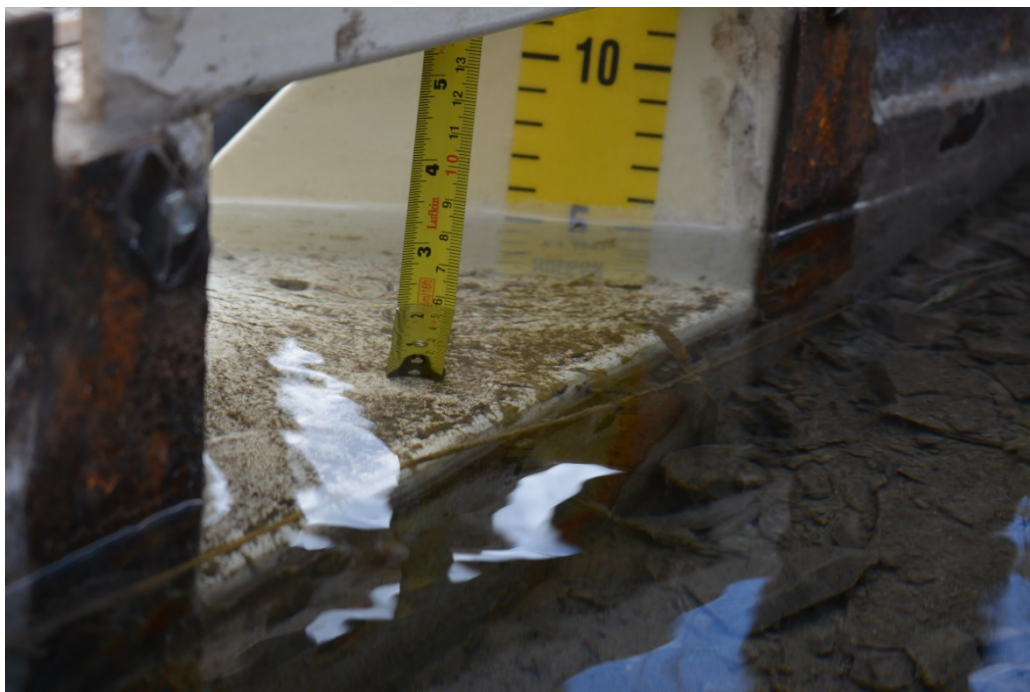
**Photograph 42: West Dam Seepage Weir; Looking Southwest – 1 September 2020**

3.6 Vegetation Growth	Not of concern		
3.7 Other Unusual Conditions	None		
<b>4. DOWNSTREAM TOE AREA</b>		31,35,40	
4.1 Seepage from Dam	Seepage observed in Site D culvert and at West Dam Weir

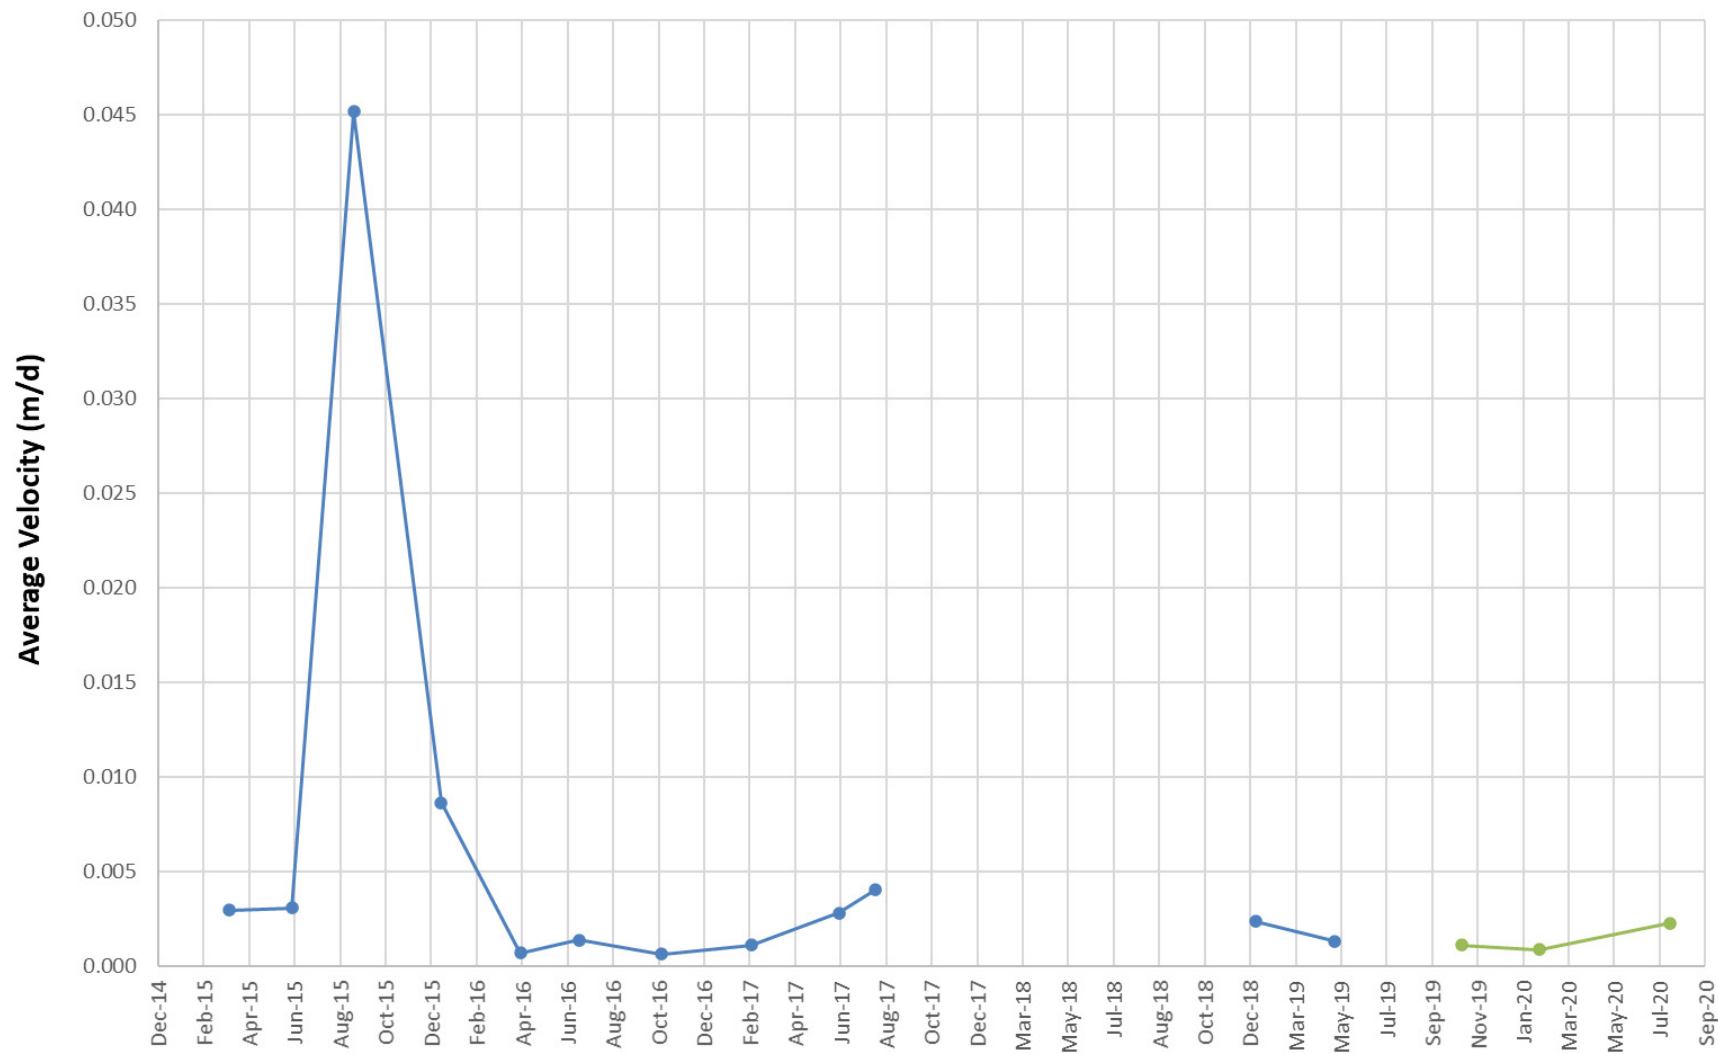
FIGURE  
**D-11**

Notes:  
-Prism data reset in February 2020 due to change in survey total station pillar  
-Data from January to August 2020 may be erroneous due to errors in total station. Total station calibrated 8 July 2020  
-Data gaps present due to survey prisms being offline or moved during dam raise construction  
-Average velocity calculated in metres per day from the average movement over the preceding approximately three-month period  
-Average velocity data presented at the end of the calculation period (i.e. end of three months of data)

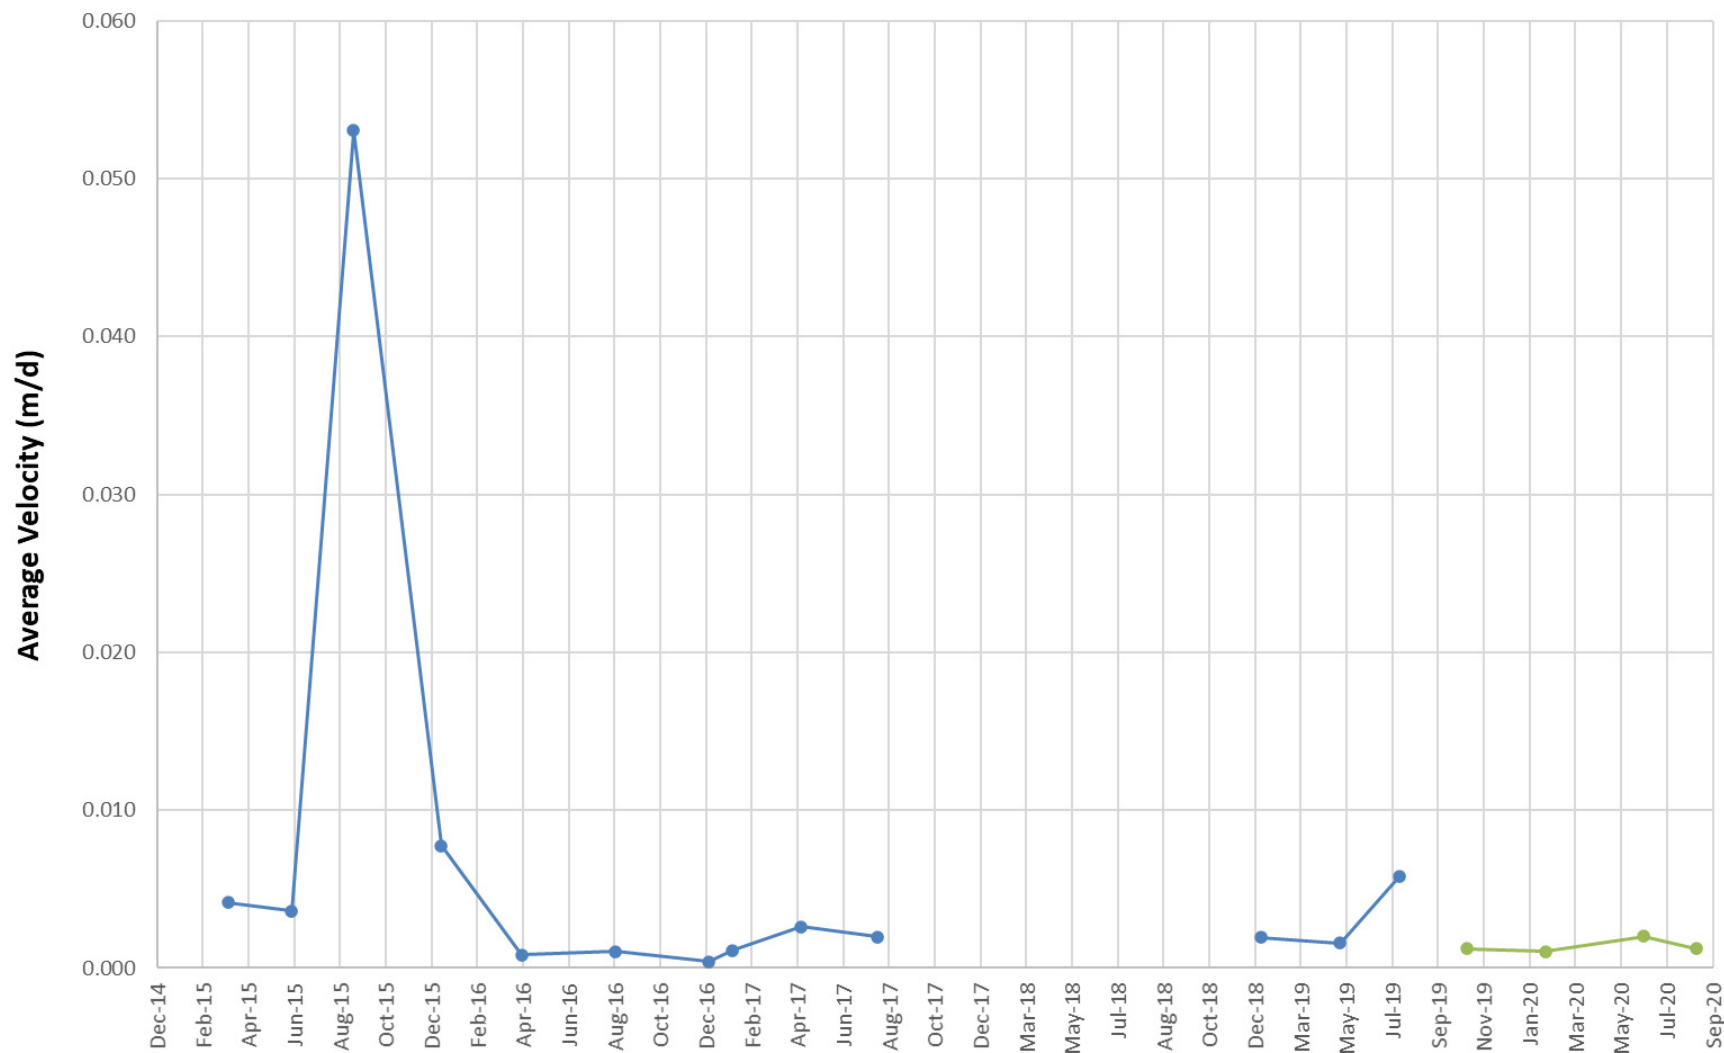
FIGURE  
**D-13**

Notes:  
 -Prism data reset in February 2020 due to change in survey total station pillar  
 -Data from January to August 2020 may be erroneous due to errors in total station. Total station calibrated 8 July 2020  
 -Data gaps present due to survey prisms being offline or moved during dam raise construction  
 -Average velocity calculated in metres per day from the average movement over the preceding approximately three-month period  
 -Average velocity data presented at the end of the calculation period (i.e. end of three months of data)

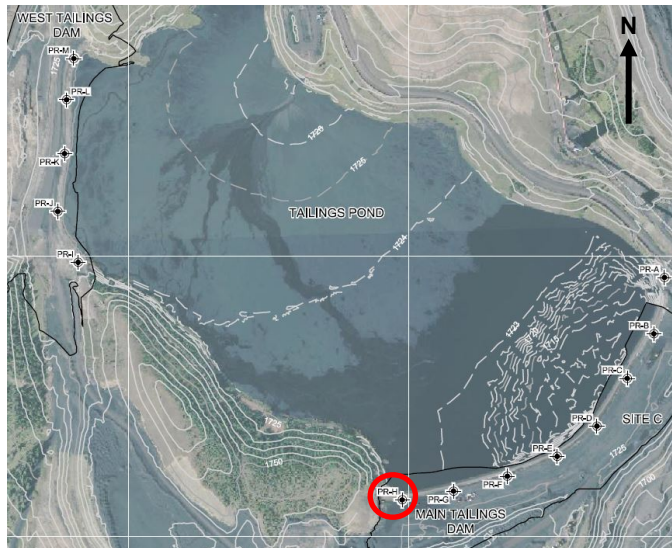
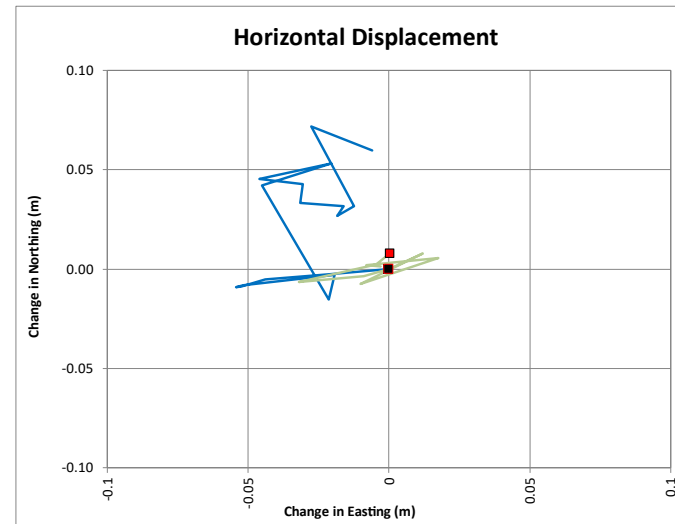
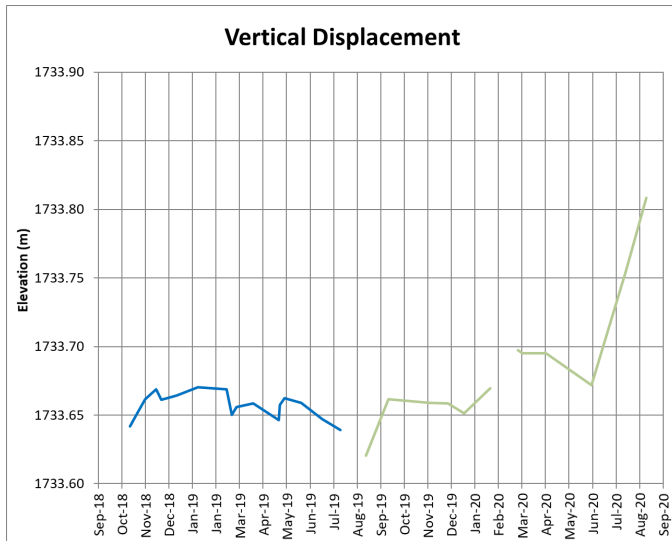
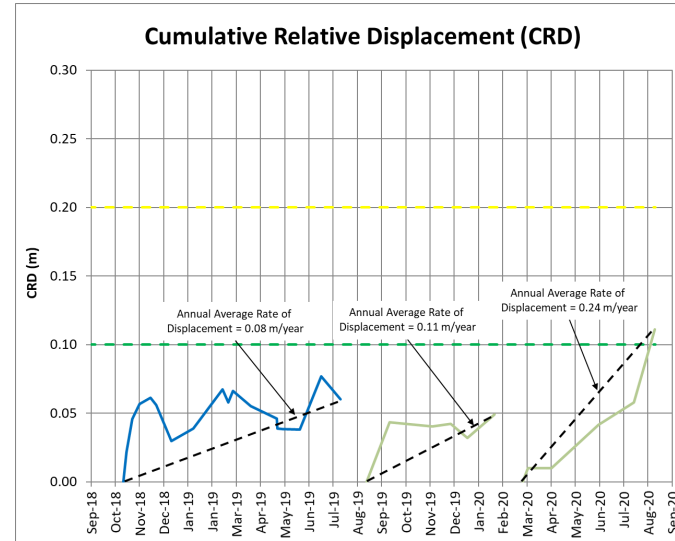
FIGURE  
 D-14

References:  
 -2018 Aerial photo and topography provided by Teck Coal Limited. Flown 16 to 16 July 2018.  
 Notes:  
 -Prism data reset in February 2020 due to change in survey total station pillar  
 -Data from January to August 2020 may be erroneous due to errors in total station. Total station calibrated 8 July 2020  
 -Annual average rate of displacement was calculated based on prorating the data available to represent 12 months of movement. i.e. data was forecast forward assuming a linear increase.  
 -Data gaps present due to survey prisms being offline or moved during dam raise construction

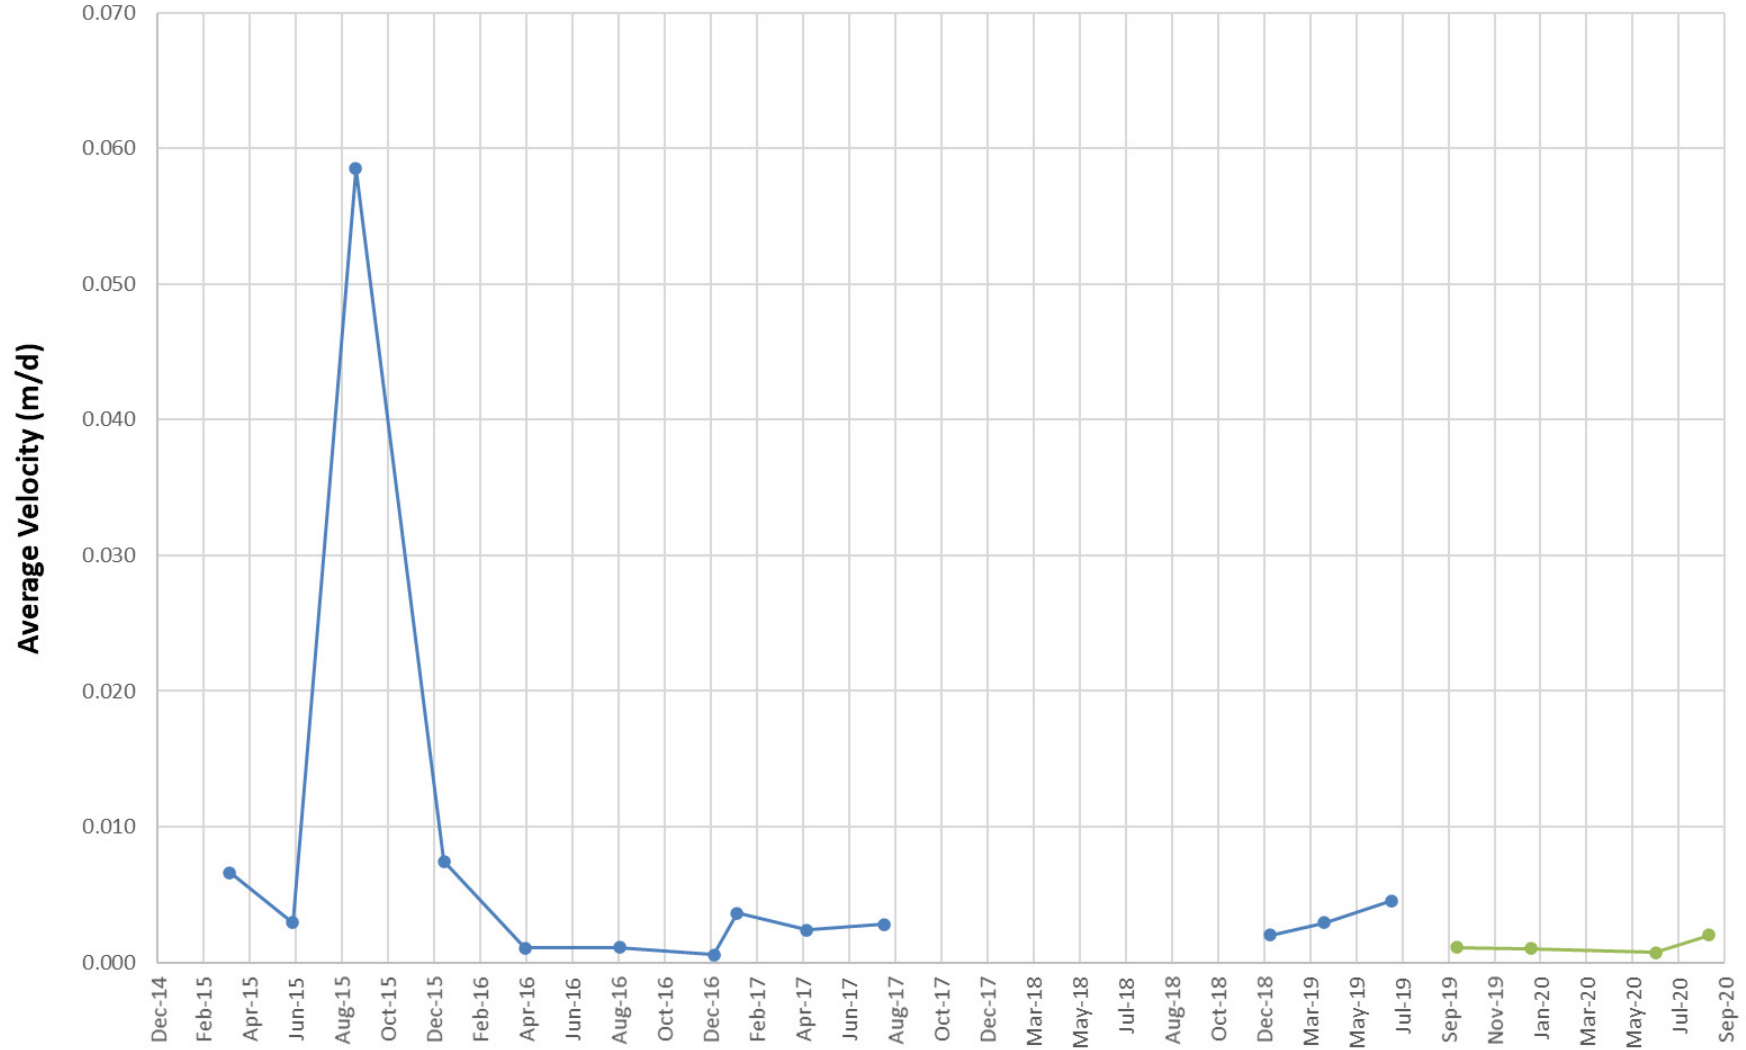
FIGURE  
**D-15**

- Prism data reset in February 2020 due to change in survey total station pillar
- Data from January to August 2020 may be erroneous due to errors in total station. Total station calibrated 8 July 2020
- Data gaps present due to survey prisms being offline or moved during dam raise construction
- Average velocity calculated in metres per day from the average movement over the preceding approximately three-month period
- Average velocity data presented at the end of the calculation period (i.e. end of three months of data)
