# 2020 Annual Inspection Report

## *Greenhills Operations Tailings Storage Facility*

**Teck Coal Limited**

**Golder Associates Ltd.**

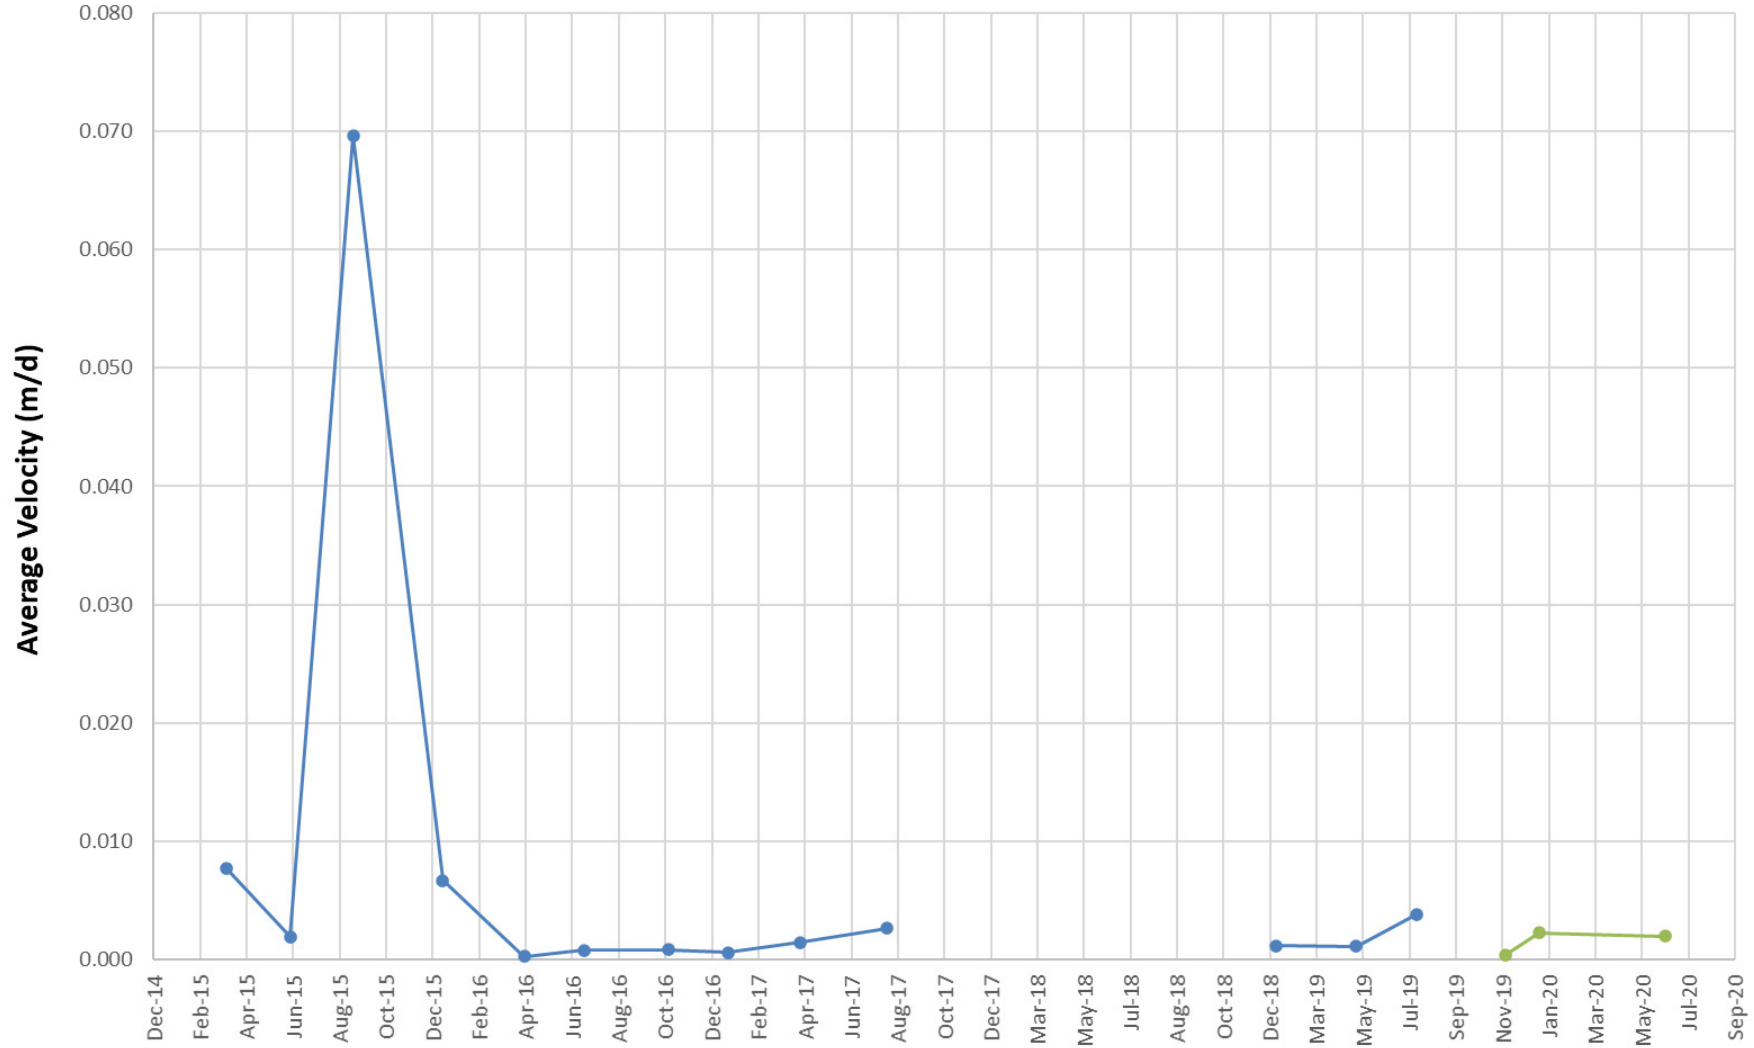
FIGURE  
**D-17**

- Prism data reset in February 2020 due to change in survey total station pillar
- Data from January to August 2020 may be erroneous due to errors in total station. Total station calibrated 8 July 2020
- Data gaps present due to survey prisms being offline or moved during dam raise construction
- Average velocity calculated in metres per day from the average movement over the preceding approximately three-month period
- Average velocity data presented at the end of the calculation period (i.e. end of three months of data)

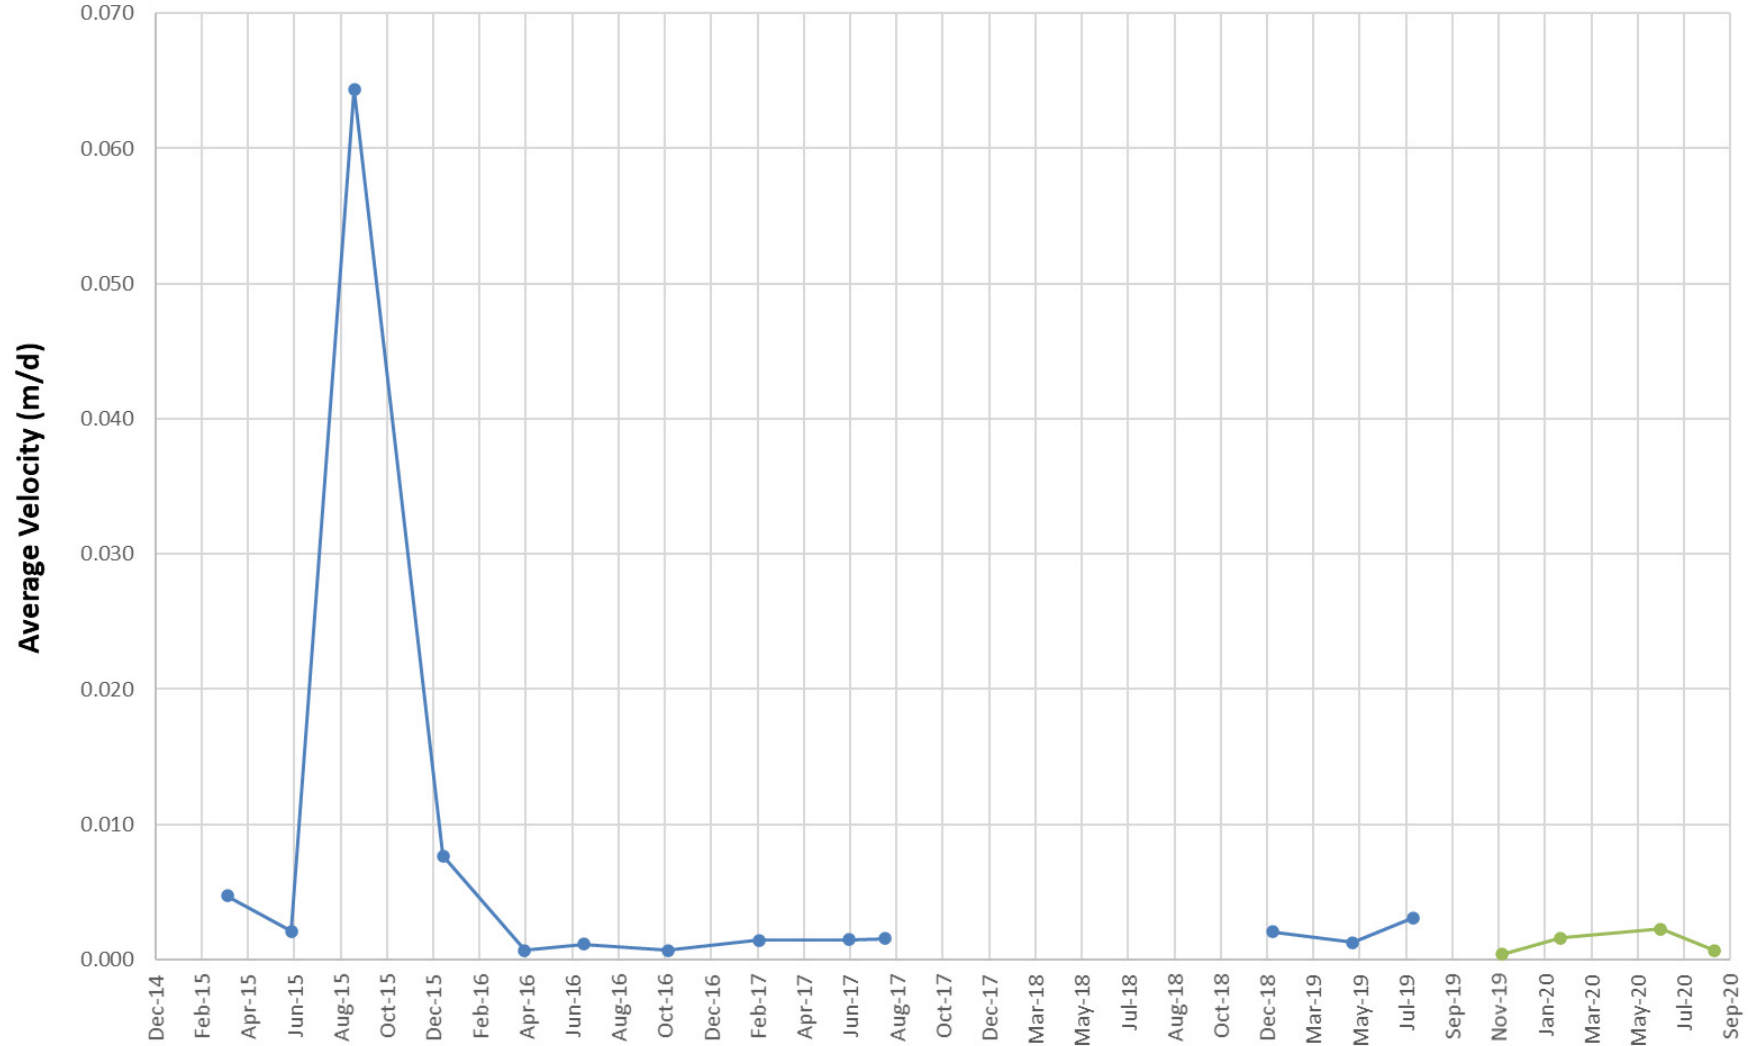
FIGURE  
**D-19**

Notes:  
 -Prism data reset in February 2020 due to change in survey total station pillar  
 -Data from January to August 2020 may be erroneous due to errors in total station. Total station calibrated 8 July 2020  
 -Data gaps present due to survey prisms being offline or moved during dam raise construction  
 -Average velocity calculated in metres per day from the average movement over the preceding approximately three-month period  
 -Average velocity data presented at the end of the calculation period (i.e. end of three months of data)

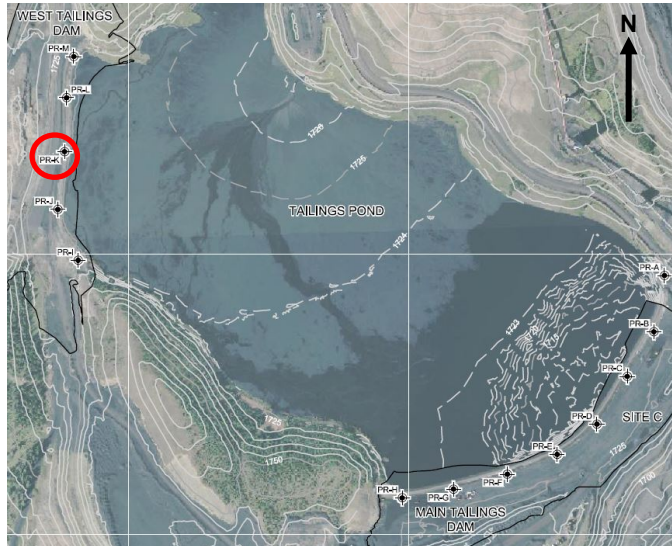
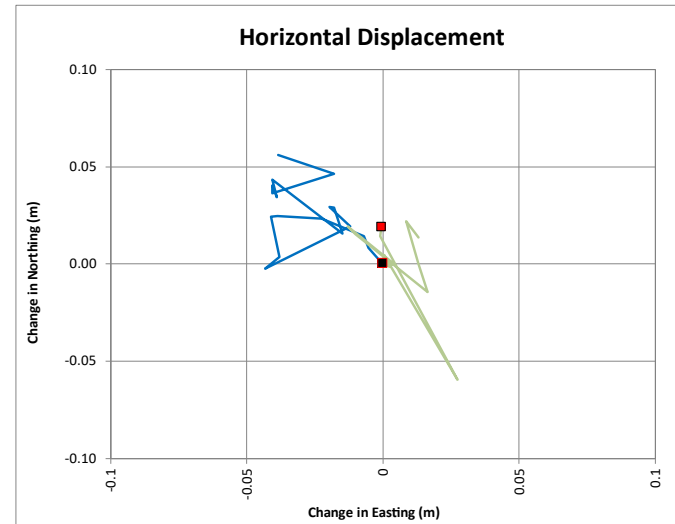
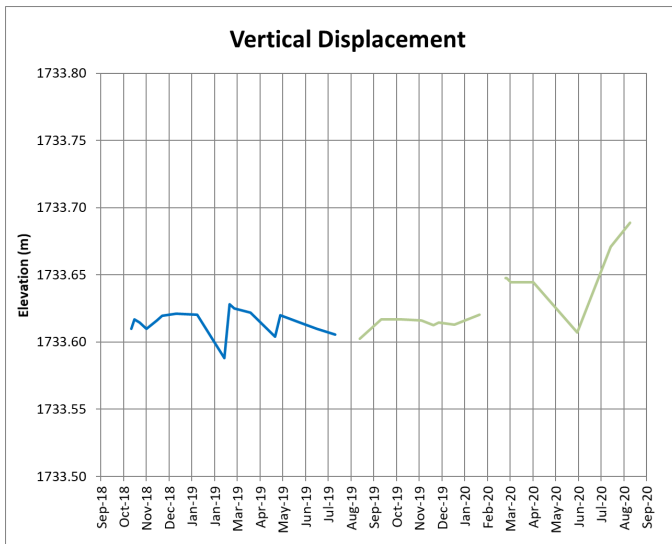
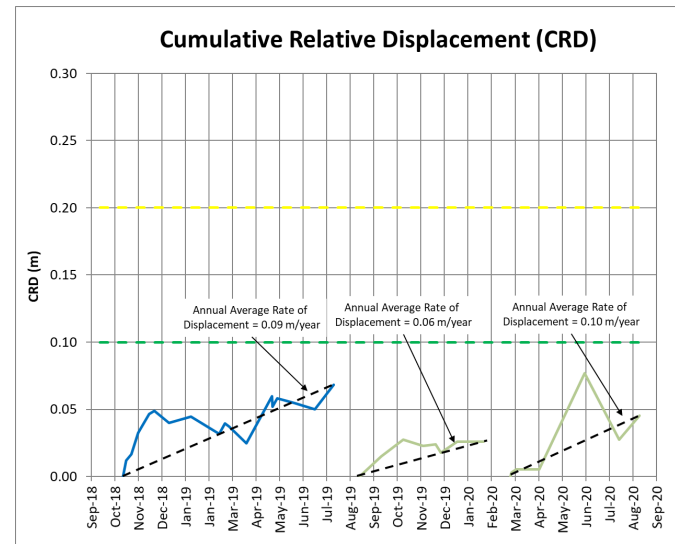
FIGURE  
 D-20

References:  
 -2018 Aerial photo and topography provided by Teck Coal Limited. Flown 16 to 16 July 2018.  
 Notes:  
 -Prism data reset in February 2020 due to change in survey total station pillar  
 -Data from January to August 2020 may be erroneous due to errors in total station. Total station calibrated 8 July 2020  
 -Annual average rate of displacement was calculated based on prorating the data available to represent 12 months of movement. i.e. data was forecast forward assuming a linear increase.  
 -Data gaps present due to survey prisms being offline or moved during dam raise construction

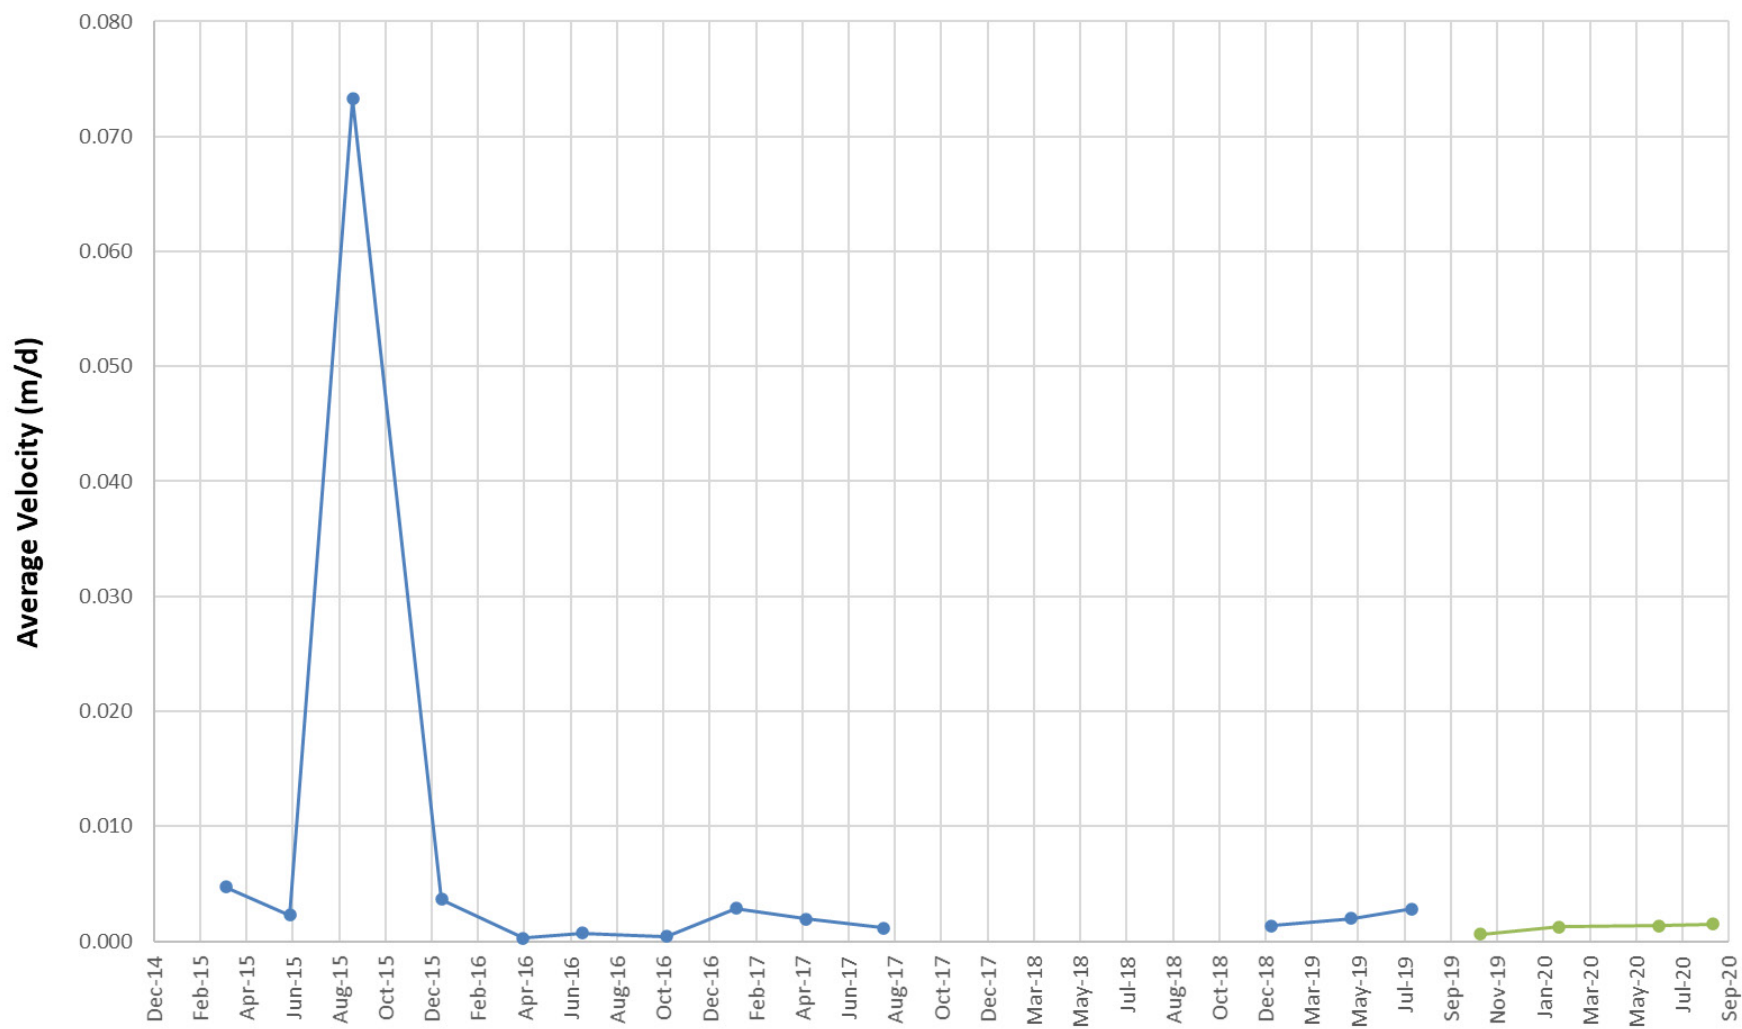
FIGURE  
**D-21**

Notes:  
 -Prism data reset in February 2020 due to change in survey total station pillar  
 -Data from January to August 2020 may be erroneous due to errors in total station. Total station calibrated 8 July 2020  
 -Data gaps present due to survey prisms being offline or moved during dam raise construction  
 -Average velocity calculated in metres per day from the average movement over the preceding approximately three-month period  
 -Average velocity data presented at the end of the calculation period (i.e. end of three months of data)

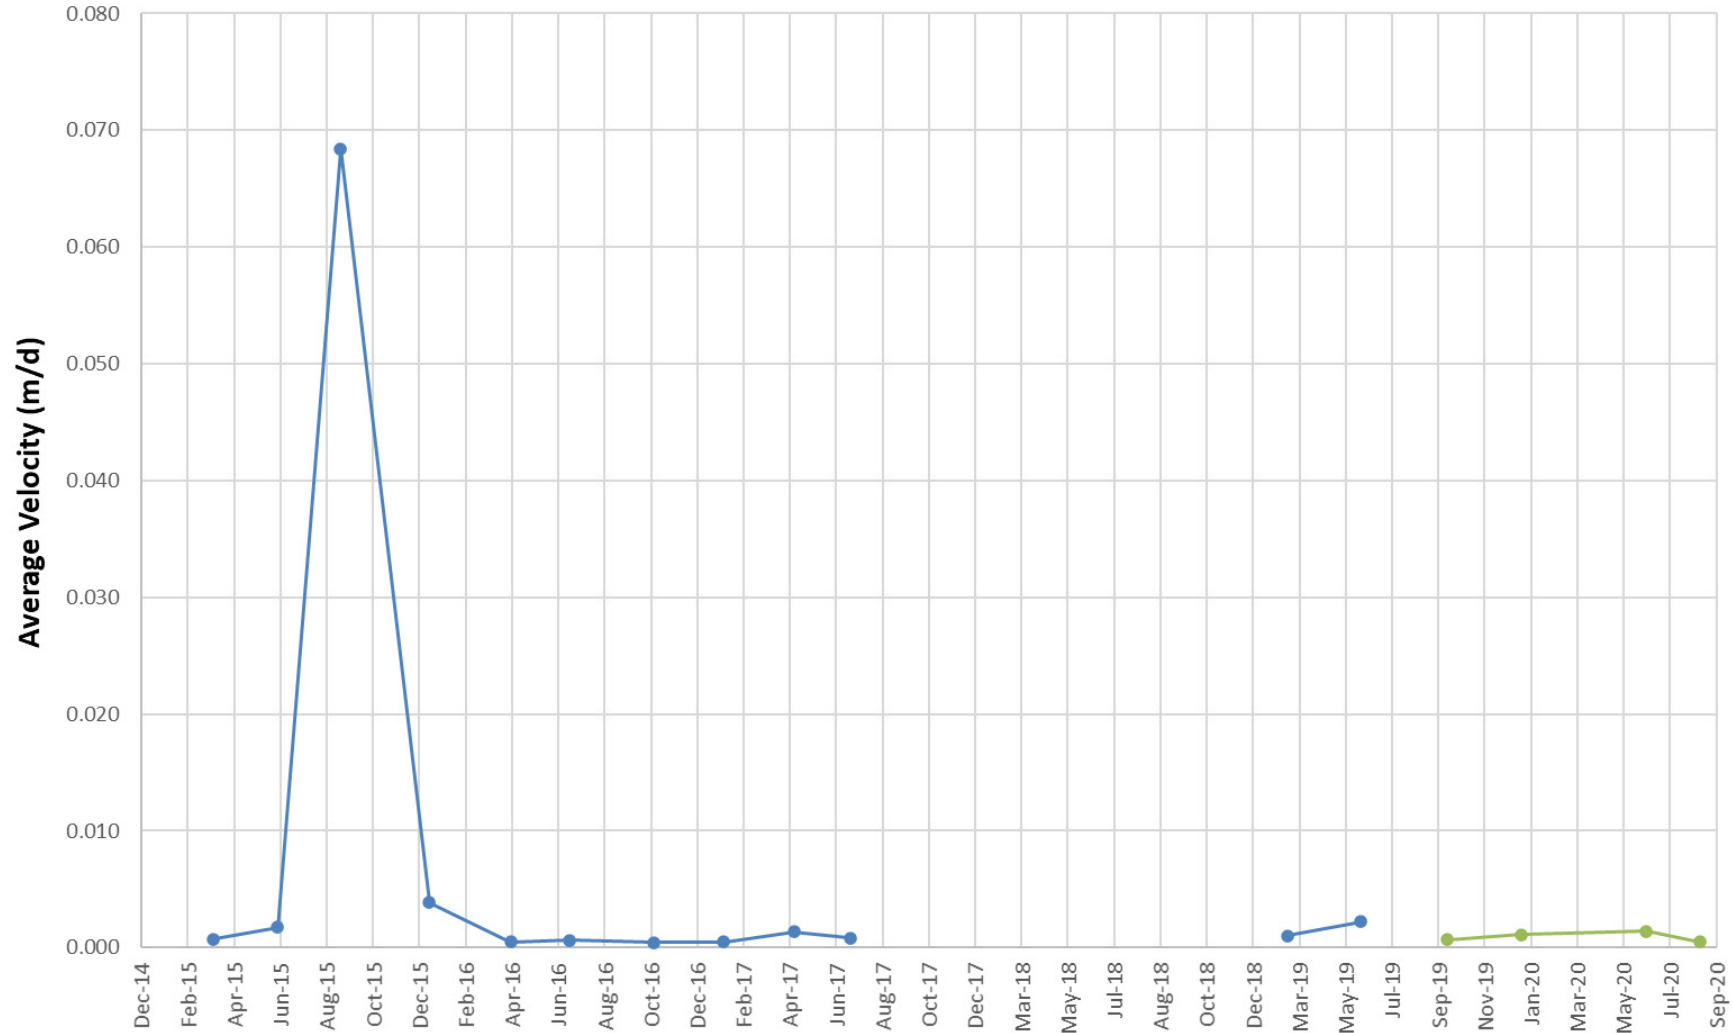
D-23

Notes:  
-Prism data reset in February 2020 due to change in survey total station pillar  
-Data from January to August 2020 may be erroneous due to errors in total station. Total station calibrated 8 July 2020  
-Data gaps present due to survey prisms being offline or moved during dam raise construction  
-Average velocity calculated in metres per day from the average movement over the preceding approximately three-month period  
-Average velocity data presented at the end of the calculation period (i.e. end of three months of data)

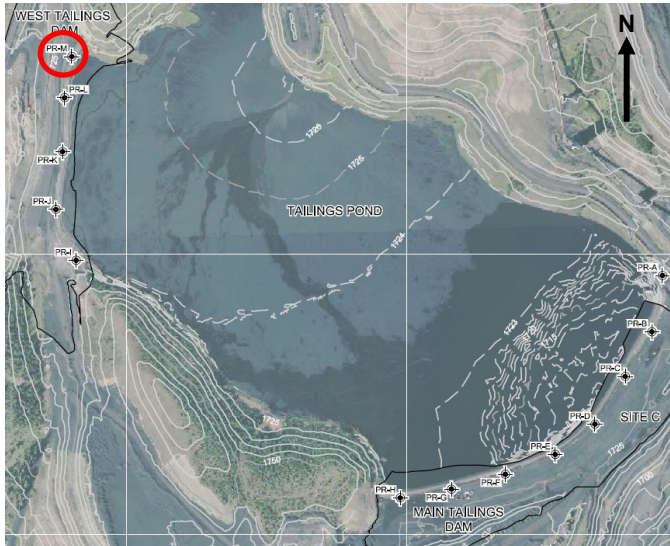
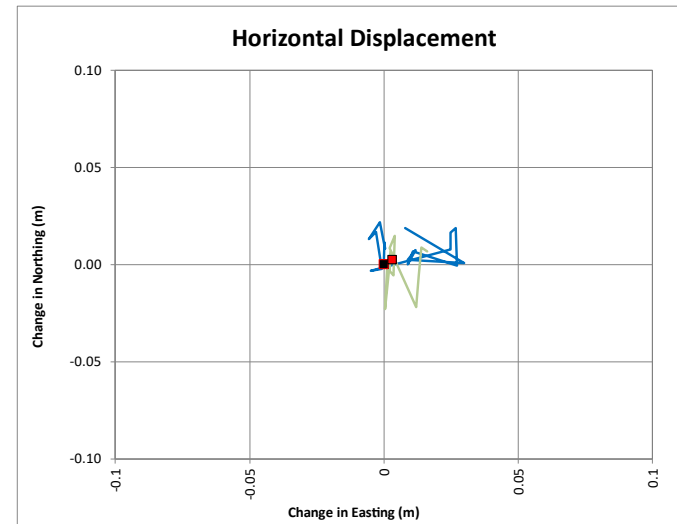
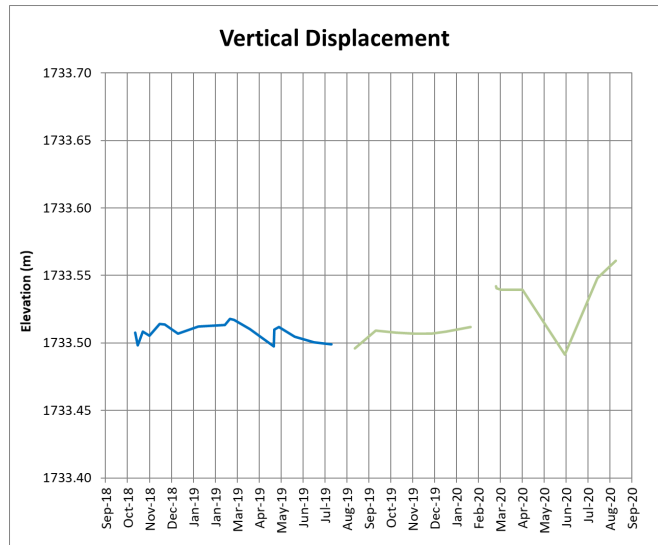
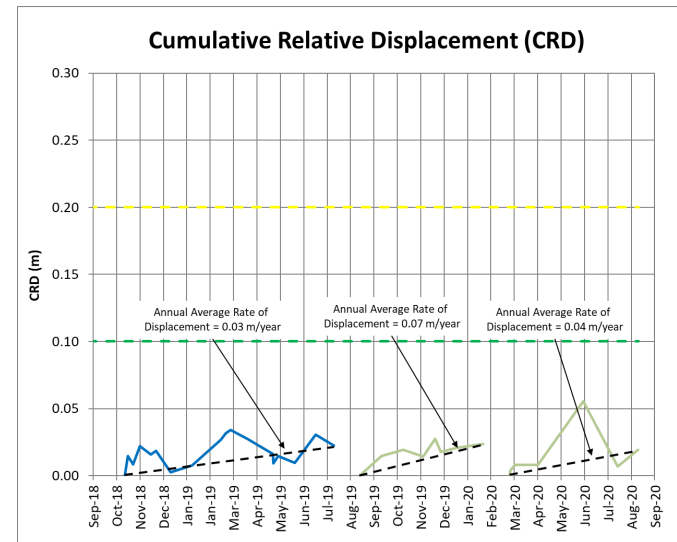
PROJECT No. <b>19133994</b>	Phase/Task/DOC. <b>3000/3003/2020-150</b>	Rev. <b>0</b>	FIGURE <b>D-24</b>
--------------------------------	--	------------------	-----------------------

References:  
 -2018 Aerial photo and topography provided by Teck Coal Limited. Flown 16 to 16 July 2018.  
 Notes:  
 -Prism data reset in February 2020 due to change in survey total station pillar  
 -Data from January to August 2020 may be erroneous due to errors in total station. Total station calibrated 8 July 2020  
 -Annual average rate of displacement was calculated based on prorating the data available to represent 12 months of movement. i.e. data was forecast forward assuming a linear increase.  
 -Data gaps present due to survey prisms being offline or moved during dam raise construction

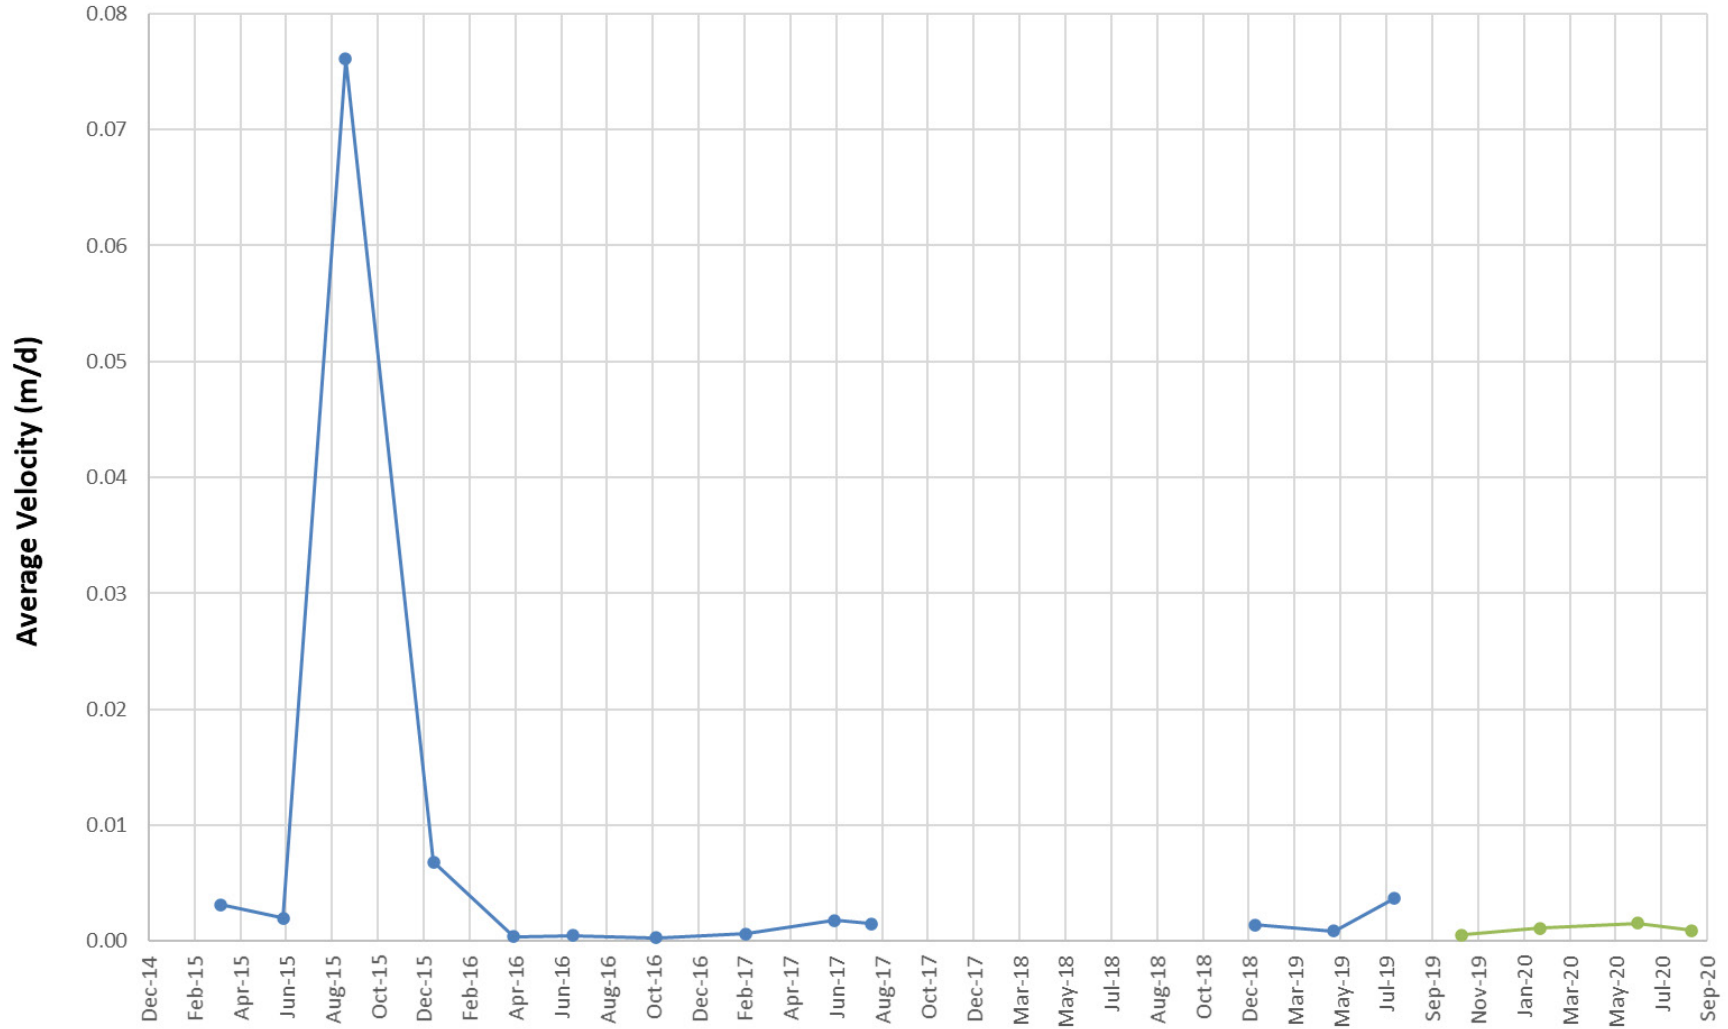
FIGURE  
**D-25**

Notes:  
 -Prism data reset in February 2020 due to change in survey total station pillar  
 -Data from January to August 2020 may be erroneous due to errors in total station. Total station calibrated 8 July 2020  
 -Data gaps present due to survey prisms being offline or moved during dam raise construction  
 -Average velocity calculated in metres per day from the average movement over the preceding approximately three-month period  
 -Average velocity data presented at the end of the calculation period (i.e. end of three months of data)

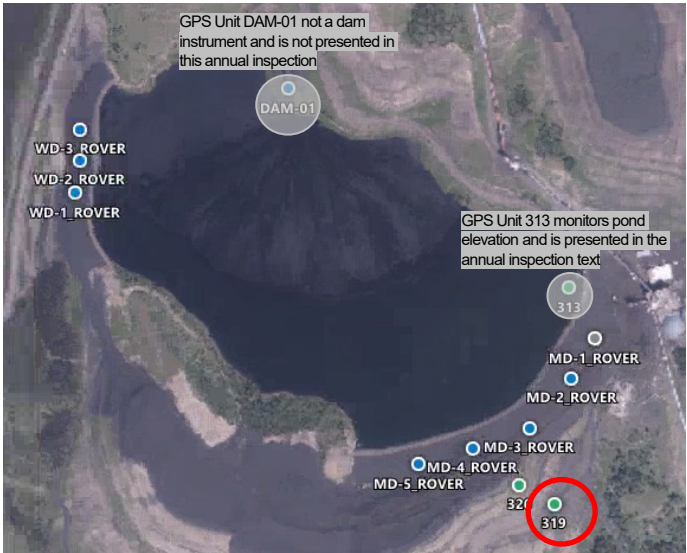
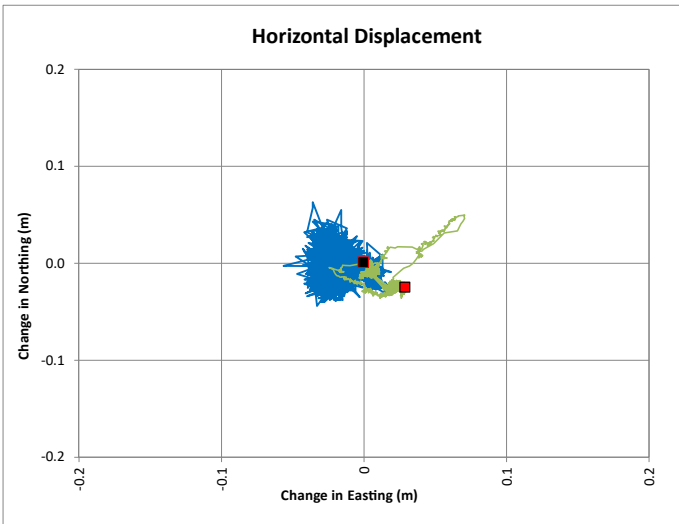
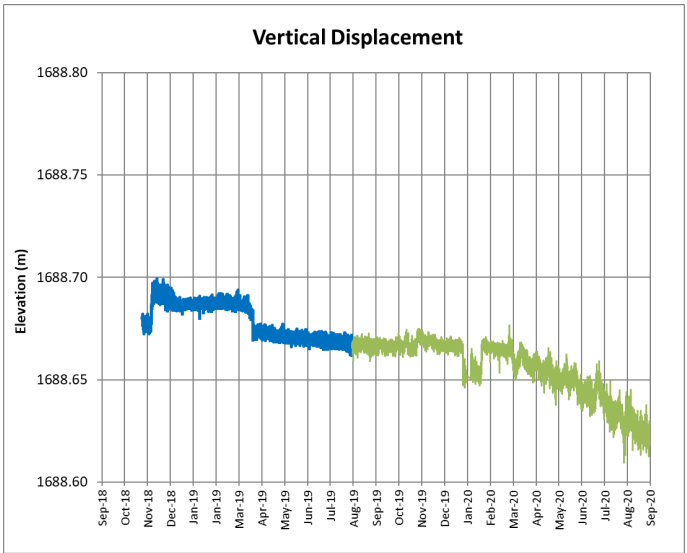
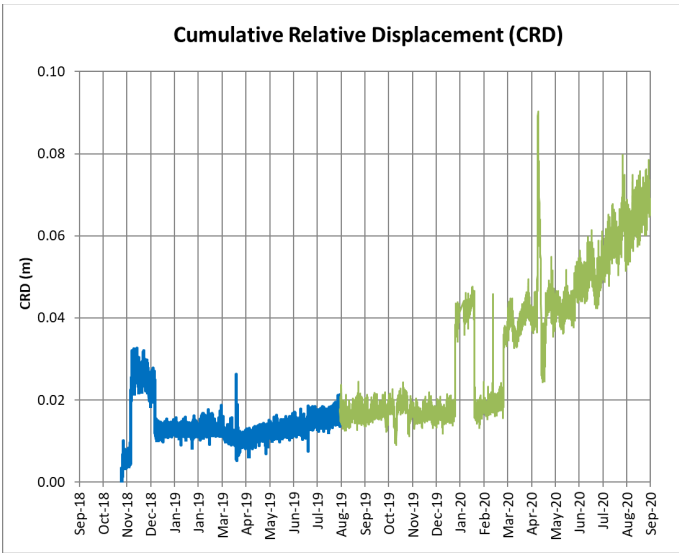
FIGURE  
 D-26

References:  
-2018 Aerial photo and topography provided by Teck Coal Limited. Flown 16 to 16 July 2018.  
Notes:  
-Data gaps present due to intermittent data signal, erroneous readings, or instrument or data logger malfunctions

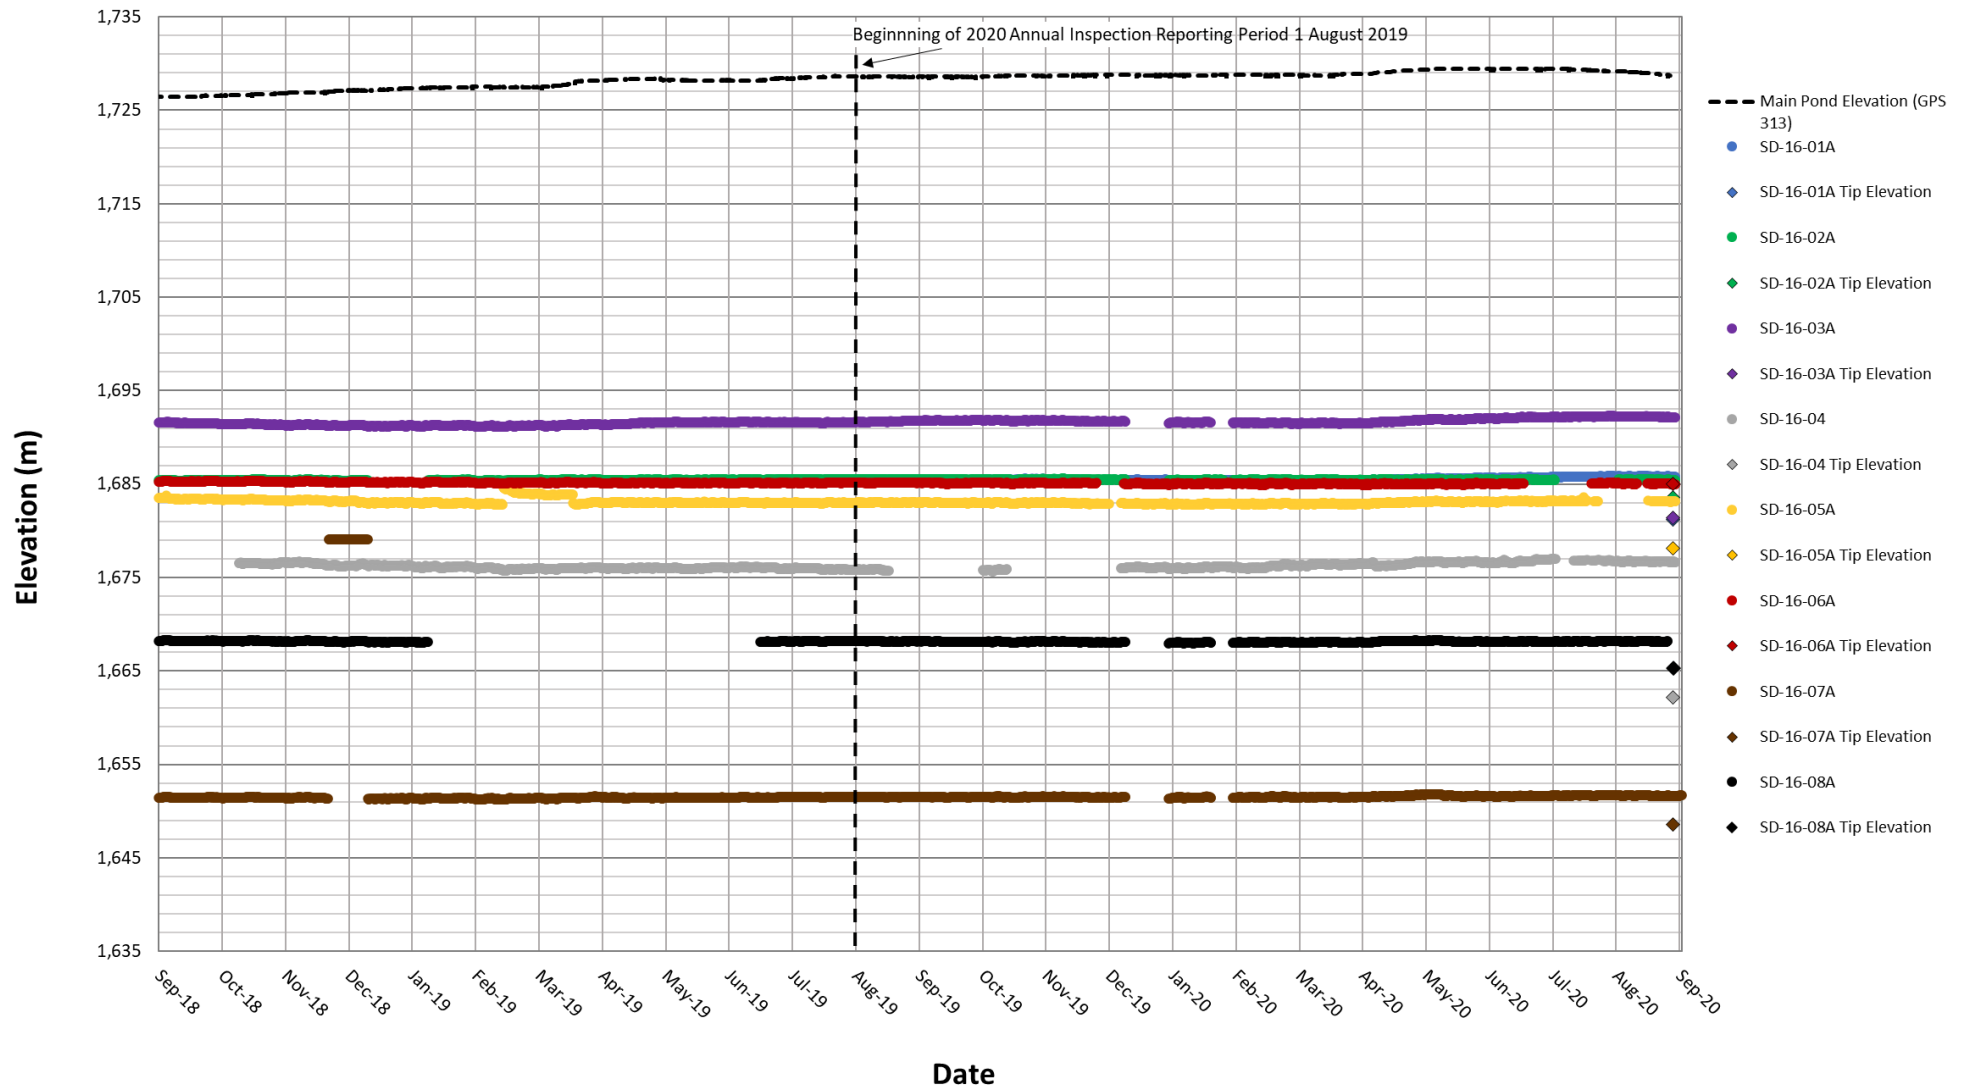
PROJECT No. <b>19133994</b>	Phase/Task/DOC. <b>3000/3003/2020-150</b>	Rev. <b>0</b>	FIGURE <b>E-1</b>
--------------------------------	--	------------------	----------------------

Data gaps present due to:

- Data being considered erroneous
- Negative pressure readings recorded indicating piezometer tip is dry. Piezometric levels cannot be determined from negative pressures
- Malfunctioning data loggers or instruments
- Intermittent data signal from instrument

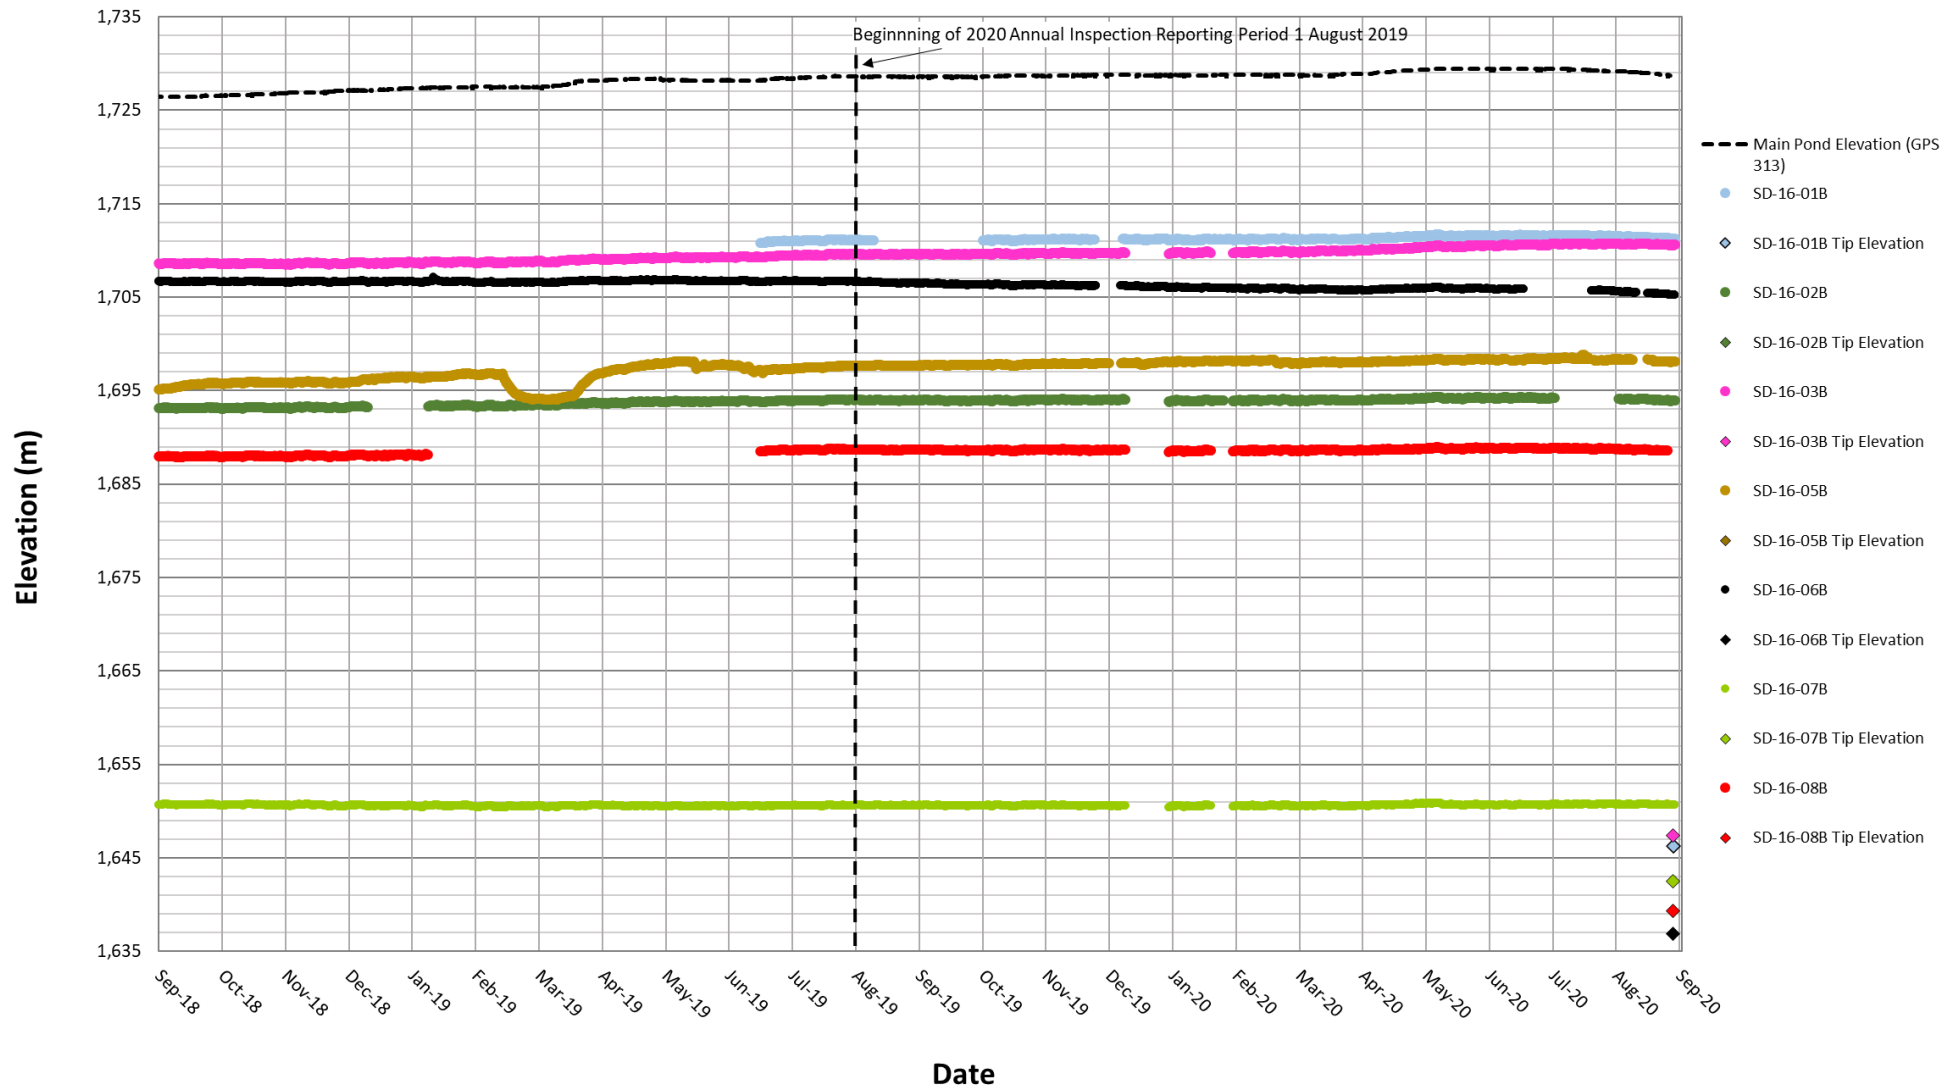
FIGURE  
**E-2**

- "B" piezometers installed in bedrock or deep till on average have higher piezometric levels than shallow piezometers due to artesian conditions

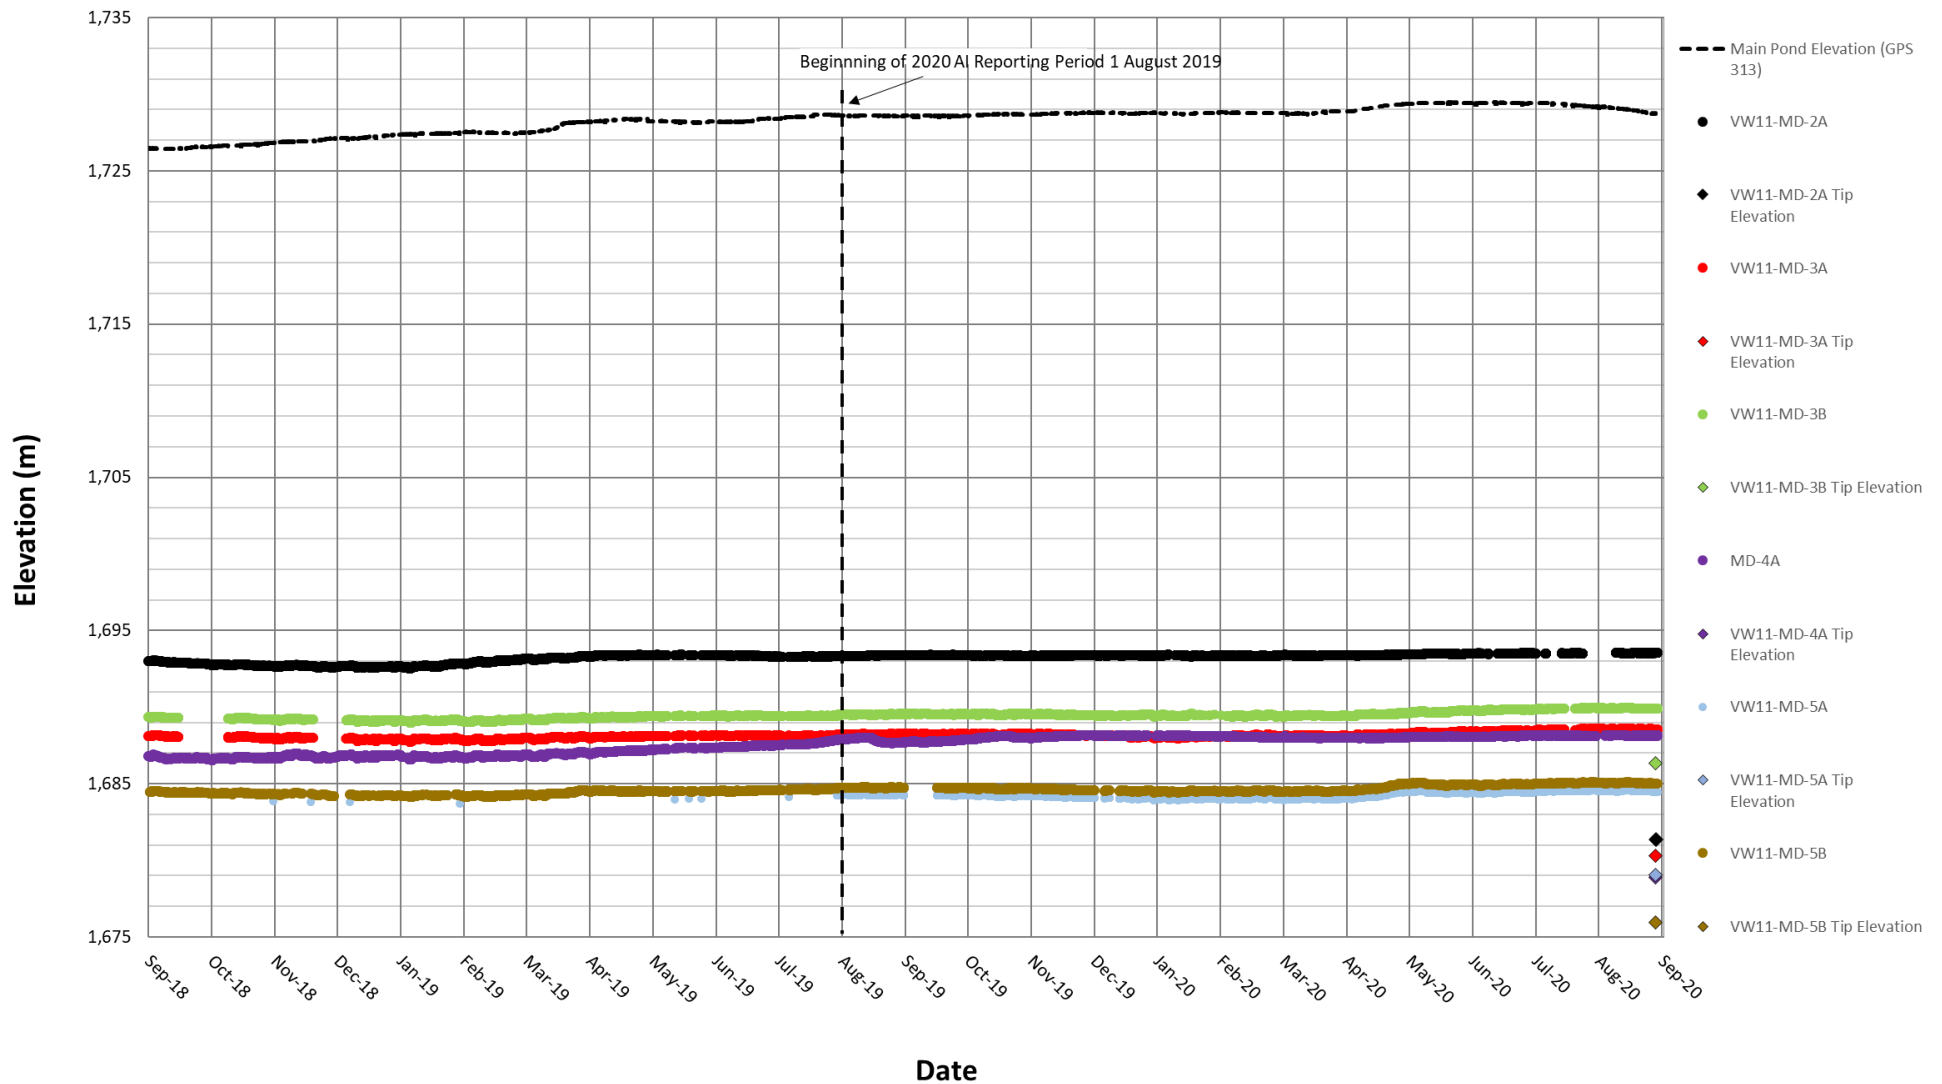
FIGURE  
**E-3**

Data gaps present due to:

- Data being considered erroneous
- Negative pressure readings recorded indicating piezometer tip is dry. Piezometric levels cannot be determined from negative pressures
- Malfunctioning data loggers or instruments
- Intermittent data signal from instrument
