Teck Highland Valley Copper Partnership

2020 Annual Facility Performance Report

Highland Tailings Storage Facility

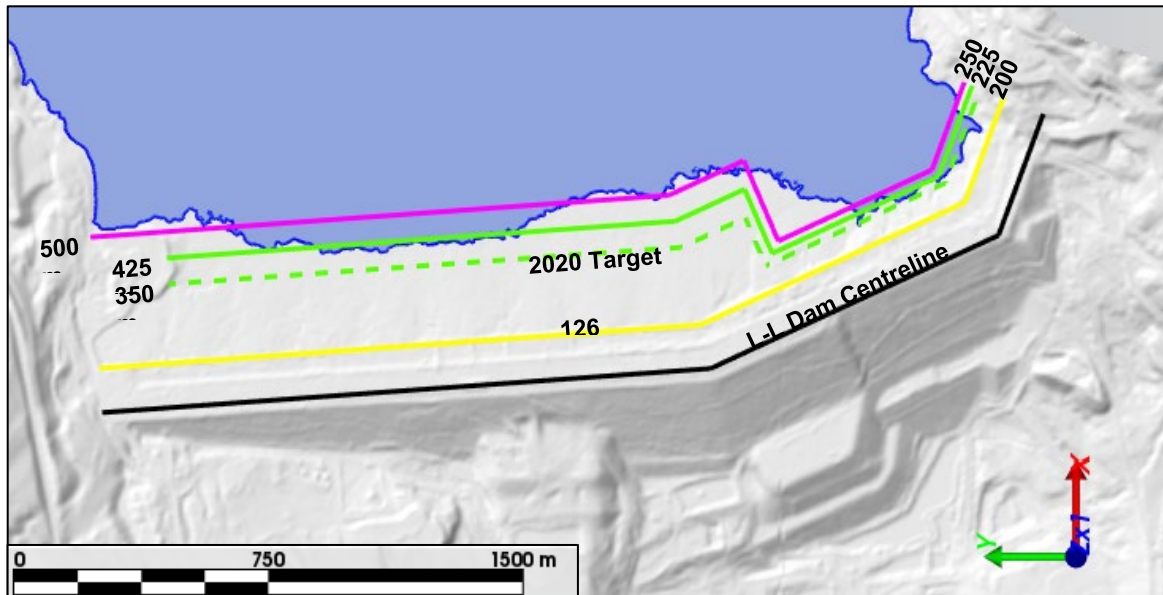
Figure 5.3 Status of L-L Dam Beach as of September 2020

A minimum beach width of 500 m at the North Abutment is required to reduce seepage flows and gradients through the foundation in this area (Section 7.4.2). During 2020, the 500 m beach width was maintained by a combination of spigotted tailings, foundation preparation spoils and overflow sediments from hydraulic placement, as shown on Figure 5.3.

In addition, THVCP has initiated a multi-year project to increase beach width along the length of the dam crest as a risk reduction activity. As part of this project, THVCP has set interim beach width targets which were met for 2020 (dashed green line, Figure 5.3).

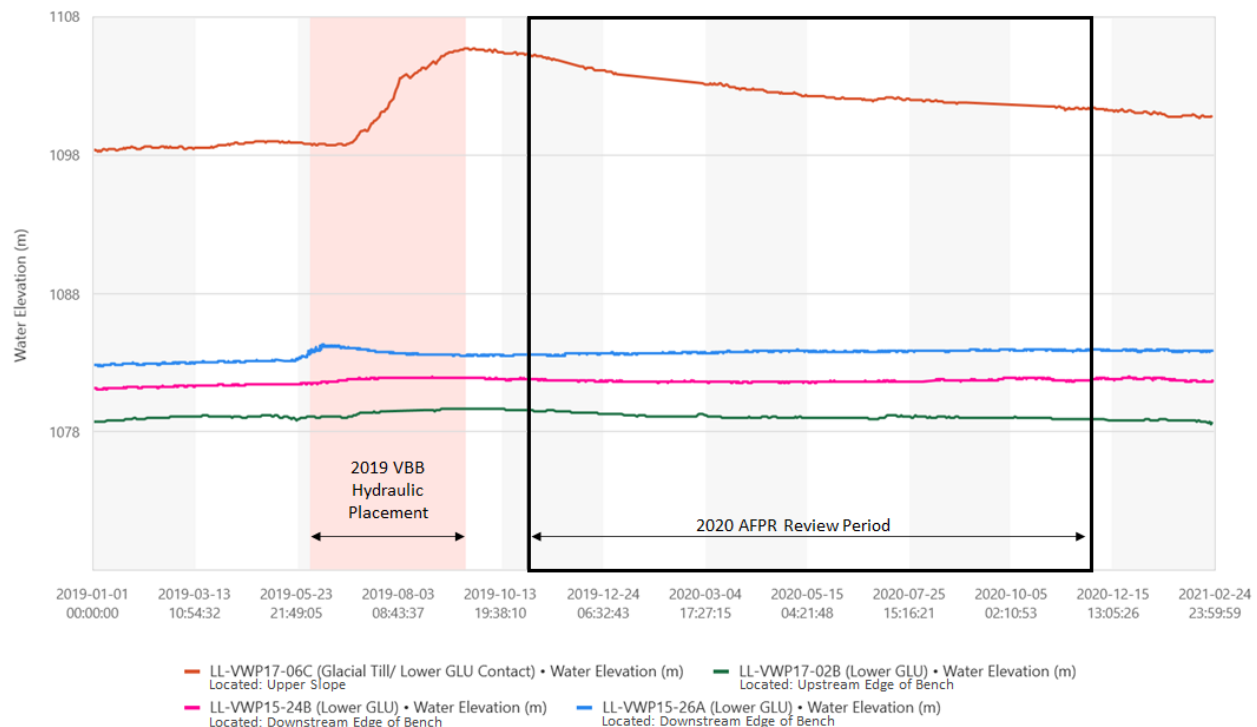
Figure 5.5 Piezometric Response In Lower-Glaciolacustrine Beneath VBB

Typical pore pressure response in the L-GLU is to increase in response to construction loading at the VBB, followed by a period of dissipation. As there was no downstream fill placement at the VBB during 2020 piezometric levels in the L-GLU continued to dissipate pore pressures from 2019 fill loading (below upper slope) or were steady throughout the review period (Figure 5.5).

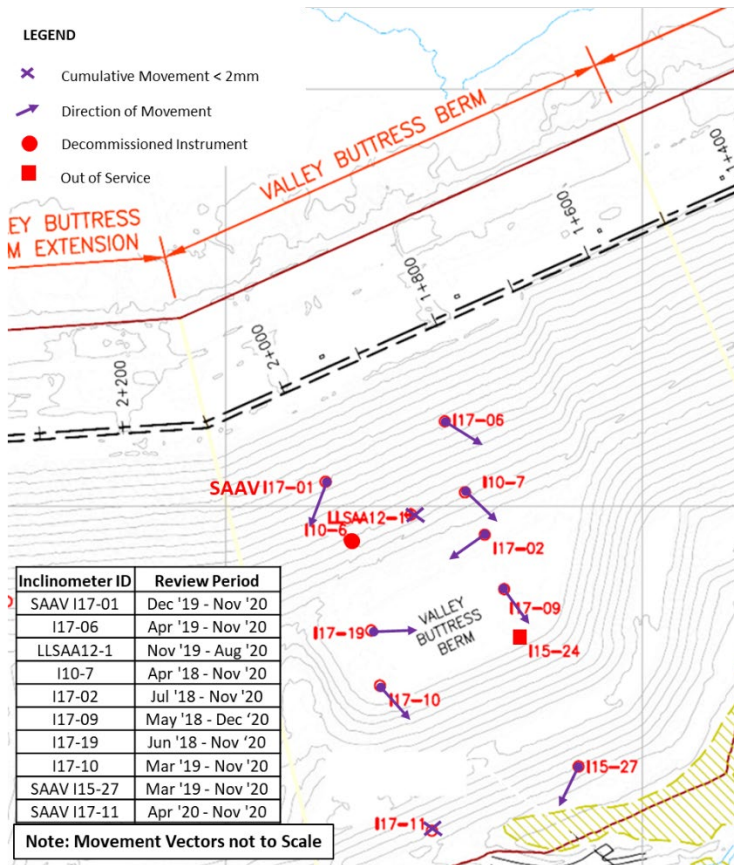
Figure 5.6 Direction of Measured Movements Within the Lower-Glaciolacustrine Unit

Figure 5.6 shows the inferred direction of movement from the inclinometer readings, note that the arrows are not scaled to magnitude of movement. The movement trend is generally downstream but variable. Both are consistent with the expected response based on design analysis, natural variability within the L-GLU deposits and given the small magnitude of movement can also be influence by the reading accuracy of the inclinometer.

As discussed in Section 5.1, three inclinometers in the same area of the downstream slope (I10-6, I10-7 and LLSAA12-01, shown on Figure 5.6) went out of service during 2019 and 2020. A replacement instrument in this area is recommended to continue use of the Observational Method as per design. When each inclinometer went out of service THVCP completed an investigation to confirm the cause. KCB reviewed this and recent dam performance in the area to confirm the cause was not related to adverse behaviour of the dam.

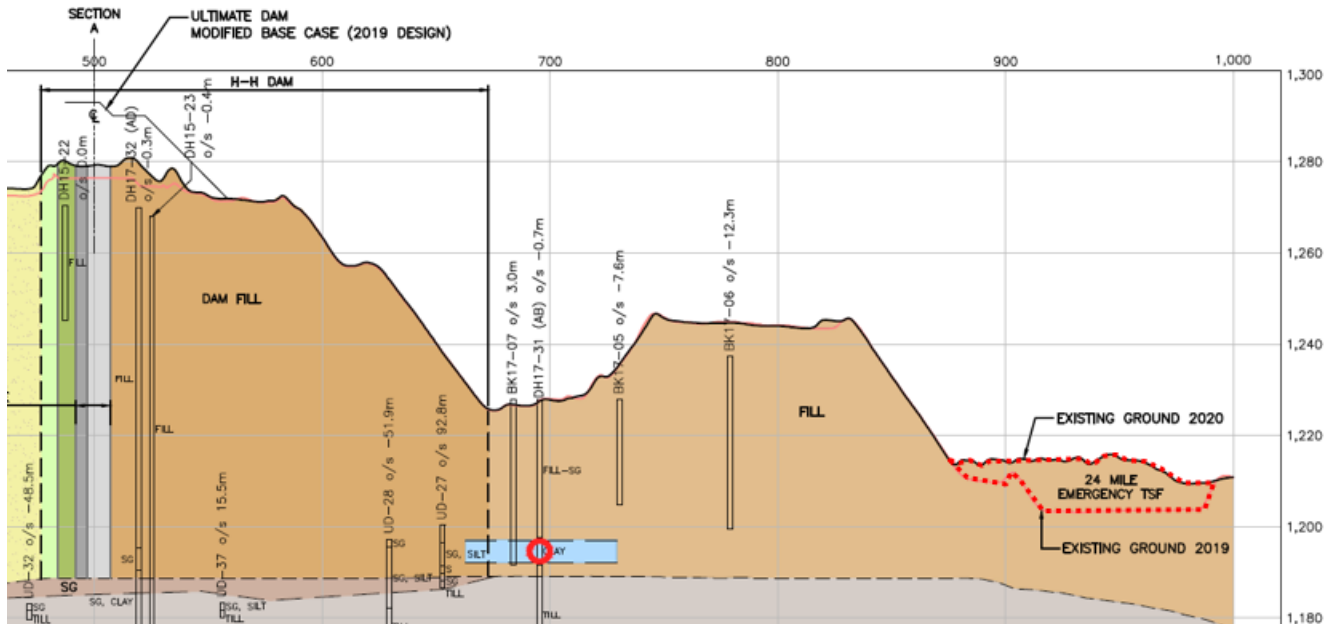
Figure 5.12 Old Tailings Channel Backfilled Area

- THVCP mine fleet placed a second lift of waste over the portion of the 24 Mile Waste Dump that is built over tailings. This included backfilling of the old channel where tailings flowed from H-H Pumphouse to 24 Mile Emergency TSF which was recommended by KCB, refer to Section 5.3.2.

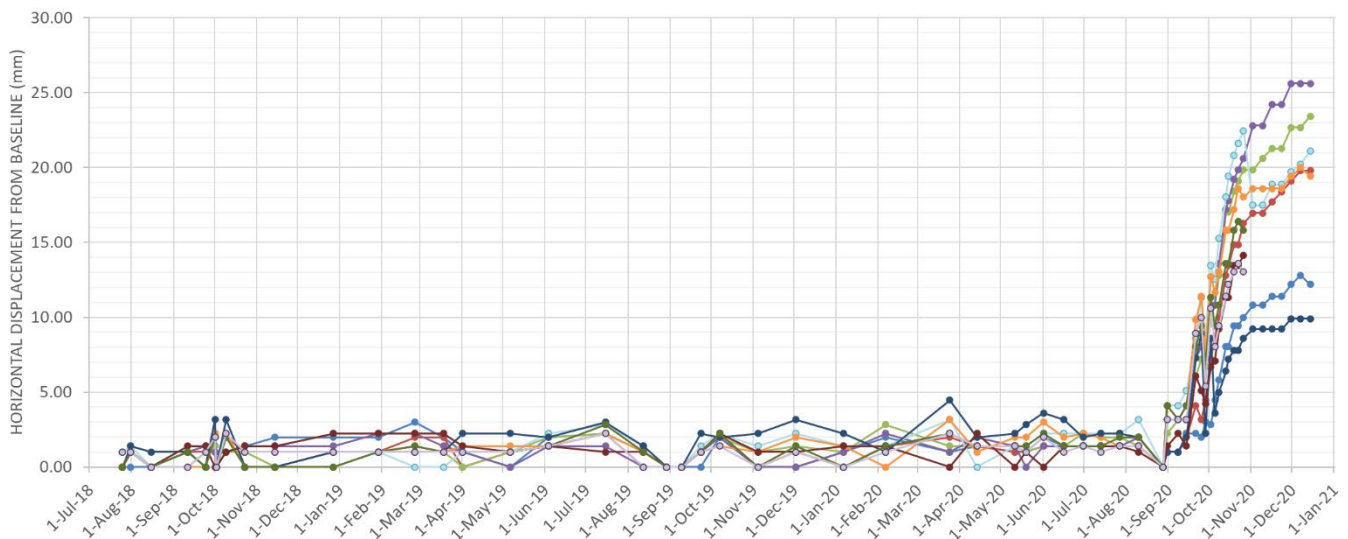
Figure 5.13 Lock Block Wall Monuments: Horizontal Displacement From Baseline (2018 to 2020)

As the upstream fill placement progressed and the fill was placed higher up on the slope (and therefore further away from the wall), the movement rate started to attenuate. At the end of October, THVCP placed fill downstream to support the lower portion of the wall (Section 3.2), which had an immediate impact on further reducing the movement rates. Fill was continuing to be placed at the end of the review period but the movement at some instruments has almost stopped. Figures of monument surveys, and their locations, are included in Appendix IV-D.

Note: Lower row of monuments were buried by fill placed downstream of wall in October.

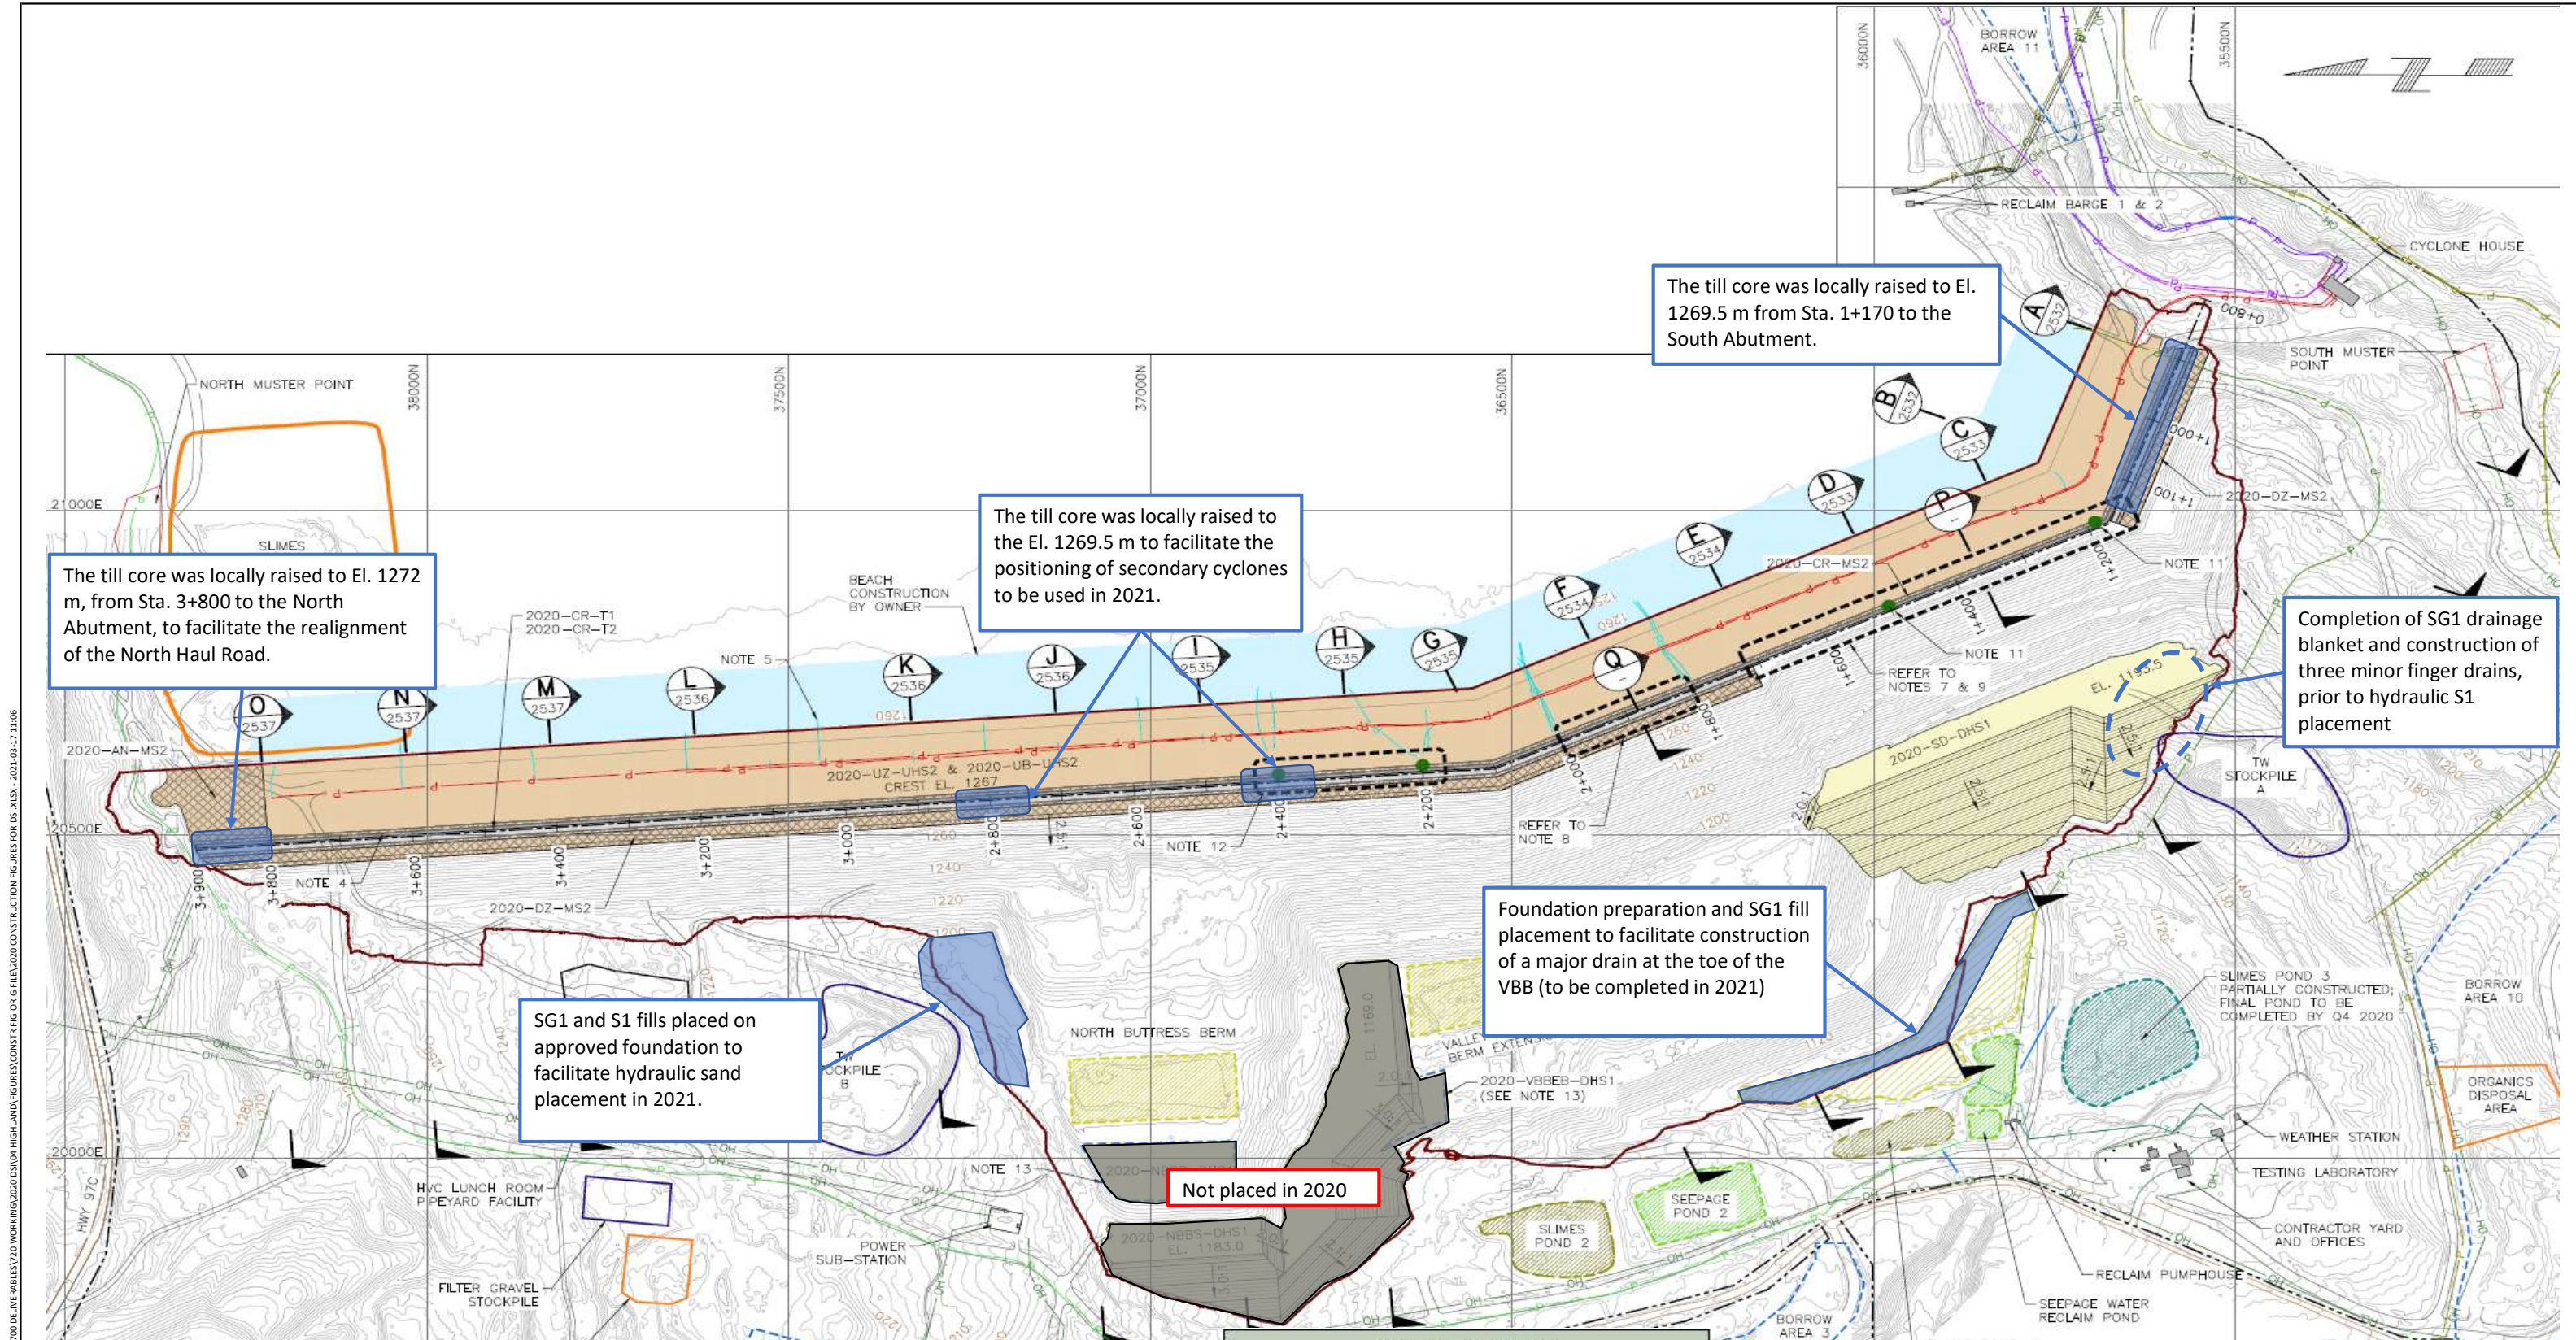
The till core was locally raised to El. 1272 m, from Sta. 3+800 to the North Abutment, to facilitate the realignment of the North Haul Road.

The till core was locally raised to the El. 1269.5 m to facilitate the positioning of secondary cyclones to be used in 2021.

Foundation preparation and SG1 fill placement to facilitate construction of a major drain at the toe of the VBB (to be completed in 2021)

SG1 and S1 fills placed on approved foundation to facilitate hydraulic sand placement in 2021.

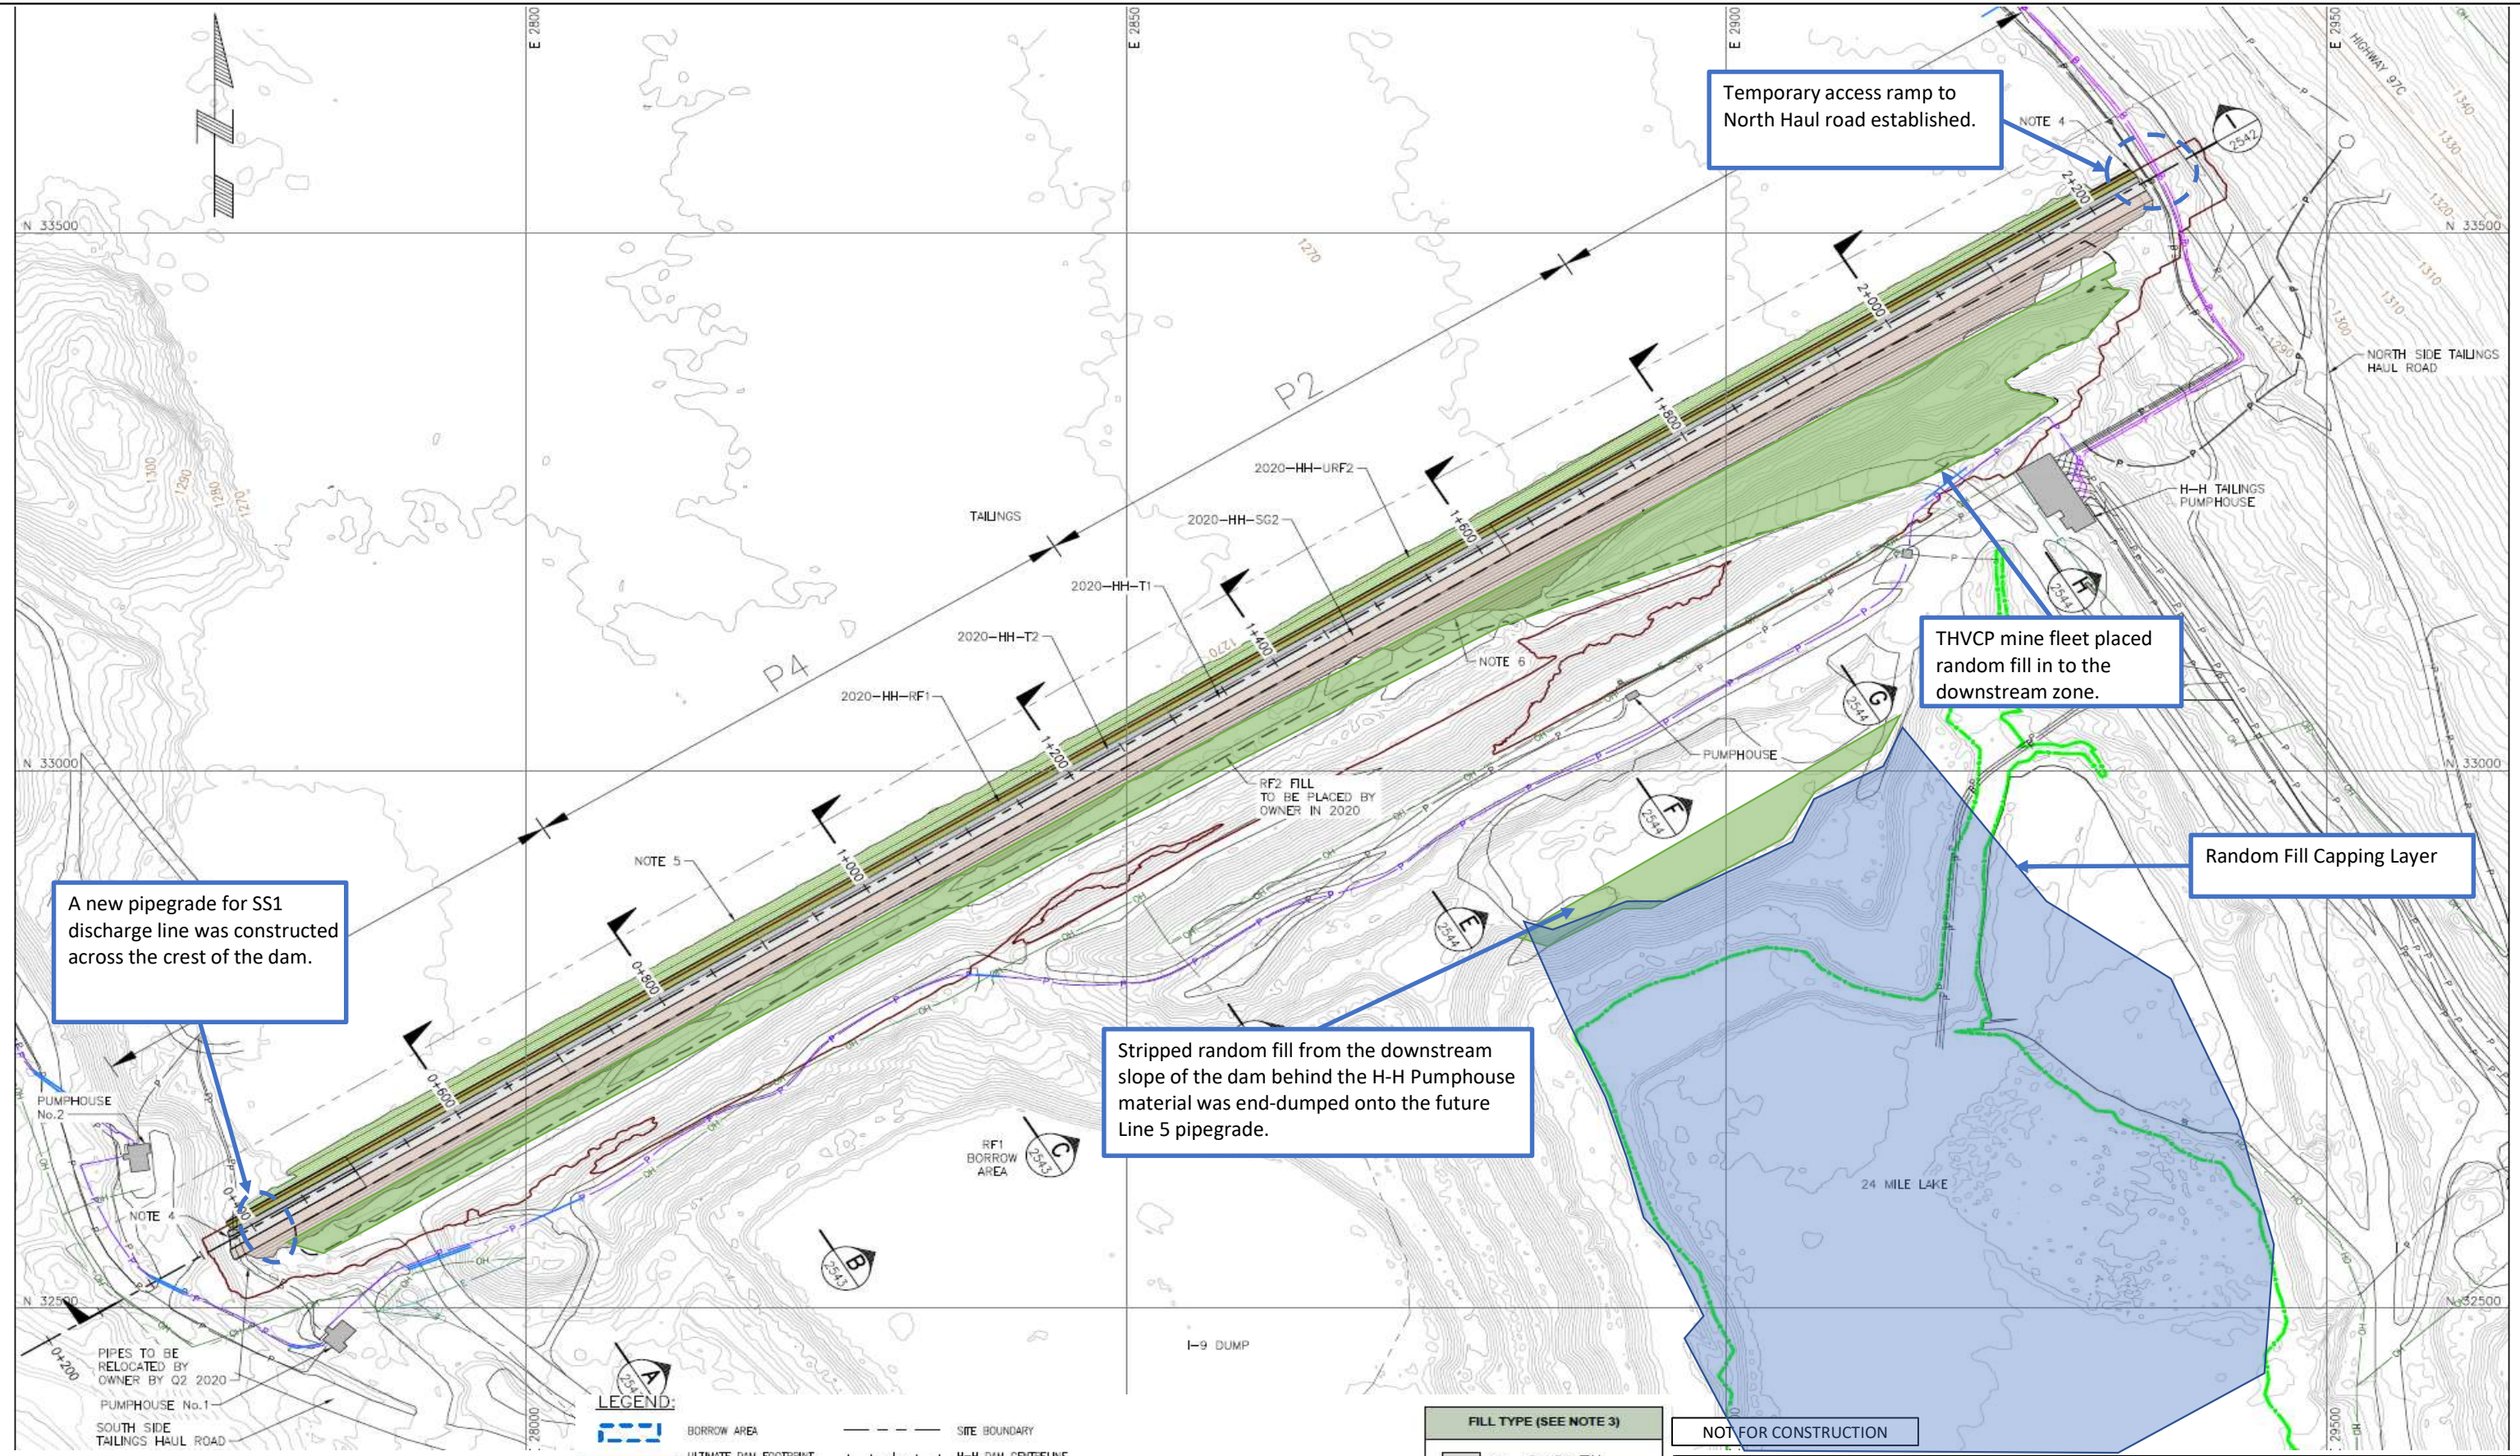
PROJECT	HIGHLAND TAILINGS STORAGE FACILITY 2020 ANNUAL FACILITY PERFORMANCE REPORT		
TITLE	H-H DAM 2020 CONSTRUCTION WORK AREAS		
SCALE	PROJECT No.	FIG. No.	
NTS	M02341B83		7

A new pipegrade for SS1 discharge line was constructed across the crest of the dam.

Temporary access ramp to North Haul road established.

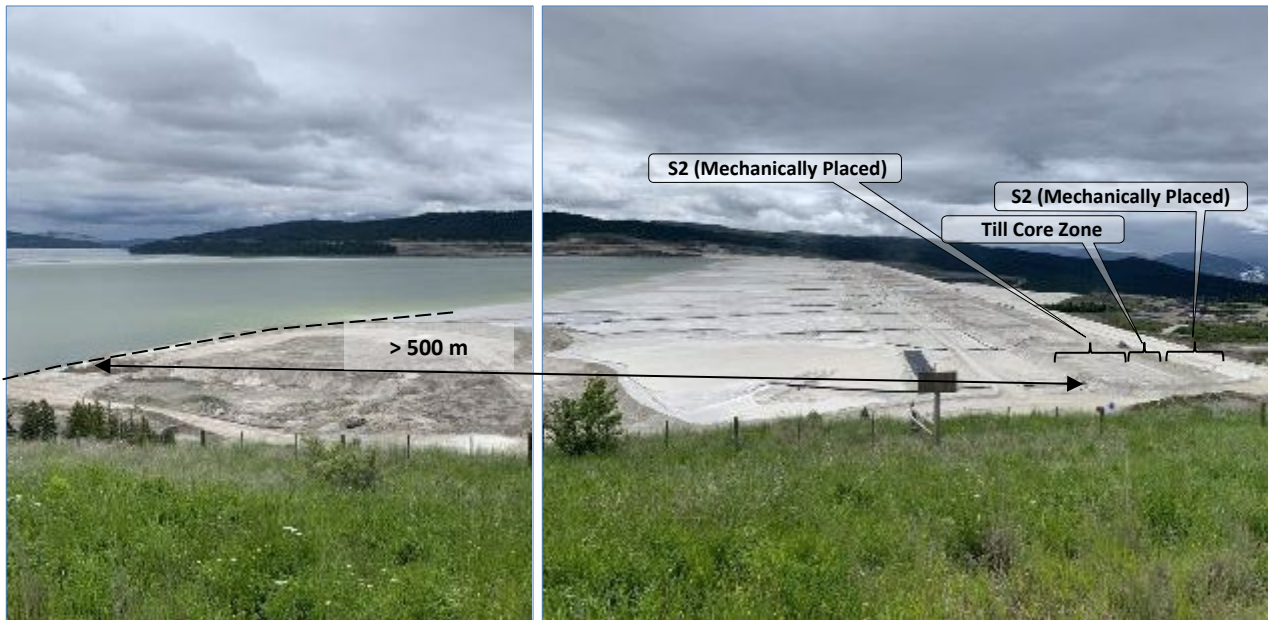
Good physical condition; no visual indicators of concern (Photo I-A-1 to Photo I-A-4).

Photo I-A-1 Overview of North Dam tailings beach (>500 m wide) and crest from North Abutment (LL-2020-01)

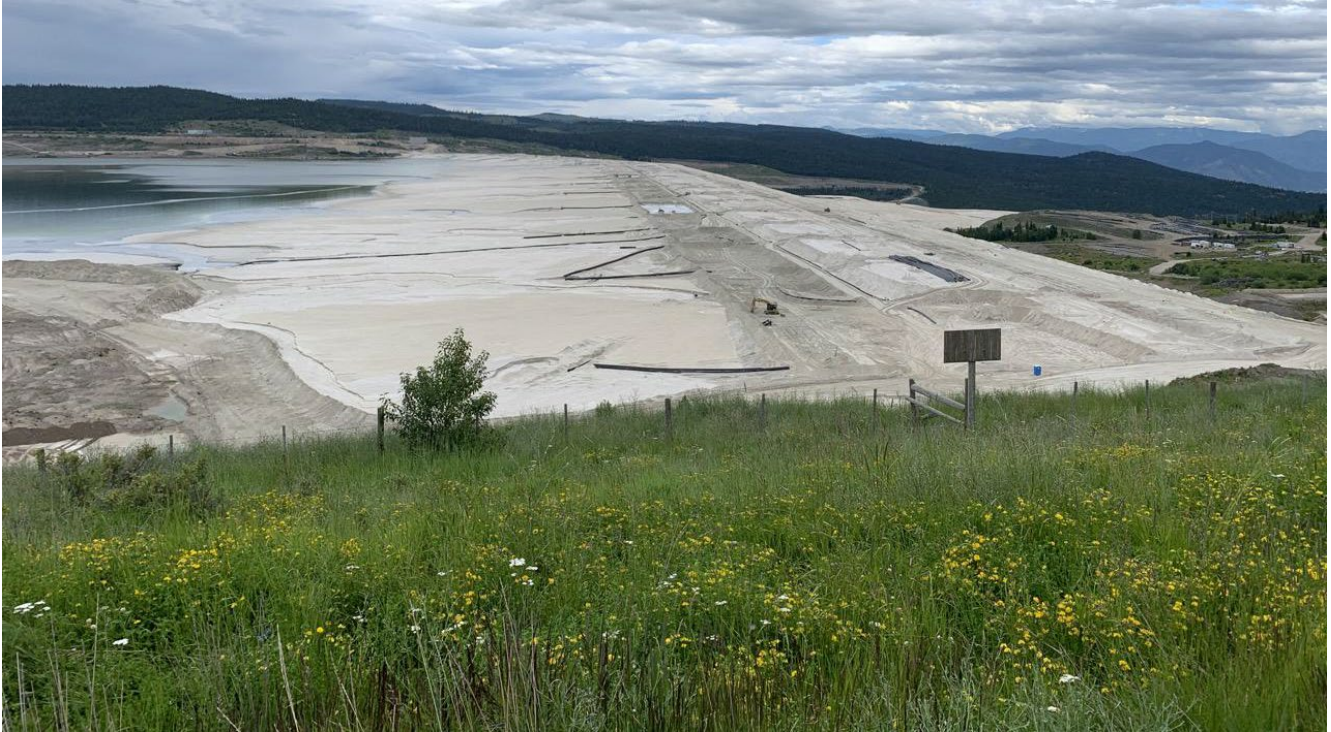
Photo I-A-2 Hydraulic sand placement was ongoing on upstream sand zone on July 16, 2020. Overview of beach development (LL-2020-02)

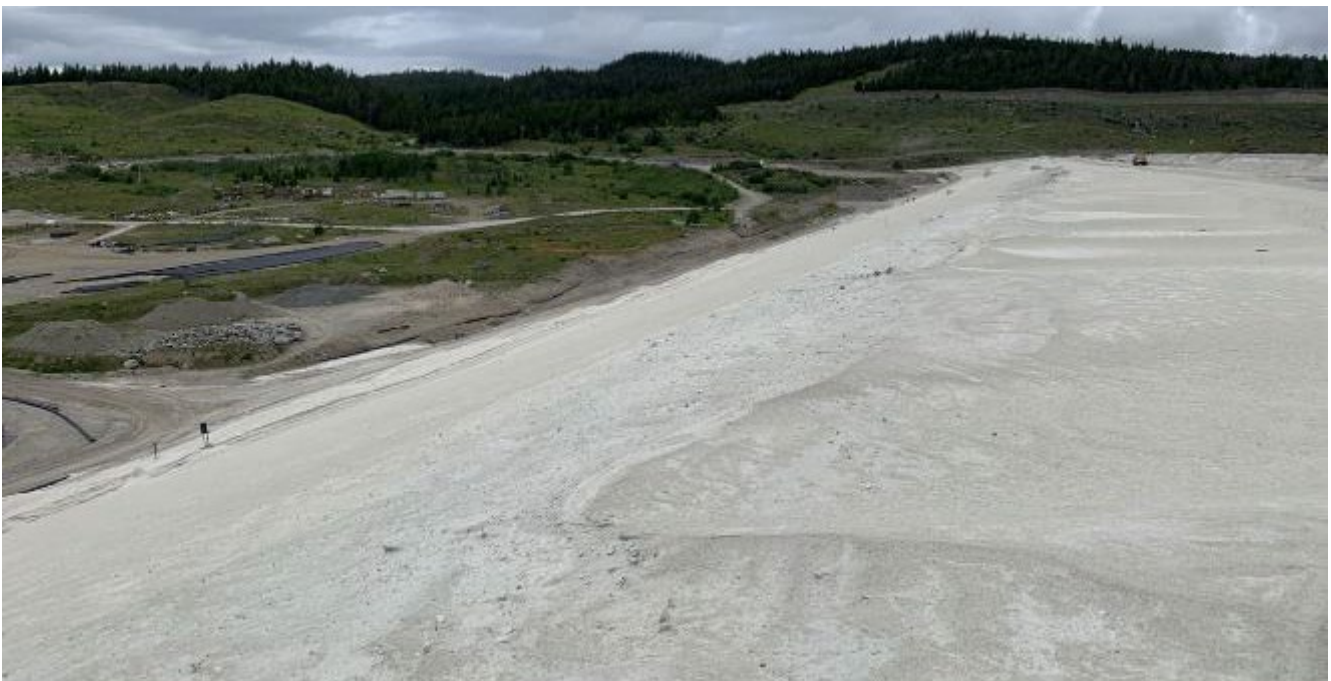
Photo I-A-3 View of North Dam crest and downstream slope, looking north (LL-2020-03)

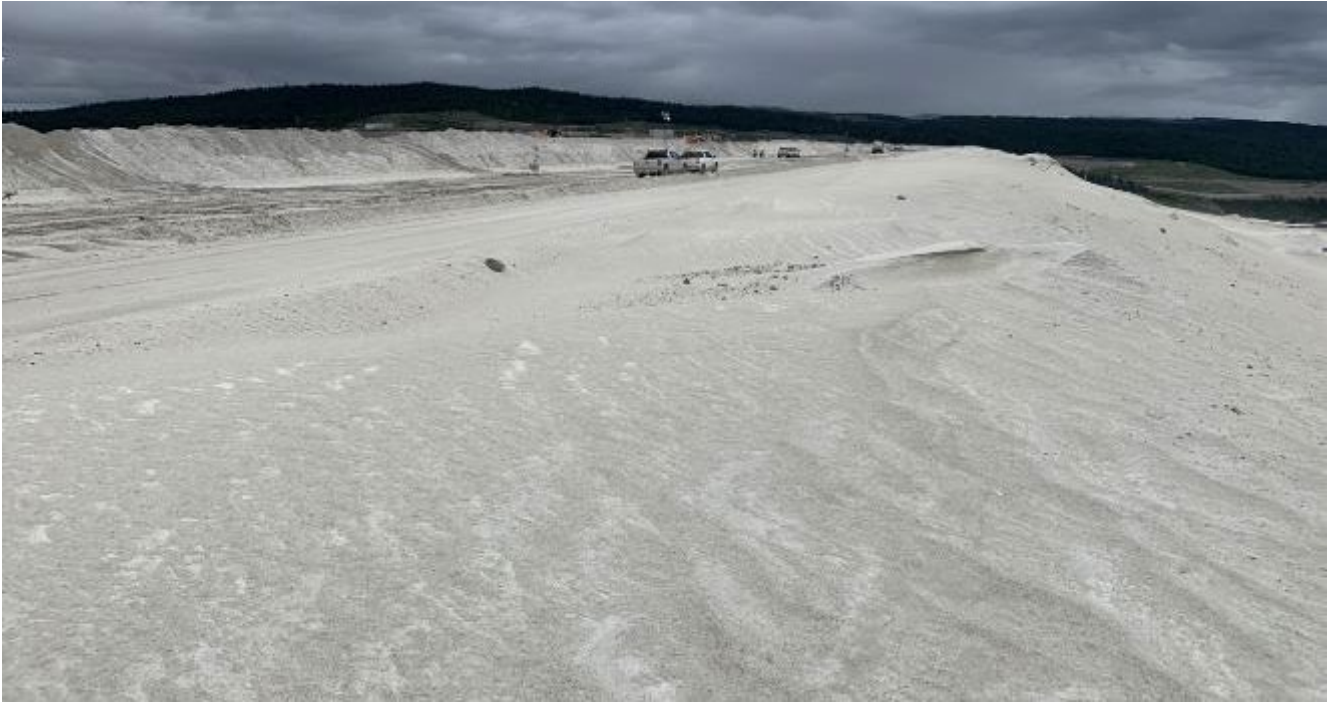
Photo I-A-4 View of L-L Dam crest – looking south (LL-2020-03)

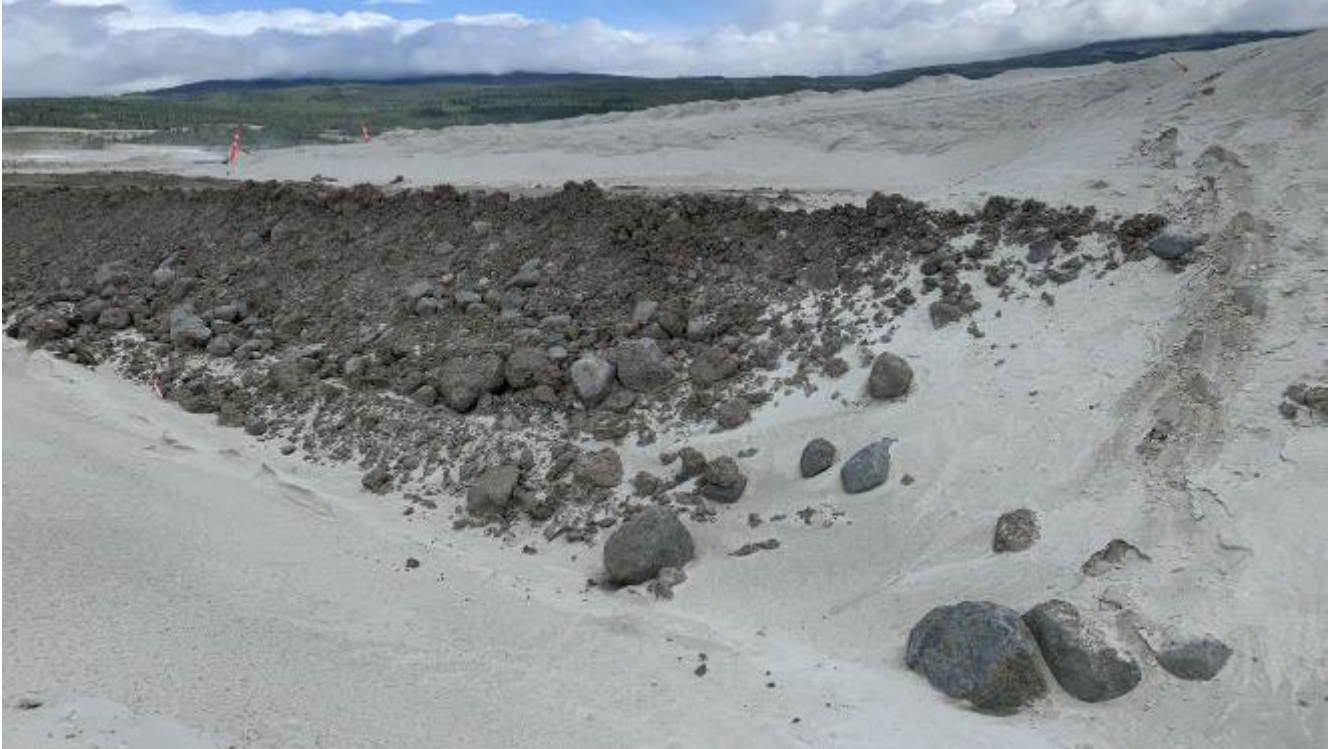
Good physical condition; no observations of significant erosion or excessive seepage (Photo I-A-5).

Photo I-A-5 View of raised Till Core Zone at South Dam. Oversized were pushed to edge of lift (LL-2020-04)

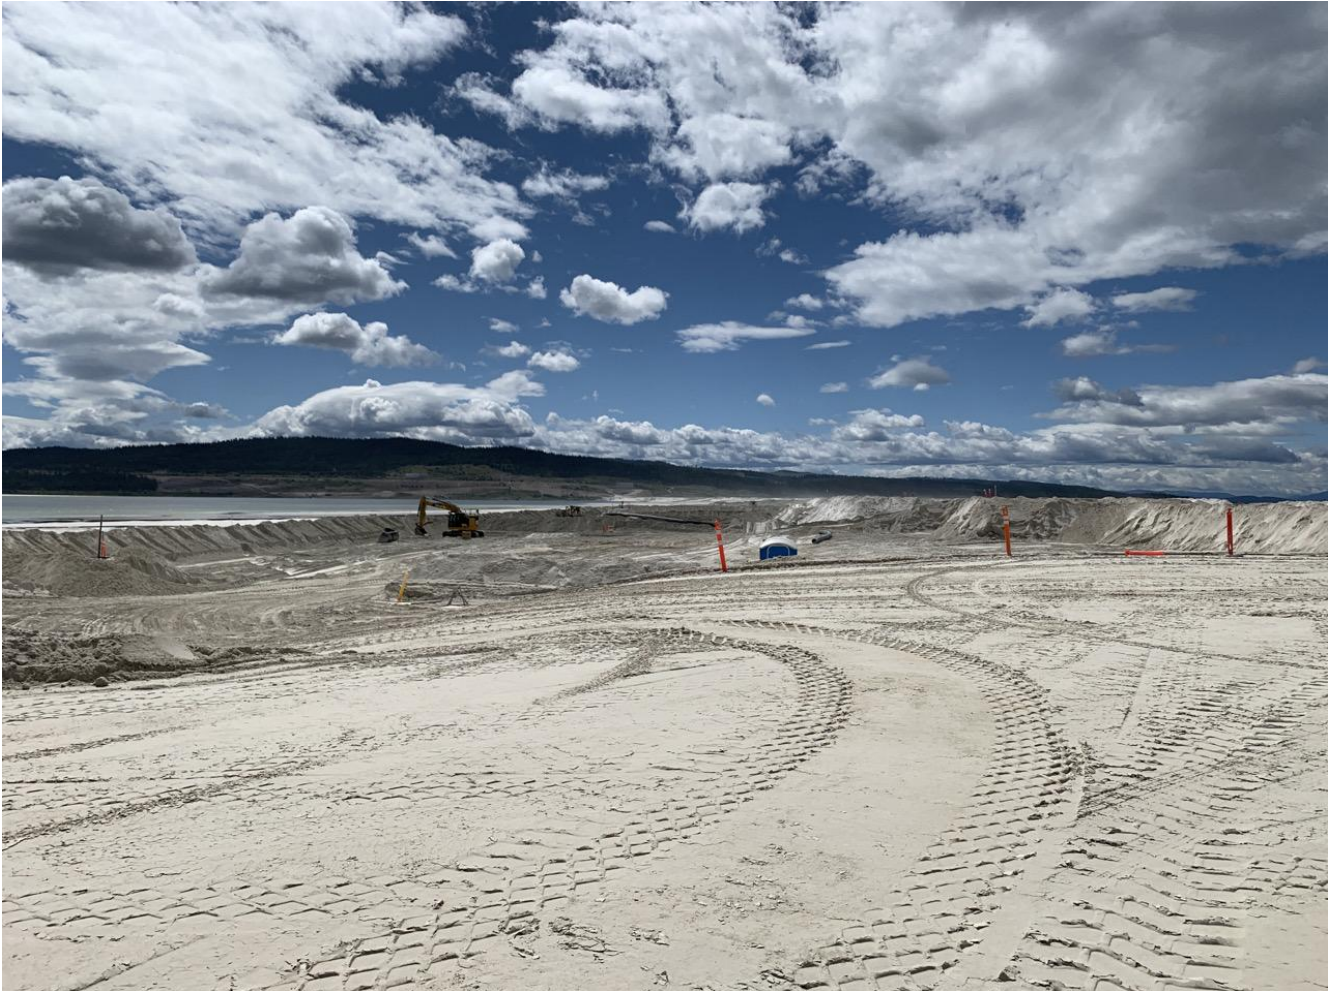
Photo I-A-6 View of an upstream hydraulic placement cell (LL-2020-05)

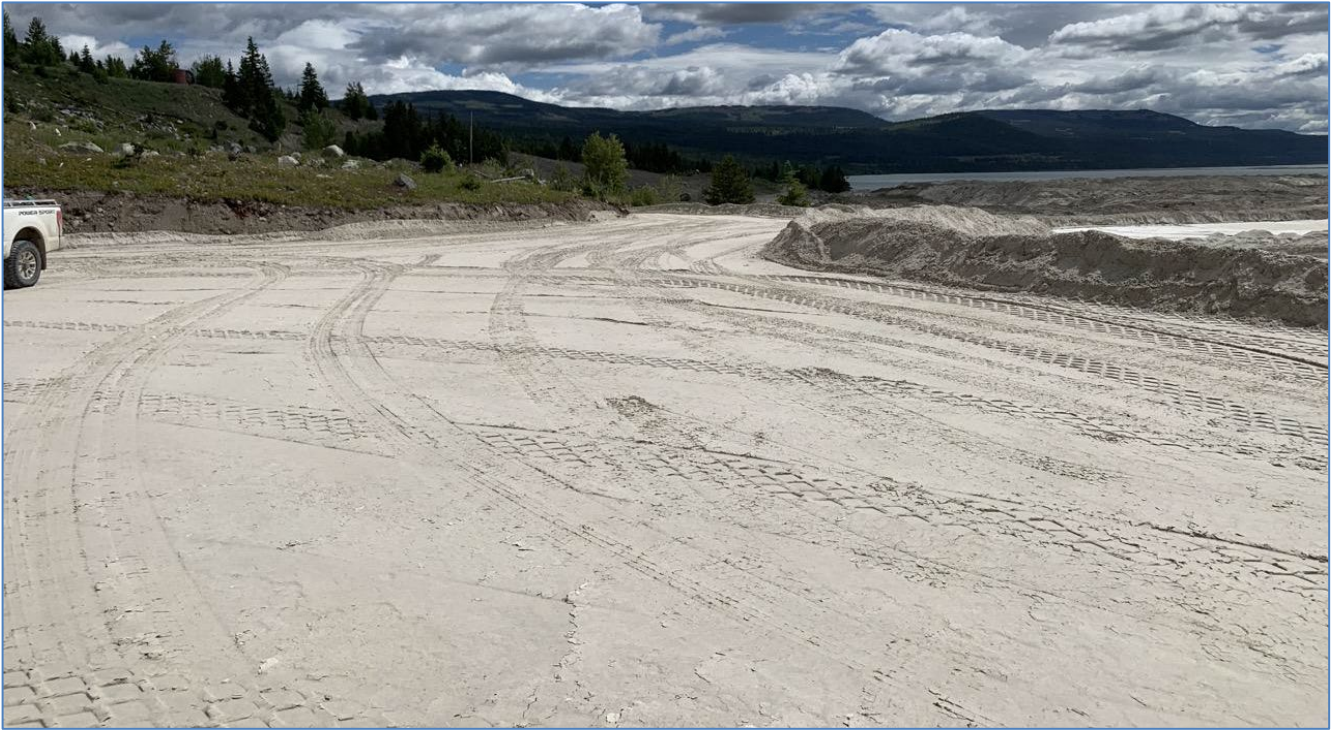
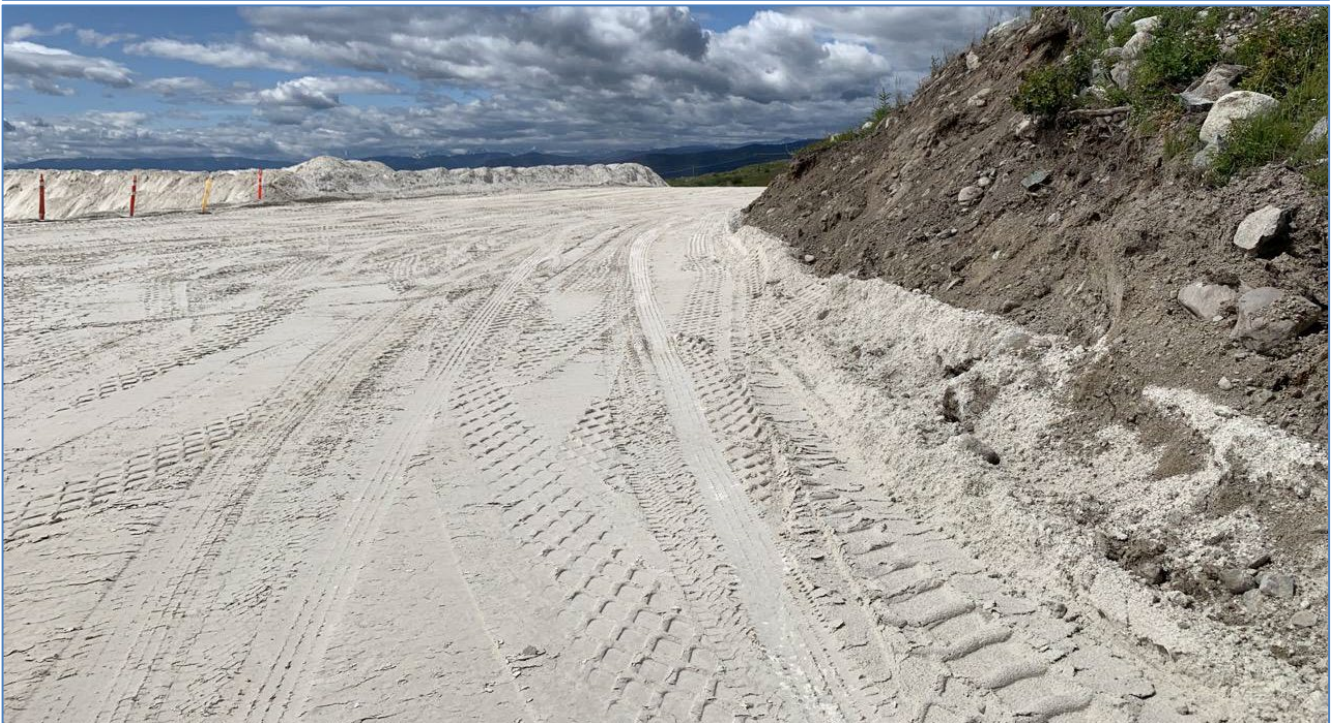
Good physical condition; no observations of significant erosion or excessive seepage (Photo I-A-7).

No observed dam safety issues of concern. At time of inspection, active construction included cell preparation for upstream cycloned sand to support the 2020 crest raise (Photo I-A-7 to Photo I-A-9).

Photo I-A-7 View of key-in of Core Zone at North Abutment (LL-2020-05)

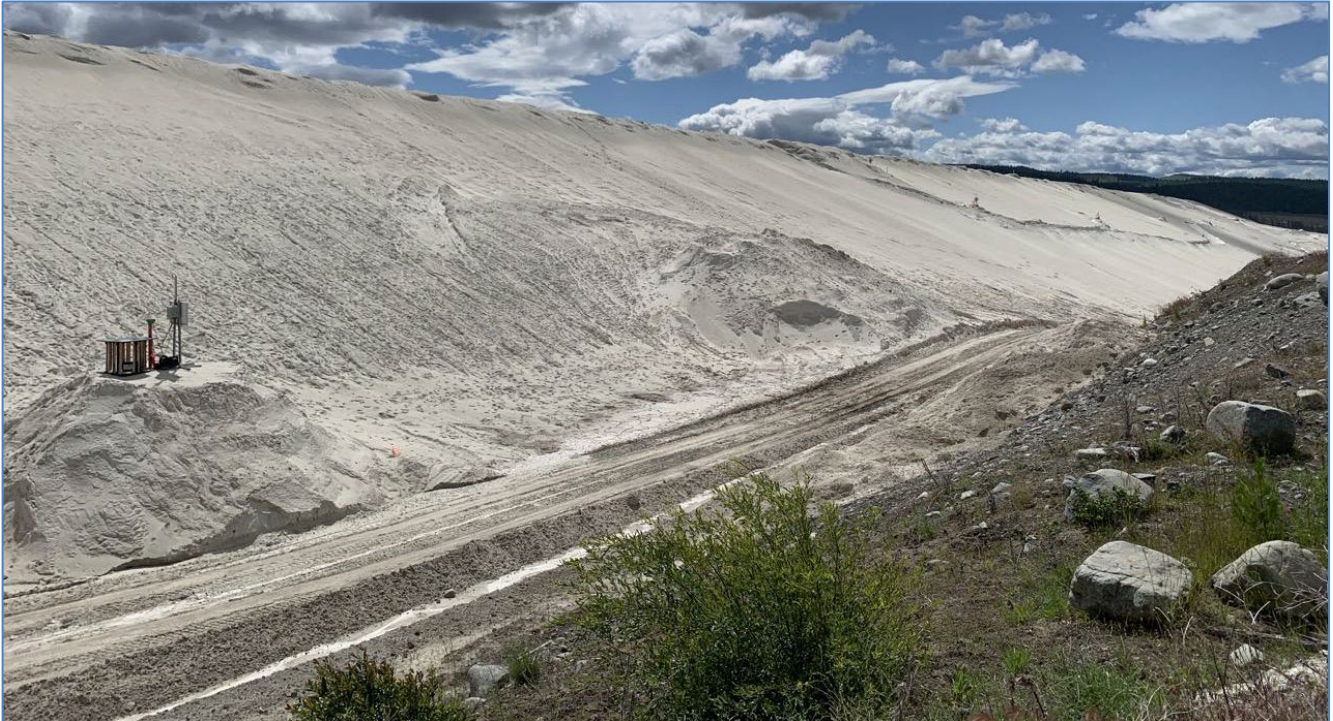
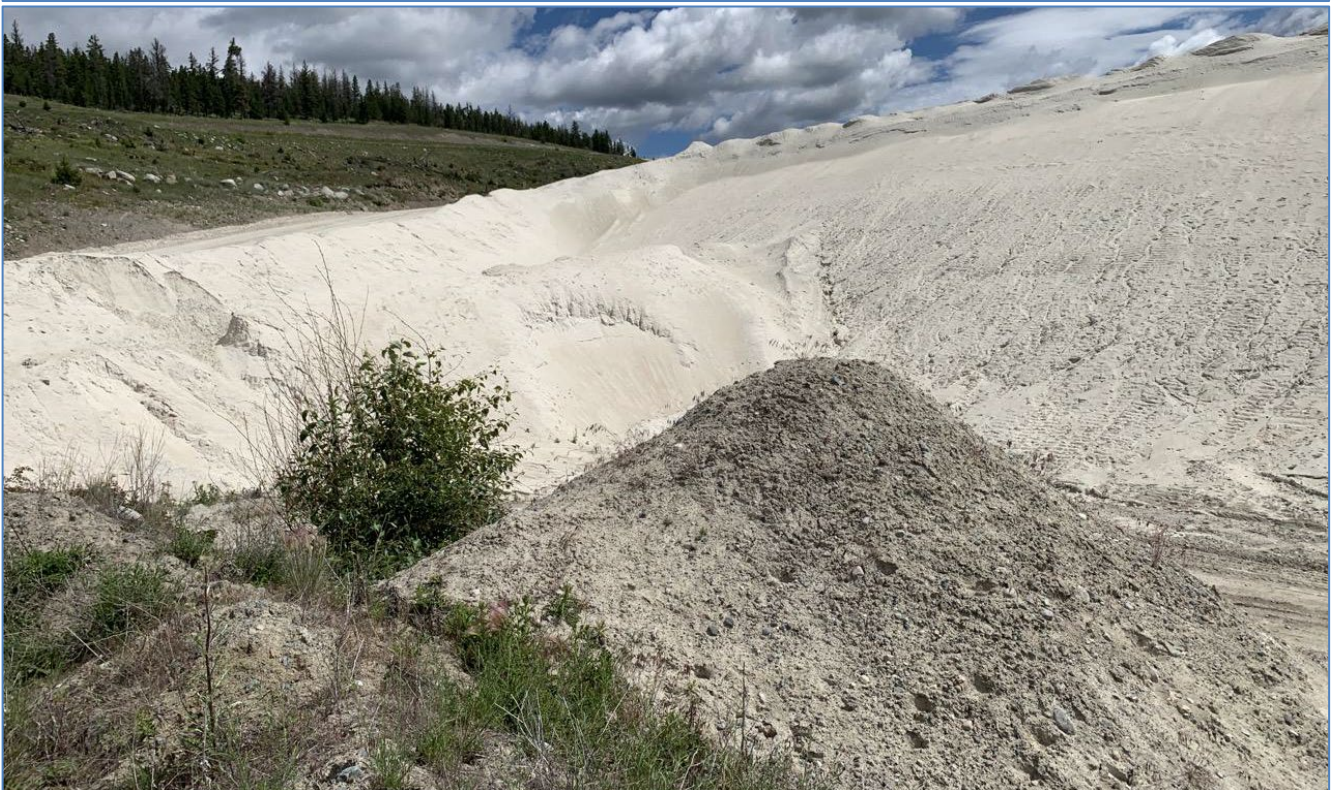
Photo I-A-8 Overview of the downstream slope of North Dam near I19-04. Wet area in low point of toe road but no seepage faces or wet areas on dam slope (LL-2020-06)
