Teck Highland Valley Copper Partnership

2020 Annual Facility Performance Report

Highland Tailings Storage Facility

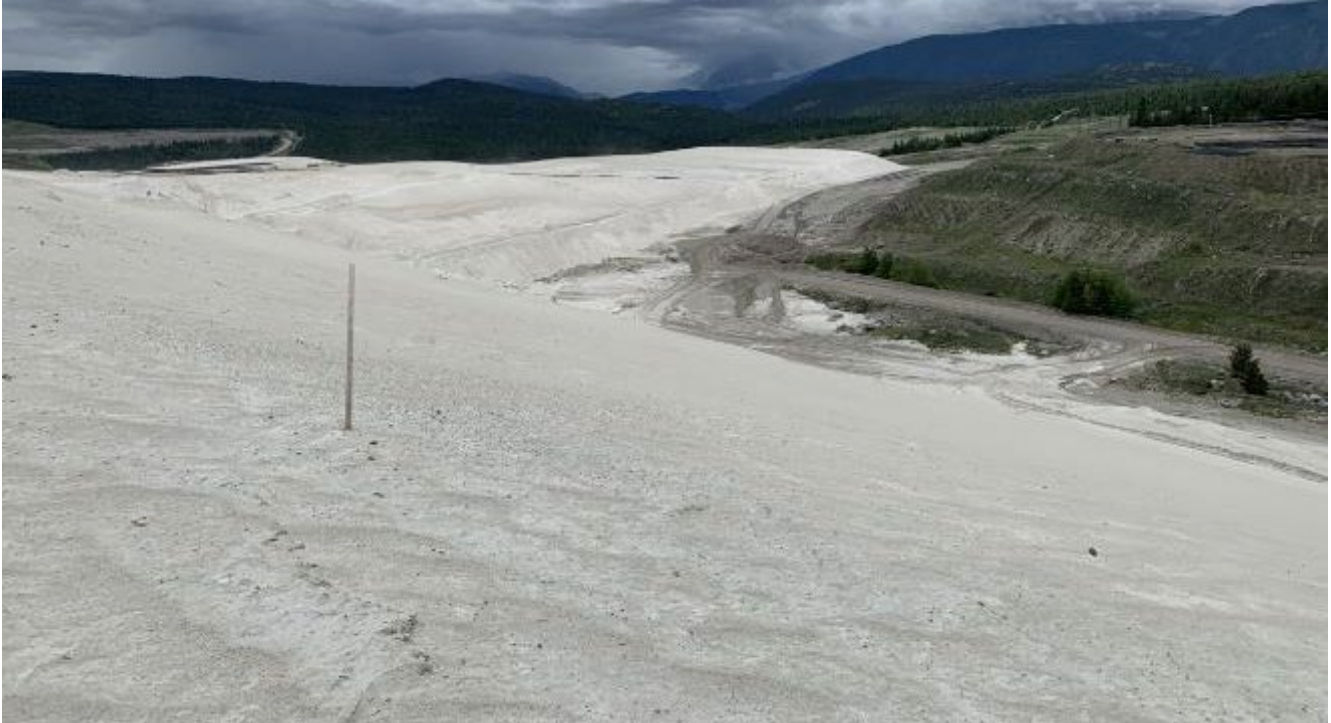
No observed dam safety issues of concern. At time of inspection, active construction included cell preparation for upstream cycloned sand to support the 2020 crest raise (Photo I-A-7 to Photo I-A-9).

Photo I-A-9 Overview of the downstream slope of North Dam and North Buttress Berm segment, looking southwest (LL-2020-03)

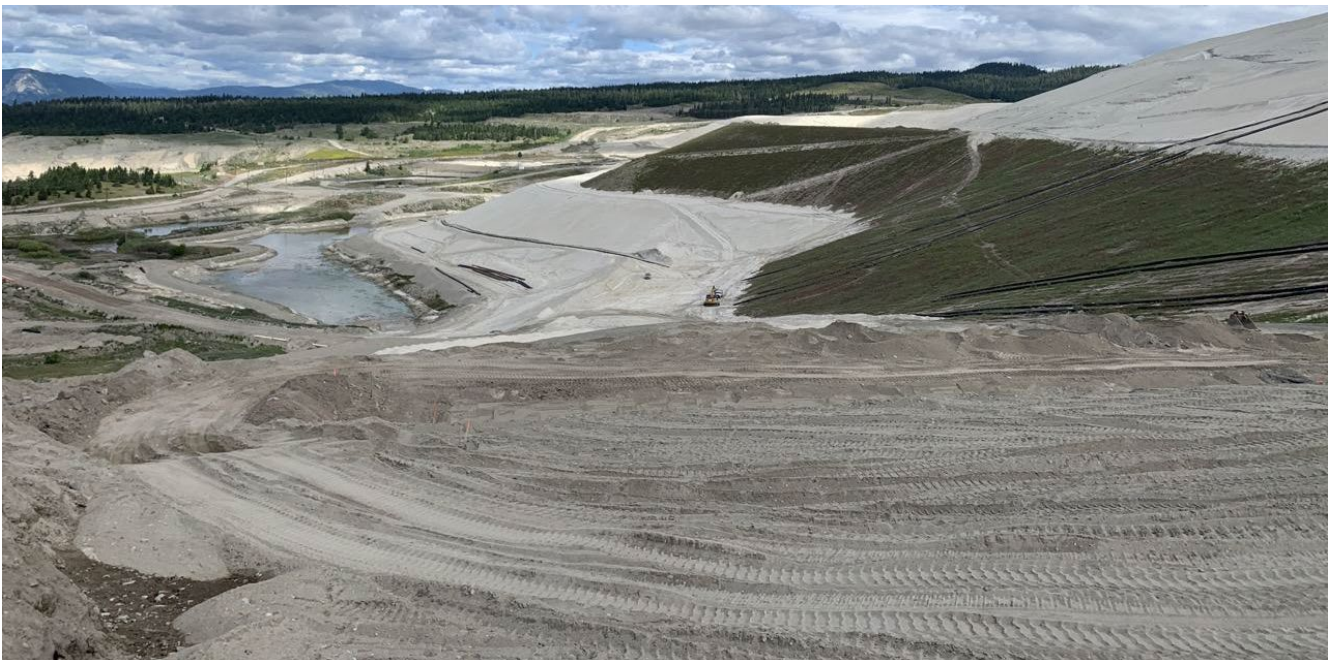
Photo I-A-10 View of Valley Buttress Berm downstream slope and south of Sediment Pond 1. Prepping for downstream sand placement (LL-2020-07)

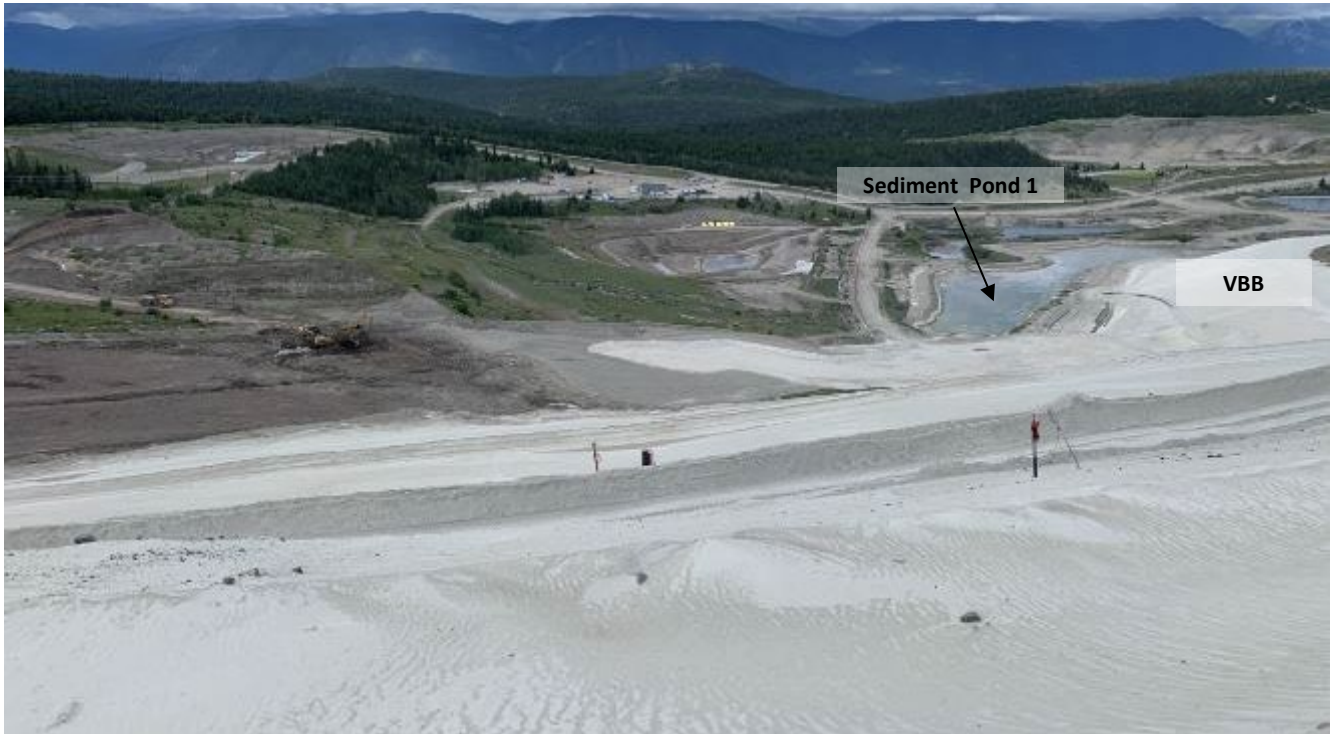
No observed dam safety issues of concern. Foundation preparation for fill placement and underdrain installation was ongoing at the time of inspection. Seepage was observed from areas where underdrains daylight from dam toe (Photo I-A-13 to Photo I-A-18).

Photo I-A-13 Overview of South Dam downstream slope from crest – looking west (LL-2020-04)

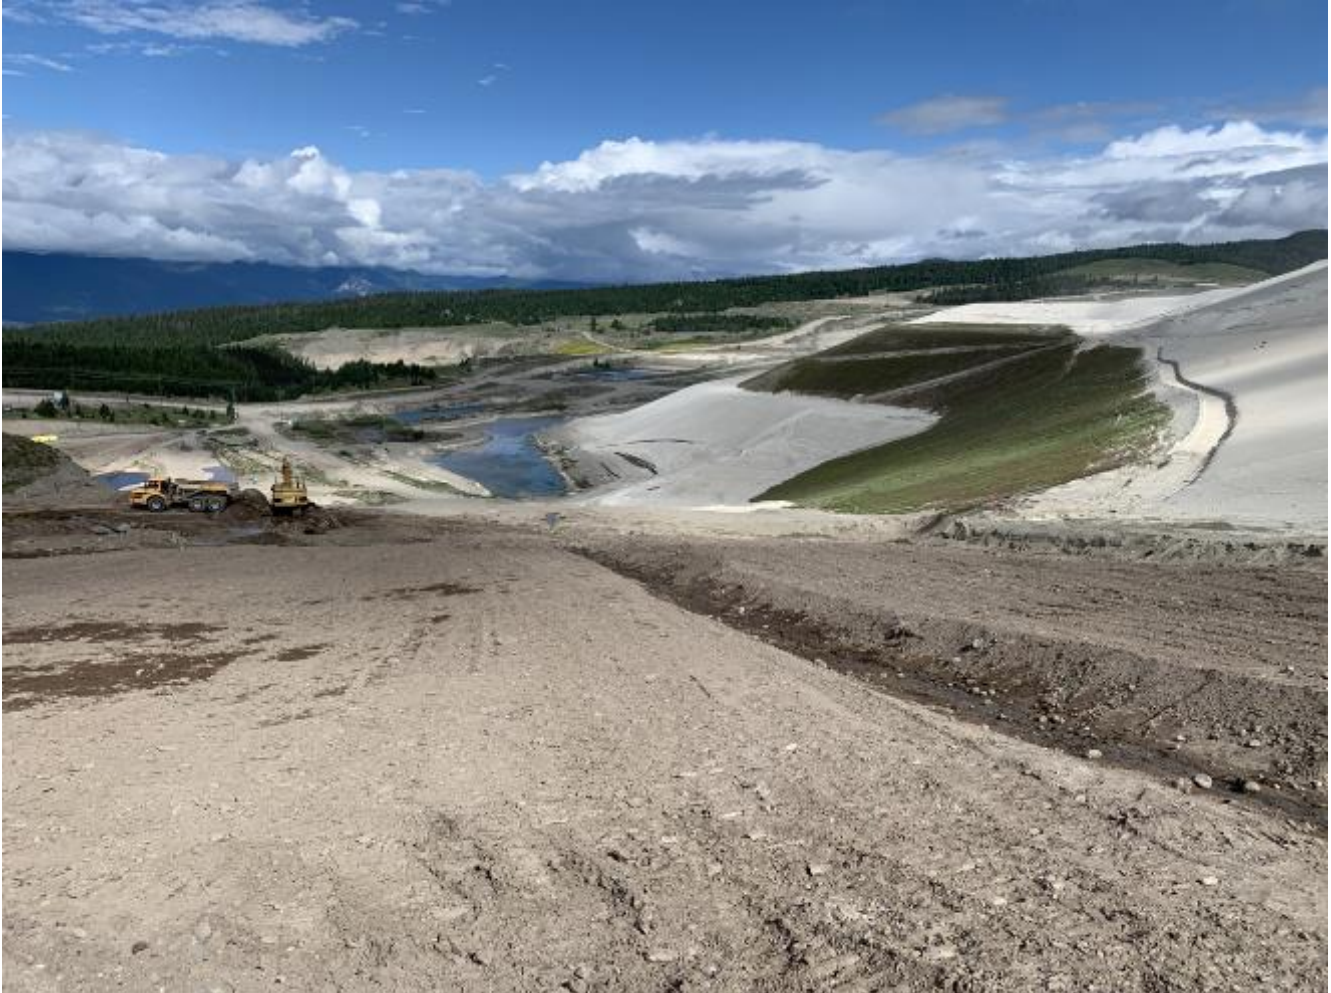
Photo I-A-15 Overview of South Dam downstream foundation area for 2020 fill placement (LL-2020-09)

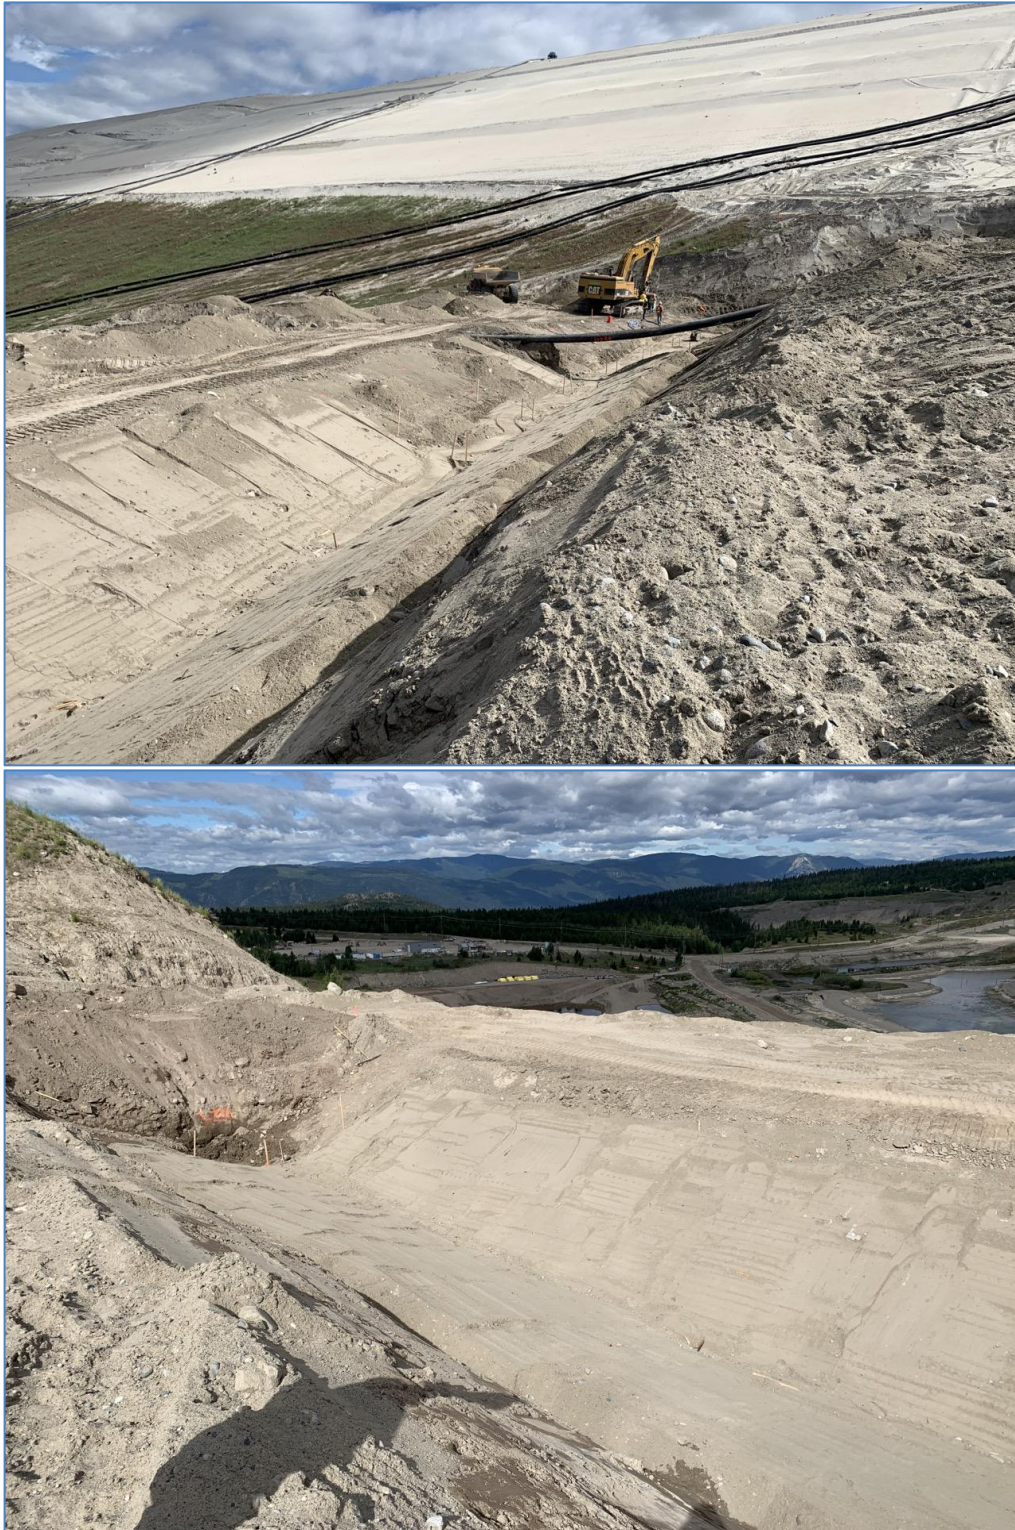
Photo I-A-16 View of Minor Drain being constructed at South Dam (LL-2020-10)

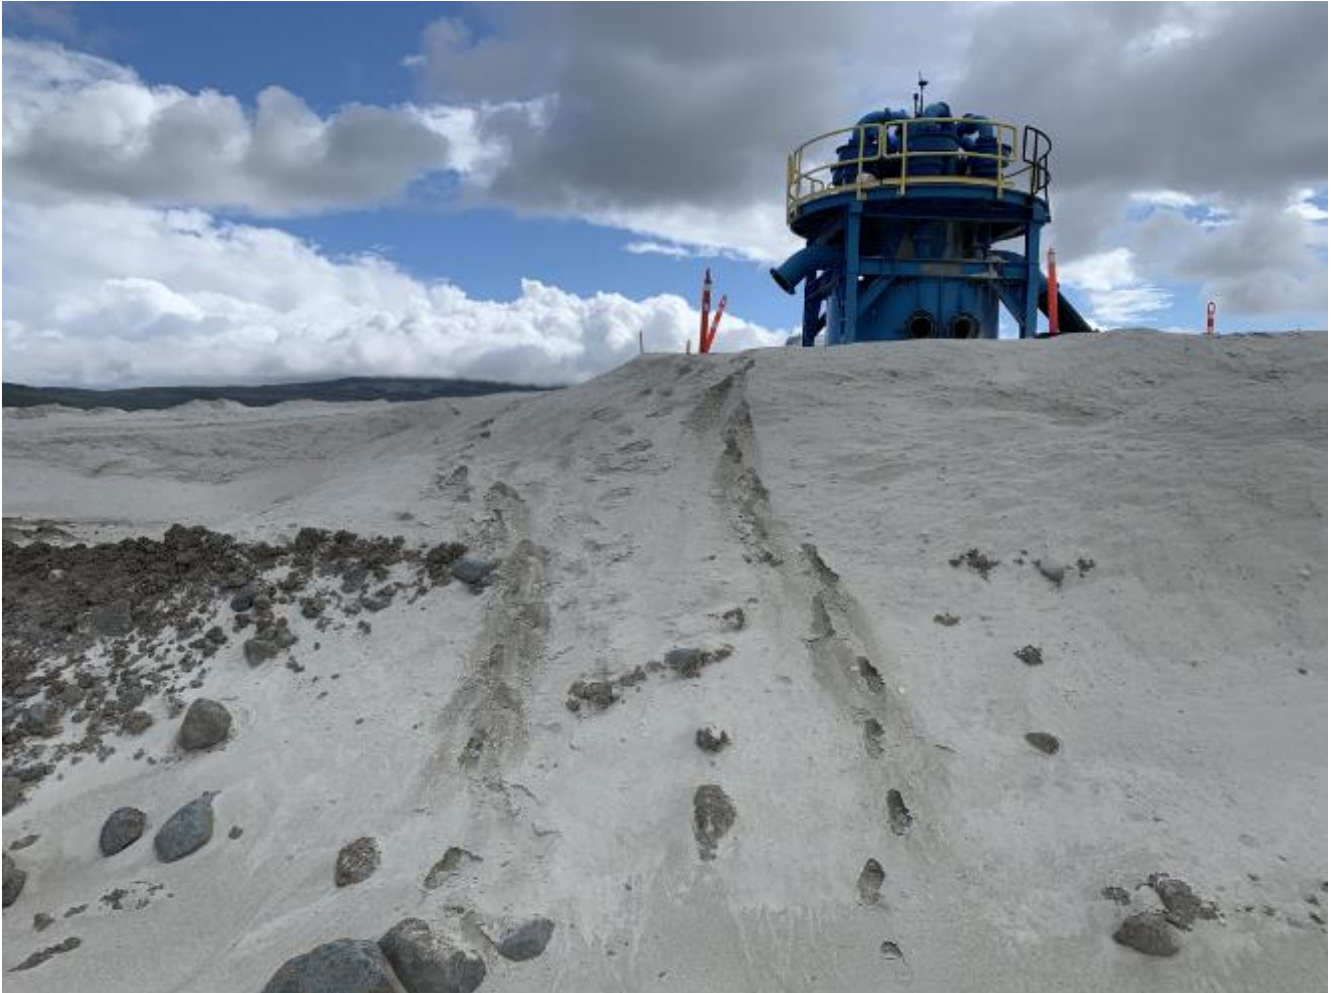
Photo I-A-17 View of Secondary Cyclones at South Dam crest – looking upstream (LL-2020-04)

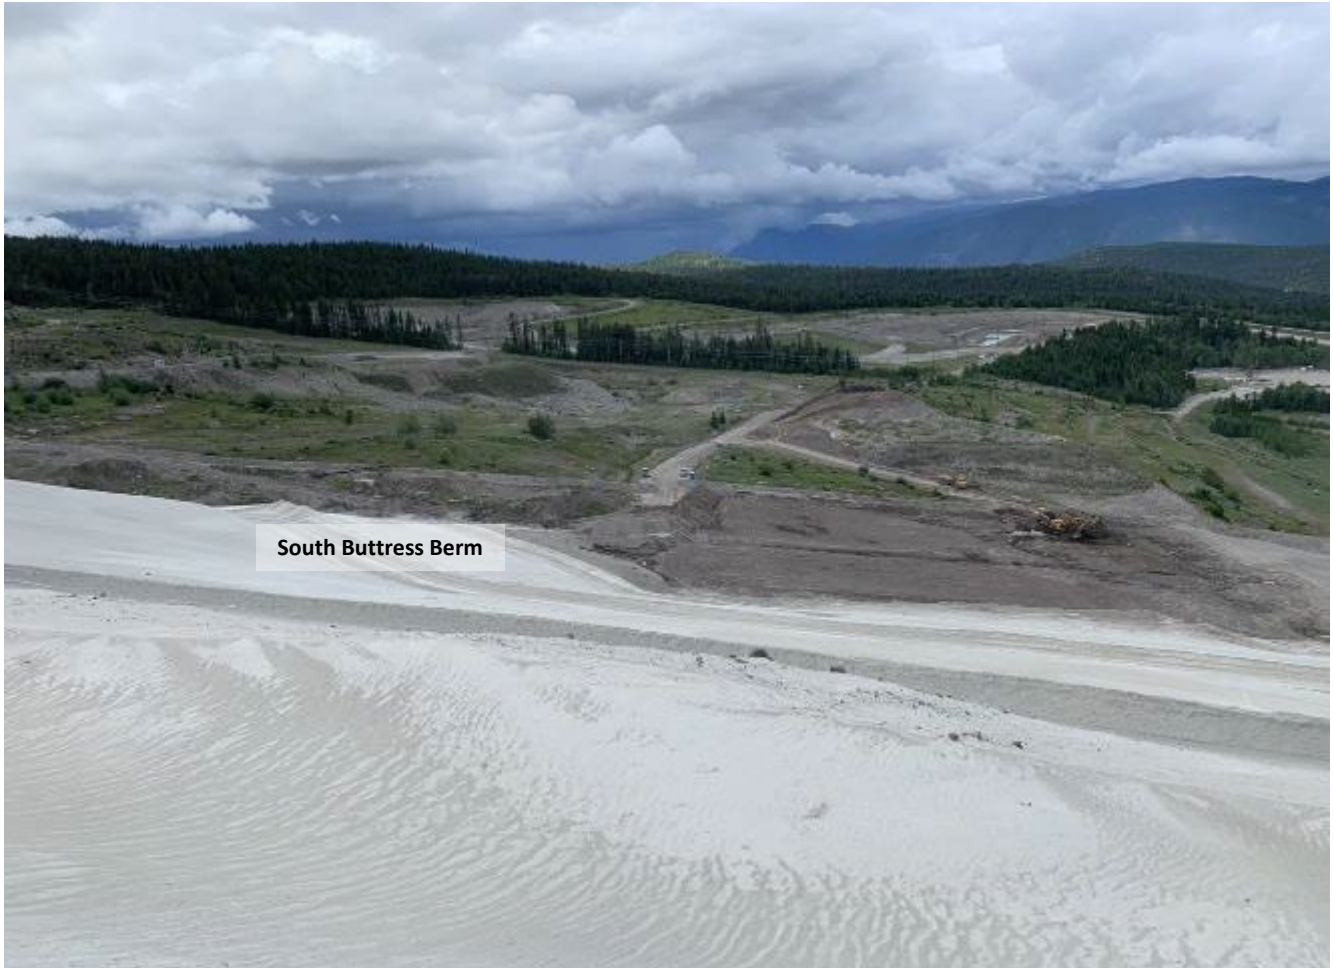
Photo I-A-18 Overview of South Dam foundation area prepared for fill placement, looking south (LL-2020-04)

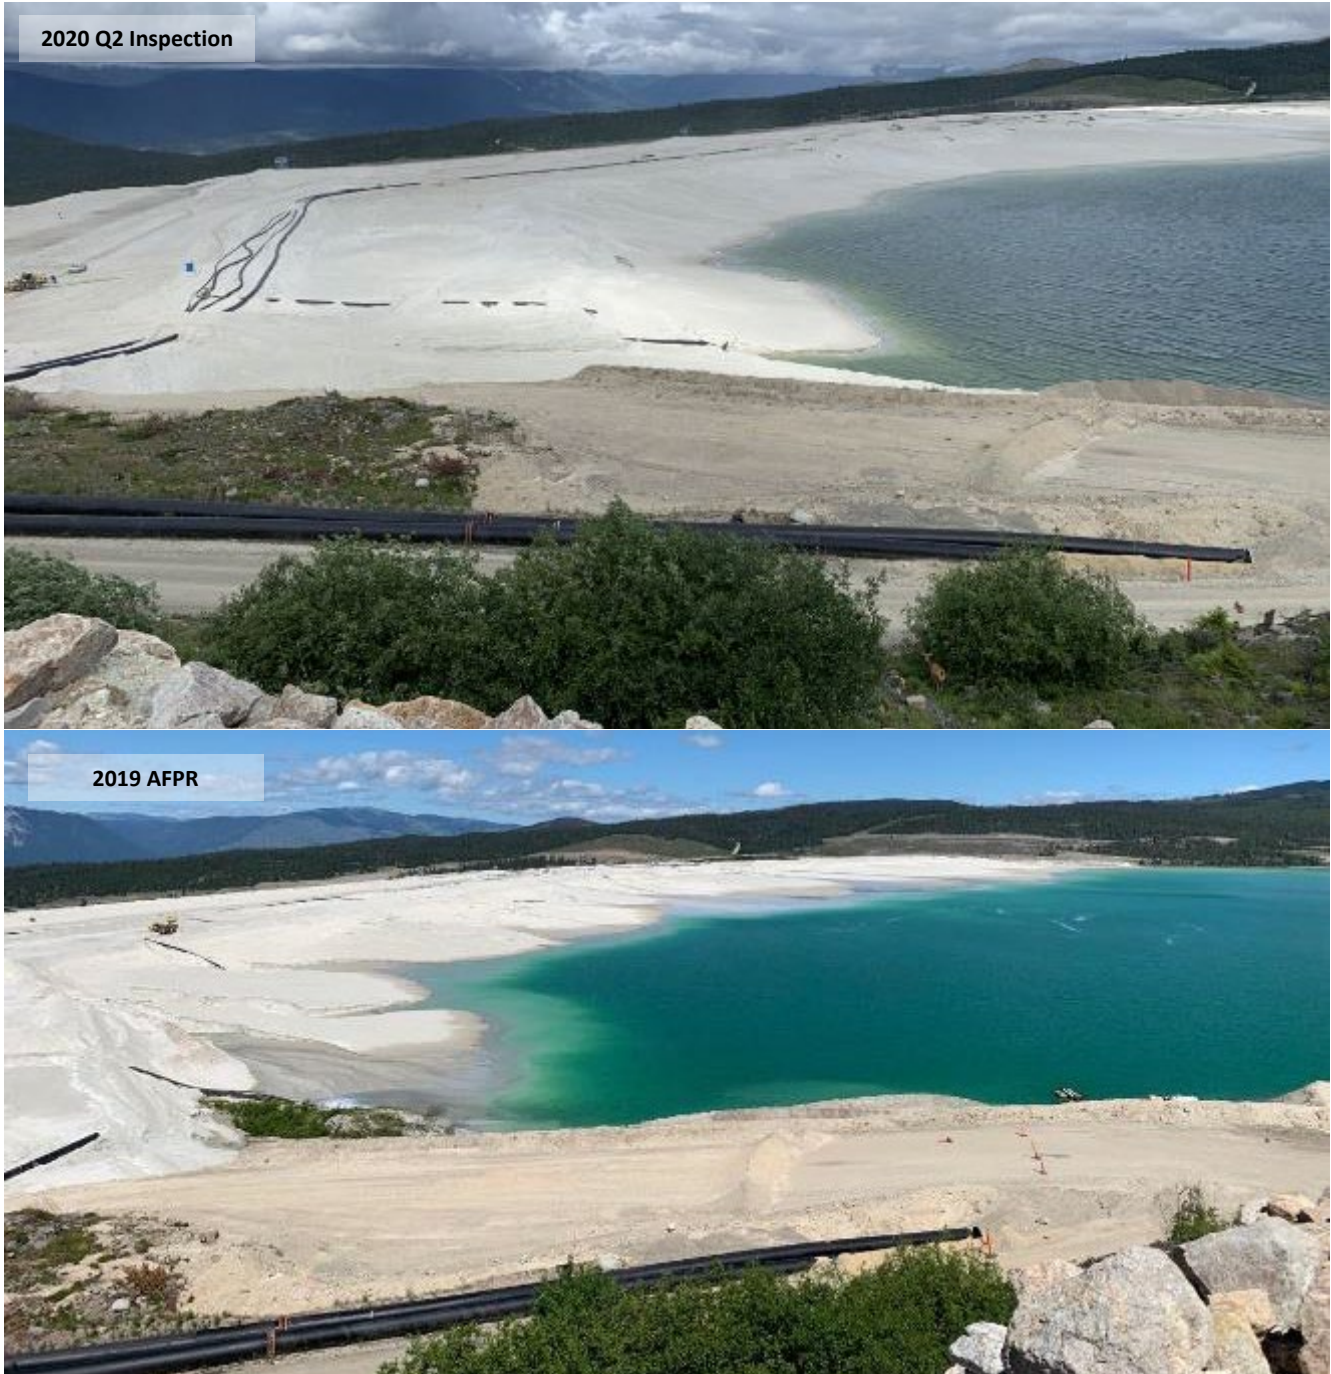
Photo I-A-19 Overview of L-L Dam beach and pond from South Abutment (top). Comparison with photo from 2019 AFPR site visit (bottom) shows beach width increase. (LL-2020-11)

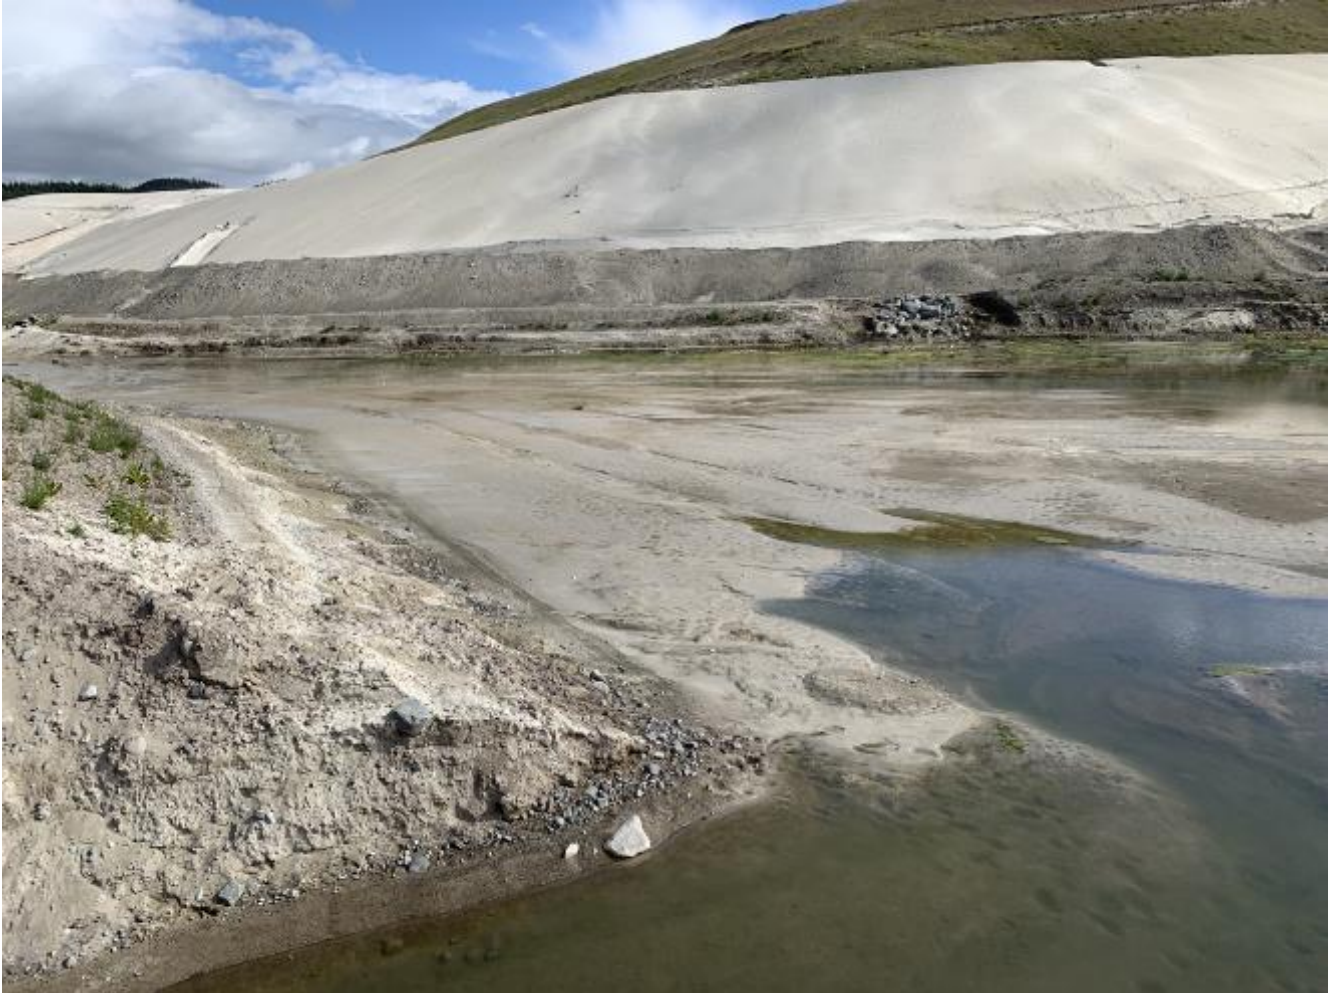
Photo I-A-20 View of Sediment Pond 1 and downstream toe of the Valley Buttress Berm (VBB) (LL-2020-12)

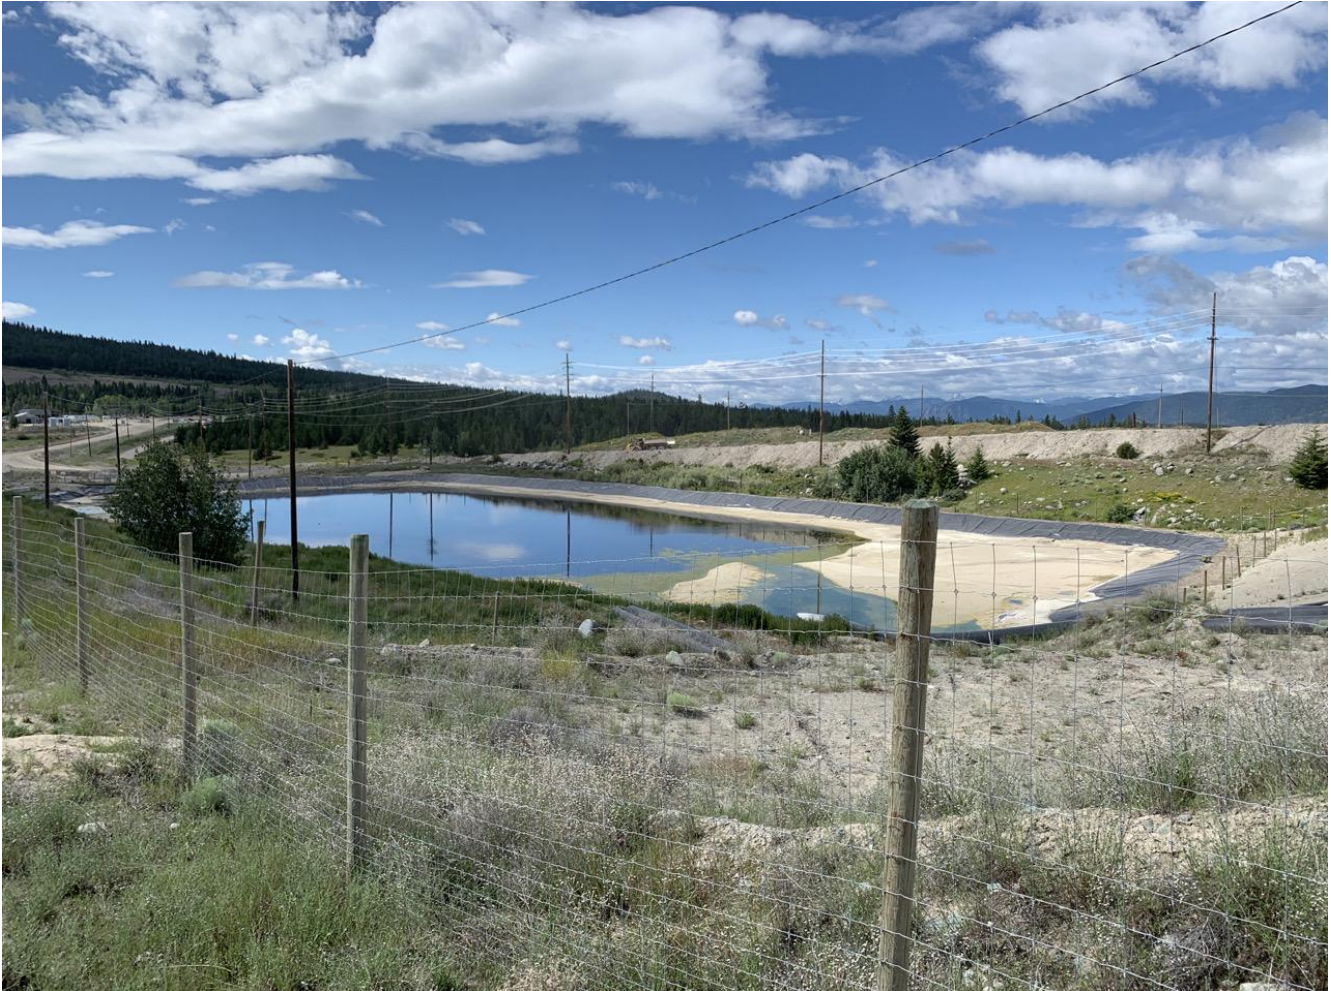
Photo I-A-24 Overview of Seepage Pond 2 (LL-2020-13)

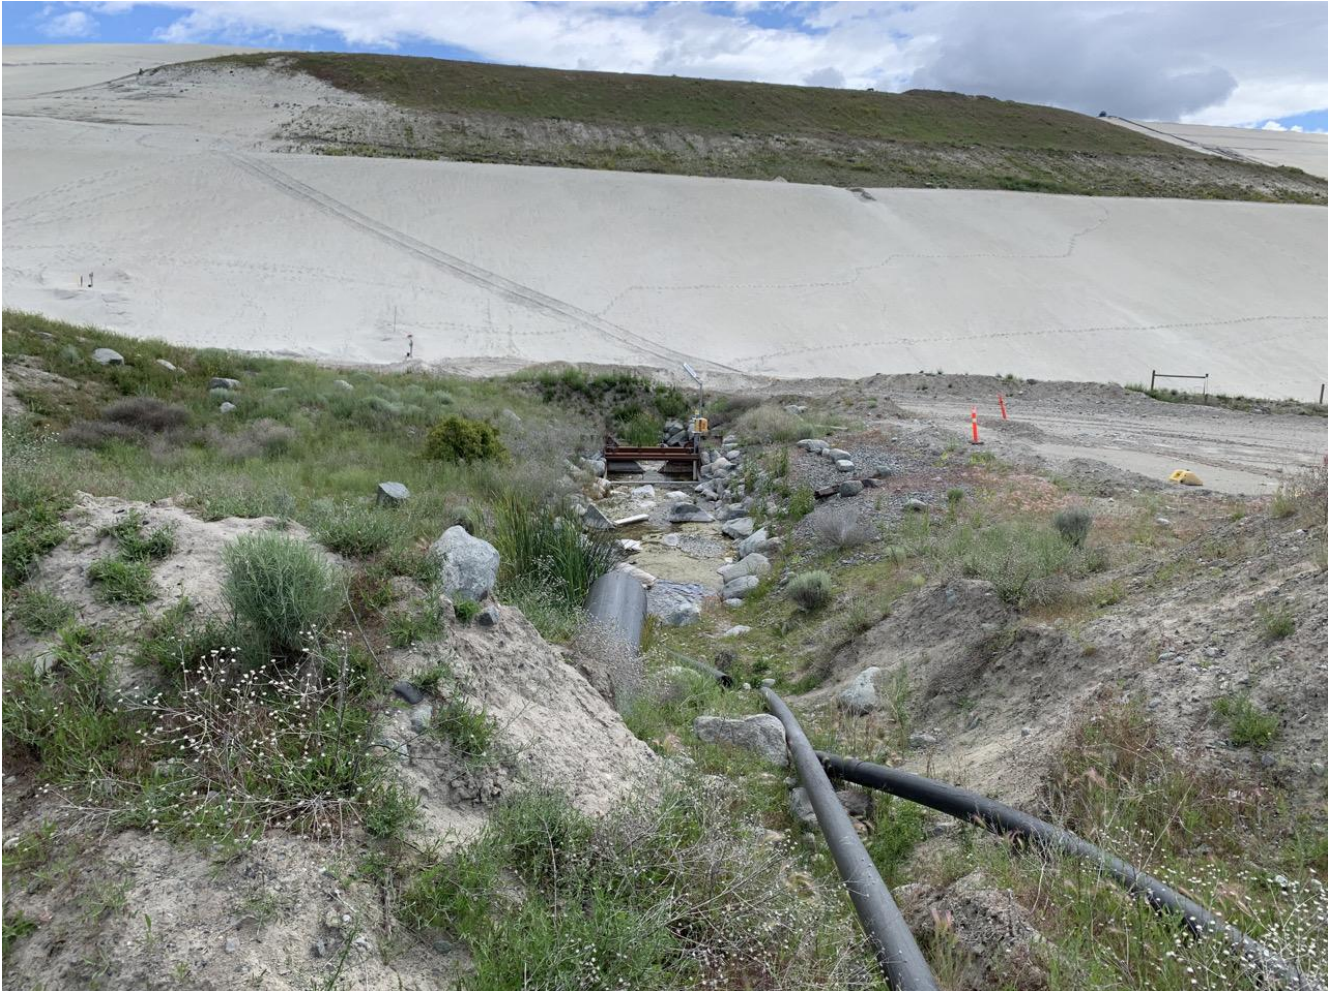
Photo I-A-25 View of Seepage Pond 2 outflow and weir (LL-2020-08)

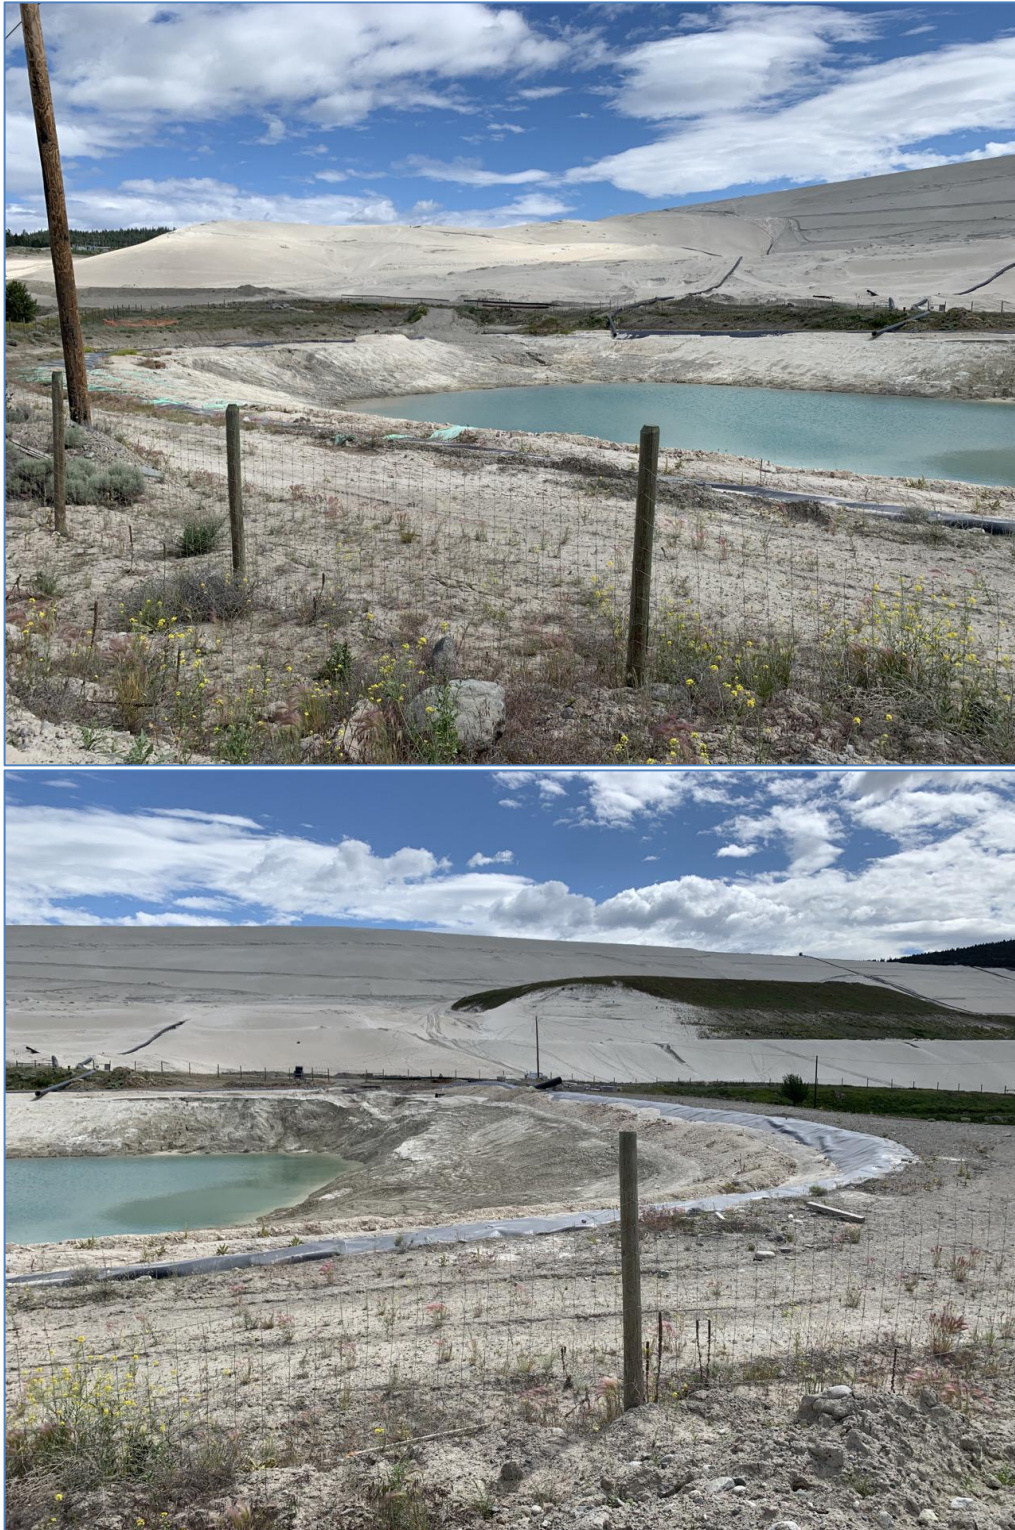
Photo I-A-26 View of Sediment Pond 2 (LL-2020-14)

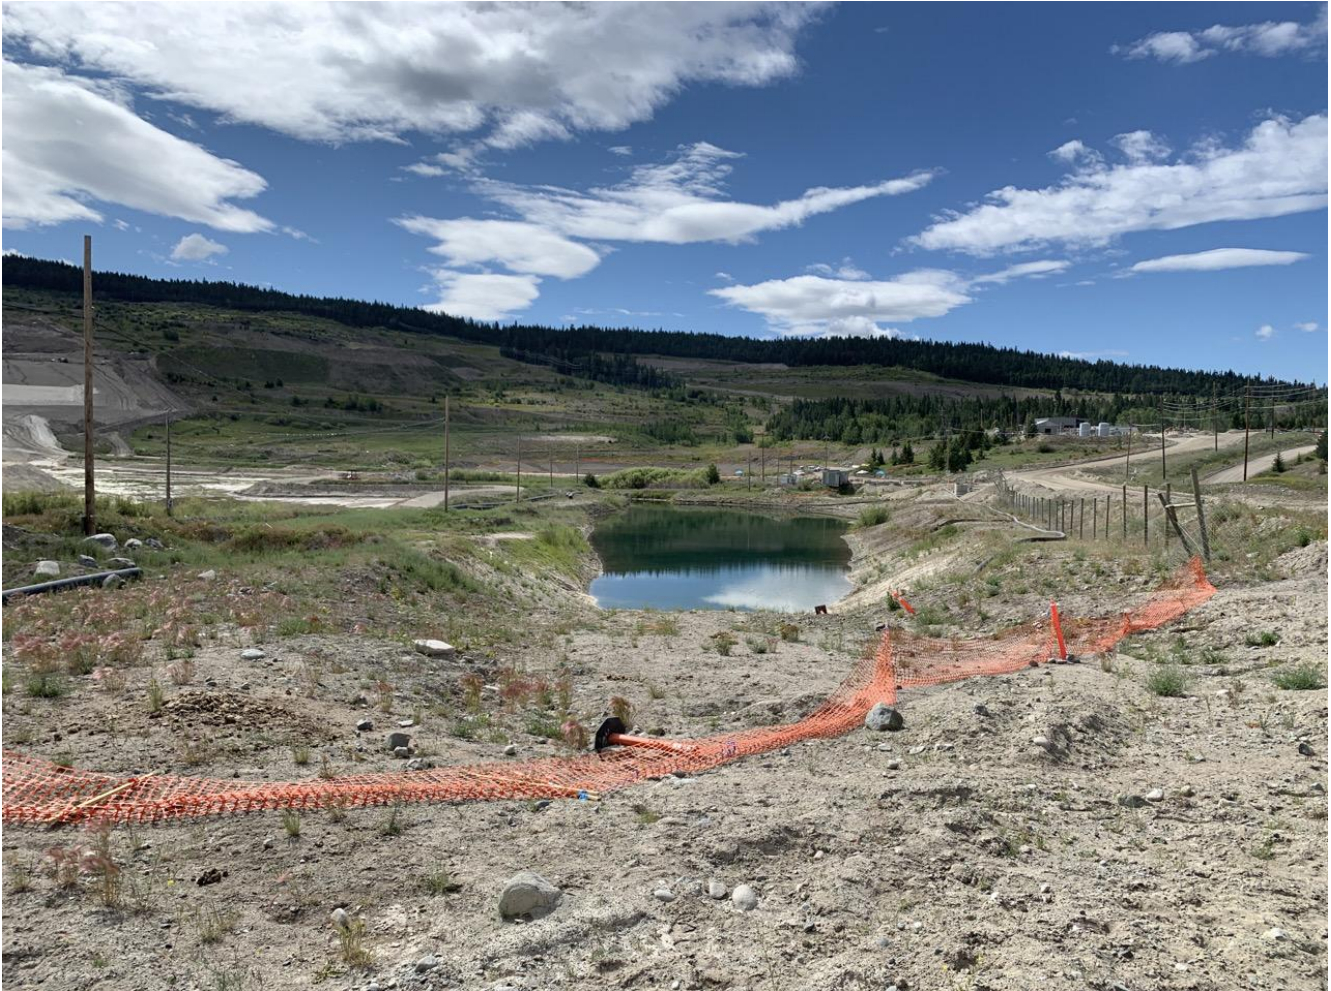
Small, ponded water was observed in Sediment Pond 4 (Photo I-A-27 and Photo I-A-28). THVCP confirmed that water had not been routed into the basin so the source of flow is likely combination of groundwater and runoff from local catchment.

Photo I-A-27 View of Sediment Pond 4 (LL-2020-15)

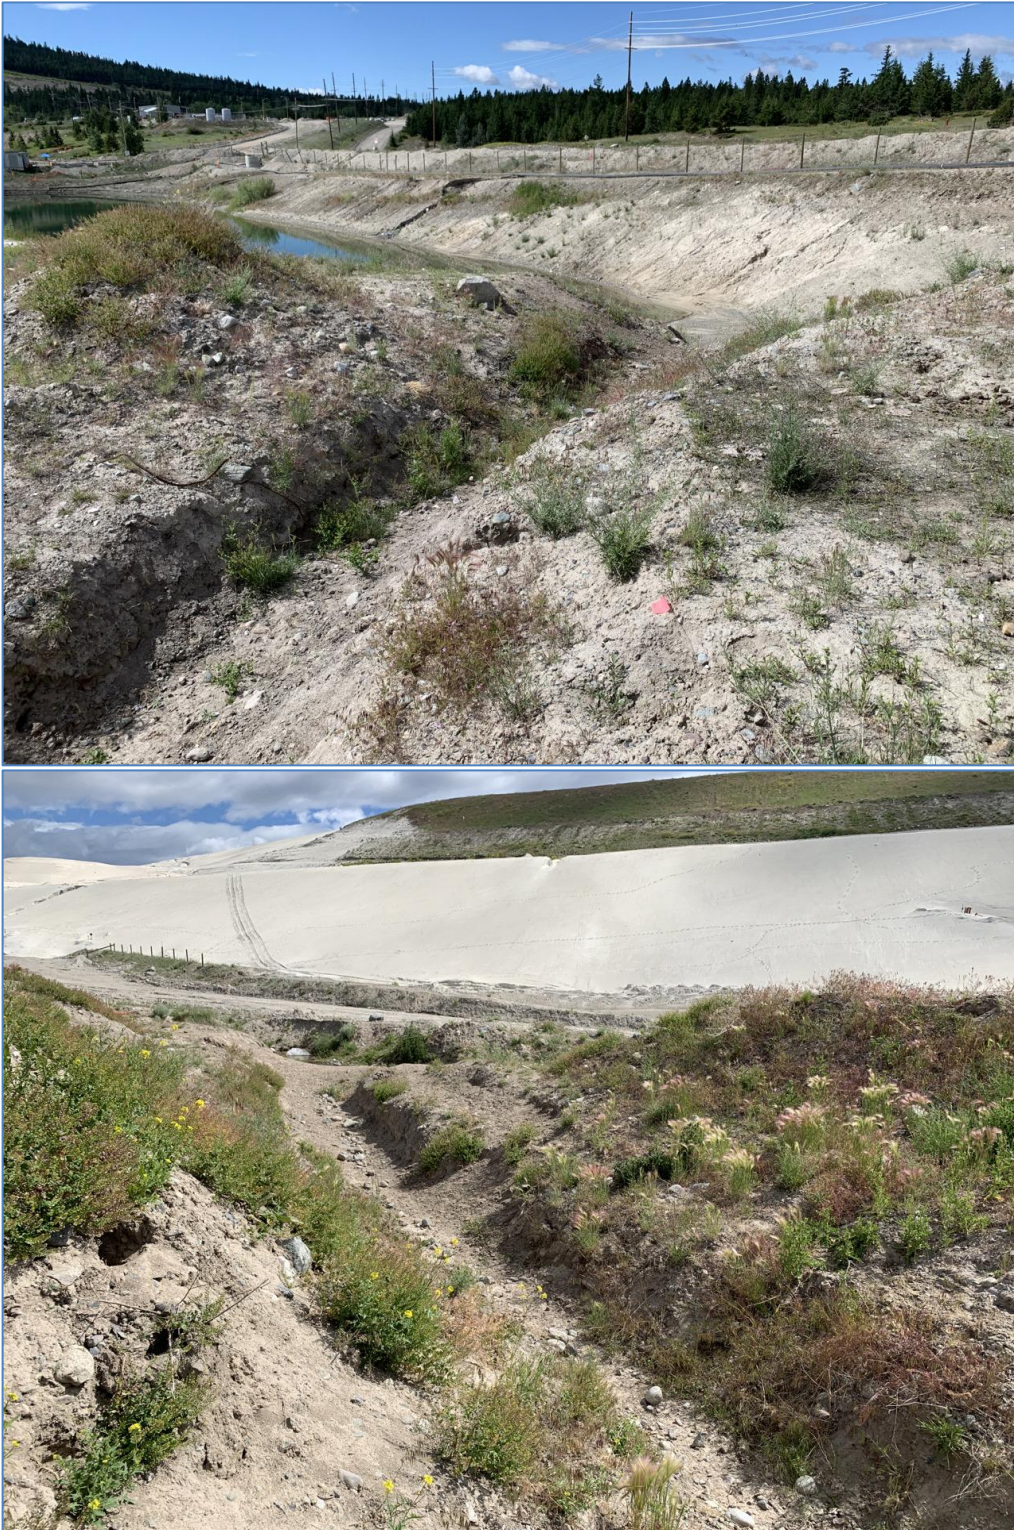
Photo I-A-28 View of channel into Sediment Pond 4 (LL-2020-16)

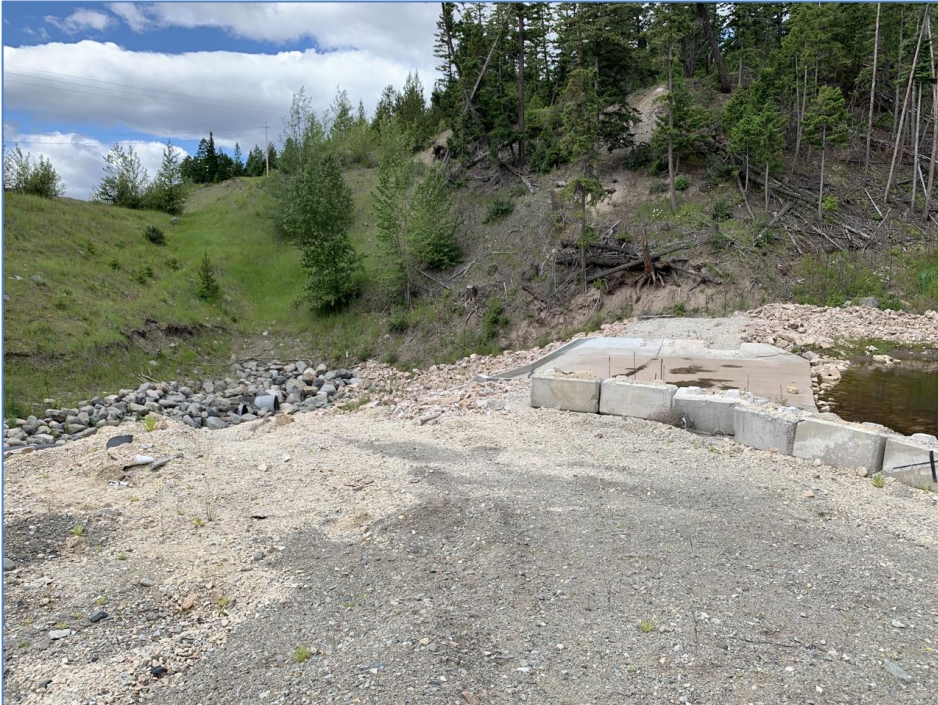
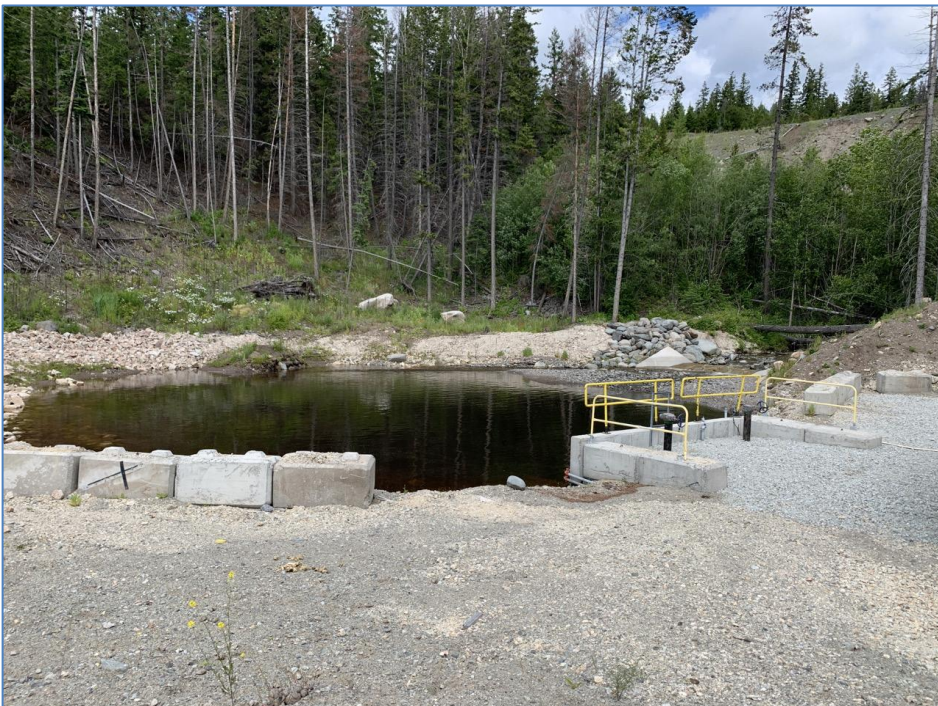
Photo I-A-30 View of Woods Creek Diversion. Pumps were working and there was no overflow into impoundment (LL-2020-18)

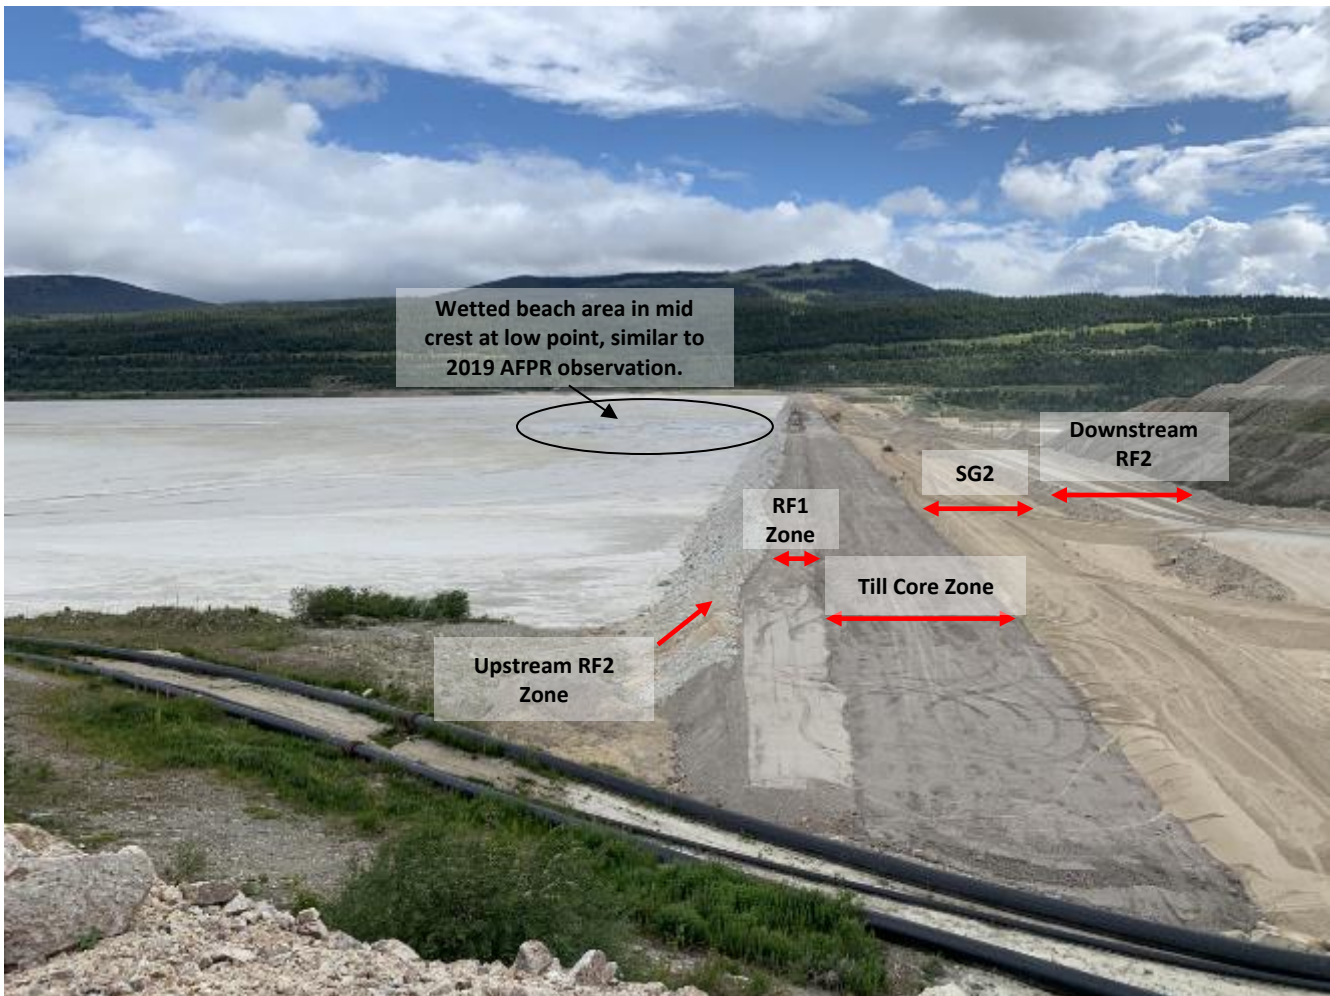
Photo I-B-1 Overview of H-H Dam crest and tailings beach – View from West Abutment (HH-2020-01)

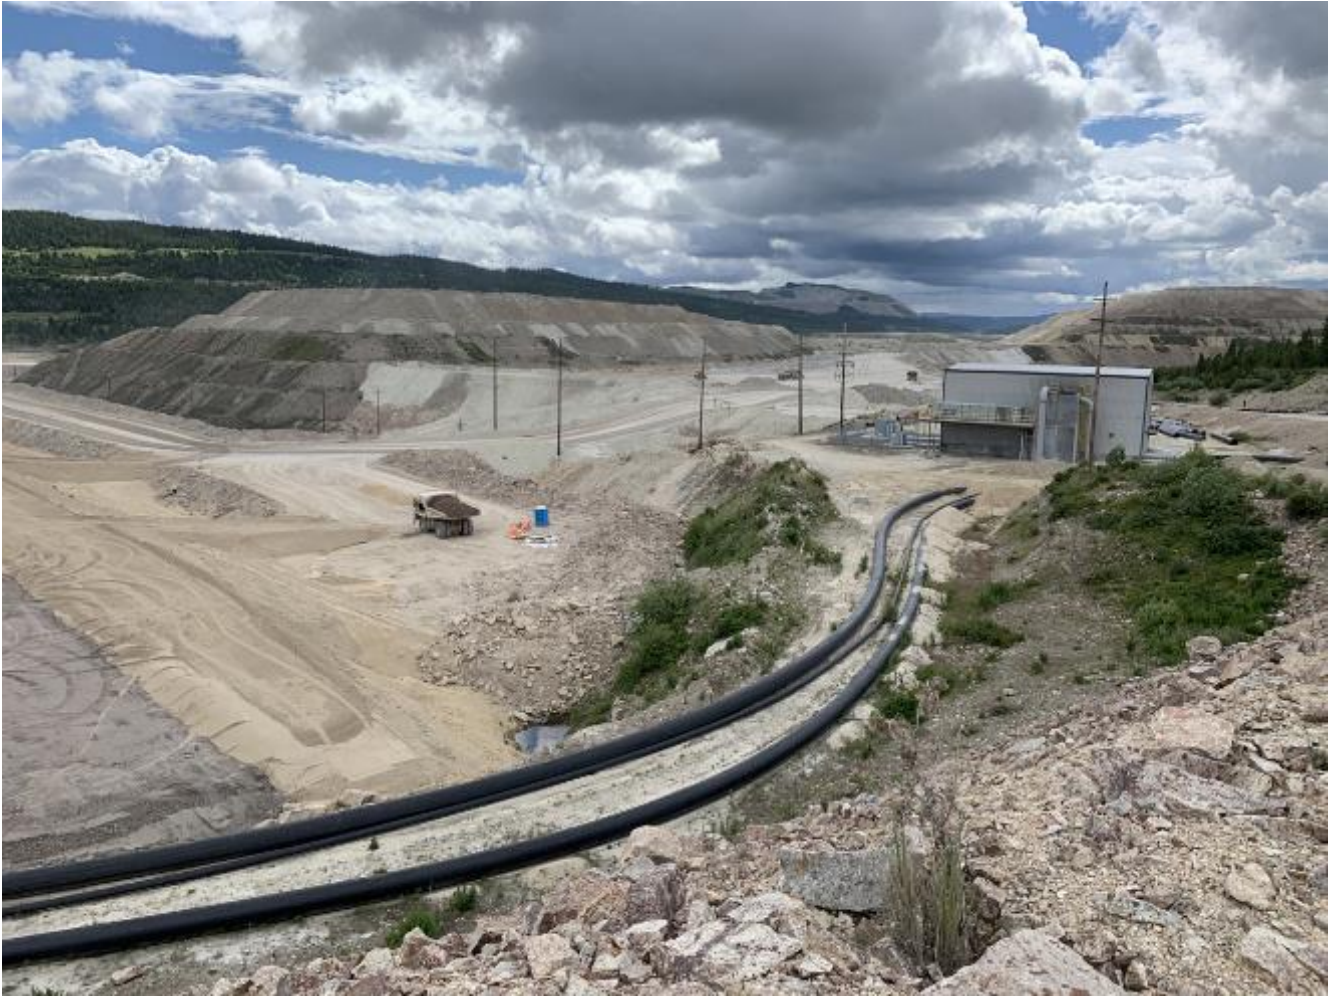
Good physical condition; significant erosion or excessive seepage not observed. THVCP was preparing to relocate SS1 pipes over till core (temporarily) to allow West Abutment foundation preparation and crest raise to be completed (Photo I-B-2 and Photo I-B-3).

Photo I-B-3 Overview of West Abutment dam raise. SG2 fill was pulled back near abutment to avoid culvert (ponded area). This area will be prepared for 2021 raise, looking southeast (HH-2020-01)
