Teck Highland Valley Copper Partnership

2020 Annual Facility Performance Report

Highland Tailings Storage Facility

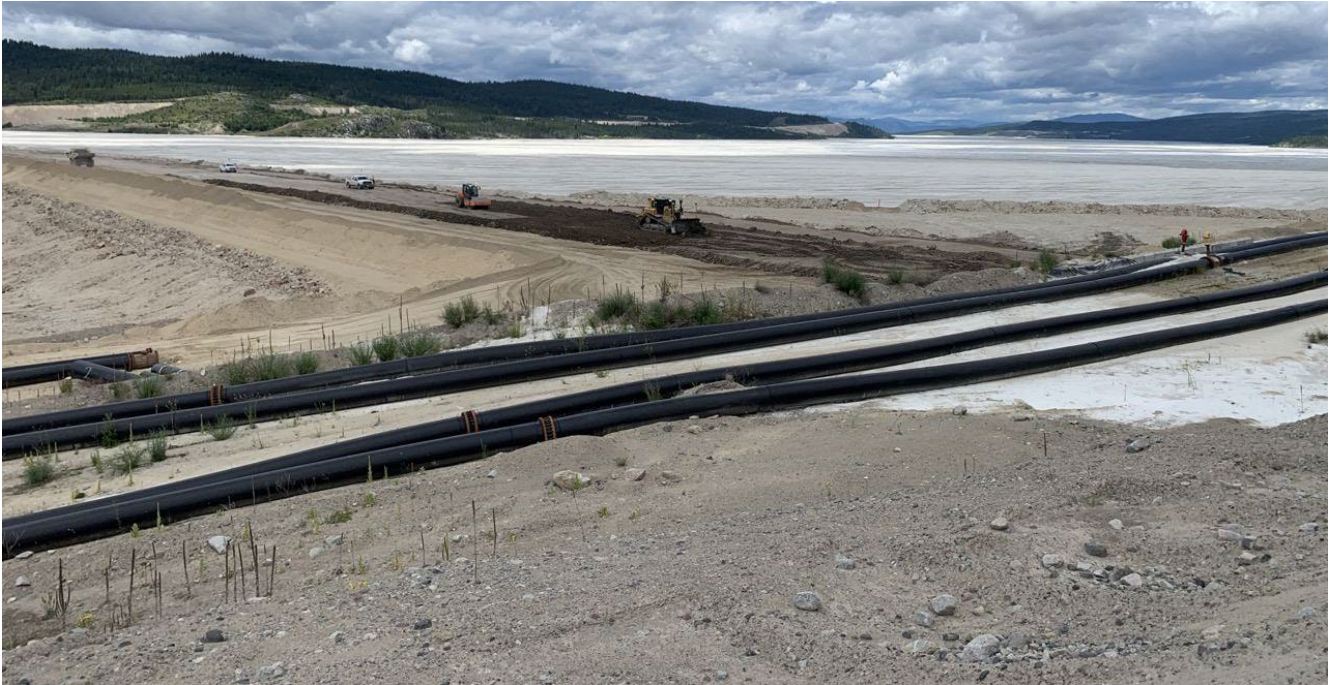
Good physical condition; no erosion of the fill or indicators of concern (e.g. sinkholes) were observed on the beach surface. Beach dry in front of dam fill except for a wet area in the low point on Photo I-B-1 which is typical and related to local runoff. East Abutment deposition point is upstream of the main tailings cone so tailings were flowing away from H-H Dam, towards L-L Dam, with no tailings deposition near H-H Dam face (Photo I-B-5).

Photo I-B-5 Active spigot point (>500 m) upstream of H-H Dam. No flow towards HH Dam. Wetted beach near the dam is from local runoff (HH-2020-03)

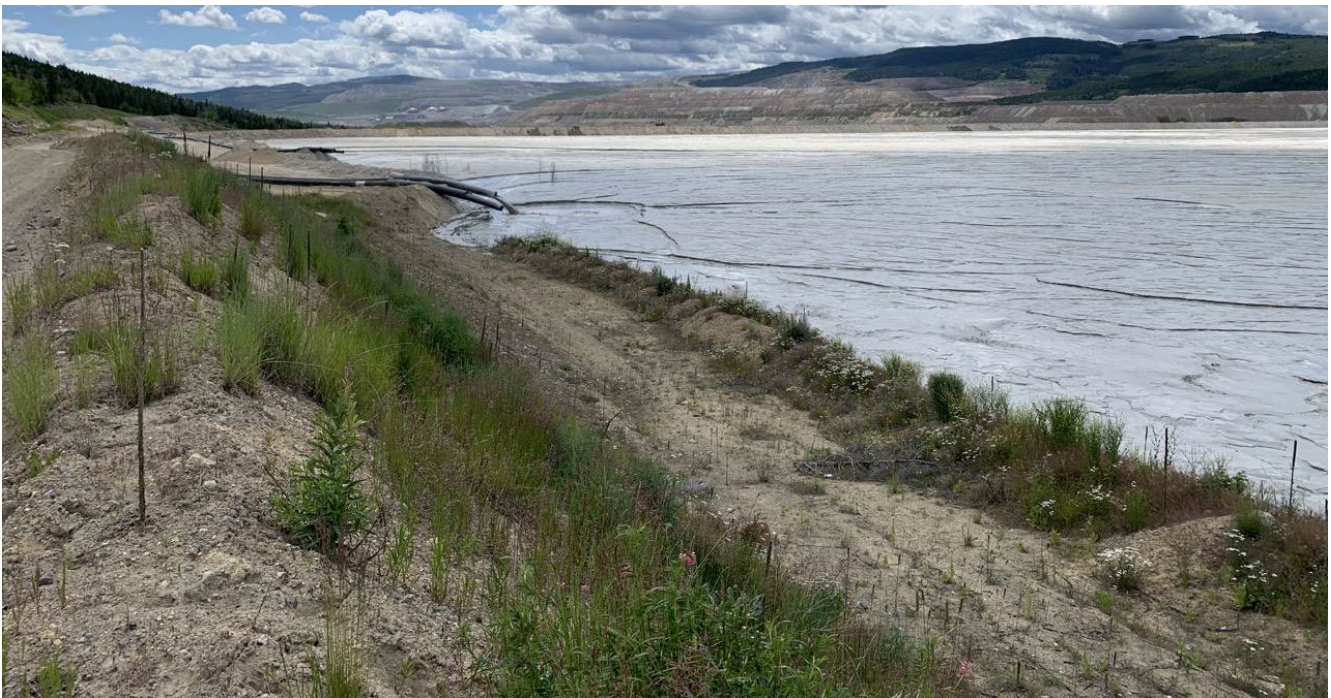
No observed dam safety issues of concern (e.g. slumping, cracking or large scour) (Photo I-B-6).

Photo I-B-6 View of downstream slope and 24 Mile Waste Dump area (HH-2020-02)

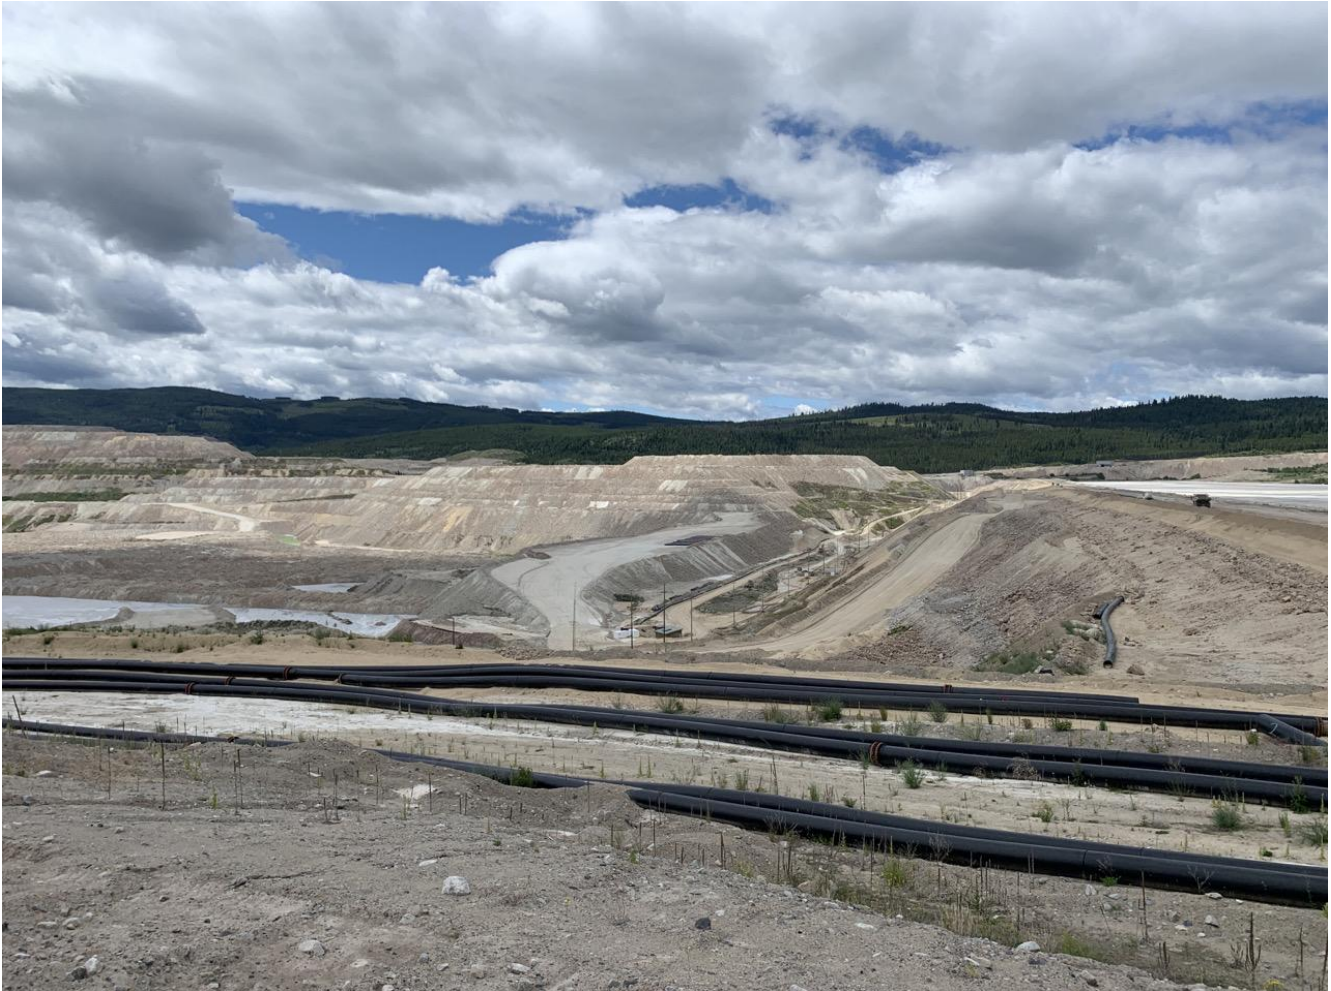
No observed issues of concern with potential to impact H-H Dam were observed. Second lift of waste fill had been placed over most of capping area. The old tailings channel (from HH Pumphouse to 24 Mile Spill Pond) was recently blocked with waste to divert flow along new channel. The old channel was backfilled with waste subsequent to the site visit as per KCB recommendation (Photo I-B-6, Photo I-B-7 and Photo I-B-10).

Photo I-B-7 Overview of 24 Mile Waste Dump, 24 Mile Spill Pond and HH Pumphouse. Tailings deposition area of flow from HH Pumphouse to 24 Mile Spill Pond, visually appeared greater than expected (HH-2020-04 and HH-2020-05)

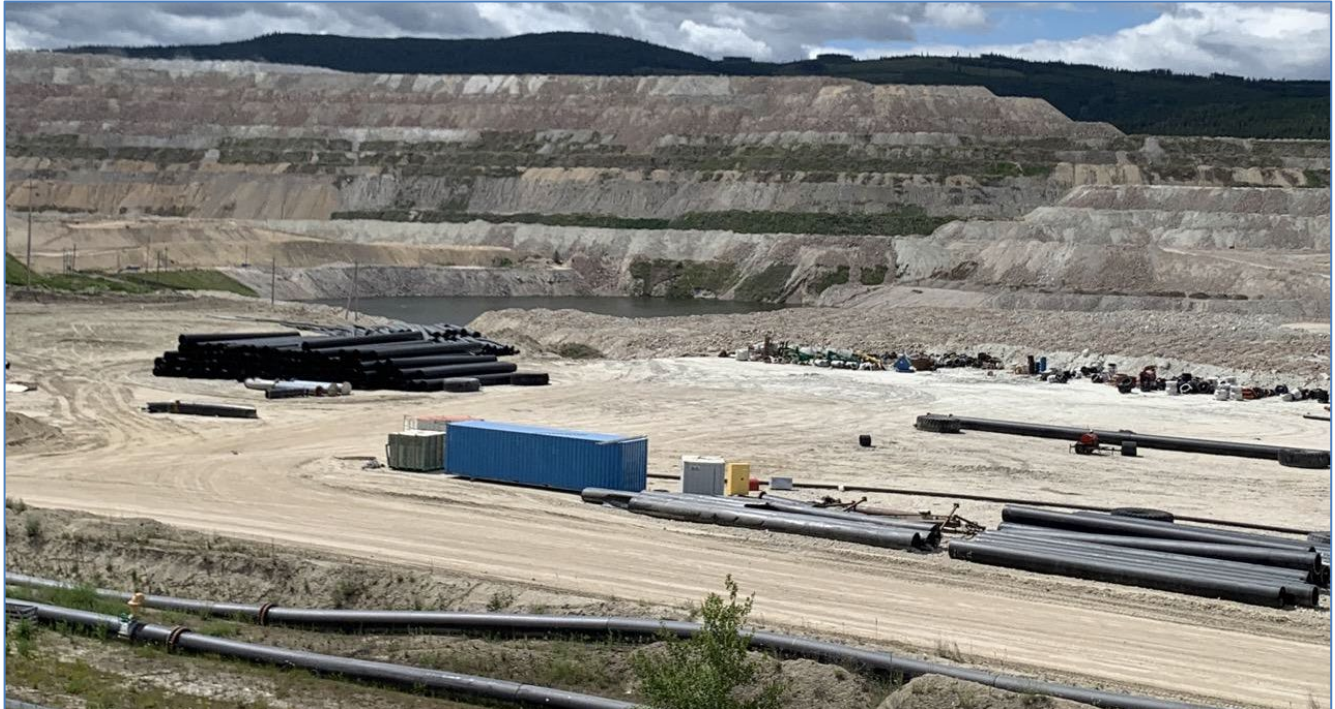
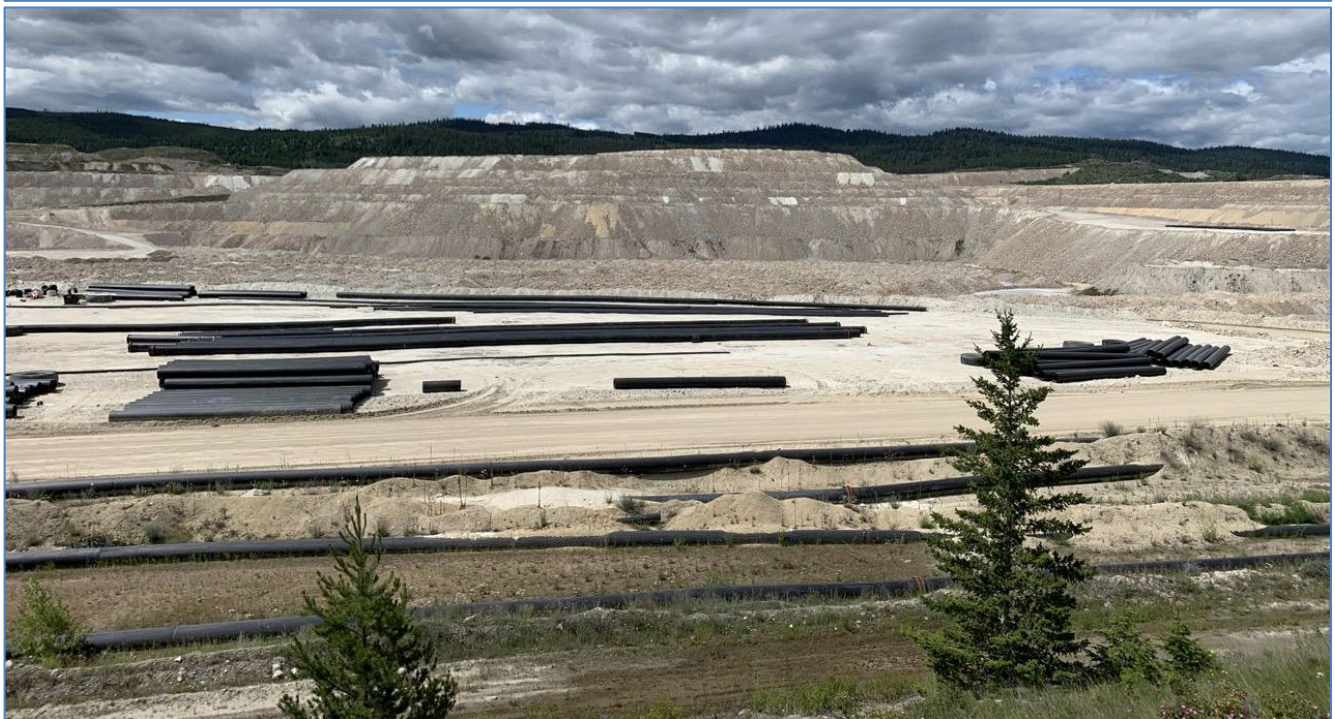
KCB requested confirmation whether light brown area observed in 24 Mile Waste Dump is the relocated tailings from 7-Day Pond (Photo I-B-10). THVCP confirmed that this was actually an area that had not yet been covered by most recent dump lift. No tailings were stored in that area.

Photo I-B-10 View of 24 Mile Waste Dump, second lift of waste has been placed (HH-2020-08)

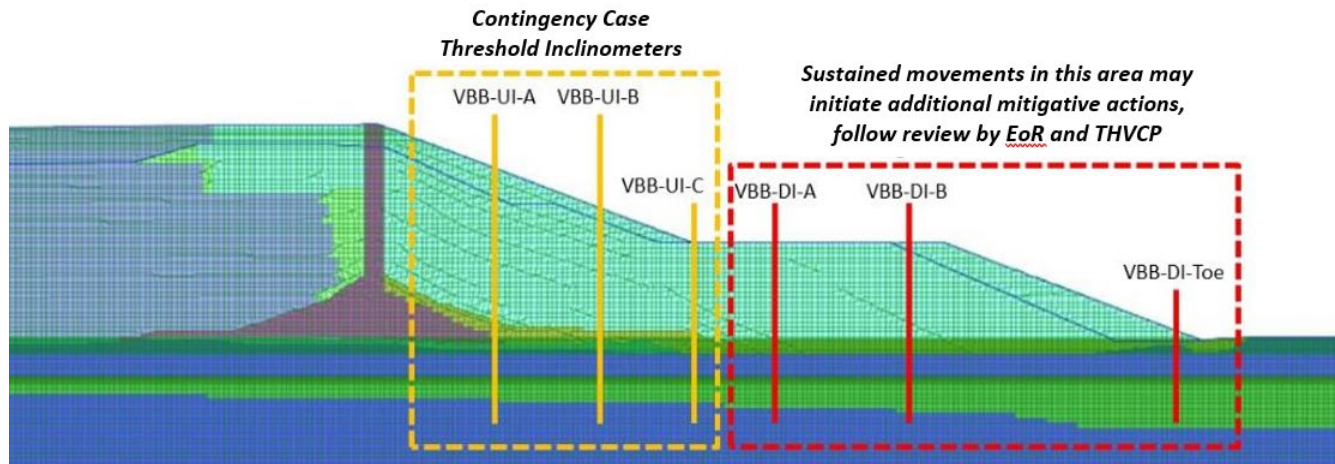
Figure III-A-1 VBB Inclinerometer Location ID

At the end of 2020, the inclinometers at location VBB-UI-B (Figure III-A-1) along VBB downstream slope are out of service. The functional inclinometers are adequate to monitor dam performance of the existing structure. However, inclinometer coverage at VBB-UI-B is required to implement the Observational Method as described in KCB (2018)². On that basis, KCB has recommended that a replacement inclinometer be installed near VBB-UI-B if one cannot be reinstated in early 2021.

KCB reviewed the cause of the casing damage at I10-6 and I10-7 and concluded they were not related to shear movements in the dam. The breakage at I10-6 occurred within cycloned sand dam fill where the casing had been raised and the segment of the casing which broke was exposed to atmosphere for an extended period which has been shown to weaken the casing and make it more brittle. The inclinometers upstream and downstream of I10-7 do not show movement zones within the cycloned sand fill and there was no indication of shear movement developing at the inclinometer before going out of service.

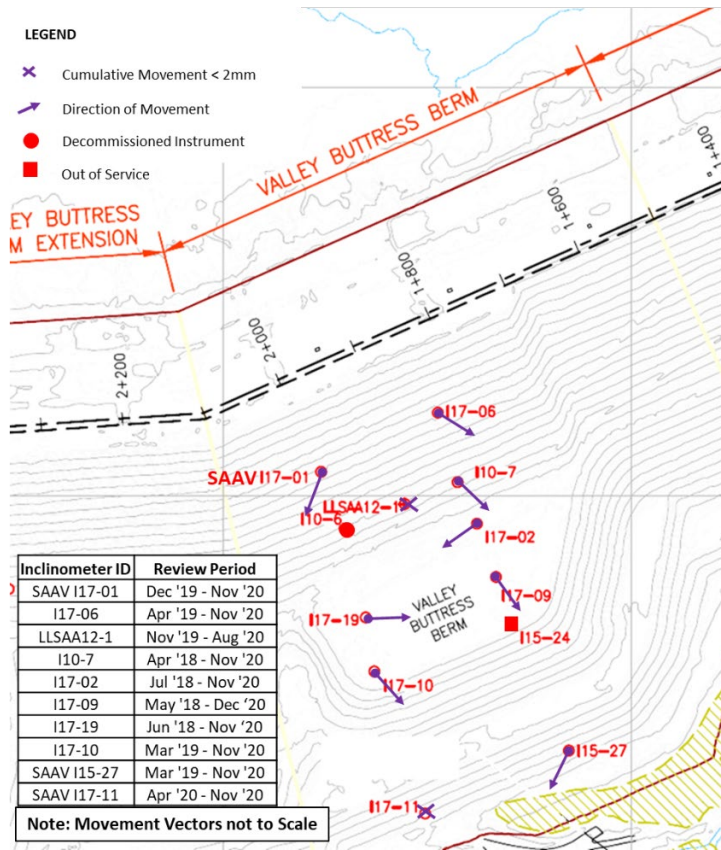
Figure III-A-2 VBB Inclinerometers Movement Directions at L-GLU unit

Typical movement rates measured with the L-GLU, which governs design, at the VBB inclinometers during 2020 are summarized in Table III-A-2 for both construction and no construction loading. Construction loading movement rates were below threshold values and those measured during 2018 and 2019 which both had downstream fill placement at the VBB which was not done during 2020. The direction of movement inferred from the inclinometer readings are summarized on Figure III-A-2 which show a movement direction which is generally downstream but variable. Both are consistent with expected behaviour based on design analysis, natural variability within the L-GLU deposits and accuracy of the inclinometers at this scale of movement (i.e. mm).

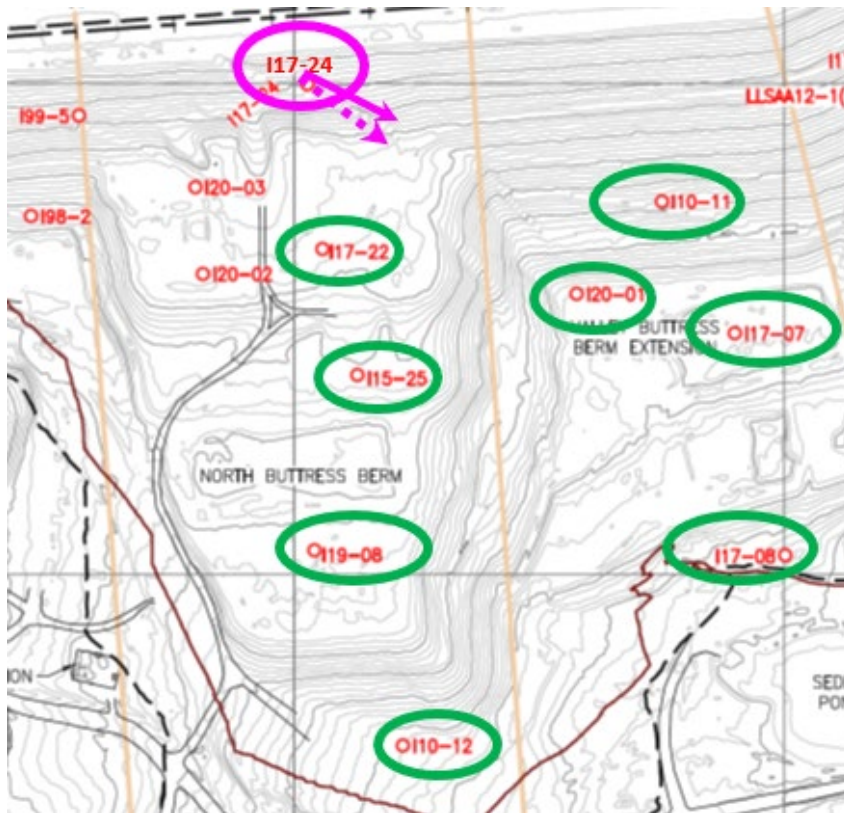
Figure III-A-3 Direction of Movement Along Mudstone Layers Measured at I17-24

At the end of 2020, all five of the inclinometers installed at the NBB are functional, refer to Figure 3 of the main report. During November 2020, two additional inclinometers were installed at the NBB which will be commissioned and add to the surveillance program in 2021. A primary function of the instruments is to monitor ongoing shear along mudstone layers within the foundation, near the crest, and whether those movements propagate towards the toe. To date, shear movements have only been measured by the inclinometer nearest to the crest (I17-24) and not at any of the downstream inclinometers which was also the case for 2020.

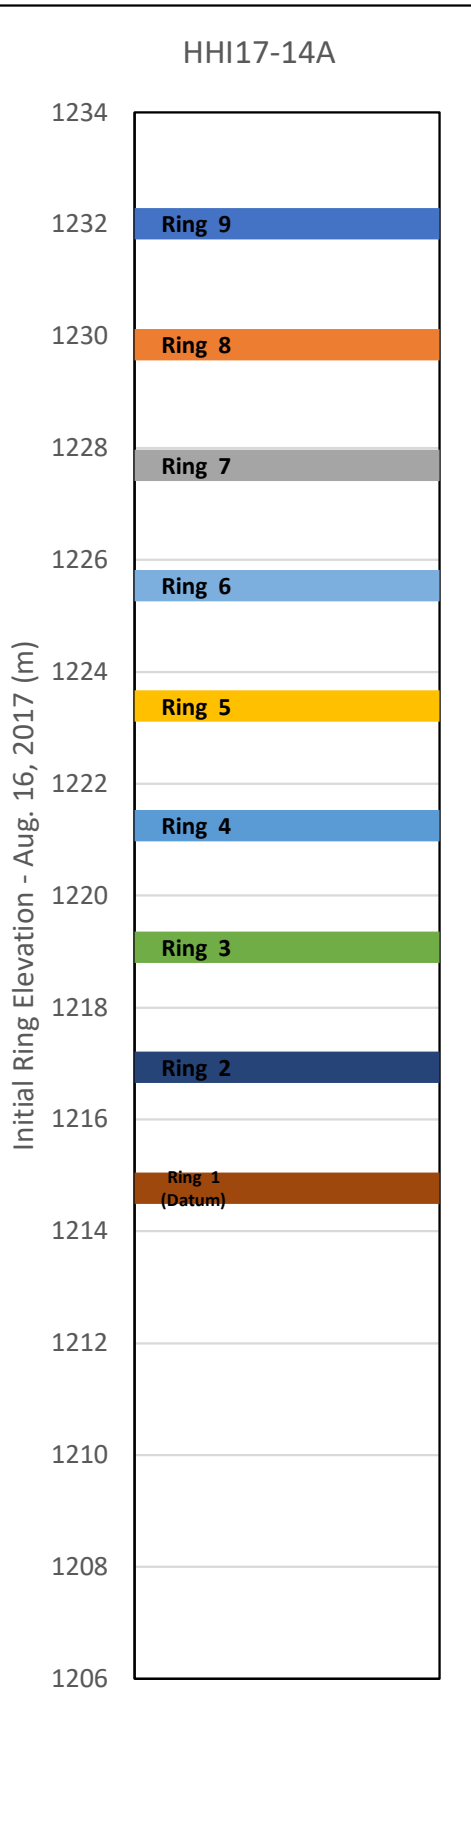
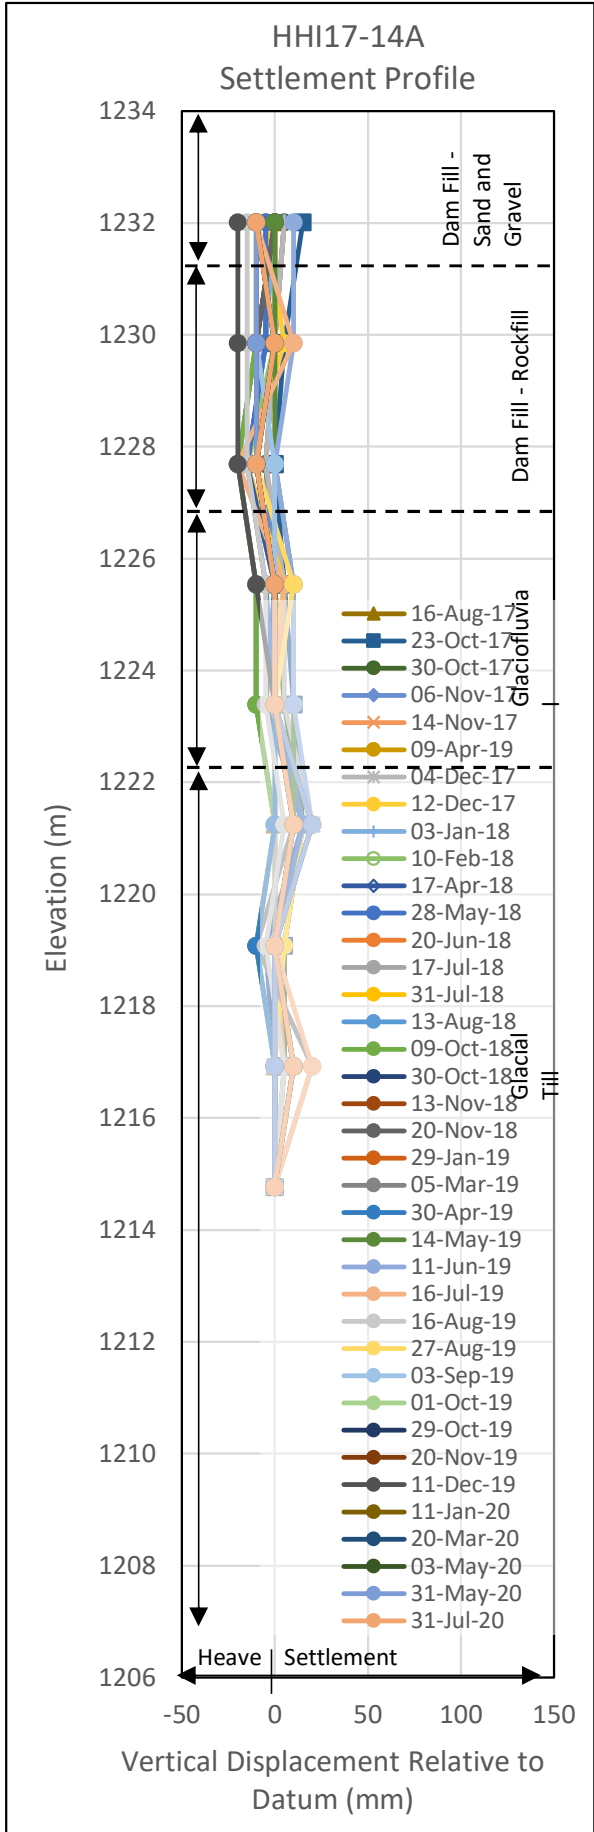
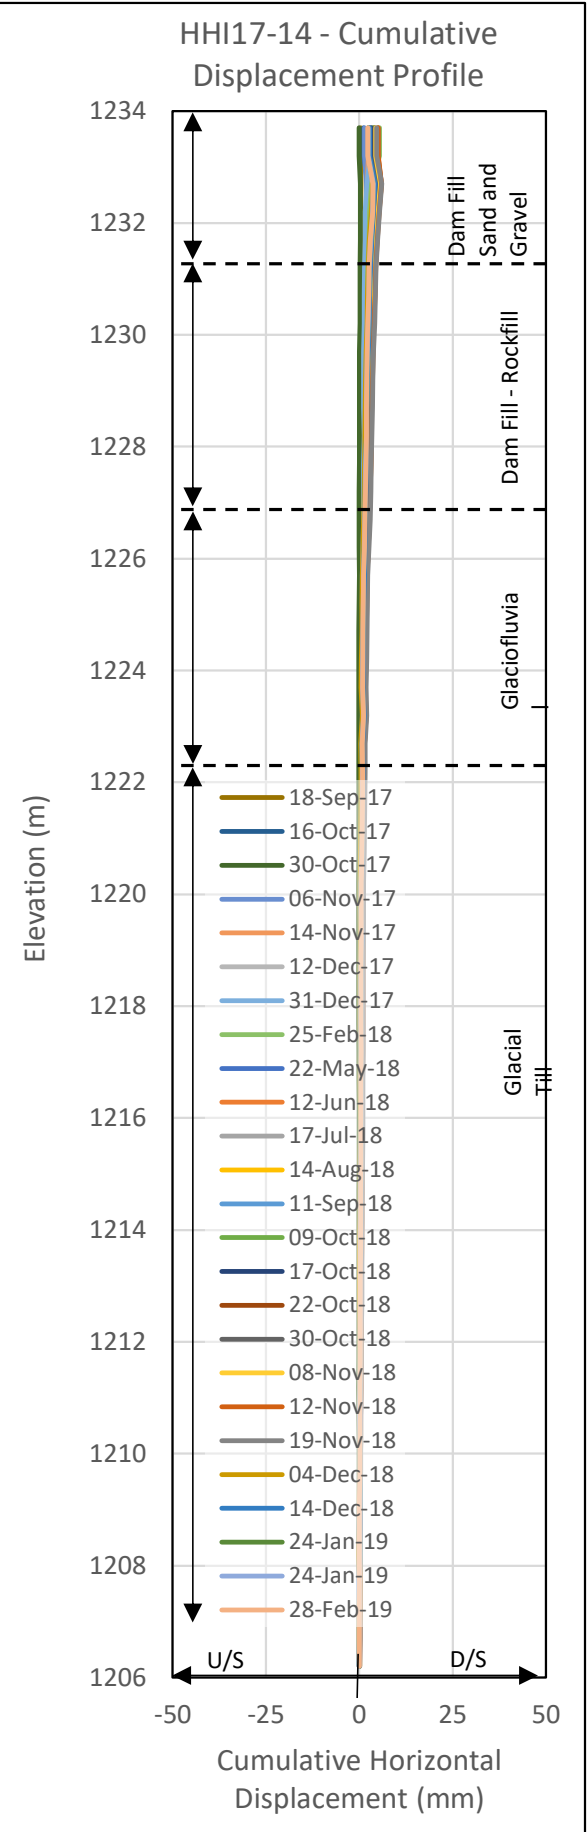
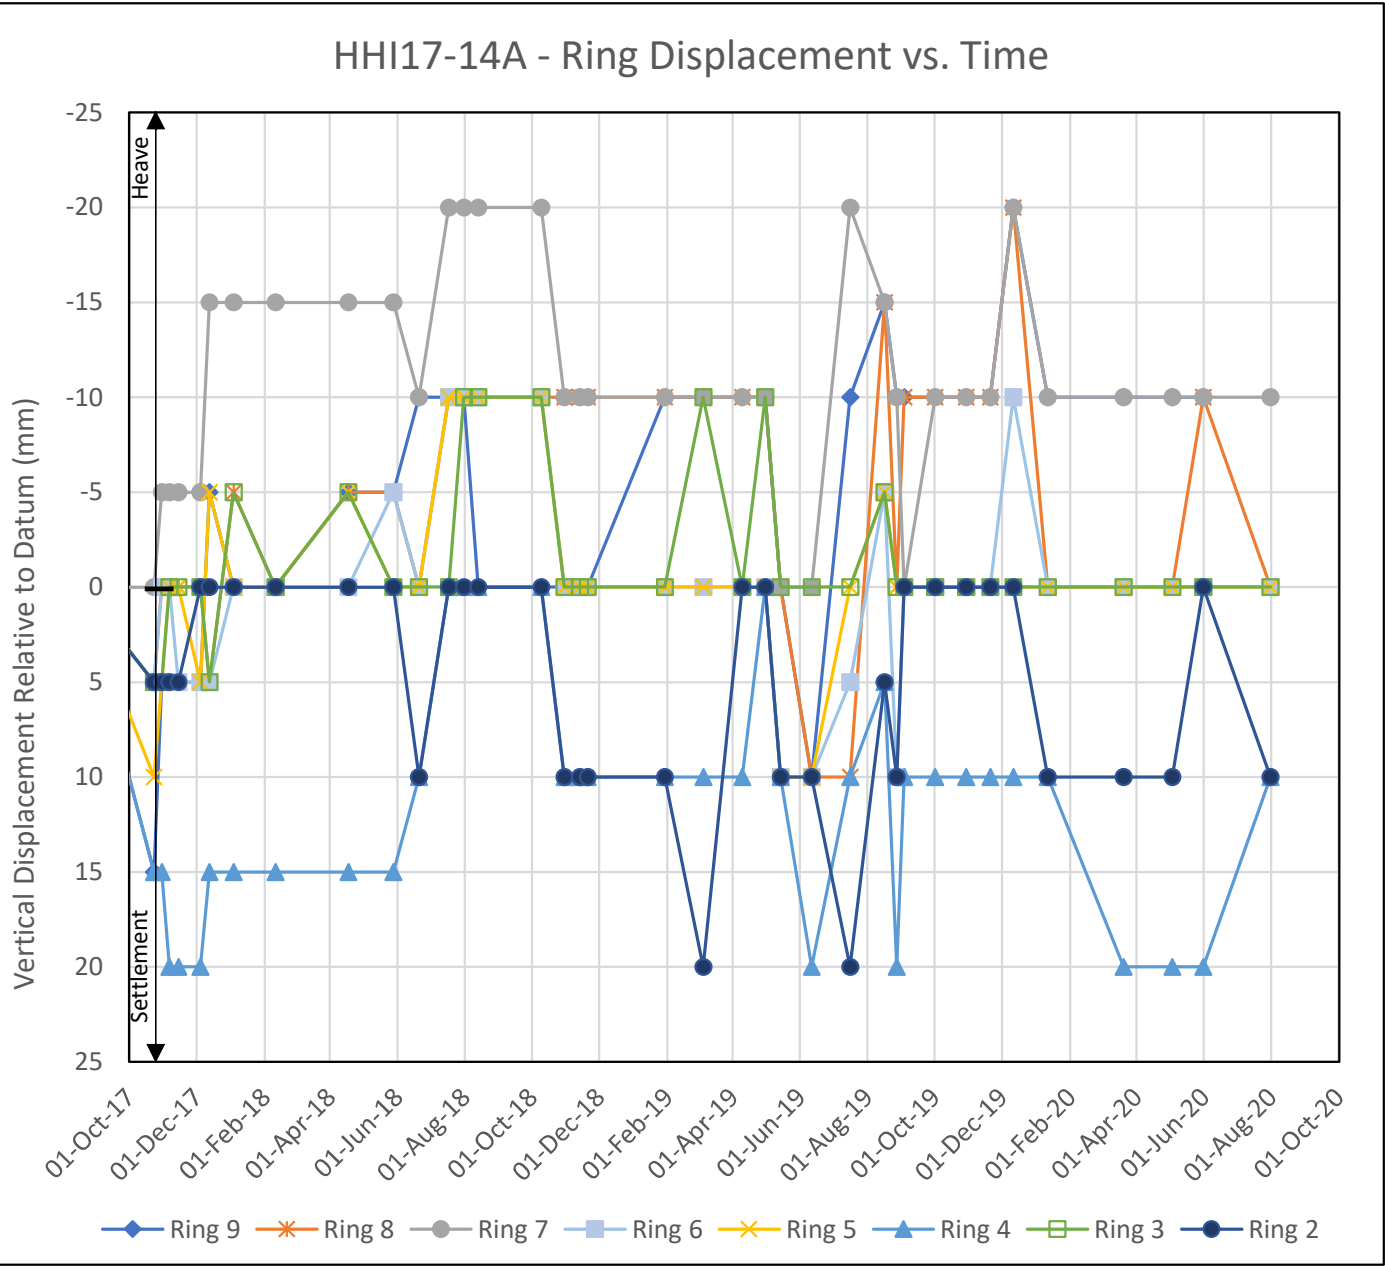
There are 8 inclinometers and 4 Sondex settlement monitoring systems installed at the H-H Dam, refer to Table IV-A-2. During 2020, the Sondex installed near HHI17-14A (~Sta. 2+020) was damaged and could not be salvaged. The primary function of the Sondex was to monitor settlement in the downstream fill placed by the THVCP mining fleet to support the interpretation that horizontal movements in the fill is related to settlement of the fill. The instruments have achieved this function and ongoing monitoring of functional instruments remain part of routine surveillance. However, the loss of a Sondex does not compromise the surveillance program or controls of the H-H Dam.

- Notes:
1. Ring displacements are calculated relative to the initial elevations for each ring. The datum is the bottom ring (Ring 1).
 2. Positive displacements represent settlement. Negative displacements represent heave.
 3. The Ring 4 reading from February 10, 2018 was not consistent with readings in the rings above and below, due to a suspected data entry error. The reading was adjusted to match the trends of Ring 3 and Ring 5.
 4. No readings after July 31, 2020. Casing is broken at approximately 3 m downhole.

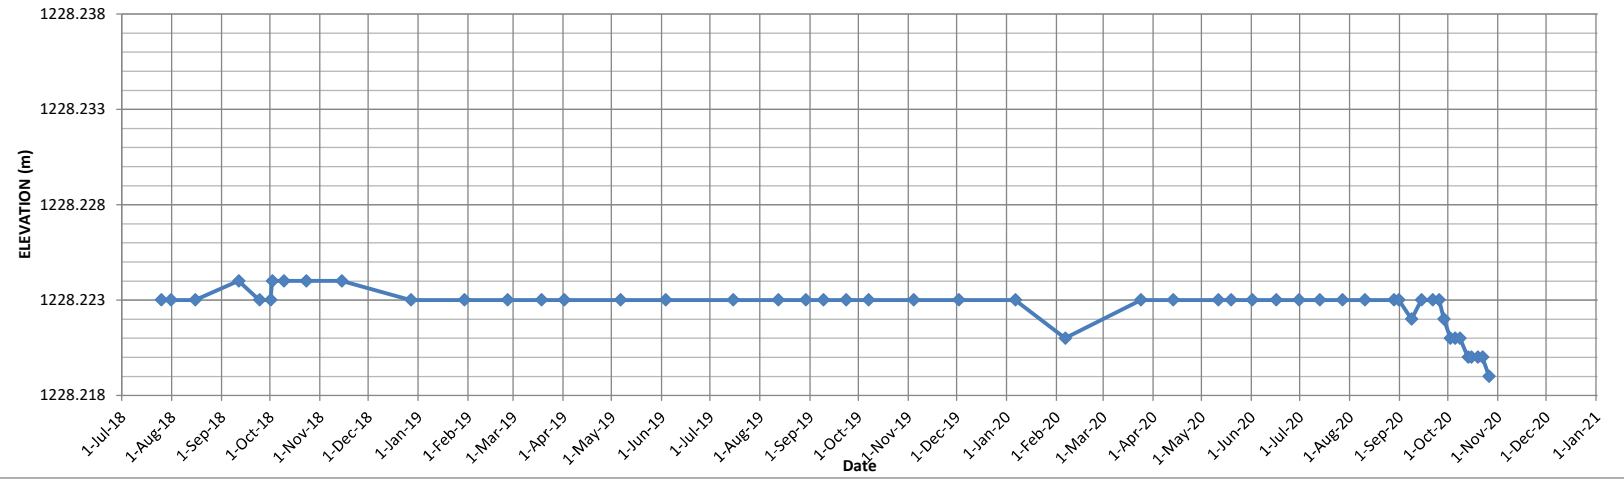
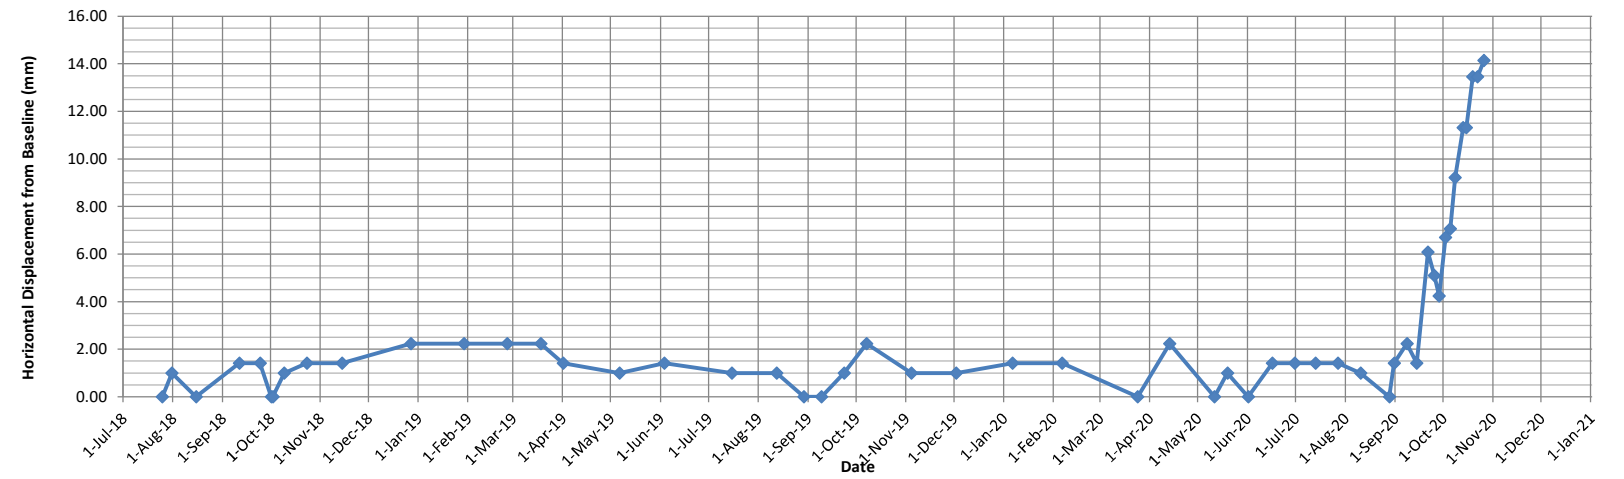
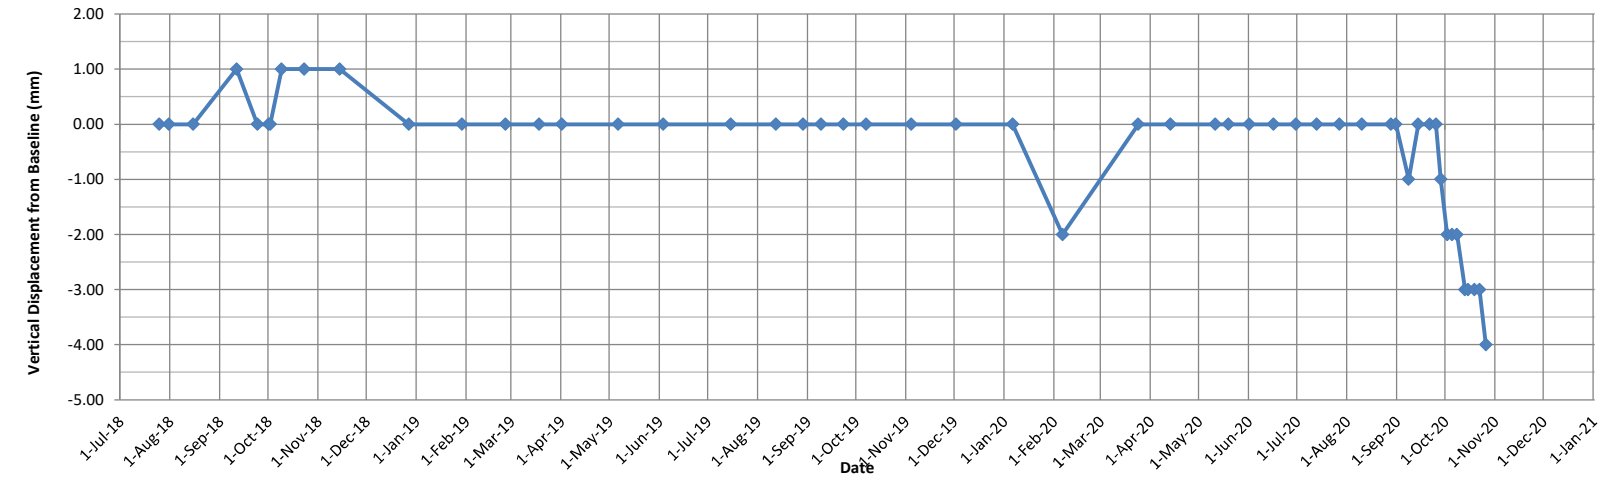
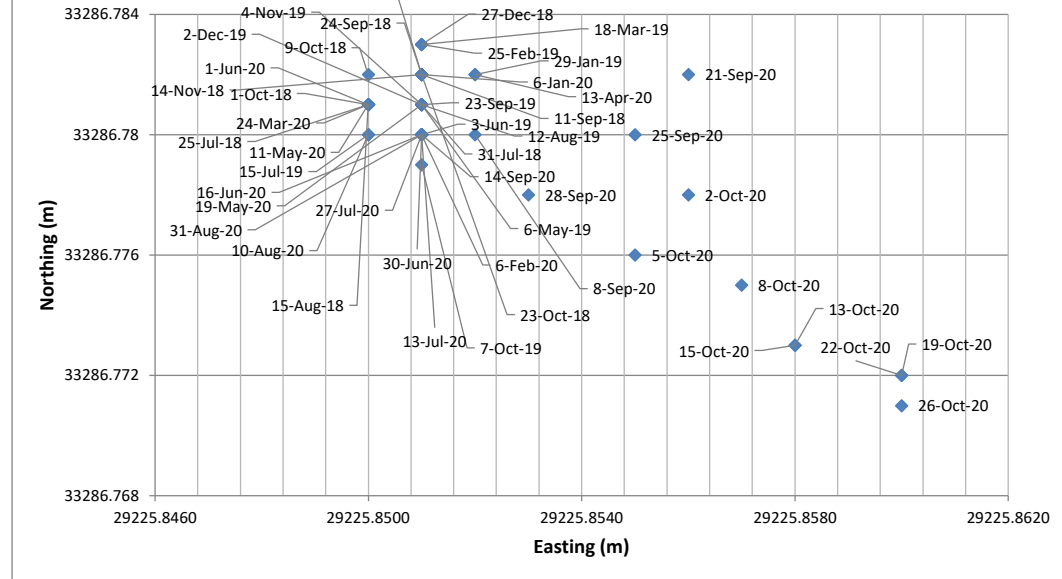
1. All data provided by THVCP.
2. LB8 buried by buttressing at the bottom of lock block wall.

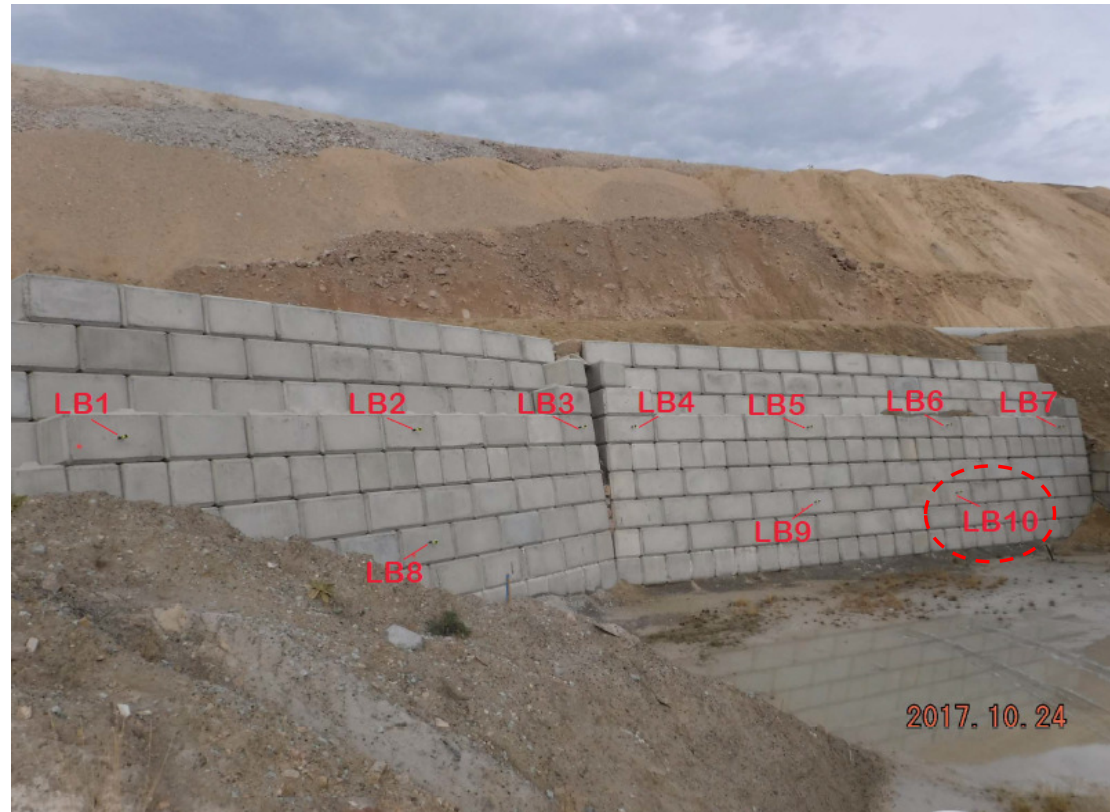
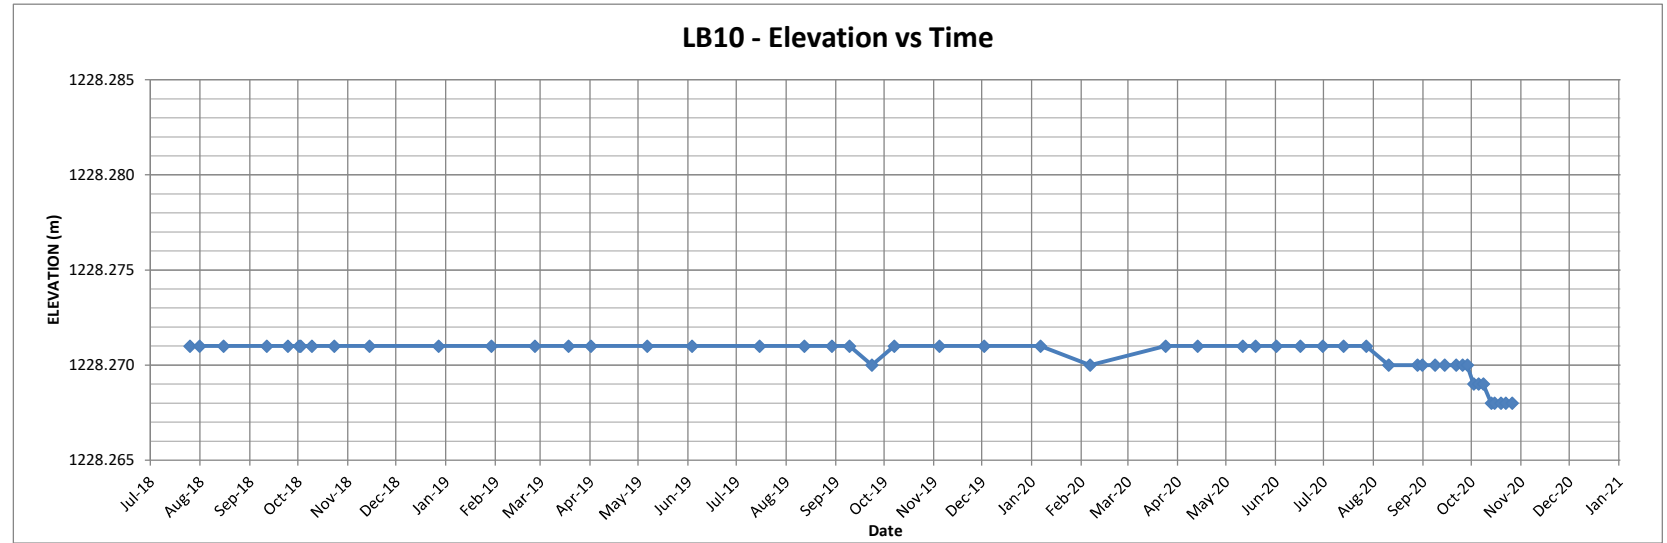
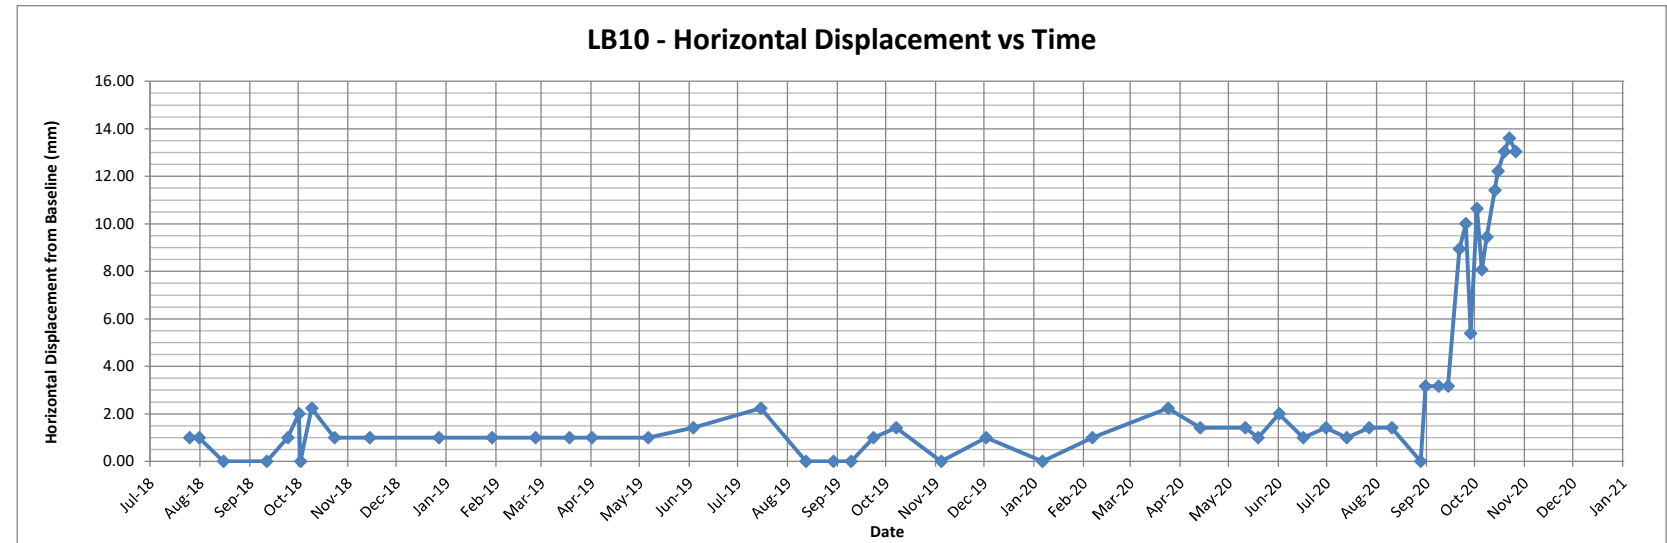
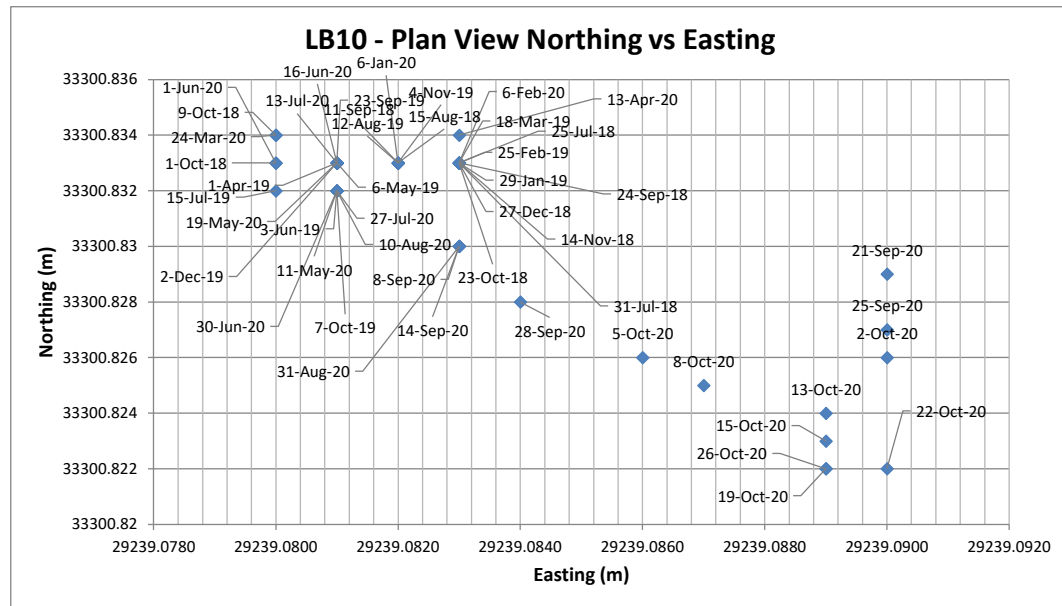
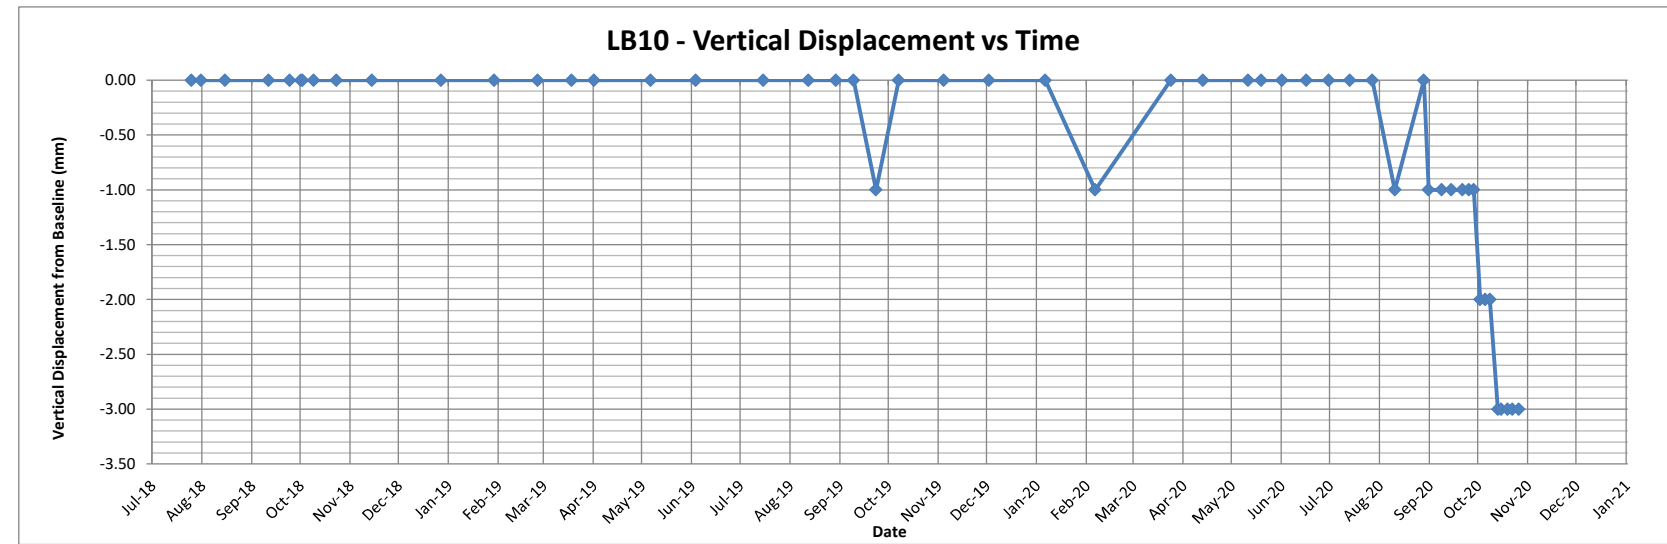
1. All data provided by THVCP.
2. LB10 buried by buttressing at the bottom of lock block wall.
