Teck Highland Valley Copper Partnership

2020 Annual Facility Performance Report

Highland Tailings Storage Facility

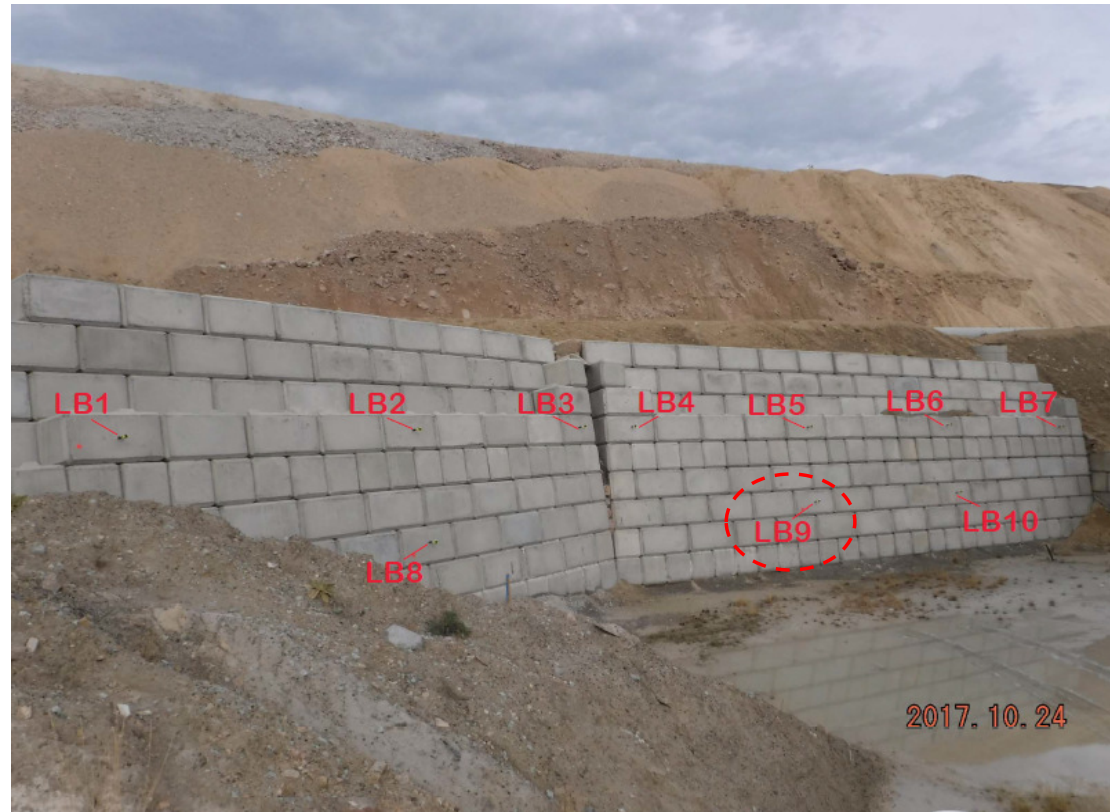
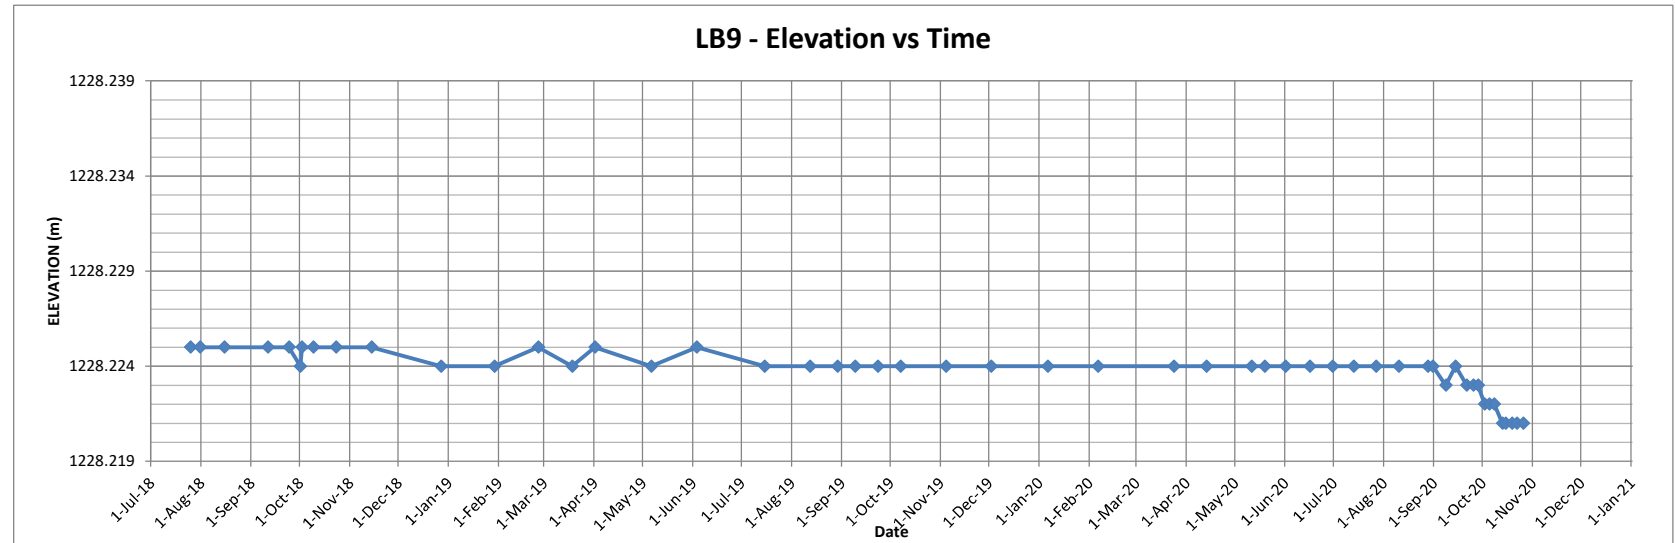
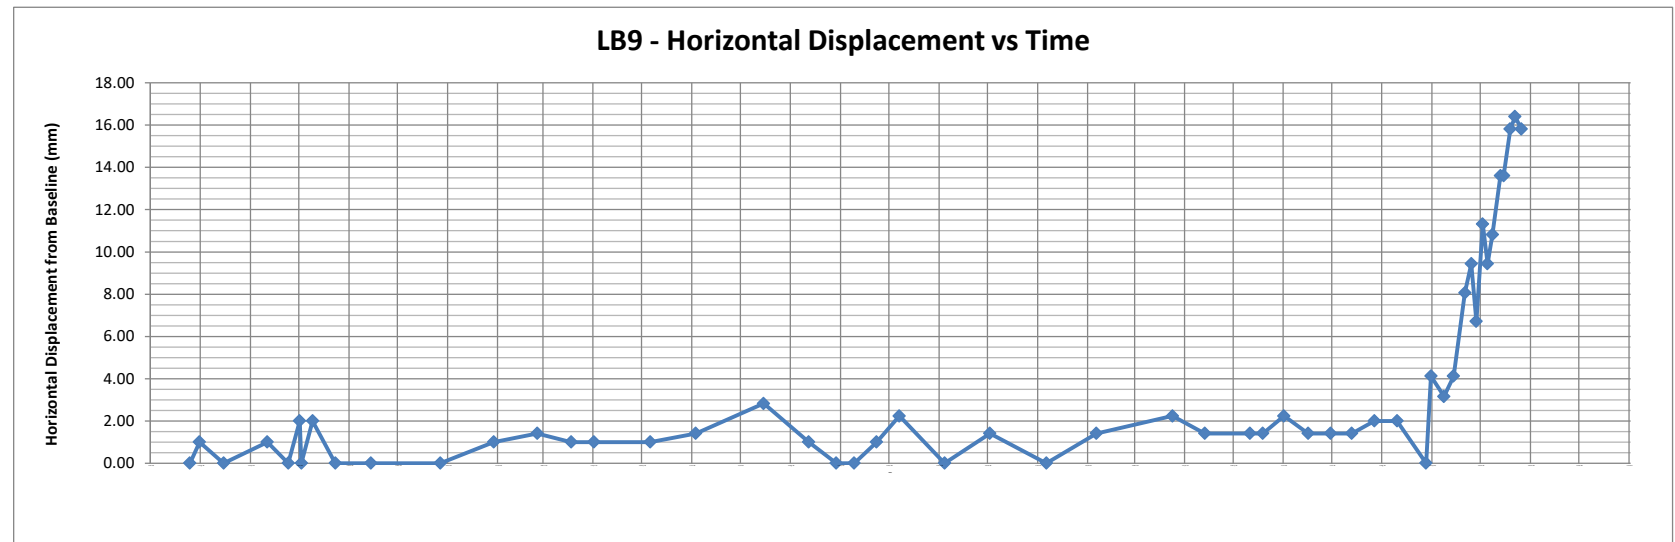
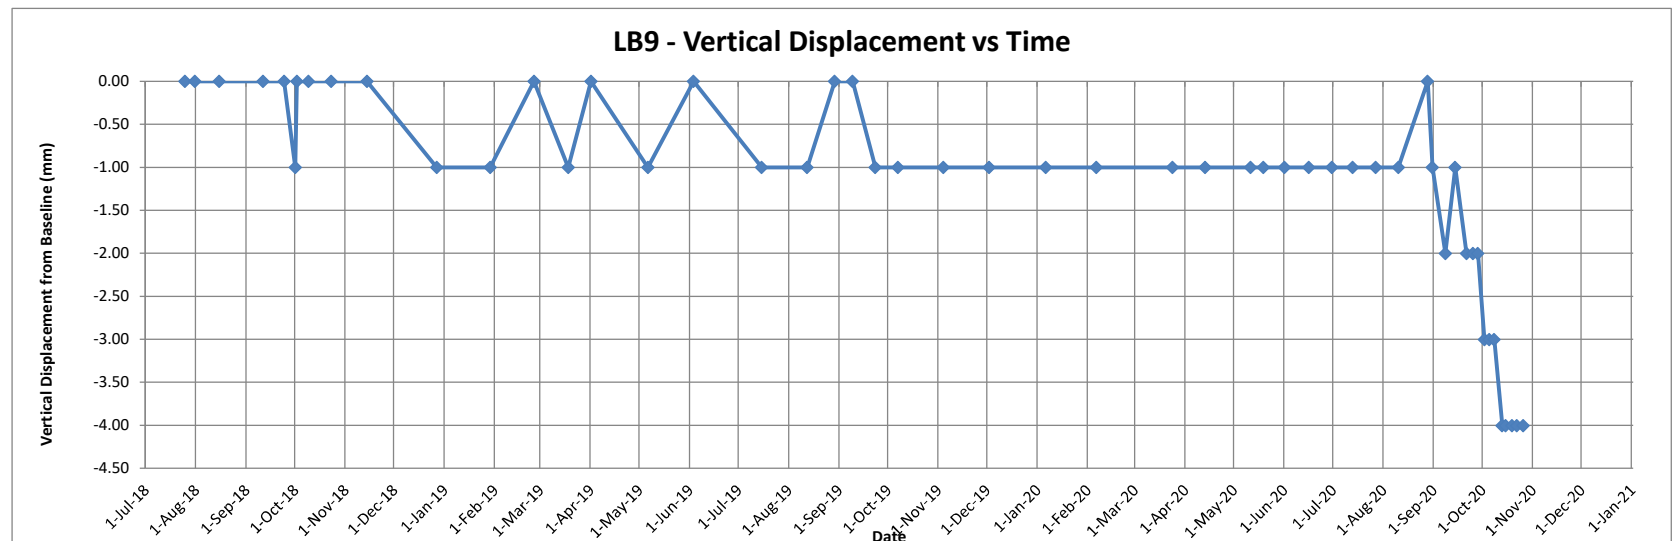
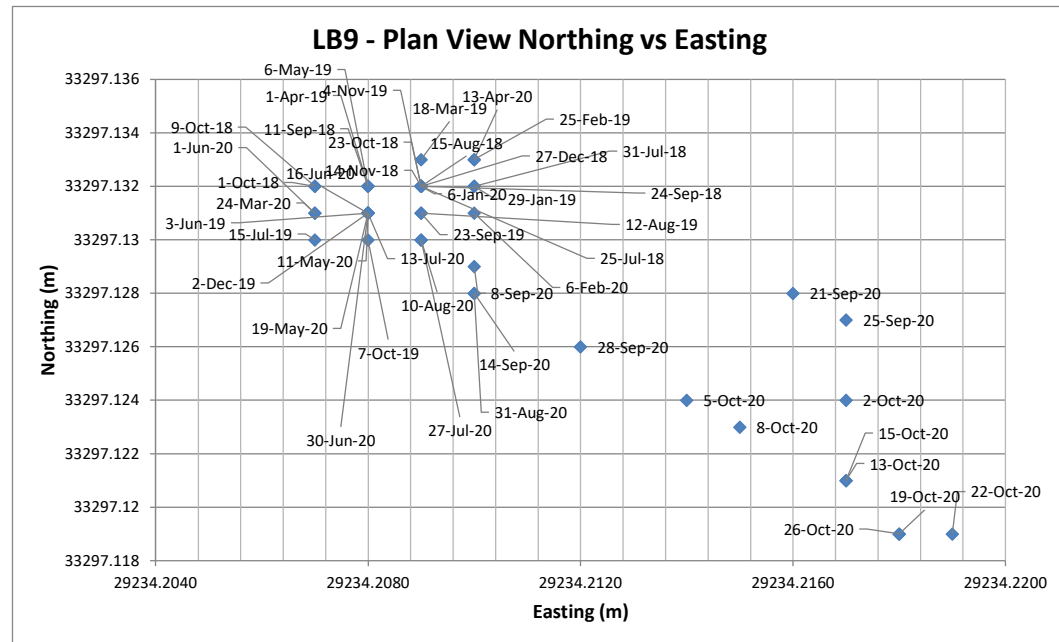
1. All data provided by THVCP.
2. LB9 buried by buttressing at the bottom of lock block wall.
