Teck Highland Valley Copper Partnership

2020 Annual Facility Performance Report

Highmont Tailings Storage Facility

March 2021

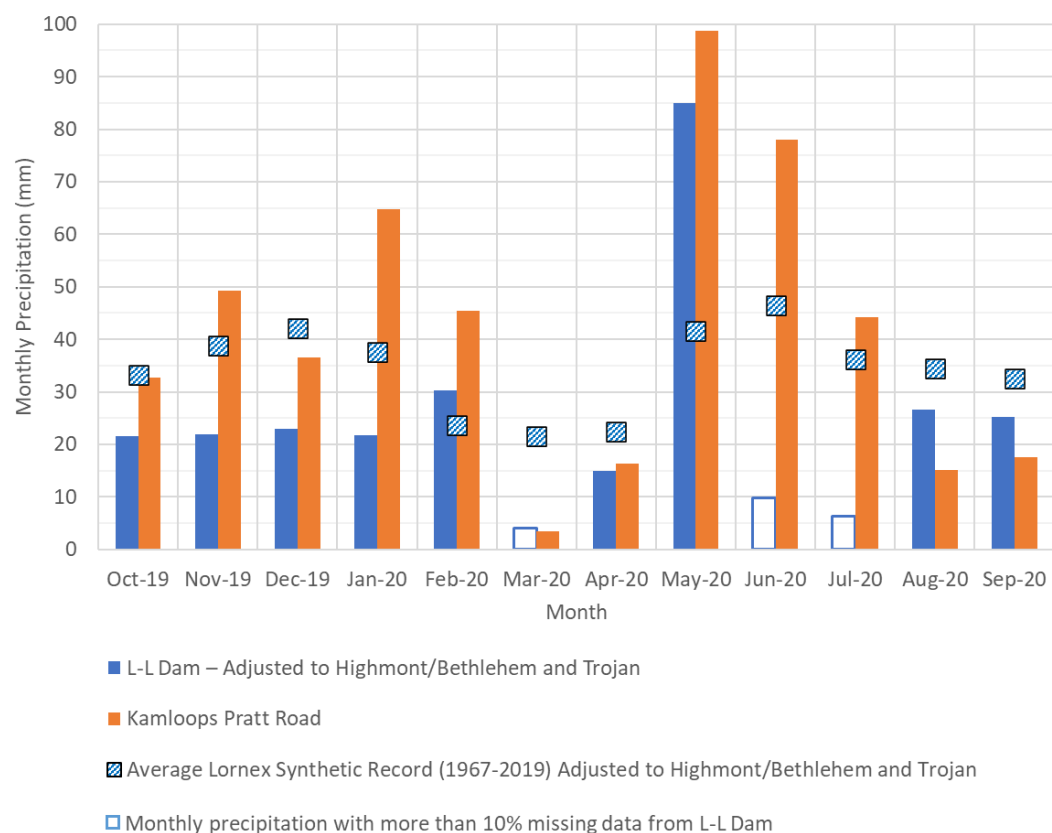
Figure 4.1 Monthly Precipitation

- Figure 4.1 indicates low precipitation at site during June and July; however, this is due to L-L Dam Weather Station data gaps during this period. THVCP inspection reports and regional climate station data indicate precipitation during this period was above historic normals.

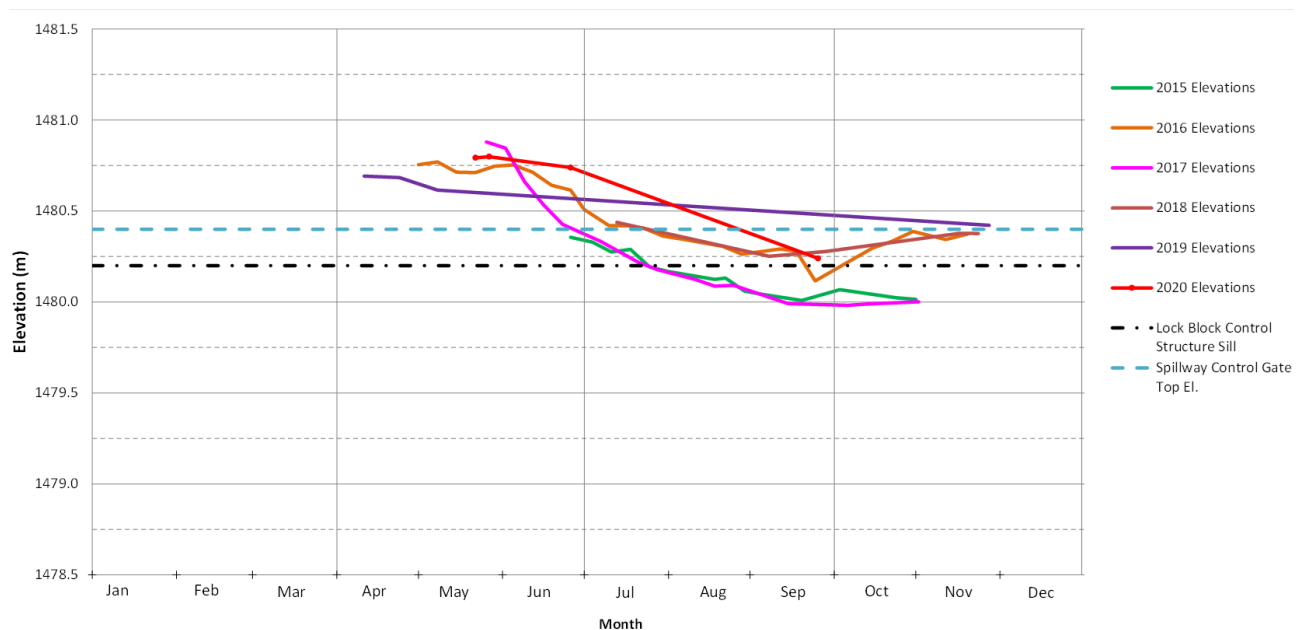
Figure 5.1 Highmont TSF Pond Water Elevations – 2015 to 2020

THVCP has a transducer installed at the Highmont TSF spillway channel, near the inlet, to monitor pond levels. In addition, the Highmont TSF pond level was surveyed five times during 2020 freshet and visually checked during routine inspections. In general, 2020 levels were higher during freshet compared to 2019 levels but the seasonal pond level variations were consistent with historic observations, which shows no long-term trend of increasing pond volume, refer to Figure 5.1. The historical annual fluctuation in pond level is less than 1 m, as shown in Table 5.2.

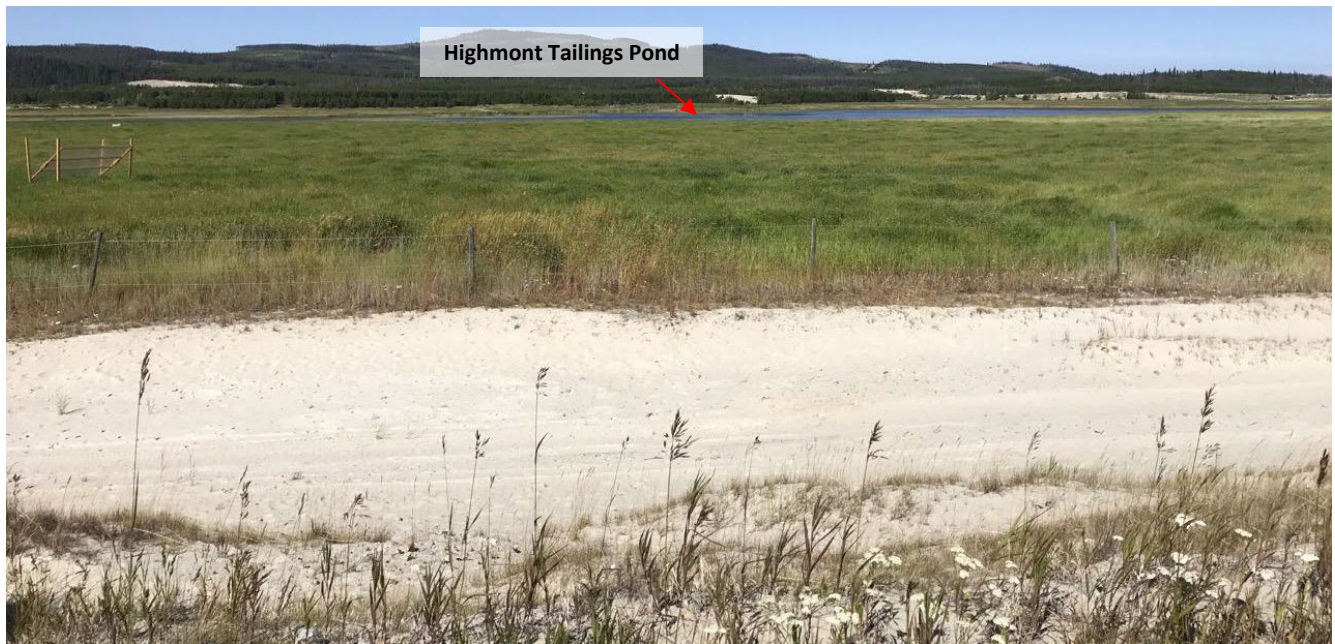
Photo I-A-2 View of tailings impoundment and beach from East Dam (HGH-2020-02)

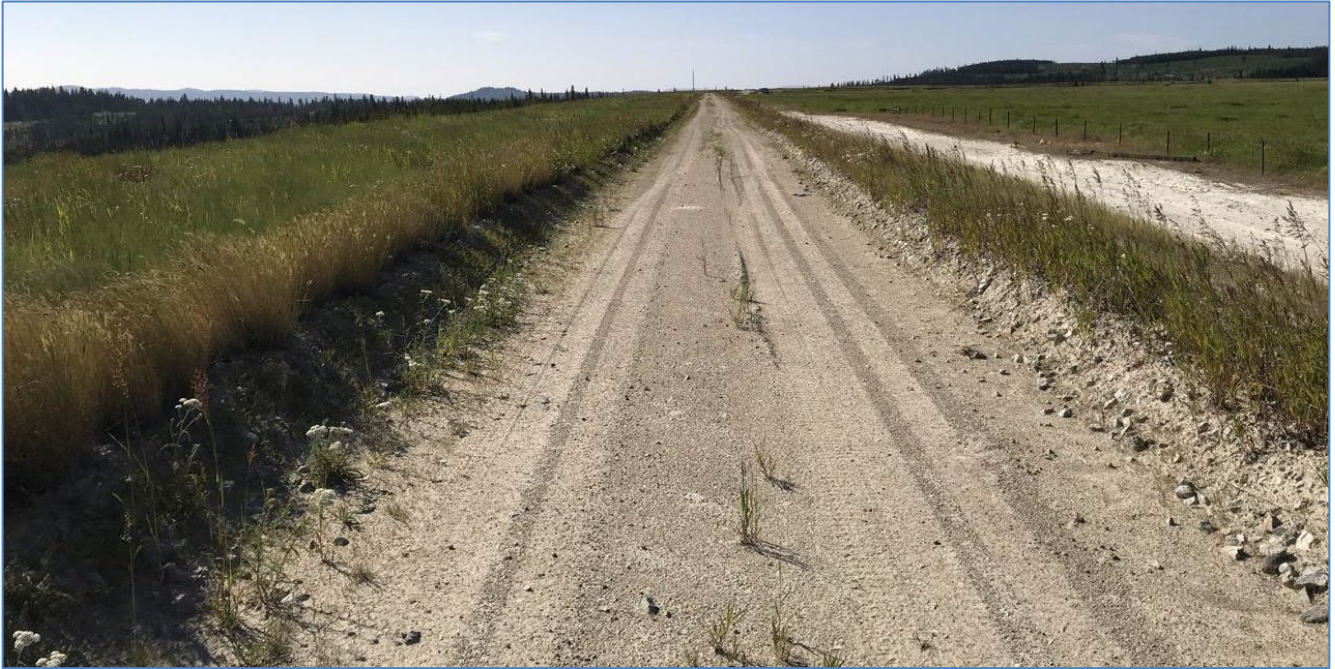
Photo I-A-7 East Dam crest. Crest is in good condition. No signs of deformation or distress were observed (HGH-2020-02)

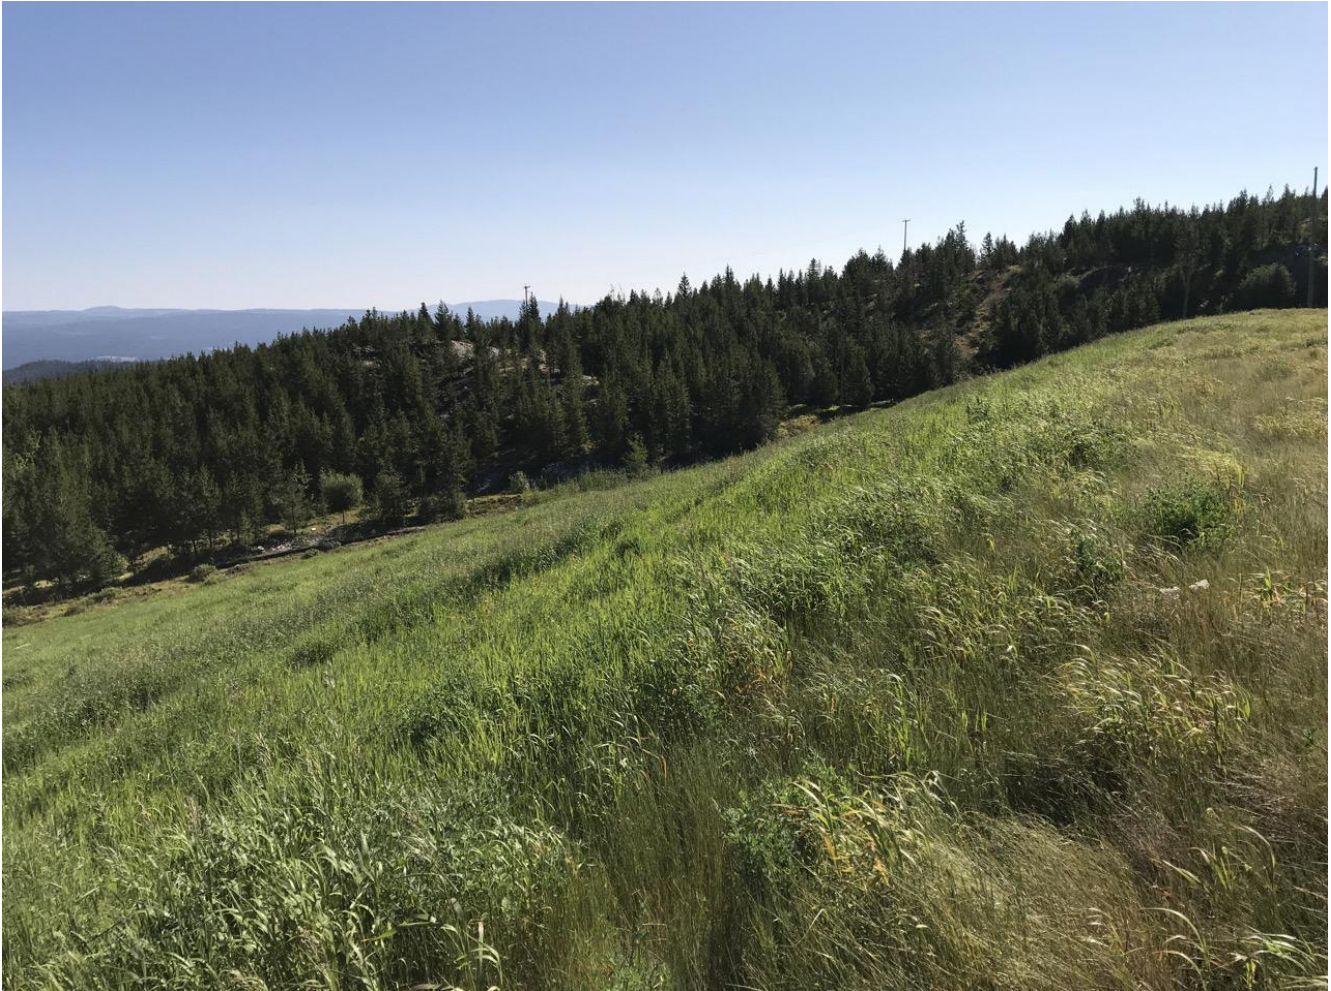
Photo I-A-10 View of North Dam downstream slope looking east (HGH-2020-06)

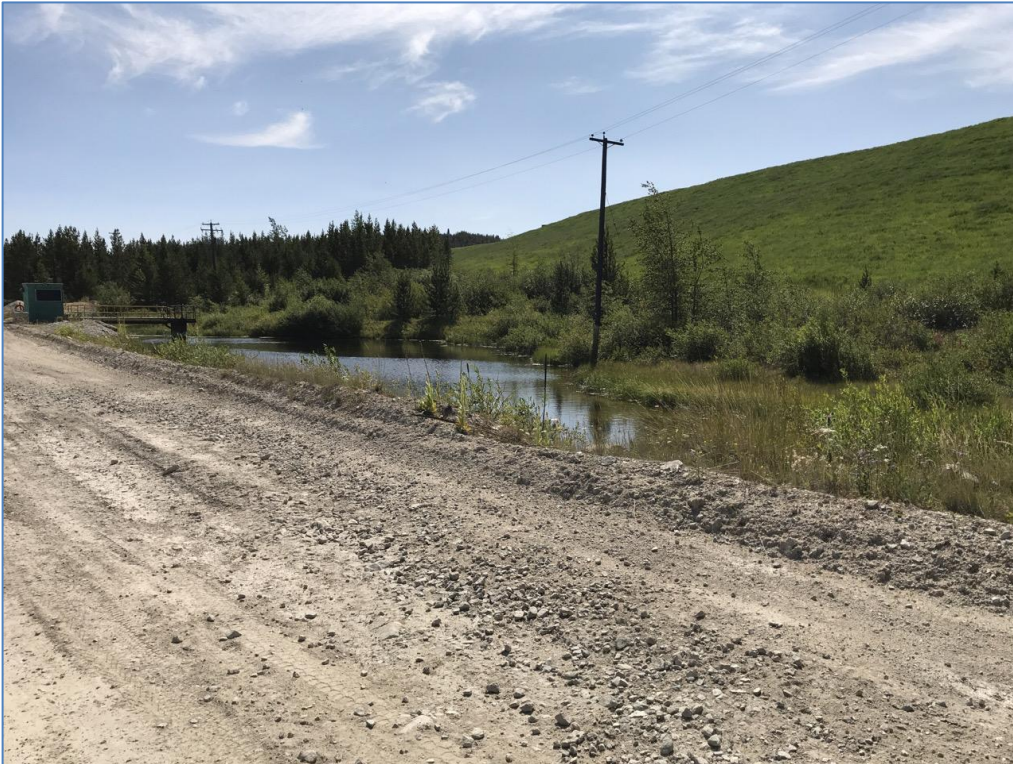
Photo I-A-11 View of North Dam downstream slope from S8 Pond access road (HGH-2020-07)

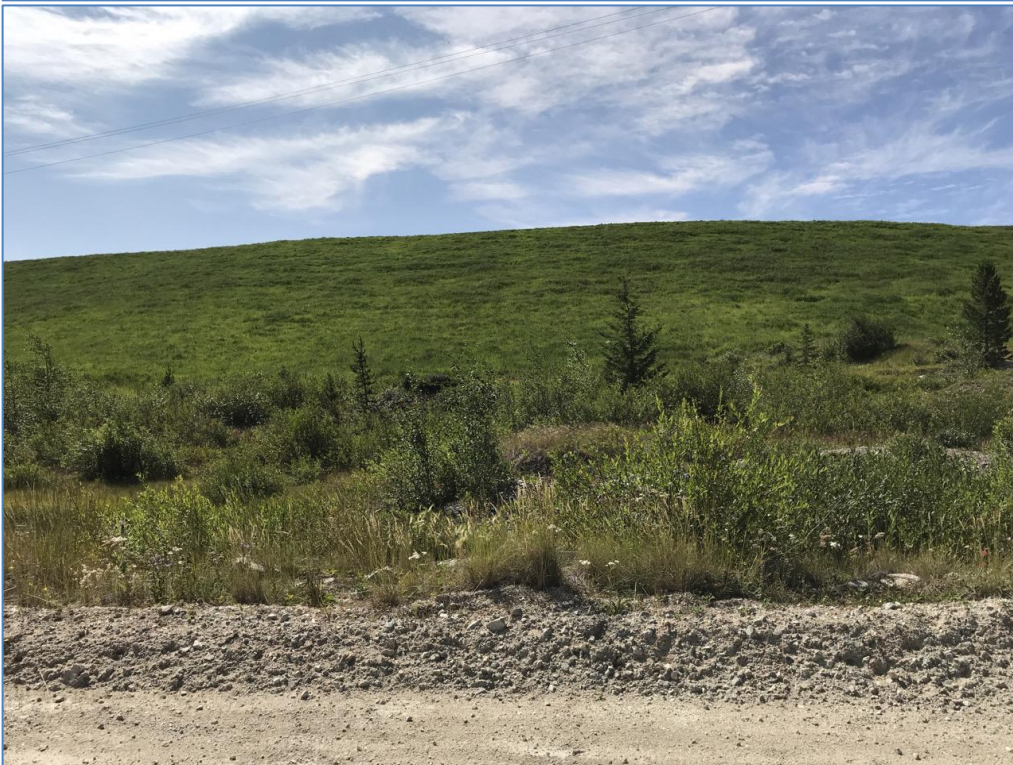
Photo I-A-12 East Dam downstream slope. Slope is vegetated and in good condition (HGH-2020-08)

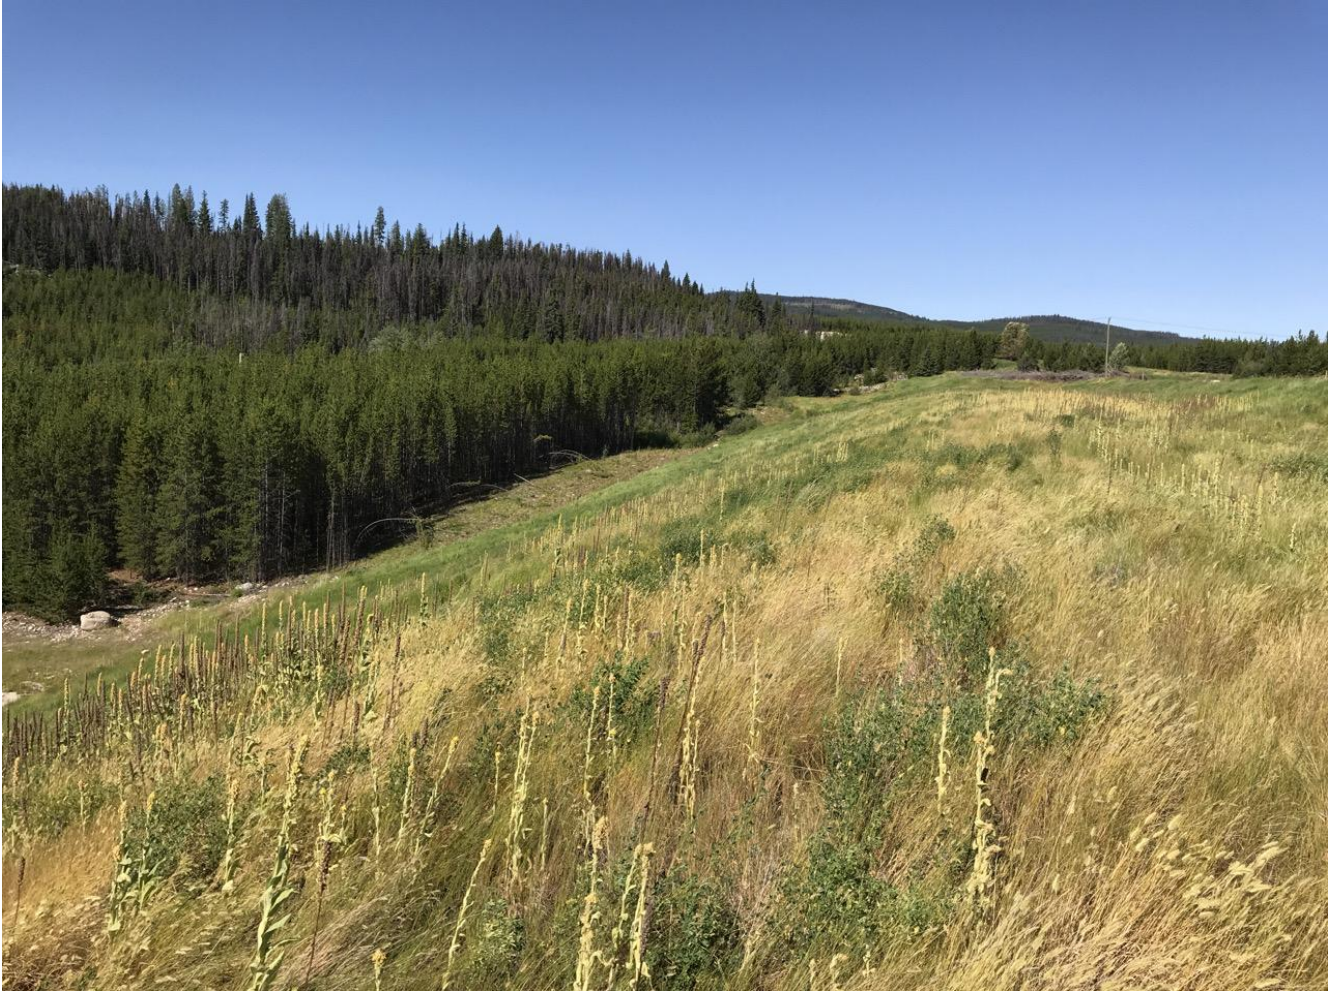
Photo I-A-18 View of South Dam downstream slope at right abutment looking northwest. Slope is vegetated and in good condition (HGH-2020-03)

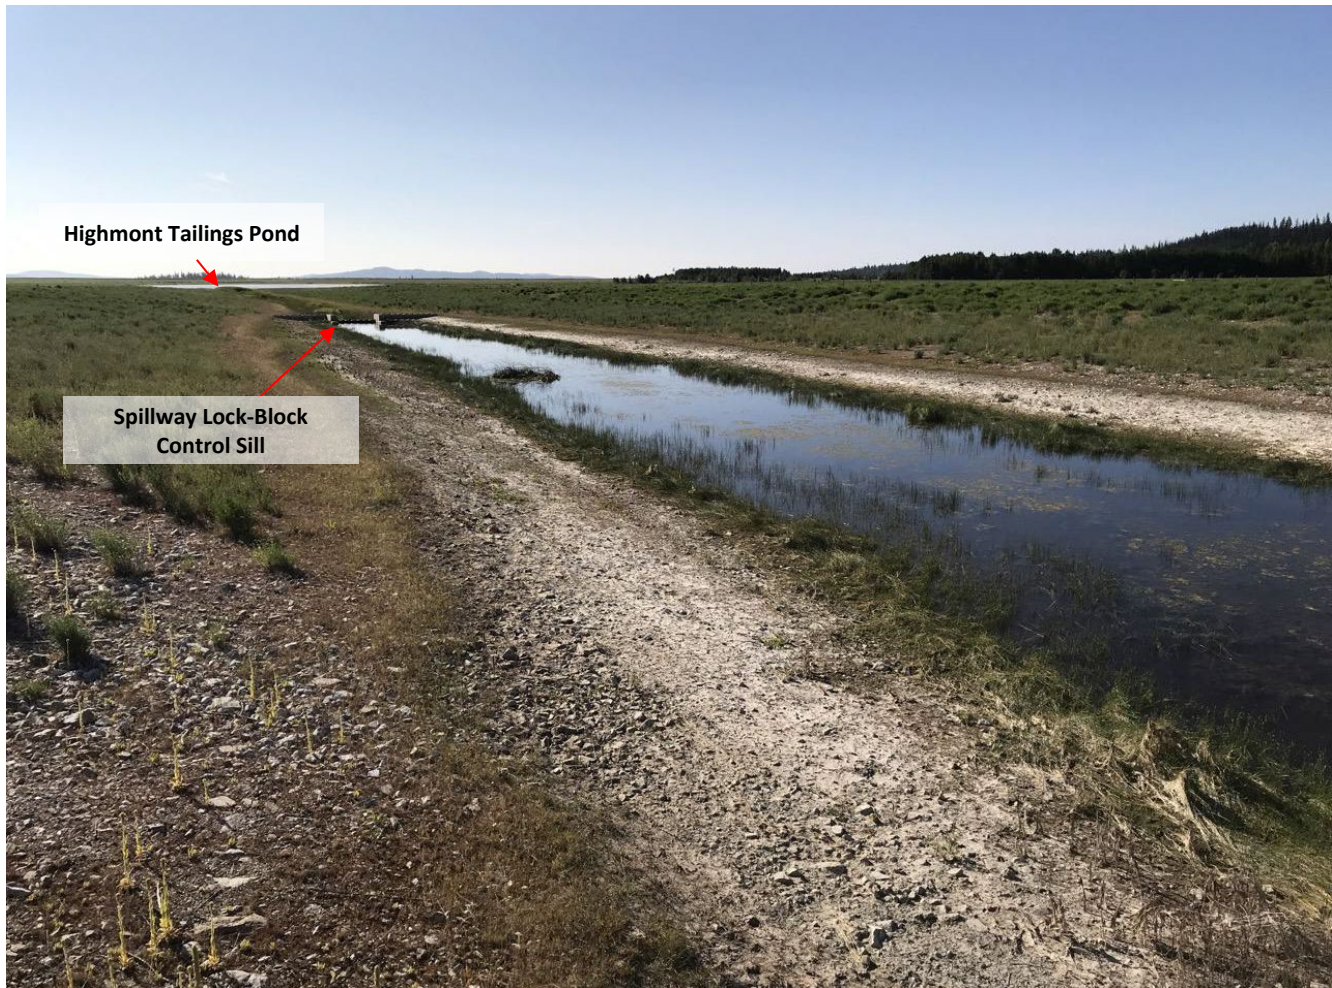
Photo I-A-19 Highmont Spillway approach channel, concrete lock-block control sill – Spillway was not flowing at the time of the inspection. Water ponded downstream of sill is controlled by level at spillway flow control gate (HGH-2020-10)

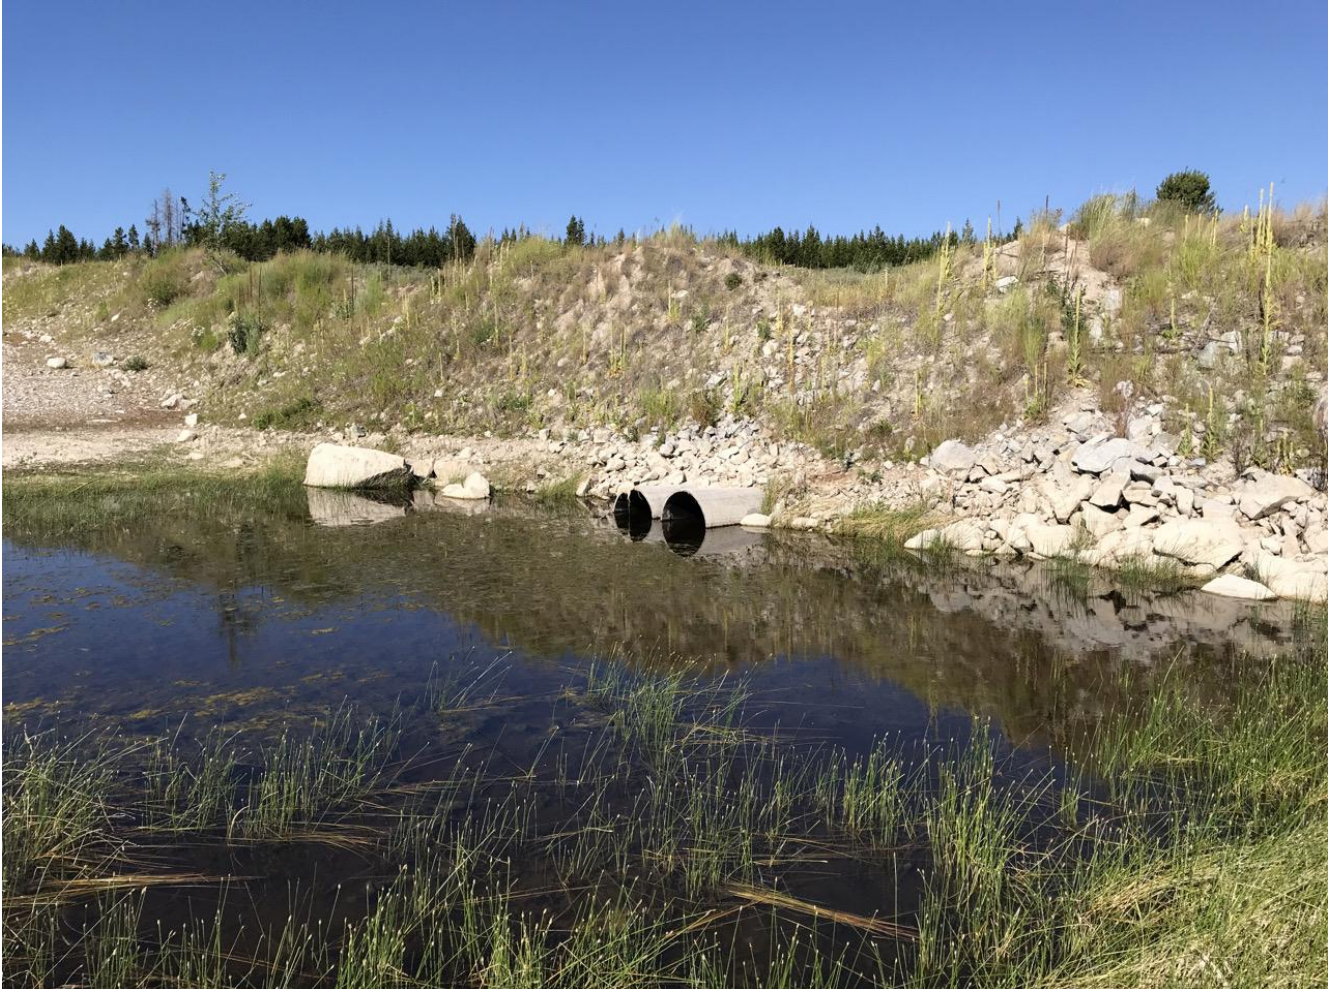
Photo I-A-20 Approach channel. Road culverts are partially submerged, section upstream of culverts is clear of debris and vegetation (HGH-2020-11)

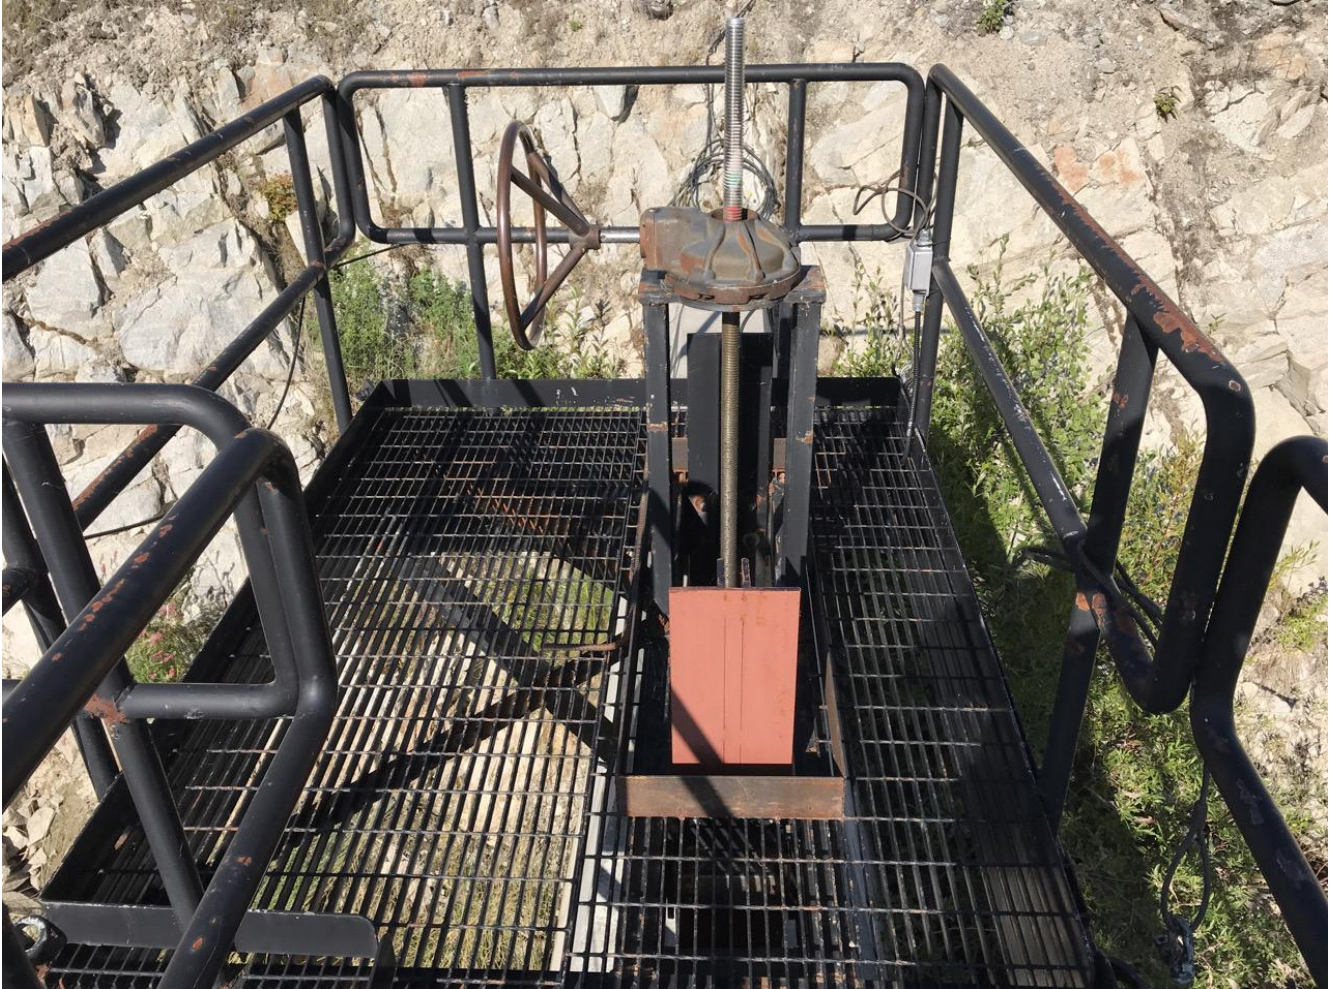
Photo I-A-22 Spillway flow control gate. Valve is operational and could move up and down (tested for slight movement). Sliding gate is slightly open (HGH-2020-13)

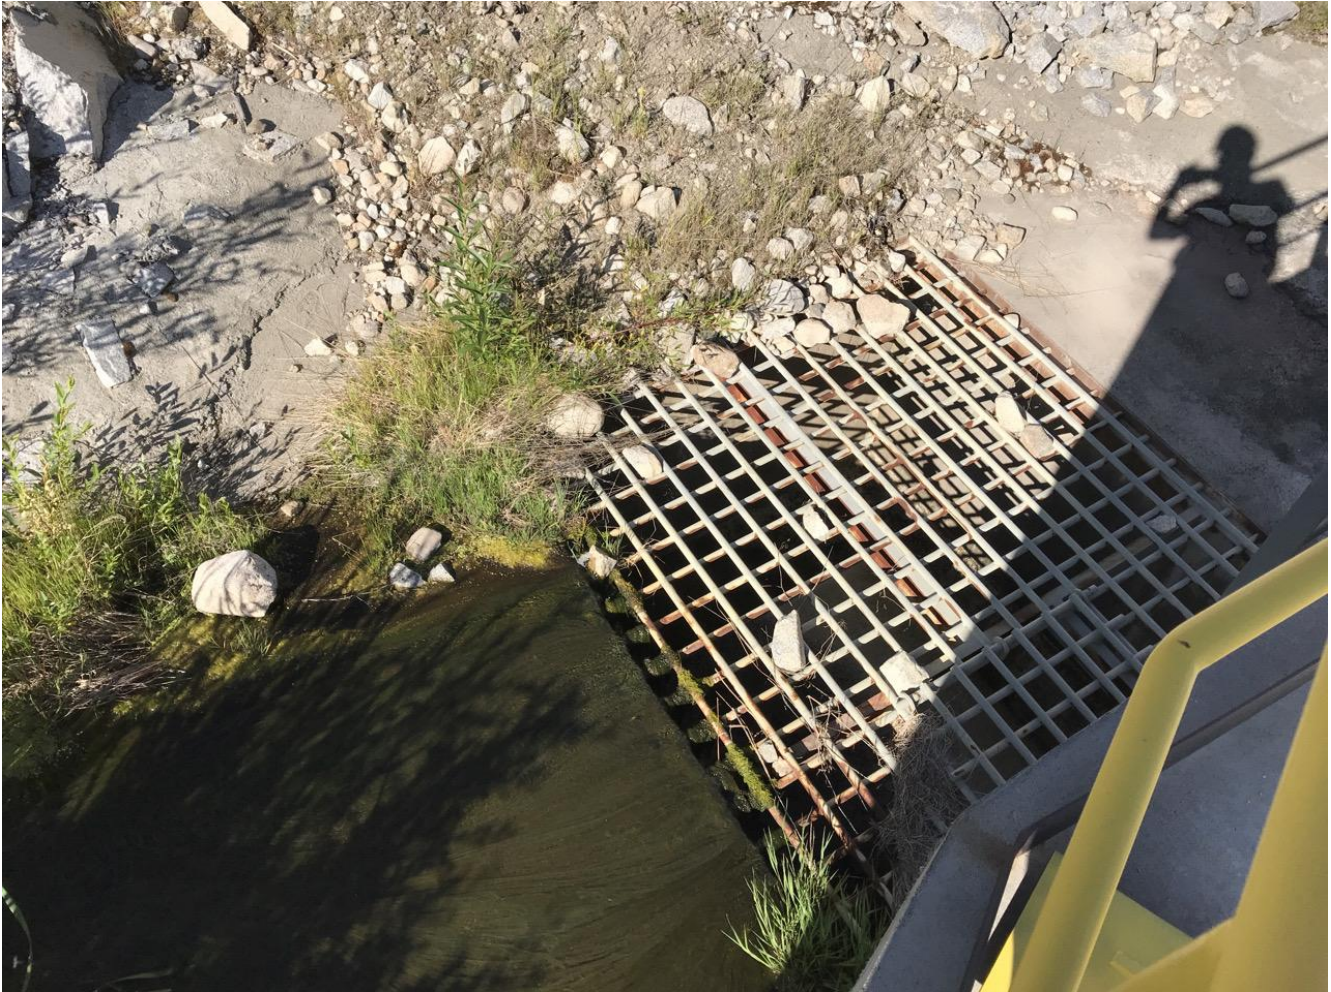
Photo I-A-24 Highmont Spillway channel, S1 Pond diversion trash rack. Minor flow into the diversion. Trash rack is clear of debris. No flow downstream of diversion (HGH-2020-15)

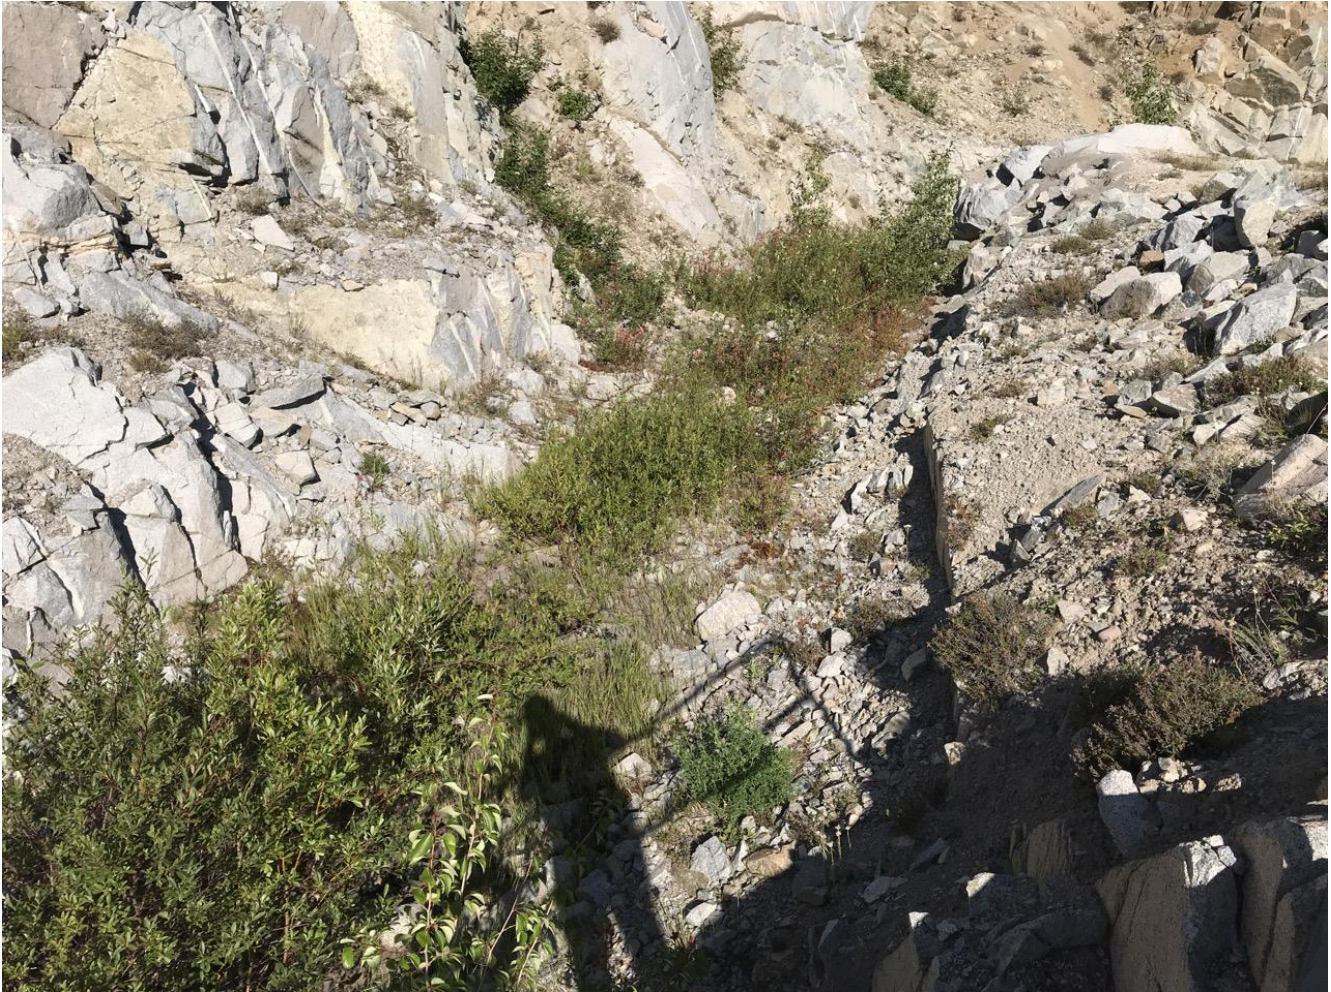
Photo I-A-26 Highmont Spillway channel, downstream of S1 Pond diversion and control. No flow downstream of S1 diversion. Minor vegetation was observed in the channel (HGH-2020-15)

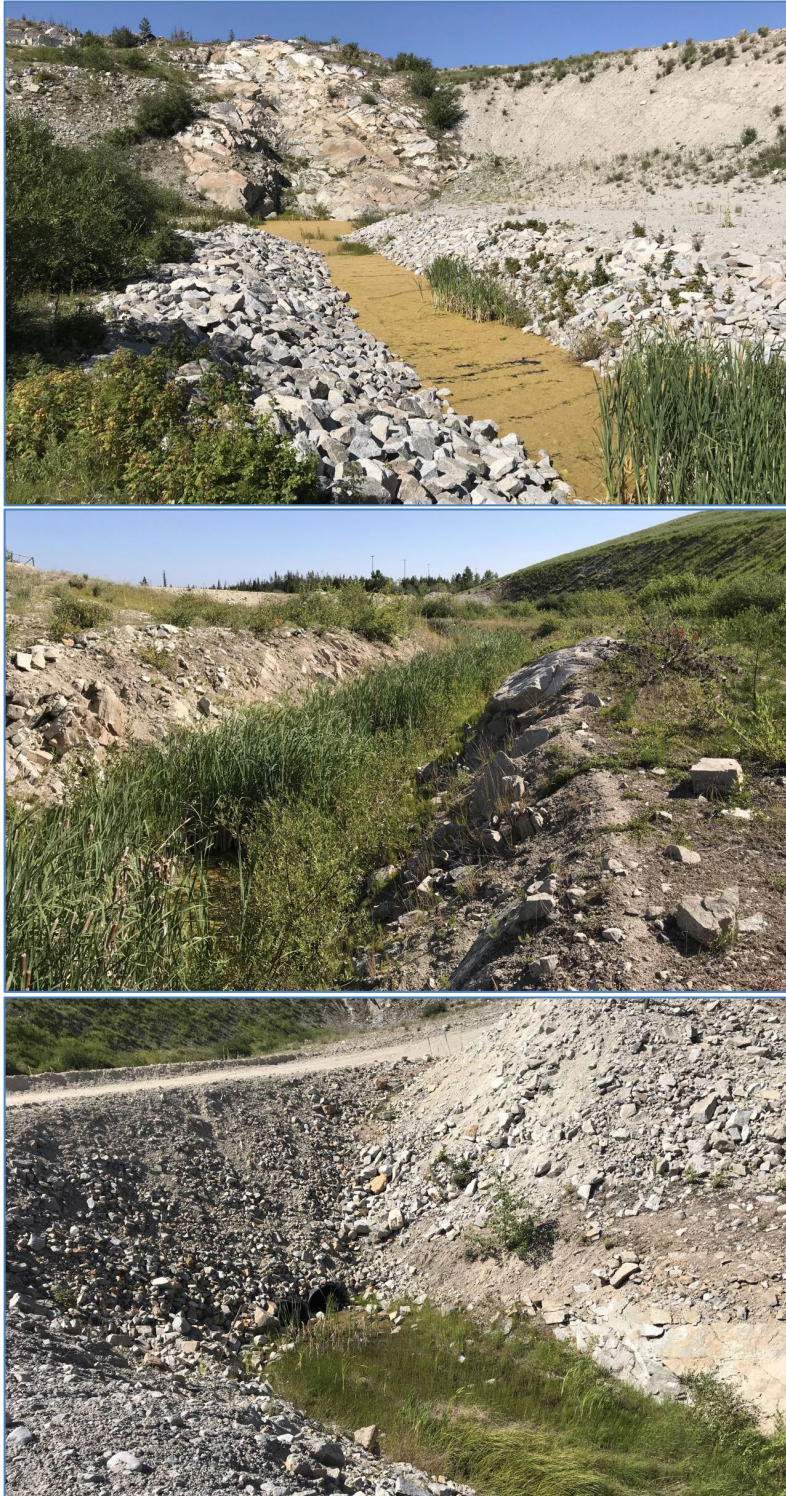
Photo I-A-31 Water is ponded downstream of spillway drop. Vegetation obstructing spillway channel (HGH-2020-18 and HGH-2020-19)

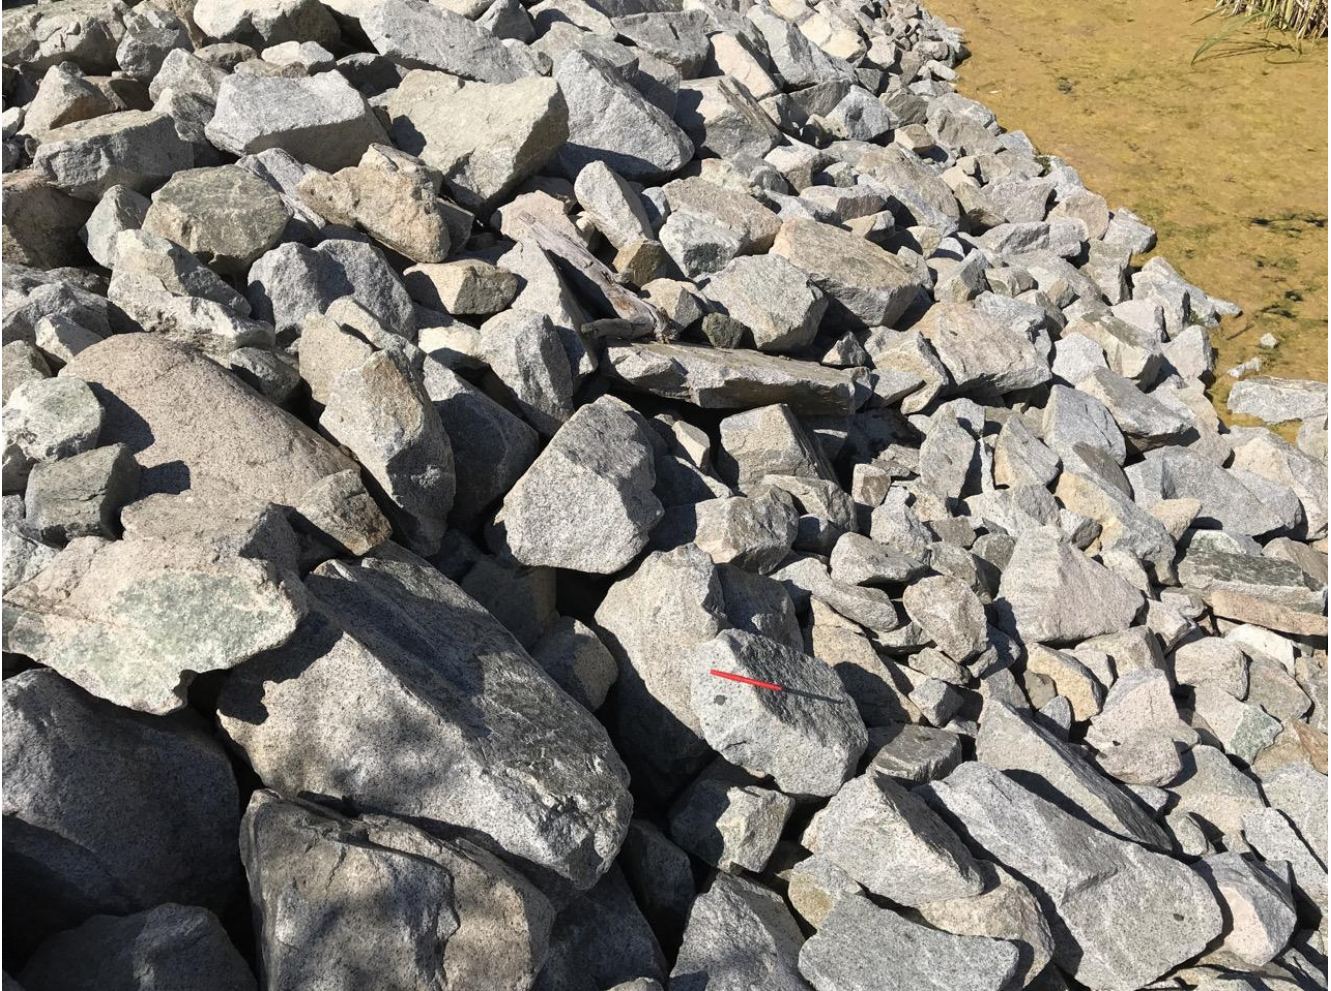
Photo I-A-32 Riprap at spillway stilling pond and channel with maximum size of approximately 1 m (HGH-2020-18)

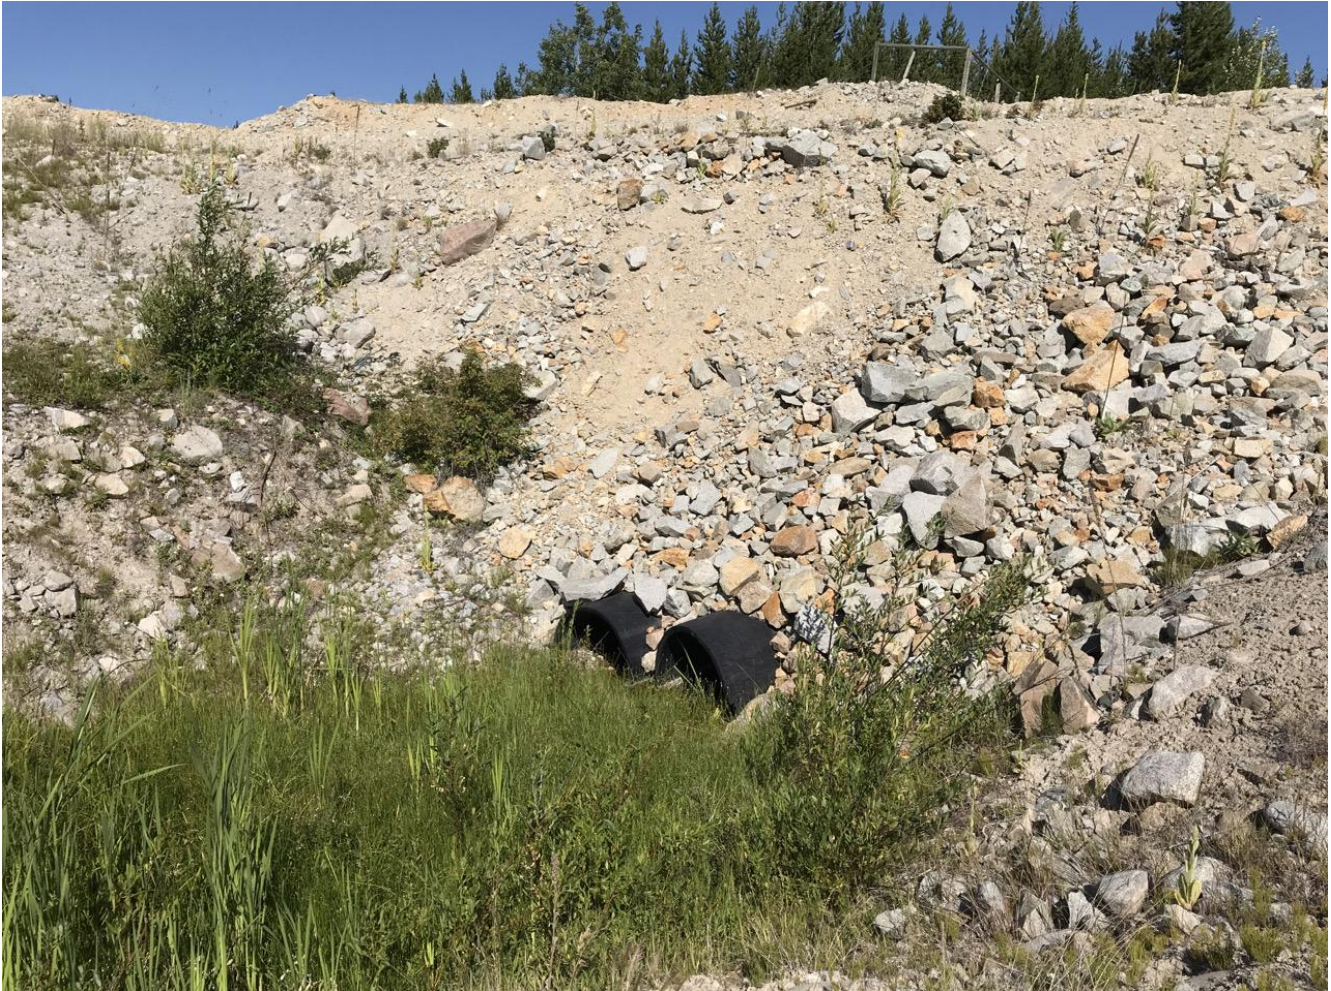
Photo I-A-33 North Dam toe access road crossing culverts. Culverts are misshapen (HGH-2020-17)

- Spillway is designed for the Probable Maximum Flood (PMF) which is greater than the minimum Inflow Design Flood (IDF) required by the Code.
- KCB recommended THVCP modify the area where the toe access road crosses the Highmont TSF Spillway channel, to allow the peak spillway flow to pass beneath the access road (e.g., bridge or arch culvert) or regrade the road surface (Recommendation HD-2017-01). THVCP has committed to completing this in 2021, following the update to flood routing. KCB agrees that waiting for flood routing to be completed is appropriate.

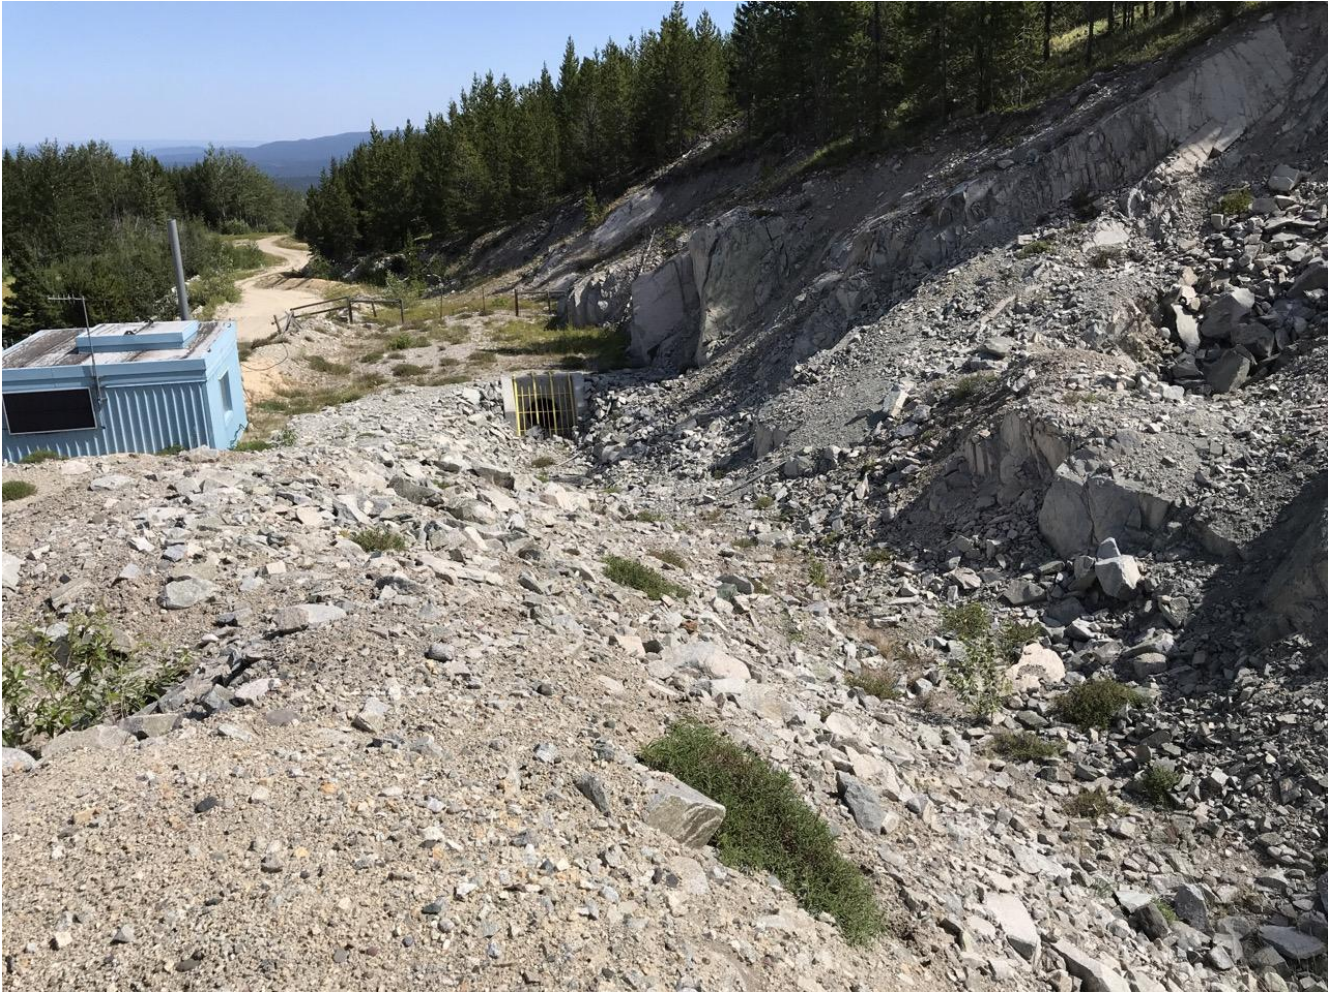
Photo I-B-5 S1 Pond: Spillway channel and pipe intake looking downstream. Channel is clear of vegetation and no sign of obstruction was observed at the pipe intake (HGH-2020-20)

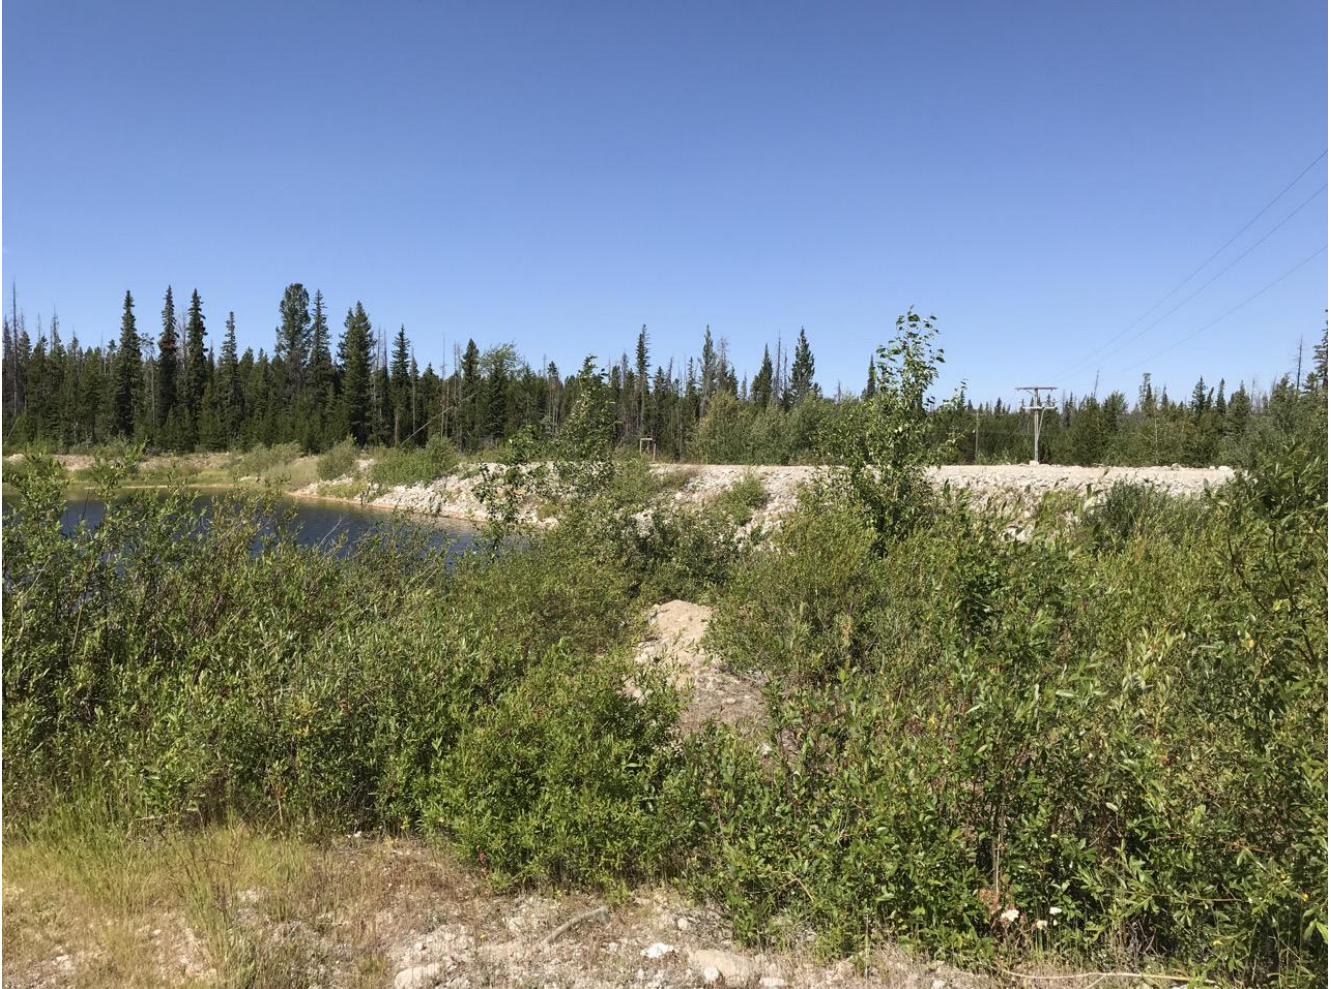
Photo I-B-11 S2 Pond: Overview of upstream slope riprap. Slope is in good condition (HGH-2020-26)

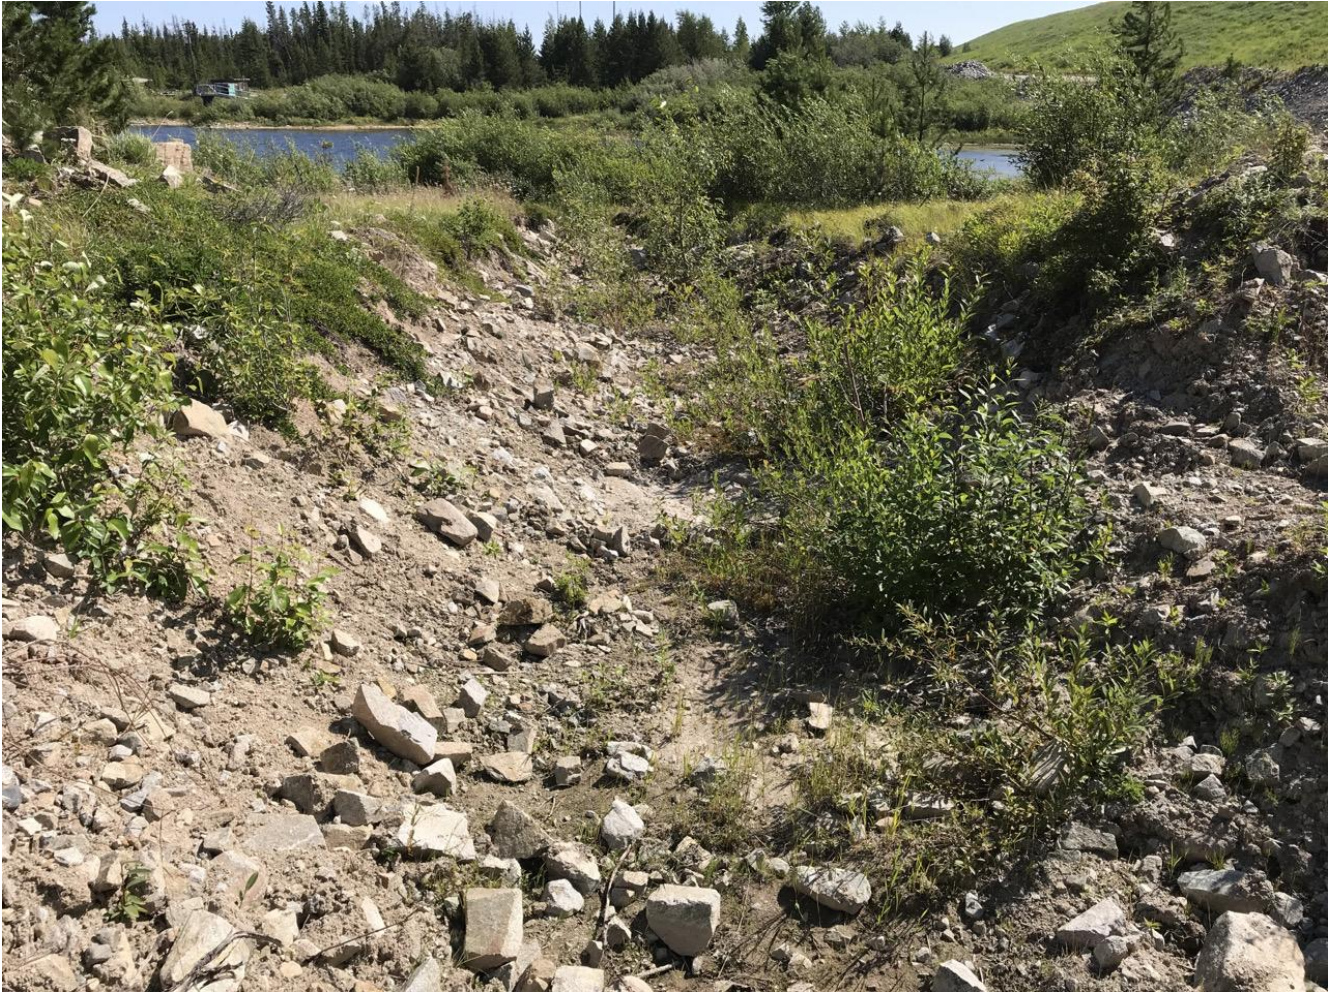
Photo I-B-15 S2 Pond: S2 Pond inlet and channel from Highmont Spillway Diversion. Channel and the inlet are heavily vegetated. Vegetation was removed after the site visit as part of routine maintenance (HGH-2020-28)
