Teck Highland Valley Copper Partnership

2020 Annual Facility Performance Report

Highmont Tailings Storage Facility

March 2021

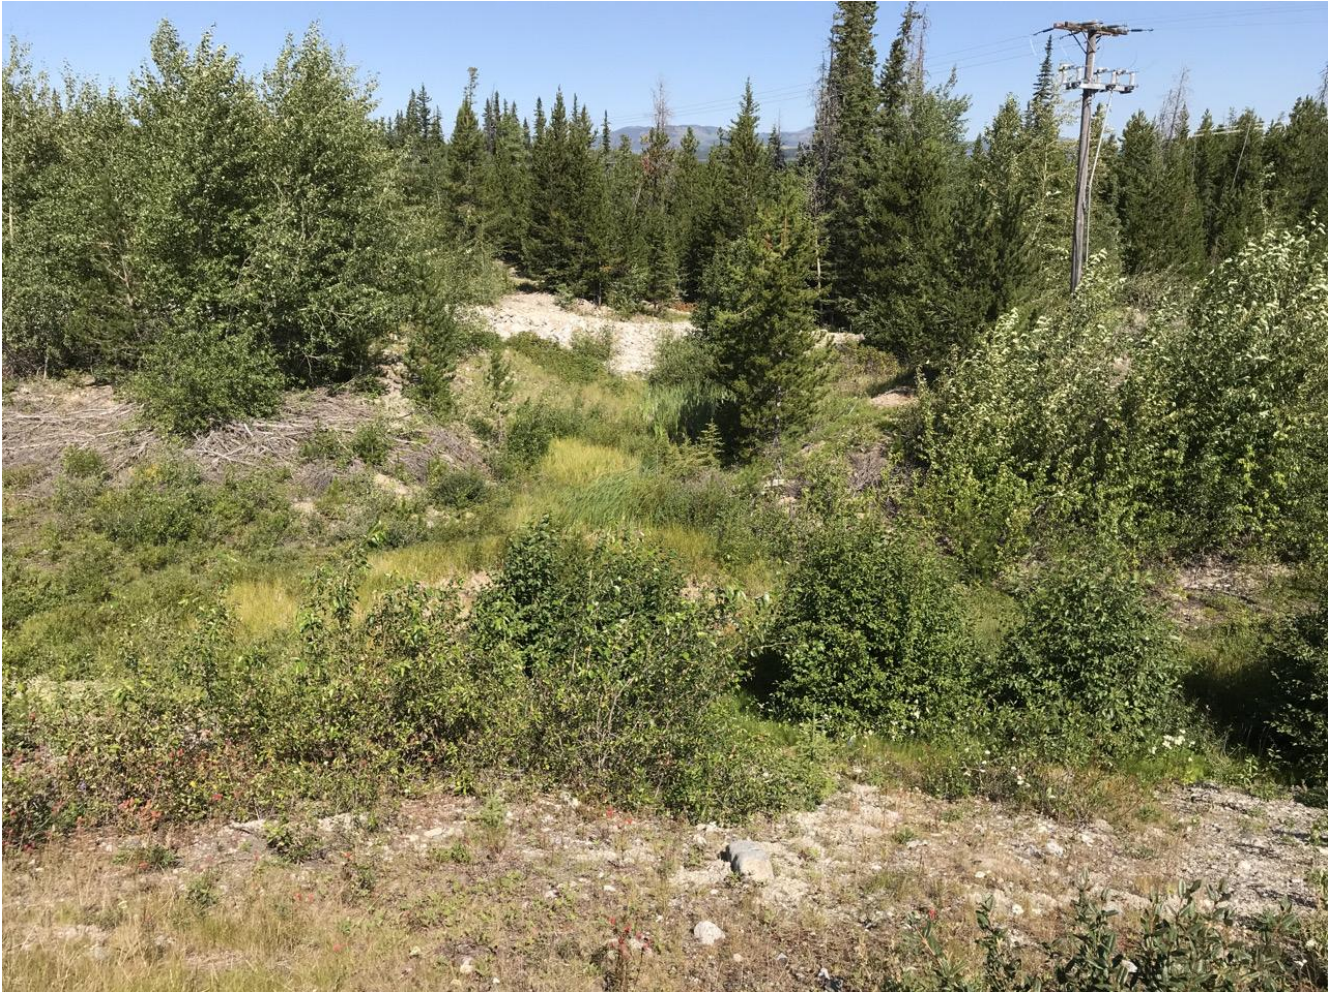
Photo I-B-18 S2 Pond: Ponded water at downstream toe, similar in size to the pond noted during AFPRs from previous years (HGH-2020-23)

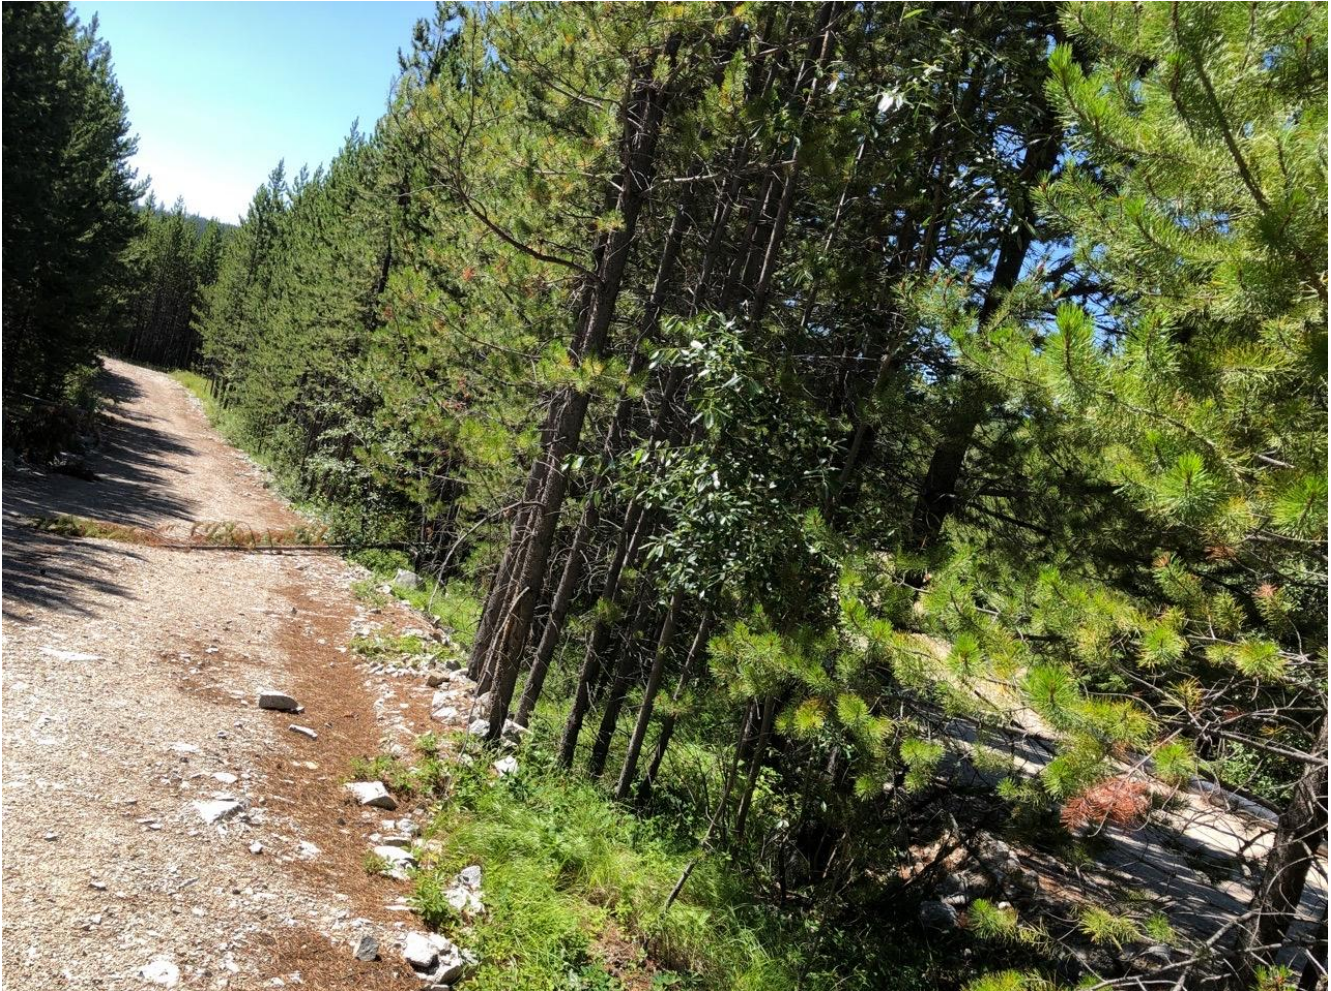
Photo I-B-19 S3 Pond: Access road to S3 was partially obstructed by a fallen tree (HGH-2020-31)

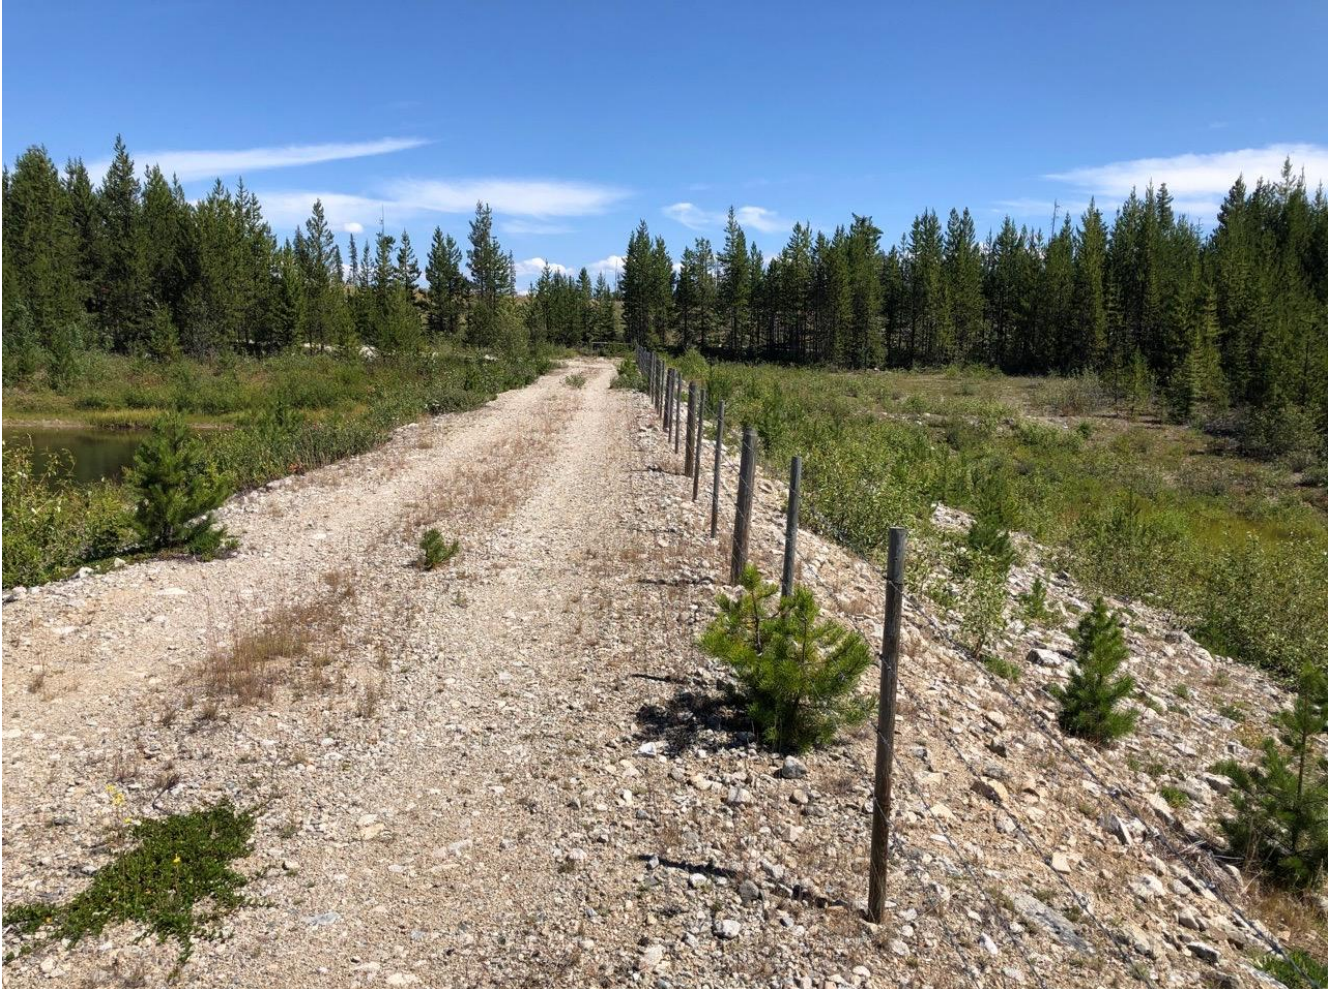
Photo I-B-22 S3 Pond: Overview of dam crest from left abutment (HGH-2020-34)

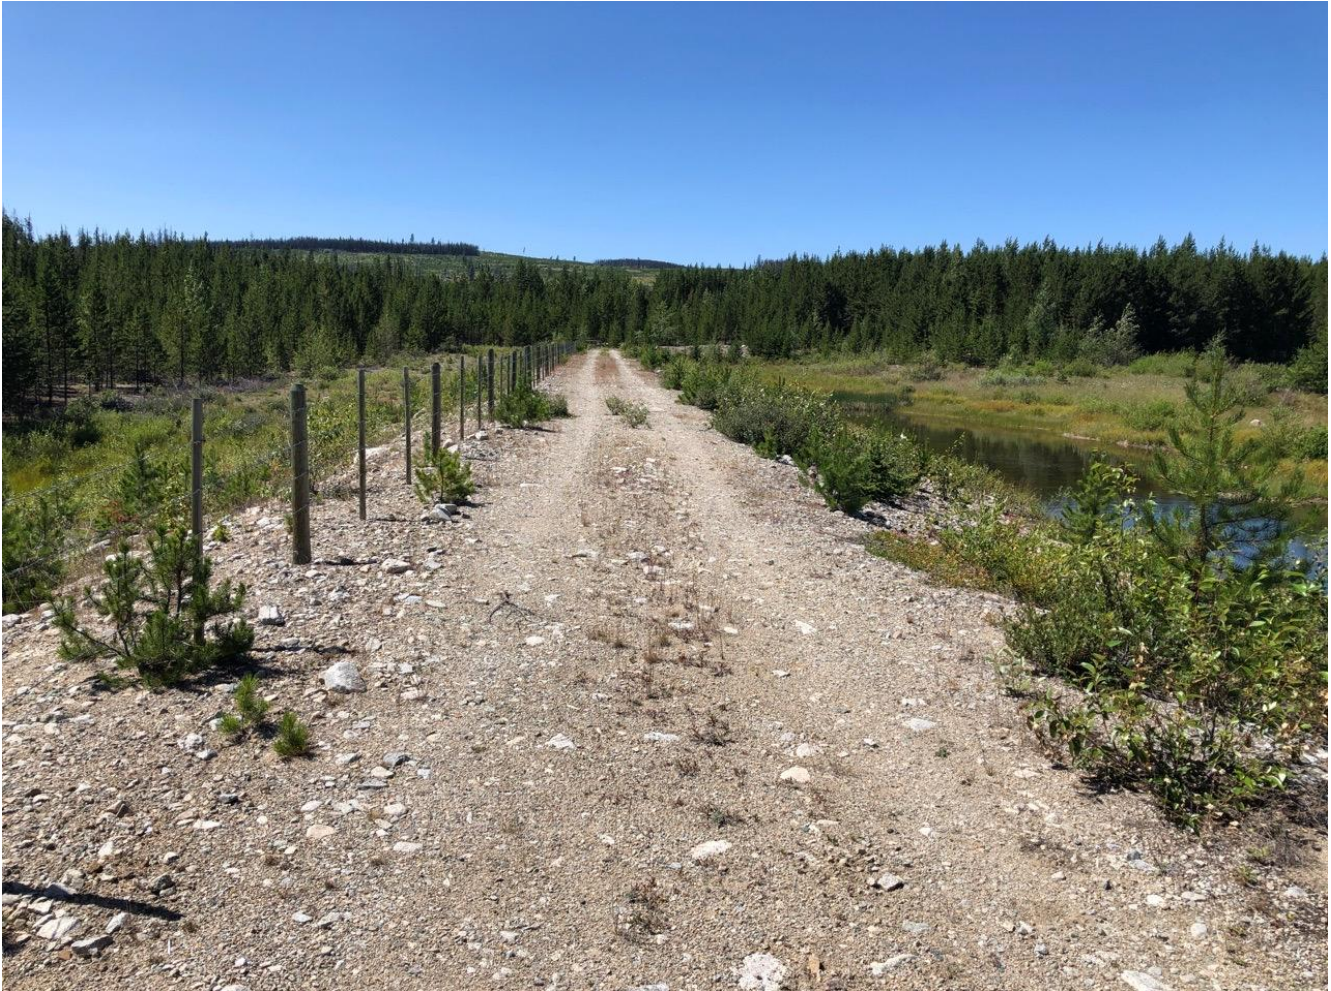
Photo I-B-23 S3 Pond: Overview of downstream slope from right abutment (HGH-2020-32)

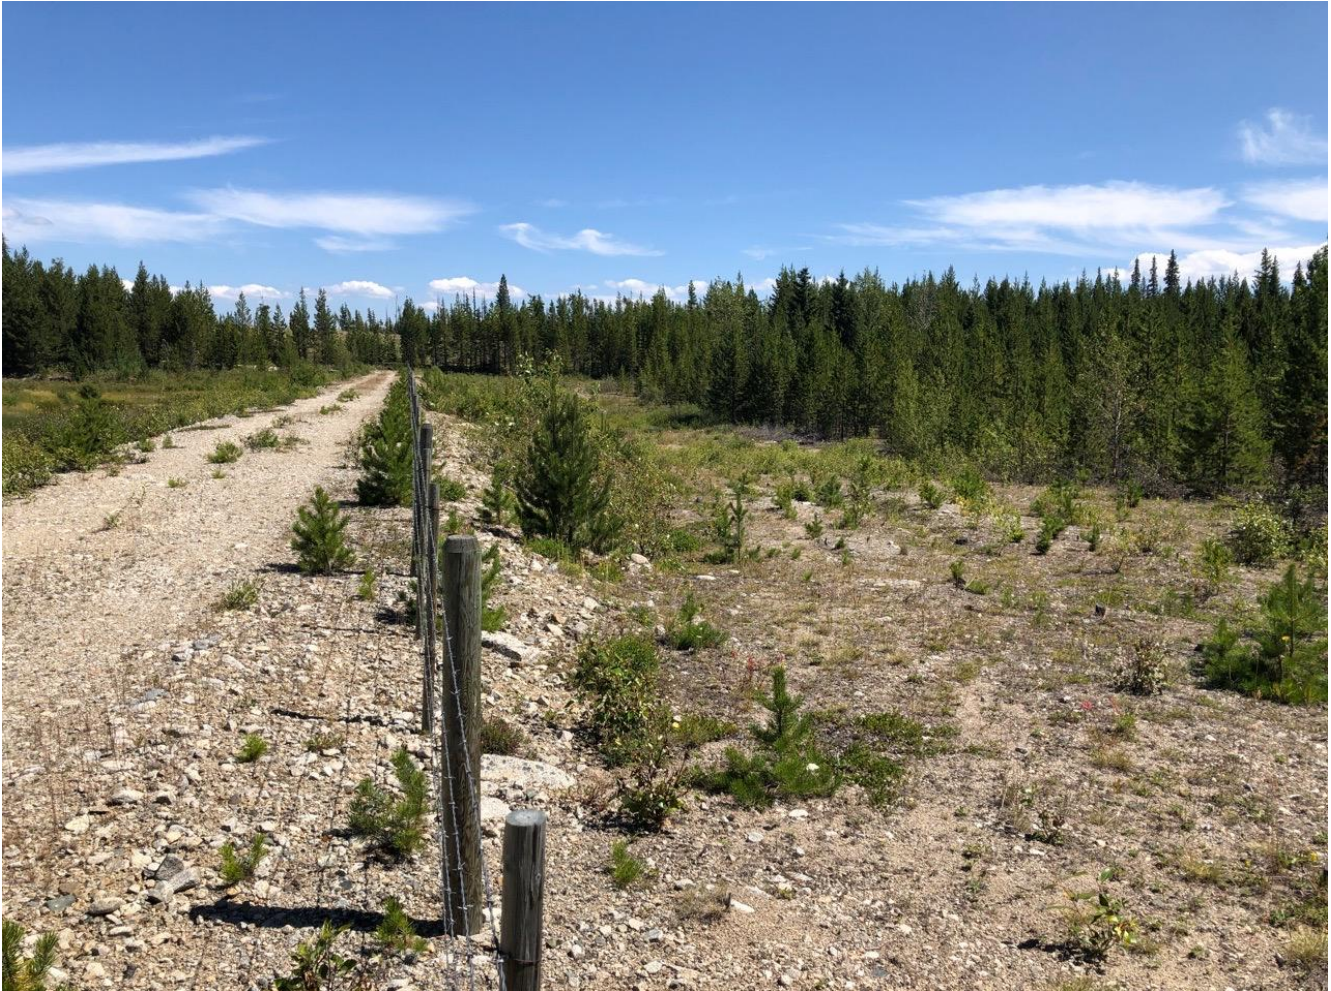
**Photo I-B-24 S3 Pond: Overview of downstream slope with small trees from mid dam
(HGH-2020-33)**

S3-004	Significant vegetation (including trees) observed on crest and downstream slope. Continue to remove trees, however grassy vegetation on slopes can be left in place, provided steady-state conditions continue.	3	OPEN (2021)	Will be completed as part of planned maintenance prior to 2021 Freshet.
S5 Pond				
S5-001	Under current operation, seepage pond S5 is not able to contain the EDF. Identify pond upgrades necessary to meet EDF compliance.	4	OPEN (2021) Refer to AFPR Recommendation S5-2018-01 and S5-2018-02.	Flood routing assessment scheduled for 2021.
S5-002	Inflow design flood is not based on most recent hydrology analysis Update the inflow design flood and flood routing analysis using the latest hydrology.	4	OPEN (2021) Refer to AFPR Recommendation HD-2018-02.	Flood routing assessment scheduled for 2021.
S5-003	Under current operations, the minimum freeboard requirement is not being met. Identify pond upgrades necessary for freeboard compliance.	4	OPEN (2021) Refer to AFPR Recommendation S5-2018-01 and S5-2018-02.	Flood routing assessment scheduled for 2021.

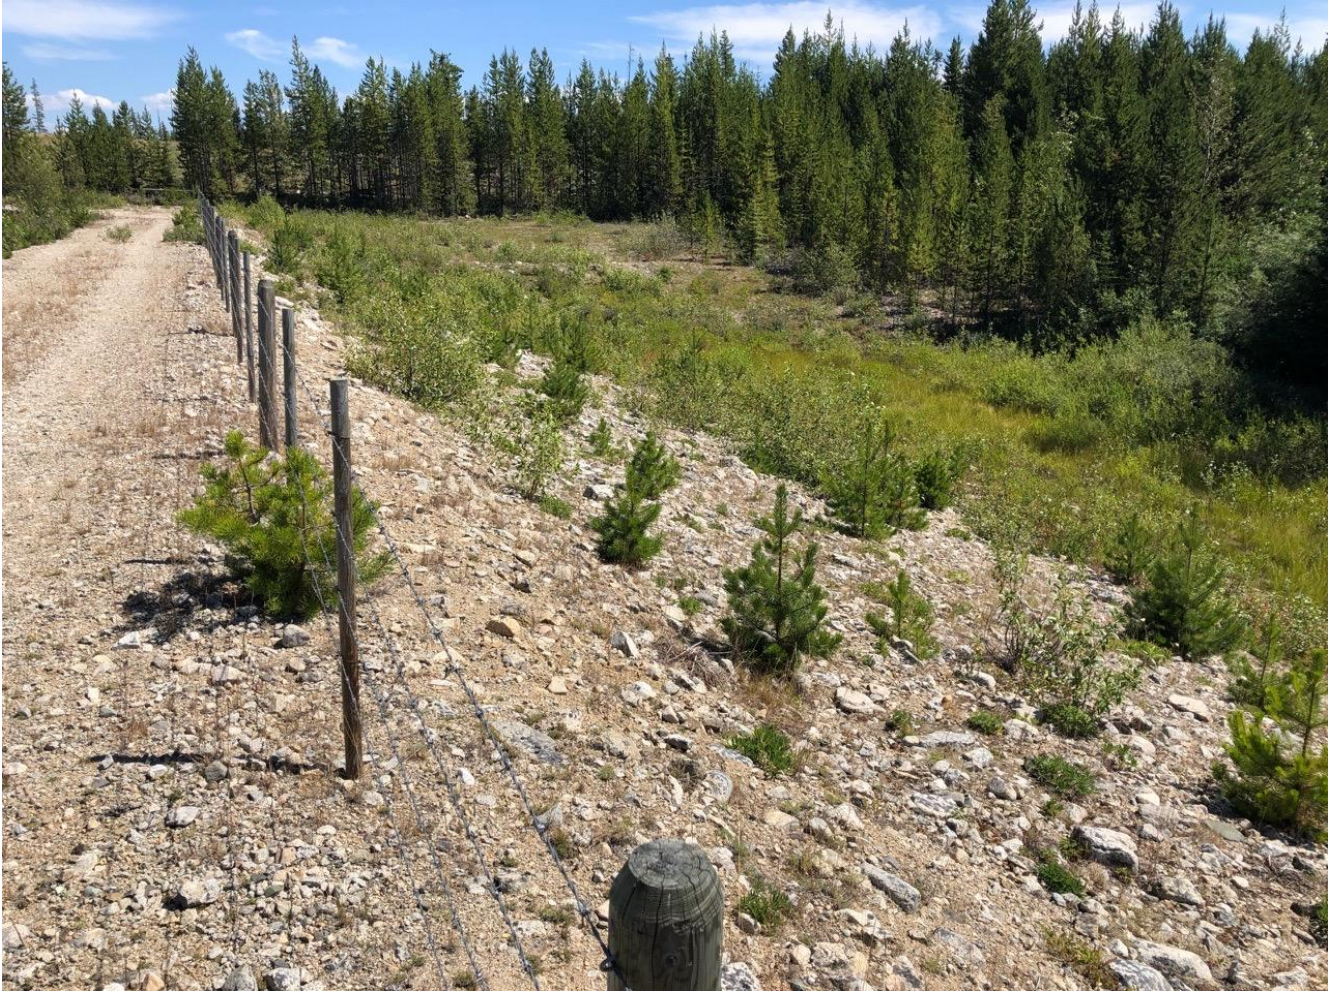
Photo I-B-25 S3 Pond: Overview of downstream slope from left abutment (HGH-2020-34)

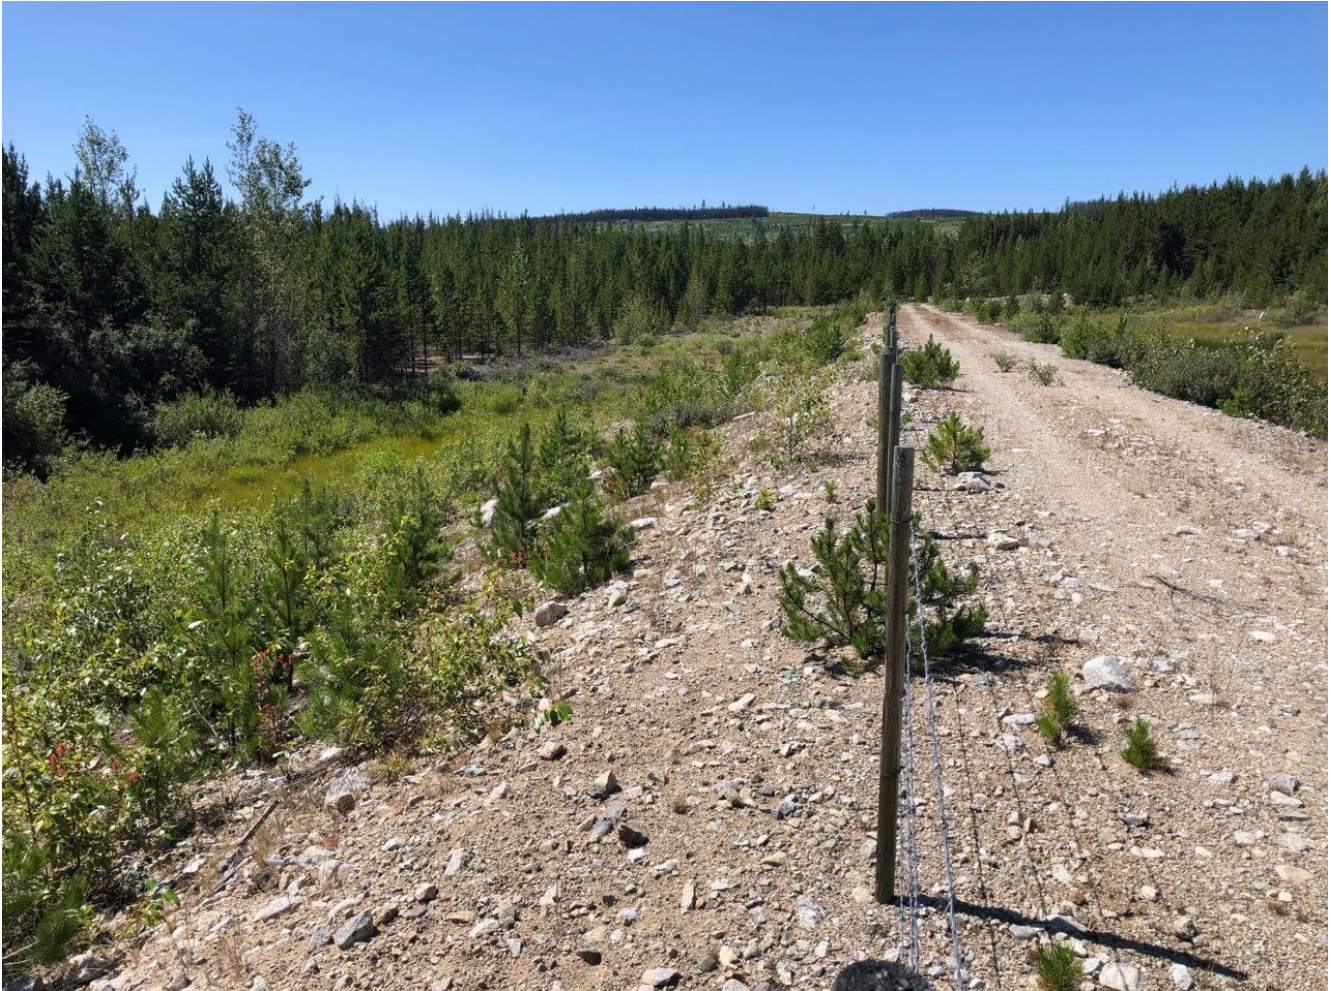
Photo I-B-26 S3 Pond: Overview of upstream slope from right abutment (HGH-2020-32)

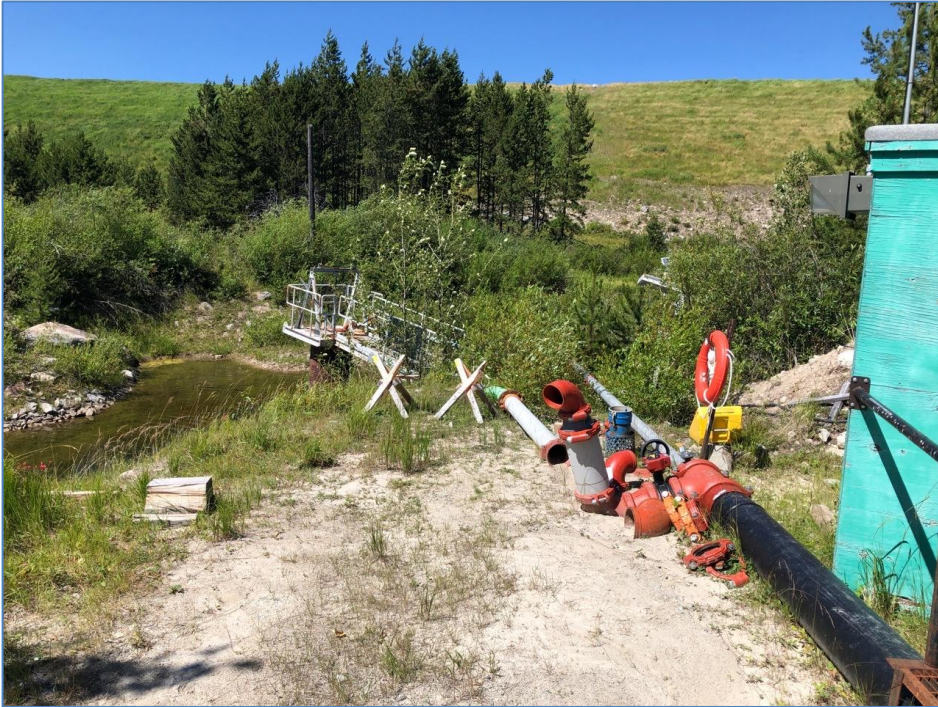
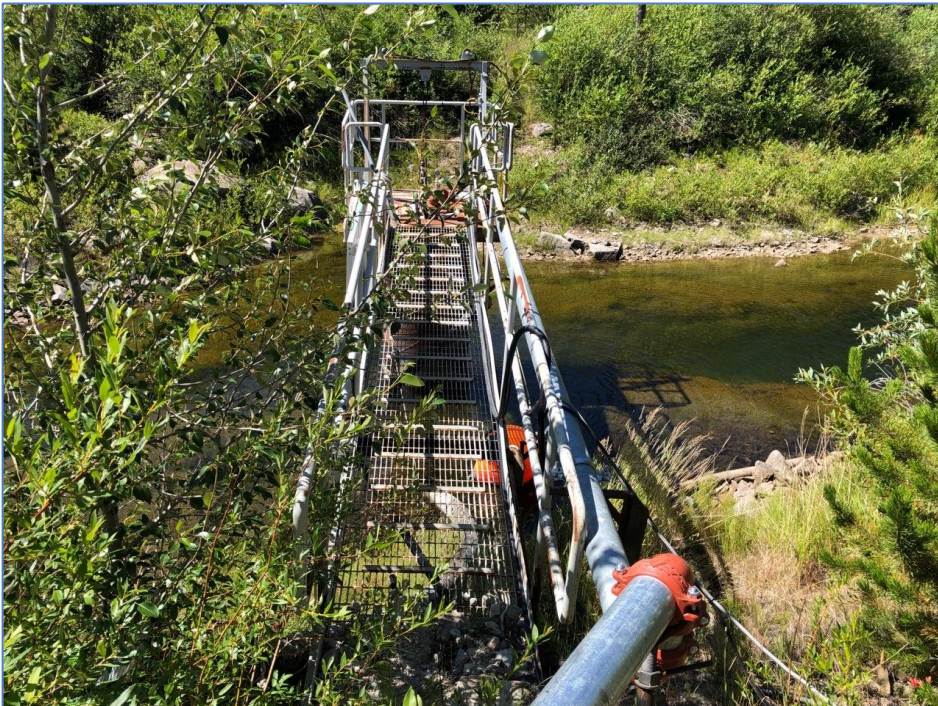
Photo I-B-29 S3 Pond: Catwalk and outlet pump to Highmont Distribution Box, personal flotation device is in place (HGH-2020-36 and HGH-2020-37)

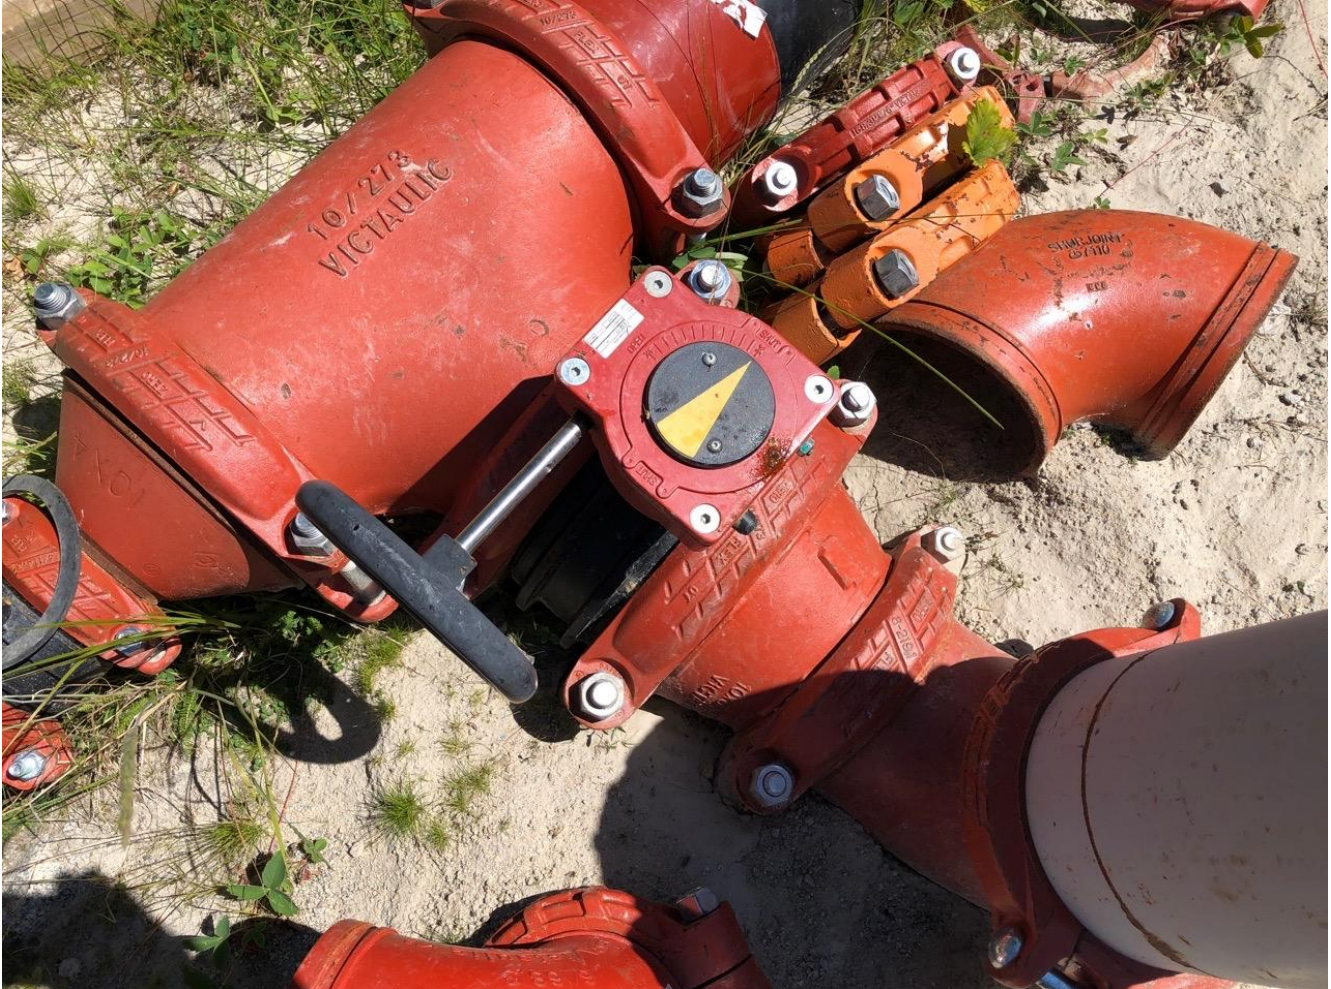
Photo I-B-30 S3 Pond: S3 inlet pipe valve works. System is clear and easily understandable (HGH-2020-38)

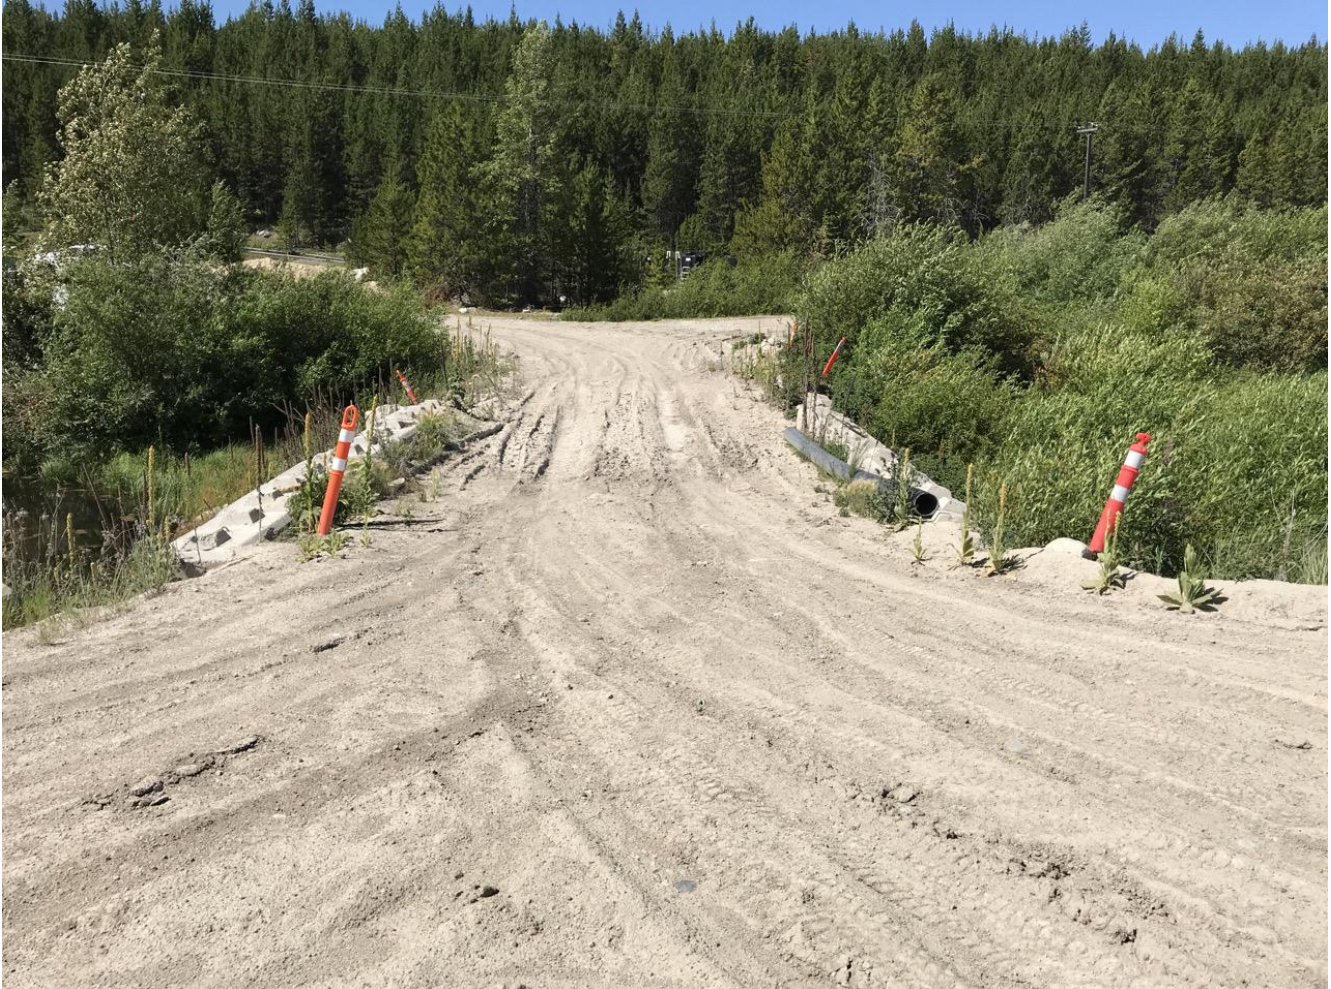
Photo I-B-32 S5 Pond: View of access road on the divider dyke. Minor rutting observed on crest of divider dyke is managed under routine maintenance (HGH-2020-39)

- **Crest:** Good physical condition. No signs of significant erosion, deterioration, displacement, or cracking (Photo I-B-31). The low point downstream of the outlet just south of Viewpoint HGH-2020-39 should be levelled (Photo I-B-32)
- **Left and Right Abutment:** Good physical condition. No signs of significant erosion, deterioration, displacement, or cracking.
- **Downstream Slope:** Good physical condition. Minor vegetation present throughout slope. No signs of erosion, deterioration, or animal activity (Photo I-B-33).
- **Pond:** During inspection pond observed to be more than 1.0 m below crest of dam which is typical for this time of the year. Pond was highly vegetated during the site visit (Photo I-B-34 to Photo I-B-36).

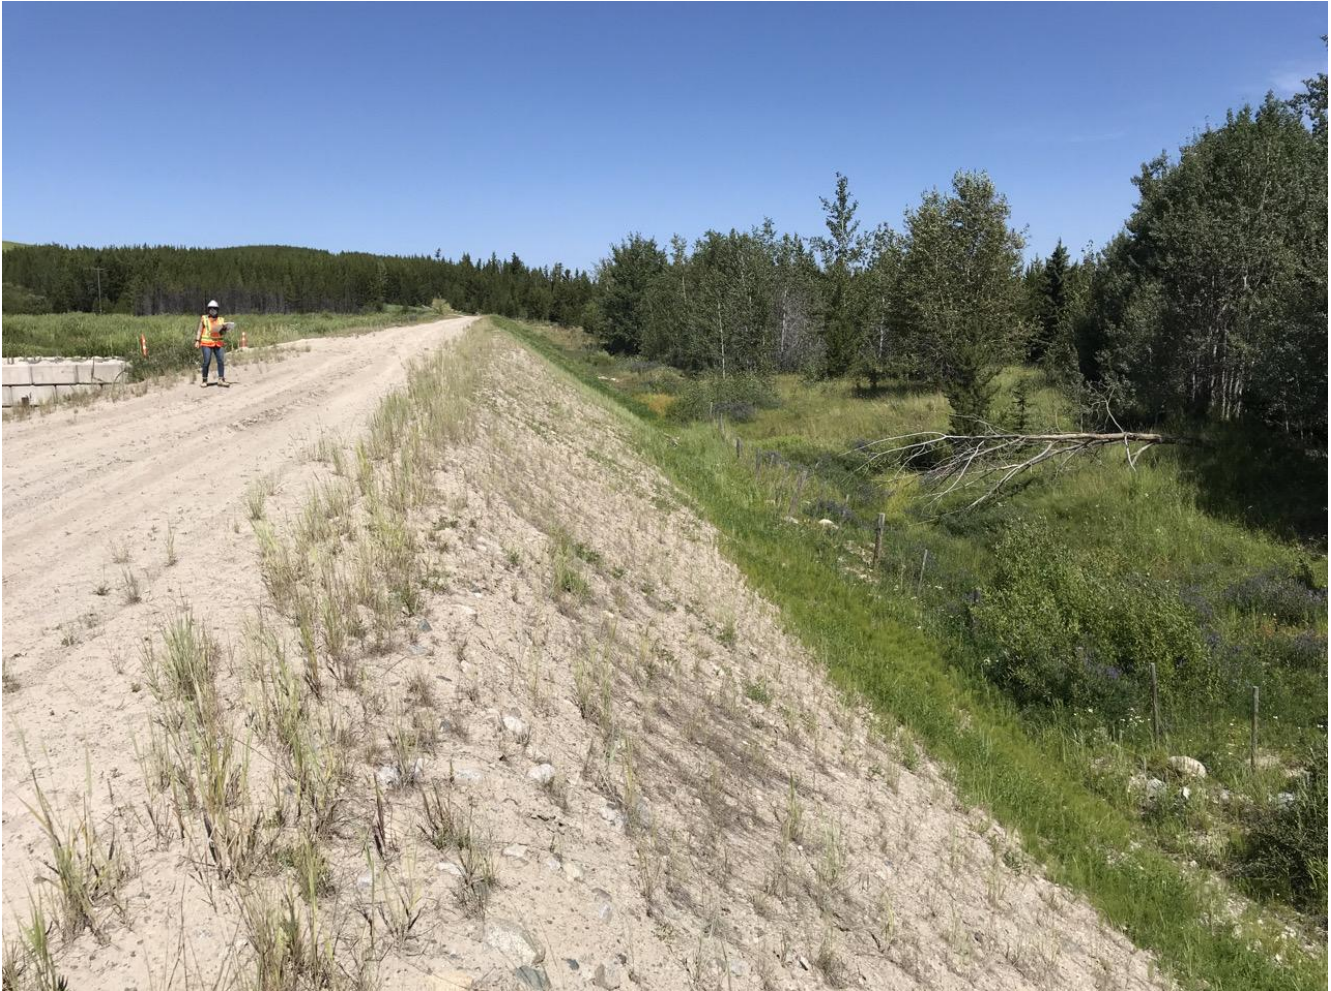
Photo I-B-33 S5 Pond: Downstream slope of perimeter crest, looking north (HGH-2020-40)

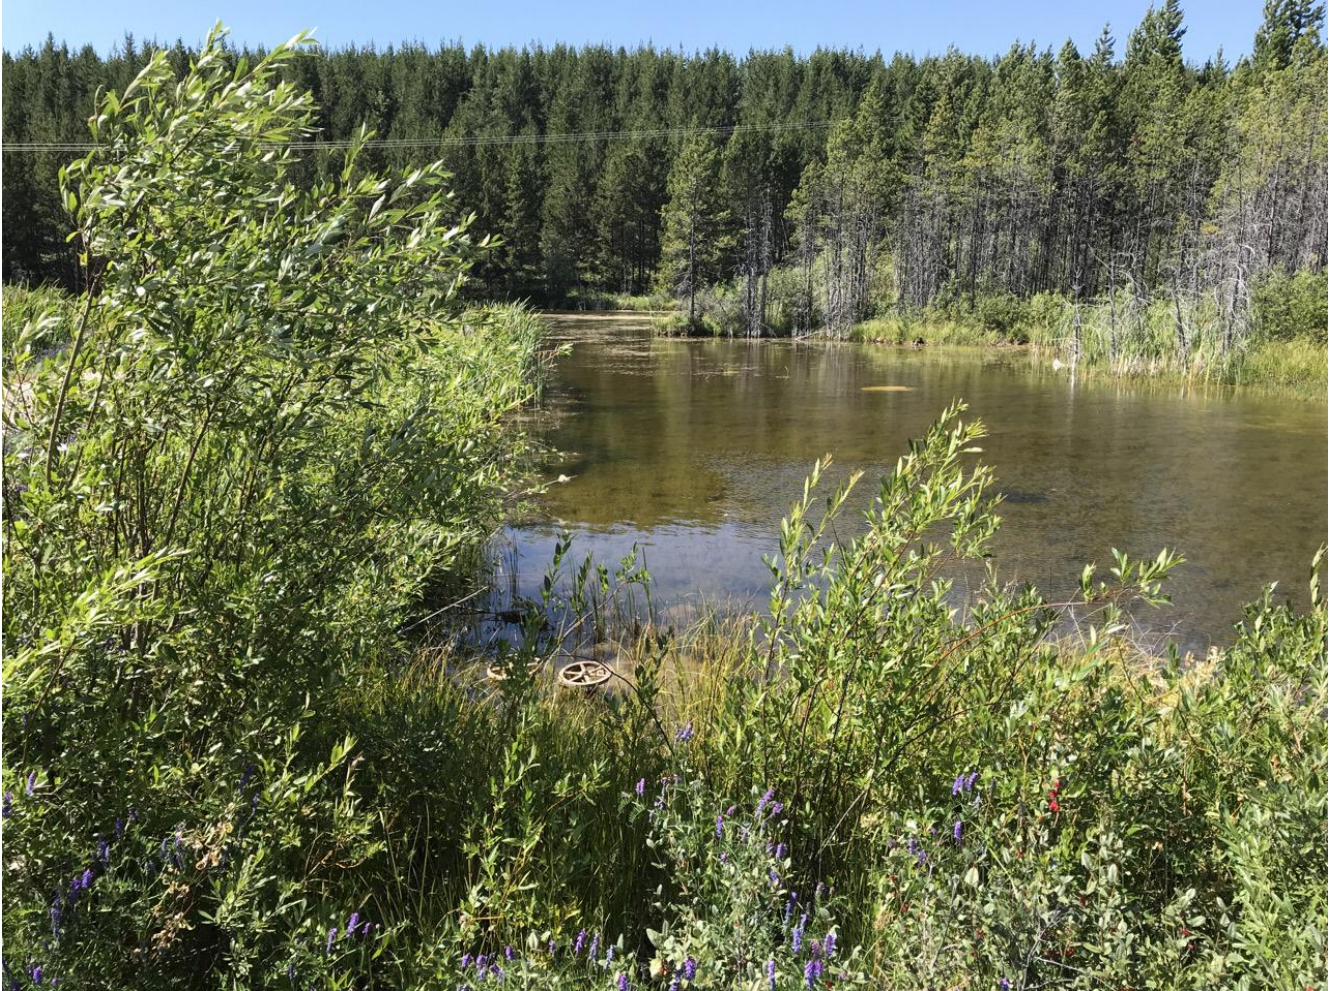
Photo I-B-34 S5 Pond: S5 Pond north outlet pipe, permanently sealed. Metal plates placed at intake and pipes filled with till in 2015 (HGH-2020-41)

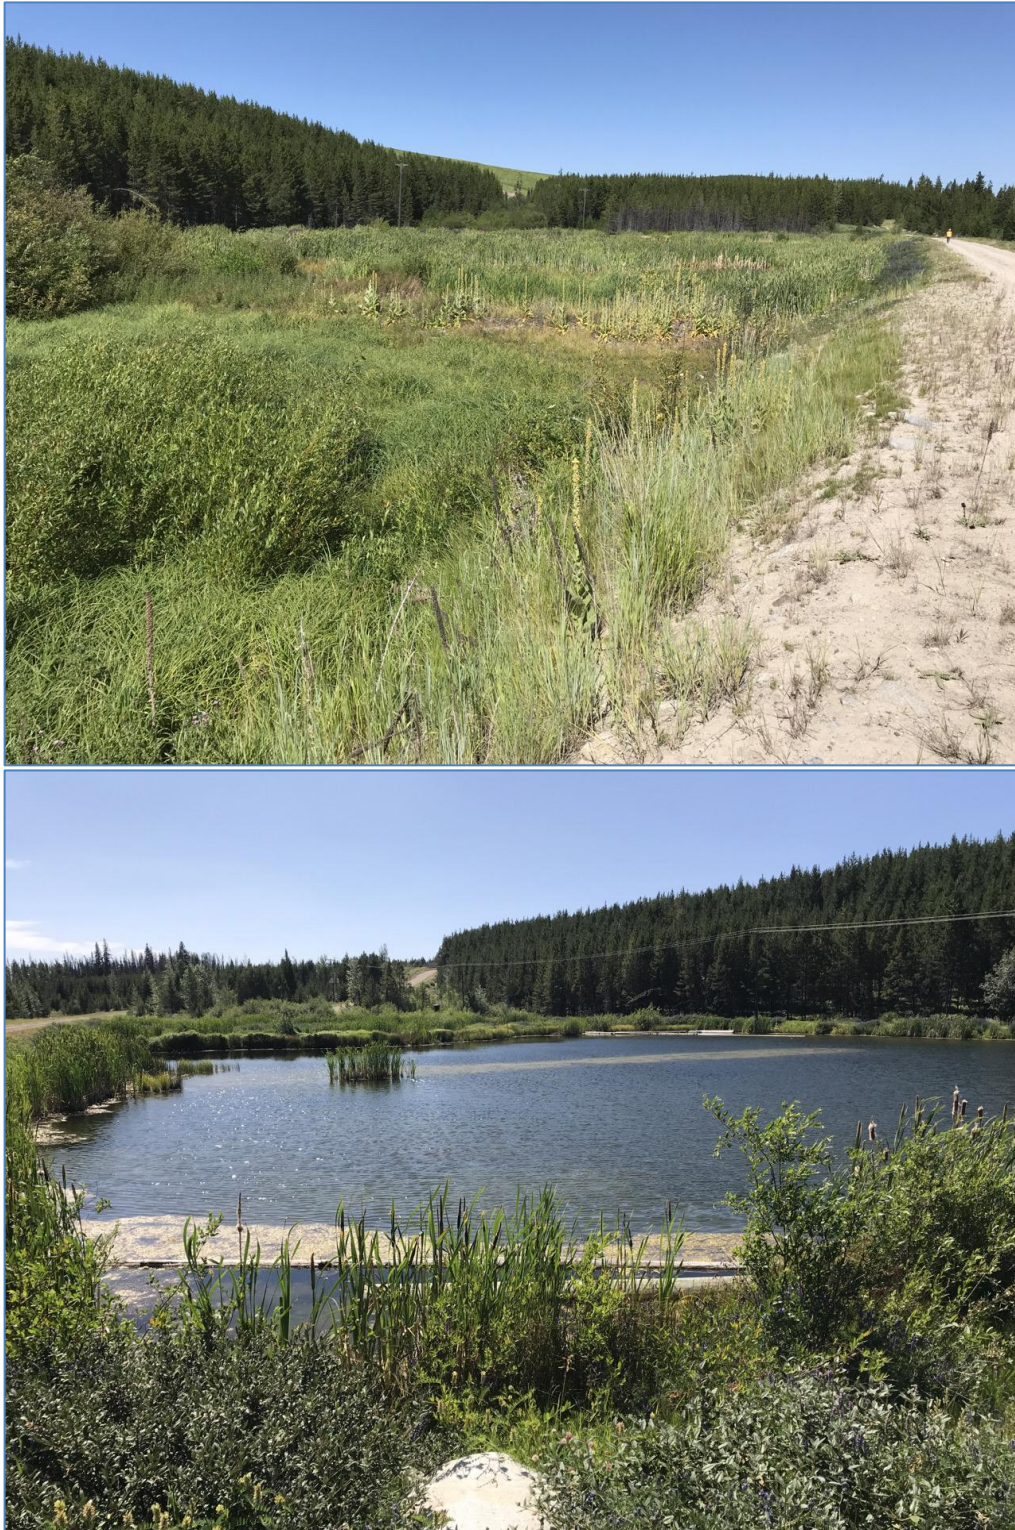
Photo I-B-36 S5 Pond: Overview of S5 Pond basin (HGH-2020-43 and HGH-2020-44)

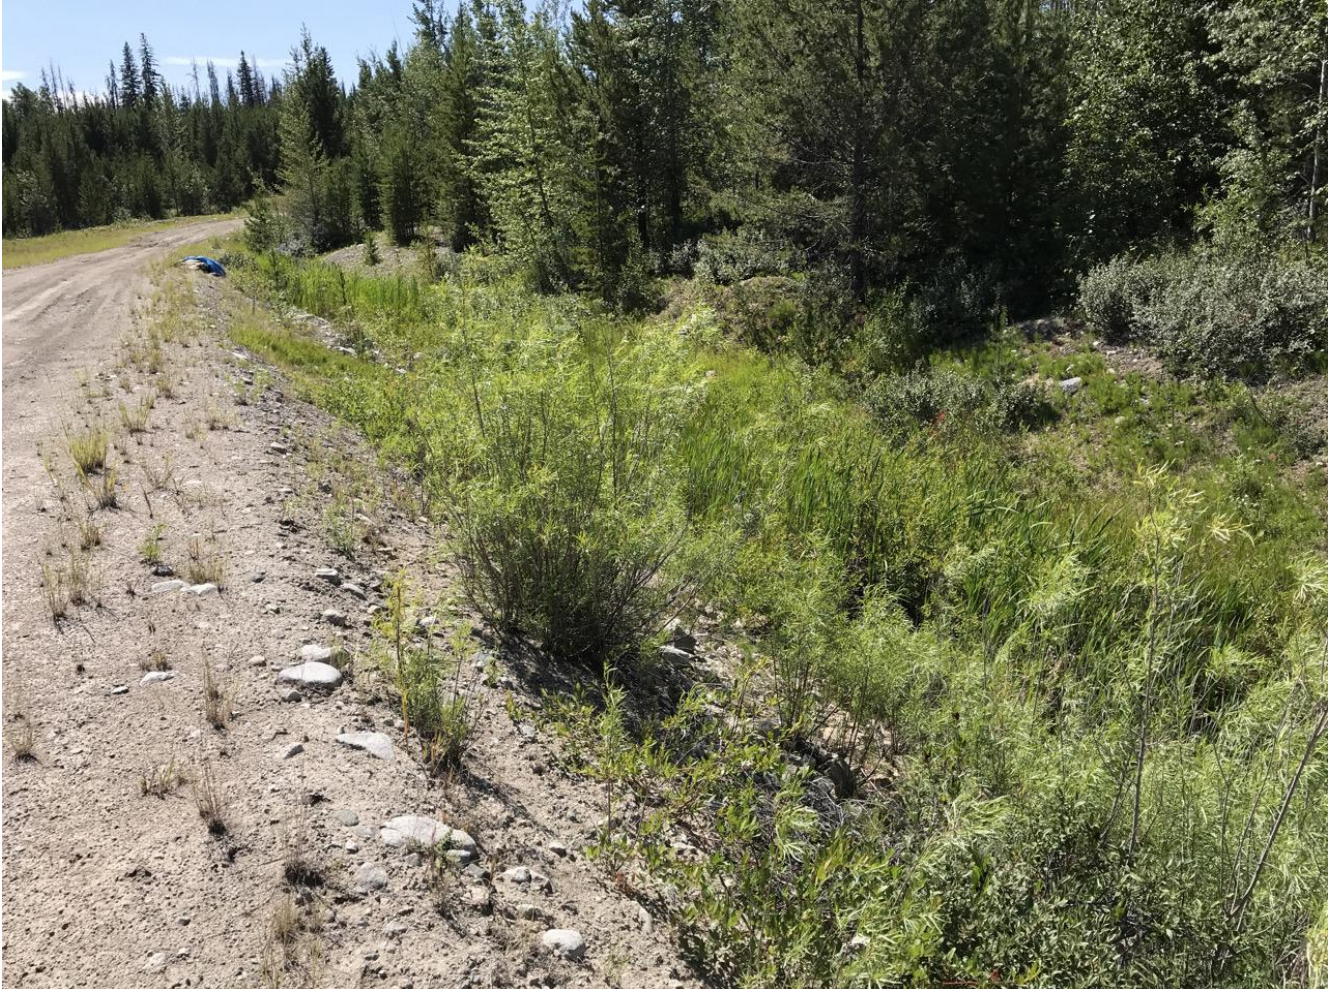
- **Low-level Outlet and Spillway:** As observed during the 2016 through 2019 AFPRs, the Low-Level Outlet valves were closed and the inlet of the spillway pipes were obstructed by sand bags (Photo I-B-37, Photo I-B-38, and Photo I-B-40).

Photo I-B-37 S5 Pond: Pumping Sub-cell spillway channel. Water was ponding in the channel (HGH-2020-42)

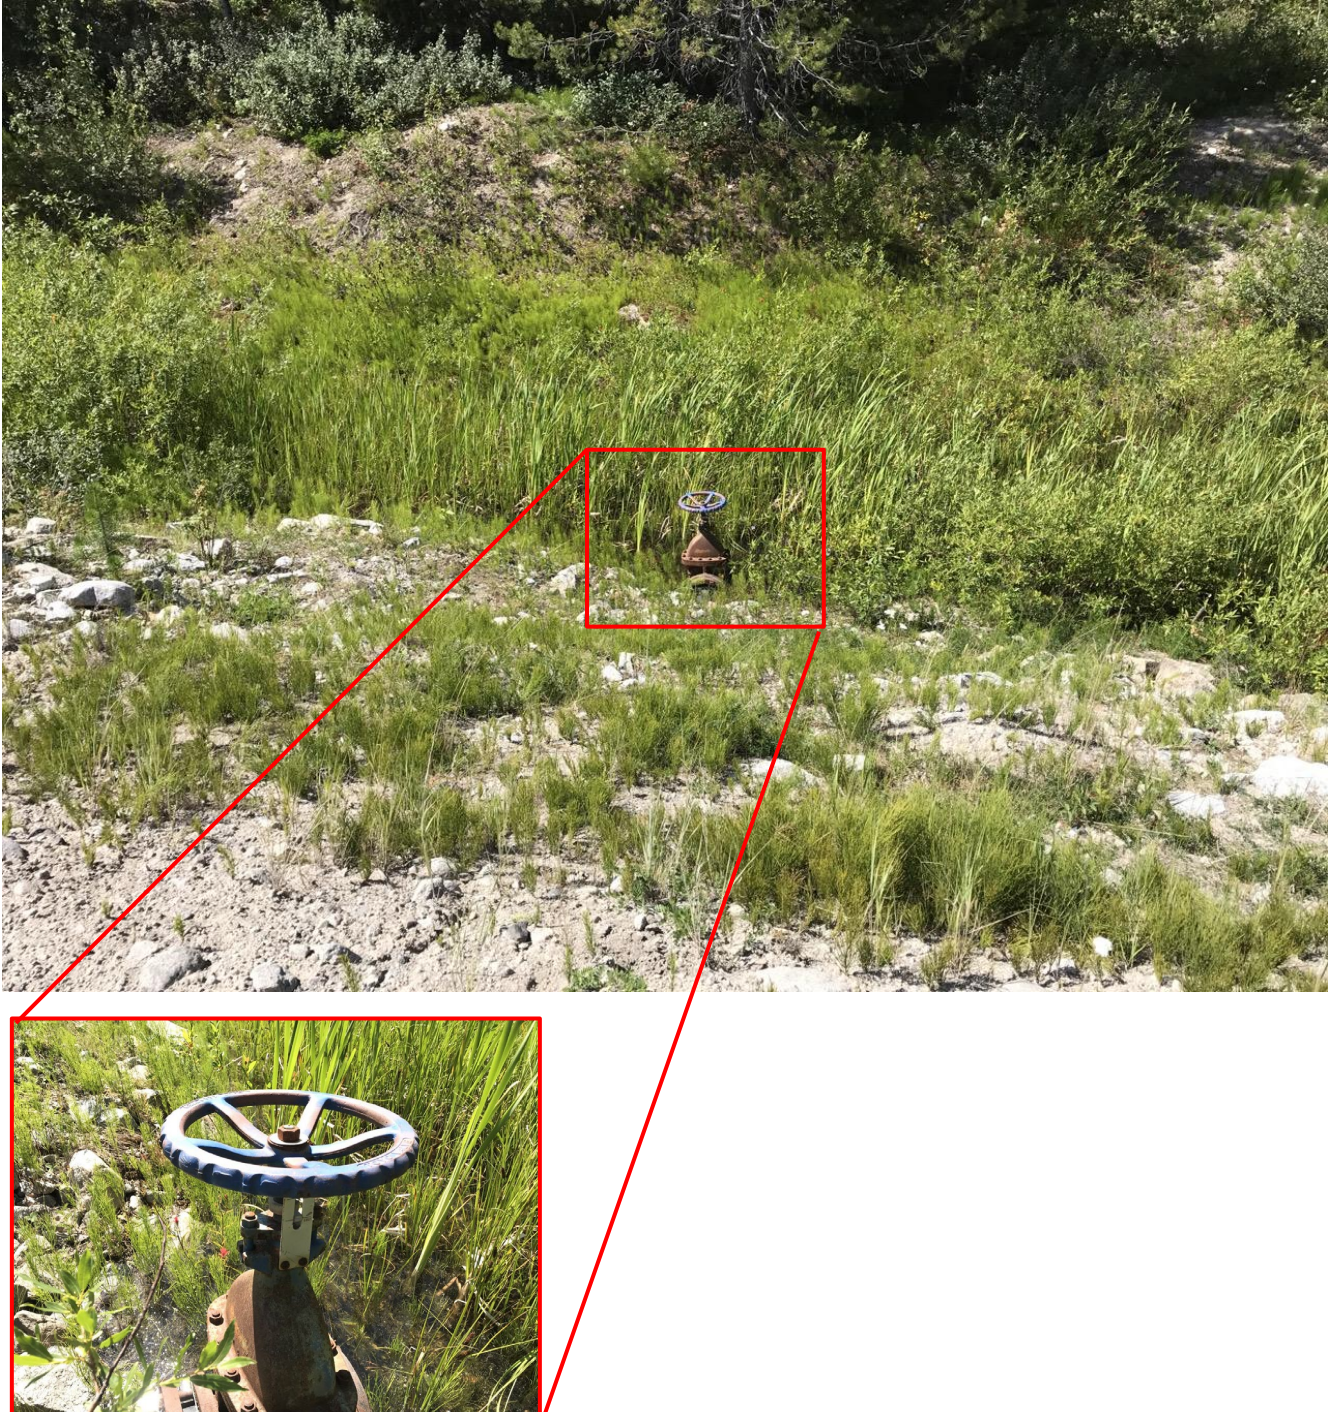
Photo I-B-38 S5 Pond: Pumping Sub-cell Outlet #2 (South). Metal plates placed at intake and pipes filled with till in 2015 (HGH-2020-45 and HGH-2020-46)

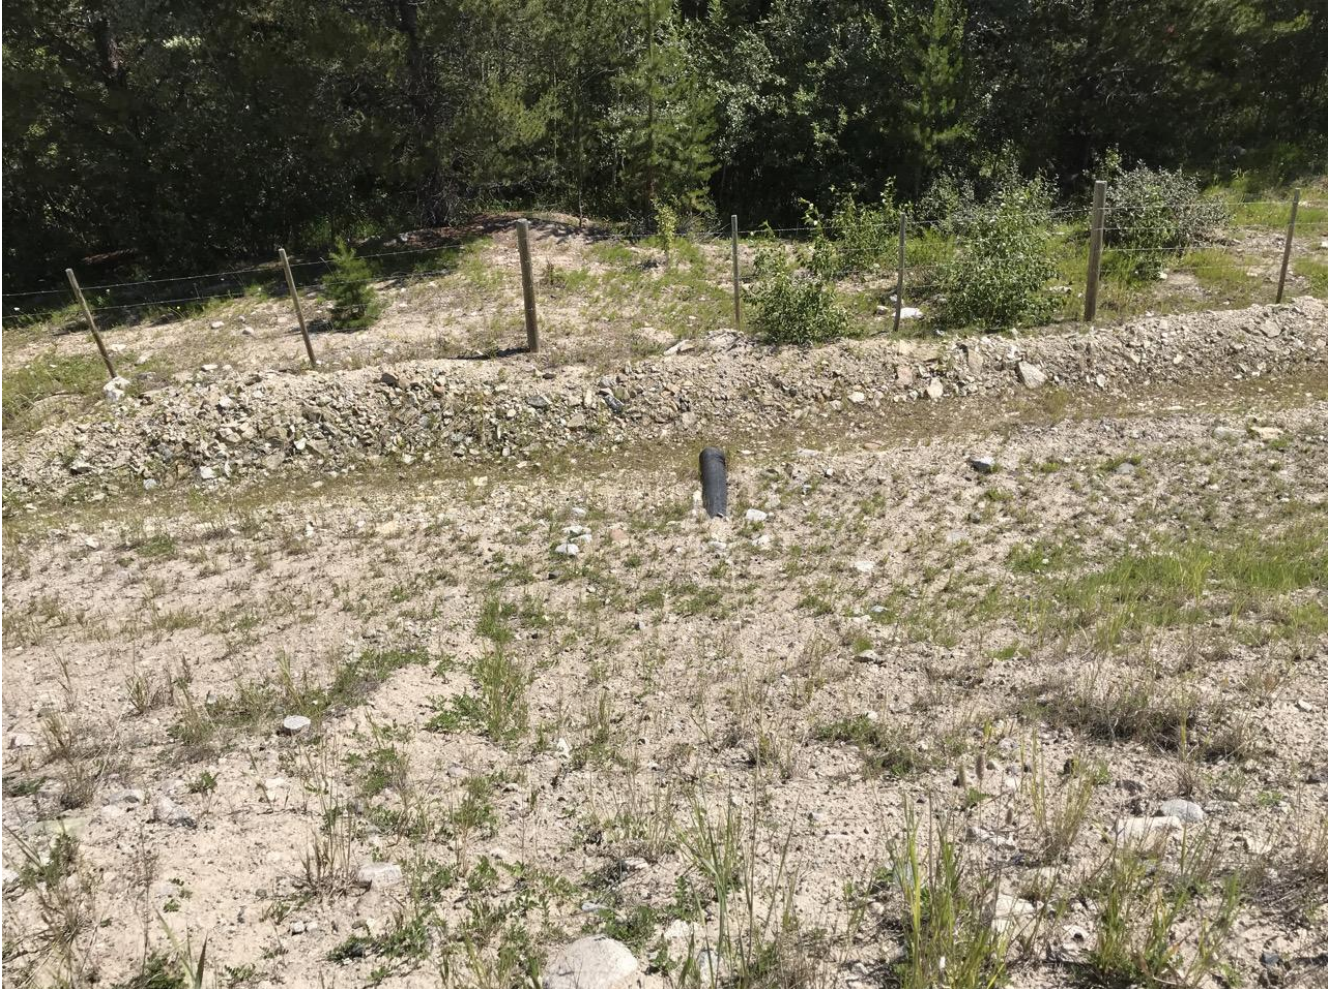
Photo I-B-39 S5 Pond: Overview of downstream slope and Outlet #2 pipe daylighting at toe, looking east (HGH-2020-45)
