Teck Highland Valley Copper Partnership

2020 Annual Facility Performance Report

Highmont Tailings Storage Facility

March 2021

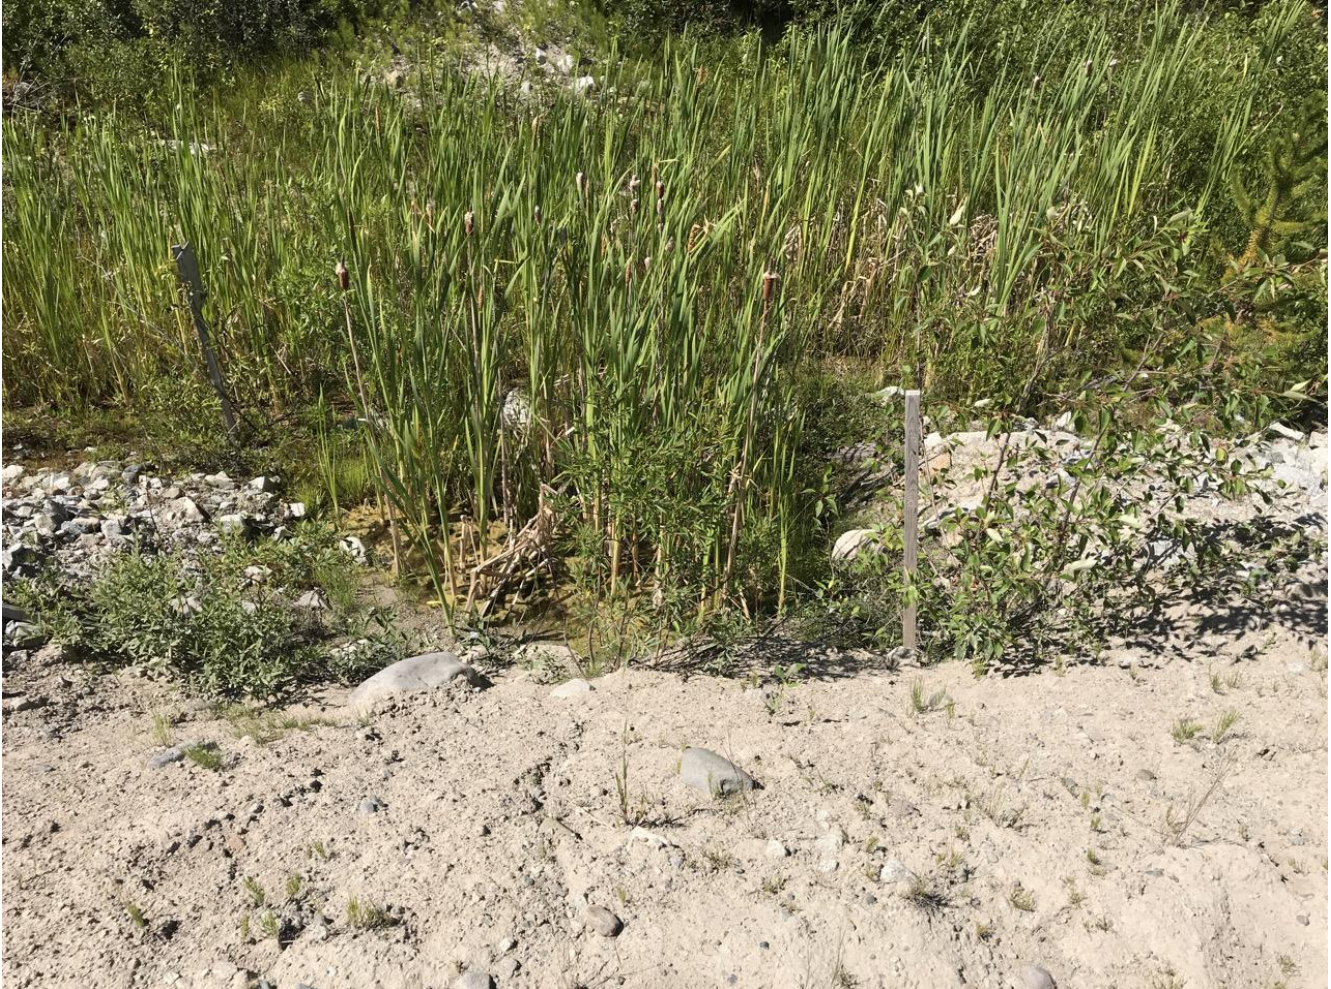
- **Low-level Outlet and Spillway:** As observed during the 2016 through 2019 AFPRs, the Low-Level Outlet valves were closed and the inlet of the spillway pipes were obstructed by sand bags (Photo I-B-37, Photo I-B-38, and Photo I-B-40).

**Photo I-B-40 S5 Pond: Pumping Sub-cell two Overflow pipes, partially blocked at intake
(HGH-2020-47)**

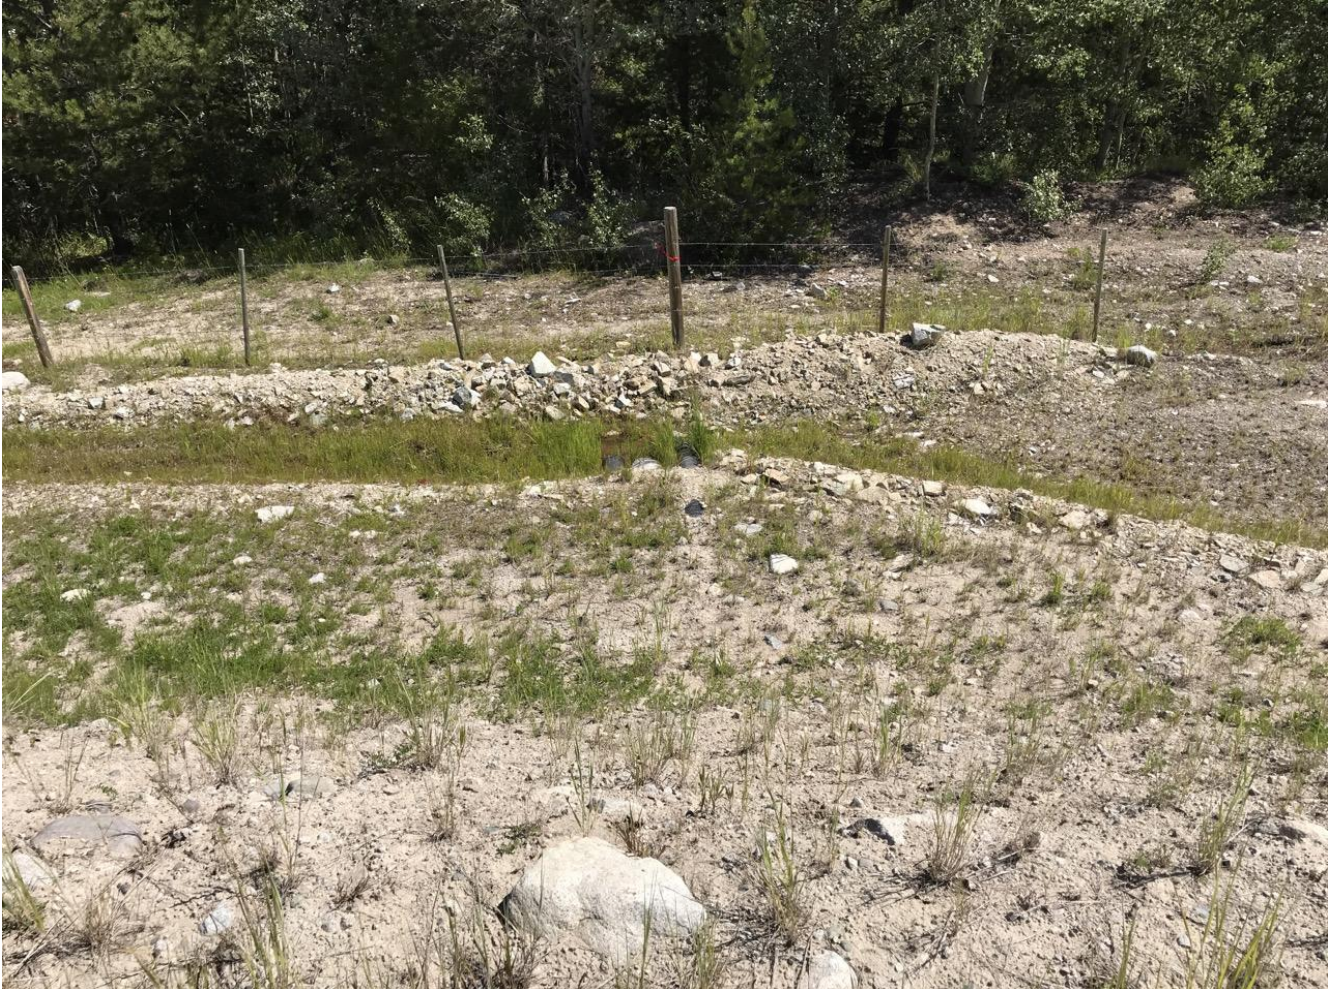
Photo I-B-41 S5 Pond: Overview of downstream slope and S5 Overflow outlet pipes daylighting at toe, looking east (HGH-2020-47)

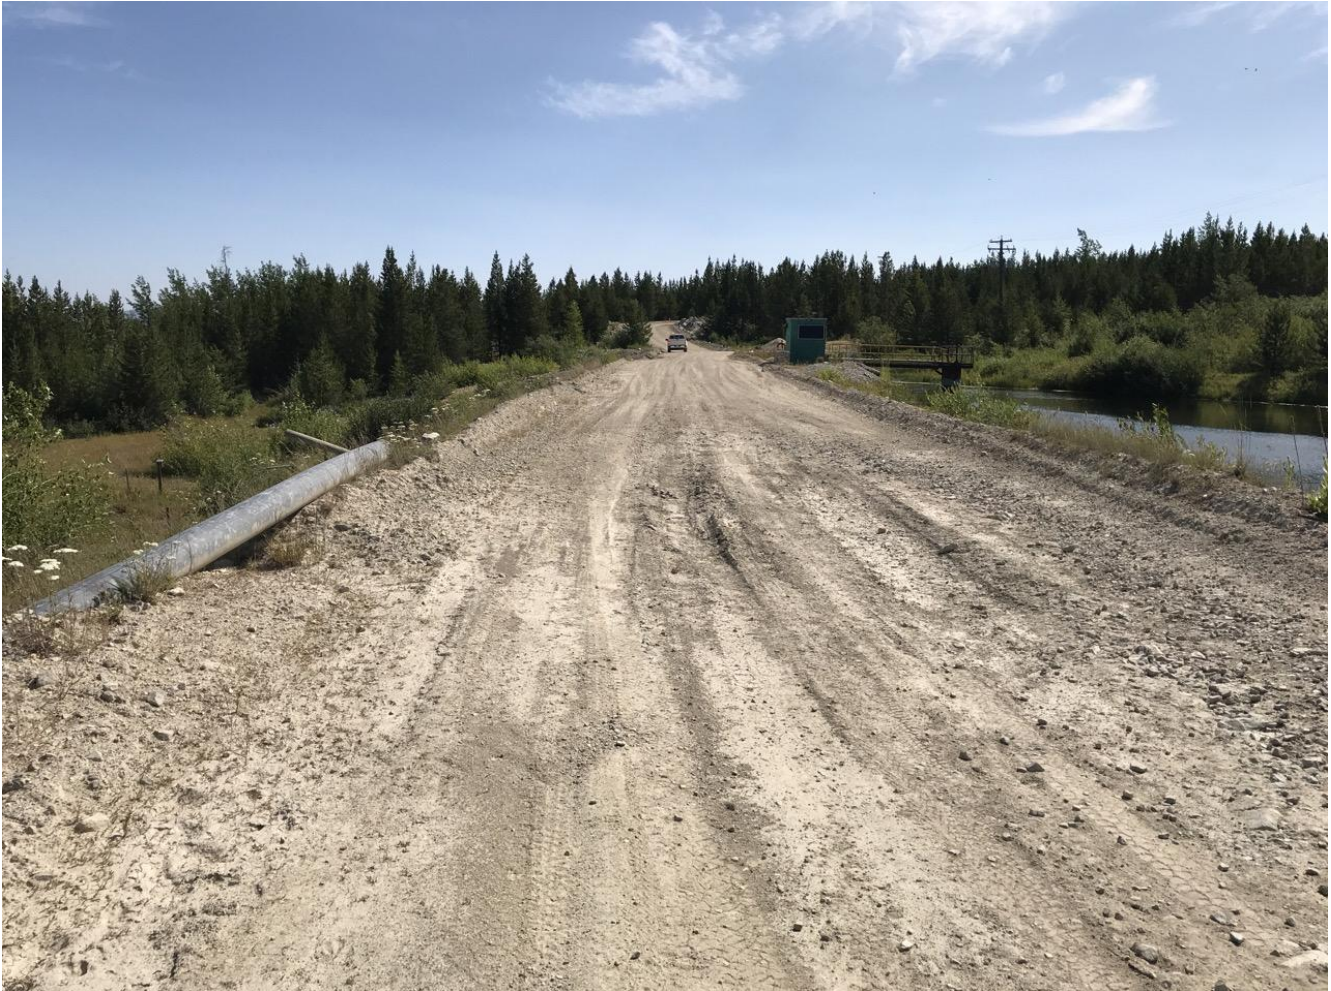
- **Crest:** Good physical condition. No signs of significant erosion, deterioration, displacement, or cracking (Photo I-B-43 and Photo I-B-44).
- **Left and Right Abutment:** Good physical condition. No signs of significant erosion, deterioration, displacement, or cracking.
- **Downstream Slope:** Good physical condition. Moderate vegetation throughout slope and large wood debris present. No observed signs of erosion, deterioration, or adverse displacement. (Photo I-B-45 and Photo I-B-46).
- **Pond:** At the time of inspection the pond appeared lower in elevation when compared to the 2019 inspection. Less than 2 m below the crest of the dam (Photo I-B-47 and Photo I-B-48).
- **Spillway:** The outlet pipe was clear of debris (Photo I-B-49).
- **Seepage:** None observed.

Photo I-B-43 S8 Pond: Overview of crest from left abutment. Minor rutting observed on crest is managed under routine maintenance. Crest elevation at the low point should be confirmed. Pipe is still in place and should be removed so it is not used as currently aligned (HGH-2020-07)

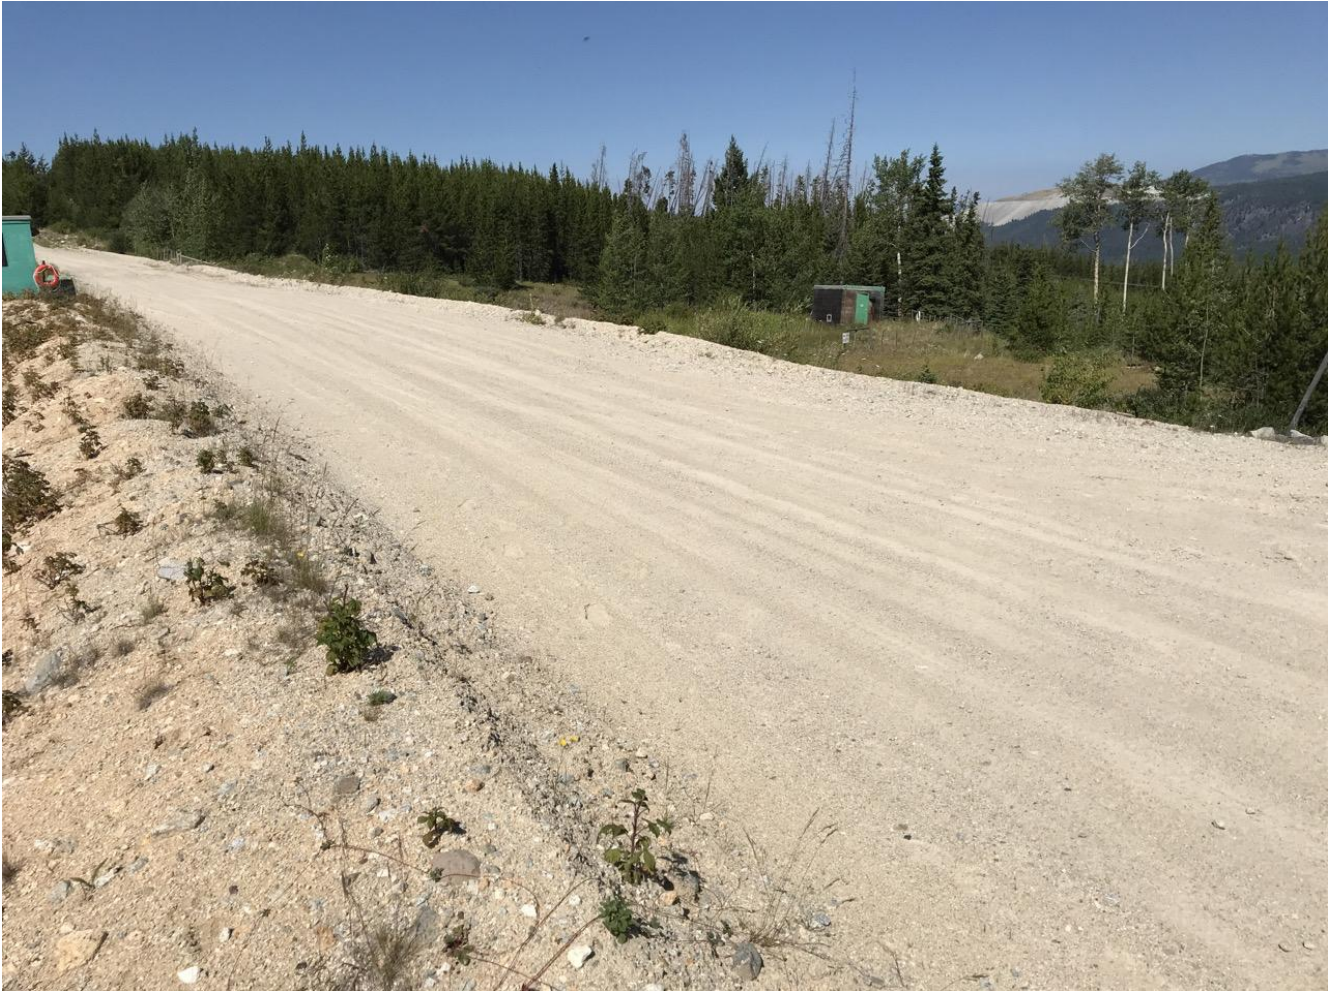
Photo I-B-44 S8 Pond: view of crest from right abutment (HGH-2020-49)

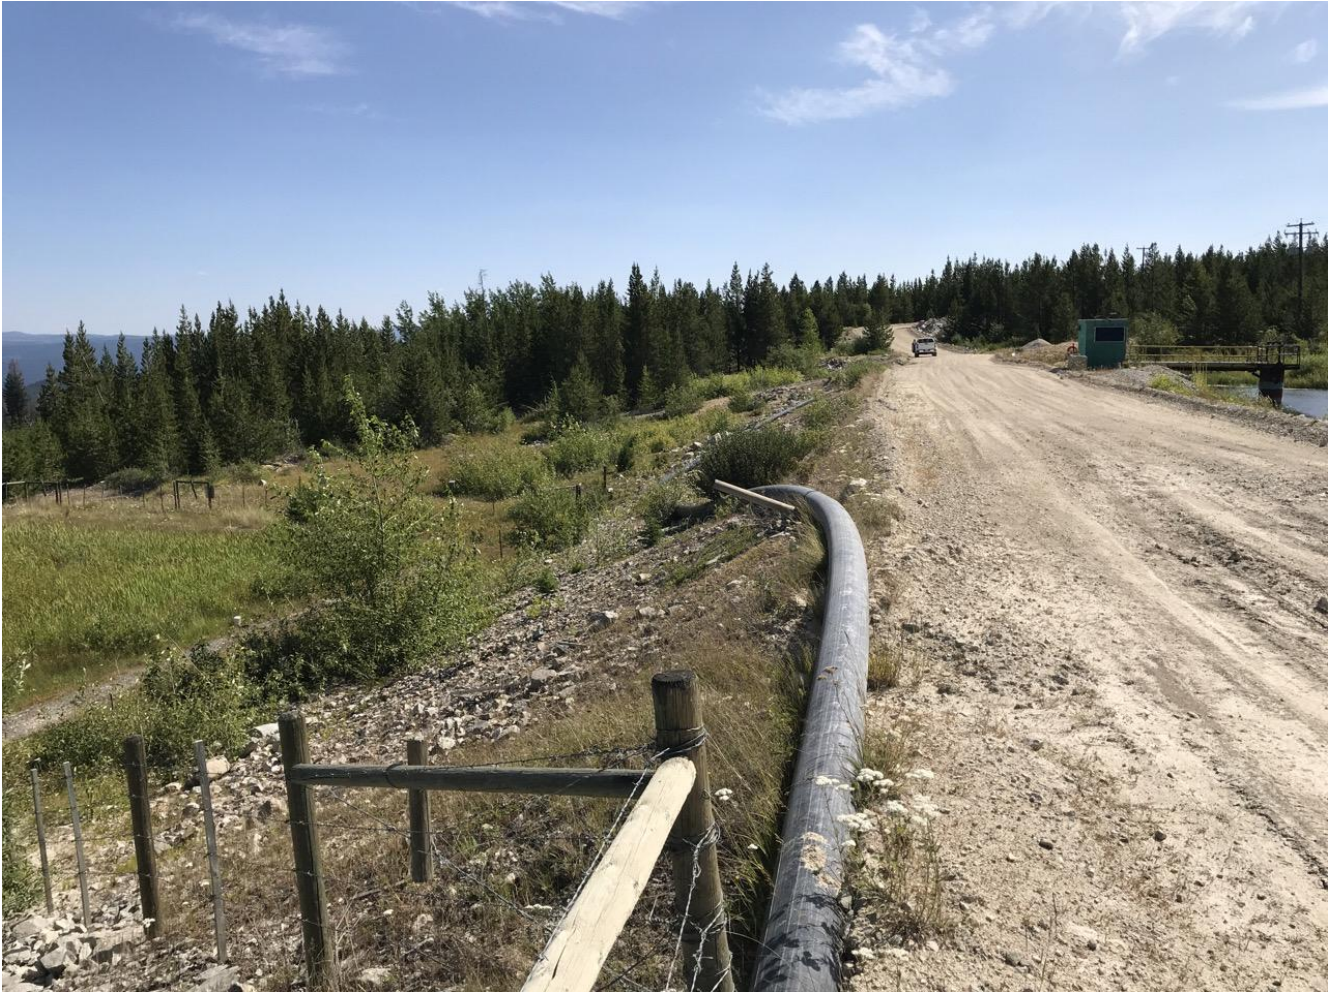
Photo I-B-45 S8 Pond: Downstream slope, looking east from left abutment. THVCP confirmed there are no potential hookups for the pipe in the current location. Therefore, the pipe presents no risk to the S8 Pond (HGH-2020-07)

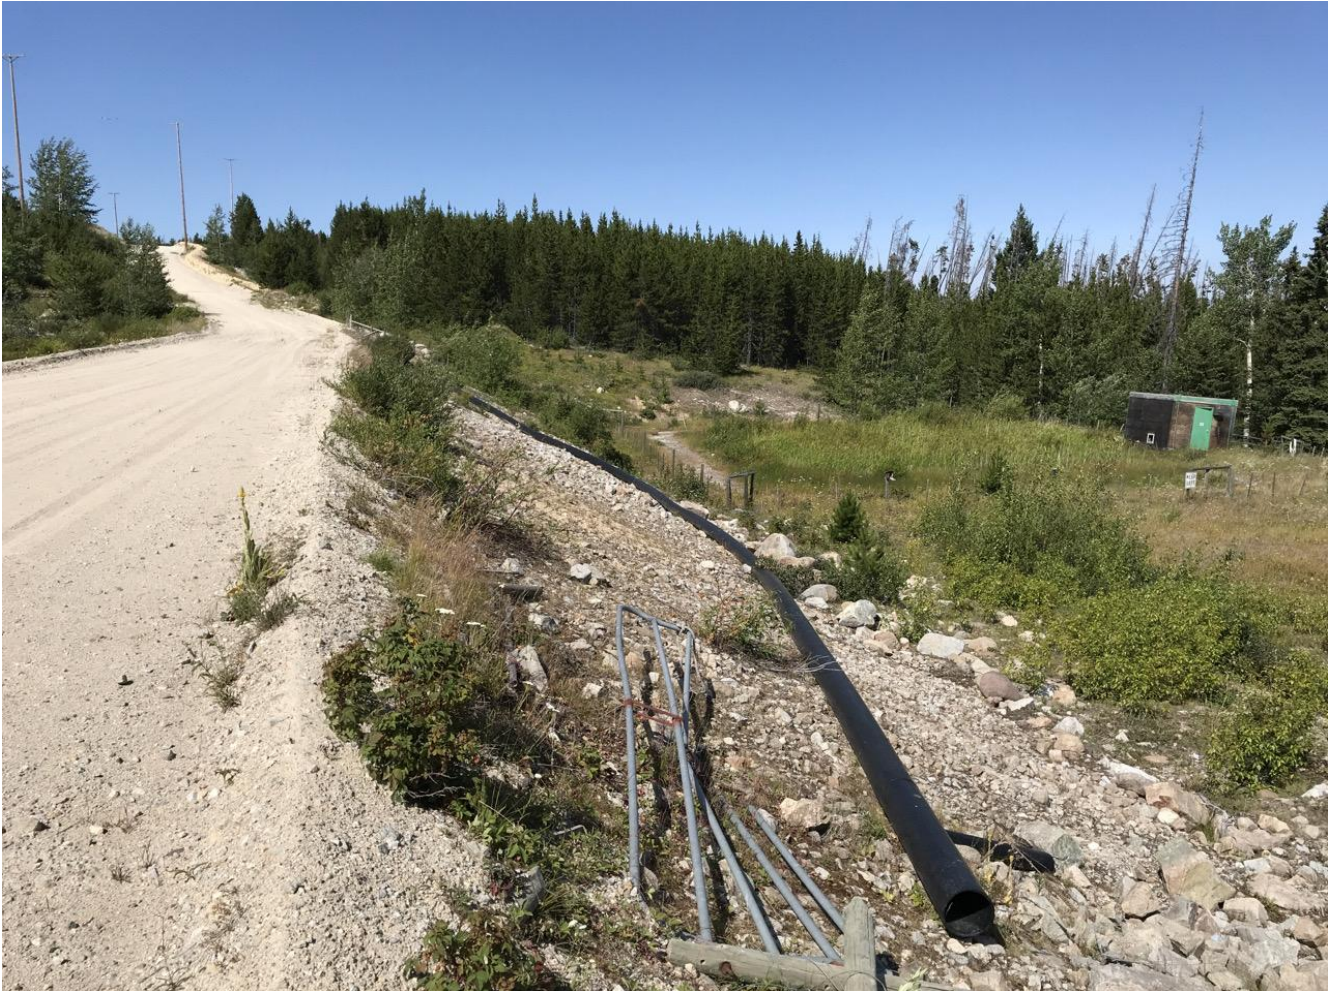
Photo I-B-46 S8 Pond: View of downstream slope (HGH-2020-50)

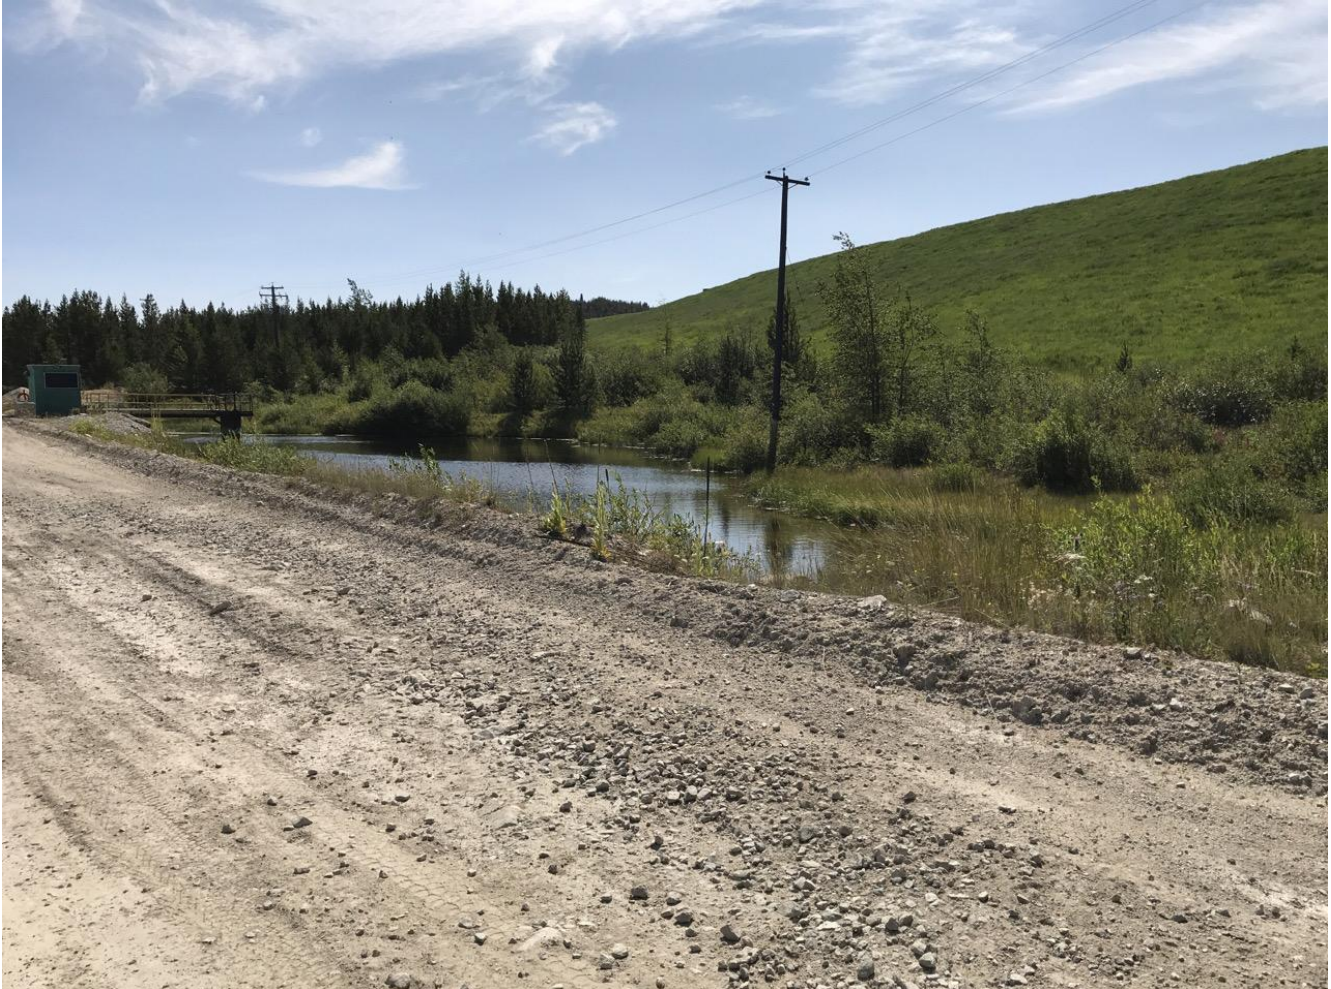
Photo I-B-47 S8 Pond: View of S8 Pond impoundment. Highmont North Dam downstream slope is visible on right hand side of picture (HGH-2020-07)

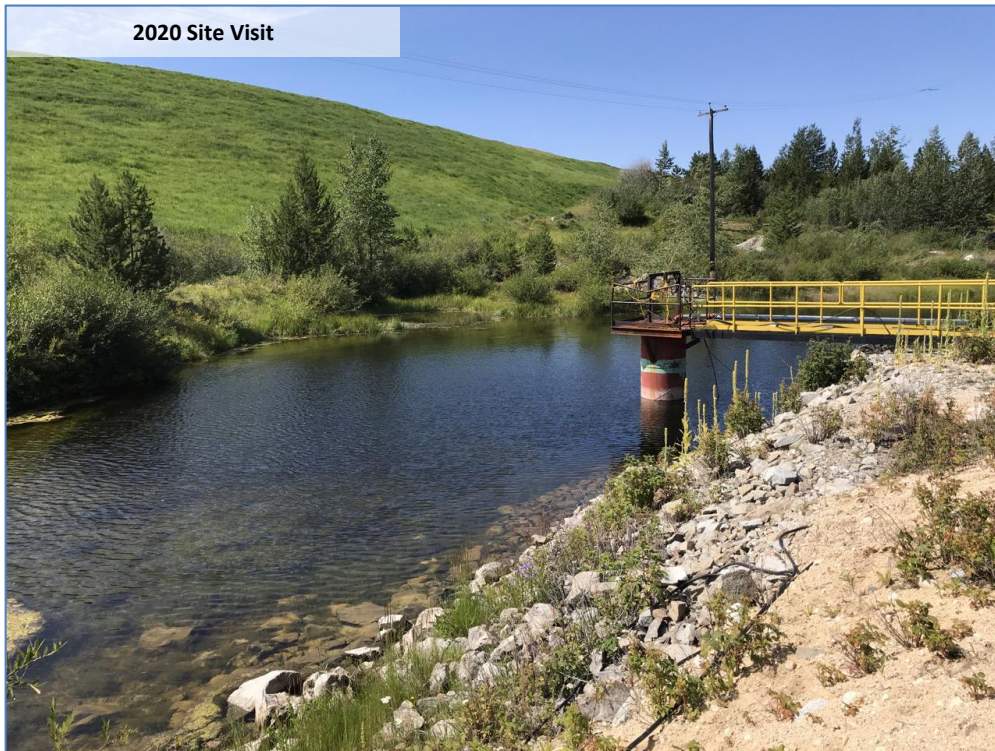
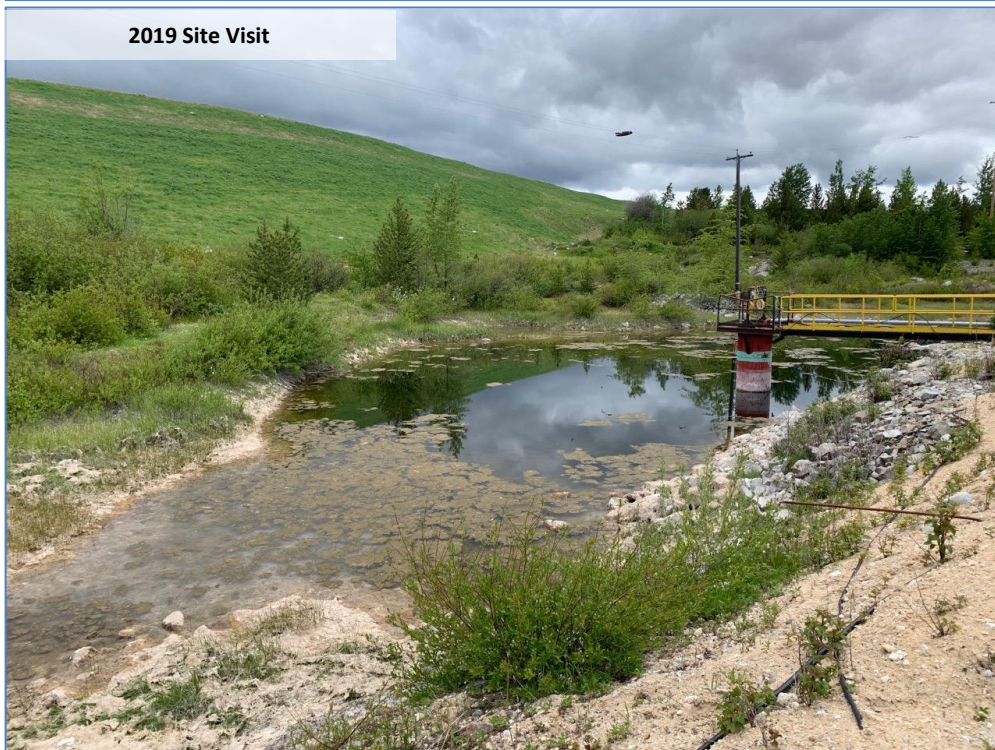
**Photo I-B-48 S8 Pond: View of impoundment, catwalk and outlet pump to S1 Pond
(HGH-2020-50)**

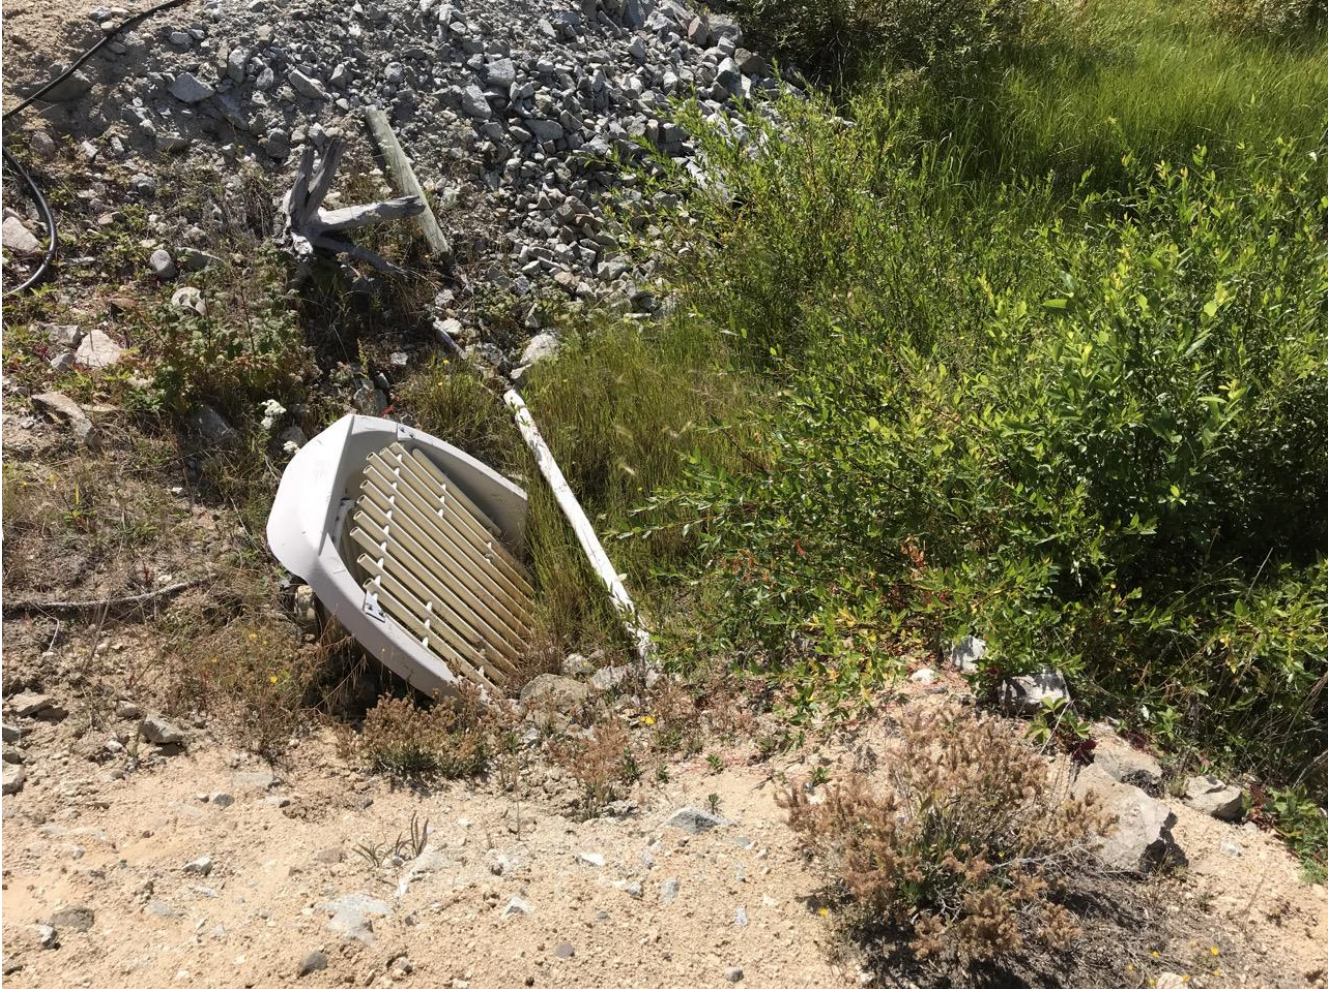
Photo I-B-49 S8 Pond: Overview of overflow pipe trash rack. Rack is clear of debris. Current water level is below the invert (HGH-2020-49)

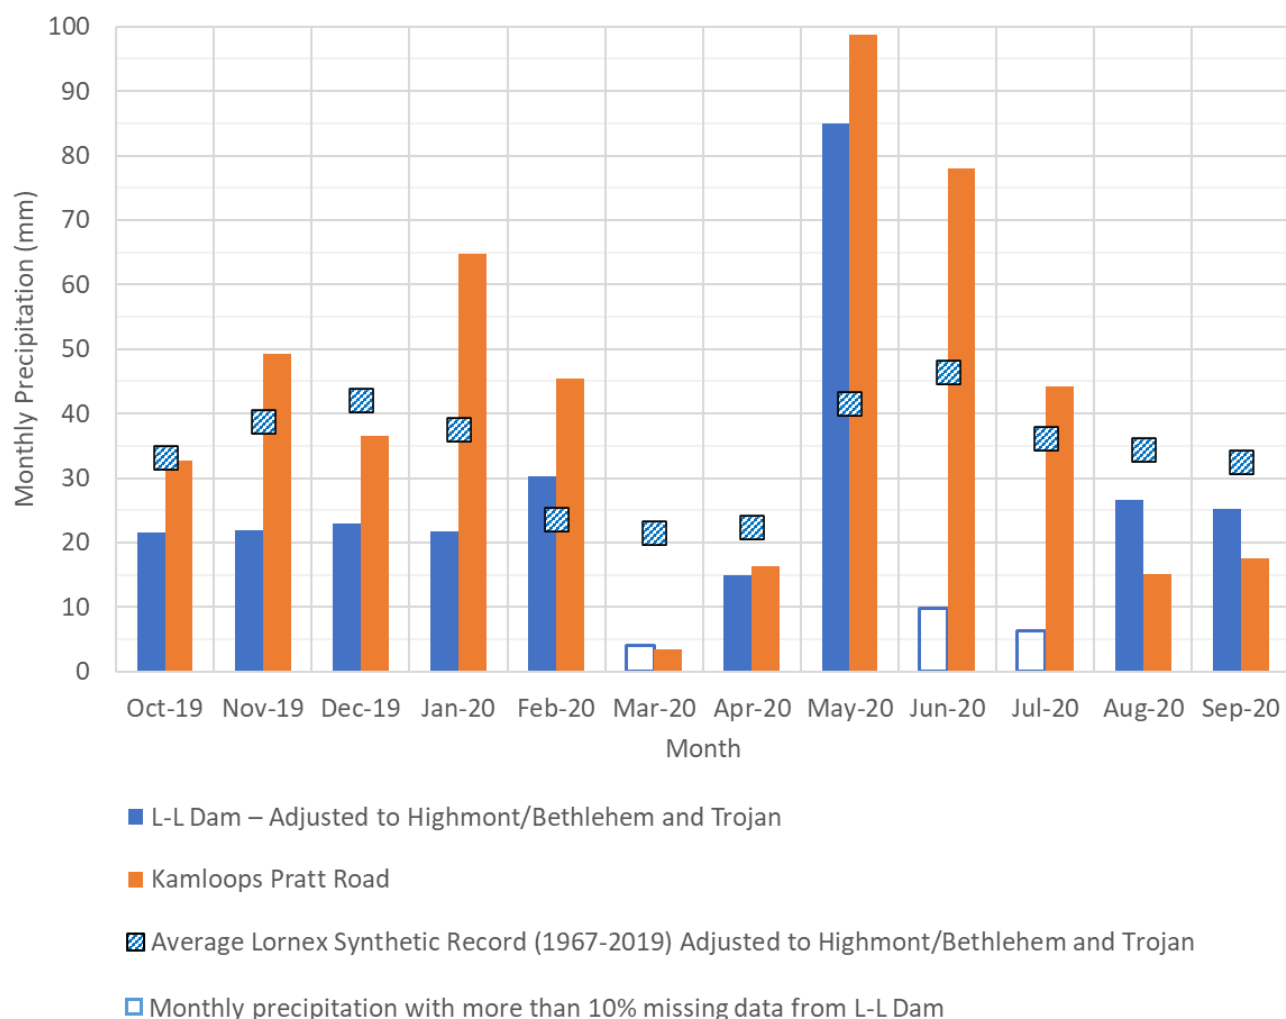
Figure II-A-1 Monthly Precipitation

- More than 10% of the L-L Dam weather station precipitation data were missing in March, June, and July. Due to these data gaps, the 2020 climate data from site was augmented with data from a regional weather station to support a comparison with historic normals.

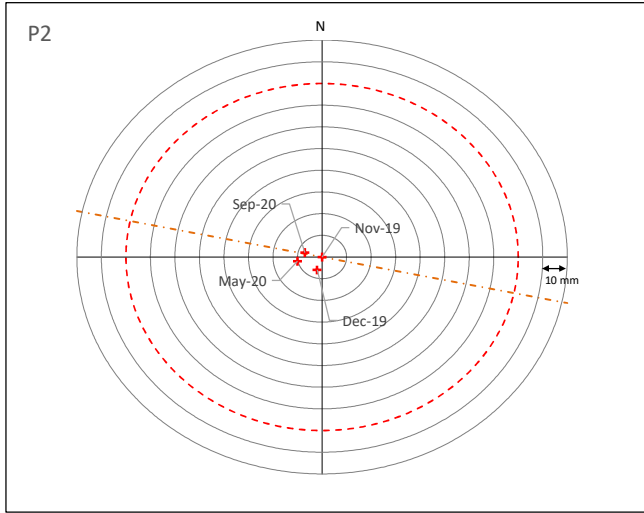
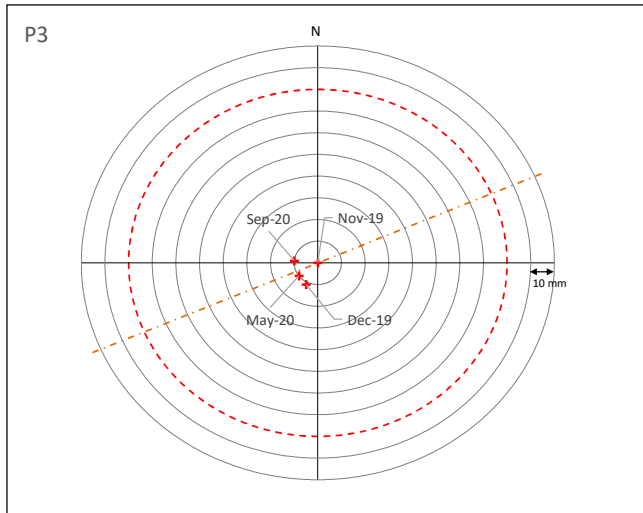
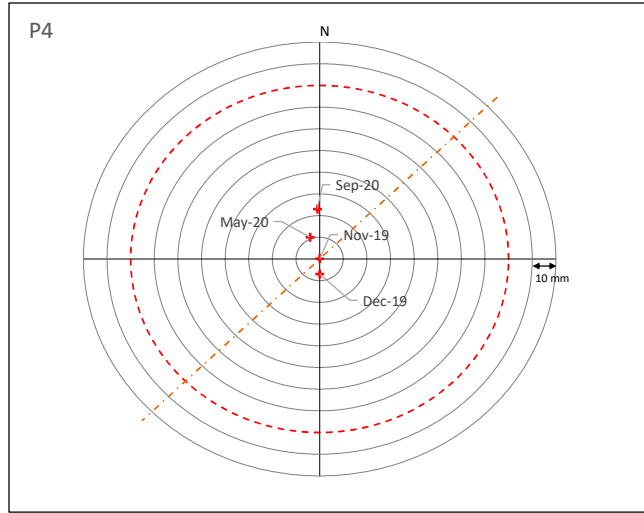
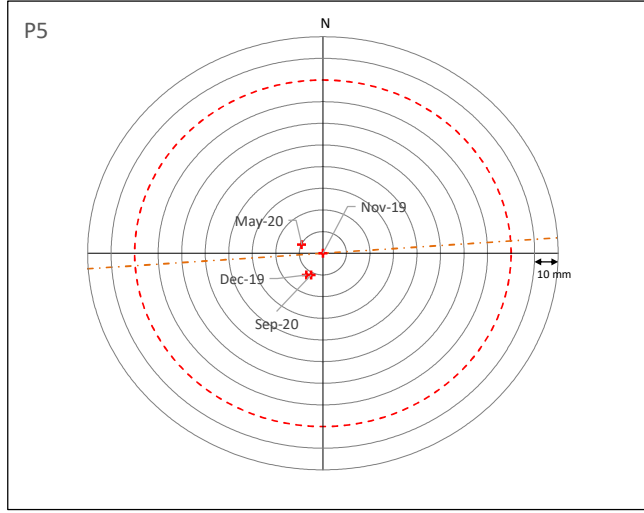
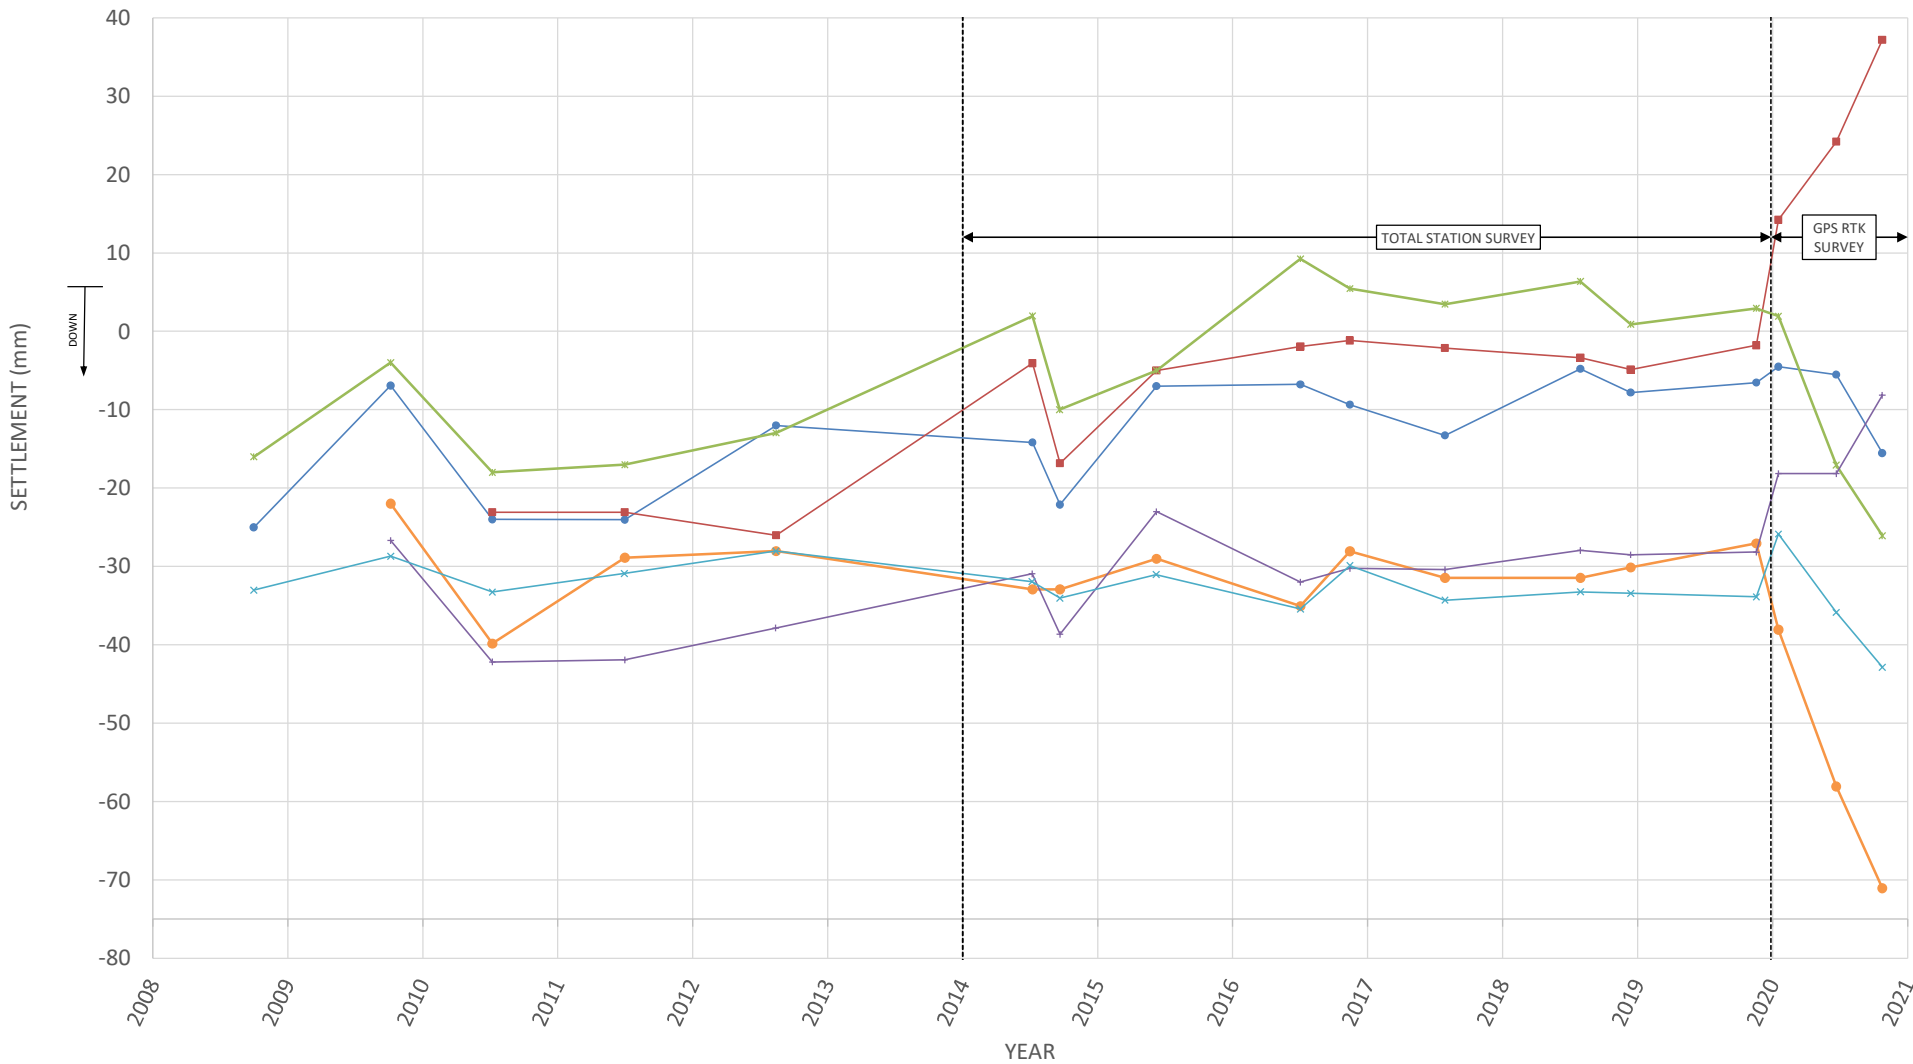
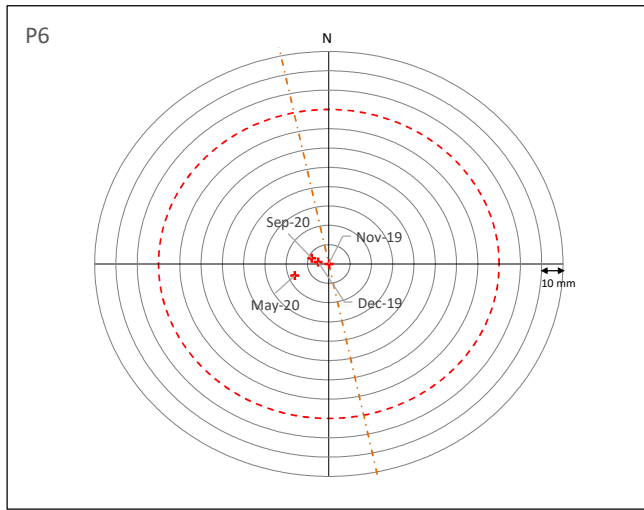
Klohn Crippen Berger</p>	<p>PROJECT</p> <p>HIGHMONT TAILINGS STORAGE FACILITY 2020 ANNUAL FACILITY PERFORMANCE REPORT</p>	
		<p>TITLE</p> <p>HIGHMONT DAM SURVEY MONUMENT READINGS</p>	
		<p>PROJECT No.</p> <p>M02341B83</p>	<p>FIG No.</p> <p>II-B-6</p>

3. HIGHMONT DAM CREST MOVEMENT MONITORING DATA PRIOR TO 2007 NOT SHOWN.
 4. P2 JUNE 2016 READING (NOT SHOWN IN PLAN PLOT) LOCATED 139 MM FROM INITIAL 2007 READING. READING WAS REVIEWED AND FOUND MORE LIKELY RELATED TO SURVEY ERROR THAN DISPLACEMENT. DISPLACEMENT WAS MOSTLY IN A NORTHWEST DIRECTION PERPENDICULAR TO THE DAM ORIENTATION, BUT SLIGHTLY IN THE DOWNSTREAM DIRECTION.

5. P4 2008, AND 2009 READINGS (NOT SHOWN IN PLAN PLOT) LOCATED 240 mm and 167 mm FROM INITIAL 2007 READING, RESPECTIVELY. READING WAS REVIEWED AND FOUND MORE LIKELY RELATED TO SURVEY ERROR THAN DISPLACEMENT.
