Louvicourt Mine Tailings Storage Facility and Polishing Pond

Tailings Storage Facility Annual Inspection

001-20145710-3000-RA-Rev0

April 2, 2021

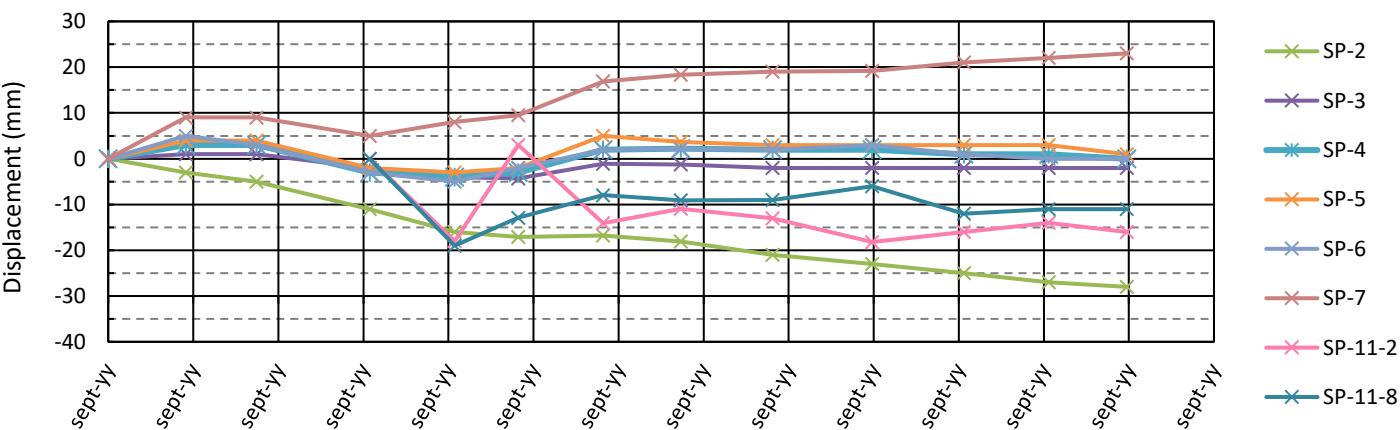
Figure 5 : Vertical Displacement of the Survey Monuments at Dam 1

Since the previous year, the vertical data shows that 2 monuments indicated minor upward movements of 1 mm and 13 monuments (i.e., all monuments on Dams 1 and 2) had settlements of 2 mm or less (which is the stated survey accuracy). All four monuments on Dam 4B showed incremental settlements greater than 2 mm (3 to 5 mm). All monuments show total settlement since installation of 31 mm or less, although, the survey data record suggests a pattern of continuing, minor settlement. In order to better assess the settlement data, plots of historical settlement have been prepared as Figures 5 to 7.

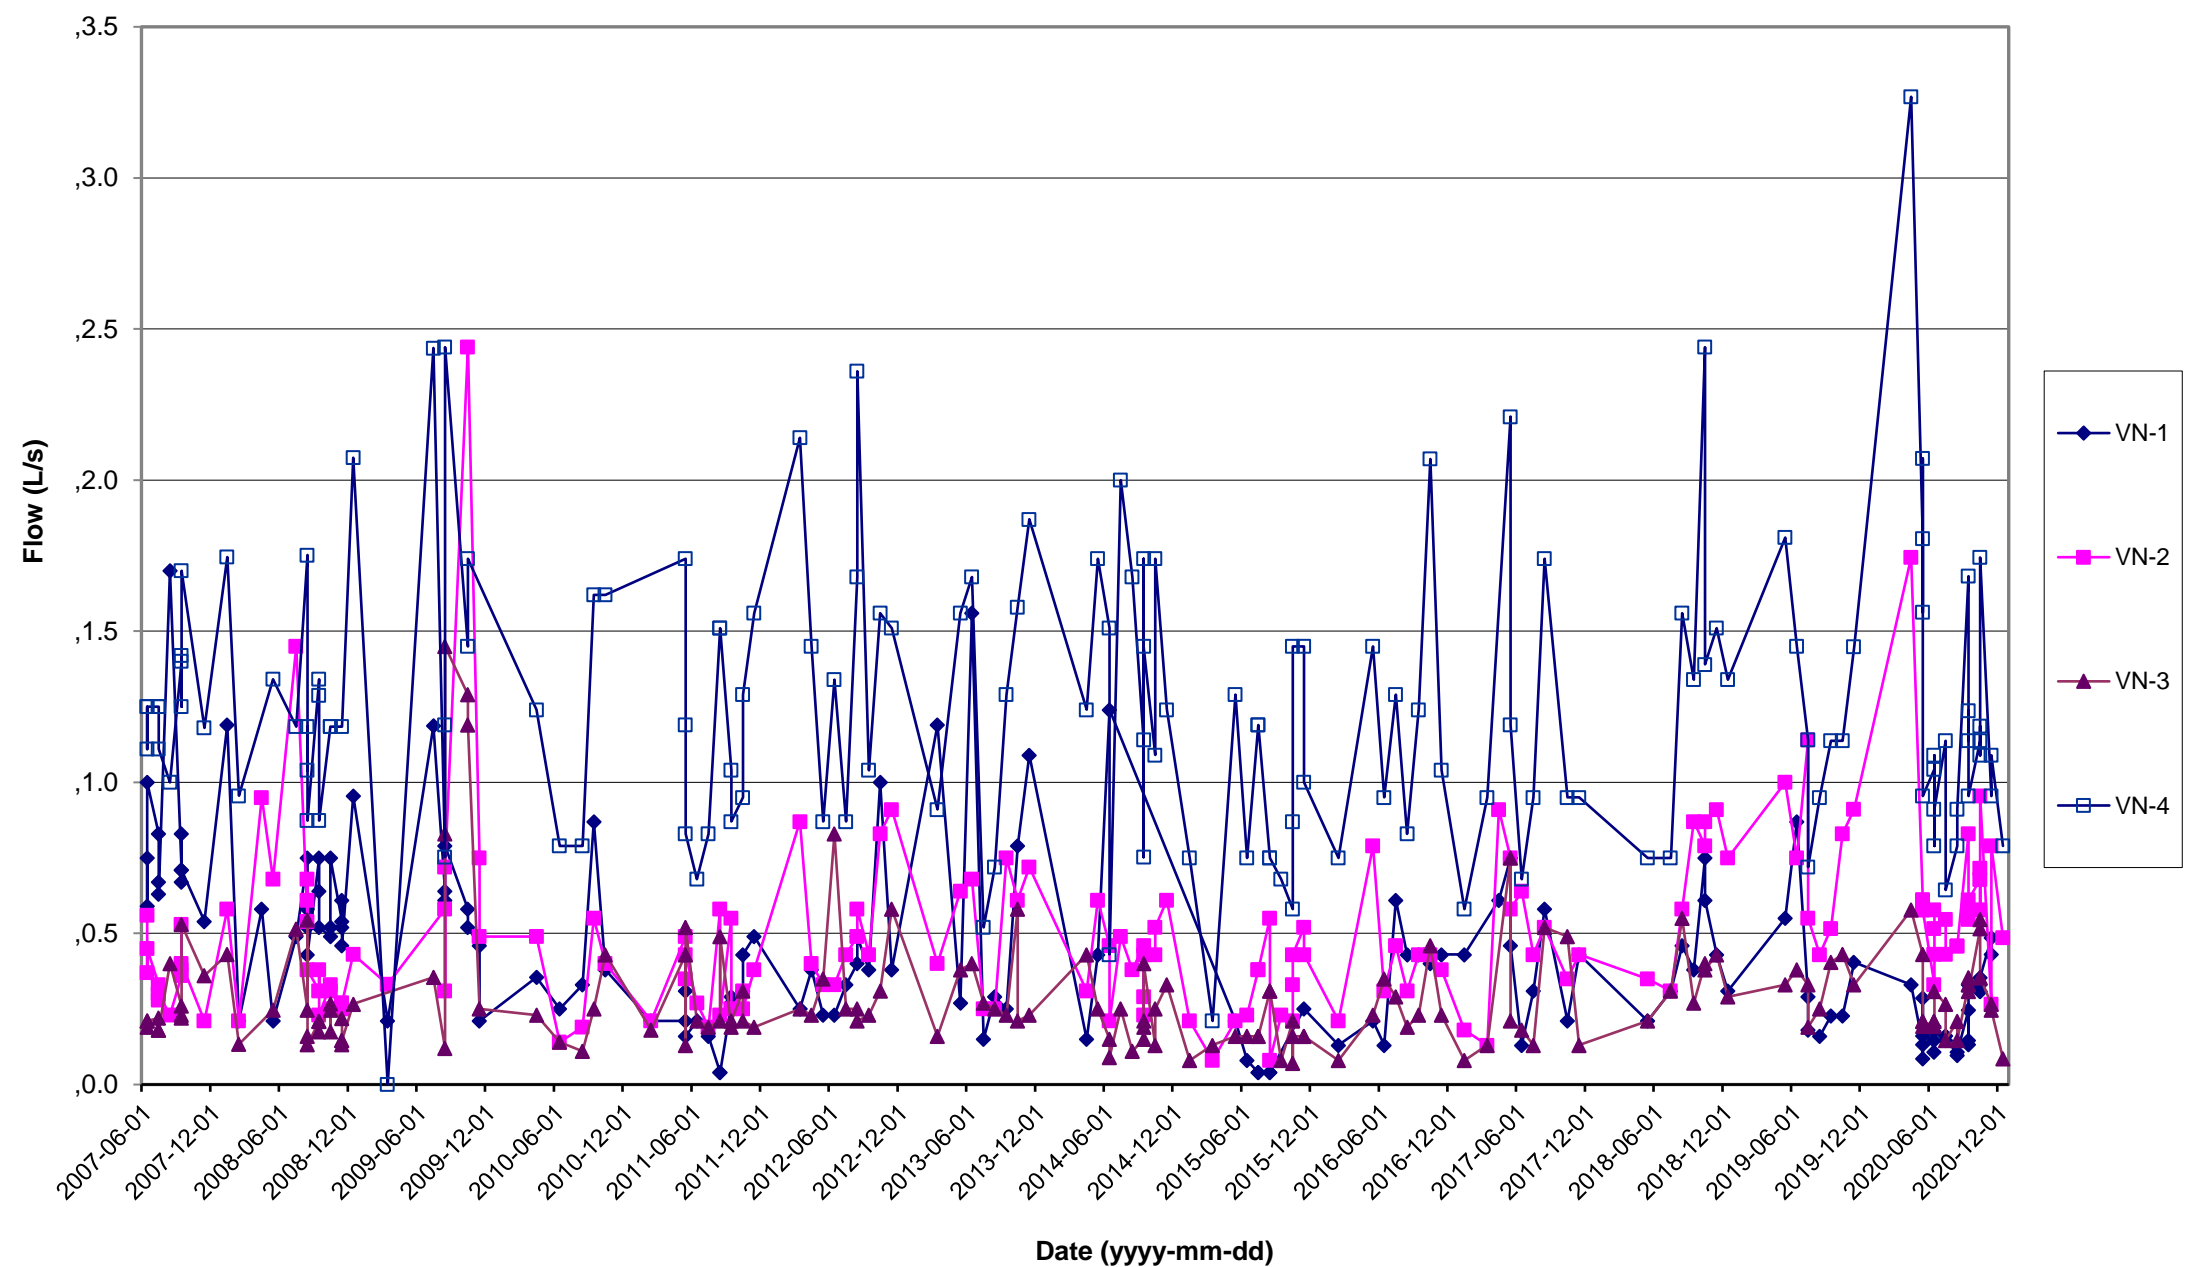
Louvicourt Mine Tailings Pond - historical trend of seepage flow measured
at the V-notch weirs
(provided by Teck)
