# 2020 Annual Inspection for Turnbull Tailings Storage Facility

*Teck Coal Limited, Fording River Operations*

Reference No. 20136981-2020-221-R-Rev0-2000

8 March 2021

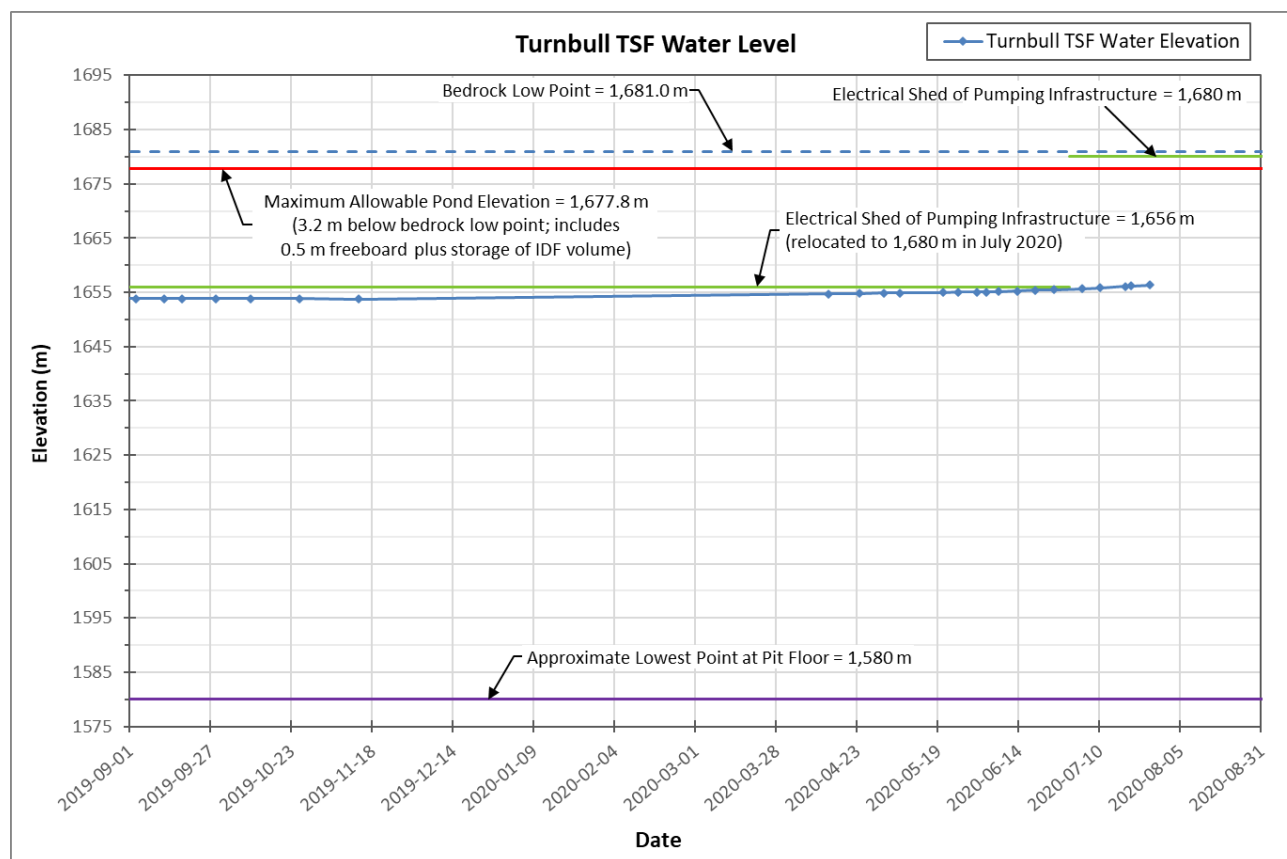
**Chart 2: Turnbull Tailings Storage Facility Pond Water Elevation for 1 September 2019 to 27 July 2020**

The Turnbull TSF pond level was surveyed two to six times per month during the reporting period, except for the winter months when there is no safe access due to snow cover and avalanche hazards to monitor freeboard. Since no tailings are deposited during the winter months, postponing the pond level survey until safe access is available is acceptable based on the current freeboard. The Turnbull TSF water level in Chart 2 shows that the pond level was increasing throughout the reporting year.
