Teck Resources Limited

Bullmoose Mine

Bullmoose Tailings Storage Facility 2021 Annual Facility Performance Review

March 22, 2022

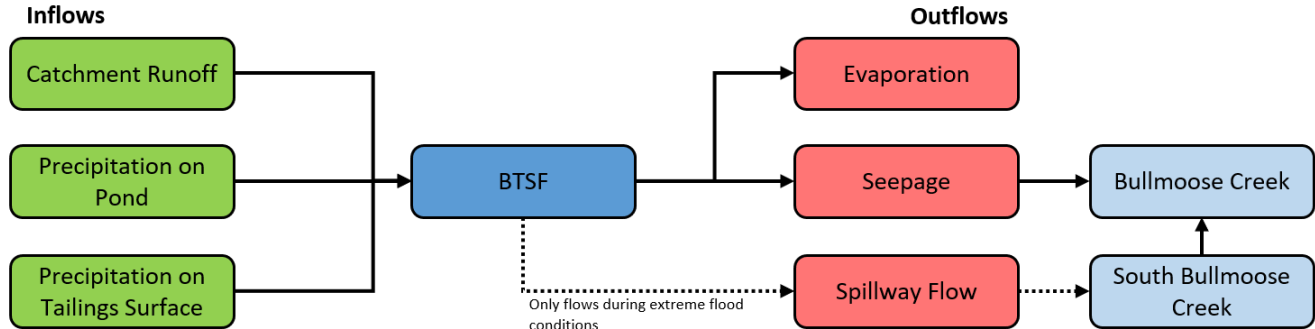
Figure 3.1 Flow Schematic for Bullmoose TSF

A flow schematic is shown on Figure 3.1. The catchment, spillway, and diversion channel are shown on Figure 4.

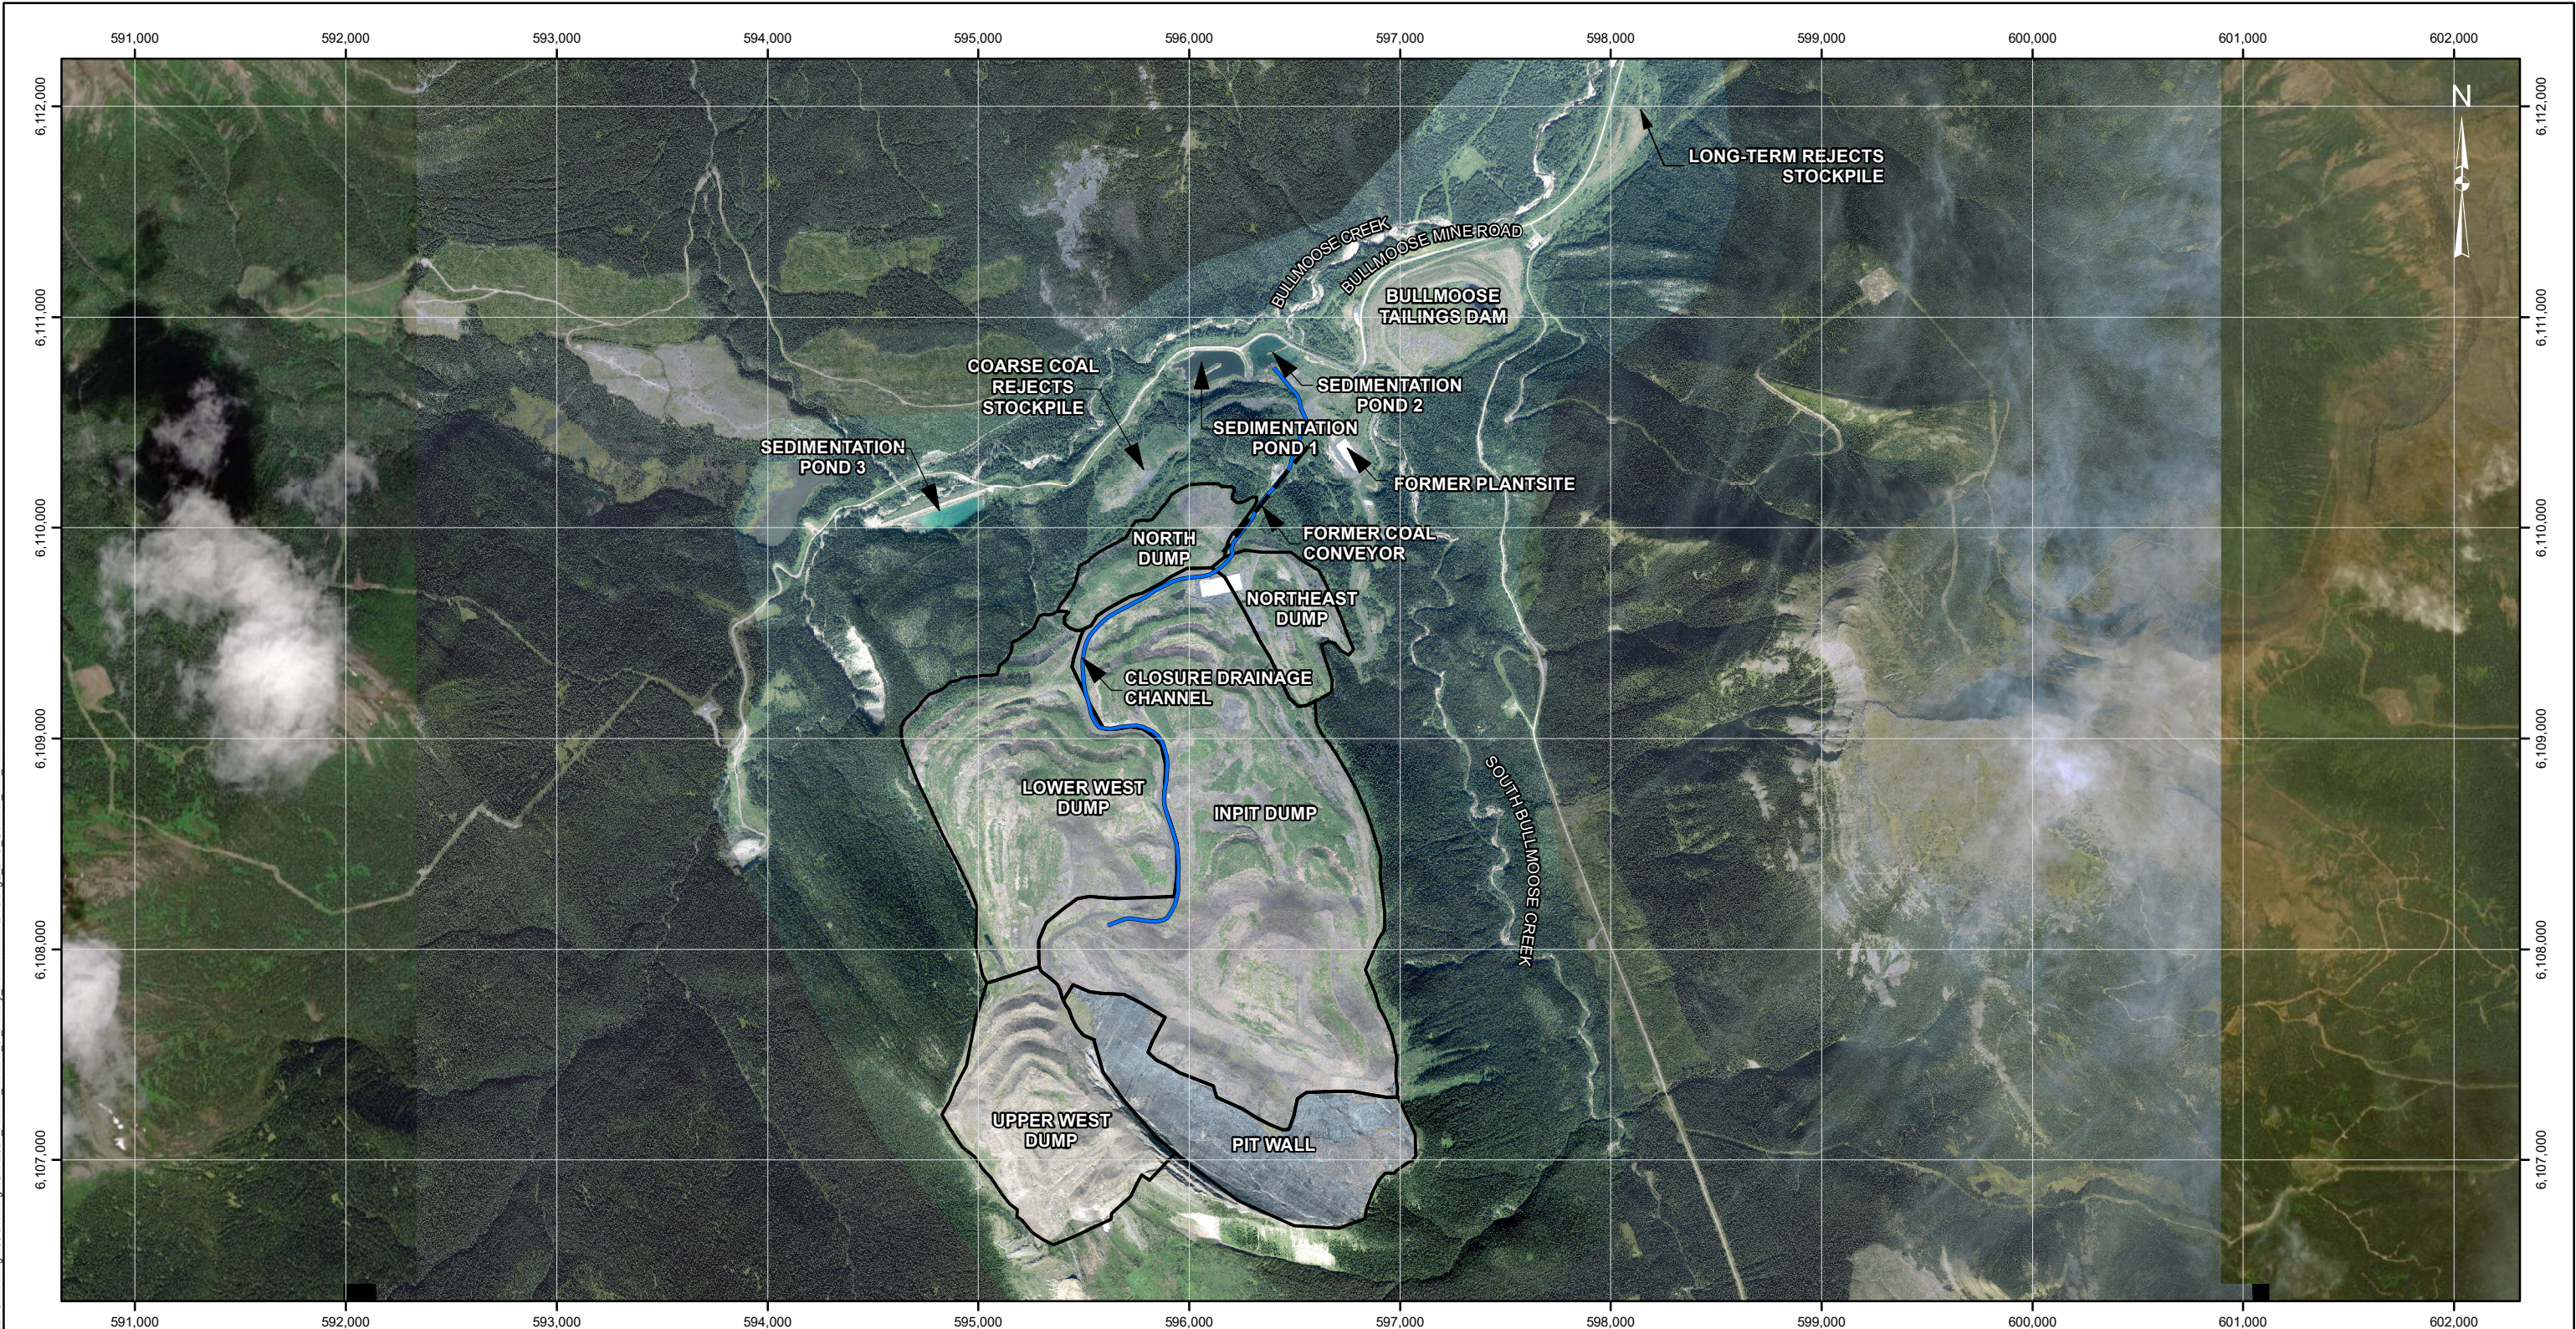
FIG No. 2

The BTSF is a side-hill tailings storage facility that was designed to store fine coal refuse tailings produced during operations. It is situated on the south flank of the valley bottom, with South Bullmoose Creek to the west and Bullmoose Creek to the north (Figure 2). Tailings are retained in the facility by the Bullmoose Tailings Dam (BTD). There is an open channel spillway located at the west abutment of the BTSF which was constructed in 2002 (BOC 2004). Key facility metrics are summarized in Table 1.1. Typical cross-sections and design drawings are included in Appendix III.

- ◆ The potential for toe erosion to affect embankment stability was evaluated (KCB 2018a); the study indicates that the maximum flood level in Bullmoose Creek near the BTSF during the IDF² event is 2 m below Bullmoose Mine Road (see Figure 2 for Bullmoose Mine road location) and the flood inundation extent is at least 40 m (horizontal) from the BTSF toe (KCB 2018a).

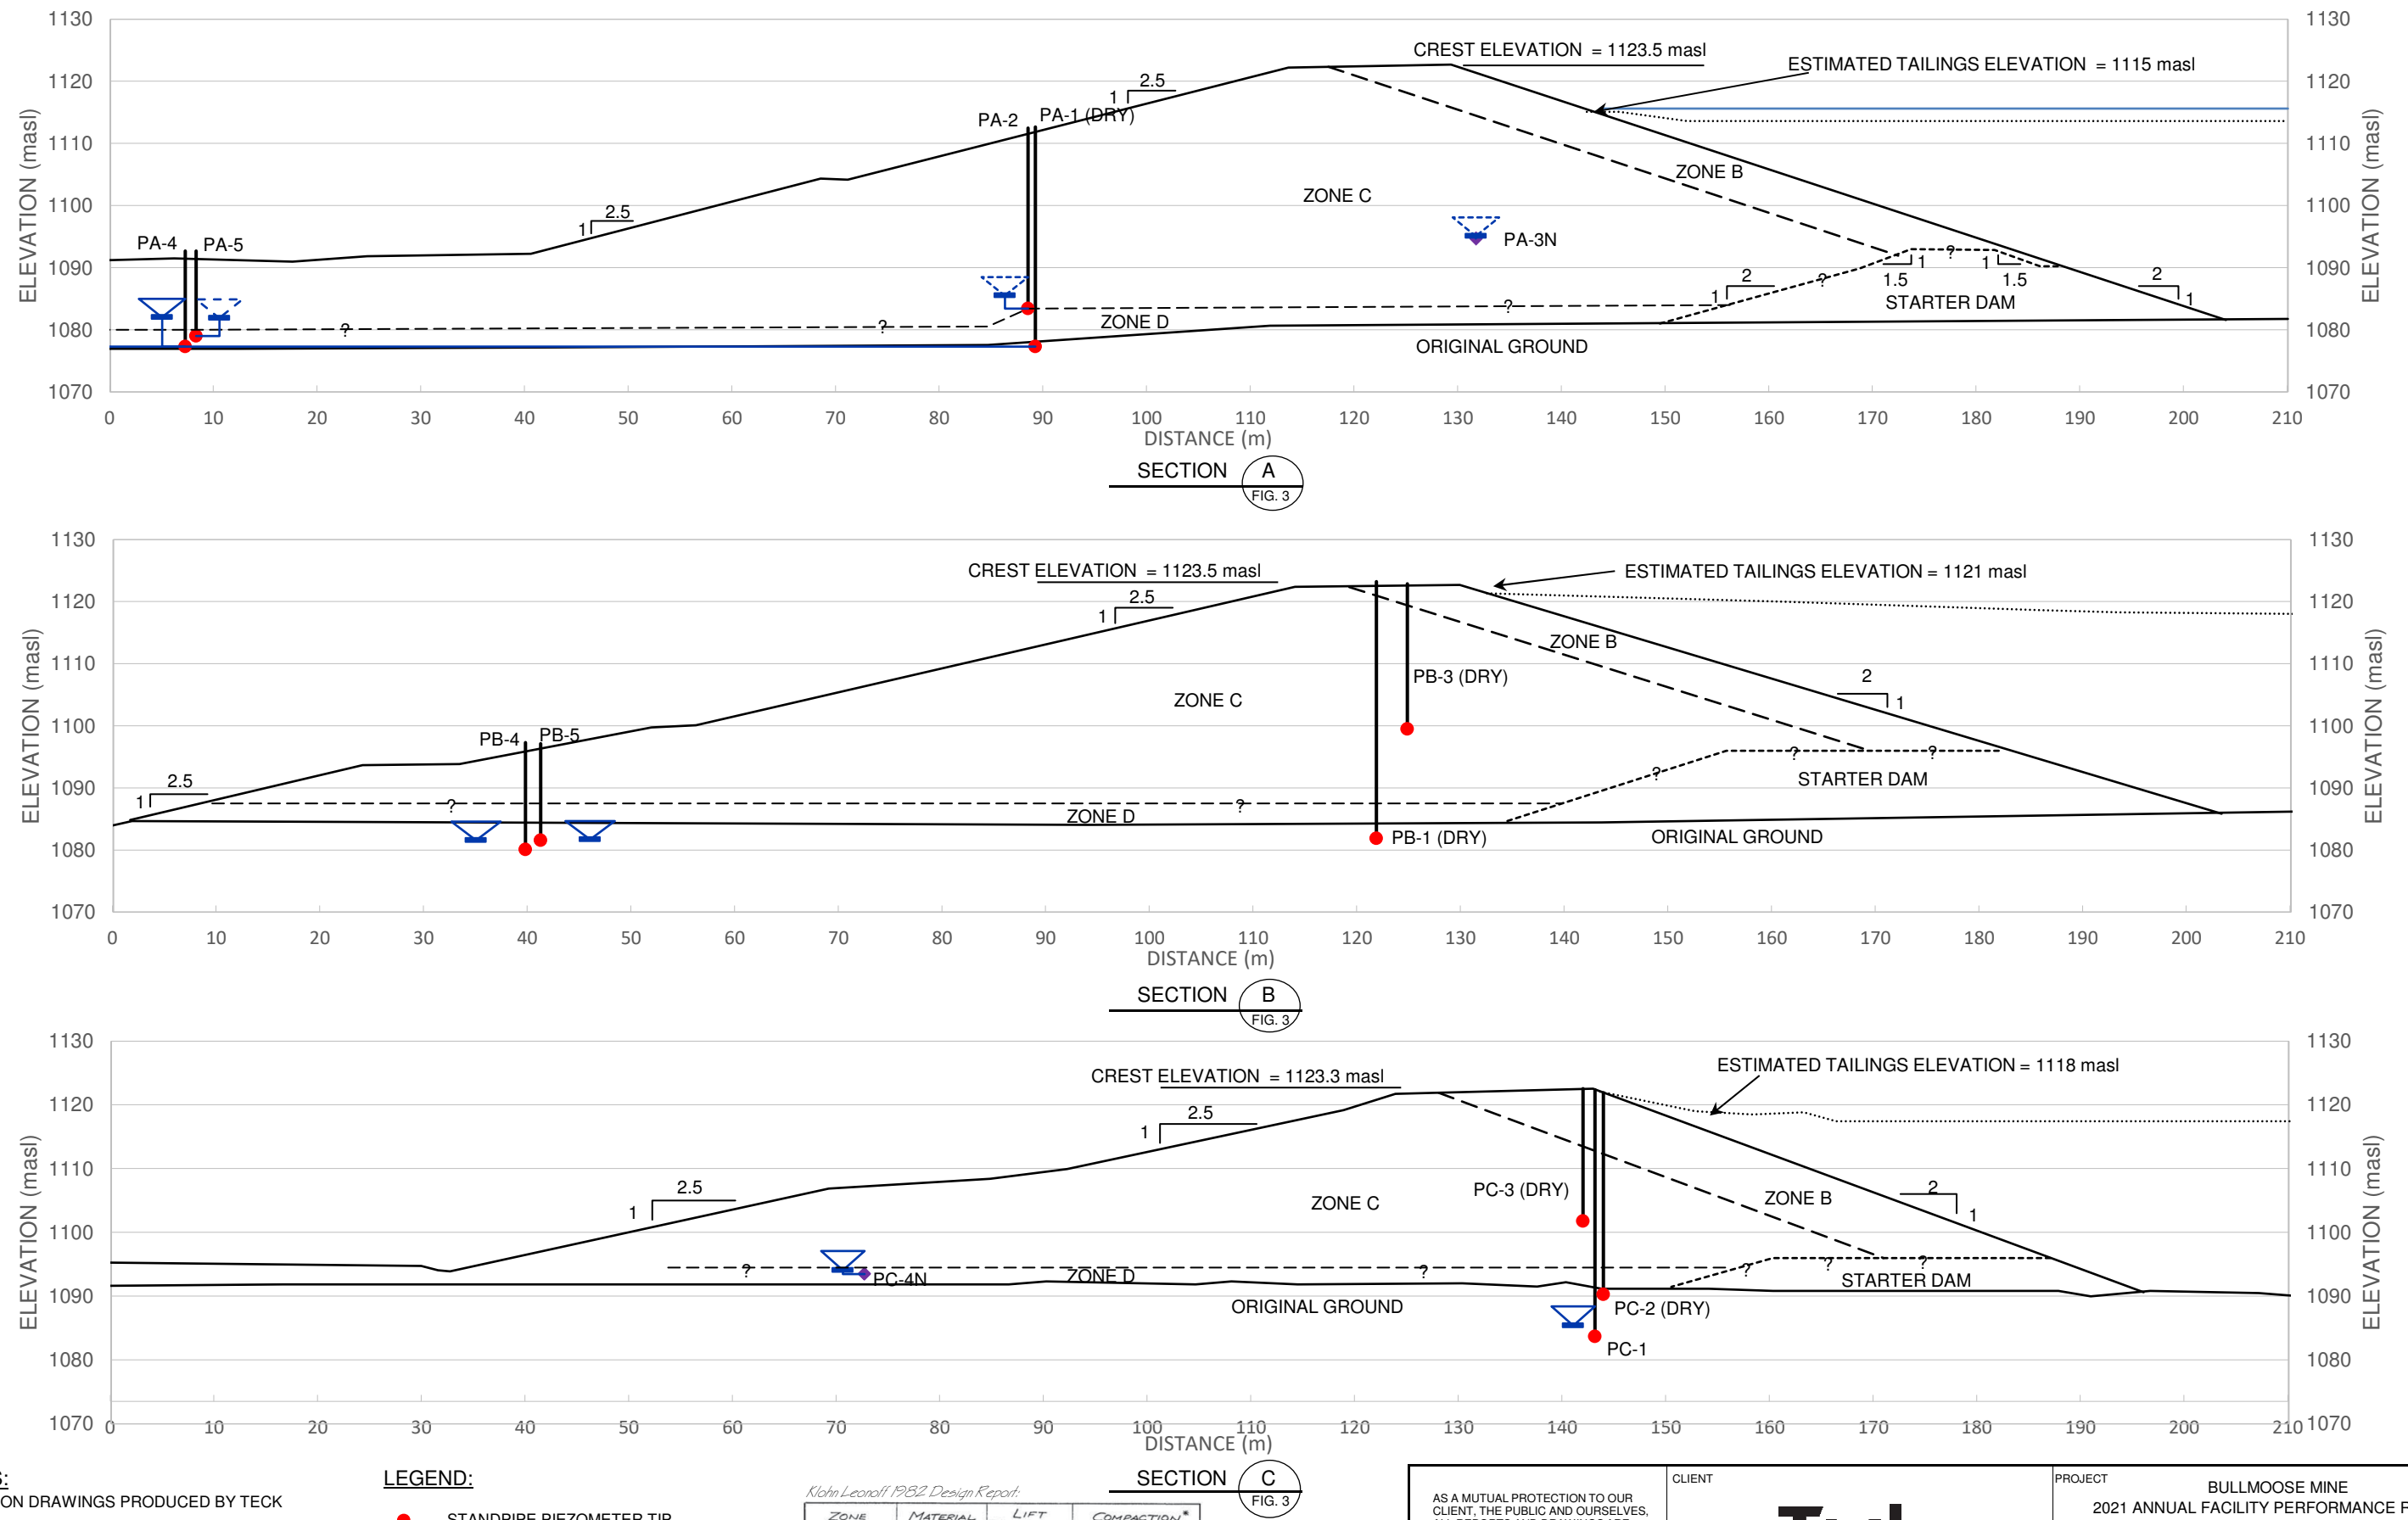
FIG. No. 7

There are 13 functional piezometers at the BTSF (11 standpipe piezometers and 2 pneumatic piezometers); installation details and threshold levels are summarized on Figure 5. The piezometer locations are shown on Figure 3. Figure 6 summarizes recent and historical piezometer readings, while Figure 7 shows piezometric levels at selected cross-sections of the facility. None of the measured piezometers exceed Threshold Level 1, and none of the piezometers indicate a trend of increasing pore pressures within the embankment or foundation. The piezometer data collected to date continues to show that the dam shell is drained with a low gradient of approximately 0.04 to 0.05 (KCB 2018b).

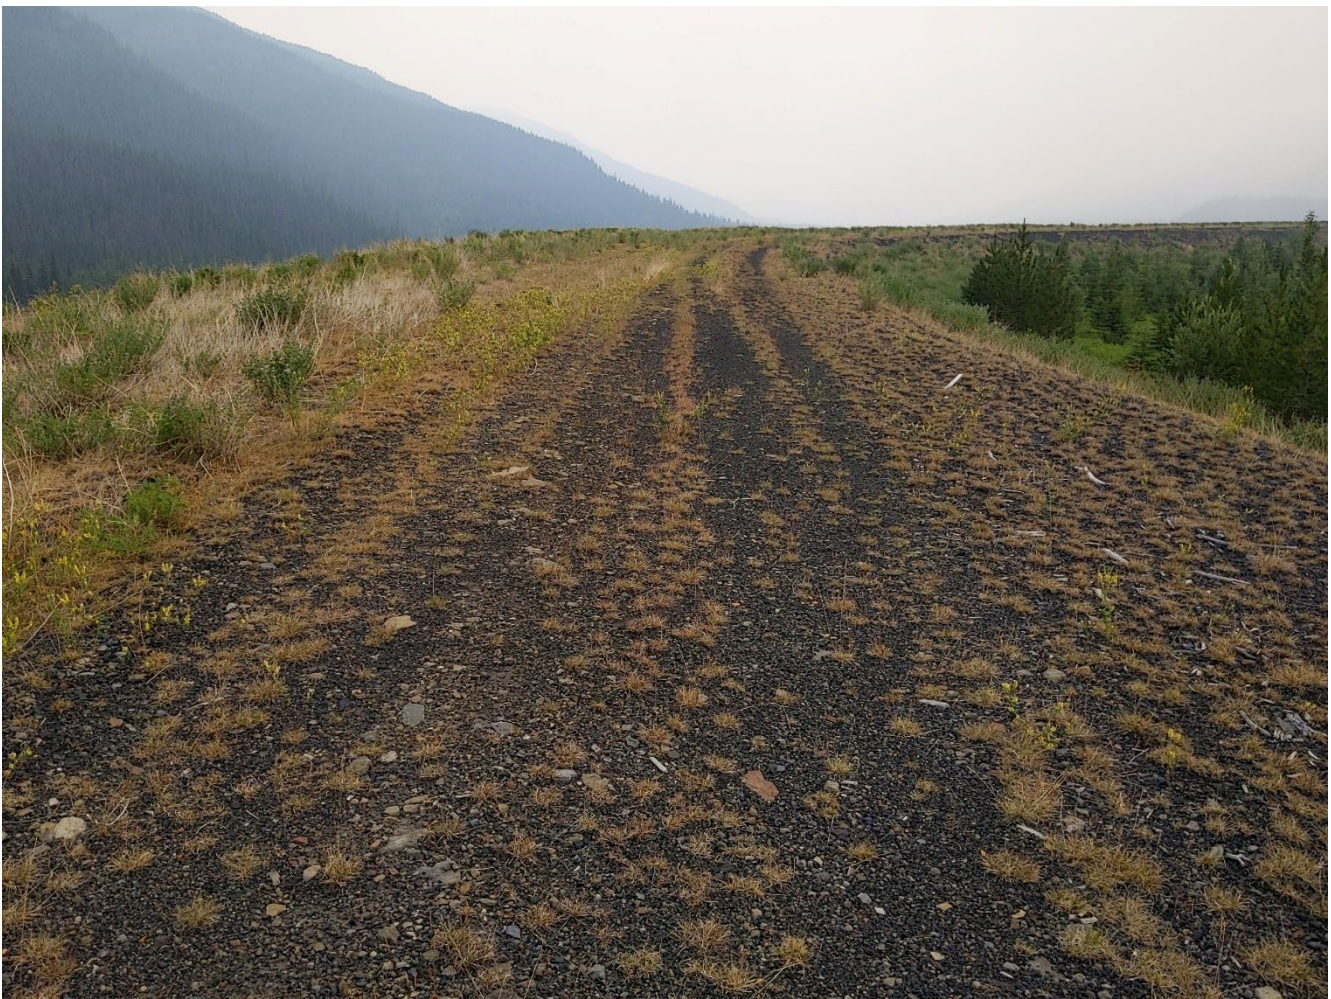
Photo II-1 BTD crest – Looking south (BTD-2021-01)

- **Dam Crest:** Good condition. No signs of lateral movement, differential settlement, or cracking of the dam crest
- **Downstream Slope and Toe:** Good condition. No signs of significant erosion, displacement, or bulging. Vegetation (grasses and mosses) are well established.

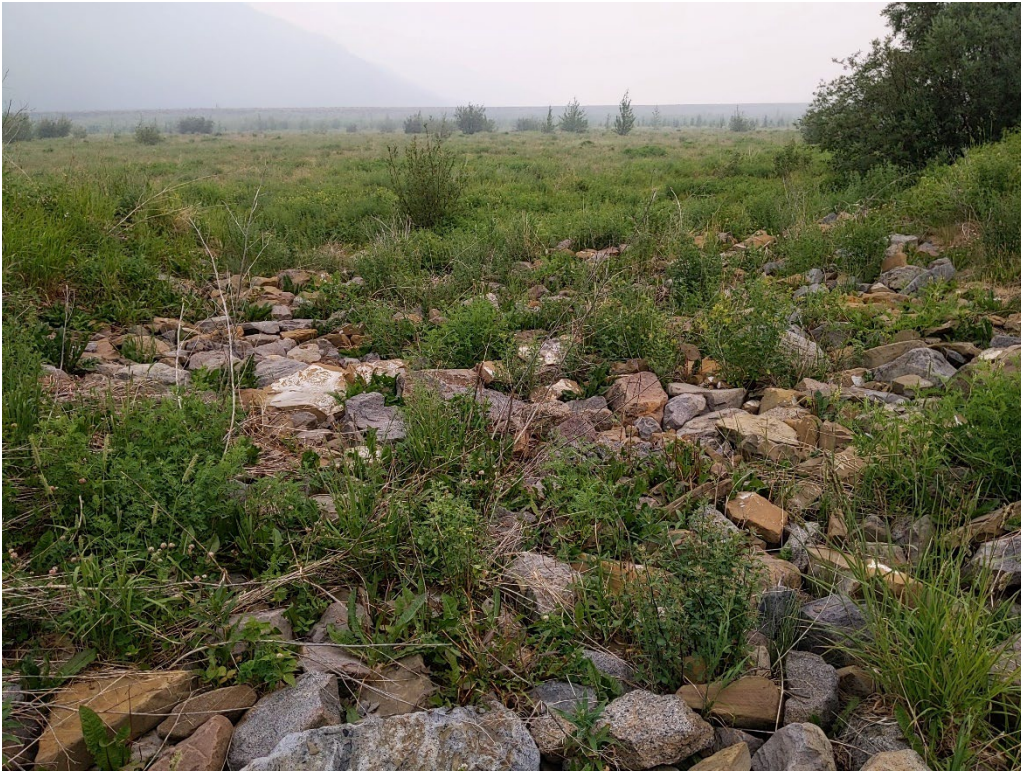
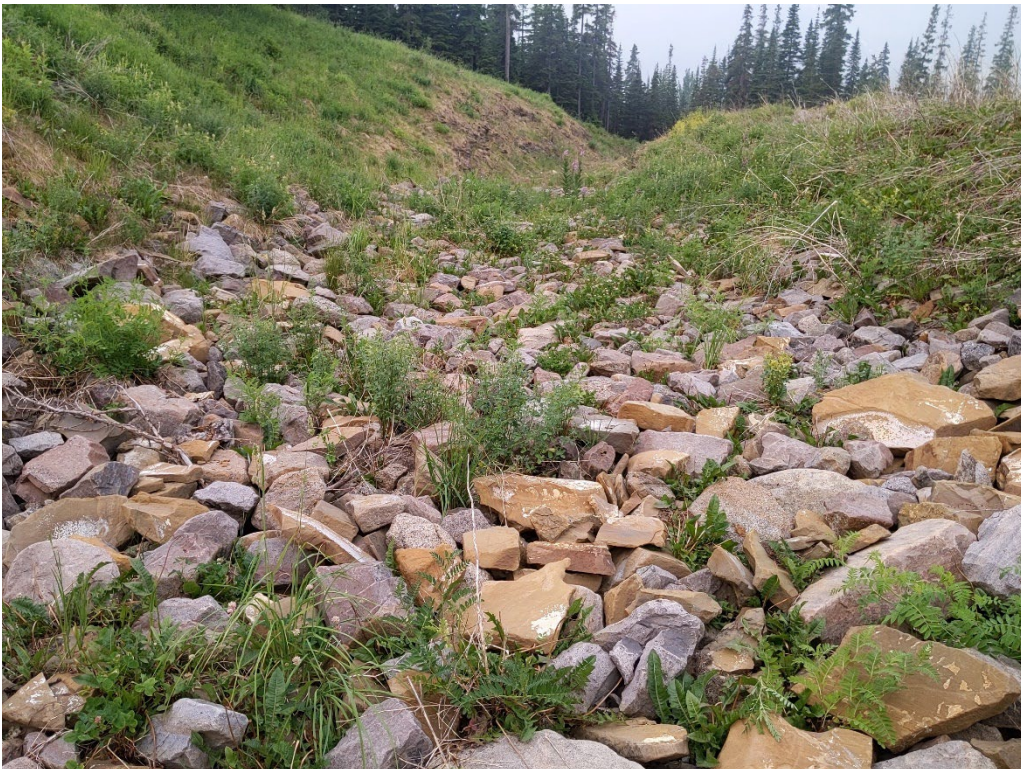
- **Spillway:** Good condition. No signs of erosion or obstructions. There was some minor re-growth of vegetation observed, but none that would affect the performance of the spillway.

Photo II-2 Spillway Inlet – Looking downstream (BTD-2021-02)

Photo II-3 Spillway Inlet– Looking downstream (BTD-2021-02)

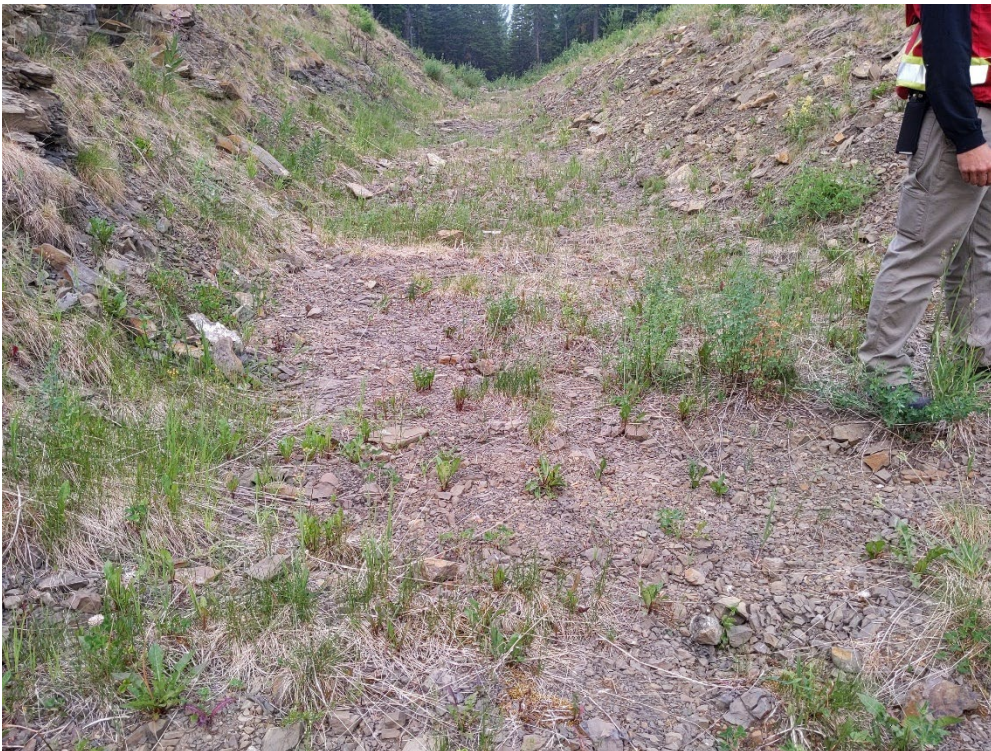
Photo II-5 Spillway – Looking upstream (BTD-2021-03)
