Teck Coal Limited

Coarse Coal Refuse Dump

2021 Annual Facility Performance Report

March 30, 2022

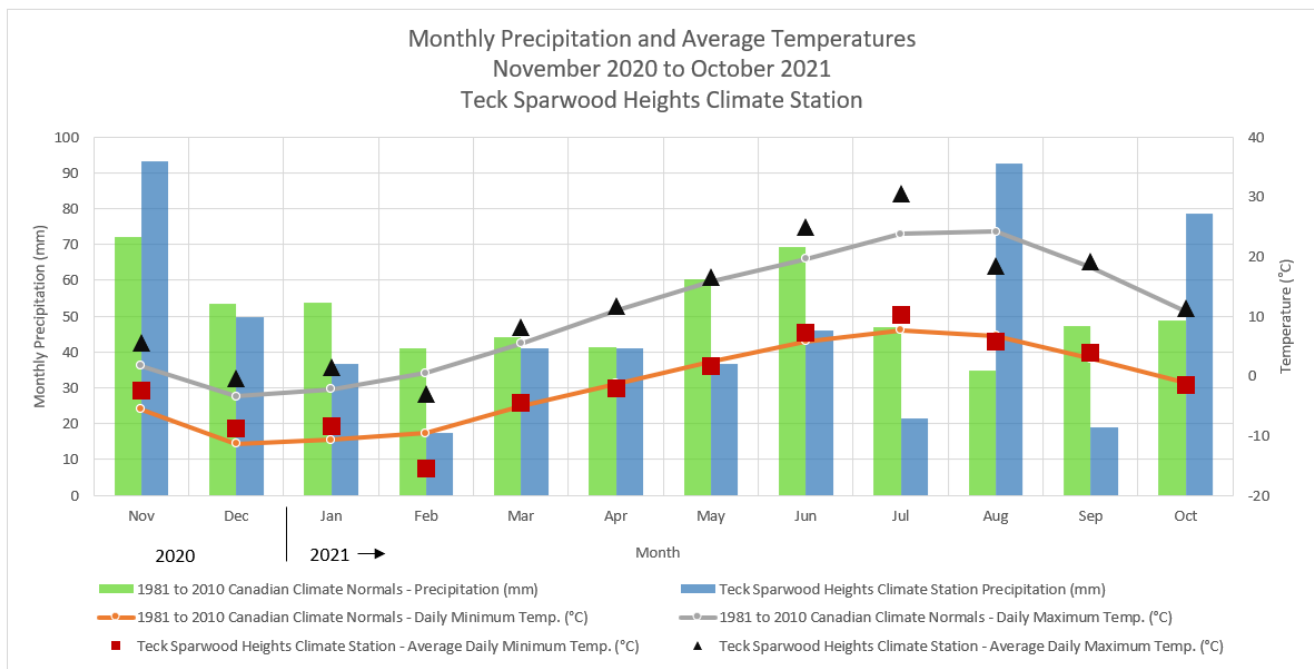
Figure 6.1 Climate Averages for Sparwood

Figure 6.1 presents the climate averages for Sparwood based on the Teck Sparwood Heights climate station. The Teck Sparwood Heights climate station data was used for this reporting period. The total recorded precipitation from the November 2020 to end of October 2021 period was approximately 574 mm, compared to the average at Sparwood of 614 mm (based on Environment Canada Sparwood climate normal from 1981 to 2010).

Precipitation during November 2020, and August and October of 2021 was higher than the 1981-2010 Canadian climate normal for Sparwood. Otherwise, the precipitation for the 2020 to 2021 period has generally been lower in comparison the 1981-2010 Canadian climate normal for Sparwood. KCB is not aware of any instances of decreased facility performance during the high precipitation months.
