REPORT 2021 Annual Facility Performance Report

Greenhills Operations Tailings Storage Facility

Reference No. 21452085-2021-204-R-Rev1-3000

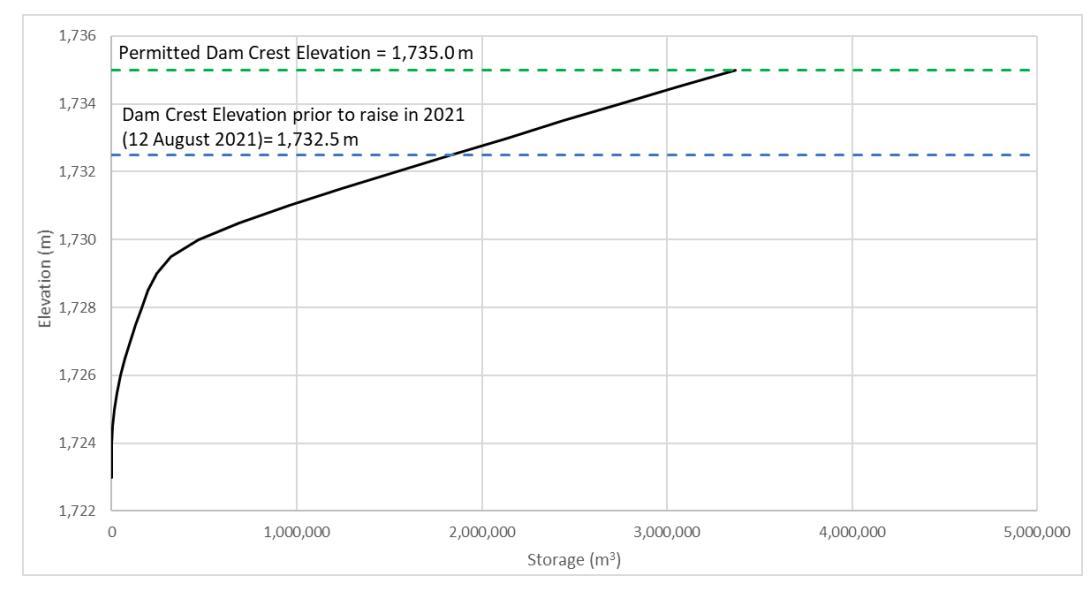
Illustration 1: Storage Capacity Curve for Elevations Above Surface Surveyed in 2021 Bathymetry Survey

Based on the 2021 bathymetric survey and topographical data obtained from Skycatch real-time kinematic (RTK) positioning drone mapping completed on 24 August 2021, it is estimated that a total struck level storage volume, without allowance for freeboard or beach angles, of approximately 3.4 million m³ is available to elevation 1,735 m (as shown in Illustration 1).

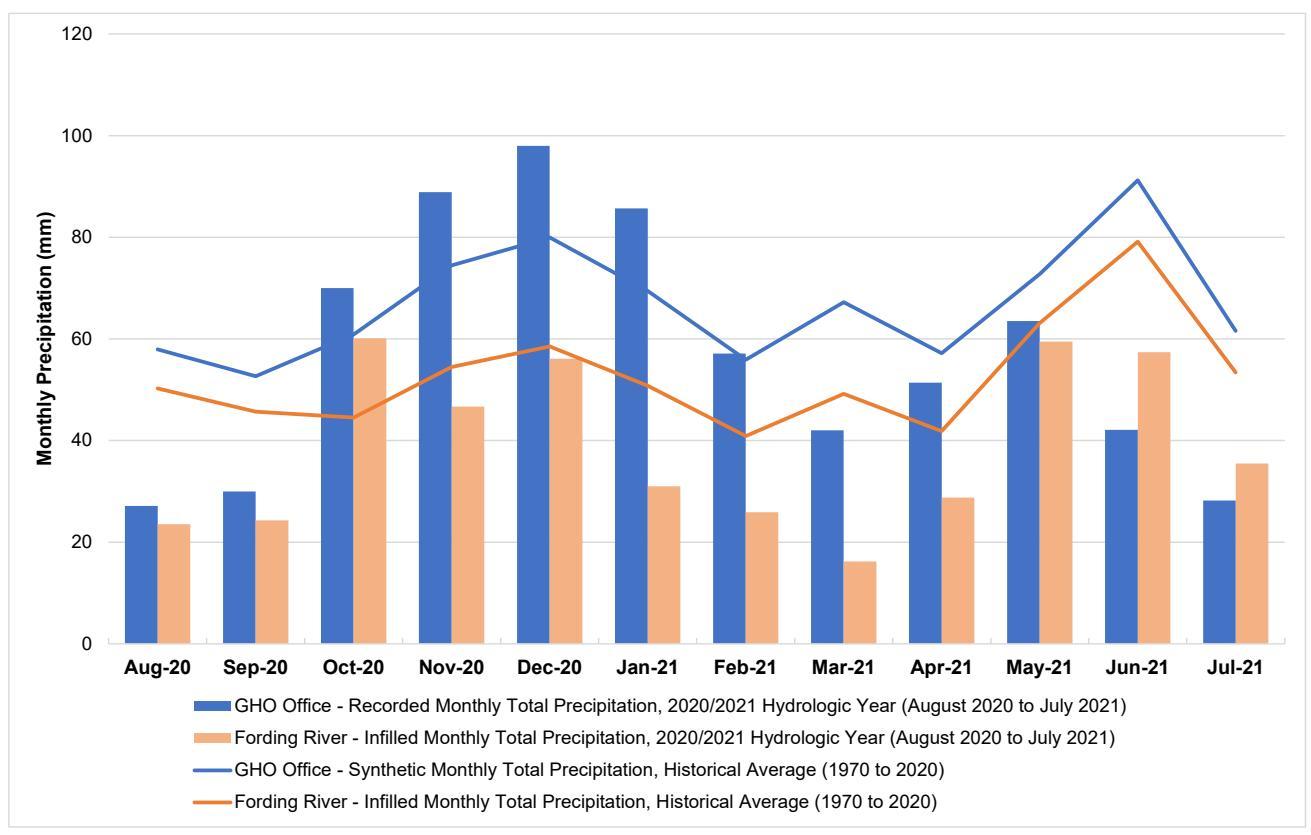
Illustration 2: Comparison Between 2020/2021 Total Precipitation and Historical Average for Greenhills Operations

Data was compared to the long-term synthetic precipitation dataset for the period 1970 to July 2020, and a summary of the recorded monthly total precipitation for the hydrologic reporting period (1 August 2020 to 31 July 2021) and the historical monthly averages at the GHO Office station location are presented in Illustration 2.

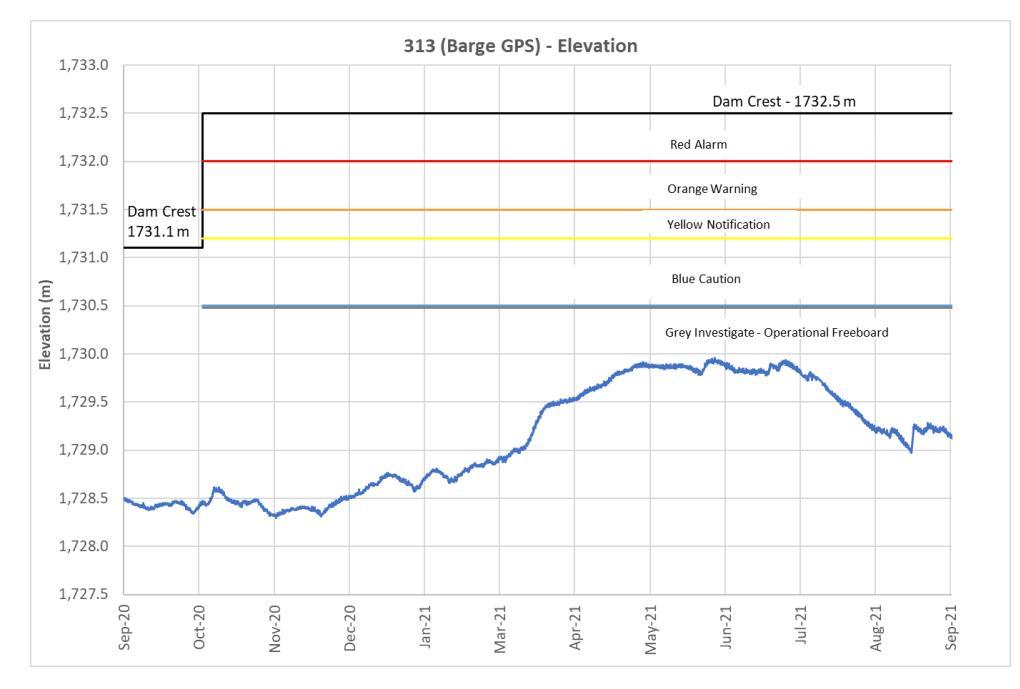
Illustration 3: Tailings Pond Elevation Relative to Freeboard Levels

The pond elevation recorded from 1 September 2020 to 31 August 2021 is presented in Illustration 3 relative to QPOs.

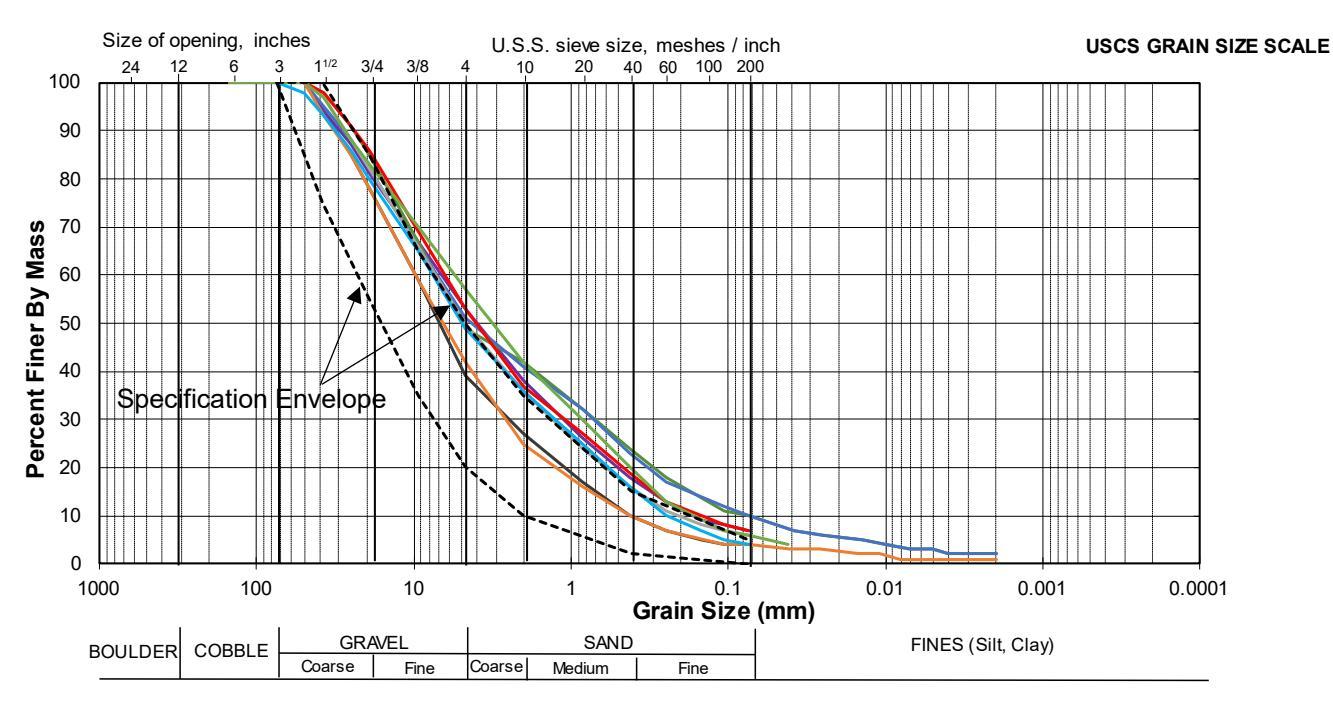
Illustration 5: Grain Size Distribution and Specification Envelopes for Coarse Coal Refuse

Grain size distribution tests were performed on five clay blanket (till) and nine CCR samples as part of the 2020 embankment raise (Golder 2021c). Results are presented in Illustration 4 (till sample) and Illustration 5 (CCR samples) along with the construction specification envelopes.

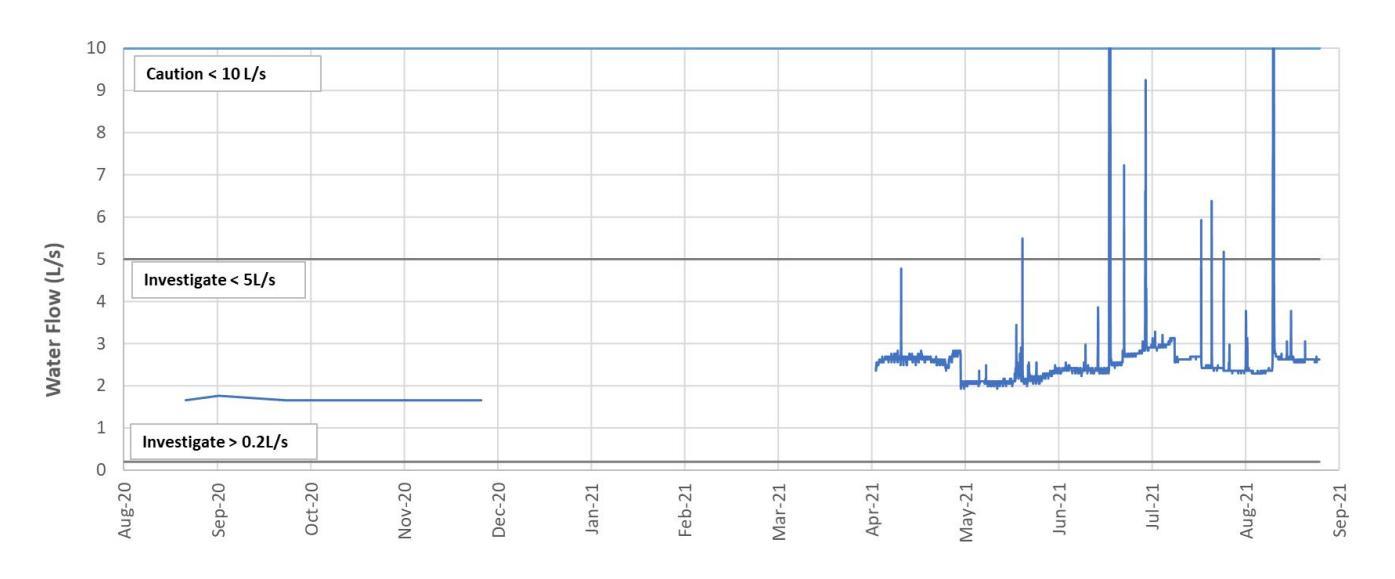
Illustration 6: Main Tailings Dam (Site C) Weir Discharge

The flows in both weirs were generally low and within the expected range for normal operation. The peaks in the Site C Weir data are due to additional flow from surface water runoff.

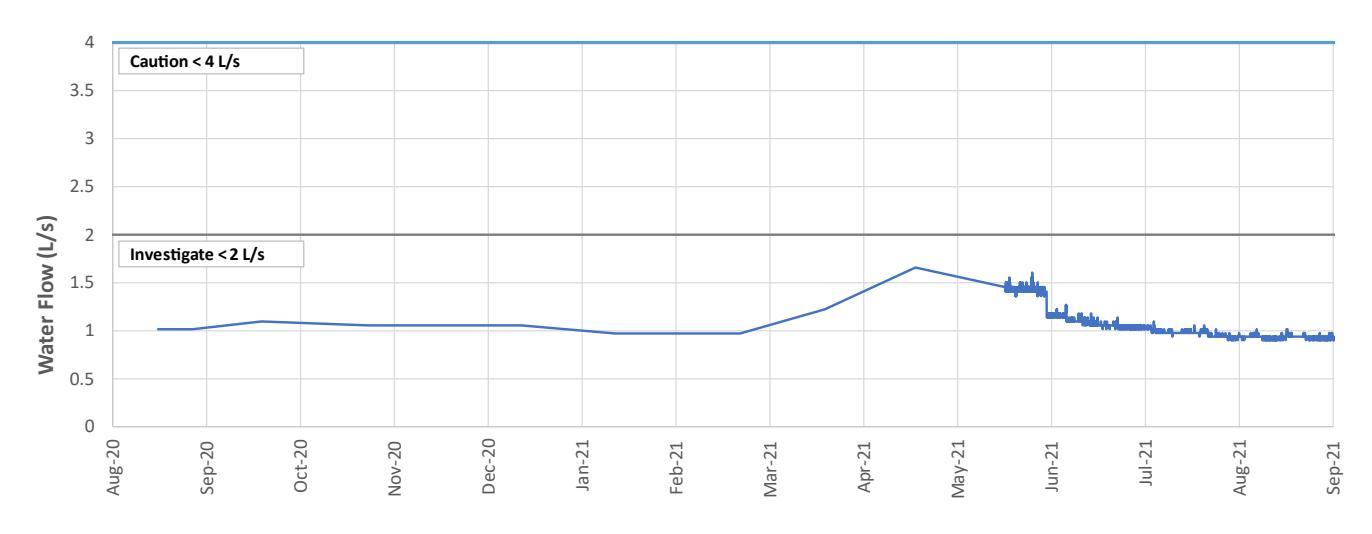
Illustration 7: West Tailings Dam Weir Discharge

During the 2021 site visit, it was observed that flow in the WTD seepage collection channel and seepage from the MTD was clear and free of visible suspended solids. Seepage rates during the reporting period were within normal operating conditions, and visual observations were not indicative of conditions attributable to internal erosion.

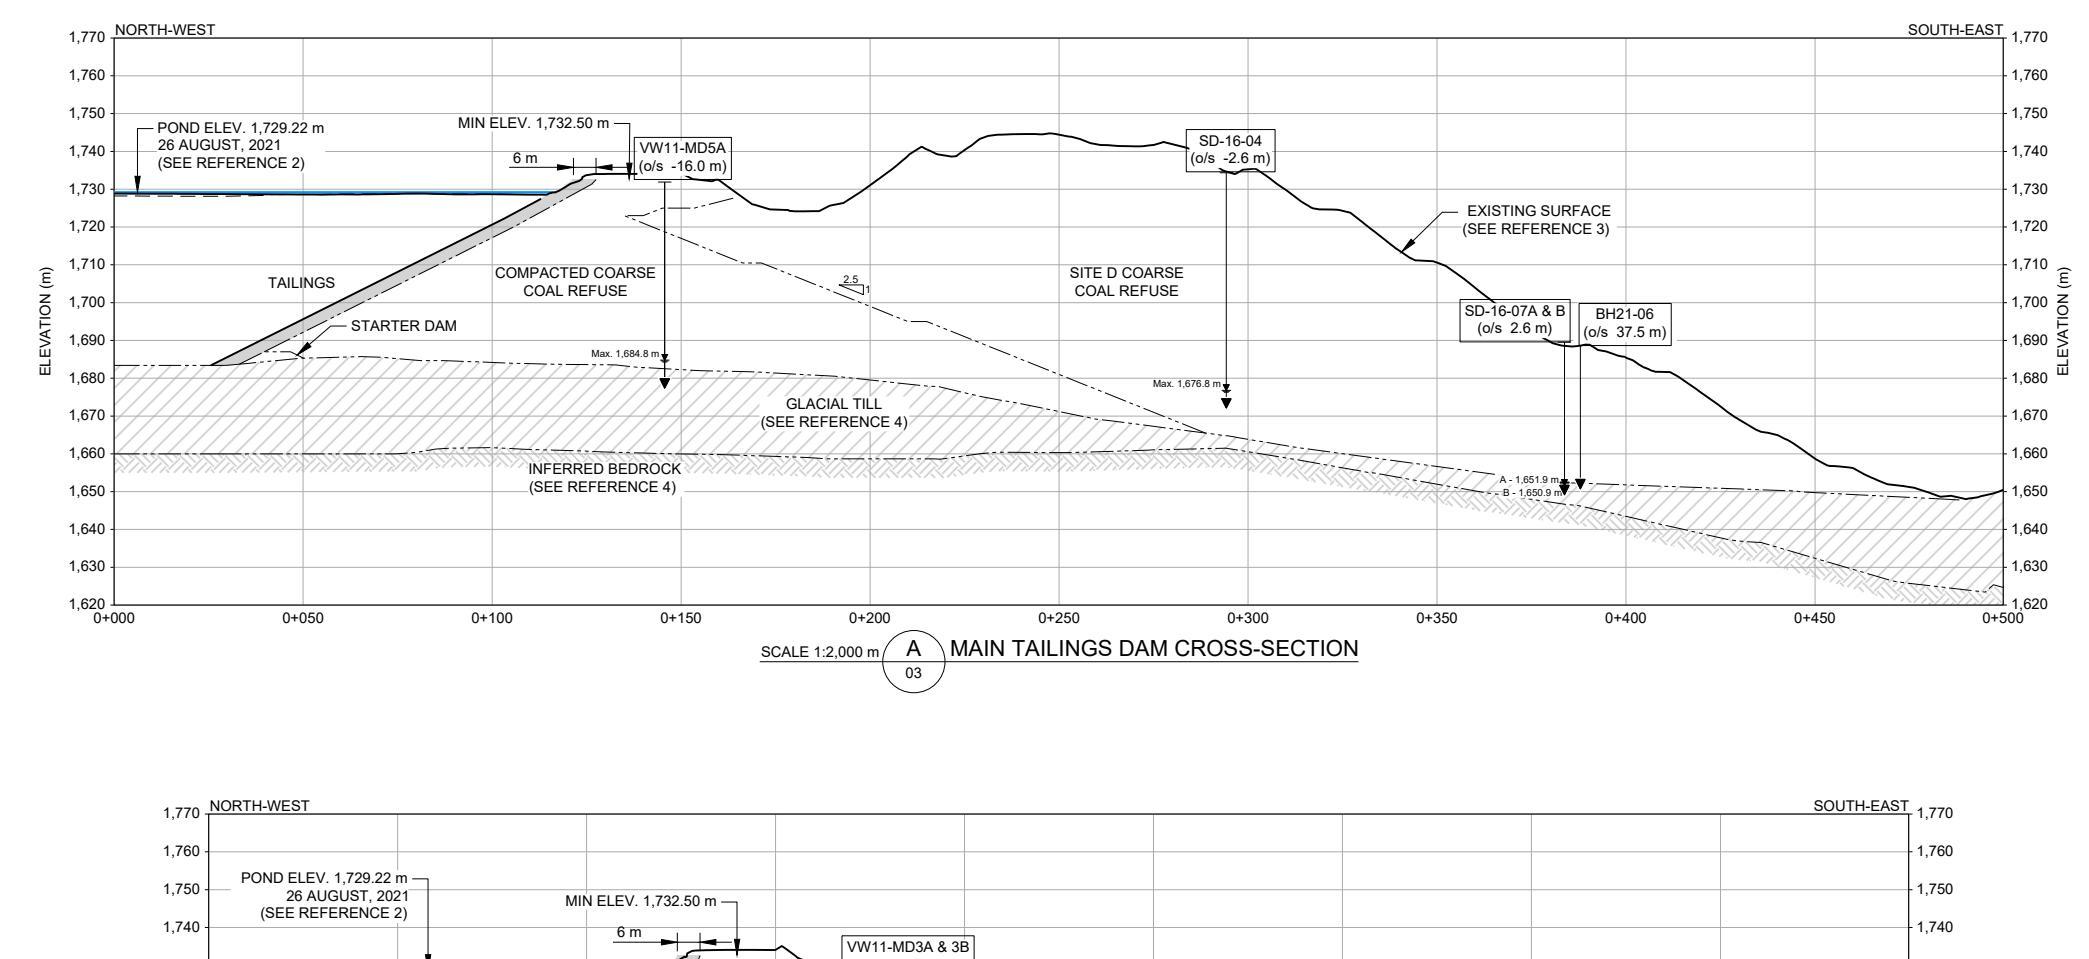
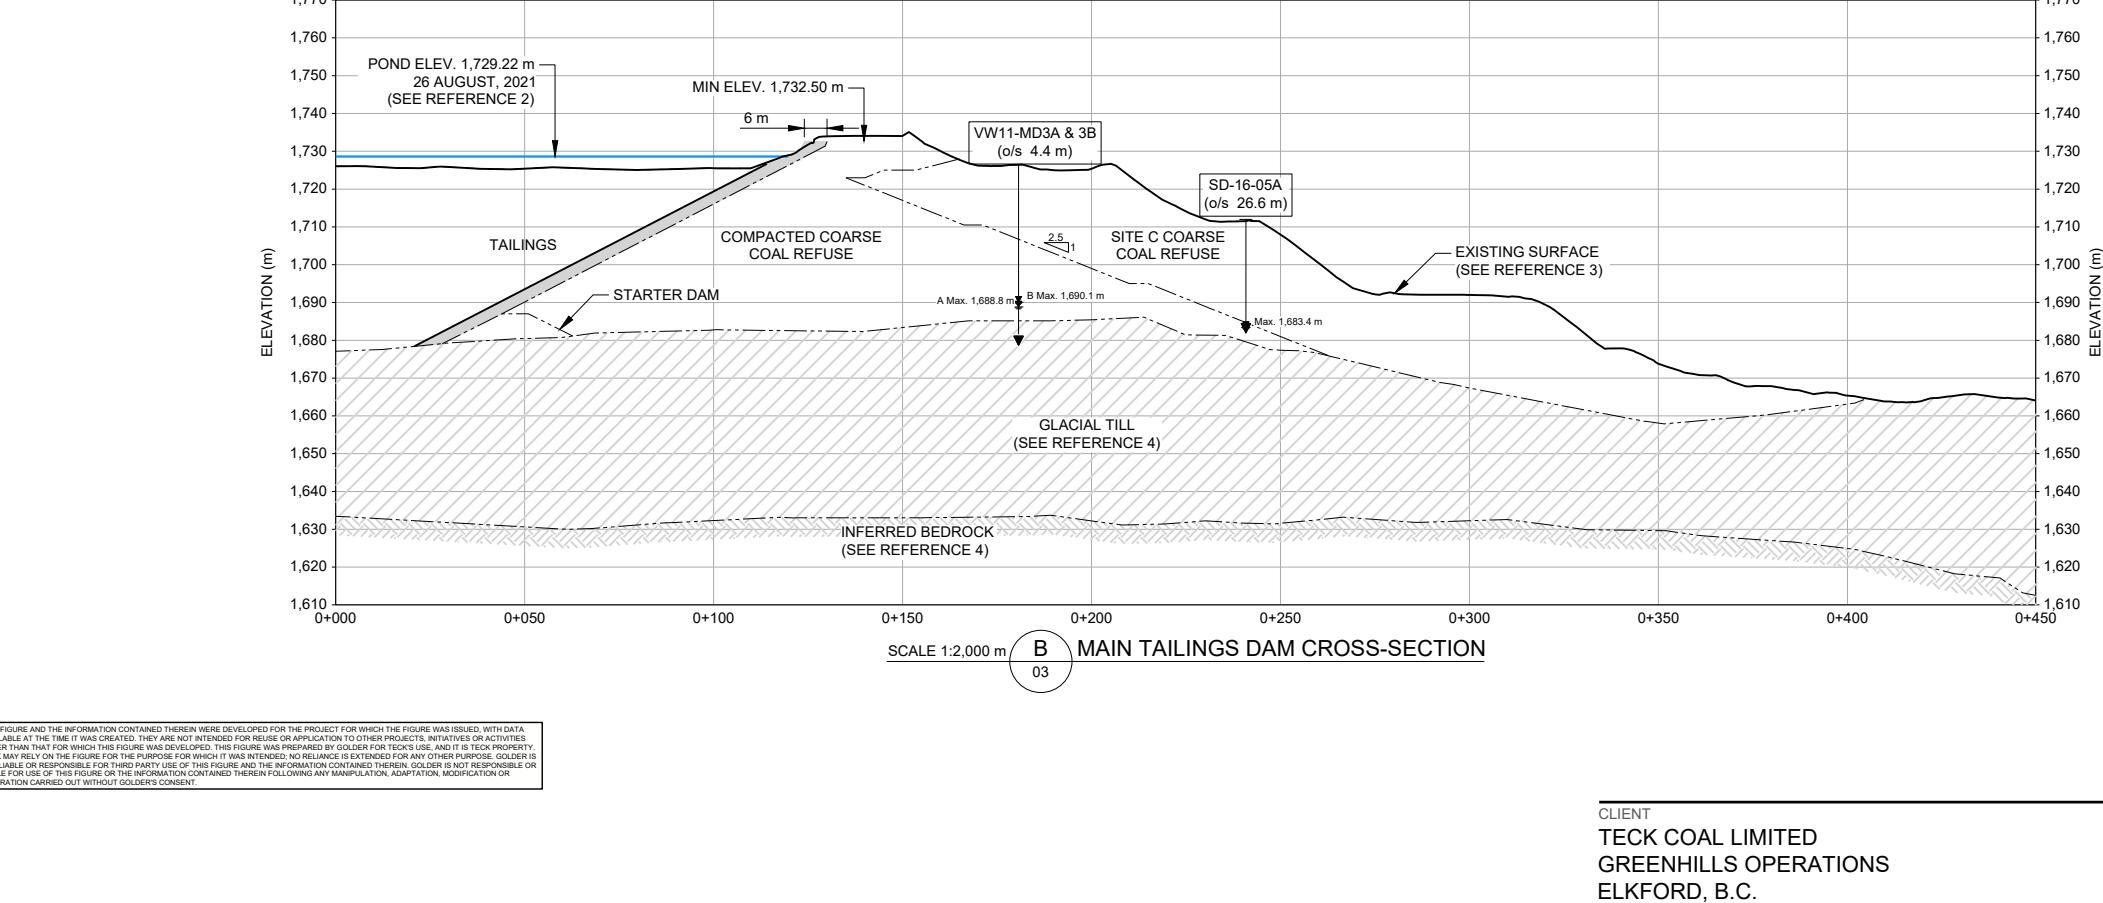
TITLE MAIN TAILINGS DAM - CROSS-SECTIONS A AND B

The elevation of the phreatic surfaces recorded in operational piezometers during the reporting period were within normal operating conditions and did not exceed the QPOs. The phreatic surface within the MTD was generally between 2 and 12 m above the glacial till foundation. The phreatic surface within the WTD was generally within the glacial till foundation. Some VWPs showed an increase in phreatic surface consistent with the increase in pond level. Water levels in select sections of the MTD and WTD are shown in Figures 4 and 5 respectively.

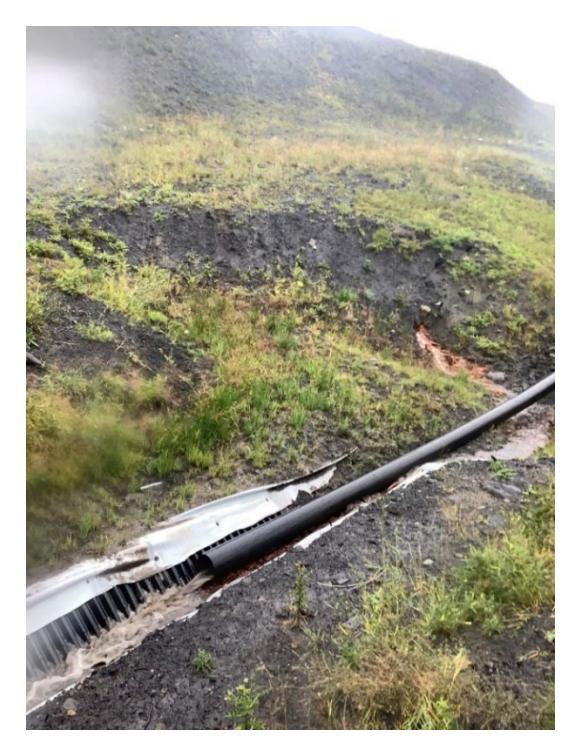
A high-density polyethylene (HDPE) pipe collects surface water from the lower bench at Site C and conveys the water to the seepage collection channel at the toe of the Site C CCR stockpile (Photo 16 and Photo 18 in Appendix A). This flow reports to the Site C Weir and is not measured separately. It is therefore not possible to distinguish whether flow at the Site C Weir is due to increased seepage or surface runoff from the lower bench at Site C. It would be preferable to convey the flow from the HDPE pipe away from the seepage collection channel to allow for more accurate monitoring of seepage from the MTD.

Photograph 16: Site C Coarse Coal Refuse Facility – Surface Water Runoff to Smart Ditch at Toe; Looking Northeast, 17 August 2021

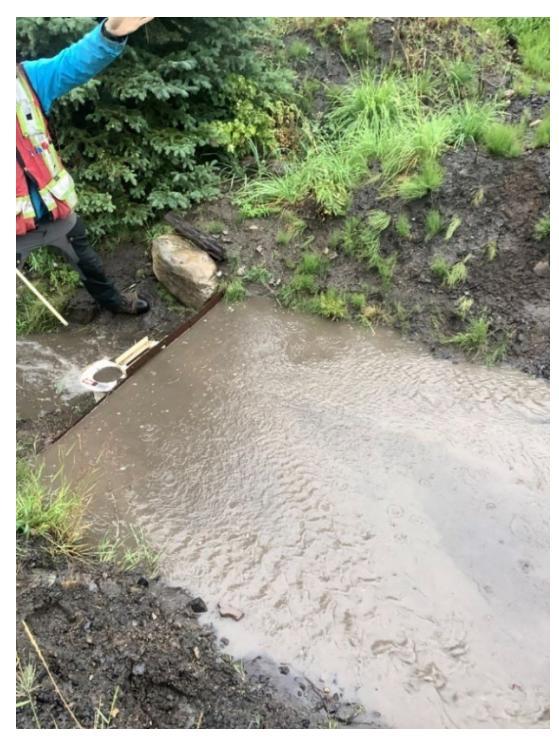
Photograph 18: Site C Weir; Looking Northwest, 17 August 2021

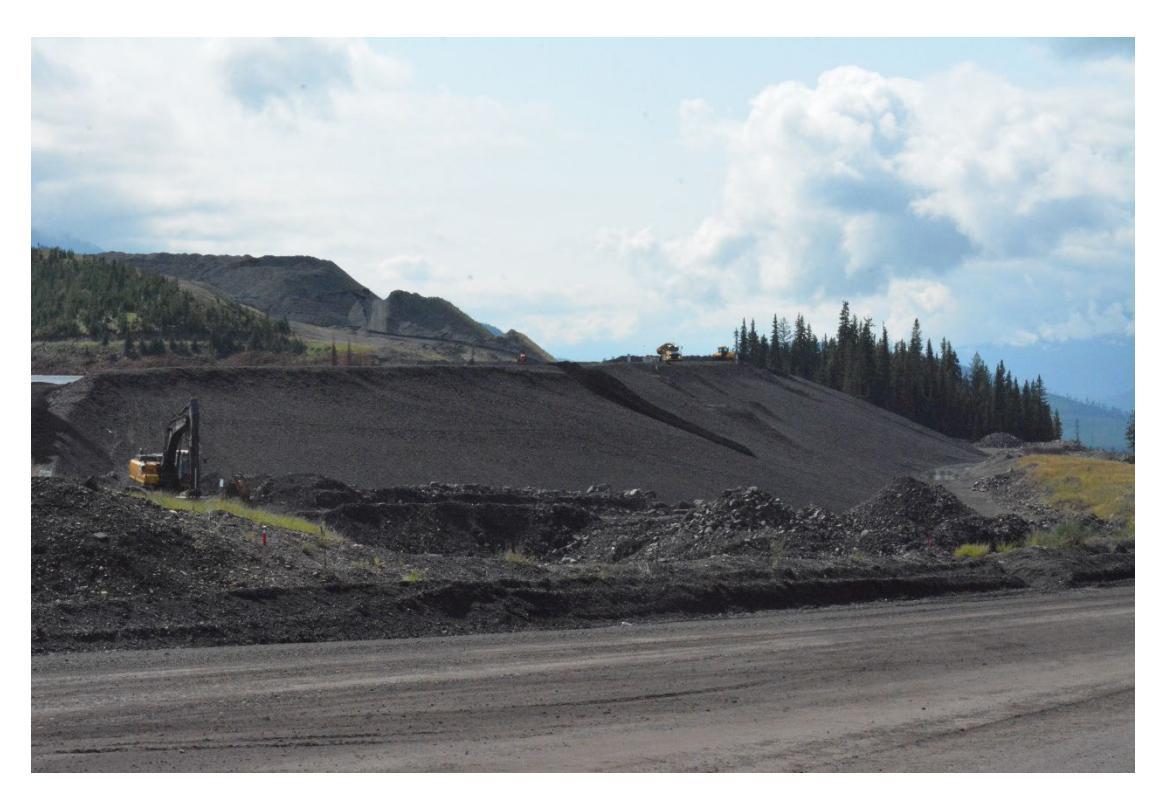
Photograph 30: West Dam Seepage Weir; Looking Southwest, 16 August 2021

3.5 Seepage or Wet Areas	None observed		
3.6 Vegetation Growth	Not of concern		
3.7 Other Unusual Conditions	None		
4. DOWNSTREAM TOE AREA			
4.1 Seepage from Embankment	Seepage observed in West Dam Weir	28,30,31

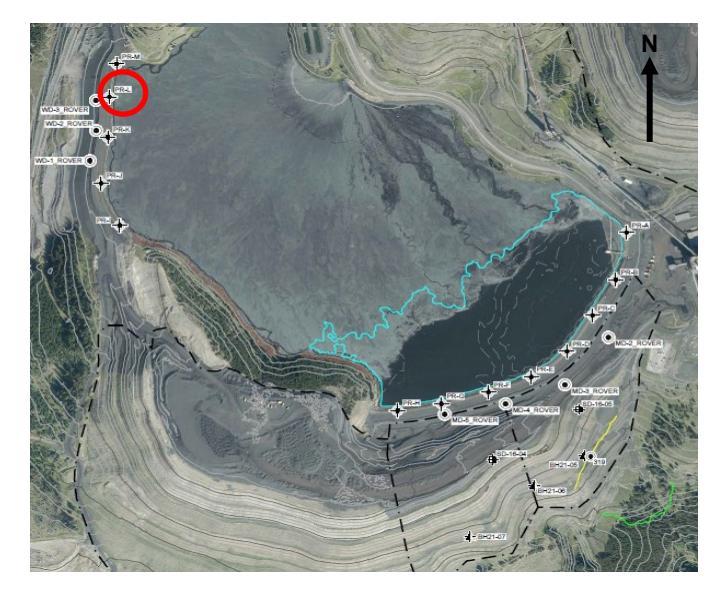
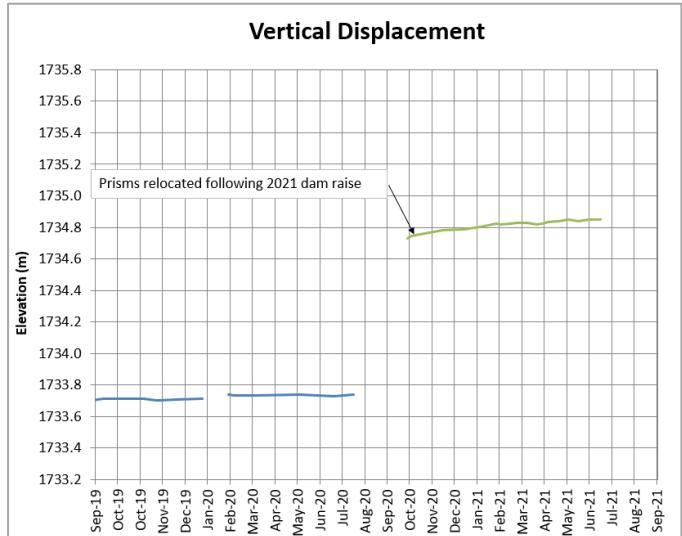
-	PROJECT No.	Phase/Task/DOC.	Rev.	FIGURE
	21452085	3000/3310/2021-204	O	C-22

WEST TAILINGS DAM - PRISM K AVERAGE INVERSE VELOCITY PLOT

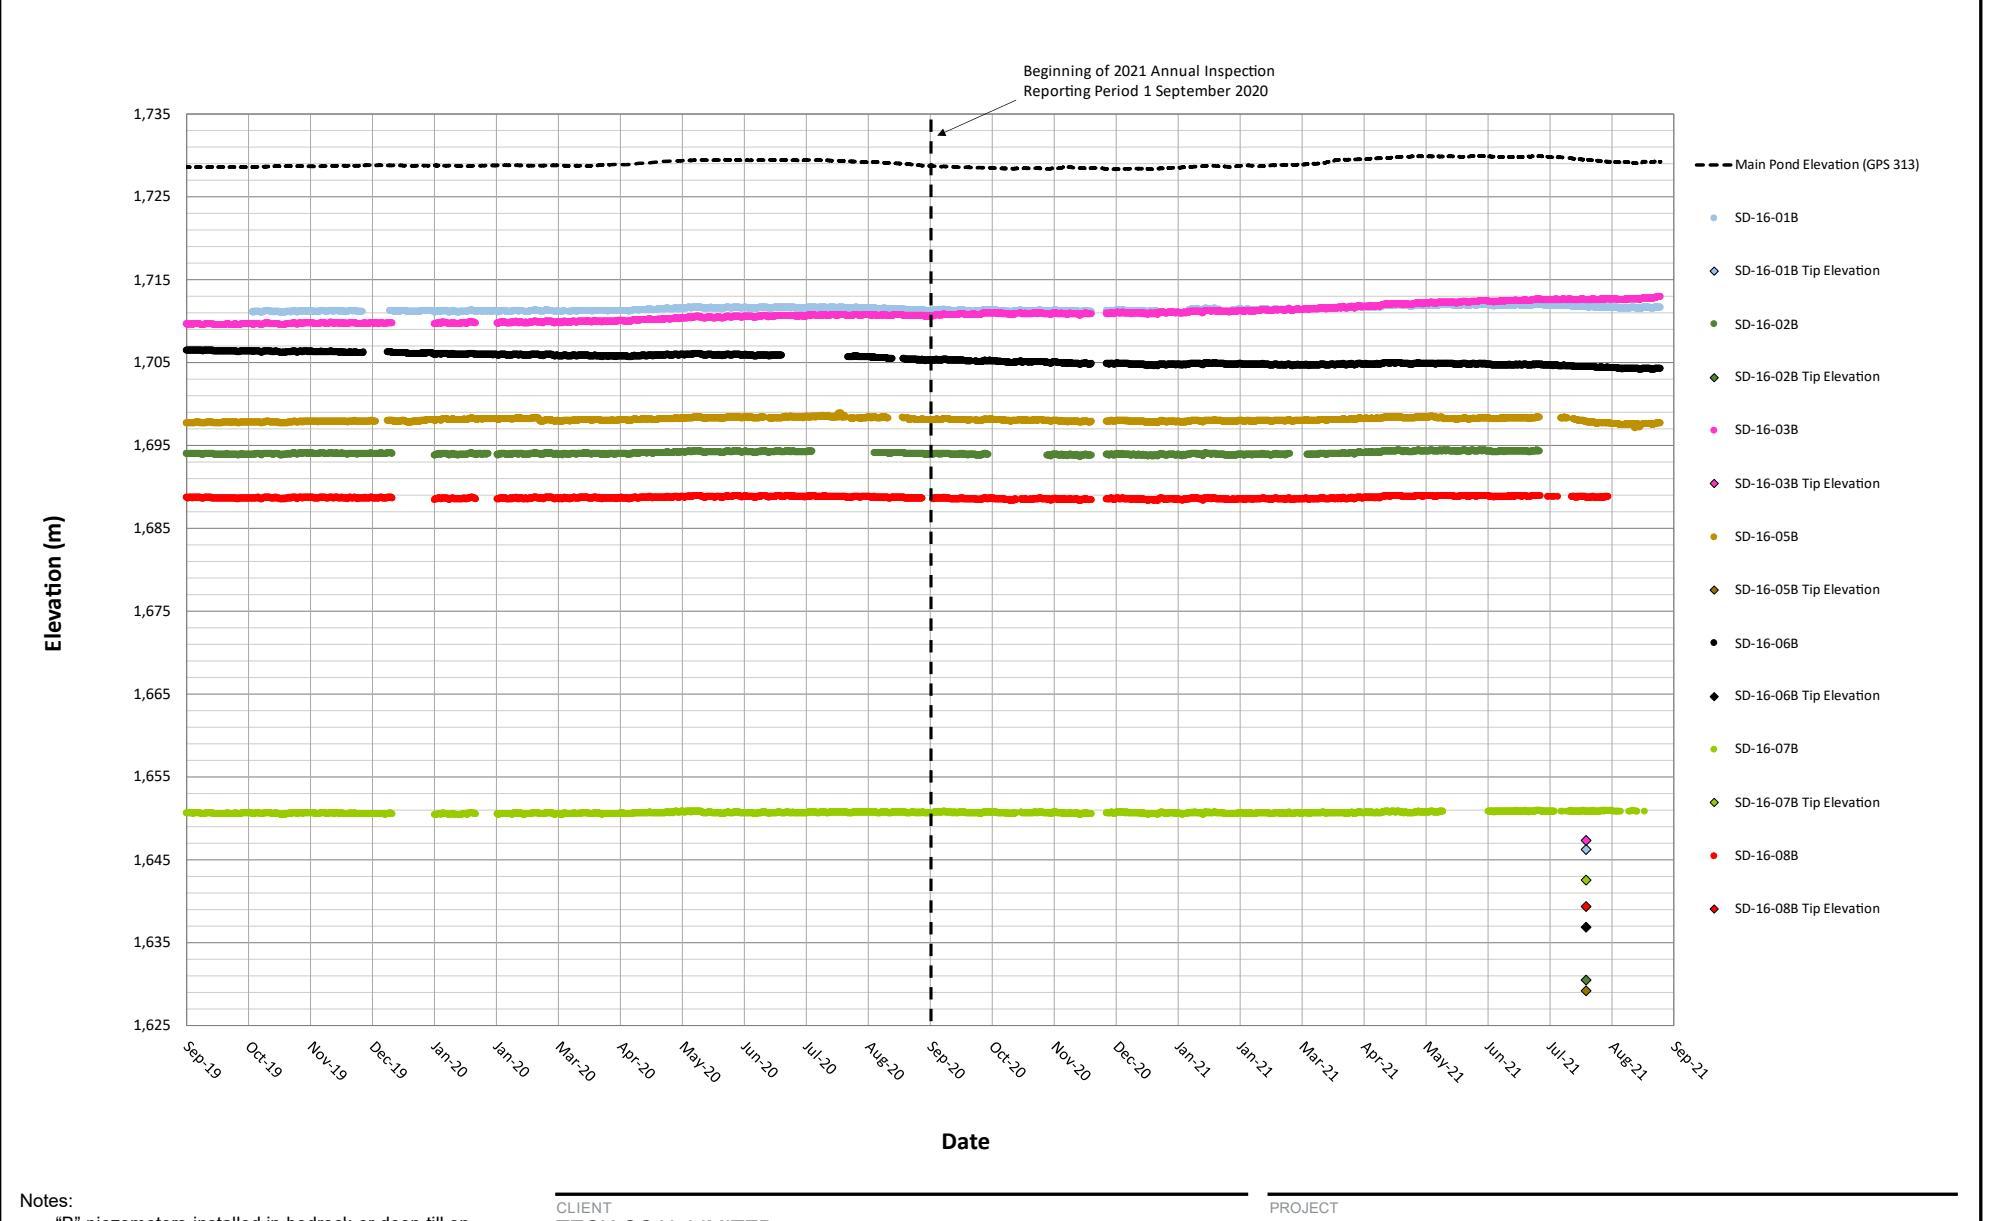
D-1

- Malfunctioning data loggers or instruments --
- Intermittent data signal from instrument

- "B" piezometers installed in bedrock or deep till on average have higher piezometric levels than shallow piezometers due to artesian conditions
- Data gaps present due to:
- Data being considered erroneous
- -Negative pressure readings recorded indicating piezometer tip is dry. Piezometric levels cannot be determined from negative pressures
- Malfunctioning data loggers or instruments --
- Intermittent data signal from instrument
