# **Teck Highland Valley Copper Partnership**

## **2021 Annual Facility Performance Report**

### ***Highland Tailings Storage Facility***

March 2022

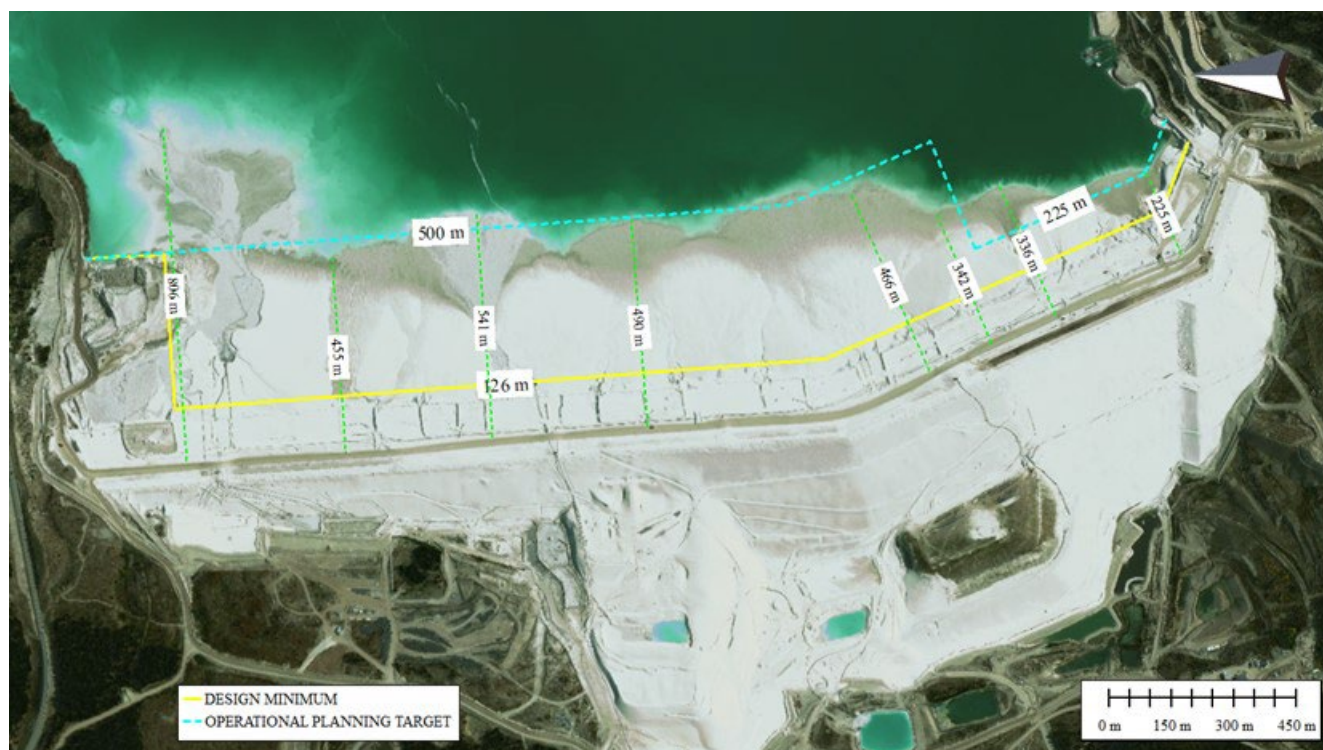
**Figure 5.3 Status of L-L Dam Beach as of October 2021**

In 2019, HVC initiated a campaign to increase beach width along the full length of the crest. This is not a design requirement but is an effective risk reduction activity supported by the EoR and the TRB. By October 2021, the target beach widths had been achieved along the majority of the crest, refer to Figure 5.3 (green line).

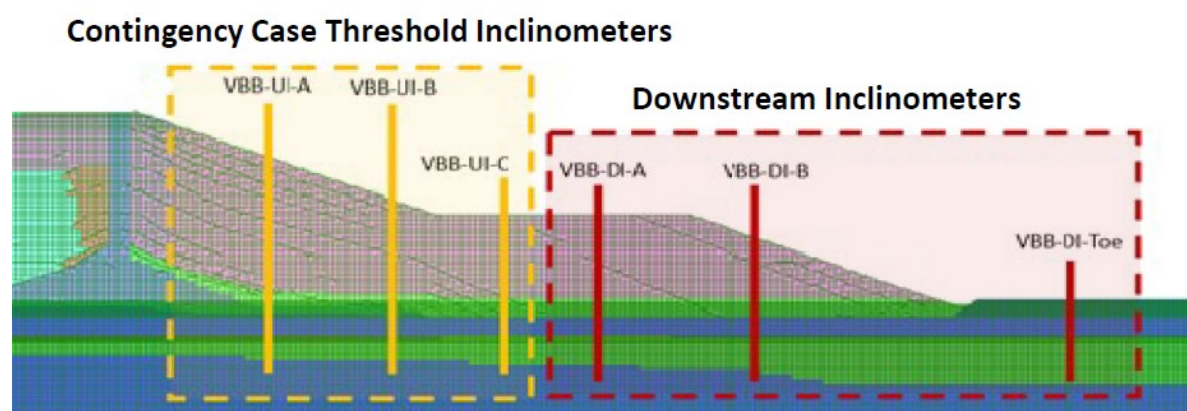
**Figure 5.7 VBB Inclinometer Location ID**

Similar to other segments of the dam where the design is governed by lower-strength units within the foundation, deformations within the lower-strength units are predicted to occur below the upper slope of the dam; however, the deformations are contained (i.e., do not progress to the toe). Based on Figure 5.7, deformations are expected within the yellow zone but negligible deformation in the red zone. Figure 21, at the end of the report, plots measured deformations since 2018 for three Contingency Case Threshold inclinometers (yellow zone) and two downstream inclinometers (red zone). The difference in deformation between the yellow and red zones clearly supports that actual behaviour is consistent with design predictions from the deformation model.

The magnitude of deformation measured within the L-GLU during the review period was also consistent with predicted based on deformation modelling. Specifically, deformations within the L-GLU were greatest below the upper slope and do not extend to the downstream toe which demonstrates deformations are contained and performance is acceptable. For example, based on deformation measured since August 2019 within the L-GLU:

- Upper slope = ~7 mm (I17-01, VBB-UI-A);
- Mid-bench = ~3 mm (I10-7, VBB-UI-B); and
- Toe = ~0.2 mm (I15-27b, VBB-DI-Toe).

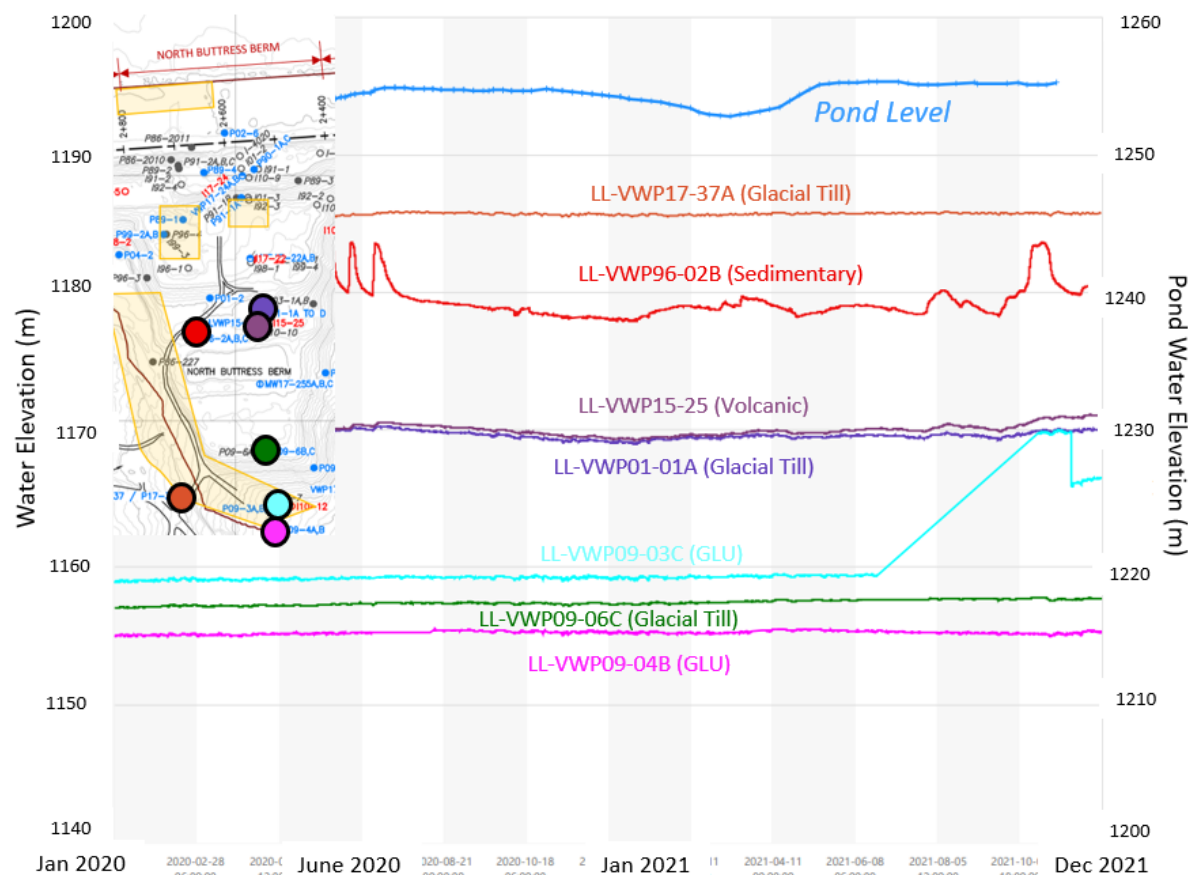
**Figure 5.9 Measured Piezometric Response at NBB: January 2020 to November 2021**

An investigation by HVC, completed after the EoR review of the exceedance, indicates the instrument tip may have been set at a different elevation (i.e., higher) than specified after the casing was raised. That would explain the sudden rise and why no similar change or response was measured by adjacent instruments. HVC are going to remove confirm this prior to construction starts in the area and if required, will set the instrument back to the specified elevation and update the monitoring record to so piezometric levels are reflective of the actual tip elevation at the time readings were taken.

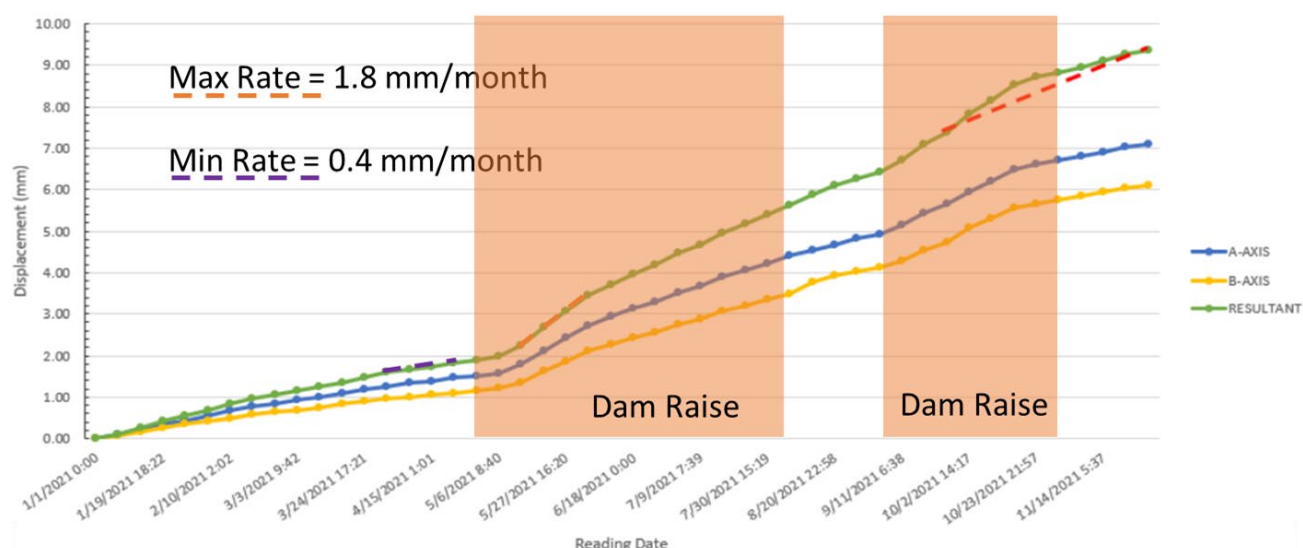
**Figure 5.11 I17-24 Measured Deformation Along Mudstone Layer (~El. 1157 m)**

Deformation along mudstone layers in the foundation near the upper bench of the downstream slope (e.g., I17-24) have been measured along discrete shear planes within mudstone layers since the early 1990s and are expected to continue. Typically, deformation rates increase temporarily during construction loading and then attenuate after loading is completed. This pattern continued at inclinometer I17-24 during the review period. I17-24 is the nearest inclinometer to crest and the only inclinometer at the NBB where shear deformations along mudstone layers were measured during the review period. Deformation along the two mudstone layers intersected at I17-24 are plotted on Figure 5.10 and Figure 5.11. Both show the expected response where rates increase during periods of loading and then attenuate. The direction of deformation was along bedding which dips to the northwest.

The magnitude and rate of deformations measured during the review period (Table 5.4) are consistent with design expectations. In 2018, which was a significant year in terms of loading near the NBB, the range of deformation rates was similar but the highest deformations rate were measured at a different mudstone layer compared to this review period. This is not significant in terms of dam safety but these observations are helpful in future forecasting and calibration of the deformation model.

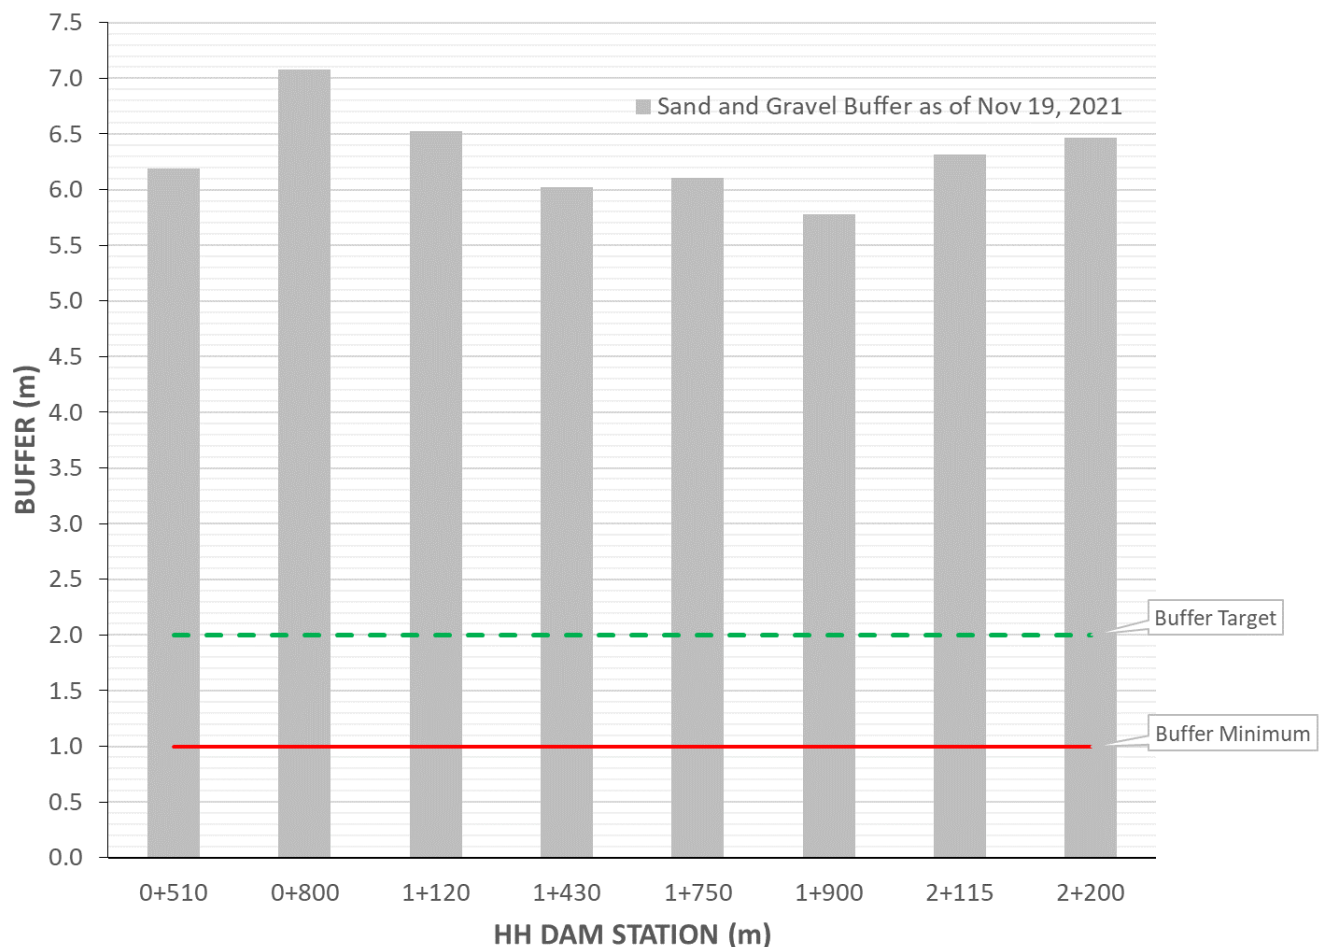
**Figure 5.15 H-H Dam Tailings Buffer – November 19, 2021 Tailings Beach (with 2021 Crest Raise)**

There is no risk of overtopping or ponded water at the H-H Dam (Section 2.3). Therefore, freeboard is not an applicable metric at the H-H Dam. The M-11 Permit (EMLCI 2021b) requires that a minimum 1 m buffer<sup>3</sup> be maintained through operations. Buffer values from the November 19, 2021 survey, after the 2021 dam crest raise was completed, are shown on Figure 5.15. HVC plans the H-H Dam crest raises to maintain a 2 m buffer. The next dam crest raise at the H-H Dam is planned for 2023 based on the available buffer and projected rate of rise.

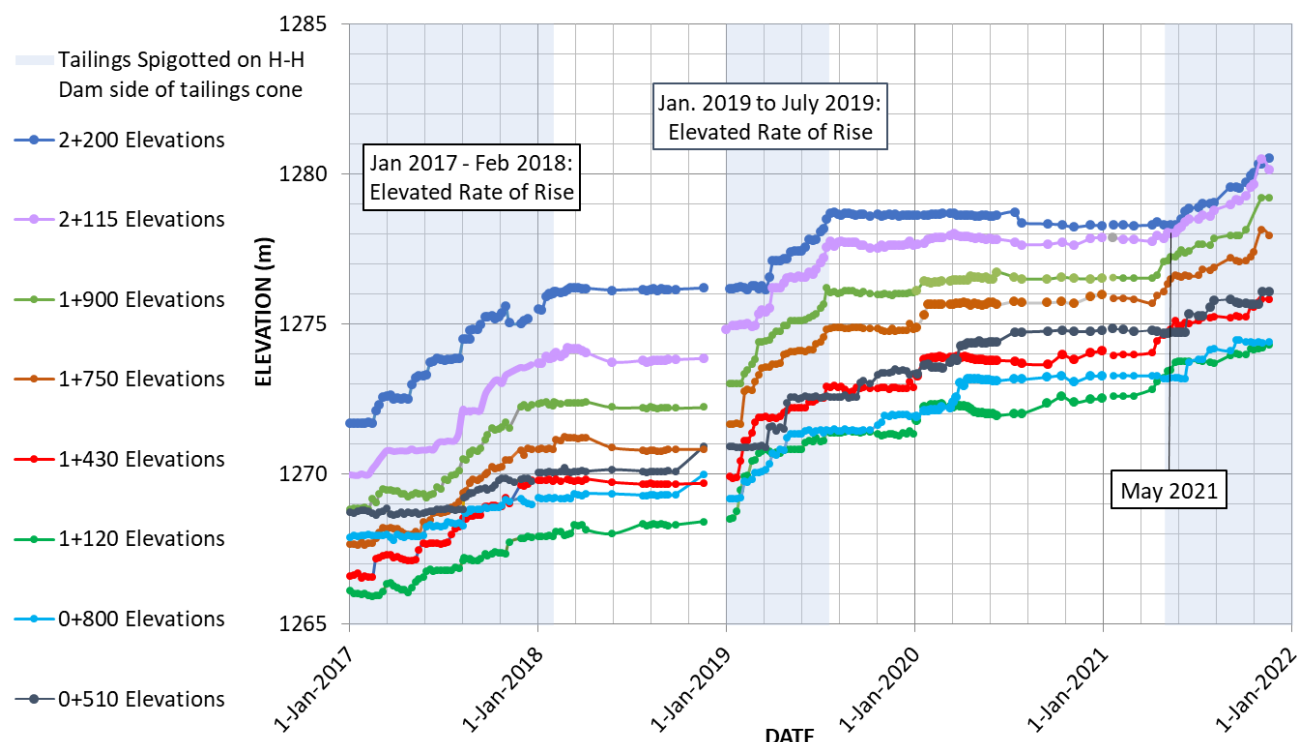
**Figure 5.16 H-H Dam Tailings Beach Elevations Along Crest: 2017 to 2021**

Figure 5.16 shows tailings beach profile since 2017 at various stations along the H-H Dam crest. The tailings beach near the H-H Dam during the review period was relatively constant up until April 2021. During this period, tailings were being discharged on the far side (relative to the H-H Dam) of the existing tailings cone and therefore the bulk of the tailings slurry flows towards the L-L Dam and not near the H-H Dam. In April 2021, tailings spigot points were shifted towards the H-H Dam and began discharging tailings on the H-H Dam side of the tailings cone. When this is done, the majority of tailings slurry flows near the H-H Dam before flowing to the L-L Dam which increases the rate of beach rise near the dam. This is the expected behaviour whenever tailings are deposited on the H-H Dam side of the cone as shown on Figure 5.16 and is factored into the crest rise schedule for the H-H Dam.

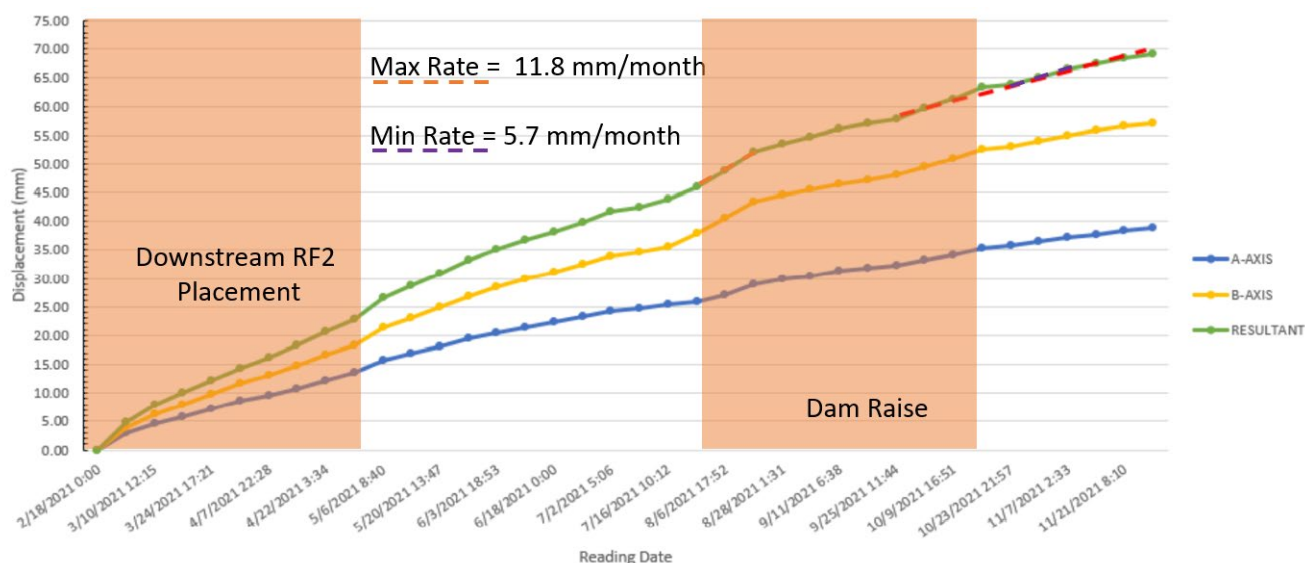
**Figure 5.19 I17-16 Measured Horizontal Deformation Within Downstream Fill (~34 m Thick)**

The measured horizontal deformations (<0.1 mm/month to 11.8 mm/month) and settlement (100 mm to 170 mm) in the fill during the review period were within the range of those observed since the instruments were installed. The settlement measured during the review period was a continued response to the fill placement during 2020. Figure 5.19 shows the horizontal deformations measured in the dam fill at inclinometer I17-16 where the largest deformations were measured during the review period. Relative to 2020, deformation rates were notably less which was expected since there was much less fill placed on the downstream slope during 2021. This magnitude of deformation can be accommodated by the structure without compromising design function. There were no visual observations of significant cracking or deformation of the fill over the crest area.

No shear deformation zones within the natural foundation were measured along the dam which is consistent with historic and expected future behaviour.

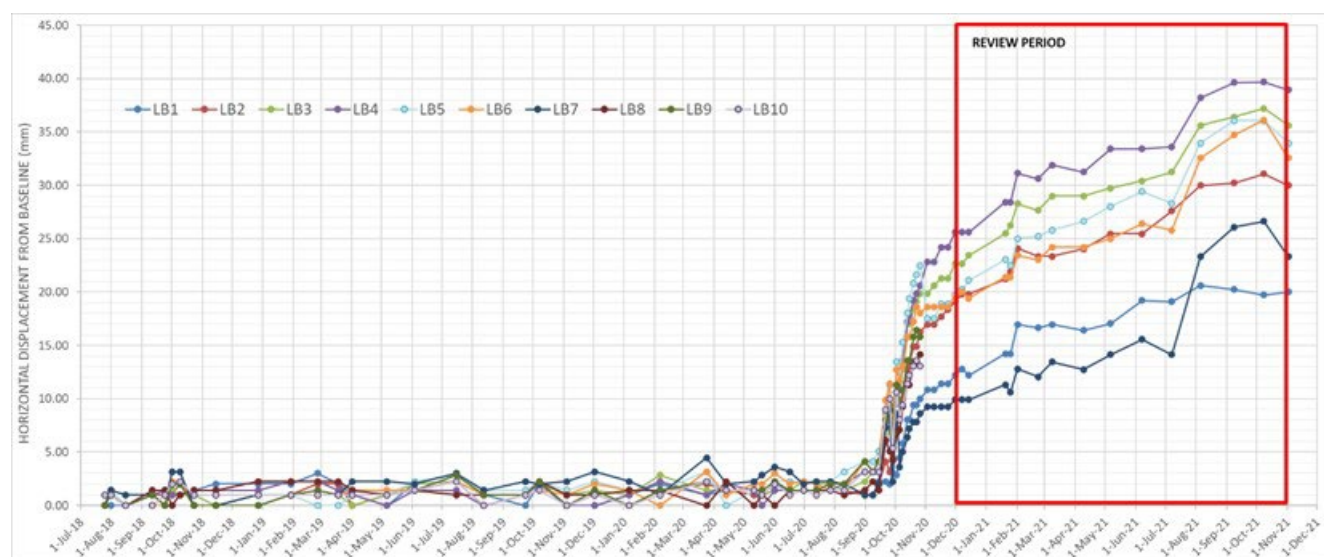
**Figure 5.20 Lock-Block Wall Monuments: Horizontal Displacement From Baseline (2018 to 2021)**

During 2020, deflection of the lock-block wall increased in response to fill placement immediately upstream of the wall by the HVC mining fleet. Although no issues of wall instability were observed, HVC took the precautionary step of placing fill downstream to support the lower half of the wall which had an immediate impact on reducing the deformation rates. The lower three monuments (LB8, LB9 and LB10) were buried by the fill.

The only fill placed upslope of the lock-block wall during the review period was the H-H Dam crest raise. As expected, wall deflection was much less than measured during 2020 construction (Figure 5.20) and deflections rates have been relatively steady since HVC placed the fill downstream of the lock-block wall. In addition, no issues of concern observed during visual inspections.

Note: Lower row of monuments were buried by fill placed downstream of wall in October 2020.

Since the monuments were first added to the surveillance program the H-H Dam slope in the area has been built to ultimate, the wall is supported by fill and there is a data set which has demonstrated the wall is stable and is undergoing small magnitude of deflection, except when placing fill immediately upslope. Based on this KCB propose the monitoring frequency for these surveys can be reduced in the next OMS Manual update.

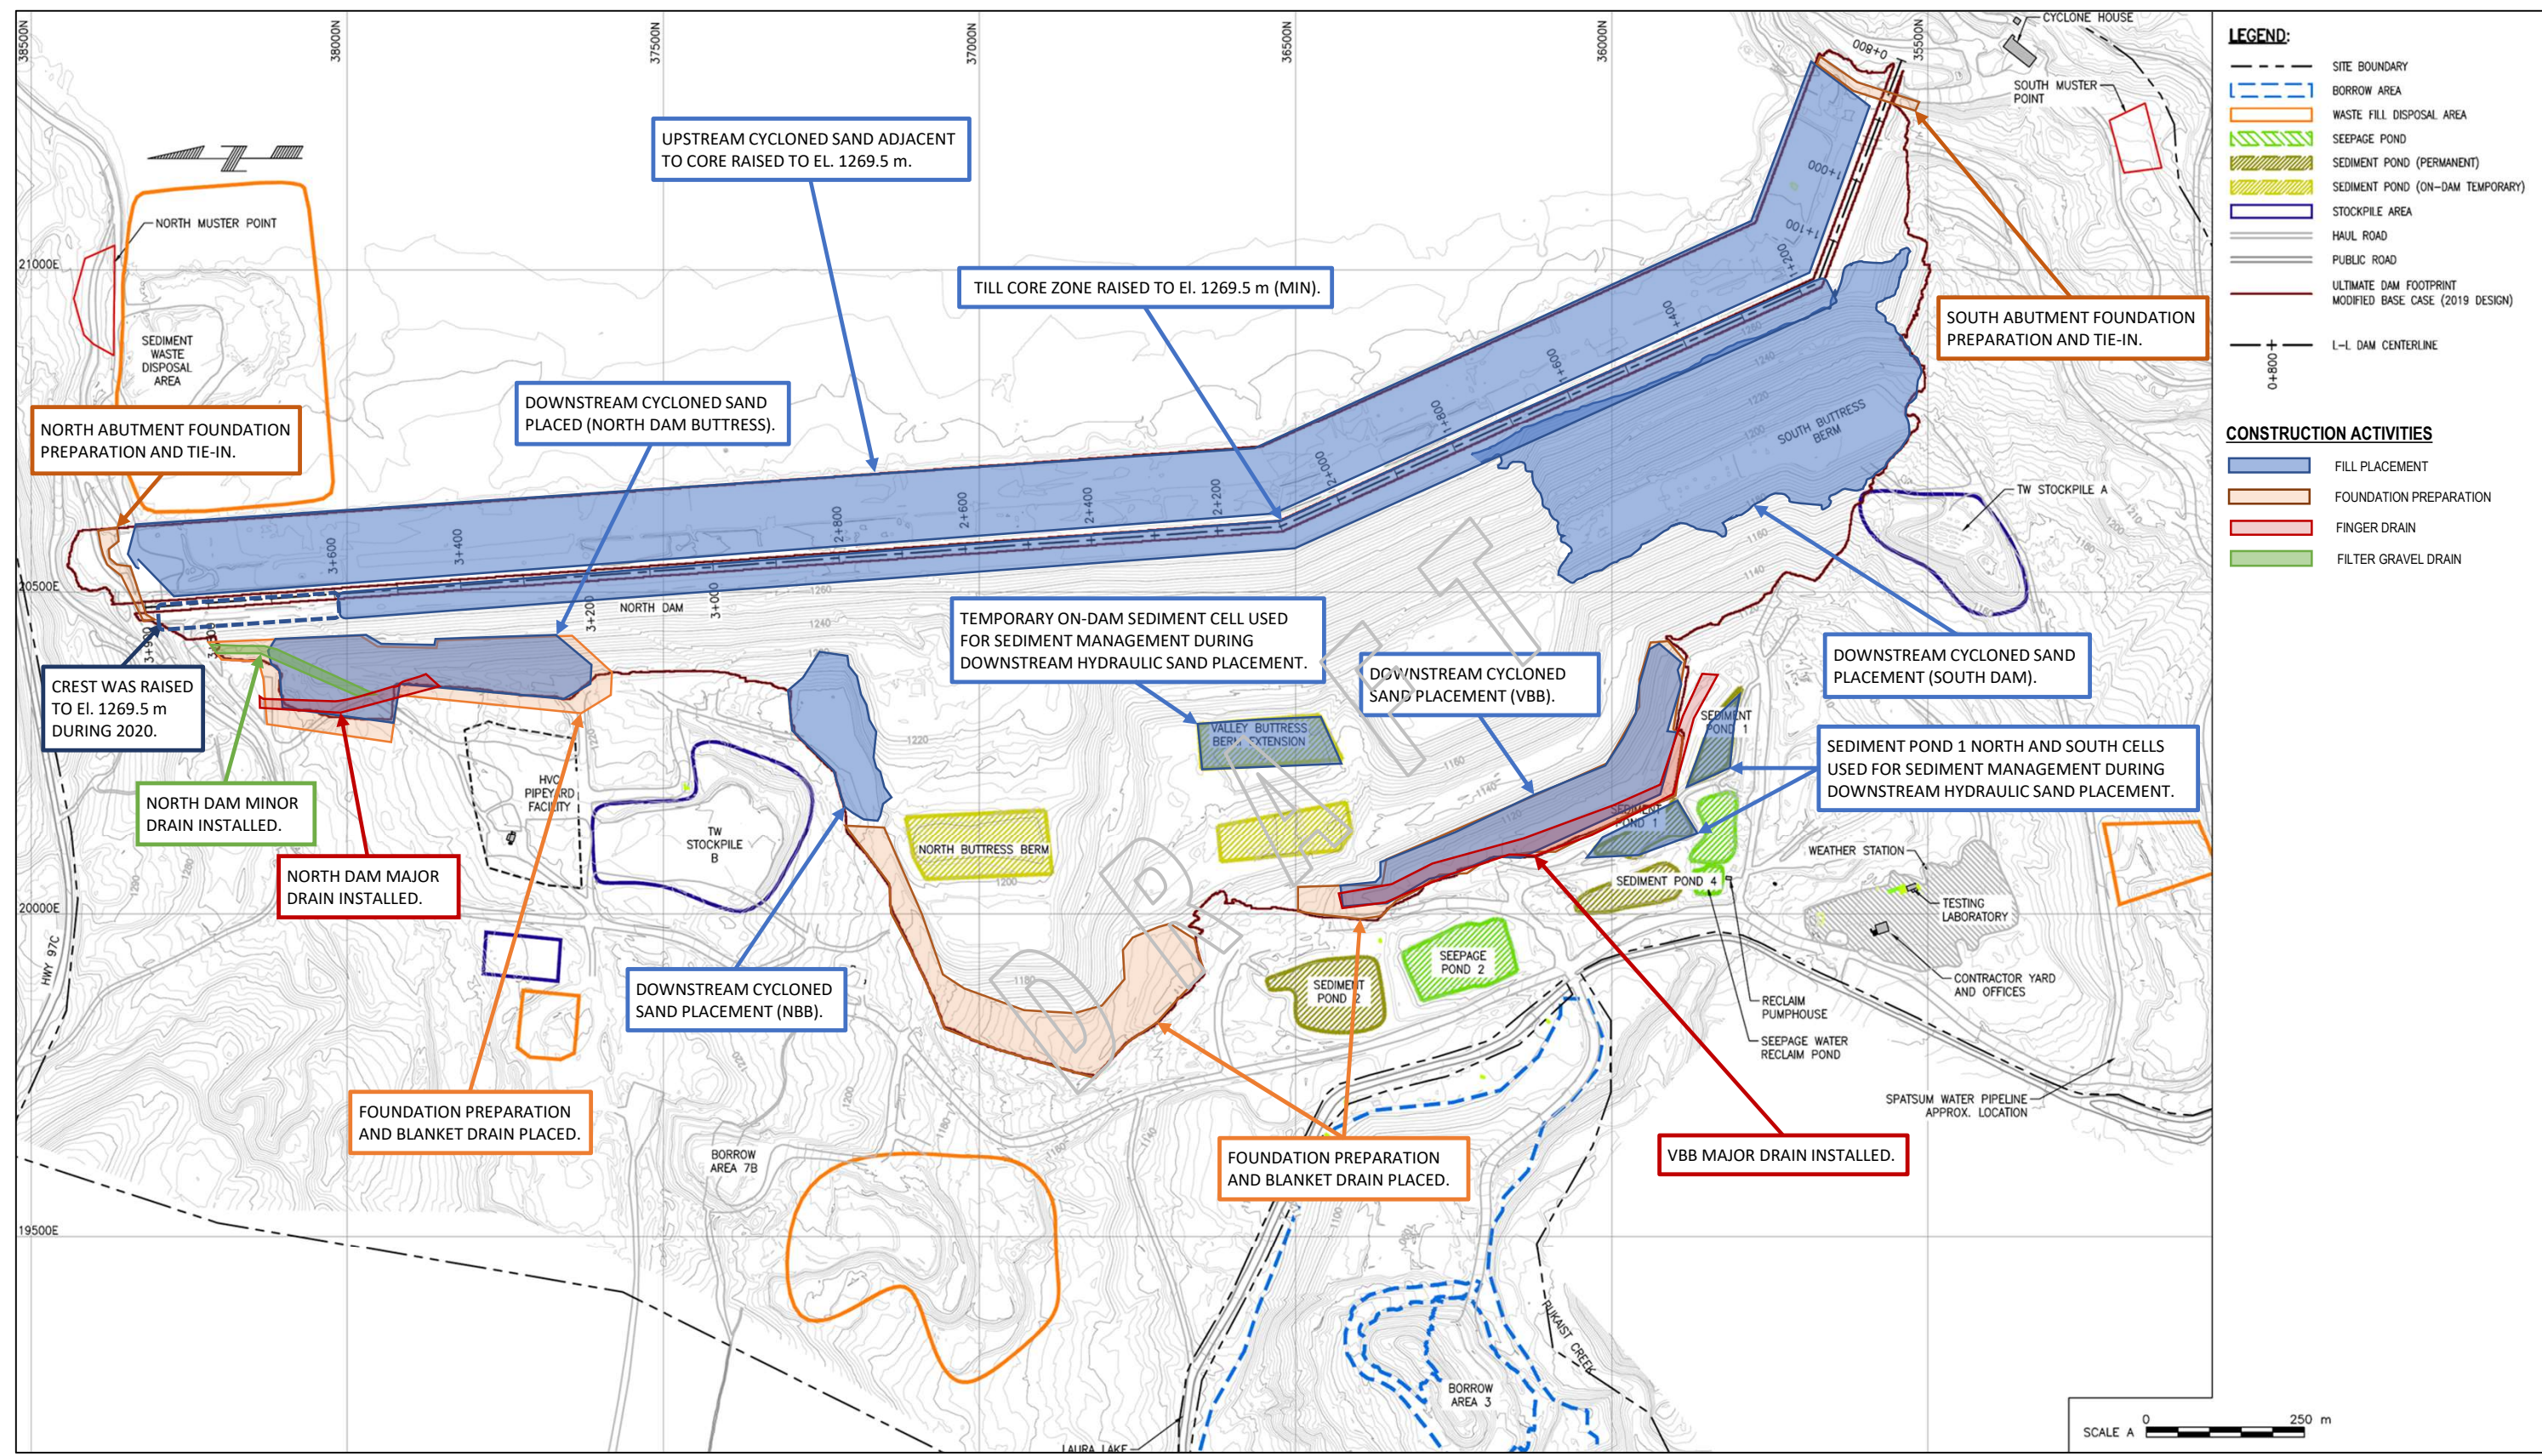
CLIENT	Highland Valley Copper / Teck		
	Klohn Crippen Berger		
	PROJECT HIGHLAND TAILINGS STORAGE FACILITY 2021 ANNUAL FACILITY PERFORMANCE REPORT		
TITLE	L-L DAM 2021 CONSTRUCTION WORK AREAS		
	SCALE AS SHOWN	PROJECT No. M02341C12	FIG. No. 6

November 2021 instrumentation readings near Sta. 2+250 are projected onto a dam cross section (Figure 10, at the end of the report). As shown on Figure 6, at the end of the report, construction activity in the VBBE area during 2021 included a crest raise only and operation of the temporary on-dam sediment storage cell.

November 2021 instrumentation readings near Sta. 2+564 are projected onto a dam cross section (Figure 11, at the end of the report). As shown on Figure 6, at the end of the report, construction activity in the NBB area during 2021 included a crest raise and extending the north side to ultimate slope.

November 2021 instrumentation readings near Sta. 2+800 are projected onto a dam cross section (Figure 12, at the end of the report). As shown on Figure 6, at the end of the report, construction activity in the North Dam Bedrock area during 2021 included a crest raise and the extension to the north side of the NBB.

November 2021 instrumentation readings near Sta. 3+300 and 3+630 are projected onto dam cross sections (Figures 13 and 14, at the end of the report). As shown on Figure 6, at the end of the report, construction activity in the North Dam U-GLU area during 2021 included a crest raise, foundation preparation and partial fill placement of the North Dam Buttress.

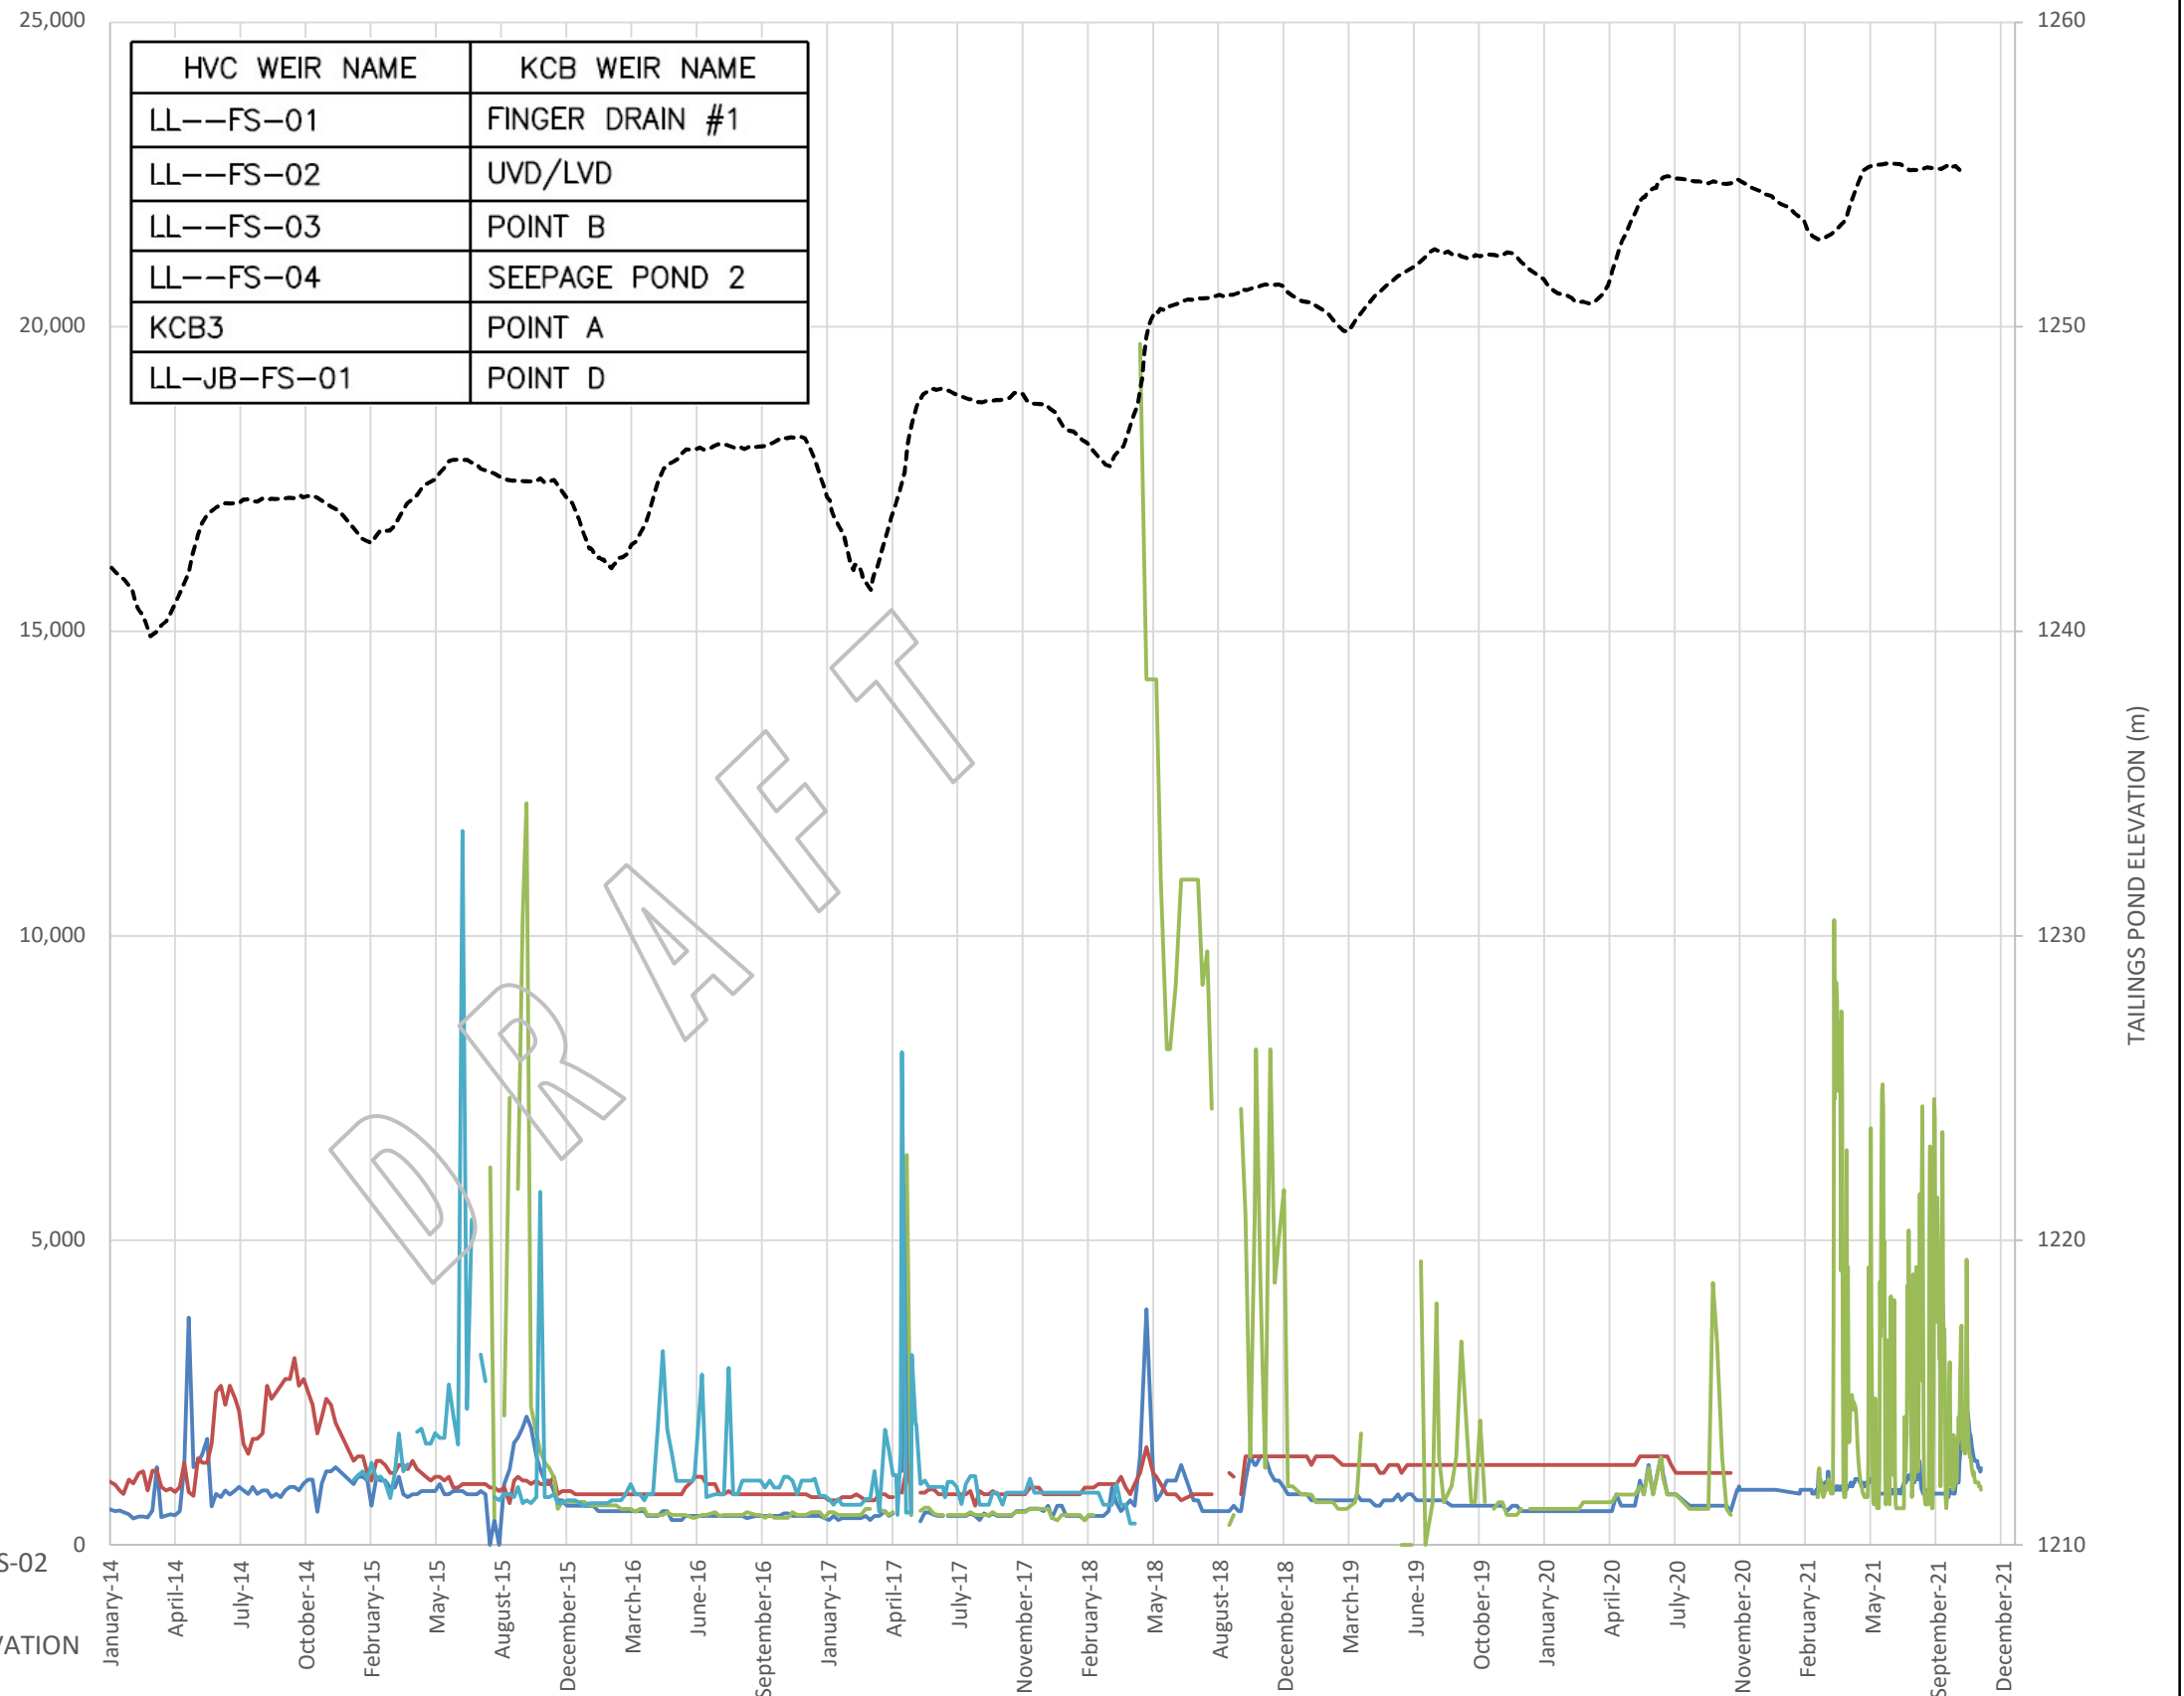
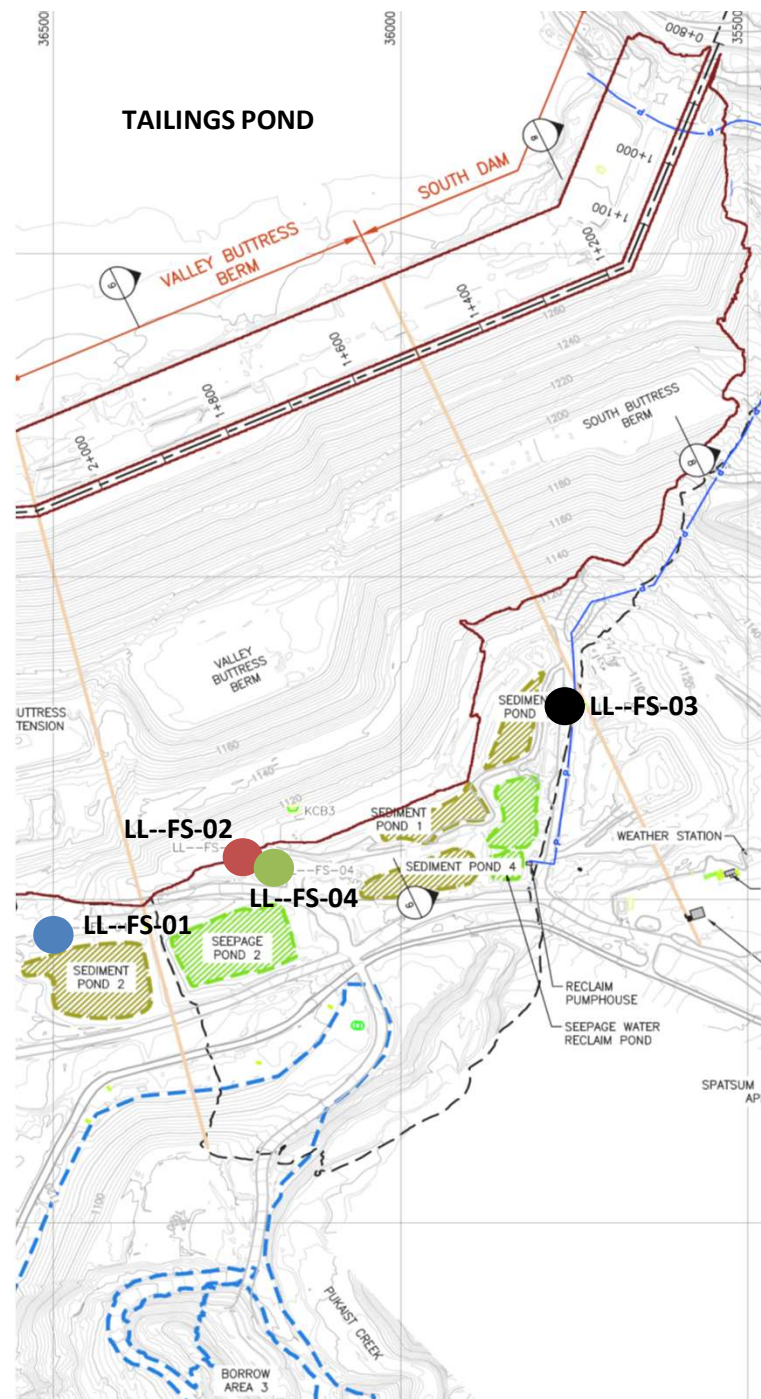
CLIENT <b>Highland Valley Copper</b> / <b>Teck</b>	PROJECT HIGHLAND TAILINGS STORAGE FACILITY 2021 ANNUAL FACILITY PERFORMANCE REPORT	
	TITLE L-L DAM POND LEVEL AND SEEPAGE FLOW 2013-2021	
	SCALE NTS	FIG. No. 22
	PROJECT No. M02341C12

Seepage measurements from weirs installed downstream of the L-L Dam, since 2017 are shown on Figure 22. Note that LL—FS-02 was removed in 2021 as it was within the footprint of 2021 dam construction. Summary of the remaining seepage weirs during the review period are:

1. IN 2016, OS-PC-FS-02 WAS MEASURED USING A DATALOGGER. ONE MANUAL READING OF THE WEIR BY HVC SUGGESTED THAT THE DATALOGGER WAS READING LOWER THAN ACTUAL FLOW RATES.
2. AS OF JUNE 2018, THE SEEPAGE POND WAS BACKFILLED AND THERE WAS NO SEEPAGE REPORTING TO LL--FS-03.
3. VALVE OF LL-FS-04 WAS REPORTED CLOSED FROM APRIL 26, 2019 TO MAY 31, 2019 TO AID IN DREDGING.
4. RUNOFF WAS OBSERVED ON MARCH 29, 2019 AT LL--FS-01.
5. LL—FS-02 WAS REMOVED IN 2021, PRIOR TO THE AREA BEING BURING TO SUPPORT DAM CONSTRUCTION.

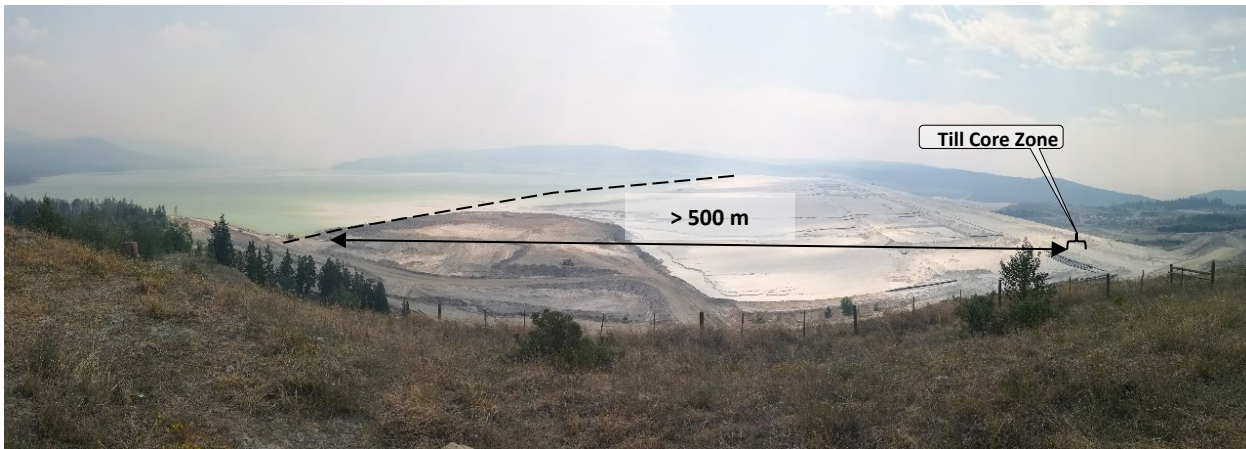
**Photo I-A-1 Overview of Tailings Beach at North Abutment which is >500 m wide (upstream of core zone) as per design. (LL-2021-01)**

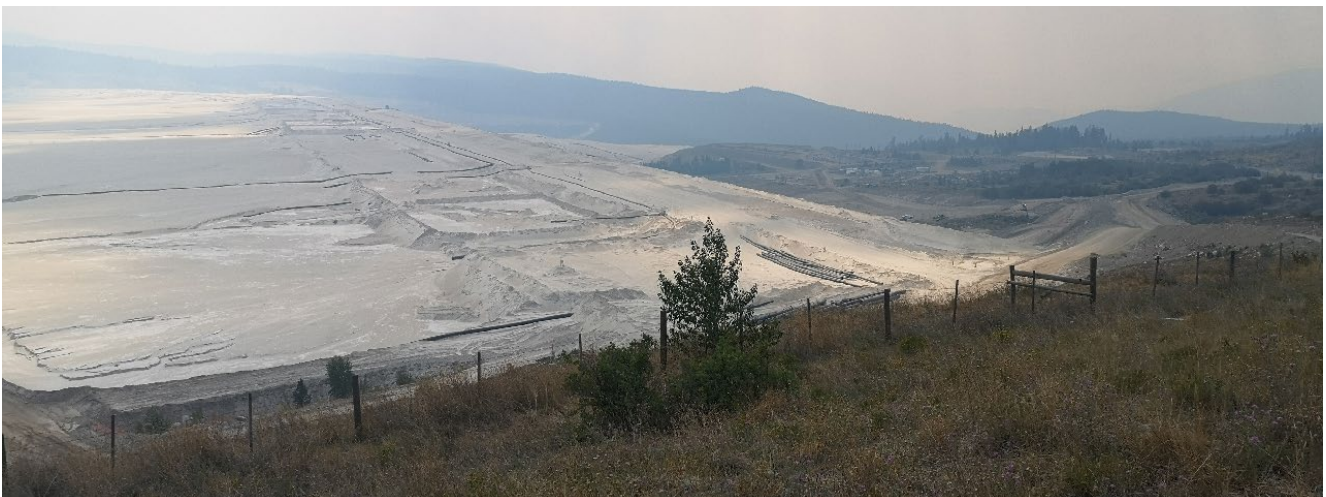
**Photo I-A-2 Overview of Tailings Beach and upstream cycloned sand hydraulic placement cells at North Dam U-GLU (LL-2021-01)**

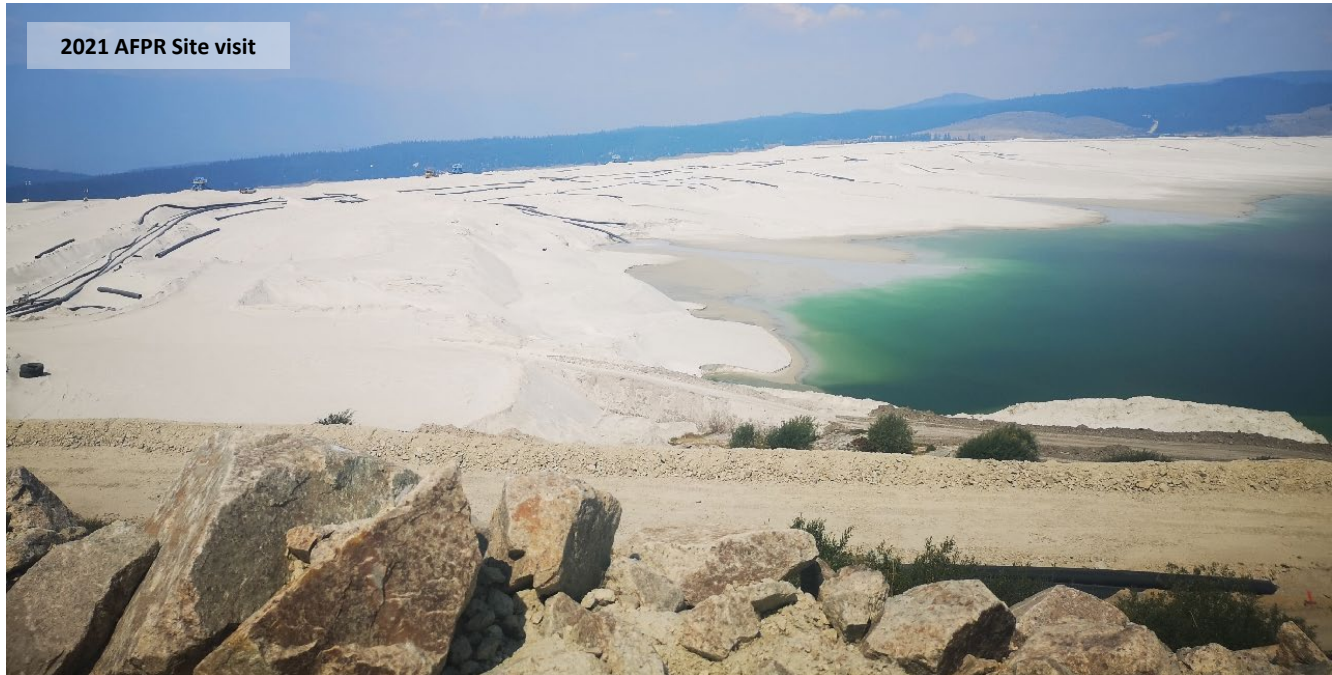
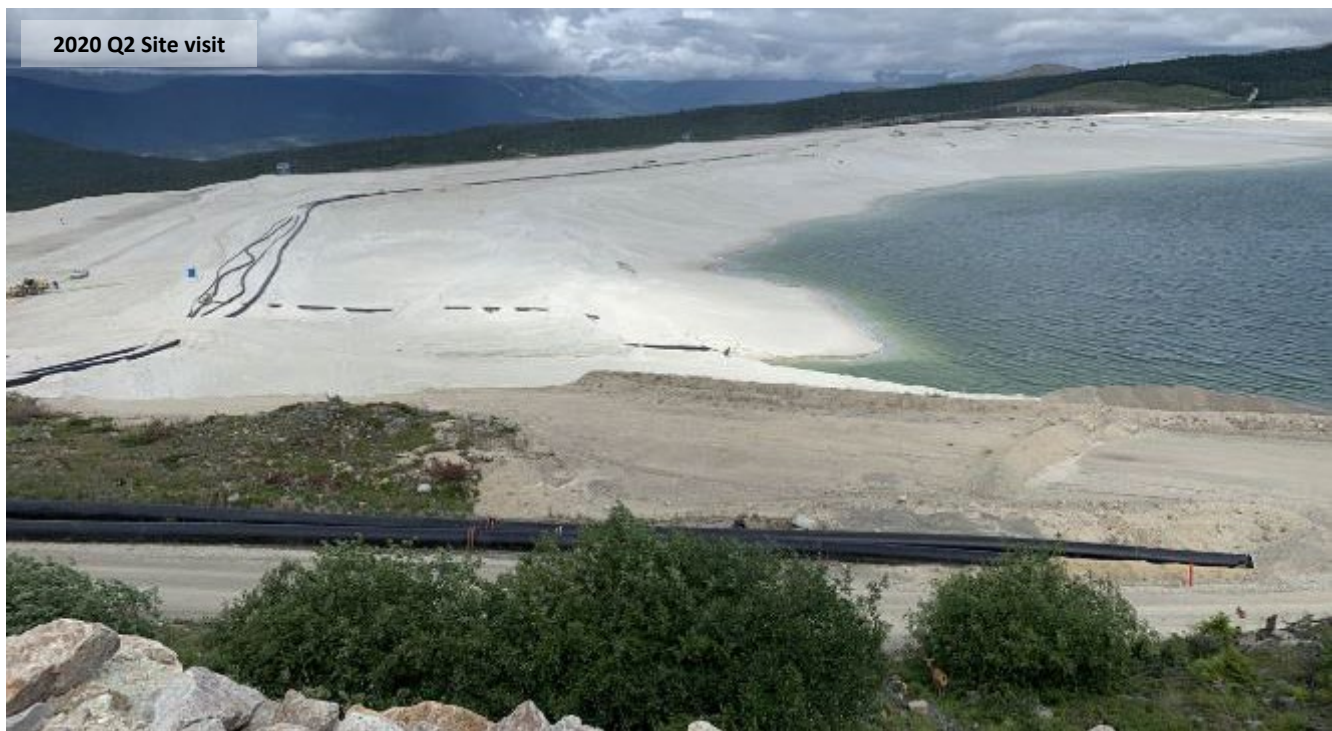
**Photo I-A-3 Overview of Tailings Dam beach and crest at South Abutment and upstream of South Dam during 2021 AFPR site visit (top). Similar photo taken during 2020 AFPR site visit (bottom) included to show beach development over past year (LL-2021-02)**

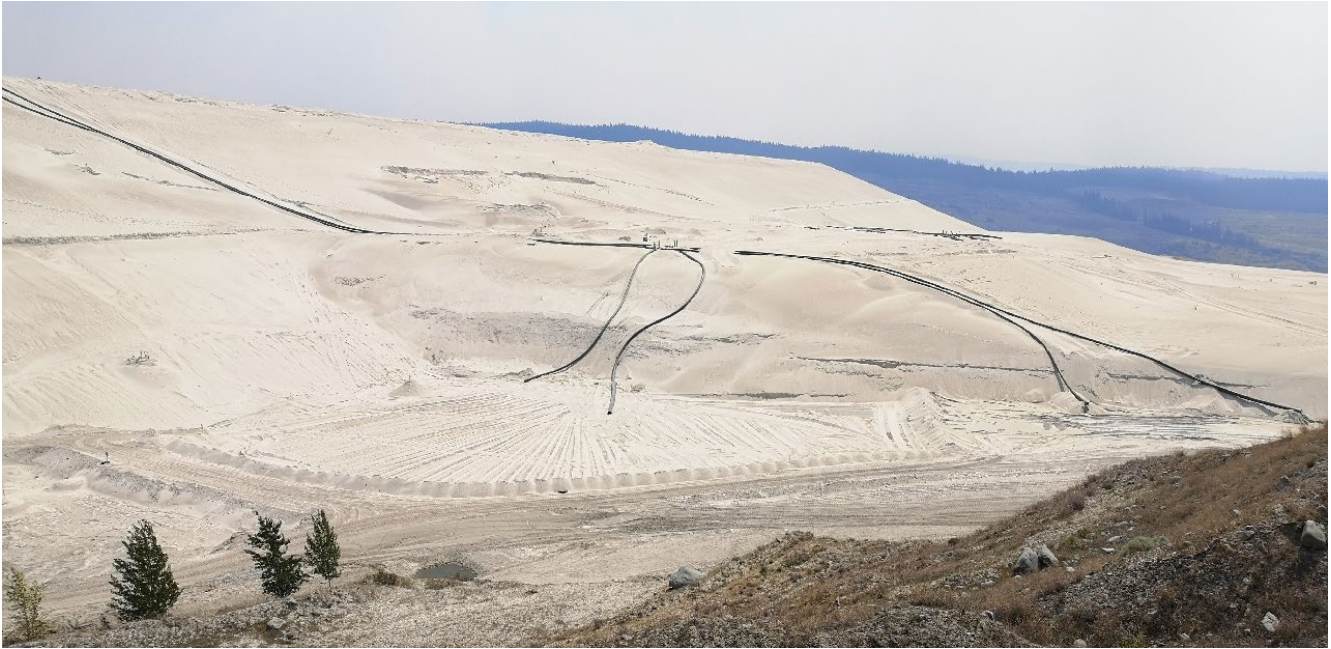
**Photo I-A-7 North side of the NBB which has been prepped for hydraulic placement. (LL-2021-05)**
