# **Teck Highland Valley Copper Partnership**

## **2021 Annual Facility Performance Report**

### ***Highland Tailings Storage Facility***

March 2022

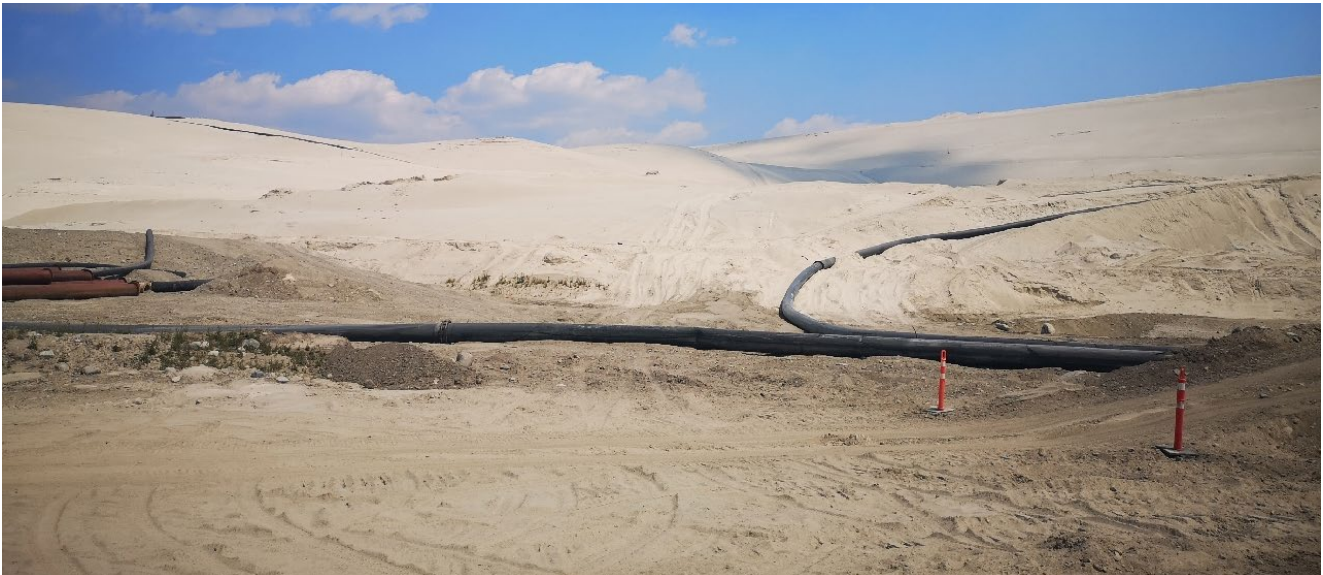
**Photo I-A-8 Overview of VBBE downstream slope, looking east from Sediment Pond 2. Temporary on-dam cell is not visible in photo, but was active during site visit. (LL-2021-06)**

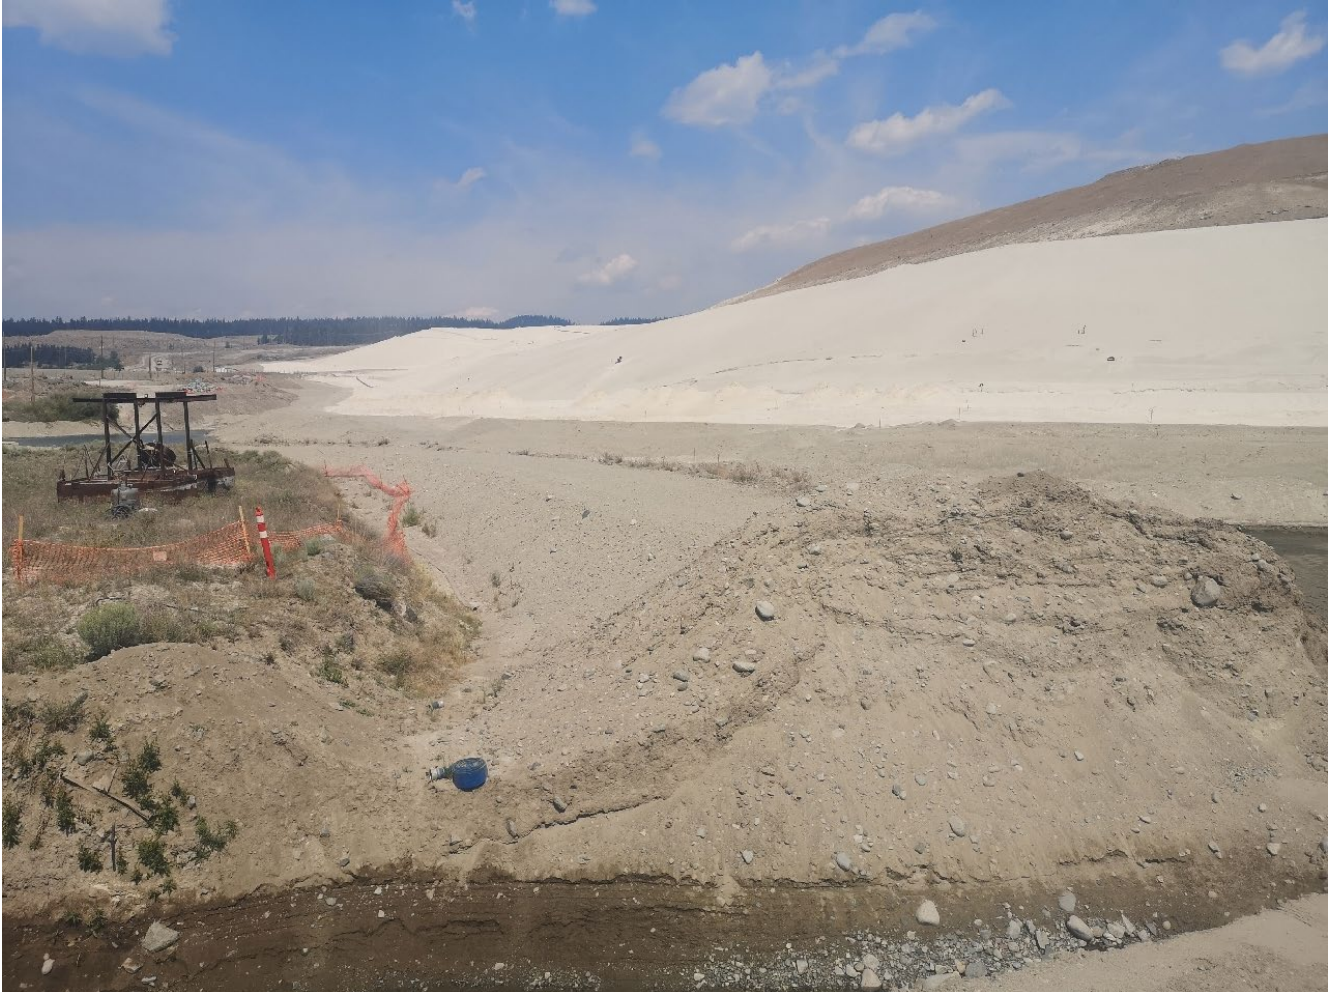
No visual indicators of concern or unusual behaviour (Photo I-A-9 to Photo I-A-12). There was no active construction at the time of site visit. Sediment Pond 1 was in operation downstream of the VBB toe (Photo I-A-10). Water levels and operating conditions were consistent with expected conditions. HVC had installed a secondary pump where Sediment Pond 1 flows into the Seepage Water Reclaim Pond (SWRP) to increase reclaim capacity during high-flow periods. The secondary pump was not in operation during the site visit as the pond level was being managed within normal levels by the SWRP reclaim system.

**Photo I-A-9** Downstream toe of the VBB with no visible seepage from cycloned sand fill above underdrain, looking north. Sediment Pond 1 present along dam toe, as well as internal sand and gravel berms which prevent sediment from encroaching on archeologically sensitive native ground. (LL-2021-07)

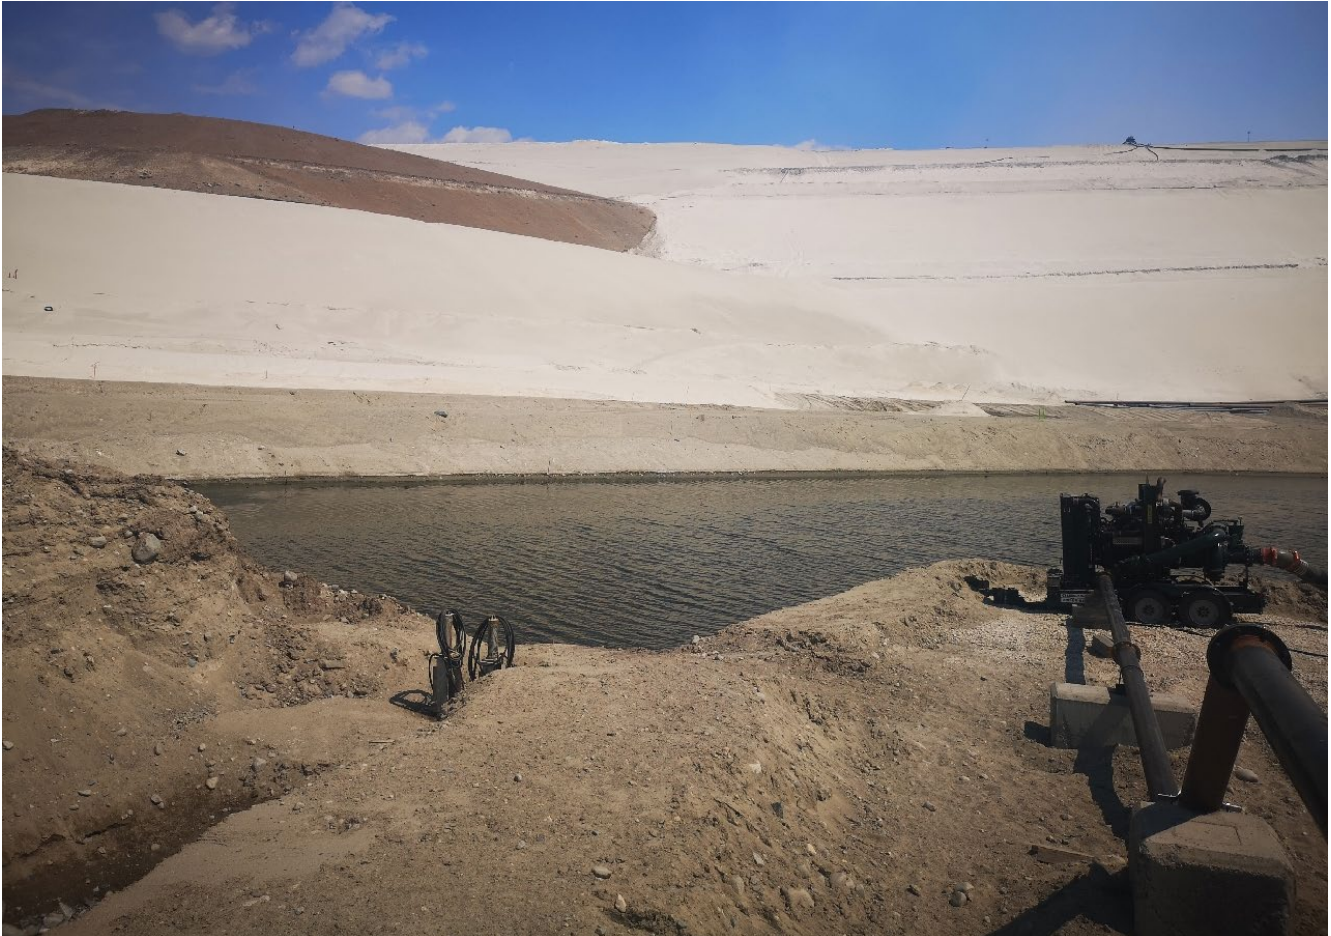
**Photo I-A-10 Overview of VBB downstream slope with Sediment Pond 1 (south cell) at dam toe, looking east. Secondary pump added to increase reclaim capacity from SWRP visible in foreground. (LL-2021-07)**

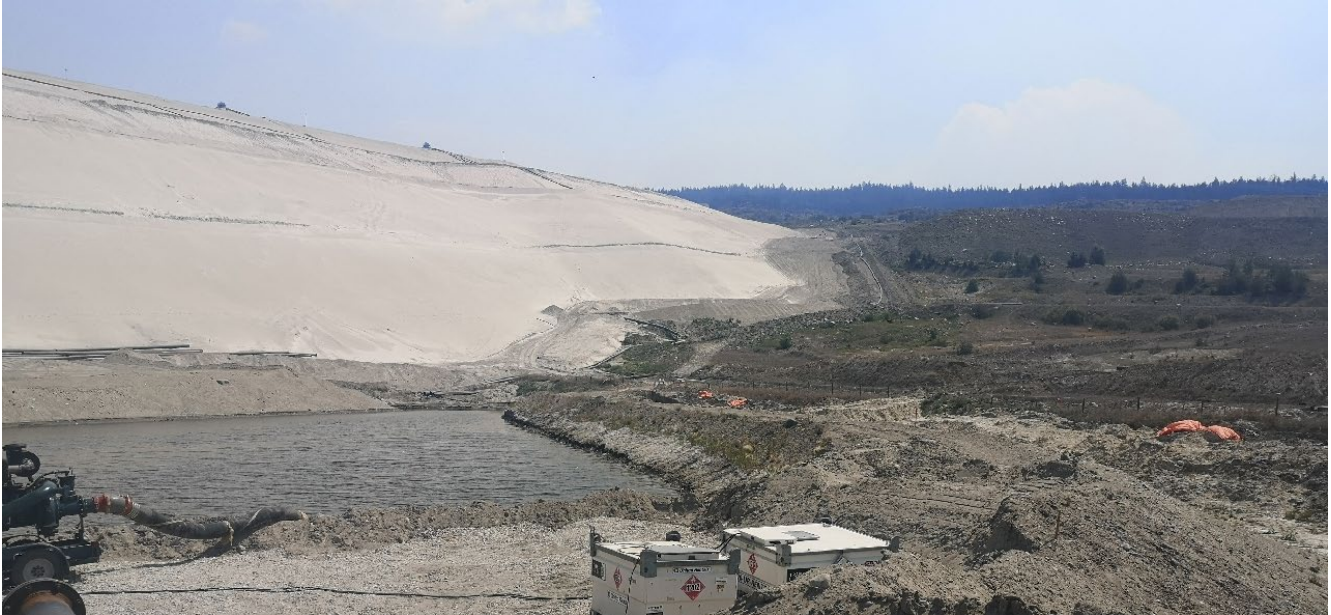
**Photo I-A-11 Overview of VBB and South Dam downstream slope and toe area, looking South.  
(LL-2021-07)**

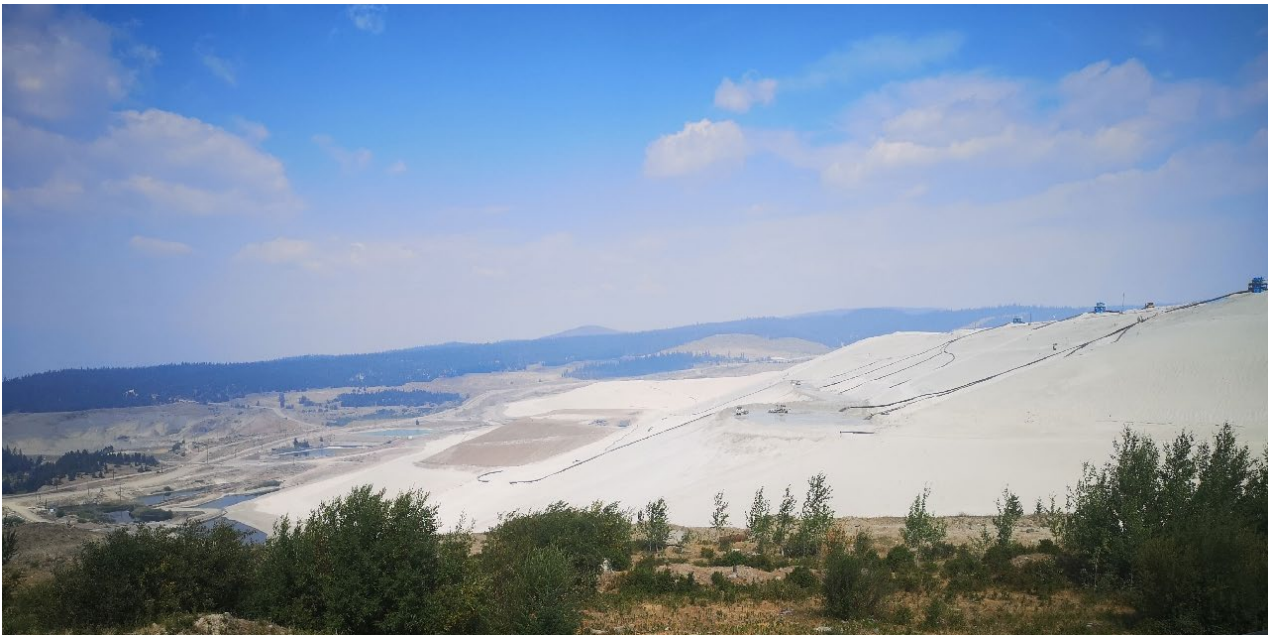
**Photo I-A-12 Overview of VBB and South Dam downstream slope and toe area, looking North.  
Active hydraulic placement to raise South Dam to ultimate downstream slope was in progress during site visit (LL-2021-08)**

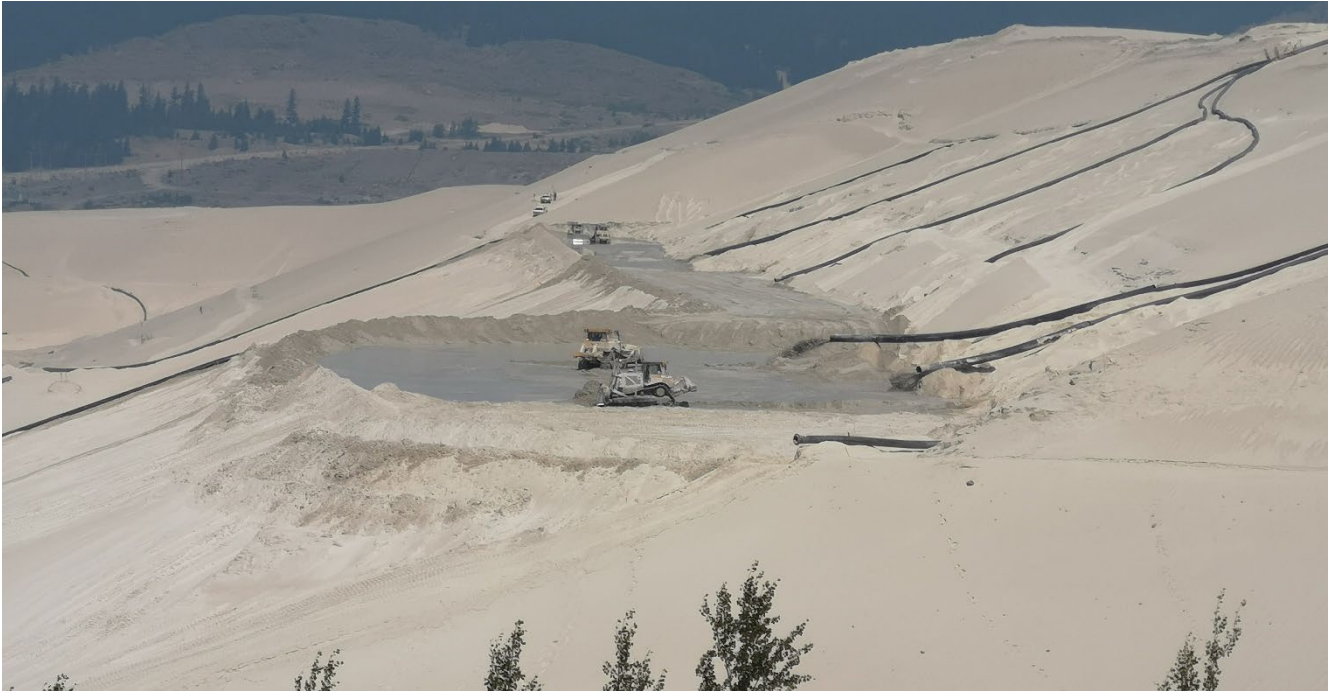
**Photo I-A-13 Downstream hydraulic fill placement at the South Dam (LL-2021-08)**

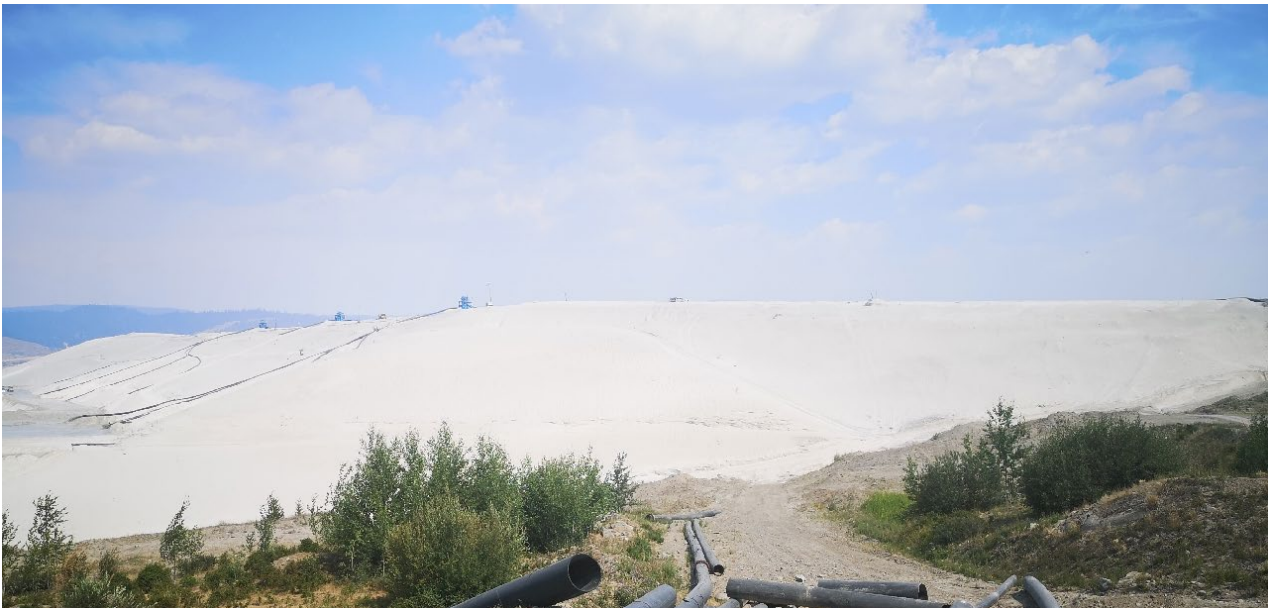
**Photo I-A-14 Overview of downstream slope of South Dam and near South Abutment, looking North. No observations of seepage from cycloned sand slope or excessive erosion. (LL-2021-08)**

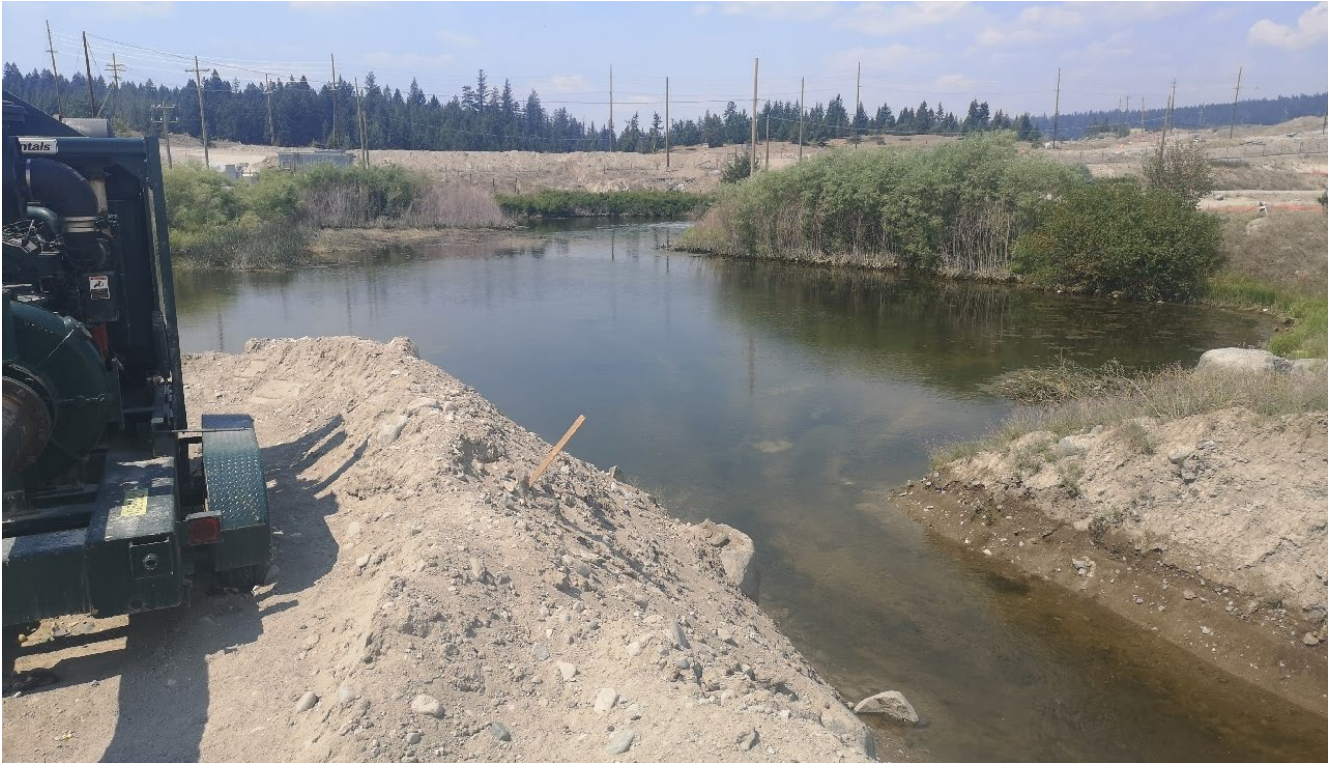
**Photo I-A-15 SWRP, pond level during site visit was within typical operating levels and the secondary reclaim pump was not in operation. Channel in foreground is connection with Sediment Pond 1. (LL-2021-07)**

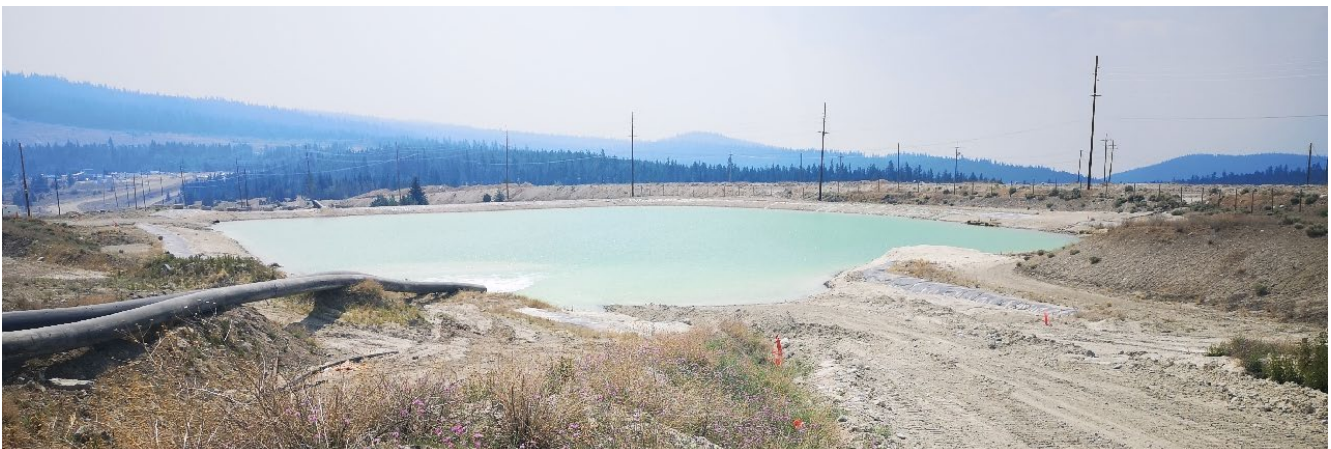
**Photo I-A-16 Overview of Sediment Pond 2 which was at typical operating levels and receiving overflow from the VBBE temporary on-dam sediment cell. (LL-2021-06)**

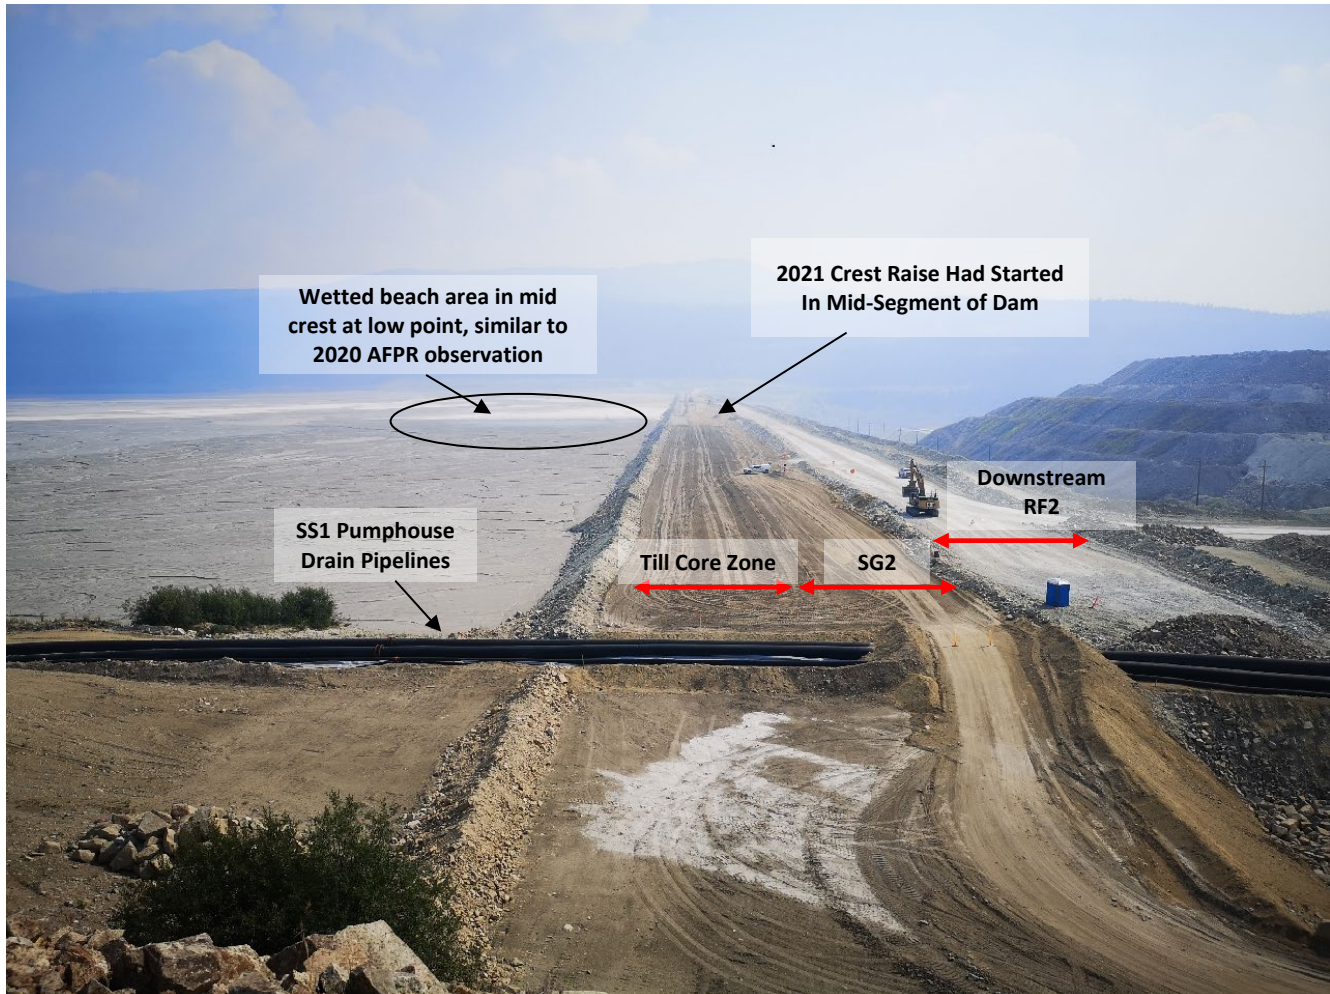
Wet area in low point of tailings beach near the H-H Dam was observed during the site visit which is typical and related to temporary ponding of surface runoff and tailings slurry in the low point of the beach. Water depth is typically less than 1 m. Based on the July 14, 2021 beach survey, the buffer<sup>1</sup> along the H-H Dam crest ranged from 3.6 m to 4.8 m, which was significantly greater than the minimum specified in design (1 m) or HVC's operating target (2 m).

**Photo I-B-1 Overview of H-H Dam crest and tailings beach from West Abutment, looking East.** The 2021 crest raise activities had started in the middle segment of the dam but had not yet reached the West Abutment area at the time of the site visit. There was a wetted area of the beach upstream of the dam. This is typical as it is the low point of the beach, near the dam, where surface runoff or tailings slurry temporarily pond. (HH-2021-01)

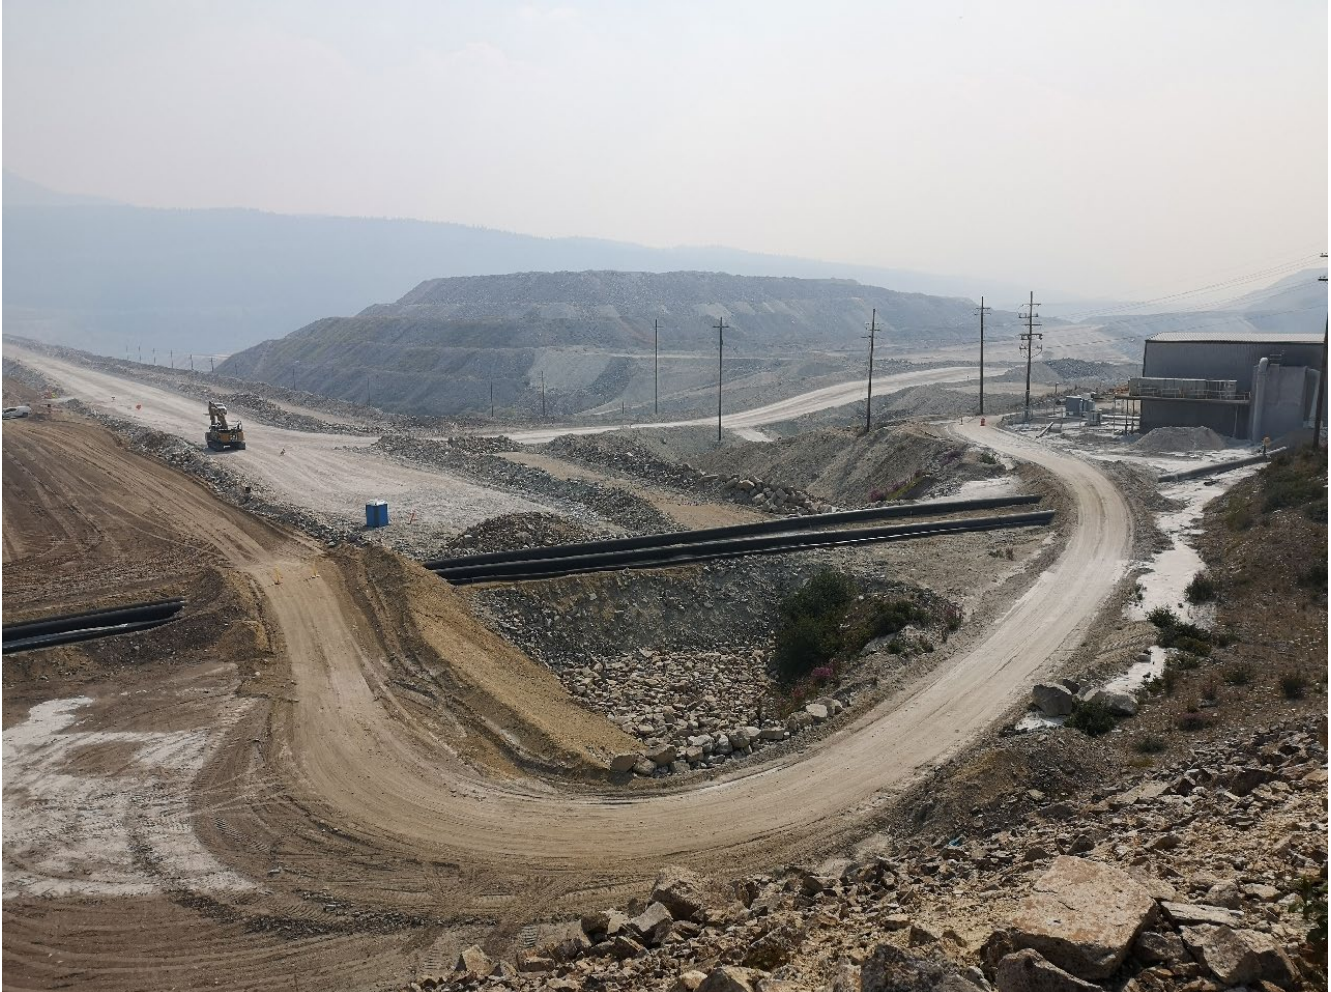
**Photo I-B-2 Overview of West Abutment, SS1 pumphouse and where the drain pipelines cross the H-H Dam crest. The pipes have secondary containment berms where they cross the sand and gravel and core zones to prevent overflow onto the crest in the event of pipe breakage. (HH-2021-01)**

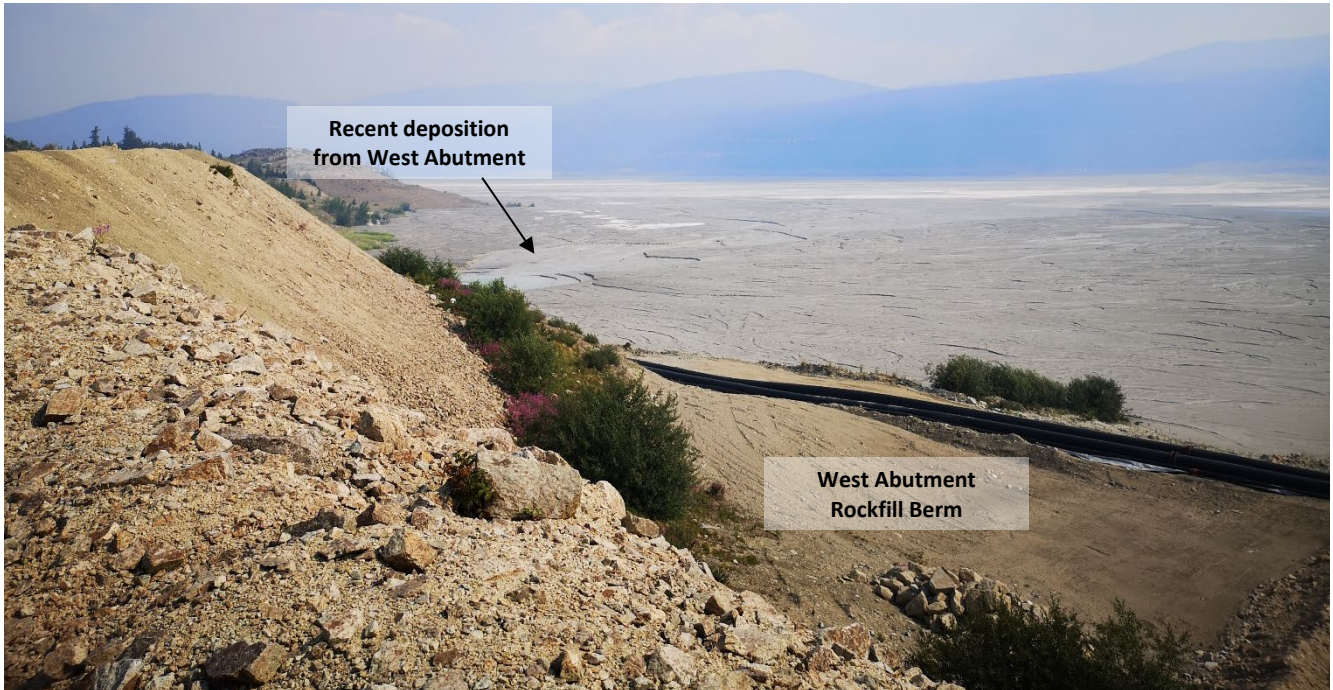
**Photo I-B-3** Tailings being discharged from the H-H Dam West Abutment. The spigot is approximately 100 m upstream of H-H Dam and not in view of the photo but the flow path of recent deposition is visible. (HH-2021-02)

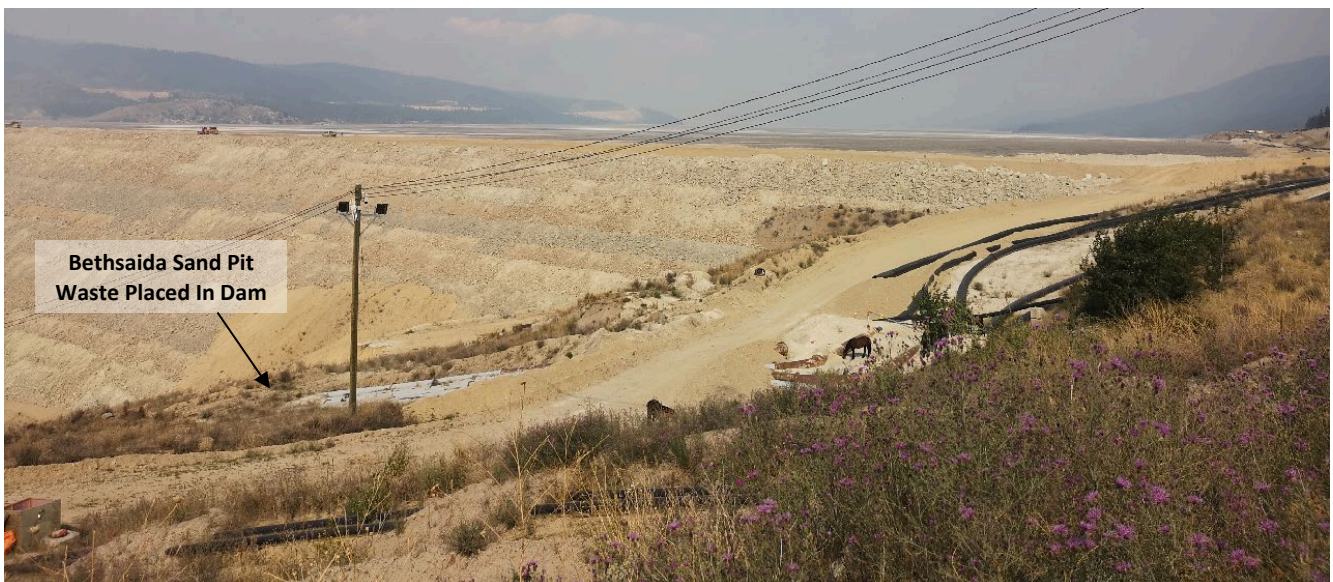
**Photo I-B-4** Overview of H-H Dam eastern downstream slope. The light colour area of the slope is where Bethsaida sand was placed in the dam shell earlier in the mine life. Bethsaida sand does not meet the current fill placement specification for the downstream shell but this zone of material has been accounted for in the design. (HH-2021-03)

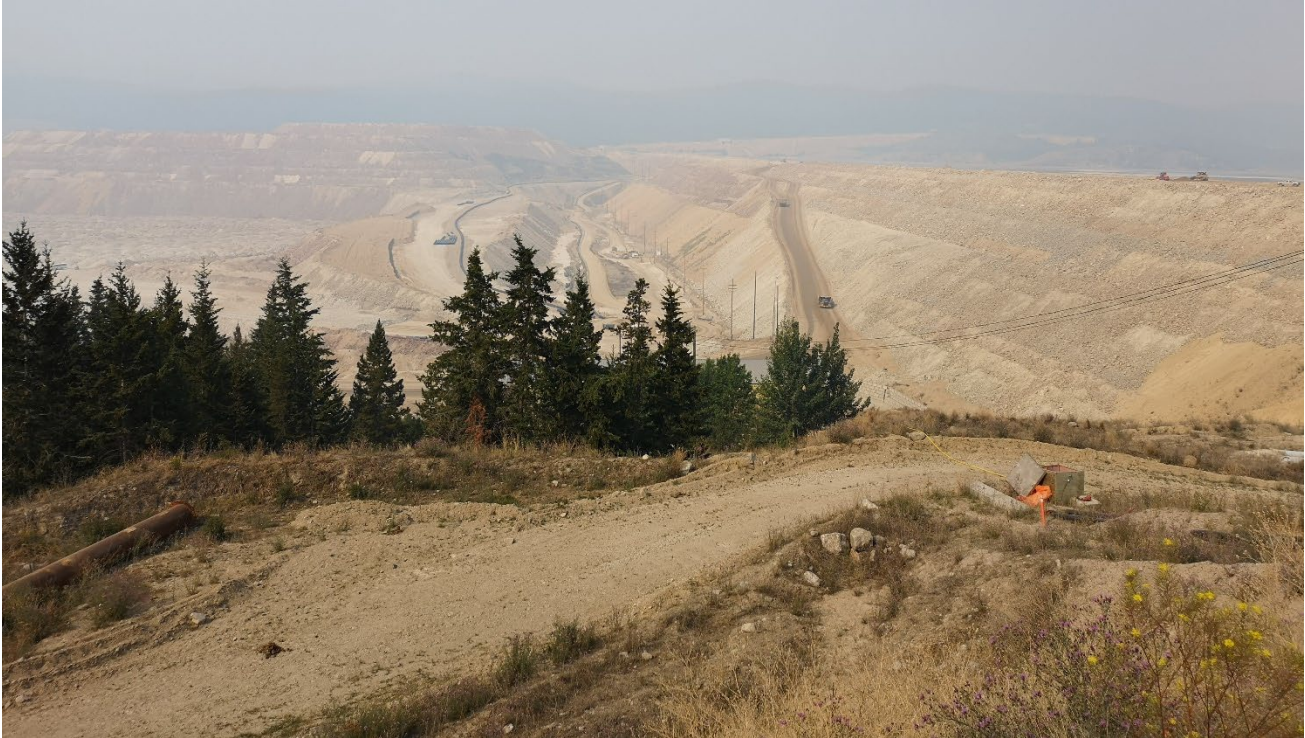
**Photo I-B-5 Overview of H-H Dam downstream slope and buttress area over 24 Mile TSF, looking west. (HH-2021-03)**

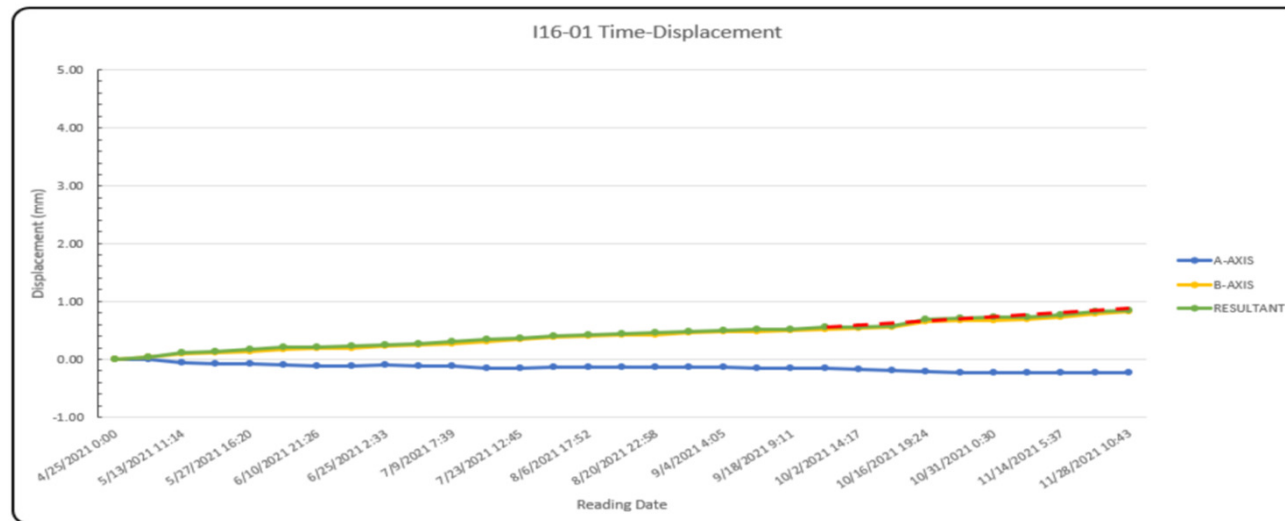
## SAAV I16-01

Displacement Plot - Upper Glaciolacustrine

Unit	Upper El. (m)	Lower El. (m)	NL (mm/month)	Rate (mm/month)
Upper GL	1233	1227	1.0	0.15
Glaciofluvial	1209	1199	1.0	
Lower GL	1193.5	1190	1.0

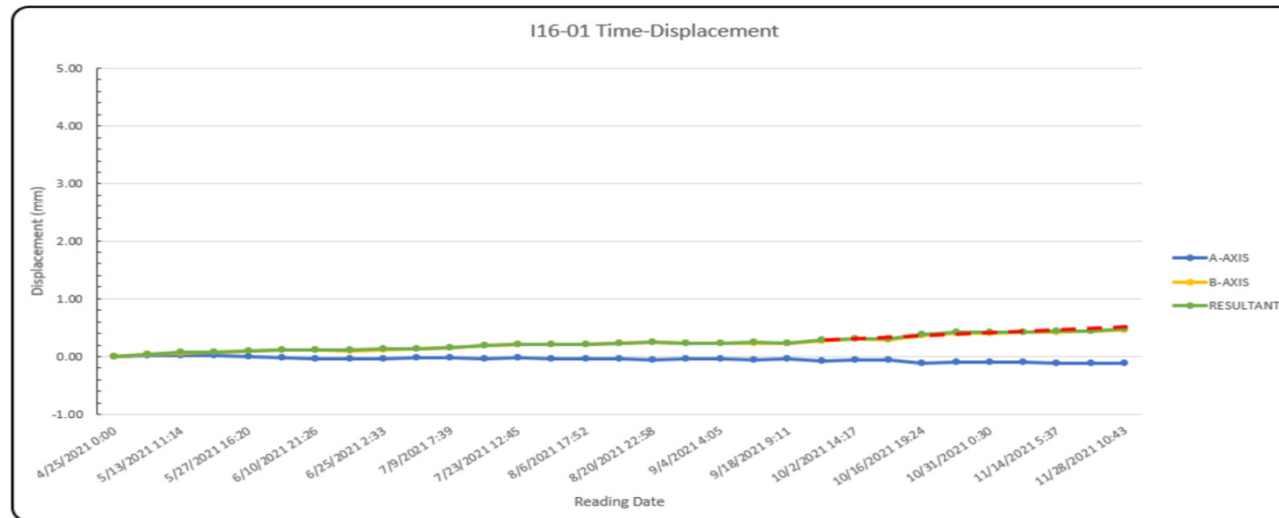
## SAAV I16-01

Displacement Plot - Glaciofluvial

Unit	Upper El. (m)	Lower El. (m)	NL (mm/month)	Rate (mm/month)
Upper GL	1233	1227	1.0	
<b>Glaciofluvial</b>	<b>1209</b>	<b>1199</b>	<b>1.0</b>	<b>0.10</b>
Lower GL	1193.5	1190	1.0

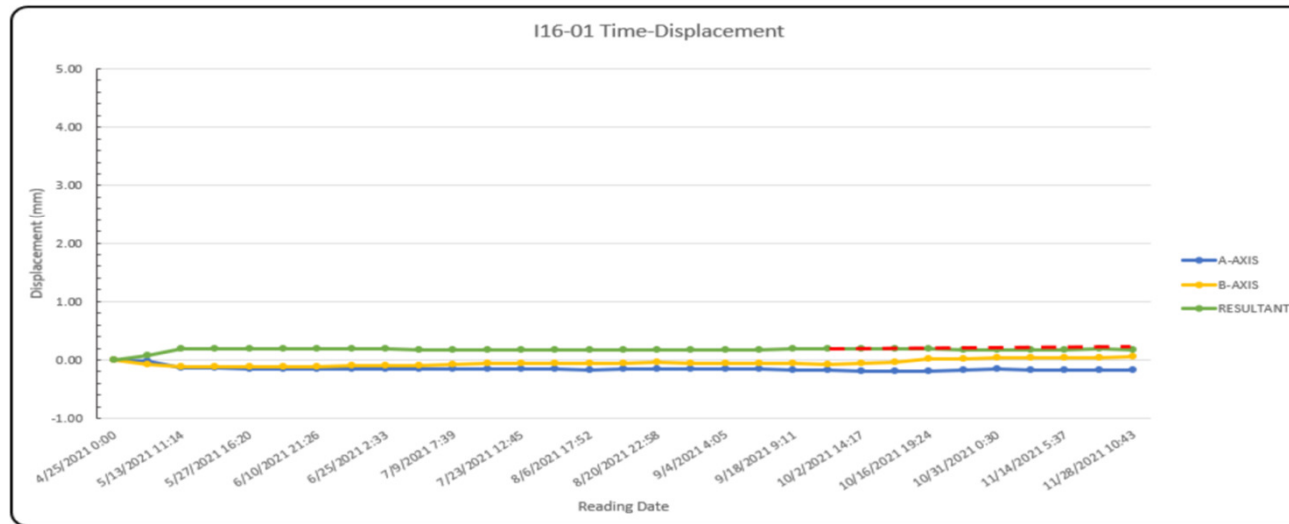
## SAAV I16-01

Displacement Plot - Lower Glaciofluvial

Unit	Upper El. (m)	Lower El. (m)	NL (mm/month)	Rate (mm/month)
Upper GL	1233	1227	1.0	
Glaciofluvial	1209	1199	1.0	
<b>Lower GL</b>	<b>1193.5</b>	<b>1190</b>	<b>1.0</b>	<b>0.01</b>

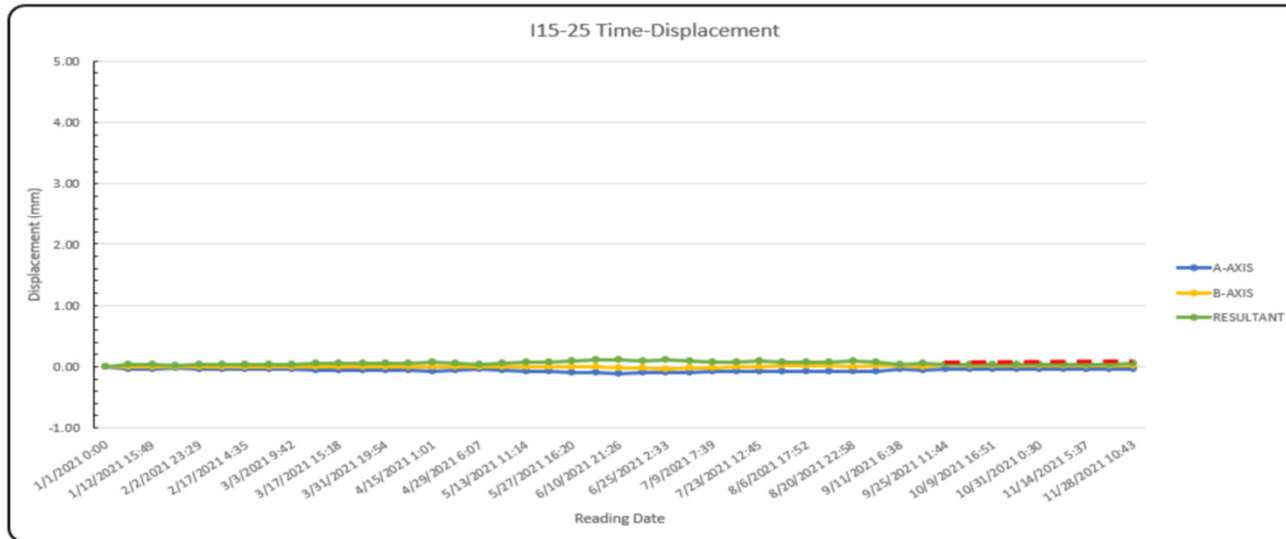
## SAAV I15-25

Unit	Upper El.(m)	Lower El. (m)	NL (mm/month)	Rate (mm/month)
Volcanic	1169.0	1159.0	1.0	0
Mudstone	1157.5	1084.0	0.5

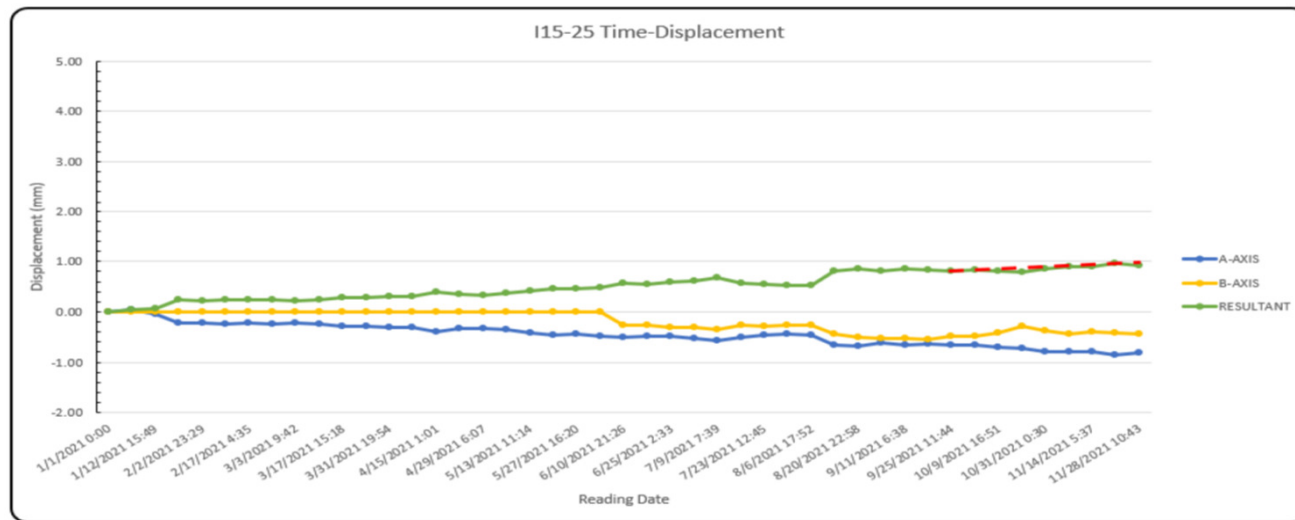
## SAAV I15-25

Unit	Upper El.(m)	Lower El. (m)	NL (mm/month)	Rate (mm/month)
Volcanic	1169.0	1159.0	1.0	
<b>Mudstone</b>	<b>1157.5</b>	<b>1084.0</b>	<b>0.5</b>	<b>0.05</b>

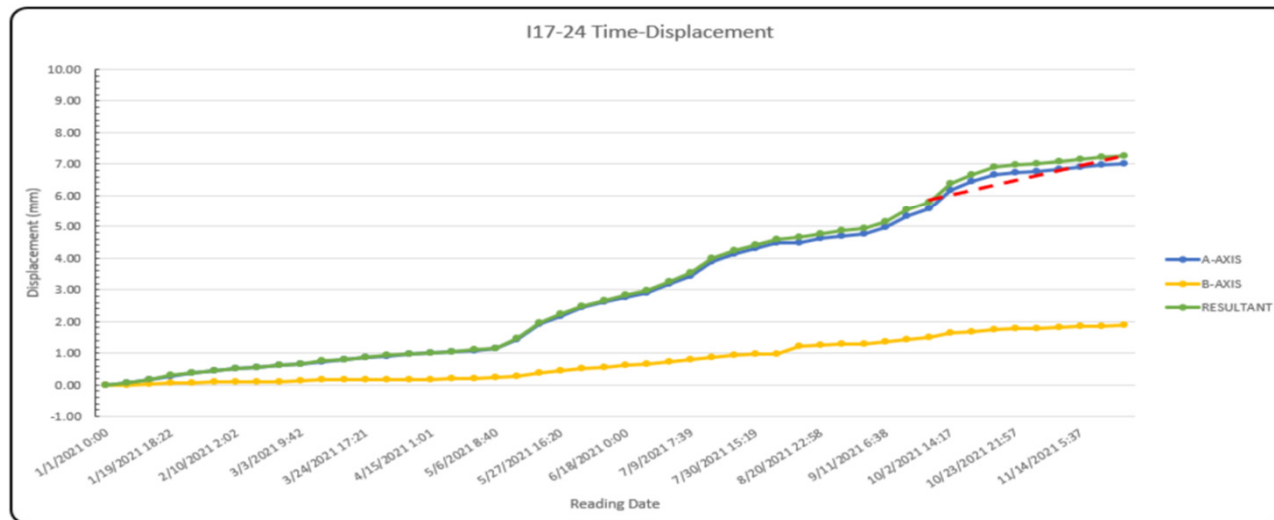
## SAAV I17-24

Unit	Upper El. (m)	Lower El. (m)	NL (mm/month)	Rate (mm/month)
Upper Sedimentary	1159.7	1151.7	3.0	
Sandstone	1141.7	1135.7	-	
<b>Lower Sedimentary</b>	<b>1120.7</b>	<b>1112.7</b>	<b>3.0</b>	<b>0.74</b>

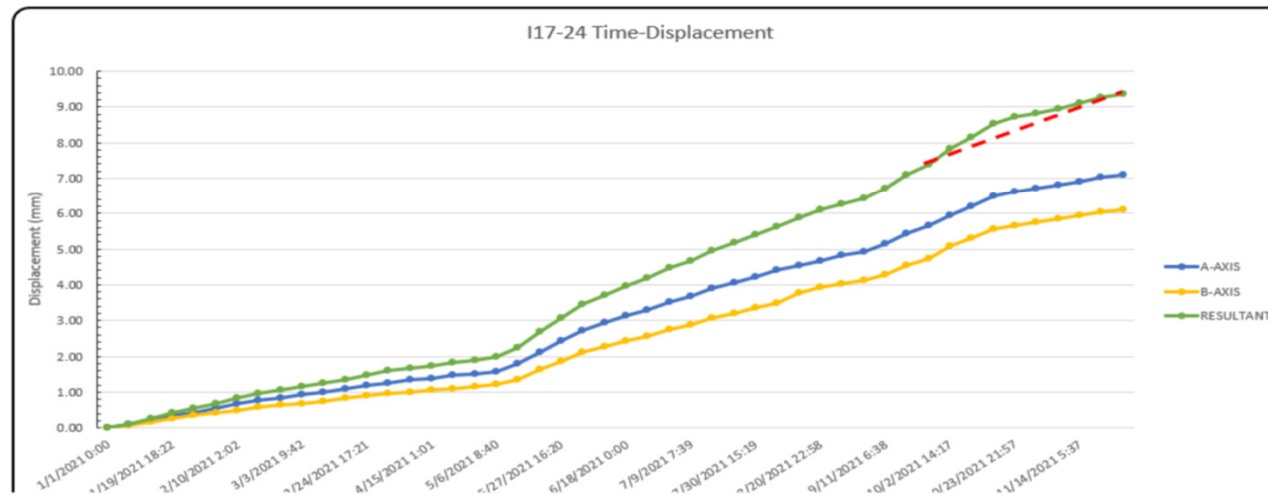
## SAAV I17-24

Unit	Upper El. (m)	Lower El. (m)	NL (mm/month)	Rate (mm/month)
Upper Sedimentary	1159.7	1151.7	3.0	0.99
Sandstone	1141.7	1135.7	-	
Lower Sedimentary	1120.7	1112.7	3.0

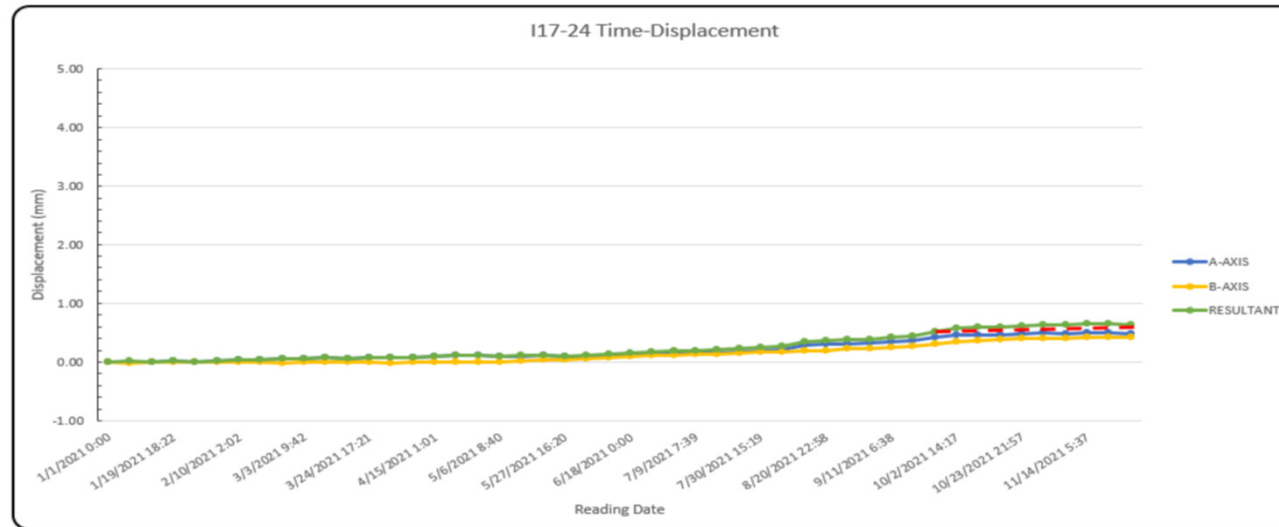
## SAAV I17-24

Unit	Upper El. (m)	Lower El. (m)	NL (mm/month)	Rate (mm/month)
Upper Sedimentary	1159.7	1151.7	3.0	
<b>Sandstone</b>	<b>1141.7</b>	<b>1135.7</b>	-	<b>0.07</b>
Lower Sedimentary	1120.7	1112.7	3.0

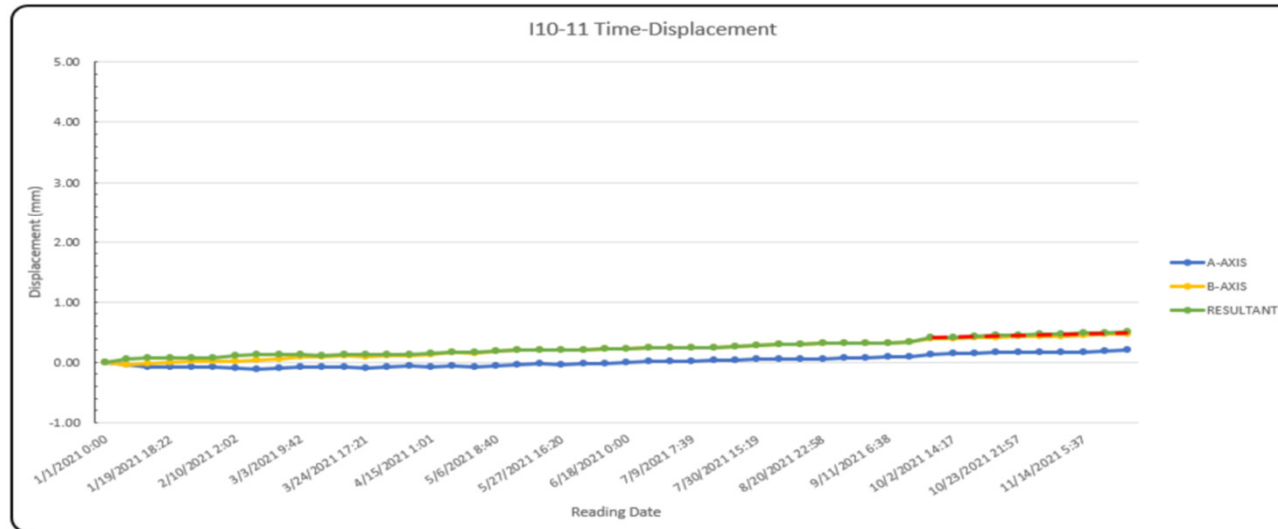
## SAAV I10-11

Unit	Upper El. (m)	Lower El. (m)	NL	Rate (mm/month)
Sand and Gravel	1087.8	1081.8	1.0	0.05
Granodiorite	1068.8	1059.3	1.0

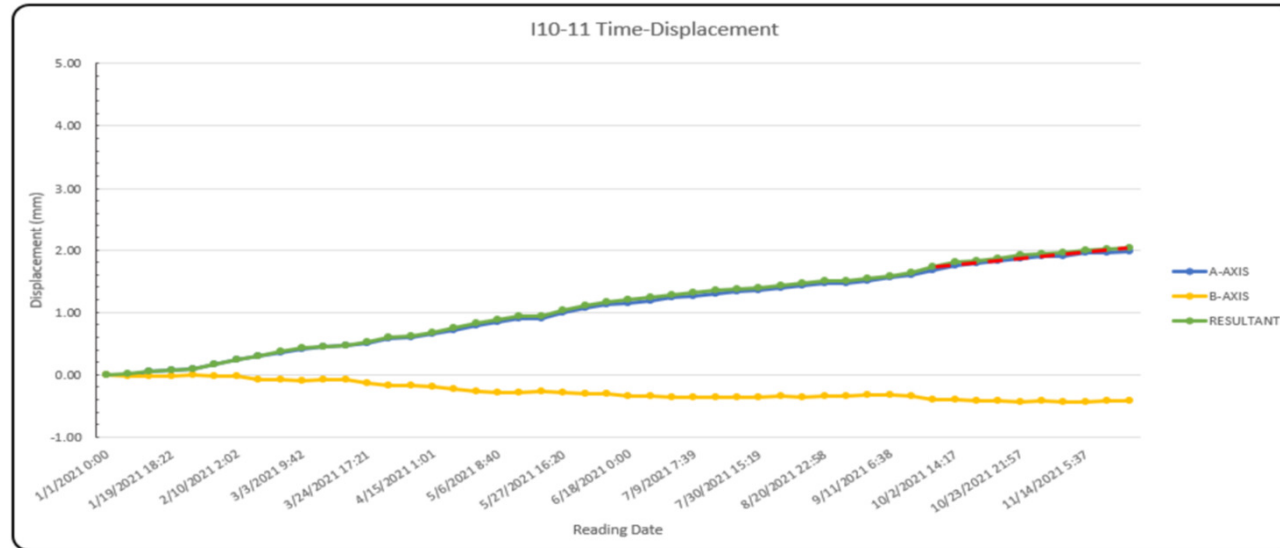
## SAAV I10-11

Unit	Upper El. (m)	Lower El. (m)	NL	Rate (mm/month)
Sand and Gravel	1087.8	1081.8	1.0	
<b>Granodiorite</b>	<b>1068.8</b>	<b>1059.3</b>	<b>1.0</b>	<b>0.15</b>

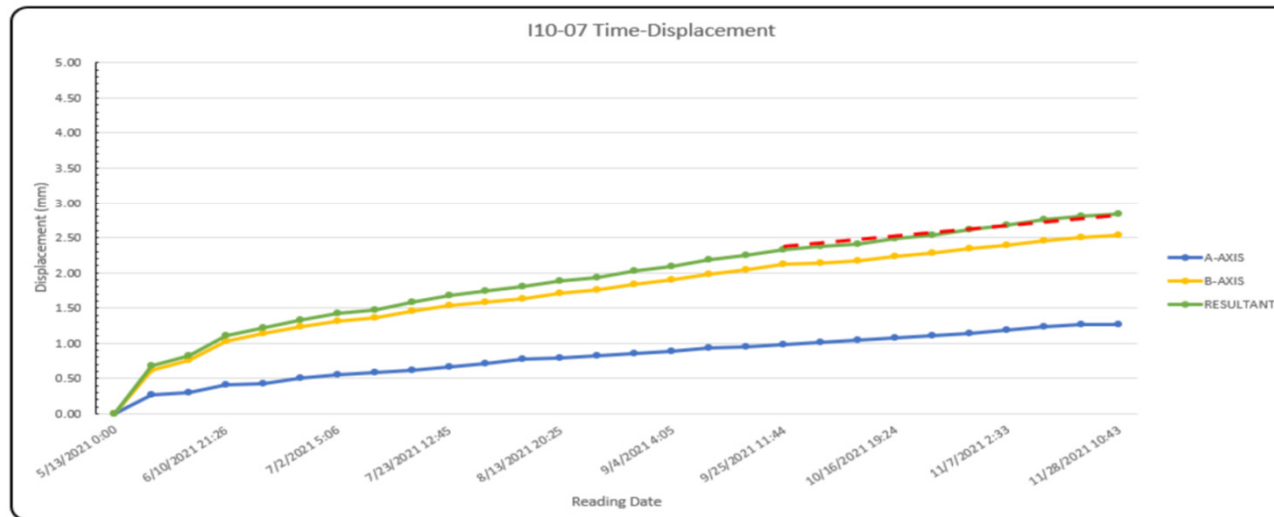
## SAAV I10-07

Displacement Plot - Glaciolacustrine

Unit	Upper El. (m)	Lower El. (m)	NL	Rate (mm/month)
Lacustrine	1100.5	1091.5	5.0	
<b>Glaciolacustrine</b>	<b>1079.5</b>	<b>1069.5</b>	<b>1.0</b>	<b>0.25</b>
Drainage Blanket	1067.5	1064.5	1.0
