# **Teck Highland Valley Copper Partnership**

## **2021 Annual Facility Performance Report**

### ***Highland Tailings Storage Facility***

March 2022

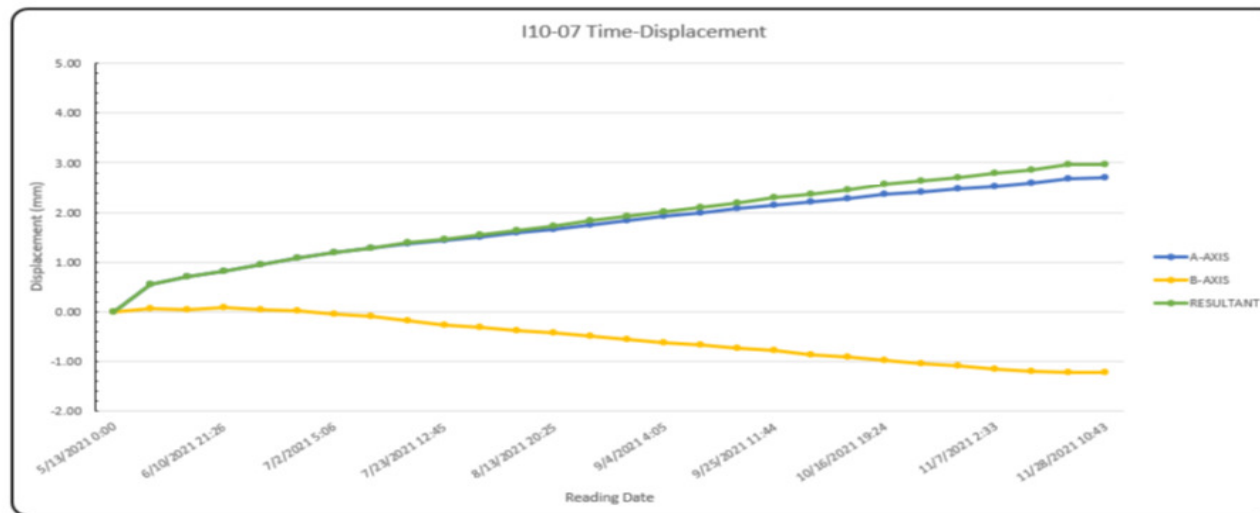
## SAAV I10-07

Displacement Plot - Lacustrine

Unit	Upper El. (m)	Lower El. (m)	NL	Rate (mm/month)
Lacustrine	1100.5	1091.5	5.0	0.34
Glaciolacustrine	1079.5	1069.5	1.0	
Drainage Blanket	1067.5	1064.5	1.0

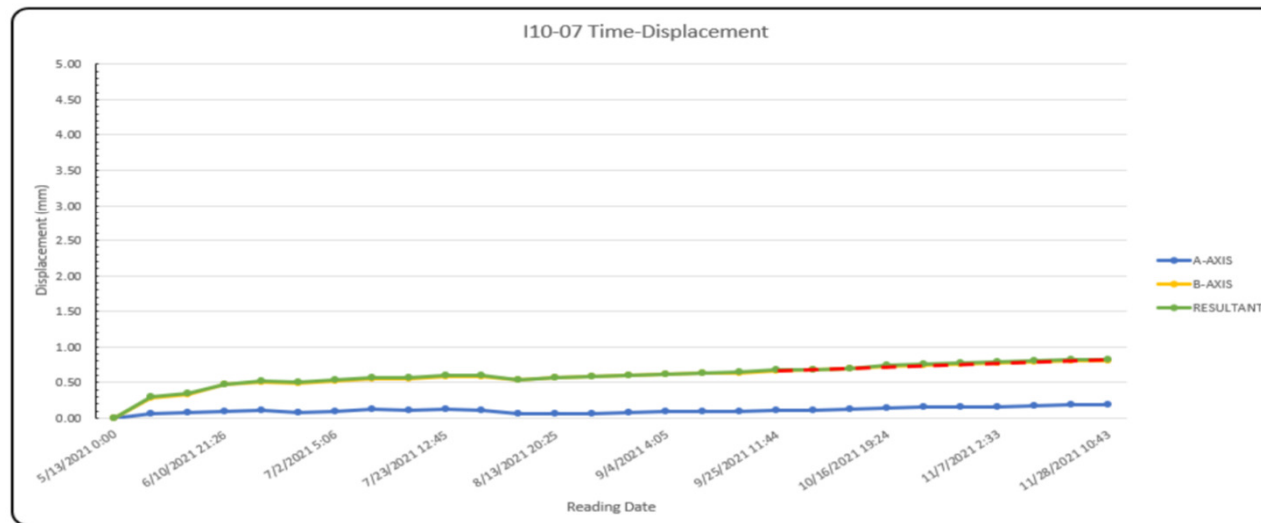
## SAAV I10-07

Displacement Plot - Drainage Blanket

Unit	Upper El. (m)	Lower El. (m)	NL	Rate (mm/month)
Lacustrine	1100.5	1091.5	5.0	
Glaciolacustrine	1079.5	1069.5	1.0	
<b>Drainage Blanke</b>	<b>1067.5</b>	<b>1064.5</b>	<b>1.0</b>	<b>0.08</b>

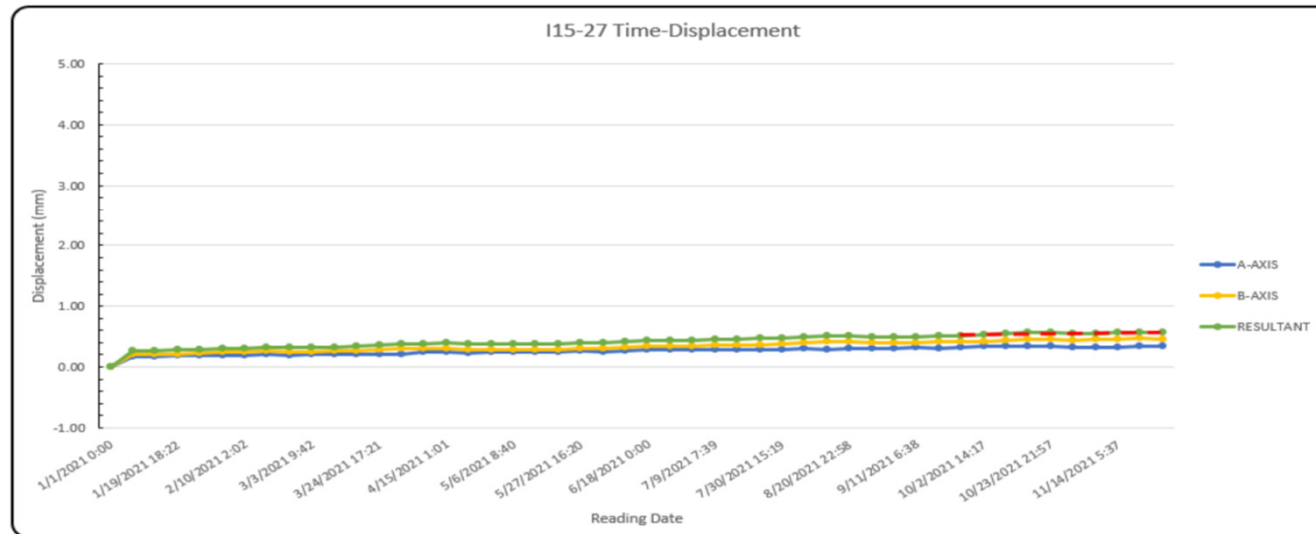
## SAAV I15-27

Displacement Plot – Upper Glaciolacustrine

Unit	Upper El. (m)	Lower El. (m)	NL (mm/month)	Rate (mm/month)
GLU/Glacial till Upper	1093.3	1088.3	0.5	0.03
GLU/Glacial till Middle	1071.8	1069.8	0.5	
GLU/Glaciofluvial Lower	1033.3	1025.3	0.5

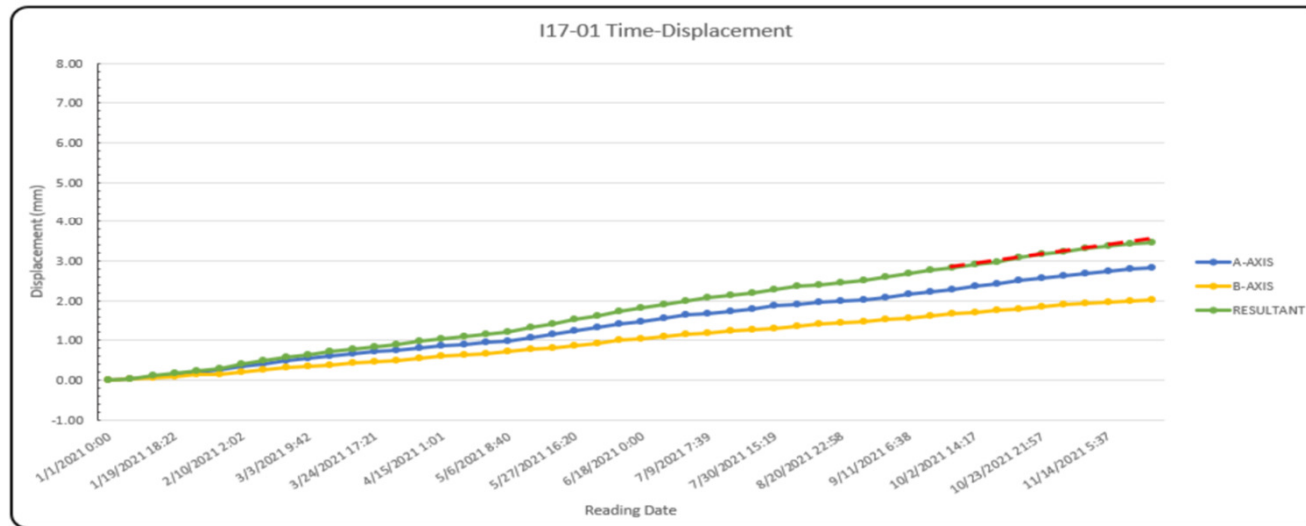
## SAAV I17-01

Displacement Plot - Lacustrine

Unit	Upper El. (m)	Lower El. (m)	NL	Rate (mm/month)
Lacustrine	1100.5	1094.5	5.0	0.33
Lower GLU	1082.5	1073.5	1.0

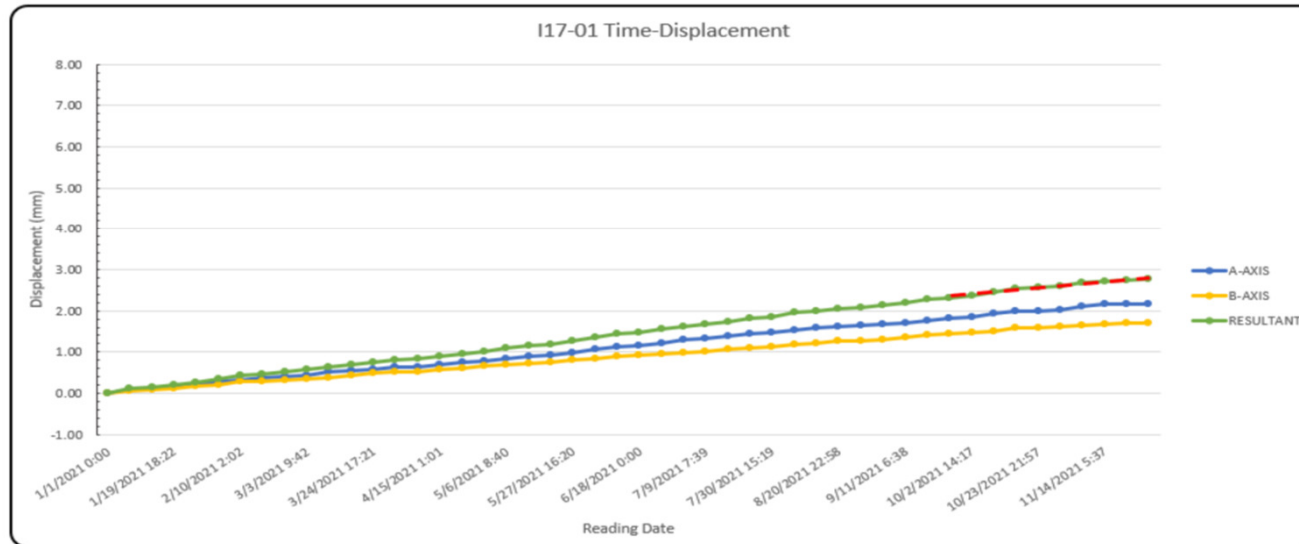
## SAAV I17-01

Displacement Plot - Lower GLU

Unit	Upper El. (m)	Lower El. (m)	NL	Rate (mm/month)
Lacustrine	1100.5	1094.5	5.0	
<b>Lower GLU</b>	<b>1082.5</b>	<b>1073.5</b>	<b>1.0</b>	<b>0.22</b>

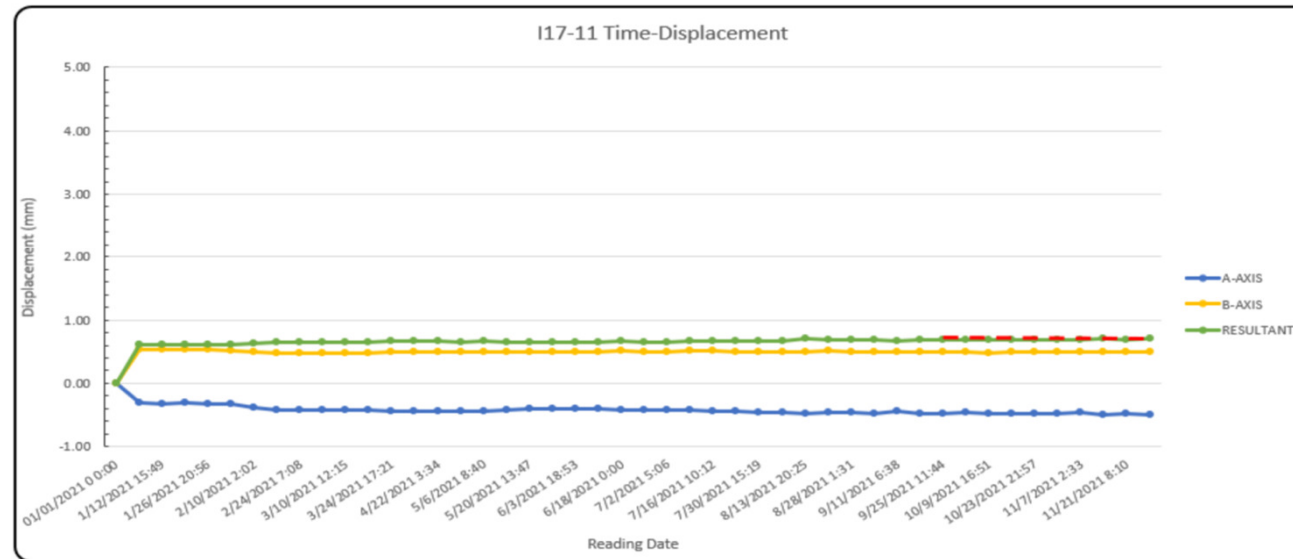
## SAAV I17-11

Displacement Plot - Glaciolacustrine

Unit	Upper El. (m)	Lower El. (m)	NL (mm/month)	Rate (mm/month)
Lower Glaciolacustrine	1075	1068	0.5	0.01

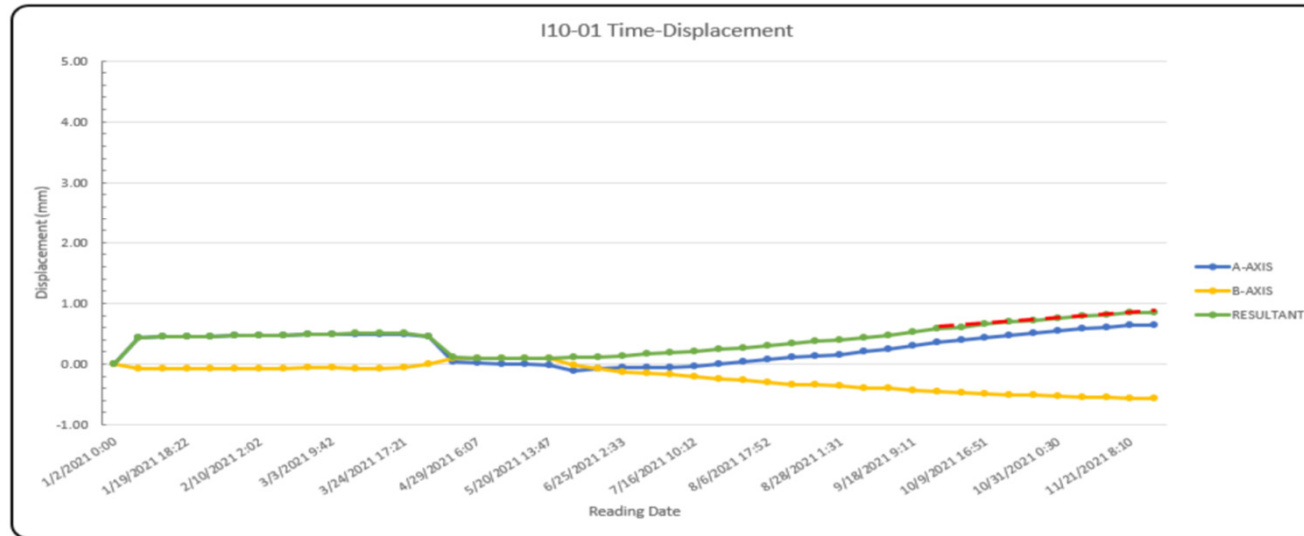
## SAA I10-01

Displacement Plot - Drainage Blanket

Unit	Upper El. (m)	Lower El. (m)	NL (mm/month)	Rate (mm/month)
<b>Drainage Blanket</b>	<b>1137.8</b>	<b>1135.8</b>	<b>5.0</b>	<b>0.14</b>
Volcanic	1135.8	1127.8	1.0

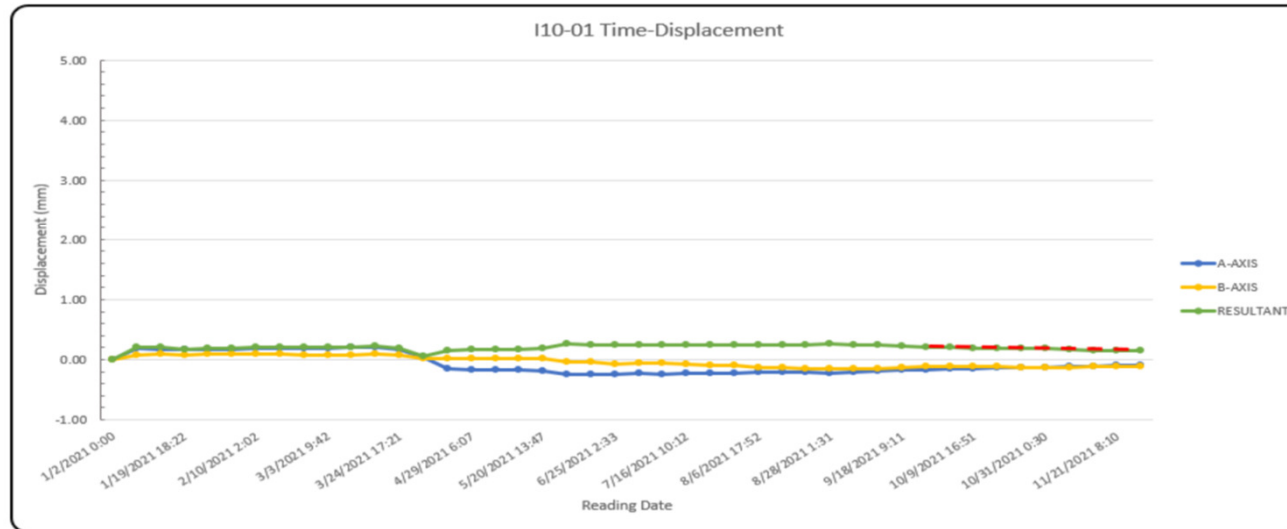
## SAA I10-01

Displacement Plot - Volcanics

Unit	Upper El. (m)	Lower El. (m)	NL (mm/month)	Rate (mm/month)
Drainage Blanket	1137.8	1135.8	5.0	
<b>Volcanic</b>	<b>1135.8</b>	<b>1127.8</b>	<b>1.0</b>	<b>0.03</b>

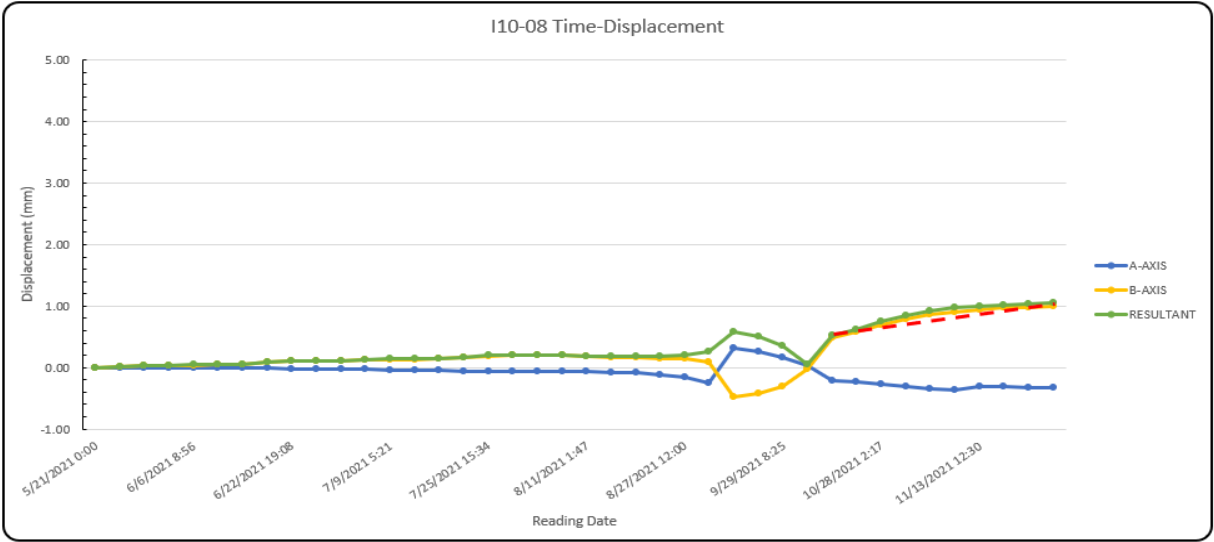
SAAV I10-08  
 Displacement Plot – Cycloned Sand

Unit	Upper El. (m)	Lower El. (m)	NL (mm/month)	Rate (mm/month)
Cycloned Sand	1202.5	1196.5	5.0	0.52

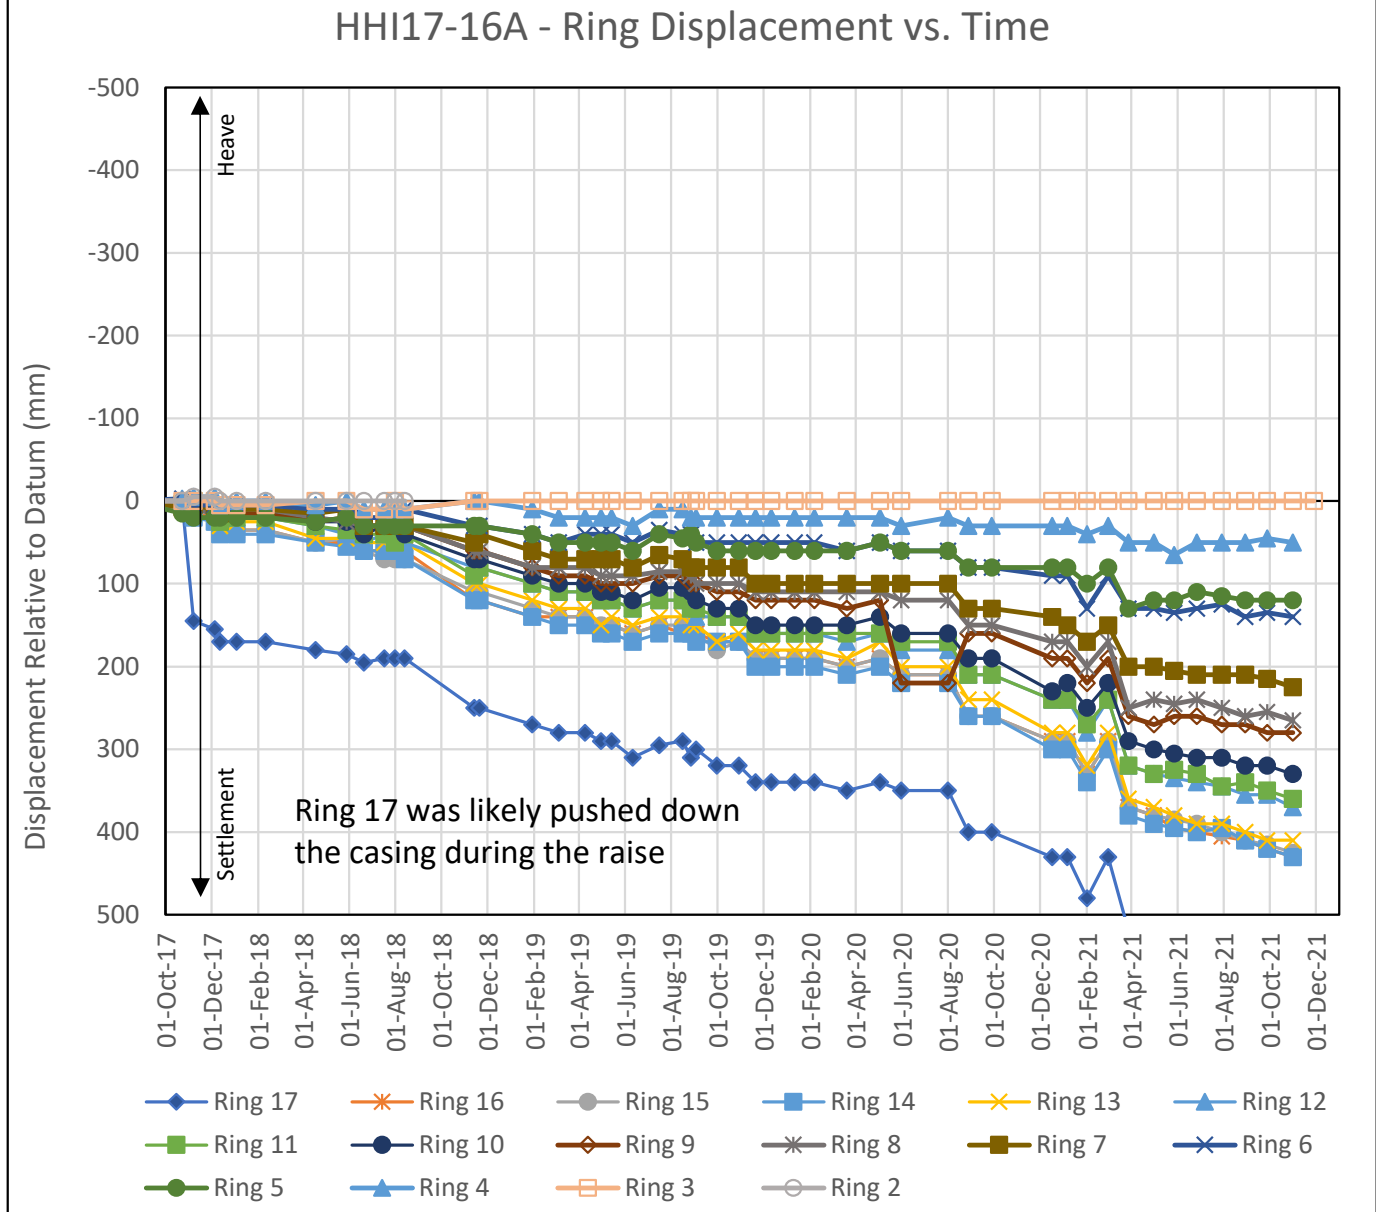
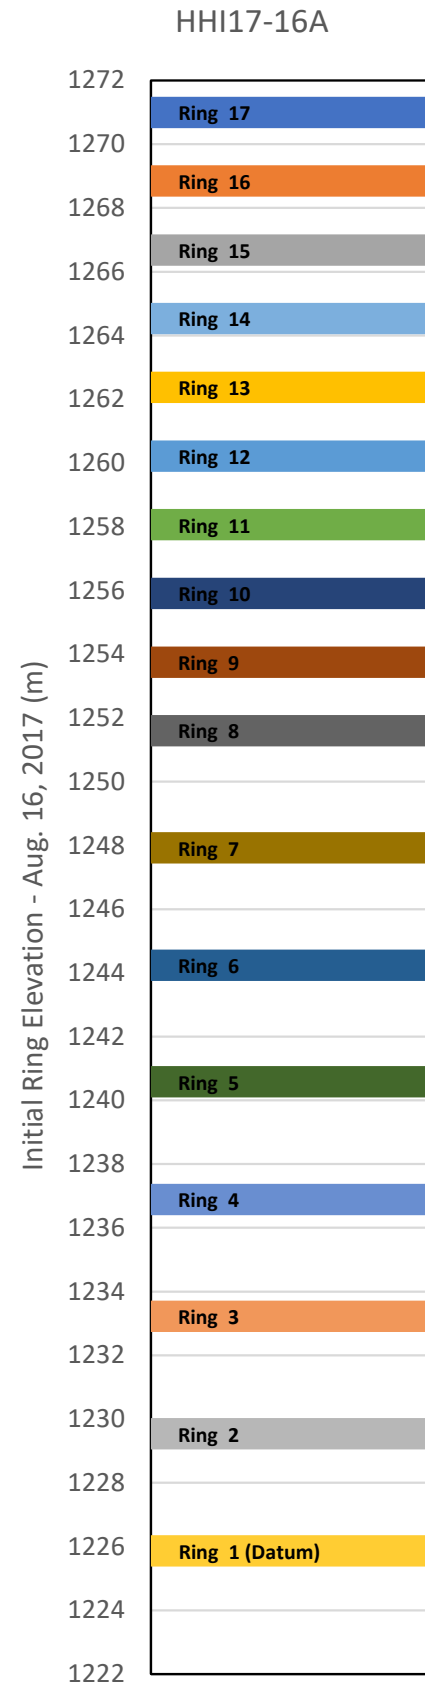
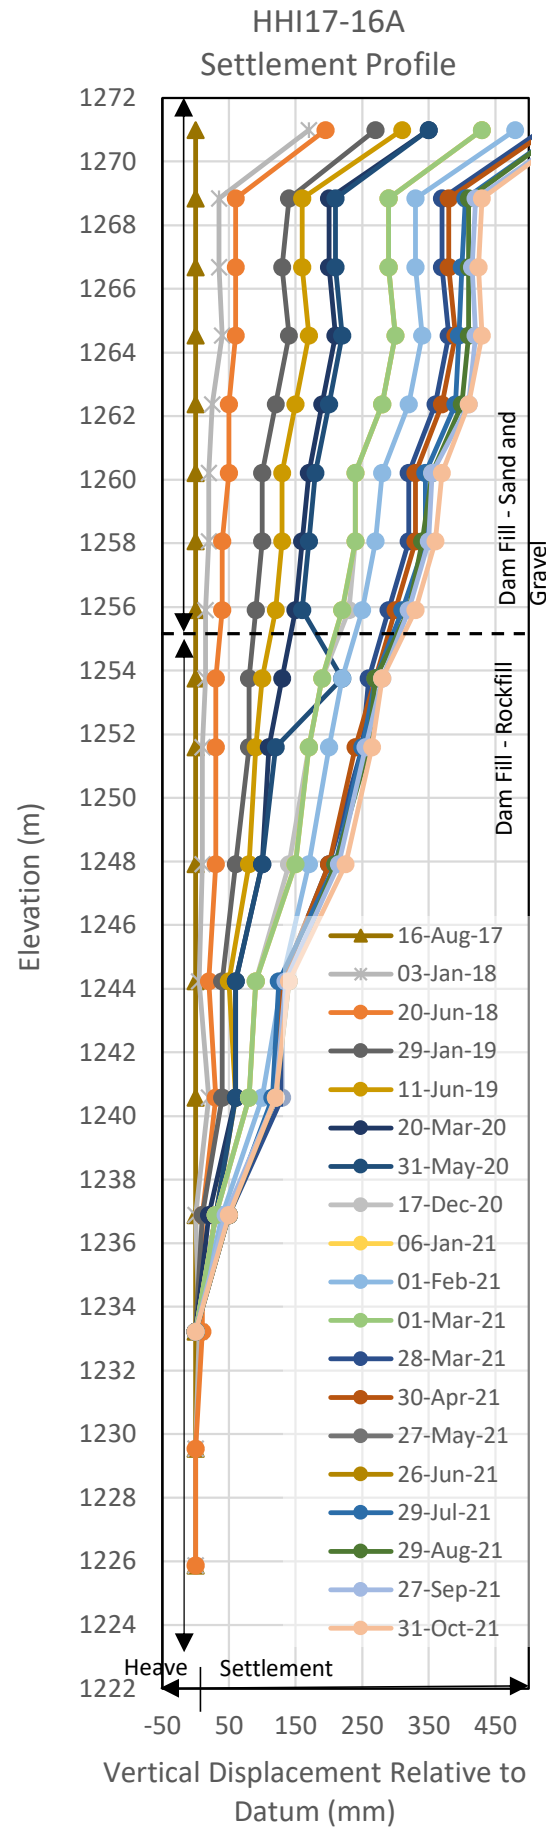
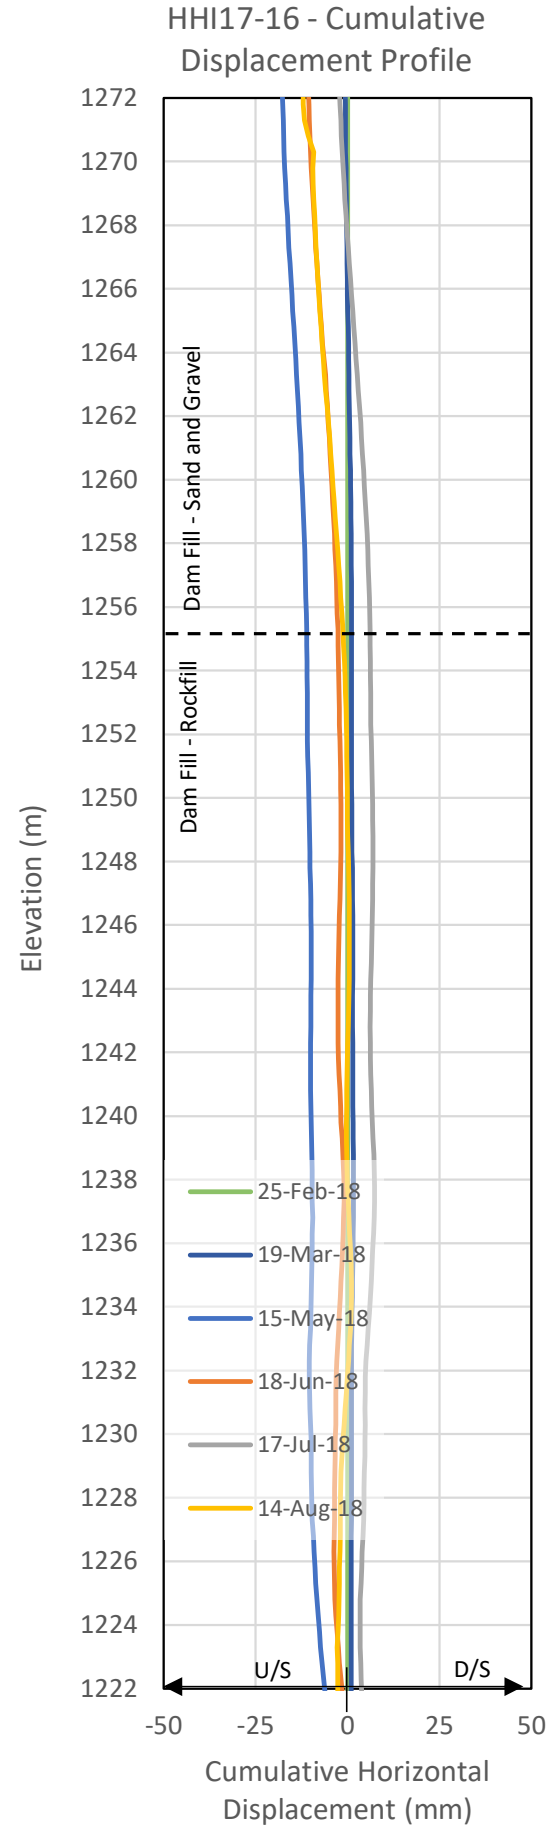
H-H DAM VERTICAL  
DISPLACEMENTS  
HH17-16A (SONDEX) - NOVEMBER

1. RING DISPLACEMENTS ARE CALCULATED RELATIVE TO THE INITIAL ELEVATIONS FOR EACH RING. THE DATUM IS THE BOTTOM RING (RING 1).
2. POSITIVE DISPLACEMENTS REPRESENT SETTLEMENT. NEGATIVE DISPLACEMENTS REPRESENT HEAVE.
3. DATA FROM NOVEMBER 28, 2021 WERE NOT CONSISTENT WITH OTHER READINGS AND ARE NOT SHOWN HERE.
4. NO READINGS RECORDED FOR RING 1 AND 2 AFTER OCTOBER 09, 2018

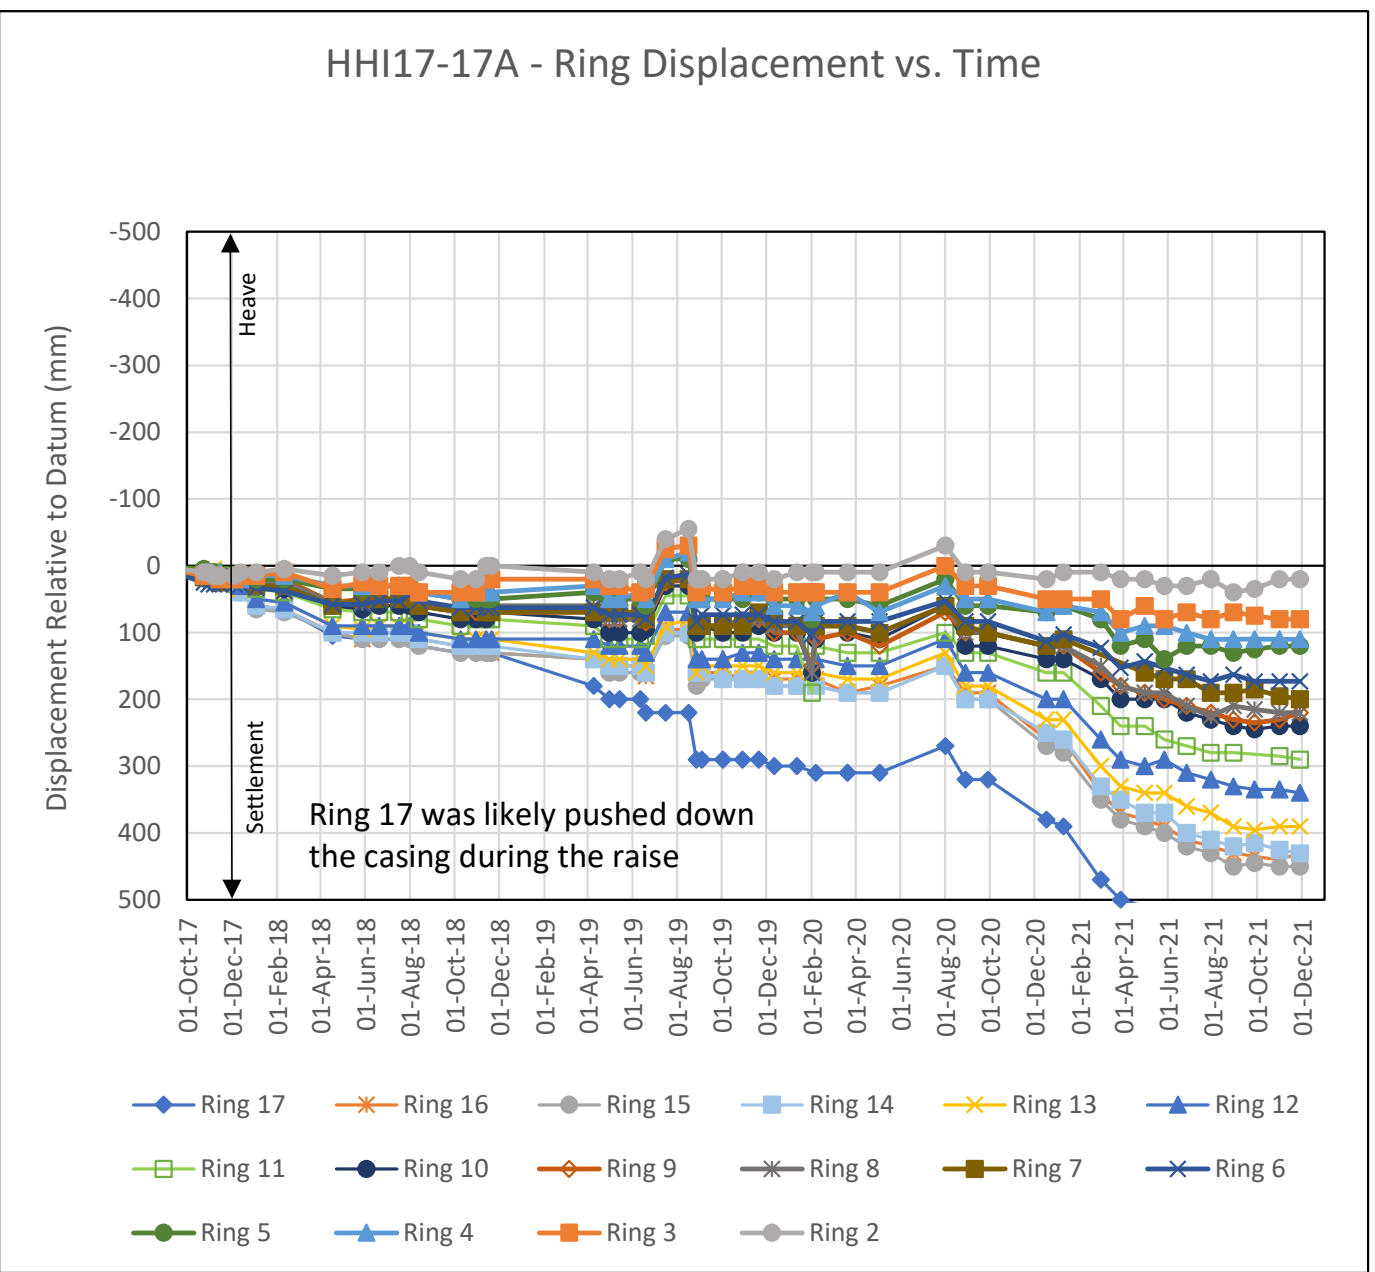
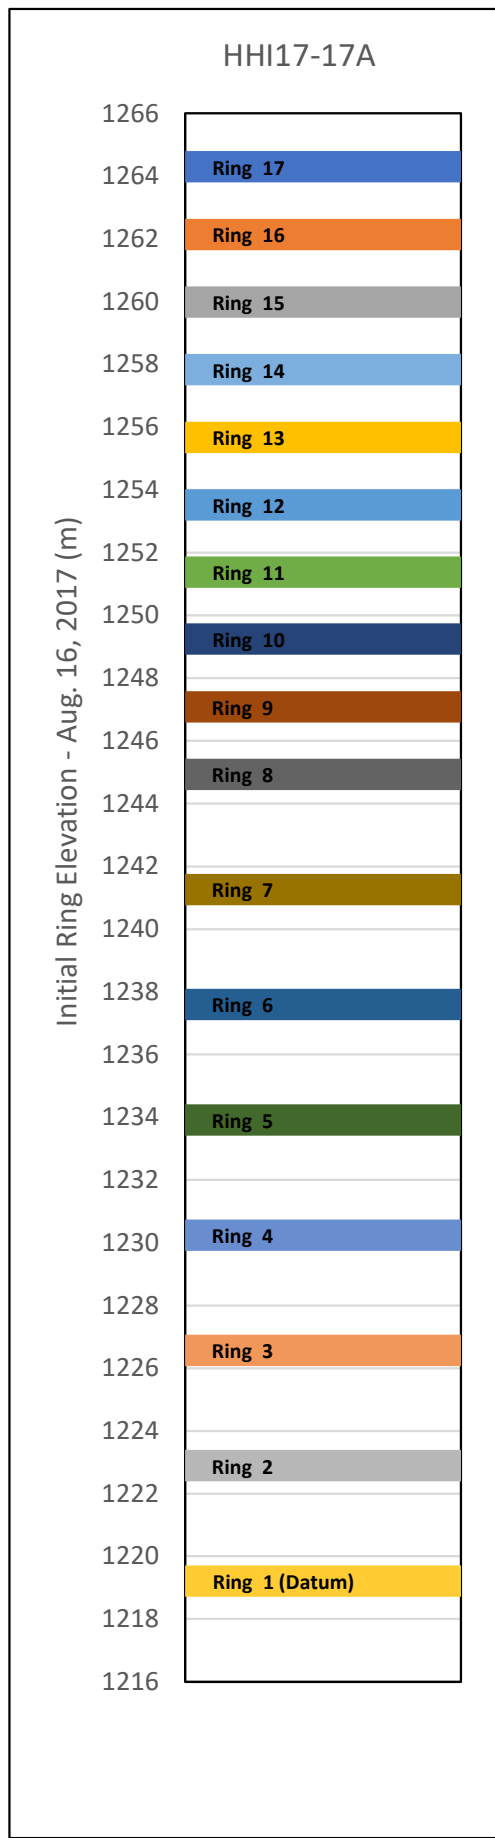
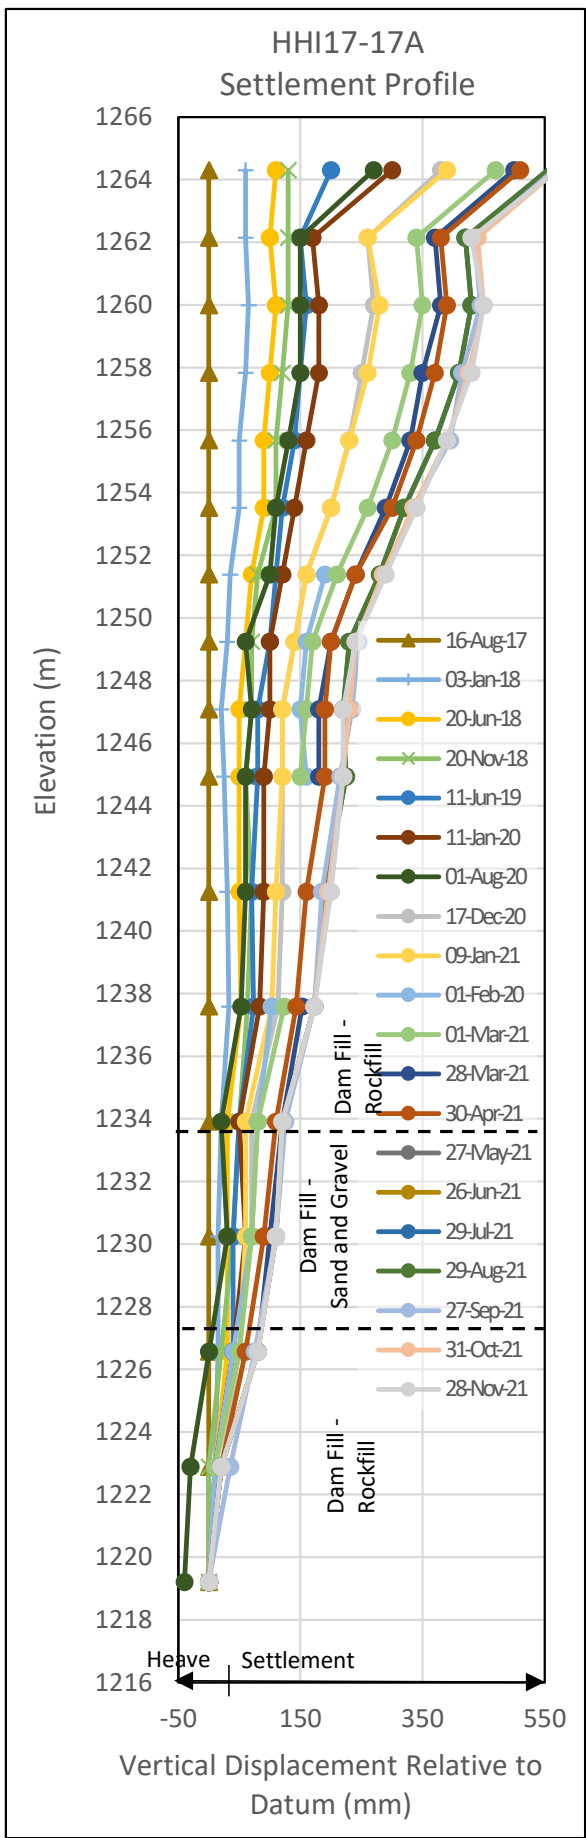
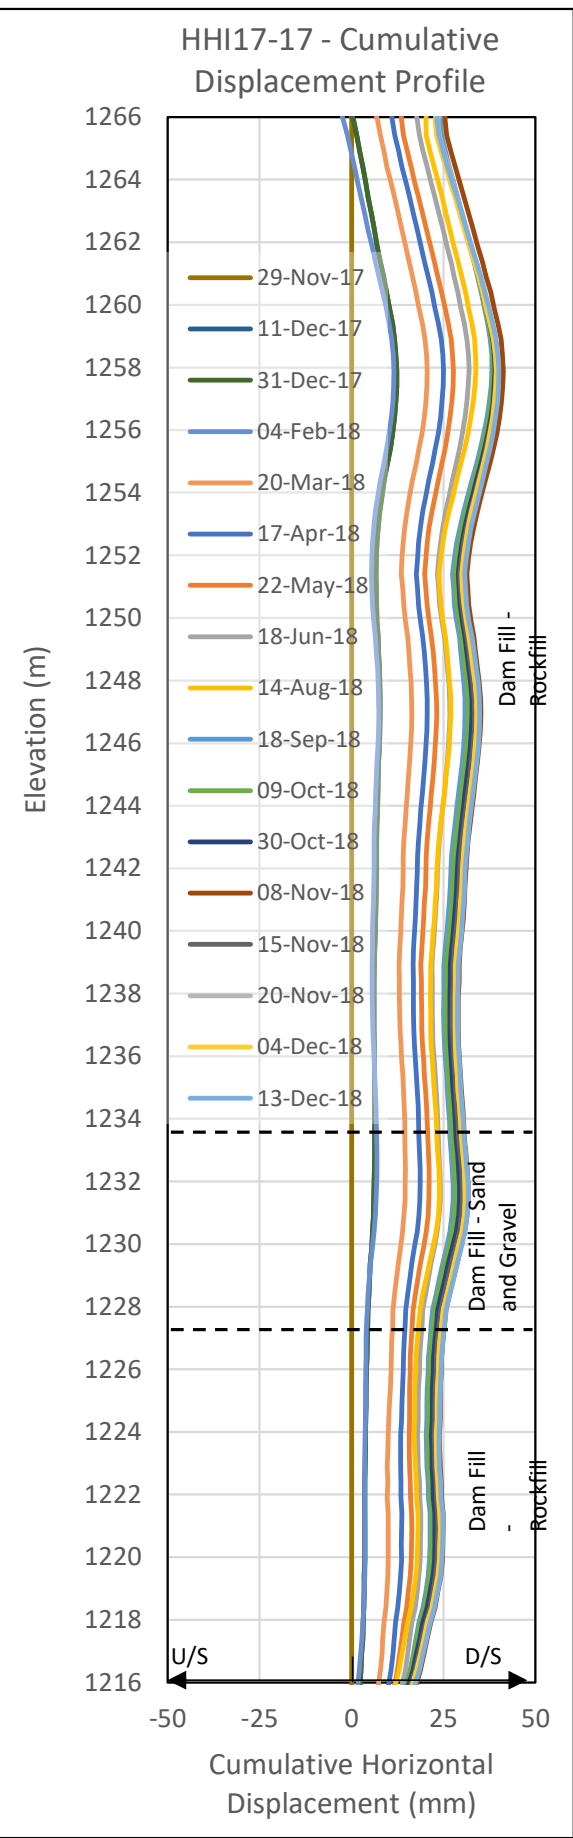
H-H DAM VERTICAL  
DISPLACEMENTS  
HH17-17A(SONDEX) - NOVEMBER

1. RING DISPLACEMENTS ARE CALCULATED RELATIVE TO THE INITIAL ELEVATIONS FOR EACH RING. THE DATUM IS THE BOTTOM RING (RING 1).
2. POSITIVE DISPLACEMENTS REPRESENT SETTLEMENT. NEGATIVE DISPLACEMENTS REPRESENT HEAVE.
3. THE FOLLOWING READINGS WERE NOT CONSISTENT WITH TRENDS AND ARE NOT SHOWN HERE:
  - RING 7 (FEBRUARY 1 TO MARCH 28, 2020)
  - RINGS 11-17 (FEBRUARY 1, 2020)

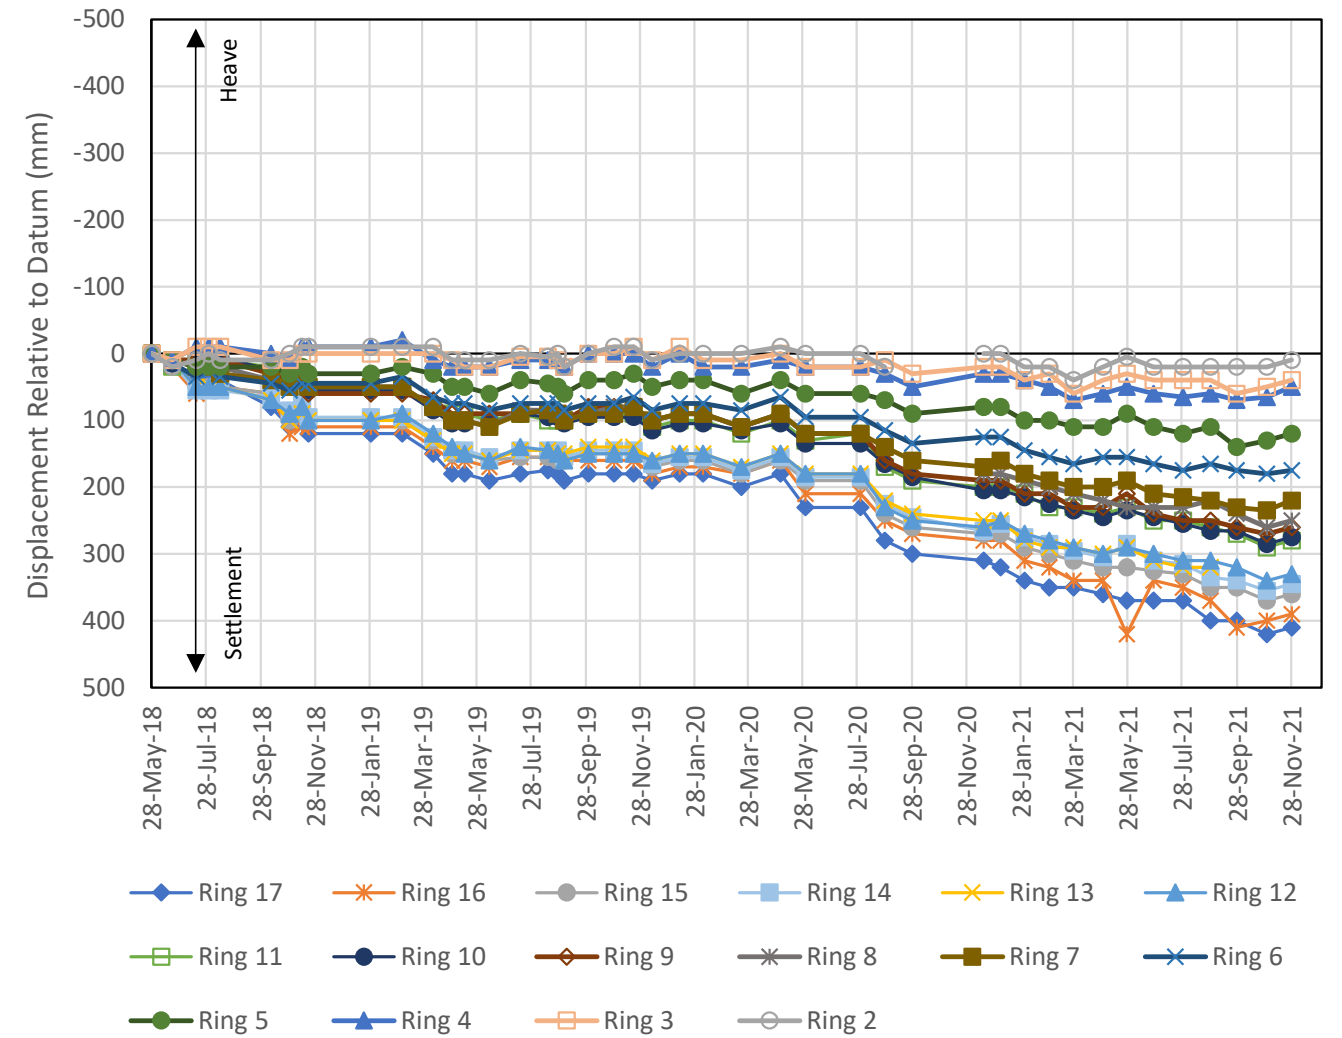
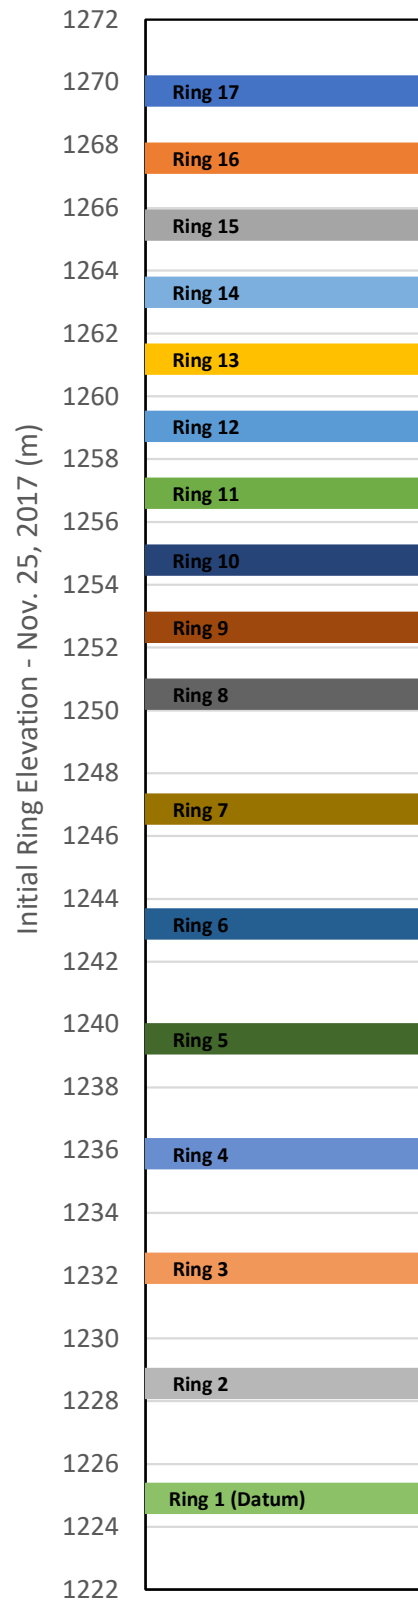
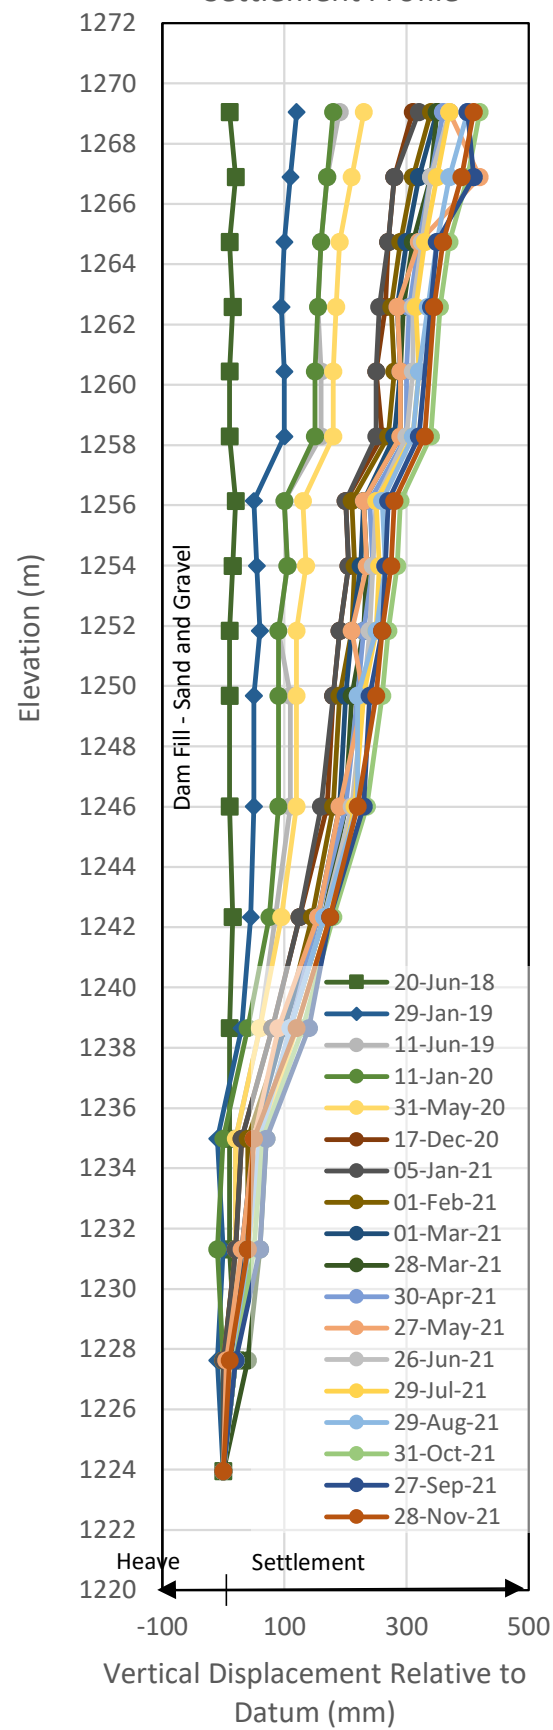
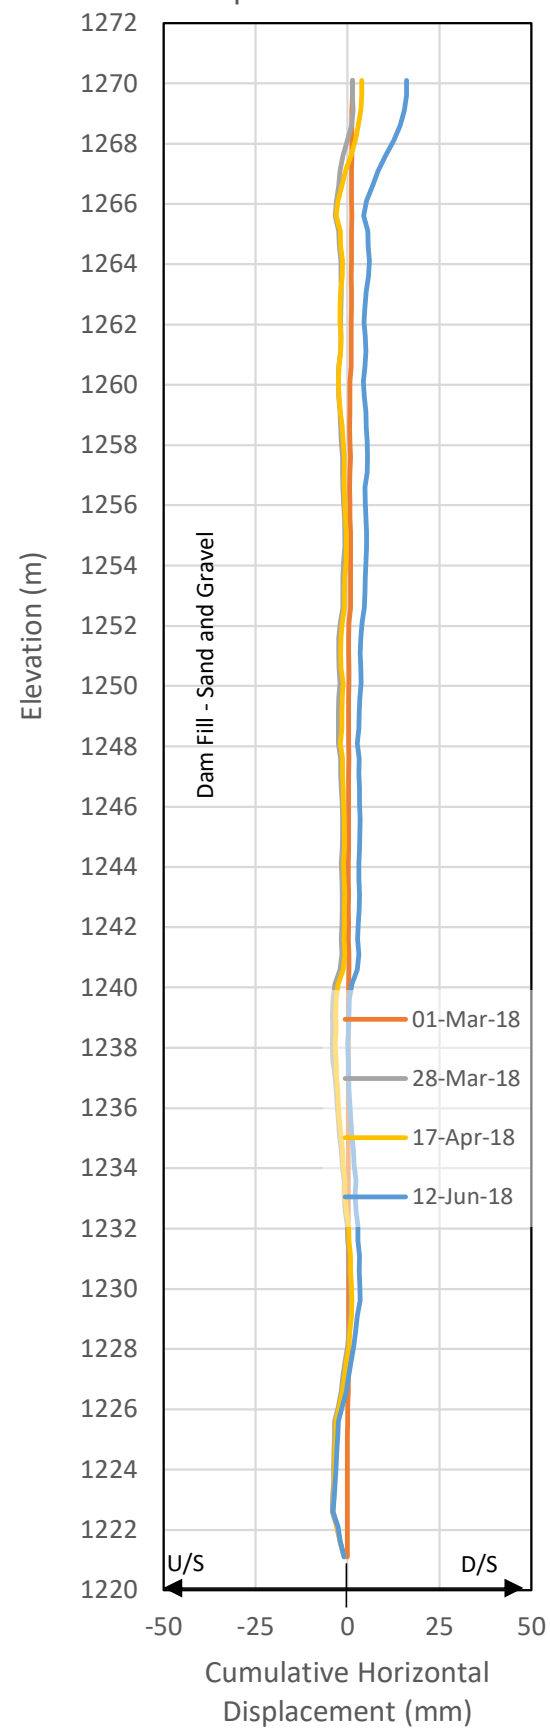
HHI17-32A

1. RING DISPLACEMENTS ARE CALCULATED RELATIVE TO THE INITIAL ELEVATIONS FOR EACH RING. THE DATUM IS THE BOTTOM RING (RING 1).
2. POSITIVE DISPLACEMENTS REPRESENT SETTLEMENT. NEGATIVE DISPLACEMENTS REPRESENT HEAVE.
3. RING 13 READINGS FROM SEPTEMBER 27, 2021 TO NOVEMBER 28, 2021 WERE NOT CONSISTENT WITH PREVIOUS TRENDS AND ARE NOT SHOWN HERE.
4. THE BASELINE READING OF VERTICAL DISPLACEMENT PLOT IS MAY 28, 2018.
