# **Teck Highland Valley Copper Partnership**

## **2021 Annual Facility Performance Report**

### ***Highland Tailings Storage Facility***

March 2022

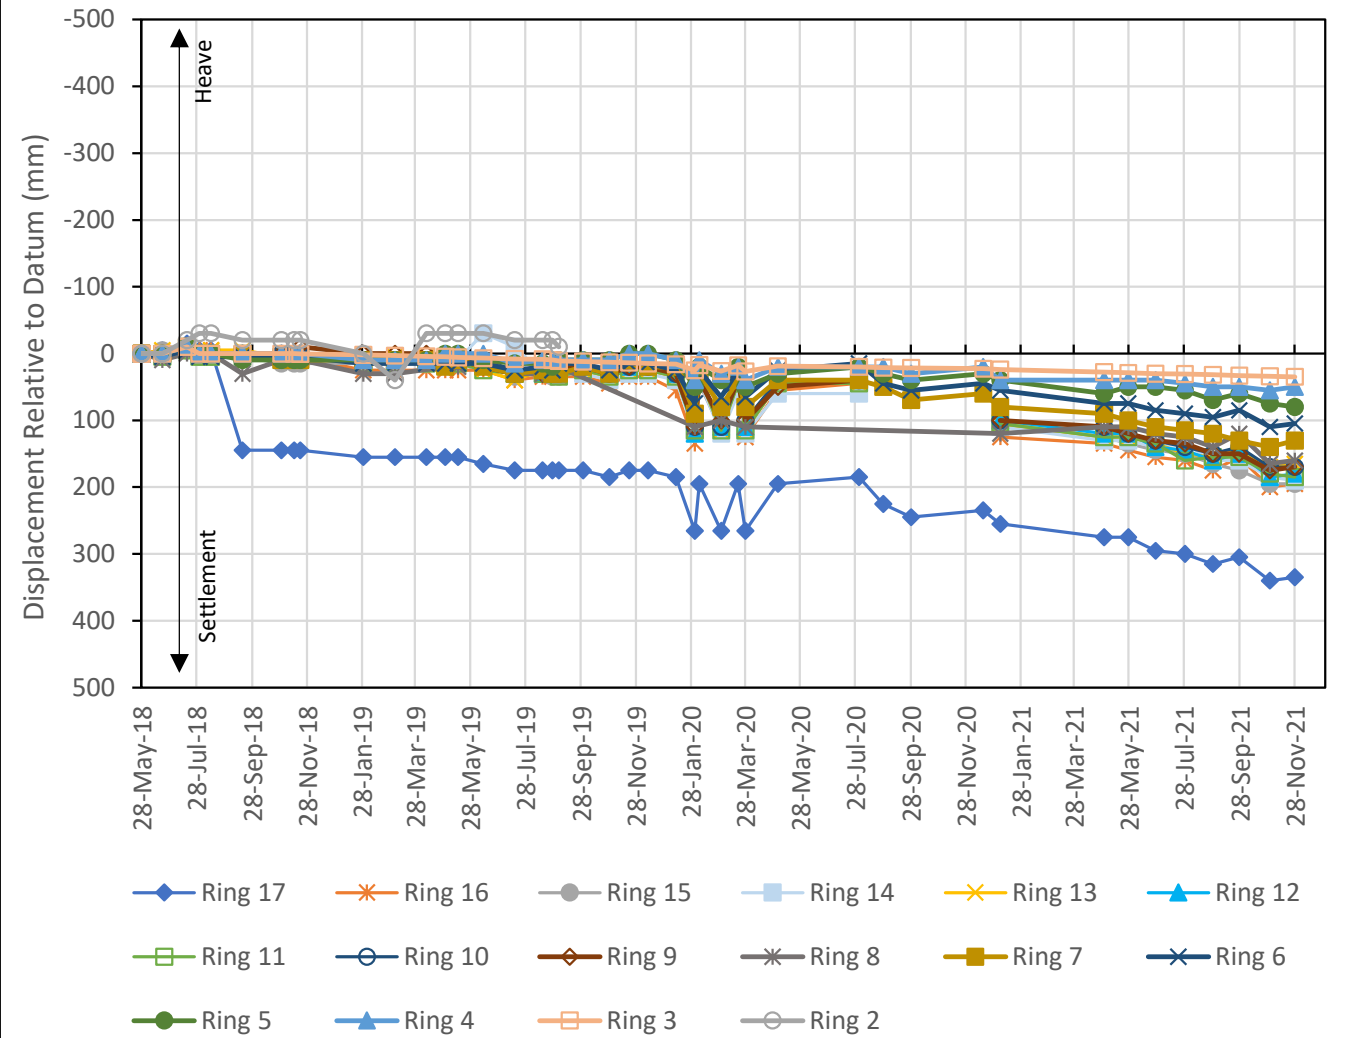
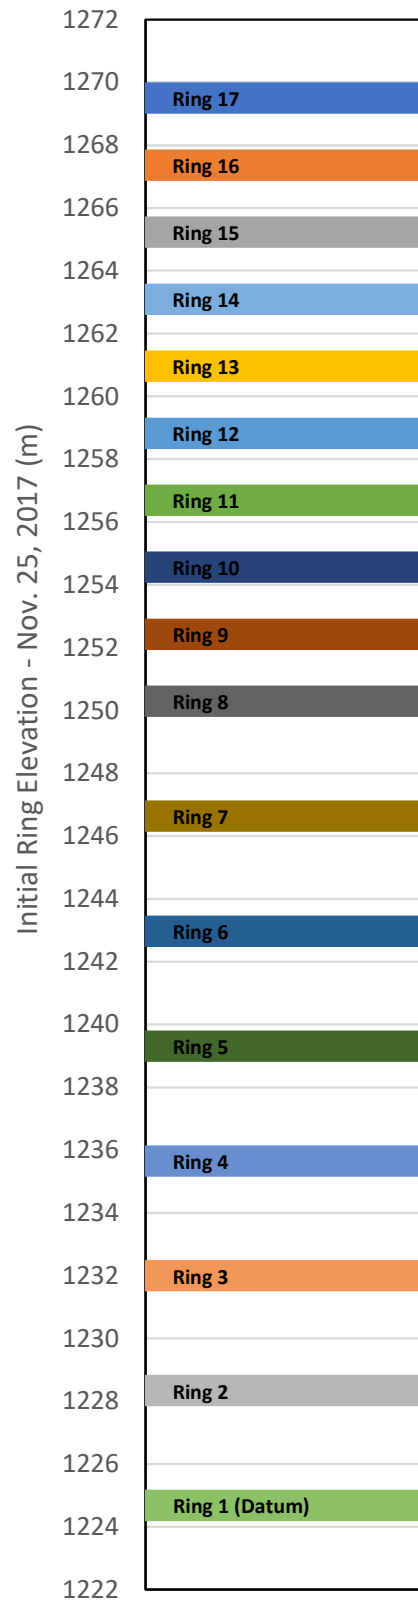
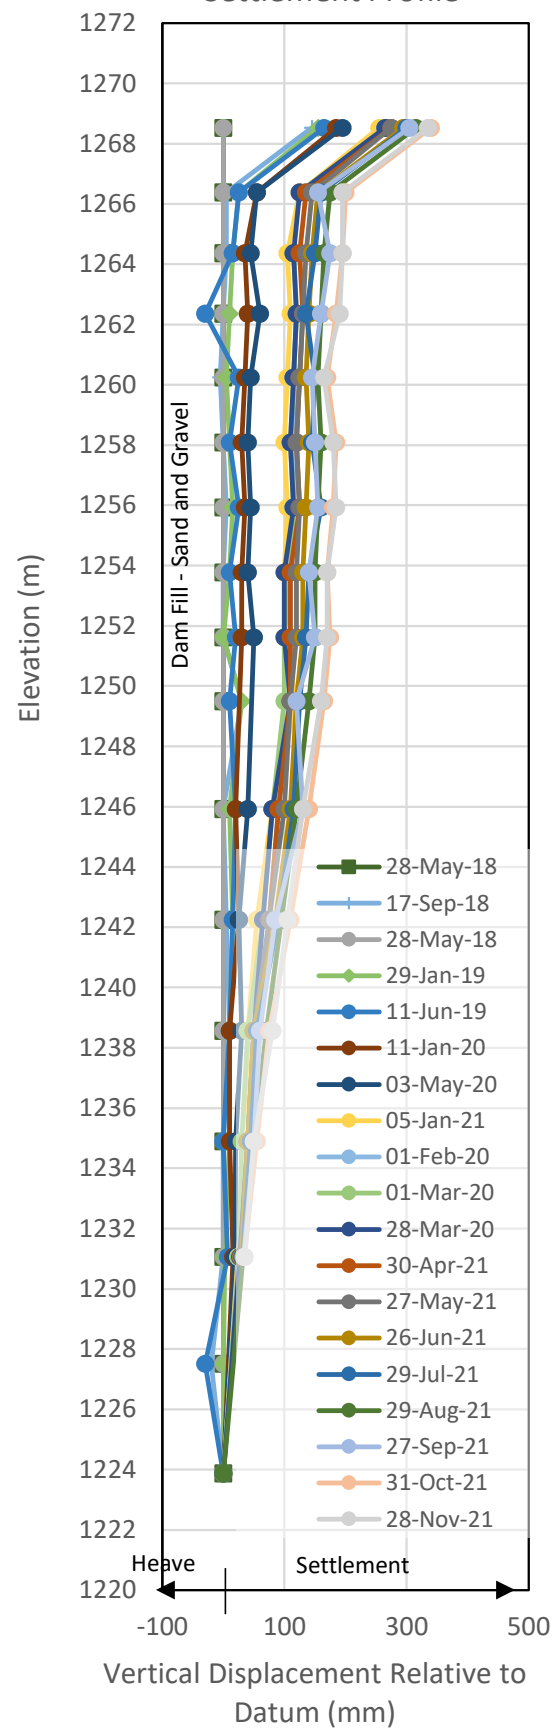
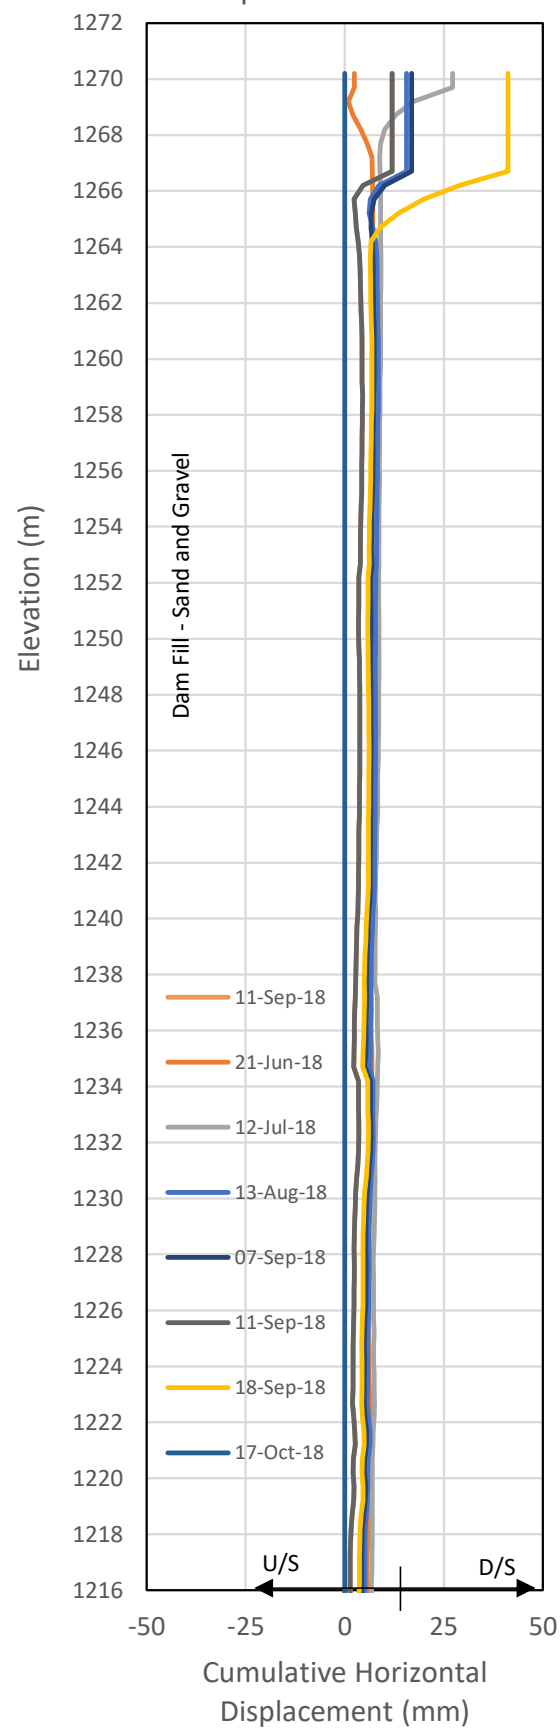
HHI17-33A

1. RING DISPLACEMENTS ARE CALCULATED RELATIVE TO THE INITIAL ELEVATIONS FOR EACH RING. THE DATUM IS THE BOTTOM RING (RING 1).
2. POSITIVE DISPLACEMENTS REPRESENT SETTLEMENT. NEGATIVE DISPLACEMENTS REPRESENT HEAVE.
3. DATA FROM AUGUST 28, 2020, SEPTEMBER 28, 2020 AND DECEMBER 17, 2020 APPEARED TO BE OUTLIERS AND ARE NOT SHOWN HERE.

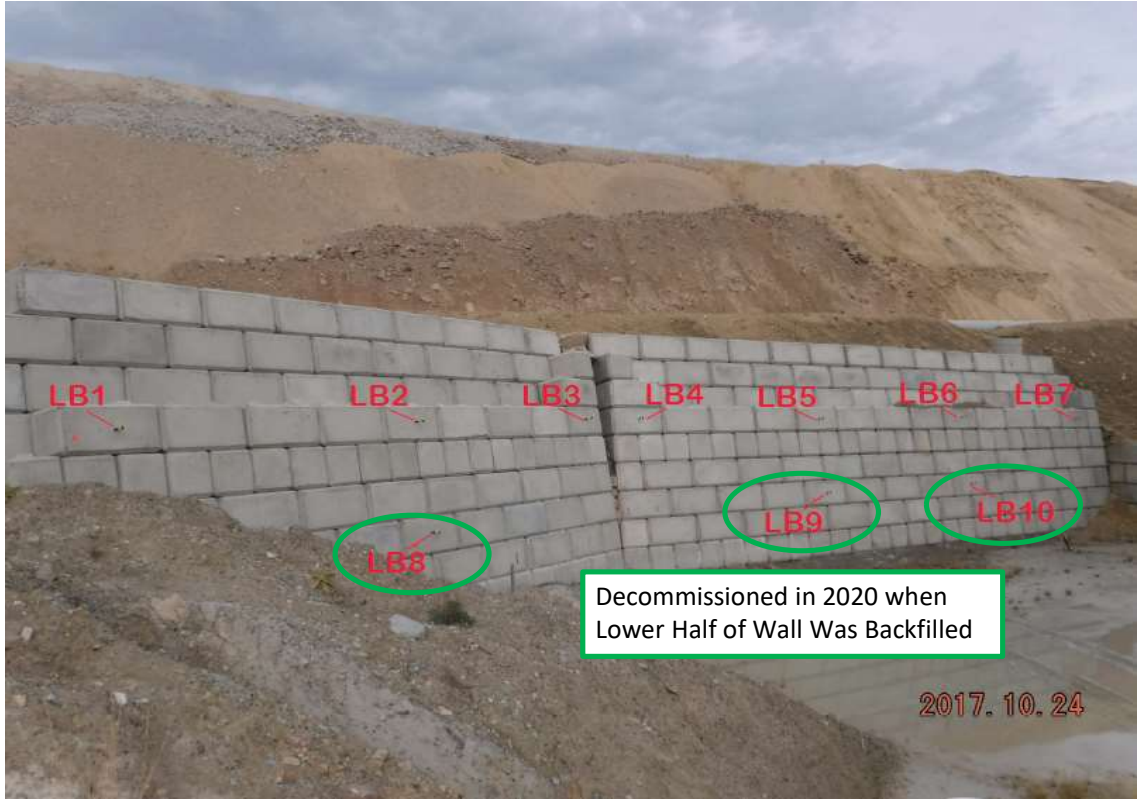
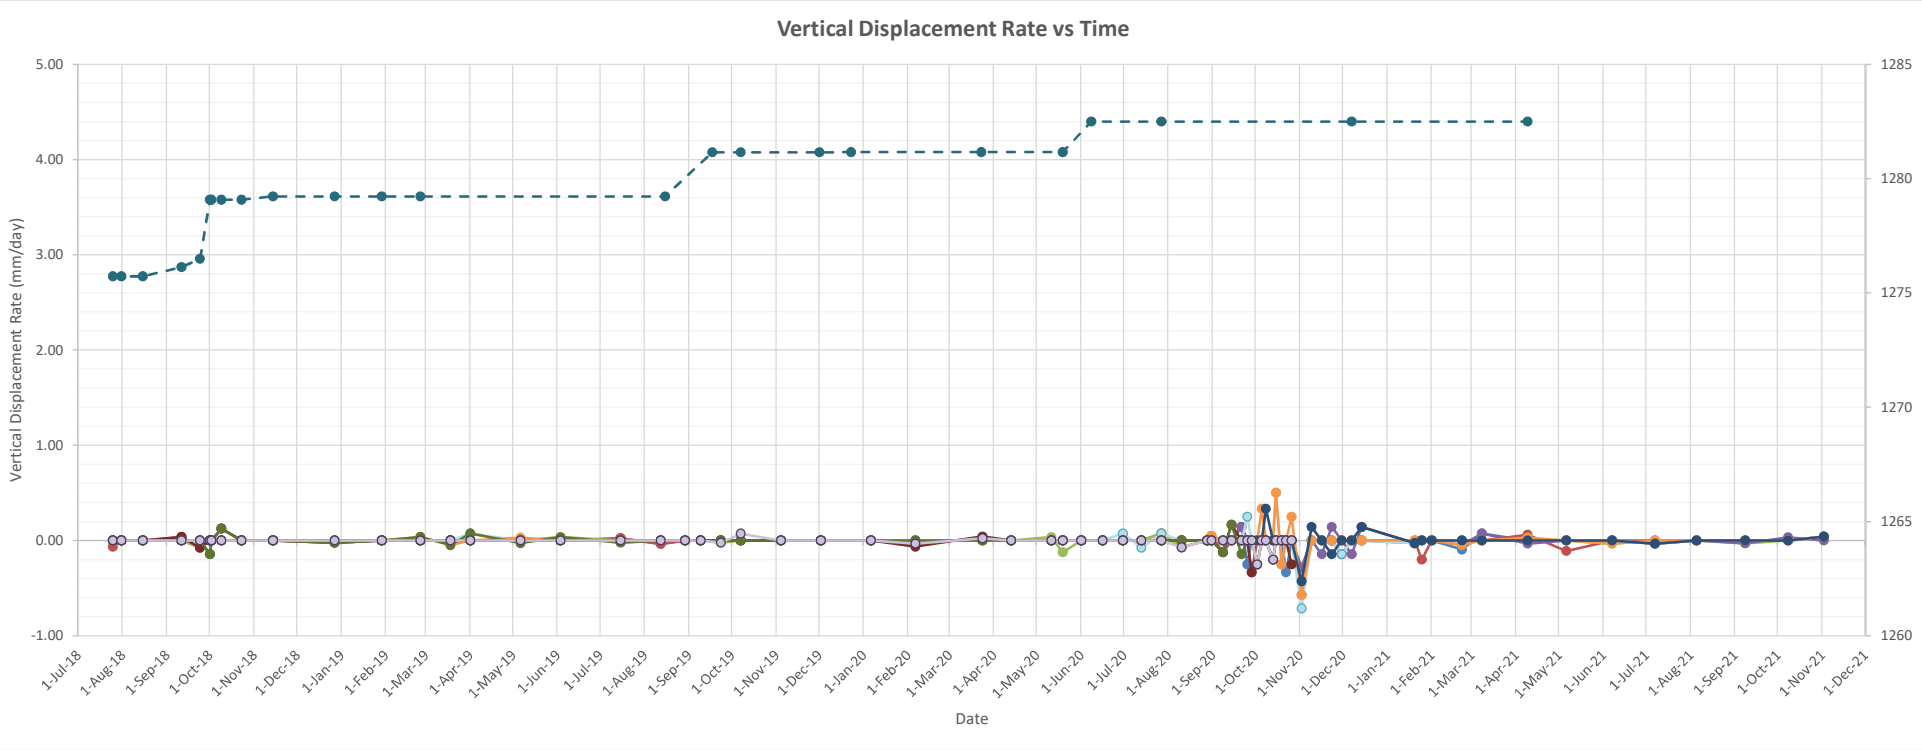
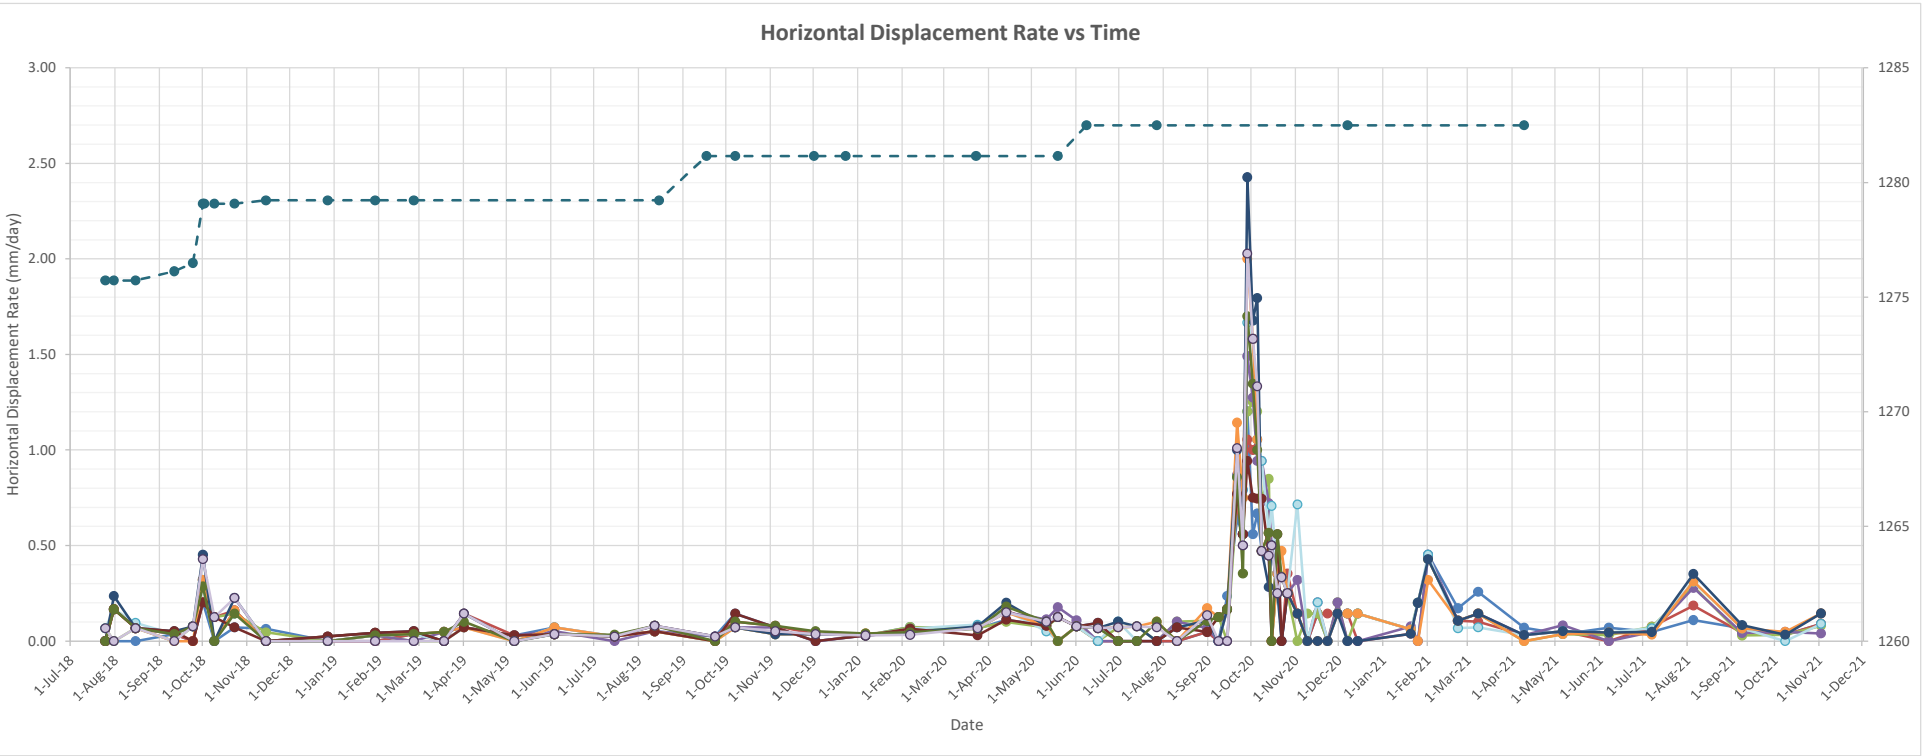
### **H-H Dam Monument Data**

1. ALL DATA PROVIDED BY THVCP.
2. TILL CORE RAISE TIMELINE IS APPROXIMATE.
3. LB8, LB9, AND LB10 BURIED BY BUTTRESSING AT THE BOTTOM OF LOCK BLOCK WALL.

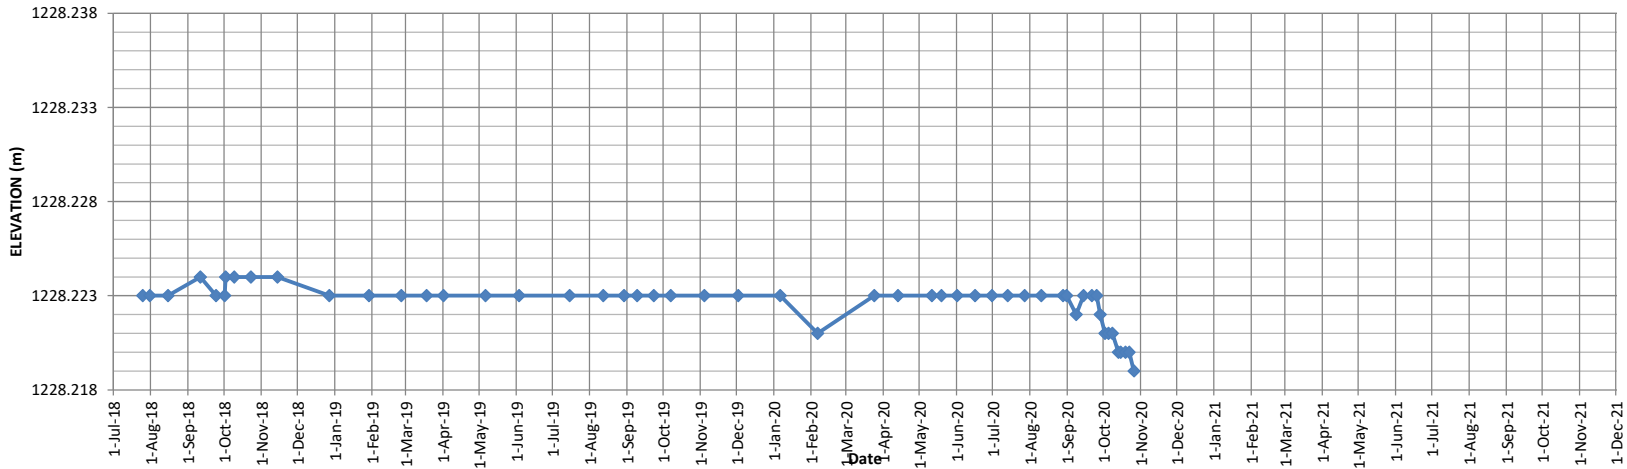
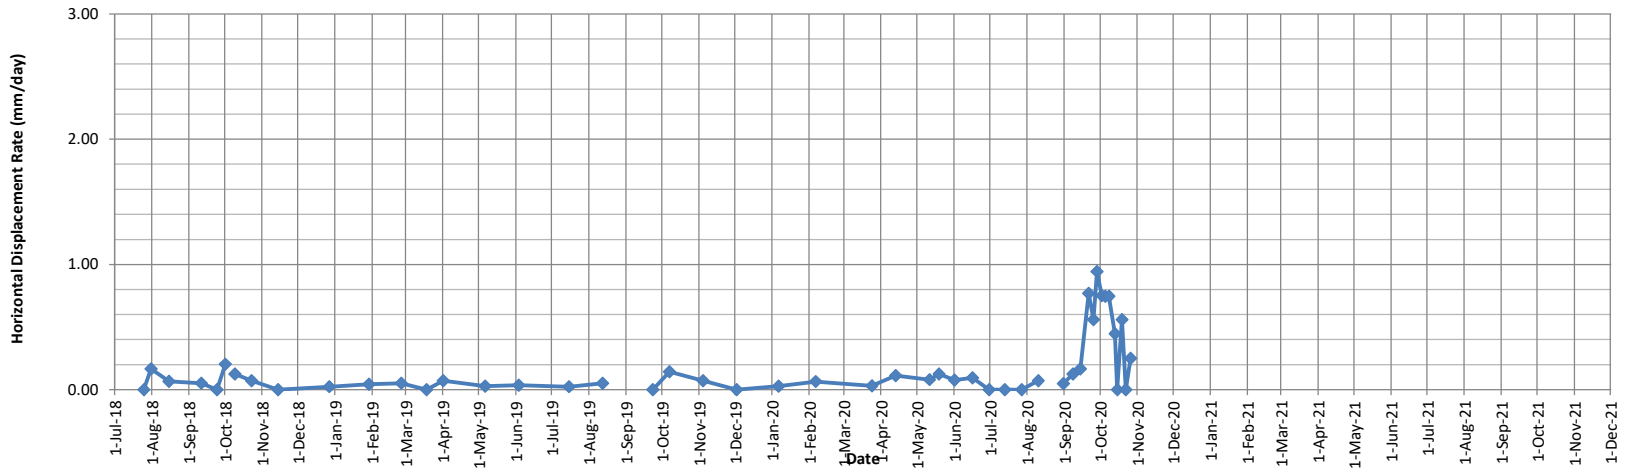
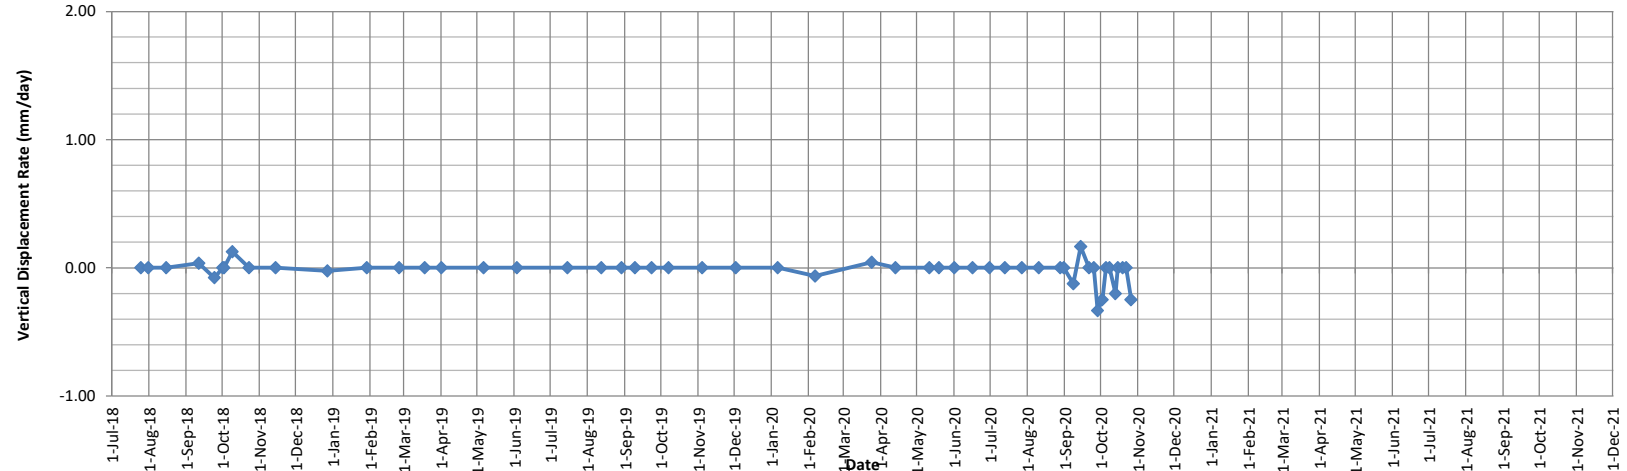
**LB8 - Elevation vs Time**

1. ALL DATA PROVIDED BY THVCP.
2. LB08 BURIED BY BUTTRESSING AT THE BOTTOM OF LOCK BLOCK WALL.

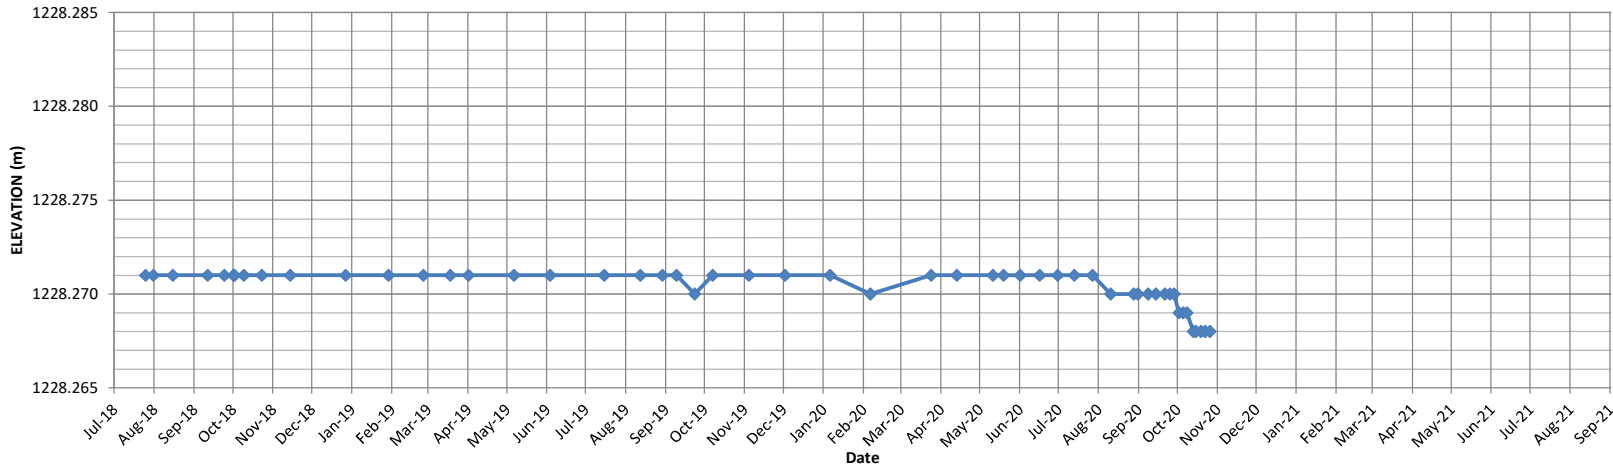
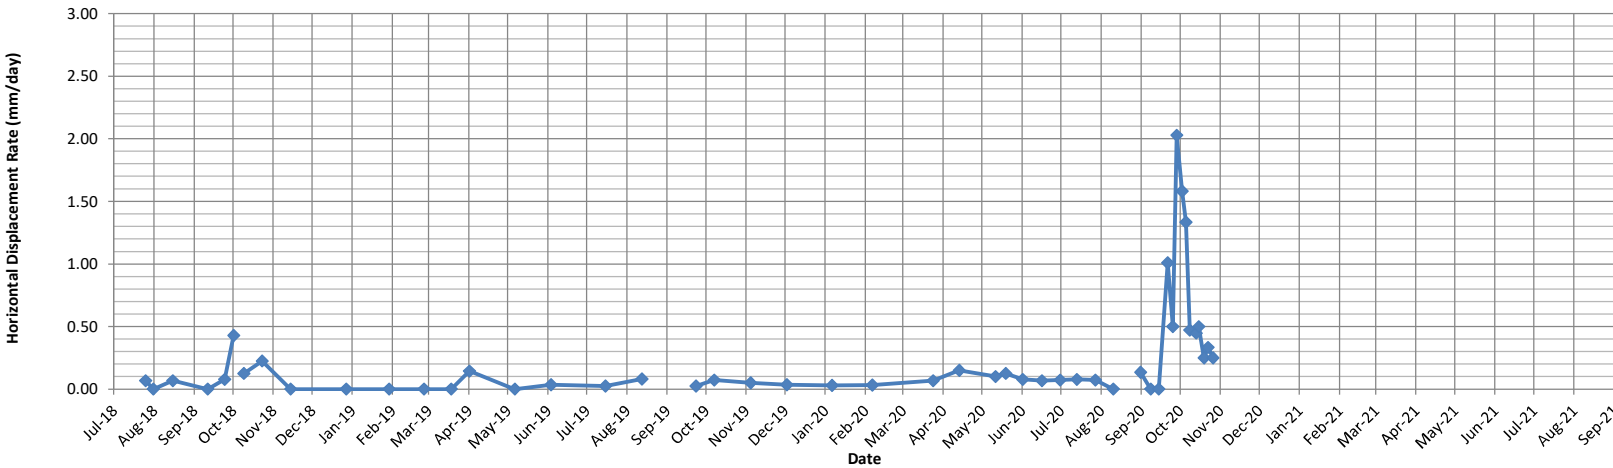
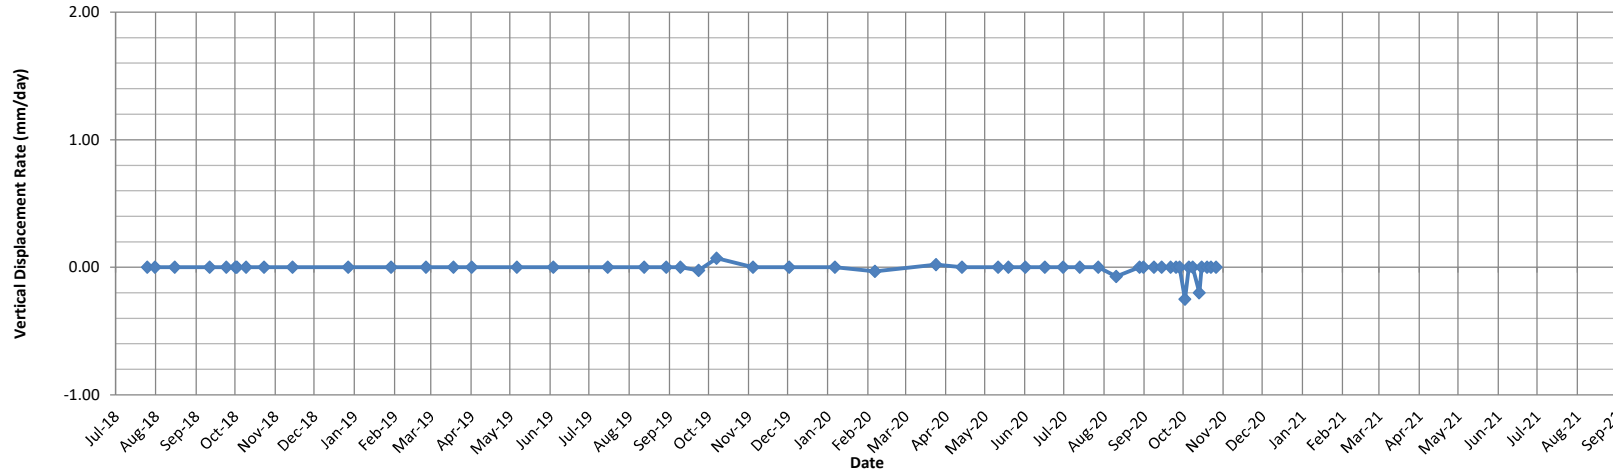
**LB10 - Elevation vs Time**

1. ALL DATA PROVIDED BY THVCP.
2. LB10 BURIED BY BUTTRESSING AT THE BOTTOM OF LOCK BLOCK WALL.
