Teck Highland Valley Copper Partnership

2021 Annual Facility Performance Report

7-Day Pond Tailings Storage Facility

March 2022

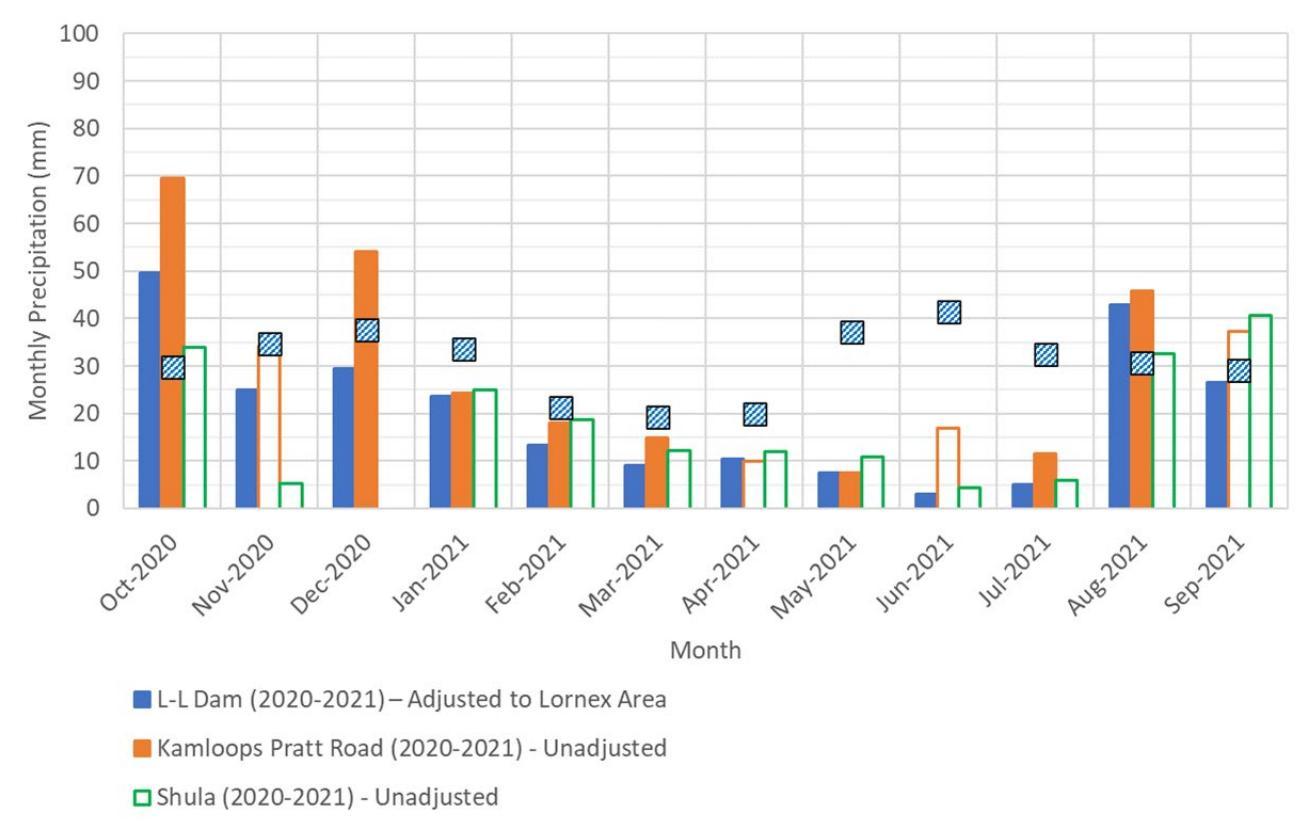
Figure 4.1 Monthly Precipitation

- In Figure 4.1, all months, except for October 2020 and August 2021 reported 9% to 93% decreases relative to average precipitation. October 2020 precipitation increased 67% relative to the historic normals; August 2021 precipitation increased 40%.

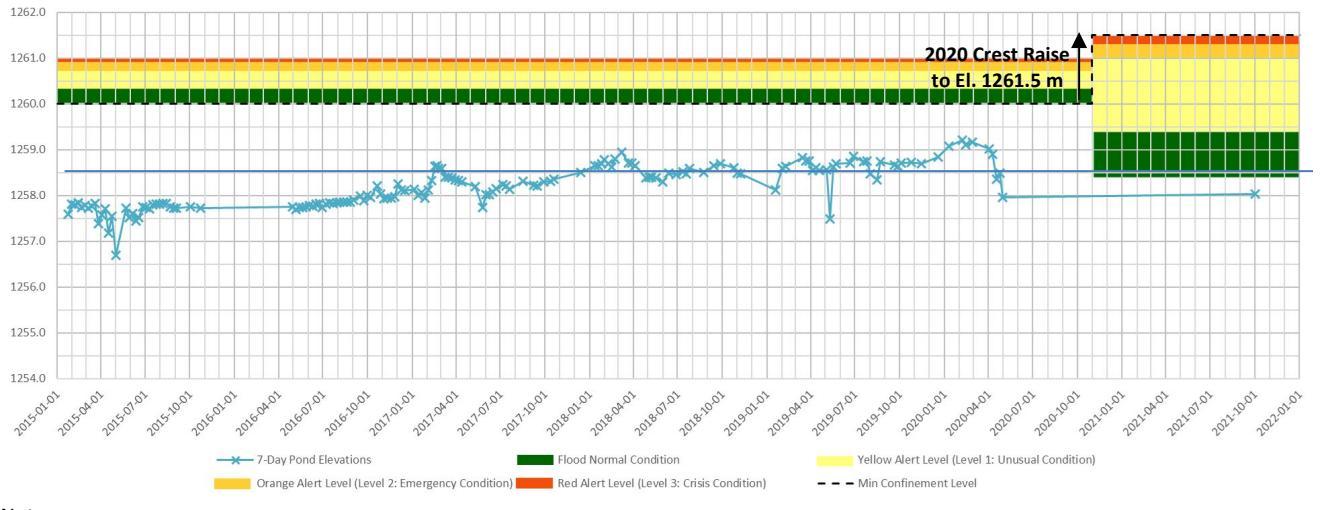
Figure 5.1 7-Day Pond TSF Pond Levels with Alert Level Ranges

During the review period, HVC has managed to operate 7-Day Pond TSF with a minimal pond by use of the fixed pumping system installed in 2020. Key observations, based on historical pond levels and during the review period (Figure 5.1), are as follows:

Notes: 1. In Figure 5.1, the shift in alert levels due to the crest raise is shown for reference.
