Teck Highland Valley Copper Partnership

2021 Annual Facility Performance Report

Trojan Tailings Storage Facility

March 2022

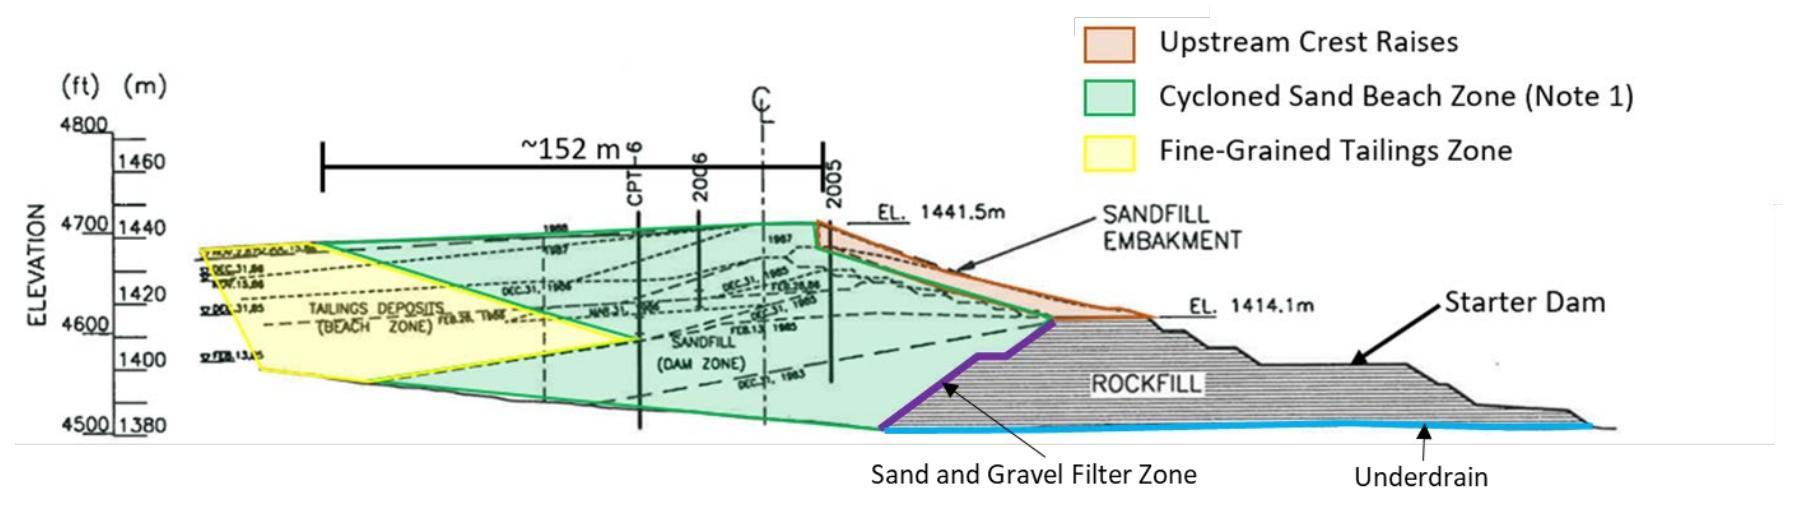
Figure 2.1 Typical Cross Section of Trojan Dam

4. These slopes are shallower than those on design drawings (KL 1987) showing cycloned sand slopes on the upper face of the dam at 3H:1V and steeper but unspecified slopes on the rockfill toe face. However, the design drawings also show raises that were never constructed.

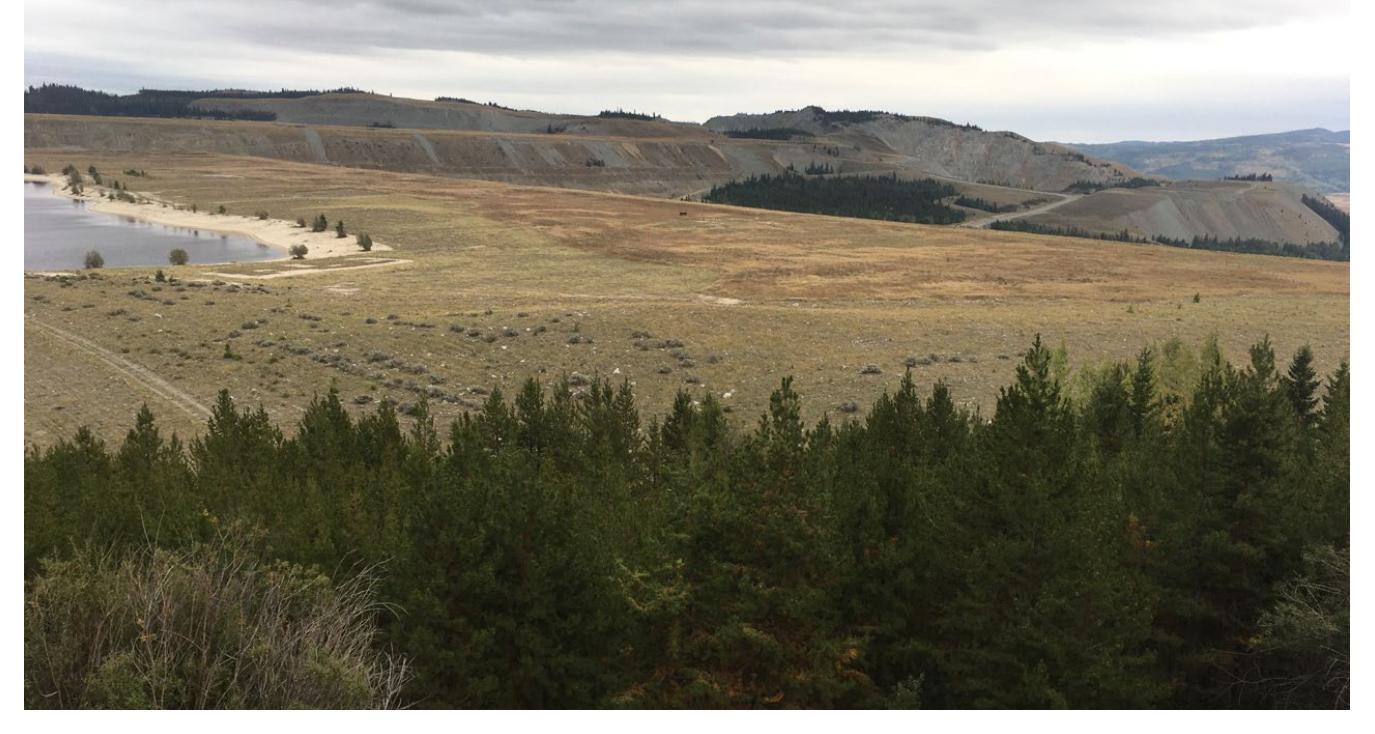
Photo I-A-3 Overview of Trojan Tailings Pond. Sand beach is exposed. Spillway inlet is visible. Debris boom is secured (TRJ-2021-03)

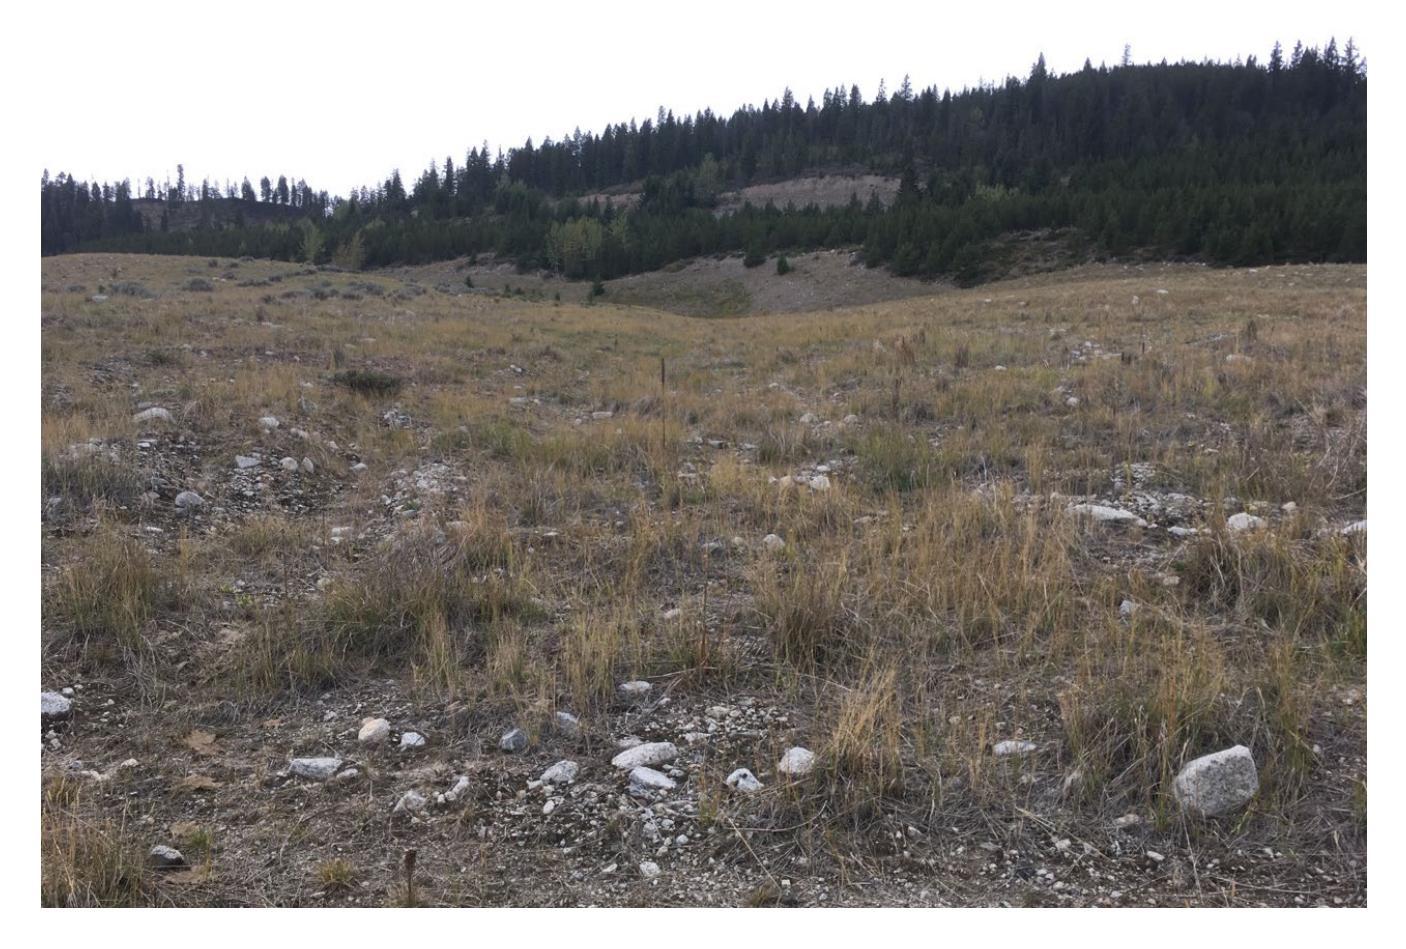
Photo I-A-6 Overview of upper segment of spillway, downstream of approach channel, looking toward southwest (top photo) and looking toward northeast (bottom photo). No sign of weathering/disruption of riprap was observed. No evidence of sloughing of cut slopes was observed. Channel is heavily vegetated with shrubs and bushes. In December 2020, THVCP received permit approvals to clear vegetation so the work can be included in routine maintenance.

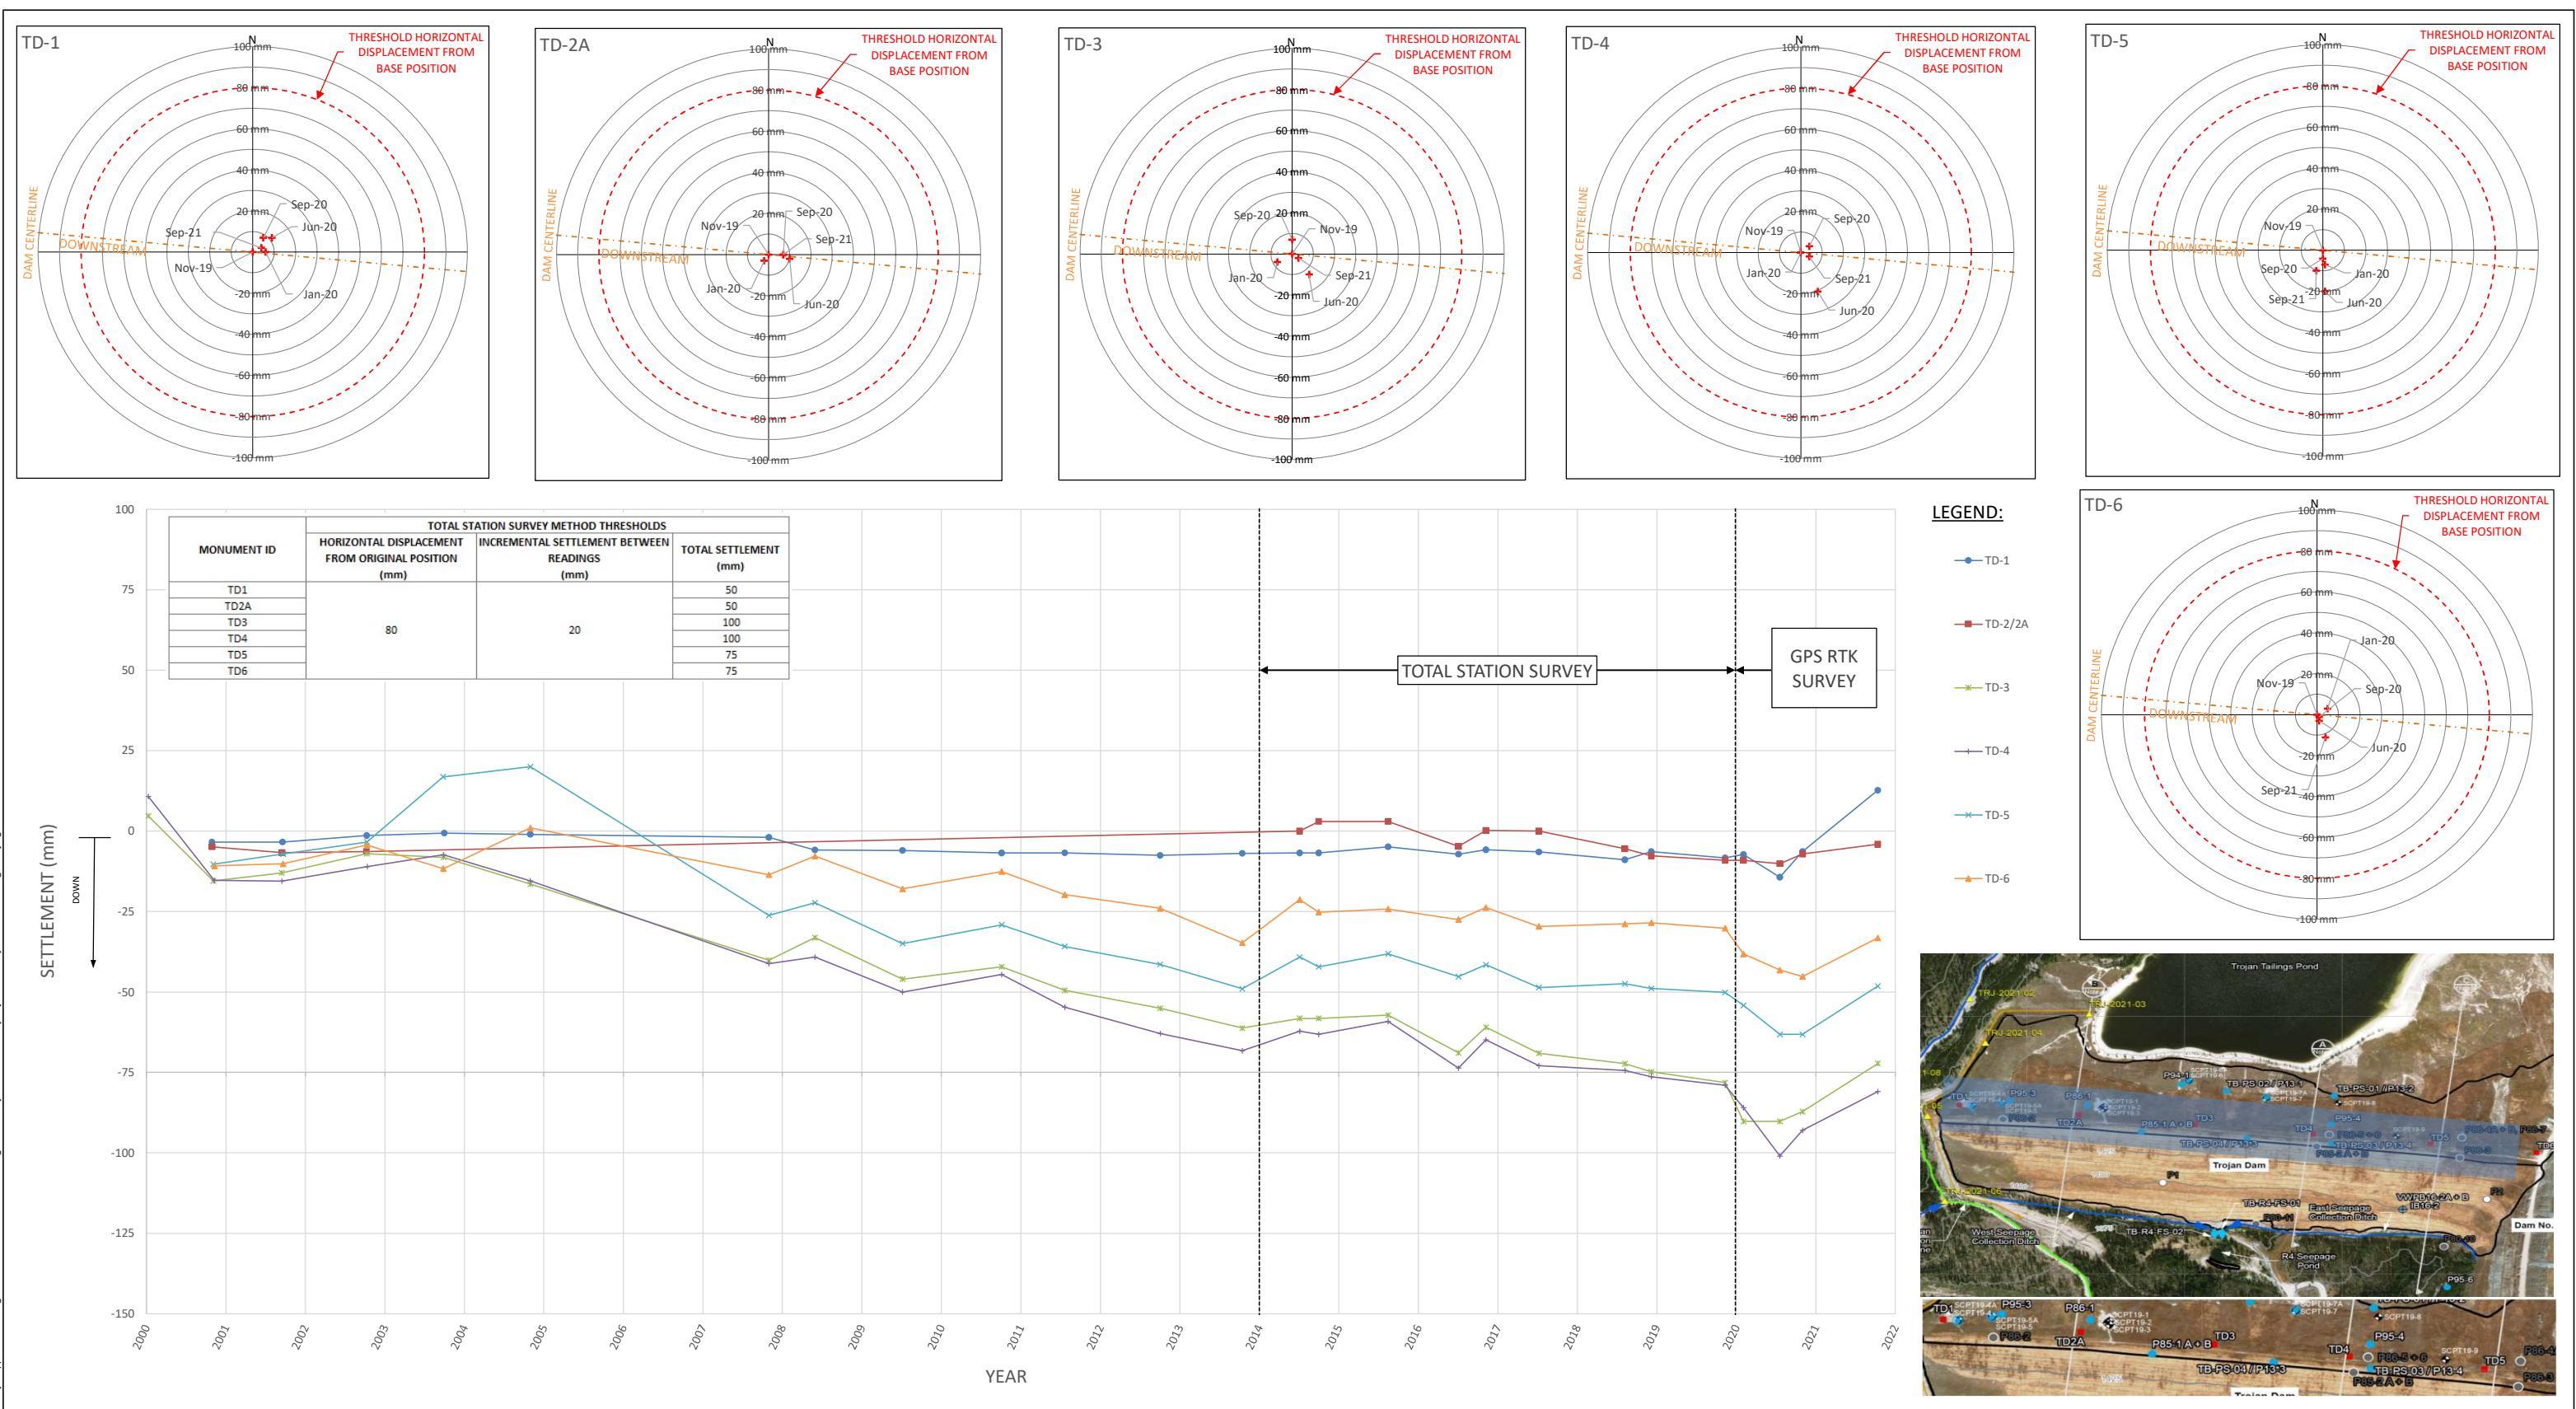
II-B-4

Survey of the monuments at the Trojan TSF (Figure 3), since November 2019, are plotted on Figure II-B-4. In November 2019, HVC started to use GPS Real Time Kinematic (RTK) to survey the monuments which is an improvement over the previous method as readings are showing less variance with respect to Northing / Easting. The baseline location for each monument using the RTK method is offset from the previous method and for that reason surveys prior to November 2019 are not shown on the Northing / Easting plots. However, a continuous record of settlement has been maintained based on incremental change between RTK surveys. During 2021, there were no threshold value exceedances and the annual survey during the review period was within the cluster of previous readings and showing no prevalent deformation trend. Incremental vertical displacements are positive (i.e., uplift) which could be due to the vertical accuracy of RTK method. Overall magnitude of settlement to date is not impacting freeboard (Section 5.2) or other aspect of performance.
