Pine Point Mine Tailings Impoundment Area

2021 Annual Facility Performance Review

November 2, 2021

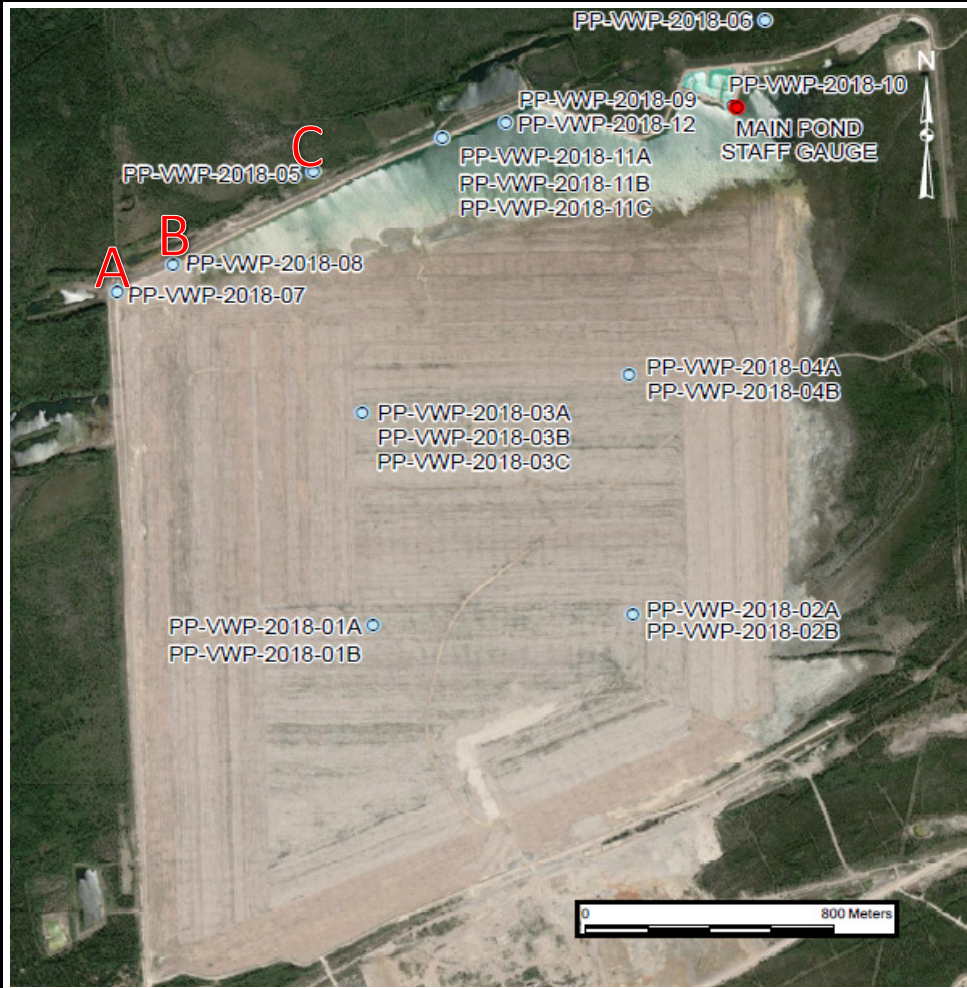
PROJECT	PINE POINT MINE TAILINGS IMPOUNDMENT AREA 2021 ANNUAL FACILITY PERFORMANCE REVIEW	
TITLE	NORTH DYKE PIEZOMETERS SHEET 1 OF 2	
PROJECT No.	M10397A01	FIG No. IV-1

- A** -Instrument PP-VWP-2018-07: Pressure head readings are negative. Piezometric levels cannot be determined from negative pressure readings.
- B** -Instrument PP-VWP-2018-08: Pressure head readings are negative. Piezometric levels cannot be determined from negative pressure readings.
- C** -Instrument PP-VWP-2018-05: Trigger action response plans (TARPS) are scheduled to be developed for this instrument. As such any malfunctioning instrument should be repaired or replaced (Golder, 2020)

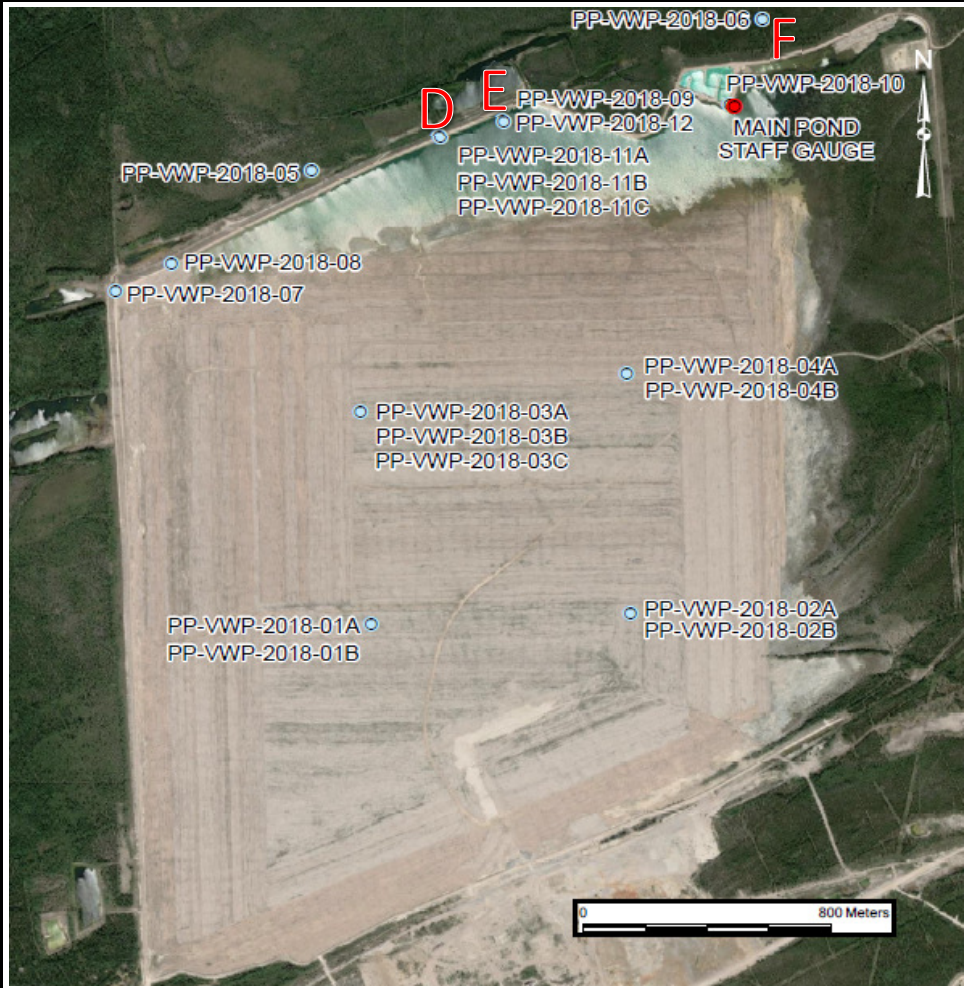
PROJECT	PINE POINT MINE TAILINGS IMPOUNDMENT AREA 2021 ANNUAL FACILITY PERFORMANCE REVIEW	
TITLE	NORTH DYKE PIEZOMETERS SHEET 2 OF 2	
PROJECT No.	M10397A01	FIG No. IV-2

- D** -Instrument PP-VWP-2020-11A: Pressure head readings equivalent to a piezometric surface on the order of 400 m elevation (omitted).
-Instrument PP-VWP-2020-11C: Single reading available for instrument.
- E** -Instrument PP-VWP-2018-09: Pressure head readings are negative. Piezometric levels cannot be determined from negative pressure readings.
- F** -Instrument PP-VWP-2018-06: Pressure readings stopped recording 2020-09-30.

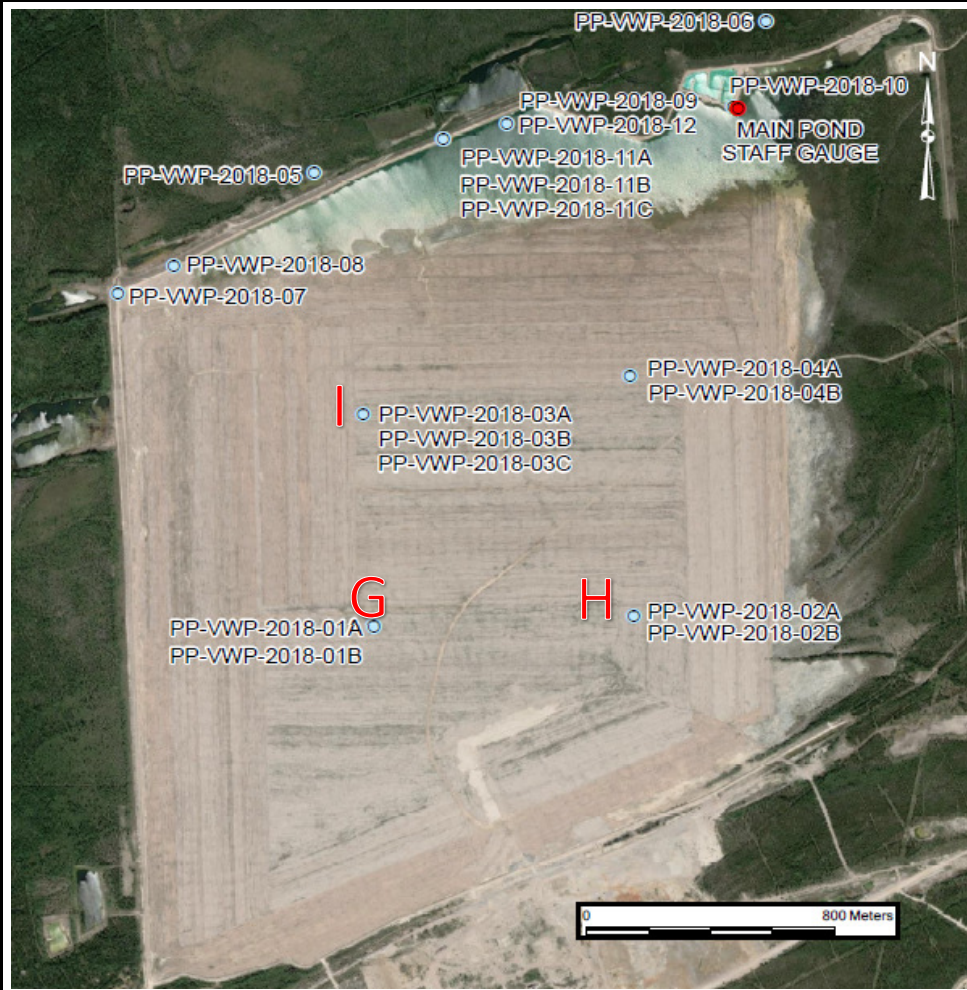
PROJECT No. M10397A01 FIG No. IV-3

- G** -Instrument PP-VWP-2018-01B: Considered not functioning as of 2020 DSI (Golder, 2020). Significant and instantaneous increase in pressure recorded is anomalous and unexplained.
- H** -Instrument PP-VWP-2018-02A and 02B: Considered not functioning as of 2020 DSI (Golder, 2020). Significant and instantaneous increase/decrease in pressure recorded is anomalous and unexplained.

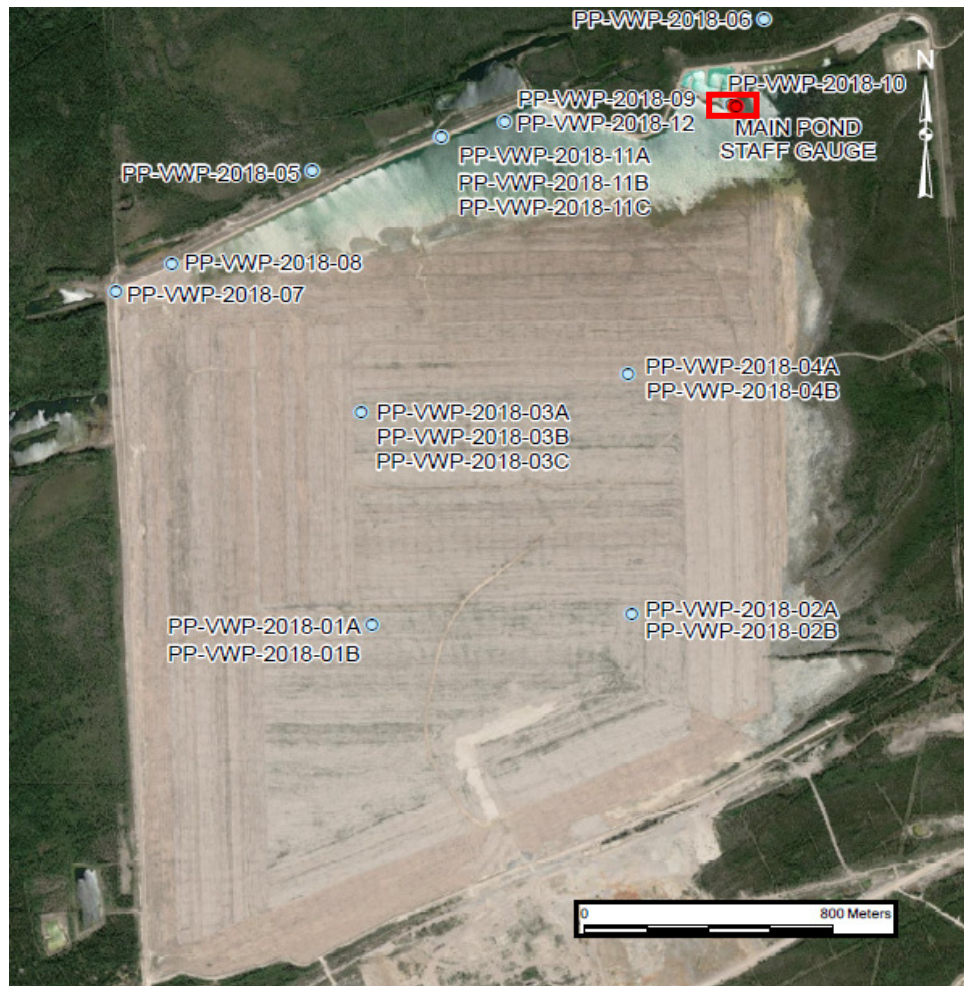
-PP-VWP-2018-10 pond level readings differ from manual readings (Golder 2021b)
