Teck Coal Ltd.

Quintette Coal Operations

Shikano North Tailings Dam

2021 Annual Summary of Tailings Facility Performance

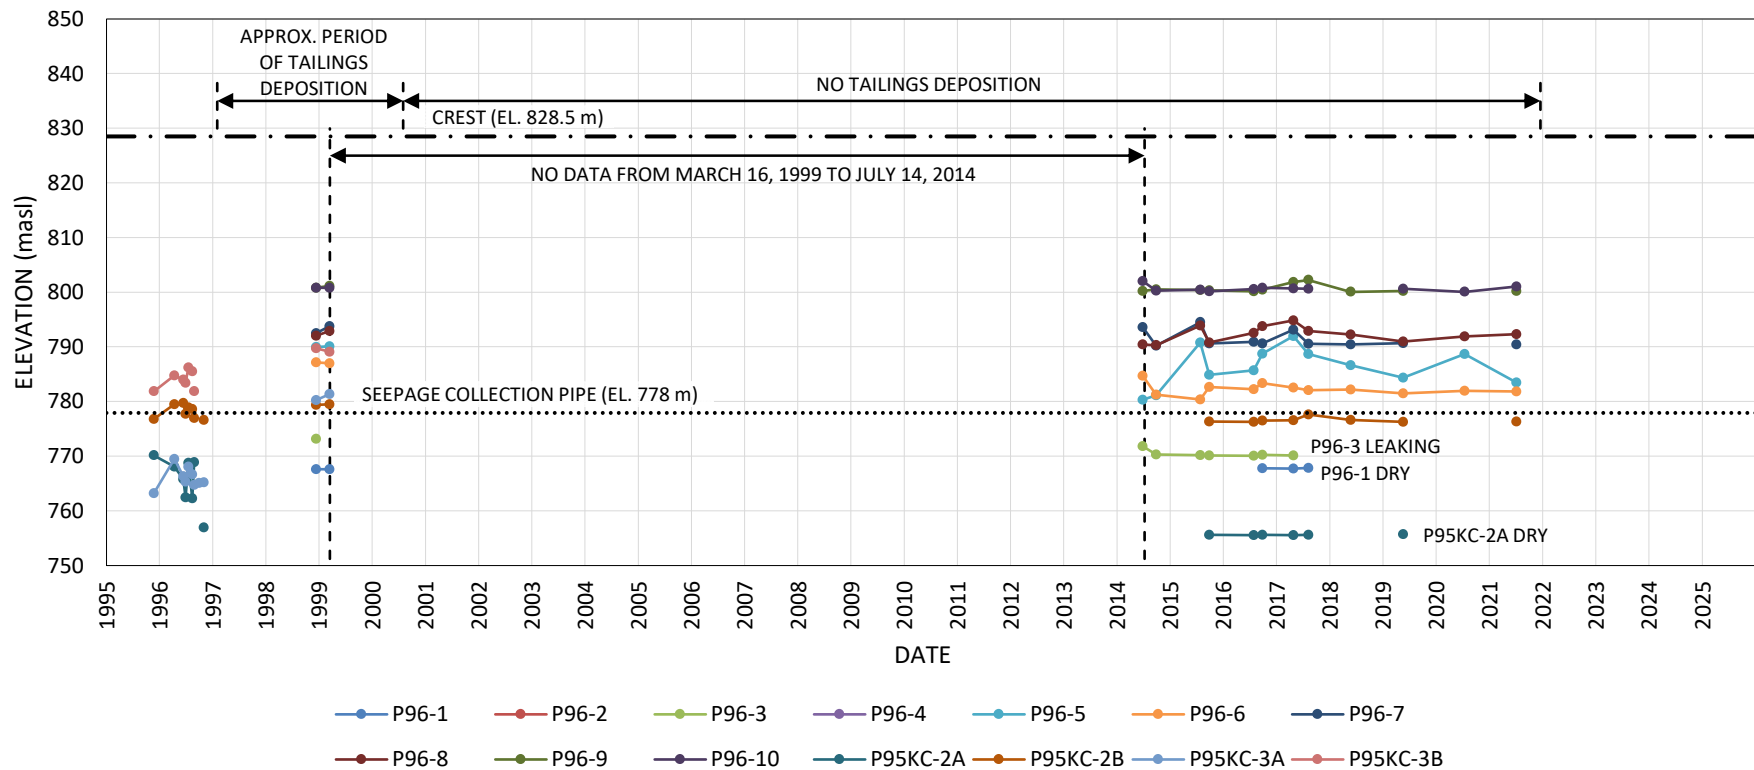
5

- Piezometer P96-3 did not have a fitting and could not be read. The fitting should be replaced; and
- Piezometer P96-8 fitting was observed to be leaking, and should be either tightened or replaced.

1. P96-1 HAS BEEN DRY SINCE 2016.
2. P96-2 HAS BEEN PLUGGED SINCE IT WAS INSTALLED IN 1996.
3. P96-3 HAS BEEN LEAKING SINCE 2016.
4. P96-4 HAS NOT STABILIZED SINCE READINGS WERE RE-INITIATED IN 2014 AND IS PRESUMED TO BE PLUGGED. PRIOR TO THAT, THE INSTRUMENT WAS DRY IN 1998 AND 1999.
5. P96-7 AND P96-9 WERE DRY IN 2020, BUT BECAME WET AGAIN IN 2021.
6. P96-10 WAS DRY IN 2018, BUT BECAME WET AGAIN IN 2019.
7. P95KC-2A WAS DRY IN 2018, 2020 AND 2021.
8. P95KC-2B WAS DRY IN 2020 BUT BECAME WET AGAIN IN 2021.
9. P95KC-3A AND P95KC-3B HAVE NOT BEEN LOCATED SINCE READINGS WERE RE-INITIATED IN 2014. PRE-2014 DATA ARE SHOWN ON THE PLOT.
10. P98-1 and P98-2 HAVE NOT BEEN LOCATED SINCE READINGS WERE RE-INITIATED IN 2014. BOTH INSTRUMENTS WERE DRY BASED ON THE MOST RECENT READINGS TAKEN IN 1999.
