Teck Highland Valley Copper Partnership

2023 Annual Facility Performance Report

Bethlehem No.1 Tailings Storage Facility

March 2024

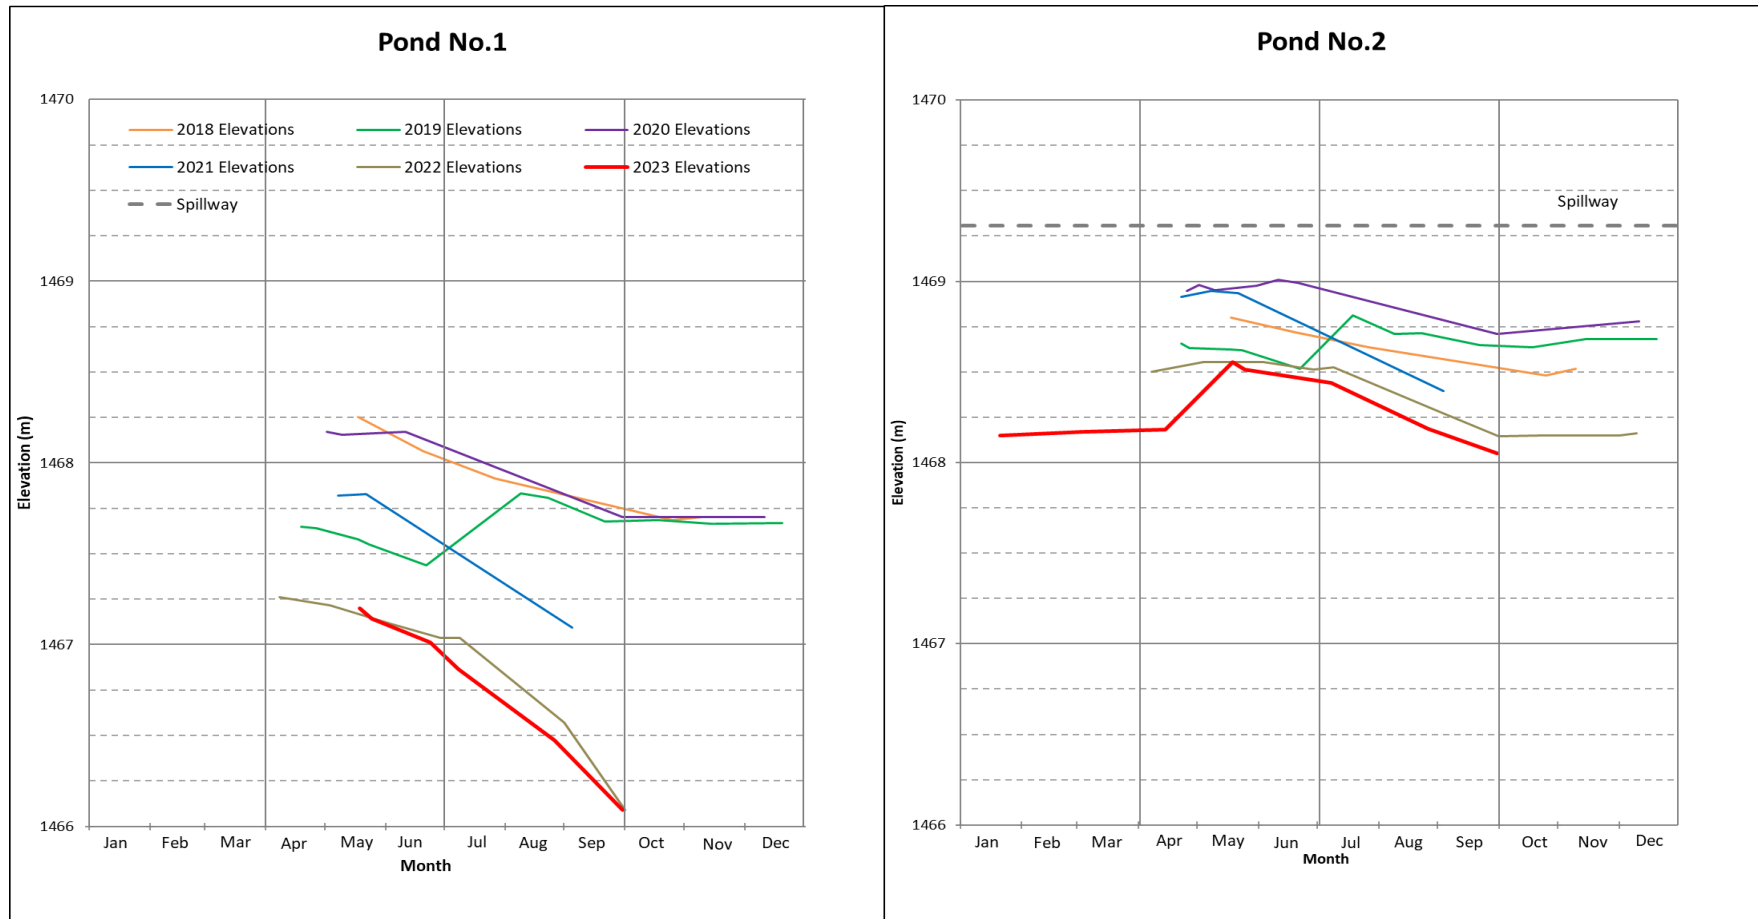
Figure 5.1 Bethlehem TSF Pond No. 1 and Pond No. 2 Levels – 2018 to 2023

- There were no surface discharges from the spillways at Bethlehem TSF or R3 Seepage Pond.
- The pond level at Pond No. 1 and Pond No. 2 followed the established seasonal pattern (Figure 5.1), peaking early in the year, related to freshet, and then dissipating during the remainder of the year.
- Since the end of 2020, the level at both ponds has decreased year-over-year.
- For the first time since 2011, no ponding was observed in the main Pond No. 1 area at the start of the review period (i.e., end of 2022). The pond reformed in May 2023, during freshet, and was no longer present by the end of the review period.

The minimum freeboard measured during the review period at the Bose Lake Dam (based on Pond No. 2) and the R3 Seepage Pond are summarized in Table 5.4 and meet the minimum requirements for normal and flood conditions⁶.

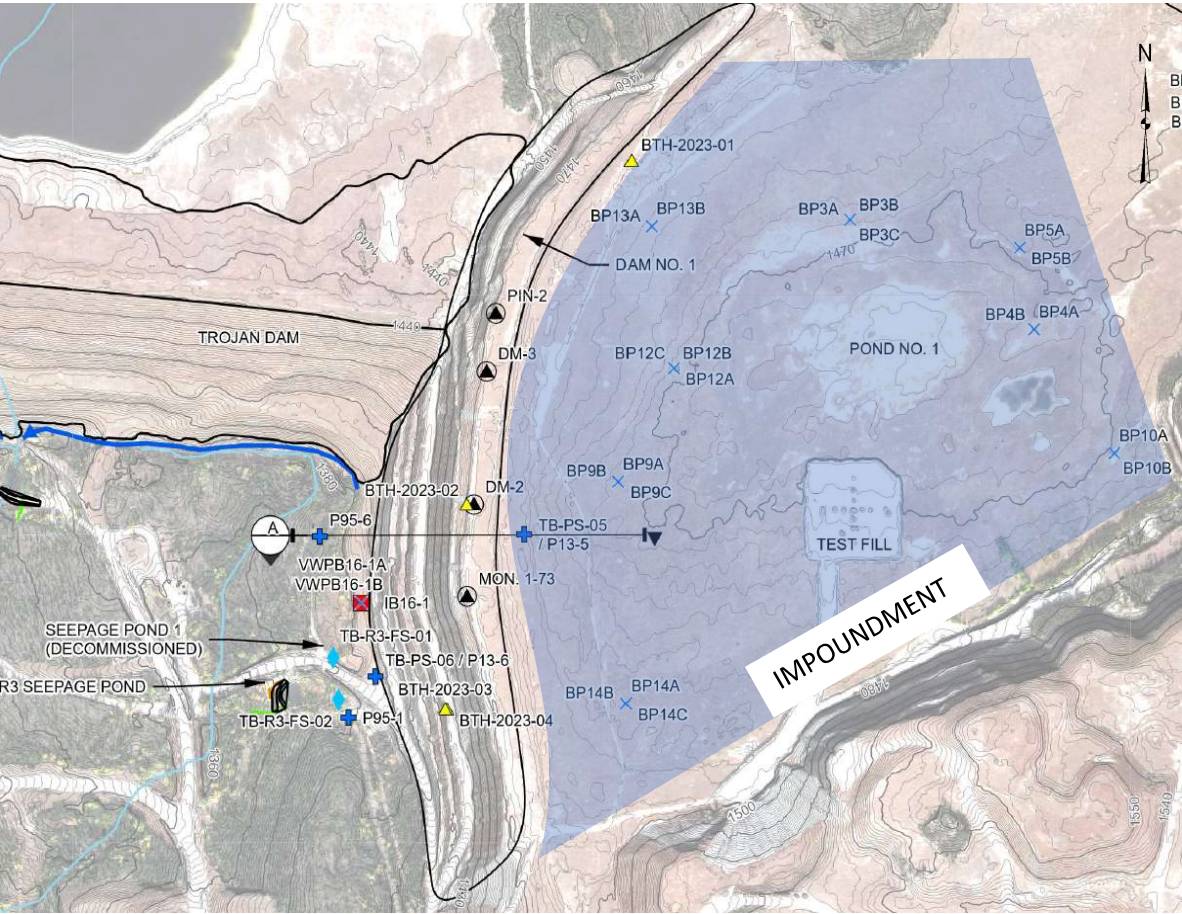
- Two piezometers exceeded their Notification Level threshold during the review period, both of which are in the impoundment area (refer to Figure 7). Neither of these exceedances represents a significant change in behaviour or performance of the structure. Each of these instruments have maintained a relatively consistent response over the past few years and the exceedances are well below piezometric level associated with a dam safety concern. Revised threshold values to reflect recent typical behaviour were incorporated in the 2024 update to the OMS Manual:

- ♦ BP12A (installed in the tailings beach ~350 m upstream of the crest) exceeded the threshold for the review period but only by 0.1 m.
 - ♦ P95-6 (installed in the foundation, near the downstream toe) exceeded the threshold for one reading. Seasonal rises have been recorded in the past, but the exceedance was recorded prior to freshet.

- Impoundment Piezometers (Figure 7): Levels throughout the year were within the historic range and did not show large variance, which is consistent with expectations. Some, but not all, piezometers show a downward trend since 2019, which could be related to the falling level in Pond No. 1 (Section 5.2).
- Crest Area Piezometers (Figure 8): Of the six piezometers installed near the crest (all of which are in dam fill or cycloned sand beach), only one is below the water table. Although the other piezometers have been measured as “dry” for 10 years, they provide value in demonstrating that the piezometric level in the cycloned sand beach remains low and is not rising.
- Downstream Slope Piezometers (Figure 9): Levels and trends are consistent with previous years and continue to indicate a downward gradient through the foundation.

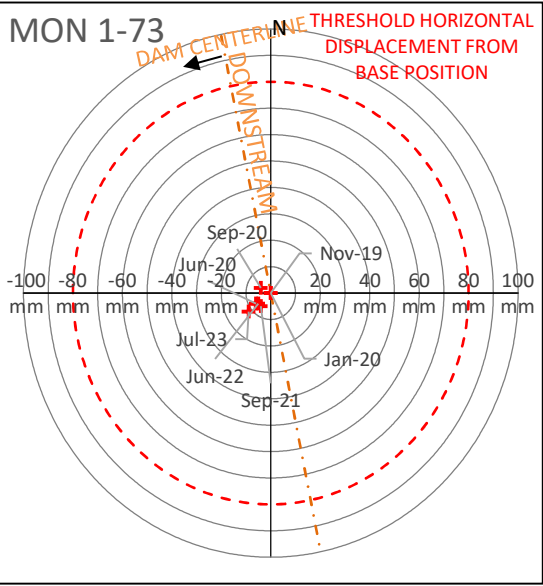
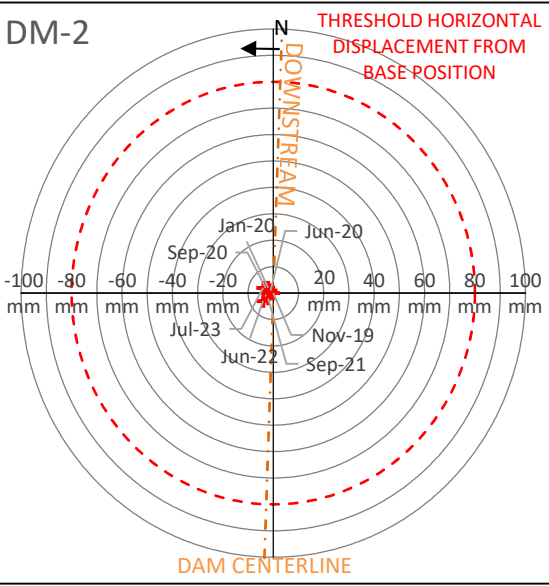
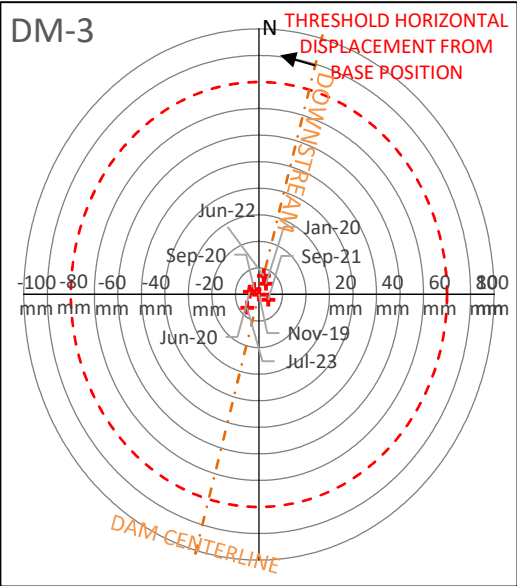
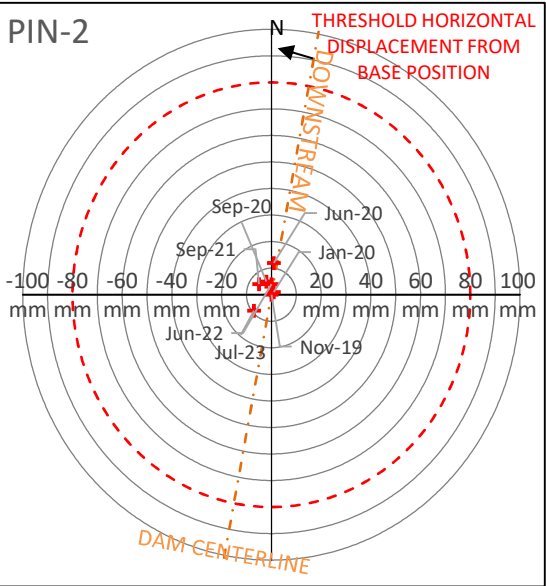
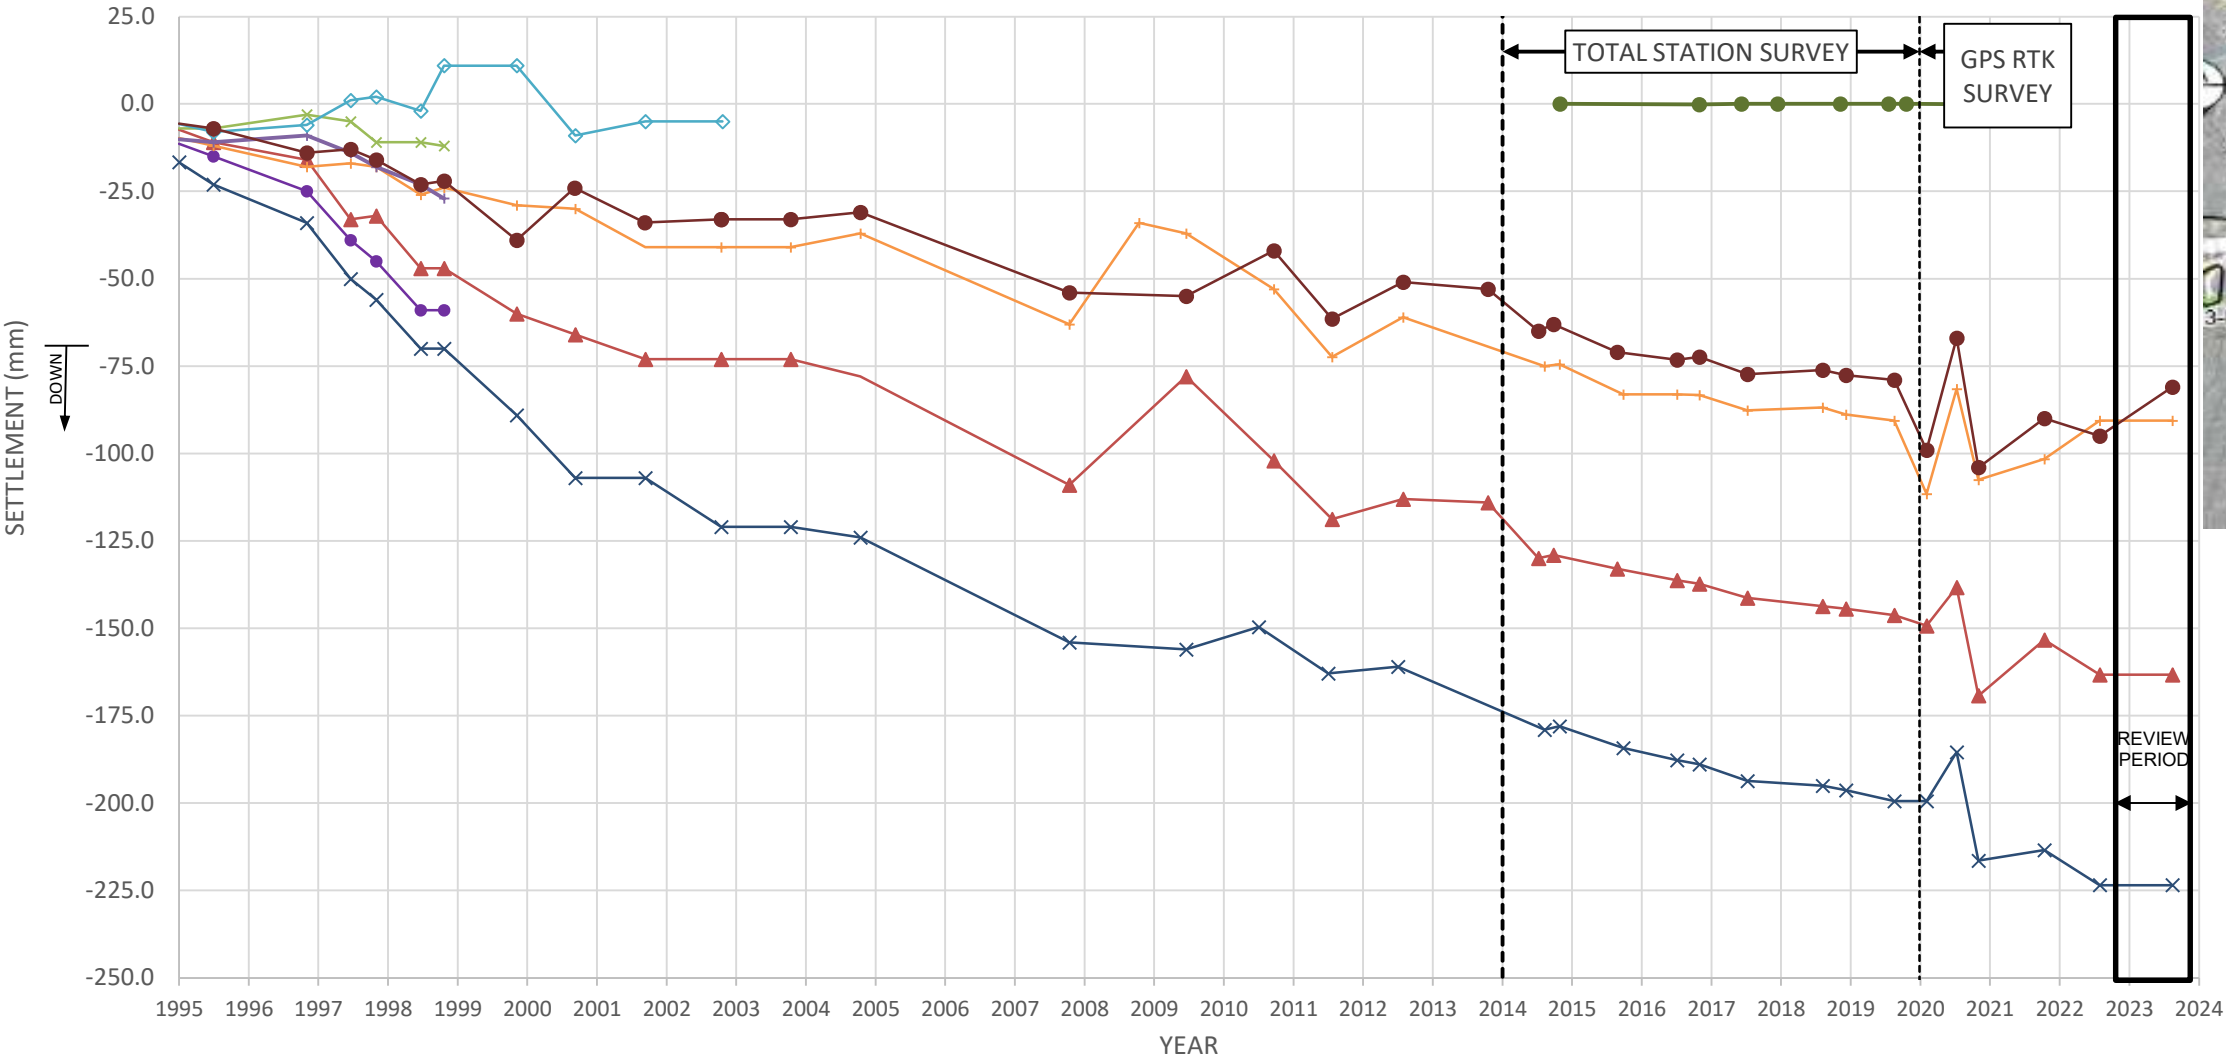
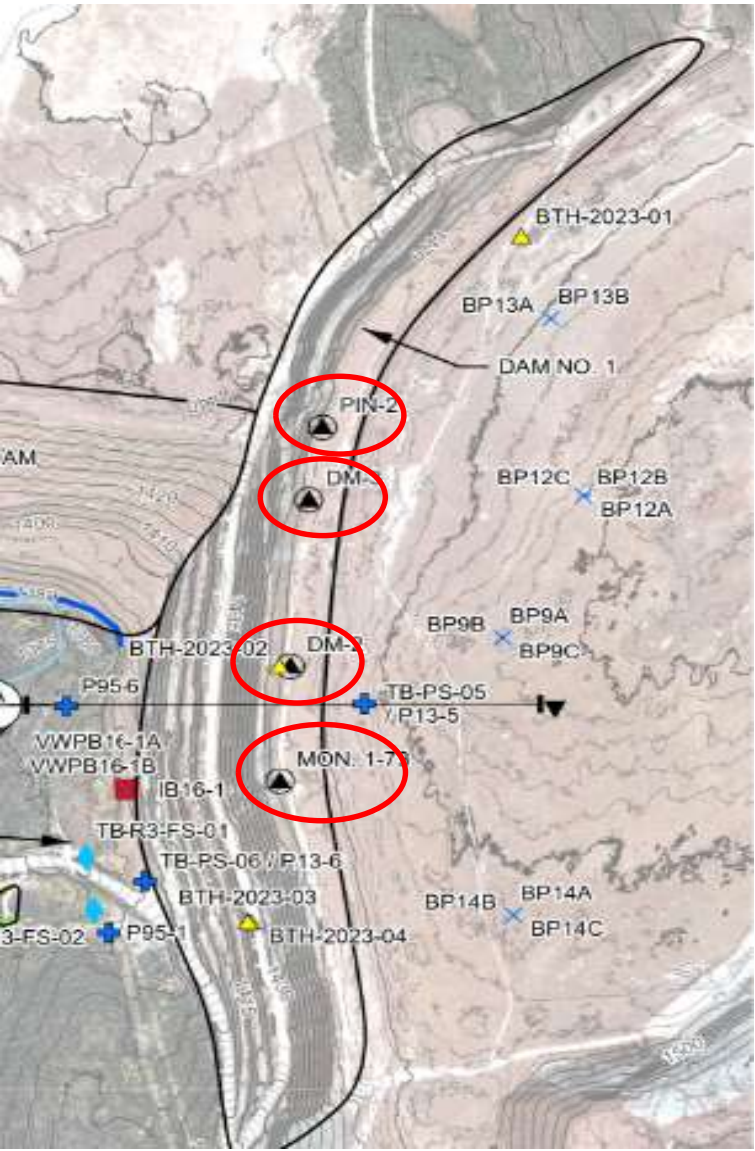
CLIENT Highland Valley Copper / Teck		PROJECT BETHLEHEM NO. 1 TAILINGS STORAGE FACILITY 2023 ANNUAL FACILITY PERFORMANCE REPORT	
Klohn Crippen Berger		TITLE DAM NO. 1 SURVEY MONUMENT READINGS	
PROJECT No. M02341C62		FIG. No. 10

In November 2019, HVC started to use GPS Real-Time Kinematics (RTK) to survey the monuments. The horizontal surveys plotted on Figures 10 and 16 are for the RTK method only, based on the baseline location from the November 2019 survey. However, a continuous record of settlement has been maintained.

The RTK surveys have shown an improvement (i.e., less variance between readings) over the previous method with respect to horizontal location (i.e., northing/easting) but show higher variance in elevation. This pattern is evident when reviewing readings since 2020 (Figure 10 and Figure 16).

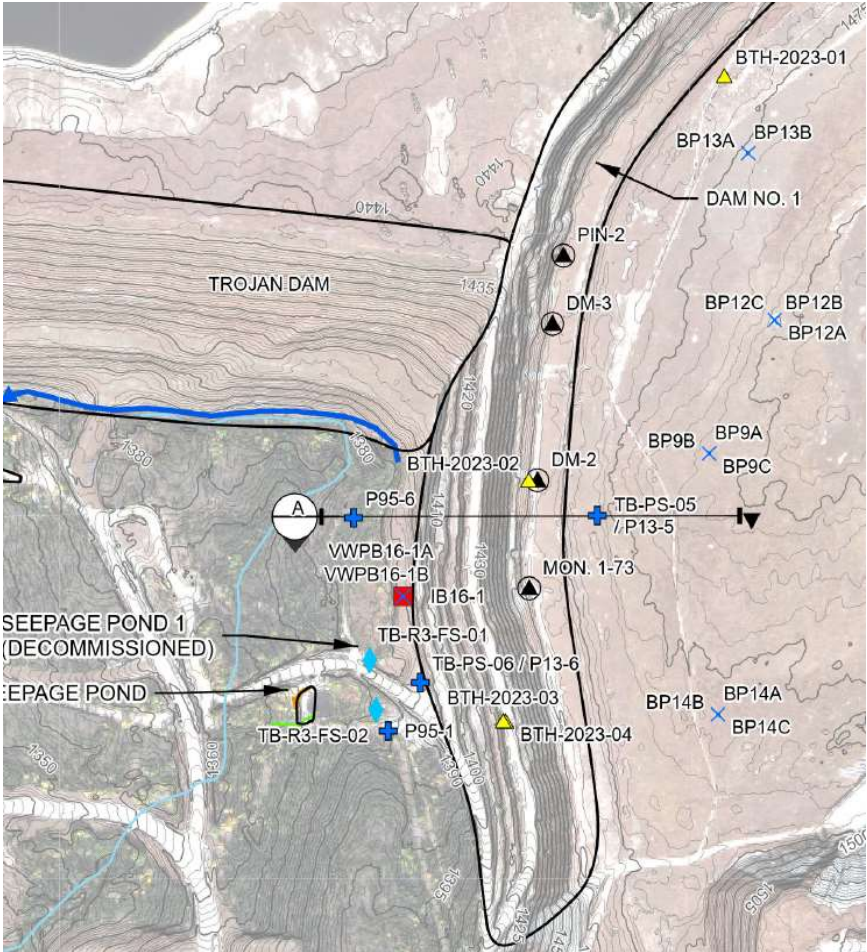
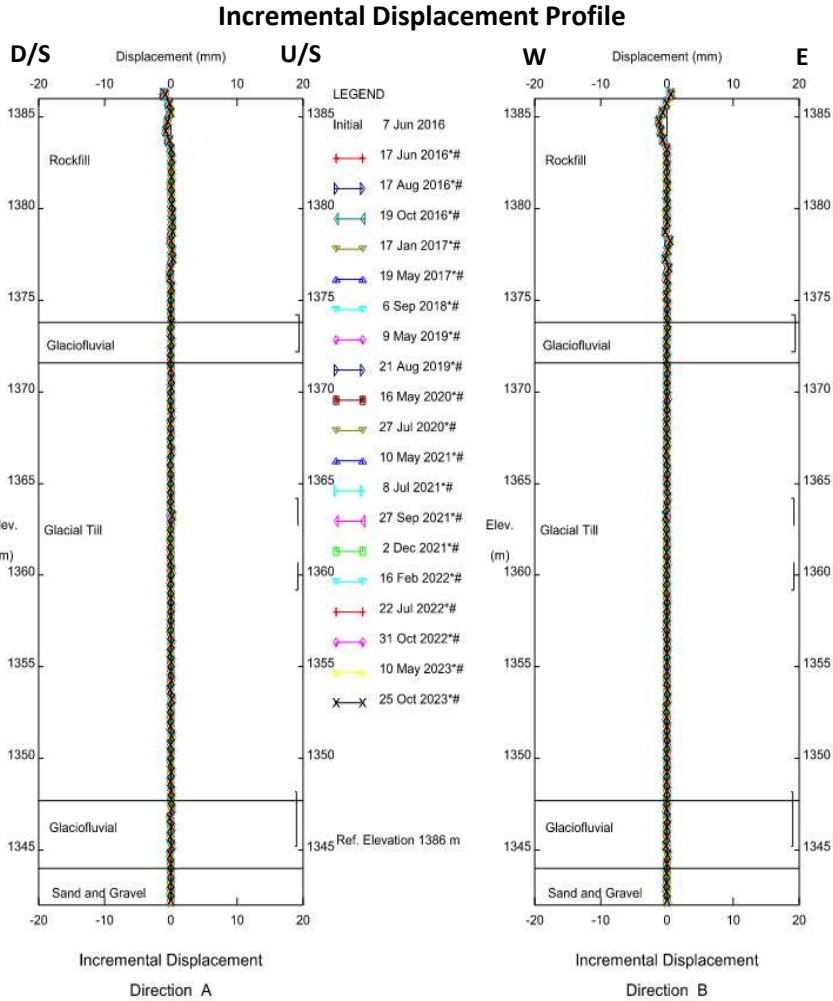
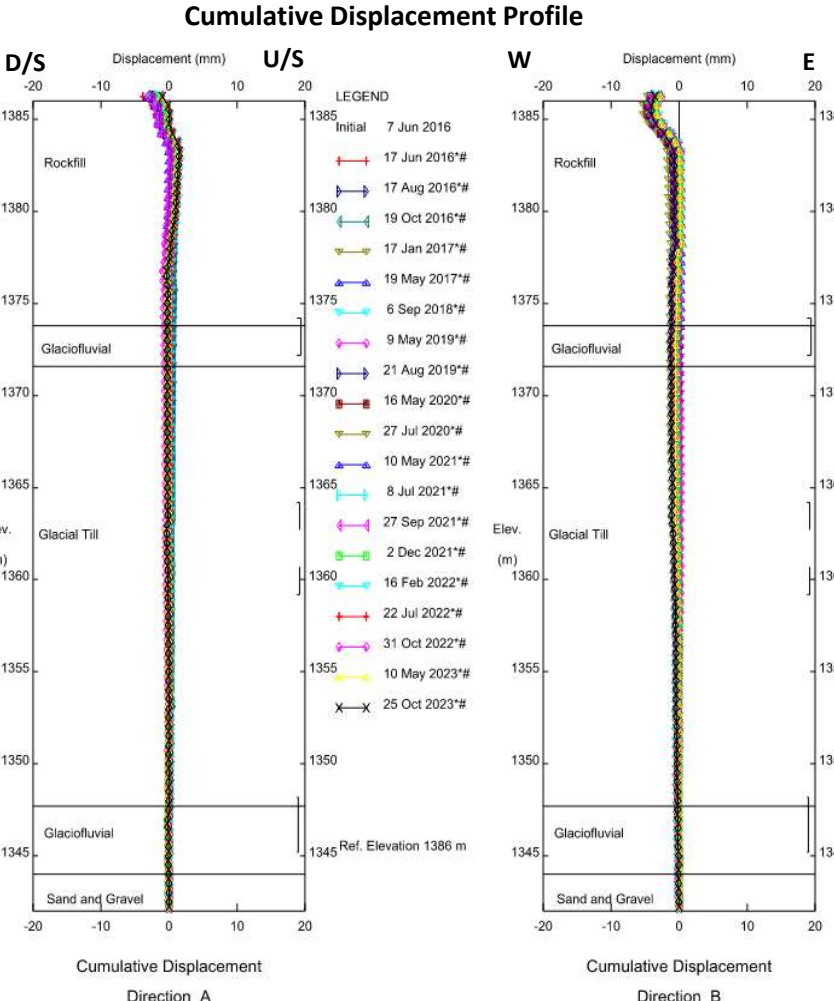
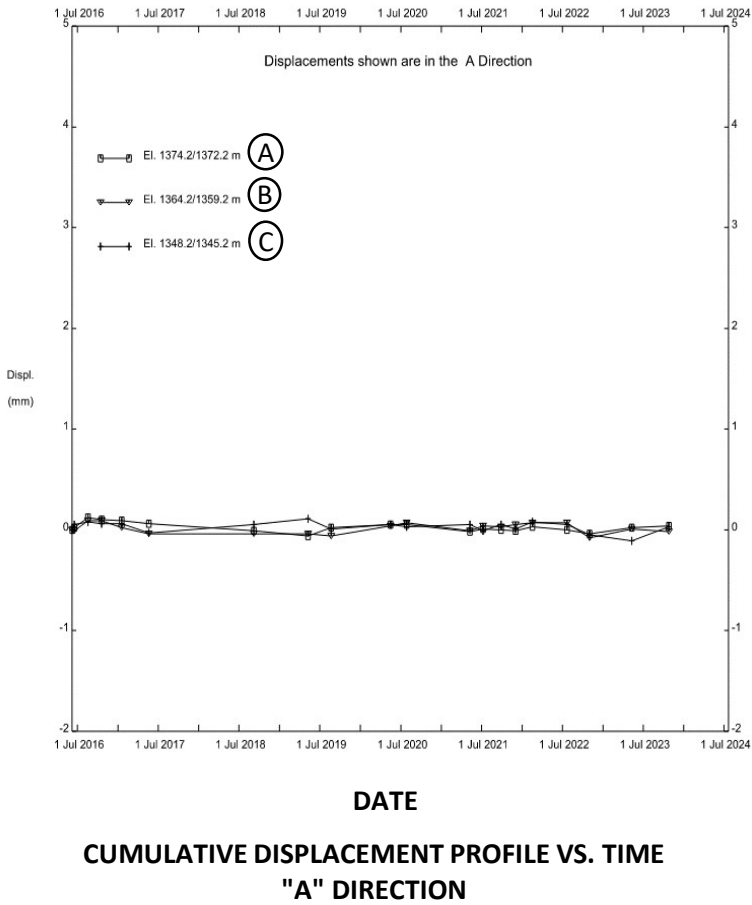
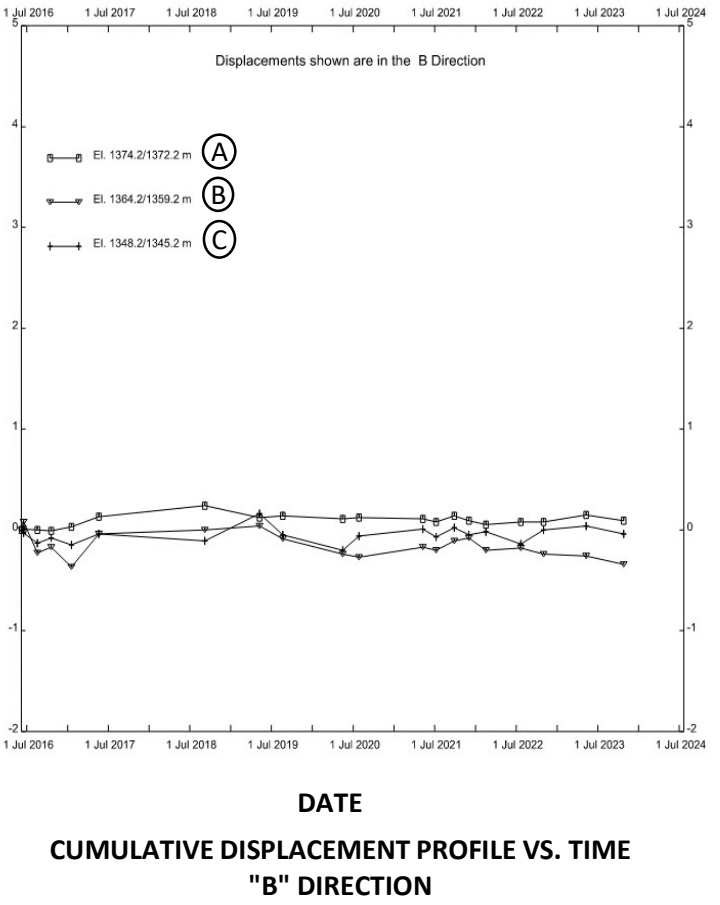
A single inclinometer (IB16-1) is installed at Dam No. 1. IB16-1 was read twice during 2023, as per the OMS Manual (HVC 2022). No significant deformations in the downstream direction have been observed (Figure 11).

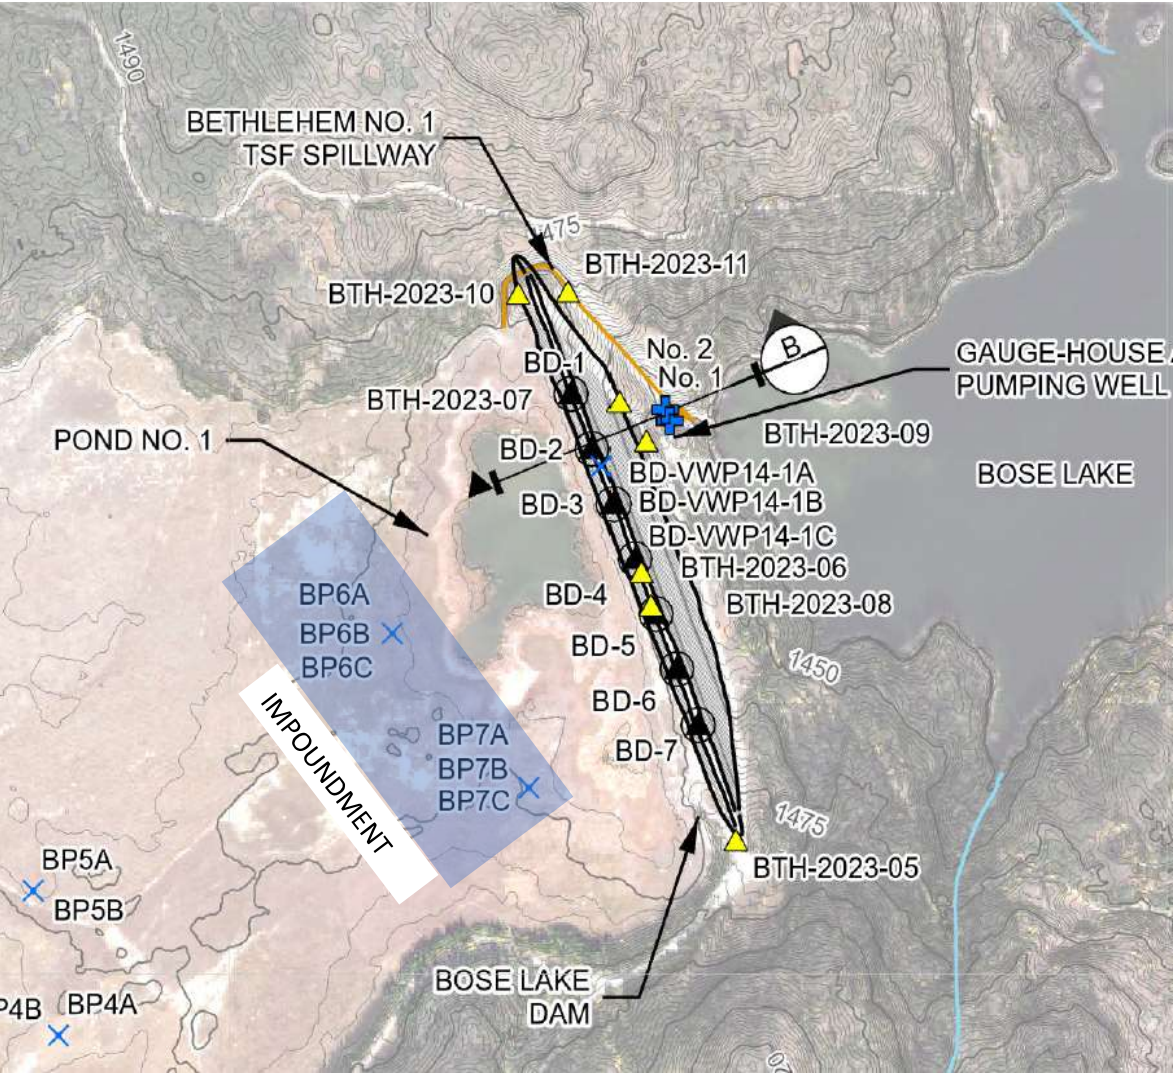
- No piezometers exceeded Notification Level thresholds during the review period.
- Impoundment Piezometers (Figure 13): Overall readings throughout the year were within the historic range but did show a greater drain down during the review period than the previous year, which is consistent with overall drain down of the ponds in the impoundment.
- Crest Area Piezometers (Figure 14): Includes three nested instruments installed in the dam fill and foundation. Similar to piezometers installed in the impoundment, they showed greater drain down during the review period than previous years.
- Toe Area Piezometers (Figure 15): Piezometric levels at these instruments have been relatively consistent over the past eight years and show less seasonal variance over the year than piezometers in the impoundment or installed below the crest.

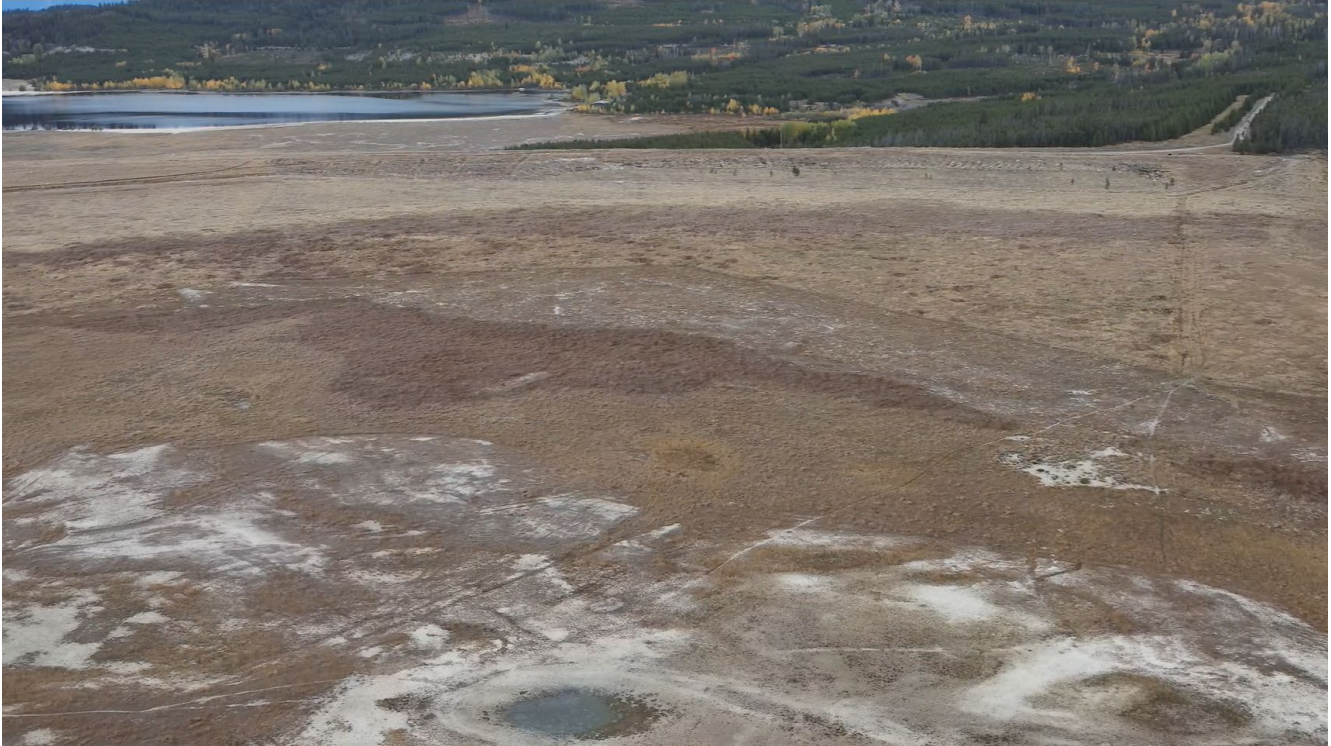
Photo I-A-3 Drone Photo – Vegetated Tailings Beach Upstream of mid-segment of Dam No. 1 with Trojan TSF in background

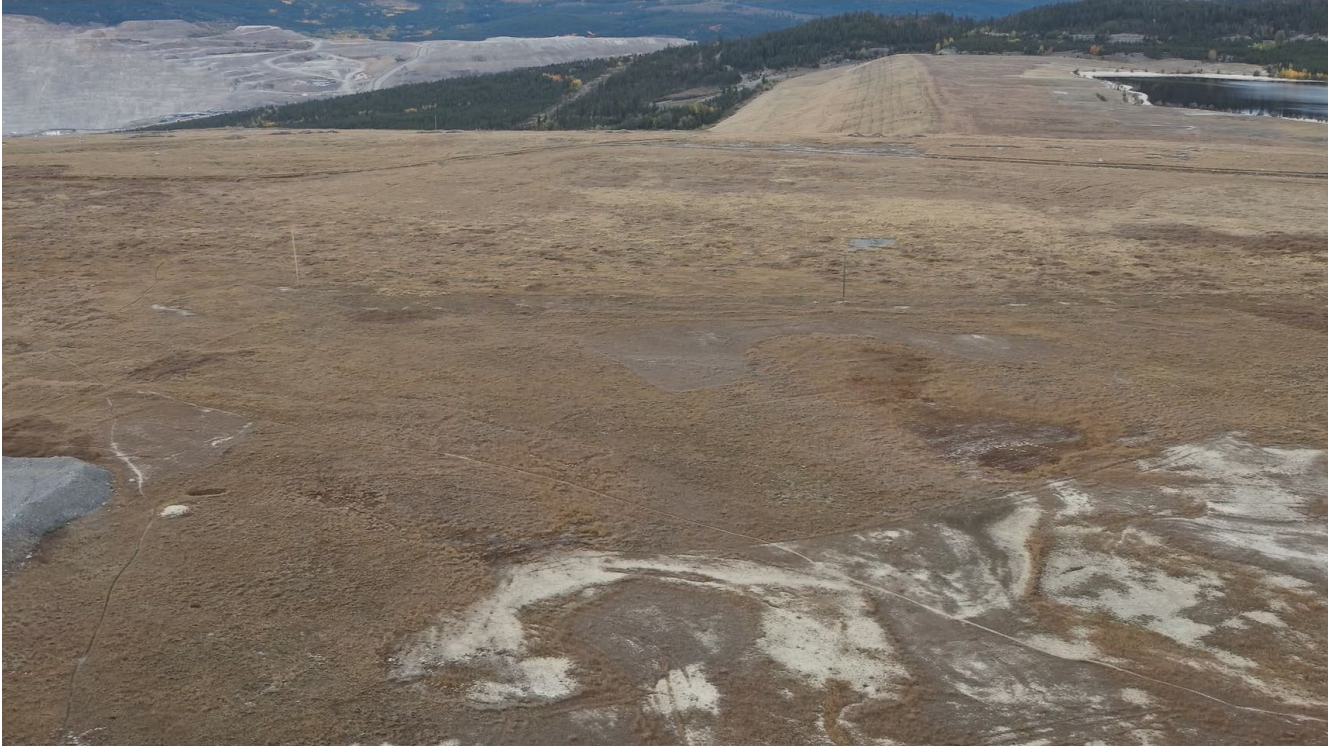
Photo I-A-4 Drone Photo – Vegetated Tailings Beach Upstream of south segment of Dam No. 1 with Trial Pad area in foreground

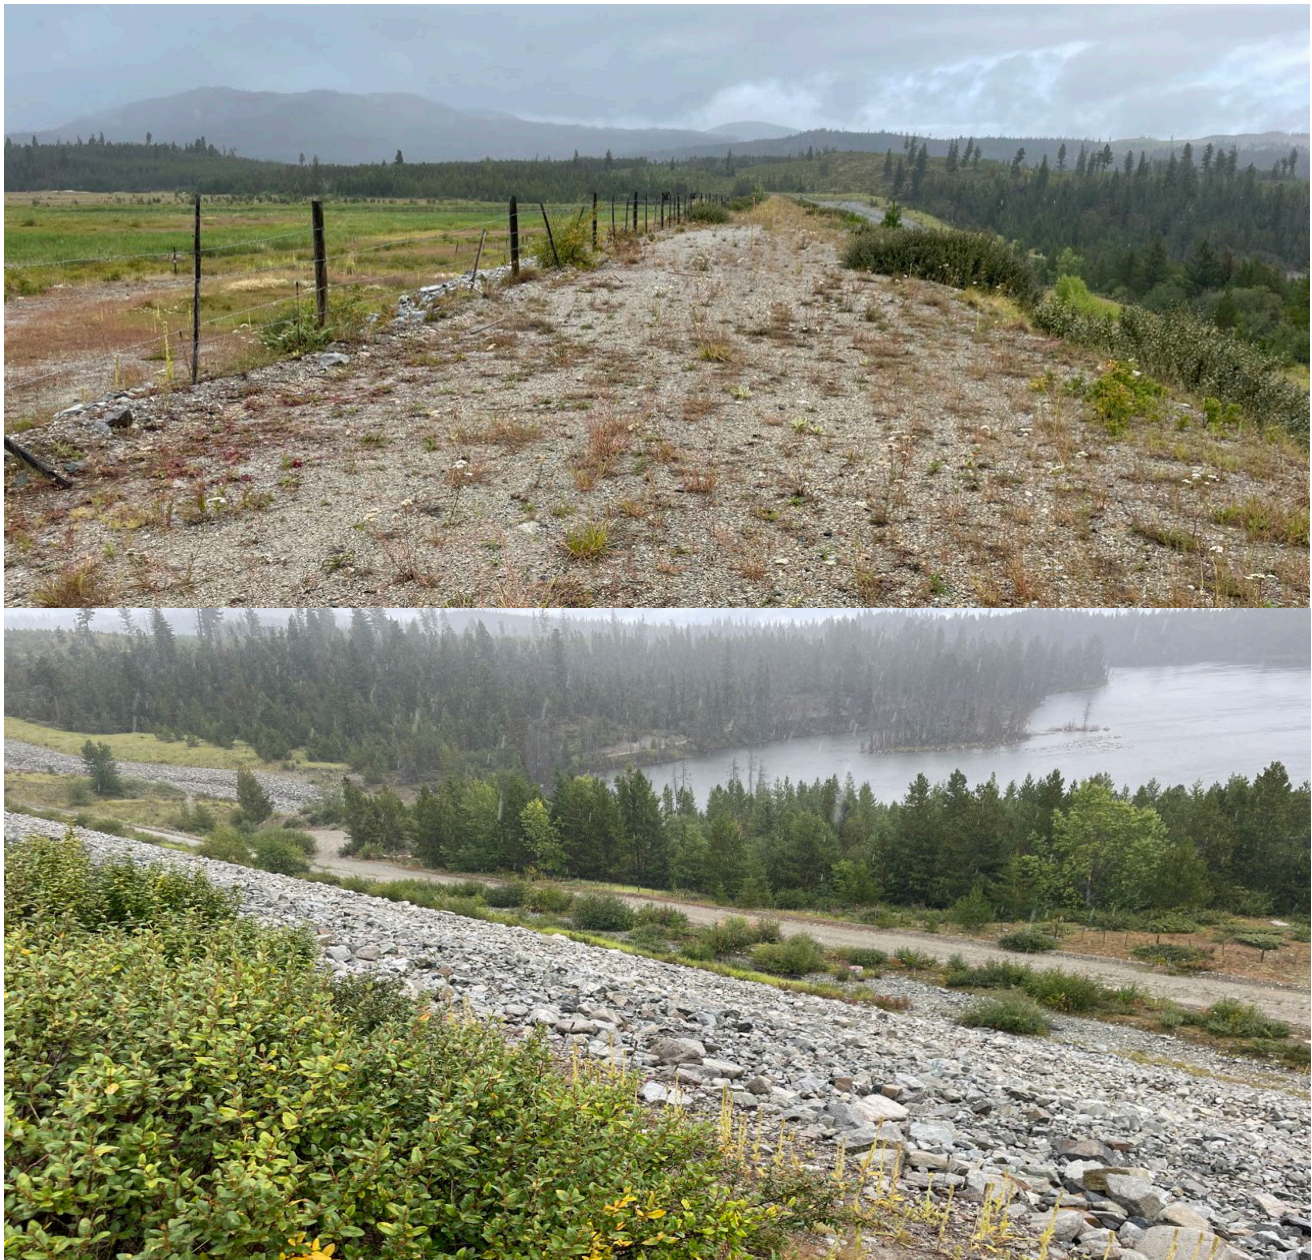
Photo I-B-2 Overview of dam crest and downstream slope from the crest at the right abutment. (BTH-2023-08)

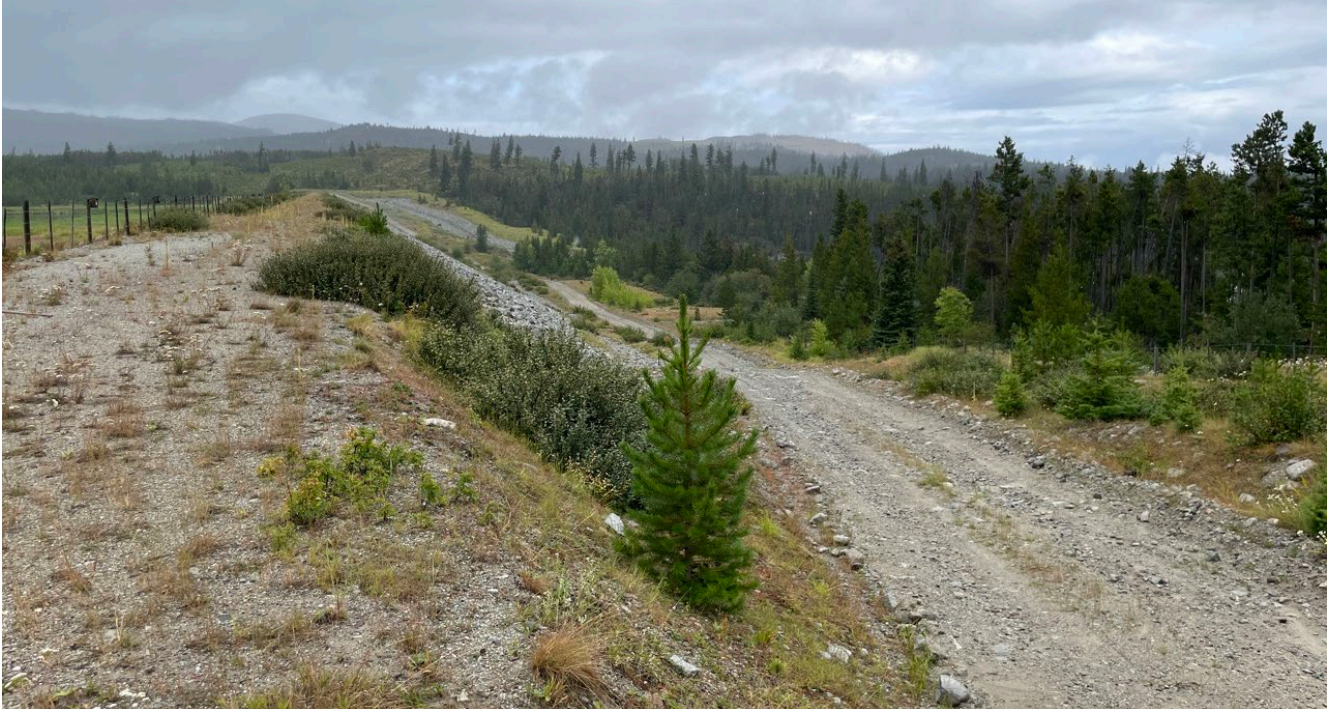
Photo I-B-3 Left abutment and downstream slope, looking north, with no observation of erosion scours or damage. (BTH-2023-07)

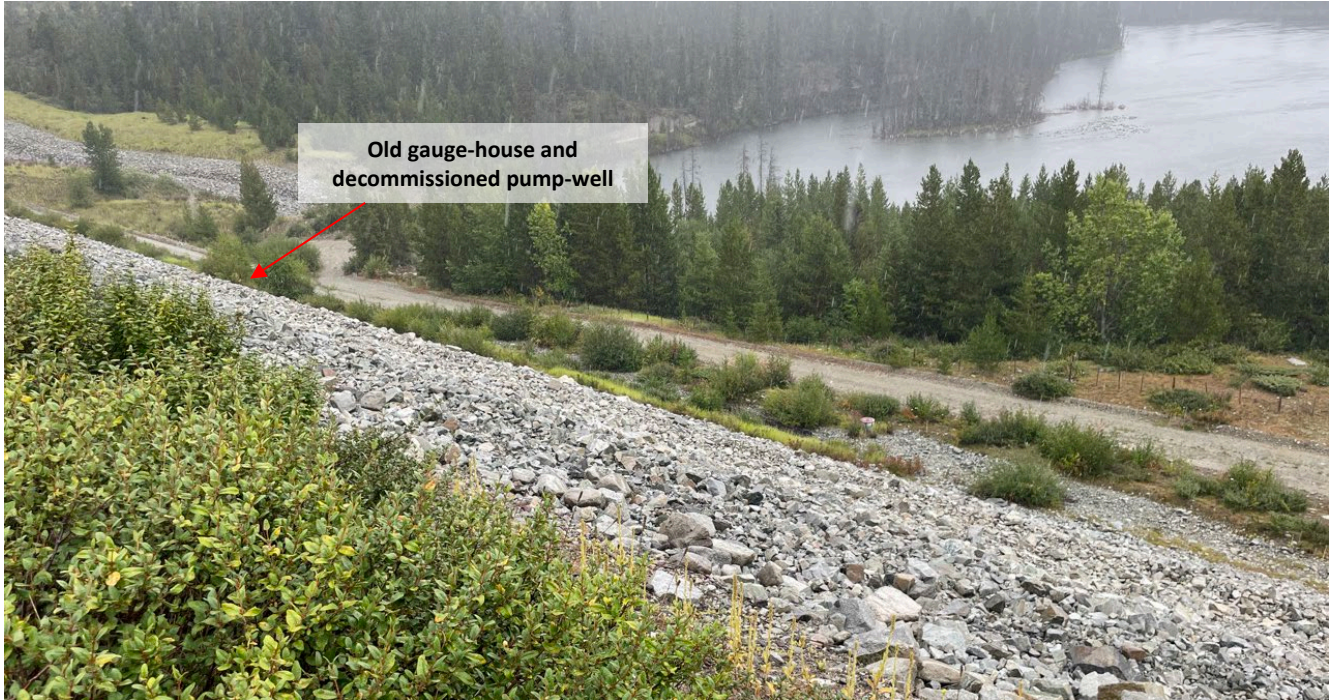
Photo I-B-6 Decommissioned pumping well and discharge point of underdrain. (BTH-2023-09)

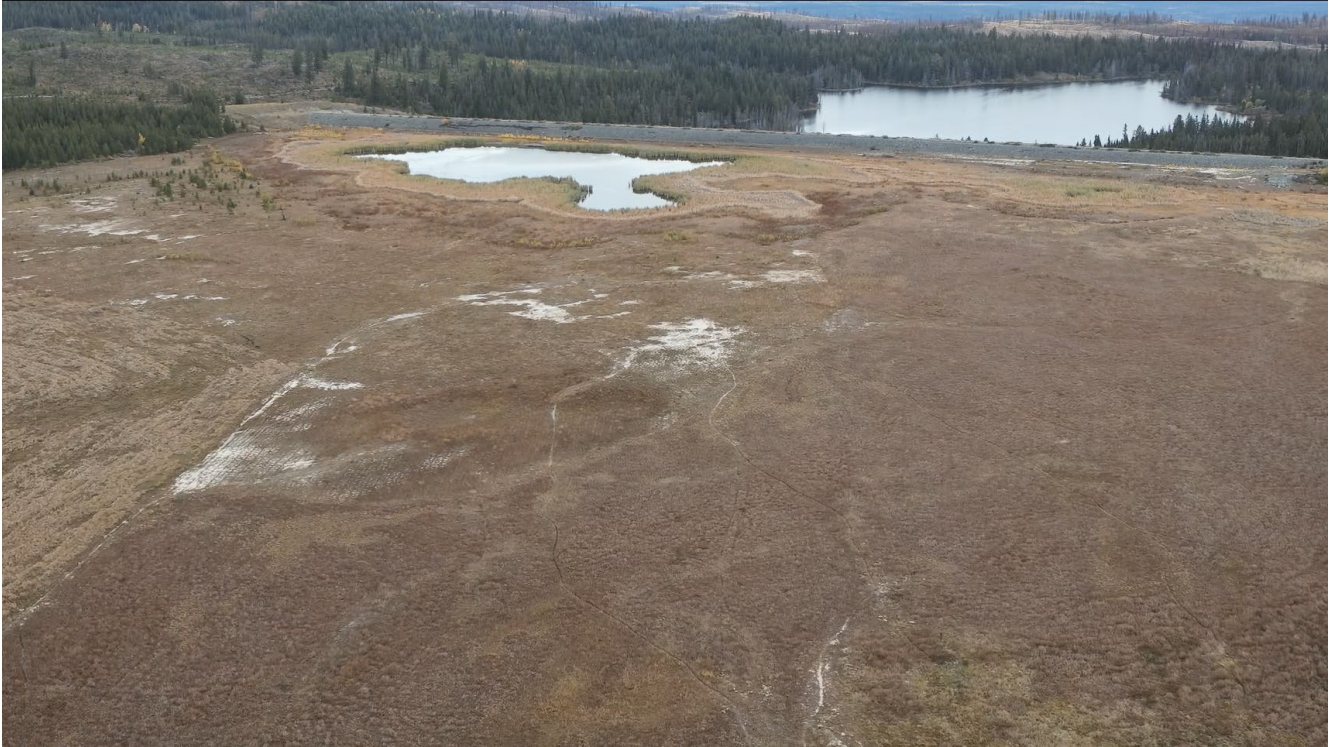
Photo I-B-8 Overview of Bethlehem No. 2 Tailings Pond and tailings beach. (BTH-2023-08)

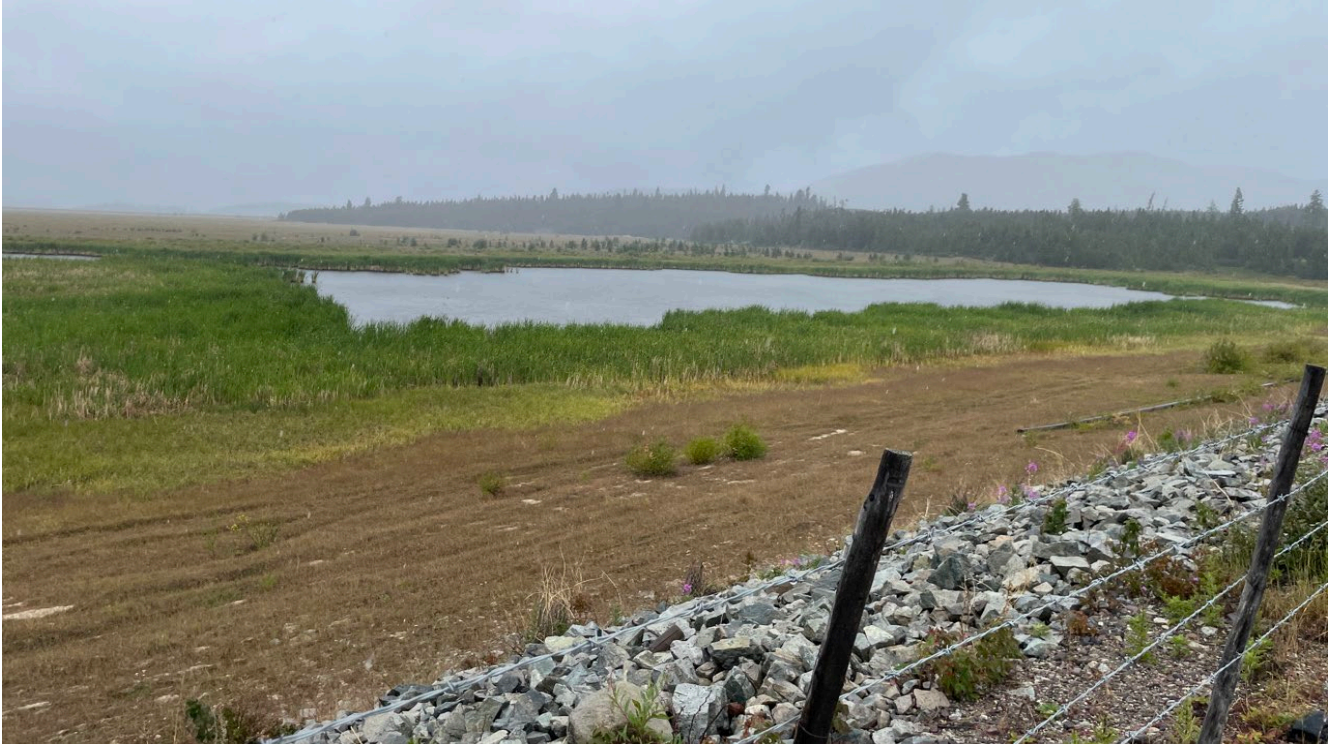
Photo I-B-9 Overview of upstream beach, looking towards dam. No sign of erosion or depression was observed. (BTH-2023-08)

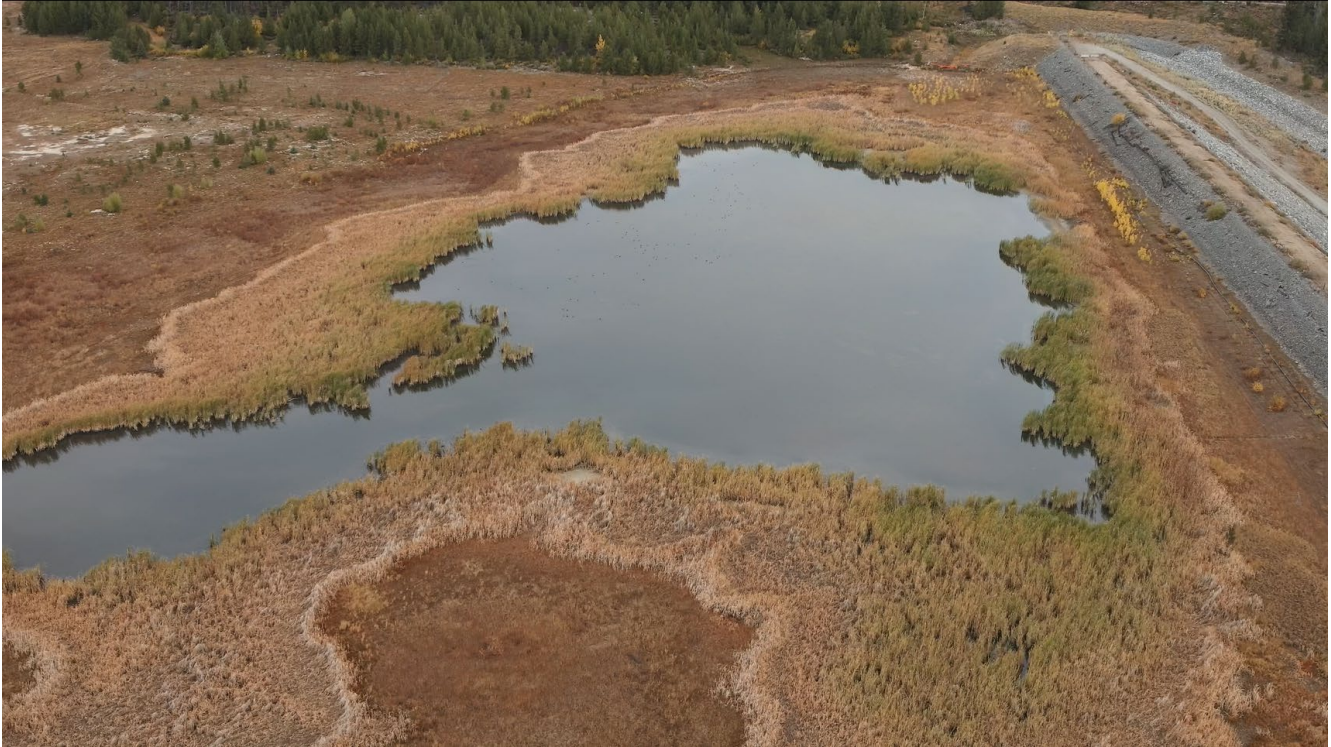
Photo I-B-11 Spillway inlet and approach channel. Channel is vegetated with grass and bushes. Clearing of vegetation is managed as part of routine maintenance. (BTH-2023-10)
