Teck Highland Valley Copper Partnership

2023 Annual Facility Performance Report

Bethlehem No.1 Tailings Storage Facility

March 2024

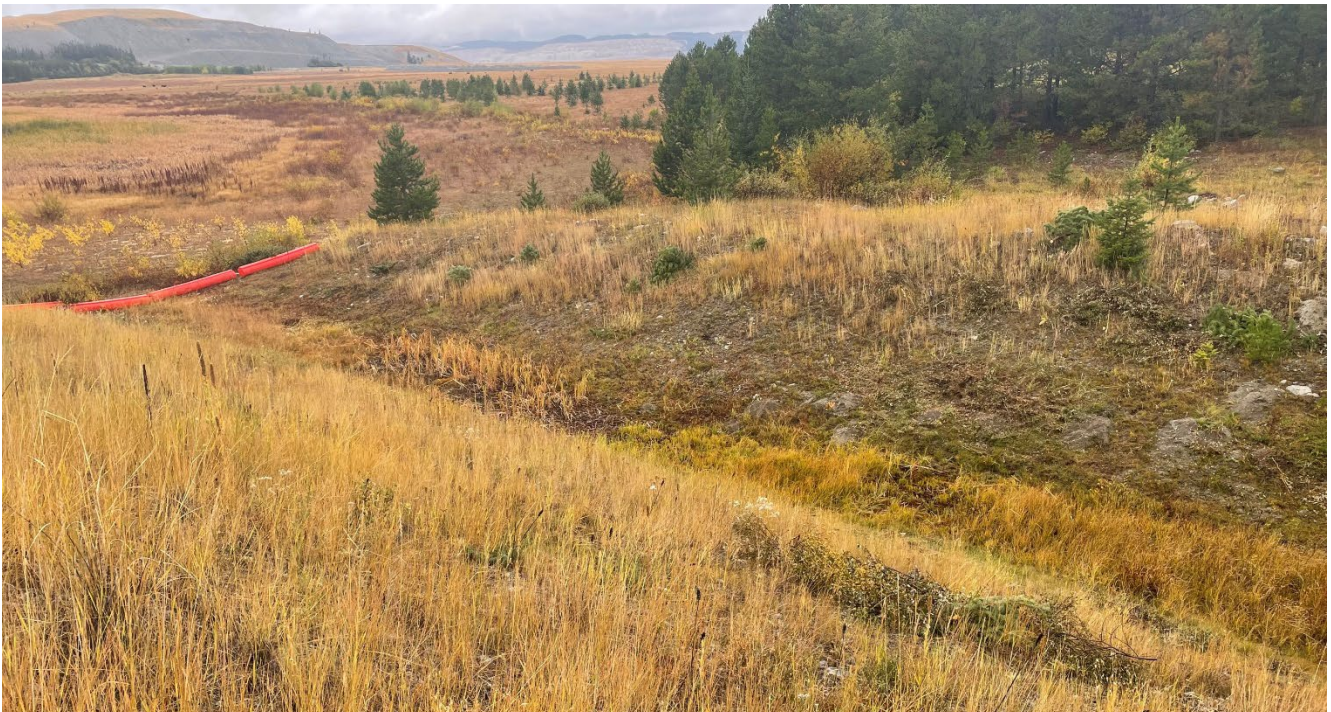
Photo I-B-13 Spillway channel at transition point between inlet and riprap-lined segment, looking towards north. (BTH-2023-10)

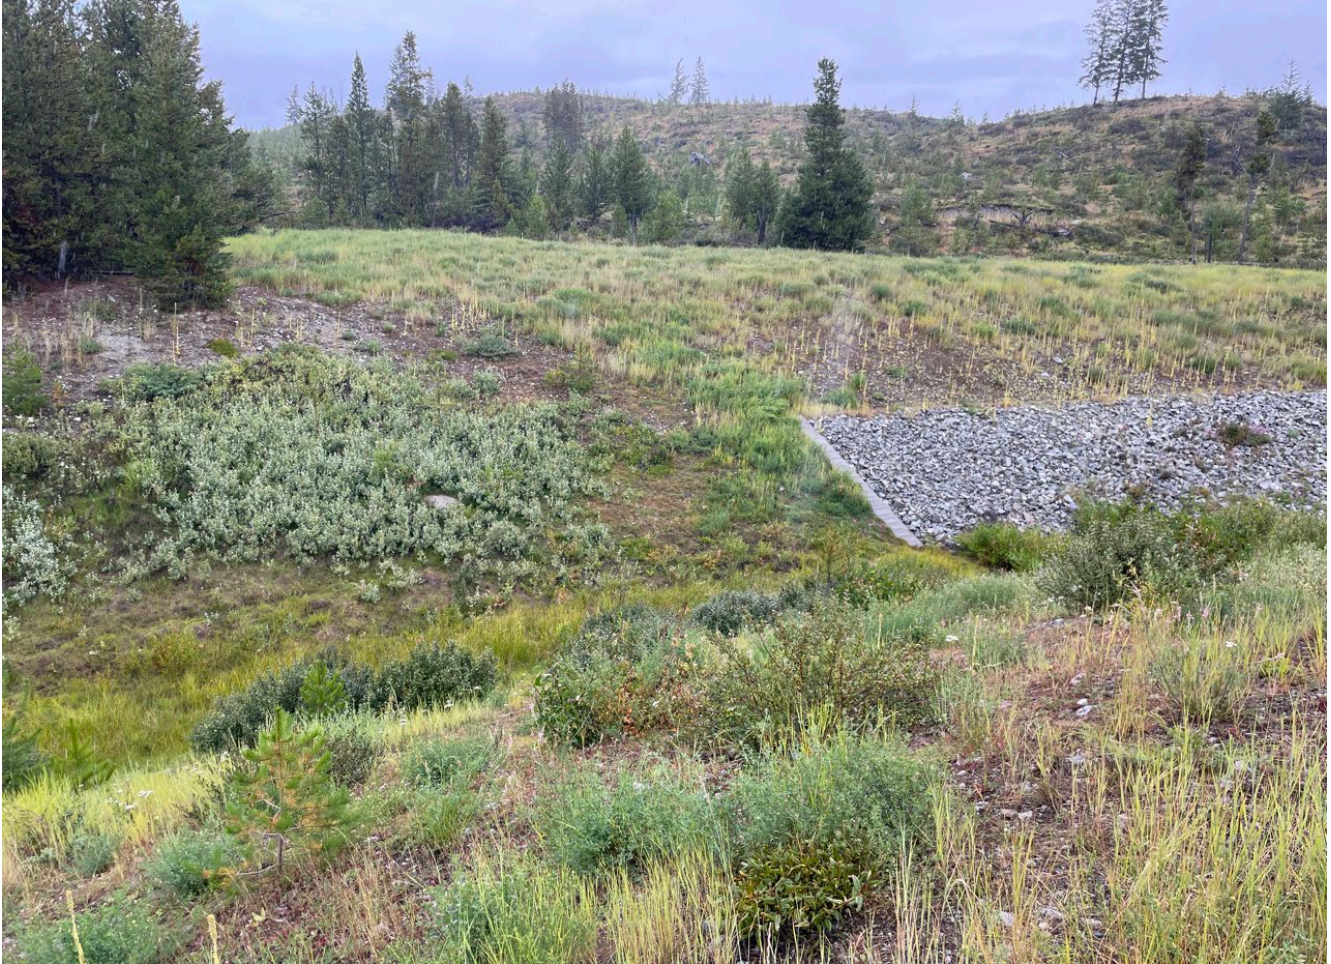
Photo I-B-14 Spillway channel between inlet and riprap-lined segment, after vegetation clearing was completed, photo provided by HVC after site visit.

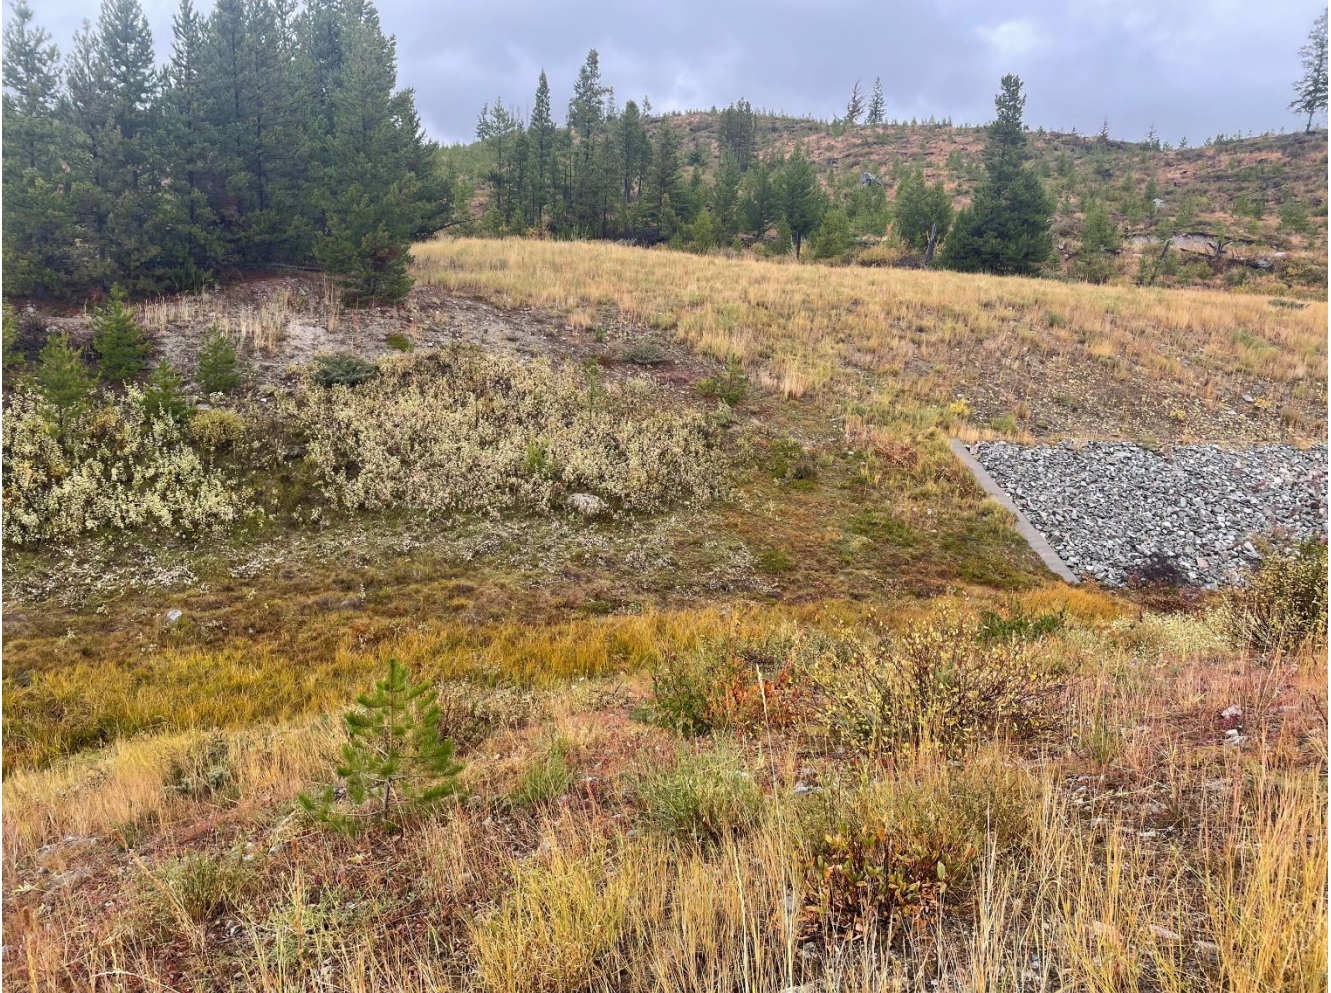
Photo I-B-15 Riprap lined portion of spillway channel looking towards Bose Lake. (BTH-2023-11)

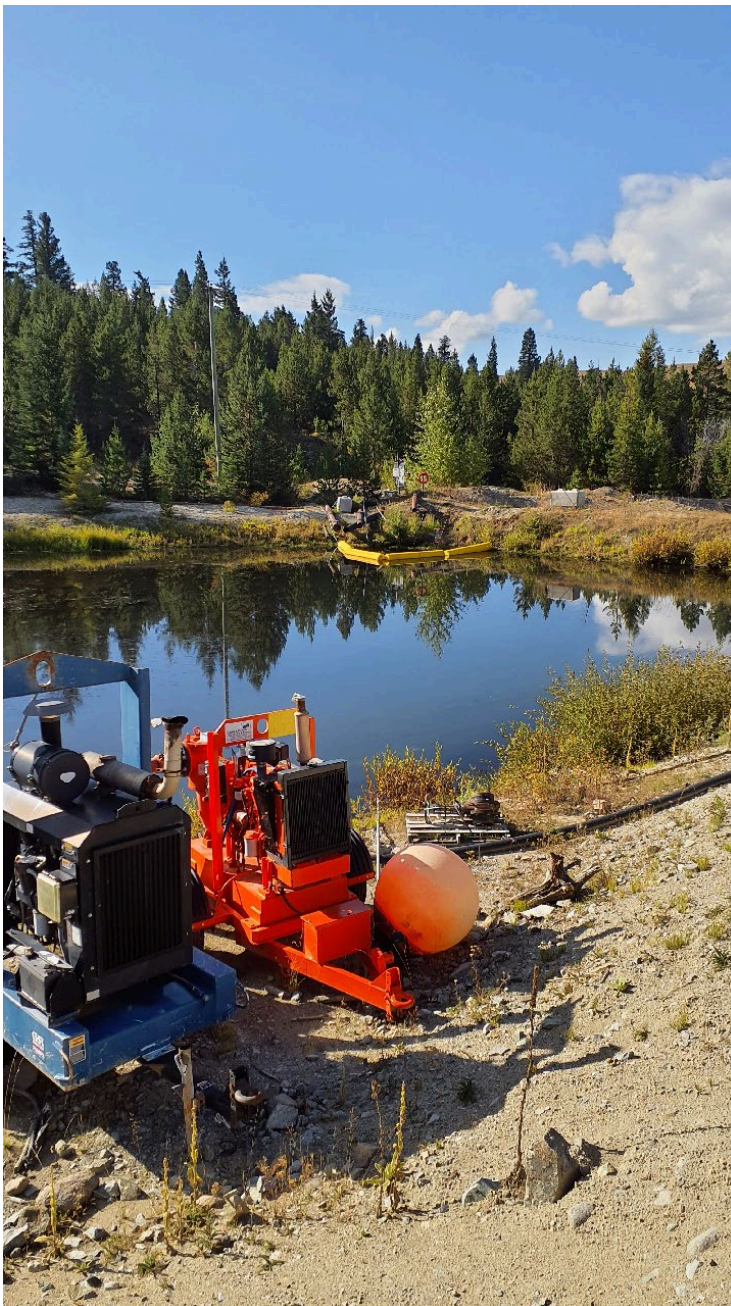
**Photo I-C-2 R3 Seepage Pond dam crest, no cracking or no sign of distress was observed.
(BTH-2023-13)**

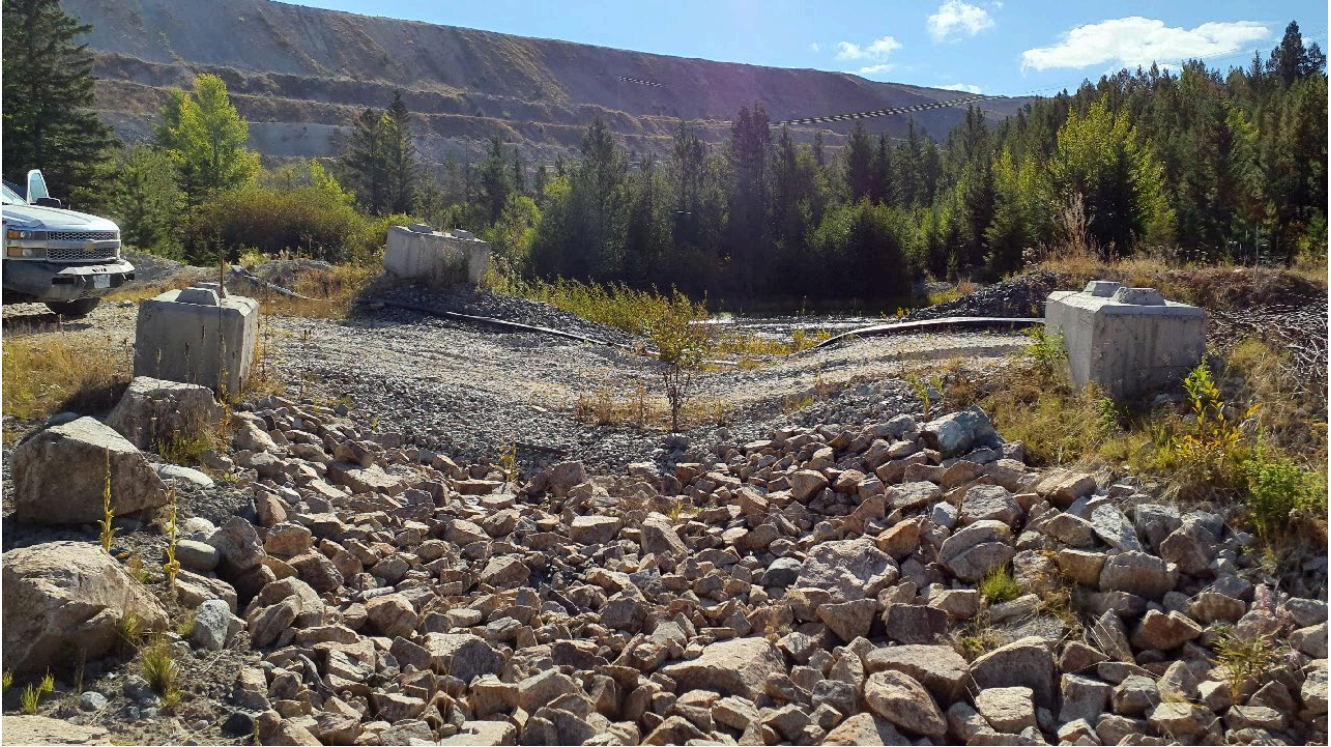
Photo I-C-6 Spillway channel, looking downstream from crest. (BTH-2023-16)

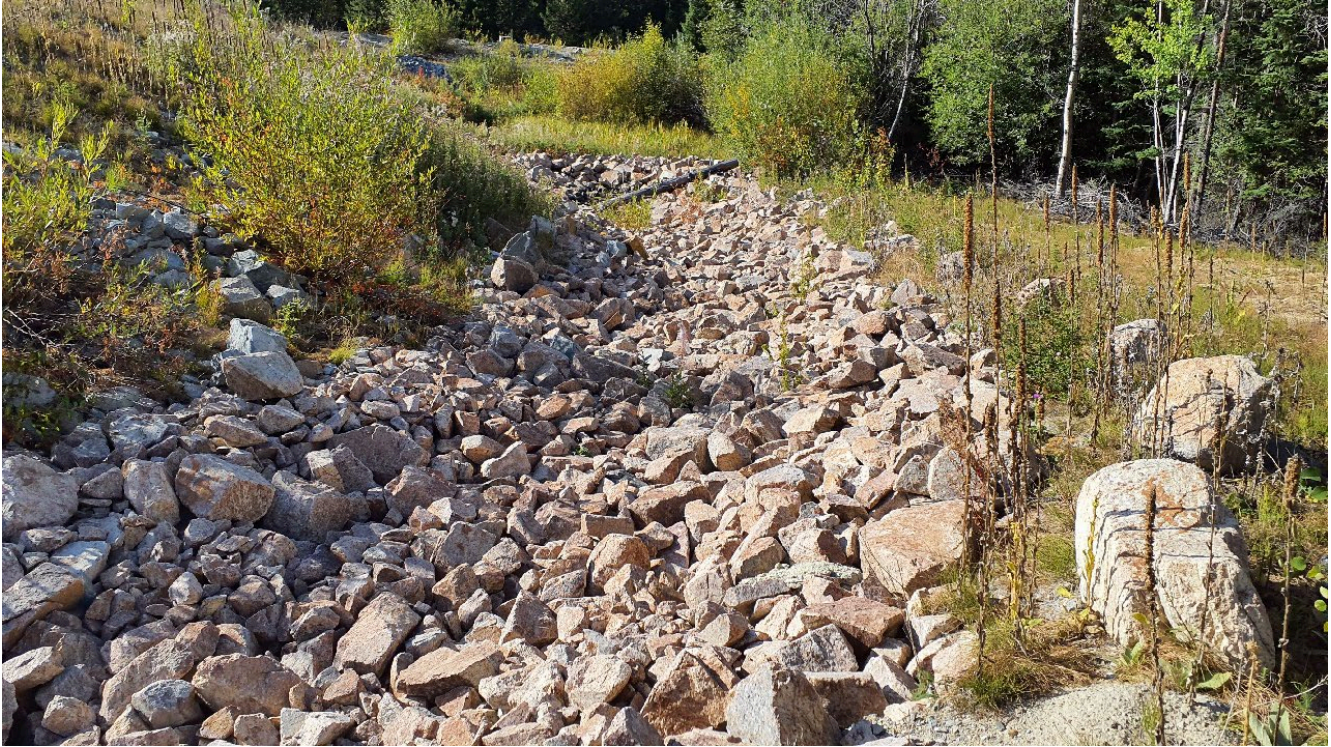
Photo I-C-7 Low point of the berm along upstream side of dam crest. KCB recommended the dam survey be checked to confirm this feature is captured and has been accounted for in the freeboard calculation. (BTH-2023-17)
