Teck Highland Valley Copper Partnership

2023 Annual Facility Performance Report

Highmont Tailings Storage Facility

March 2024

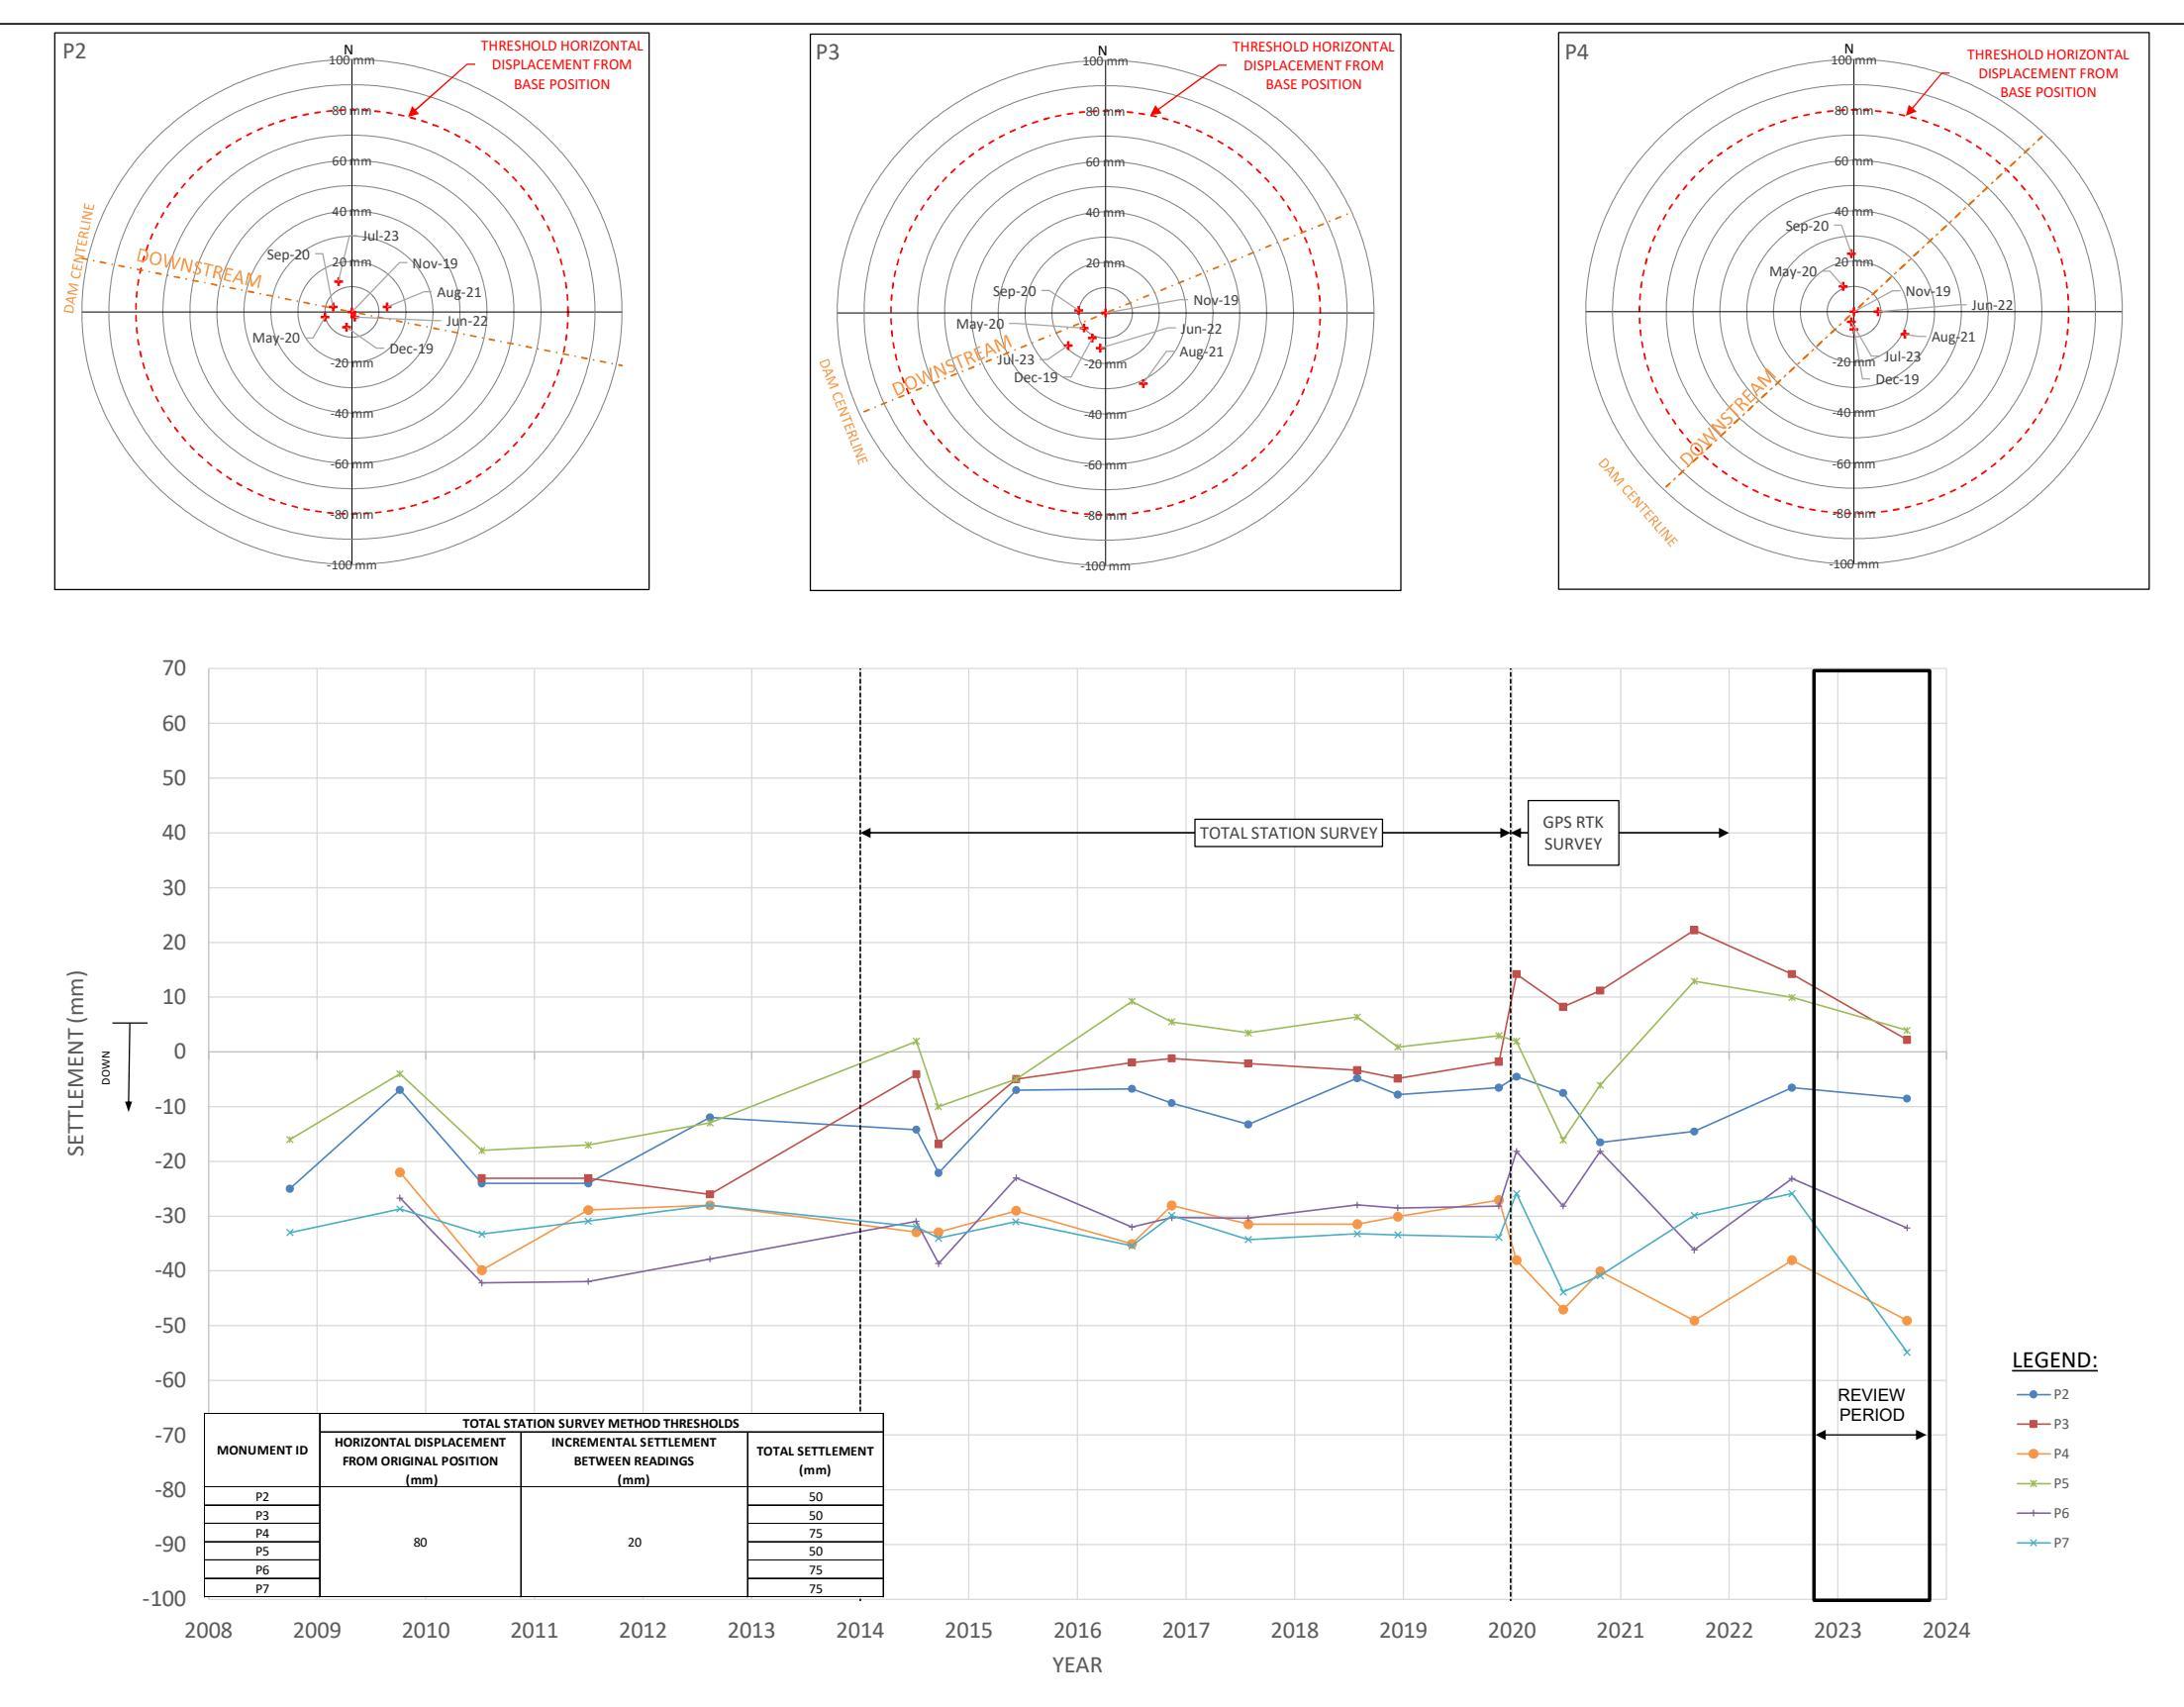
DISPLACEMENT WAS MOSTLY IN A NORTHWEST DIRECTION PERPENDICULAR TO THE DAM ORIENTATION, BUT SLIGHTLY IN THE DOWNSTREAM DIRECTION.

5. P4 2008, AND 2009 READINGS (NOT SHOWN IN PLAN PLOT) LOCATED 240 mm and 167 mm FROM INITIAL 2007 READING, RESPECTIVELY. READING WAS REVIEWED AND FOUND MORE LIKELY RELATED TO SURVEY ERROR THAN DISPLACEMENT. 6. 2021 SETTLEMENT PLOTTED BY ADDING INCREMENTAL DISPLACEMENT BETWEEN GPS RTK SURVEY READINGS TO CUMULATIVE TOTAL DISPLACEMENT ON OCTOBER 17, 2019. THIS ASSUMES NO SETTLEMENT OCCURED BETWEEN OCTOBER. 17 AND NOVEMBER 12, 2019.

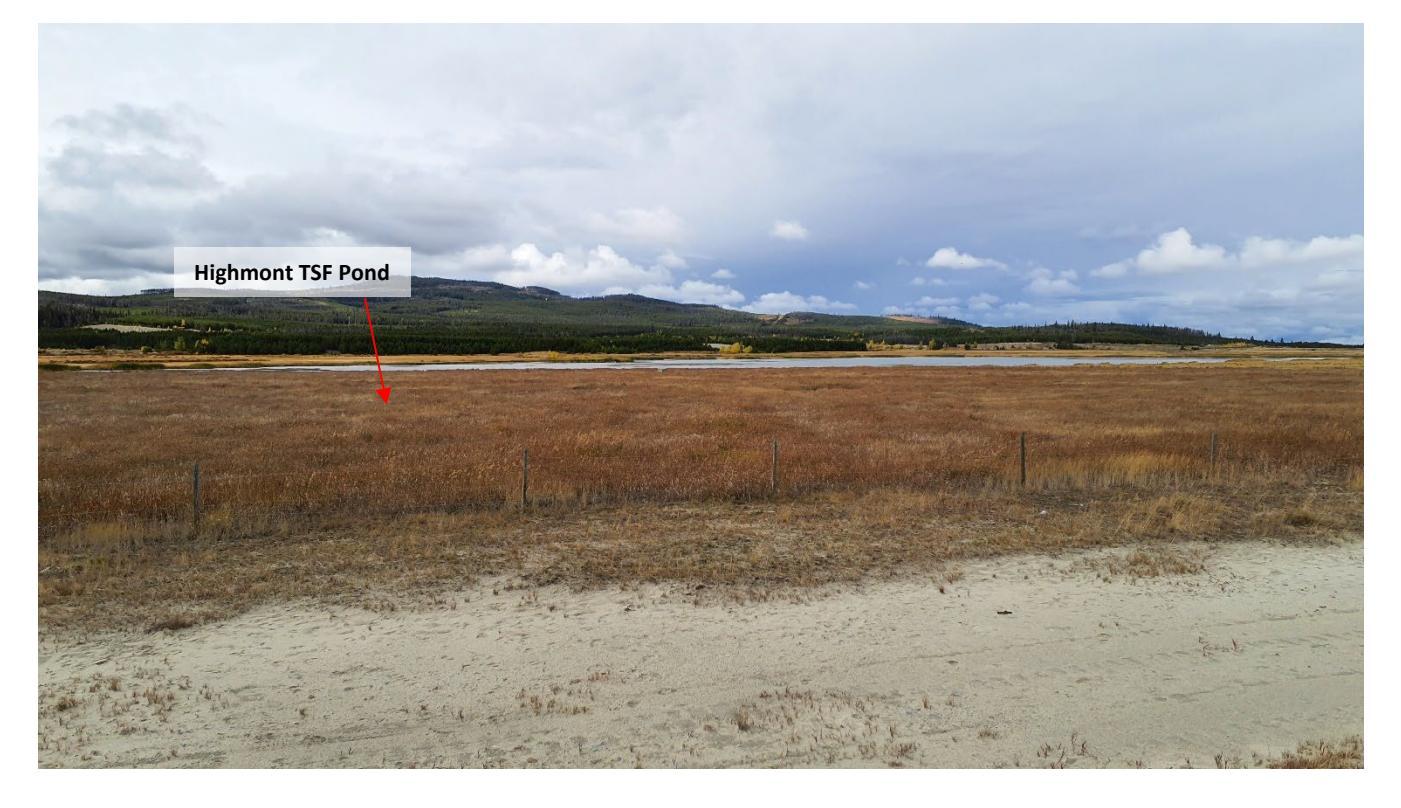
- Tailings Beach: The tailings beach is well vegetated, and the pond was well setback from the dam crest (>290 m) based on reservoir level, typical for this time of year (Photo I-A-1 to Photo I-A-3).
- **Pond**: At the time of the site visit the pond was centrally located in the impoundment, similar to the image on Figure 1 through Figure 3 (Photo I-A-1 to Photo I-A-3).

Photo I-A-2 View of tailings impoundment and beach from East Dam (HGH-2023-02)

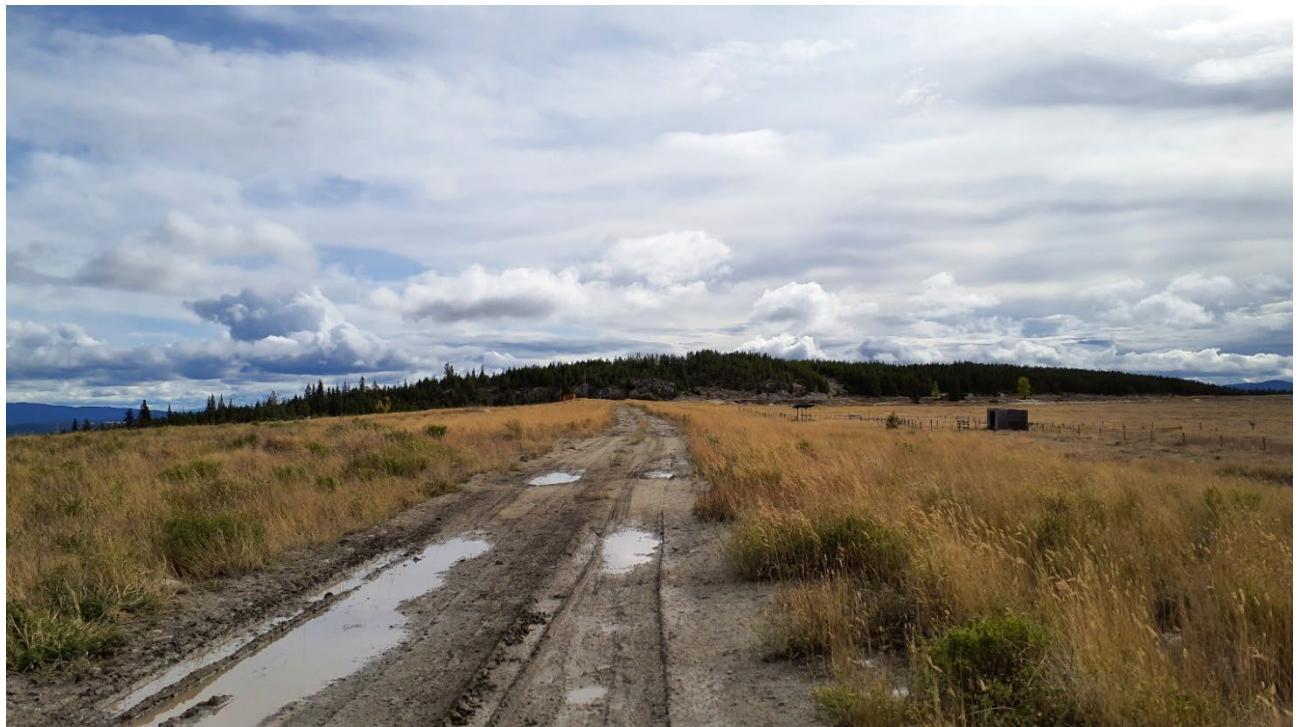
Photo I-A-4 View of North Dam crest looking west and east respectively. Crest is in good condition. No signs of distress, settlement, or depression (HGH-2023-01 and HGH-2023-04)

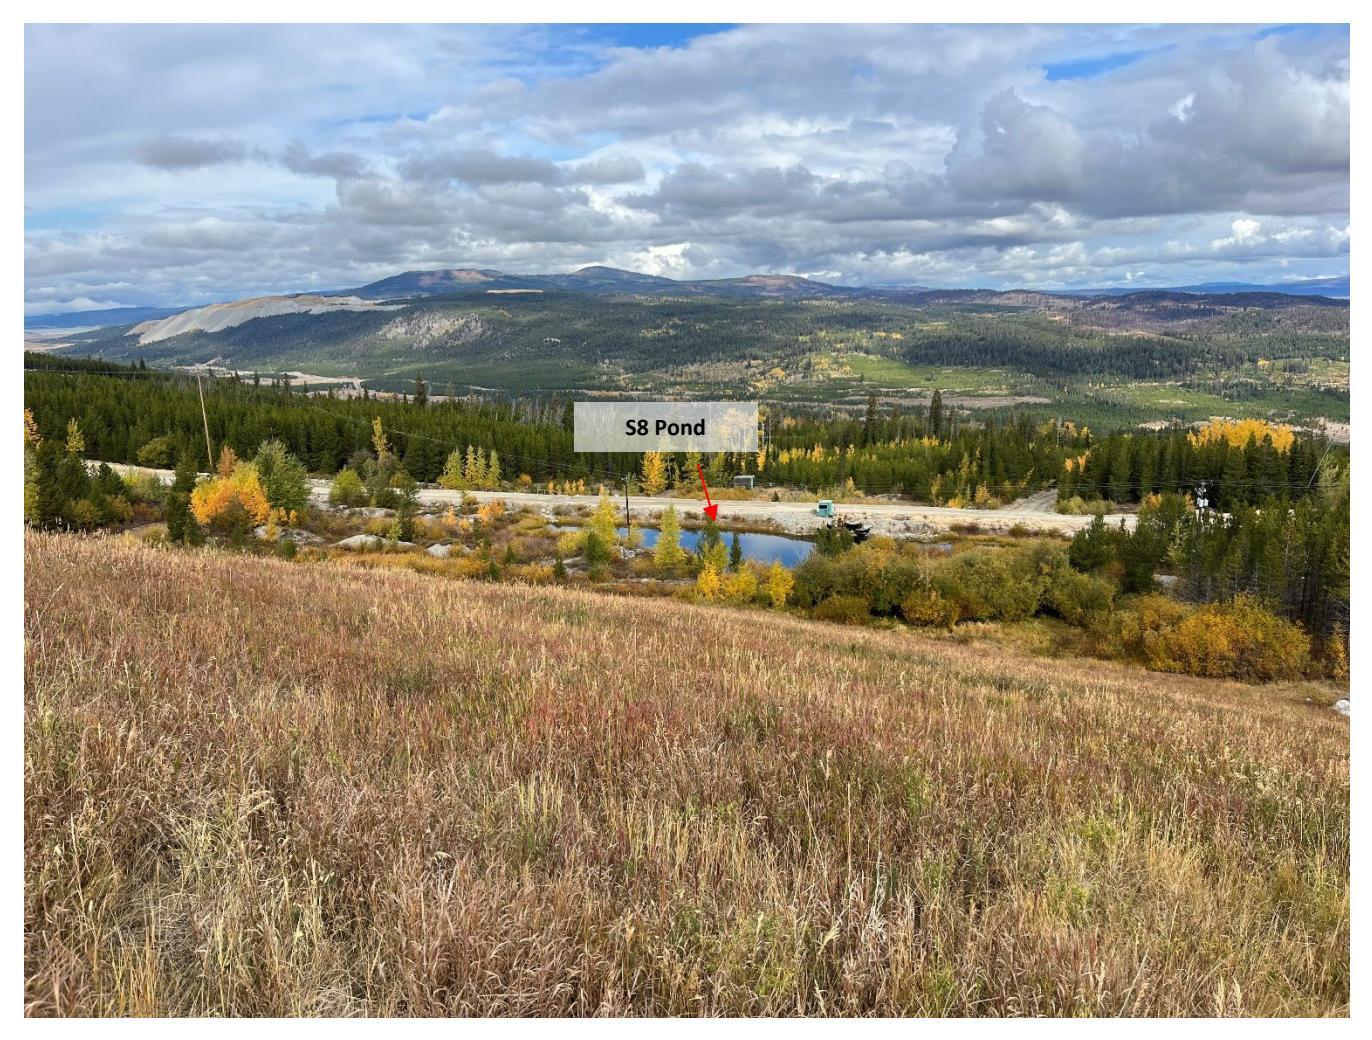
Photo I-A-7 View of North Dam downstream toe and S8 Pond. No signs of distress or deformation were observed (HGH-2023-06)

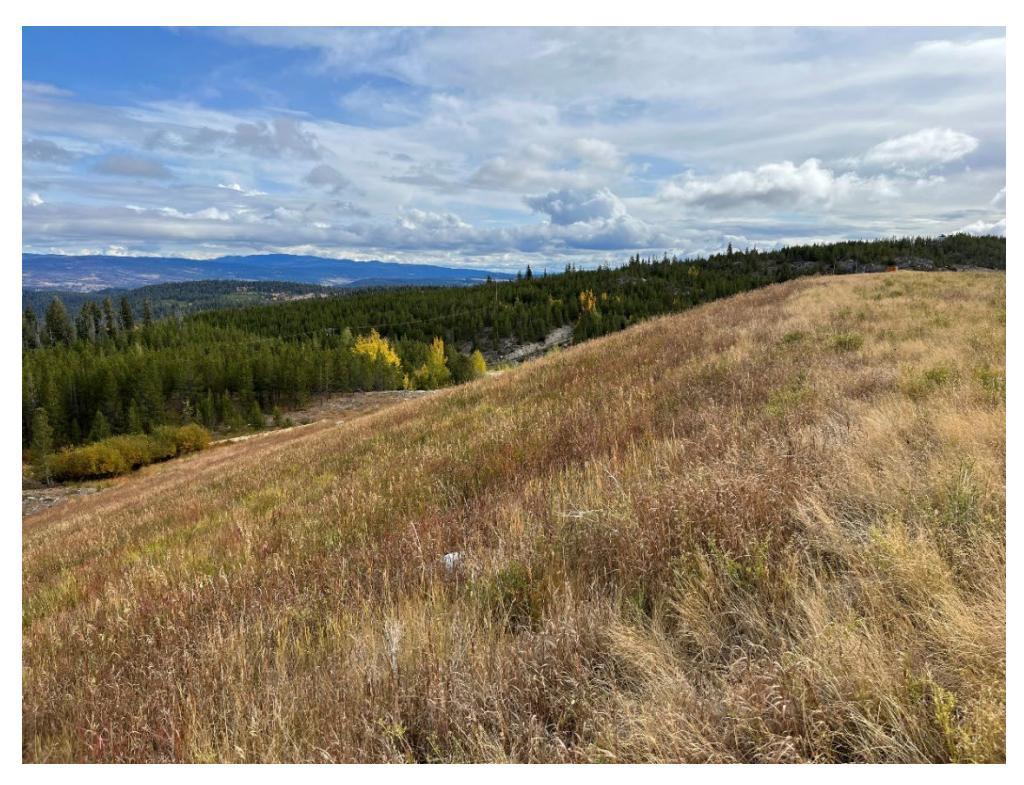
Photo I-A-8 View of North Dam downstream slope looking east and west respectively (HGH-2023-06)

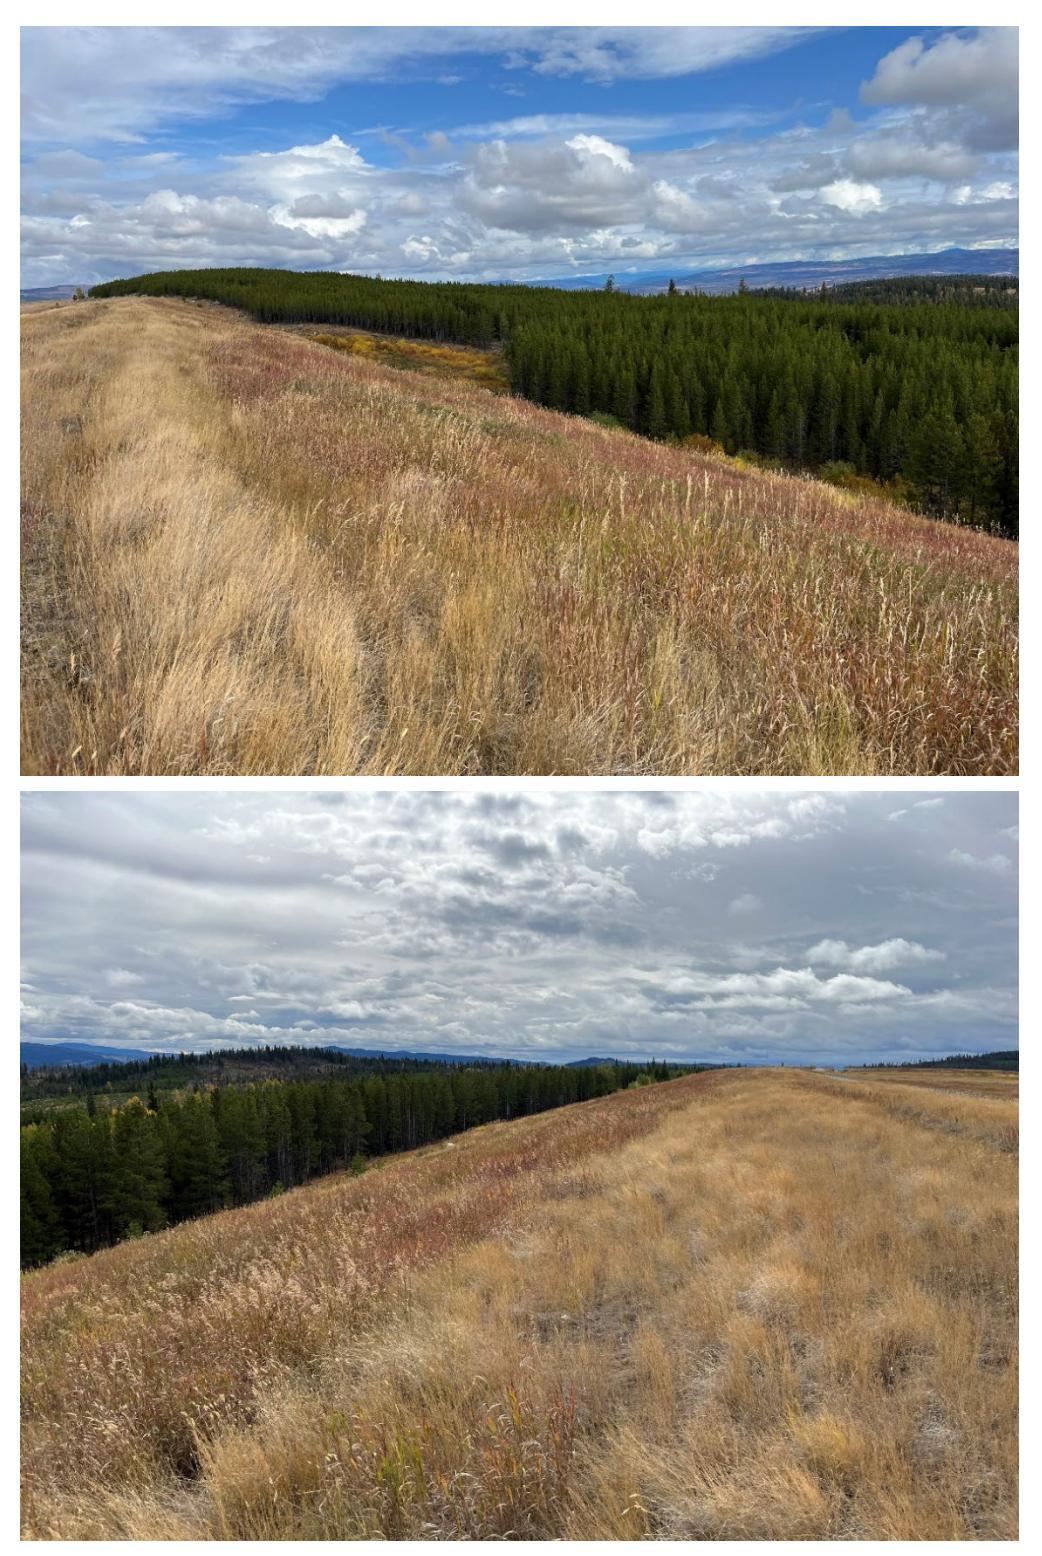
Photo I-A-9 East Dam downstream slope. Slope is vegetated and in good condition (HGH-2023-07)

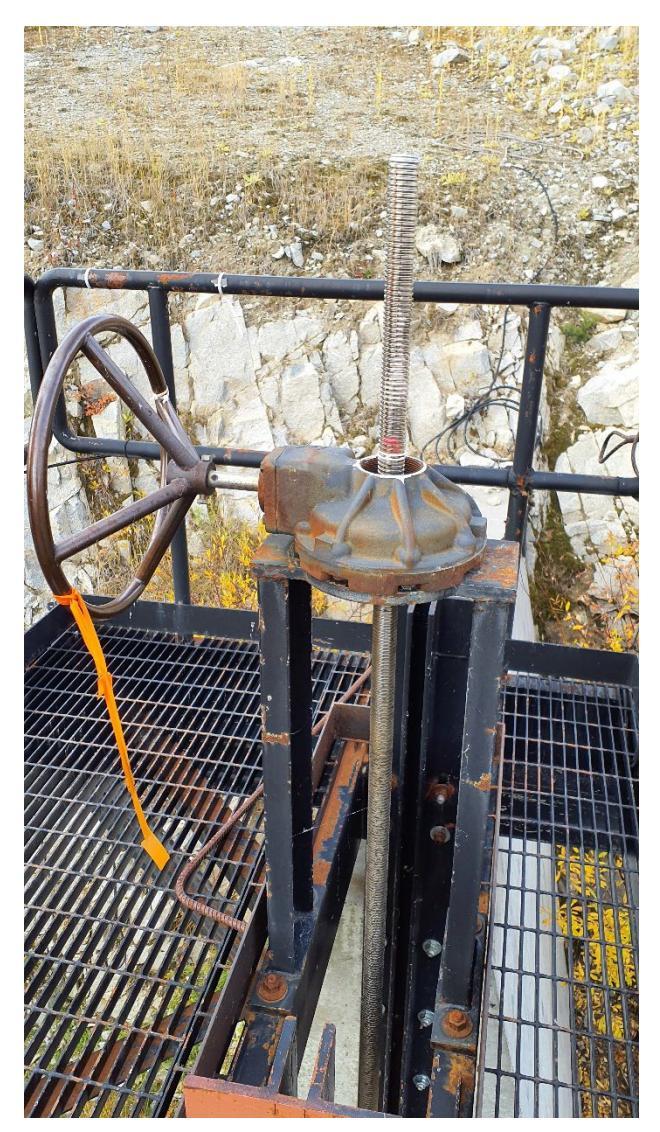
Photo I-A-15 Spillway flow control gate. Sliding gate is slightly open (HGH-2023-12)

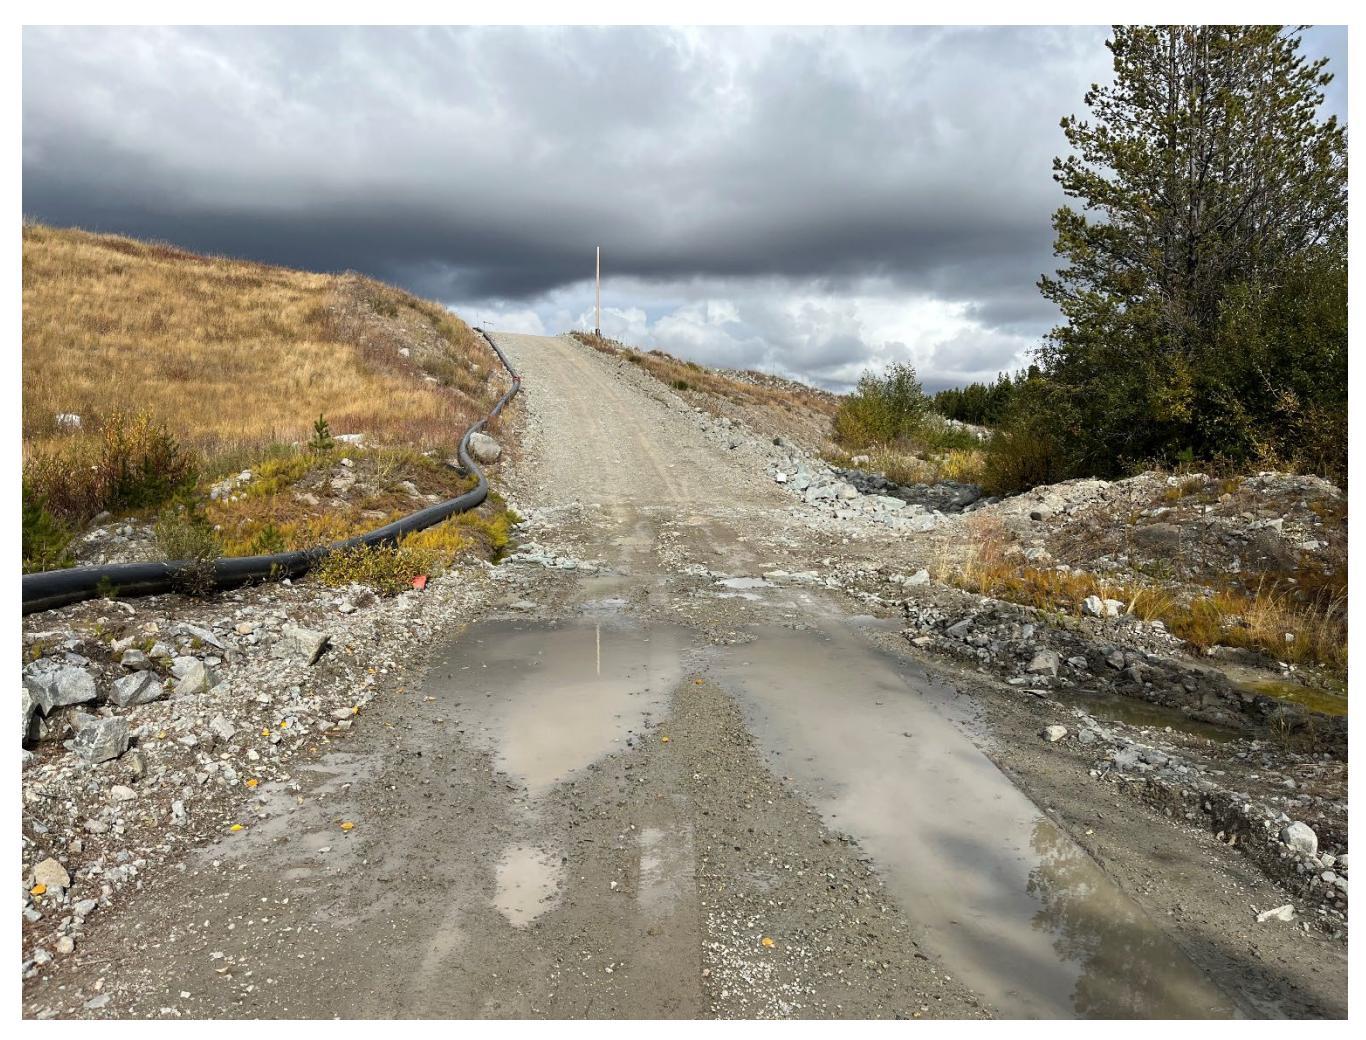
Photo I-A-22 South Dam toe access road to S3 Pond. Clear seepage observed through the road fill and ponding in lower elevation rut; refer to Section 5.1 in the main text for further discussion (HGH-2023-20)

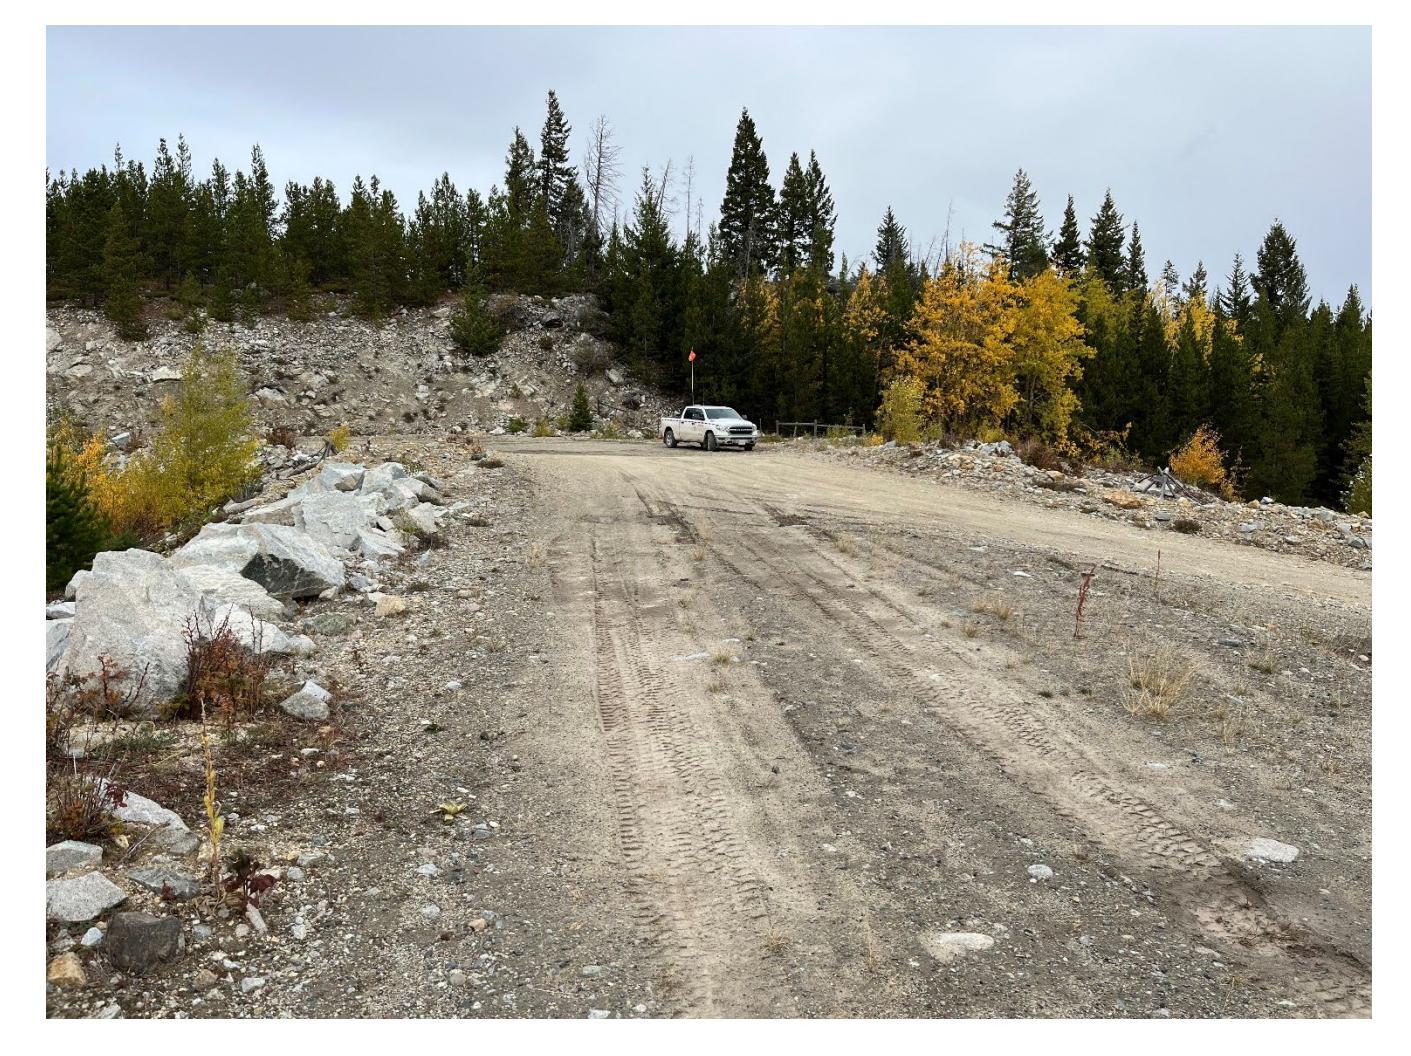
- **Crest**: Good physical condition. No signs of significant erosion, deterioration, displacement, or cracking (Photo I-B-1).
- Left and Right Abutment: Good physical condition. No signs of significant erosion, deterioration, displacement, or cracking.
- Downstream Slope: Good physical condition. Slope covered in gravel and moderately vegetated. This provides adequate erosion protection based on performance over the service life (Photo I-B-2).
- **Pond**: At the time of site visit was about 1.5 m below the spillway invert, which is typical for this time of the year (Photo I-B-3).
- Spillway: Good physical condition (Photo I-B-5).
- Low-level Outlet: The outlet pipe trash rack was clear of large debris (Photo I-B-4).
- Seepage: None observed.

Photo I-B-1 S1 Pond: Overview of crest looking west towards left abutment (HGH-2023-21)

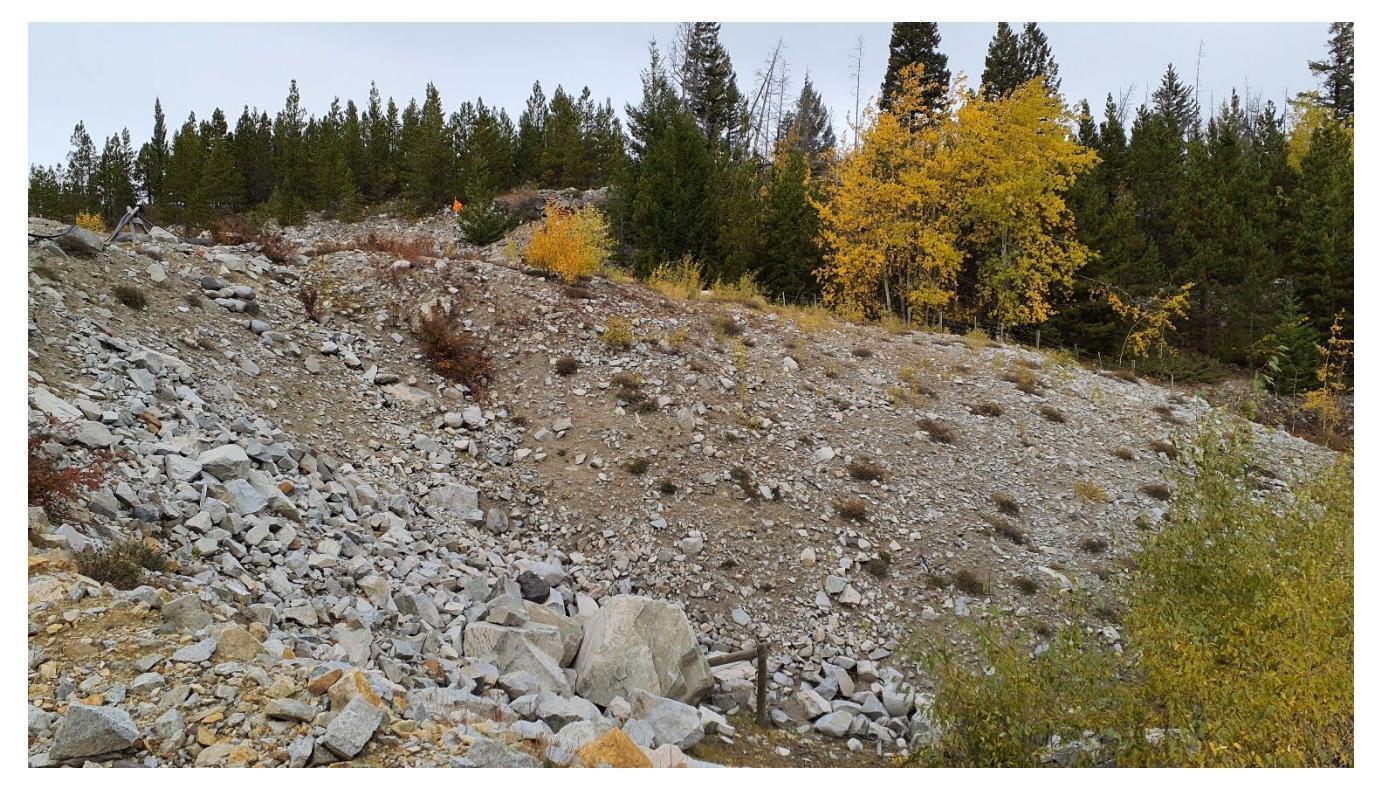
Photo I-B-3 S1 Pond: View of impoundment, spillway intake, and Low-Level Outlet (LLO) (HGH-2023-21)

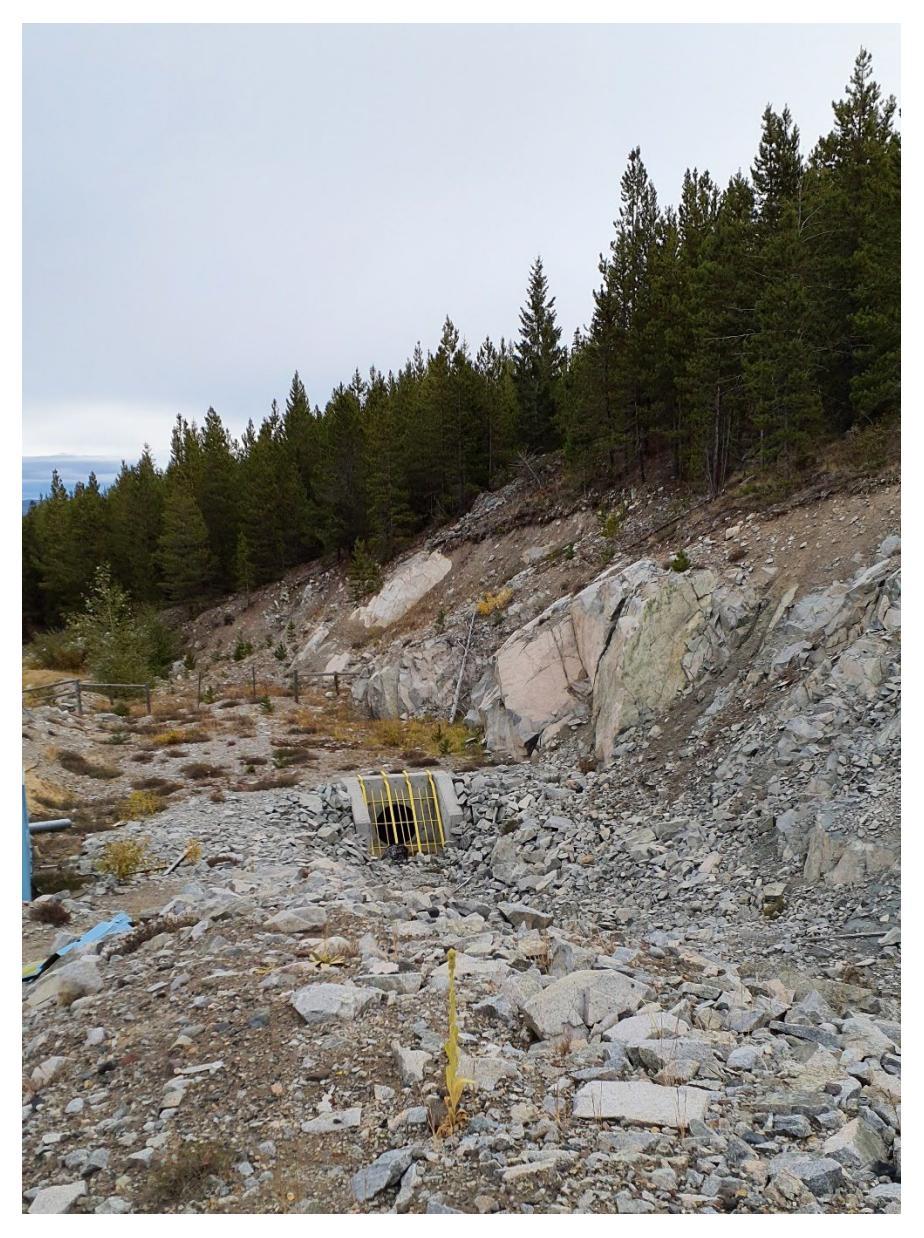
Photo I-B-5 S1 Pond: Spillway channel and pipe intake looking downstream. Channel is clear of vegetation and no sign of obstruction was observed at the pipe intake (HGH-2023-24).

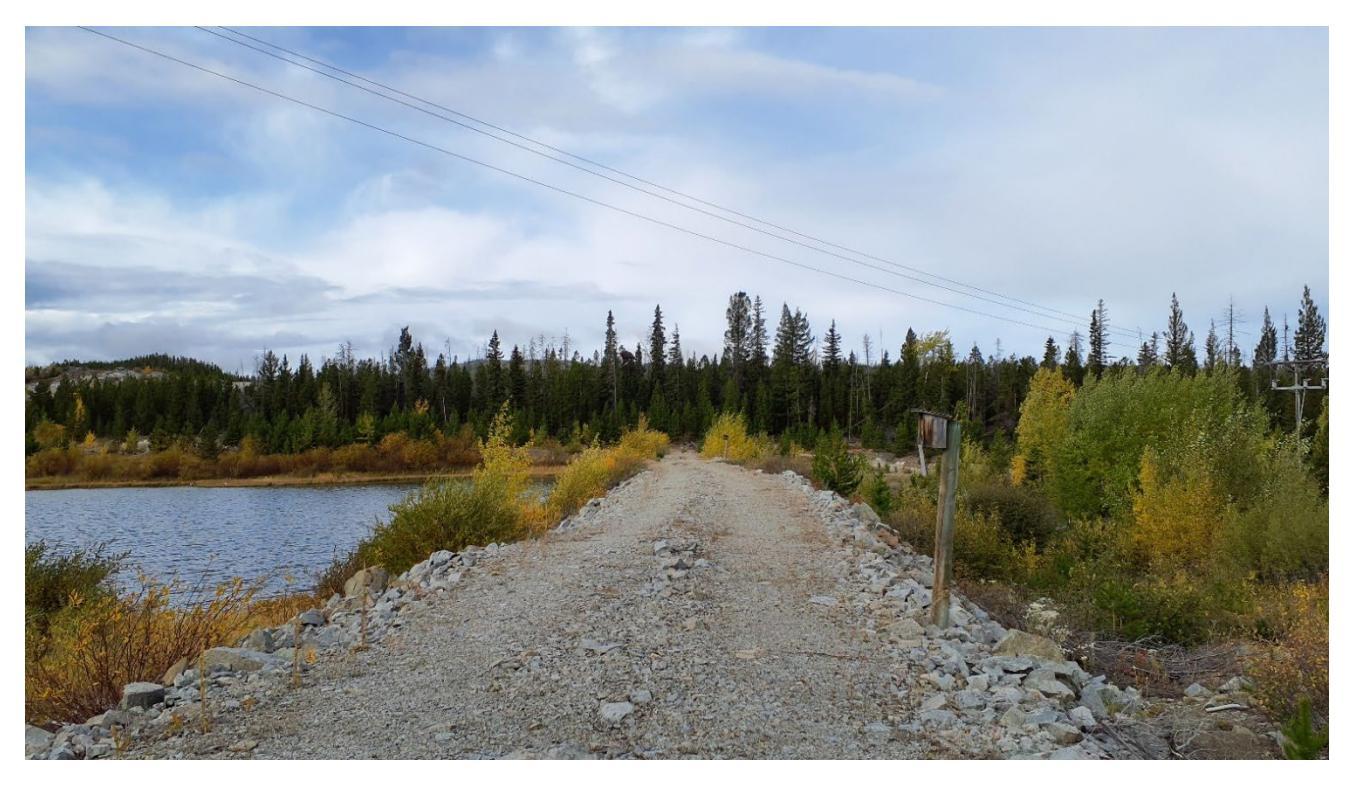
- **Crest**: Good physical condition. No signs of significant erosion, deterioration, displacement, or cracking (Photo I-B-6).
- Left and Right Abutment: Good physical condition. No signs of significant erosion, deterioration, displacement, or cracking.

Photo I-B-6 S2 Pond: View of embankment crest, looking toward left abutment (HGH-2023-25).

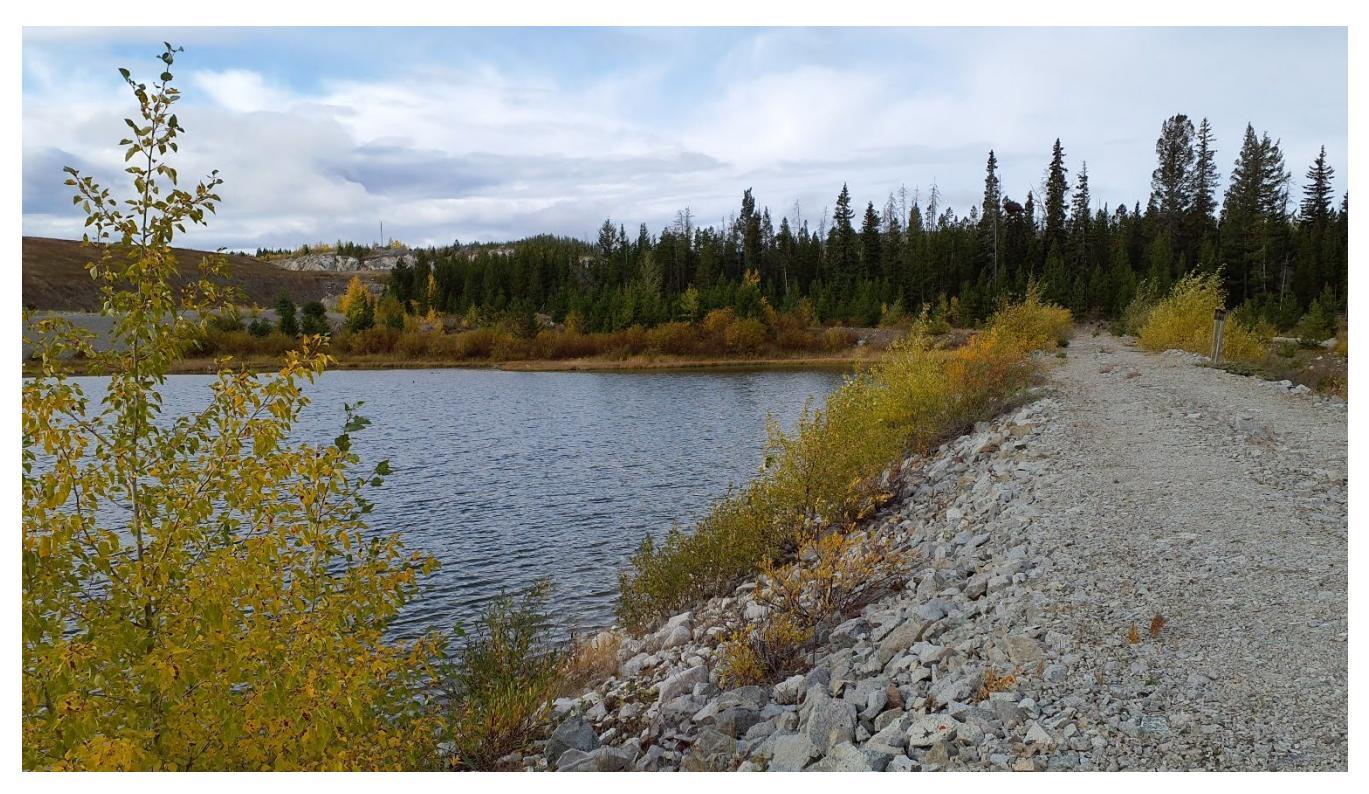
Photo I-B-8 S2 Pond: Overview of upstream slope riprap. Slope is in good condition (HGH-2023-27).

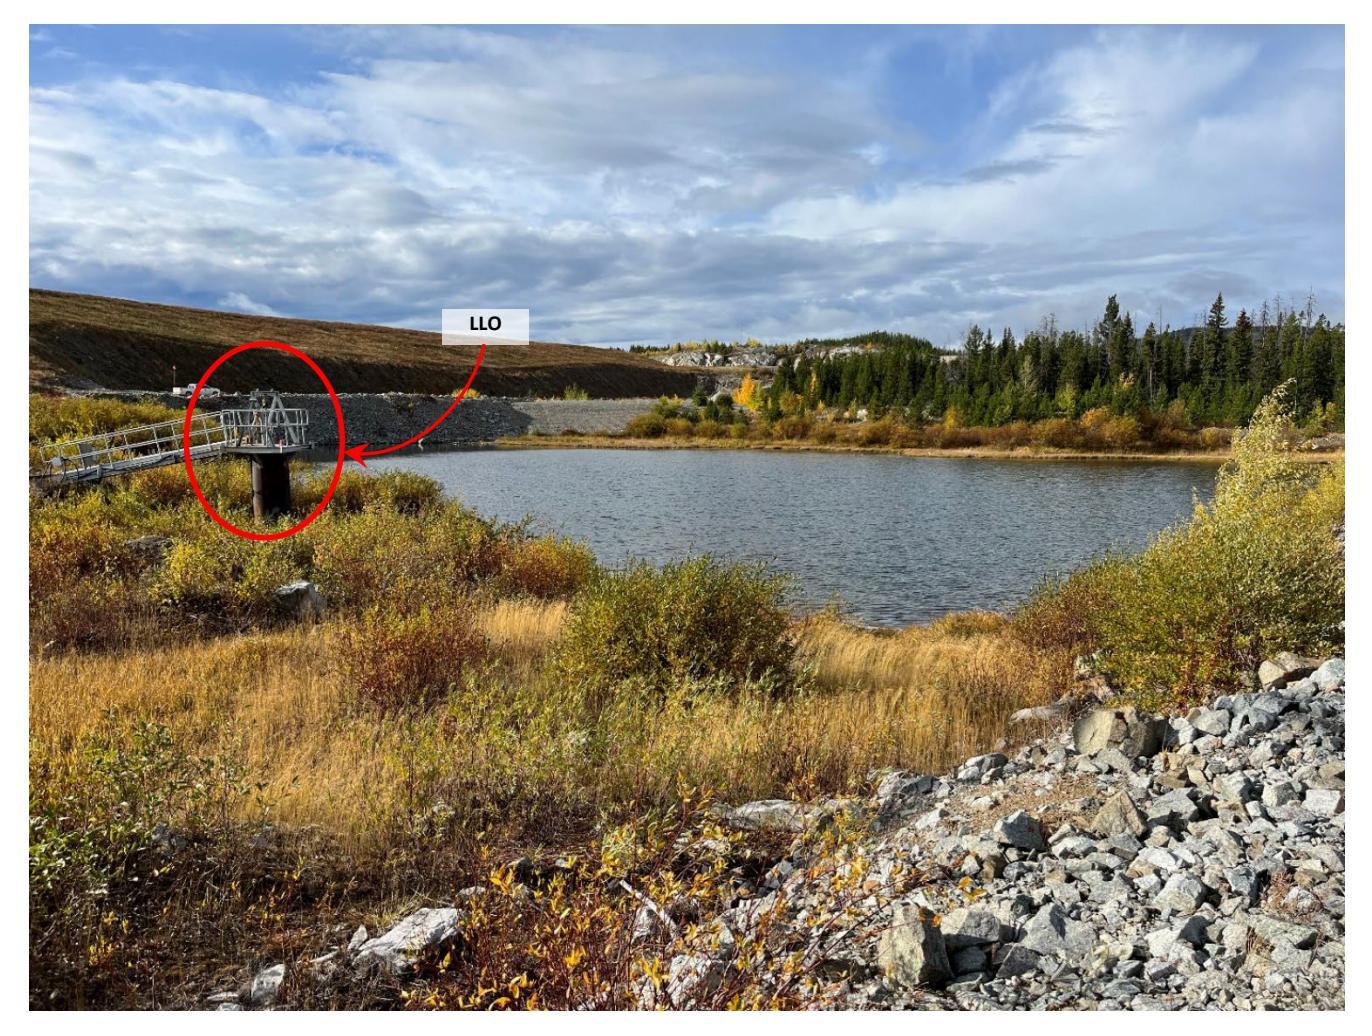
Photo I-B-9 S2 Pond: Impoundment with view of downstream slope of Highmont North Dam in the background and Low-Level Outlet (HGH-2023-25).

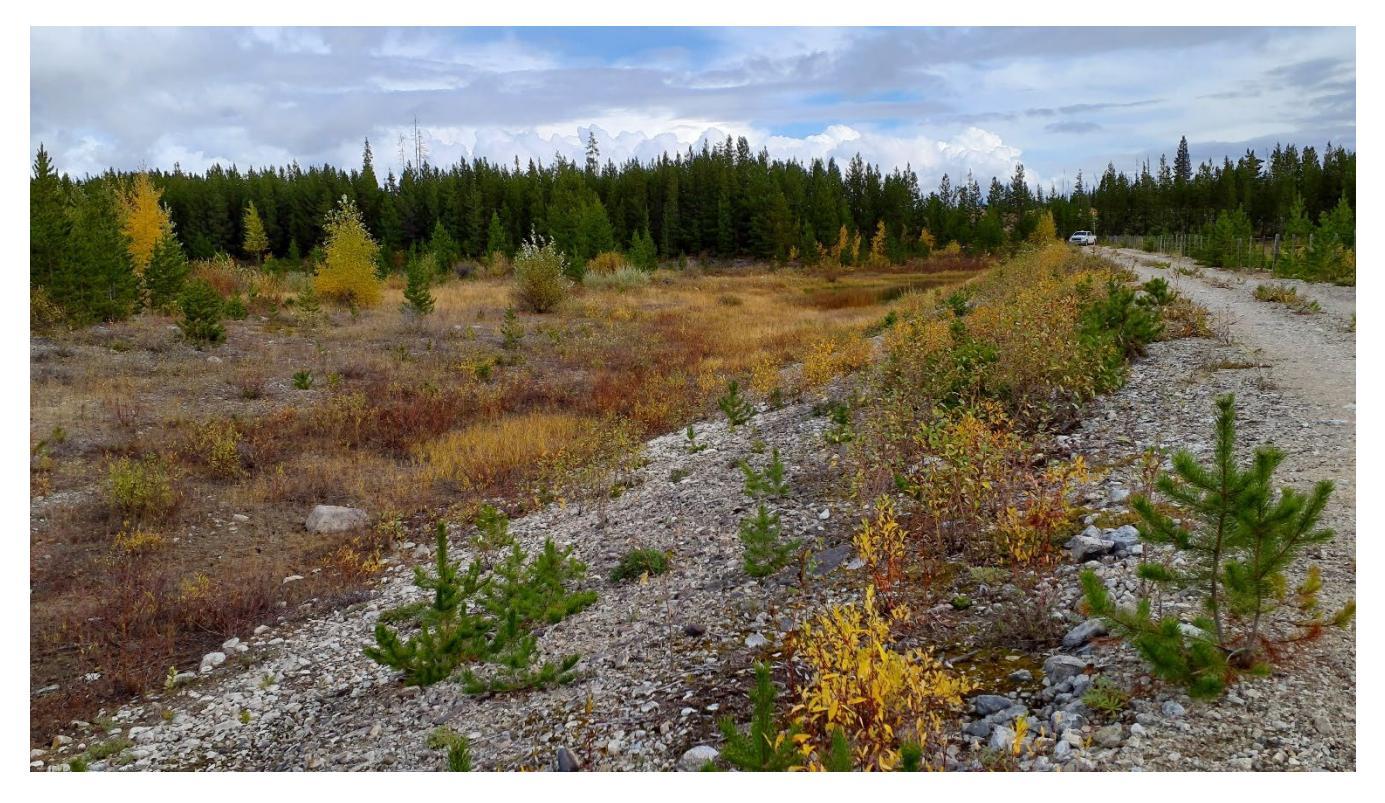
Photo I-B-11 S3 Pond: Overview of upstream slope right abutment (HGH-2023-29).

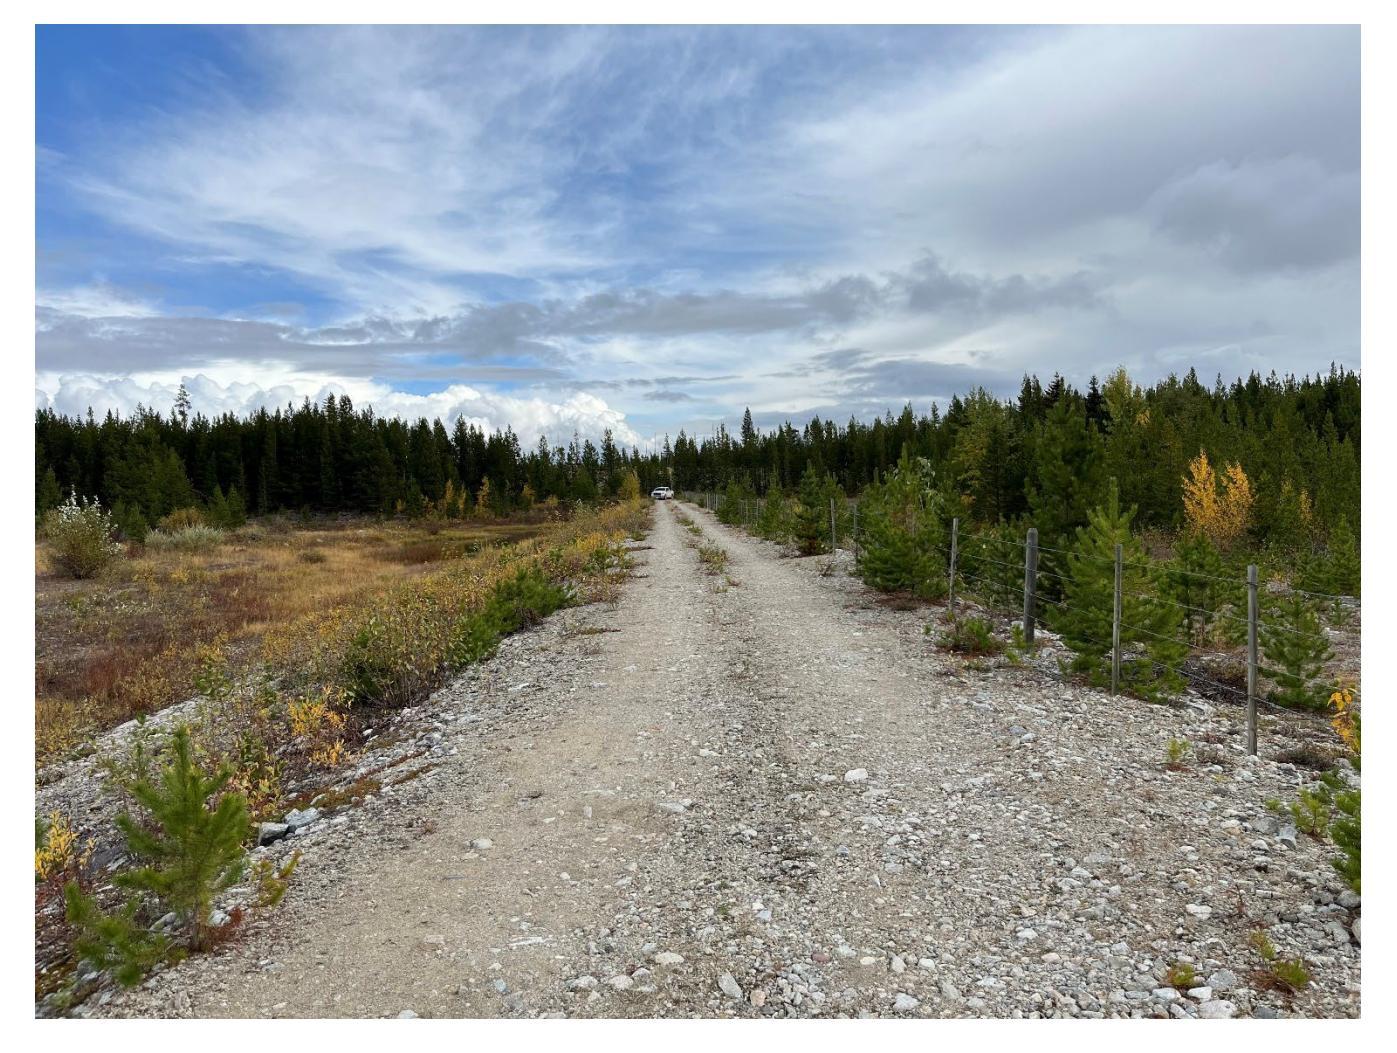
- **Crest**: Good physical condition. No indicators of significant concern observed (e.g., cracking, slumping, horizontal displacement) (Photo I-B-12 to Photo I-B-14).

Photo I-B-12 S3 Pond: View of embankment crest, looking toward left abutment (HGH-2023-29).
