Teck Highland Valley Copper Partnership

2023 Annual Facility Performance Report

Highmont Tailings Storage Facility

March 2024

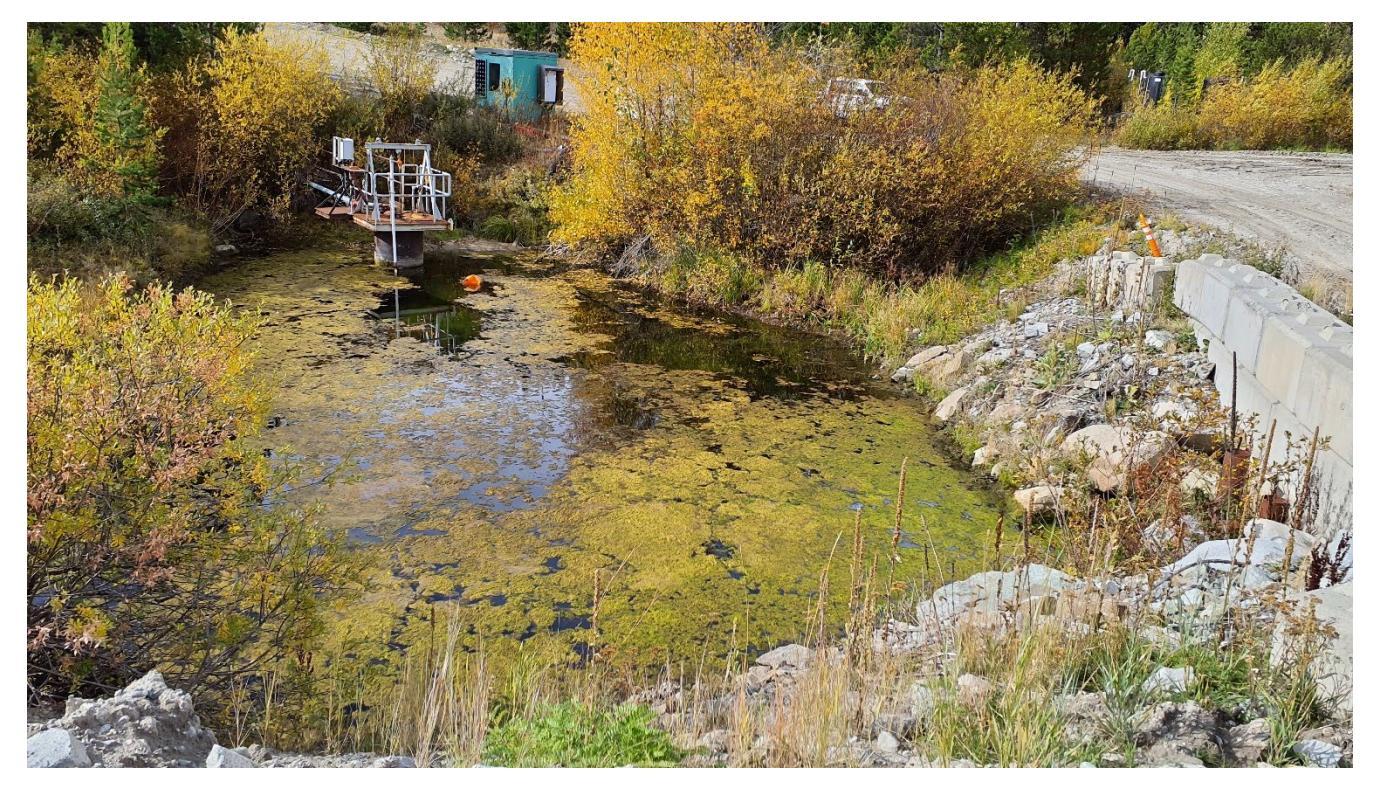
Photo I-B-18 S5 Pond: Downstream slope of perimeter crest, looking north (HGH-2023-33).

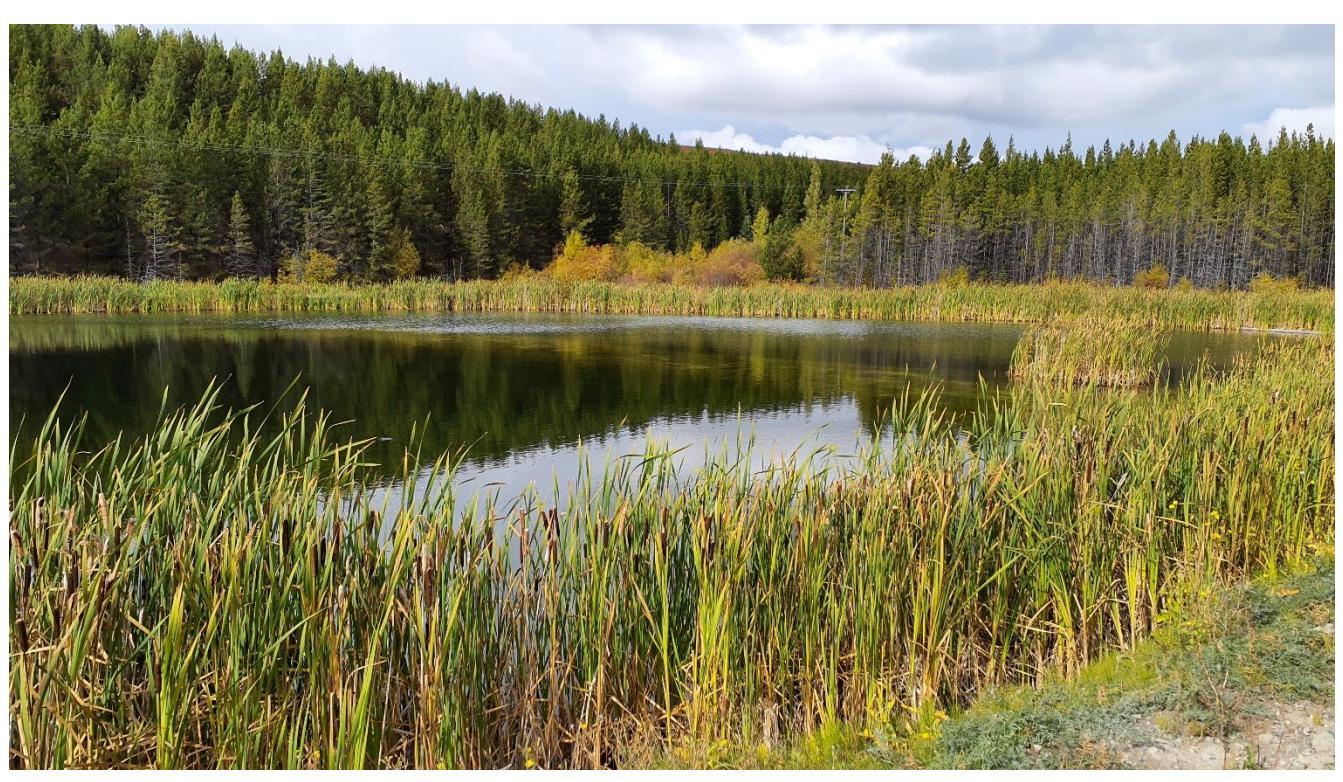
Photo I-B-20 S5 Pond: Overview of pond from left abutment (HGH-2023-35).

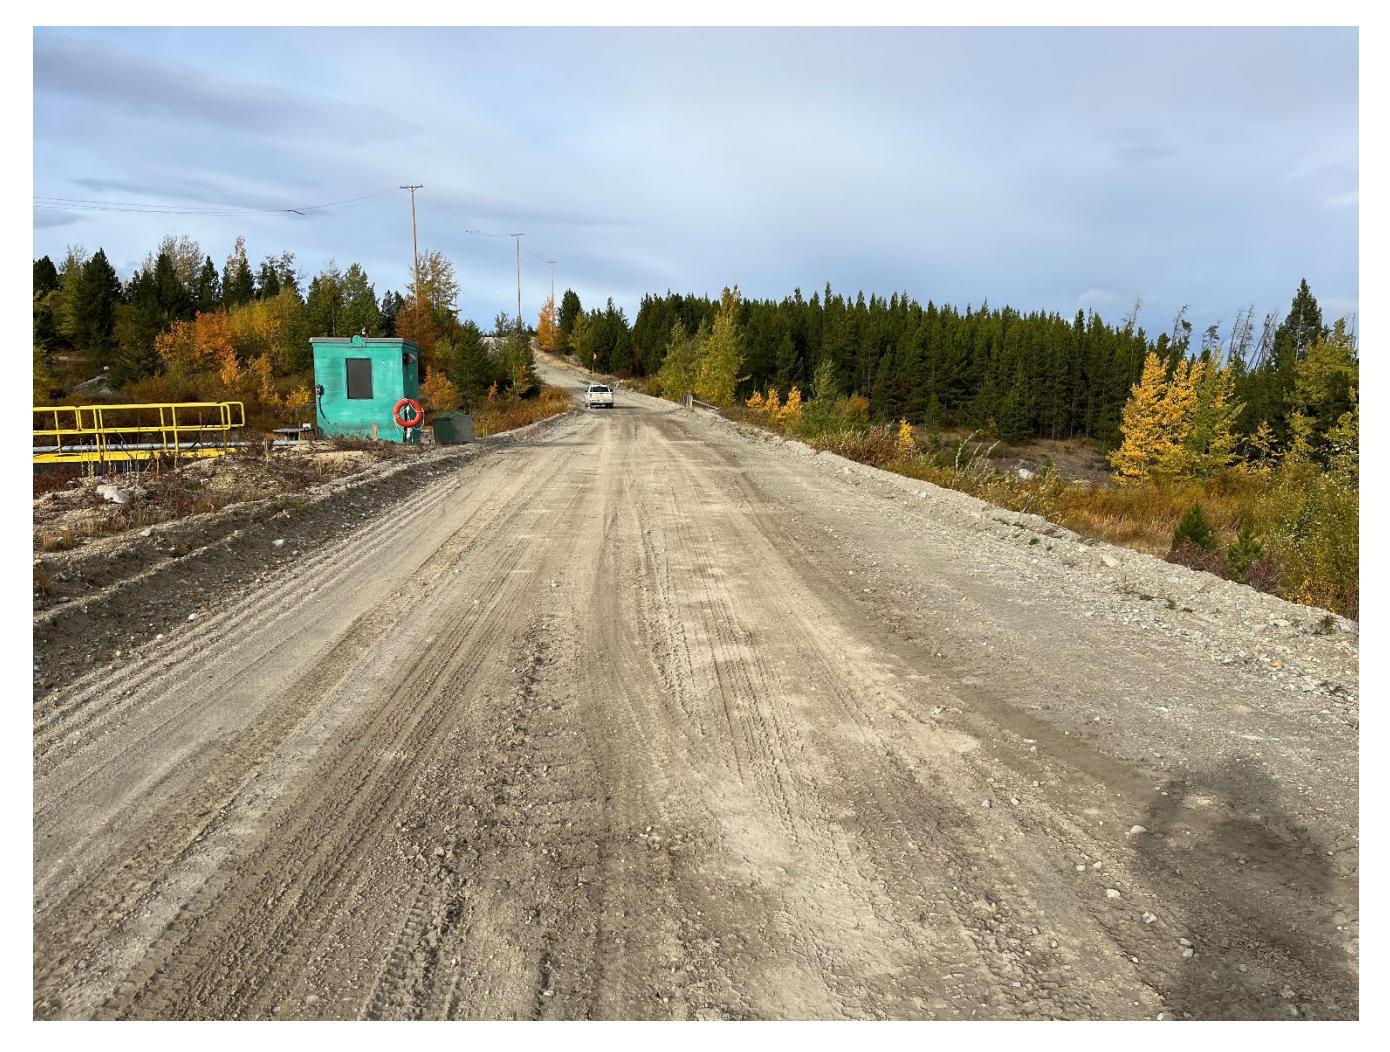
Photo I-B-21 S8 Pond: Overview of crest from right abutment (HGH-2023-36).

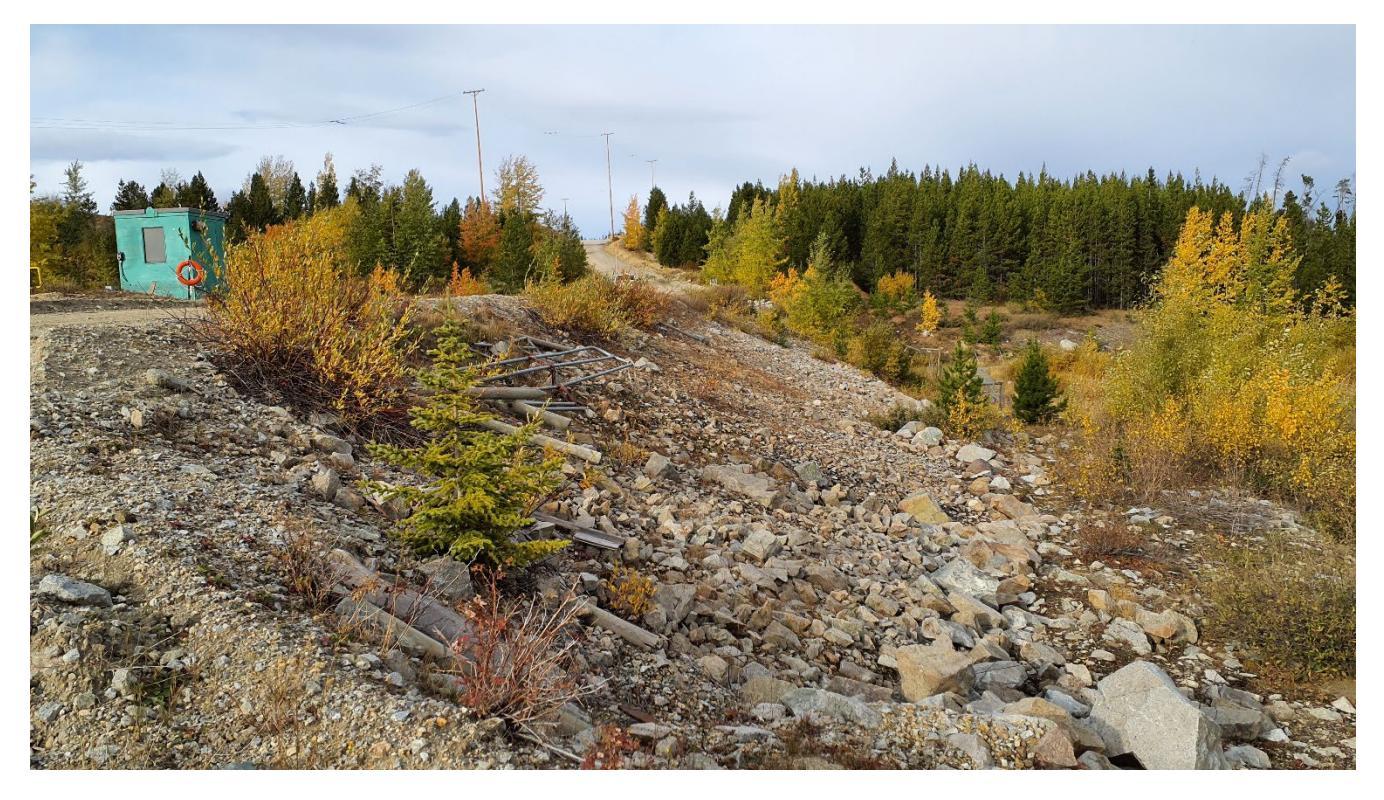
Photo I-B-22 S8 Pond: View of downstream slope (HGH-2023-37).

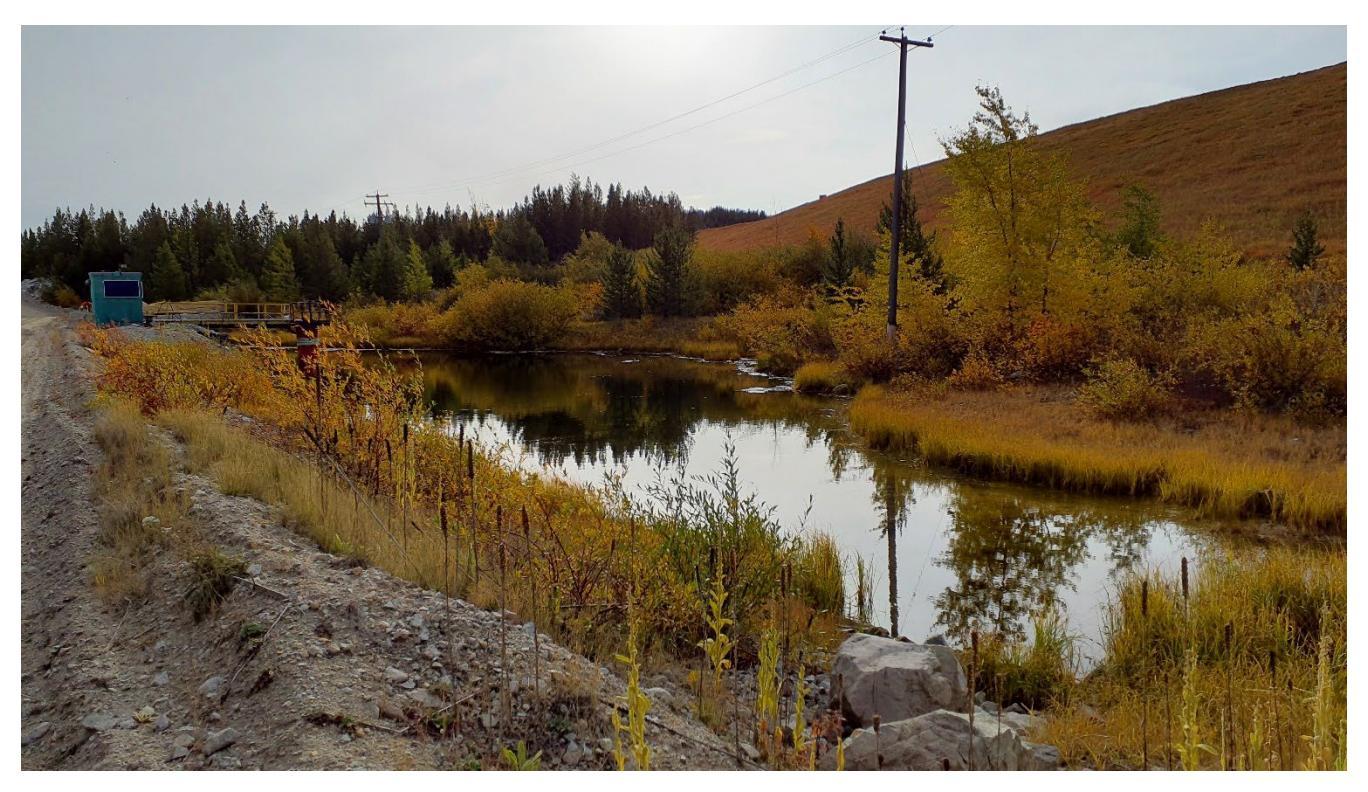
Photo I-B-23 S8 Pond: View of S8 Pond impoundment. Highmont North Dam downstream slope is visible on right hand side of picture (HGH-2023-38).

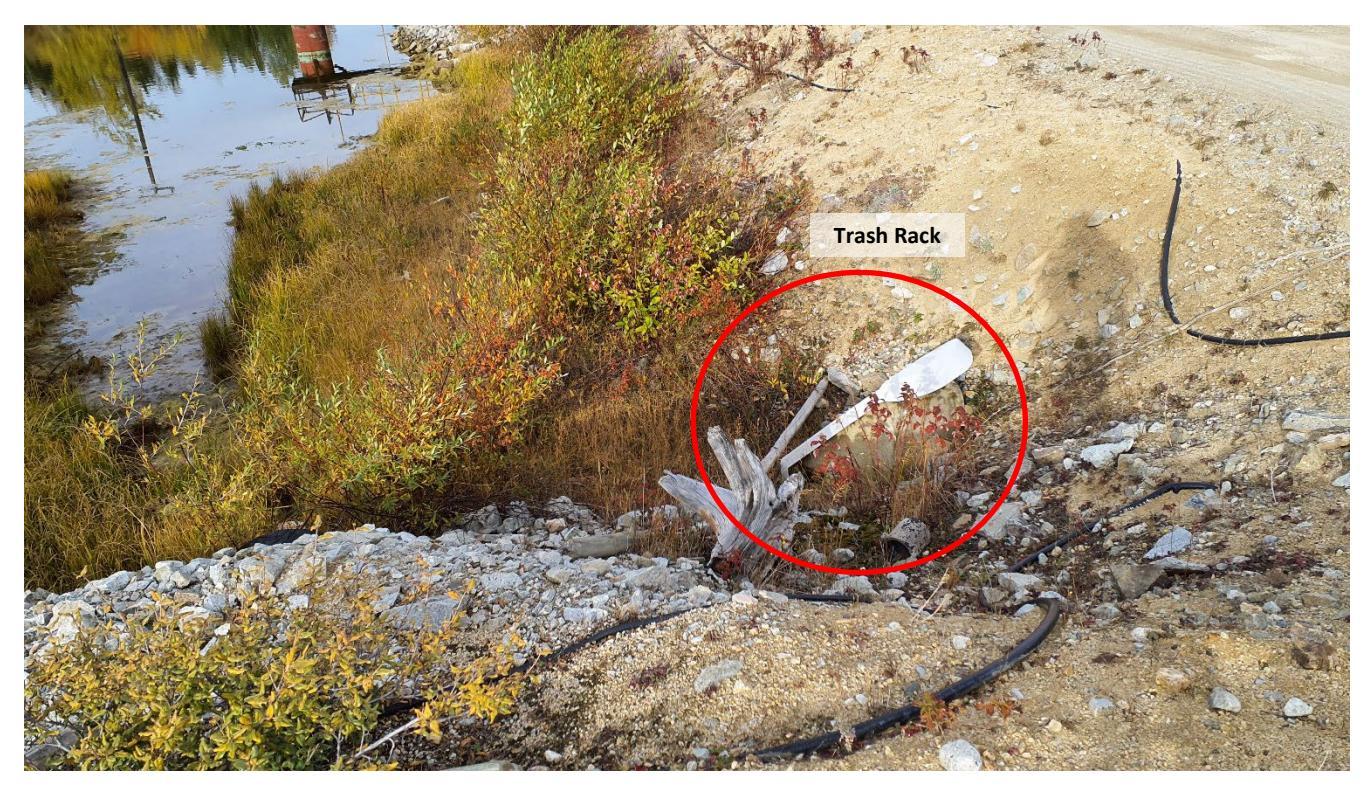
Photo I-B-25 S8 Pond: Overview of overflow pipe trash rack. Rack is clear of debris. Current water level is below the invert (HGH-2023-39).
