Teck Highland Valley Copper Partnership

2023 Annual Facility Performance Report

7-Day Pond Tailings Storage Facility

March 2024

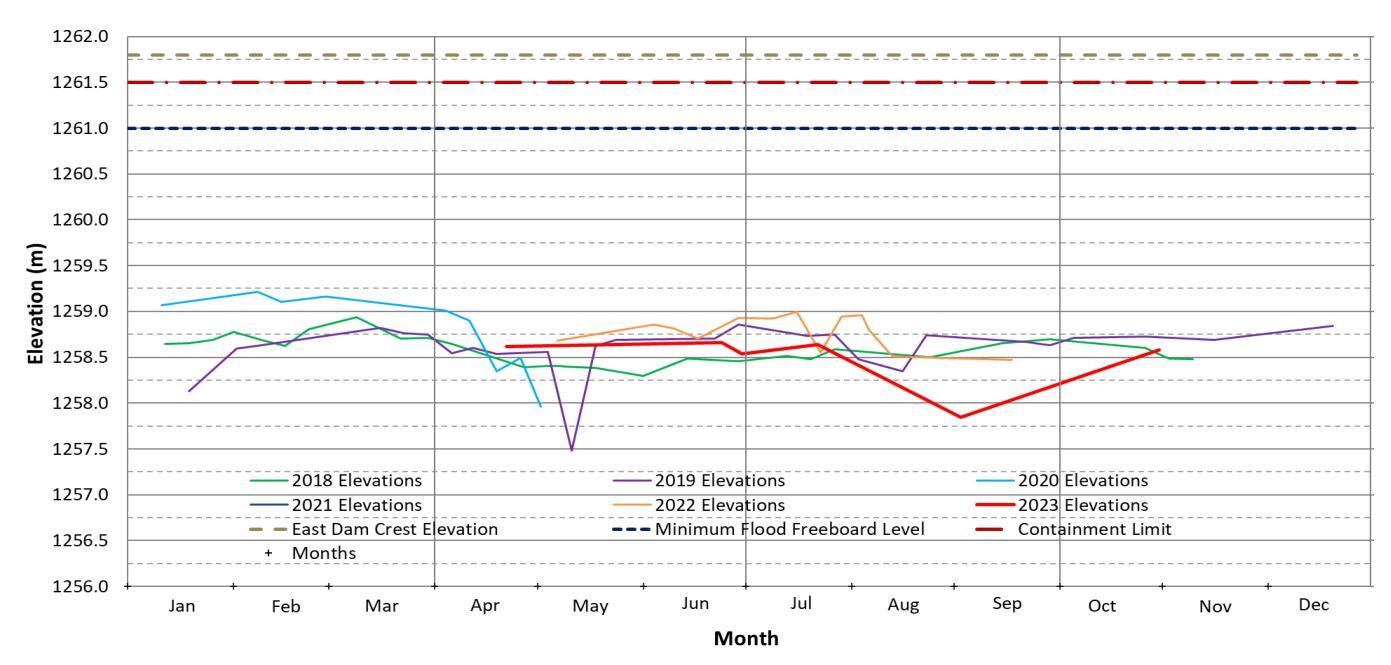
Figure 5.1 7-Day Pond TSF Pond Levels – 2018 to 2023

HVC has adopted 0.5 m as the target minimum flood freeboard⁵ for the facility. This exceeds the minimum freeboard required to accommodate wind and wave run-up based on the method proposed by CDA (2019), which is recommended by HSRC (EMLI 2022). The minimum freeboard measured during the review period at the 7-Day Pond TSF was more than 2.5 m.

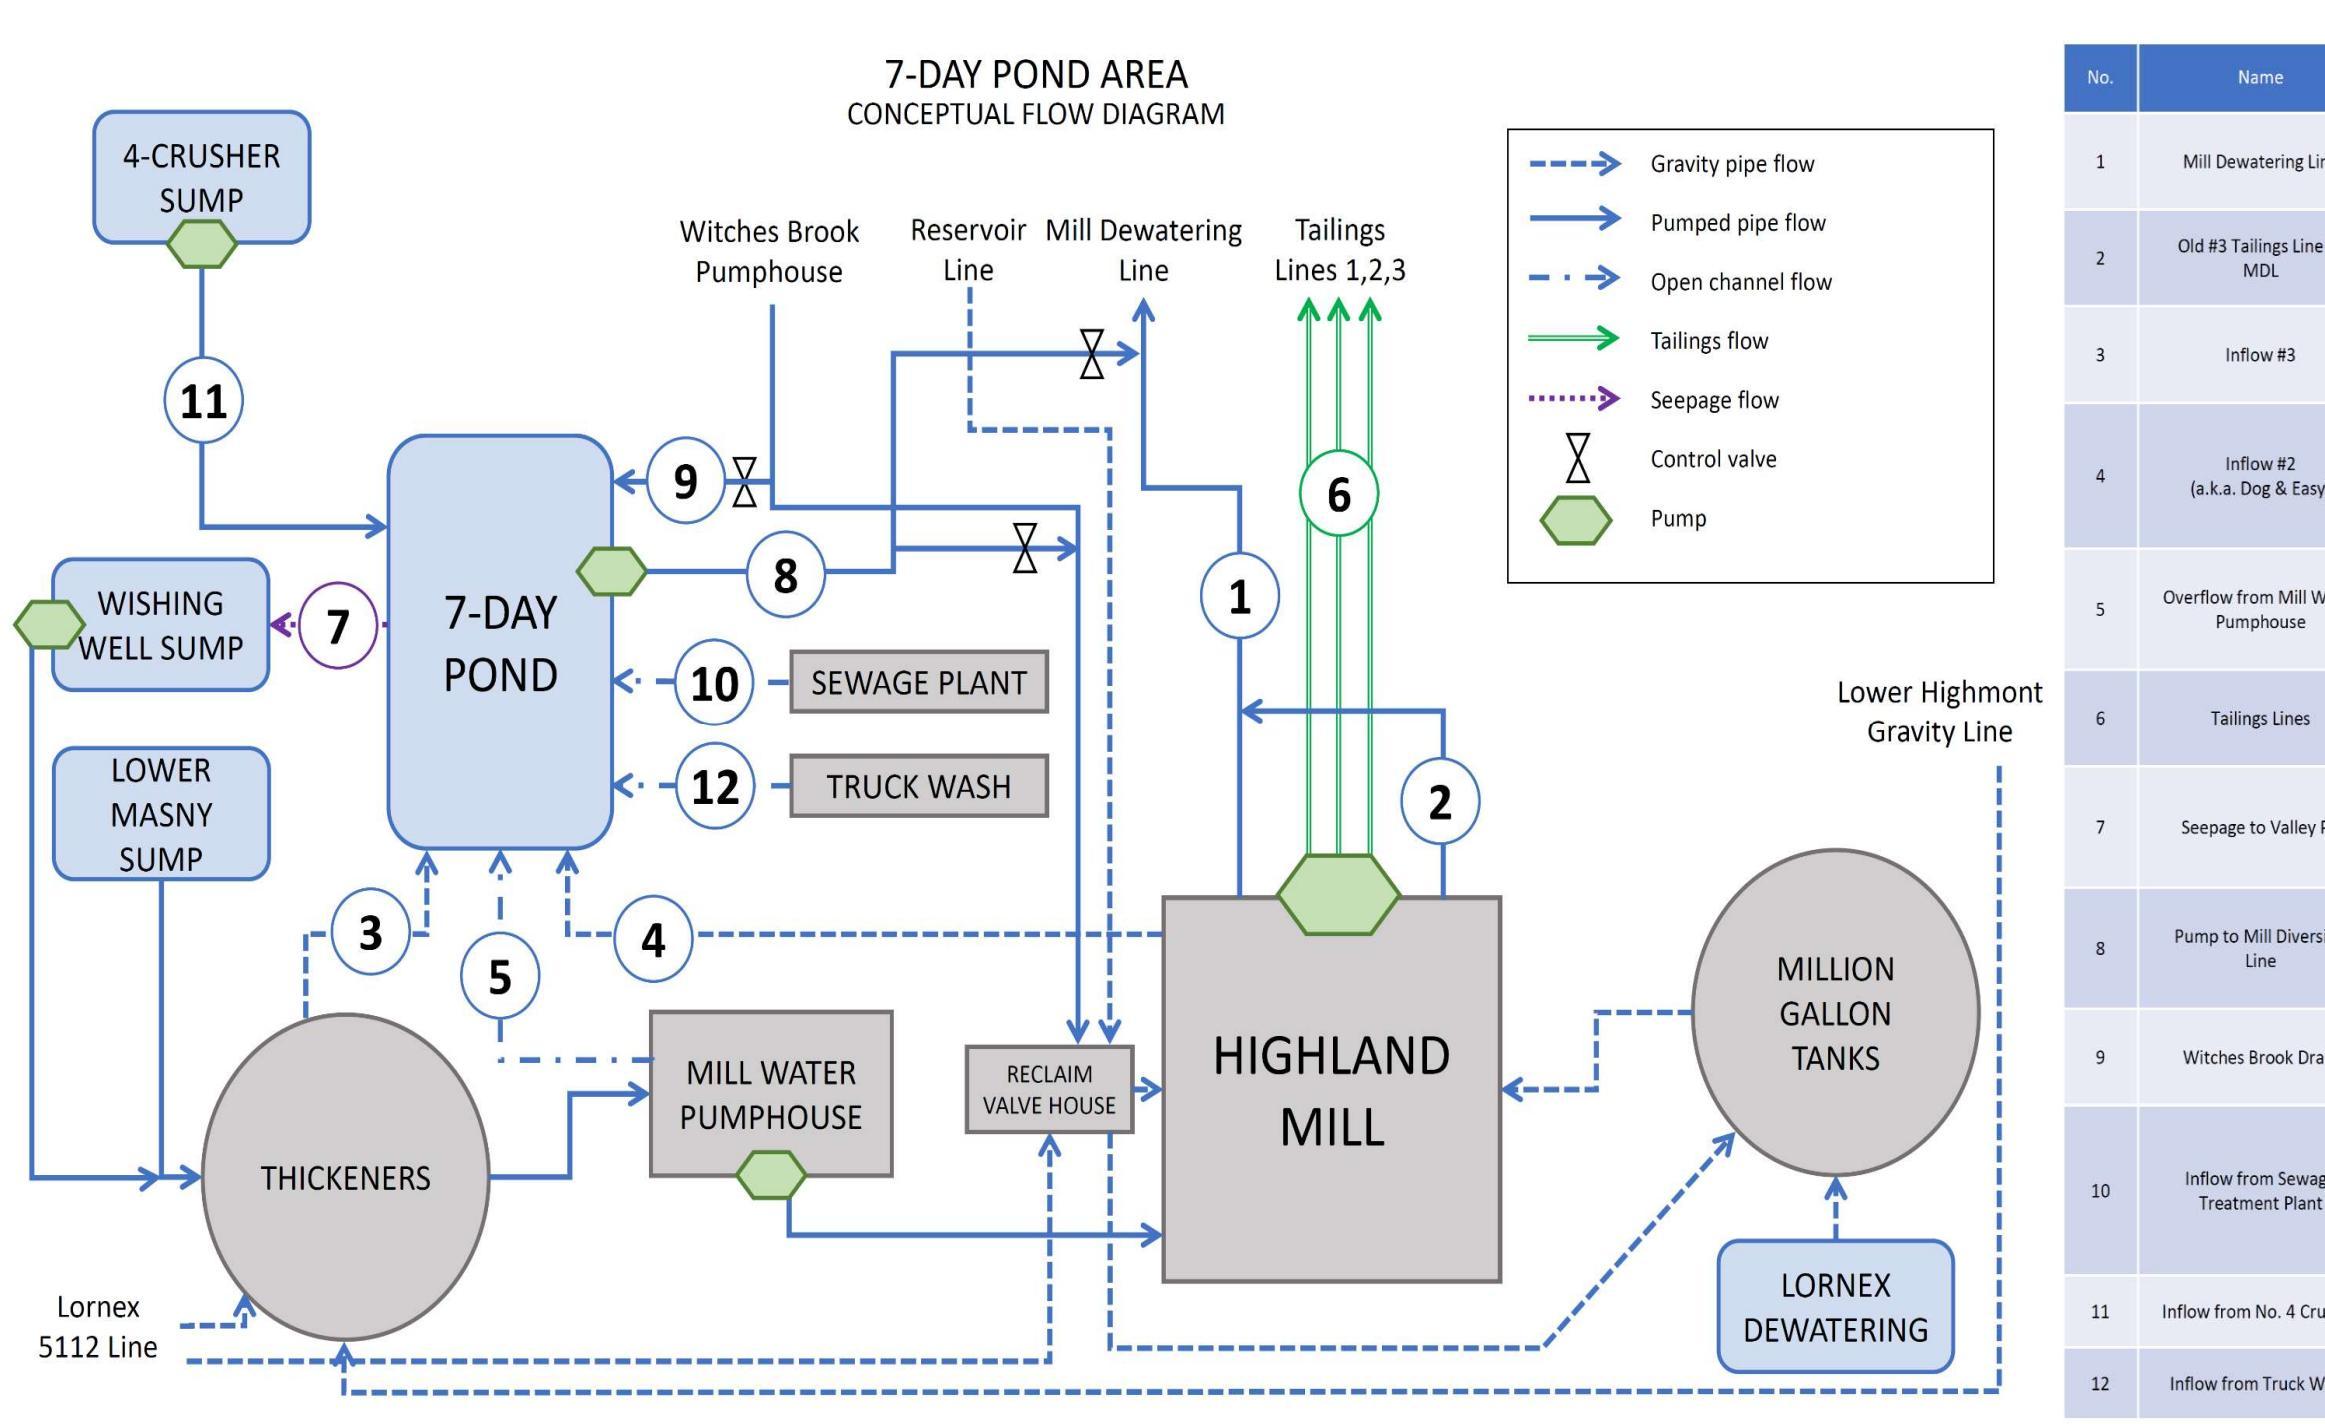
NOT FOR CONSTRUCTION 7-DAY POND TAILINGS STORAGE FACILITY 2023 ANNUAL FACILITY PERFORMANCE REPORT Teck FLOW SCHEMATIC FOR 7-DAY POND TAILINGS STORAGE FACILITY Klohn Crippen Berger SCALE NTS ROJECT No. FIG. No. 3 M02341C62

The schematic of the tailings and water management system for the 7-Day Pond TSF is shown on Figure 3. Inflow and outflow rates/volumes are not monitored. The primary outflows from the facility are:

Figure 3 is a simplified flow schematic for the pond. Inflows and outflows are not measured but the capacity of the fixed pumping system has been demonstrated to have sufficient capacity to manage the pond level and maintain sufficient flood storage (i.e., inflow design flood (IDF) volume) within the impoundment under typical seasonal climate conditions and during tailings discharge from the Highland Mill. Refer to Section 5.3 for further discussion of pond levels during the review period.

Seepage from the 7-Day Pond TSF flows towards the Valley Pit (northwest) and is collected in the Wishing Well Sump (Figure 3). This sump also collects water from other sources, and water from the sump is pumped to the thickeners at the Highland Mill. No seepage was observed from the East Berm downstream slope during the September 28, 2023 AFPR site visit, or reported by HVC visual inspections completed during the review period.

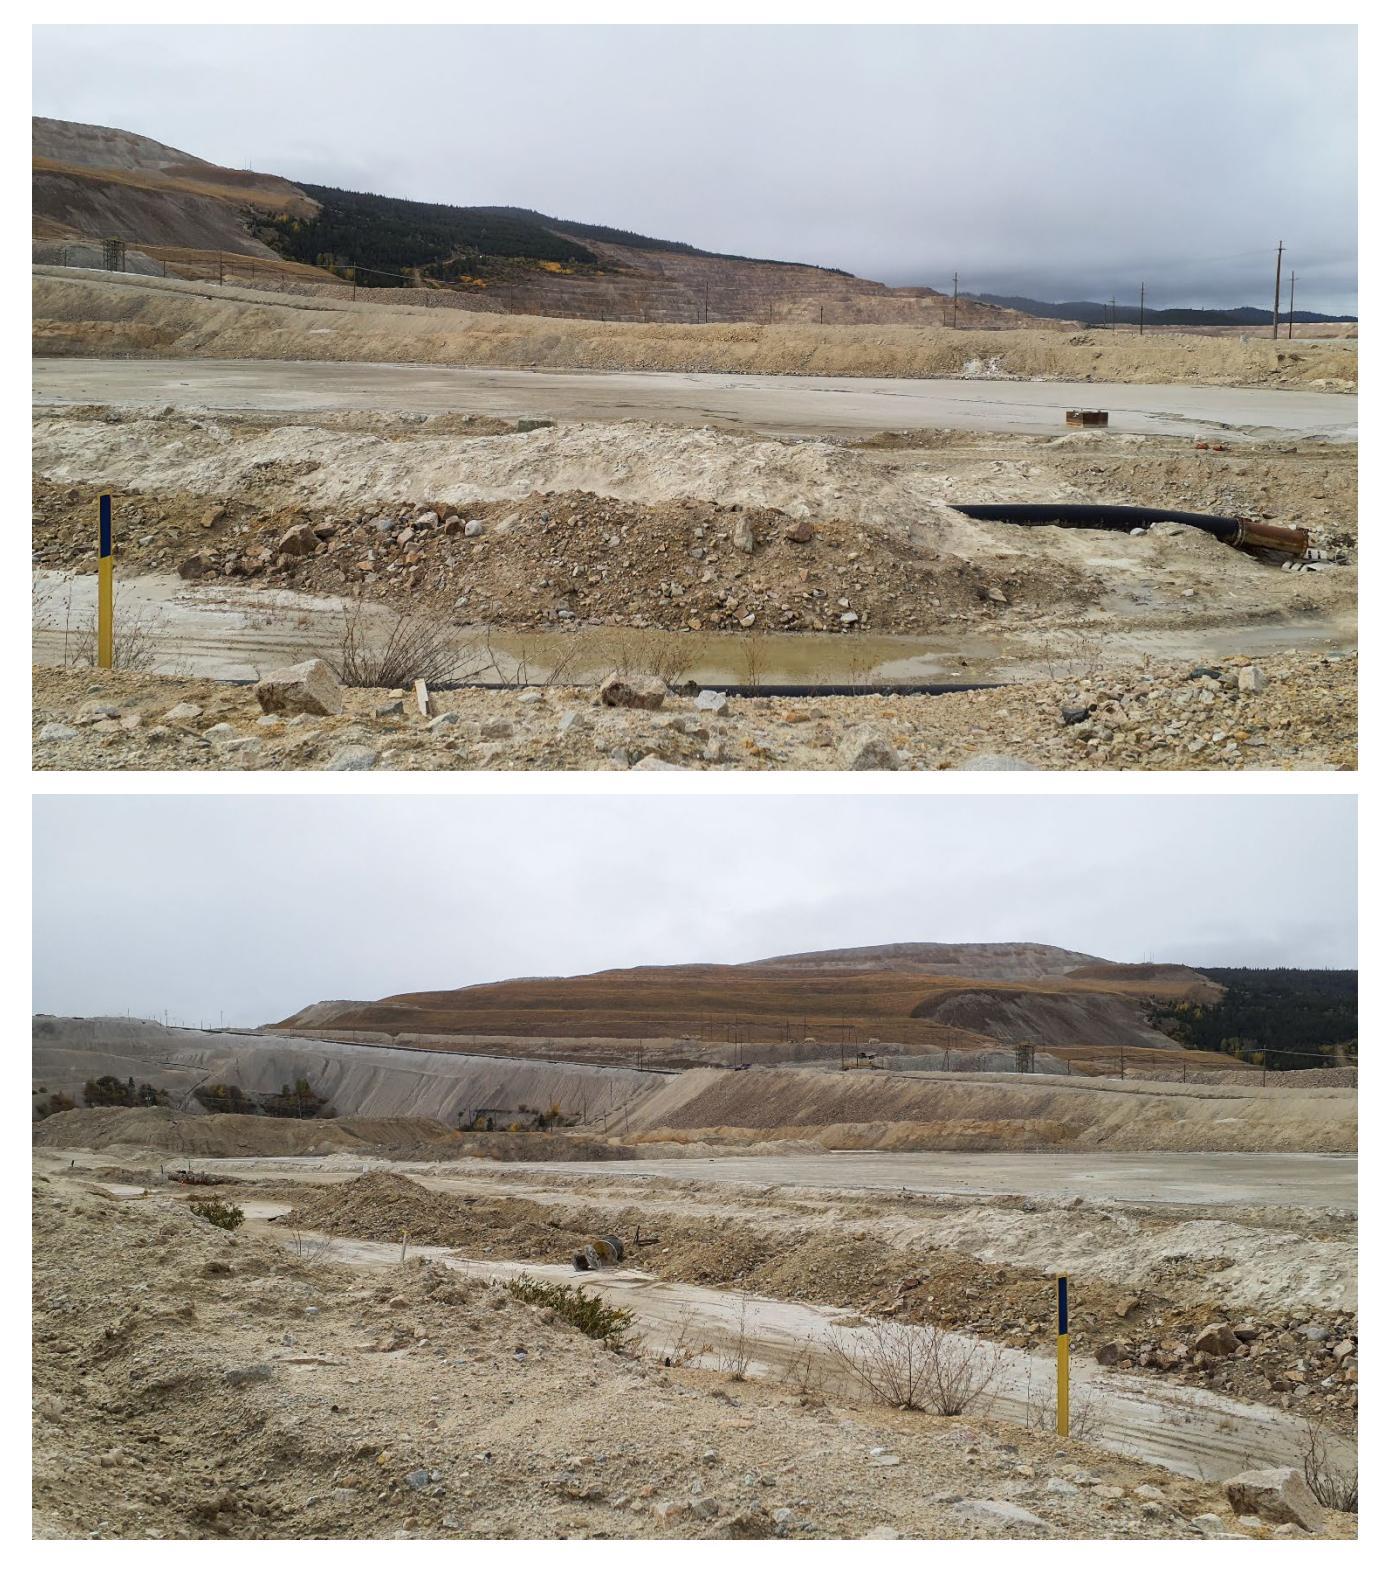
Photo I-4 7-Day Pond TSF tailings. No visible pond during site visit (SDP-2023-04)
