Teck Highland Valley Copper Partnership

2023 Annual Facility Performance Report

Highland Tailings Storage Facility

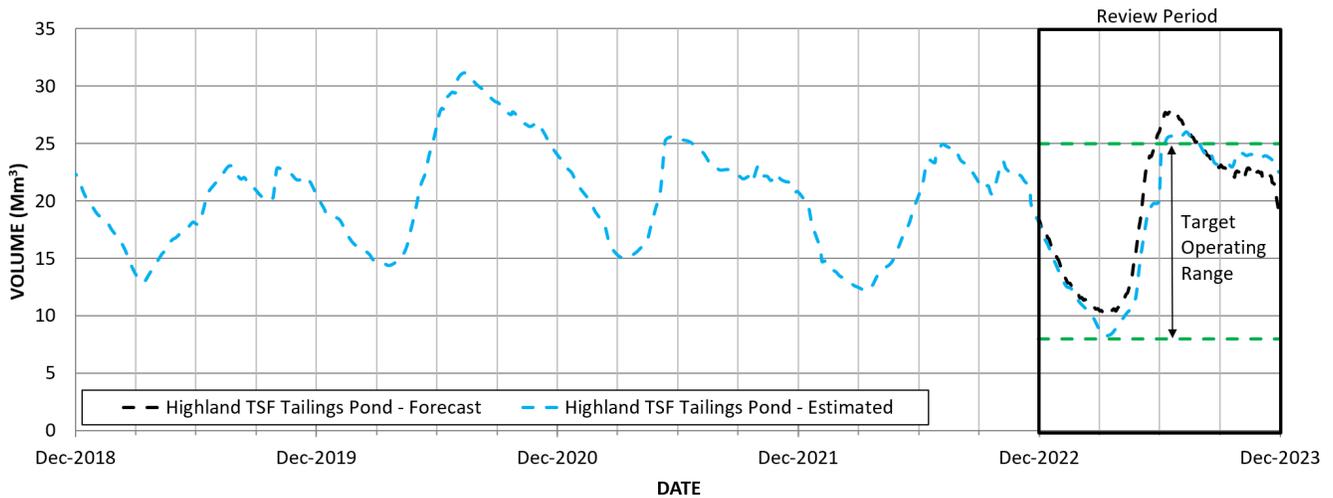
Figure 4.3 Highland TSF Pond Volume: December 2018 through November 2023

The estimated pond volume at the end of the review period was 22.5 Mm³ which is within the typical range over the past five years. Relative to the start of the review period, the estimated pond volume increased 2.7 Mm³ (Table 4.2) but was within the typical pond volume range as shown on Figure 4.3.

There was good agreement between estimated pond volumes during the review period and those predicted by the model (Figure 4.3). The general pattern from both was consistent with typical seasonal fluctuation. The large increase in the estimated pond volume at the start of June 2023 is due to the effects of freshet (i.e., increase in pond volume) and a new bathymetric survey being applied. The volume of the pond is estimated based on pond level and an assumed shape of the pond basin below the water. The shape of the pond changes over time as tailings settle in the basin. To account for this, HVC completes two bathymetric surveys of the pond each year. To account for change over time between surveys, an average rate of rise to the base of the pond is assumed in the pond volume calculation.

KCB recommends that into the next update of the OMS Manual, HVC documents the process to estimate pond volumes based on pond level, how estimated pond volumes are corrected based on bathymetric surveys (both future and previous estimates) and how pond volumes are integrated with the Highland TSF water balance.

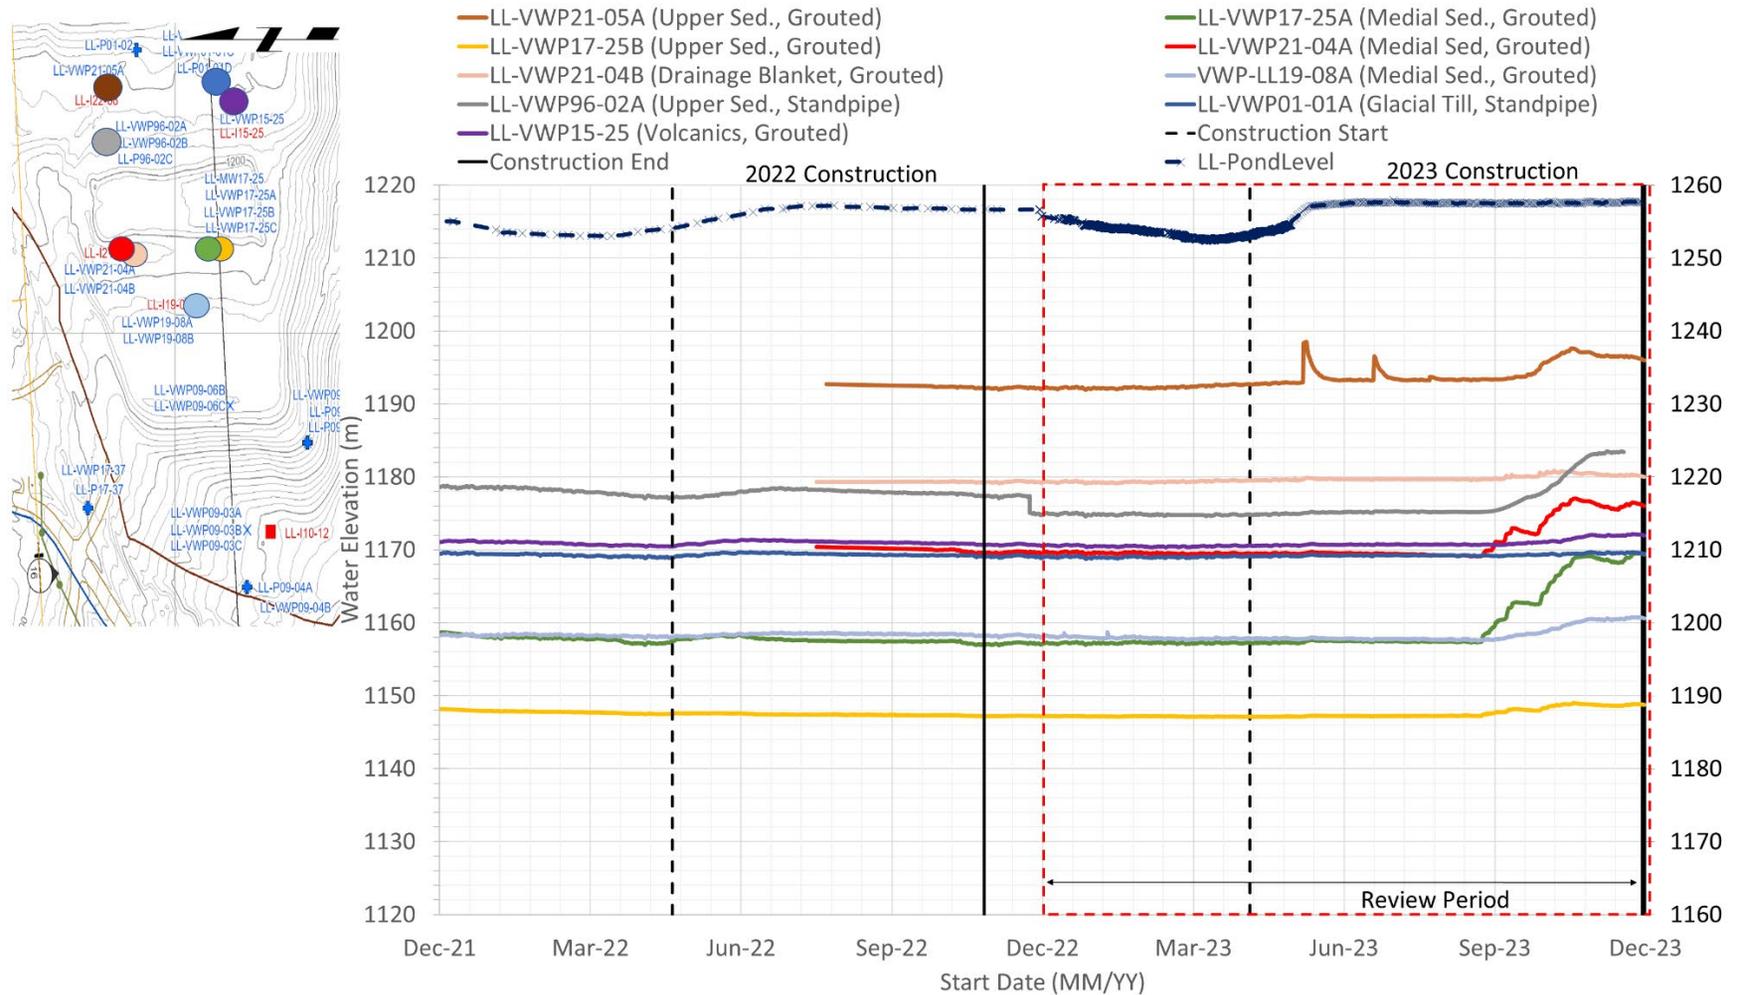
Figure 5.10 Measured Piezometric Response in the Foundation of the NBB Upstream of Hydraulic Placement: December 2021 to November 2023

This piezometric response to hydraulic placement was the cause for six of the Notification Level exceedances during the review period.

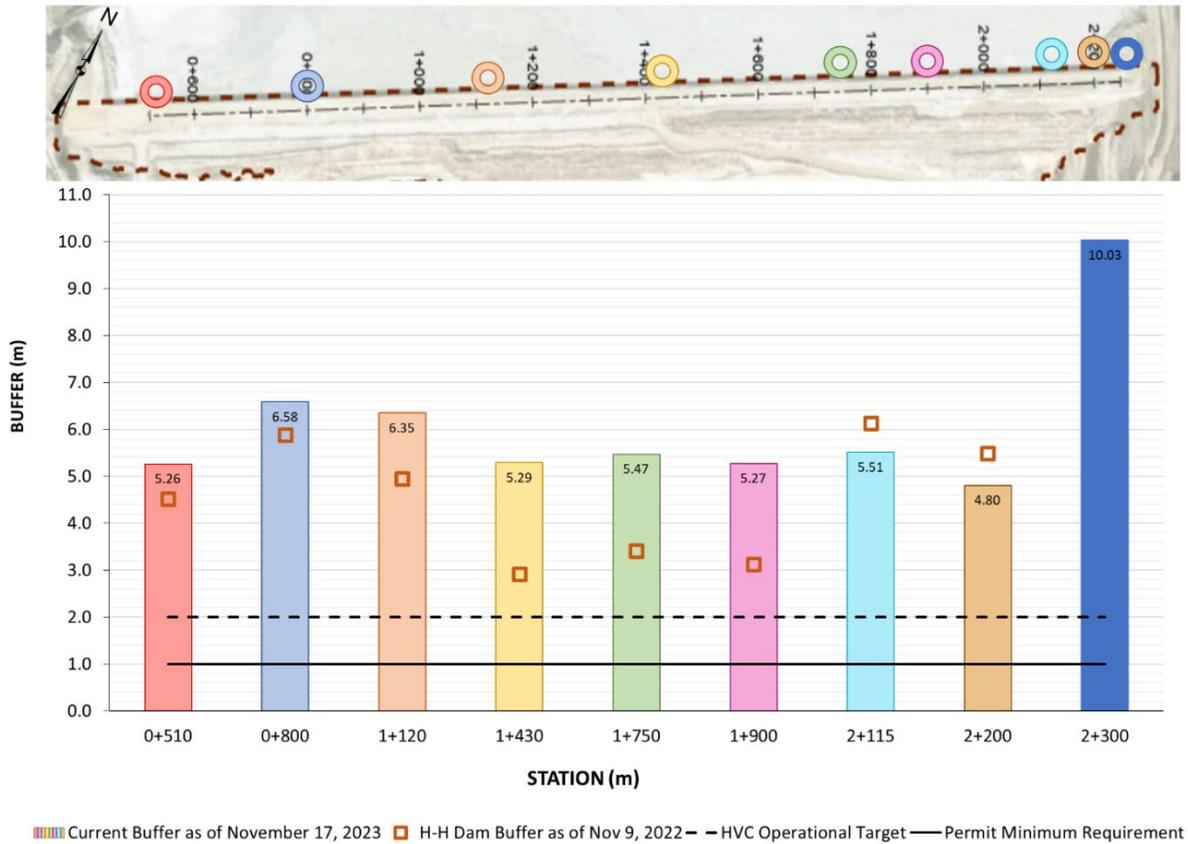
Figure 5.18 H-H Dam Tailings Buffer – November 17, 2023, Tailings Beach

There is no risk of overtopping at the H-H Dam (Section 2.3). Therefore, freeboard is not an applicable metric at the H-H Dam. The M-11 permit (EMLI 2021) requires that a minimum 1 m buffer¹⁰ be maintained throughout operations. HVC targets maintaining a minimum 2 m buffer along the dam when planning crest raises. Buffer values from the November 17, 2023, survey are shown in Figure 5.18, as well as the buffer present at the start of the review period. During the review period, HVC added another buffer monitoring point near the east abutment (Sta. 2+300).

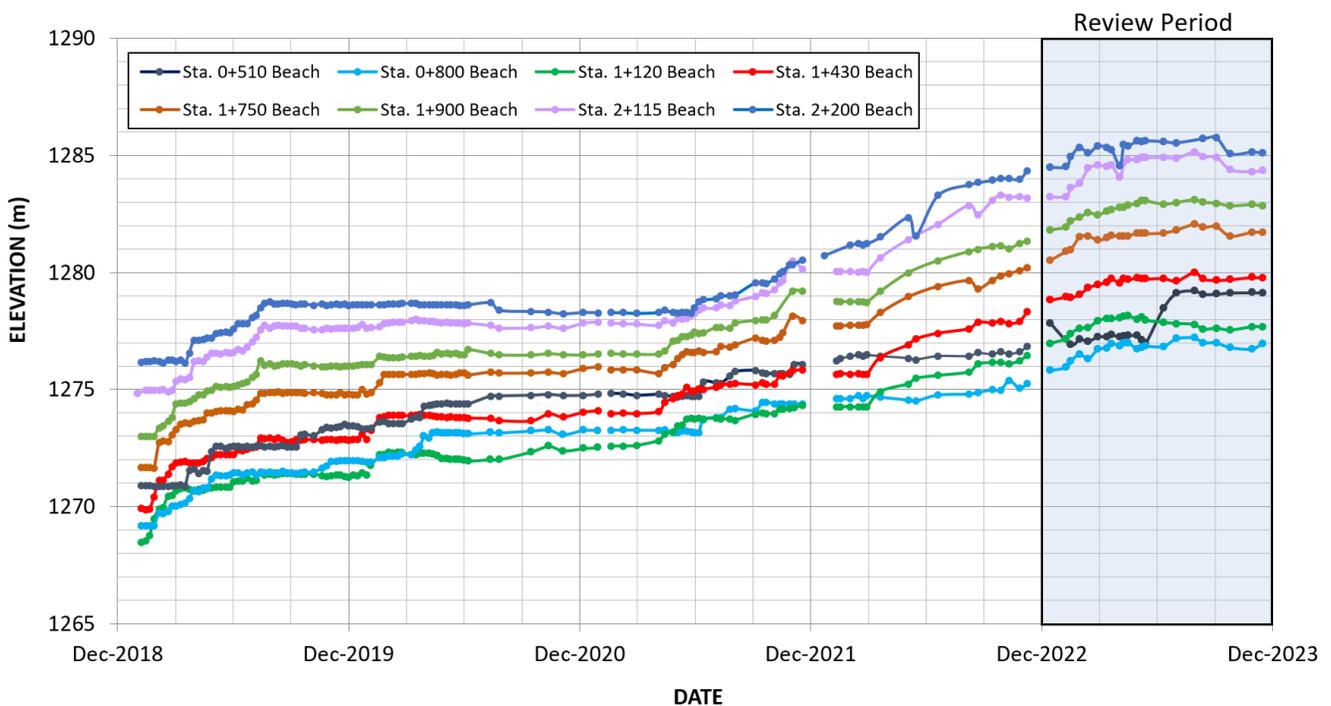
Figure 5.19 H-H Dam Tailings Beach Elevations Along the Crest: Dec. 2018 to Nov.2023

Figure 5.19 plots tailings beach elevations near the upstream face of the H-H Dam at the monitoring stations along the crest, since December 2018. The tailings beach rate of rise had been relatively steady since mid-2020 before starting to level off in February 2023. This was due to HVC shifting the spigot location near the H-H Dam east abutment further away from the dam. Following that shift, the tailings were deposited on the leeward side of the tailings mound (i.e., the opposite side relative to H-H Dam) and flowed directly towards the pond with no deposition occurring near the dam crest. This was an expected change based on the planned move of the deposition point. A similar shift occurred in 2018 and beach levels remained relatively level until mid-2020 when the deposition point was moved closed to H-H Dam.

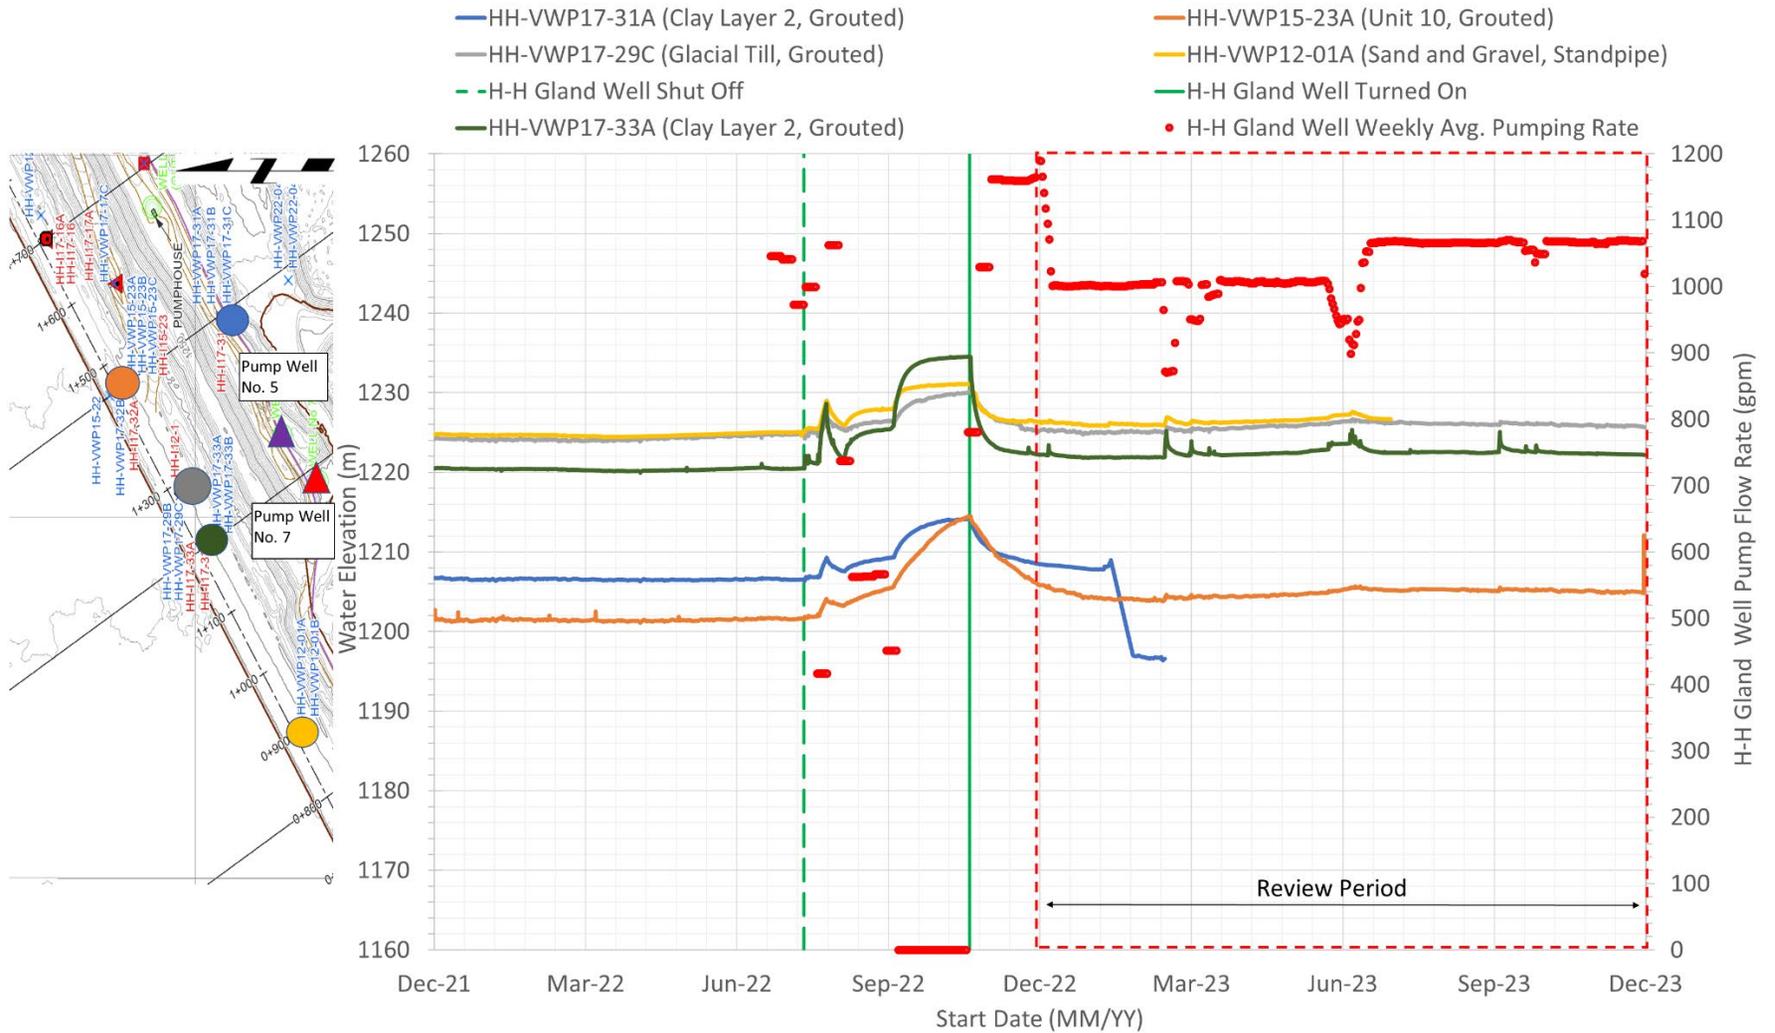
Figure 5.20 H-H Dam Piezometric Response in Glacial Till and Underlying Units: December 2021 to November 2023

As shown on Figure 5.20 and Figure 5.21, H-H Gland Wells were operated consistently throughout the review period. Consistent with expected behaviour, piezometric levels in the Glacial Till and underlying foundation units fluctuated when there was a disruption in pumping (Figure 5.20). However, no similar response was measured in dam fill (Figure 5.21). HVC increased the H-H Gland Well pumping rate to approximately 1,075 gpm, from approximately 1,000 gpm, during the review period. No significant change in piezometric level was observed.

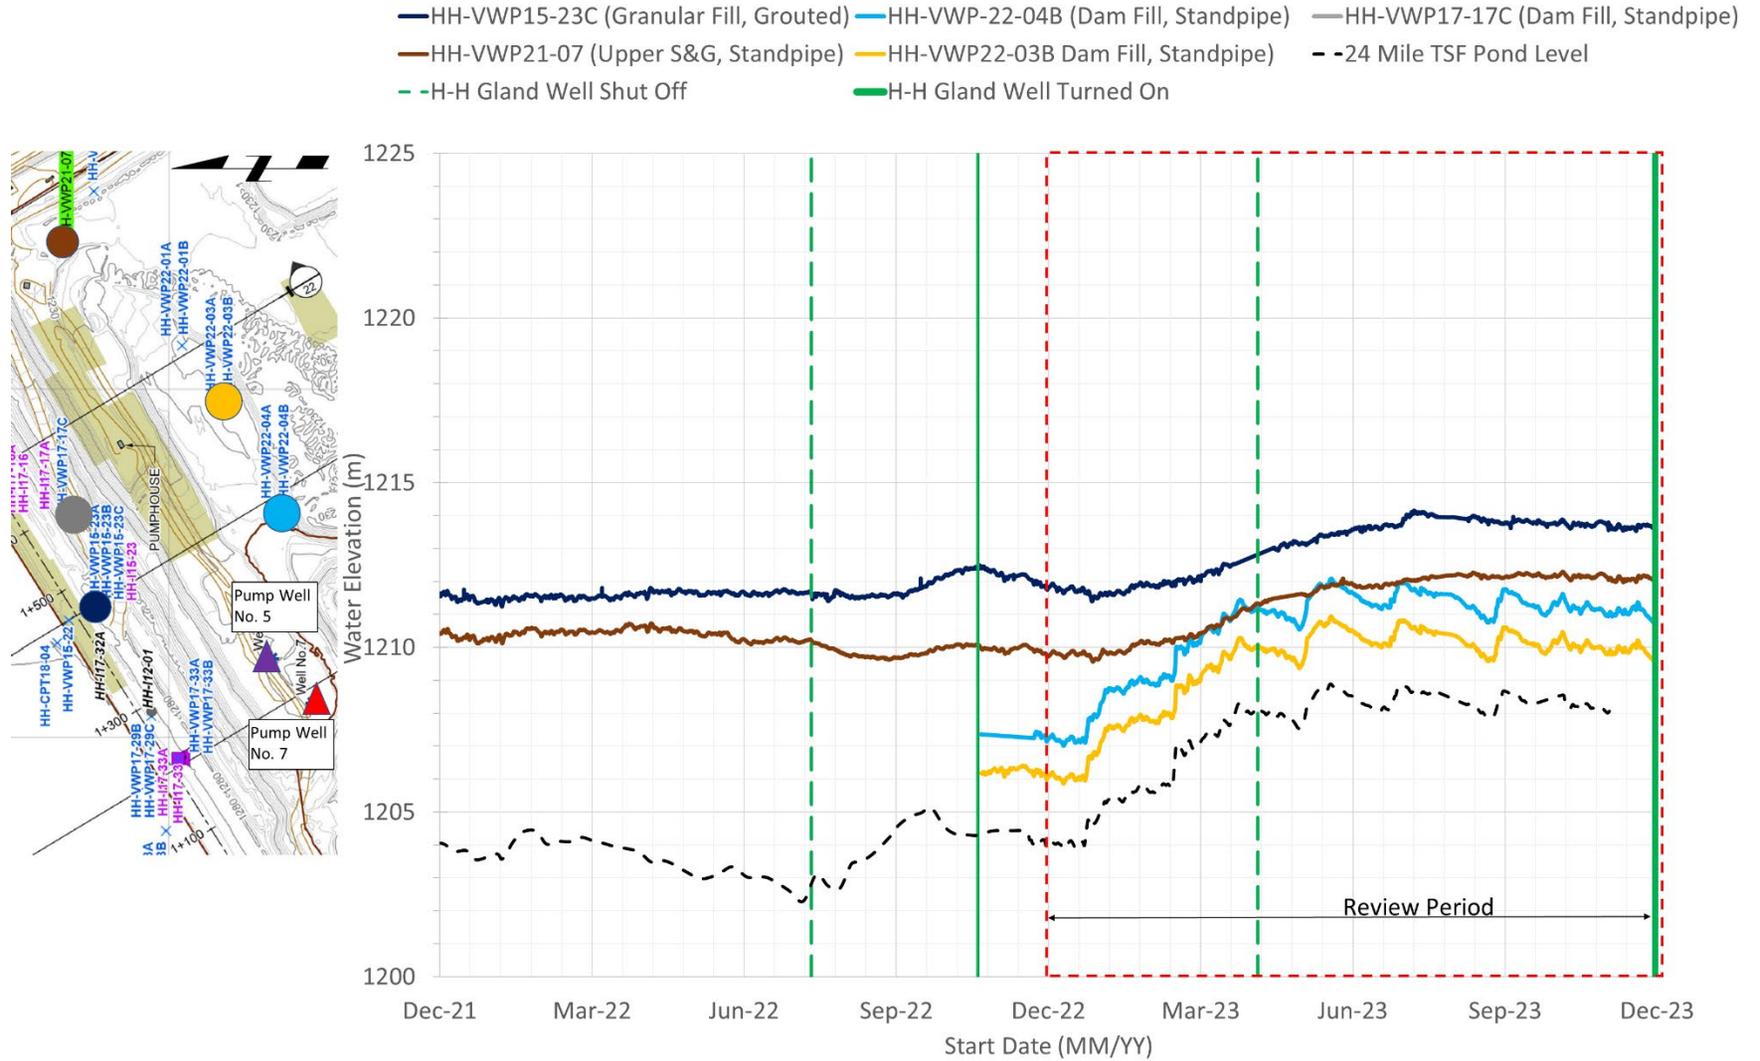
Figure 5.22 H-H Dam Piezometric Response in the Dam Fill and 24 Mile TSF Pond Level: December 2021 to November 2023

The greater than expected increase in the 24 Mile TSF pond level coincided with a greater than expected piezometric rise measured in the dam fill downstream of the centreline (Figure 5.22). This resulted in Notification Level threshold value exceedances at two piezometers (HH-VWWP15-15C and HH-VWP21-07) and one T1 Level threshold value exceedance at HH-VWP17-17C during June 2023.

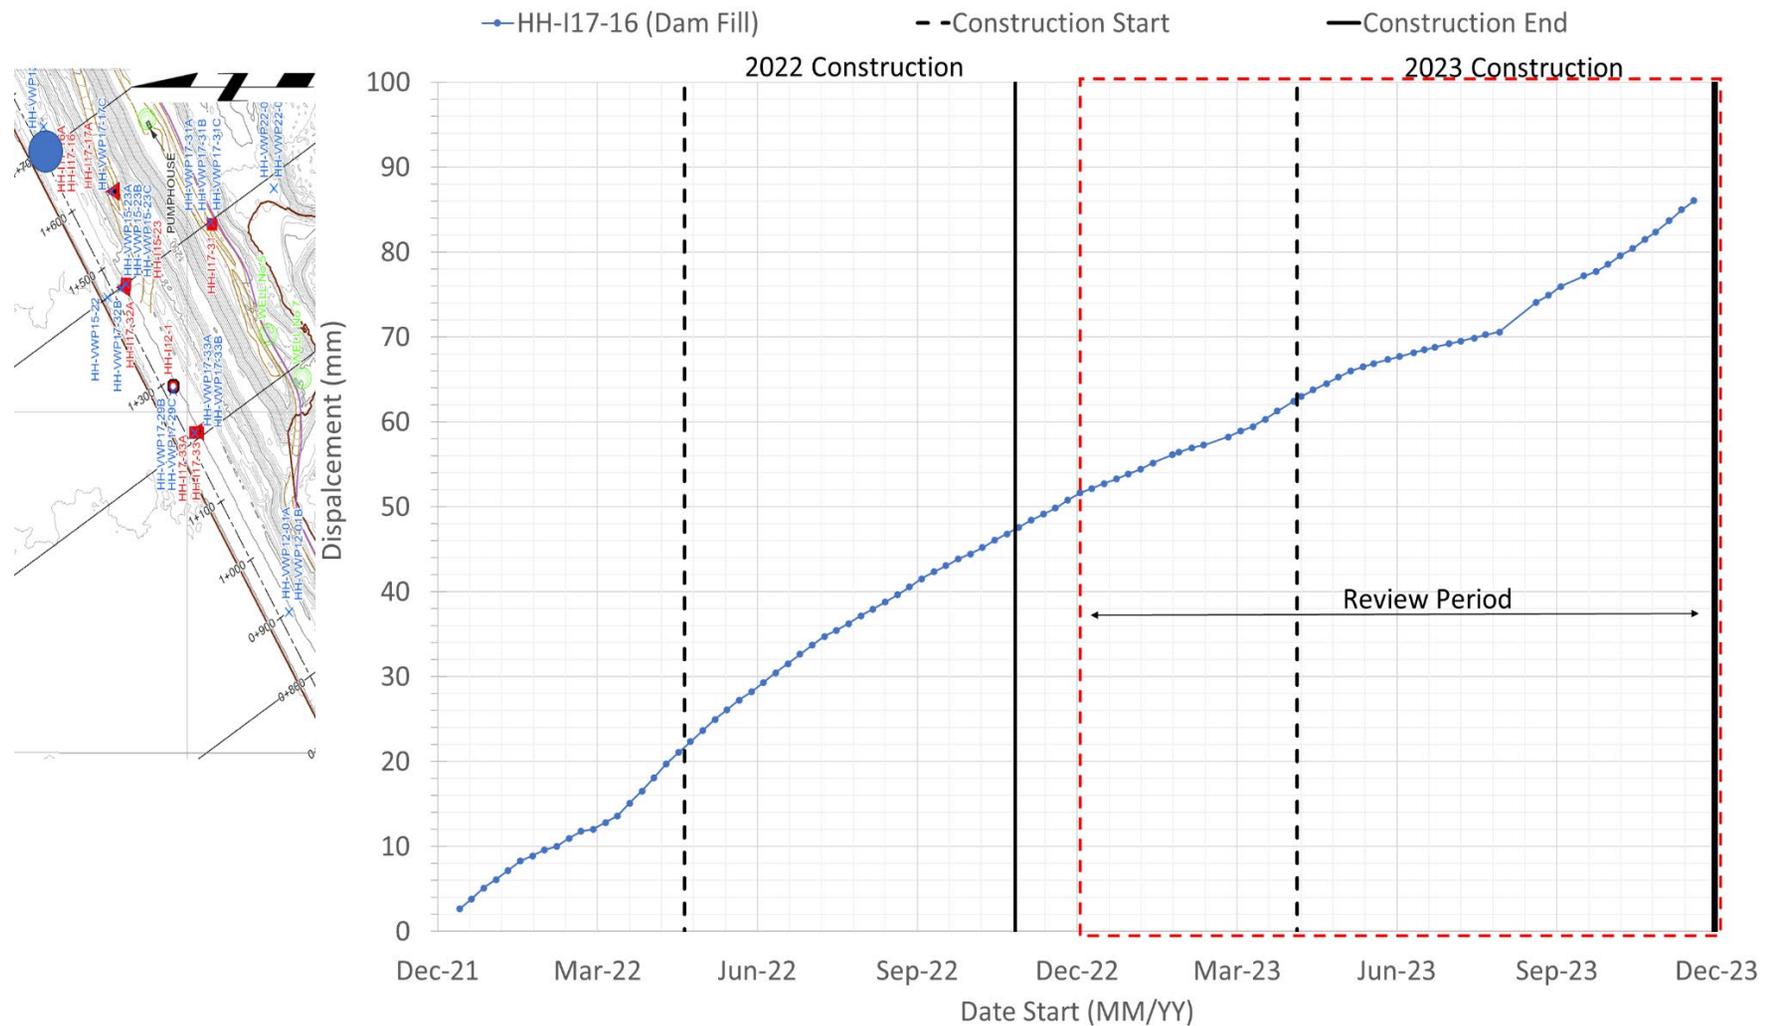
Figure 5.23 Measured Horizontal Deformation Within Downstream Fill at HH-I17-16: December 2021 to November 2023

Horizontal deformations in the H-H Dam fill are interpreted as a response to settlement in the downstream fill, which was placed by the mining fleet in thick lifts (up to 10 m). Consistent with this interpretation, locations where the largest settlements are measured (e.g., HH-I17-16) correspond to the areas where horizontal deformations are also largest (Figure 5.23). In comparison, the least amount of settlement and horizontal deformation in the fill has been measured at HH-I17-33. As expected, the peak horizontal deformation rates during the review period were higher than during 2022 (Table 5.9) when there was not construction on the H-H Dam crest and downstream slope.

The measured horizontal deformations (<1 mm/month to 4.5 mm/month) and settlements (<50 mm) in the fill during the review period are within the lower range of those observed since the instruments were installed. This is consistent with construction activity during the review period that was primarily constrained to the crest as the majority of the downstream slope, other than the buttress, has already been constructed to ultimate shell.

This magnitude of deformation can be accommodated by the structure without compromising design function. There were no visual observations of significant cracking or deformation of the fill over the crest area.

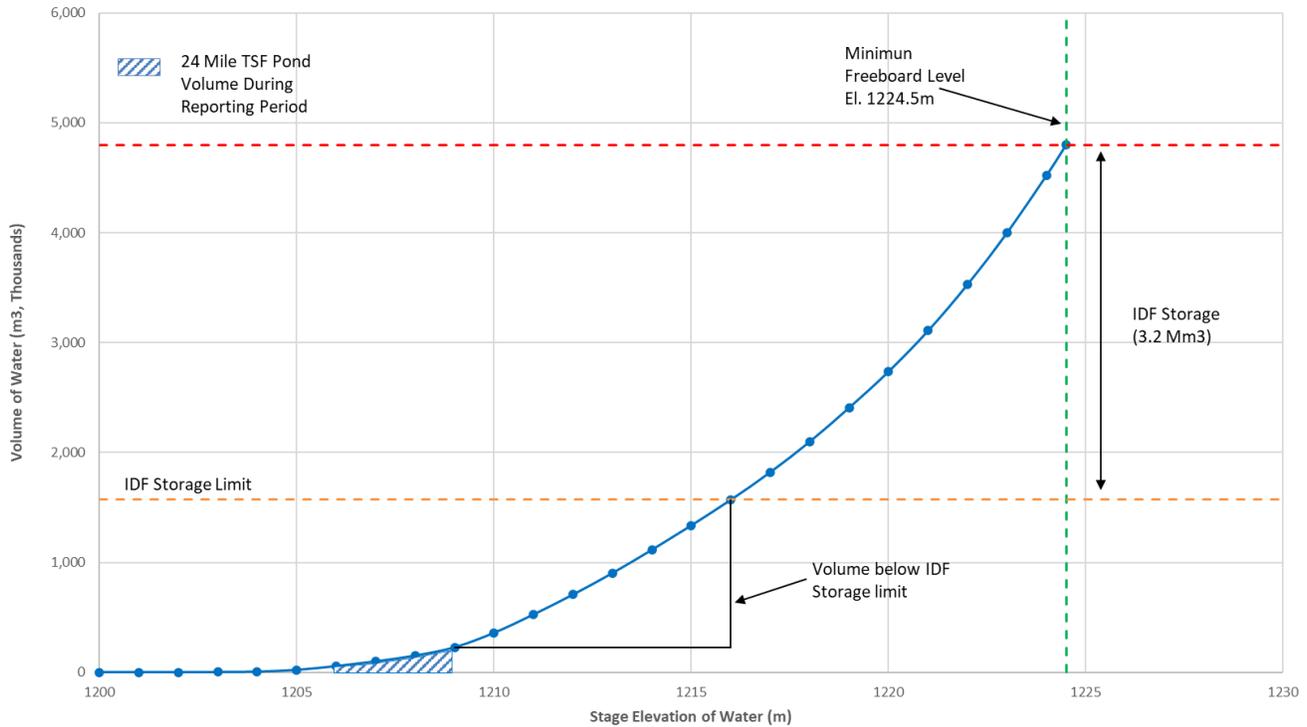
Figure 5.24 24 Mile TSF Pond Level and Storage Capacity During Reporting Period

The 24 Mile TSF pond level rose approximately 5 m, to a peak El. 1209 m, during the review period (Figure 5.22). This was greater than expected and the pond level was outside of HVC's target operating range. From mid-2020 to the start of the review period, the 24 Mile TSF pond levels had been maintained within a similar operating range (El. 1204 m to El. 1207 m). During the first half of 2023 the reclaim barge system was out of operation resulting in the greater than expected pond rise. A temporary diesel pumping system was installed in mid-2023 and operated until the replacement electrical pump reclaim system was installed at the end of the review period.

The 24 Mile TSF must be operated with sufficient capacity to store the IDF (3.2 Mm³, refer to Table 4.3) with freeboard (0.5 m) below the perimeter crest level (El. 1225 m). The perimeter crest is defined by the surrounding pit waste and there is excess capacity to store the forecasted tailings and IDF volume without requiring routine crest raises such as those at the L-L Dam and the H-H Dam. Figure 5.24 shows the stage-storage relationship within the 24 Mile TSF based on the November 2023 survey, as well as the pond level range during the review period and IDF storage requirement. Although the pond level was greater than expected, there was still more than 1 Mm³ of excess capacity, in addition to the IDF requirement, below the freeboard level (El. 1224.5 m).

The flood storage in the 24 Mile TSF is reduced as additional tailings are deposited and additional waste is placed in the surrounding area. A life-of-mine forecast of flood storage was prepared to predict whether a raise the perimeter area would be required. However, KCB recommends HVC update this forecast based on existing conditions and that it be added to the OMS Manual during the next review and update of the document.

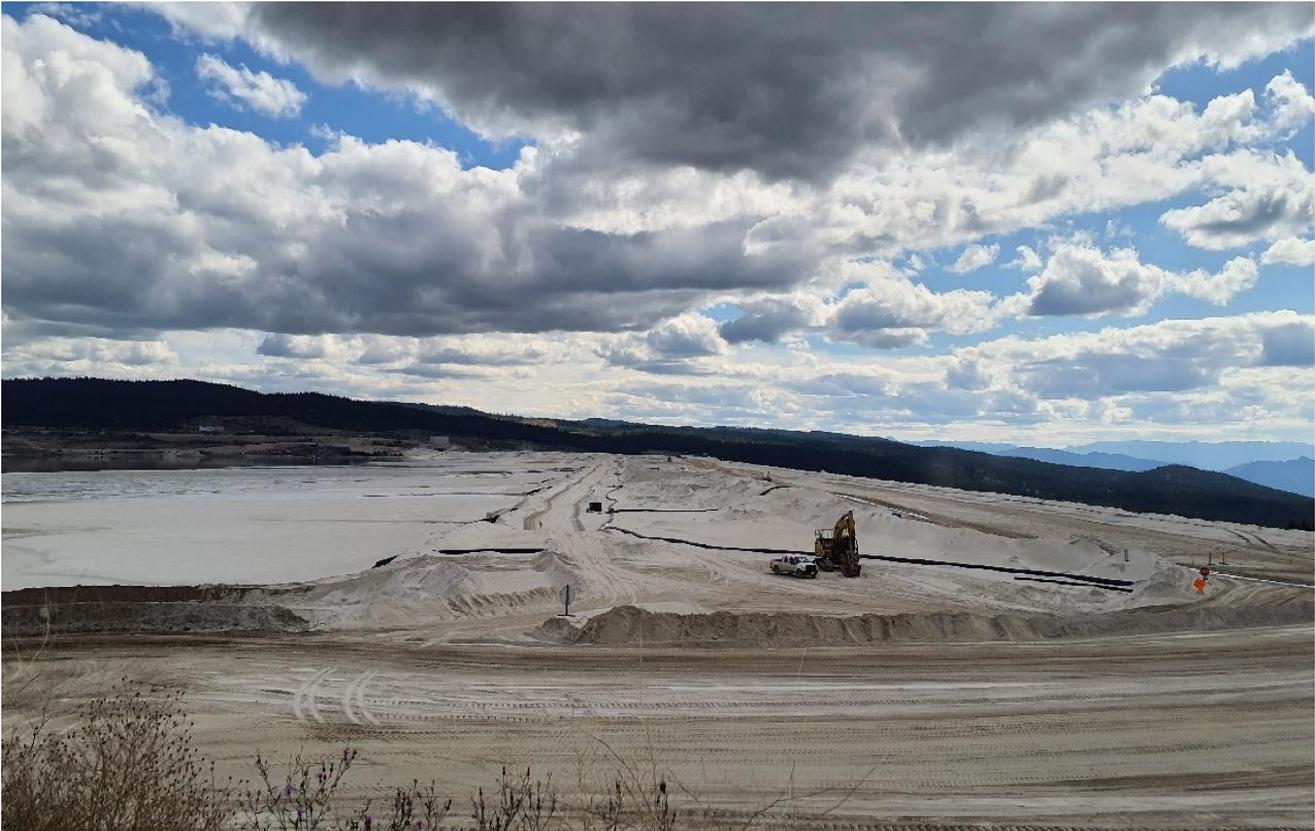
No visual indicators of concern or unusual behavior, such as excessive erosion or deformation were observed (Photo I-A-1 to Photo I-A-3).

Photo I-A-1 Tailings beach at north abutment was >500 m wide during the site visit as required by design. (LL-2023-01)

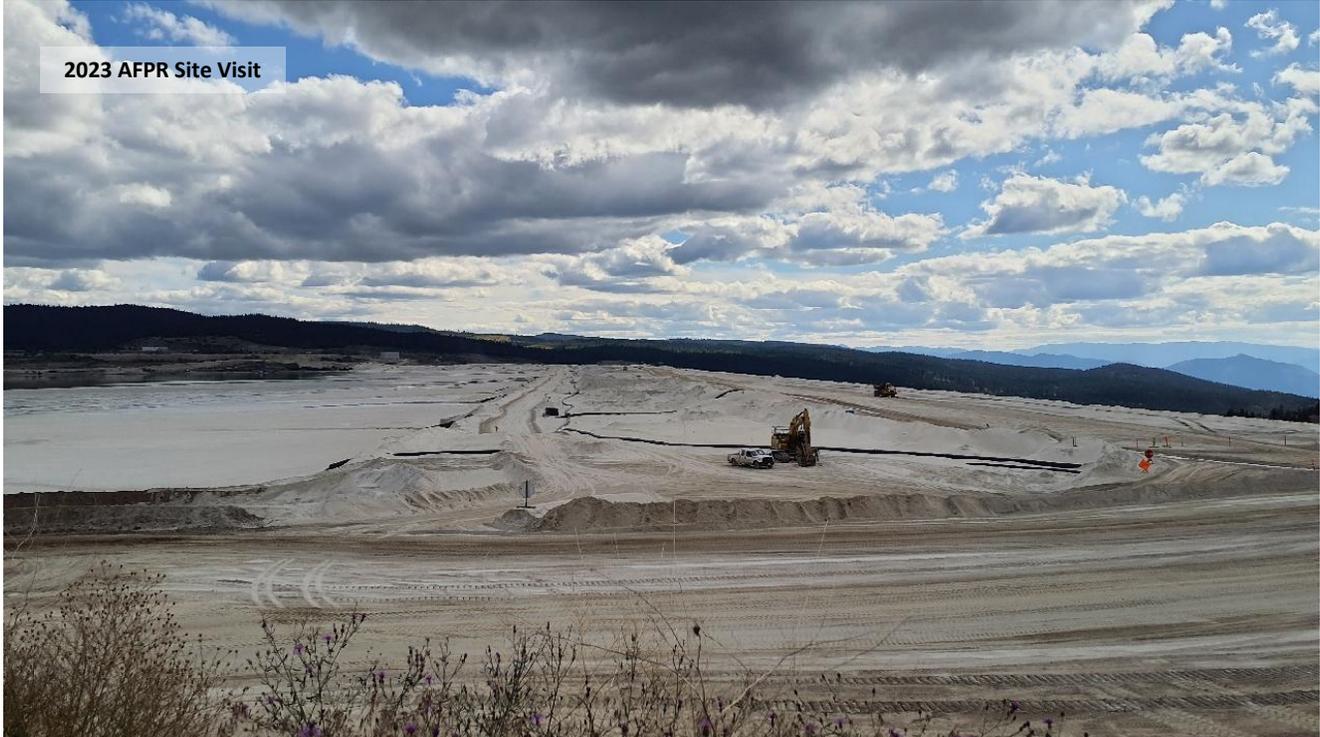
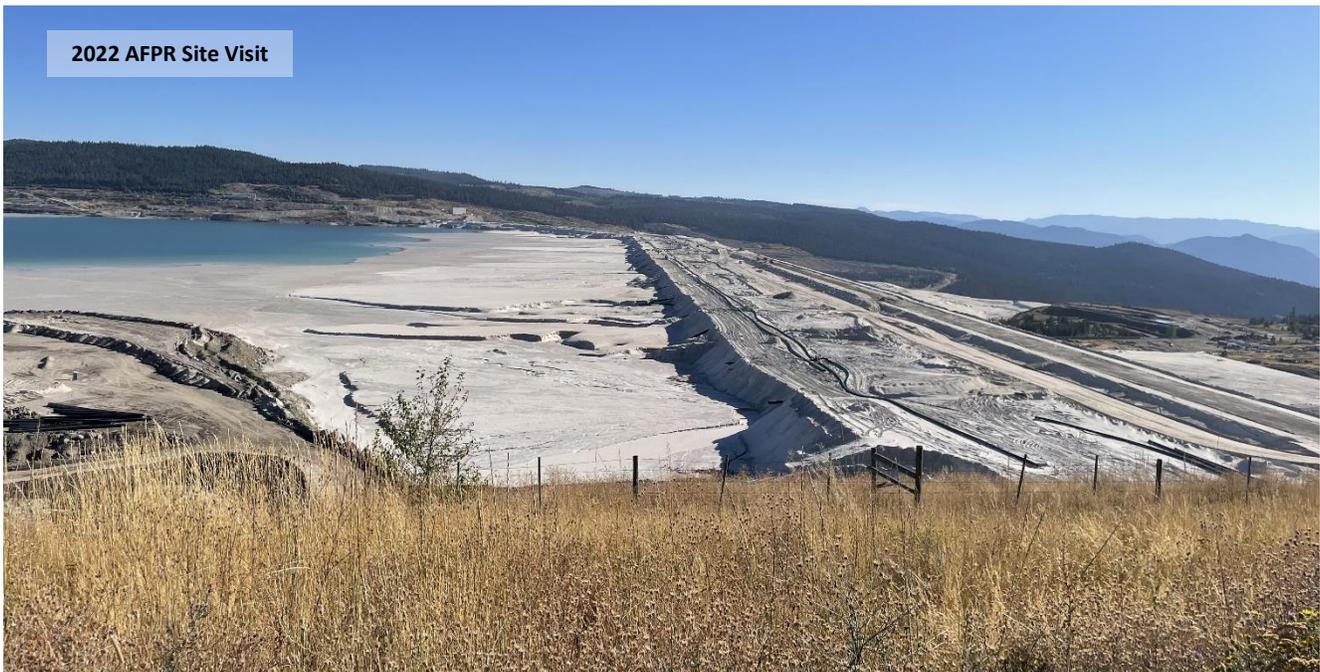
Photo I-A-2 Tailings beach and upstream hydraulic placement cells along North Dam U-GLU and North Dam Bedrock segments during 2022 and 2023 AFPR site visits. (LL-2023-01)

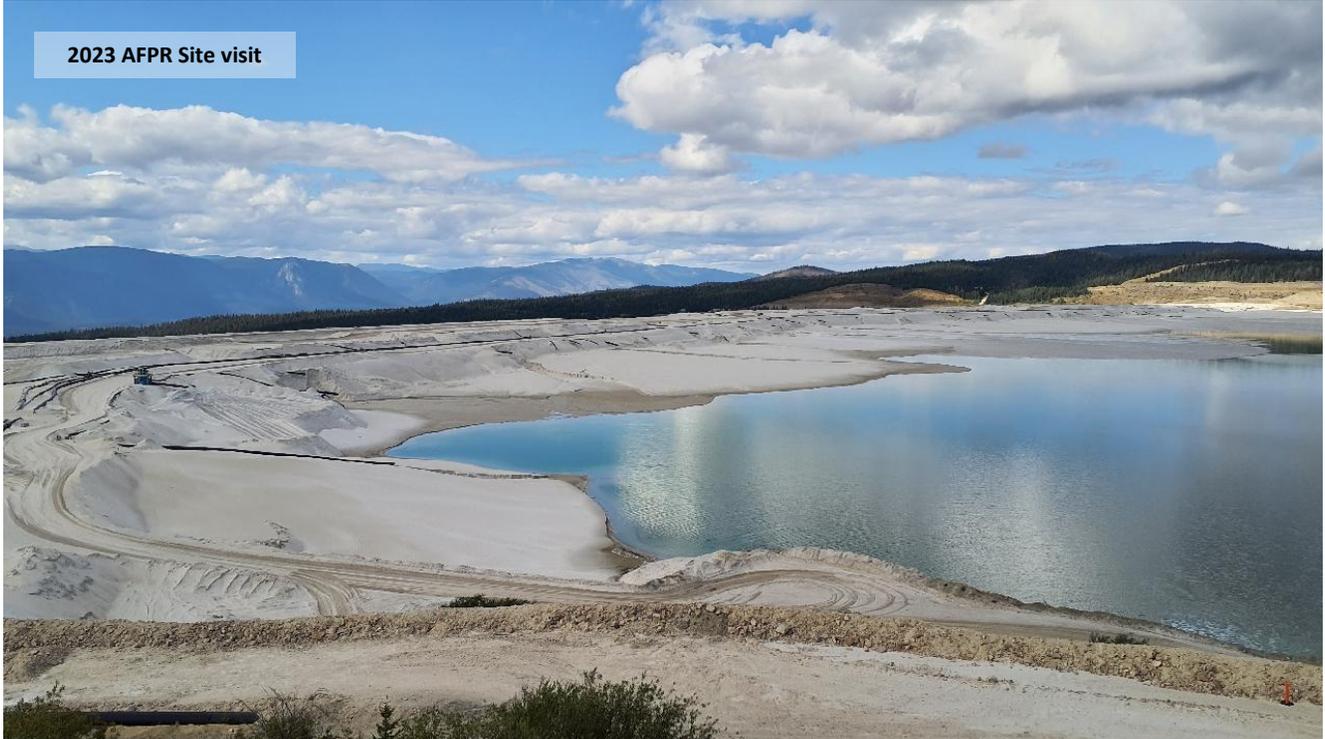
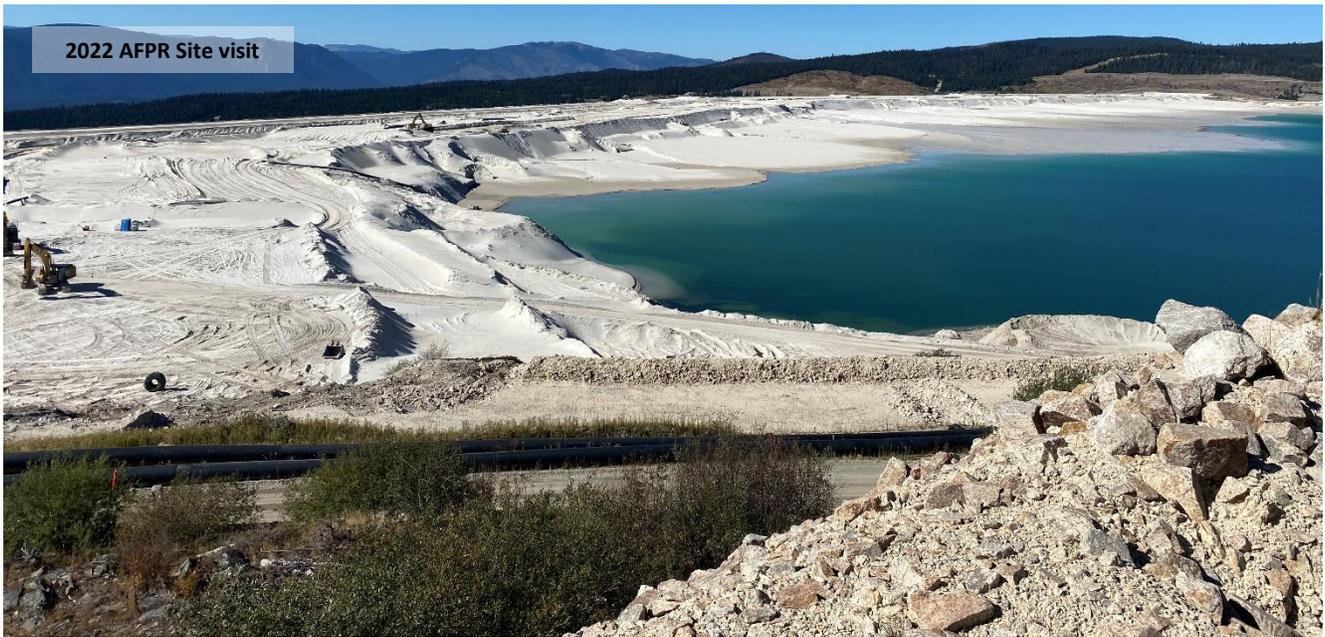
Upstream of the South Dam crest (Photo I-A-3), where the beach width is narrowest, the upstream edge of the fill zone was stepped and slope regraded to reduce risk of localized instability of the slope. Both controls were effective and no signs of slumping into the impoundment was observed.

Photo I-A-3 Tailings beach and upstream cycloned sand hydraulic placement cells along South Dam and VBB segments during 2022 and 2023 AFPR site visits. (LL-2023-02)

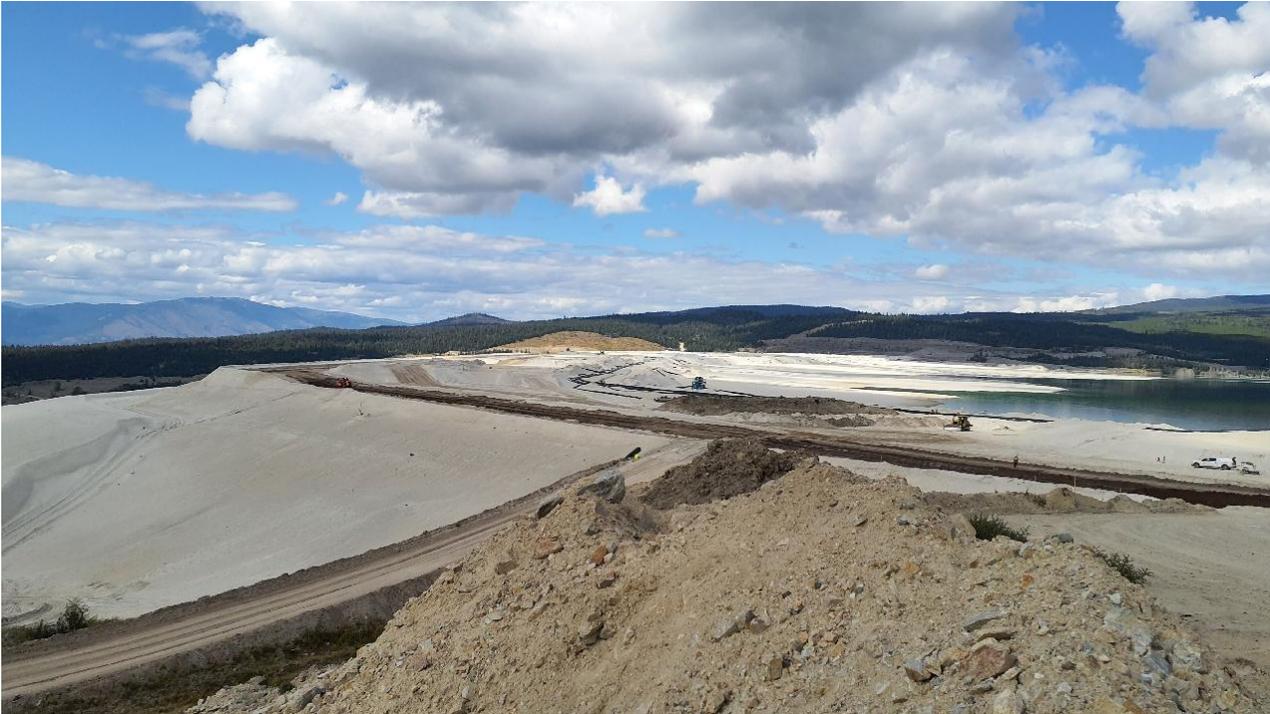
No visual indicators of concern or unusual behavior were observed. The downstream slope in this segment of the dam have been built to ultimate configuration. During the site visit, the raise of the core zone was in progress, advancing towards the South Abutment (Photo I-A-4).

Photo I-A-4 South Dam core zone raise in progress (looking north). (LL-2022-03)

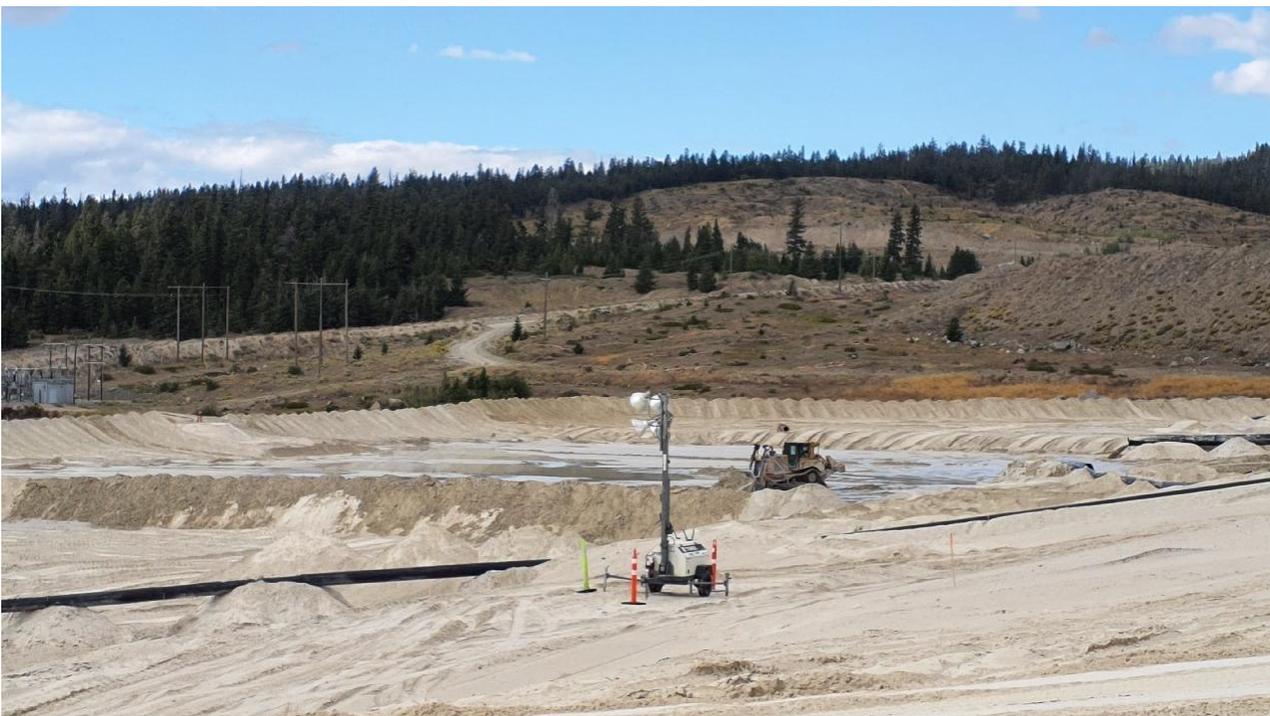
No visual indicators of concern or unusual behavior were observed (Photo I-A-6). Hydraulic cycloned sand placement was ongoing on the mid-bench during the site visit (Photo I-A-5).

Photo I-A-5 Overview of hydraulic cycloned sand fill placement at the mid-bench of the NBB downstream slope (looking north). (LL-2023-04)

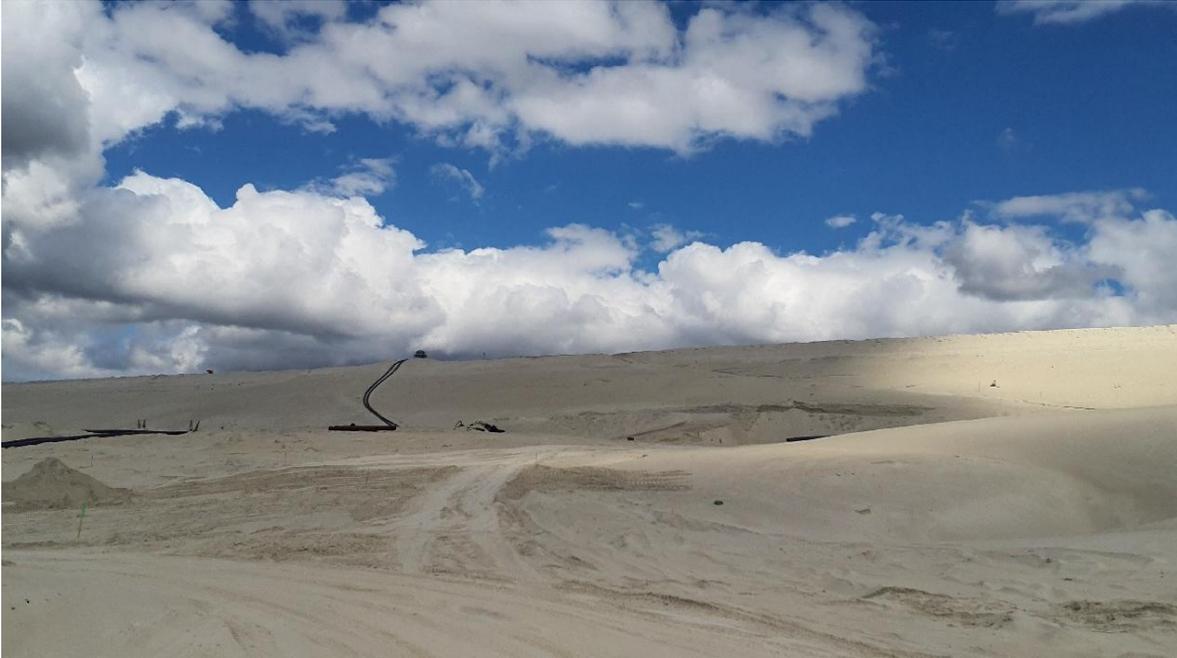
Photo I-A-6 Overview of the NBB downstream slope, above active fill placement, secondary cyclones at the crest and underflow pipes over the slope (looking east). (LL-2023-05)

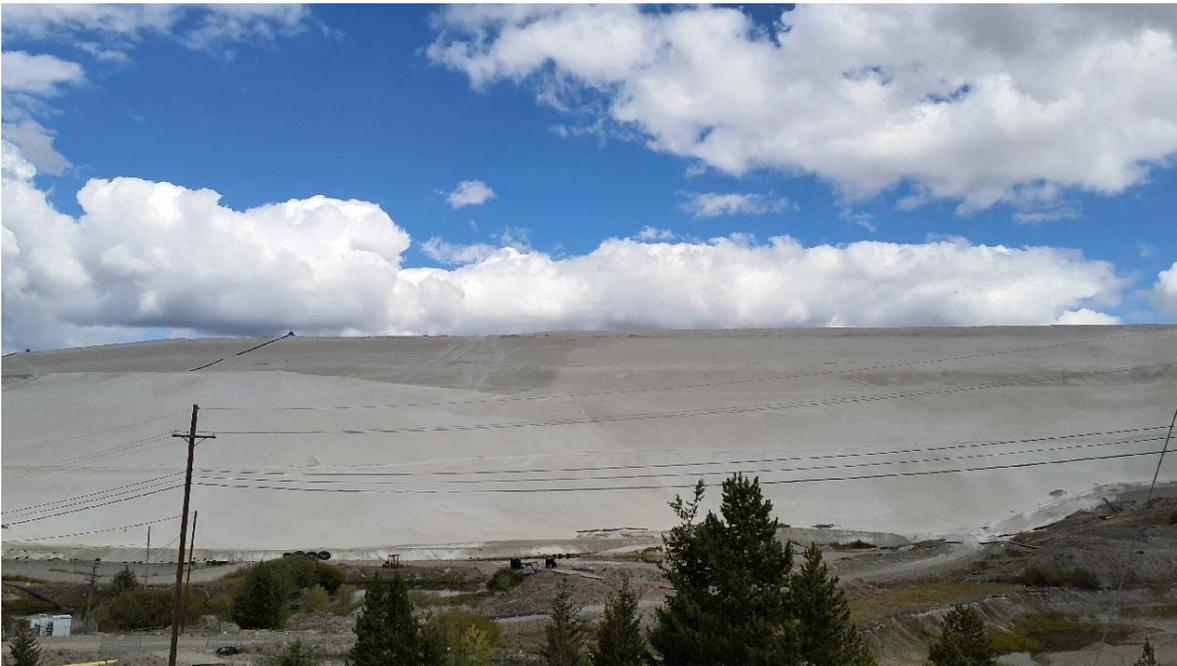
No visual indicators of concern or unusual behavior were observed (Photo I-A-7). Hydraulic cycloned sand placement had recently completed in the area and the VBB downstream slope had been completed to the ultimate configuration.

Photo I-A-7 Overview of VBB and downstream sediment and seepage ponds looking east from dam toe. (LL-2023-06)

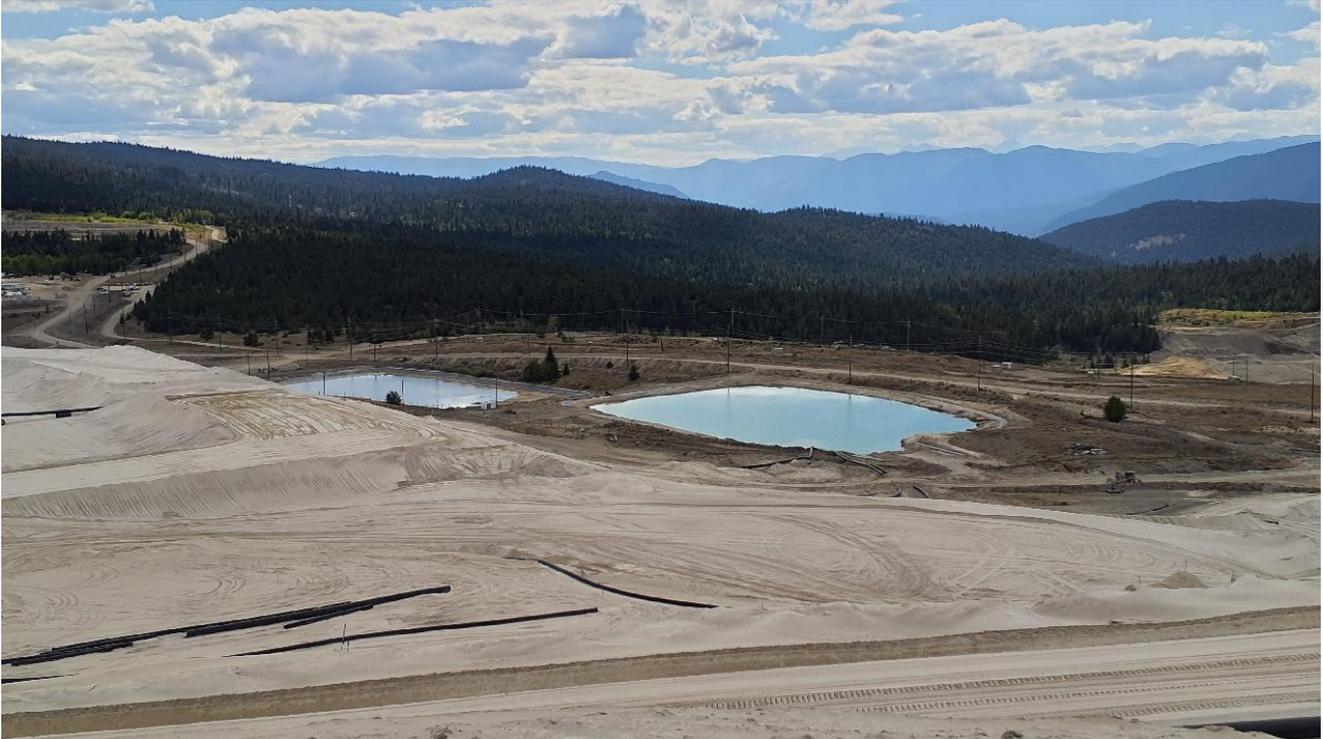
All seepage and sediment ponds were observed to be in good physical condition with no significant visual change or issues of concern. During 2023 construction, Sediment Pond 1, Sediment Pond 2 and the temporary on-dam cell at the VBBE and NBB were in operation supporting hydraulic cycloned sand placement.

Photo I-A-8 Overview of Sediment Pond 2 (right) and Seepage Pond 2 (left) downstream of the VBBE. (LL-2023-07)
