Teck Highland Valley Copper Partnership

2023 Annual Facility Performance Report

Highland Tailings Storage Facility

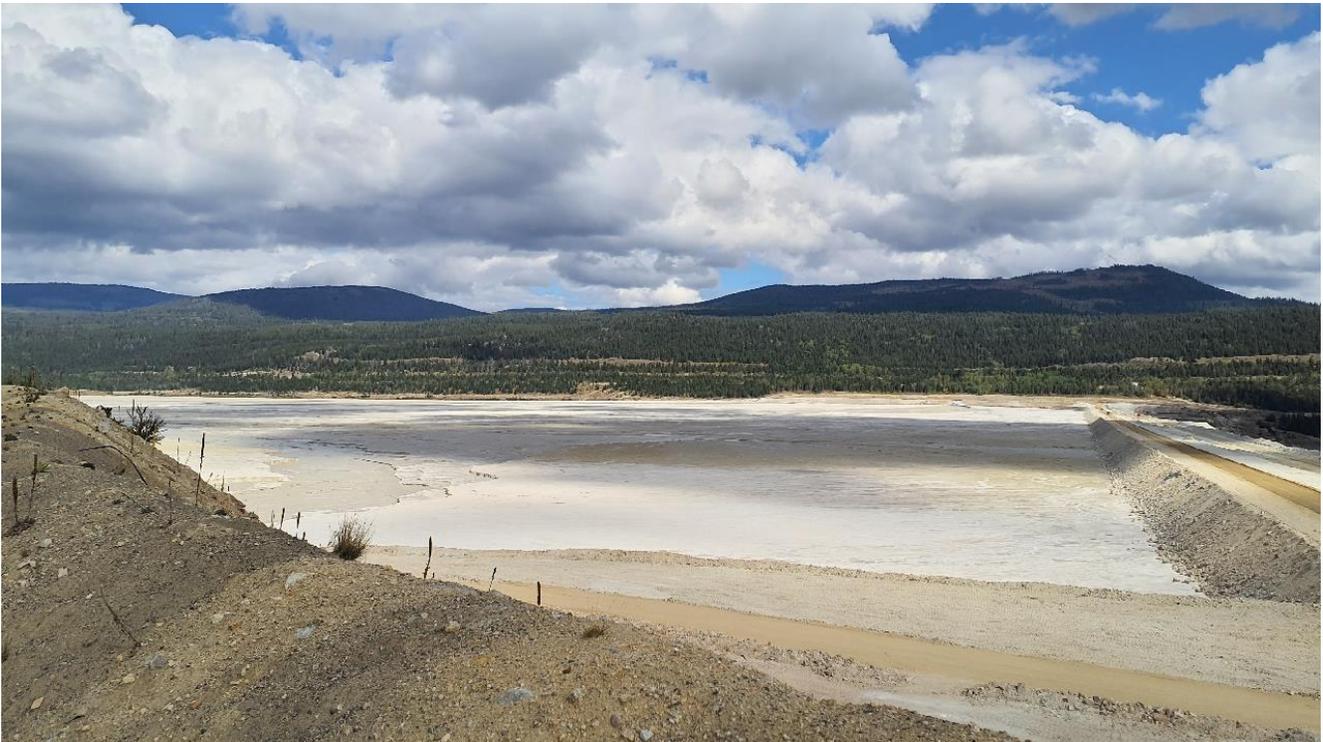
Photo I-B-1 Overview of H-H Dam crest and upstream beach area, looking northeast, from the West Abutment. There was no localized ponding near the dam crest at the time of the site visit. (HH-2023-01)

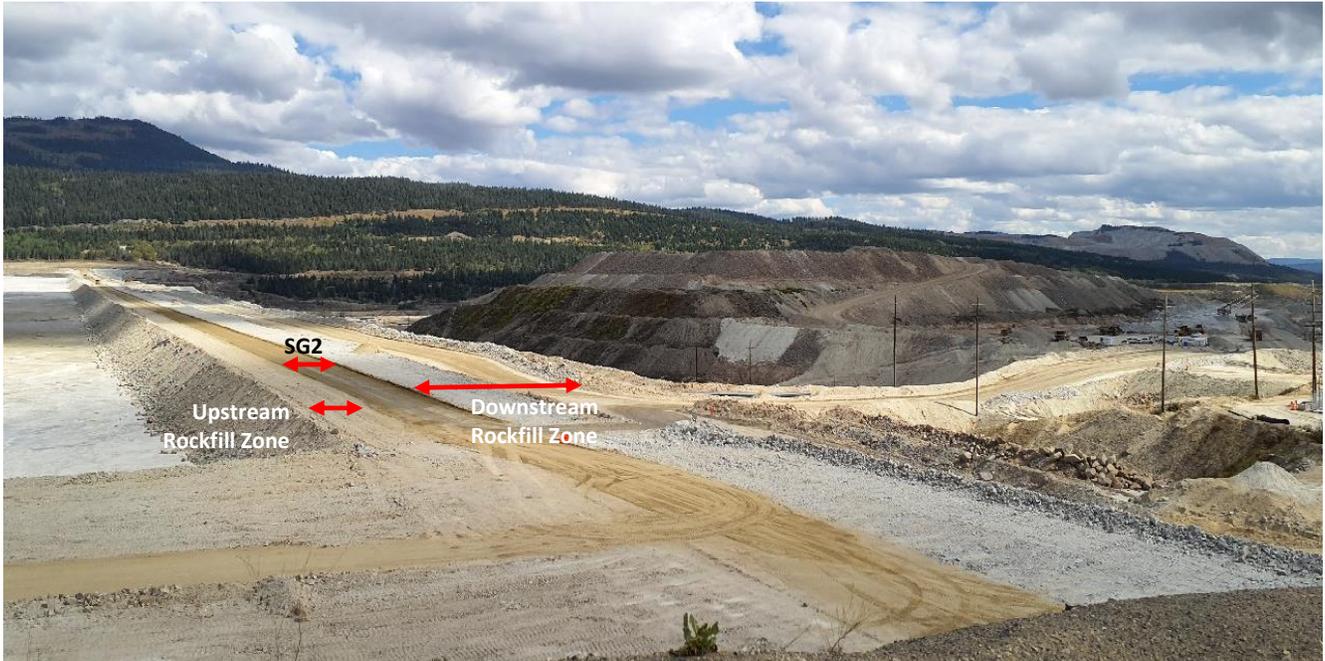
Photo I-B-2 H-H Dam crest area looking east, from west abutment. Active fill placement was ongoing during site visit. (HH-2023-01)

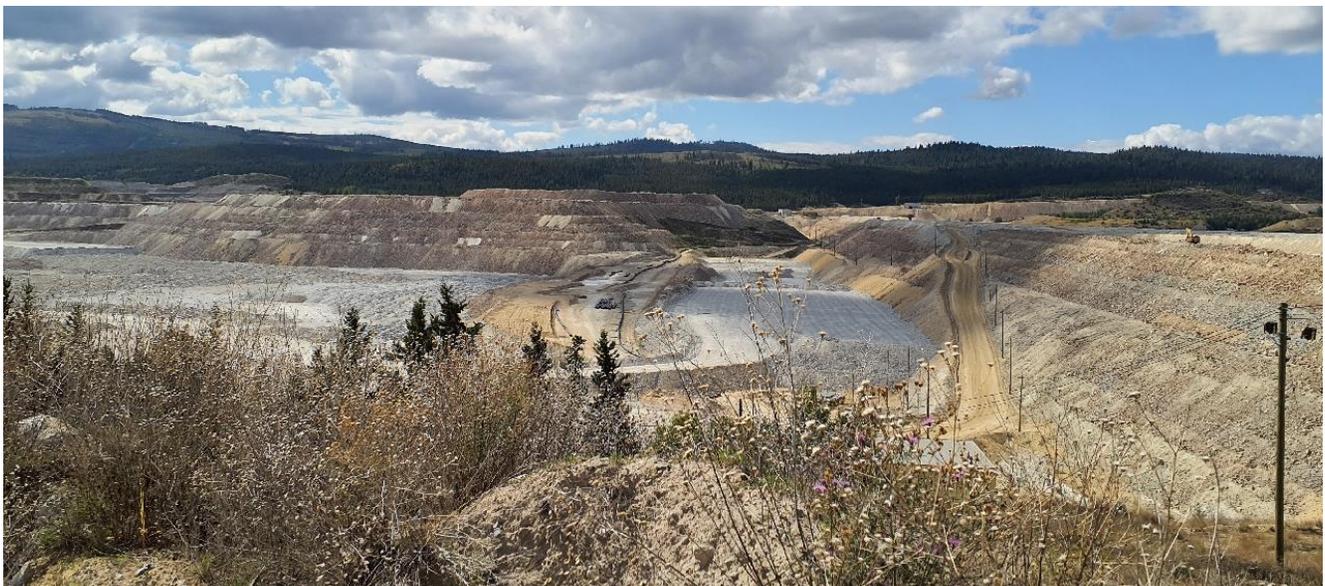
Photo I-B-3 H-H Dam downstream slope, buttress areas, 24 Mile Waste Dump and I-9 Waste Dump, looking west. Power lines along the toe of slope were relocated to allow 2023 buttress fill placement along toe of the downstream slope. (HH-2023-03)

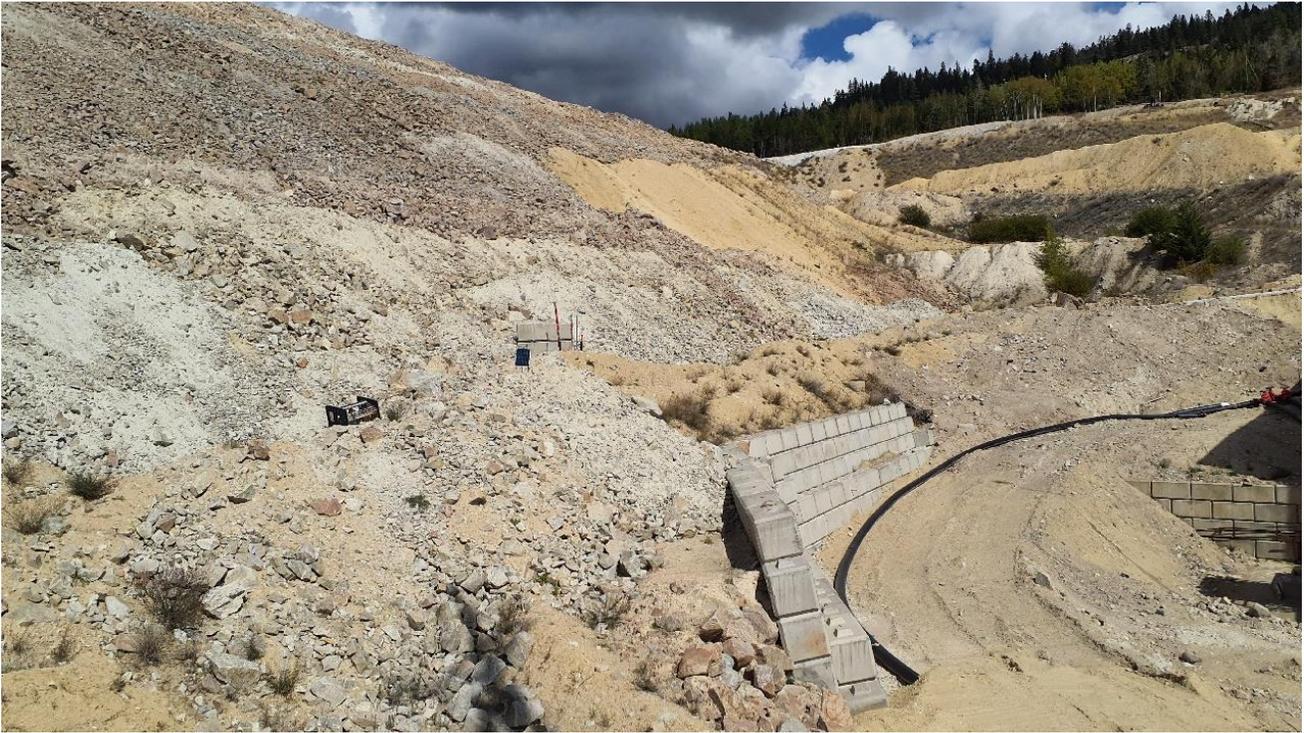
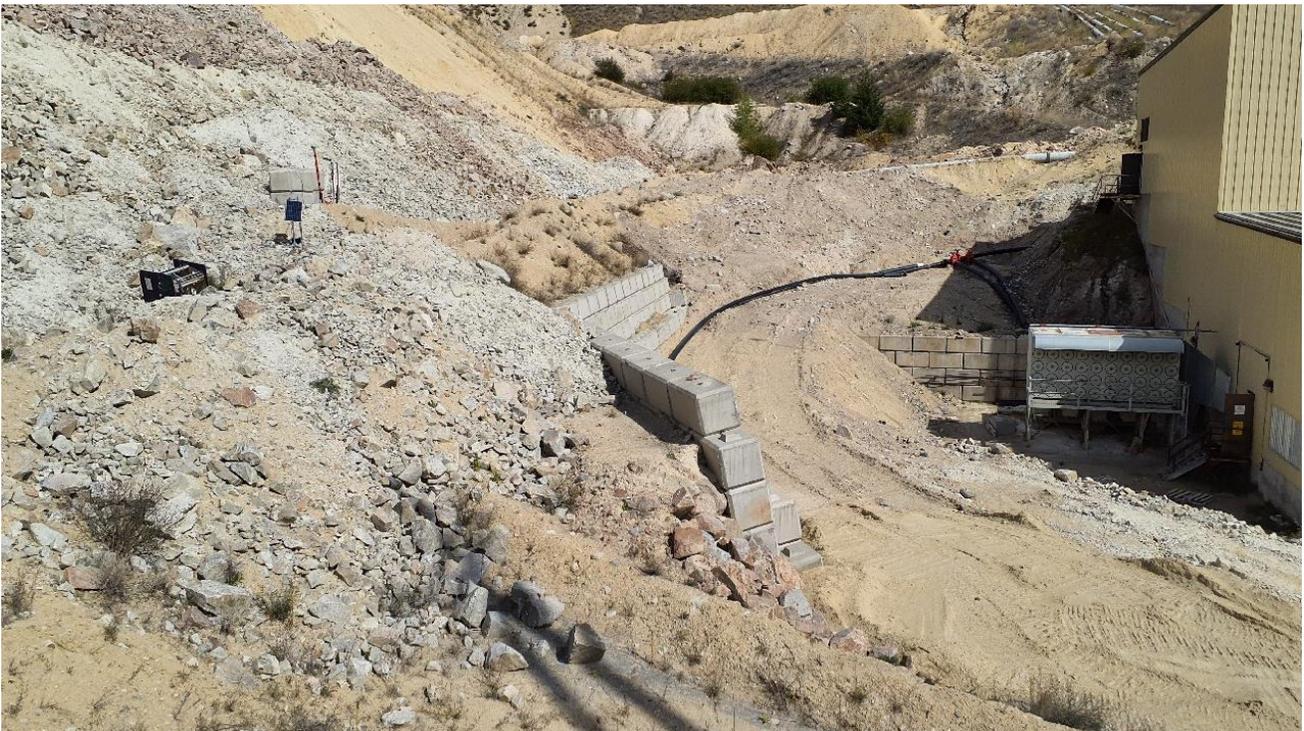
No visual indicators of concern or unusual behavior were observed (Photo I-B-4 and I-B-5). The East Abutment was prepared up to the ultimate dam crest level.

Photo I-B-4 Downstream slope of the East Segment of H-H Dam, looking east. Lock block wall at the toe is not a structural component of the dam. (HH-2023-02)

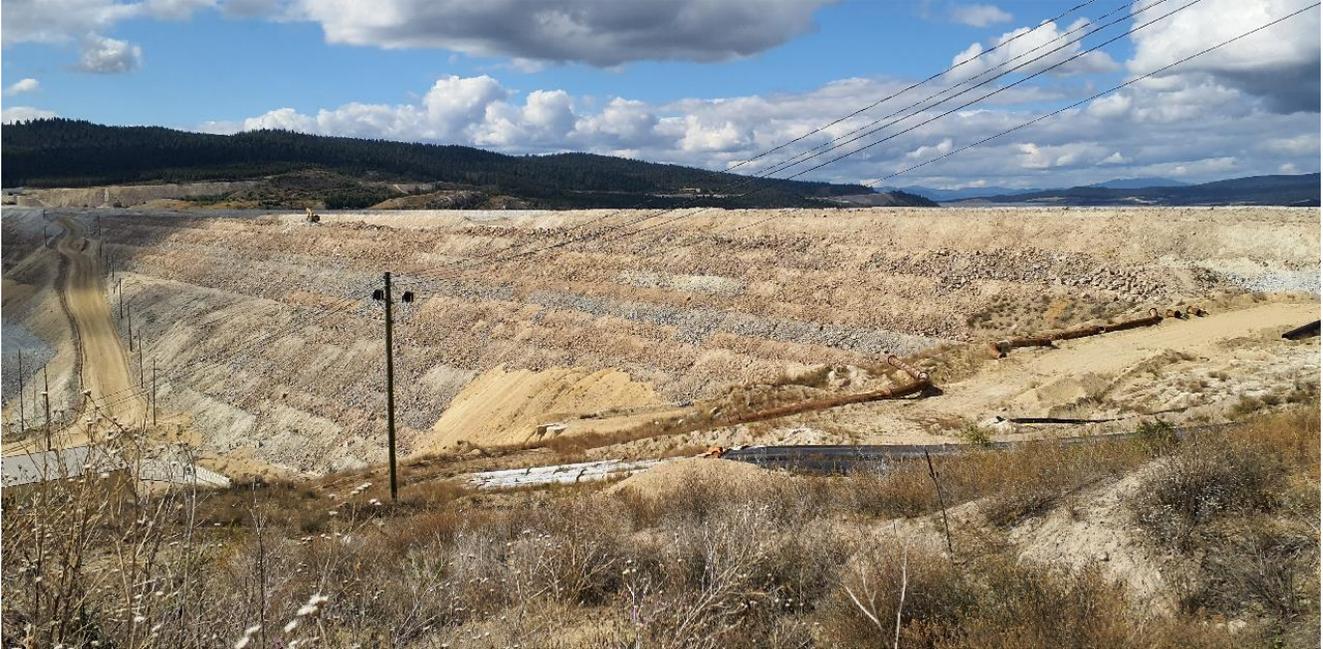
Photo I-B-5 Downstream slope of the East Segment of H-H Dam, looking west. (HH-2023-03)

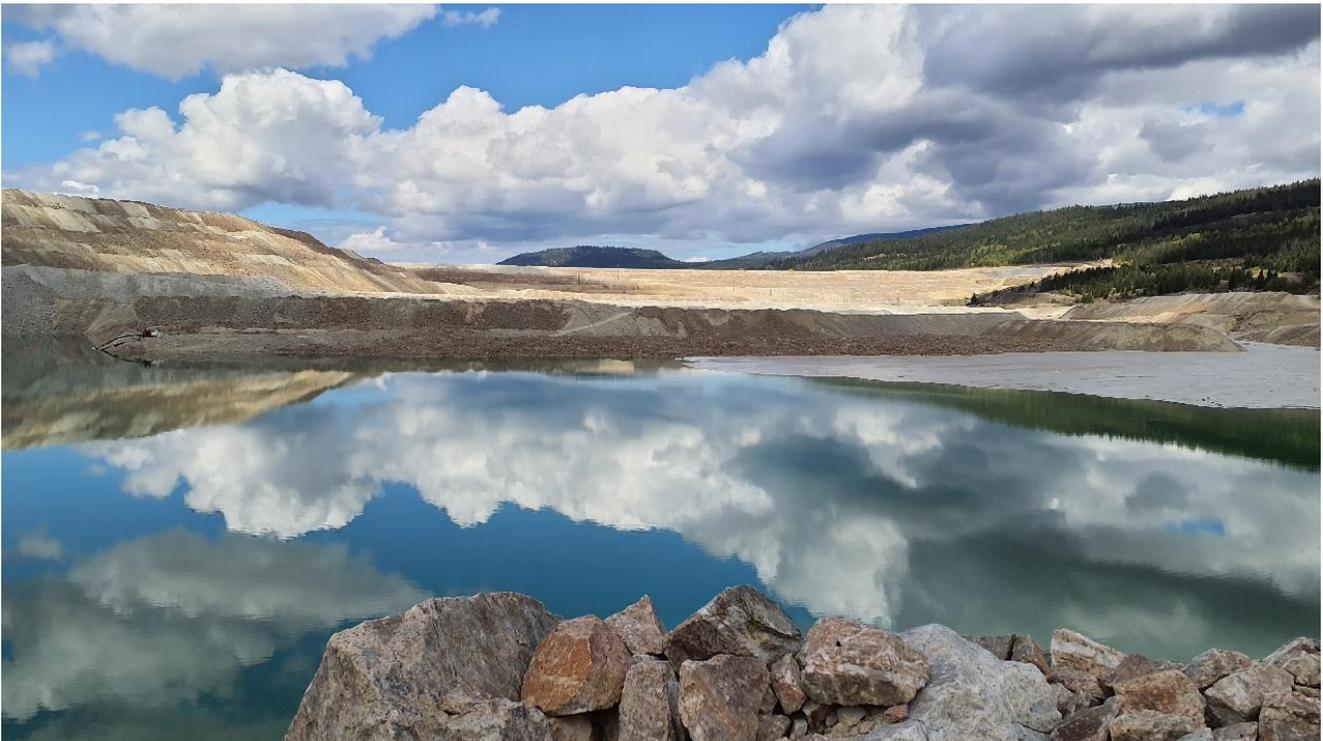
Photo I-B-8 24 Mile TSF pond and tailings beach, looking south towards H-H Dam downstream slope. I-9 Dump on left. (HH-2023-06)

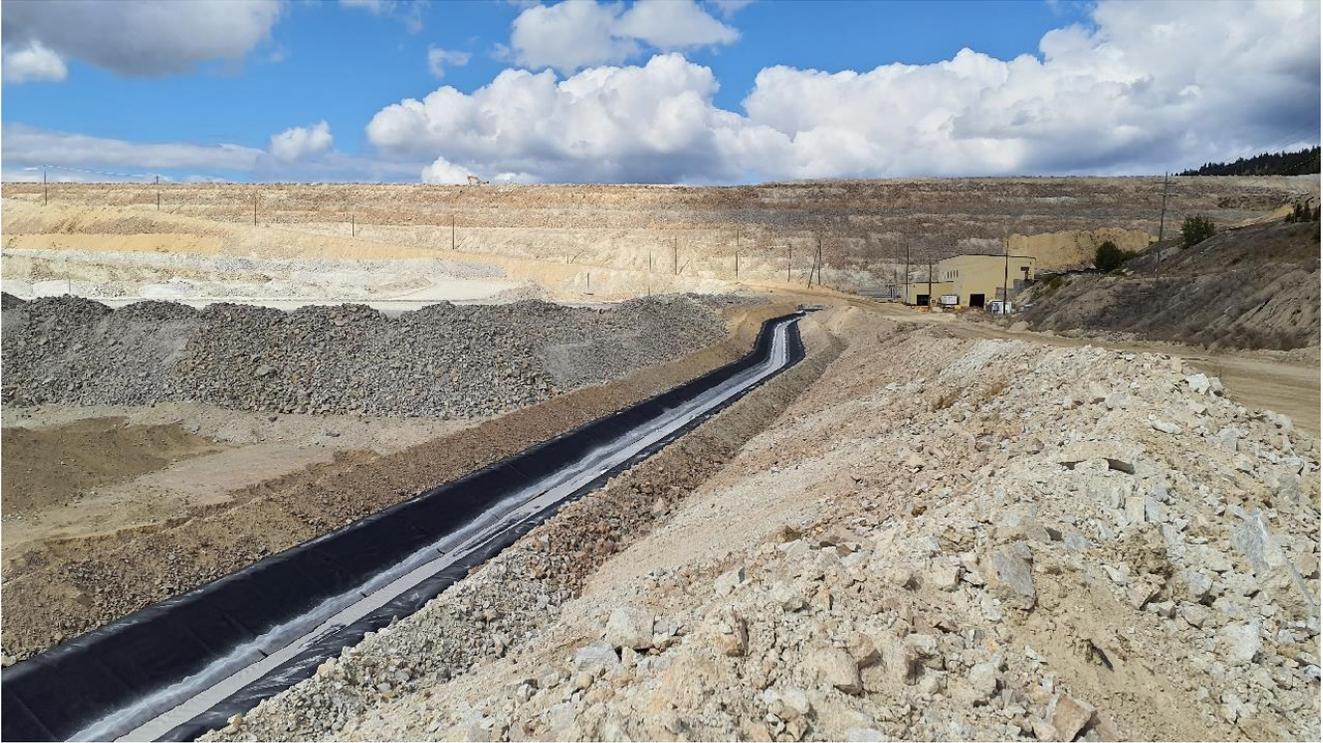
Photo I-B-9 Discharge channel to convey tailings slurry flows from HH Pumphouse to 24 Mile TSF. (HH-2023-08)

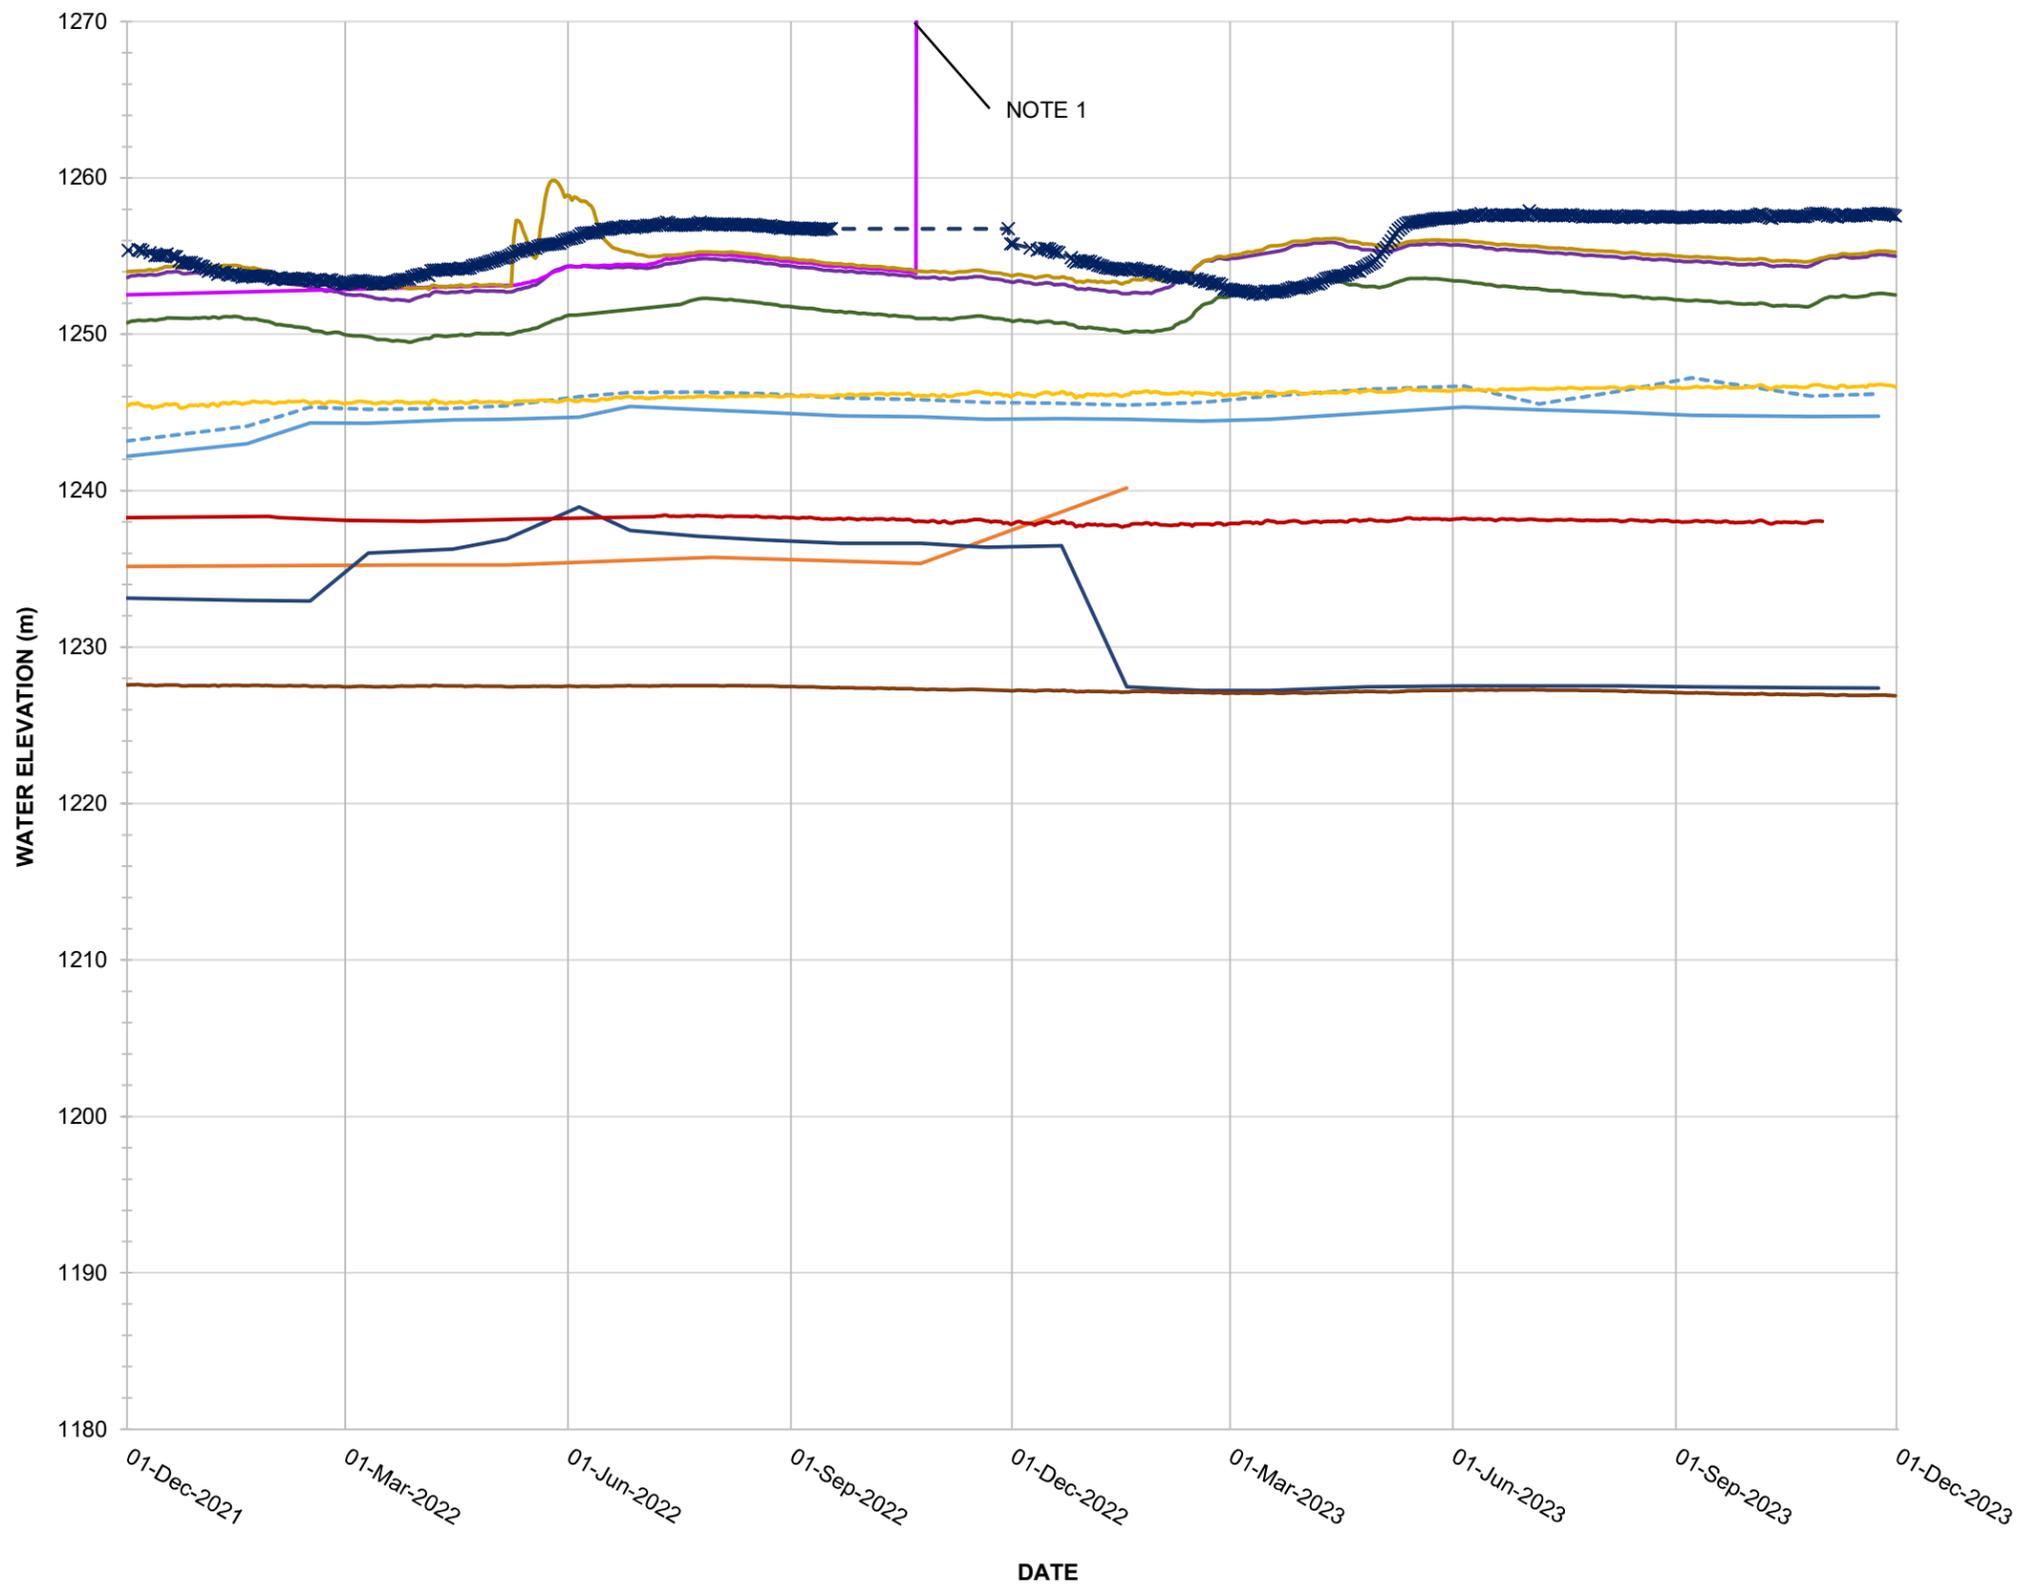
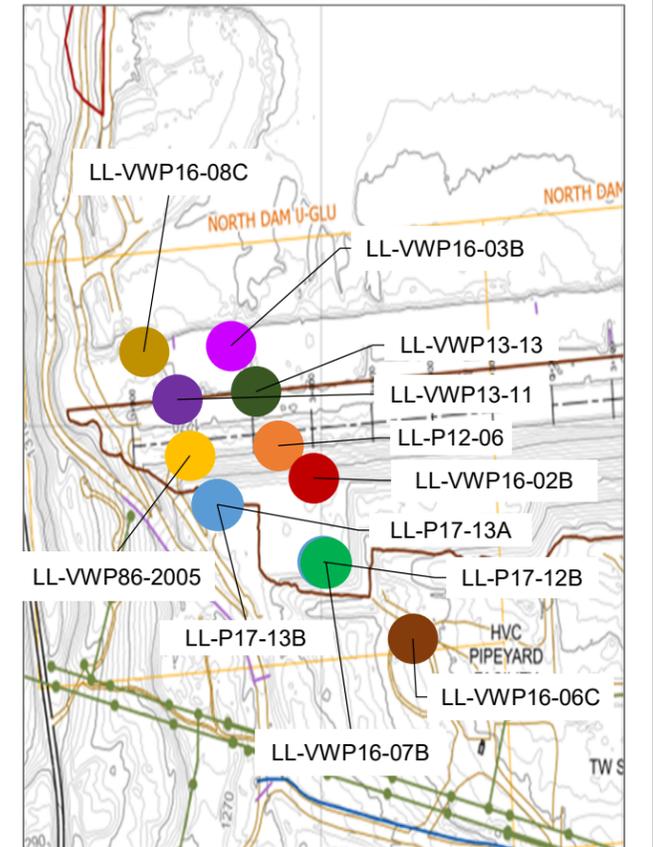
CLIENT Highland Valley Copper / Teck	PROJECT HIGHLAND TAILINGS STORAGE FACILITY 2023 ANNUAL FACILITY PERFORMANCE REPORT	
	TITLE L-L DAM NORTH DAM UPPER GLACIOLACUSTRINE SAND AND GRAVEL 2022 TO 2024 PIEZOMETER PLOTS	
	SCALE AS SHOWN	PROJECT No. M02341C62
	FIG. No. II-A-14

1. LL-VWP16-03B REPORTED A 219.5 m JUMP IN PORE WATER PRESSURES ON 2022-10-24. FOLLOWING THIS JUMP, THE WATER LEVELS DID NOT DISSIPATE AND SURROUNDING INSTRUMENTS IN SIMILAR GEOLOGICAL UNITS DID NOT EXHIBIT THE SAME BEHAVIOR. THE INSTRUMENT WAS MARKED AS DEFUNCT ON 2022-10-11.

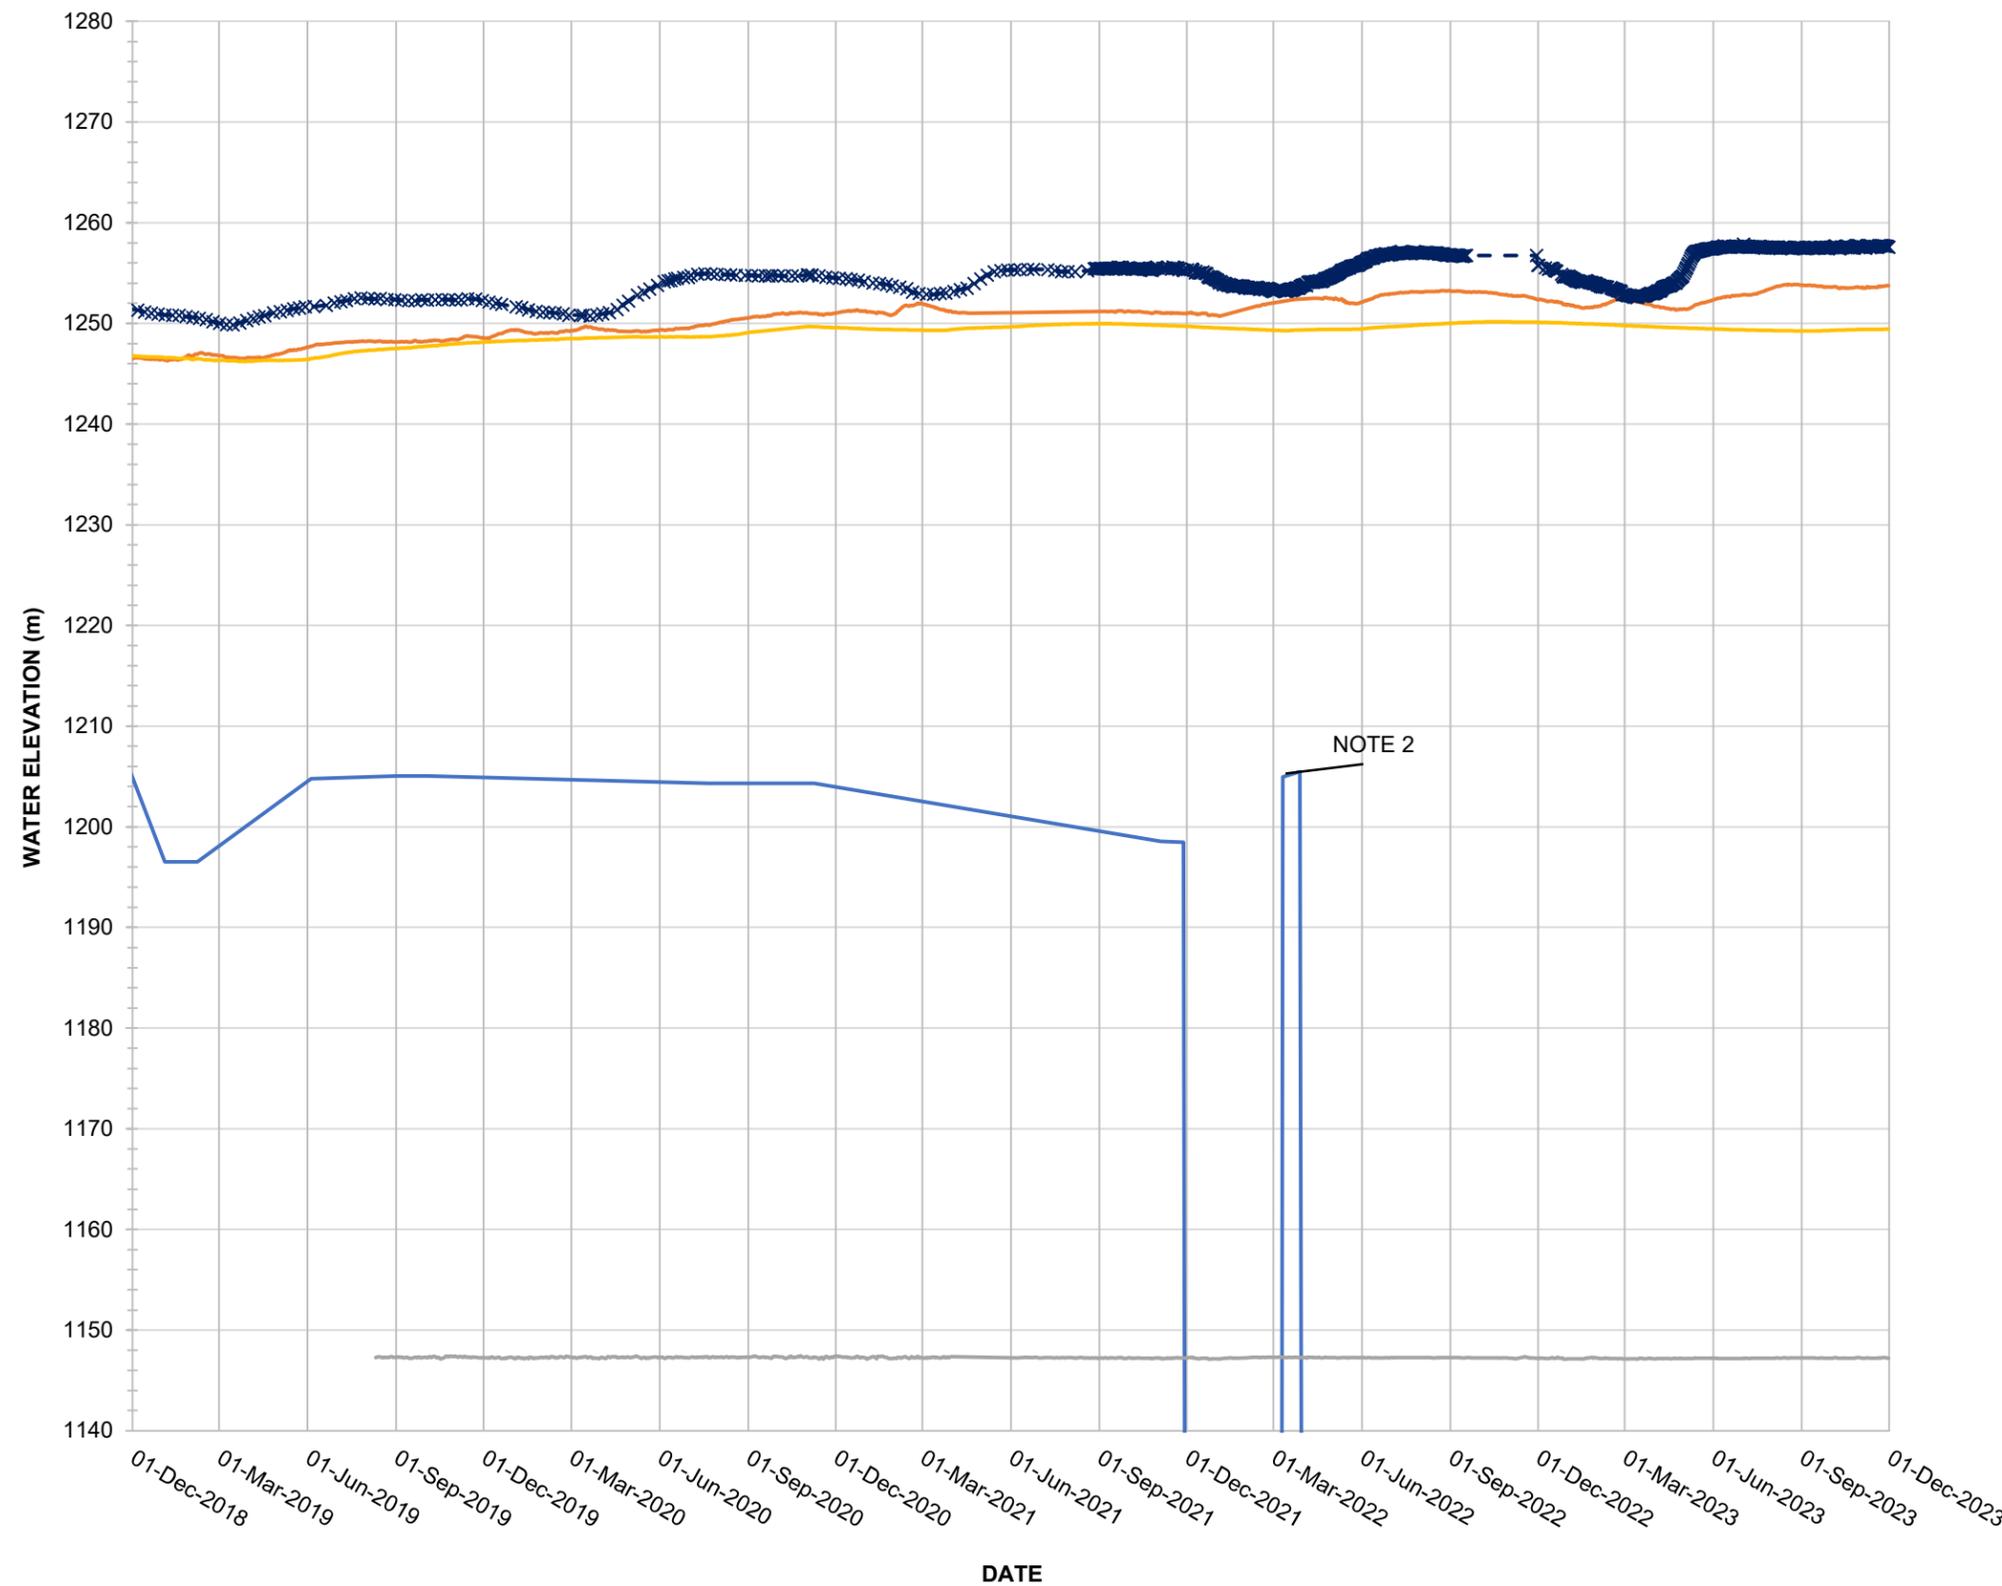
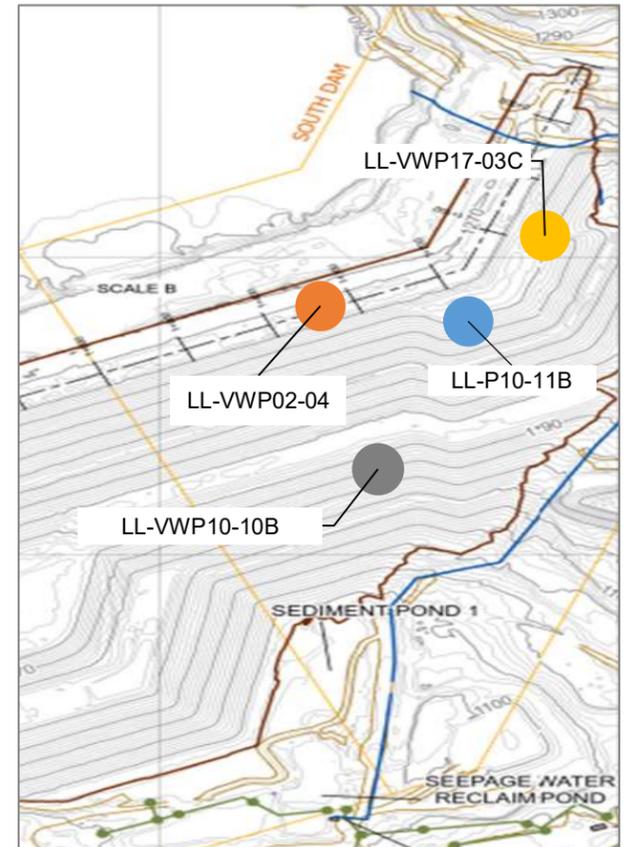
CLIENT Highland Valley Copper / Teck	PROJECT HIGHLAND TAILINGS STORAGE FACILITY 2023 ANNUAL FACILITY PERFORMANCE REPORT	
	TITLE L-L DAM SOUTH DAM DAM FILL 2019 TO 2024 PIEZOMETER PLOTS	
	SCALE	FIG. No.
	AS SHOWN	M02341C62 II-A-101

- HVC PROVIDES DRY READINGS ELEVATIONS AS El. -8000 m.
- LL-P10-11B WAS REPORTED DRY ON 2022-01-27, READ POSITIVE PORE PRESSURES IN MARCH 2022 AND RETURNED TO DRY STATUS AS OF 2022-06-05.

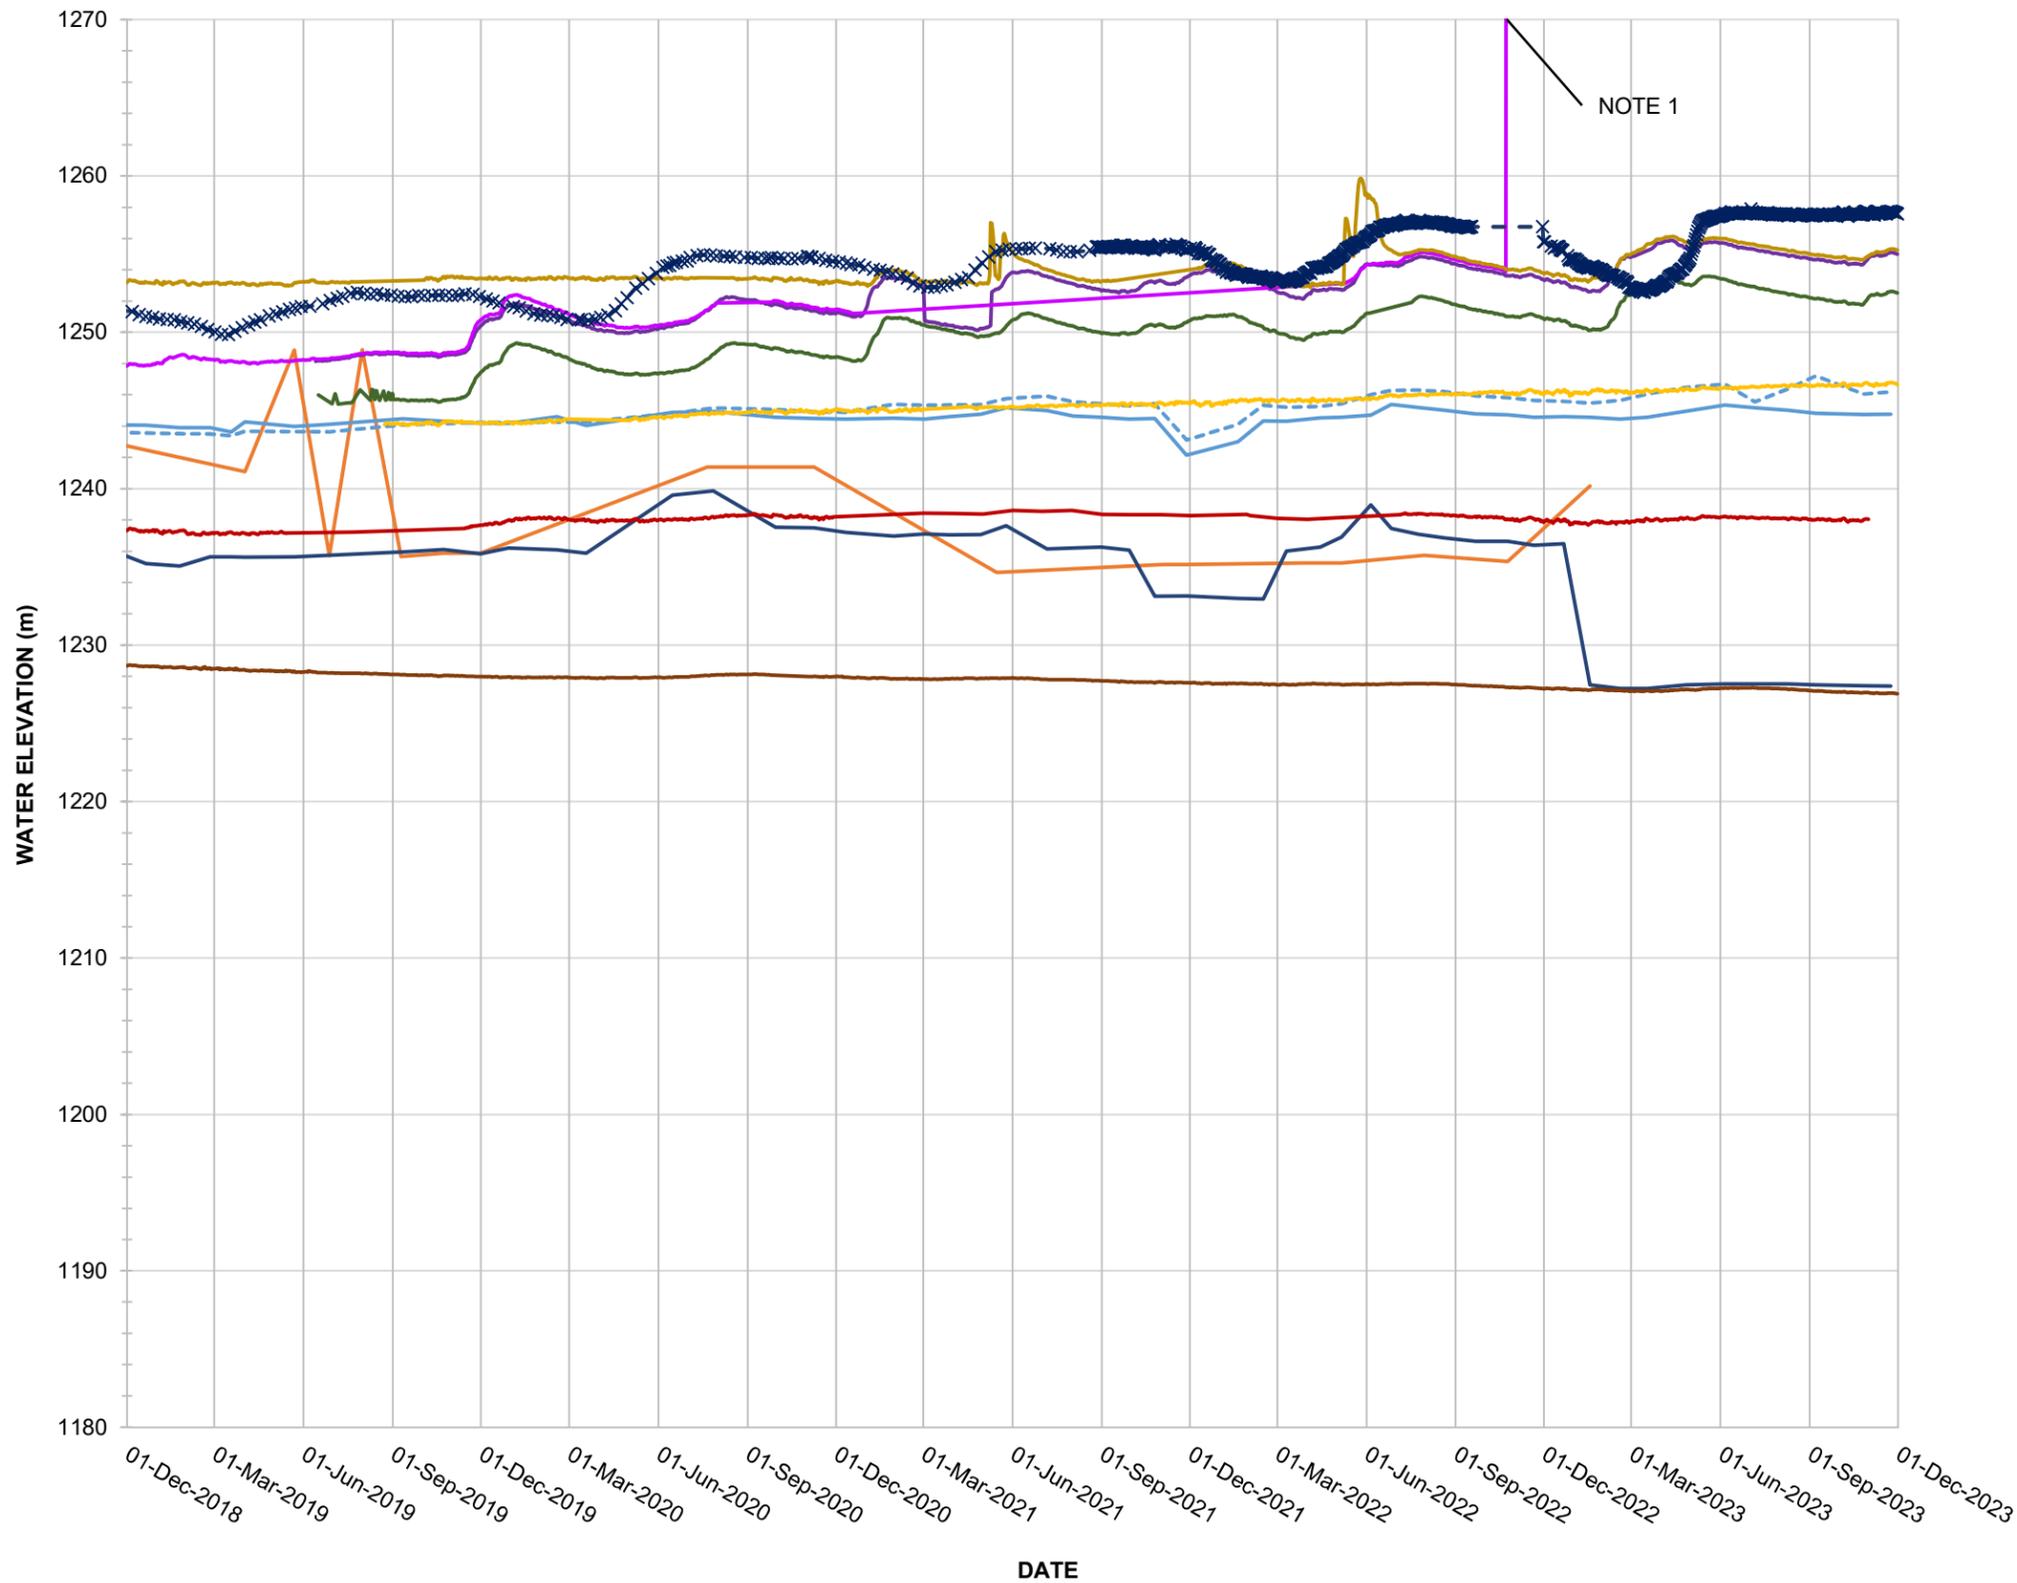
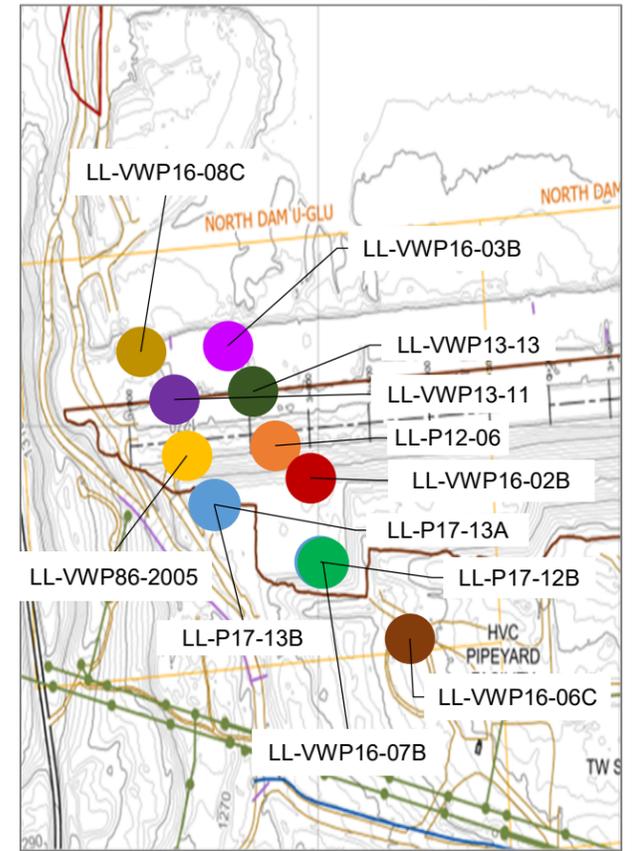
CLIENT Highland Valley Copper / Teck	PROJECT HIGHLAND TAILINGS STORAGE FACILITY 2023 ANNUAL FACILITY PERFORMANCE REPORT	
	TITLE L-L DAM NORTH DAM UPPER GLACIOLACUSTRINE SAND AND GRAVEL 2019 TO 2024 PIEZOMETER PLOTS	
	SCALE AS SHOWN	PROJECT No. M02341C62
	FIG. No. II-A-114

1. LL-VWP16-03B REPORTED A 219.5 m JUMP IN PORE WATER PRESSURES ON 2022-10-24. FOLLOWING THIS JUMP, THE WATER LEVELS DID NOT DISSIPATE AND SURROUNDING INSTRUMENTS IN SIMILAR GEOLOGICAL UNITS DID NOT EXHIBIT THE SAME BEHAVIOR. THE INSTRUMENT WAS MARKED AS DEFUNCT ON 2022-10-11.

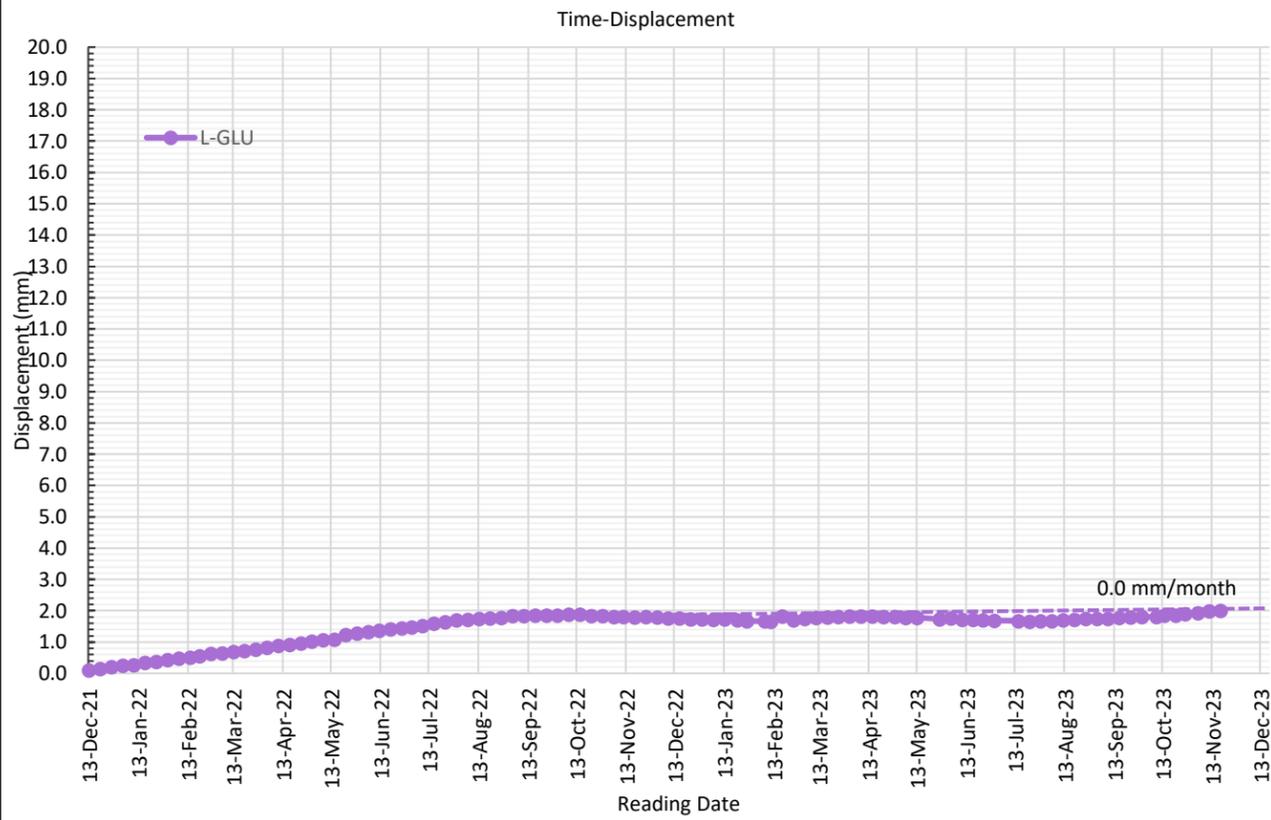
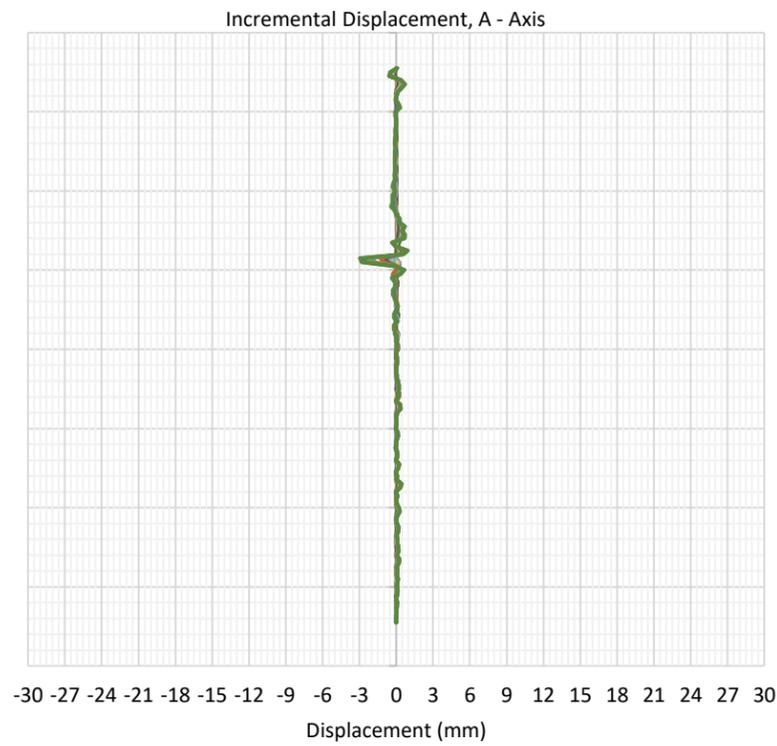
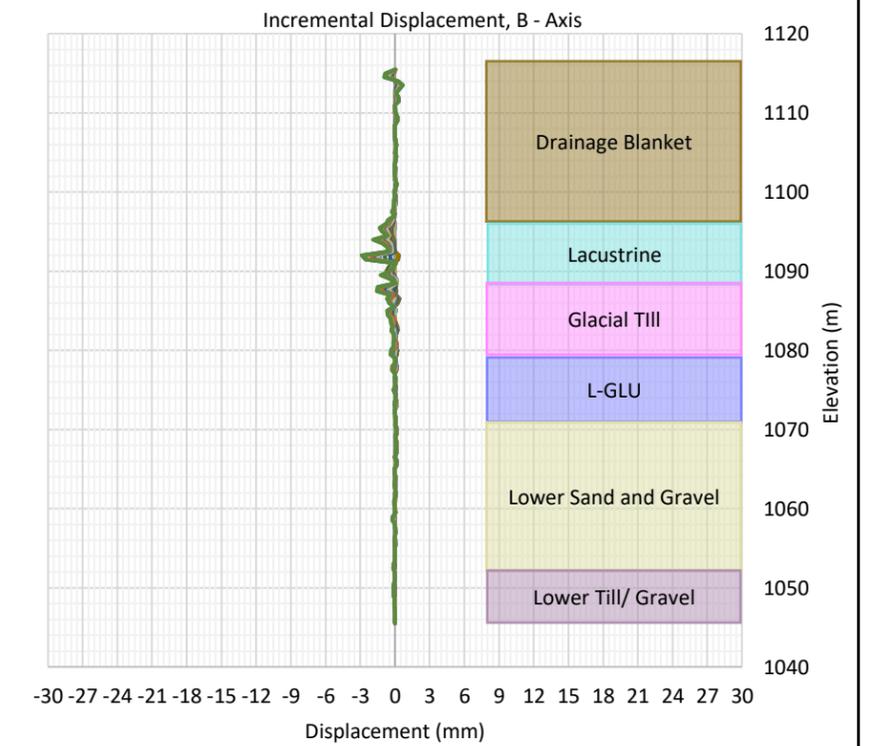
CLIENT Highland Valley Copper / Teck	PROJECT HIGHLAND TAILINGS STORAGE FACILITY 2023 ANNUAL FACILITY PERFORMANCE REPORT	
	TITLE LL DAM INCLINOMETER PLOTS LL-110-07 (VBB) DEC. 2021 TO NOV. 2023	
Kohn Crippen Berger	SCALE NTS	PROJECT No. M02341C62
		FIG. No. II-B-3

1. DATA PROCESSED AND PROVIDED BY HVC
2. LAST READING OF EACH MONTH PLOTTED ON THE INCREMENTAL AND CUMULATIVE PROFILES.
3. X-AXIS, Y-AXIS, AND LEGEND IS THE SAME FOR THE INCREMENTAL AND CUMULATIVE PROFILES.
4. INCREMENTAL DISPLACEMENT PROFILES ARE BASED ON READINGS WITHIN ONE WEEK OF THE CUMULATIVE PROFILES.
5. BASED ON DISCUSSIONS AND REVIEW OF SAAV WITH MANUFACTURER, MEASURAND, ABOVE INSTRUMENT IS MEASURE A BENT/HELIX SHAPE OF THE CASING ABOVE APPROXIMATELY EL. 1080 M CAUSED BY COMPRESSION STRESSES. THIS IS NOT REPRESENTATIVE OF MOVEMENT RELATED TO DAM PERFORMANCE AND NO MONITORING ZONE HAS BEEN DEFINED.
