Teck Highland Valley Copper Partnership

2023 Annual Facility Performance Report

Highland Tailings Storage Facility

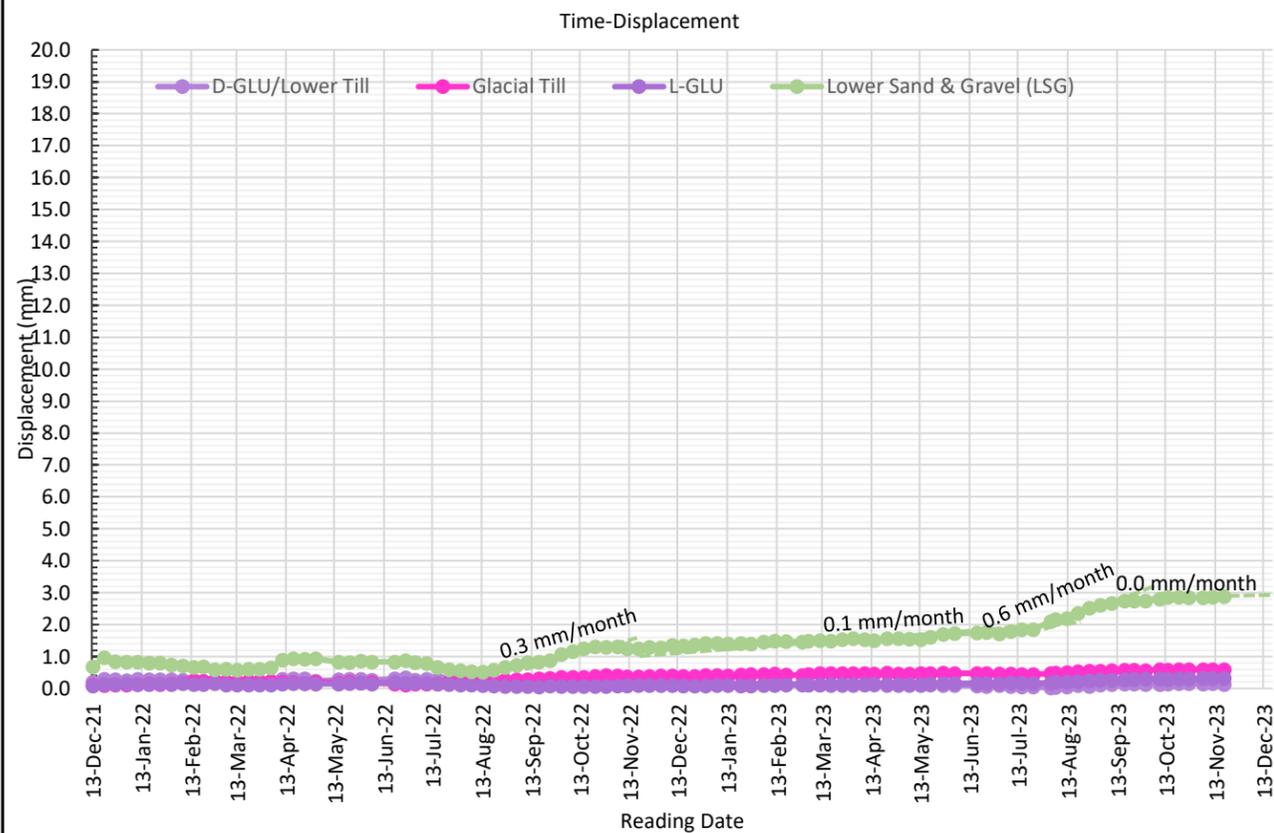
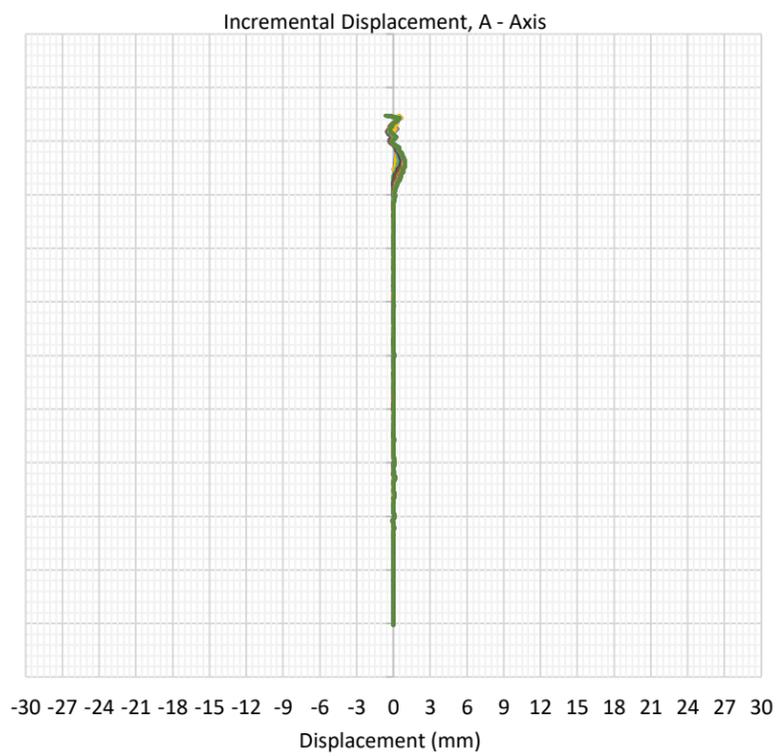
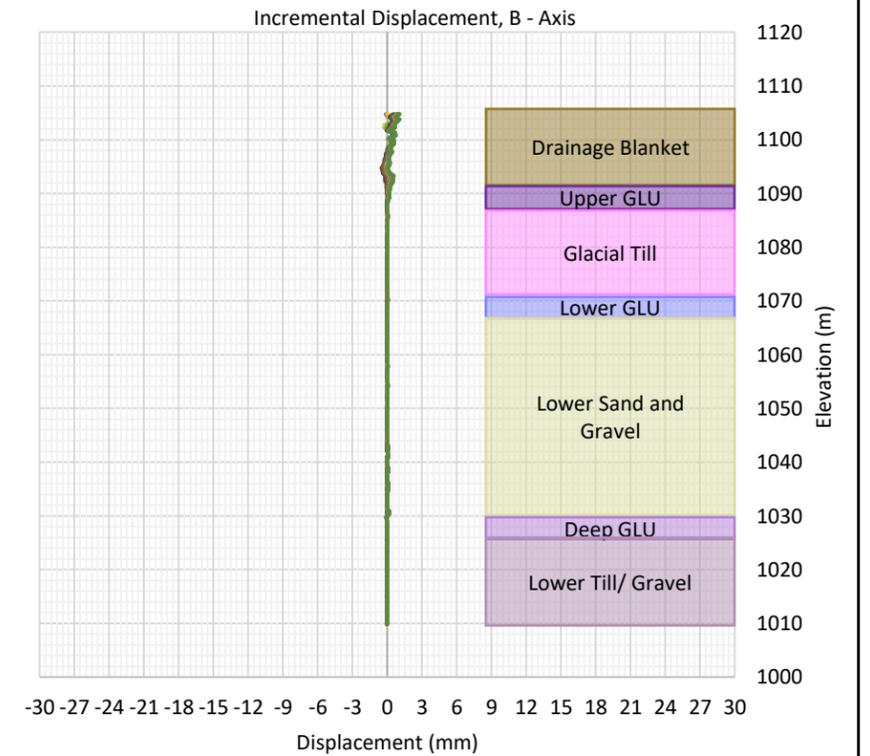
CLIENT Highland Valley / Teck Copper	PROJECT HIGHLAND TAILINGS STORAGE FACILITY 2023 ANNUAL FACILITY PERFORMANCE REPORT	
	TITLE LL DAM INCLINOMETER PLOTS LL-I15-27 (VBB) DEC. 2021 TO NOV. 2023	
	SCALE	FIG. No.
	NTS	II-B-4

1. DATA PROCESSED AND PROVIDED BY HVC
2. LAST READING OF EACH MONTH PLOTTED ON THE INCREMENTAL AND CUMULATIVE PROFILES.
3. X-AXIS, Y-AXIS, AND LEGEND IS THE SAME FOR THE INCREMENTAL AND CUMULATIVE PROFILES.
4. INCREMENTAL DISPLACEMENT PROFILES ARE BASED ON READINGS WITHIN ONE WEEK OF THE CUMULATIVE PROFILES.
5. MOVEMENT IN THE COMPACTED DRIANAGE BLANKET WAS A LOCALISED RESPONSE AT THE END OF DRILLING AS THE CASING WAS LEFT IN THE GROUND DURING INSTALLATION. REFER TO SECTION 5.2.3.4 OF MAIN TEXT.

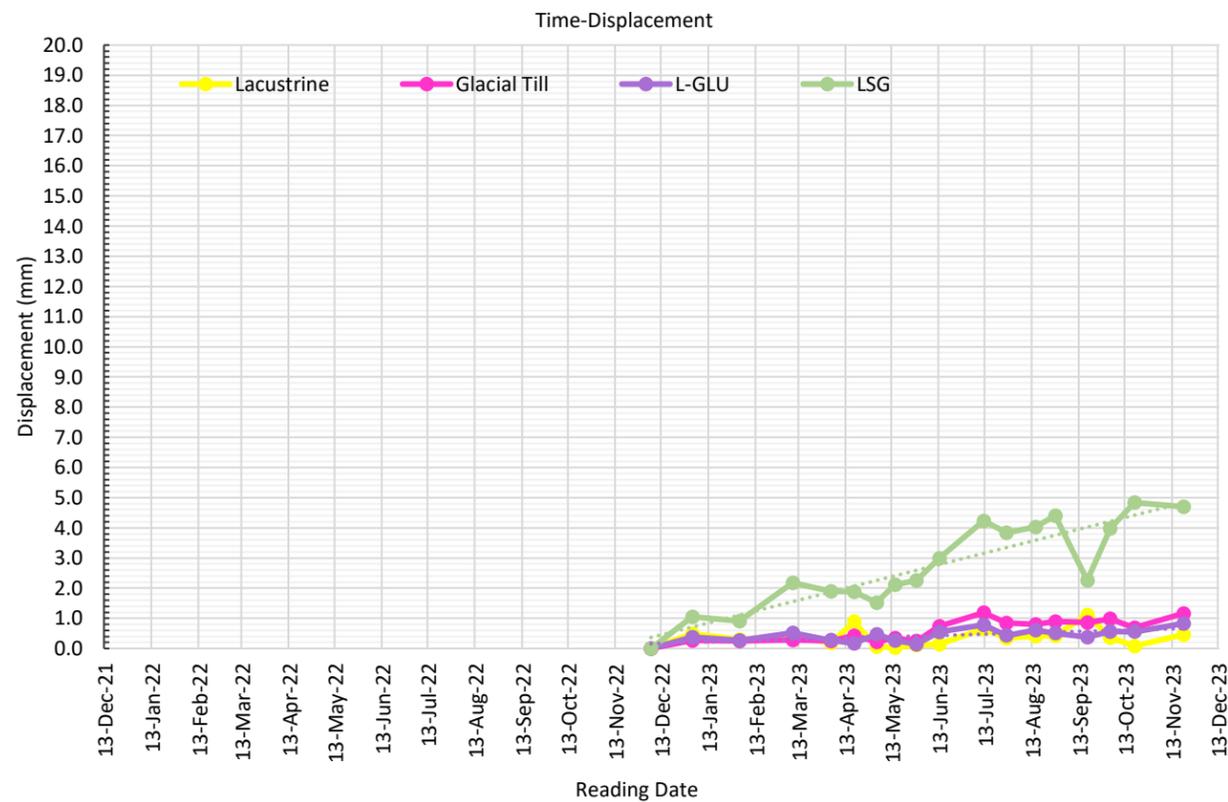
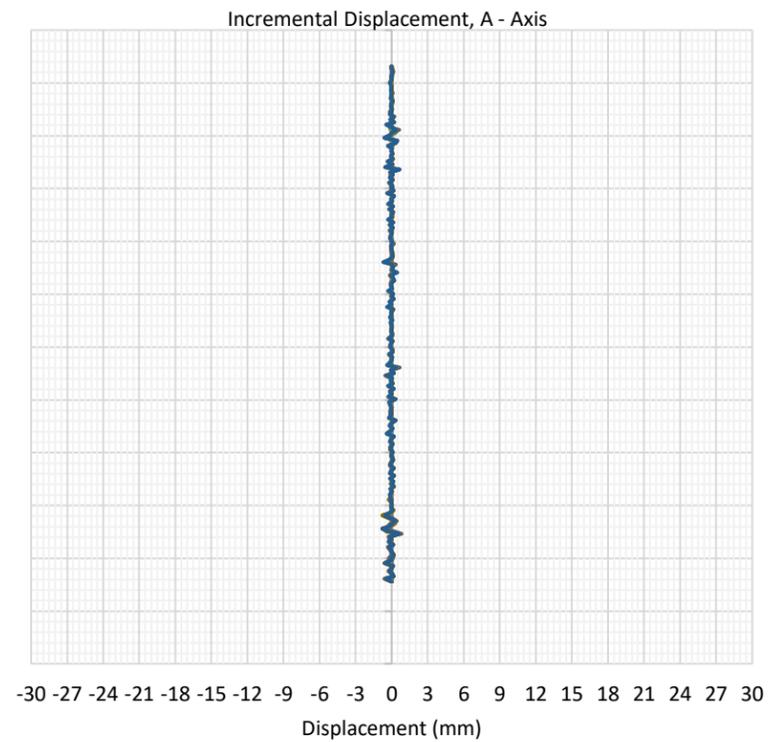
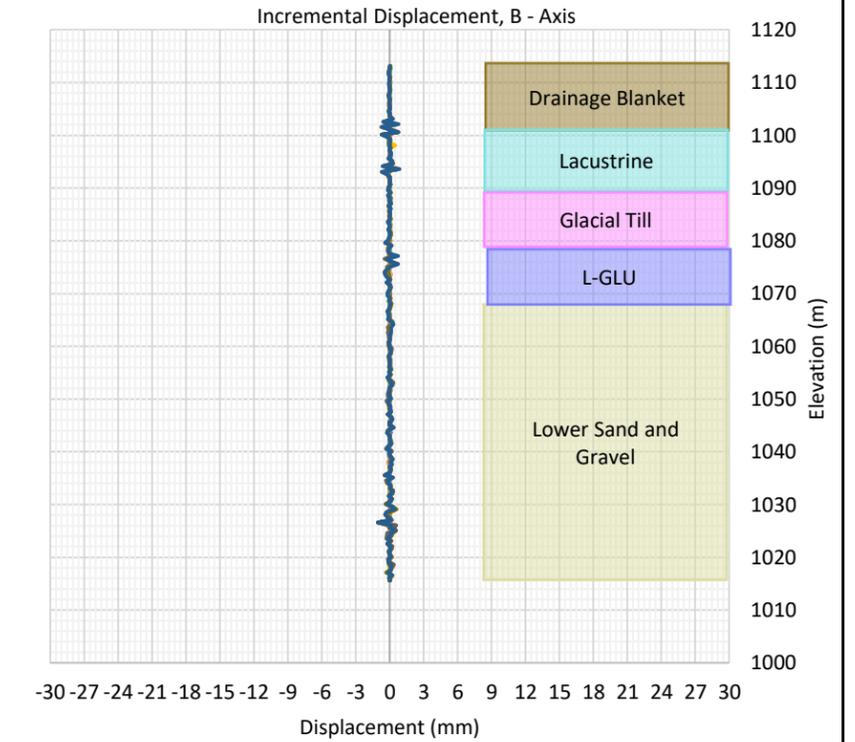
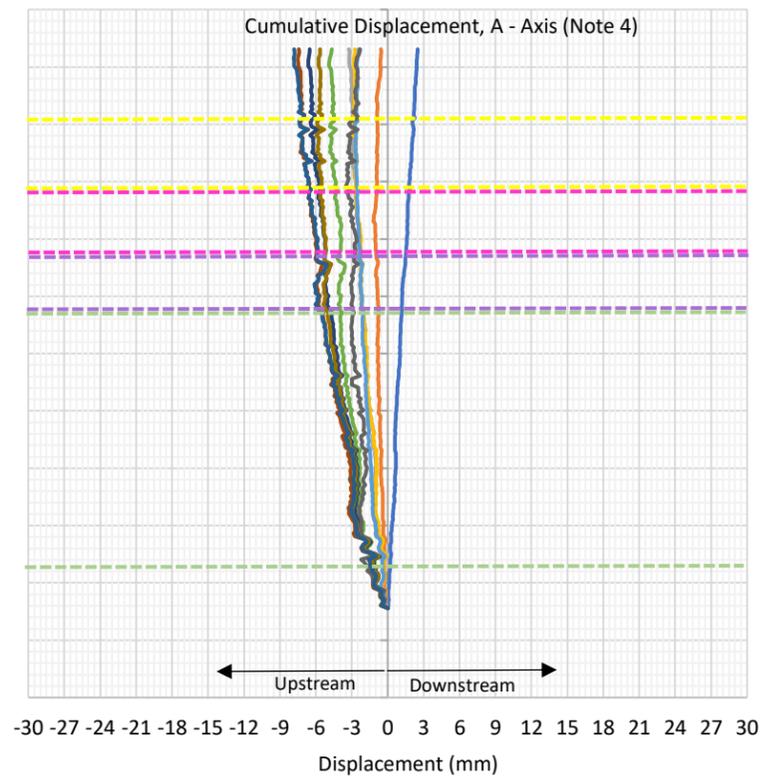
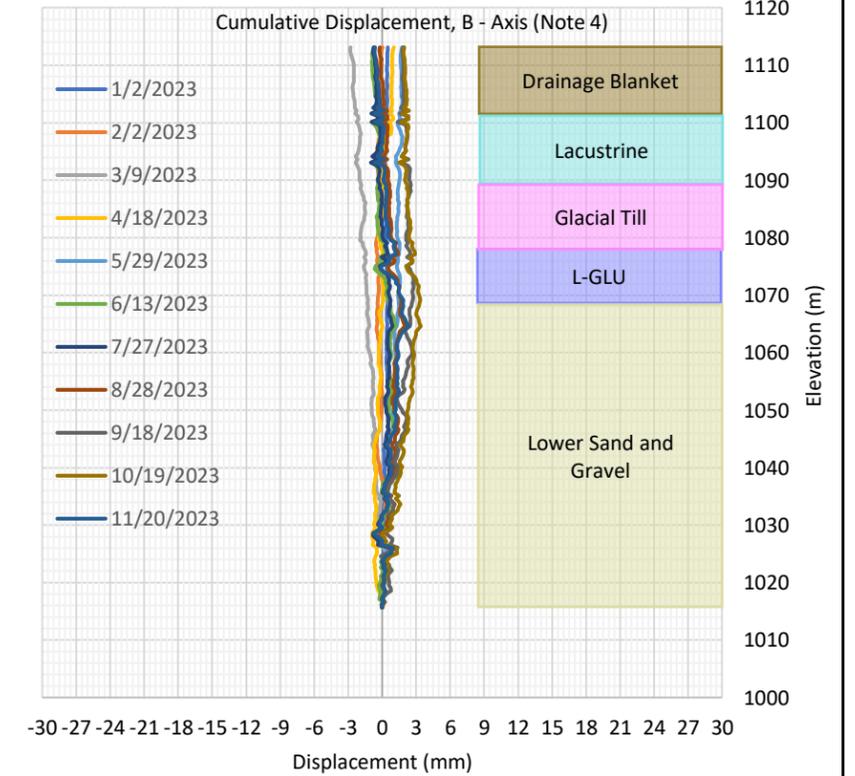
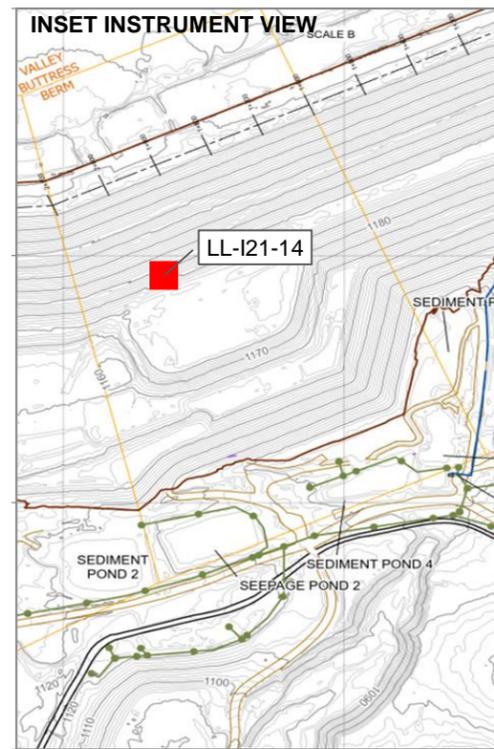
CLIENT Highland Valley Copper / Teck	PROJECT HIGHLAND TAILINGS STORAGE FACILITY 2023 ANNUAL FACILITY PERFORMANCE REPORT	
	TITLE LL DAM INCLINOMETER PLOTS LL-117-19 (VBB) DEC. 2021 TO NOV. 2023	
	SCALE NTS	PROJECT No. M02341C62
	FIG. No. II-B-11

1. DATA PROCESSED AND PROVIDED BY HVC
2. LAST READING OF EACH MONTH PLOTTED ON THE INCREMENTAL AND CUMULATIVE PROFILES.
3. X-AXIS, Y-AXIS, AND LEGEND IS THE SAME FOR THE INCREMENTAL AND CUMULATIVE PROFILES.
4. AZIMUTH CORRECTION HAS NOT BEEN APPLIED TO THIS INSTRUMENT.
5. DATA SHOWN ON THE PLOTS IS AFTER THE INSTRUMENT WAS BASELINED. HVC HAVE MONITORED THIS INSTRUMENT PRIOR TO THE BASELINE AND MET THE READING FREQUENCY.
6. GEOLOGY PRESENTED WAS LOGGED FOR LL-110-06.

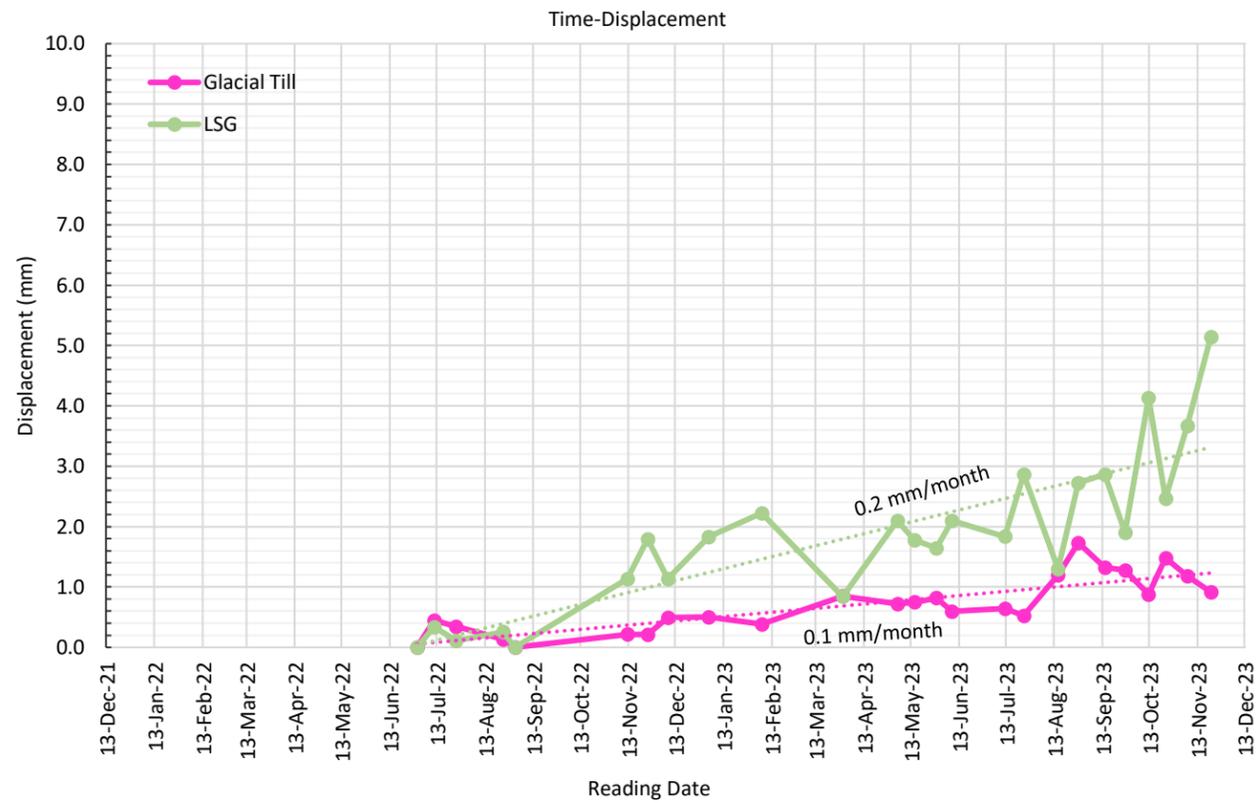
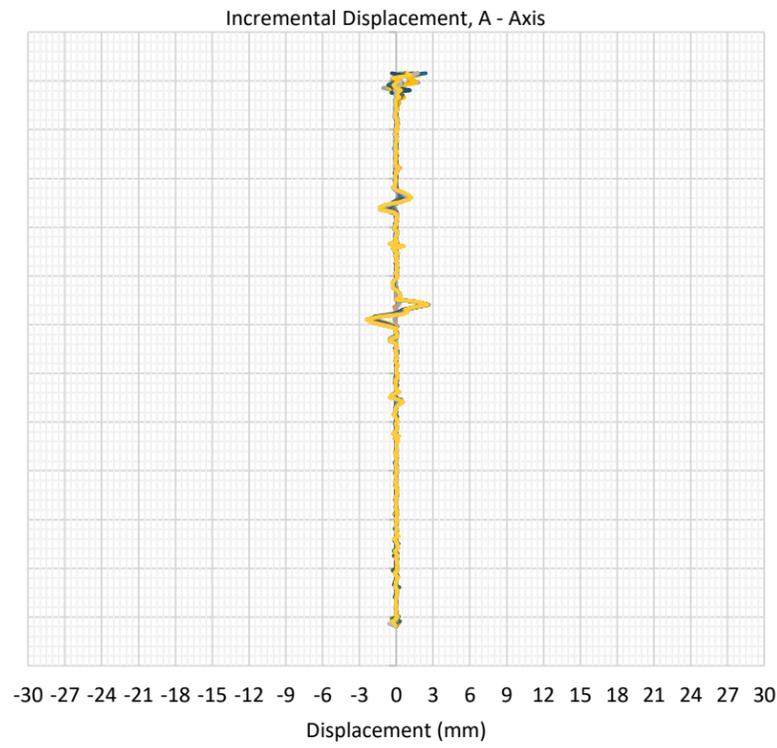
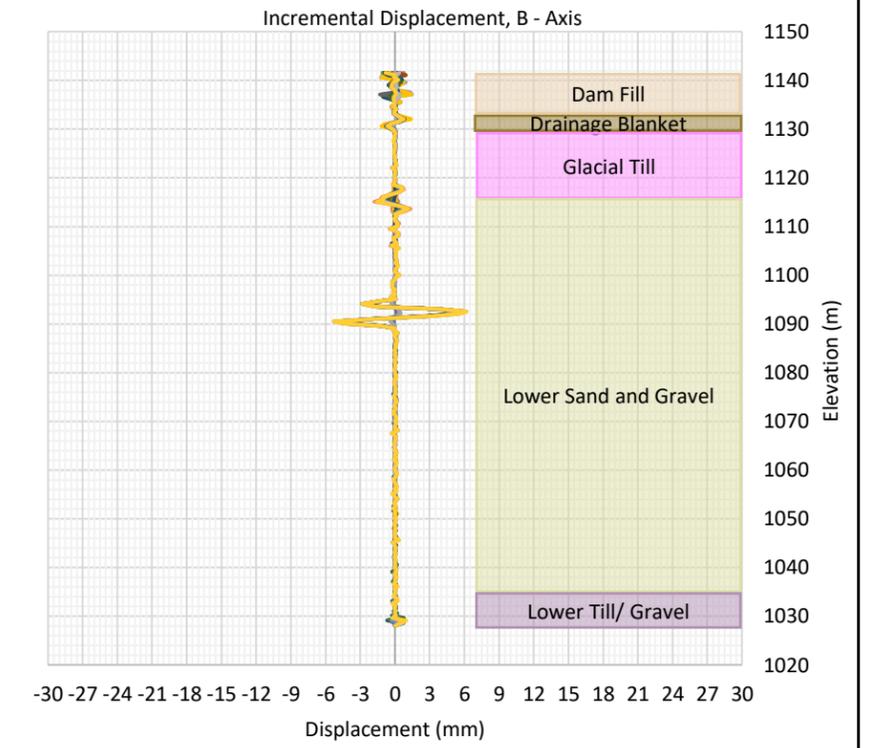
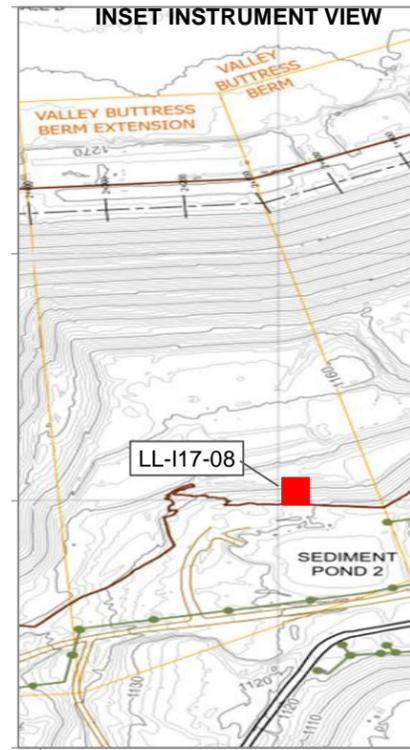
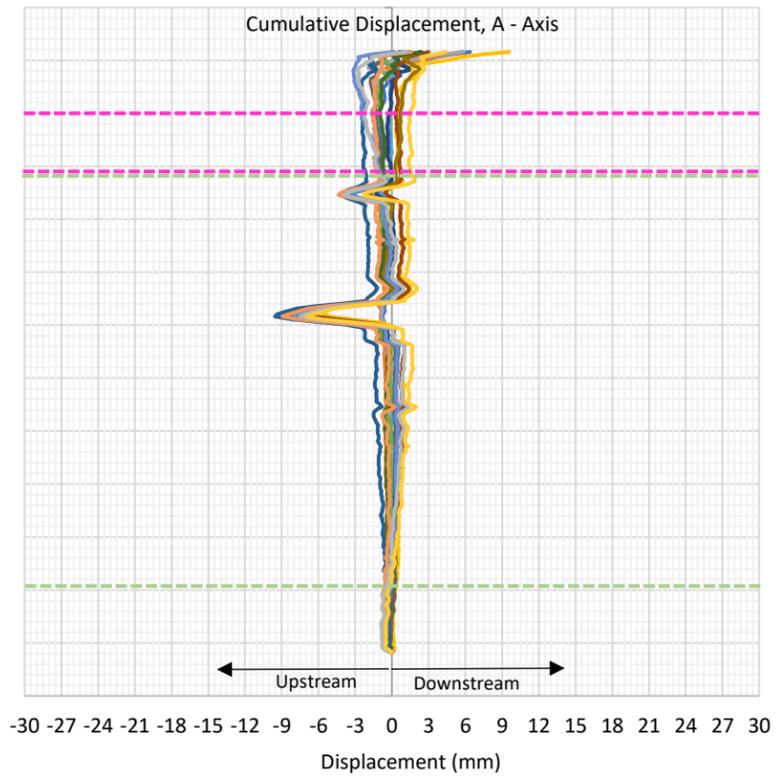
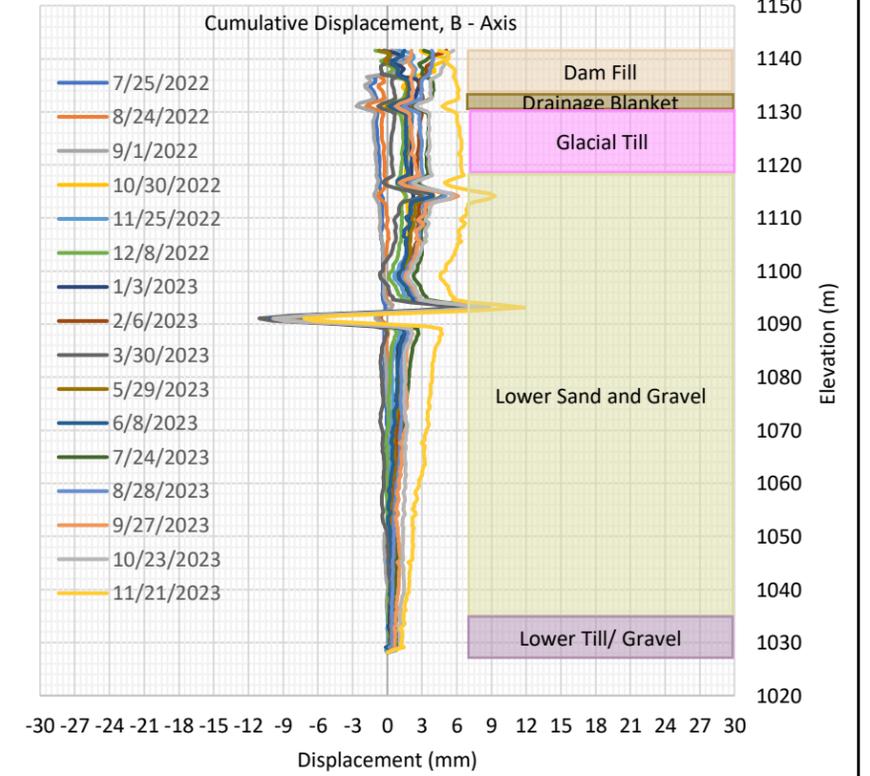
CLIENT Highland Valley Copper / Teck	PROJECT HIGHLAND TAILINGS STORAGE FACILITY 2023 ANNUAL FACILITY PERFORMANCE REPORT	
	TITLE LL DAM INCLINOMETER PLOTS LL-110-11 (VBBE) DEC. 2021 TO NOV. 2023	
	SCALE NTS	PROJECT No. M02341C62
	FIG. No. II-B-13

1. DATA PROCESSED AND PROVIDED BY HVC
2. LAST READING OF EACH MONTH PLOTTED ON THE INCREMENTAL AND CUMULATIVE PROFILES.
3. X-AXIS, Y-AXIS, AND LEGEND IS THE SAME FOR THE INCREMENTAL AND CUMULATIVE PROFILES.
4. DATA SHOWN ON THE PLOTS IS AFTER THE INSTRUMENT WAS BASELINED. HVC HAVE MONITORED THIS INSTRUMENT PRIOR TO THE BASELINE AND MET THE READING FREQUENCY.

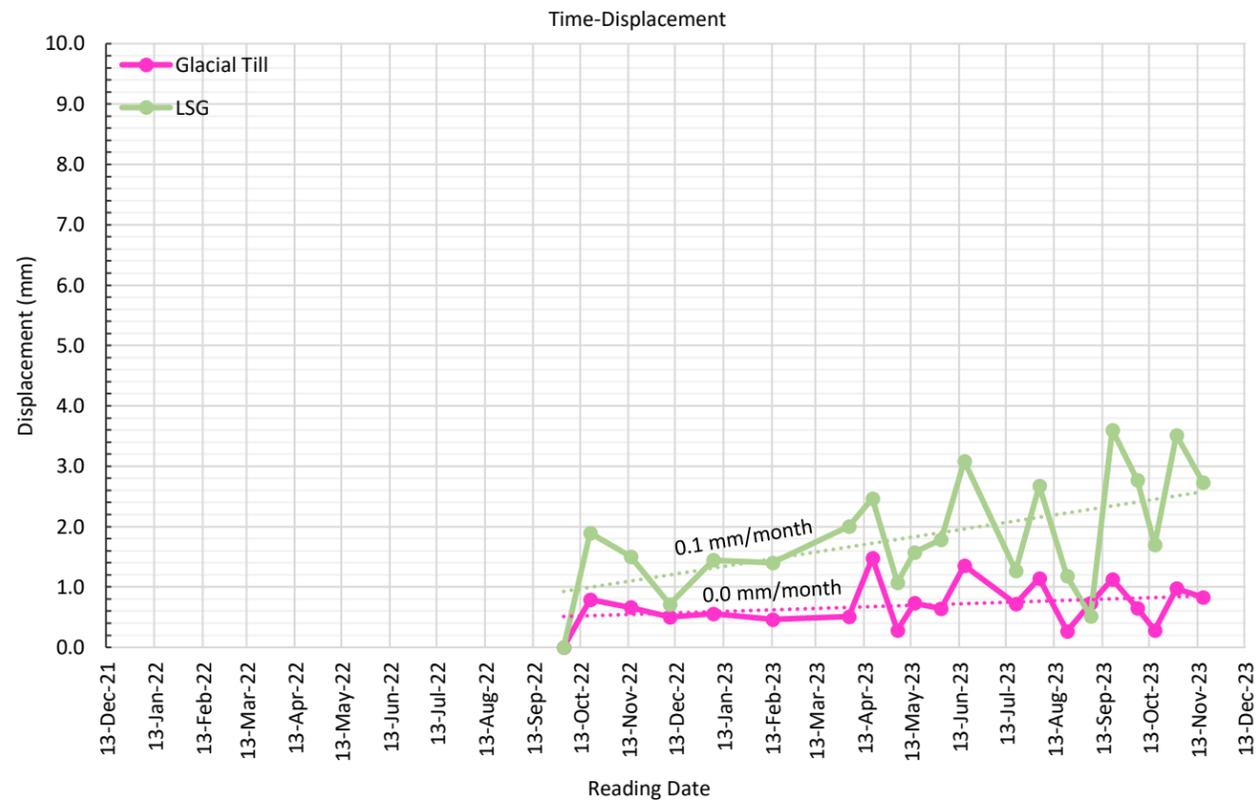
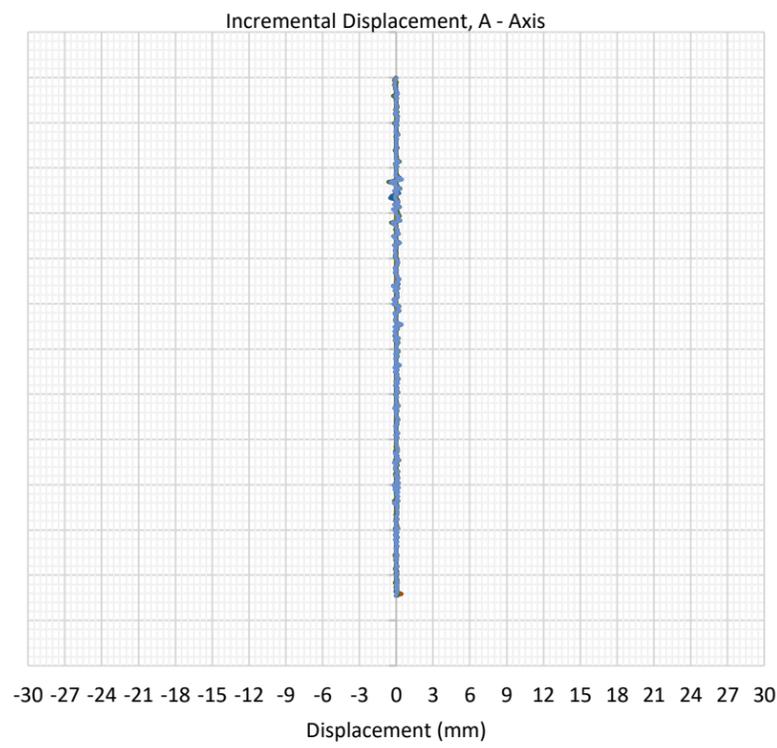
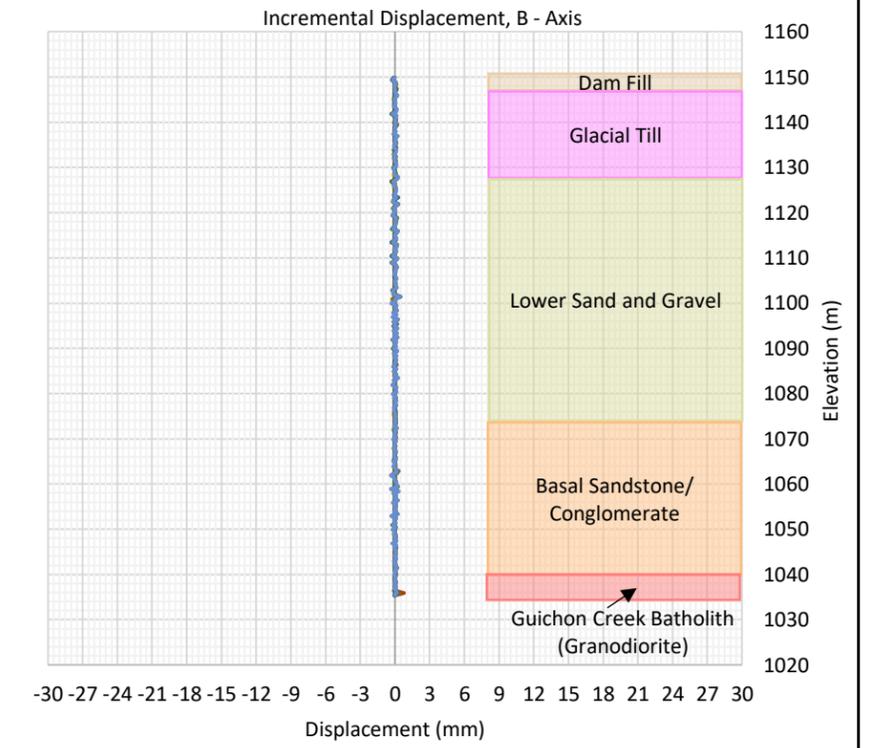
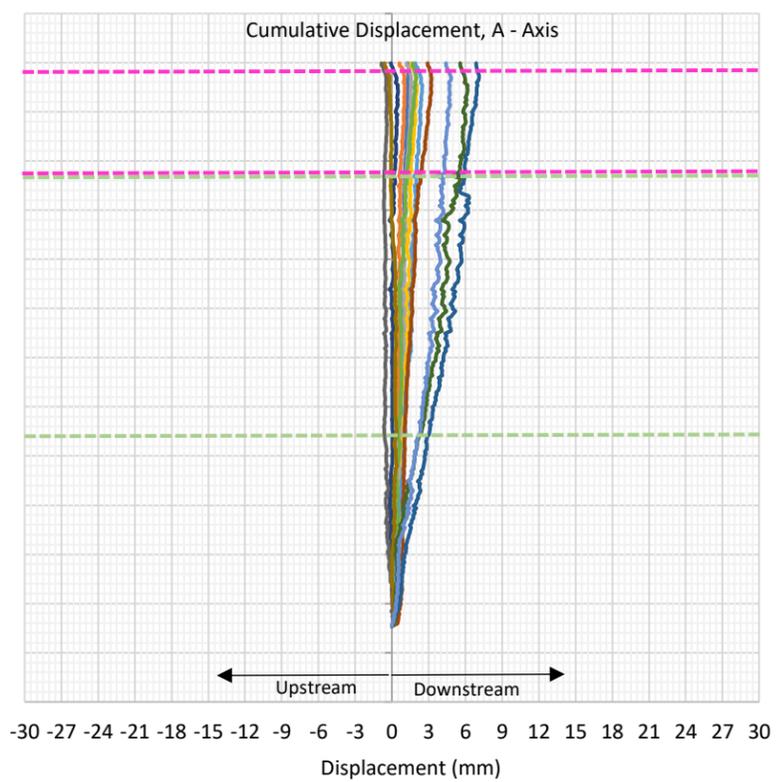
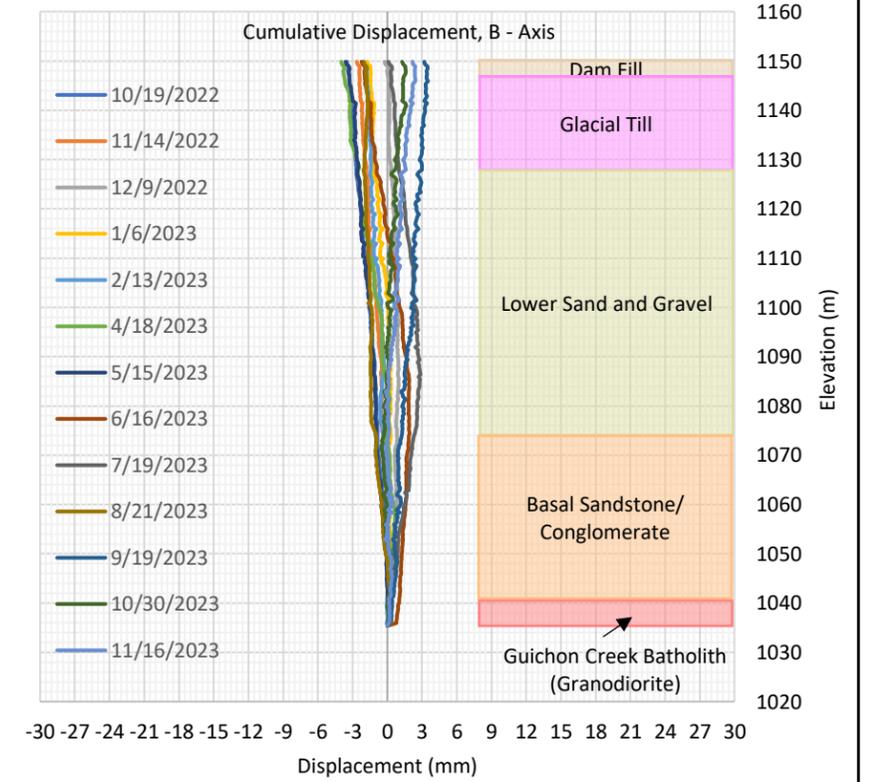
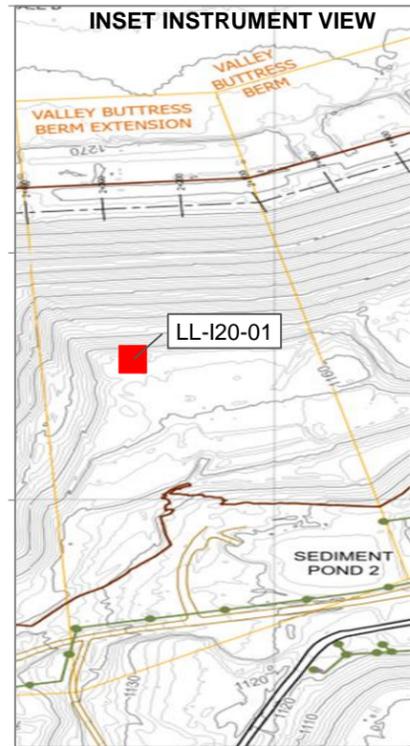
CLIENT Highland Valley / Teck Copper	PROJECT HIGHLAND TAILINGS STORAGE FACILITY 2023 ANNUAL FACILITY PERFORMANCE REPORT	
	TITLE LL DAM INCLINOMETER PLOTS LL-117-08 (VBBE) DEC. 2021 TO NOV. 2023	
SCALE NTS	PROJECT No. M02341C62	FIG. No. II-B-14

1. DATA PROCESSED AND PROVIDED BY HVC
2. LAST READING OF EACH MONTH PLOTTED ON THE INCREMENTAL AND CUMULATIVE PROFILES.
3. X-AXIS, Y-AXIS, AND LEGEND IS THE SAME FOR THE INCREMENTAL AND CUMULATIVE PROFILES.
4. DATA SHOWN ON THE PLOTS IS AFTER THE INSTRUMENT WAS BASELINED. HVC HAVE MONITORED THIS INSTRUMENT PRIOR TO THE BASELINE AND MET THE READING FREQUENCY.

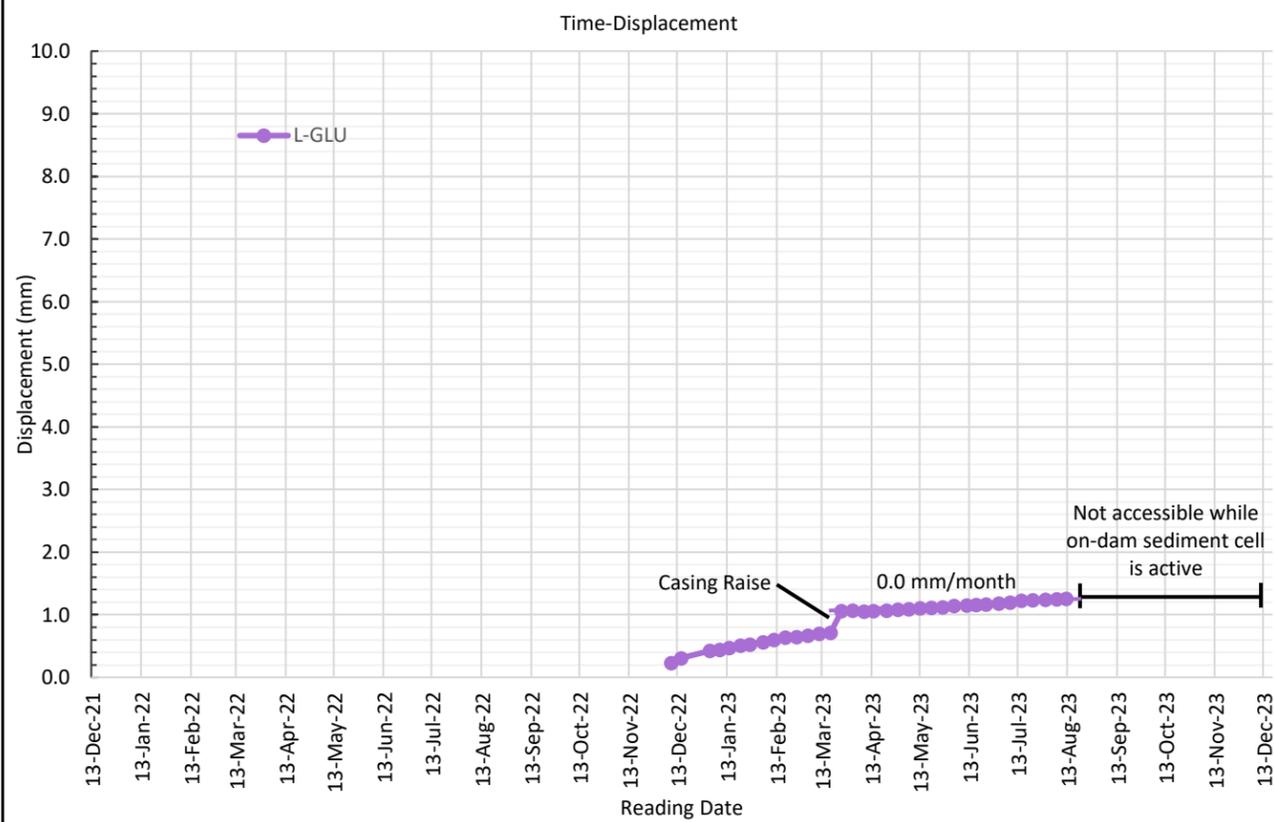
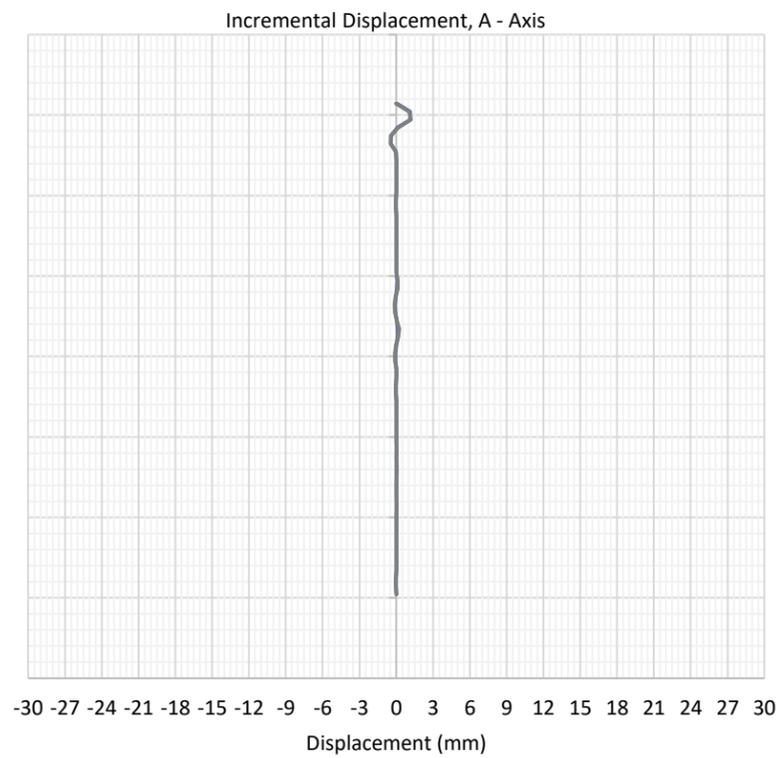
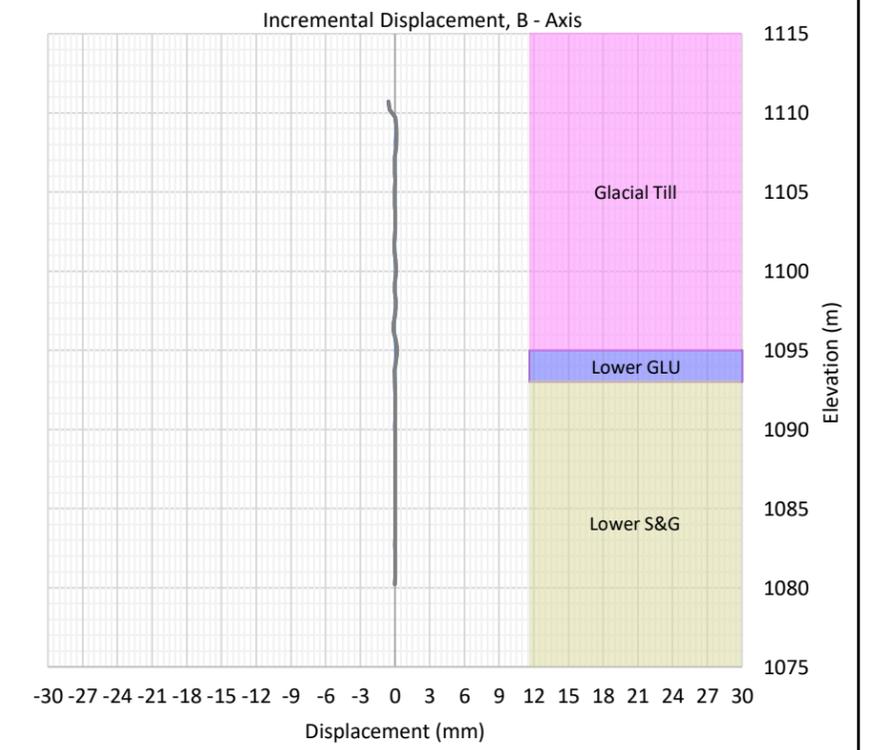
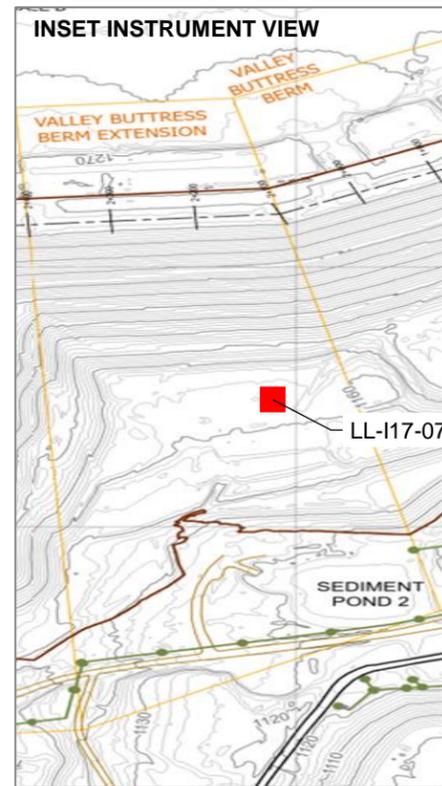
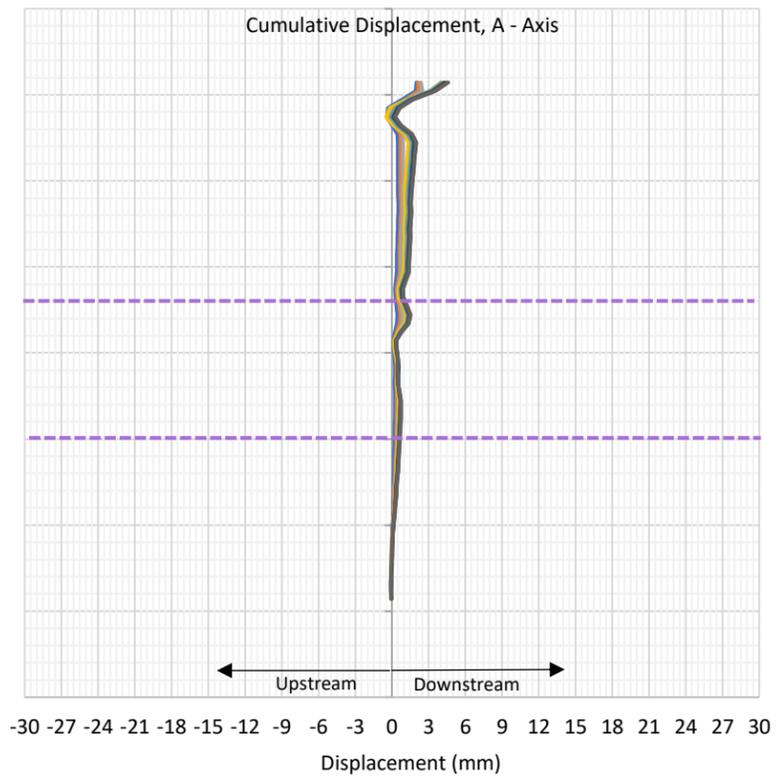
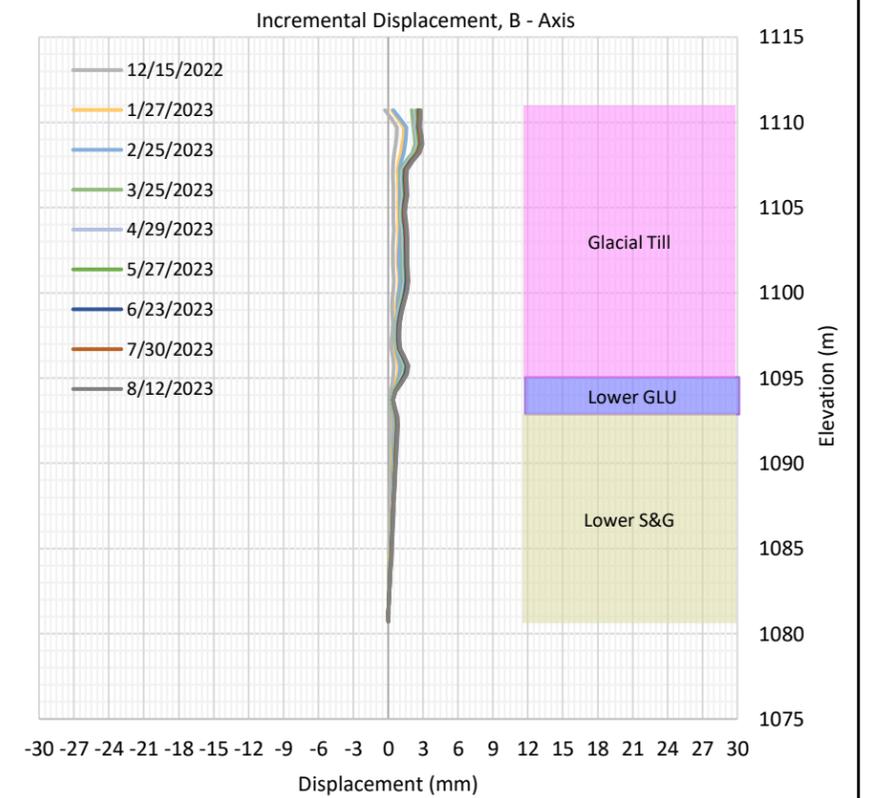
CLIENT Highland Valley Copper / Teck	PROJECT HIGHLAND TAILINGS STORAGE FACILITY 2023 ANNUAL FACILITY PERFORMANCE REPORT	
	TITLE LL DAM INCLINOMETER PLOTS LL-I20-01 (VBBE) DEC. 2021 TO NOV. 2023	
SCALE NTS	PROJECT No. M02341C62	FIG. No. II-B-15

1. DATA PROCESSED AND PROVIDED BY HVC
2. LAST READING OF EACH MONTH PLOTTED ON THE INCREMENTAL AND CUMULATIVE PROFILES.
3. X-AXIS, Y-AXIS, AND LEGEND IS THE SAME FOR THE INCREMENTAL AND CUMULATIVE PROFILES.
4. INCREMENTAL DISPLACEMENT PROFILES ARE BASED ON READINGS WITHIN ONE WEEK OF THE CUMULATIVE PROFILE
5. INSTRUMENT WAS CONVERTED TO SAAV.
6. HVC NOTE THAT THE INSTRUMENT WAS NOT ACCESSIBLE TOWARDS THE END OF 2023.

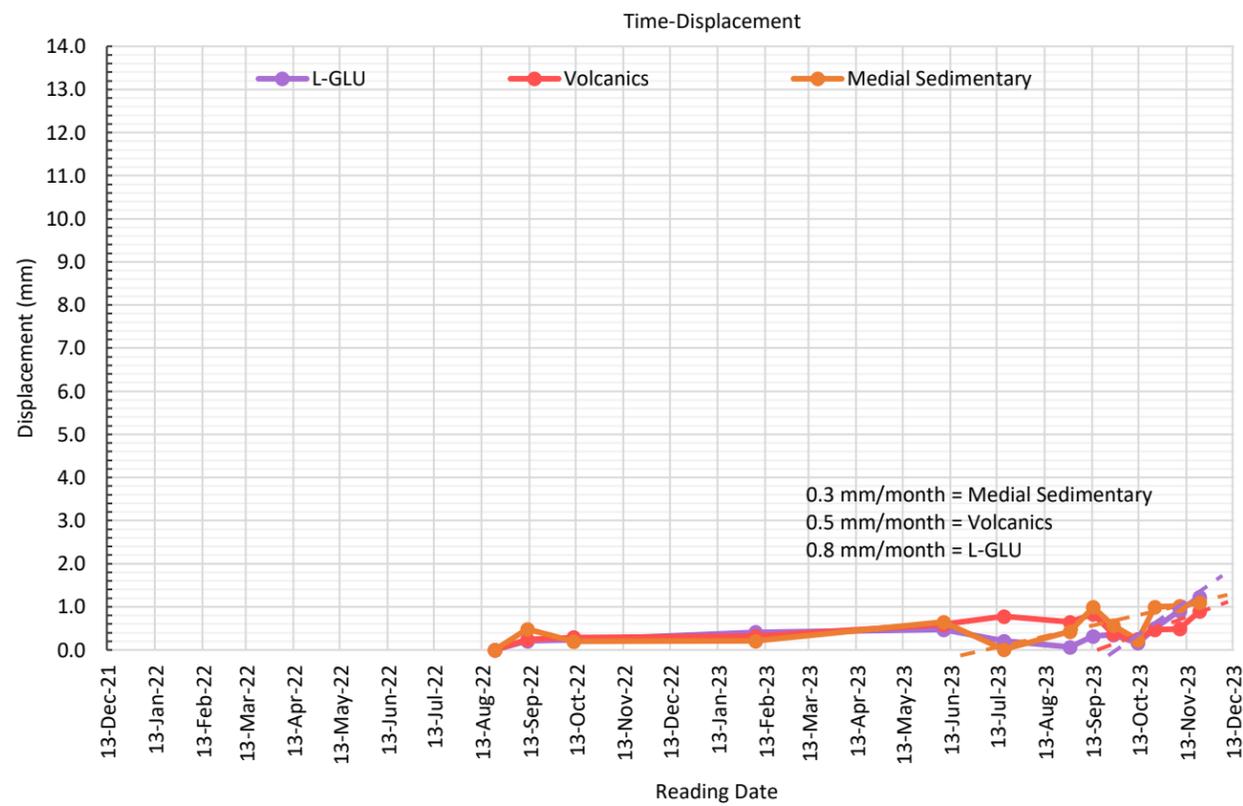
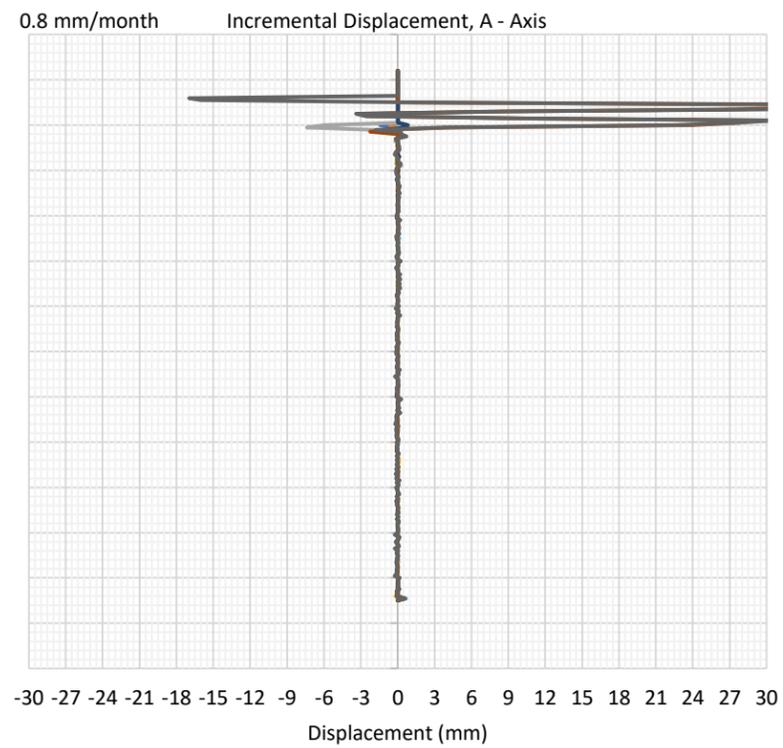
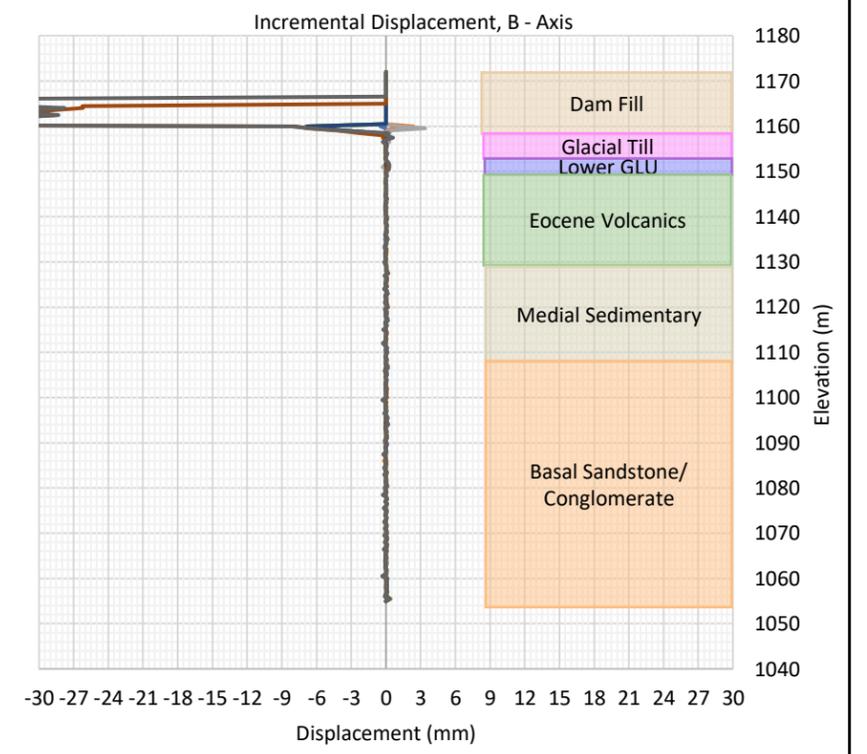
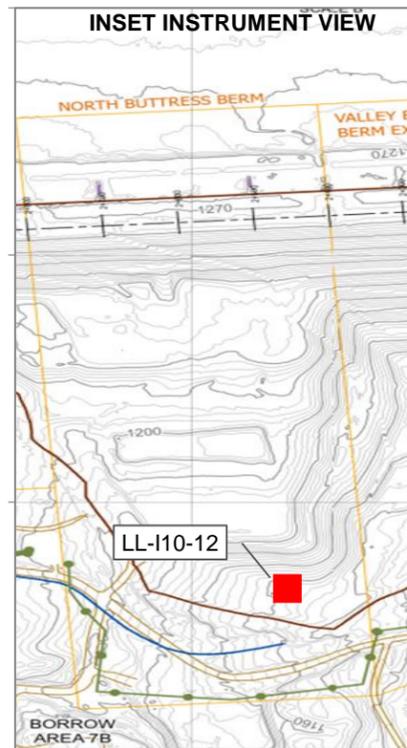
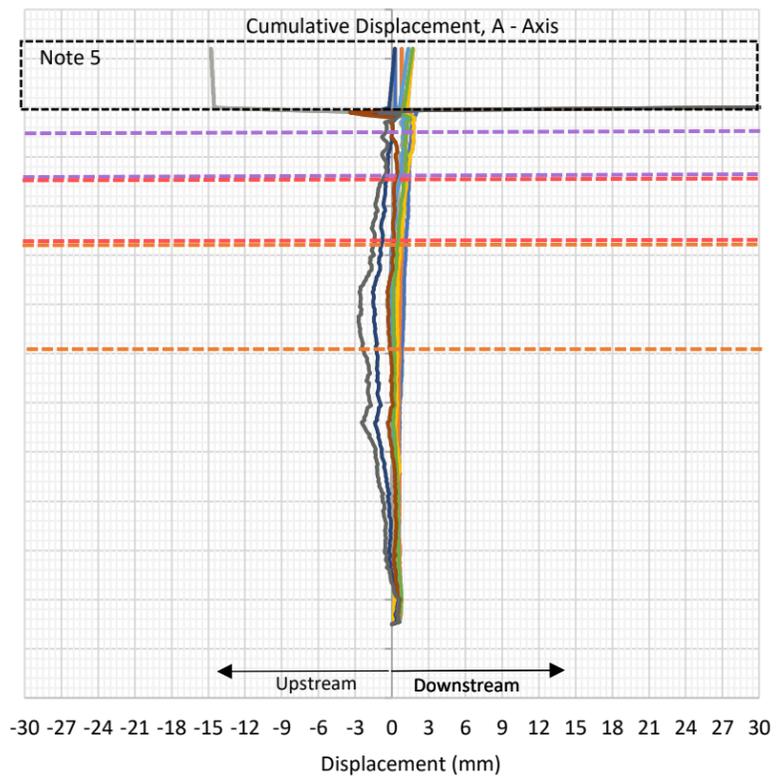
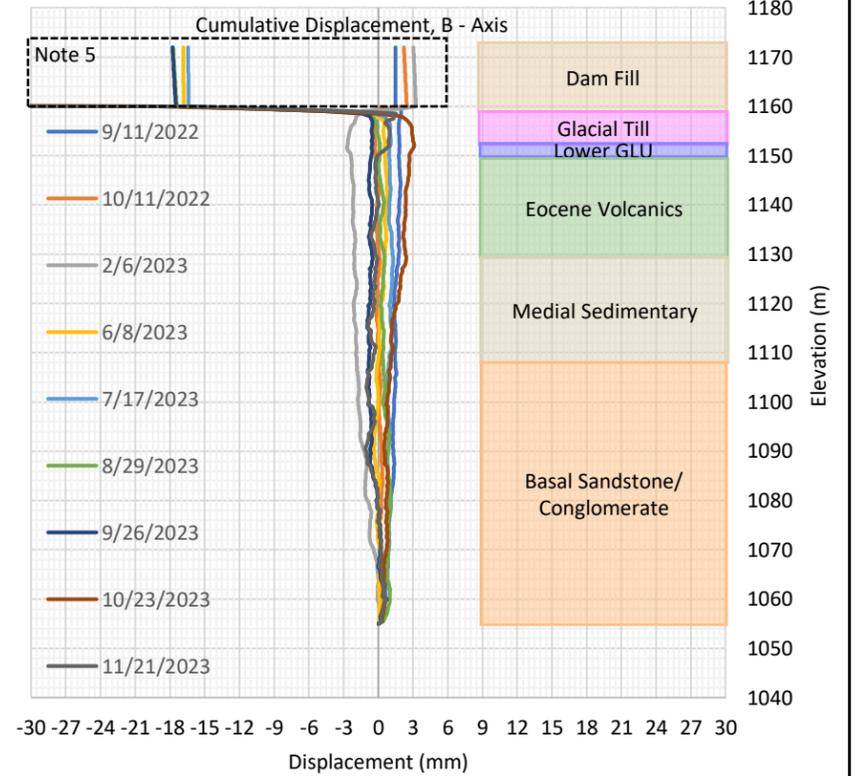
CLIENT Highland Valley Copper / Teck	PROJECT HIGHLAND TAILINGS STORAGE FACILITY 2023 ANNUAL FACILITY PERFORMANCE REPORT	
	TITLE LL DAM INCLINOMETER PLOTS LL-I19-08 (NBB) DEC. 2021 TO NOV. 2023	
SCALE NTS	PROJECT No. M02341C62	FIG. No. II-B-17

1. DATA PROCESSED AND PROVIDED BY HVC
2. LAST READING OF EACH MONTH PLOTTED ON THE INCREMENTAL AND CUMULATIVE PROFILES.
3. X-AXIS, Y-AXIS, AND LEGEND IS THE SAME FOR THE INCREMENTAL AND CUMULATIVE PROFILES.
4. A SPIRAL CORRECTION AND A SKEW ANGLE OF 4 DEGREES HAS BEEN APPLIED TO THIS INSTRUMENT.
5. READINGS ABOVE EL. 1160 m ARE NOT REFLECTIVE OF ACTUAL MOVEMENT AND SHOULD BE IGNORED.
