Teck Highland Valley Copper Partnership

2023 Annual Facility Performance Report

Highland Tailings Storage Facility

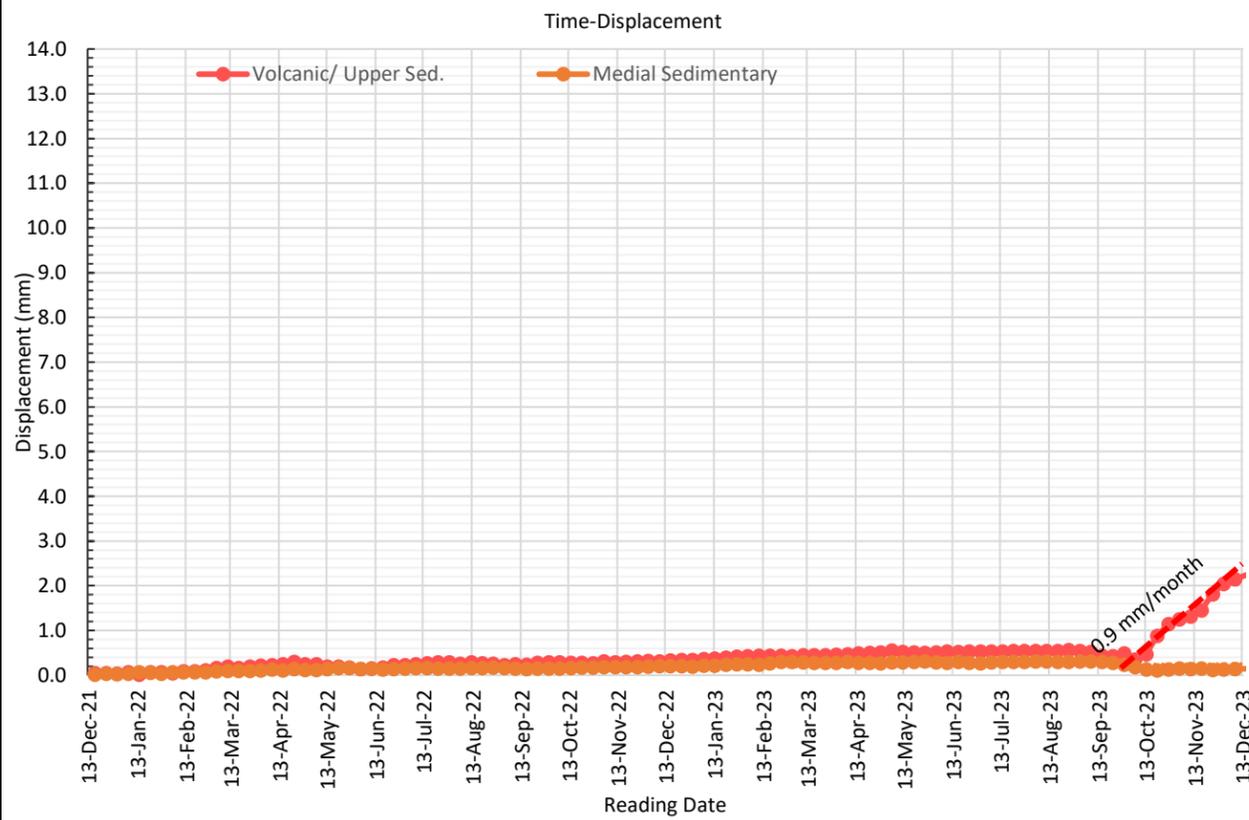
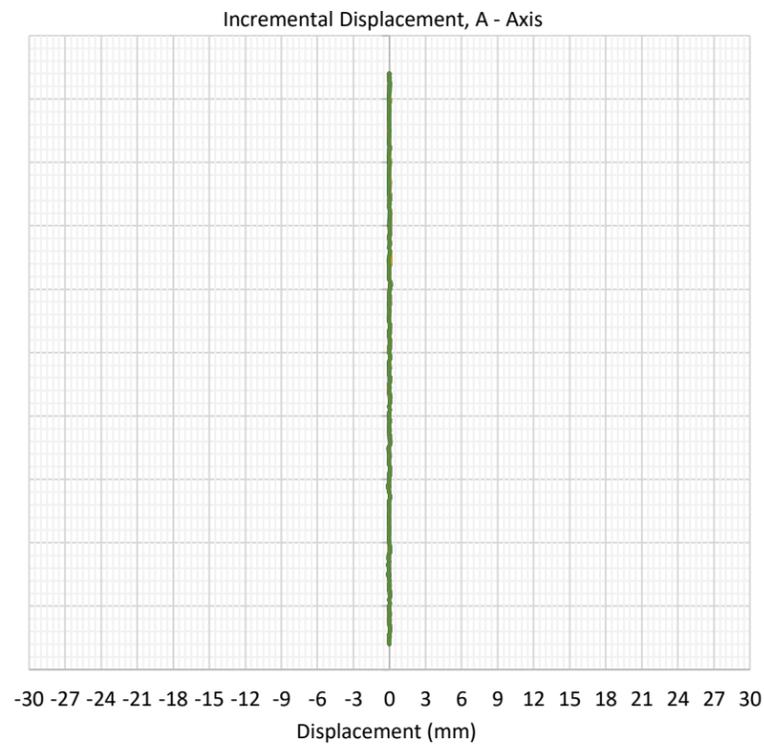
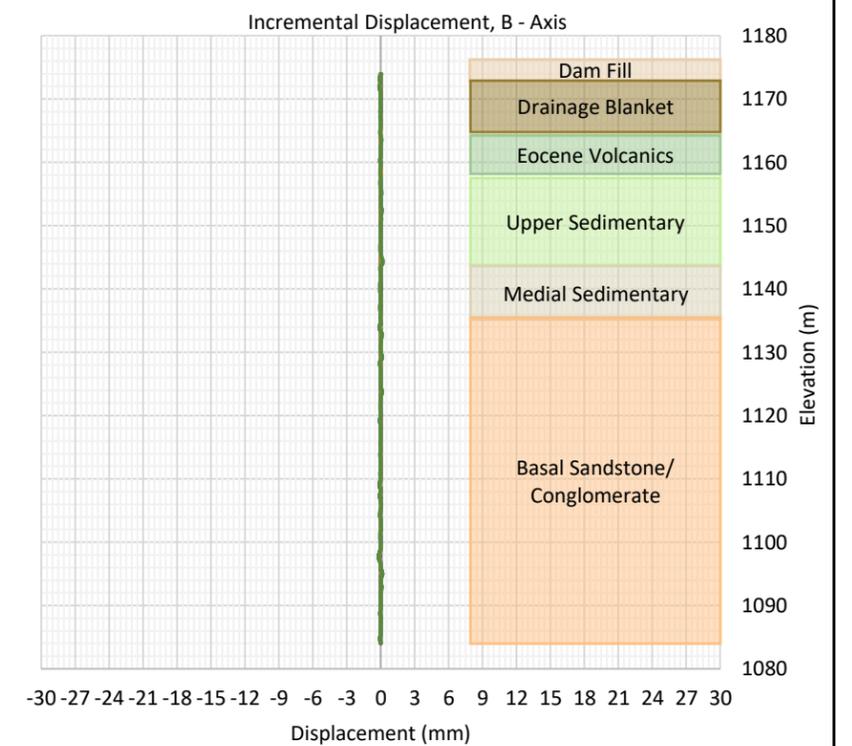
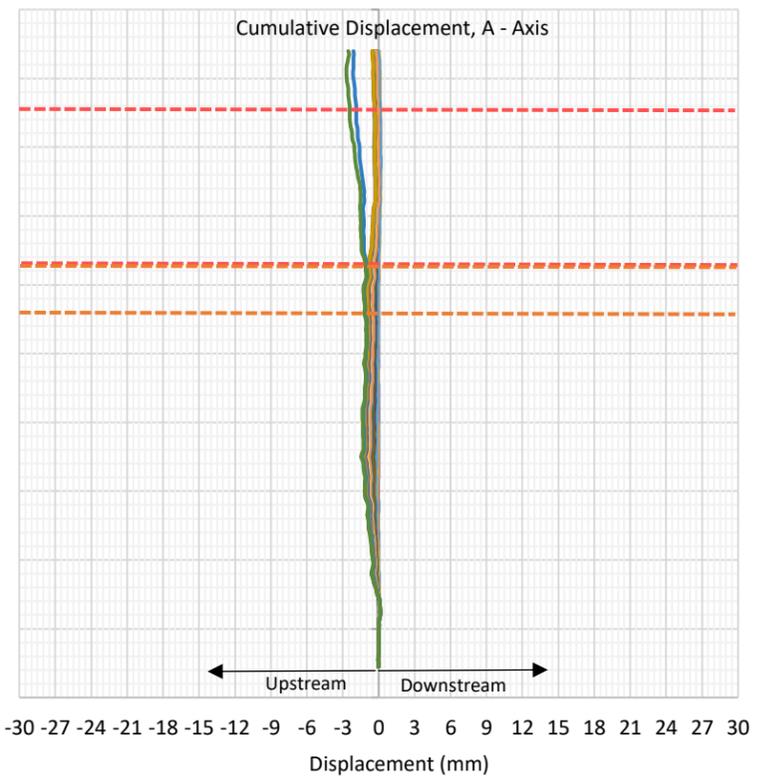
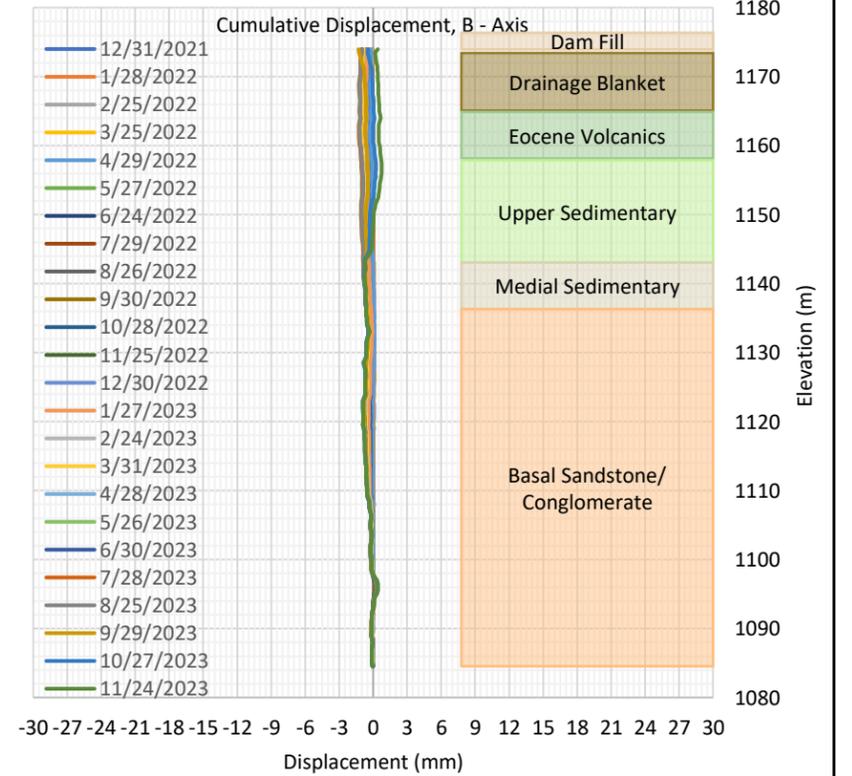
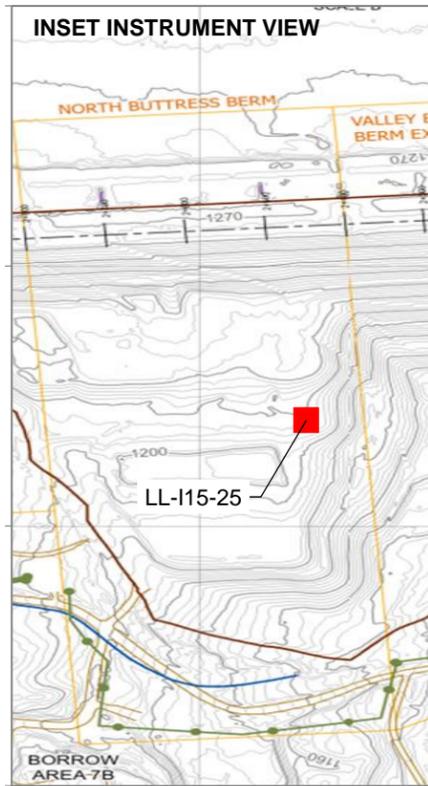
CLIENT Highland Valley Copper / Teck	PROJECT HIGHLAND TAILINGS STORAGE FACILITY 2023 ANNUAL FACILITY PERFORMANCE REPORT	
	TITLE LL DAM INCLINOMETER PLOTS LL-110-12 (NBB) DEC. 2021 TO NOV. 2023	
SCALE NTS	PROJECT No. M02341C62	FIG. No. II-B-18

1. DATA PROCESSED AND PROVIDED BY HVC
2. LAST READING OF EACH MONTH PLOTTED ON THE INCREMENTAL AND CUMULATIVE PROFILES.
3. X-AXIS, Y-AXIS, AND LEGEND IS THE SAME FOR THE INCREMENTAL AND CUMULATIVE PROFILES.
4. AN AZIMUTH CORRECTION OF 334 DEGREES HAS BEEN APPLIED TO THIS INSTRUMENT.

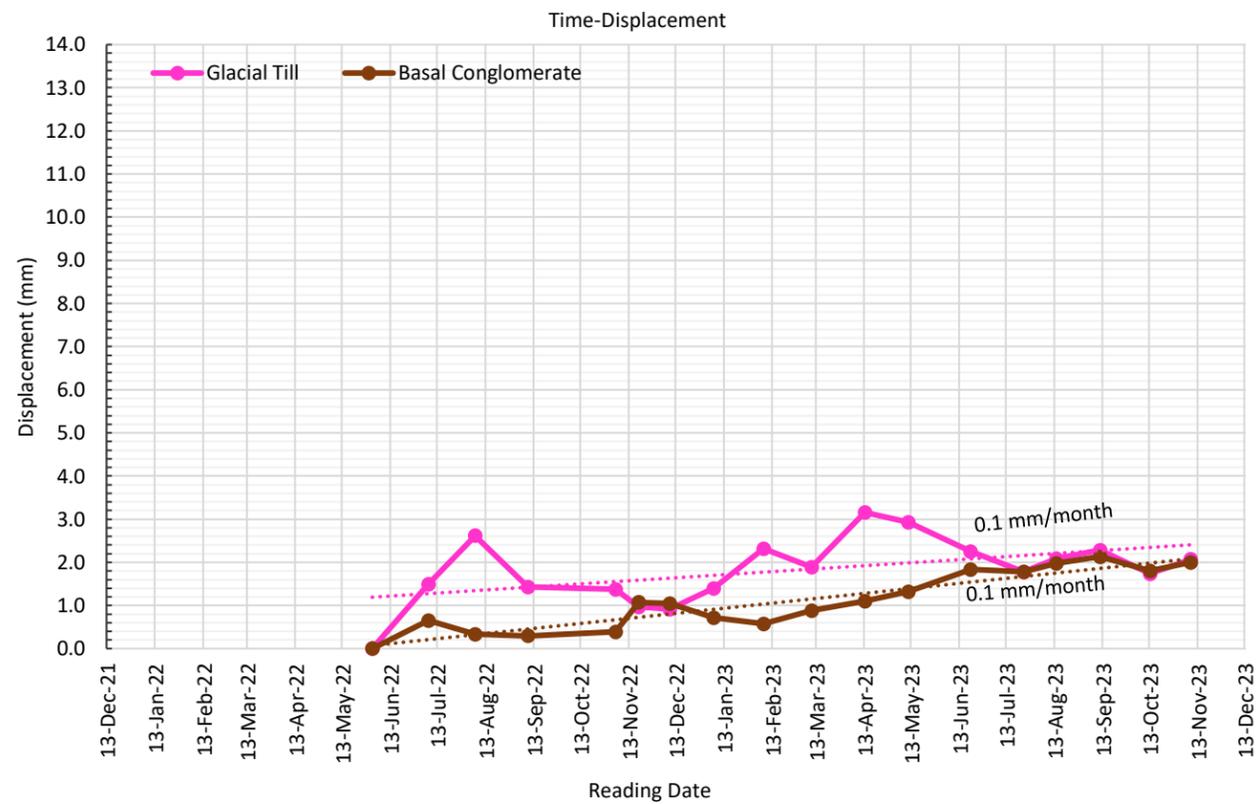
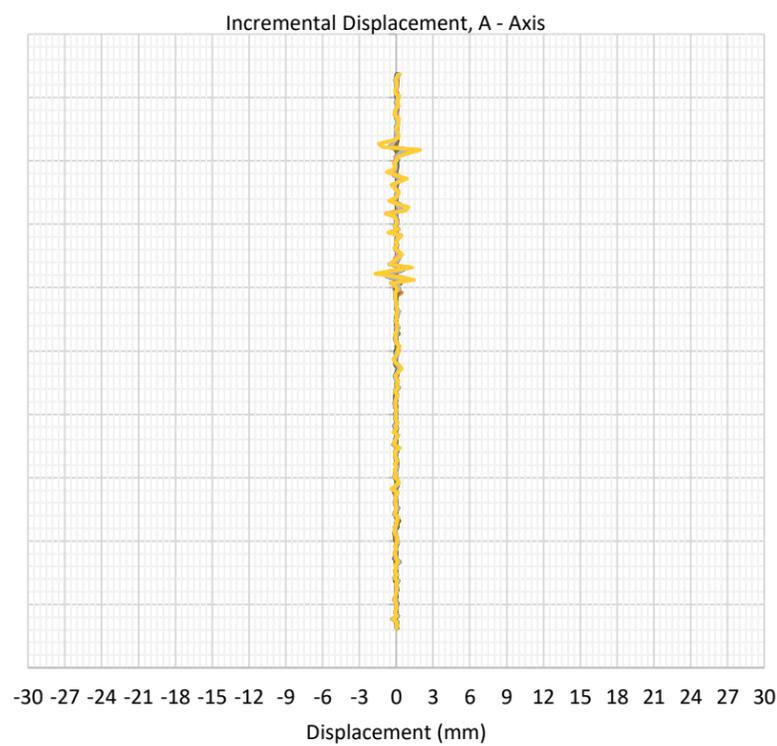
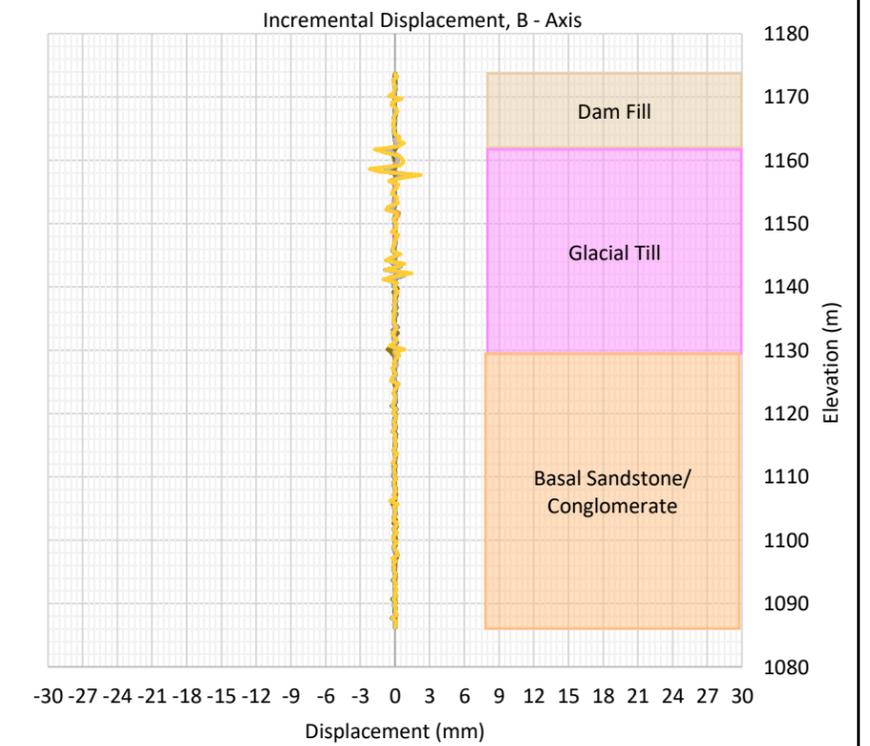
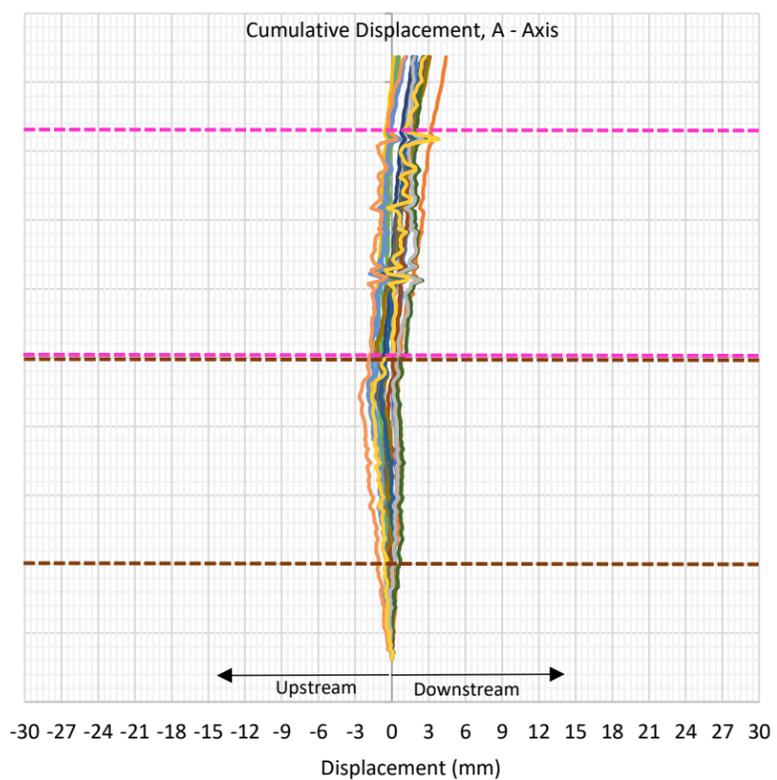
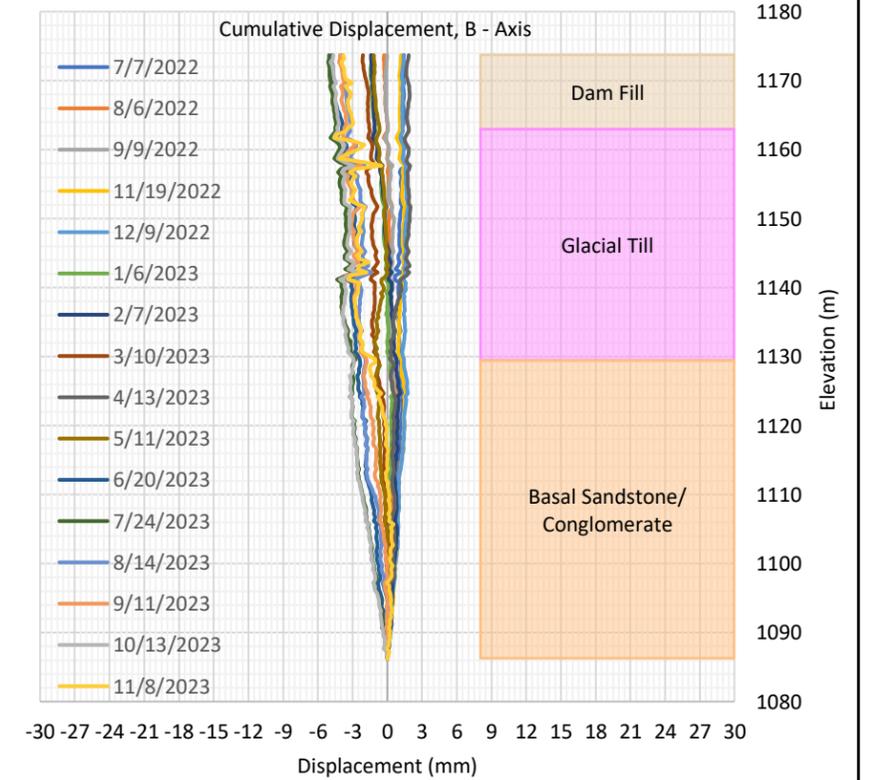
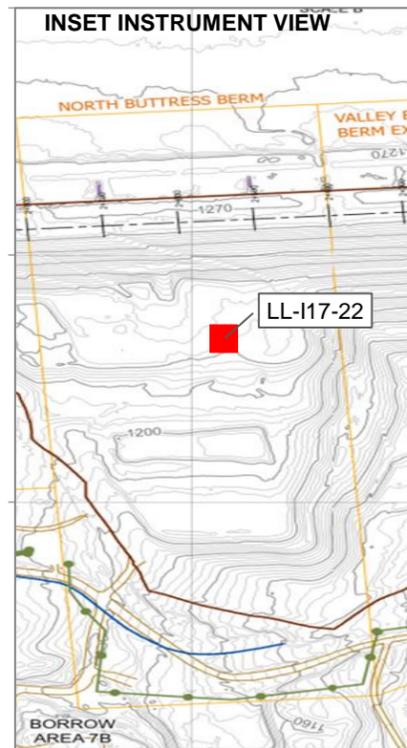
CLIENT Highland Valley Copper / Teck	PROJECT HIGHLAND TAILINGS STORAGE FACILITY 2023 ANNUAL FACILITY PERFORMANCE REPORT	
	TITLE LL DAM INCLINOMETER PLOTS LL-I15-25 (NBB) DEC. 2021 TO NOV. 2023	
SCALE NTS	PROJECT No. M02341C62	FIG. No. II-B-19

1. DATA PROCESSED AND PROVIDED BY HVC
2. LAST READING OF EACH MONTH PLOTTED ON THE INCREMENTAL AND CUMULATIVE PROFILES.
3. X-AXIS, Y-AXIS, AND LEGEND IS THE SAME FOR THE INCREMENTAL AND CUMULATIVE PROFILES.
4. DATA SHOWN ON THE PLOTS IS AFTER THE INSTRUMENT WAS BASELINED. HVC HAVE MONITORED THIS INSTRUMENT PRIOR TO THE BASELINE AND MET THE READING FREQUENCY.
5. A SPIRAL CORRECTION AND A SKEW ANGLE OF 348 DEGREES HAS BEEN APPLIED TO THIS INSTRUMENT.

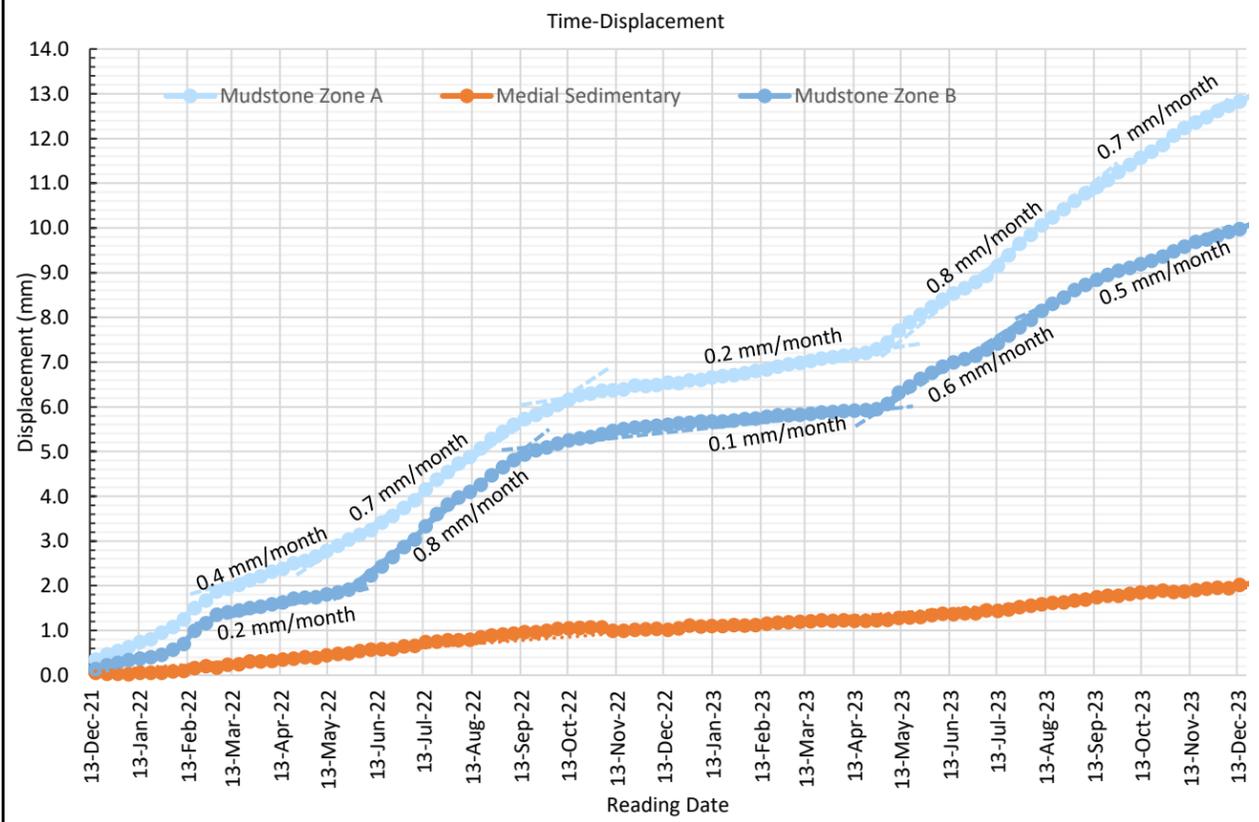
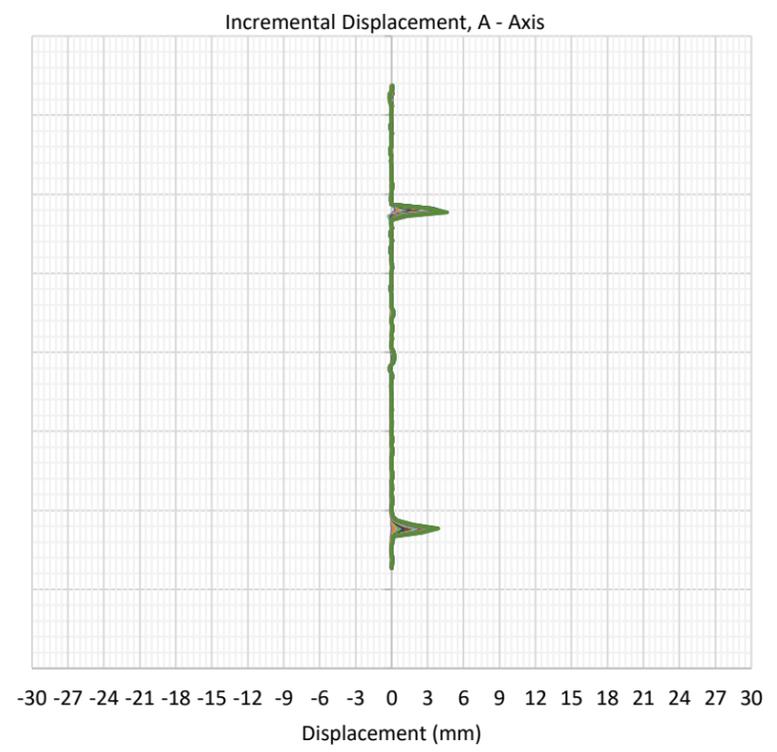
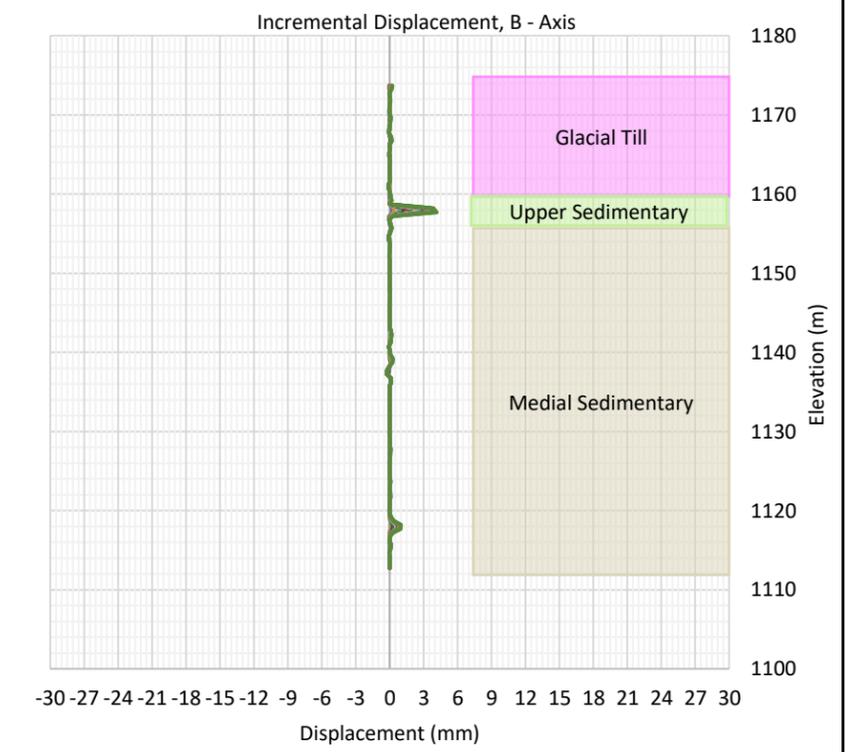
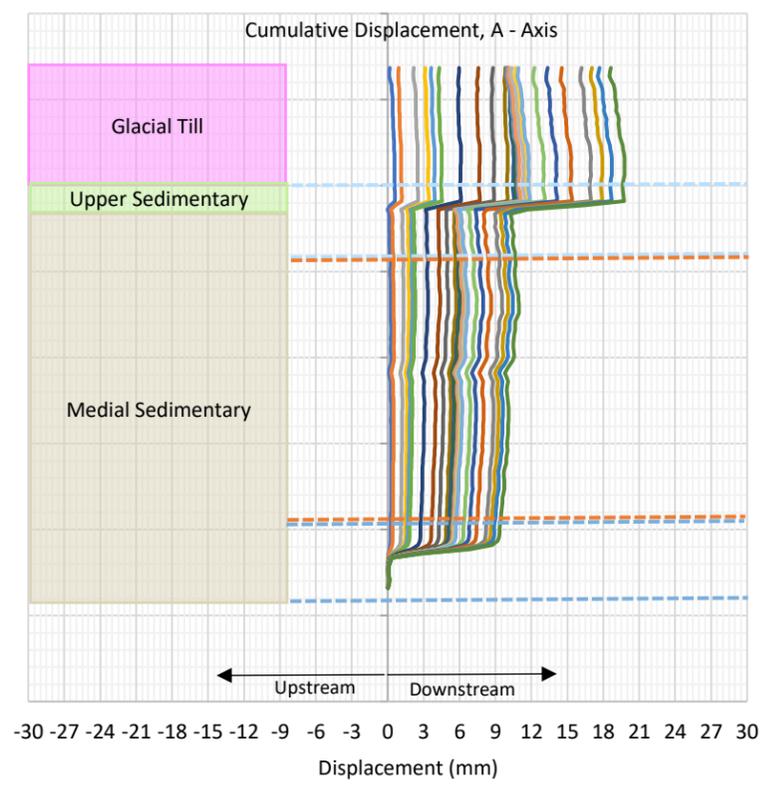
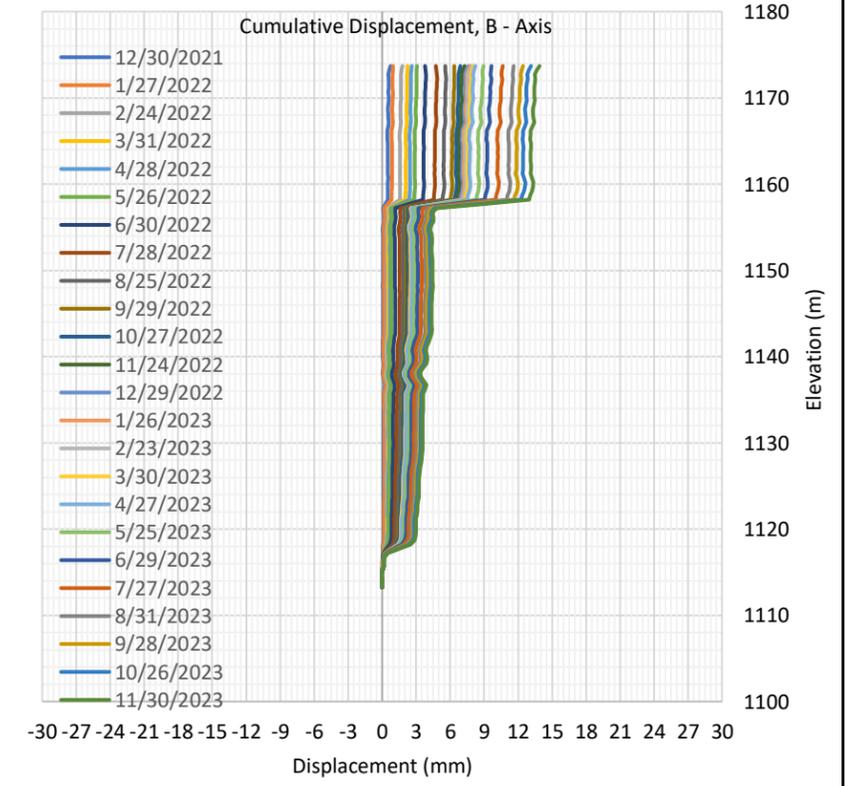
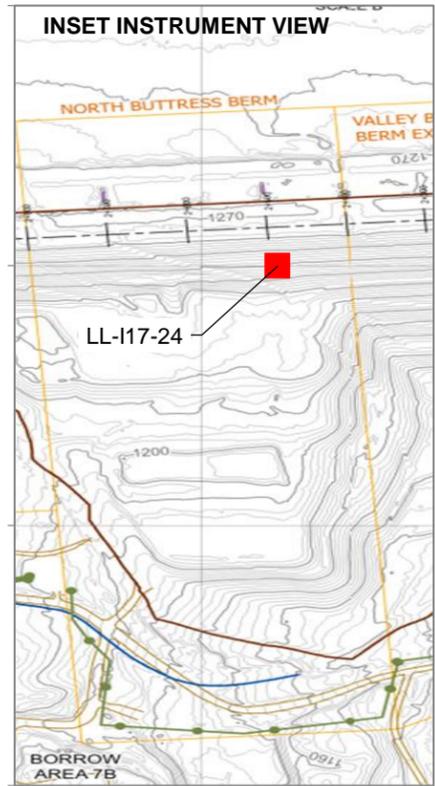
CLIENT Highland Valley Copper / Teck	PROJECT HIGHLAND TAILINGS STORAGE FACILITY 2023 ANNUAL FACILITY PERFORMANCE REPORT	
	TITLE LL DAM INCLINOMETER PLOTS LL-117-22 (NBB) DEC. 2021 TO NOV. 2023	
SCALE NTS	PROJECT No. M02341C62	FIG. No. II-B-20

- NOTES**
1. DATA PROCESSED AND PROVIDED BY HVC
 2. LAST READING OF EACH MONTH PLOTTED ON THE INCREMENTAL AND CUMULATIVE PROFILES.
 3. X-AXIS, Y-AXIS, AND LEGEND IS THE SAME FOR THE INCREMENTAL AND CUMULATIVE PROFILES.
 4. AN AZIMUTH CORRECTION OF 357 DEGREES HAS BEEN APPLIED TO THIS INSTRUMENT.

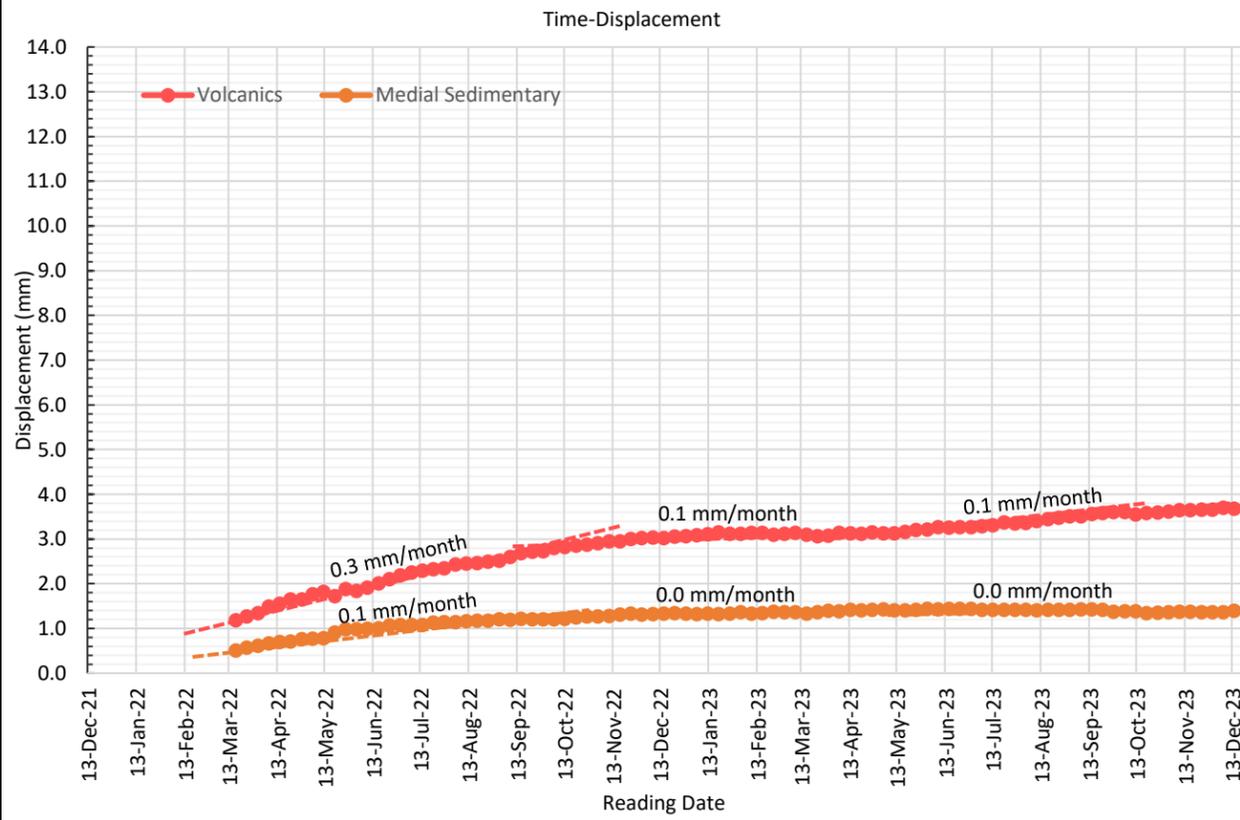
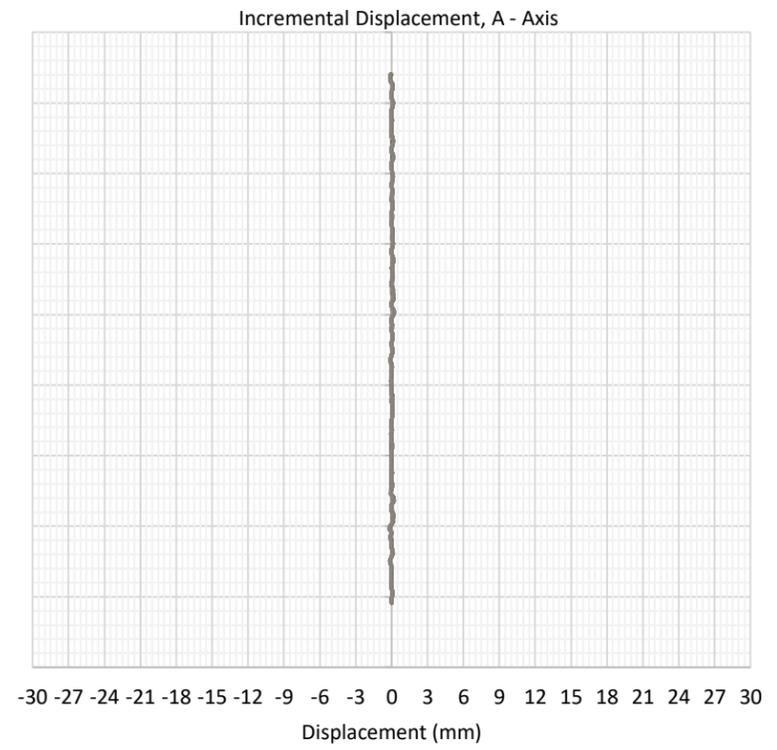
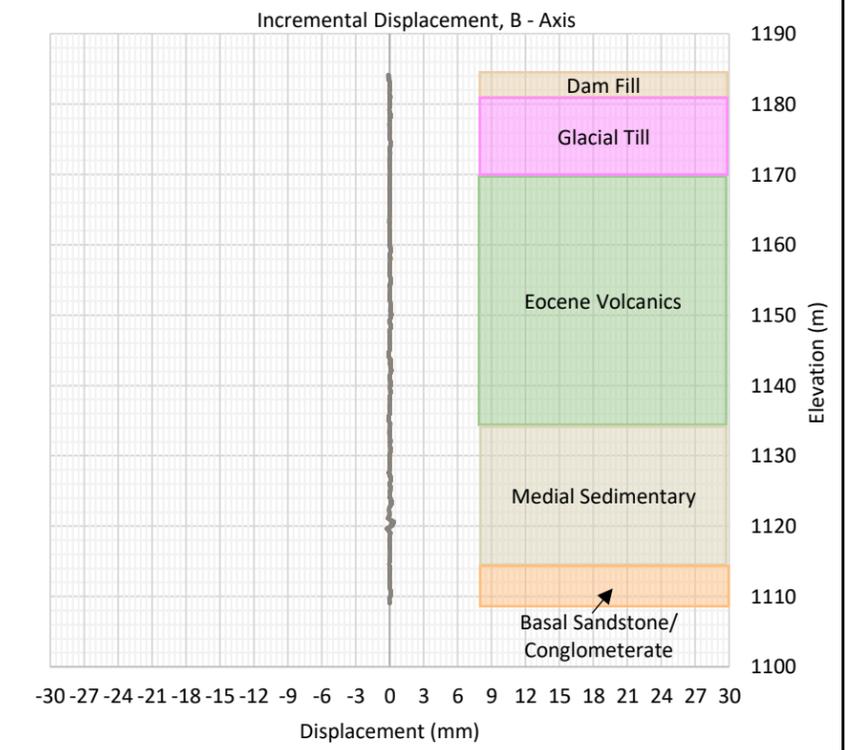
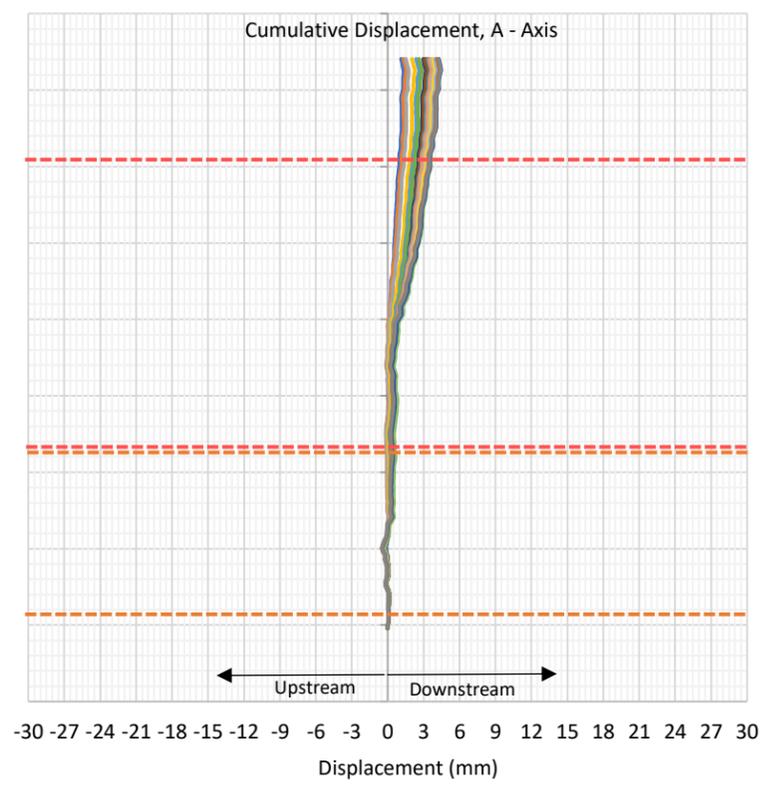
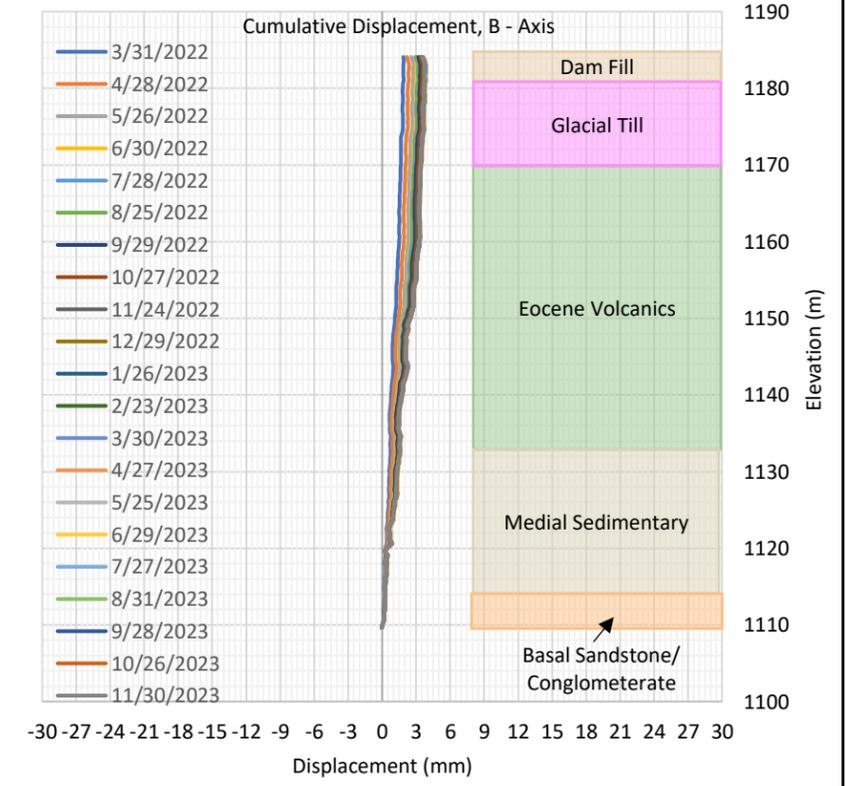
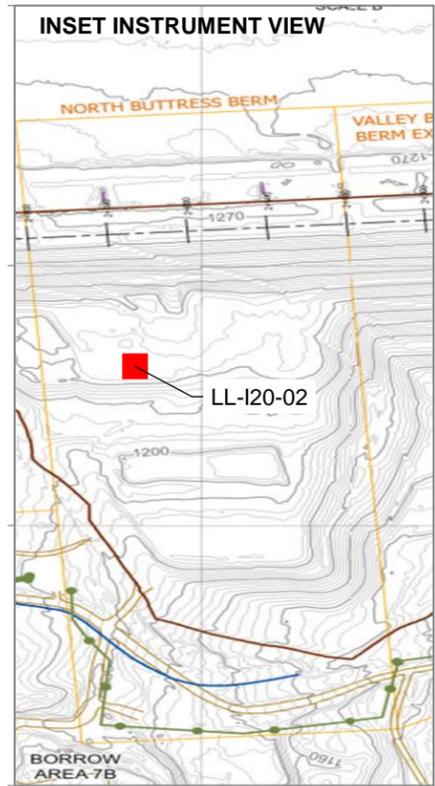
CLIENT Highland Valley Copper / Teck	PROJECT HIGHLAND TAILINGS STORAGE FACILITY 2023 ANNUAL FACILITY PERFORMANCE REPORT	
	TITLE LL DAM INCLINOMETER PLOTS LL-I17-24 (NBB) DEC. 2021 TO NOV. 2023	
SCALE NTS	PROJECT No. M02341C62	FIG. No. II-B-21

1. DATA PROCESSED AND PROVIDED BY HVC
2. LAST READING OF EACH MONTH PLOTTED ON THE INCREMENTAL AND CUMULATIVE PROFILES.
3. X-AXIS, Y-AXIS, AND LEGEND IS THE SAME FOR THE INCREMENTAL AND CUMULATIVE PROFILES.
4. AN AZIMUTH CORRECTION OF 16 DEGREES HAS BEEN APPLIED TO THIS INSTRUMENT.

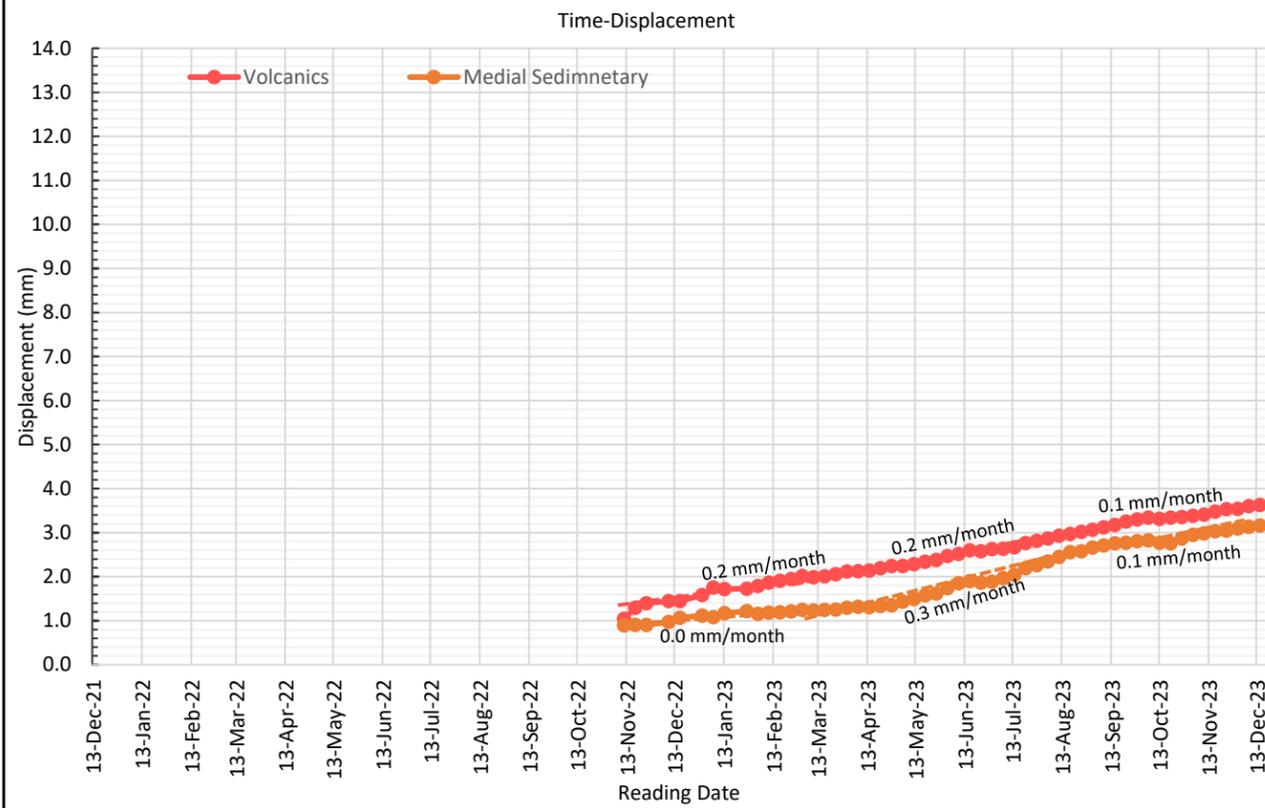
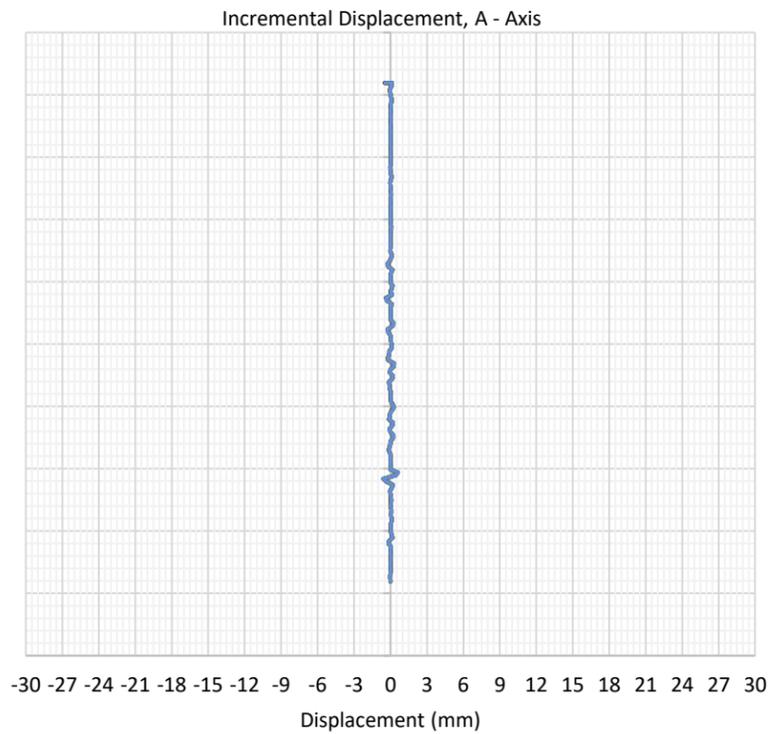
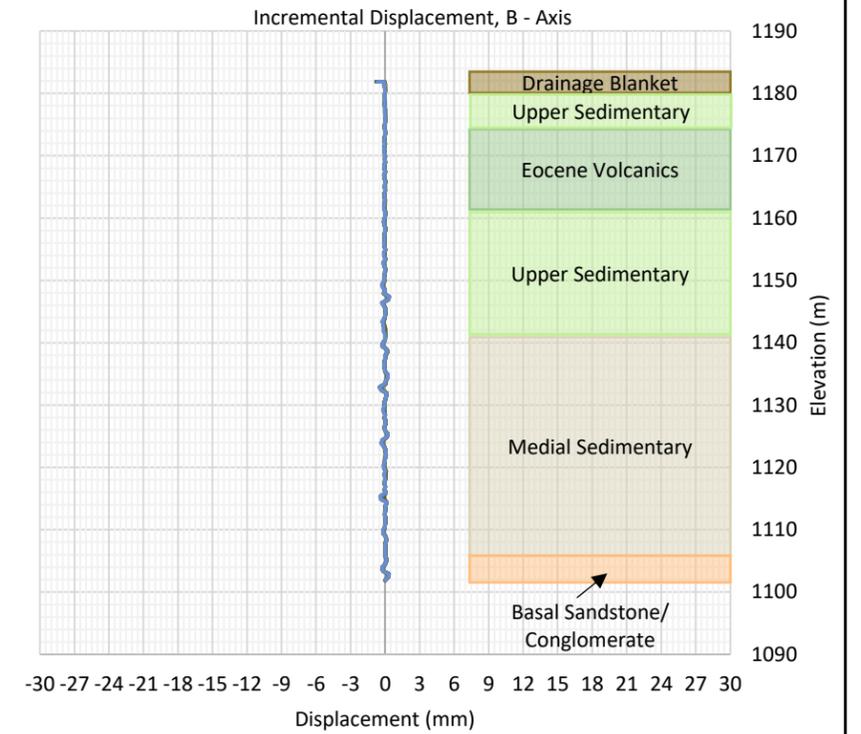
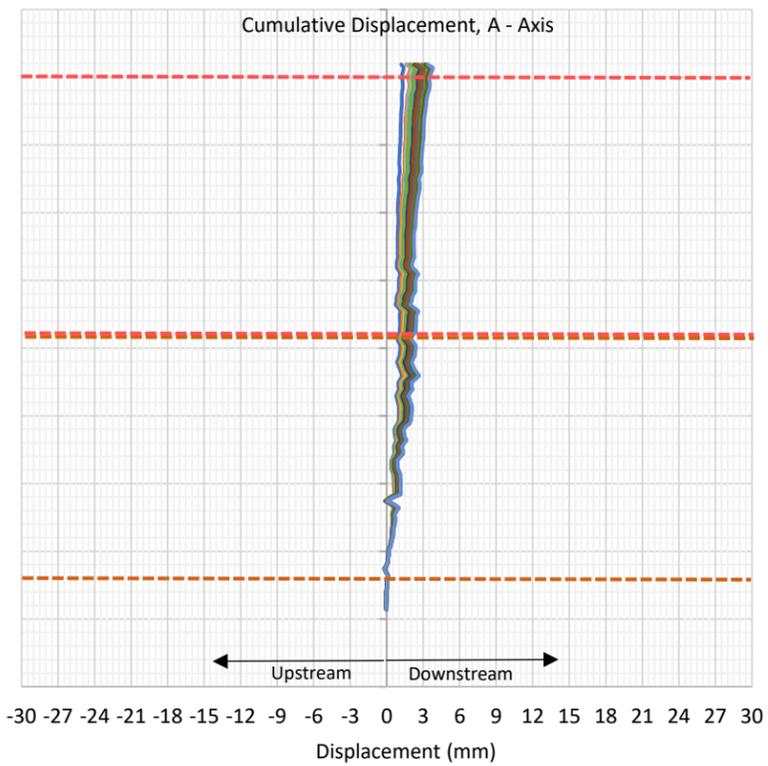
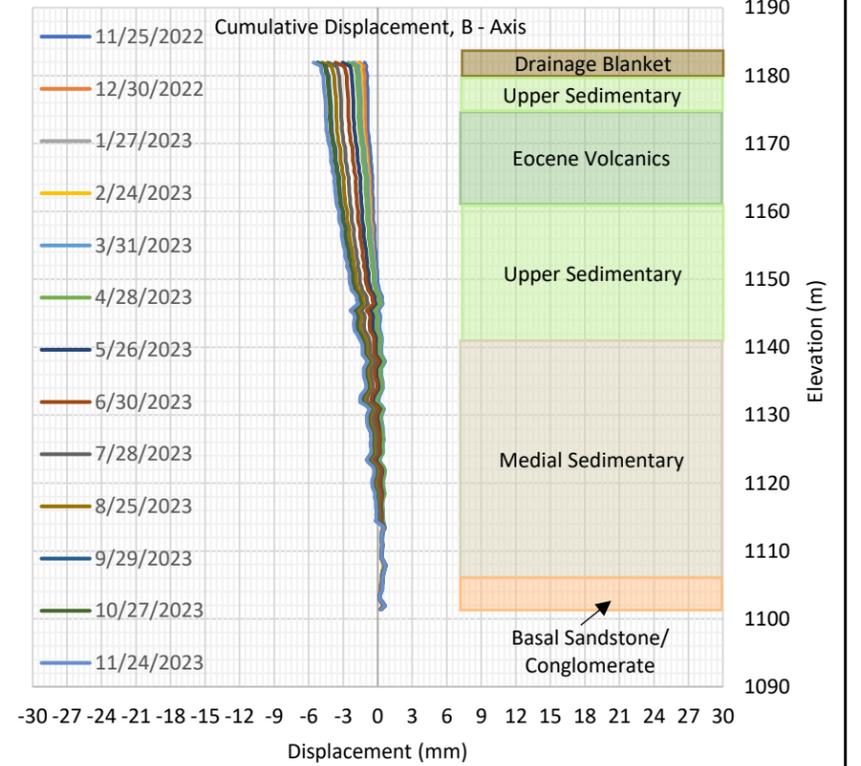
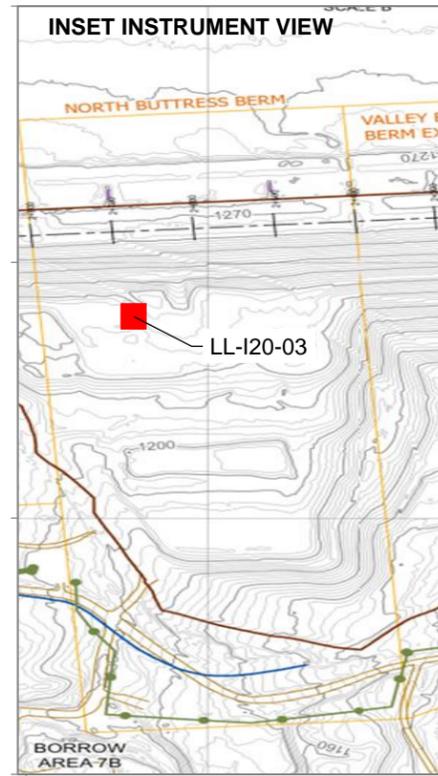
CLIENT Highland Valley Copper / Teck	PROJECT HIGHLAND TAILINGS STORAGE FACILITY 2023 ANNUAL FACILITY PERFORMANCE REPORT	
	TITLE LL DAM INCLINOMETER PLOTS LL-120-02 (NBB) DEC. 2021 TO NOV. 2023	
SCALE NTS	PROJECT No. M02341C62	FIG. No. II-B-22

1. DATA PROCESSED AND PROVIDED BY HVC
2. LAST READING OF EACH MONTH PLOTTED ON THE INCREMENTAL AND CUMULATIVE PROFILES.
3. X-AXIS, Y-AXIS, AND LEGEND IS THE SAME FOR THE INCREMENTAL AND CUMULATIVE PROFILES.
4. AN AZIMUTH CORRECTION OF 39 DEGREES HAS BEEN APPLIED TO THIS INSTRUMENT.
