Teck Highland Valley Copper Partnership

2023 Annual Facility Performance Report

Highland Tailings Storage Facility

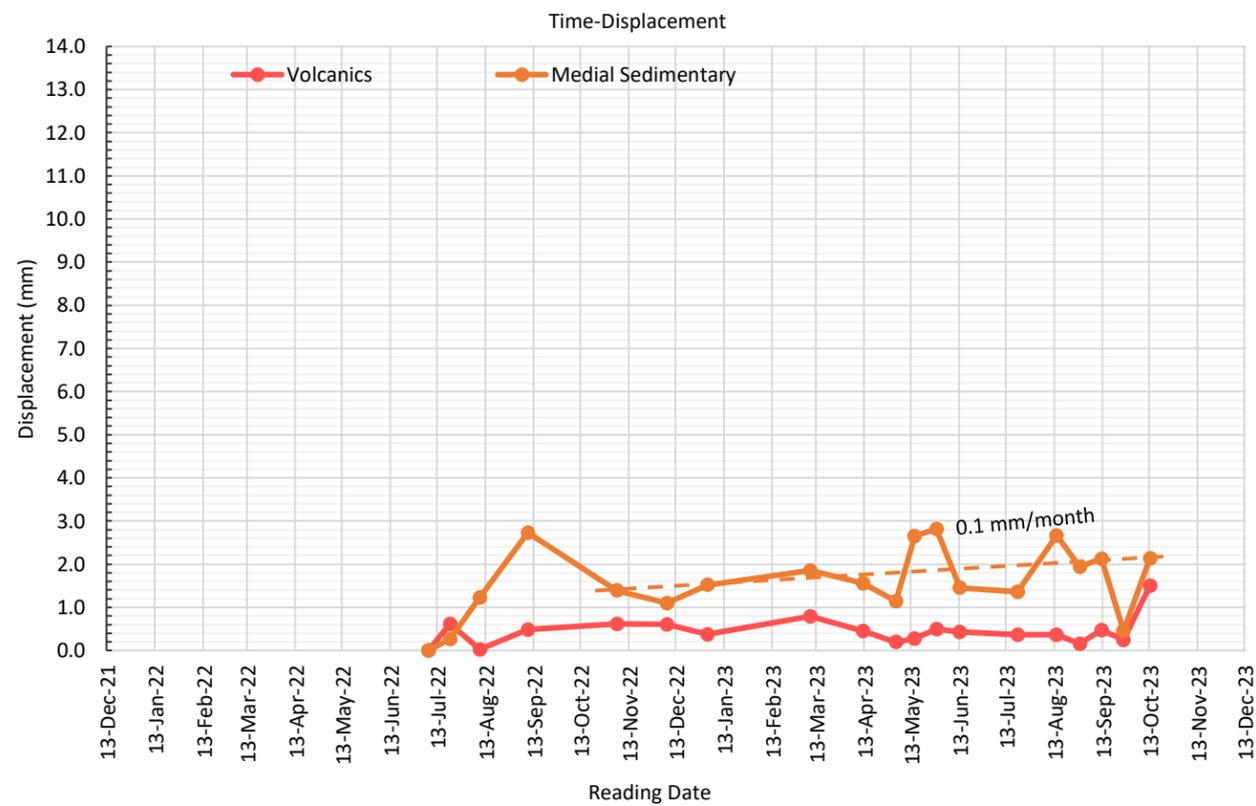
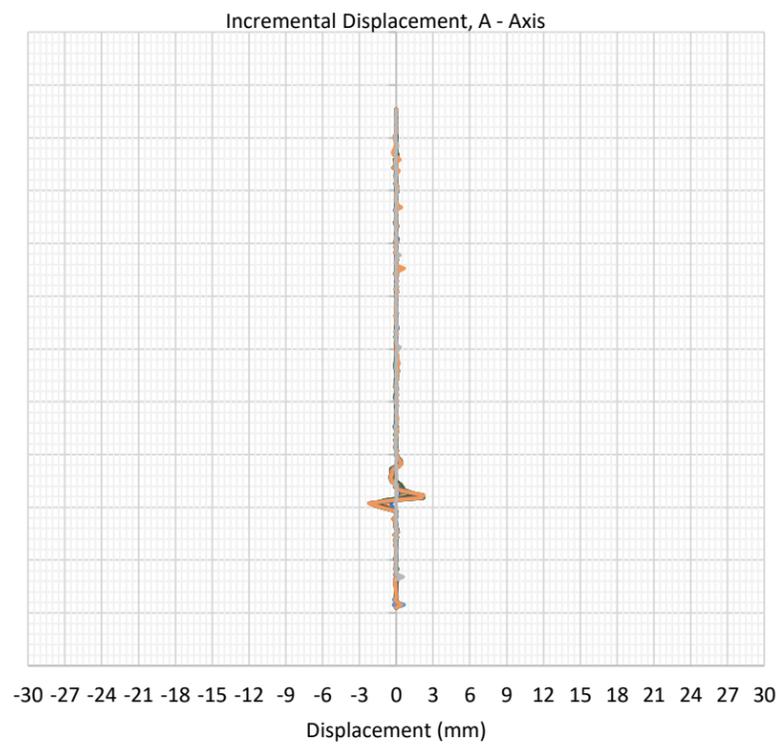
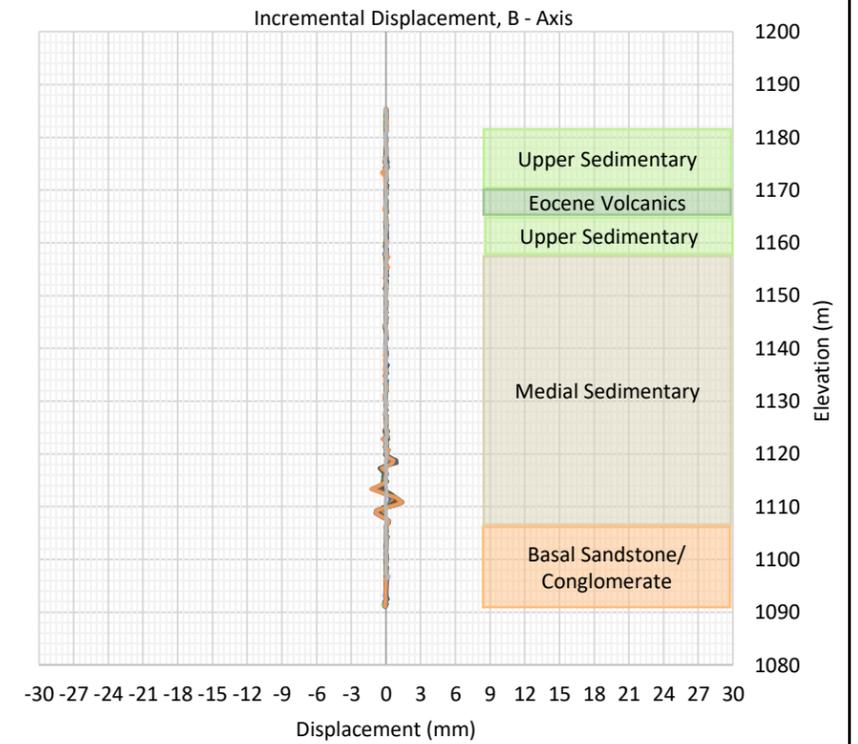
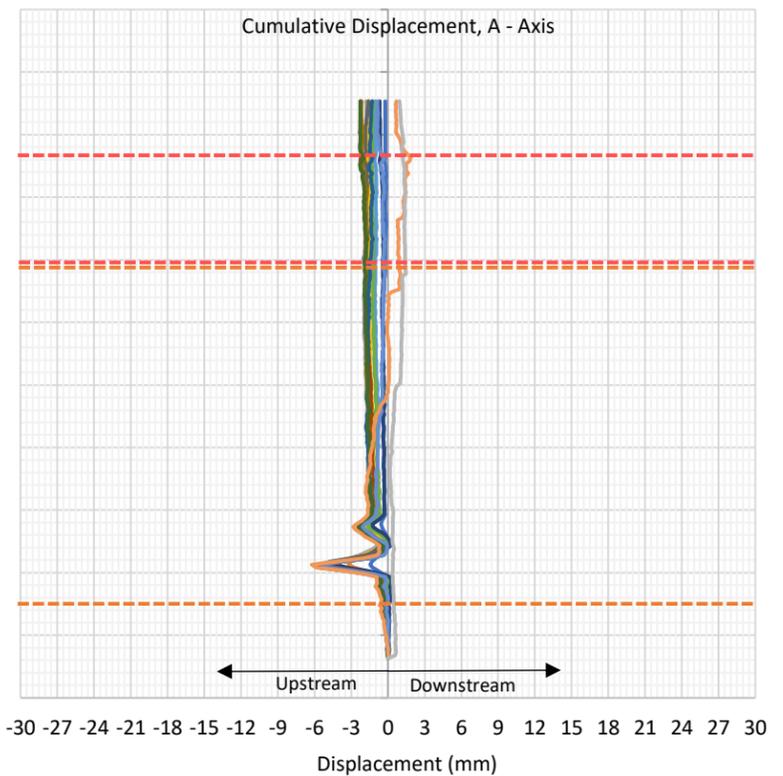
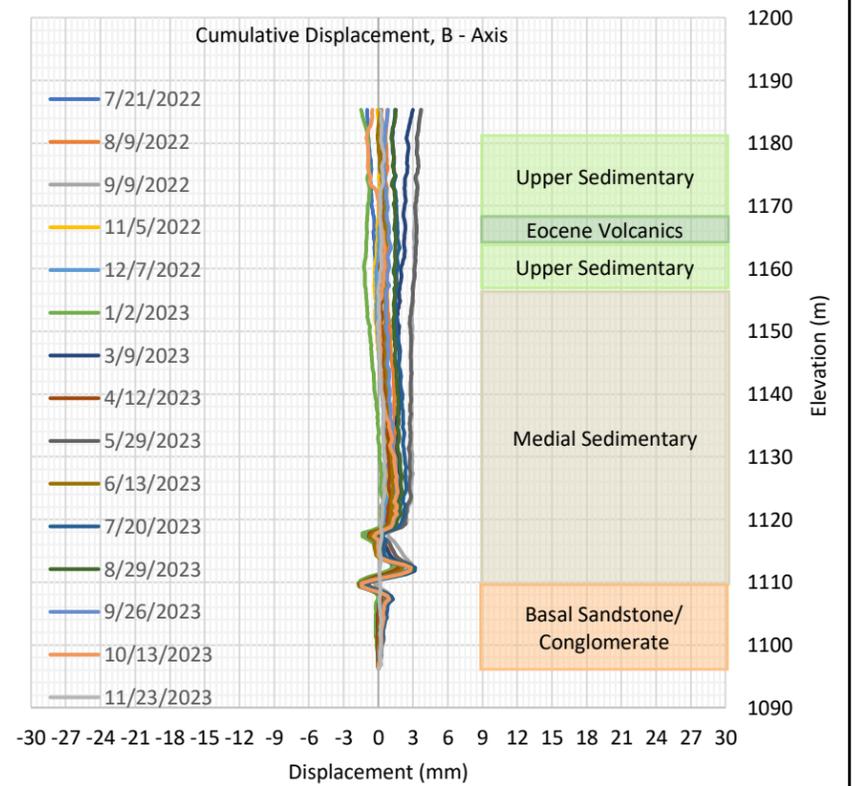
CLIENT Highland Valley Copper / Teck	PROJECT HIGHLAND TAILINGS STORAGE FACILITY 2023 ANNUAL FACILITY PERFORMANCE REPORT	
	TITLE LL DAM INCLINOMETER PLOTS LL-I20-03 (NBB) DEC. 2021 TO NOV. 2023	
	SCALE NTS	PROJECT No. M02341C62
	FIG. No. II-B-23

1. DATA PROCESSED AND PROVIDED BY HVC
2. LAST READING OF EACH MONTH PLOTTED ON THE INCREMENTAL AND CUMULATIVE PROFILES.
3. X-AXIS, Y-AXIS, AND LEGEND IS THE SAME FOR THE INCREMENTAL AND CUMULATIVE PROFILES.
4. A SPIRAL CORRECTION AND A SKEW ANGLE OF 352 DEGREES HAS BEEN APPLIED TO THIS INSTRUMENT.
5. THE INSTRUMENT CASING HAD TO BE CUT AFTER A RAISE IN OCTOBER WHICH REQUIRED THE INSTRUMENT TO BE REBASELINED AFTER. FOR THIS REASON, THE NOVEMBER 23, 2023 READING IS BASED ON A DIFFERENT BASELINE COMPARED TO OTHER READINGS. HOWEVER THE READING IS PLOTTED ON THE PROFILE PLOTS TO SUPPORT INTERPRETATION OF POTENTIAL MOVEMENT ZONES THAT APPEARED IN THE OCTOBER 13, 2023 READING.

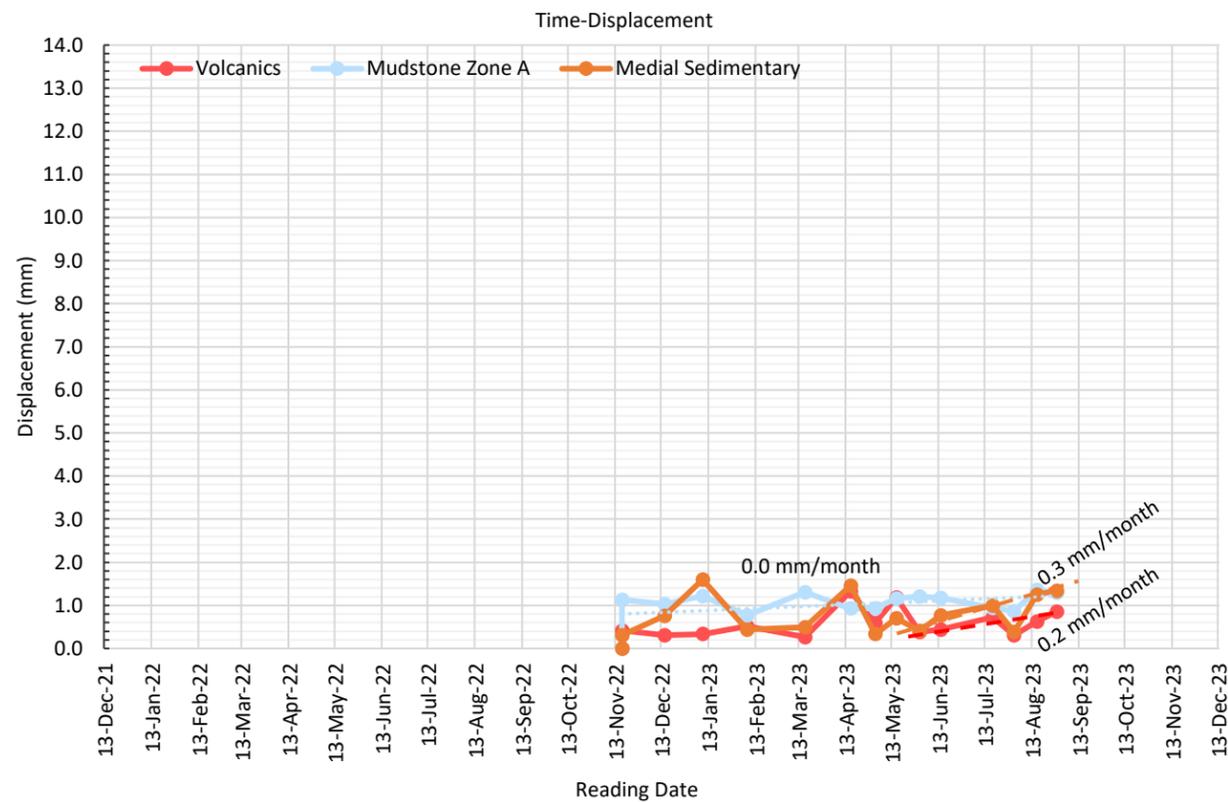
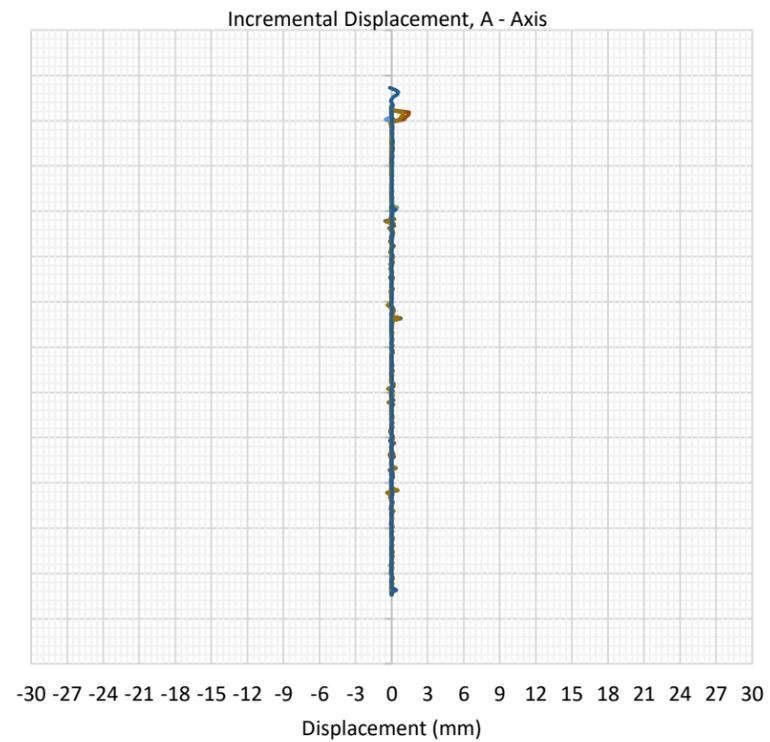
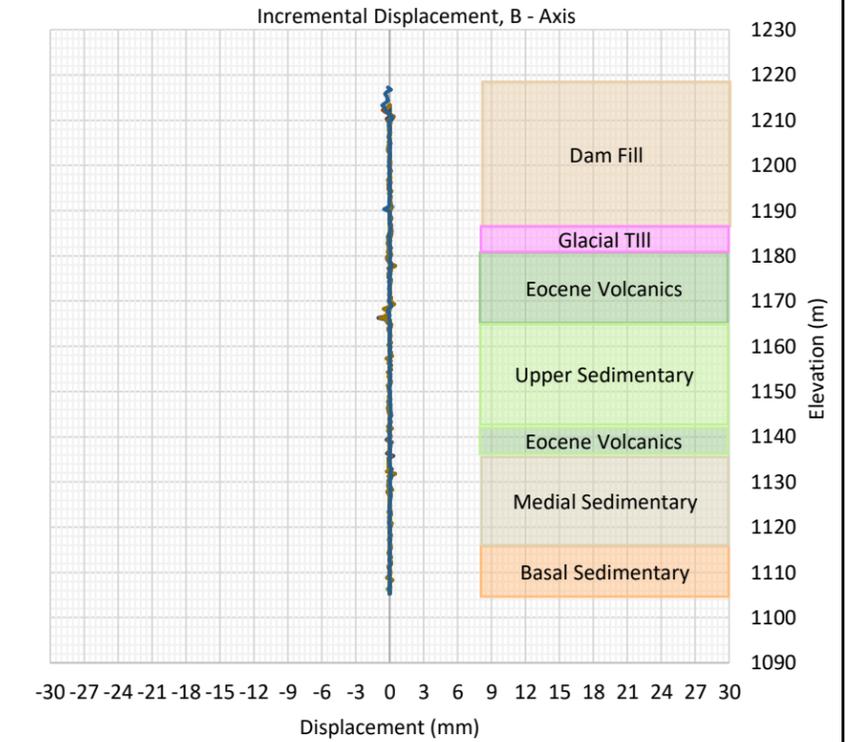
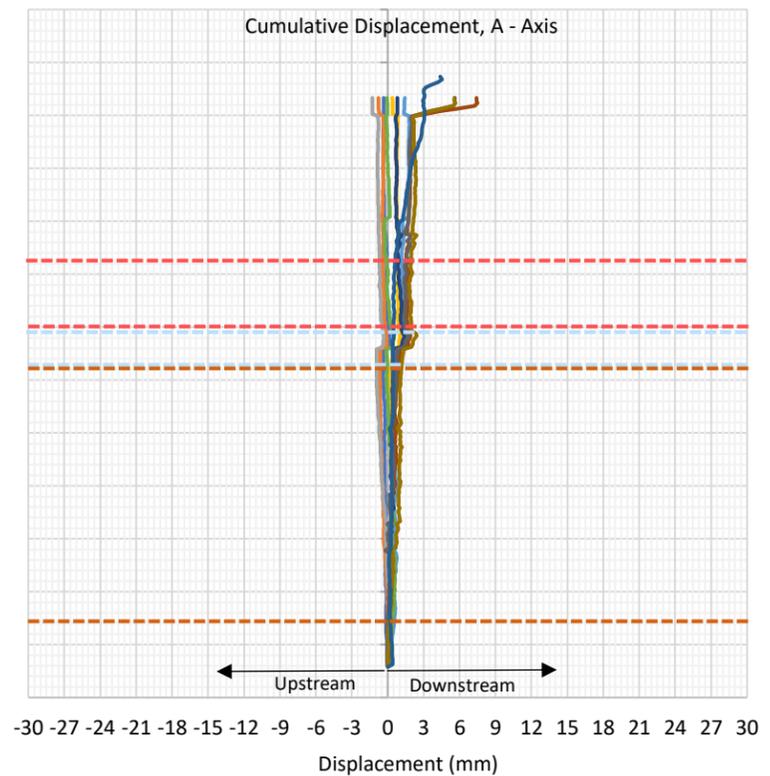
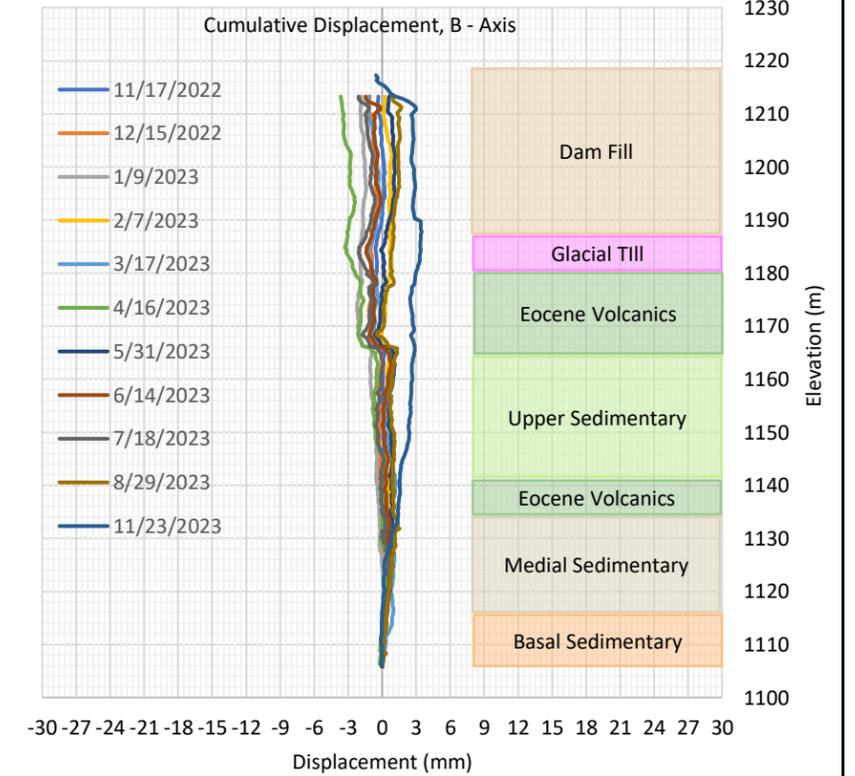
CLIENT Highland Valley Copper / Teck	PROJECT HIGHLAND TAILINGS STORAGE FACILITY 2023 ANNUAL FACILITY PERFORMANCE REPORT	
	TITLE LL DAM INCLINOMETER PLOTS LL-I21-04 (NBB) DEC. 2021 TO NOV. 2023	
	SCALE	FIG. No.
	NTS	II-B-24

1. DATA PROCESSED AND PROVIDED BY HVC
2. LAST READING OF EACH MONTH PLOTTED ON THE INCREMENTAL AND CUMULATIVE PROFILES.
3. X-AXIS, Y-AXIS, AND LEGEND IS THE SAME FOR THE INCREMENTAL AND CUMULATIVE PROFILES.
4. A SPIRAL CORRECTION AND A SKEW ANGLE OF 348 DEGREES HAS BEEN APPLIED TO THIS INSTRUMENT.
5. THE INSTRUMENT CASING WAS DAMAGED AND HAD TO BE REPAIRED IN SEPTEMBER 2023. AFTER THE REPAIR WAS COMPLETED IN OCTOBER 2023, THE INSTRUMENT WAS REBASELINED FOR THIS REASON, THE NOVEMBER 23, 2023 READING IS BASED ON A DIFFERENT BASELINE COMPARED TO OTHER READINGS. HOWEVER THE READING IS PLOTTED ON THE PROFILE PLOTS TO SUPPORT INTERPRETATION OF POTENTIAL MOVEMENT ZONES THAT MAY HAVE OCCURED AFTER DURING CONSTRUCTION LOADING IN NOVEMBER 2023.

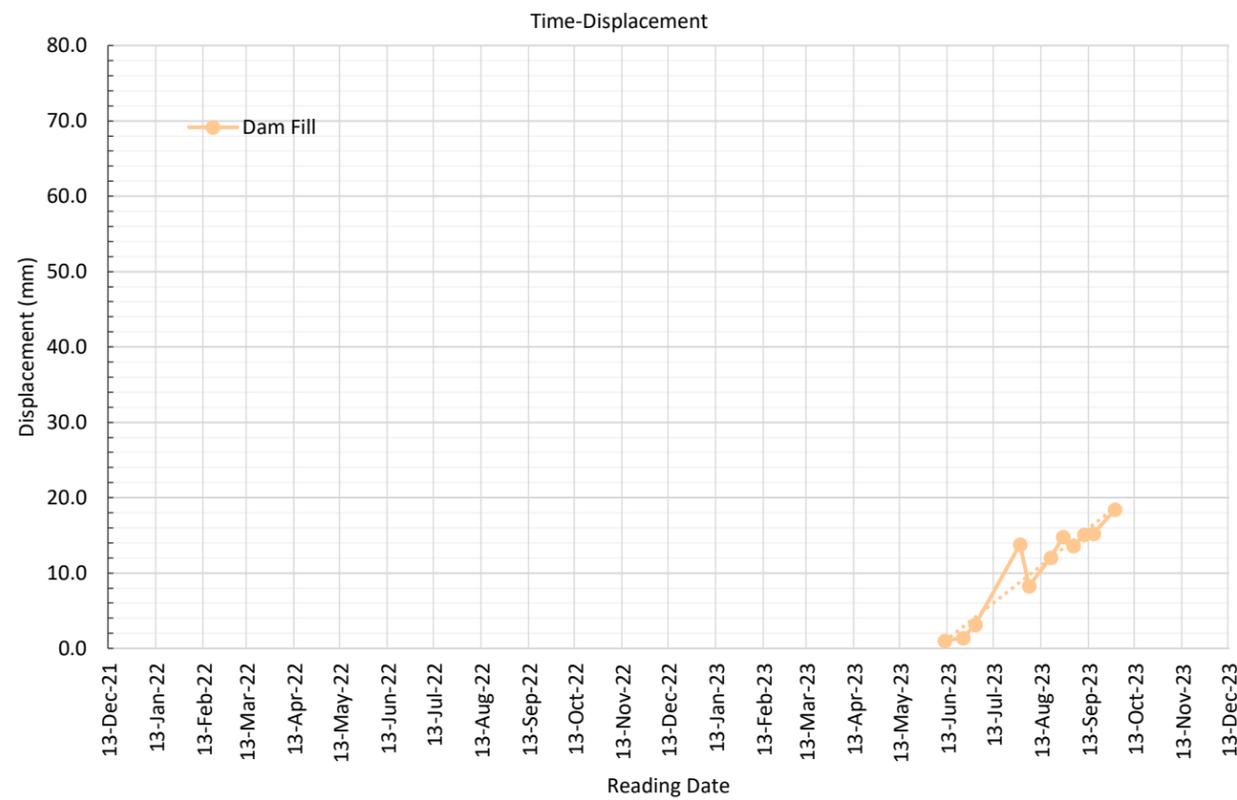
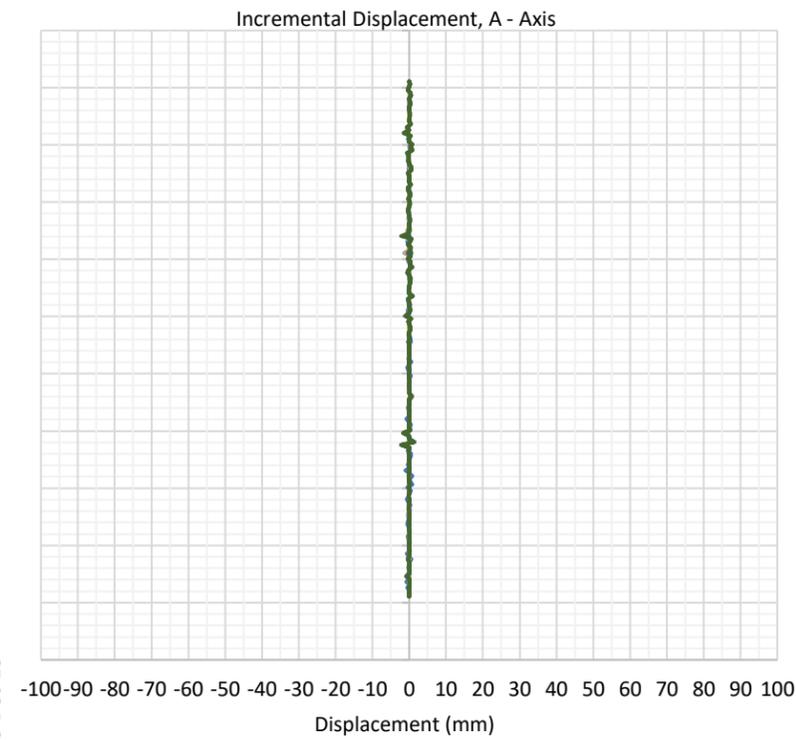
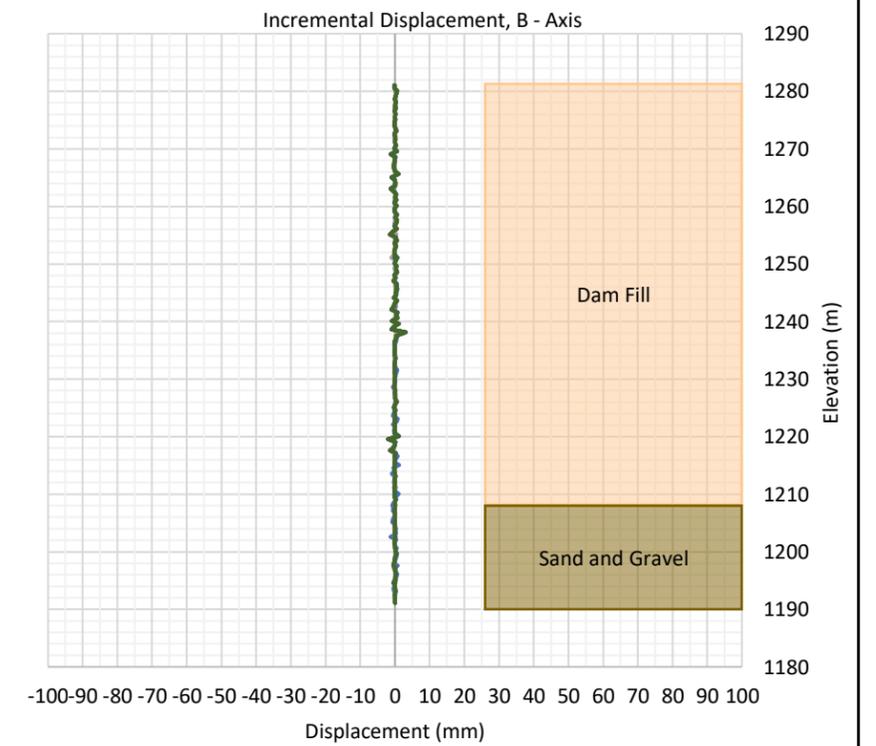
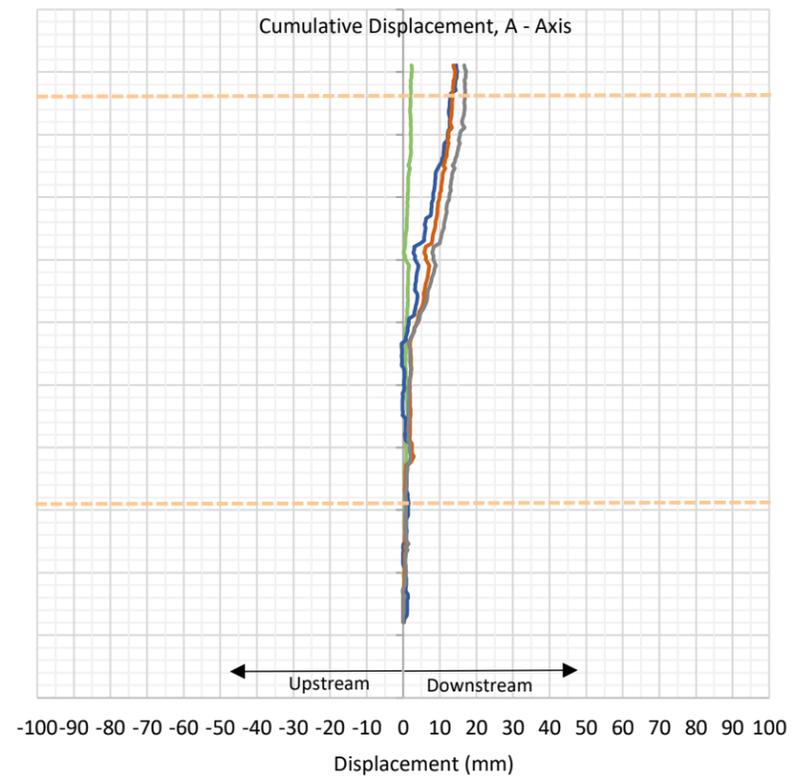
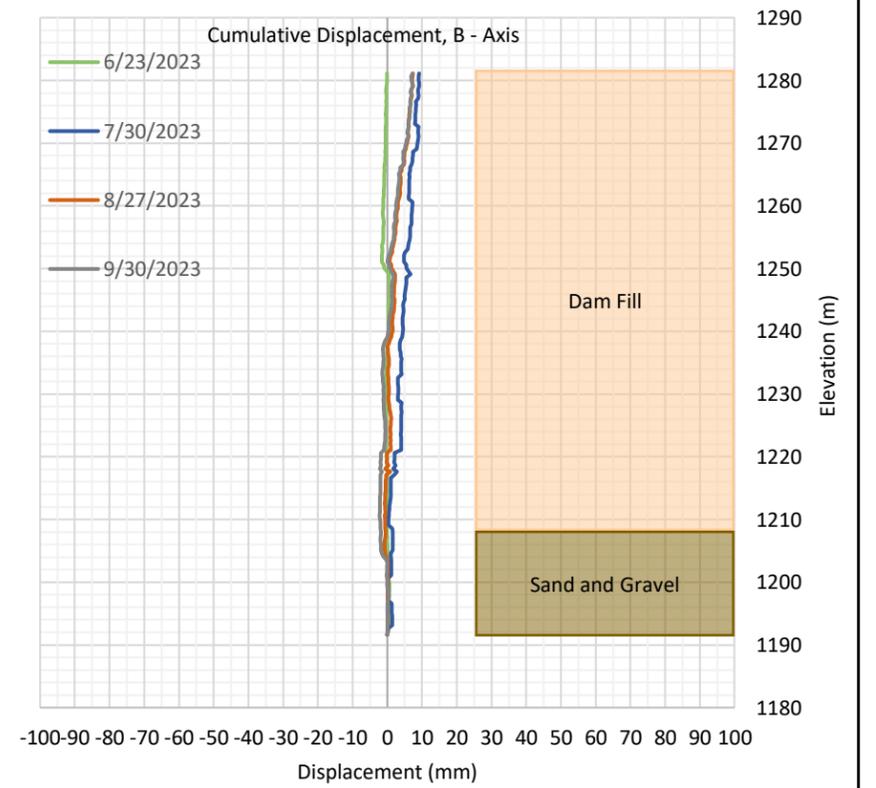
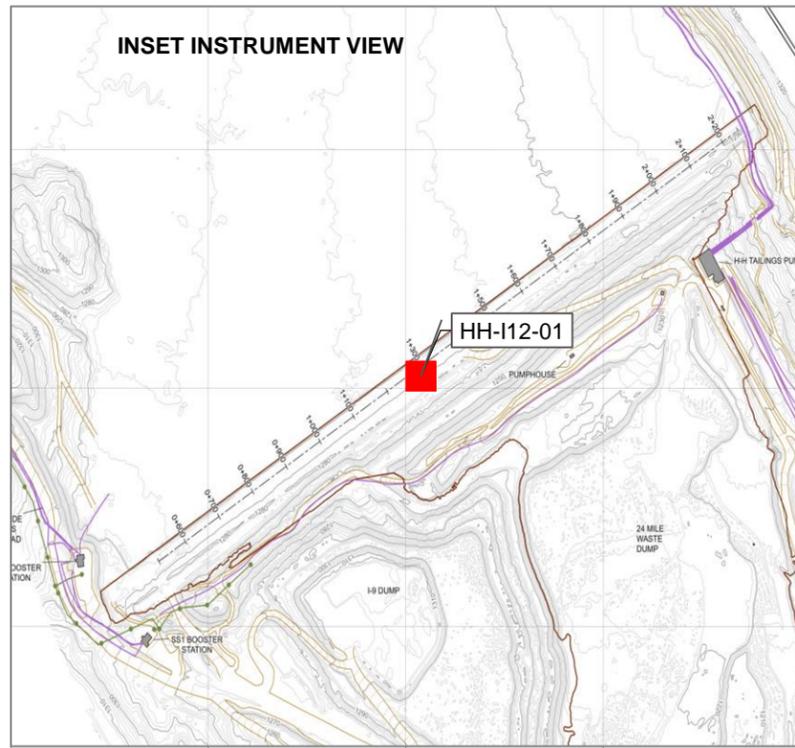
CLIENT Highland Valley Copper / Teck	PROJECT HIGHLAND TAILINGS STORAGE FACILITY 2023 ANNUAL FACILITY PERFORMANCE REPORT	
	TITLE HH DAM INCLINOMETER PLOTS HH-I12-01 (MID SEGMENT) DEC. 2021 TO NOV. 2023	
SCALE NTS	PROJECT No. M02341C62	FIG. No. III-B-1

1. DATA PROCESSED AND PROVIDED BY HVC
2. LAST READING OF EACH MONTH PLOTTED ON THE INCREMENTAL AND CUMULATIVE PROFILES.
3. X-AXIS, Y-AXIS, AND LEGEND IS THE SAME FOR THE INCREMENTAL AND CUMULATIVE PROFILES.
4. INCREMENTAL DISPLACEMENT PROFILES ARE BASED ON READINGS WITHIN ONE WEEK OF THE CUMULATIVE PROFILES.
5. THERE WERE PROCESSING AND READING ERRORS ASSOCIATED WITH HH-I12-01 STARTING IN EARLY 2023. THESE WERE THOUGHT TO BE RESOLVED IN JUNE AND READING RESUMED. HOWEVER, SUBSEQUENT INVESTIGATIONS HAVE INDICATED THAT PROBLEMS PERSISTED AND WERE NOT FULLY RESOLVED UNTIL DECEMBER 2023. READINGS PLOTTED ON THIS FIGURE ARE NOW BELIEVED TO NO LONGER BE REPRESENTATIVE OF ACTUAL BEHAVIOUR.

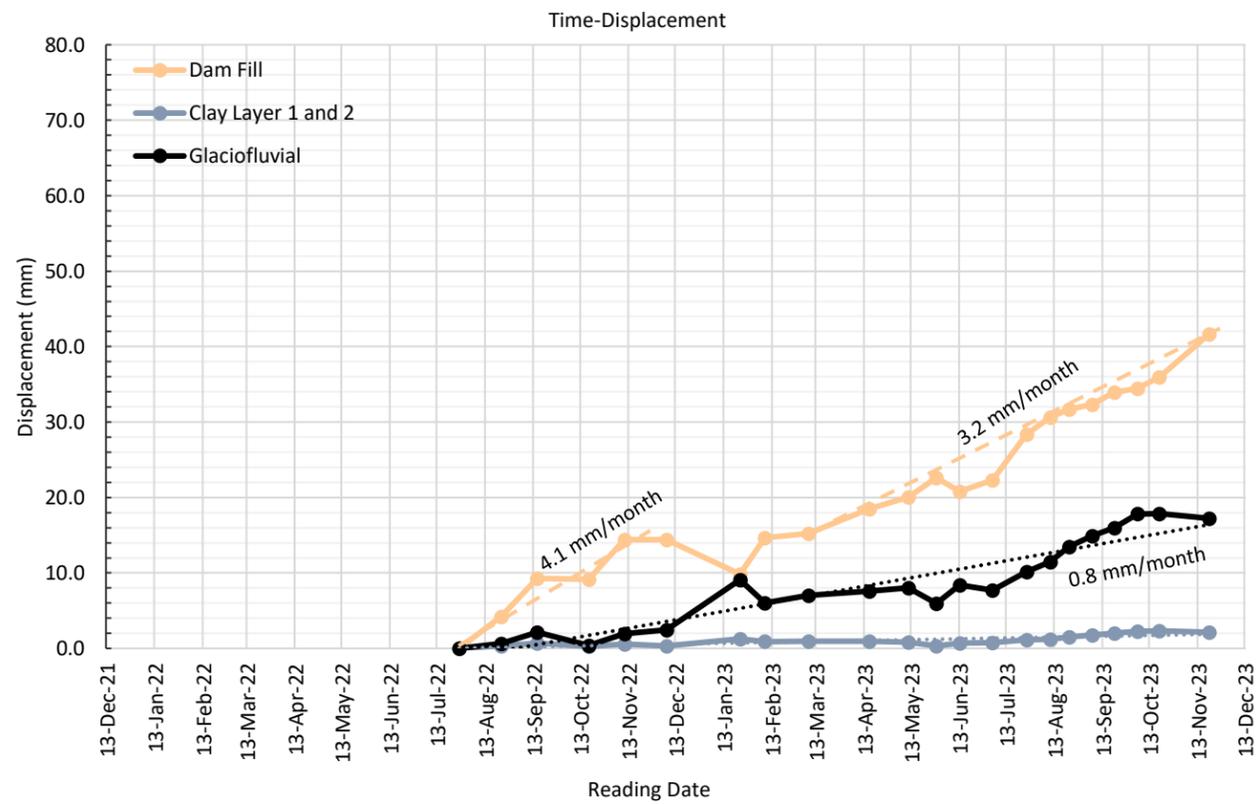
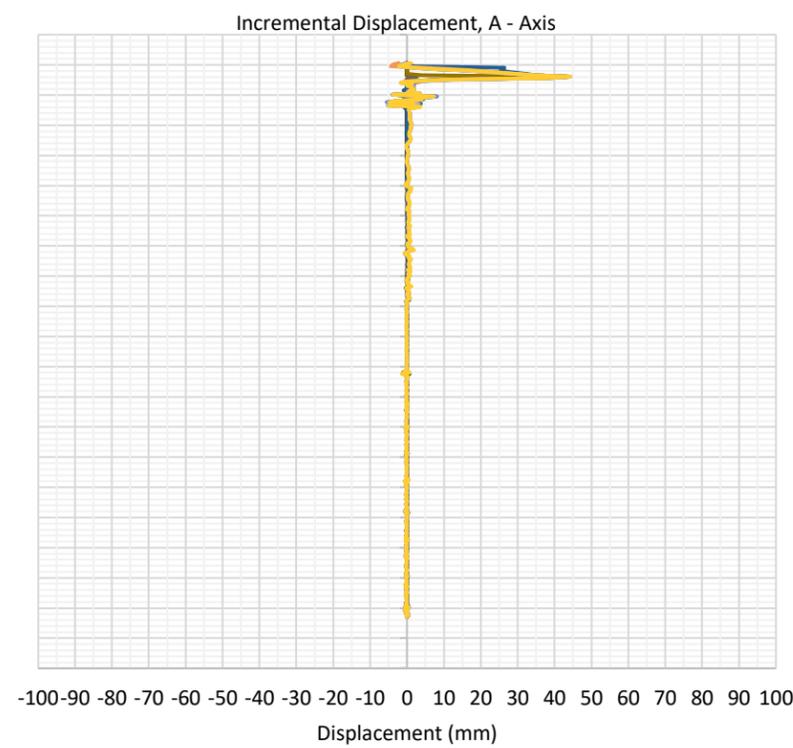
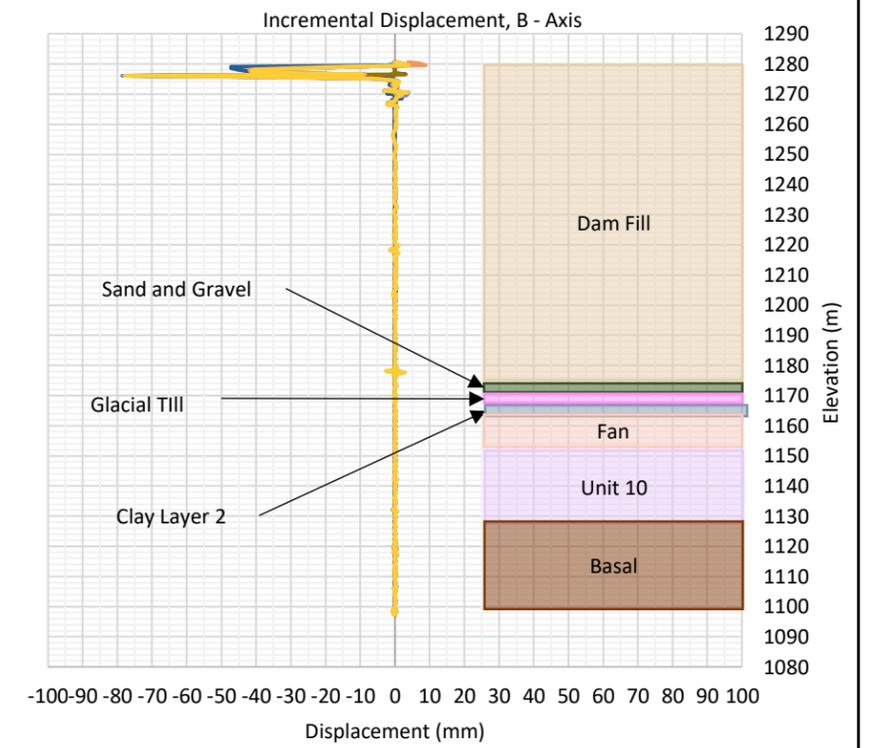
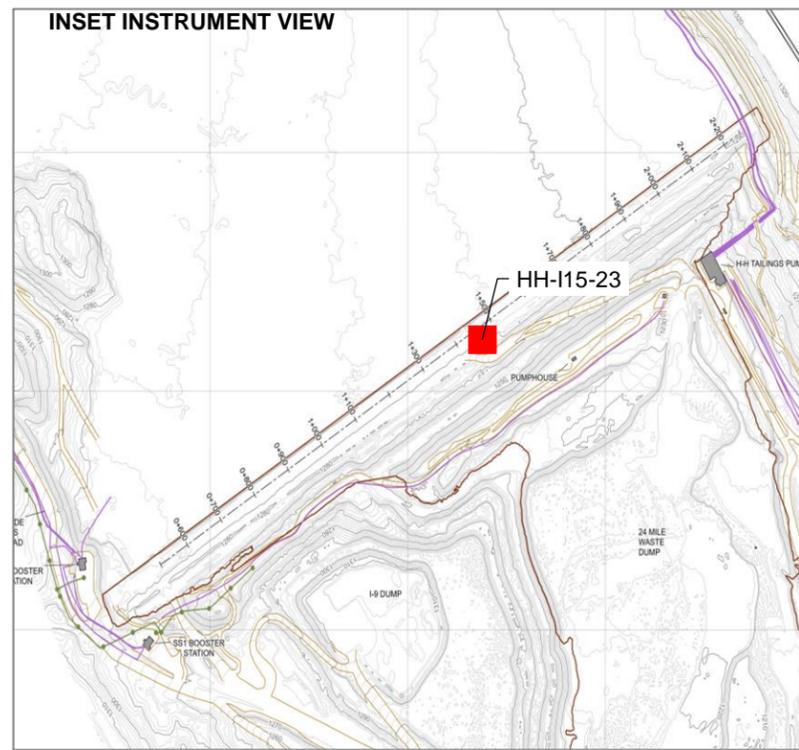
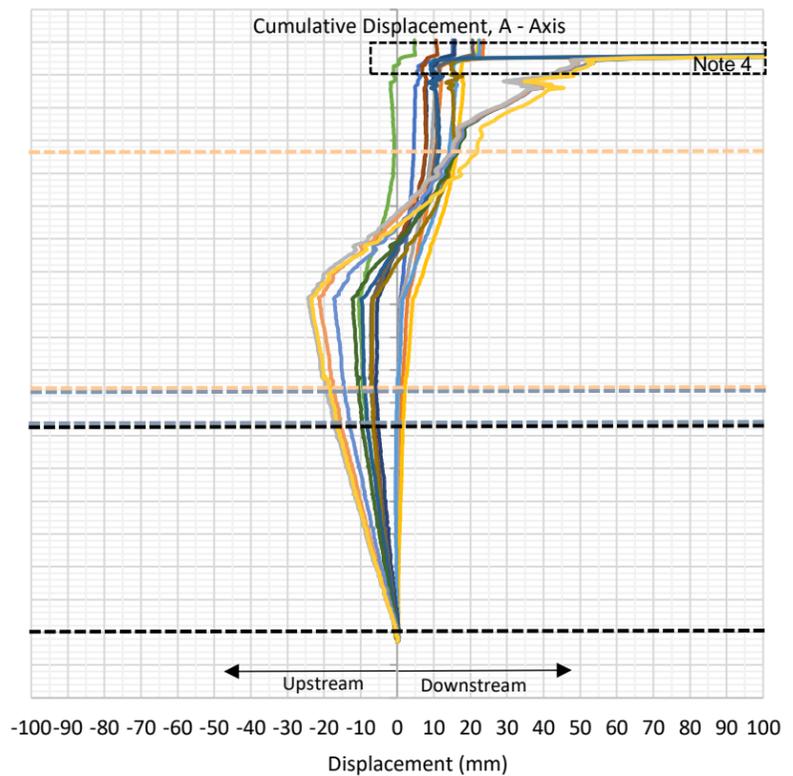
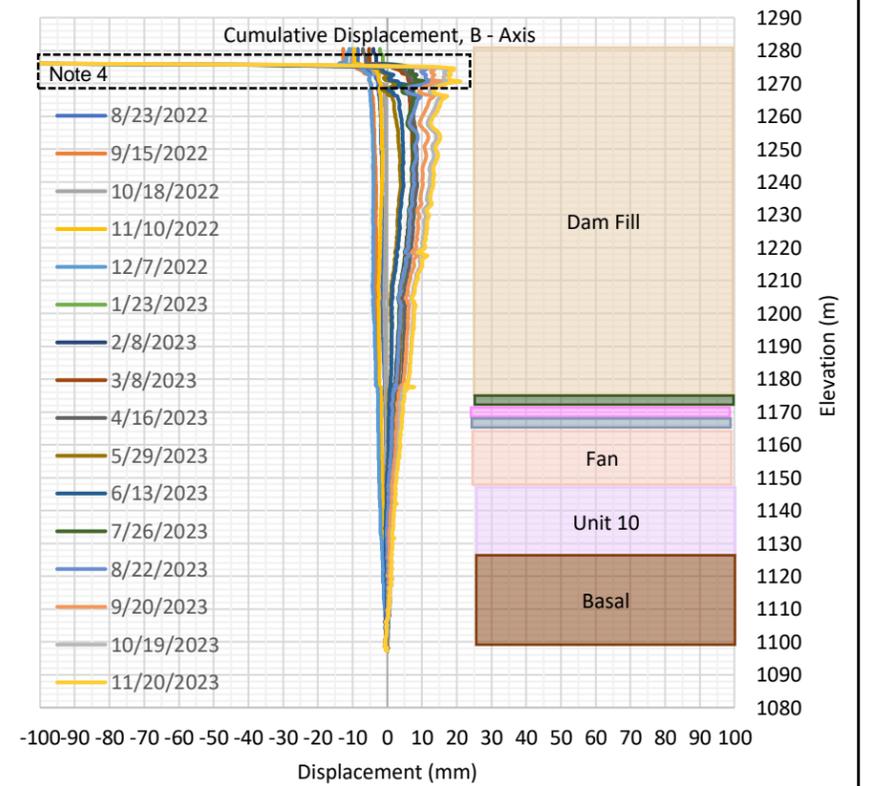
CLIENT Highland Valley / Teck Copper	PROJECT HIGHLAND TAILINGS STORAGE FACILITY 2023 ANNUAL FACILITY PERFORMANCE REPORT	
	TITLE HH DAM INCLINOMETER PLOTS HH-115-23 (MID SEGMENT) DEC. 2021 TO NOV. 2023	
SCALE NTS	PROJECT No. M02341C62	FIG. No. III-B-2

1. DATA PROCESSED AND PROVIDED BY HVC
2. LAST READING OF EACH MONTH PLOTTED ON THE INCREMENTAL AND CUMULATIVE PROFILES.
3. X-AXIS, Y-AXIS, AND LEGEND IS THE SAME FOR THE INCREMENTAL AND CUMULATIVE PROFILES.
4. READINGS ABOVE EL. 1272.0 m ARE NOT REFLECTIVE OF ACTUAL MOVEMENT AND SHOULD BE IGNORED.

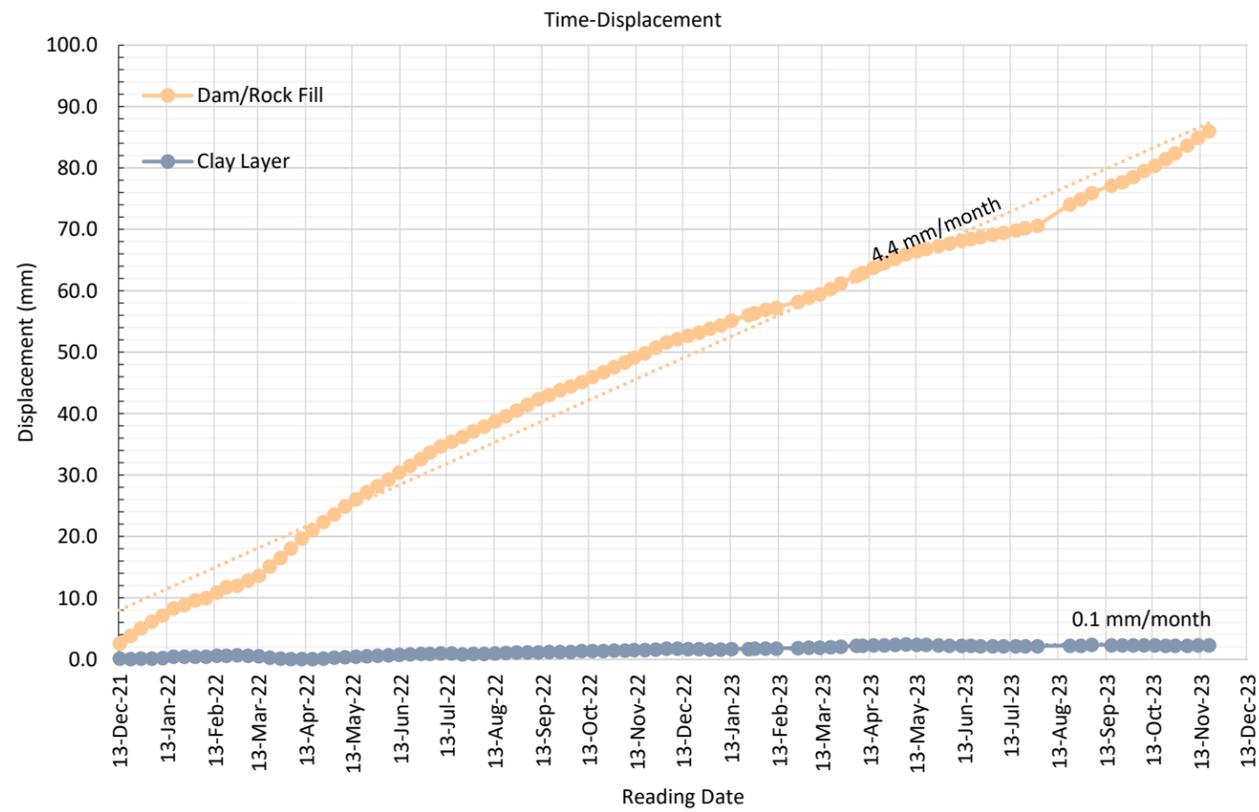
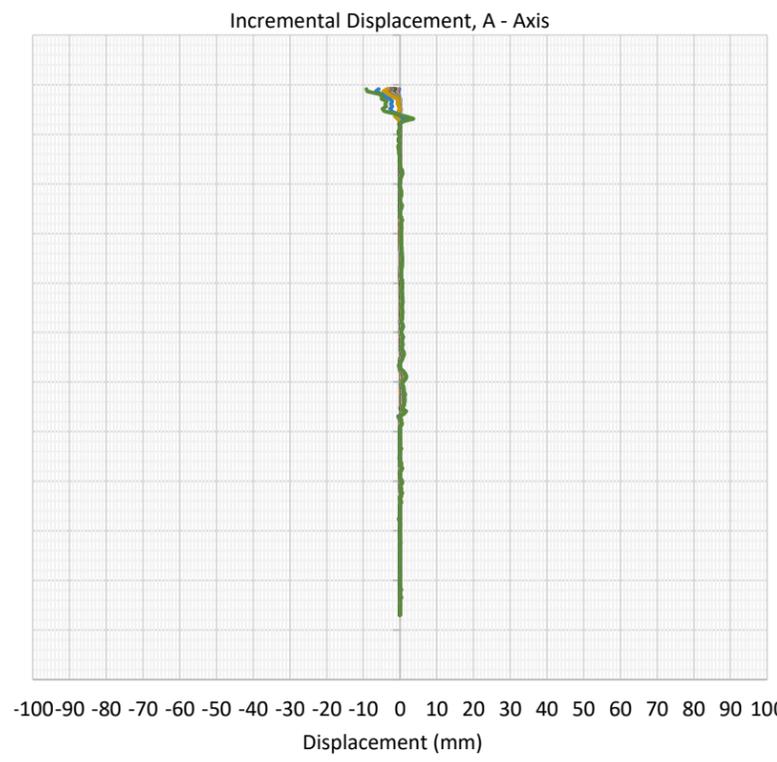
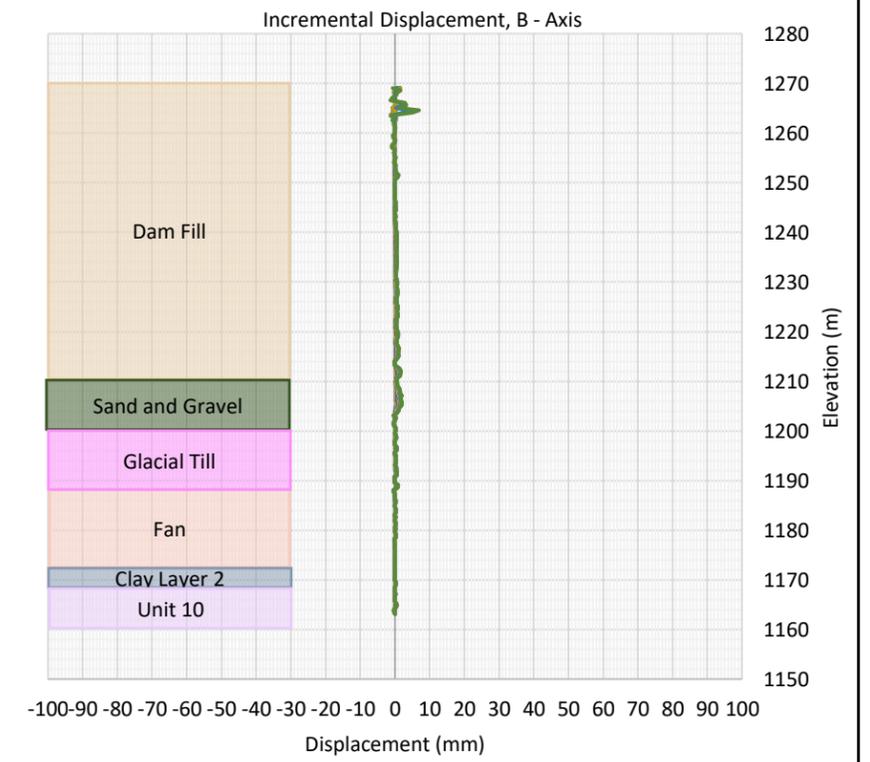
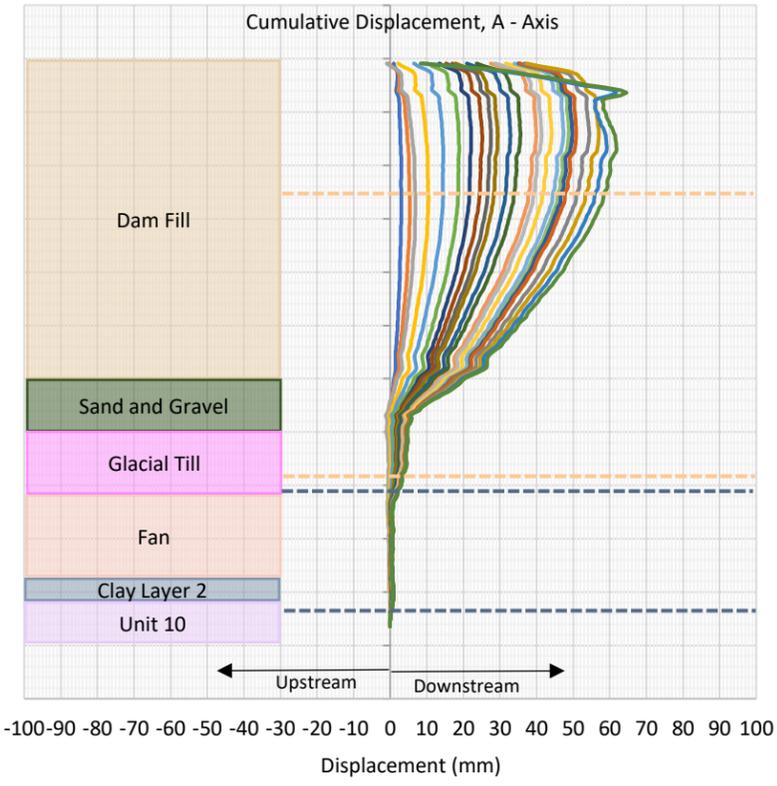
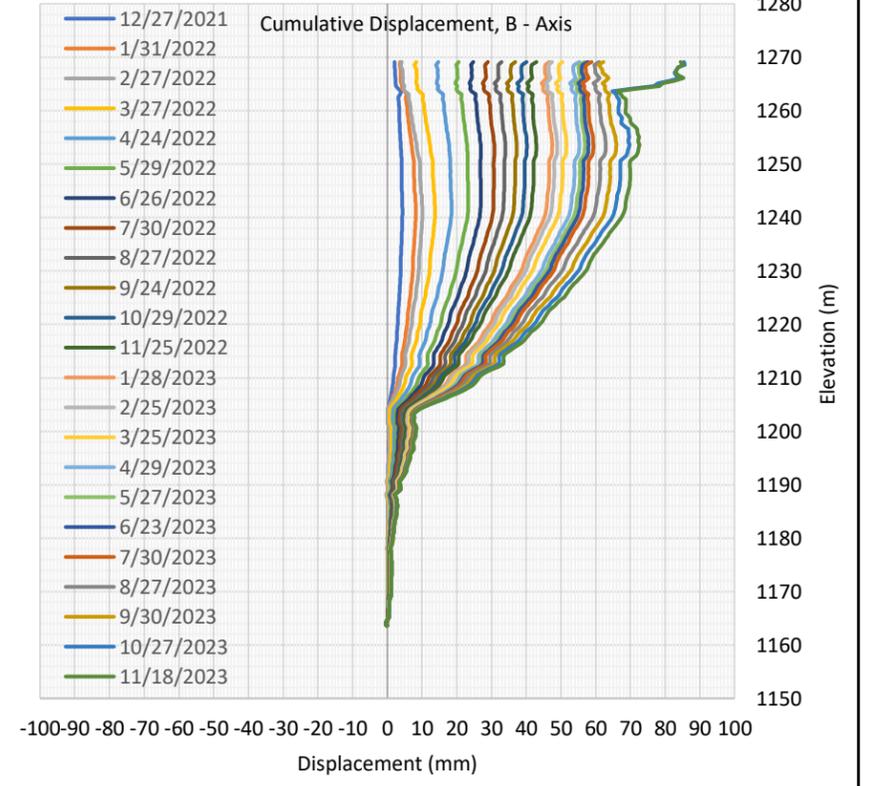
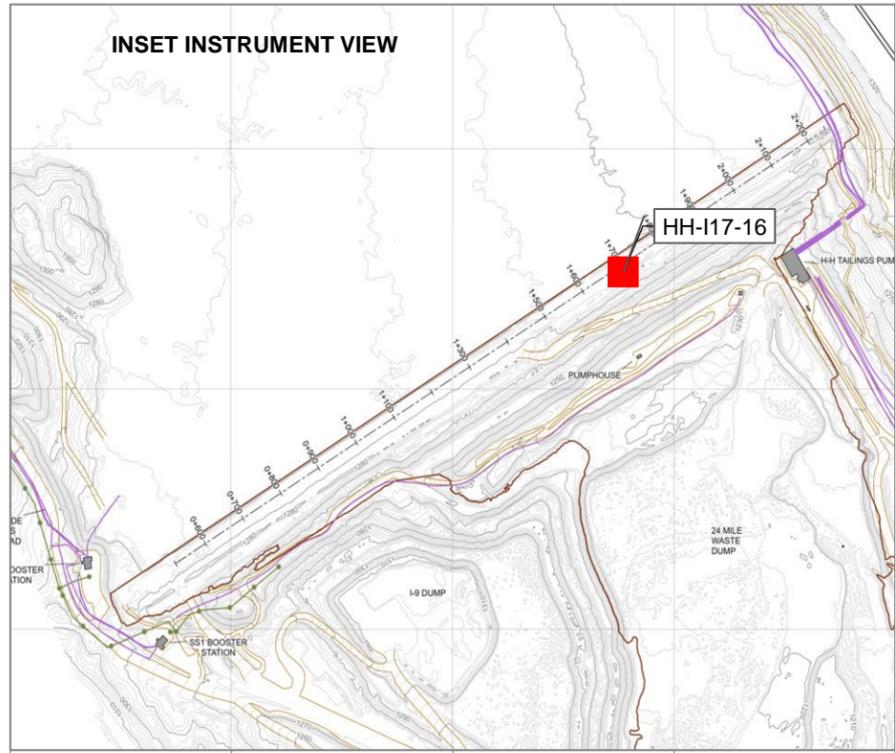
PROJECT HIGHLAND TAILINGS STORAGE FACILITY 2023 ANNUAL FACILITY PERFORMANCE REPORT	
	TITLE HH DAM INCLINOMETER PLOTS HH-117-14 (EAST SEGMENT) DEC. 2021 TO NOV. 2023	
	SCALE	FIG. No.
	NTS	M02341C62 III-B-3

1. DATA PROCESSED AND PROVIDED BY HVC
2. LAST READING OF EACH MONTH PLOTTED ON THE INCREMENTAL AND CUMULATIVE PROFILES.
3. X-AXIS, Y-AXIS, AND LEGEND IS THE SAME FOR THE INCREMENTAL AND CUMULATIVE PROFILES.
4. INCREMENTAL DISPLACEMENT PROFILES ARE BASED ON READINGS WITHIN ONE WEEK OF THE CUMULATIVE PROFILES.
5. THE INSTRUMENT WAS RAISED ON OCTOBER 18, 2023, WHICH REQUIRED THE COMPRESSION CAP TO BE REMOVED TEMPORARILY. THIS IS THE CAUSE OF THE CHANGE IN DEFORMATION SHOWN BETWEEN THE SEPTEMBER AND OCTOBER 2023 READINGS ABOVE EL. 1264.0. THIS CHANGE IS NOT REFLECTIVE OF ACTUAL DEFORMATION OF THE FILL. THERE WAS NO INCREMENTAL CHANGE IN READINGS BETWEEN THE READINGS AFTER THE COMPRESSION CAP WAS PLACED BACK ON.
