Teck Highland Valley Copper Partnership

2023 Annual Facility Performance Report

Highland Tailings Storage Facility

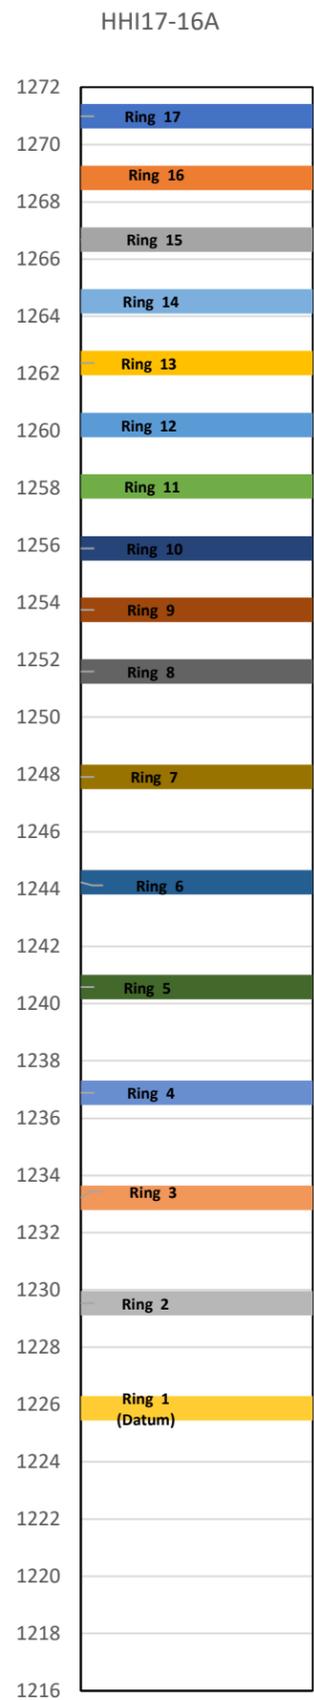
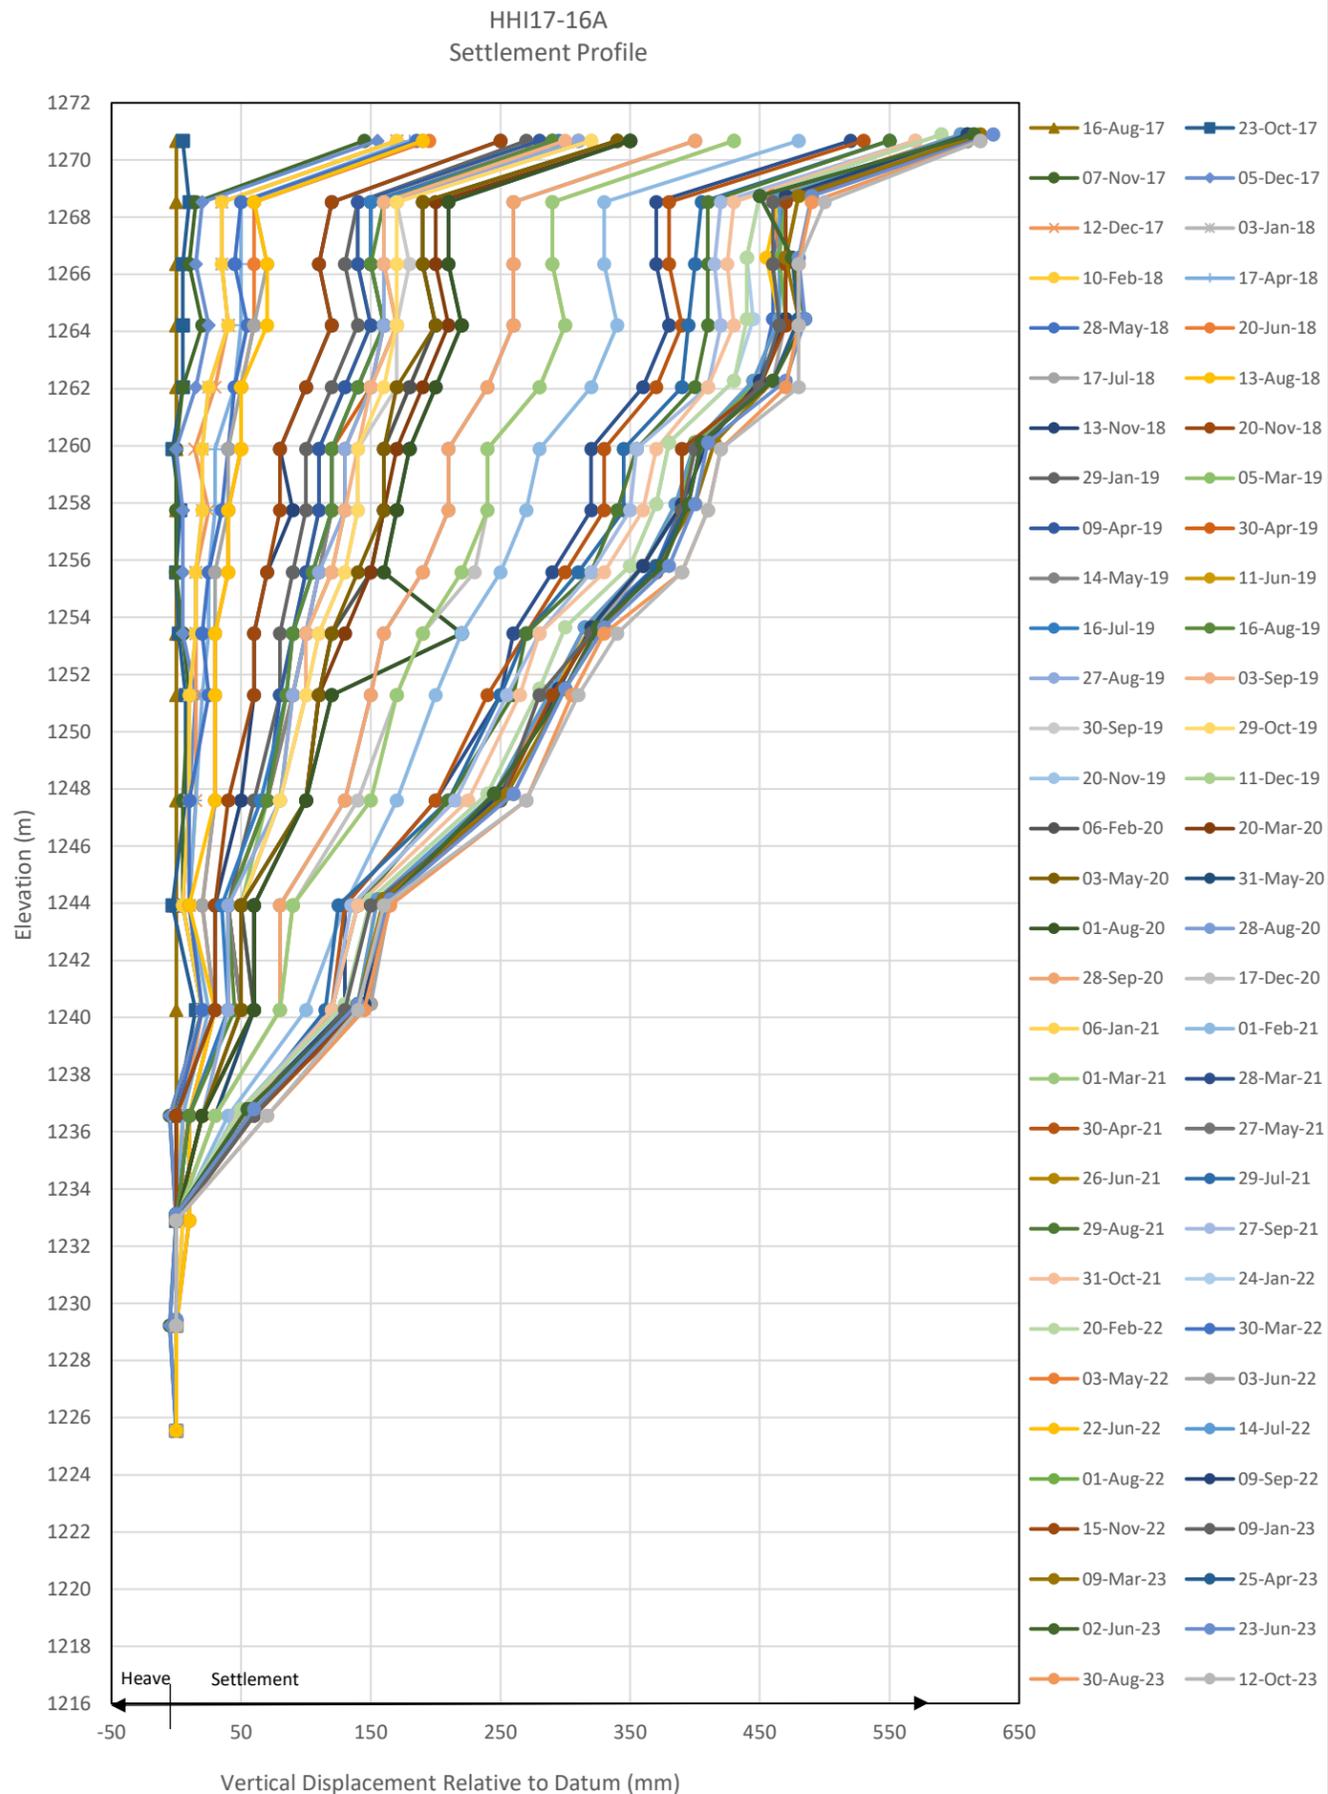
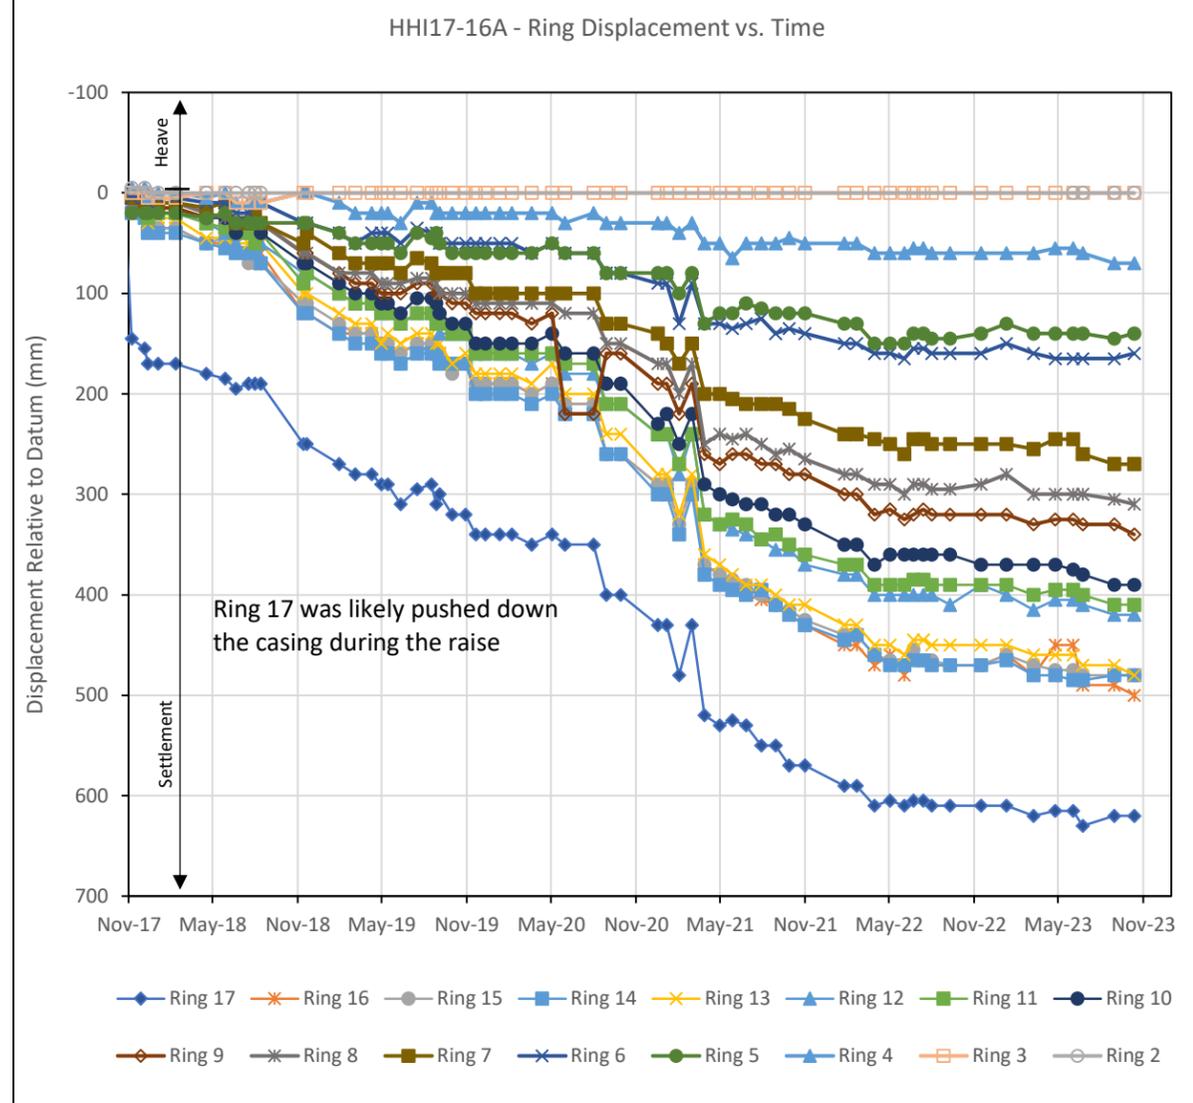
<p>CLIENT</p> <p>Highland Valley Copper</p>	<p>PROJECT</p> <p>HIGHLAND TAILINGS STORAGE FACILITY 2023 ANNUAL FACILITY PERFORMANCE REPORT</p>	<p>TITLE</p> <p>H-H DAM VERTICAL DISPLACEMENTS HH-117-16A (SONDEX) - NOVEMBER 2023</p>	PROJECT No.	FIG No.
			M02341C62	III-C-1
<p>Klohn Crippen Berger</p>

- Notes:
1. Ring displacements are calculated relative to the initial elevations for each ring. The datum is the bottom ring (Ring 1).
 2. Positive displacements represent settlement. Negative displacements represent heave.
 3. The Ring 12 reading from December 11, 2017 was not consistent with readings in the rings above and below, due to a suspected data entry error. The reading was adjusted to match the trends of Ring 11 and Ring 13.
 4. Data from October 09, and 30, 2018 were not consistent with other readings and not showed here.
 5. No readings recorded for Ring 1 and 2 after October 09, 2018
 6. Data from November 28, 2021, and December 30, 2021, appeared to be outliers and are not shown here

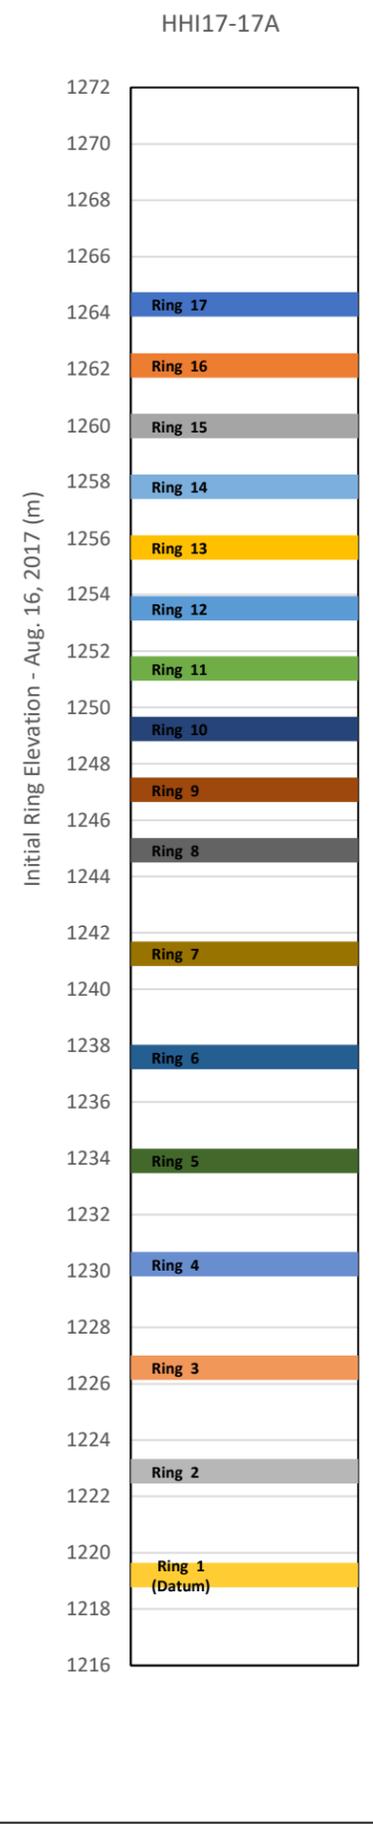
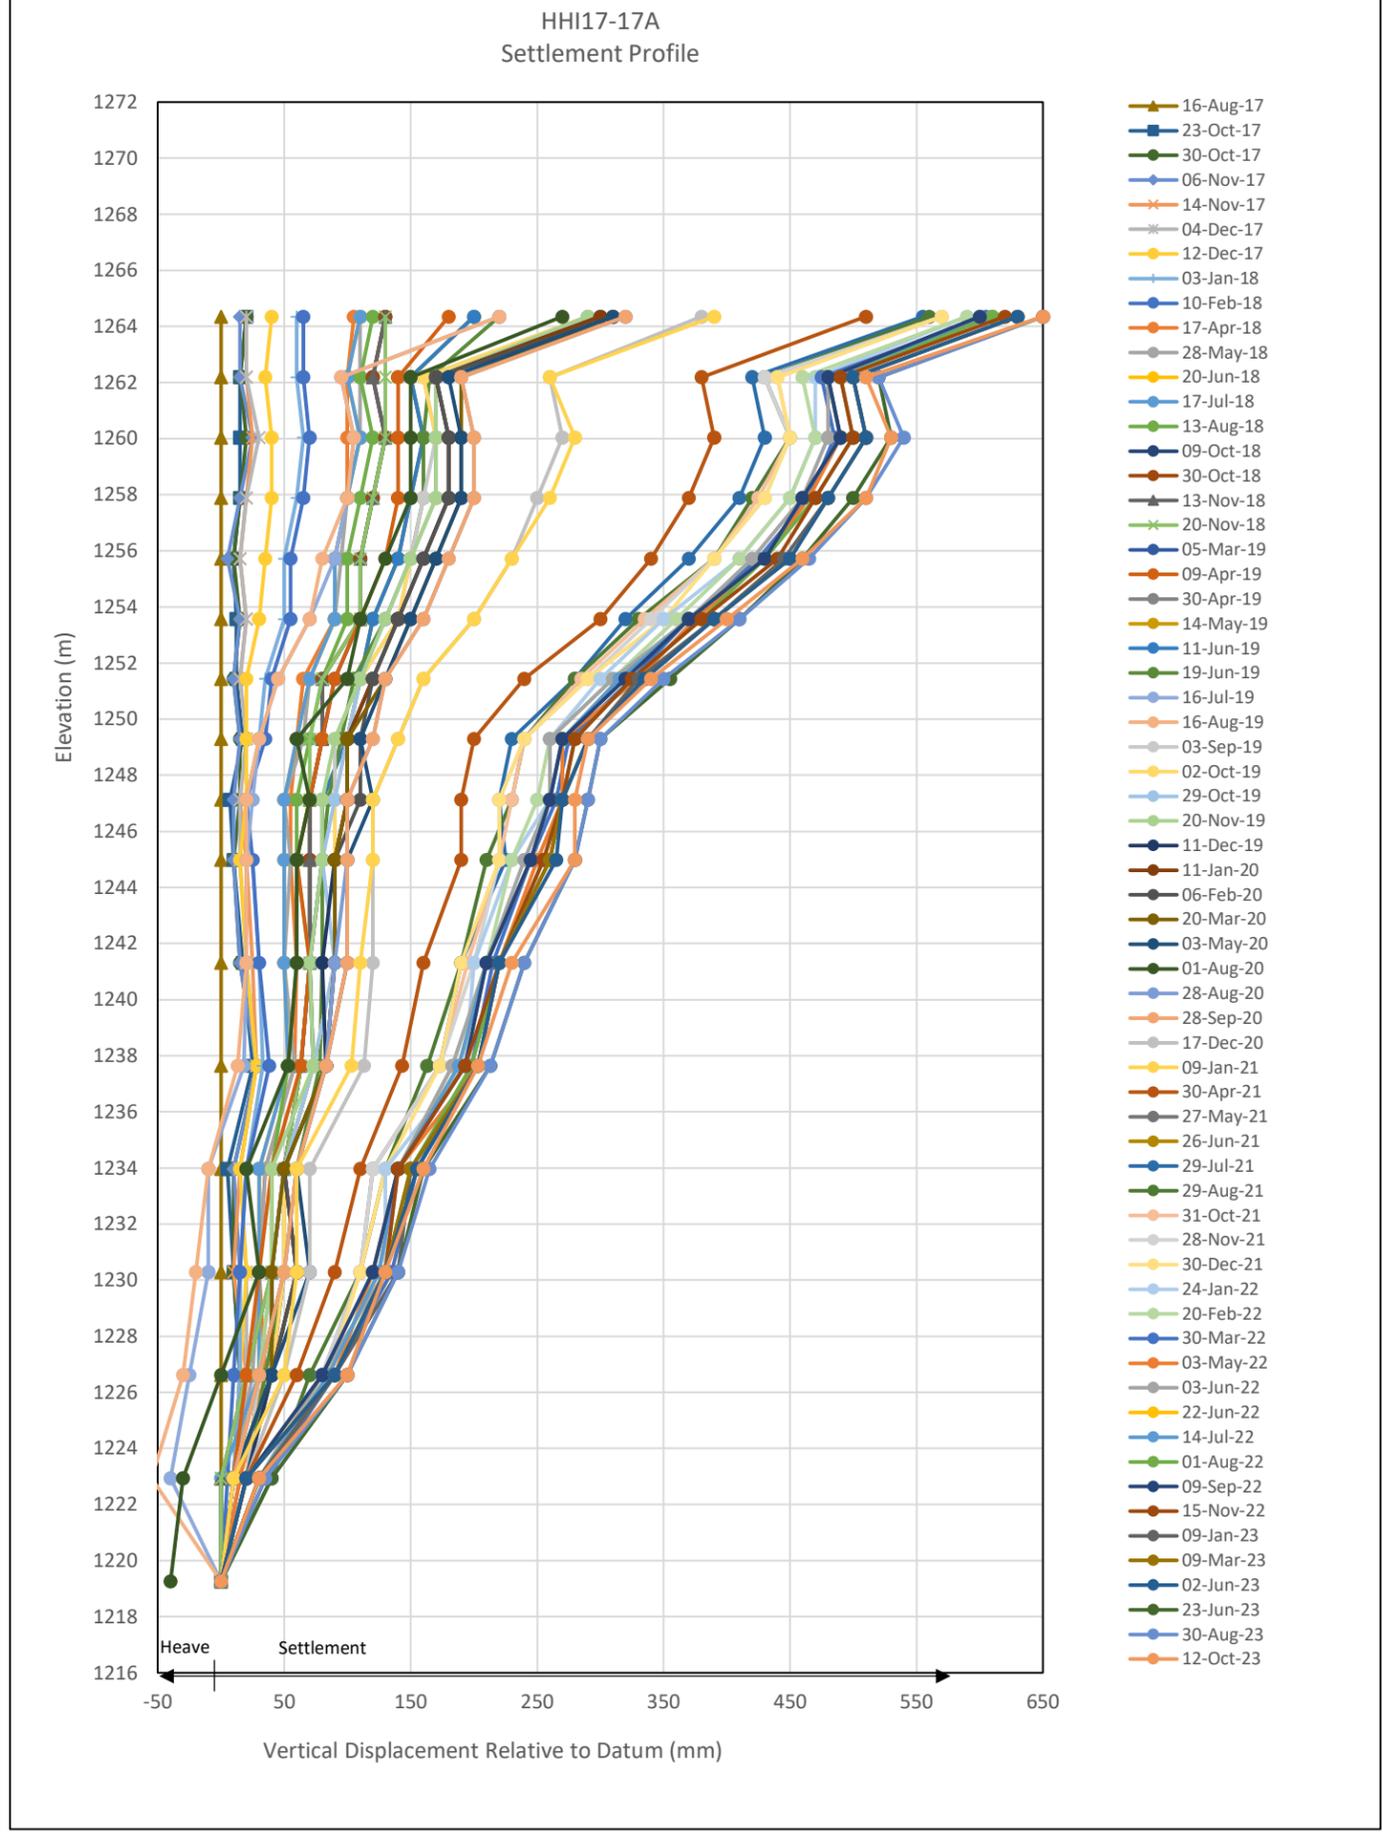
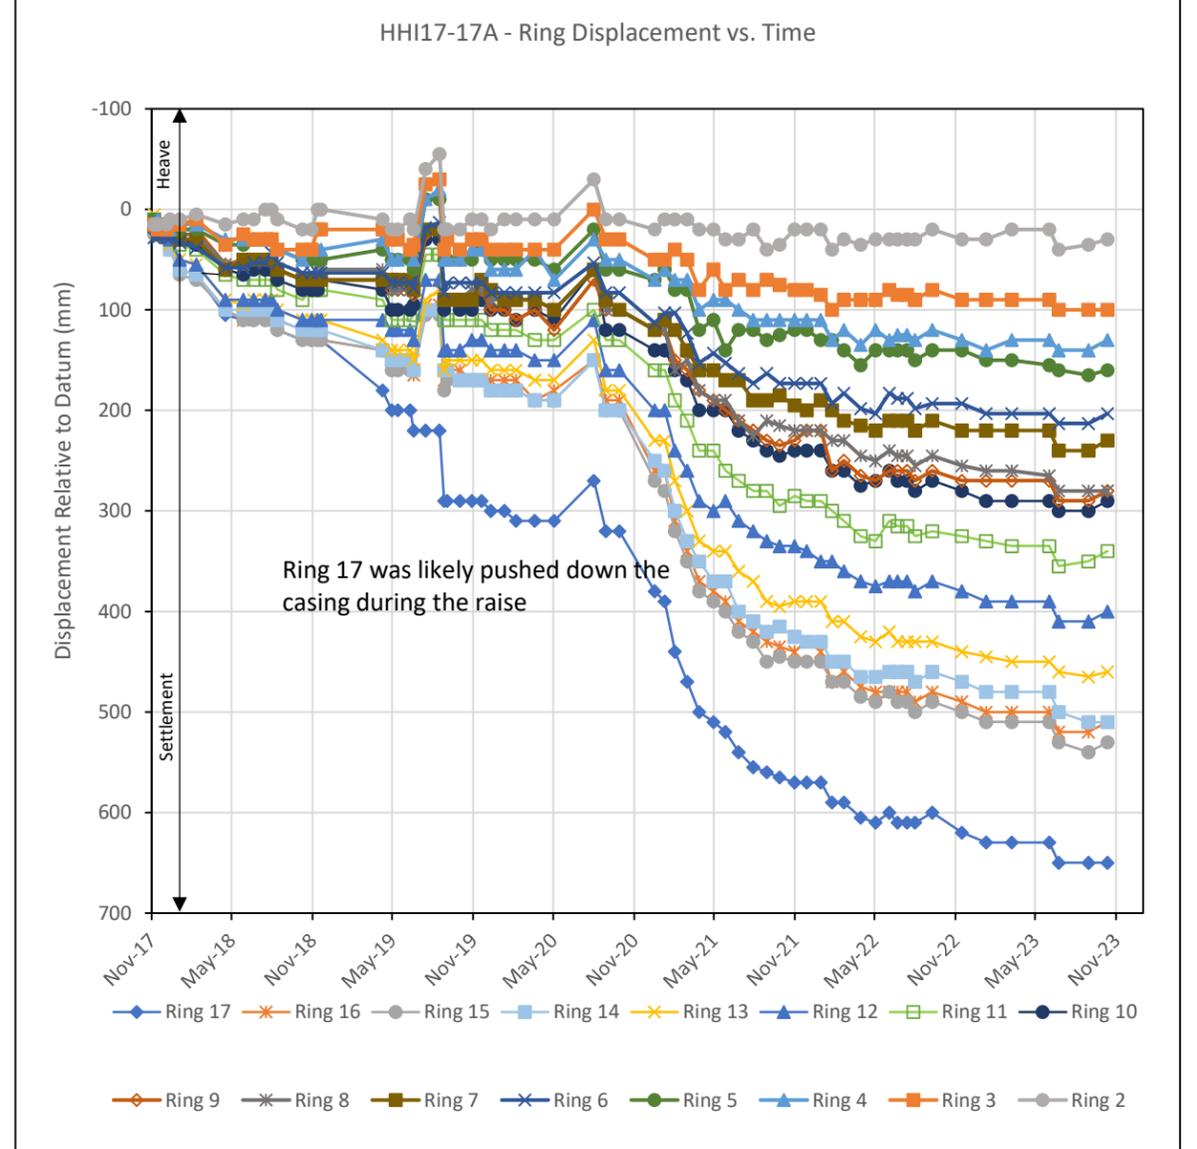
- Notes:**
1. Ring displacements are calculated relative to the initial elevations for each ring. The datum is the bottom ring (Ring 1).
 2. Positive displacements represent settlement. Negative displacements represent heave.
 3. The following readings were not consistent with readings in the rings above and below, due to suspected data entry errors. The readings were adjusted to match the trends of adjacent rings:
 - Ring 5 (December 11, 2017, January 3, 2018, February 10, 2018)
 - Ring 6 (January 3, 2018)
 4. Data from March 05, 2019 were not consistent with other readings and not showed here

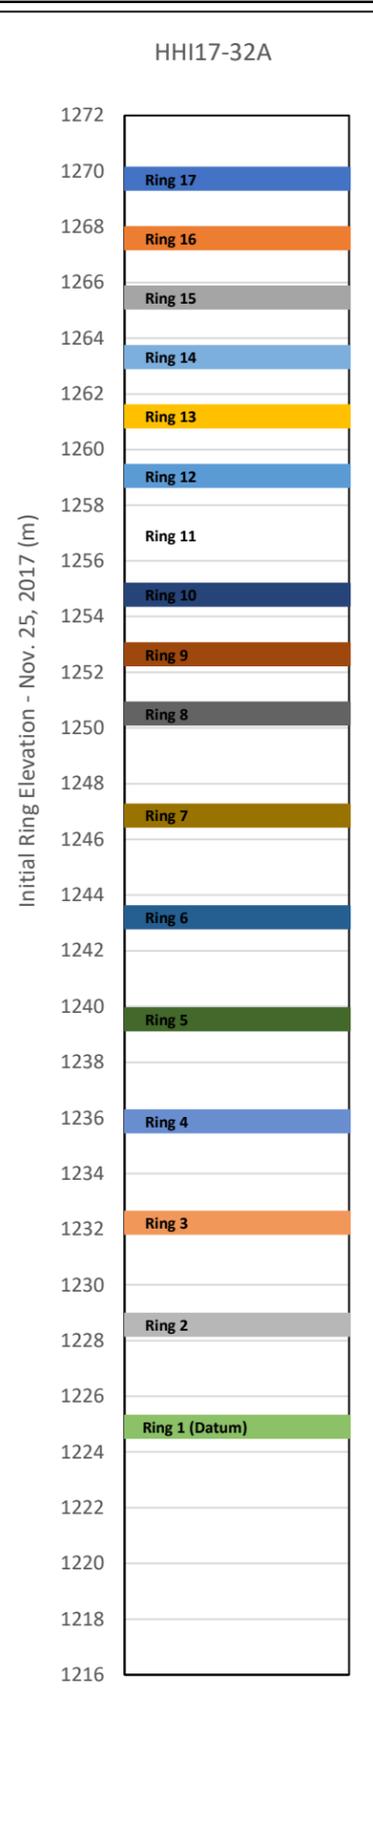
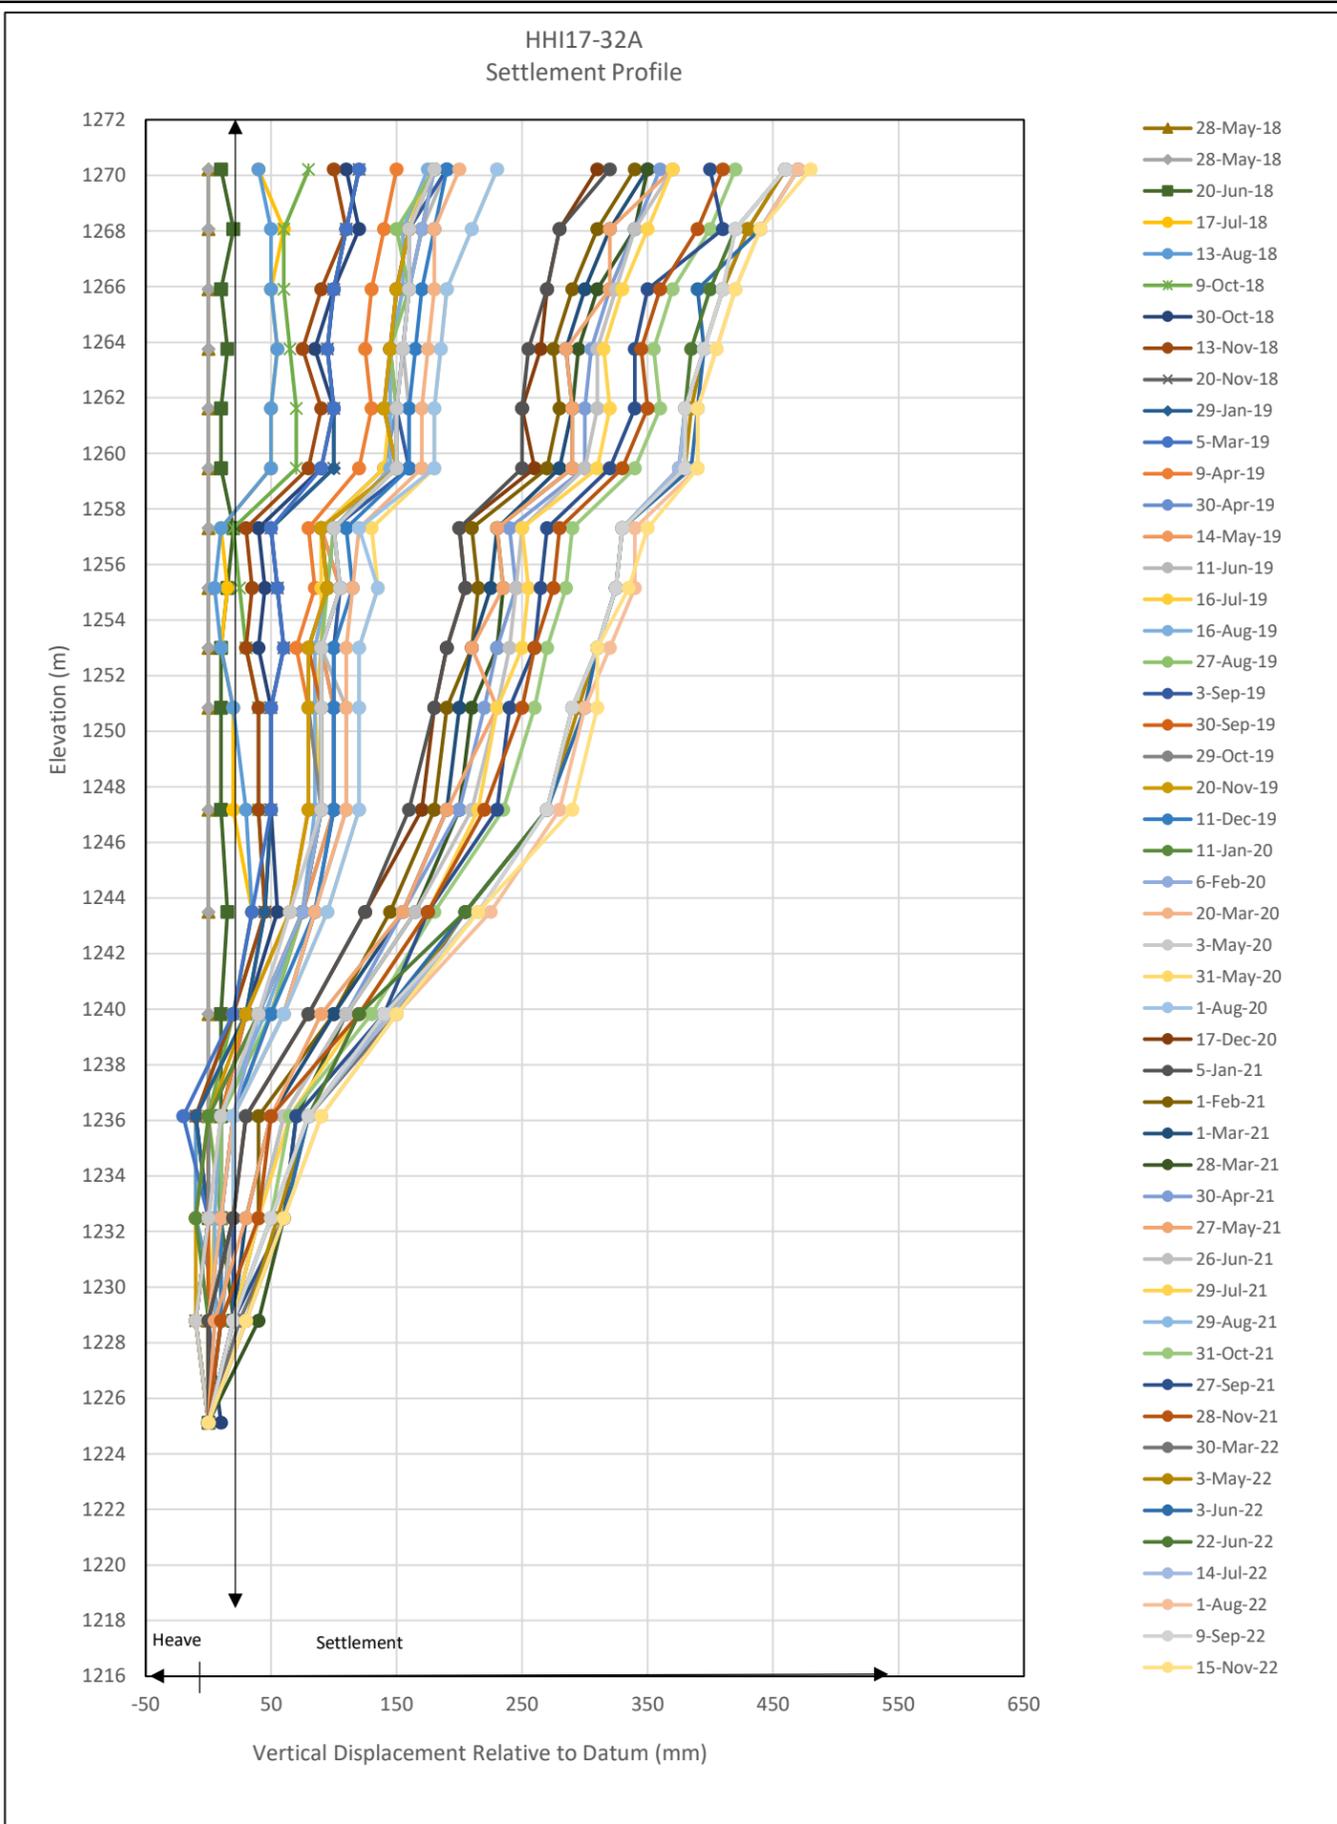
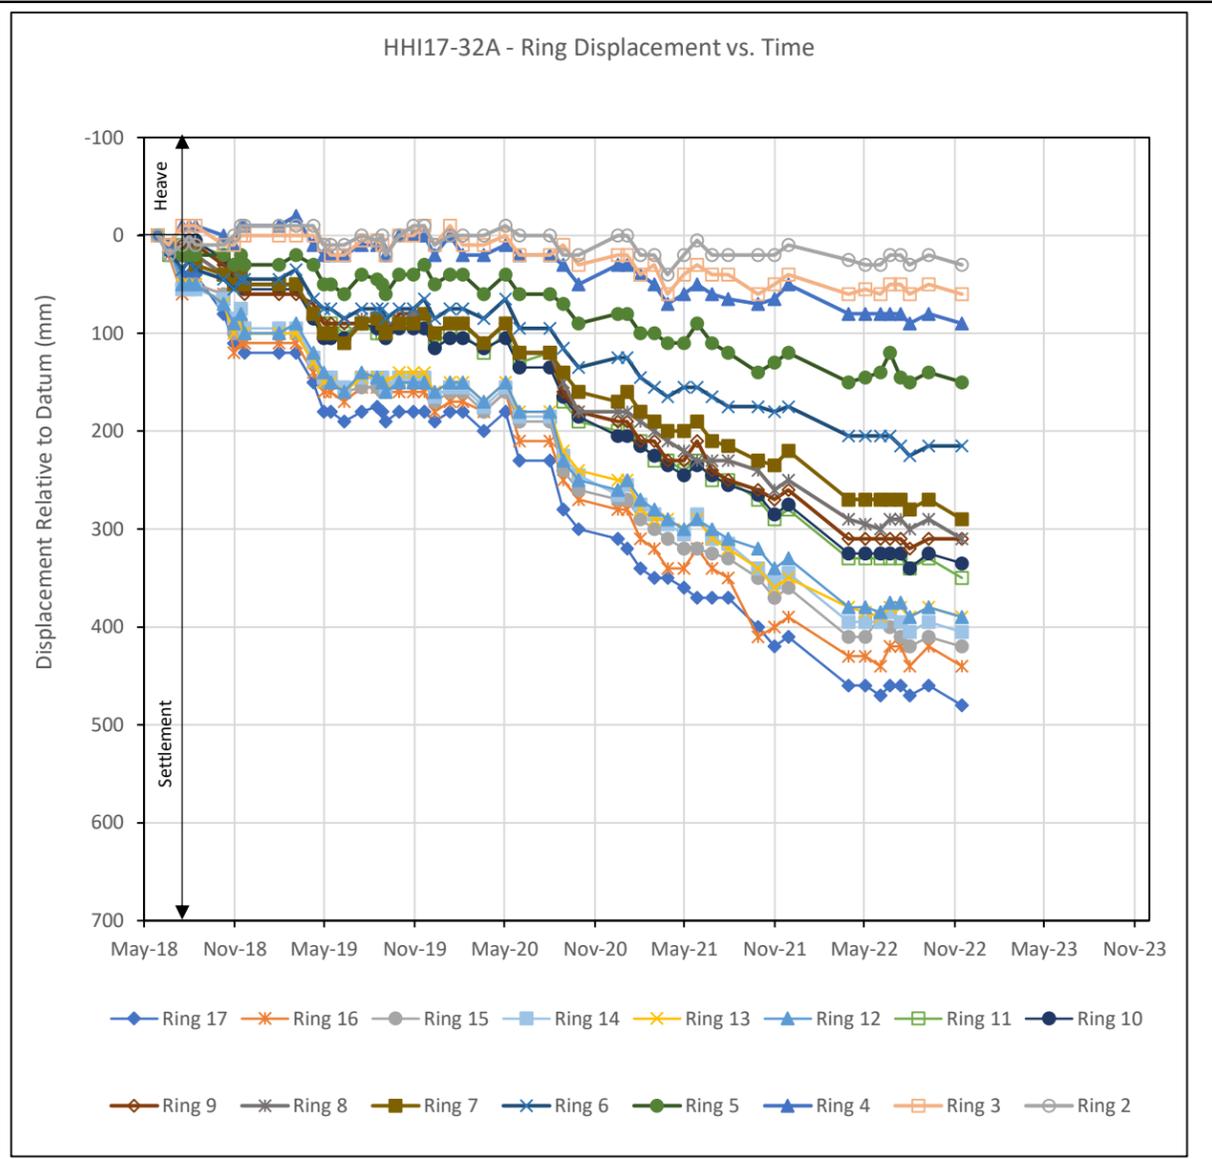
- Notes:
- Ring displacements are calculated relative to the initial elevations for each ring. The datum is the bottom ring (Ring 1).
 - Positive displacements represent settlement. Negative displacements represent heave.
 - Readings of October 30, and November 13, 2018 were not consistent and are adjusted.
 - The baseline reading of vertical displacement plot is May 28, 2018.
 - Data from August 29, 2021 appeared to be outliers and are not shown here.
 - Readings from September 27, 2021, onwards were not consistent for Ring 13 and are adjusted.

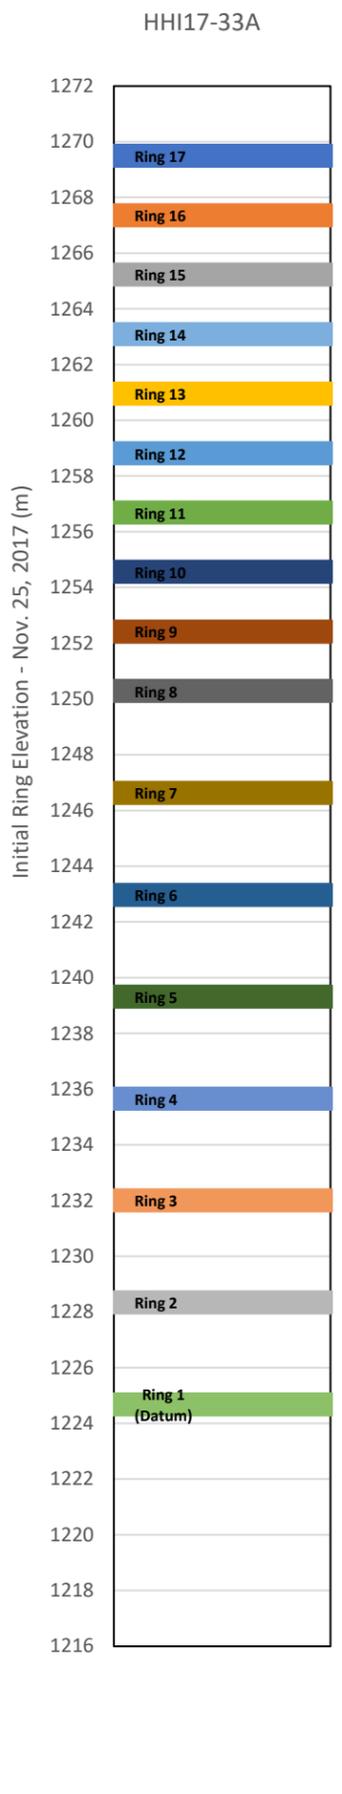
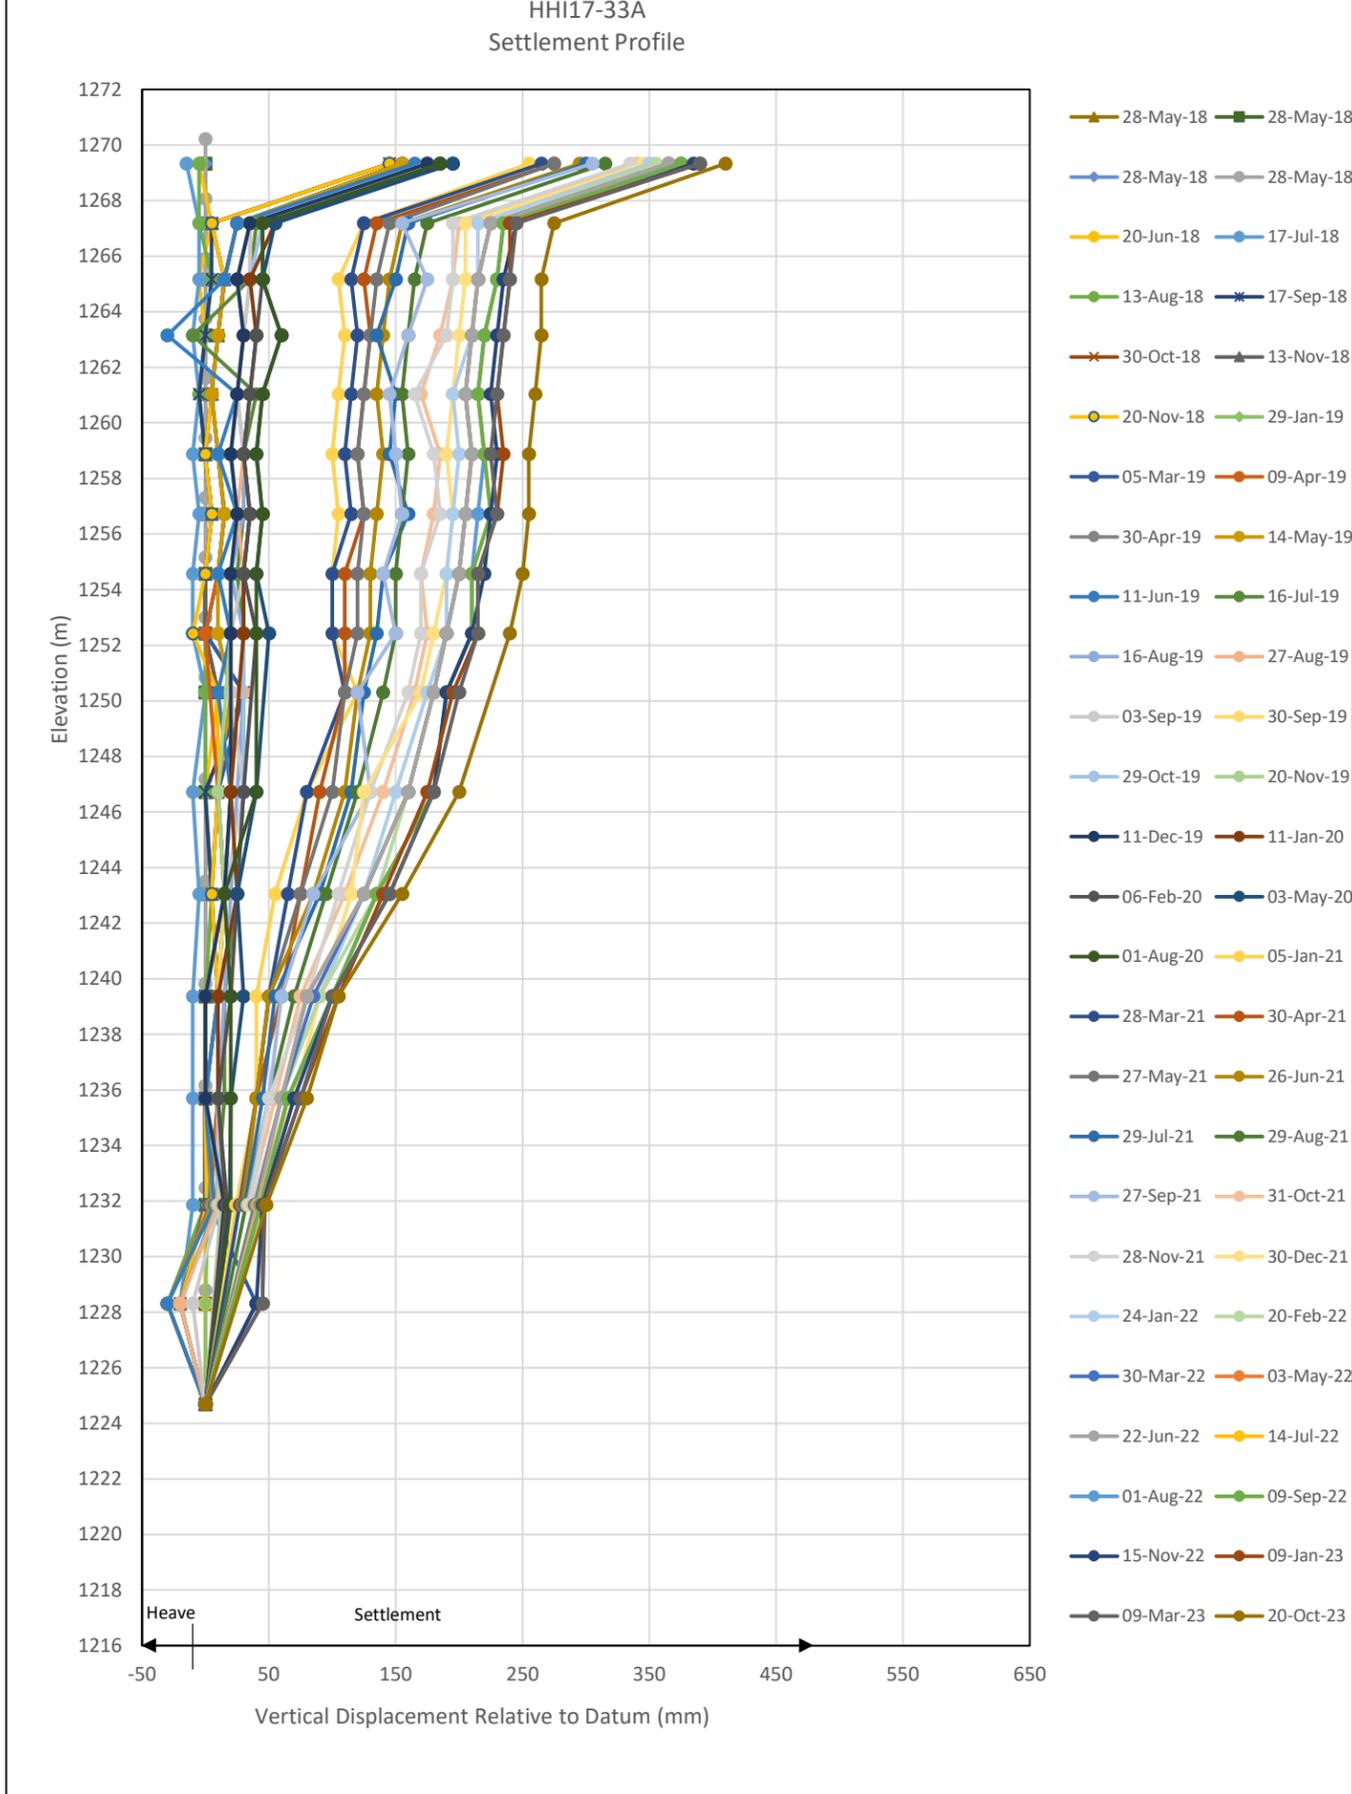
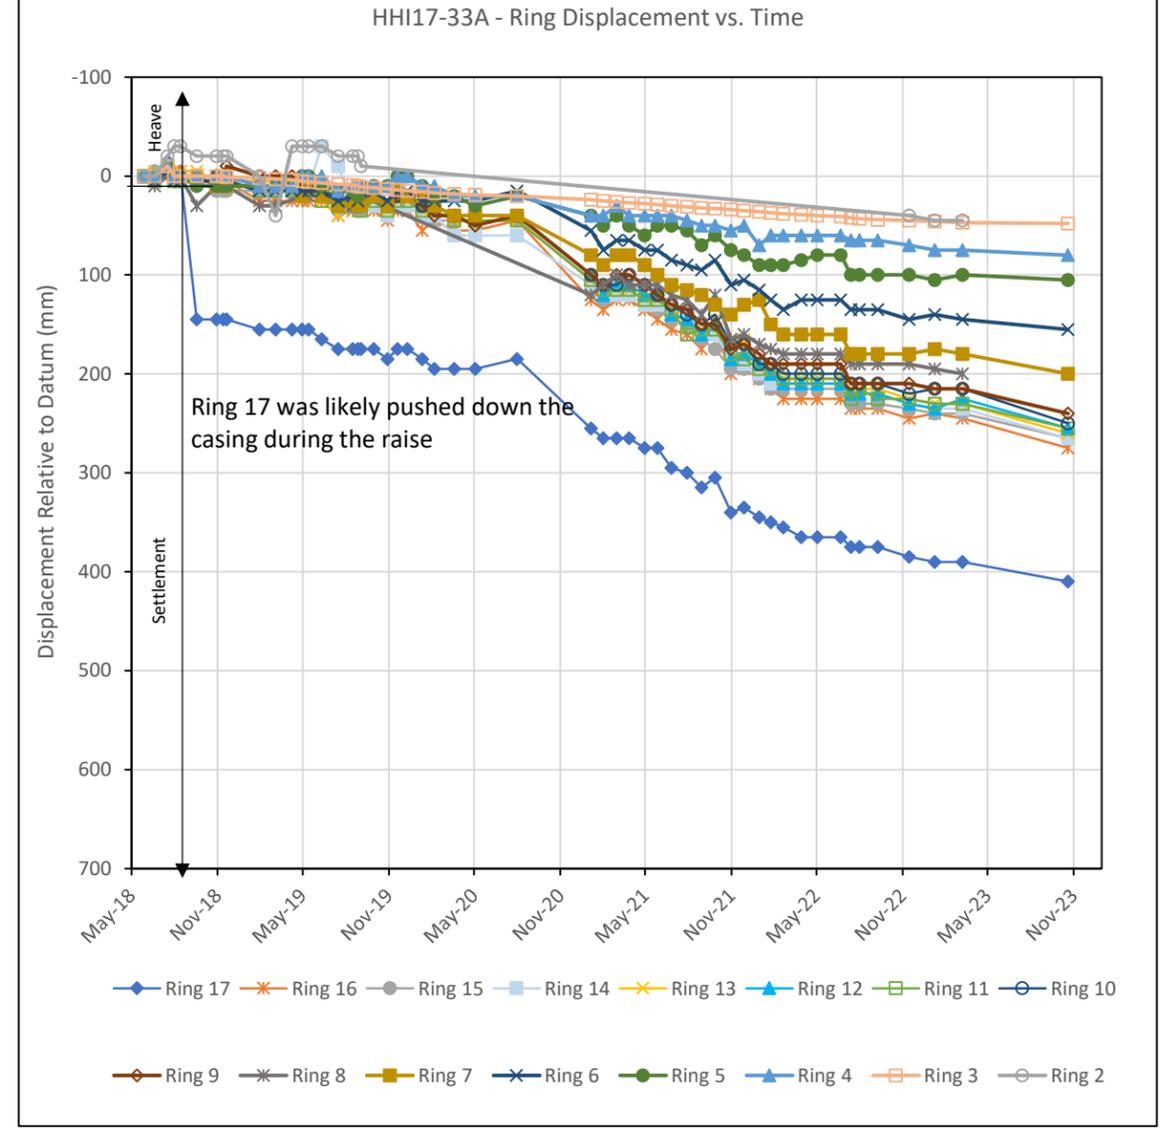
- Notes:
1. Ring displacements are calculated relative to the initial elevations for each ring. The datum is the bottom ring (Ring 1).
 2. Positive displacements represent settlement. Negative displacements represent heave.
 3. Data from August 28, 2020 and September 28, 2020 appeared to be outliers and are not shown here.
 4. Data for Ring 3 not available since September 17, 2018.
 5. Data for Ring 2 and Ring 8 not available since September 30, 2019

Reading of Ring 3 in September 2018 is suspected to error. This ring became off-line after this date.
